**REPORT NUMBER: 214D-MGA-2001-008**

**SAFETY COMPLIANCE TESTING FOR FMVSS 214  
SIDE IMPACT PROTECTION**

**Volvo Cars of North America, Inc.  
2001 Volvo S60 4 door  
NHTSA NUMBER:C15901**

**PREPARED BY:  
MGA RESEARCH CORPORATION  
5000 WARREN ROAD  
BURLINGTON, WI 53105**

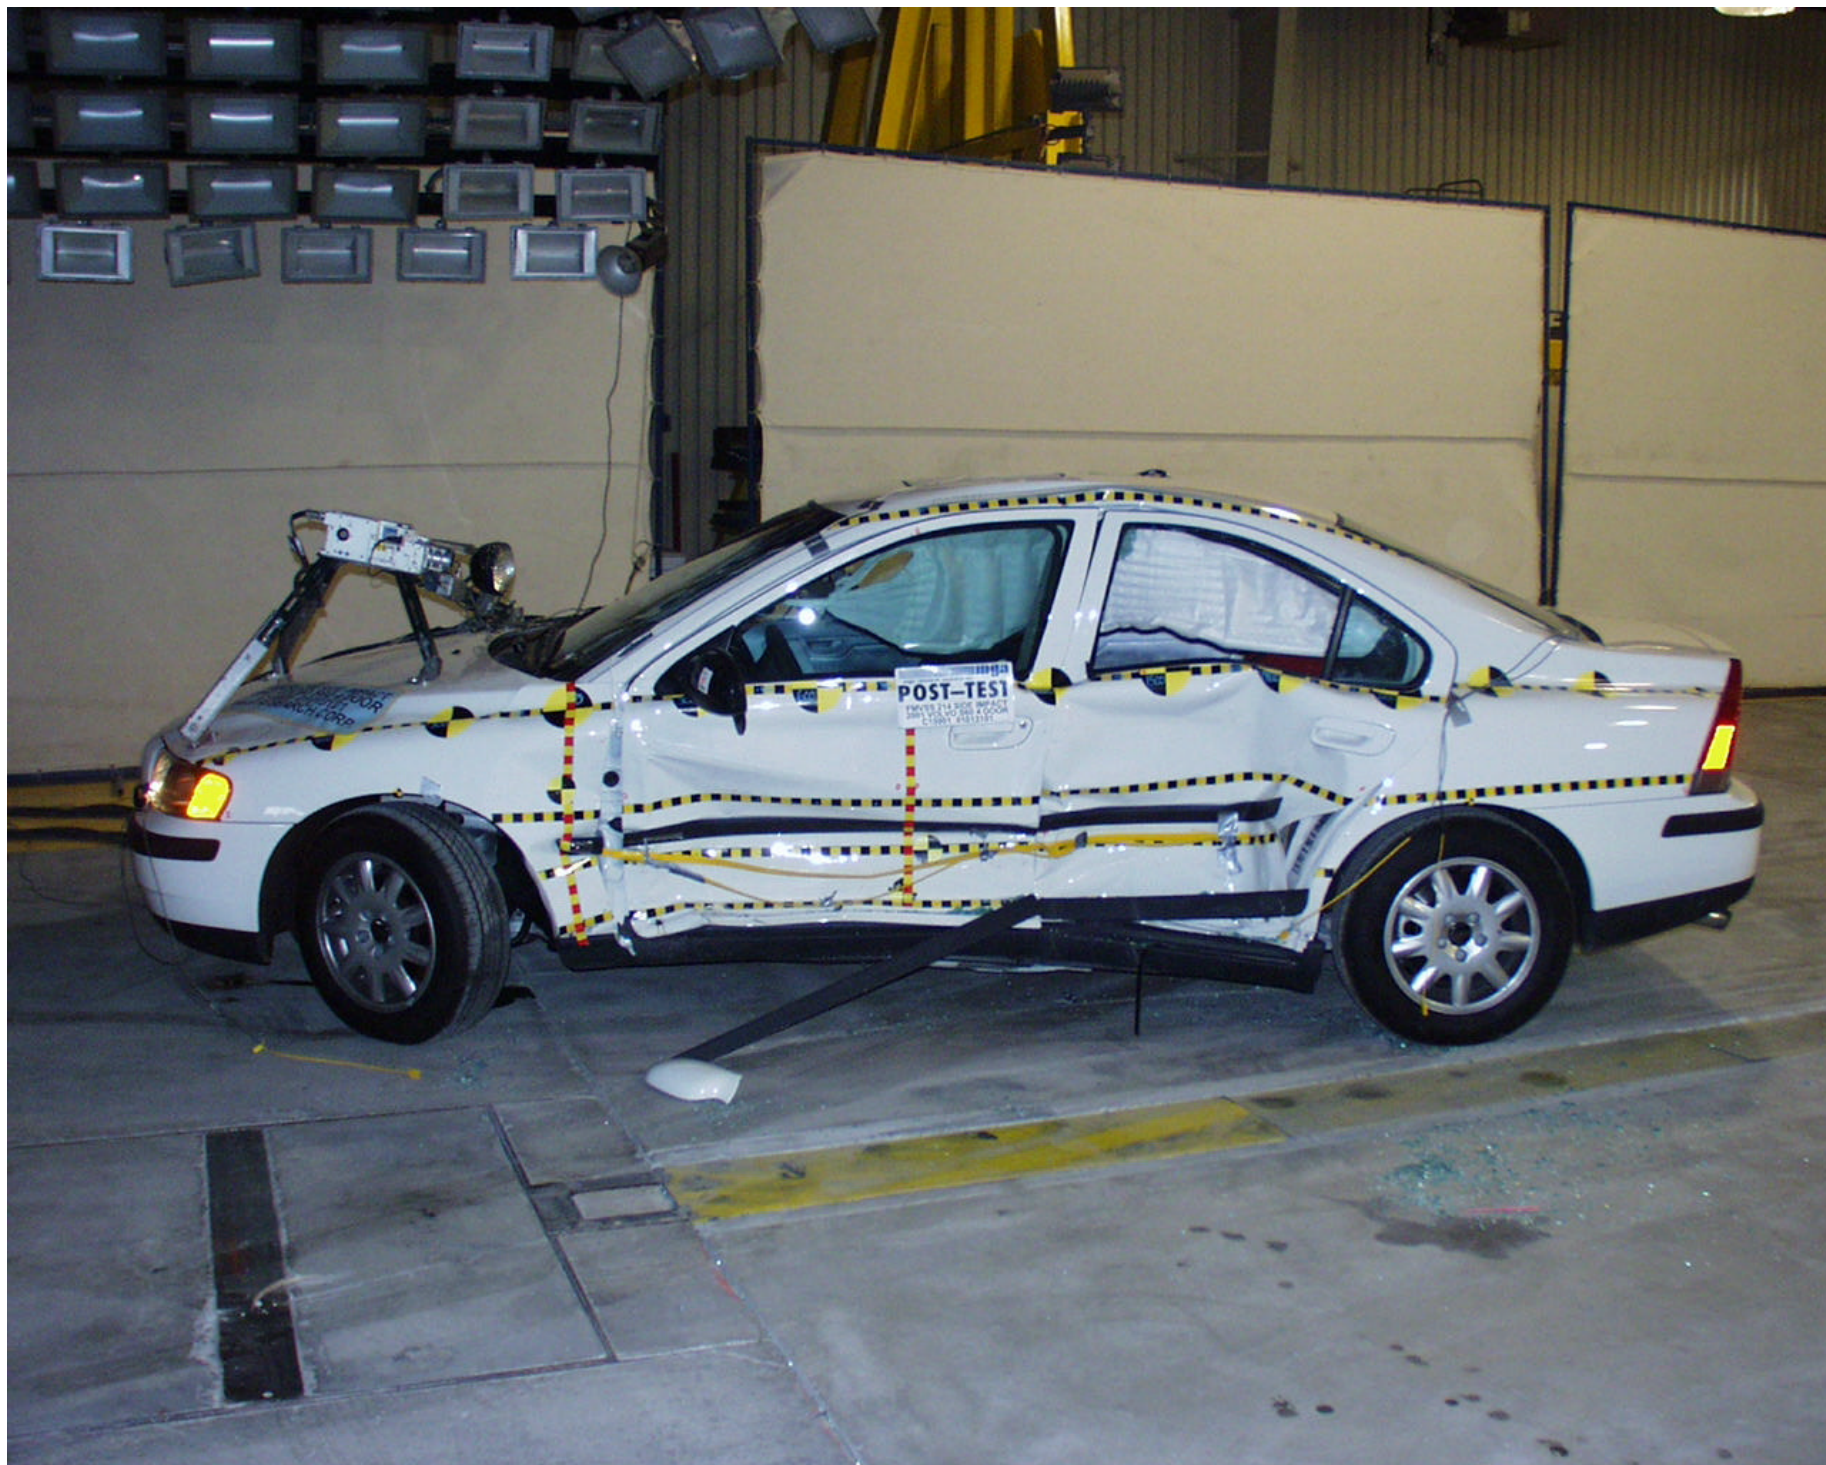
Photo No. A-6 - Post-Test Left Side View of Test Vehicle

The test vehicle sustained a maximum static crush of 263 mm at level 2, 1350 mm rearward of the left vertical impact point. The driver and passenger SID's, Serial Nos. 037 and 036 respectively, were calibrated just prior to this test. The SID's injury criteria is summarized as follows:

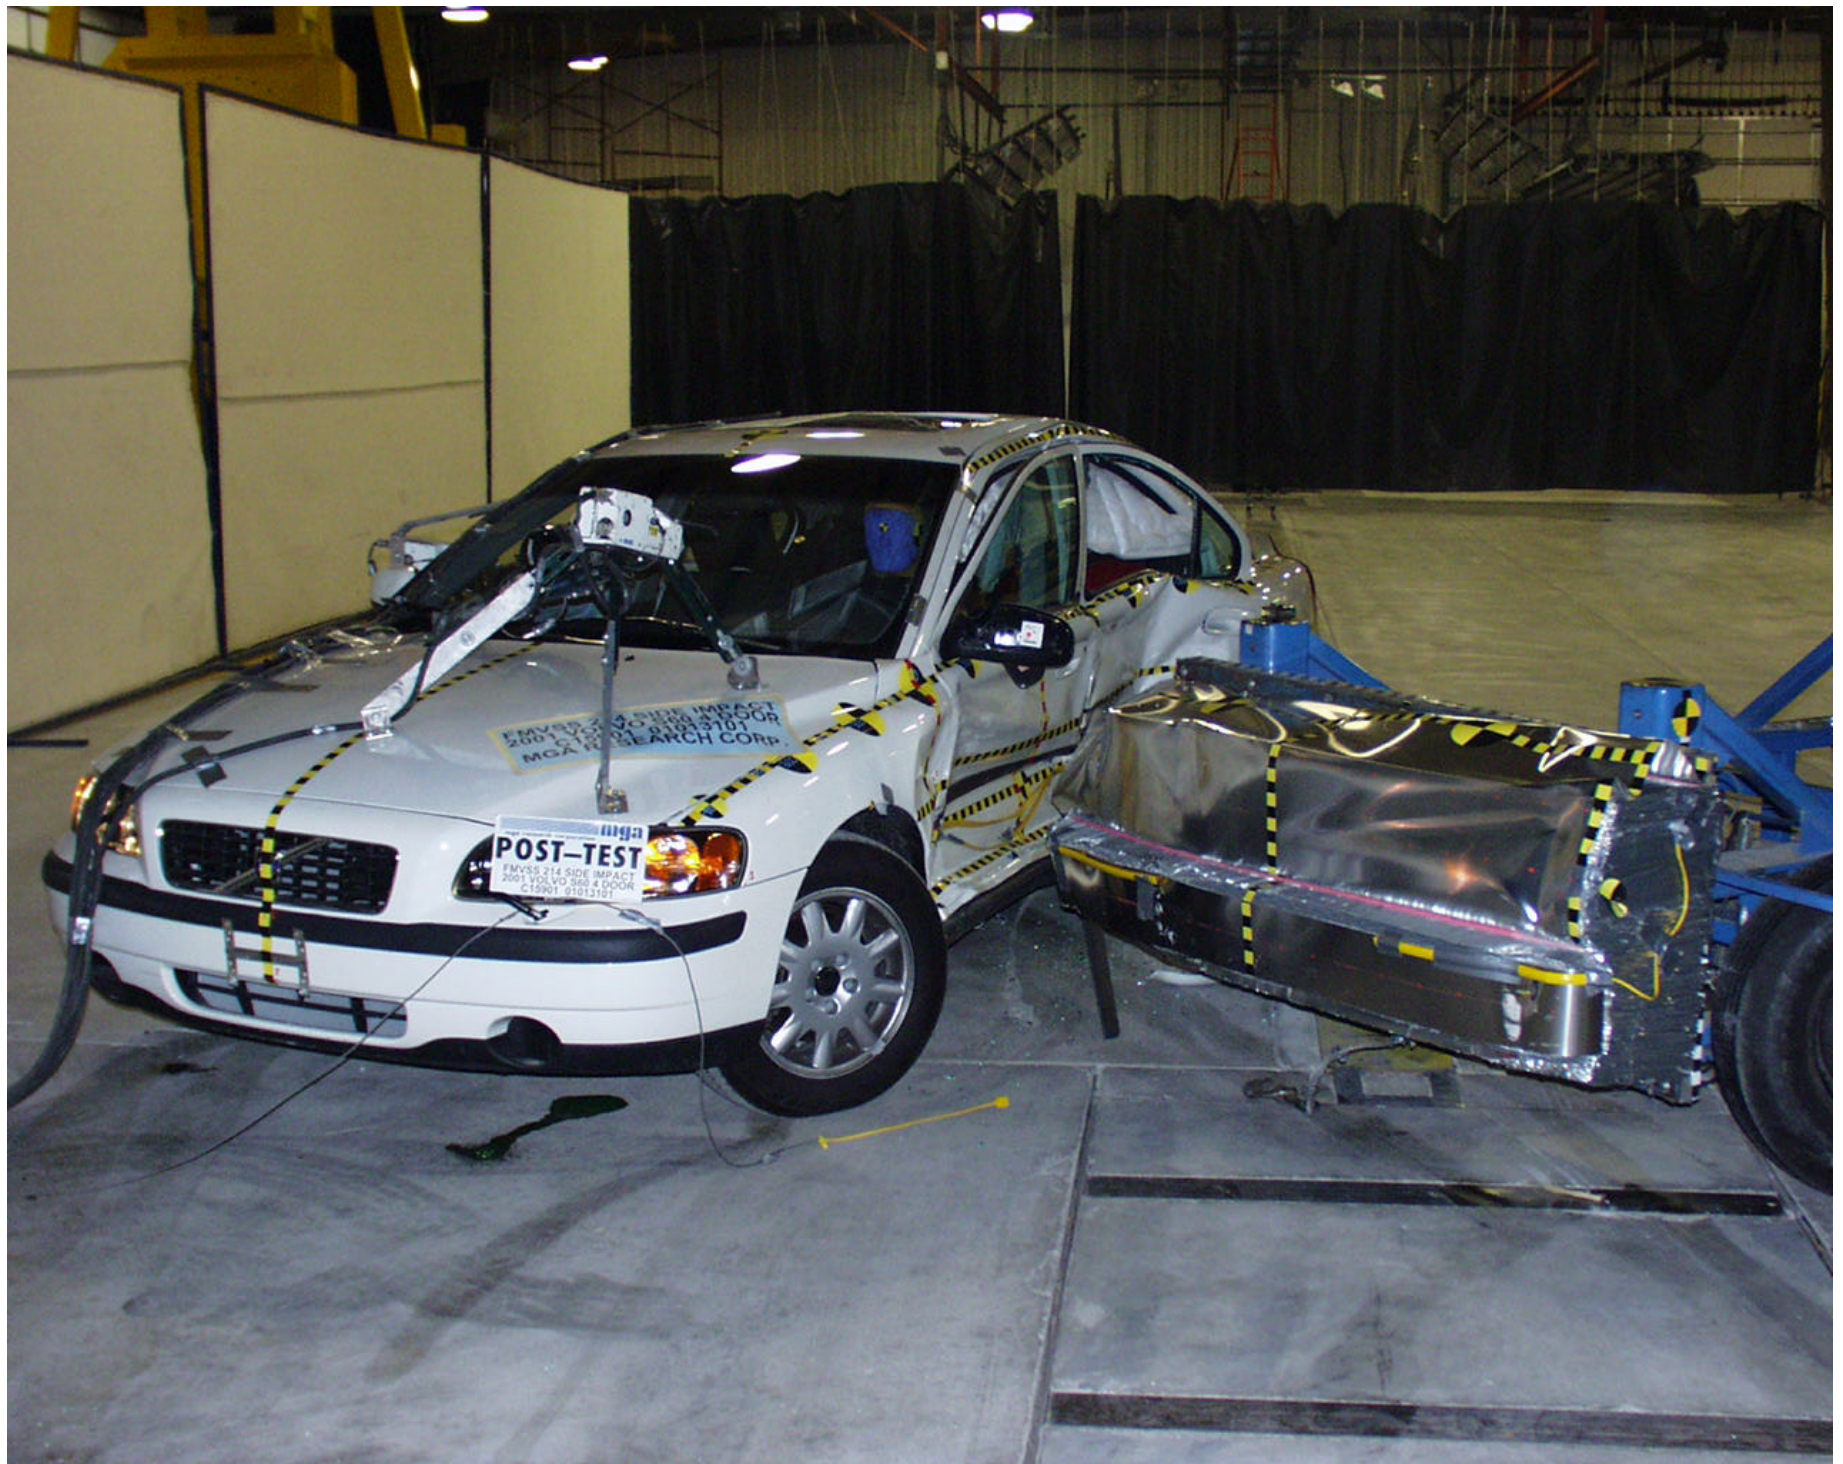
Photo No. A-10 - Post-Test MDB and Vehicle (left side)

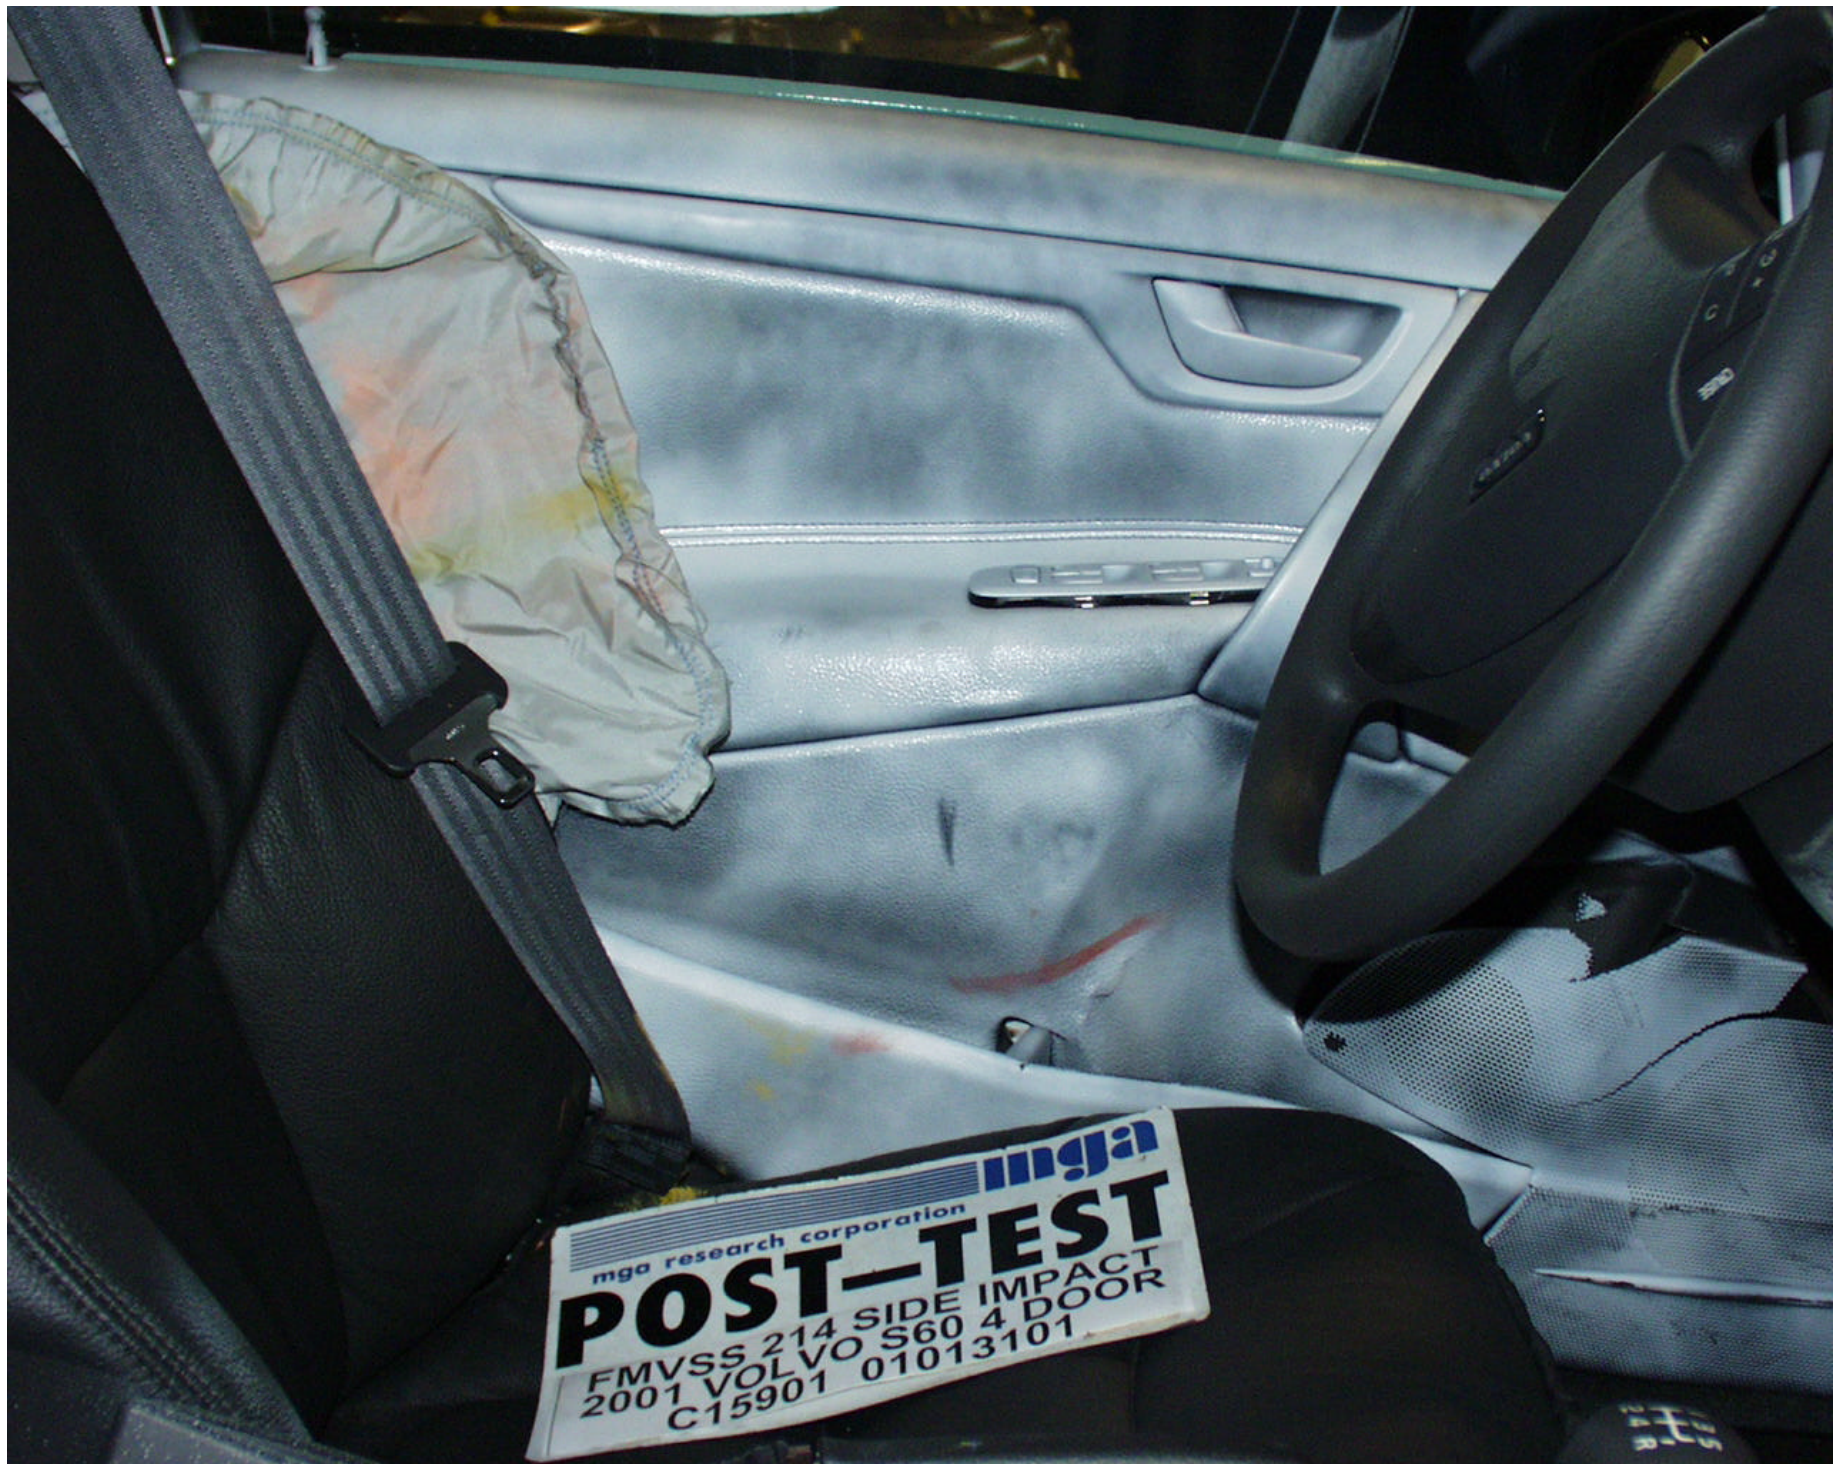
Photo No. A-28 - Post-Test Driver Dummy Contact

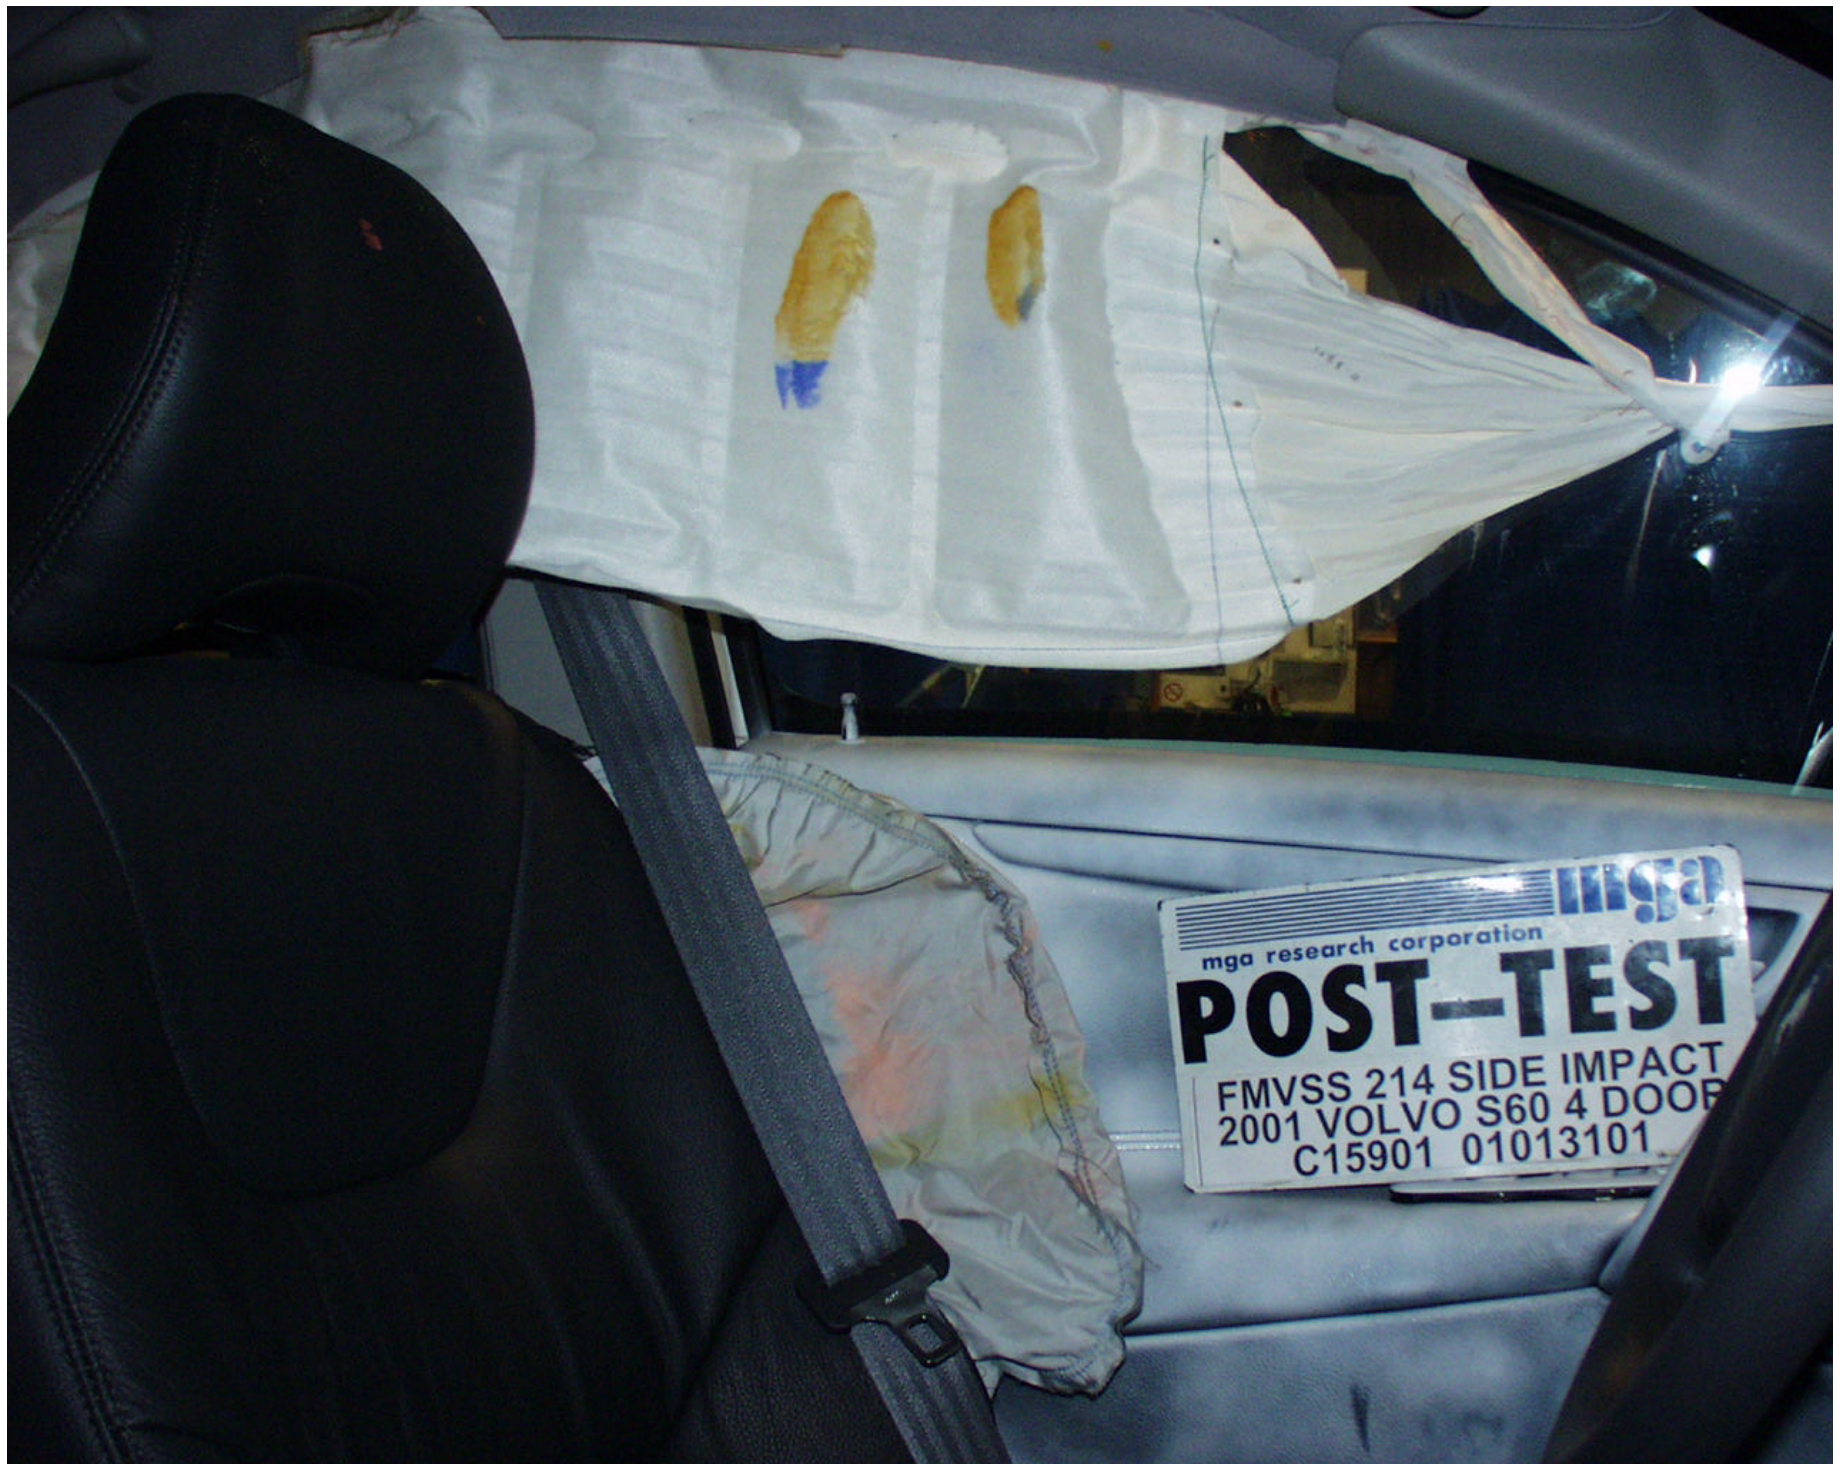
Photo No. A-29 - Post-Test Driver Dummy Head Contact

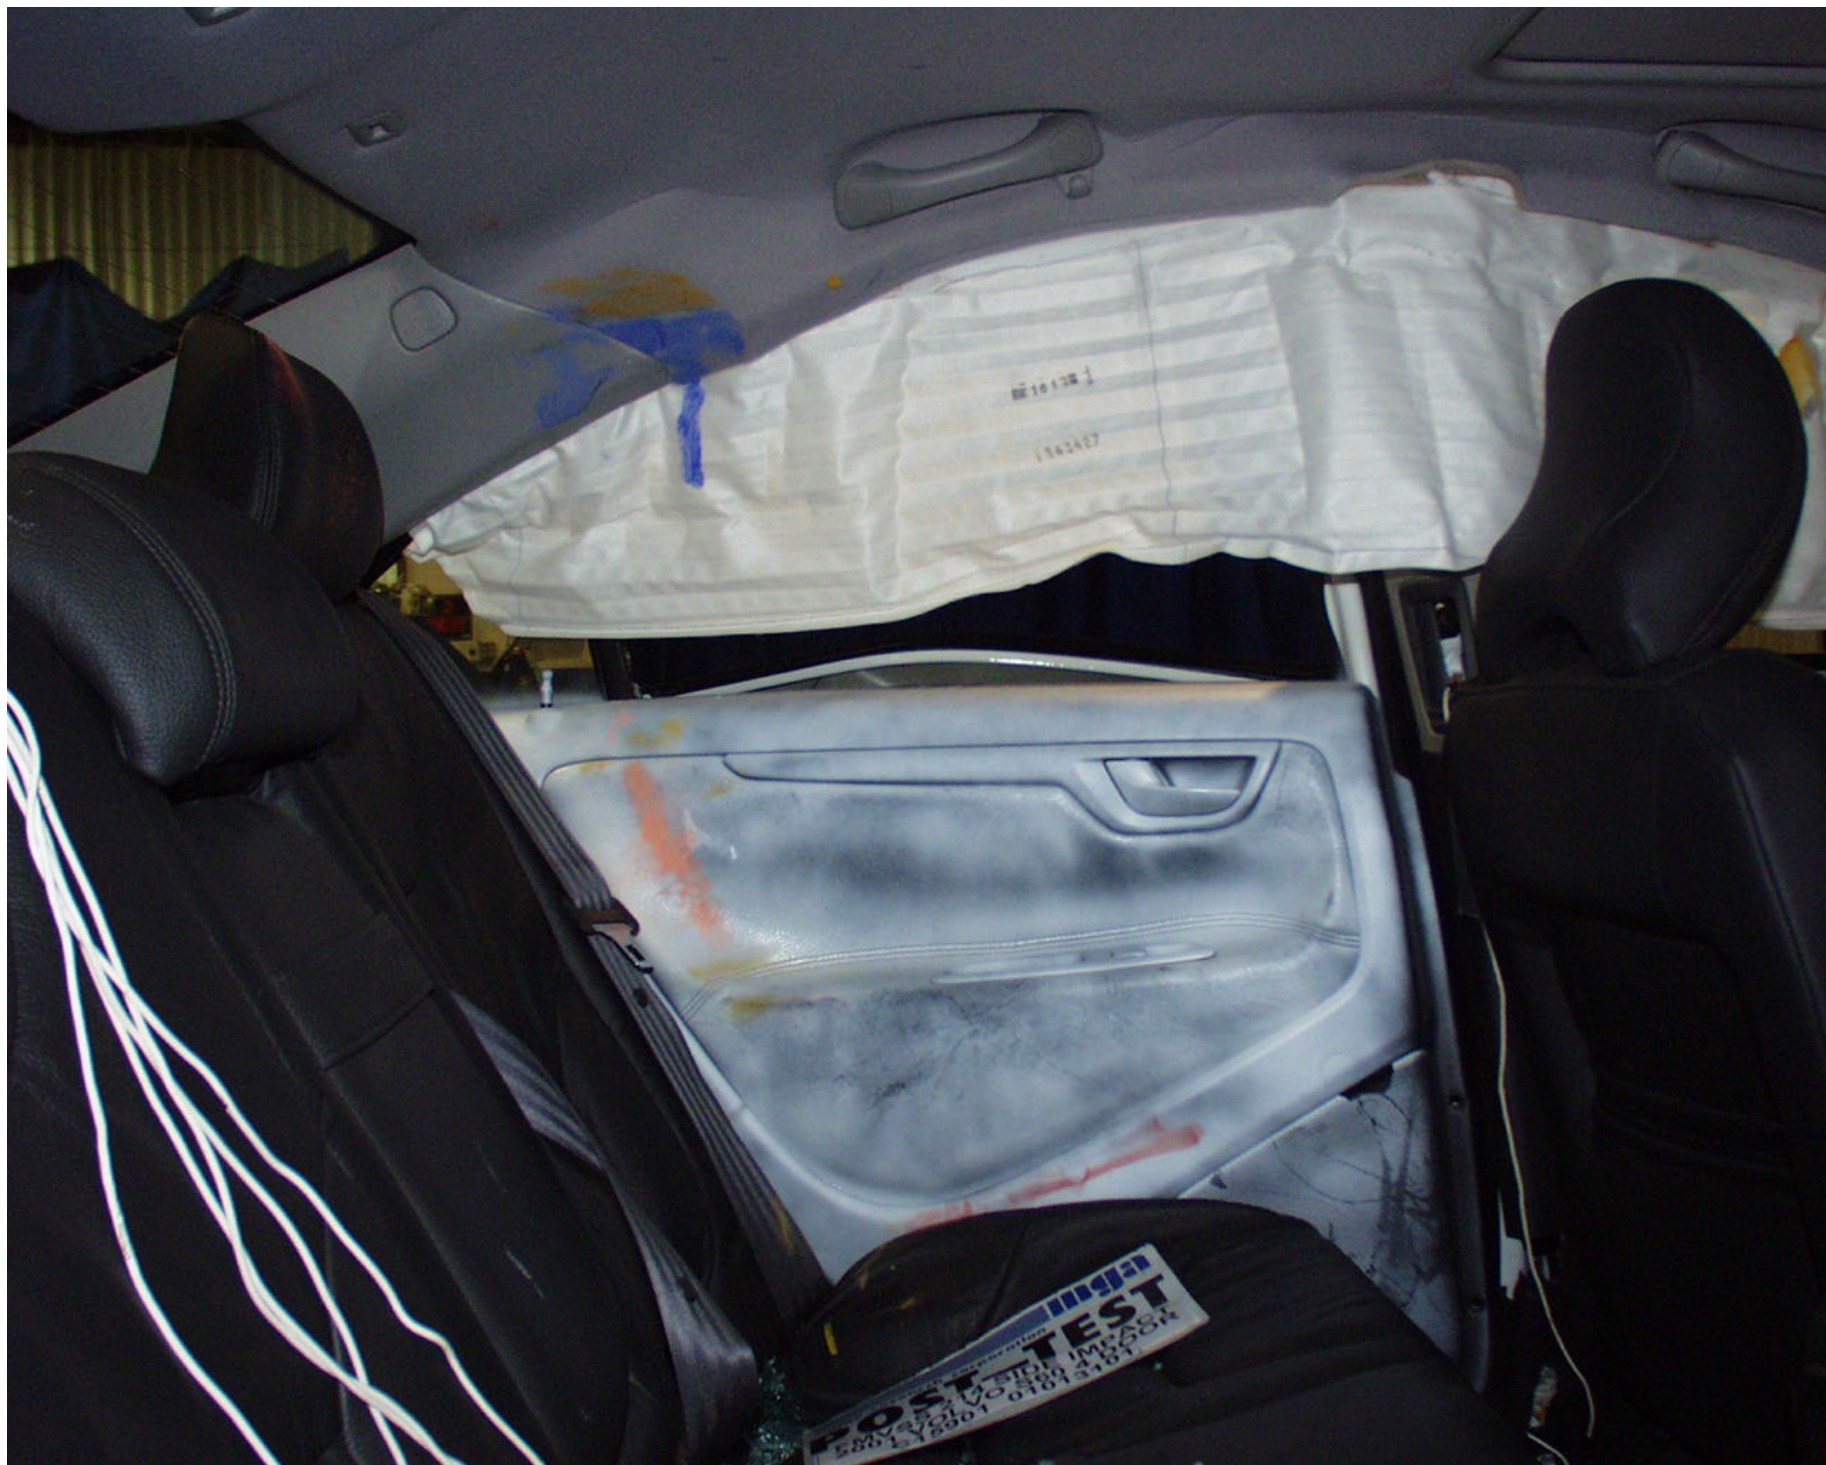
Photo No. A-37 - Post-Test Passenger Dummy Contact

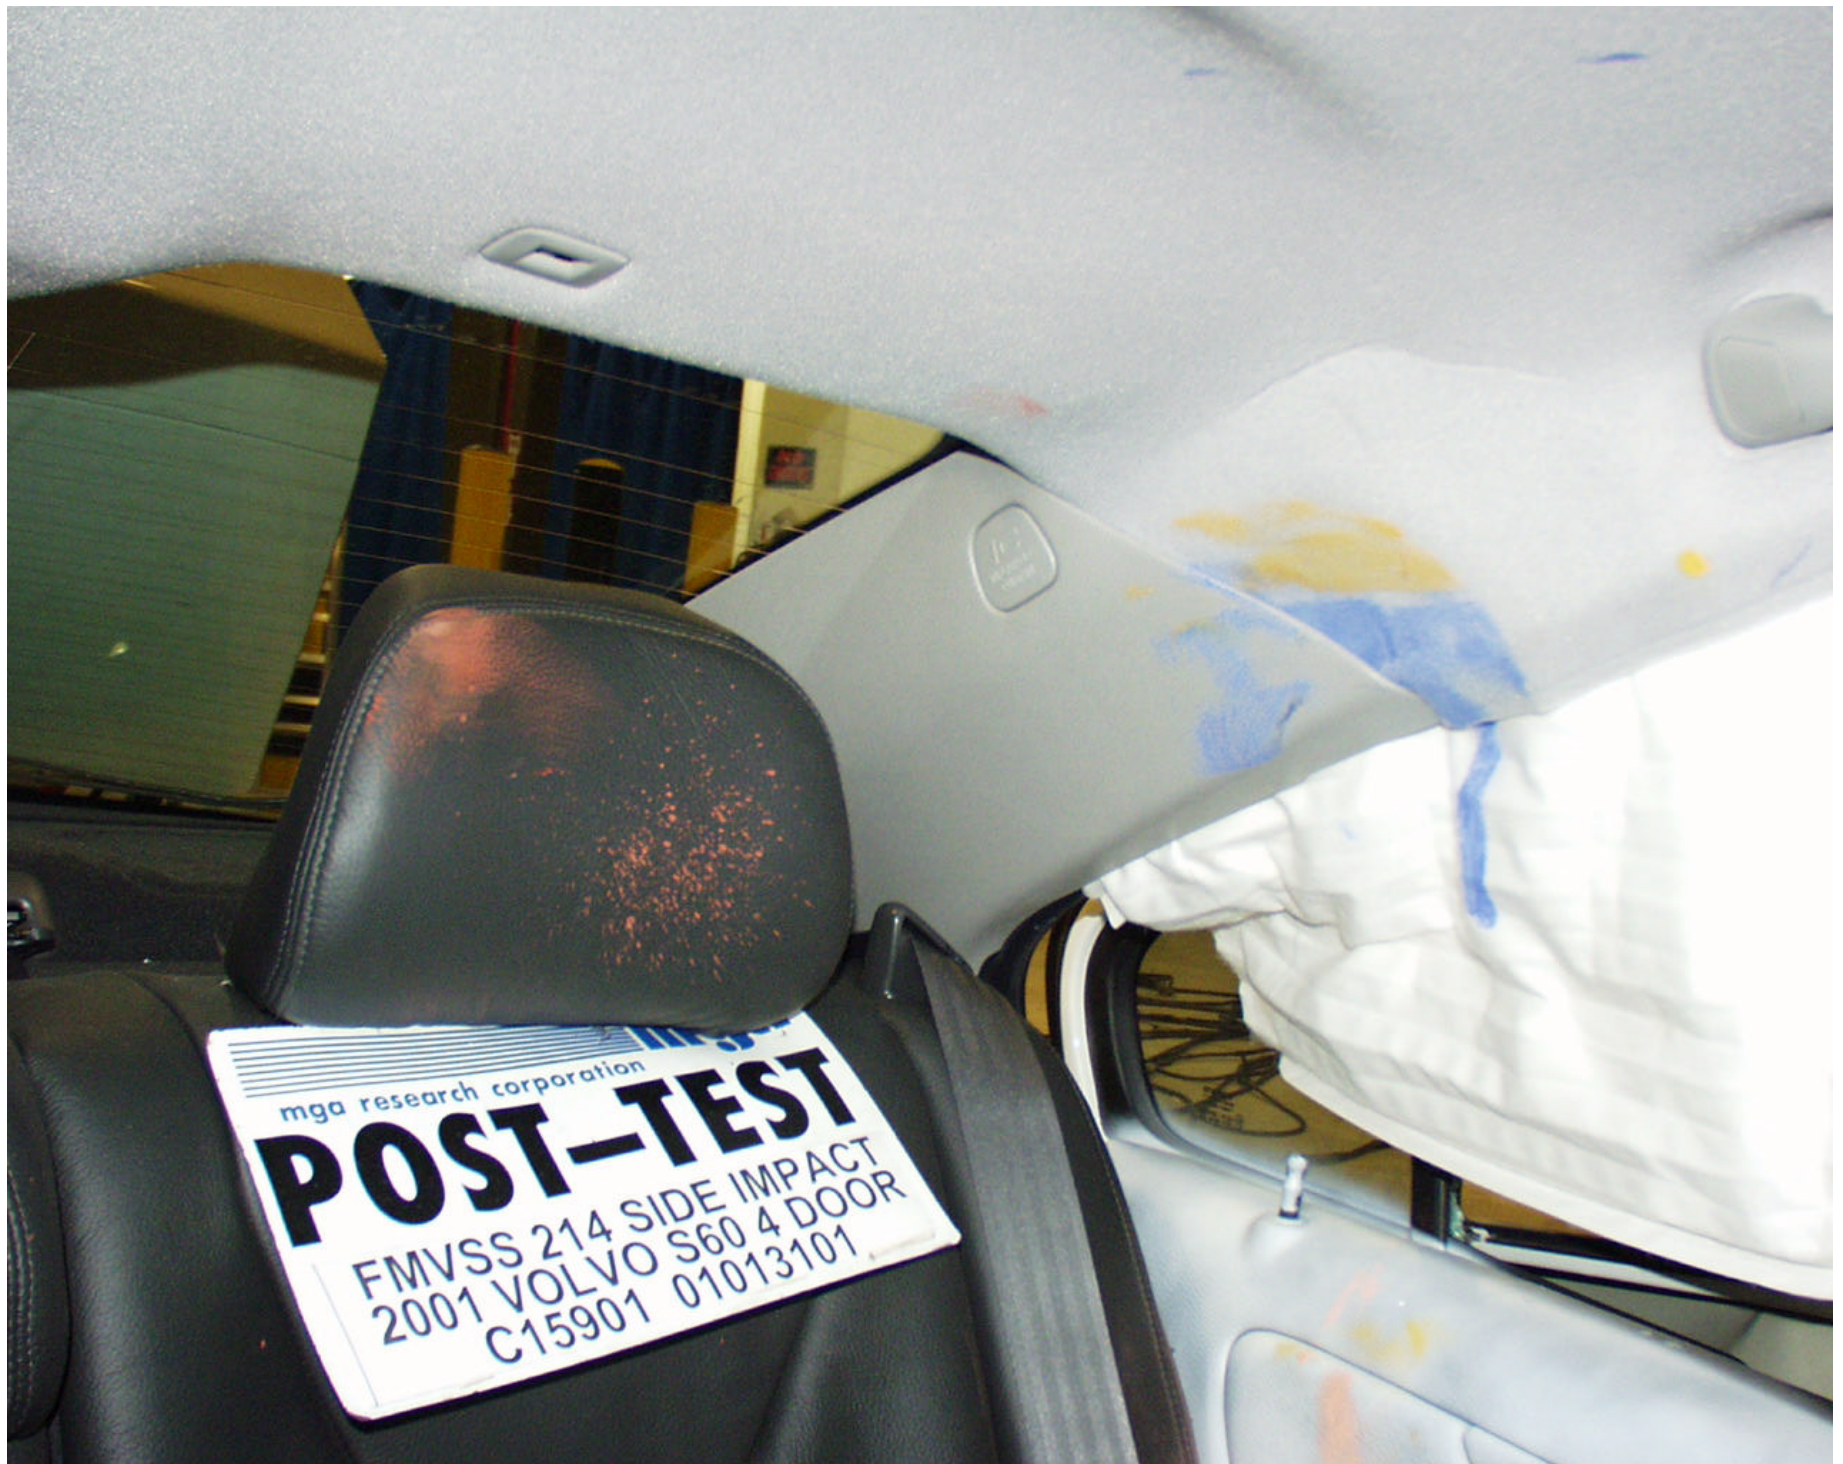
Photo No. A-38 - Post-Test Passenger Dummy Head Contact

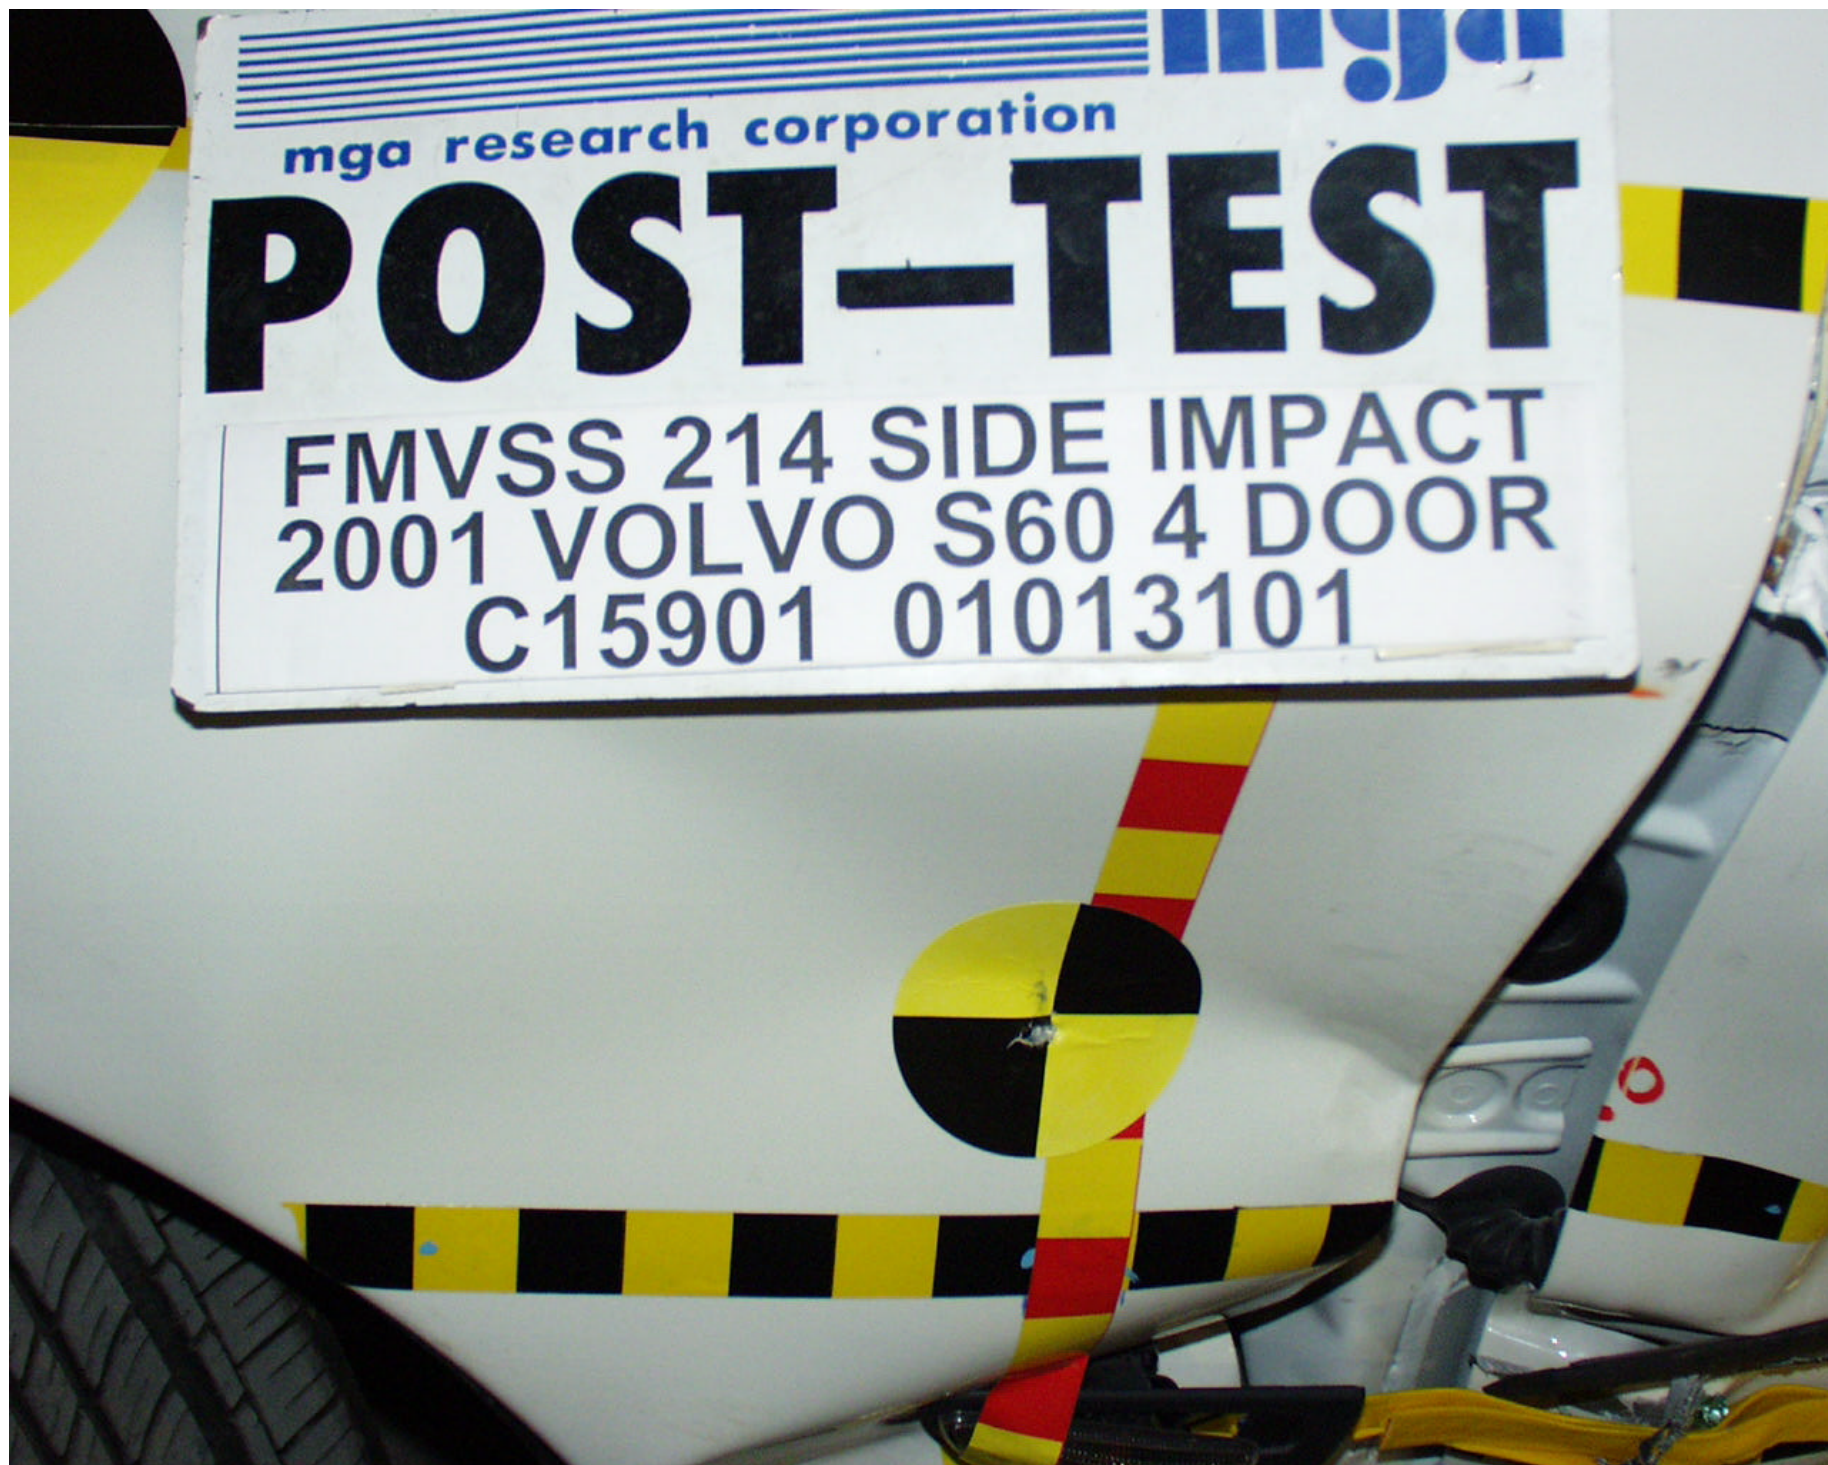
Photo No. A-40 - Post-Test Left Front Impact Point on Vehicle
