REPORT NUMBER: SNCAP-CAL-01-6

**NEW CAR ASSESSMENT PROGRAM
SIDE IMPACT TEST**

GENERAL MOTORS OF CANADA LTD.
2001 CHEVROLET IMPALA
4-DOOR SEDAN

FINAL REPORT

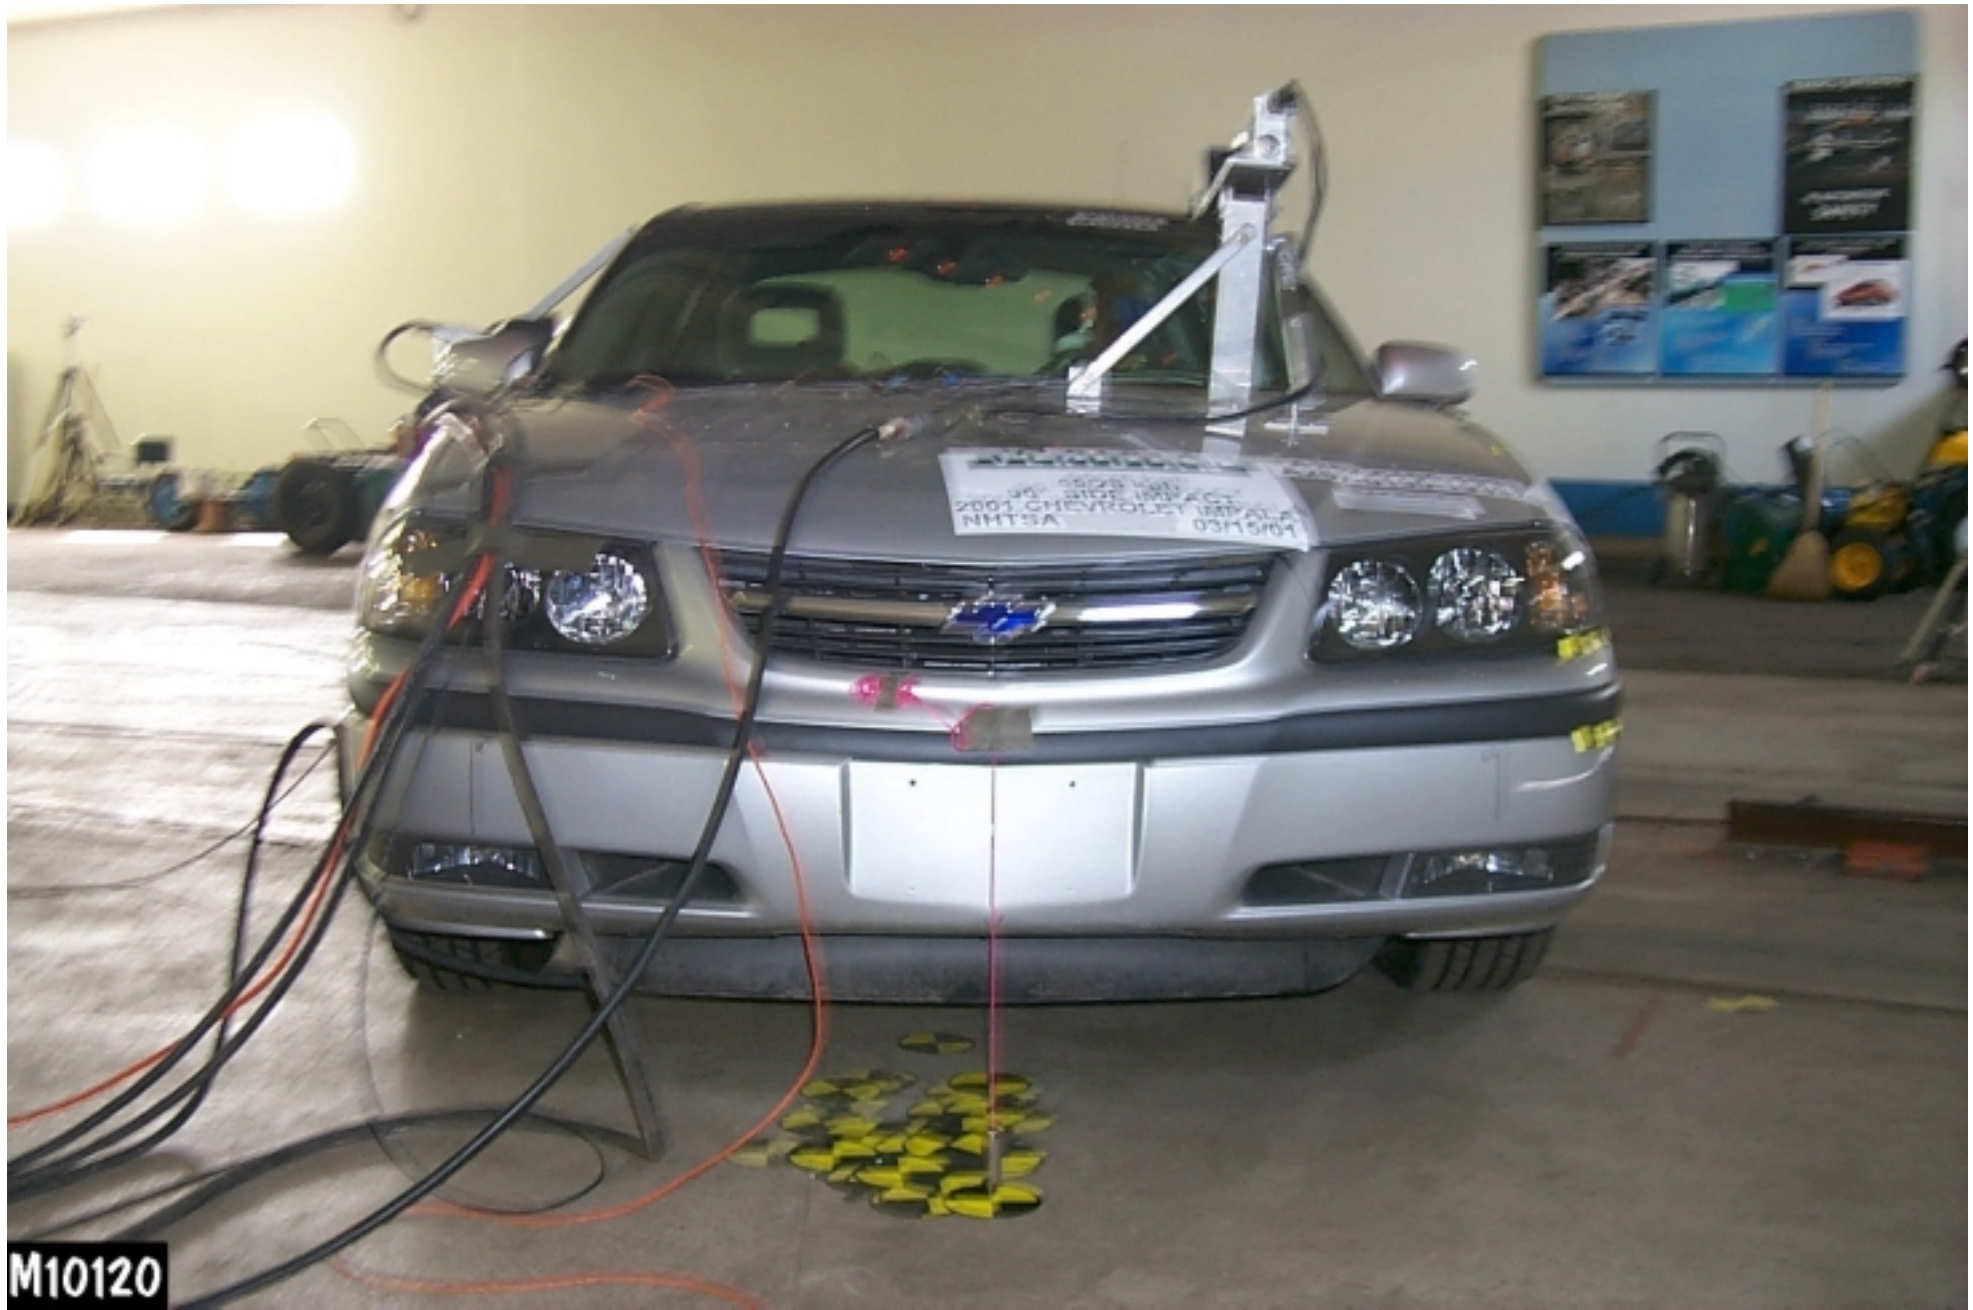
Figure A-1: PRE-TEST FRONTAL VIEW OF TEST VEHICLE

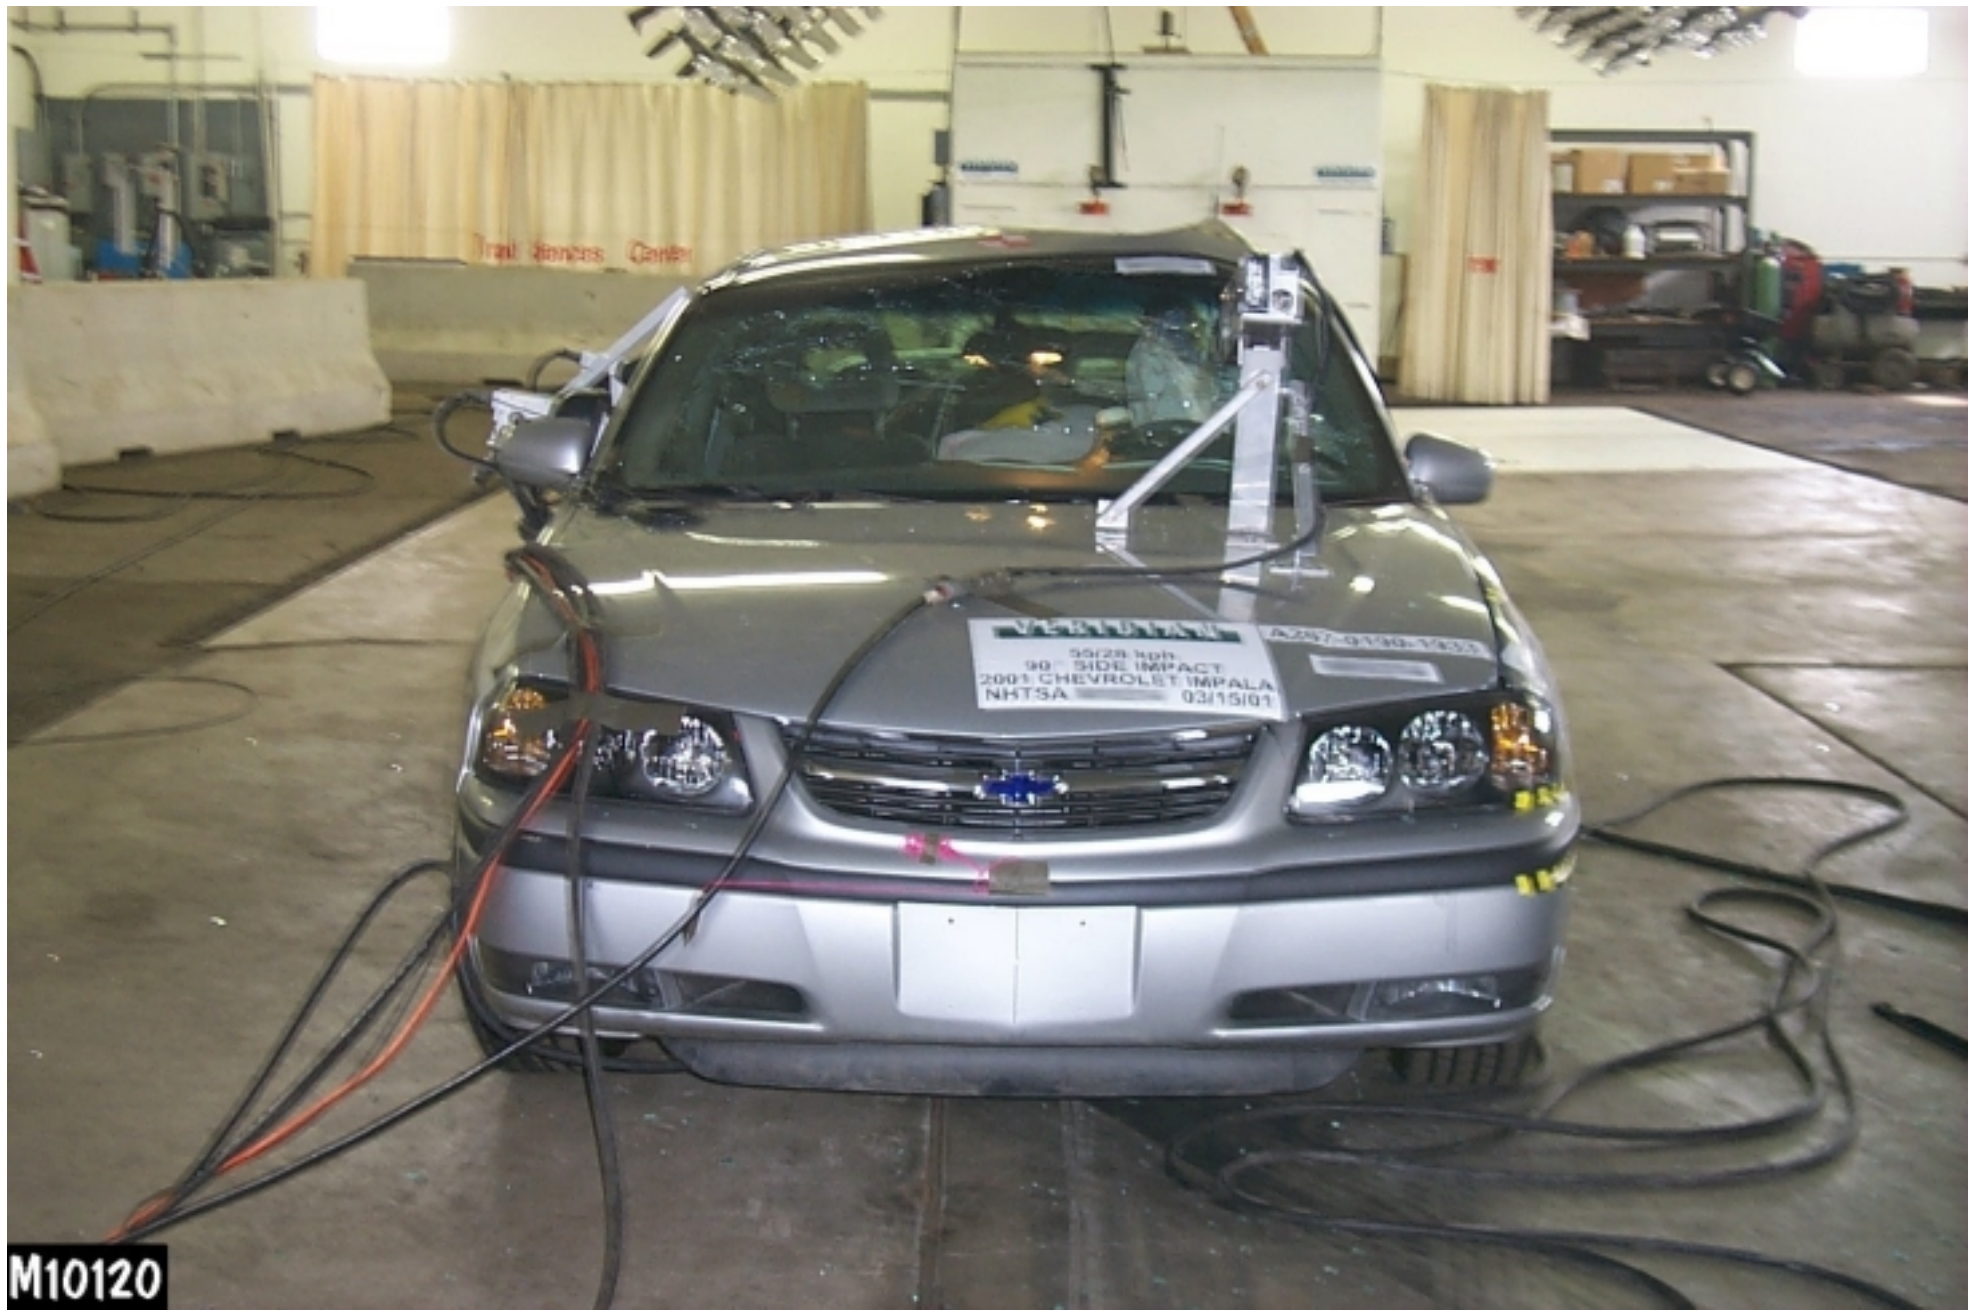
Figure A-2: POST-TEST FRONTAL VIEW OF TEST VEHICLE

Windshield:	<u>Windshield cracked along top and left edge</u>
Window:	<u>Left door windows and left rear quarter window shattered during the impact</u>

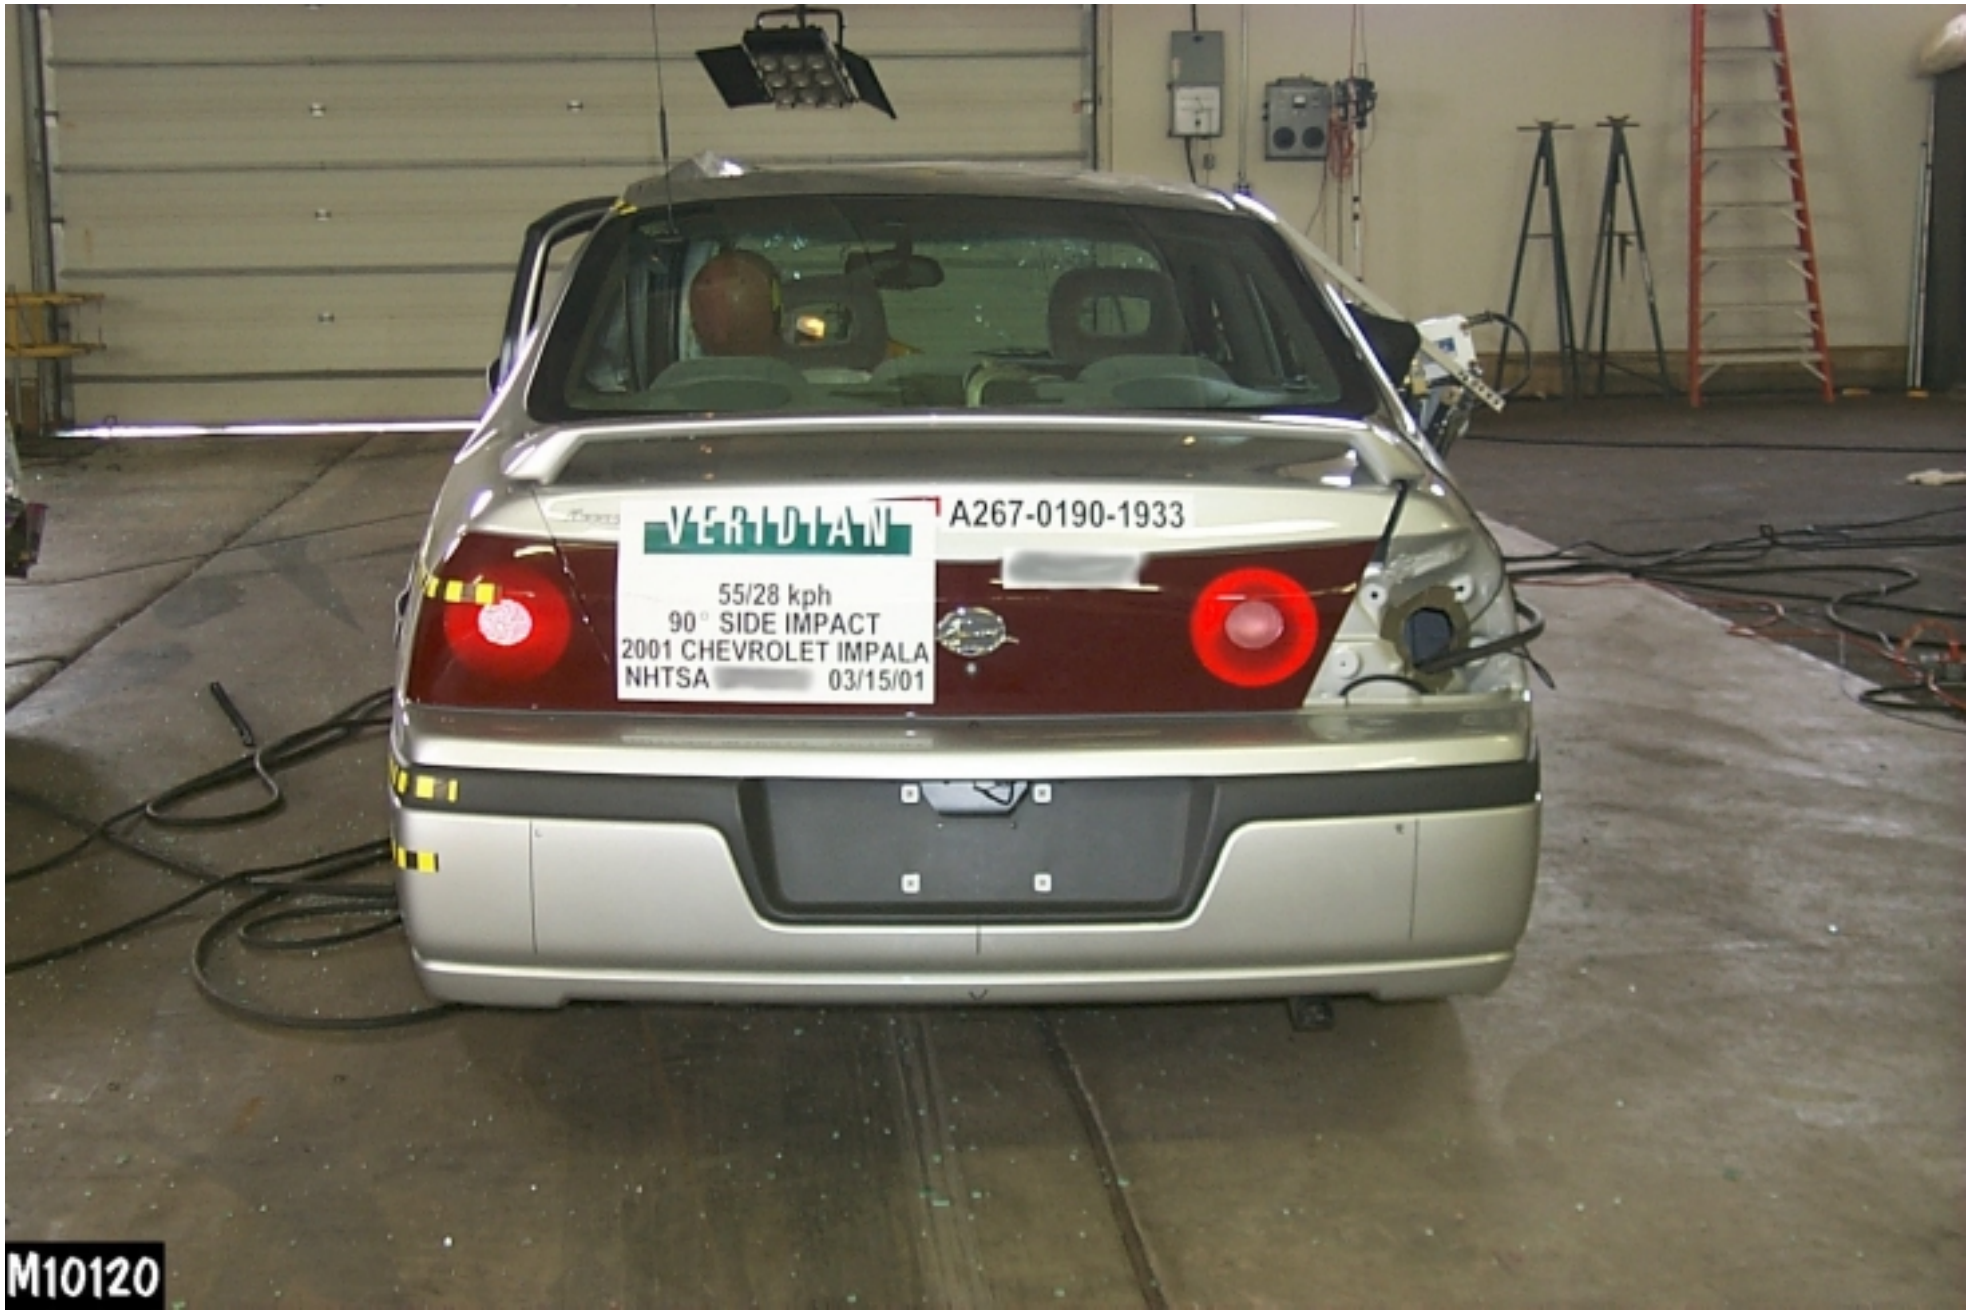
Figure A-4: POST-TEST REAR VIEW OF TEST VEHICLE

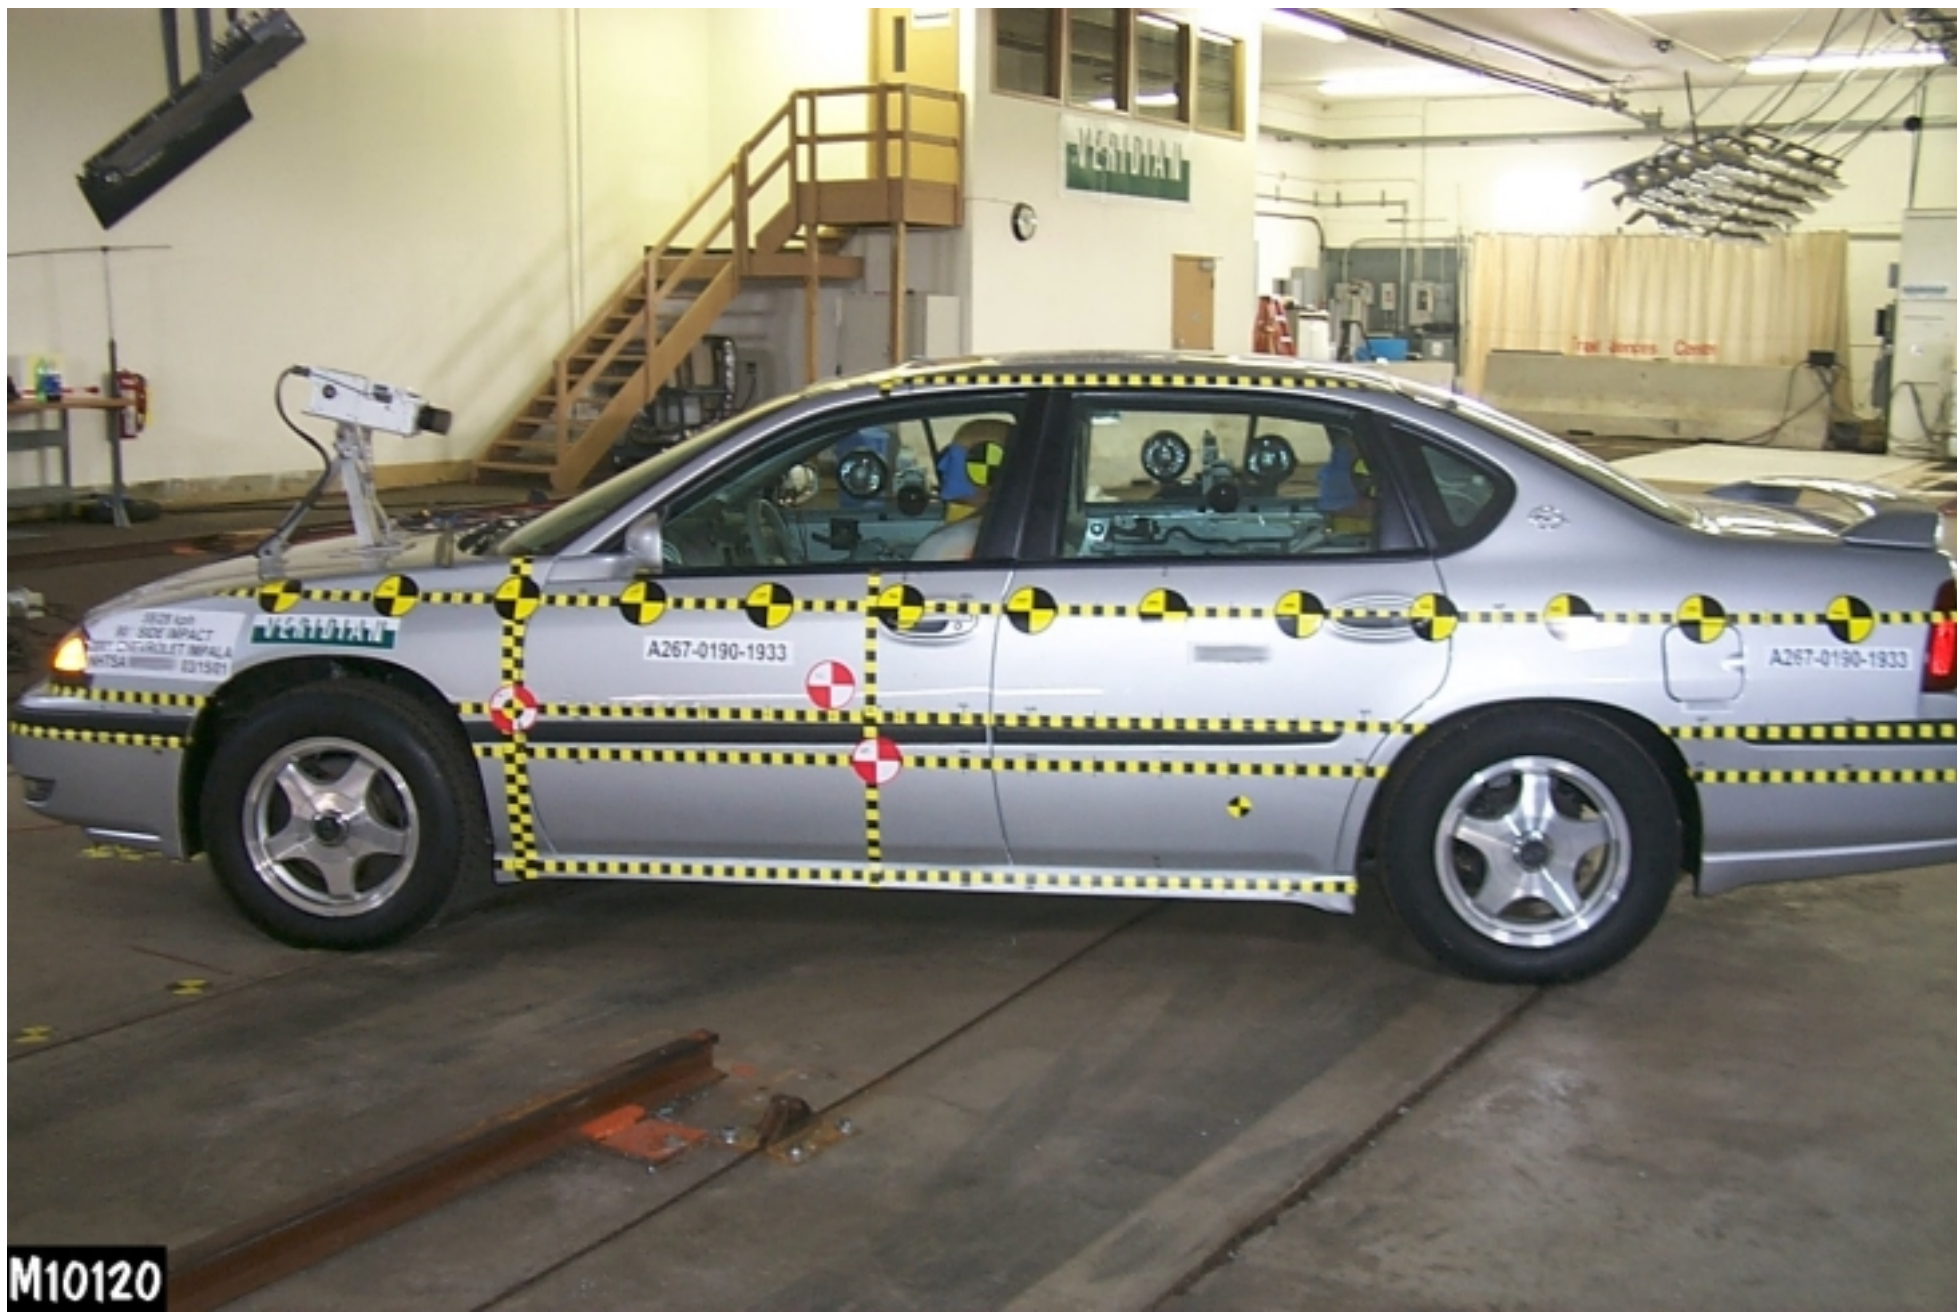
Figure A-5: PRE-TEST IMPACTED SIDE VIEW OF TEST VEHICLE

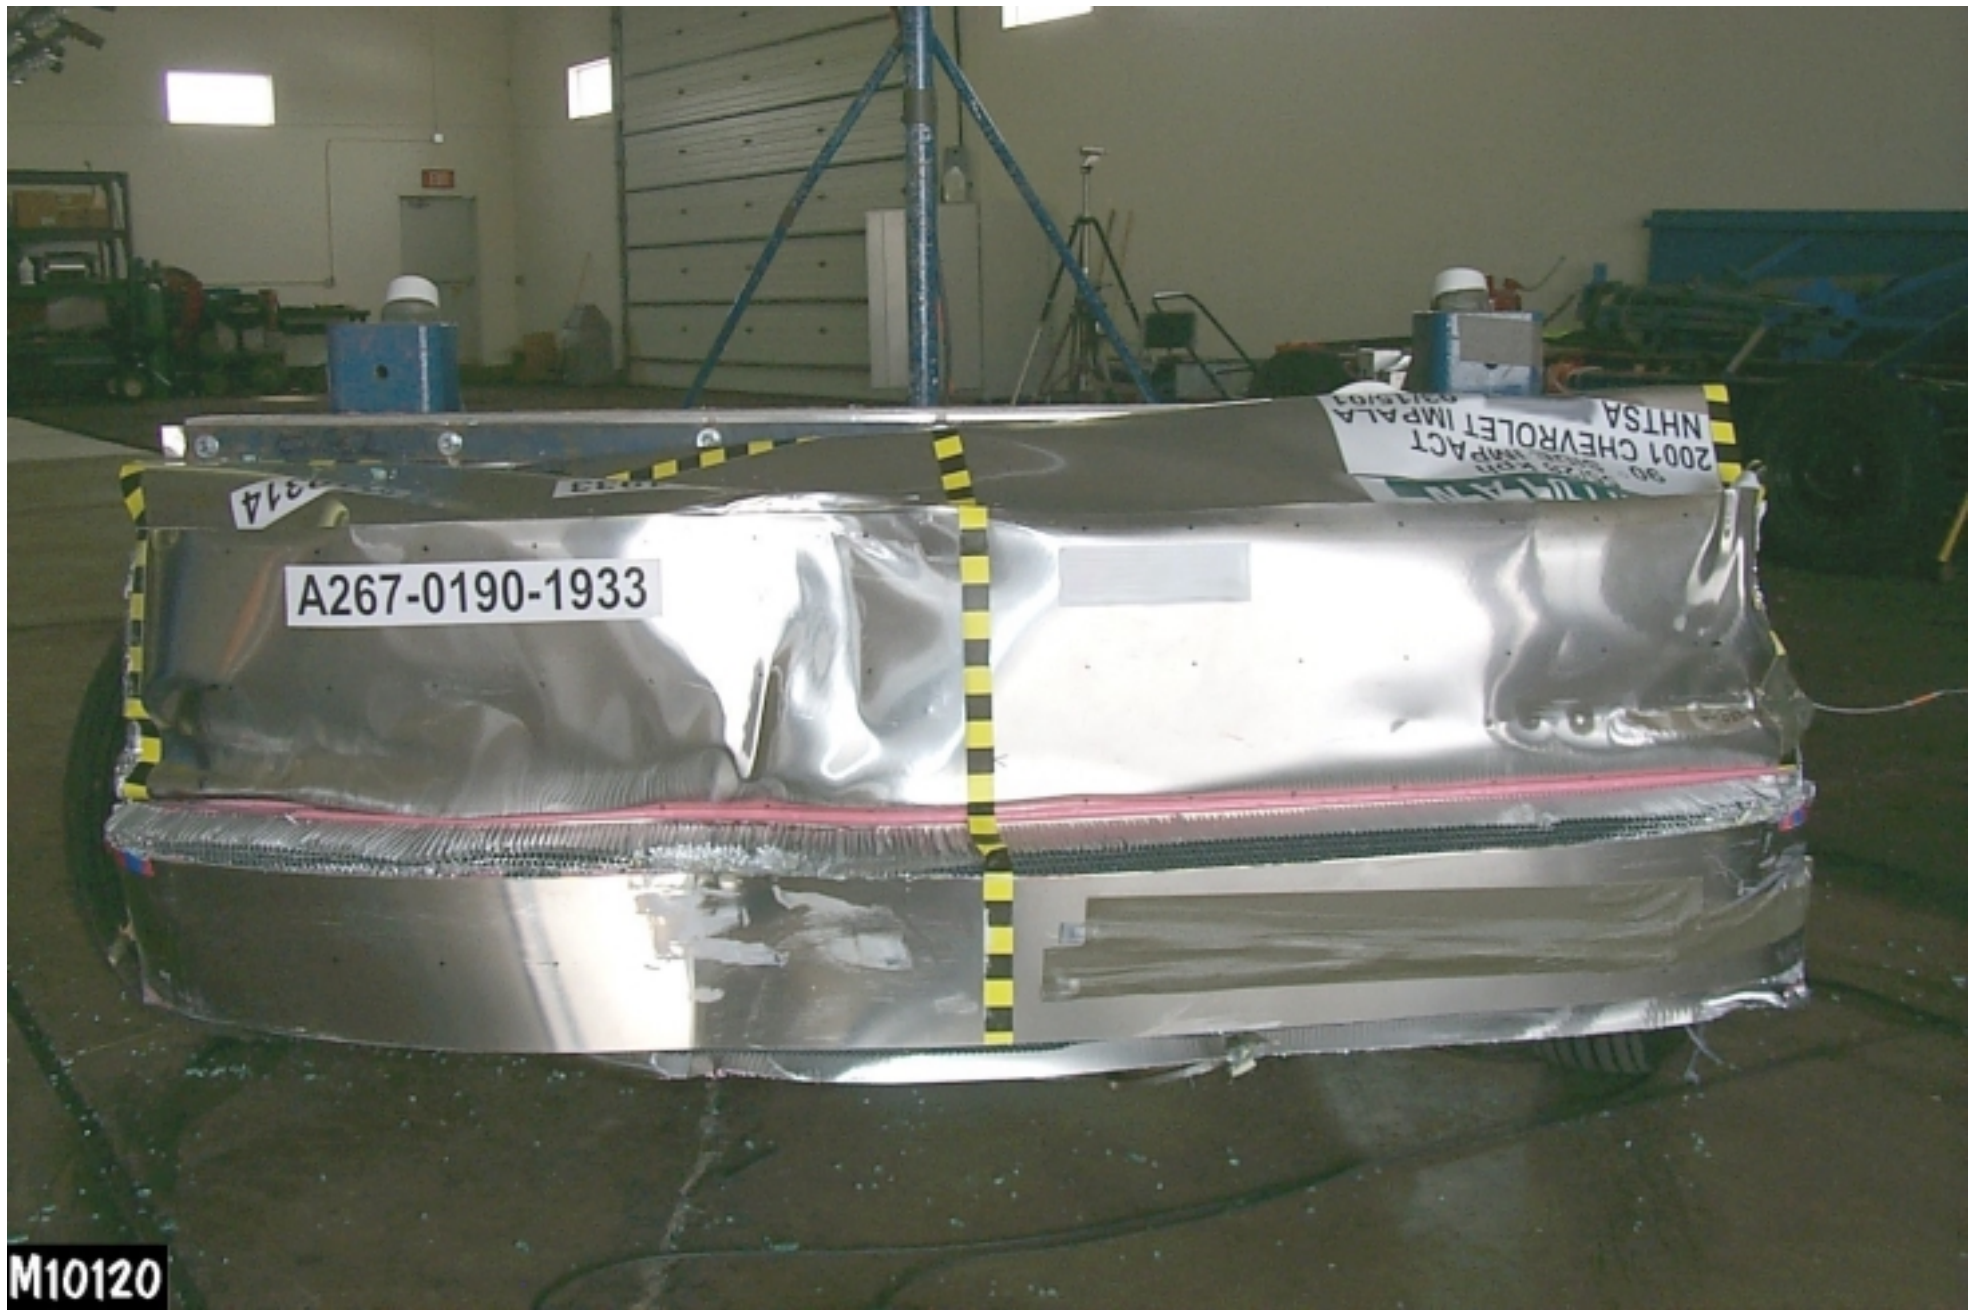
Figure A-8: POST-TEST FRONTAL VIEW OF IMPACTOR FACE

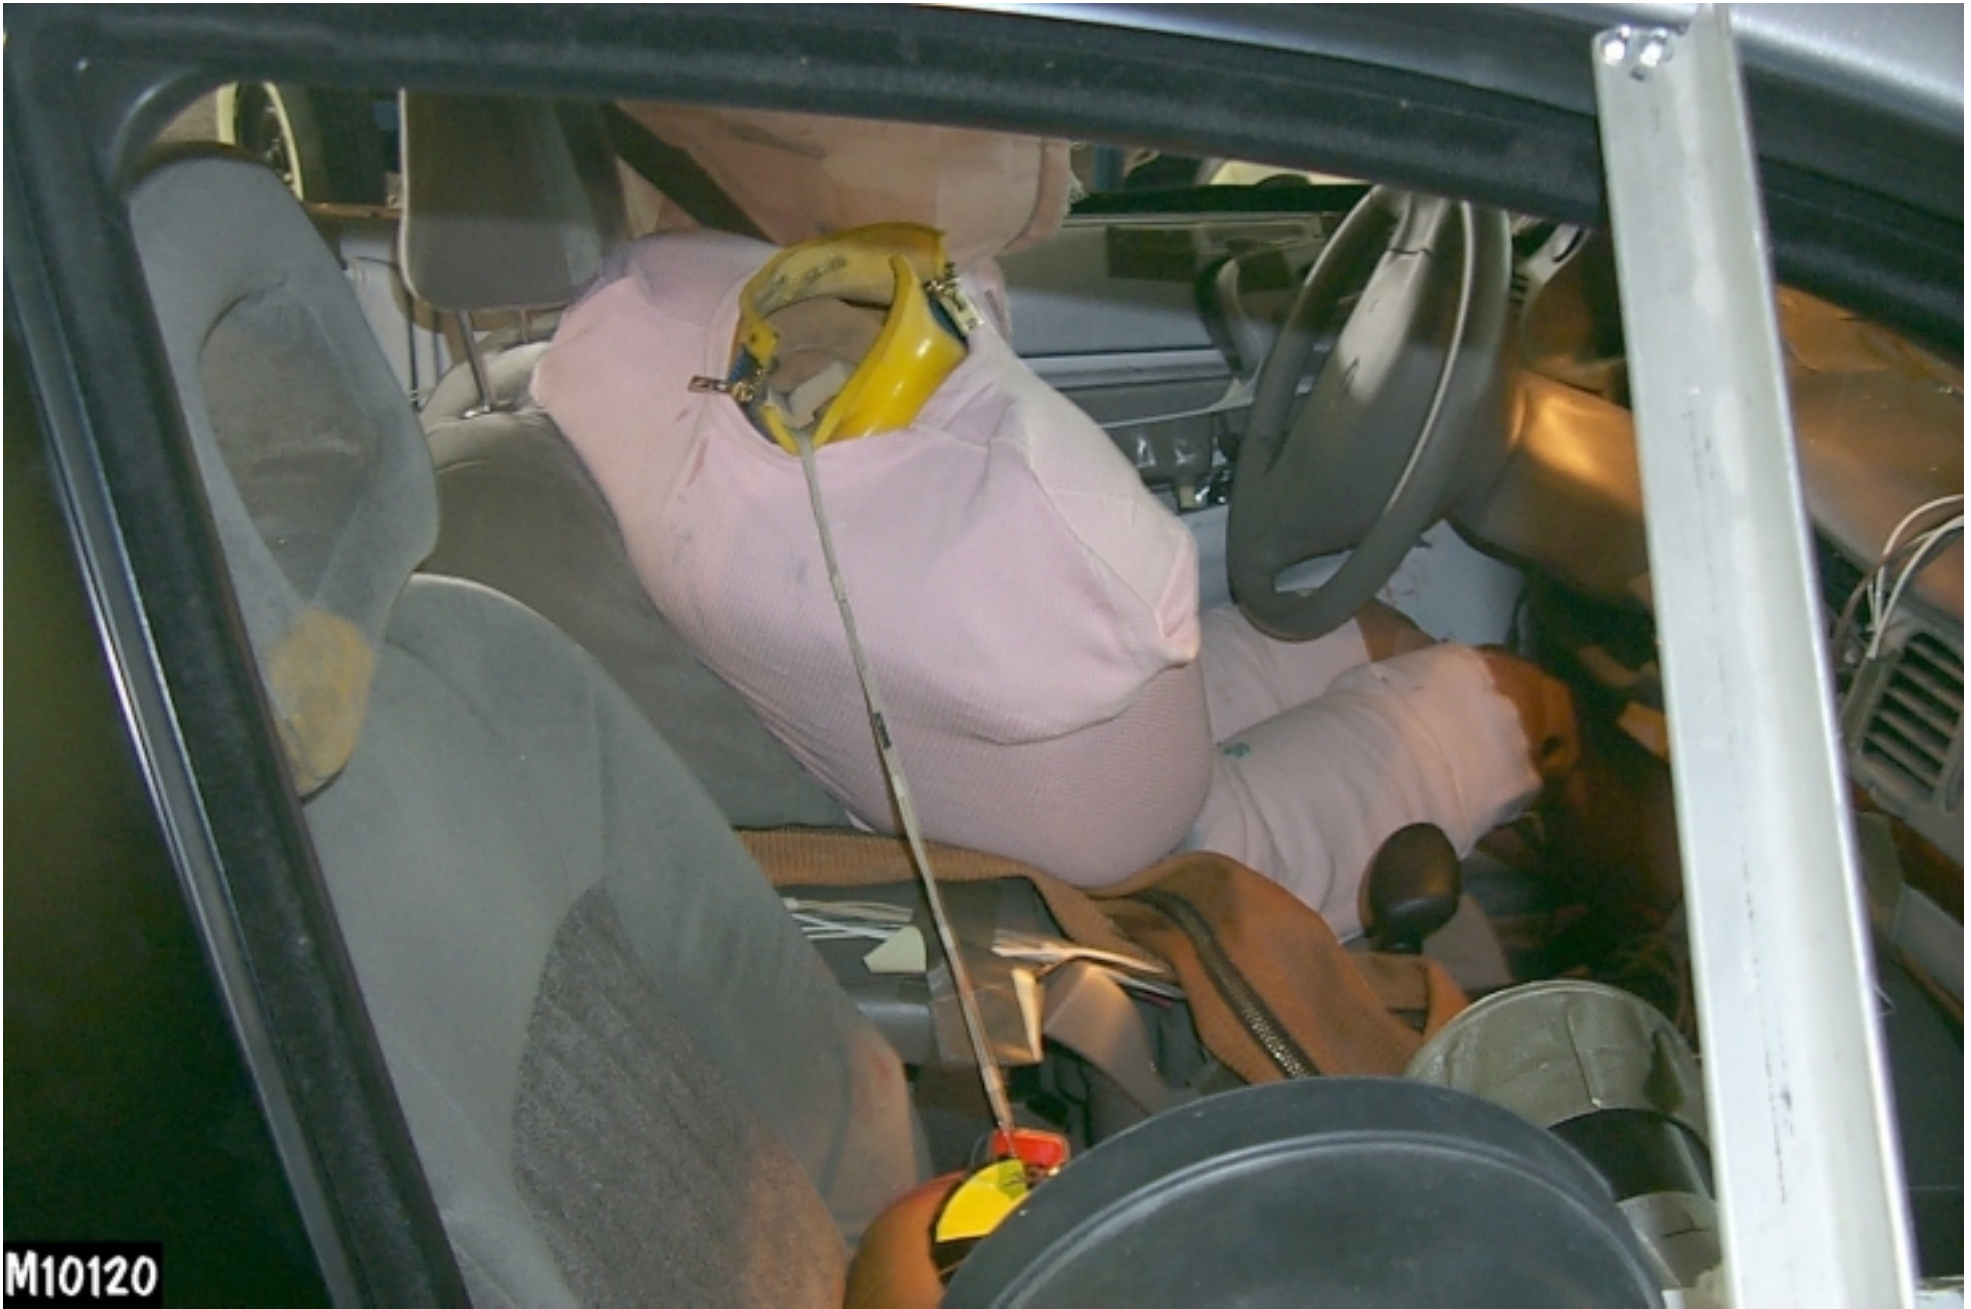
Figure A-18: POST-TEST RIGHT OCCUPANT COMPARTMENT VIEW OF FRONT SID

The driver position SID neck bracket welds failed during the impact causing the head to fully detach from the torso.

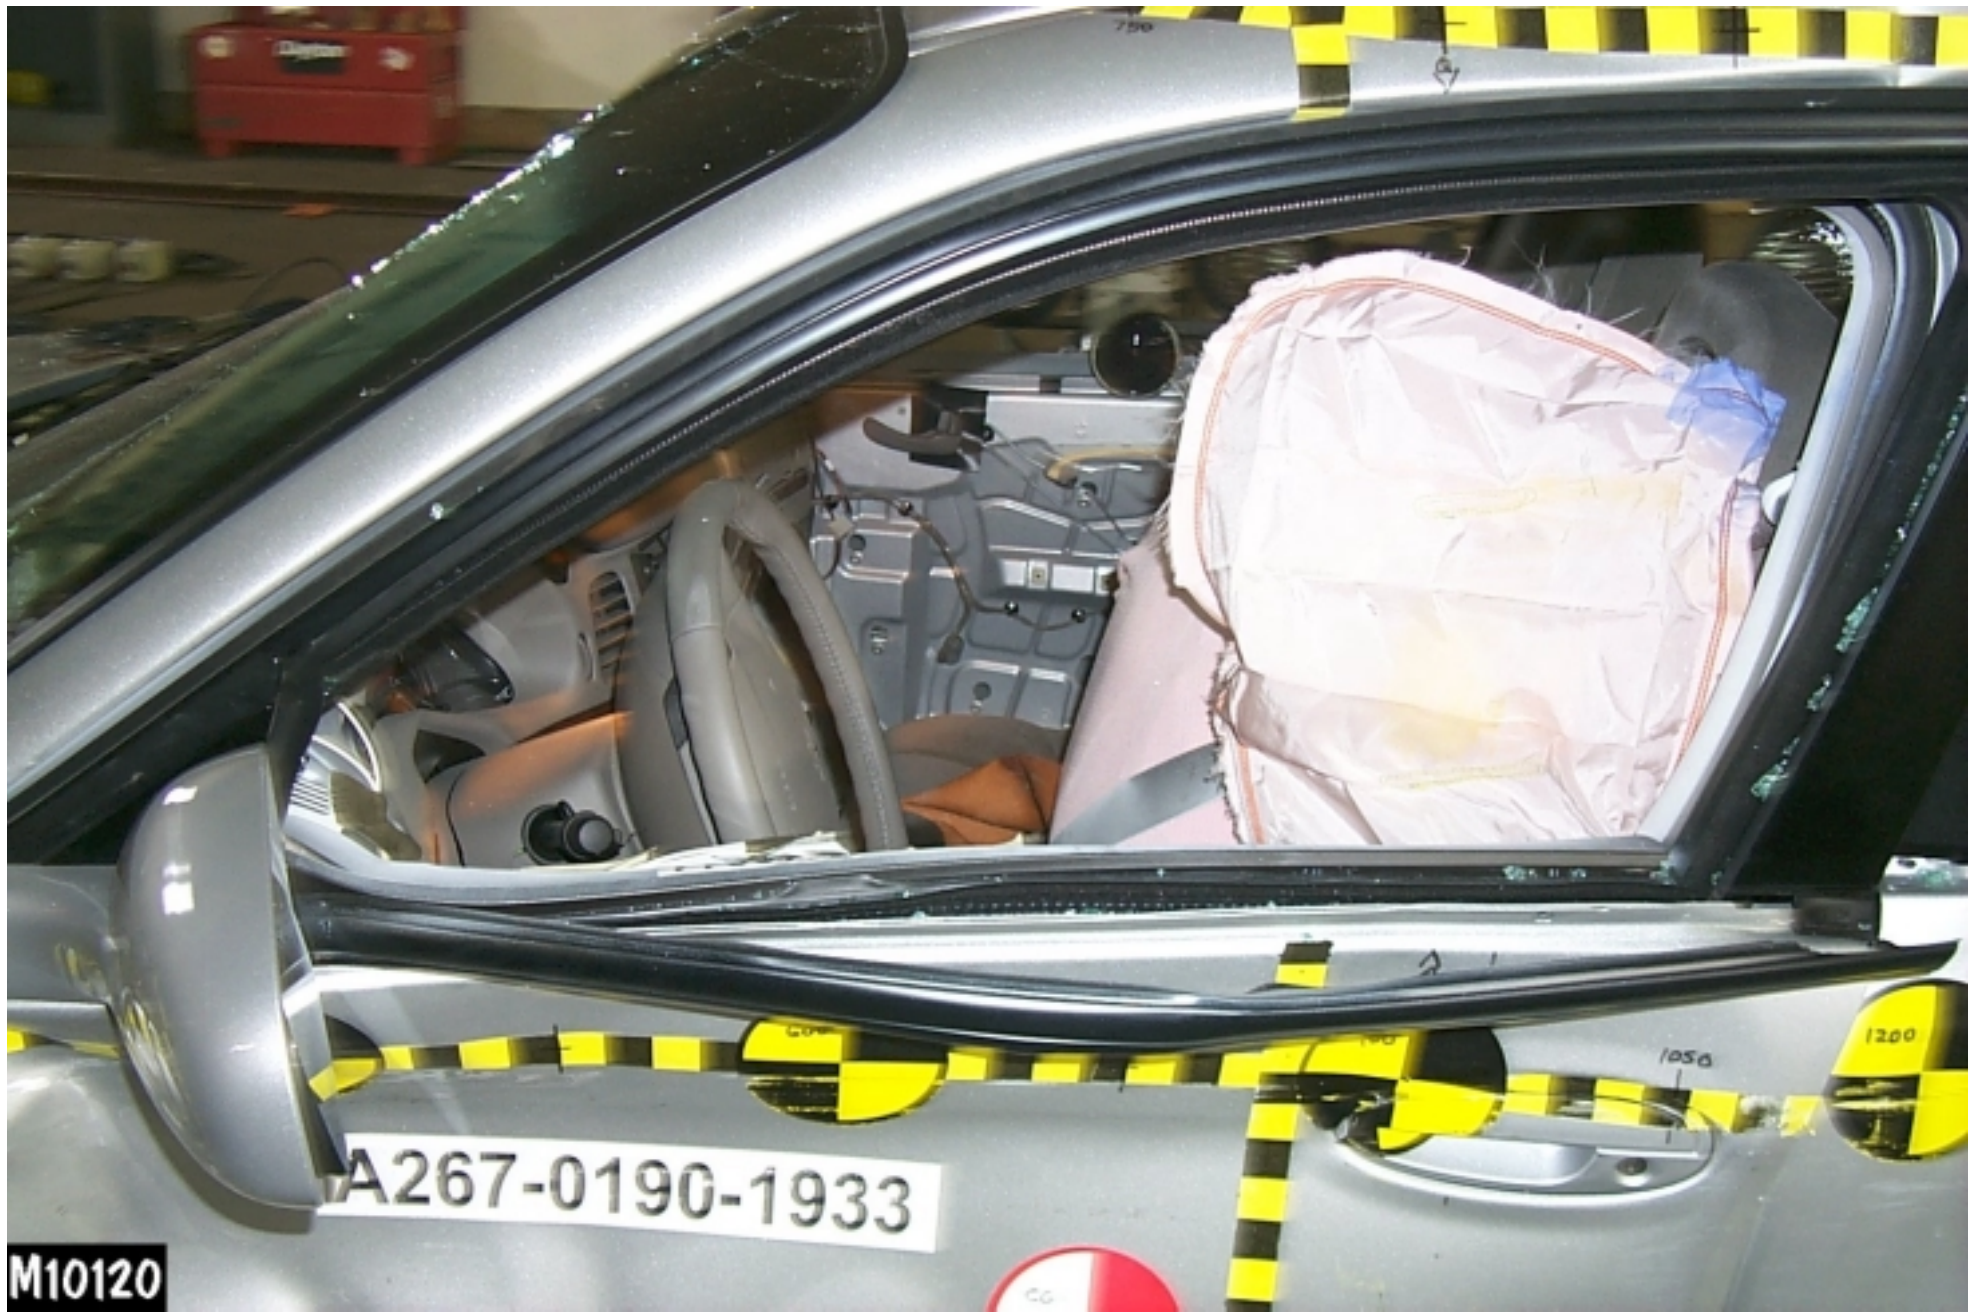
Figure A-22: POST-TEST LEFT OCCUPANT COMPARTMENT VIEW OF FRONT SID

† Data is questionable. Welds on the left side front SID (driver) neck bracket failed approximately 84 ms into the impact.

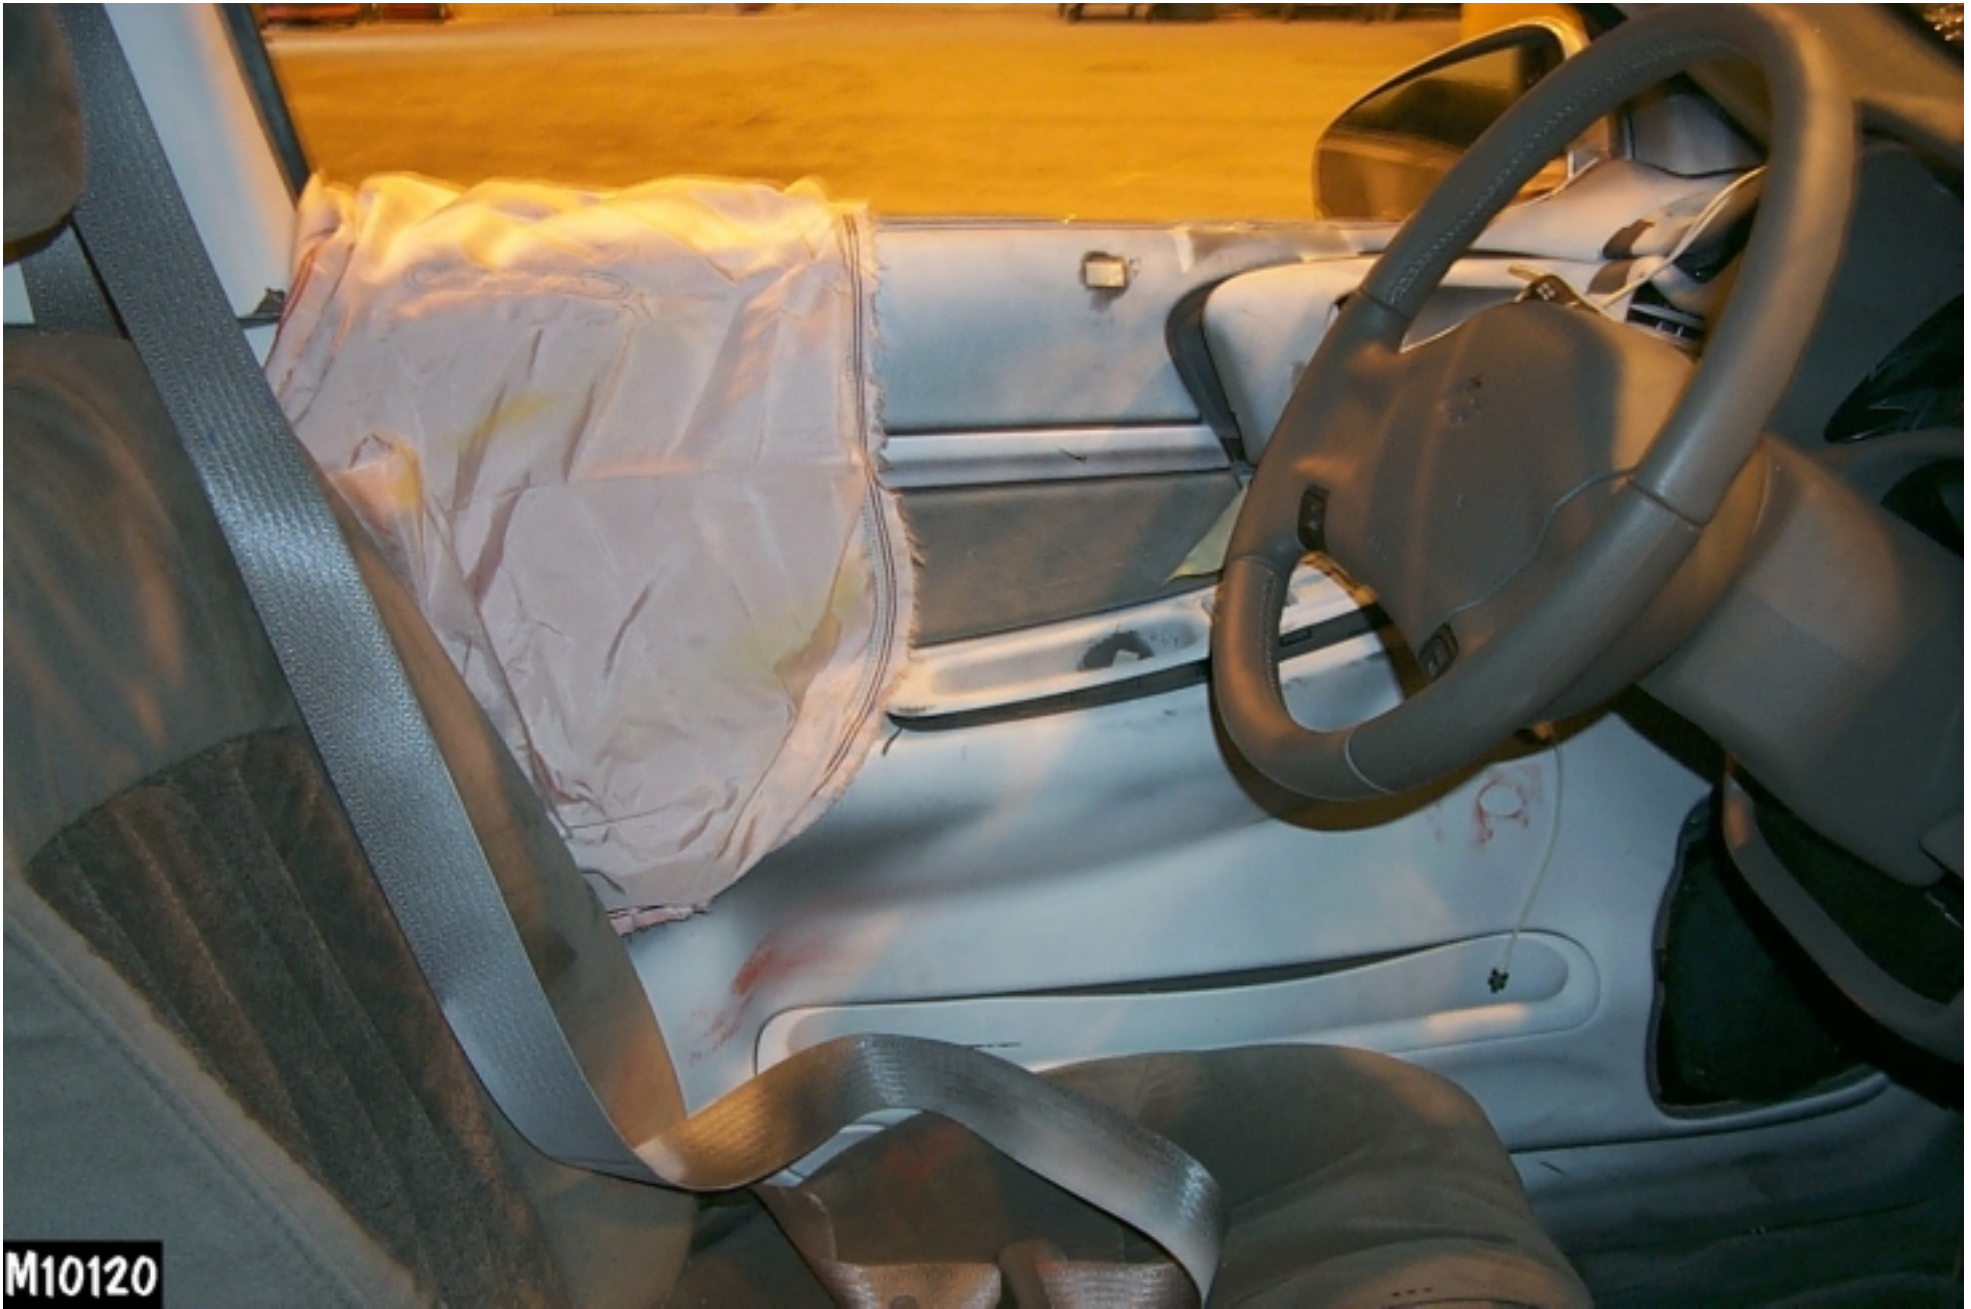
Figure A-26: POST-TEST FRONT INTERIOR TRIM SHOWING SID IMPACT LOCATIONS
