REPORT NUMBER: SNCAP-CAL-01-6

**NEW CAR ASSESSMENT PROGRAM
SIDE IMPACT TEST**

GENERAL MOTORS OF CANADA LTD.
2001 CHEVROLET IMPALA
4-DOOR SEDAN

FINAL REPORT

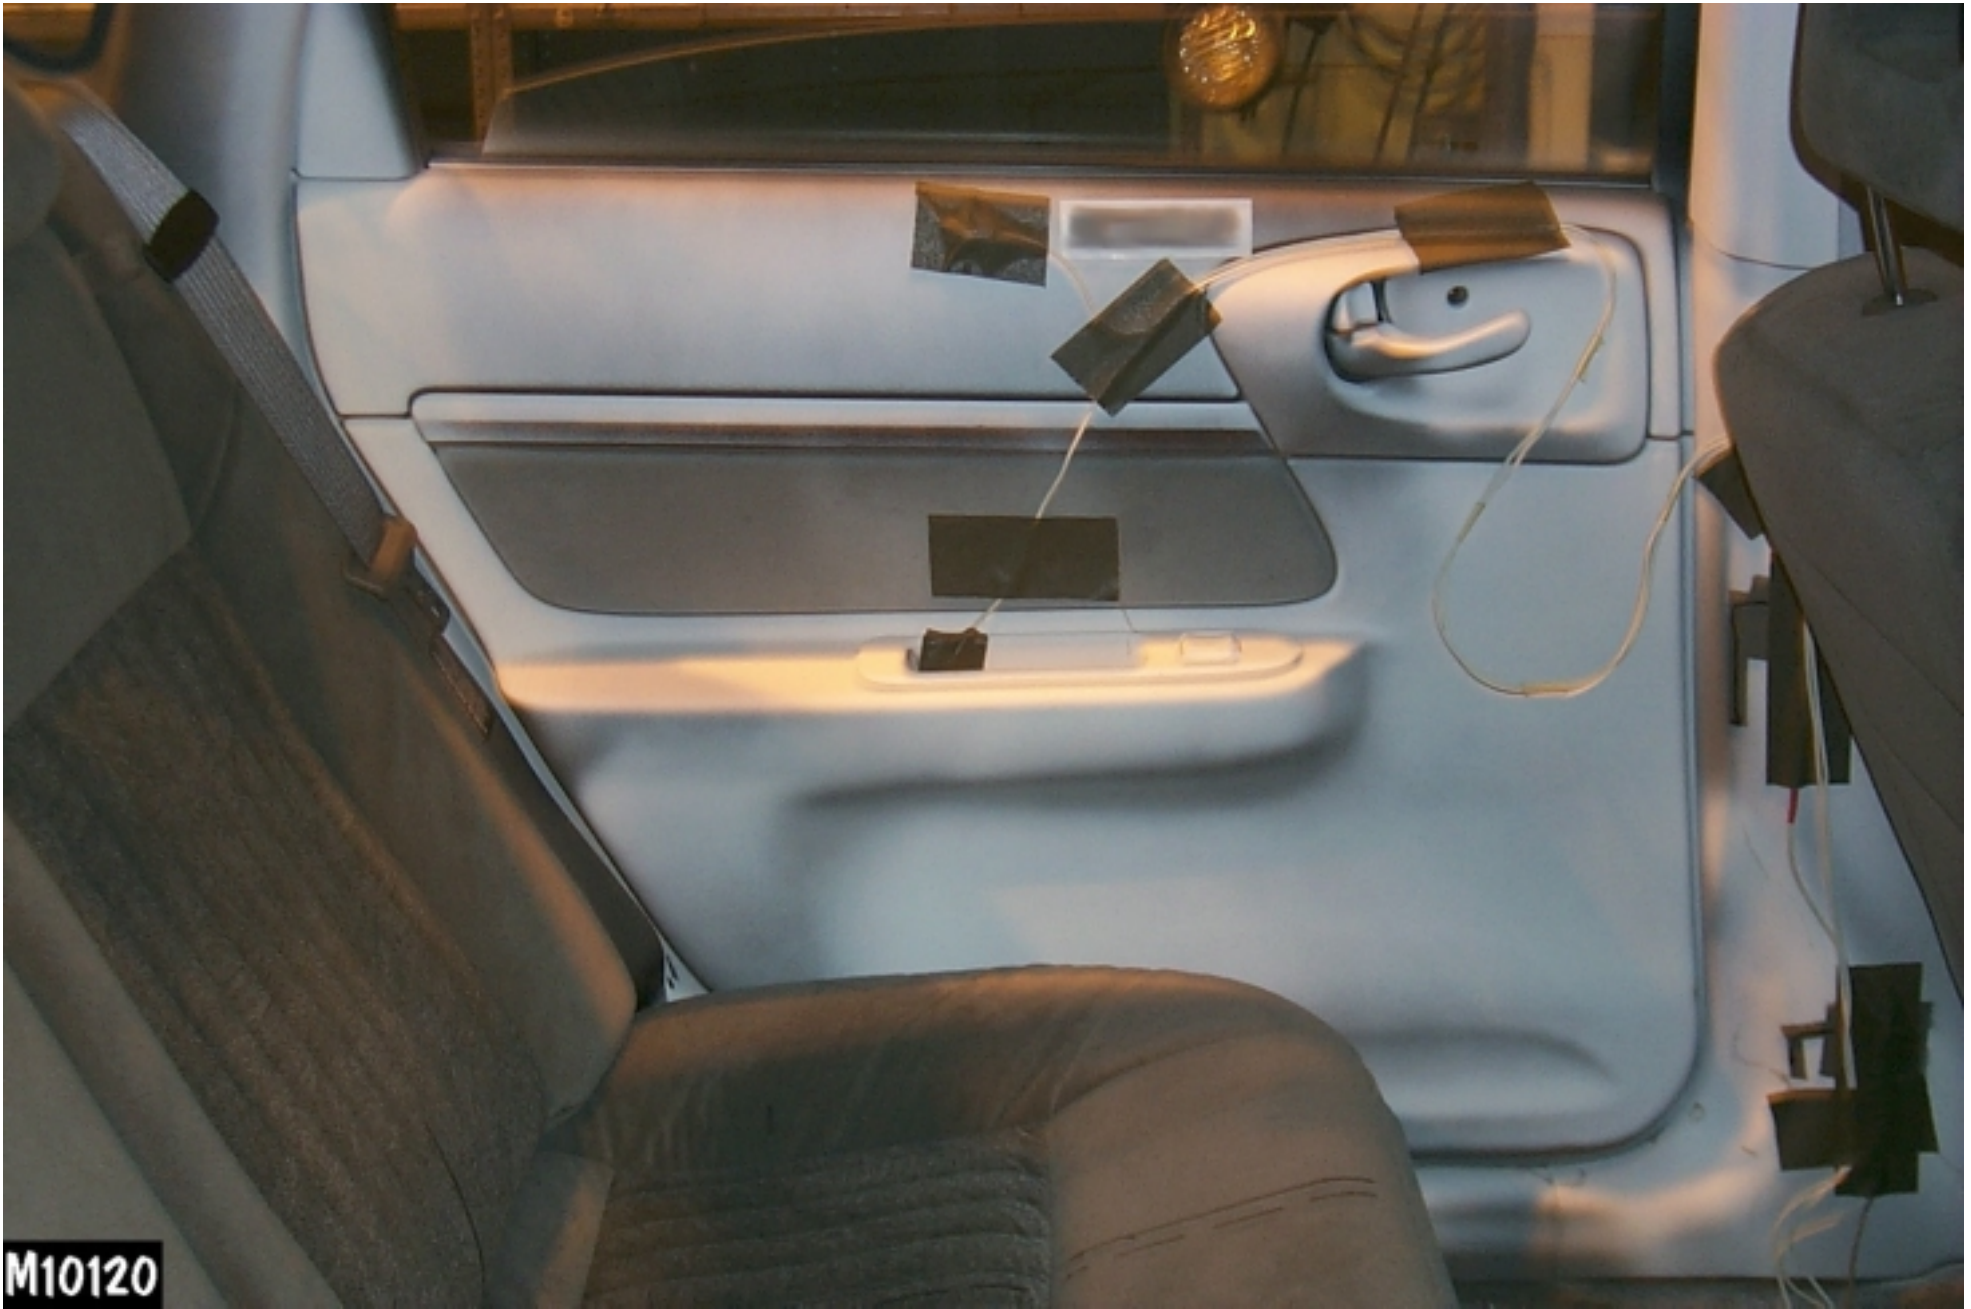
Figure A-28: POST-TEST REAR INTERIOR TRIM SHOWING SID IMPACT LOCATIONS

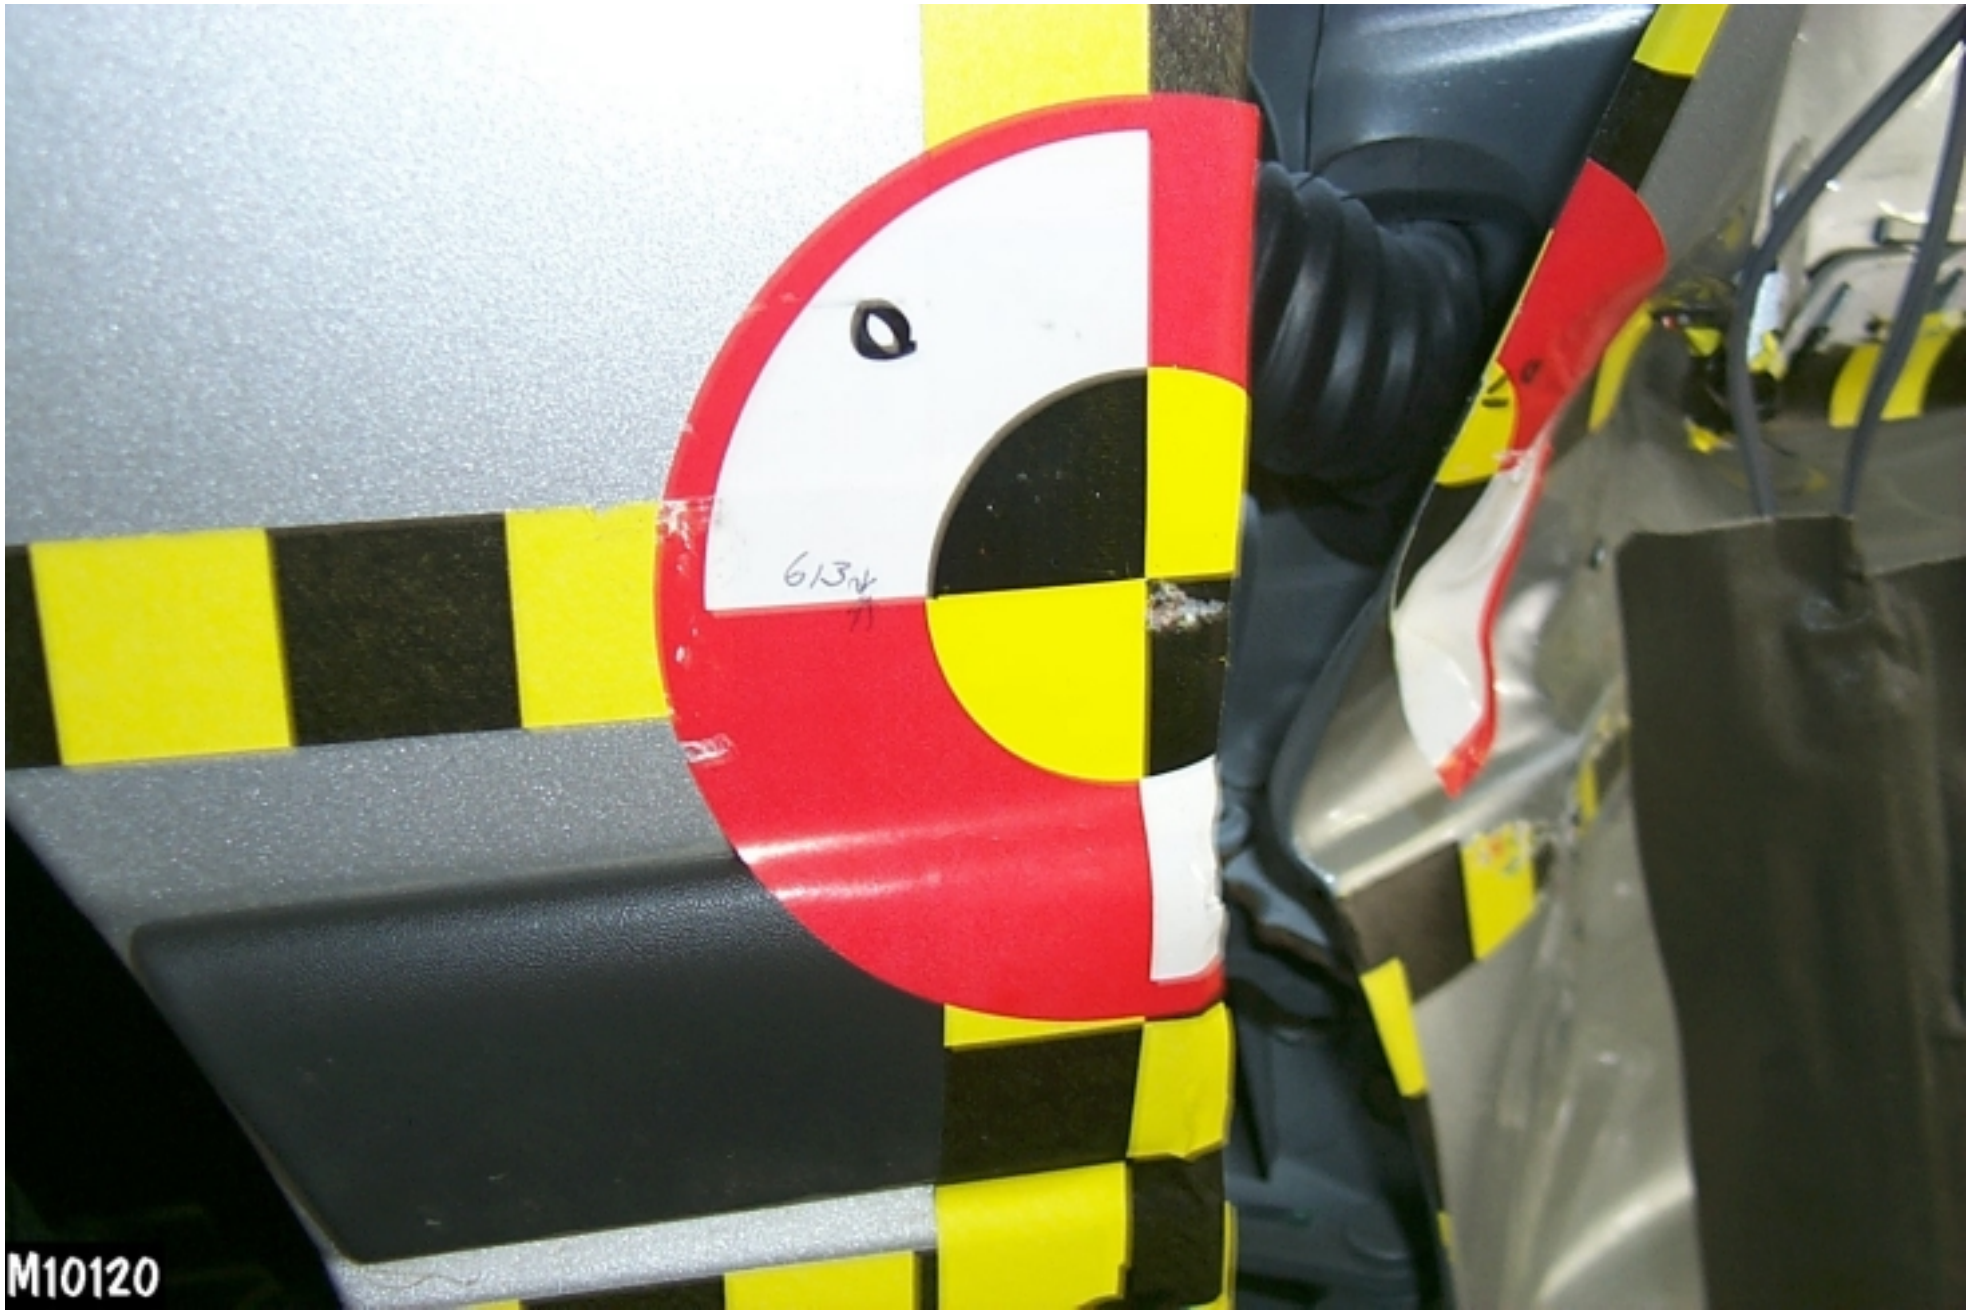
Figure A-31: POST-TEST CLOSE-UP VIEW OF IMPACT POINT TARGET

Actual Impact Point is 2 mm rearward of nominal impact ref. line (Lateral)

Actual Impact Point is 4 mm below nominal impact point (Vertical)
