**REPORT NUMBER KAR21001-08**

**NEW CAR ASSESSMENT PROGRAM  
FRONTAL BARRIER IMPACT TEST**

**DAIMLER CHRYSLER CORPORATION  
2001 DODGE DURANGO SPORT  
SUV  
NHTSA NUMBER: M10305**

**FINAL REPORT**

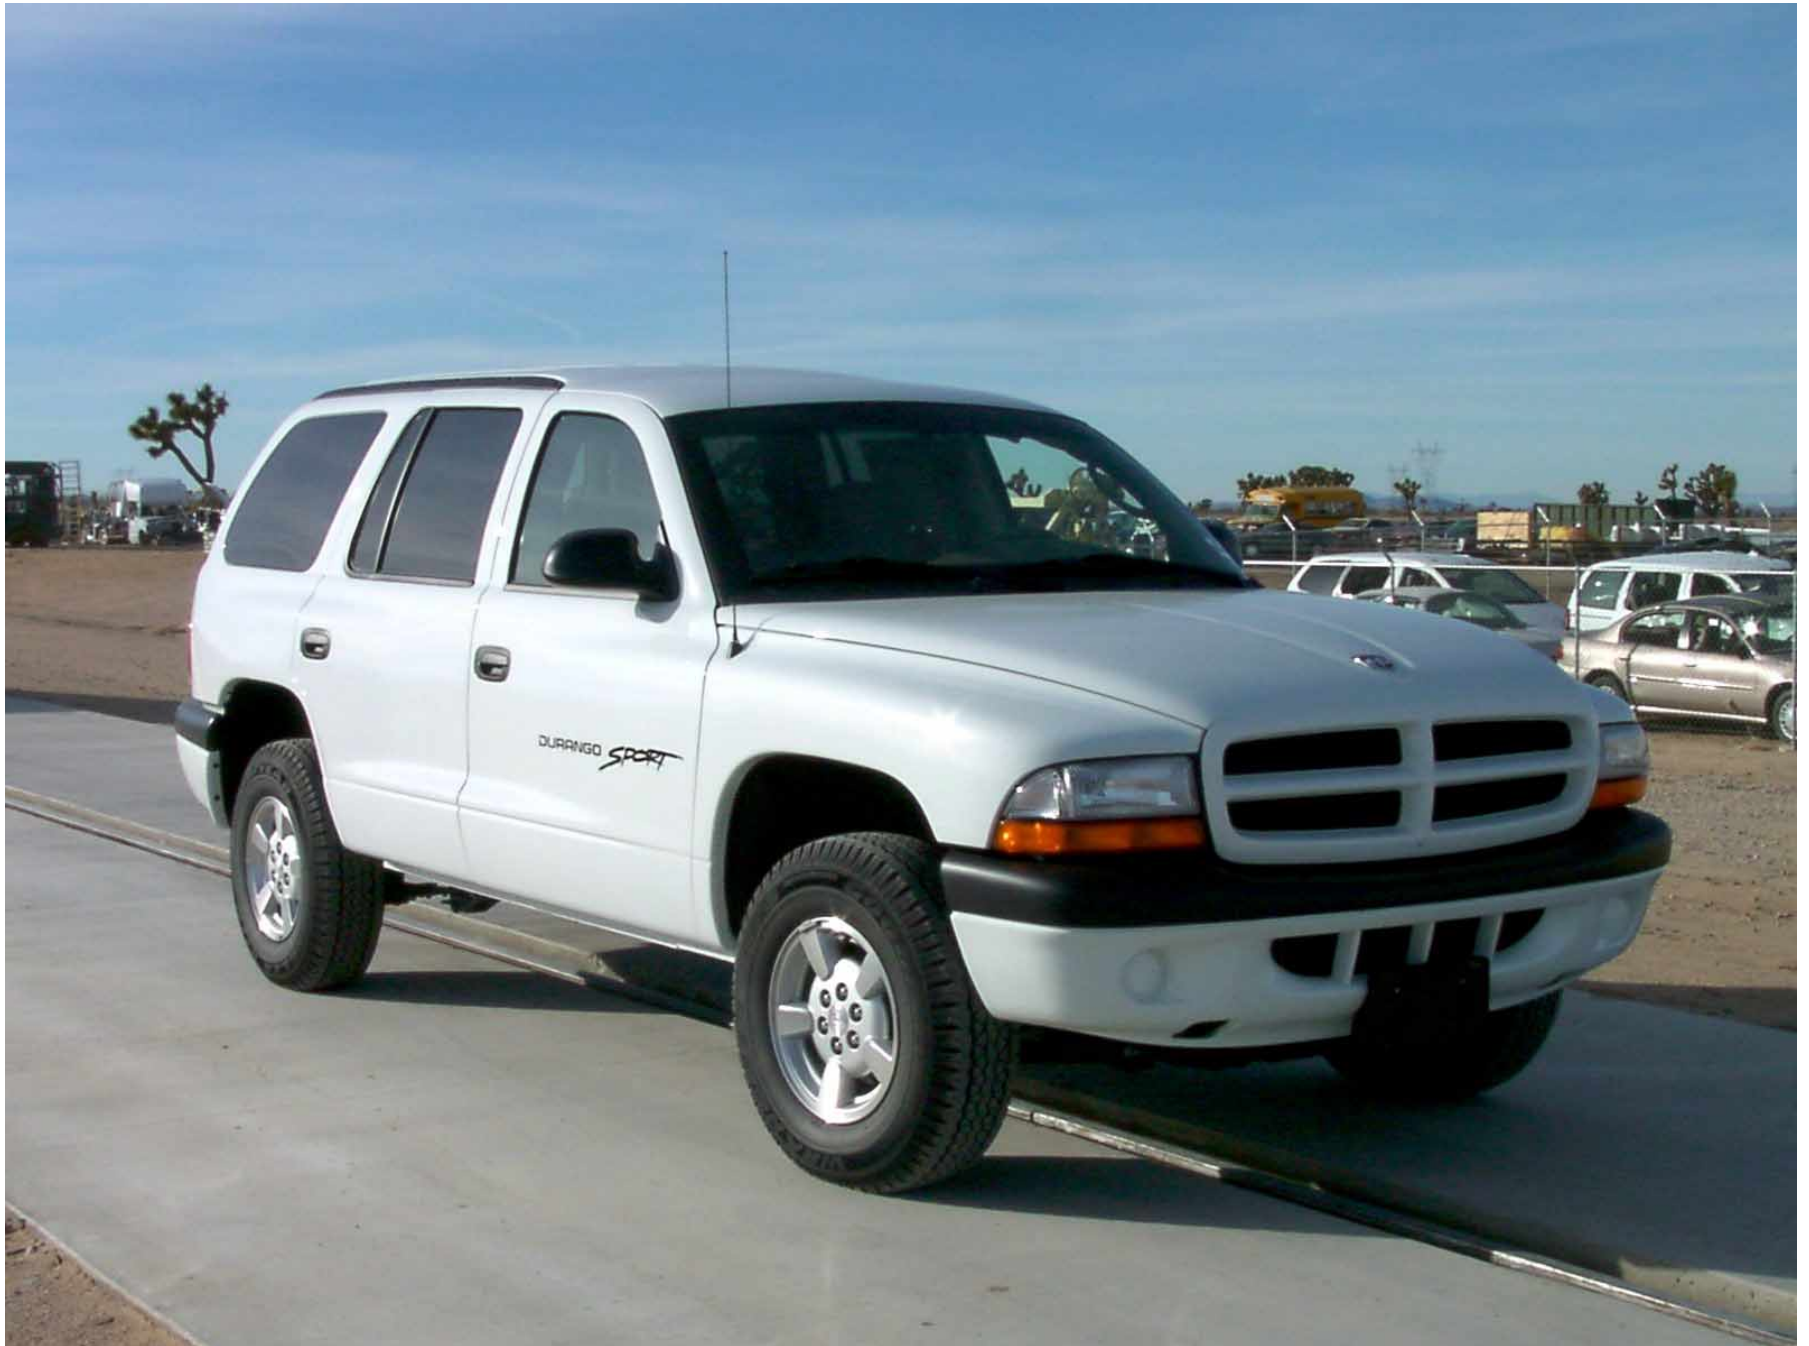
Figure A-1: Right Front, as Received

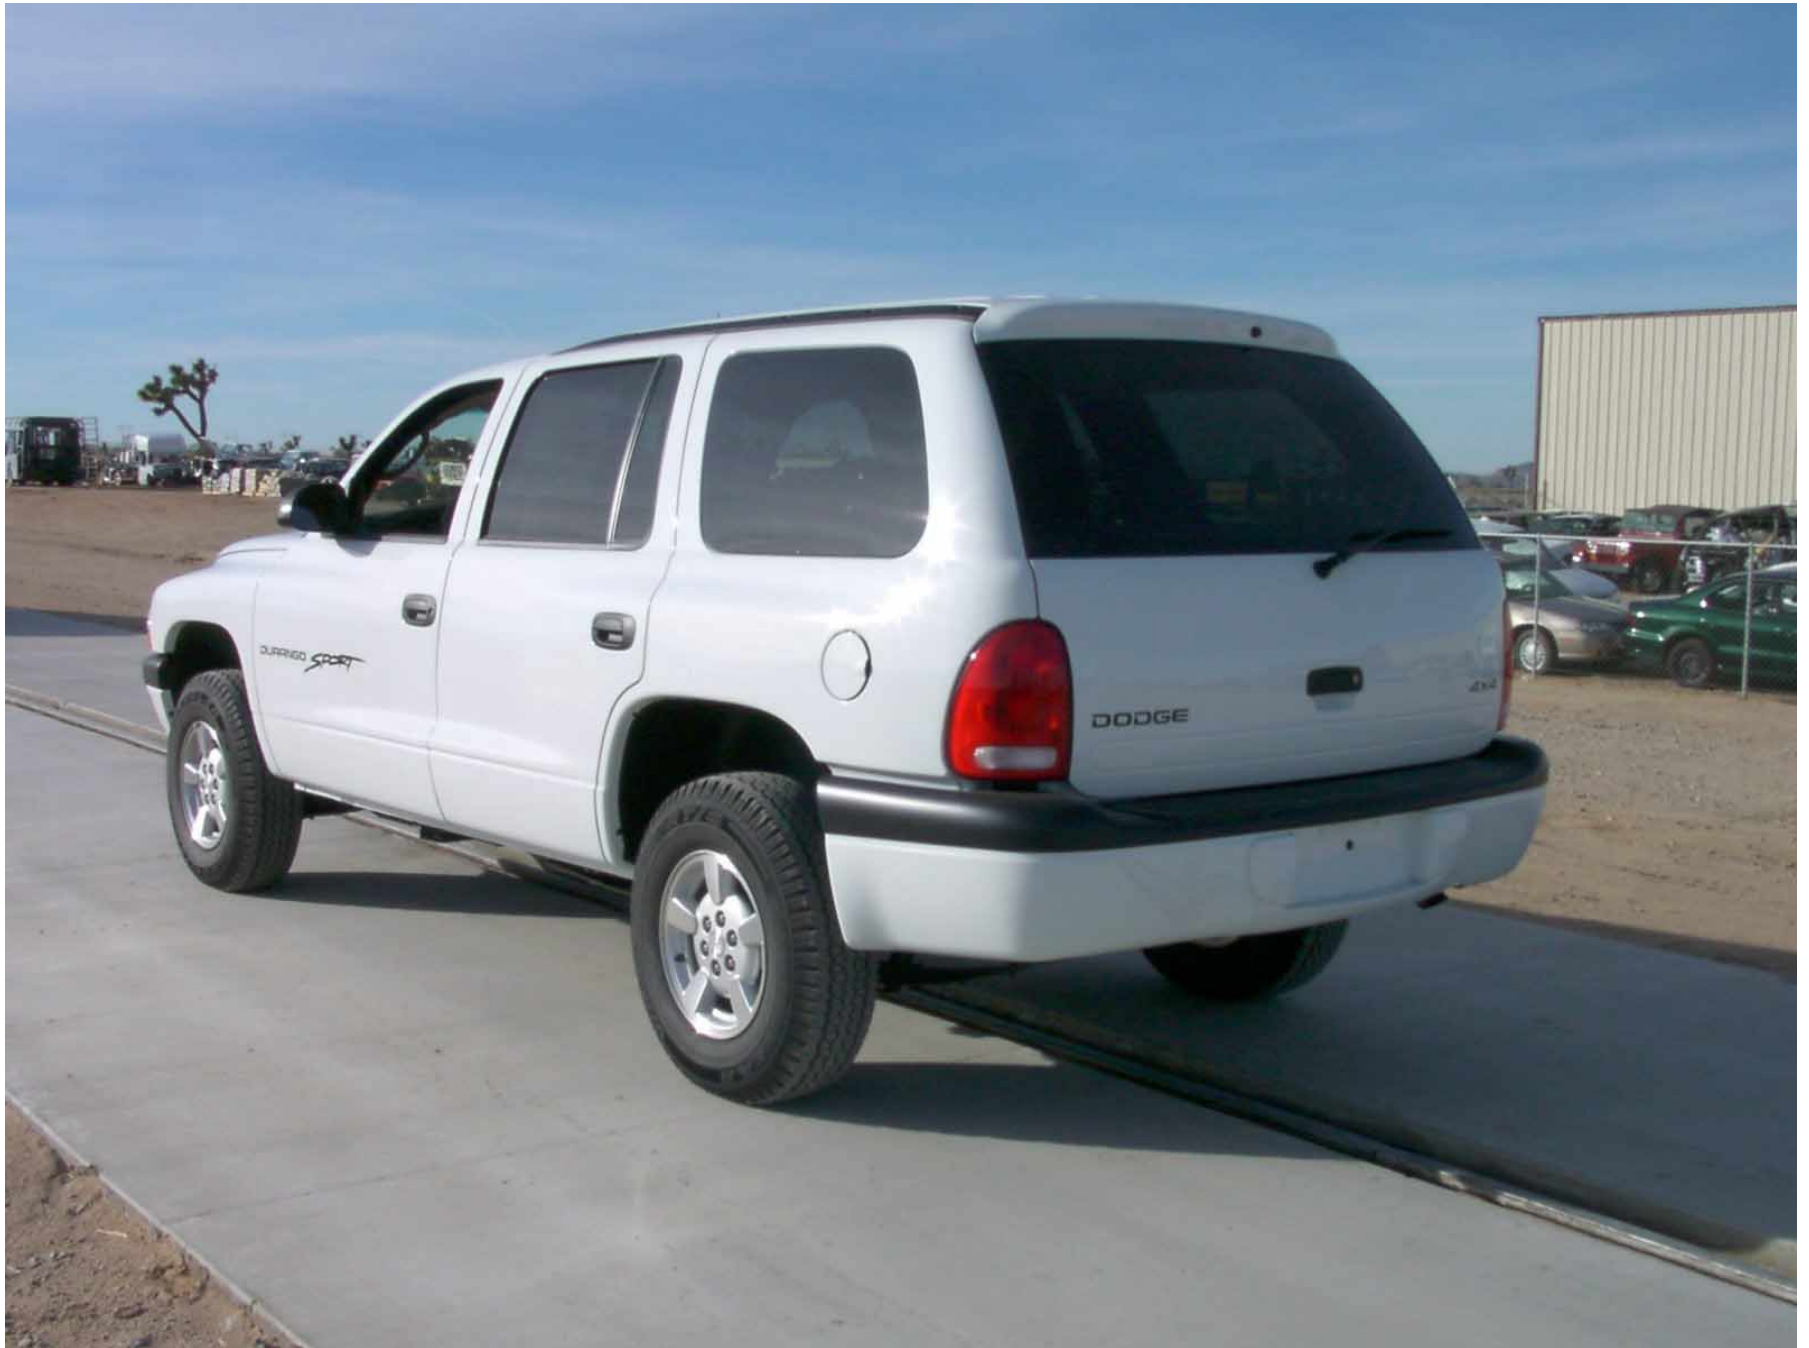
Figure A-2: Left Rear, as Received

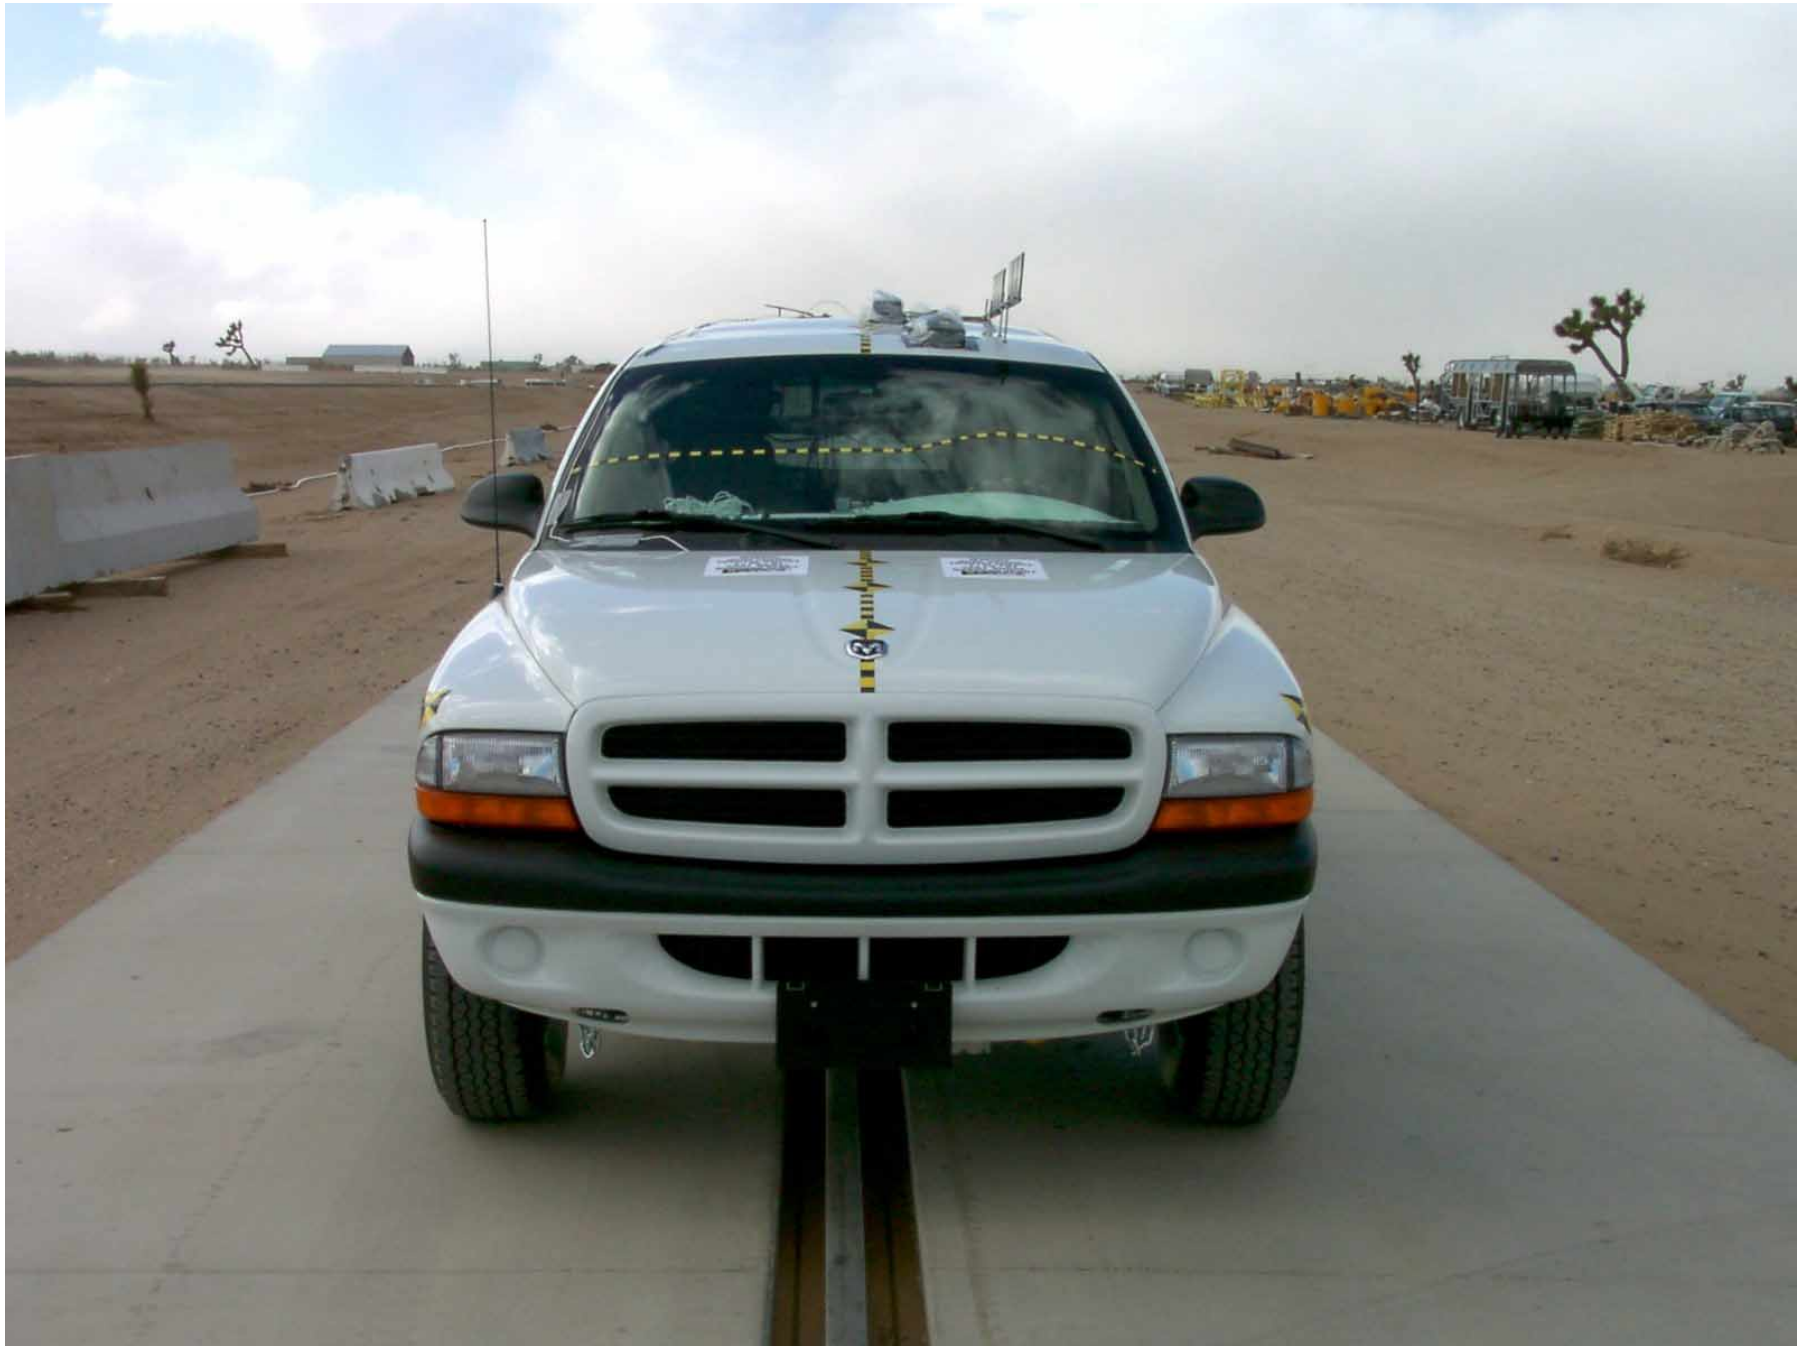
Figure A-5: Front View, Pre-Test

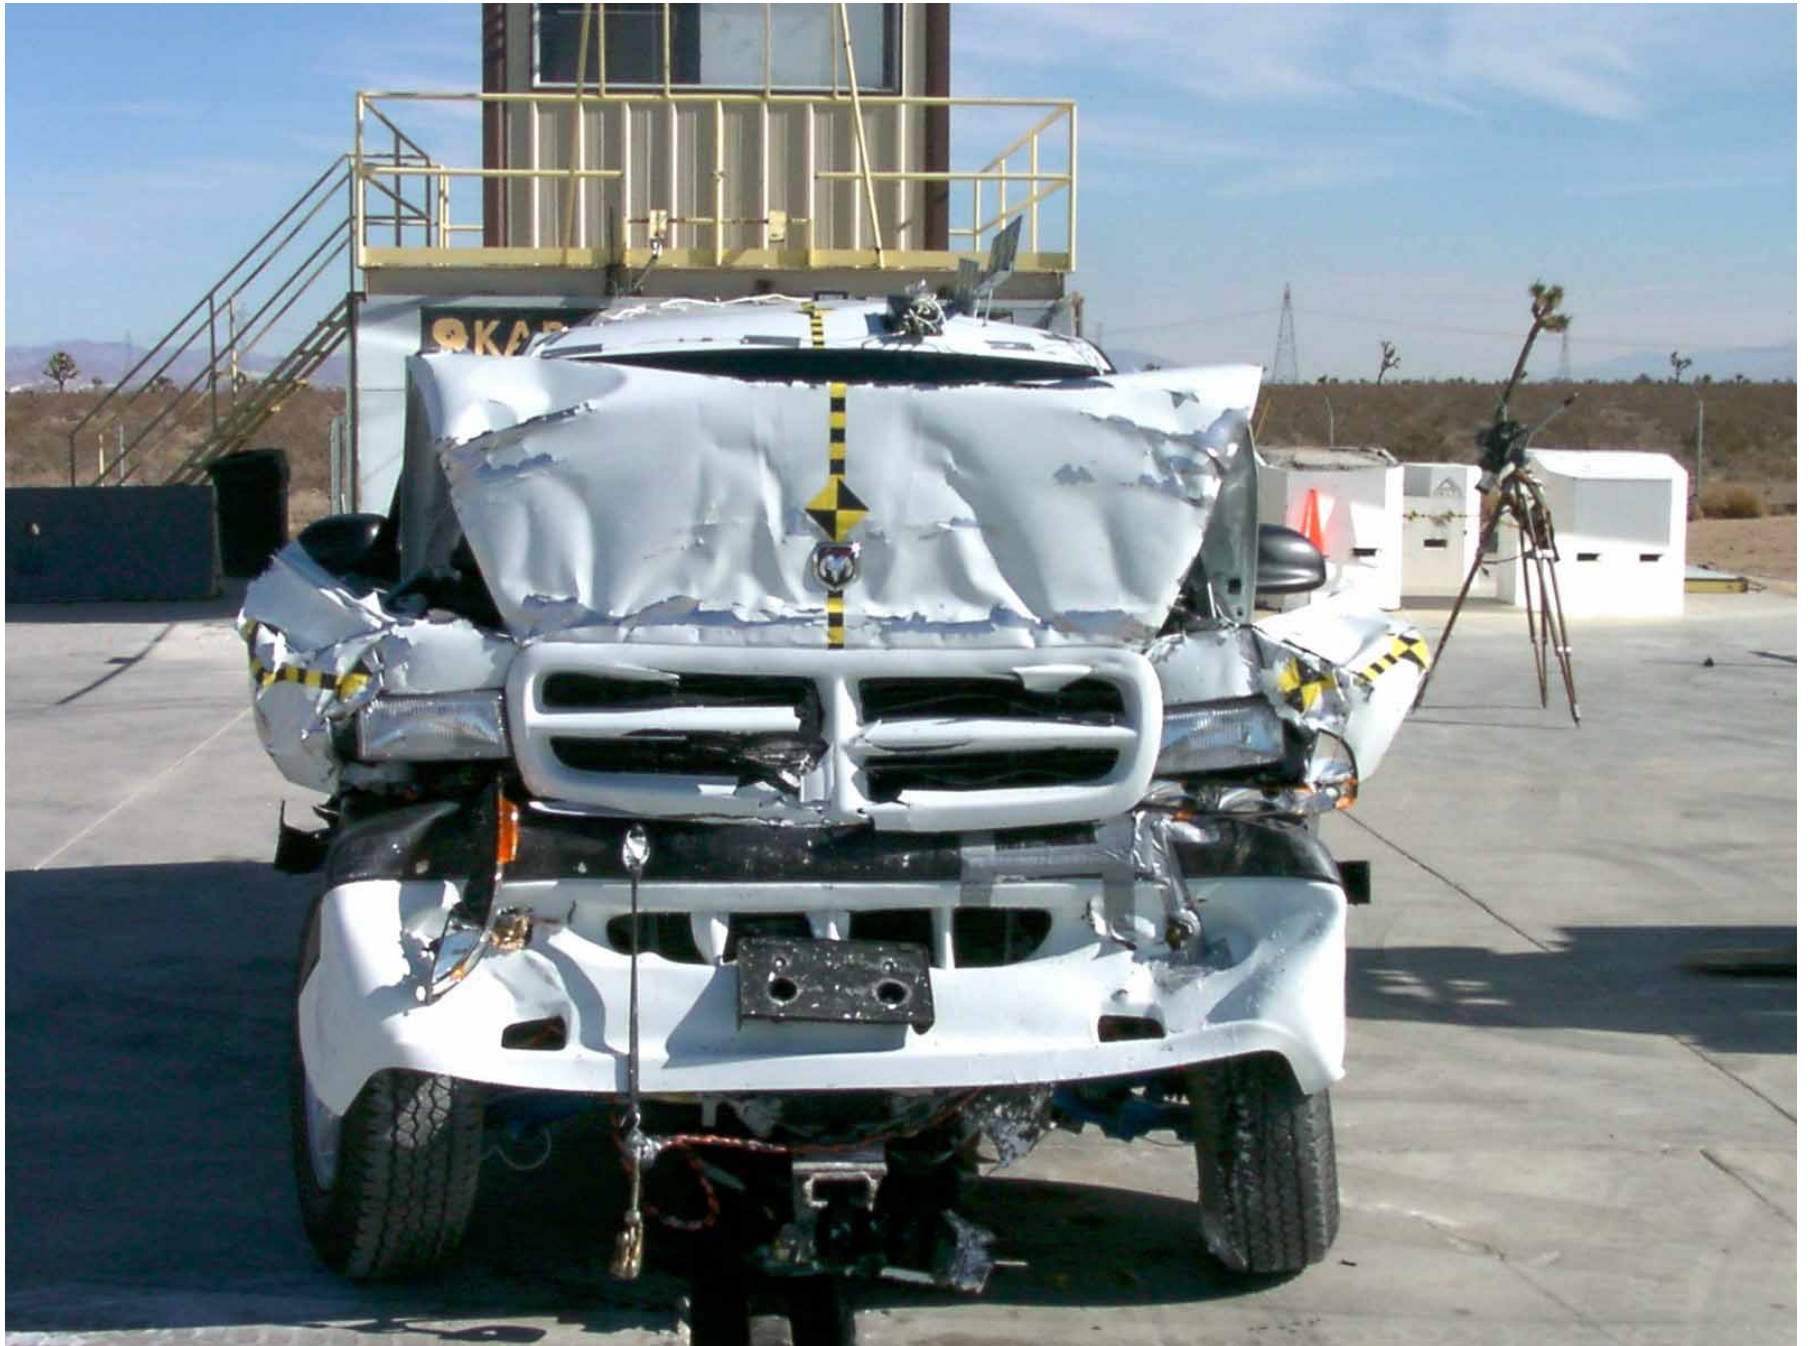
Figure A-6: Front View, Post-Test

Collision Deformation Classification: 12FDEW6 ; Midpoint of Damage: Vehicle Centerline  
Damage Region Length (mm): 1621 ; Impact Mode: Full Frontal

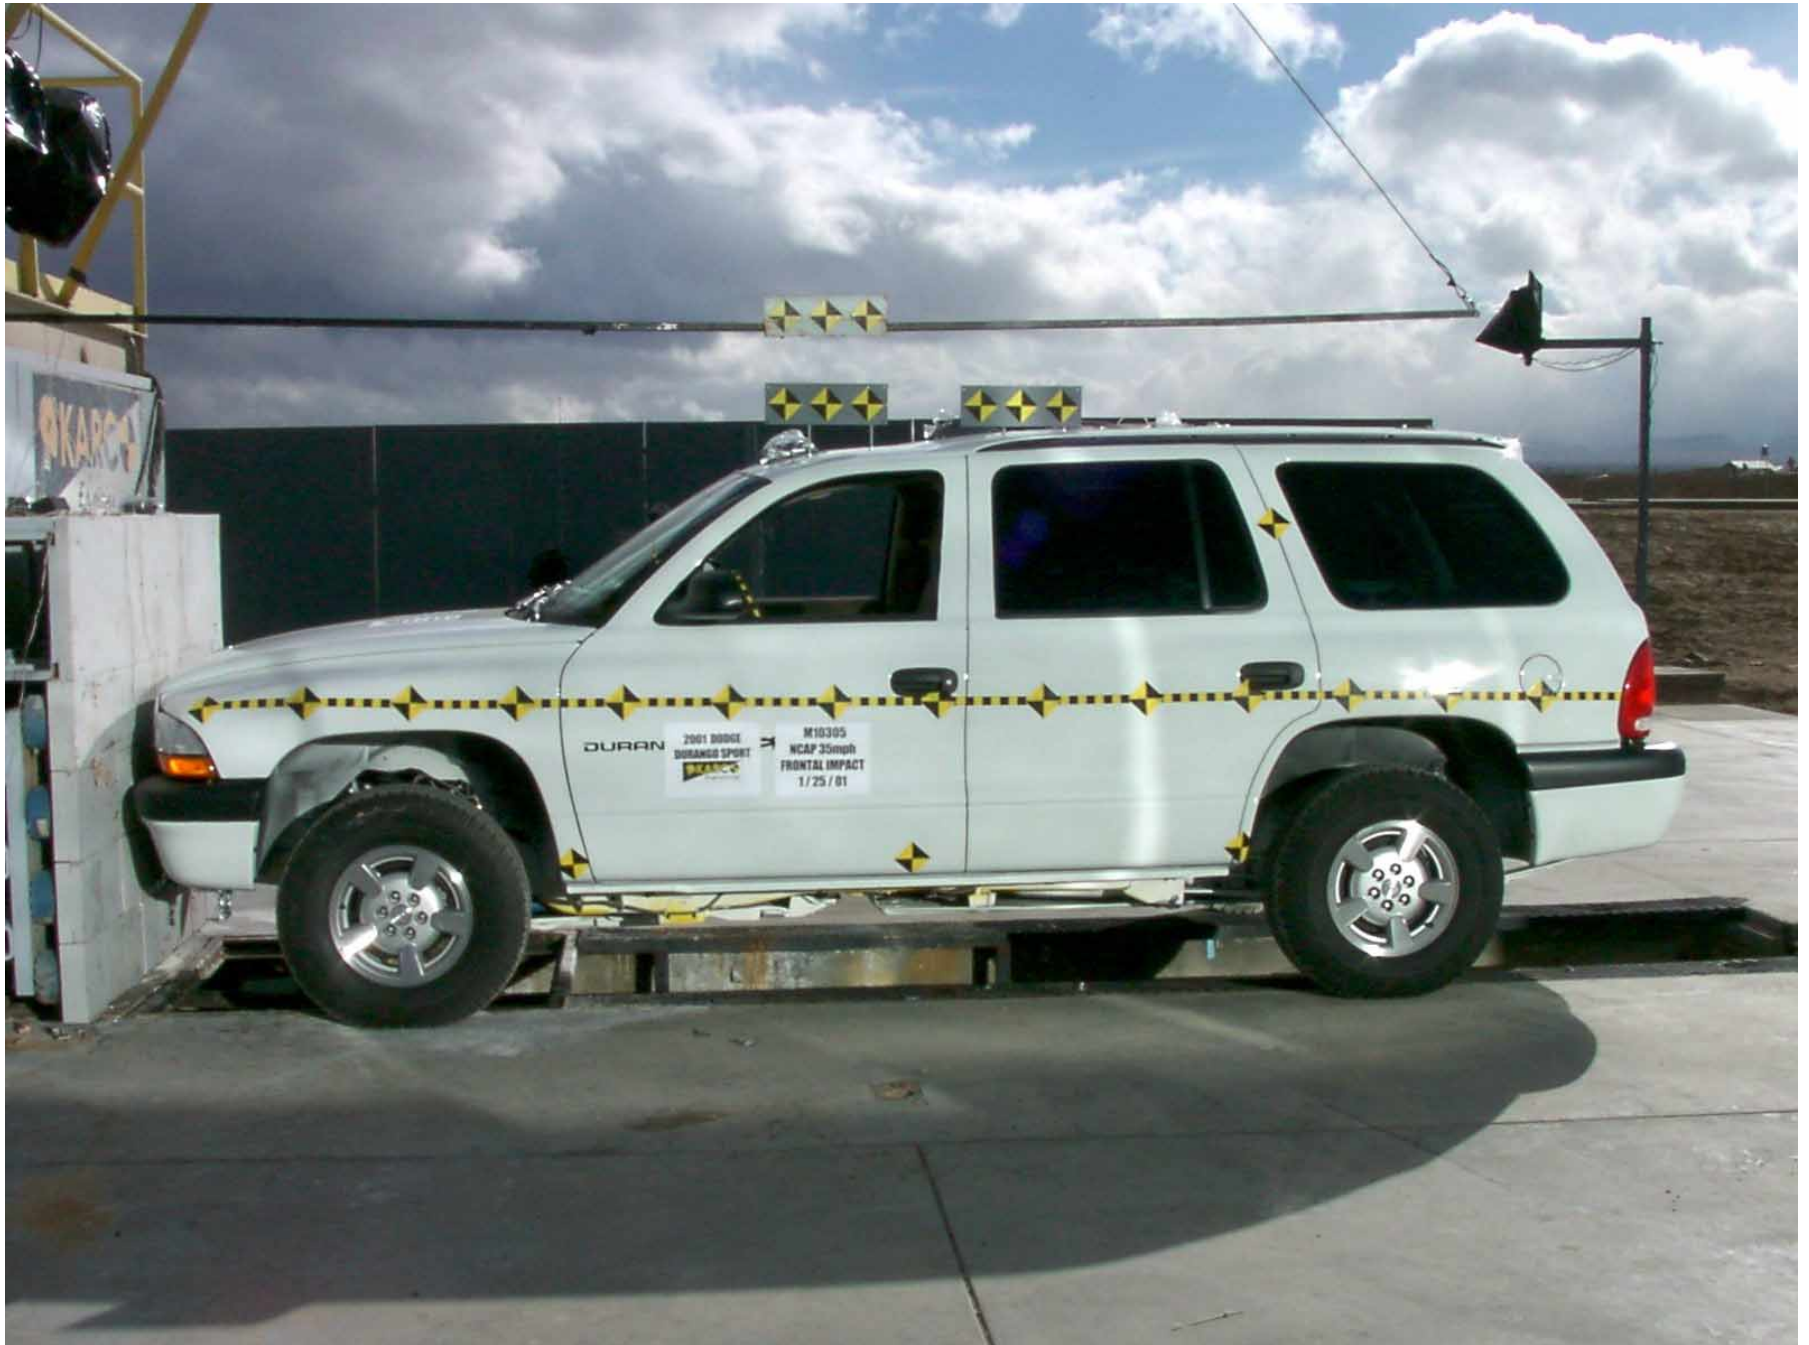
Figure A-7: Left Side View, Pre-Test

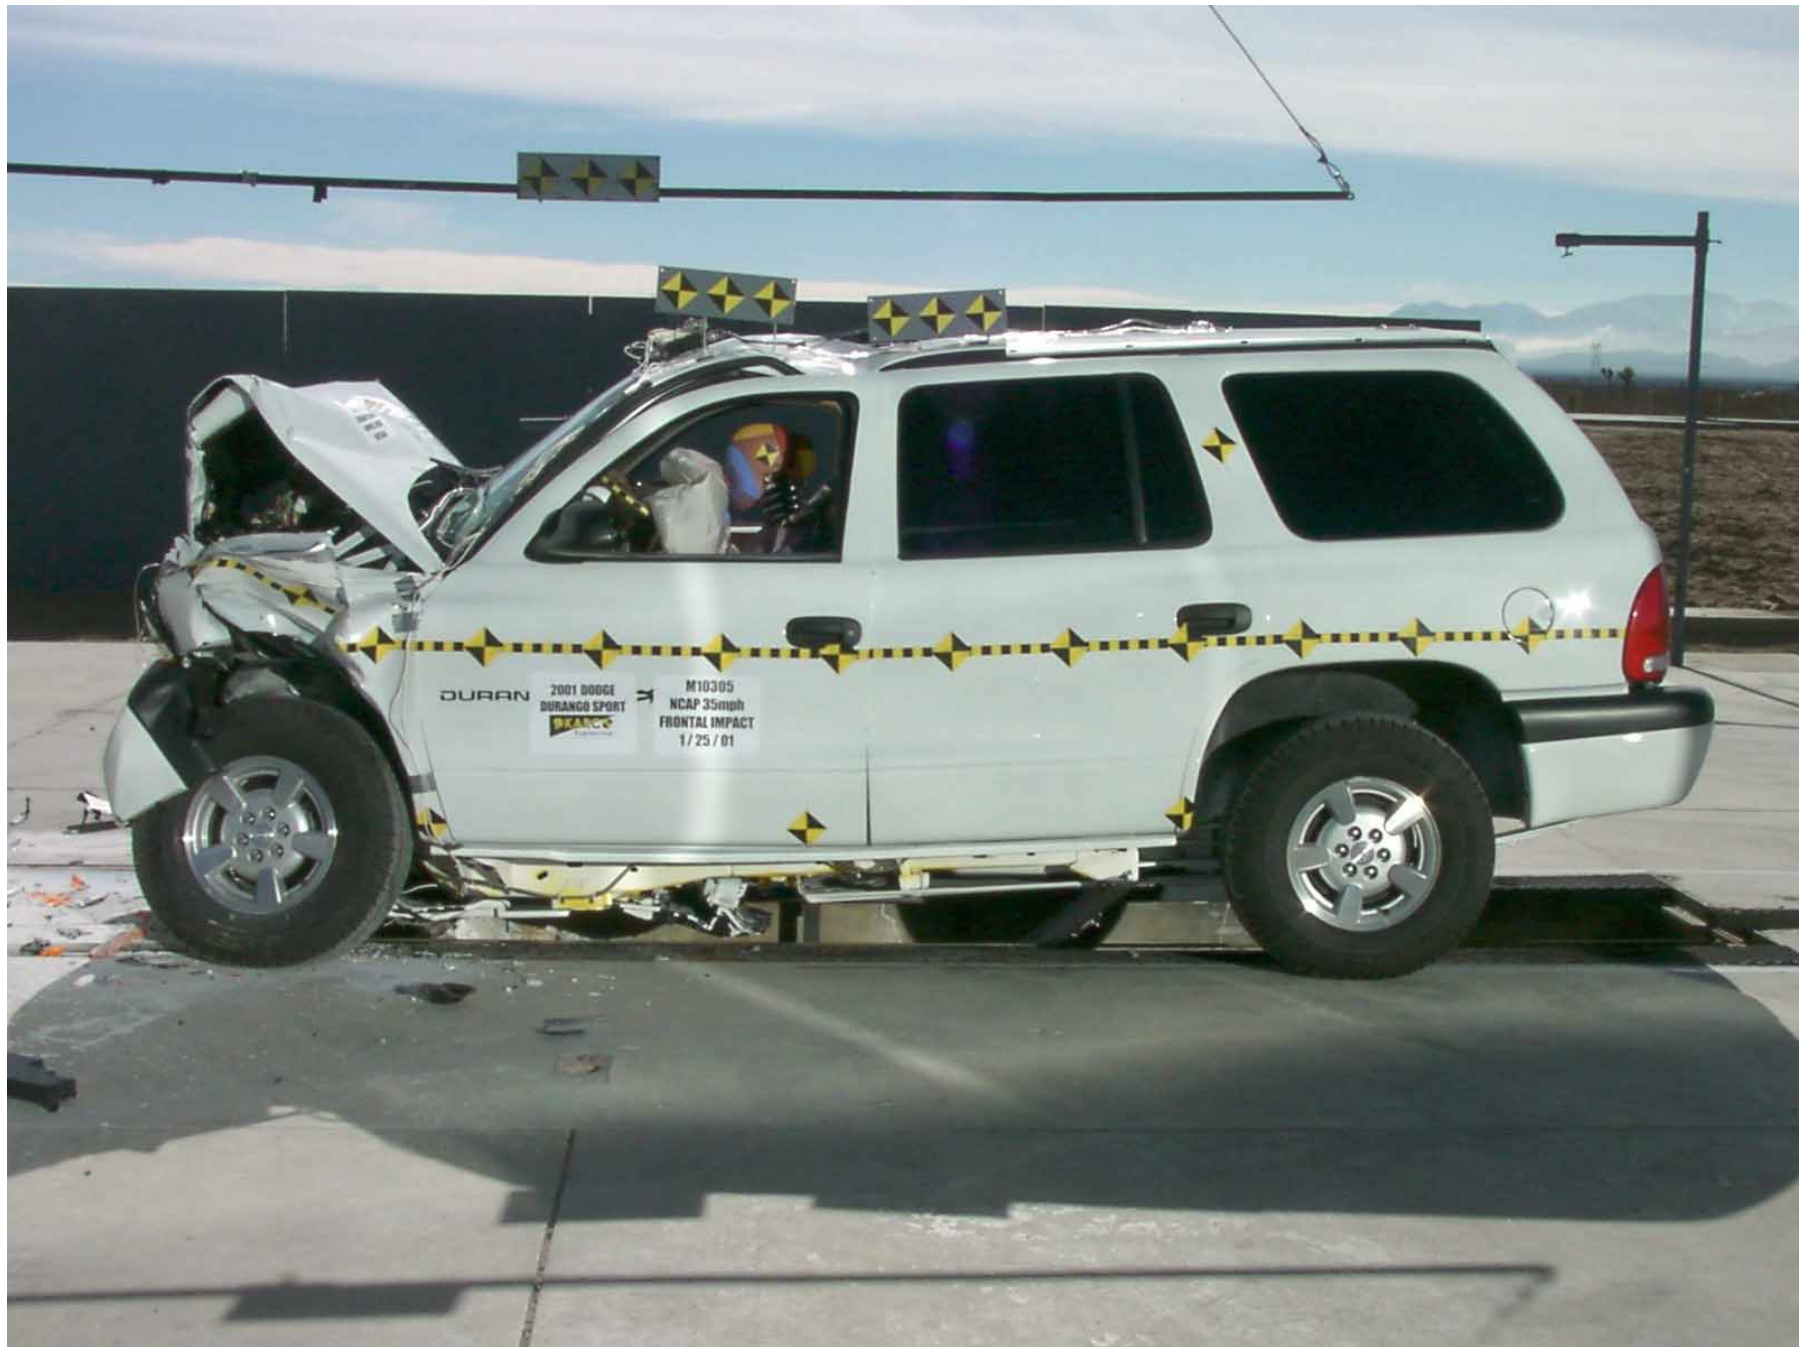
Figure A-8: Left Side View, Post-Test

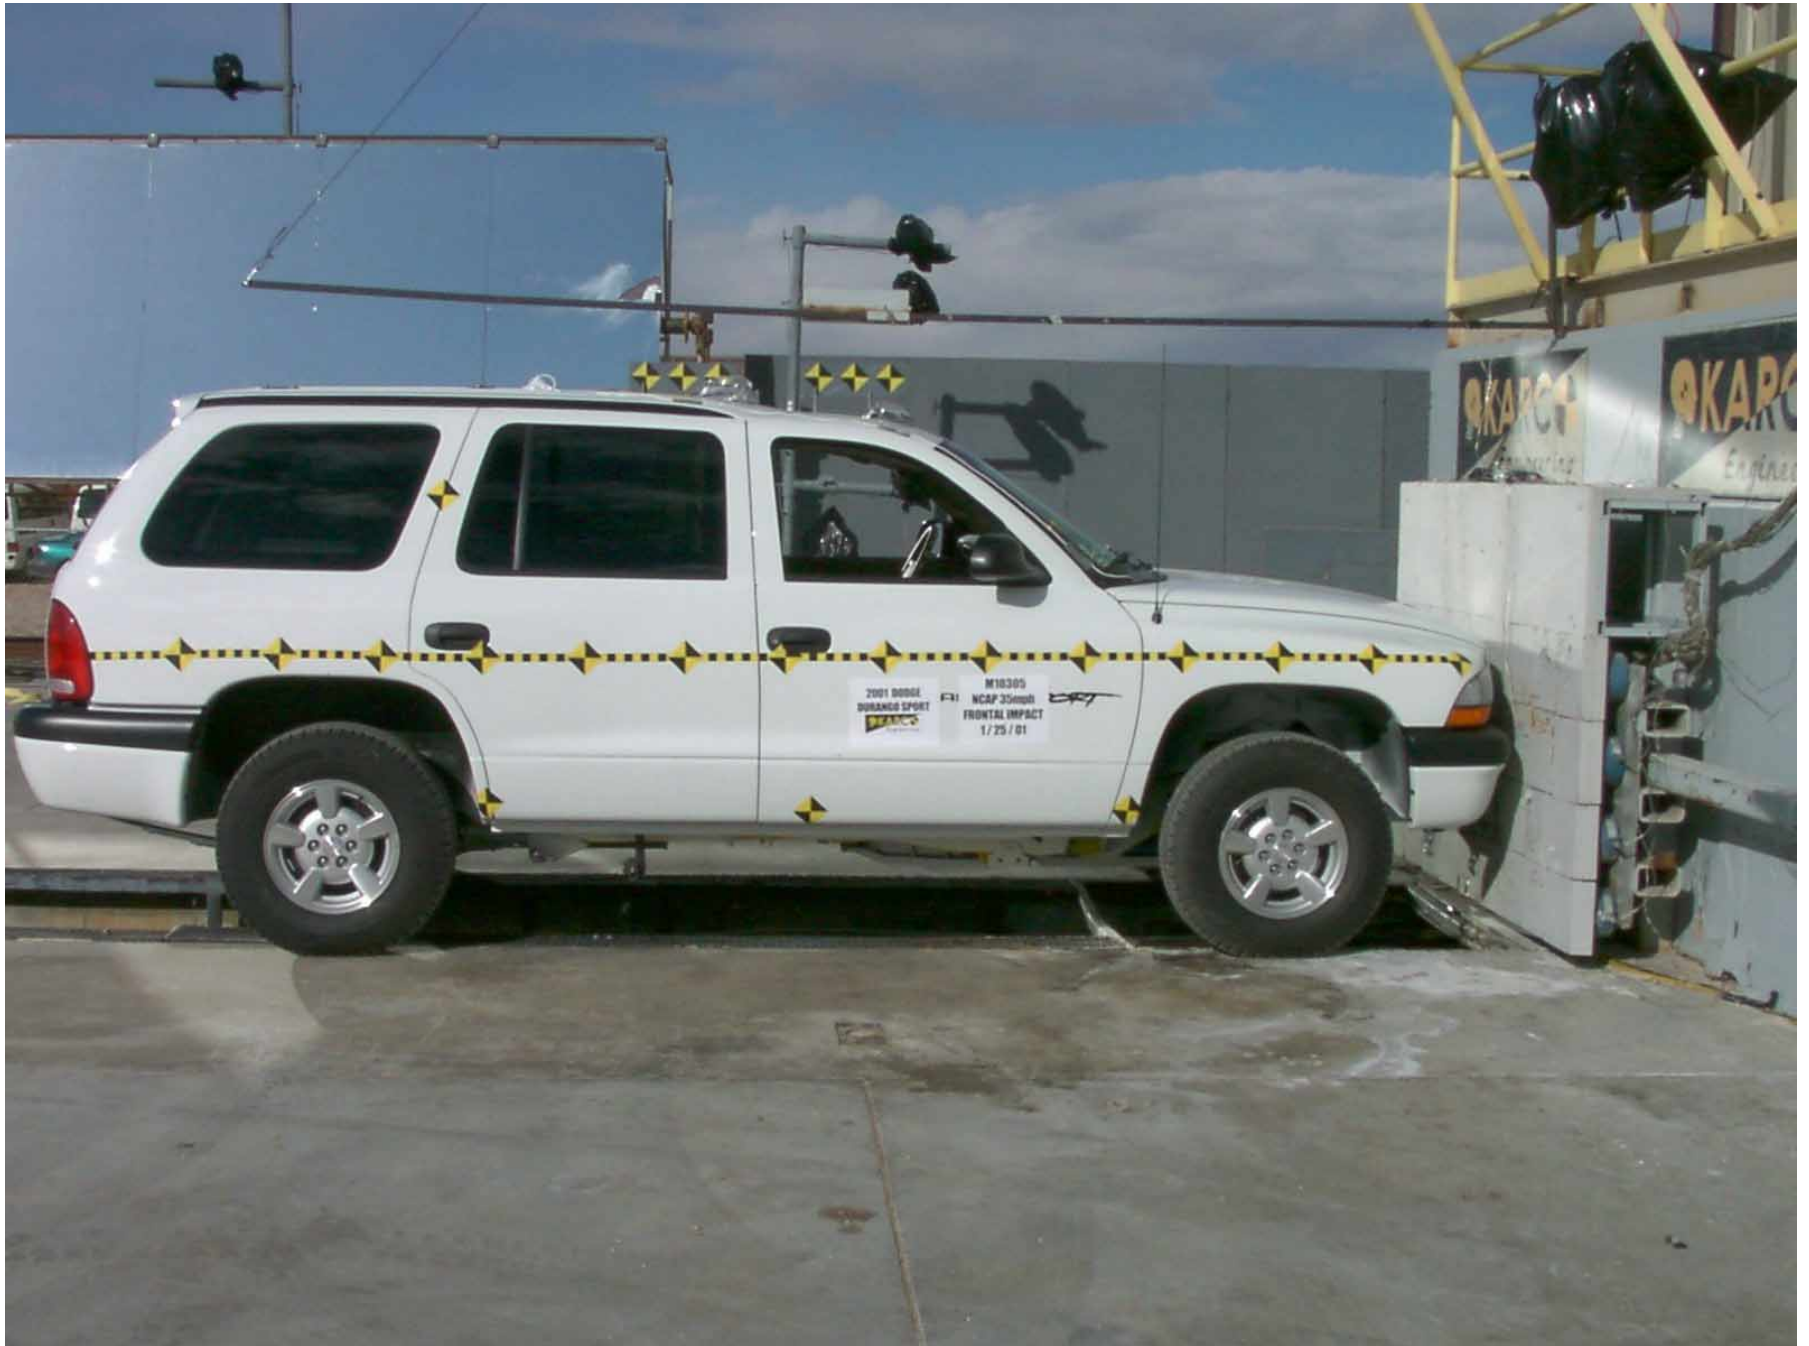
Figure A-9: Right Side View, Pre-Test

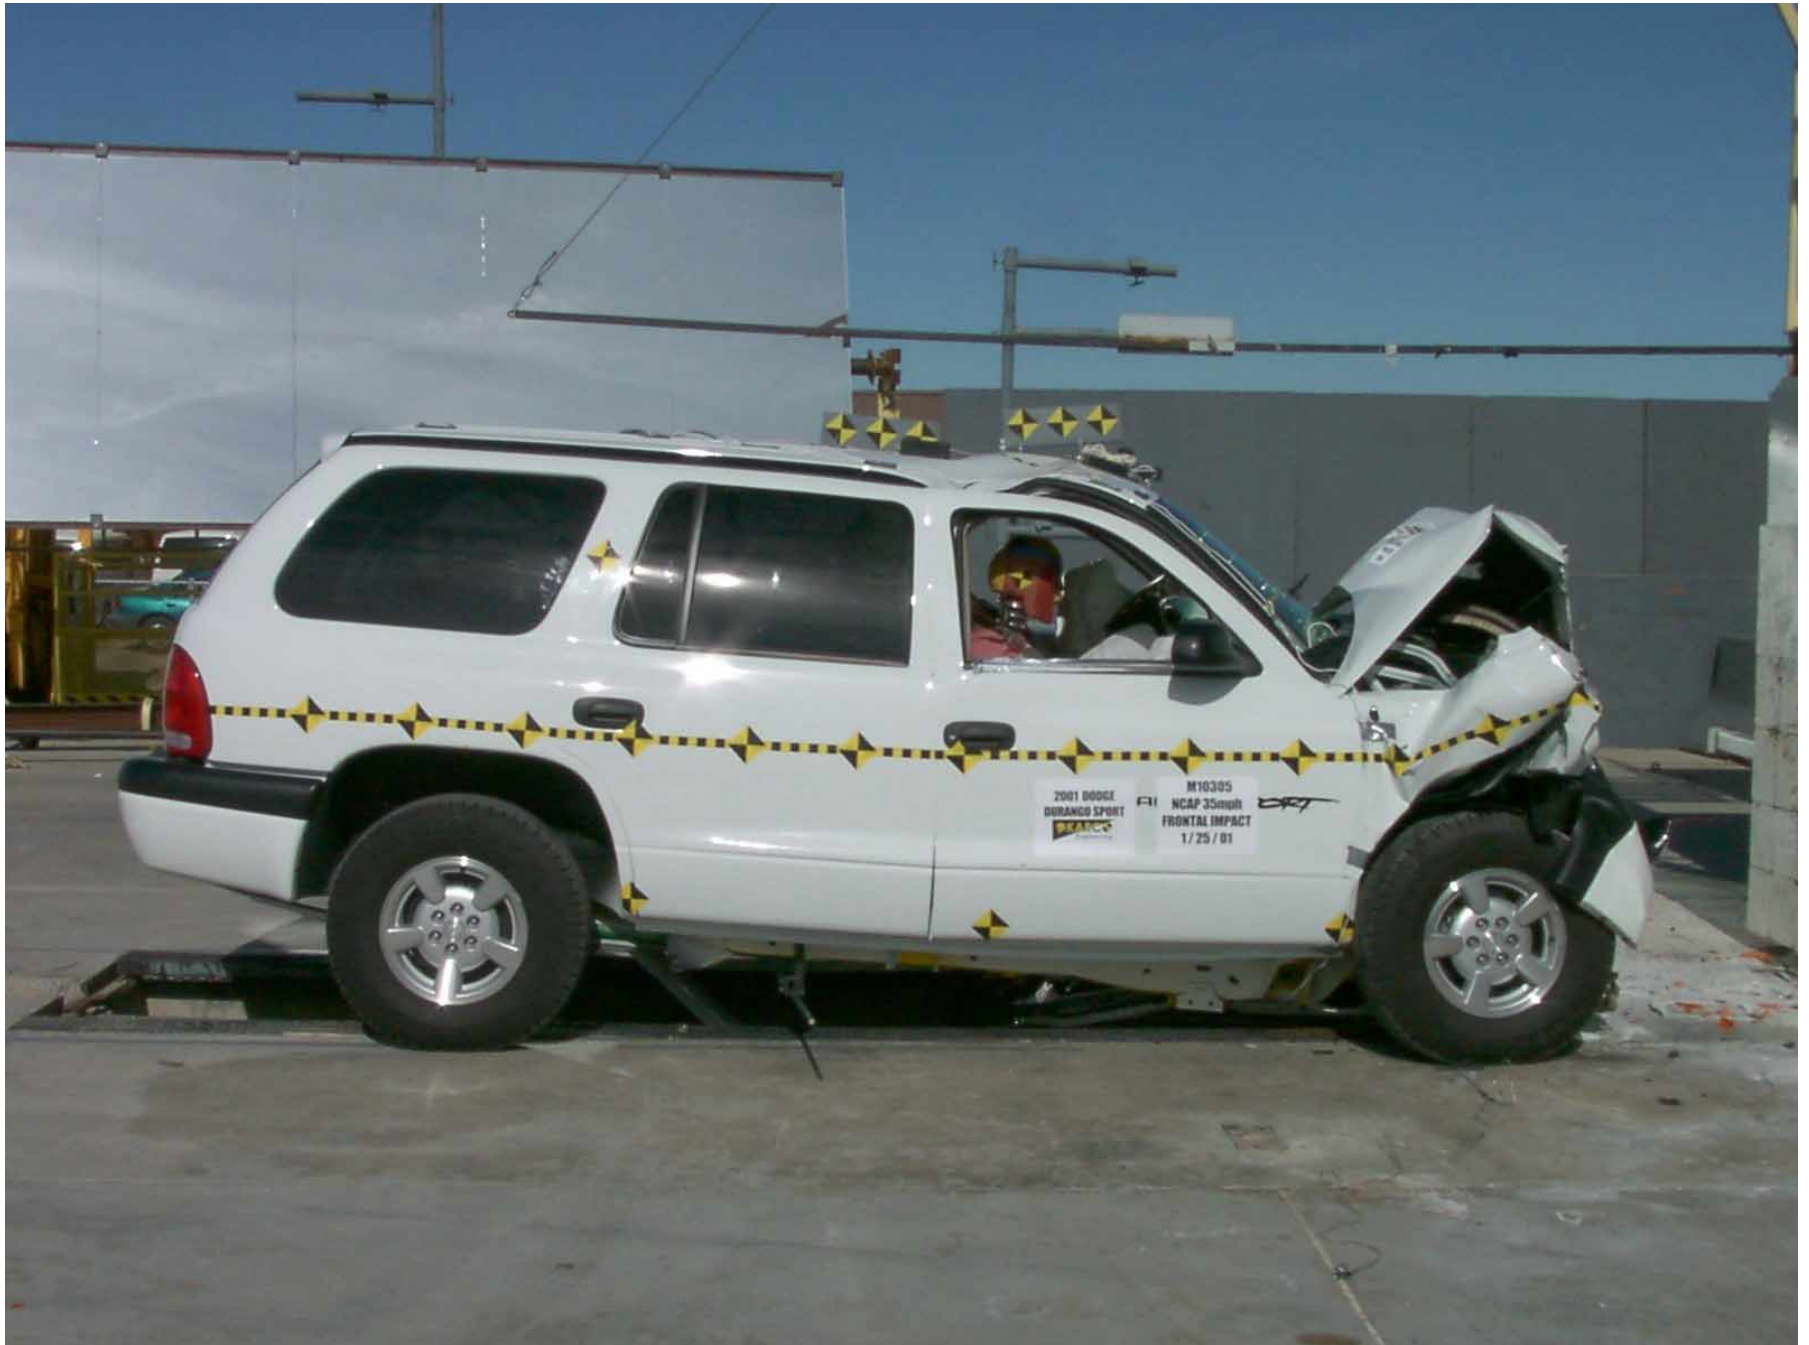
Figure A-10: Right Side View, Post-Test

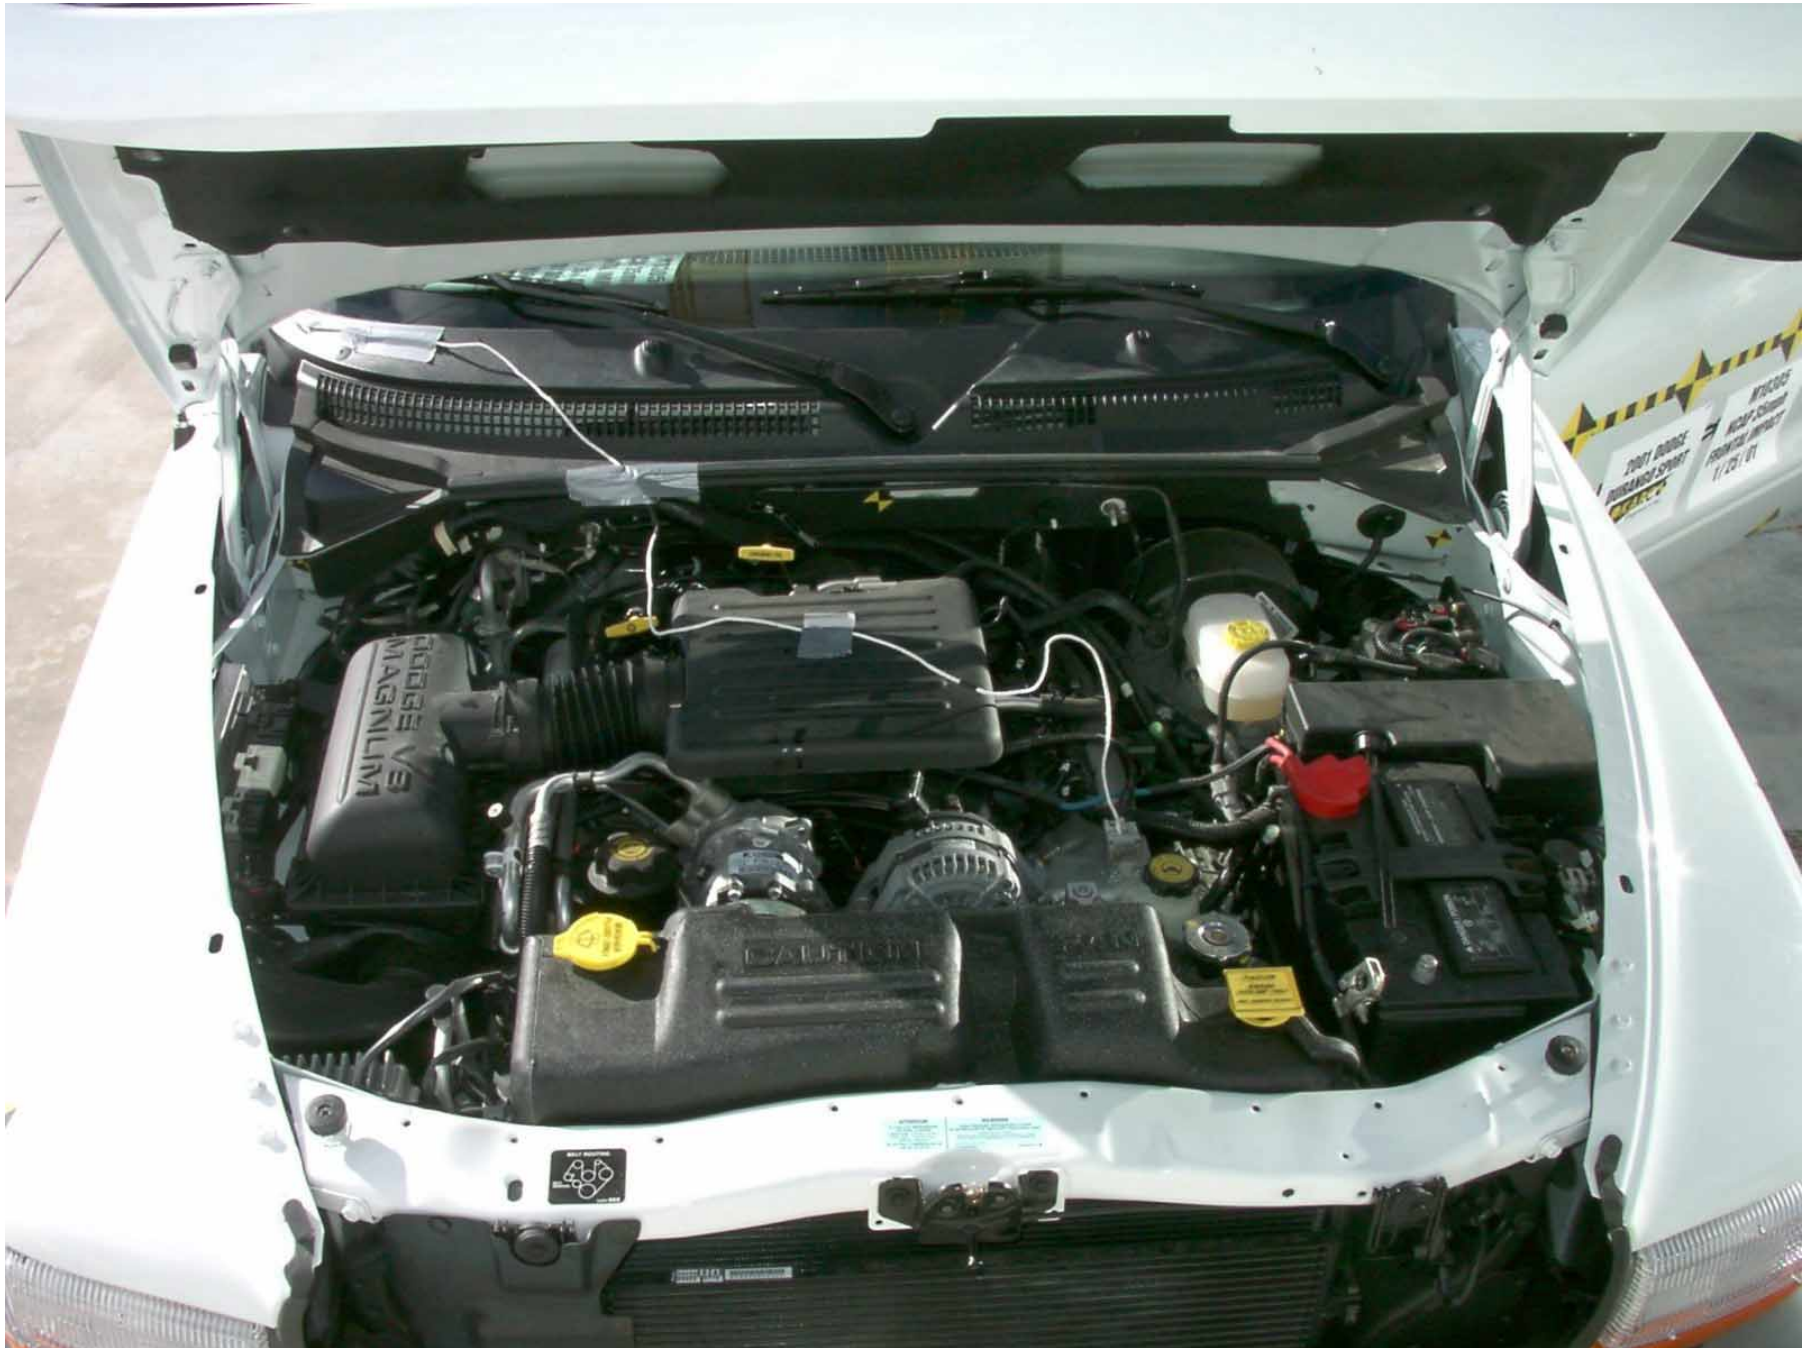
Figure A-17: Engine Compartment, Pre-Test
