**REPORT NUMBER KAR21001-08**

**NEW CAR ASSESSMENT PROGRAM  
FRONTAL BARRIER IMPACT TEST**

**DAIMLER CHRYSLER CORPORATION  
2001 DODGE DURANGO SPORT  
SUV  
NHTSA NUMBER: M10305**

**FINAL REPORT**

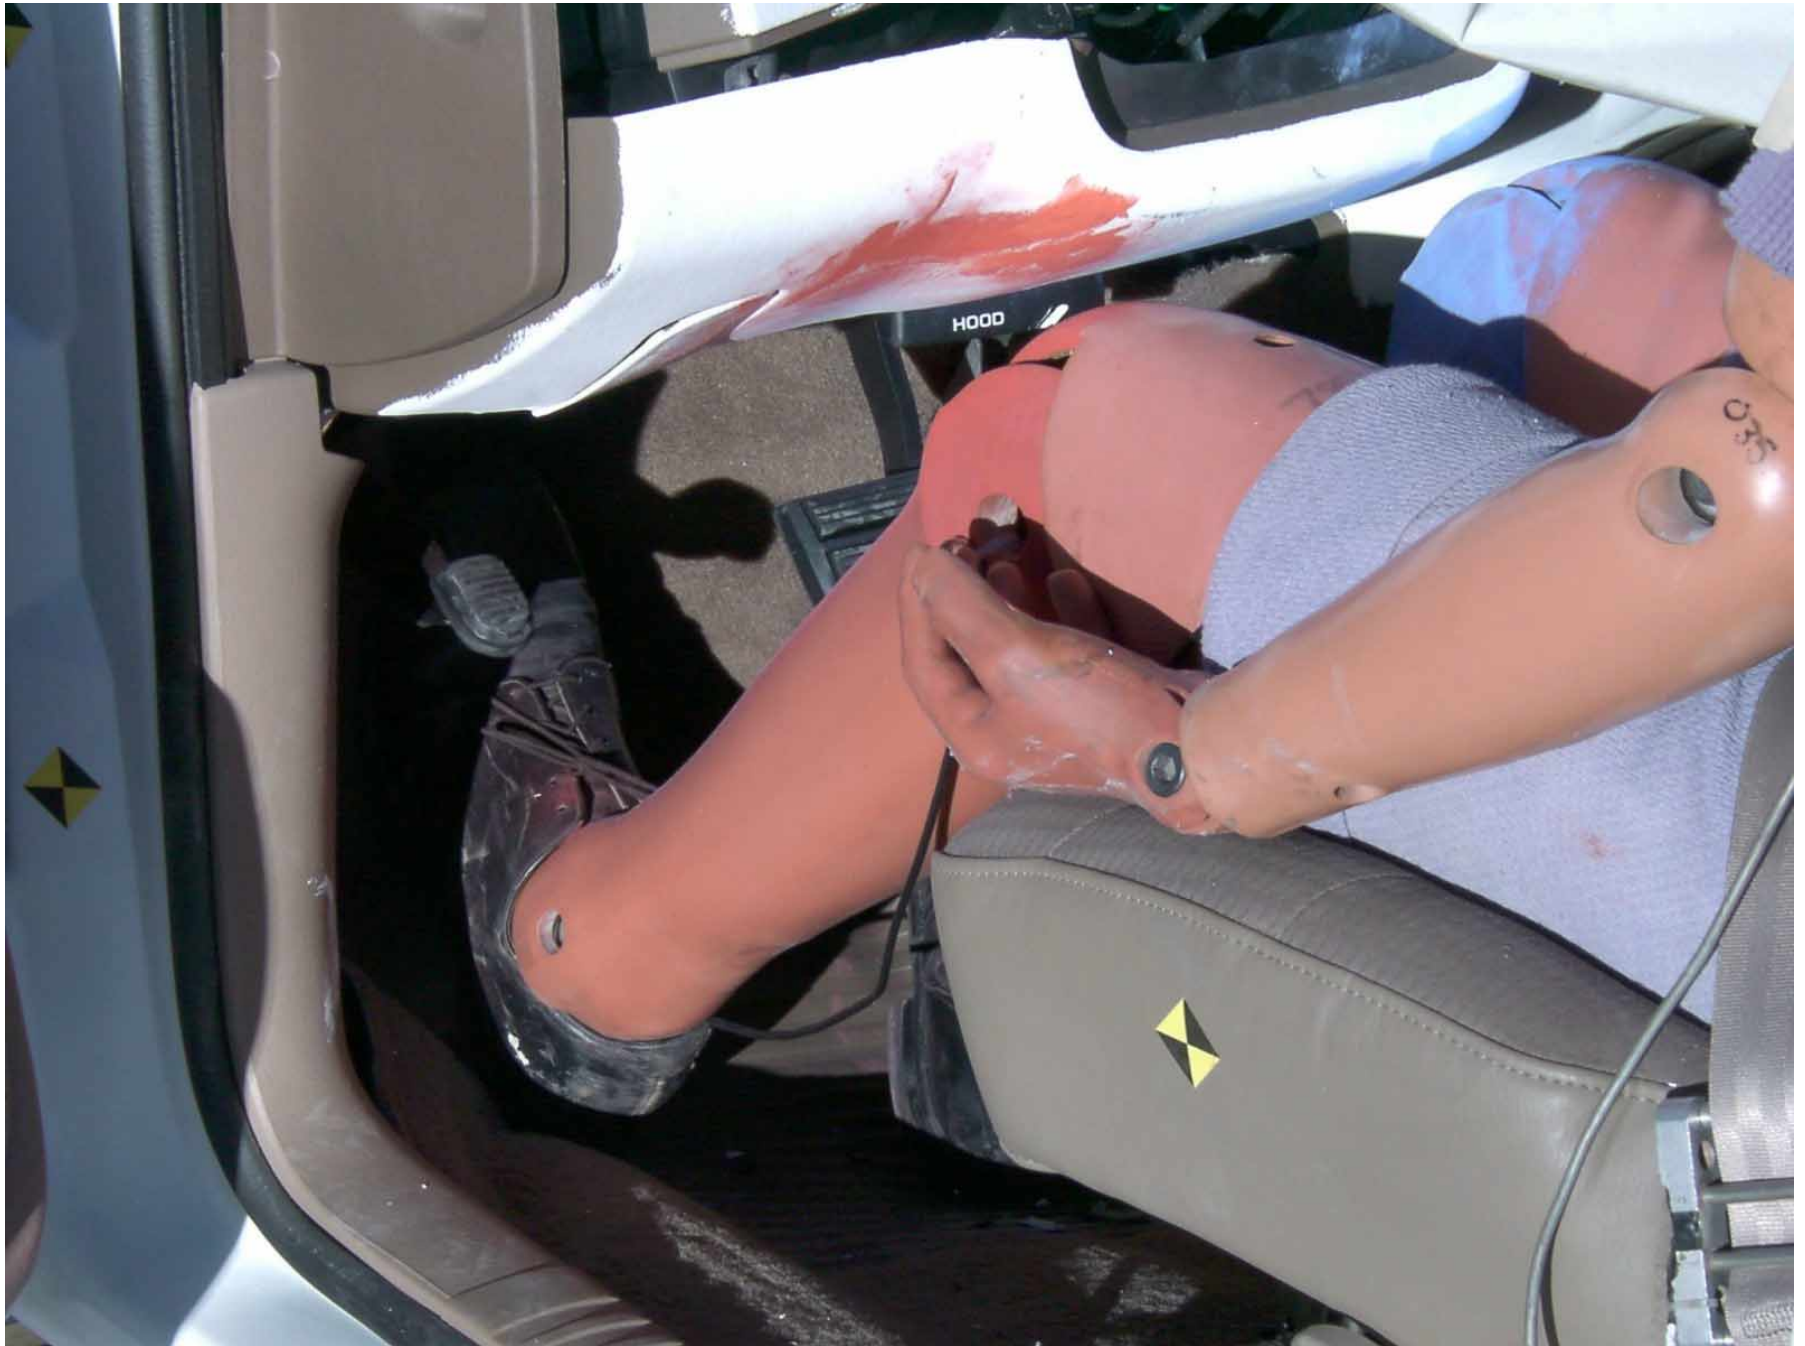
Figure A-34: Driver Dummy Feet and Knee Contact, Post-Test

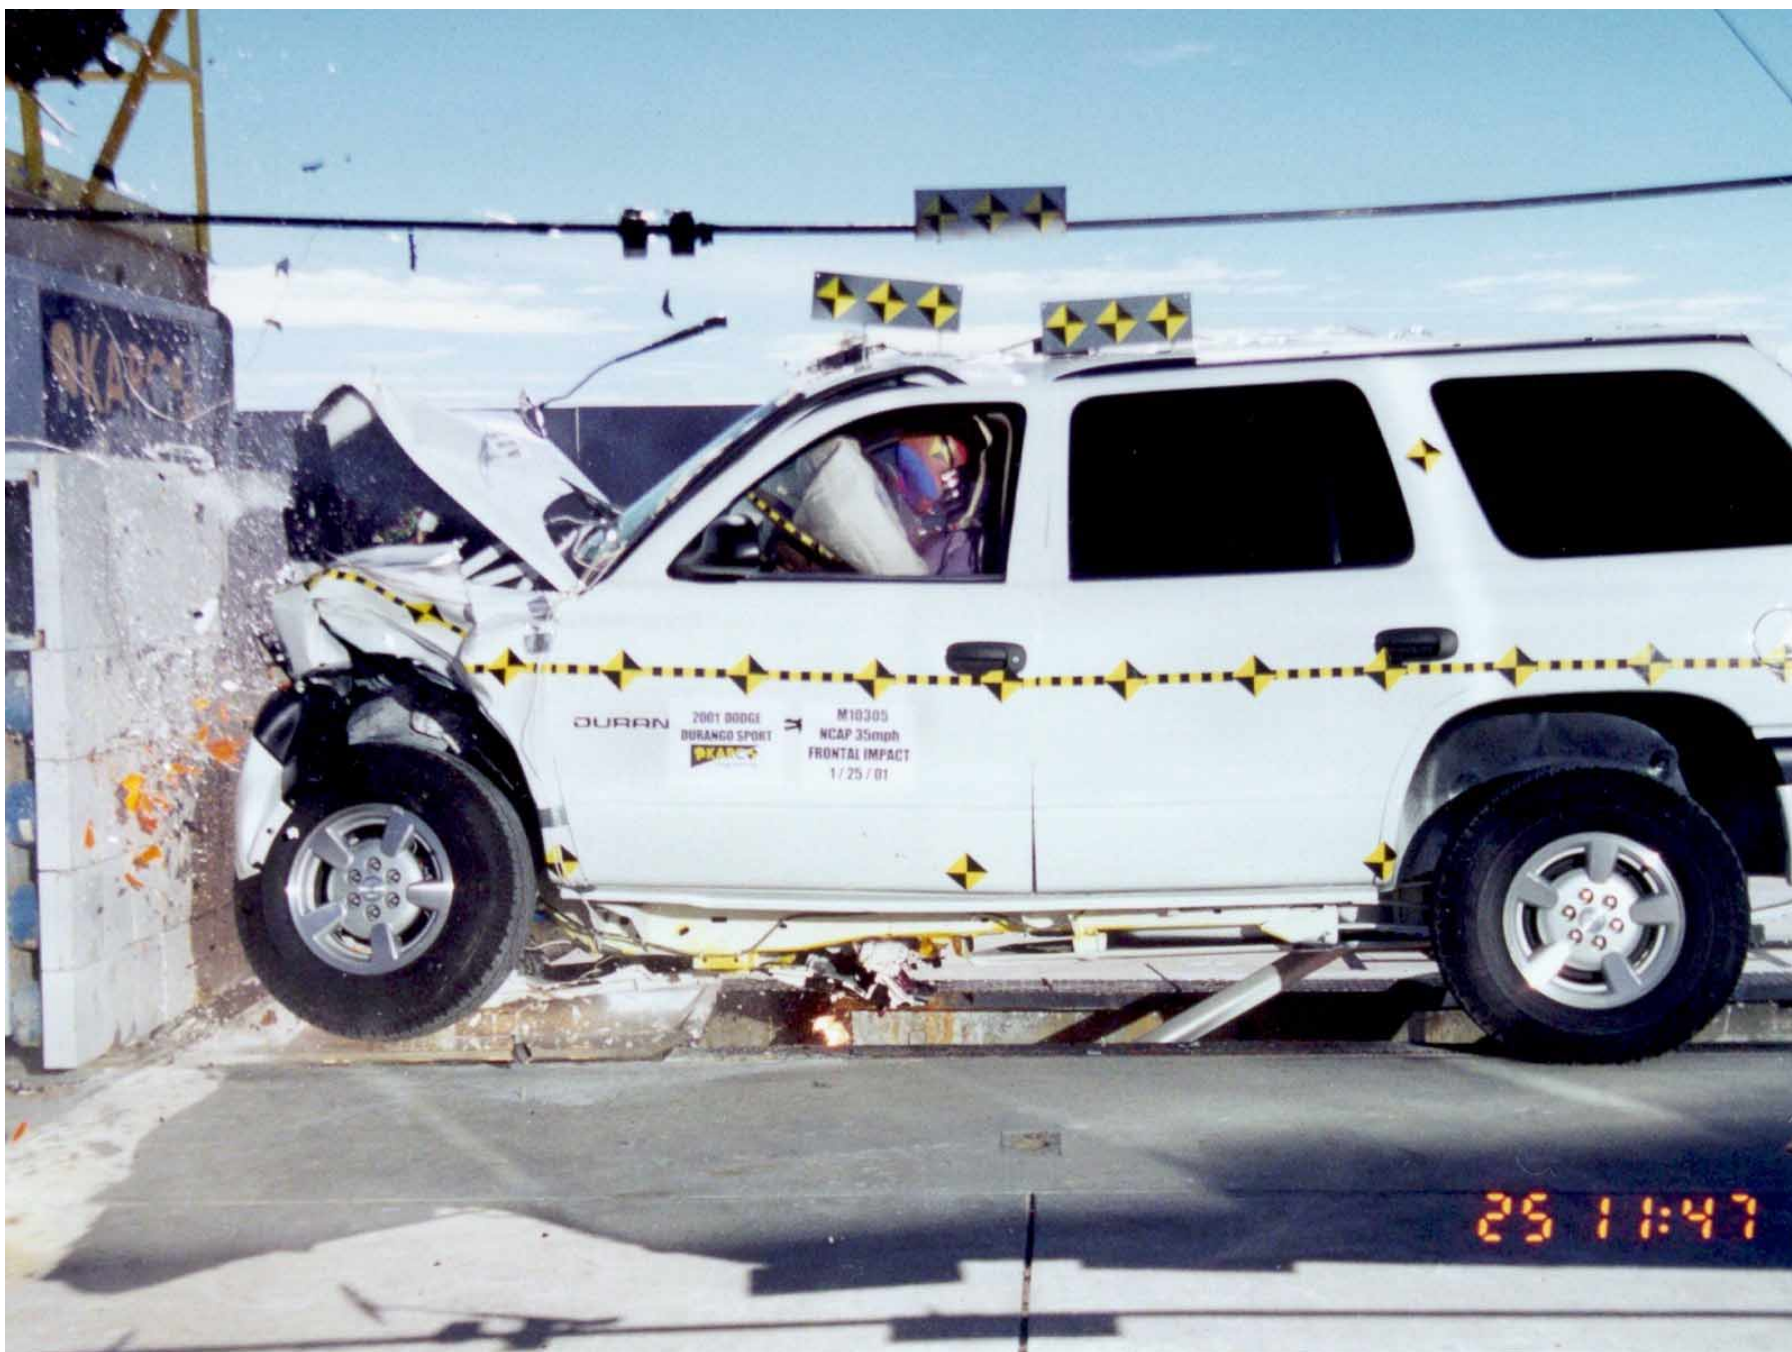
Figure A-58: Vehicle During Impact

The test was conducted at KARCO Engineering on January 25, 2001 at a speed of 55.74 km/h. The test vehicle was instrumented with eight (8) accelerometers to measure longitudinal axis accelerations. The driver and passenger's restraint systems were instrumented with four (4) seat belt load cells to measure lap and shoulder belt tension. The specified impact velocity range was 55.5 to 57.1 km/h. The frontal barrier impact event was documented by one (1) real-time panning motion picture camera and seventeen (17) high-speed motion picture cameras. The pre- and post-test conditions were recorded by one (1) real-time motion picture camera. Camera locations and pertinent camera information is documented in the data sheets. Pre- and post-test photographs of the vehicle and dummies can be found in Appendix A.
