**REPORT NUMBER KAR21003-09**

**NEW CAR ASSESSMENT PROGRAM  
SIDE IMPACT TEST**

**GENERAL MOTORS CORPORATION  
2001 BUICK PARK AVENUE  
4 DOOR SEDAN  
NHTSA NUMBER: M10118**

**PREPARED BY:  
KARCO ENGINEERING  
9270 HOLLY ROAD  
ADELANTO, CALIFORNIA 92301**

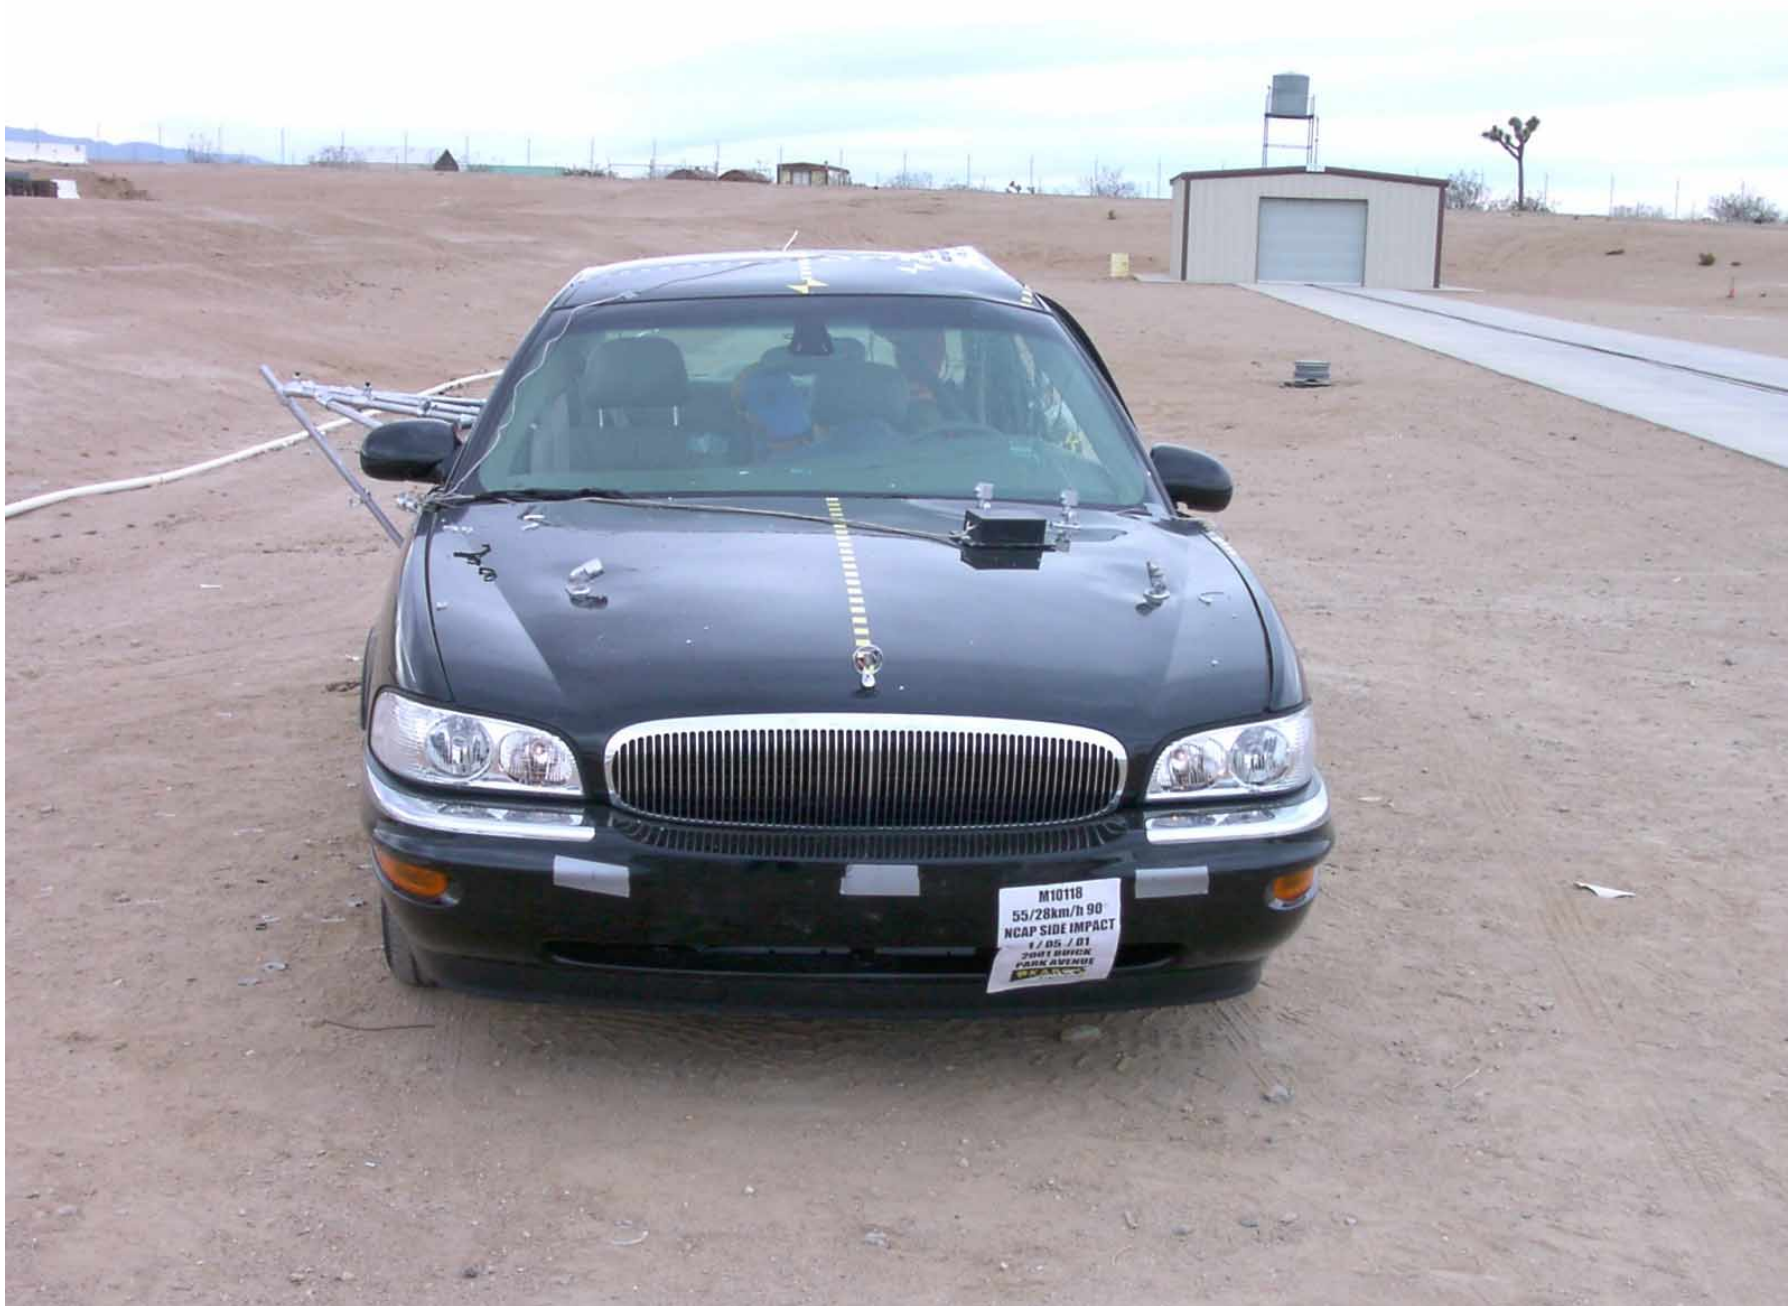
Figure A-6: Front View, Post-Test

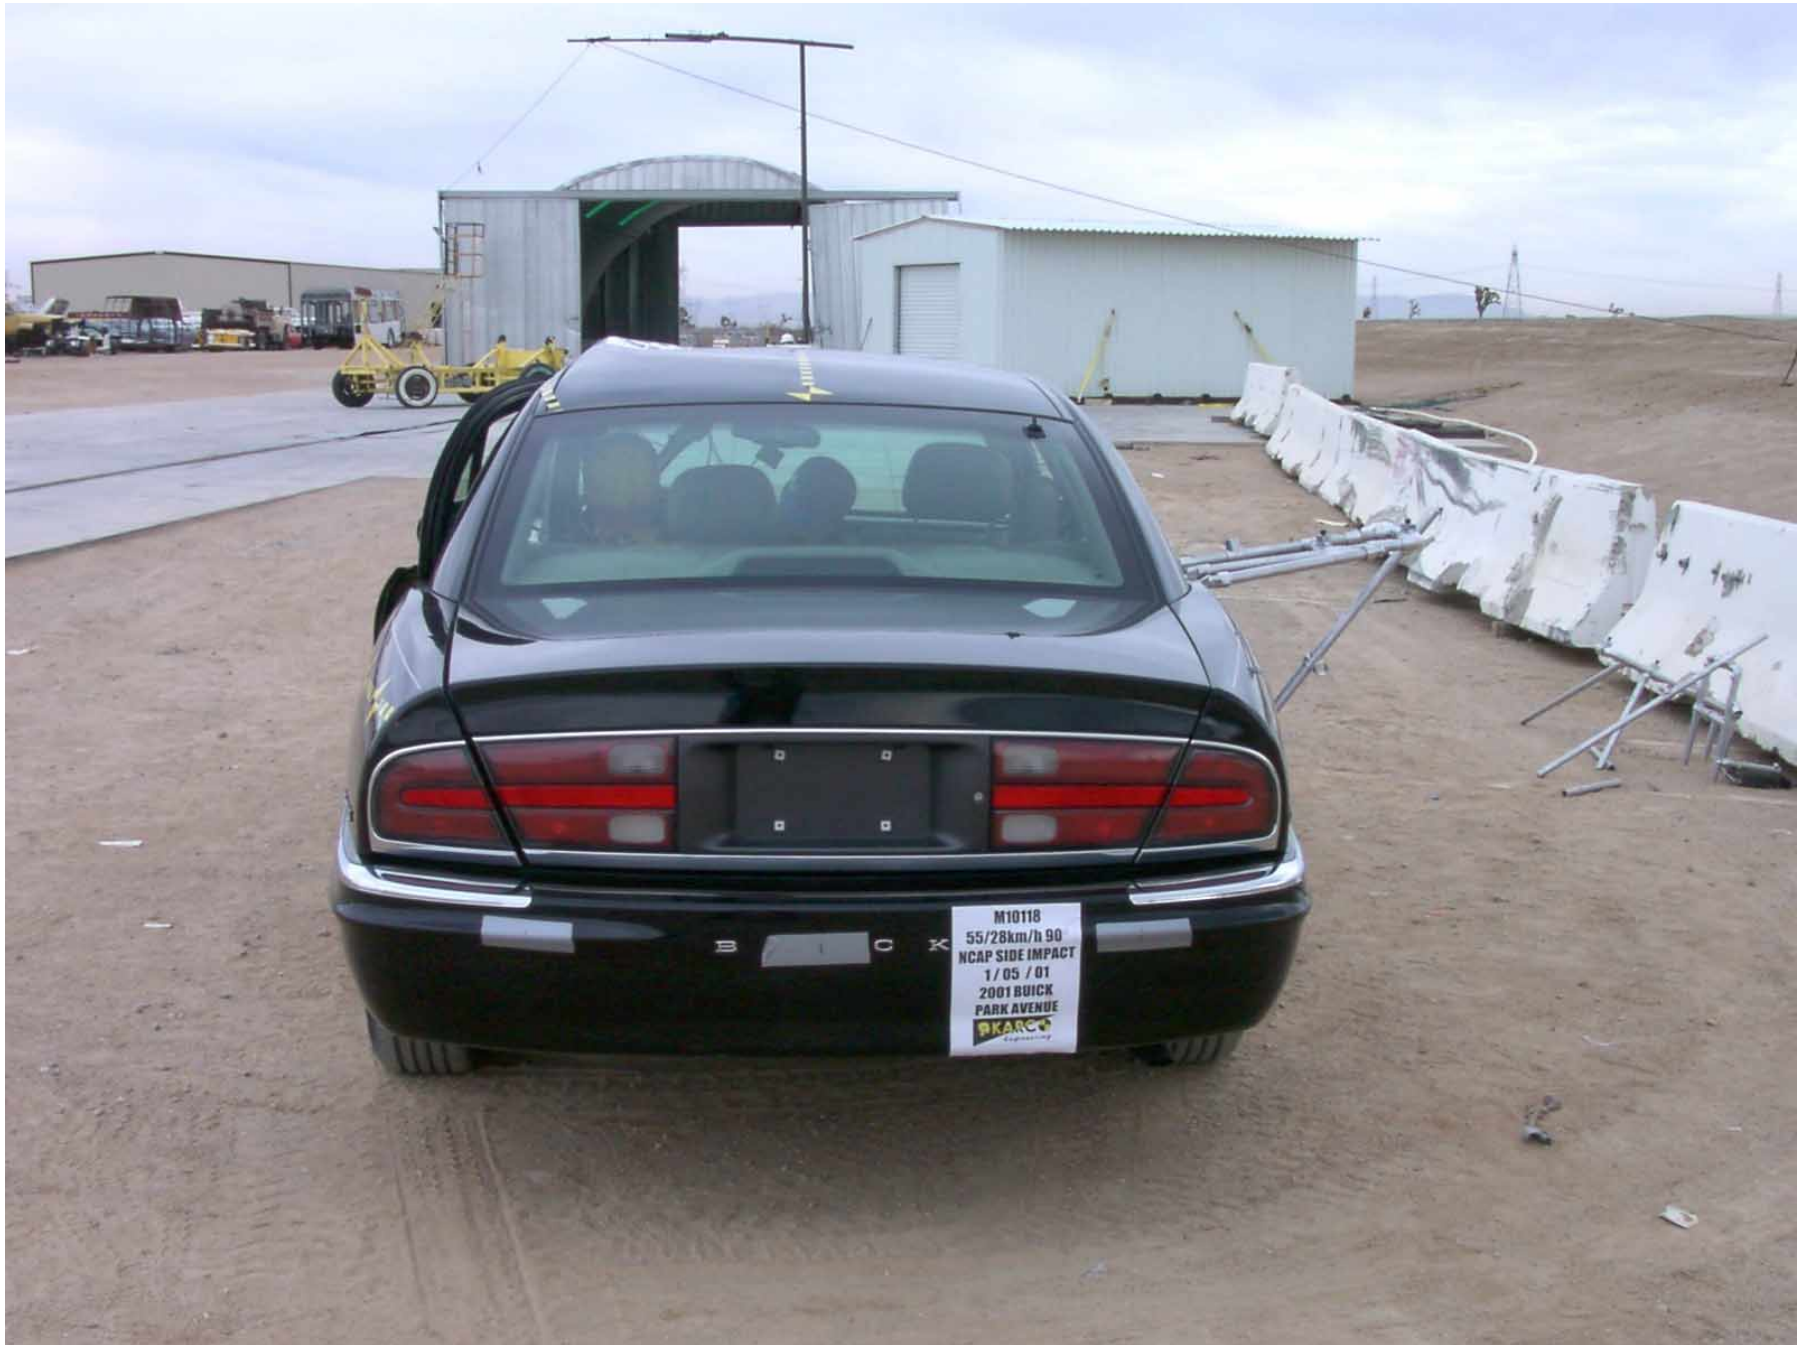
Figure A-8: Rear View, Post-Test

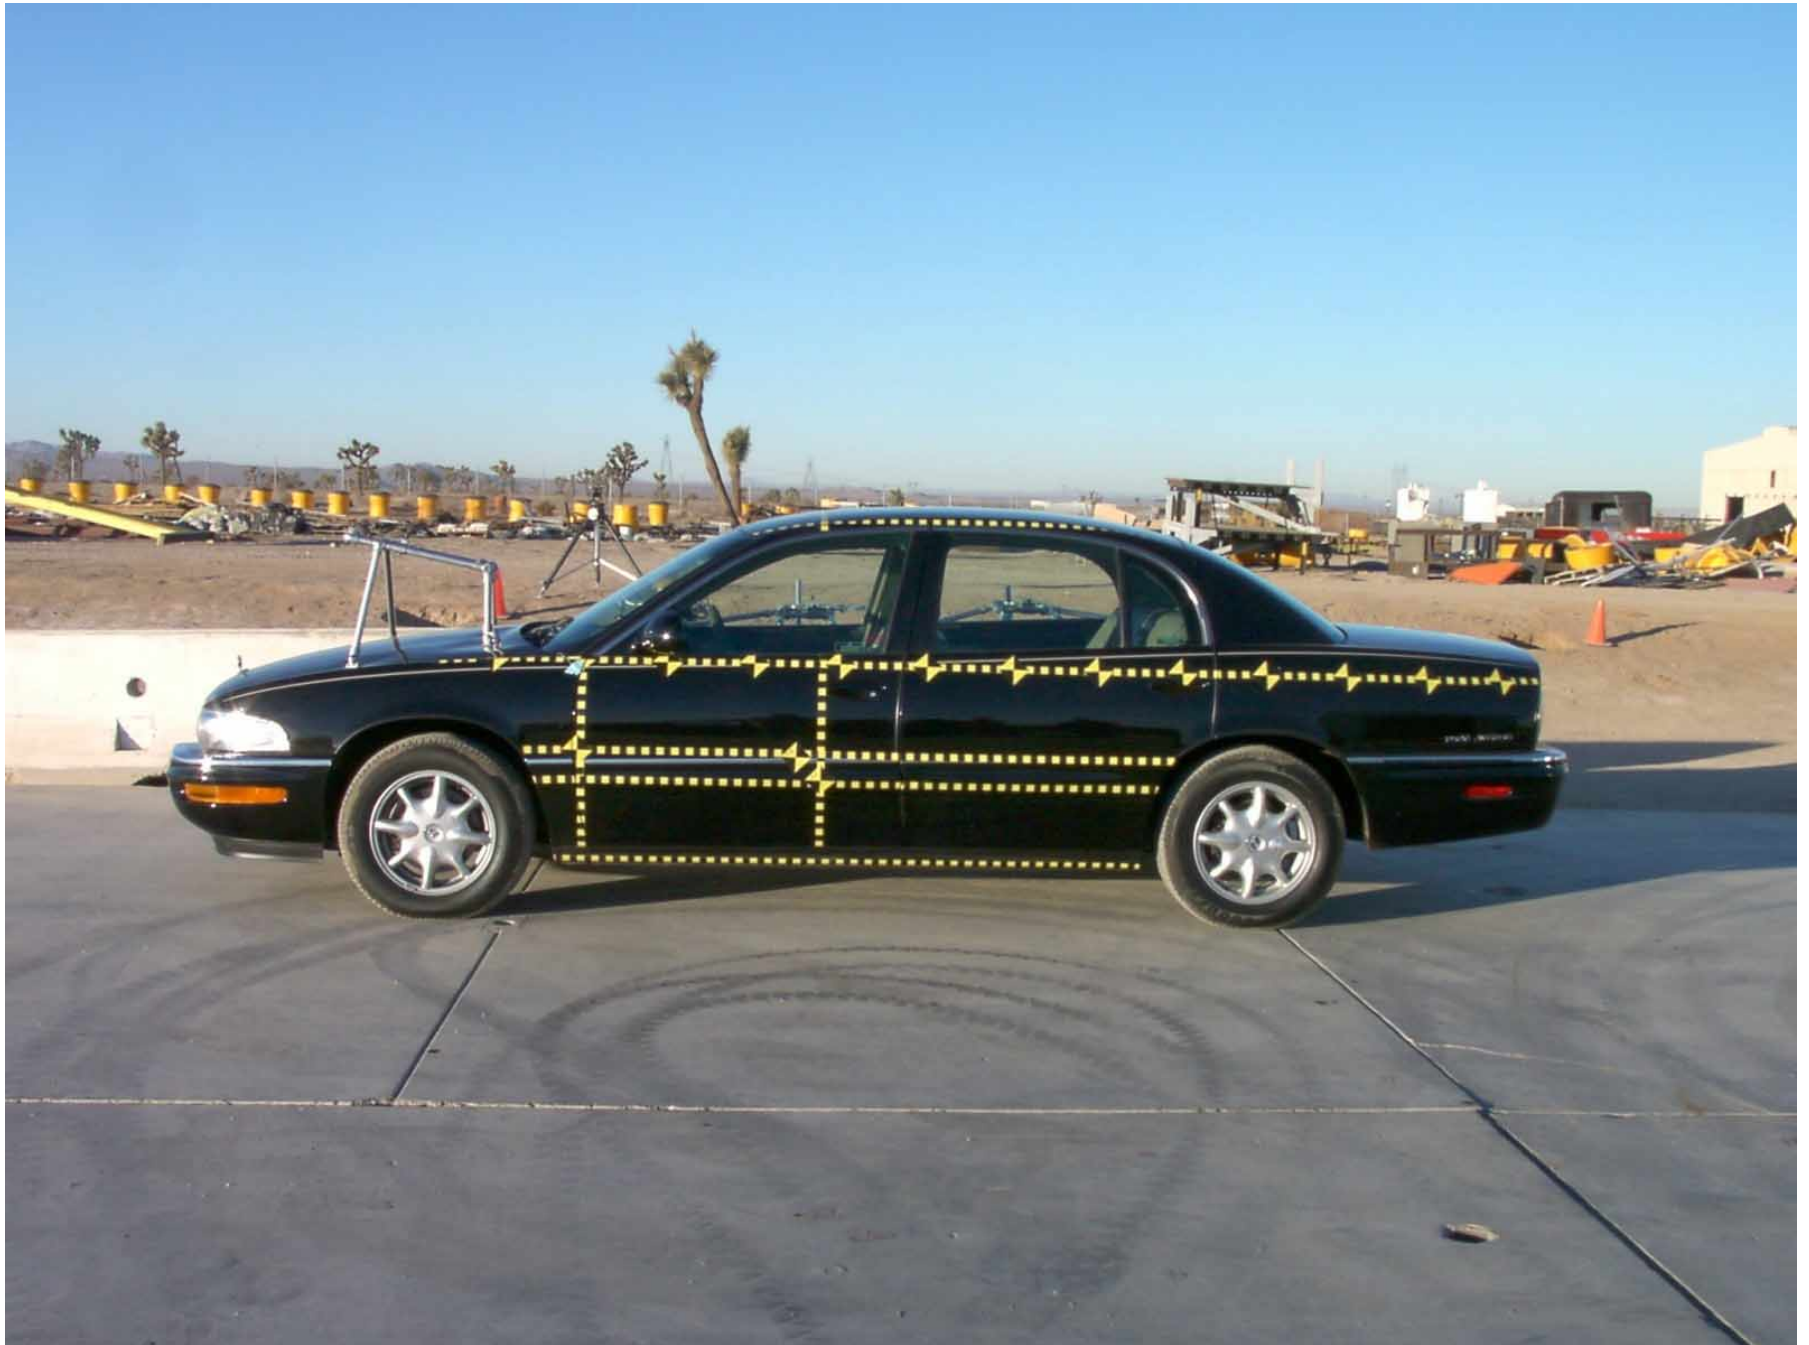
Figure A-9: Left (Impacted) Side View, Pre-Test

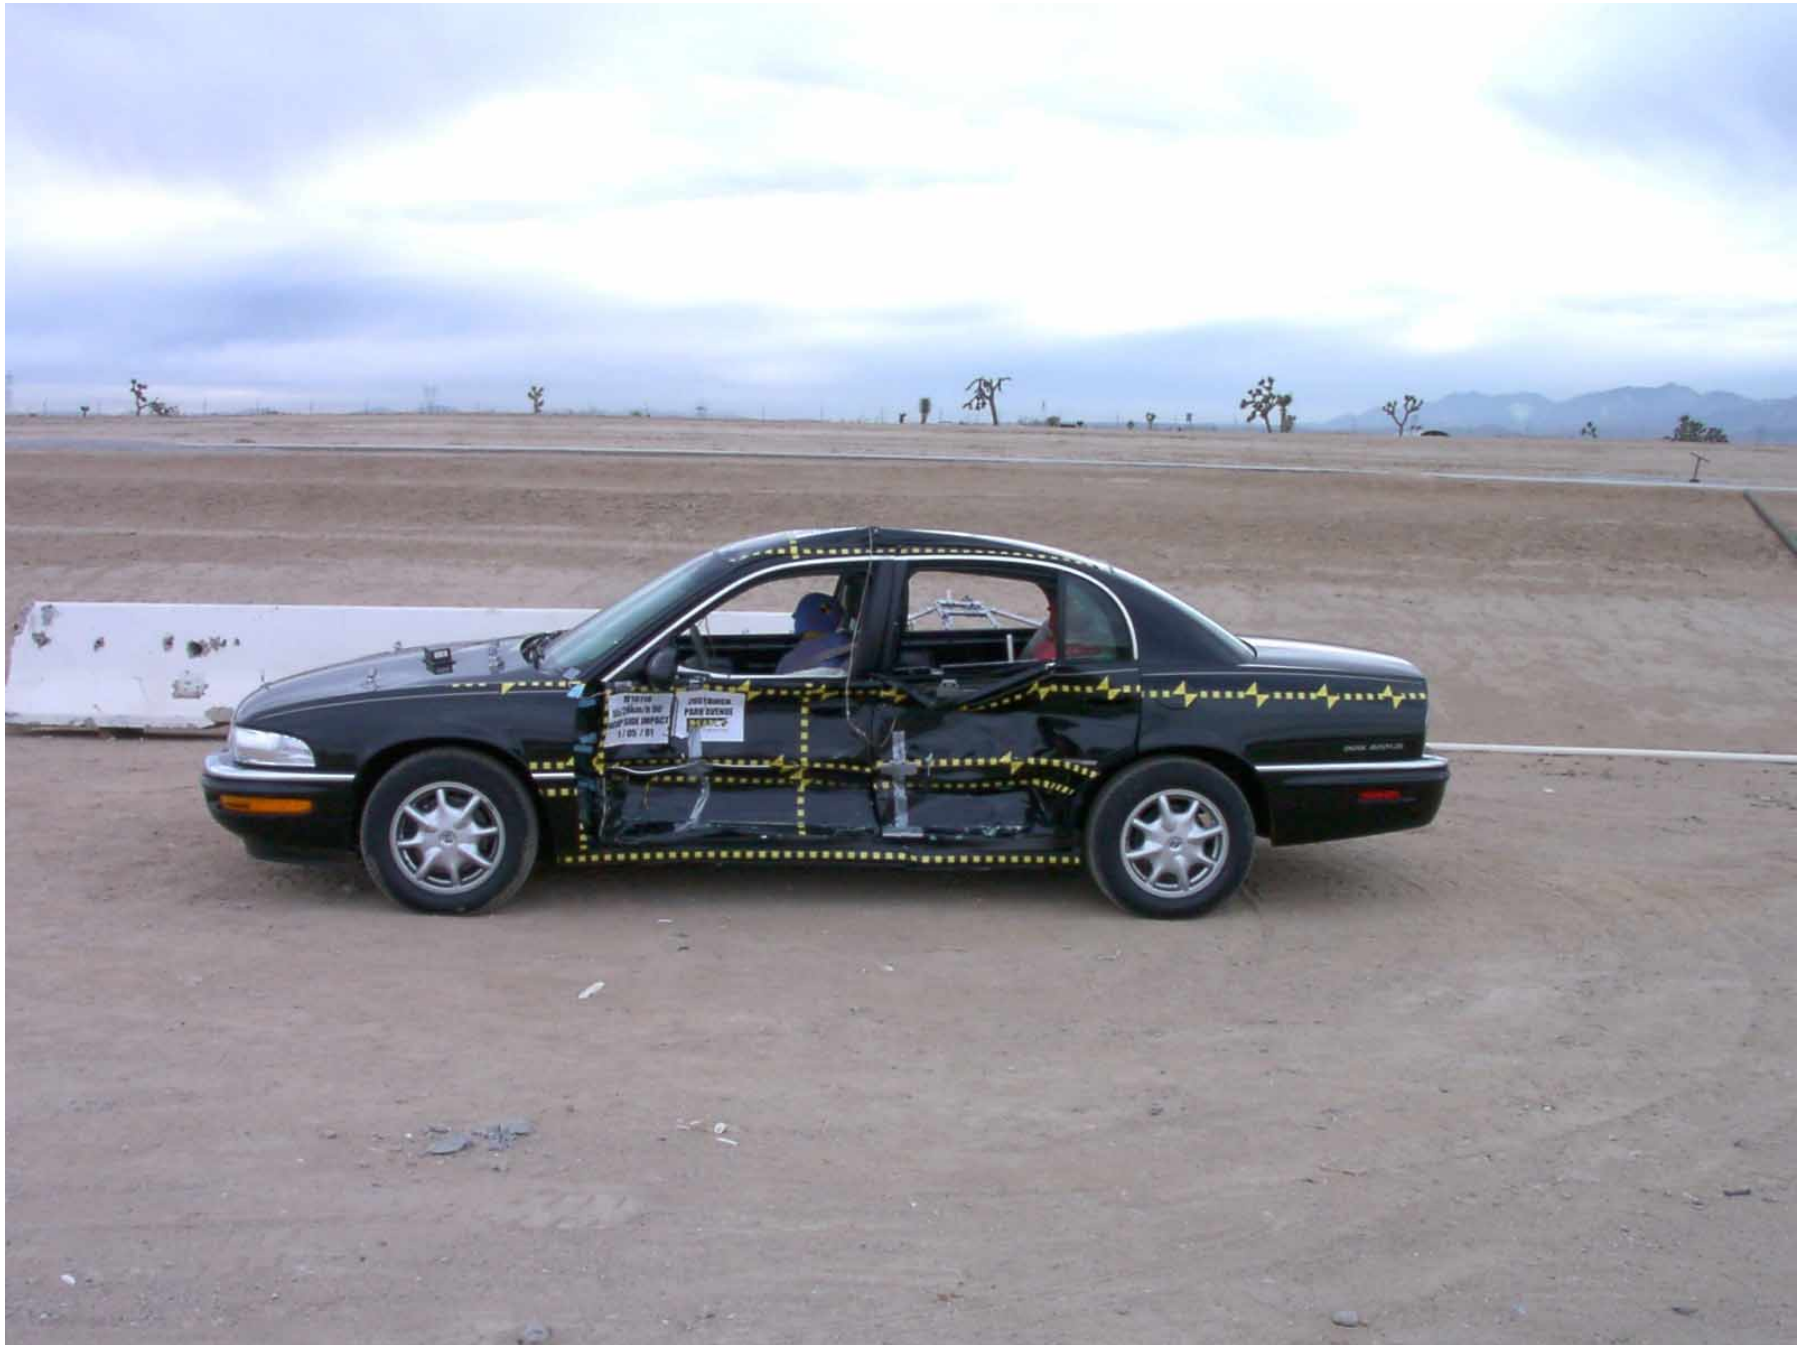
Figure A-10: Left (Impacted) Side View, Post-Test

| Critical Areas of Performance | Observations and Conclusions |
|---|---|
| Pillar Performance | Pillars pushed inward with no apparent failure |
| Sill Separation | No Apparent Visible Failure |
| Windshield Damage | Glazing Cracks on Struck Side Only |
| Window Damage | Both Left Side Windows Broke |

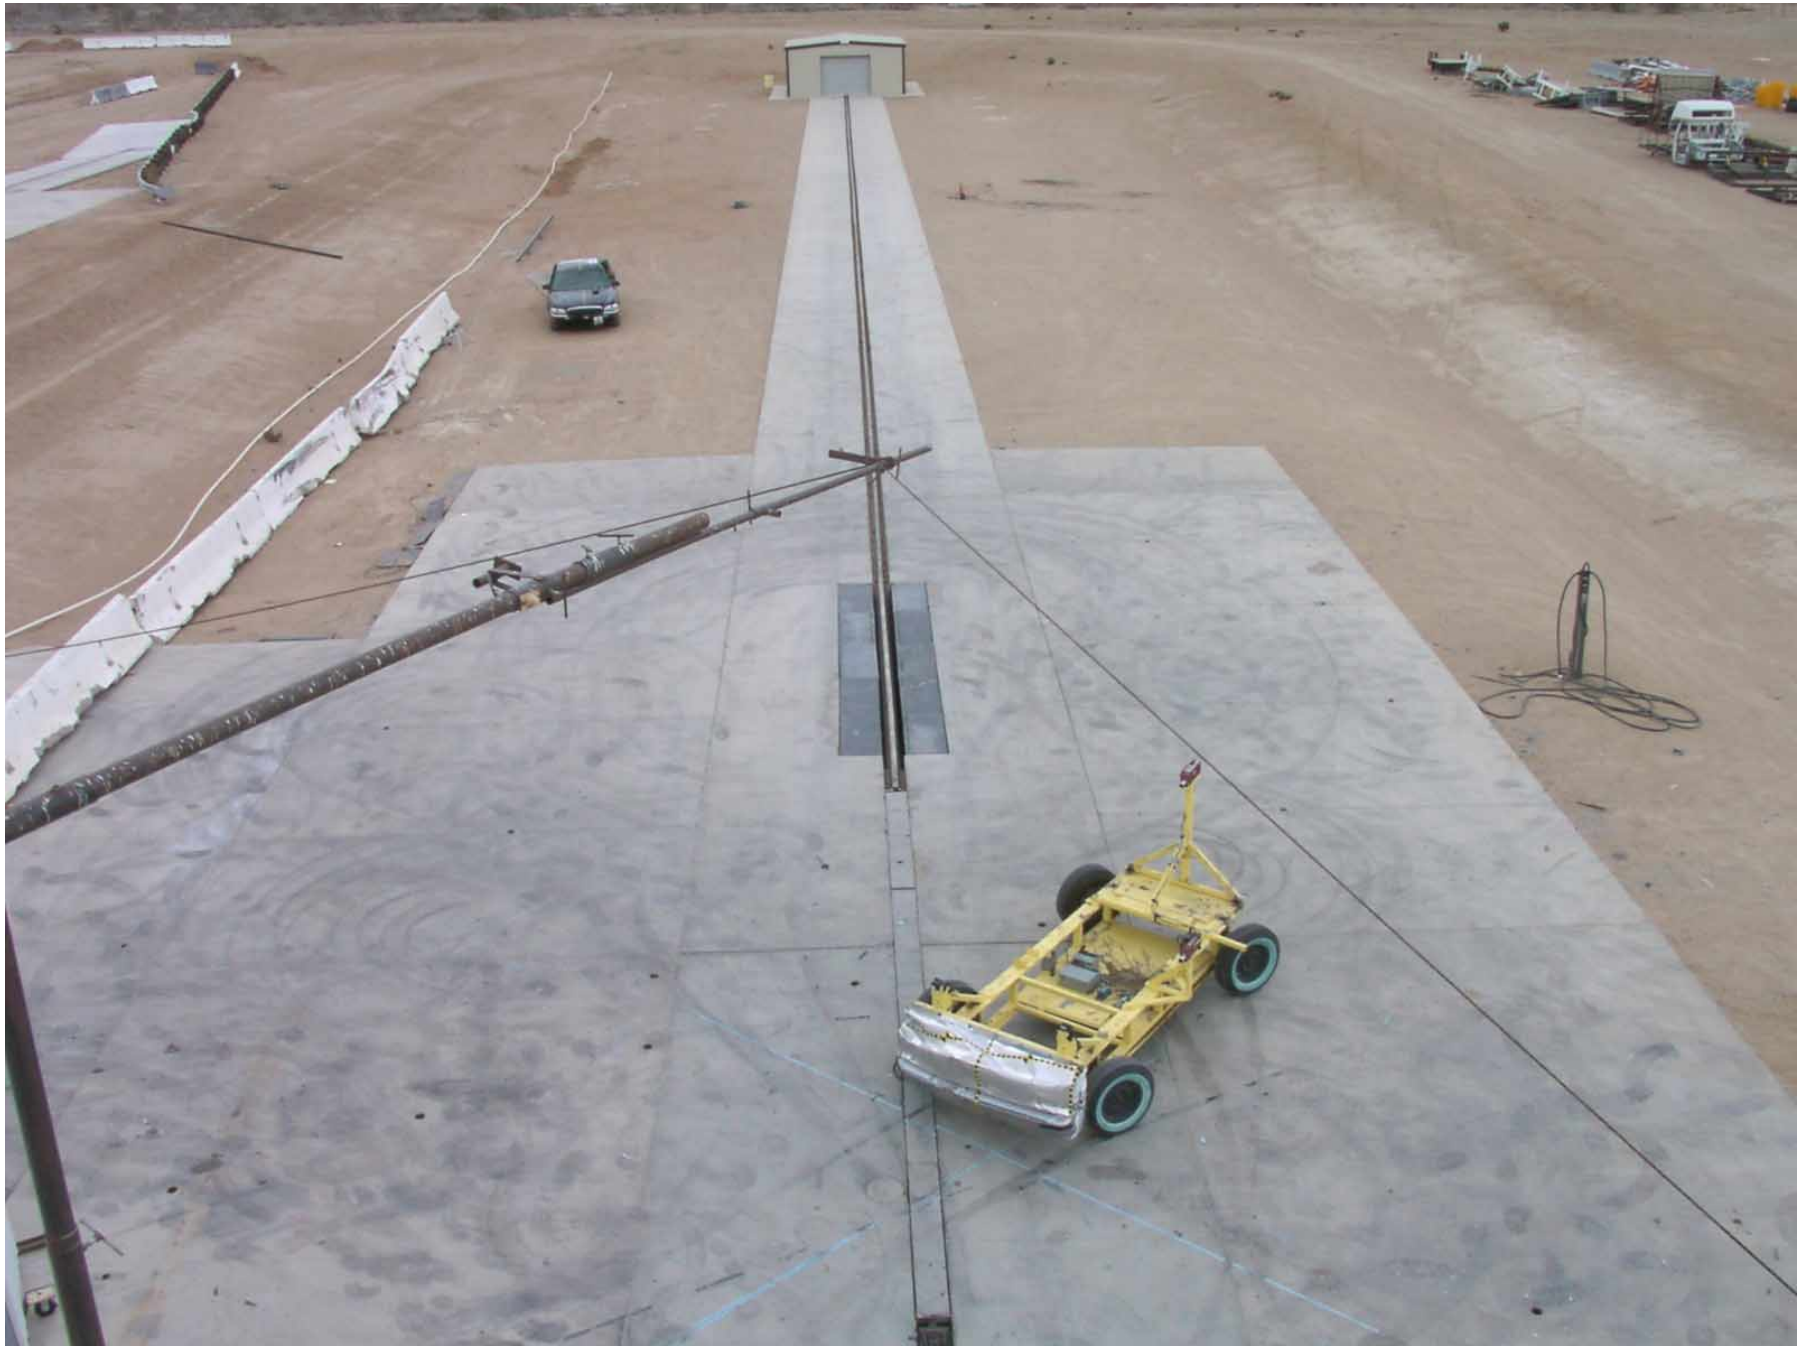
Figure A-13: Overhead Overall View, Post-Test

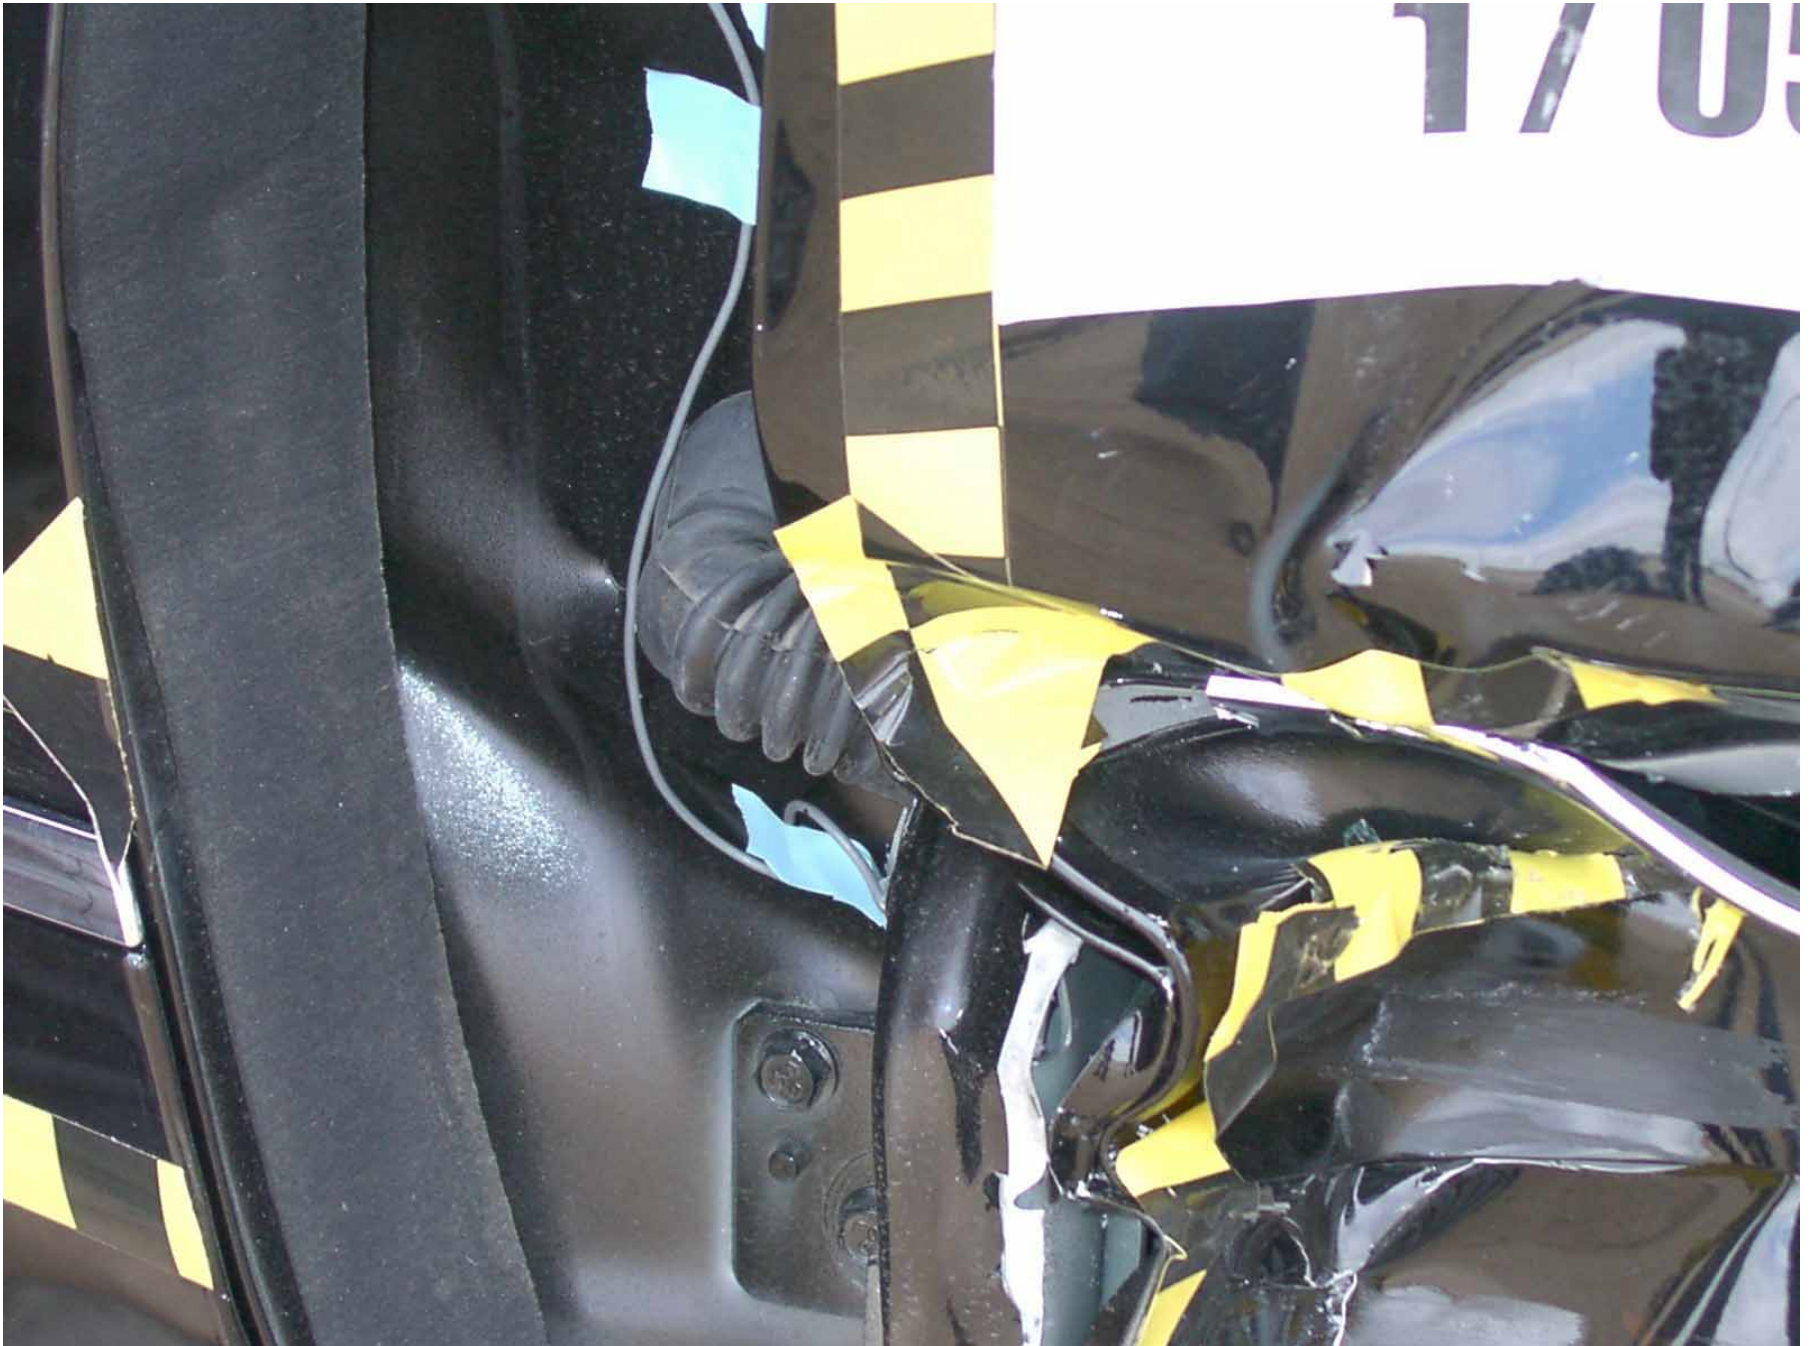
Figure A-17: Impact Point Target Close-up, Post-Test

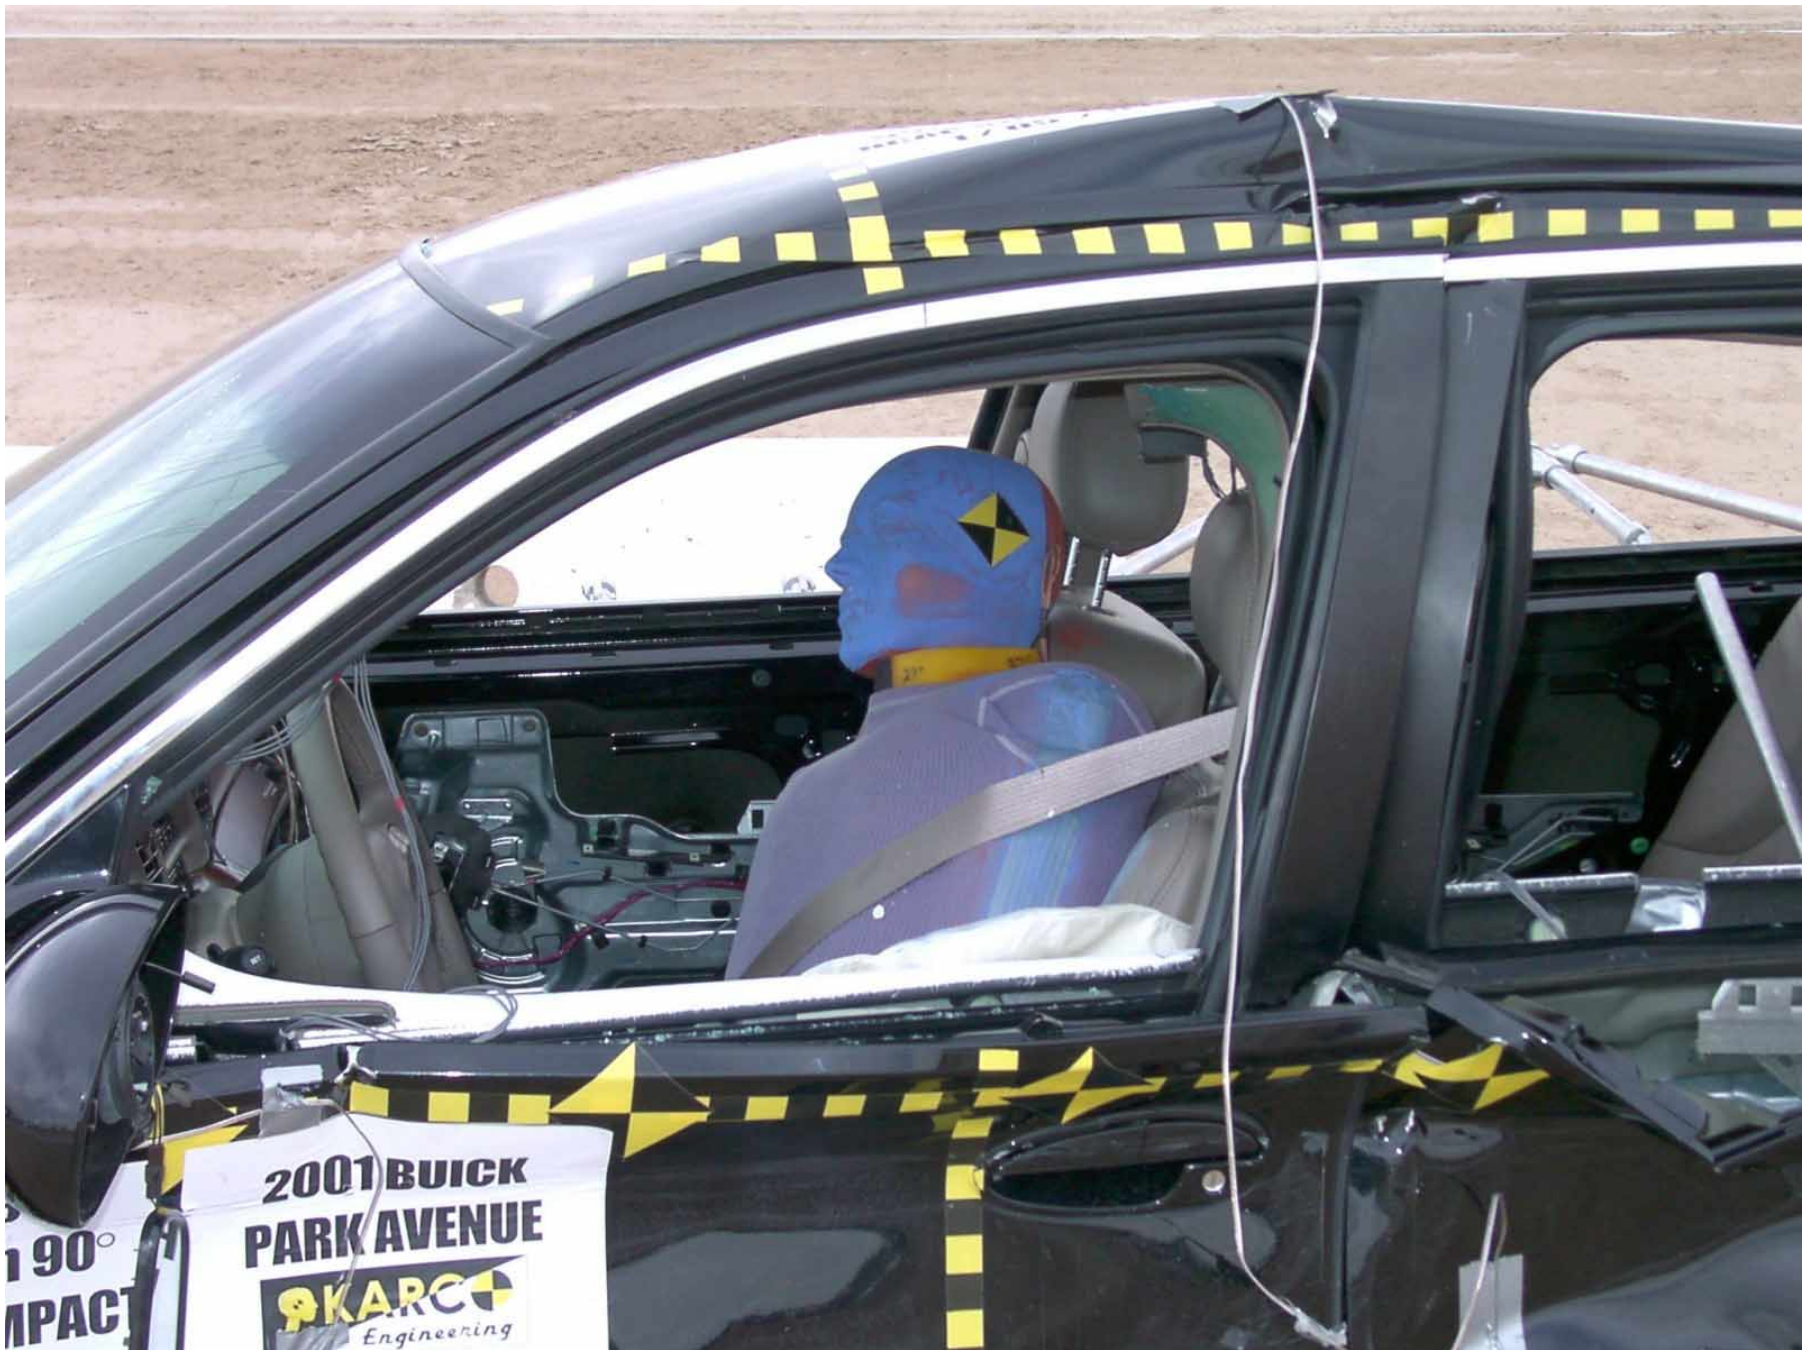
Figure A-20: Driver Dummy Left Side, Post-Test

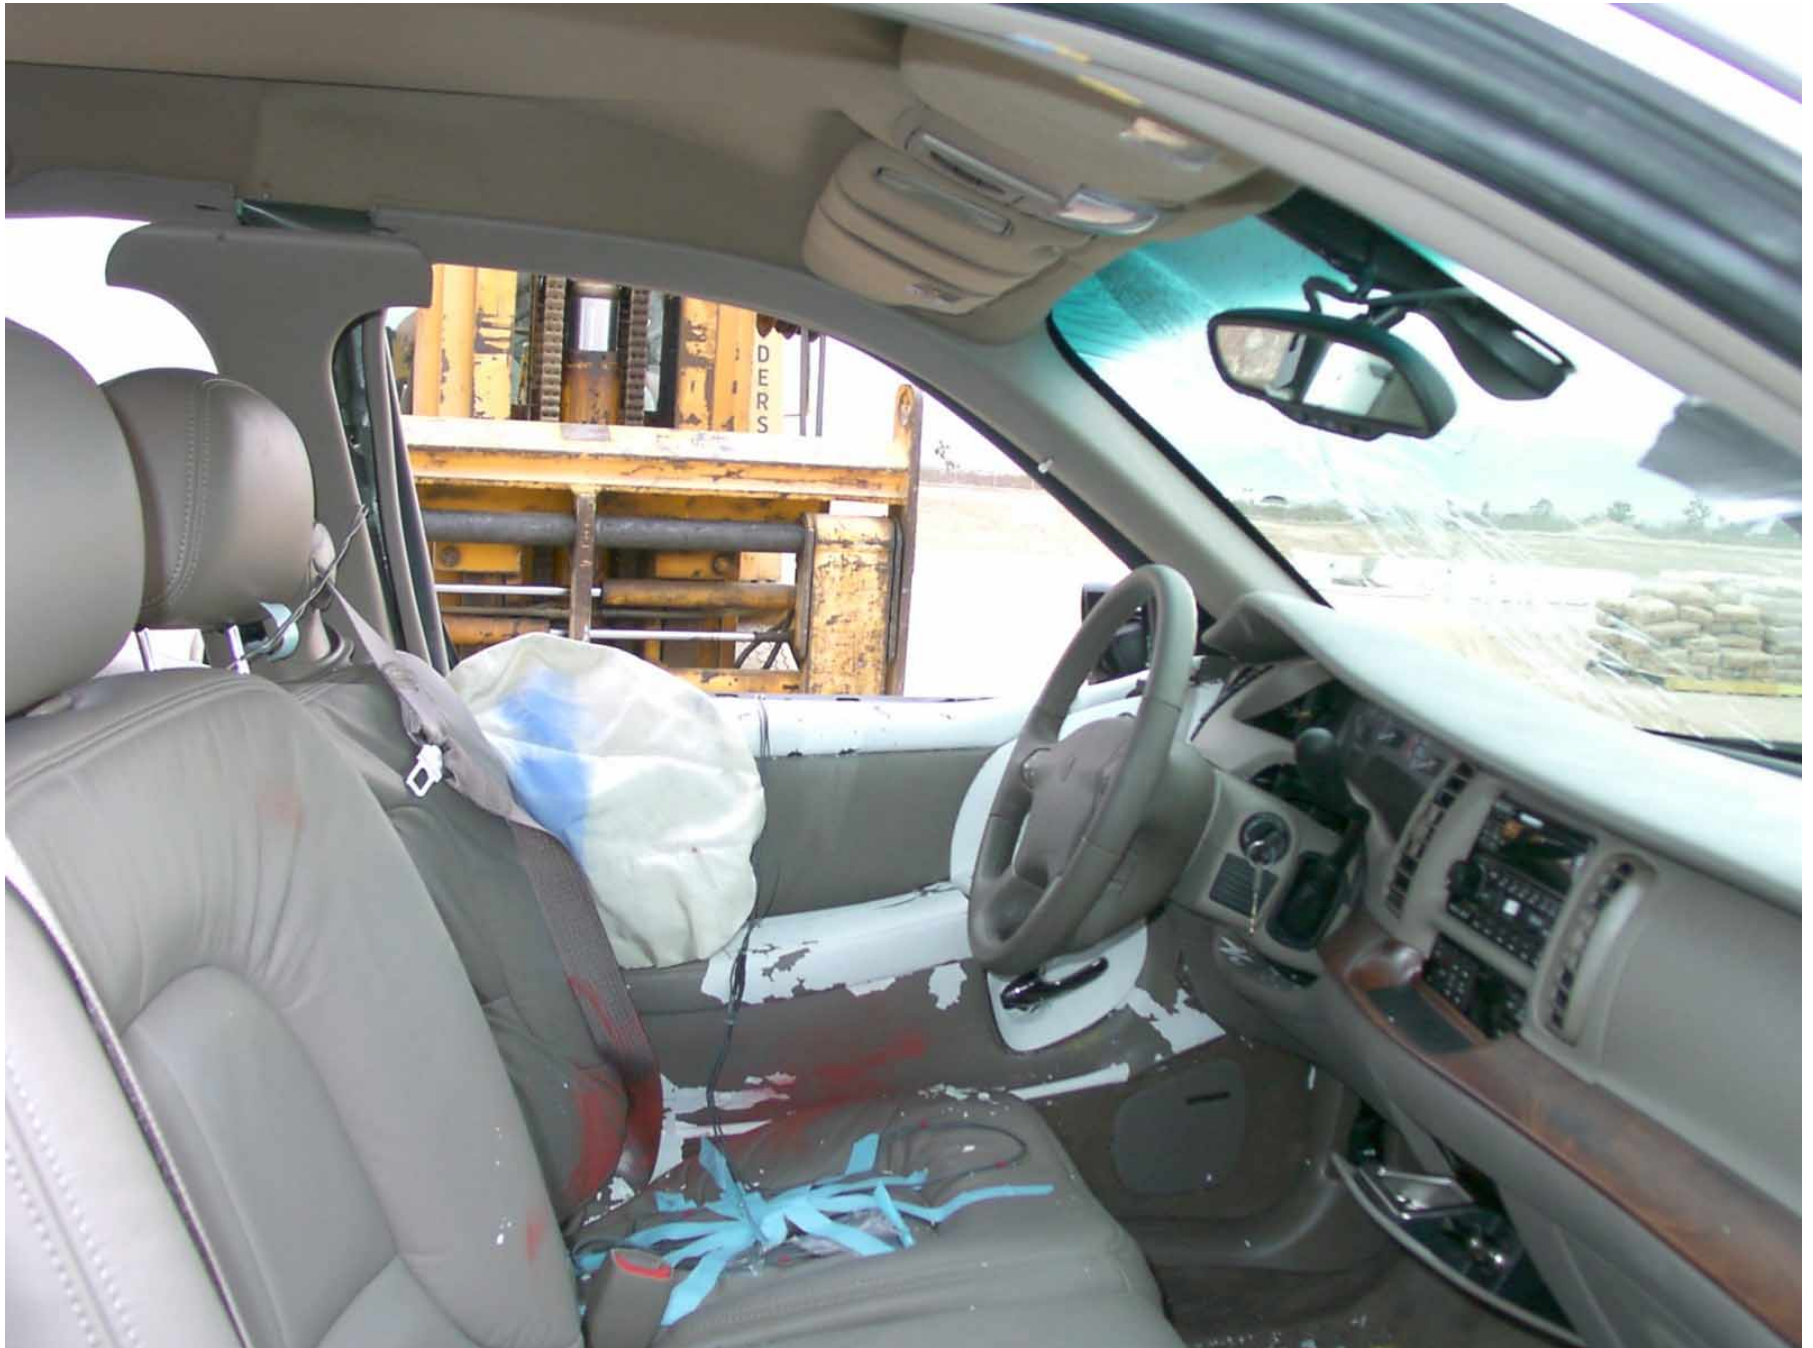
Figure A-26: Driver Dummy Contact Points Inside View, Post-Test

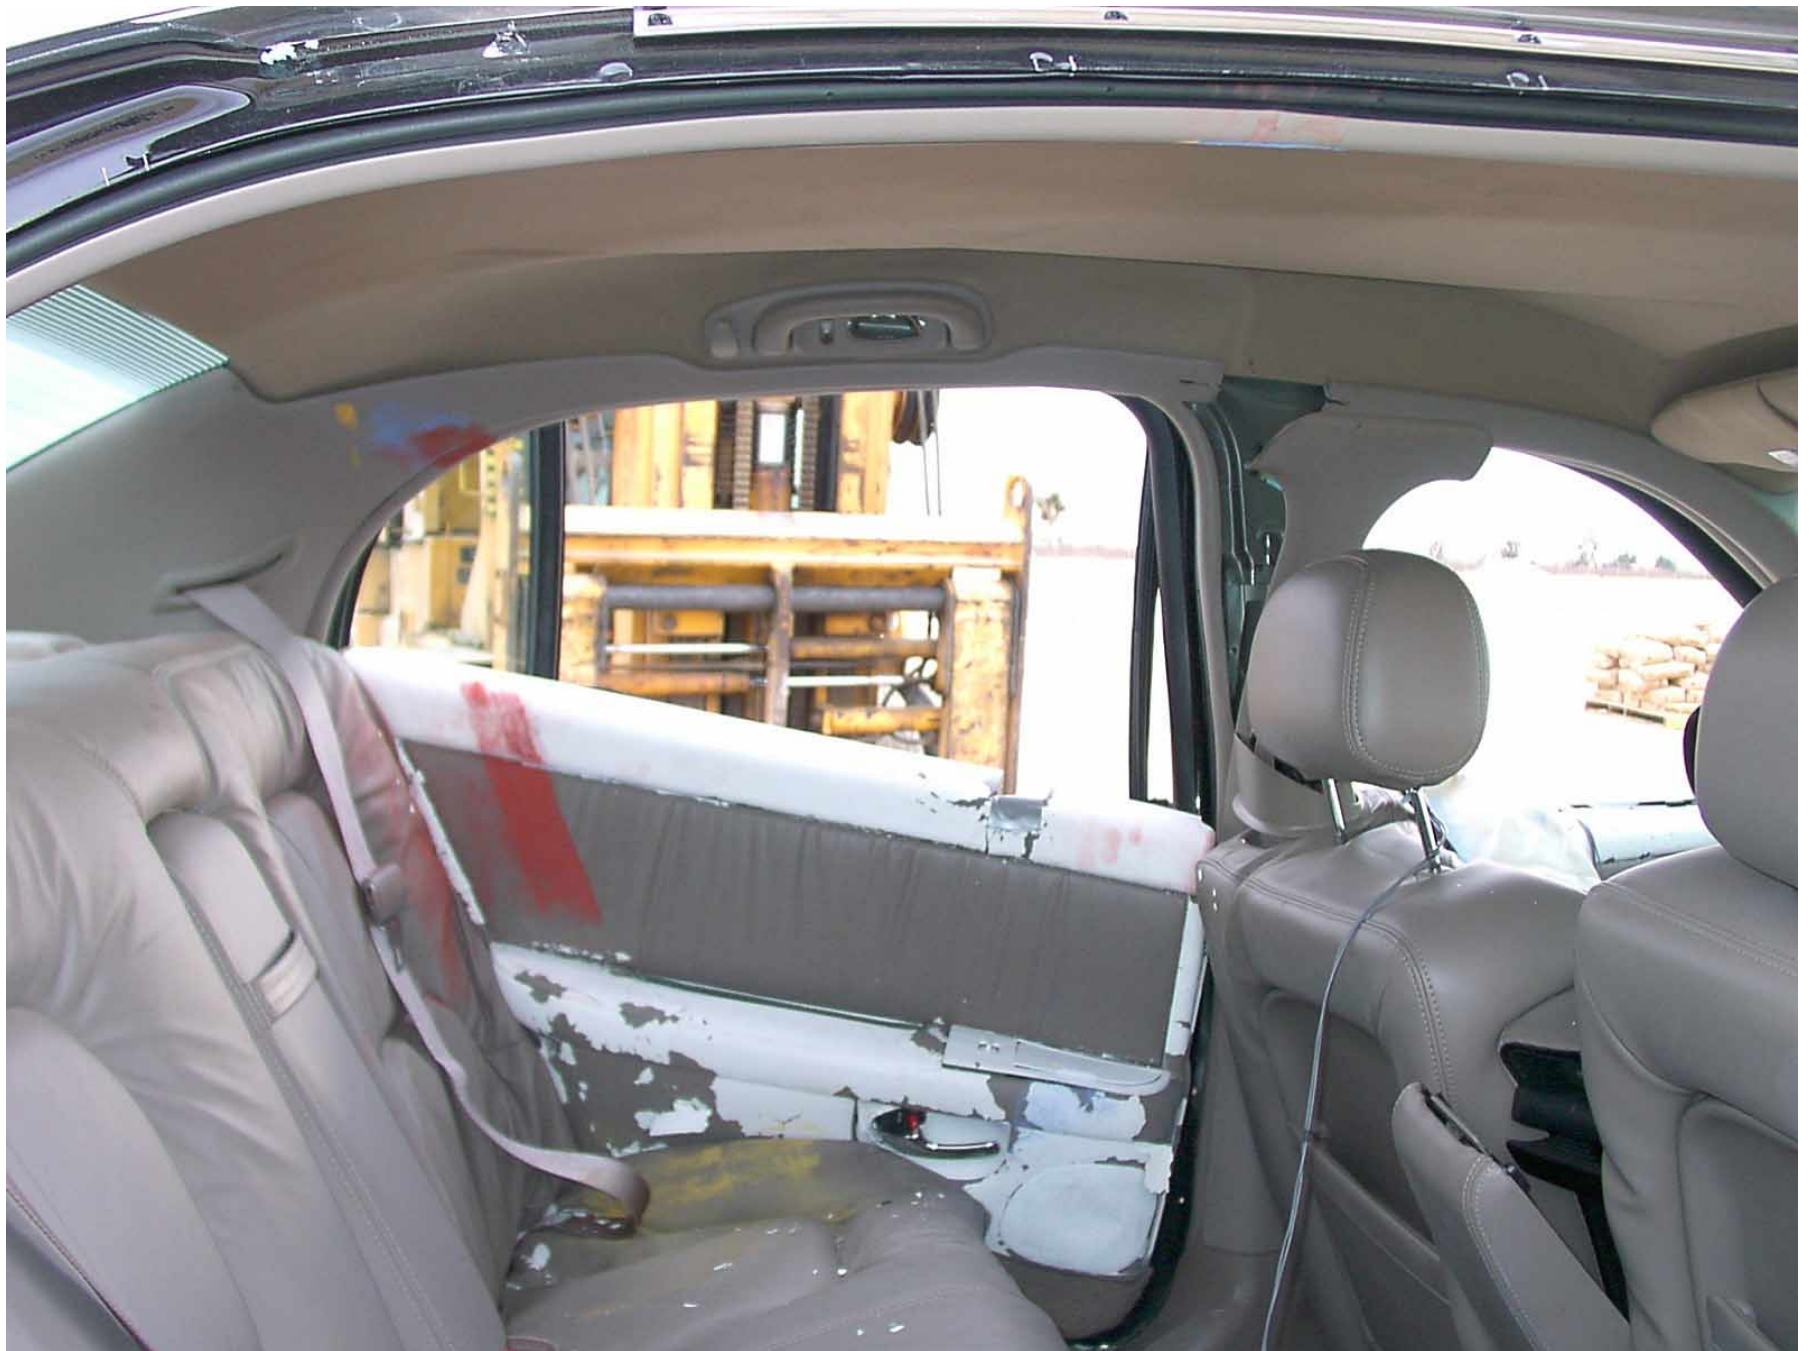
Figure A-35: Passenger Dummy Contact Points Inside View, Post-Test
