**REPORT NUMBER KAR21003-09**

**NEW CAR ASSESSMENT PROGRAM  
SIDE IMPACT TEST**

**GENERAL MOTORS CORPORATION  
2001 BUICK PARK AVENUE  
4 DOOR SEDAN  
NHTSA NUMBER: M10118**

**PREPARED BY:  
KARCO ENGINEERING  
9270 HOLLY ROAD  
ADELANTO, CALIFORNIA 92301**

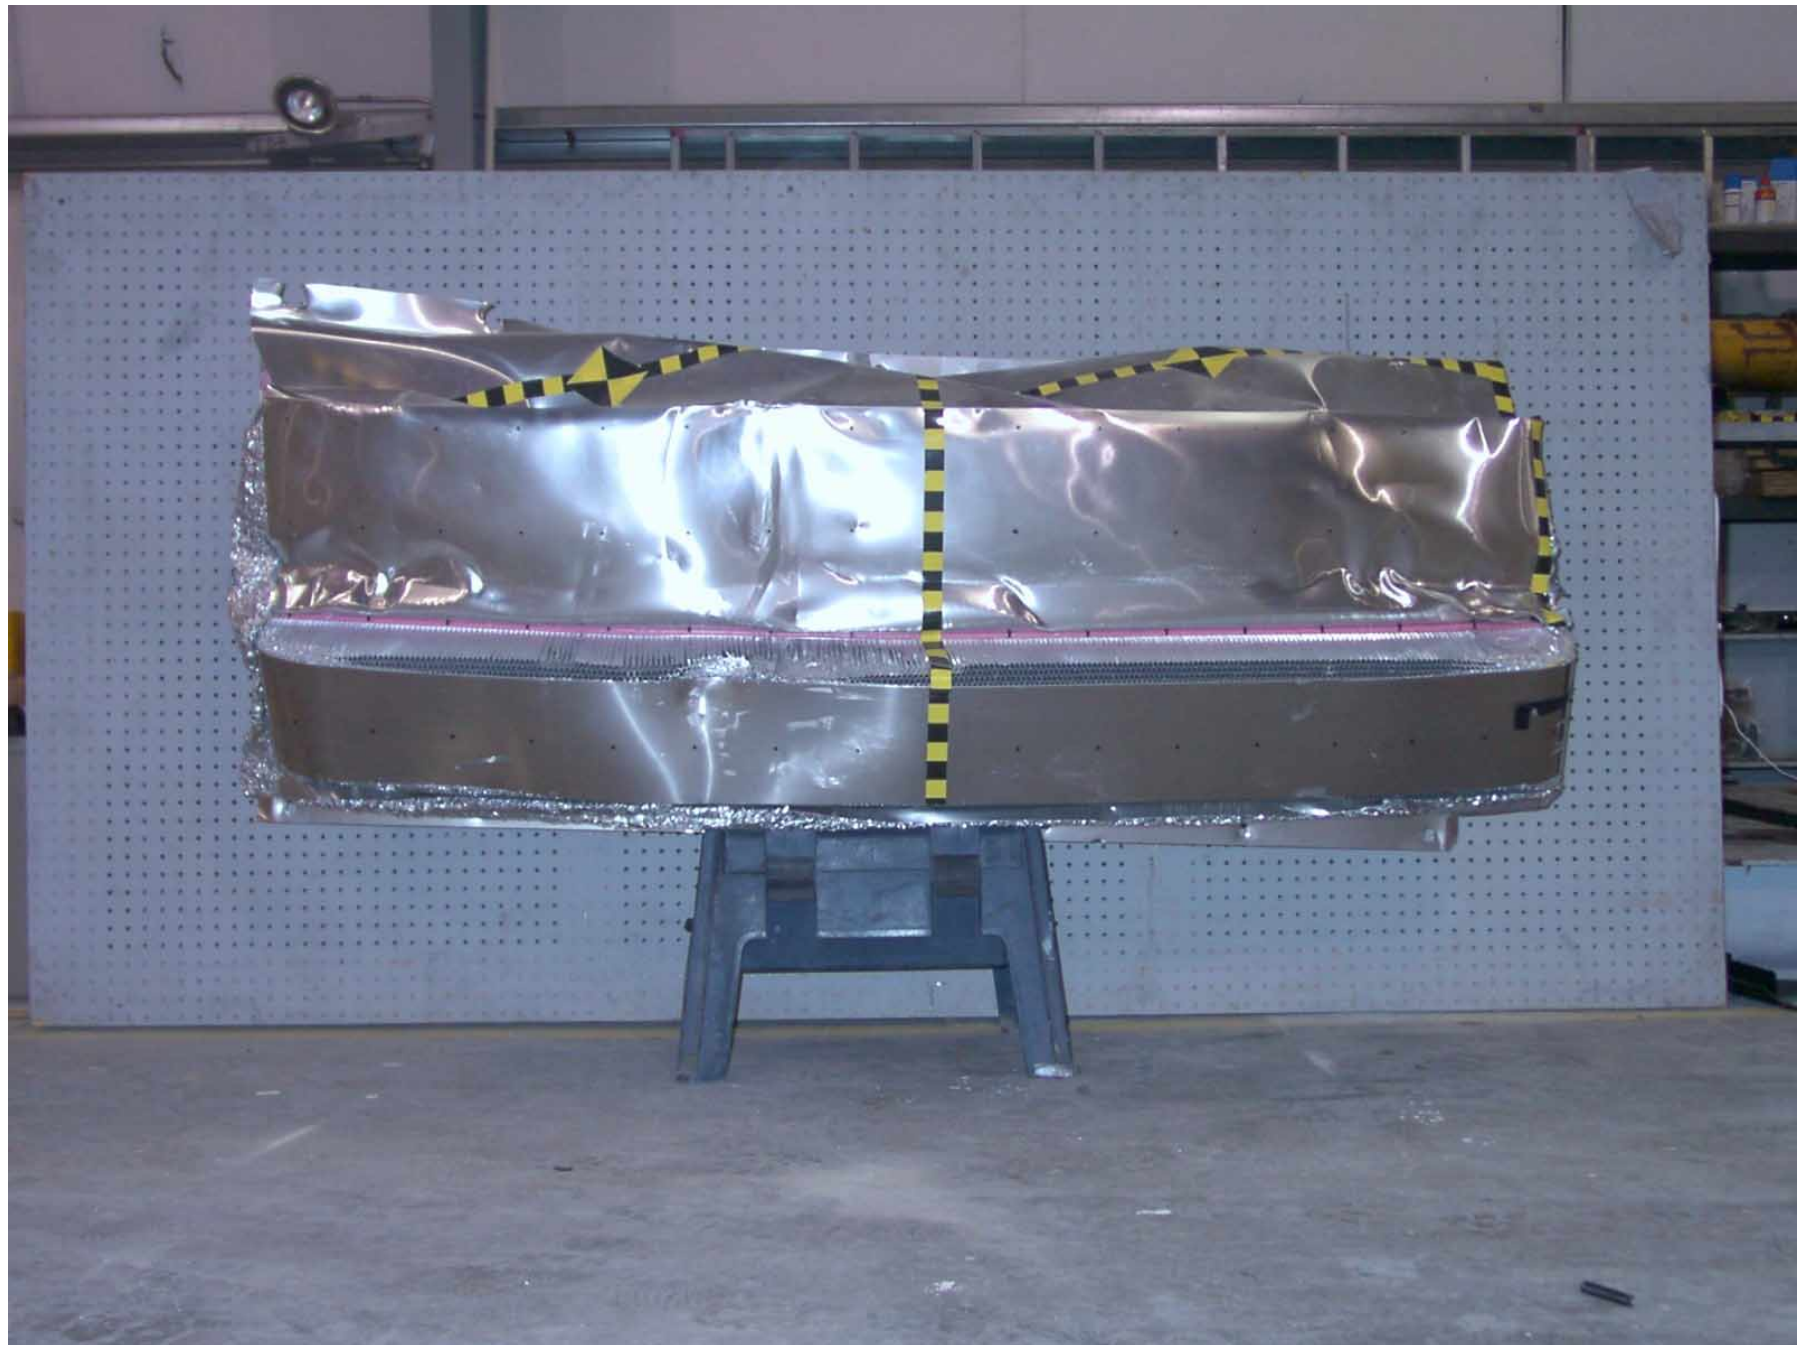
Figure A-37: Front View of Deformable Barrier, Post-Test

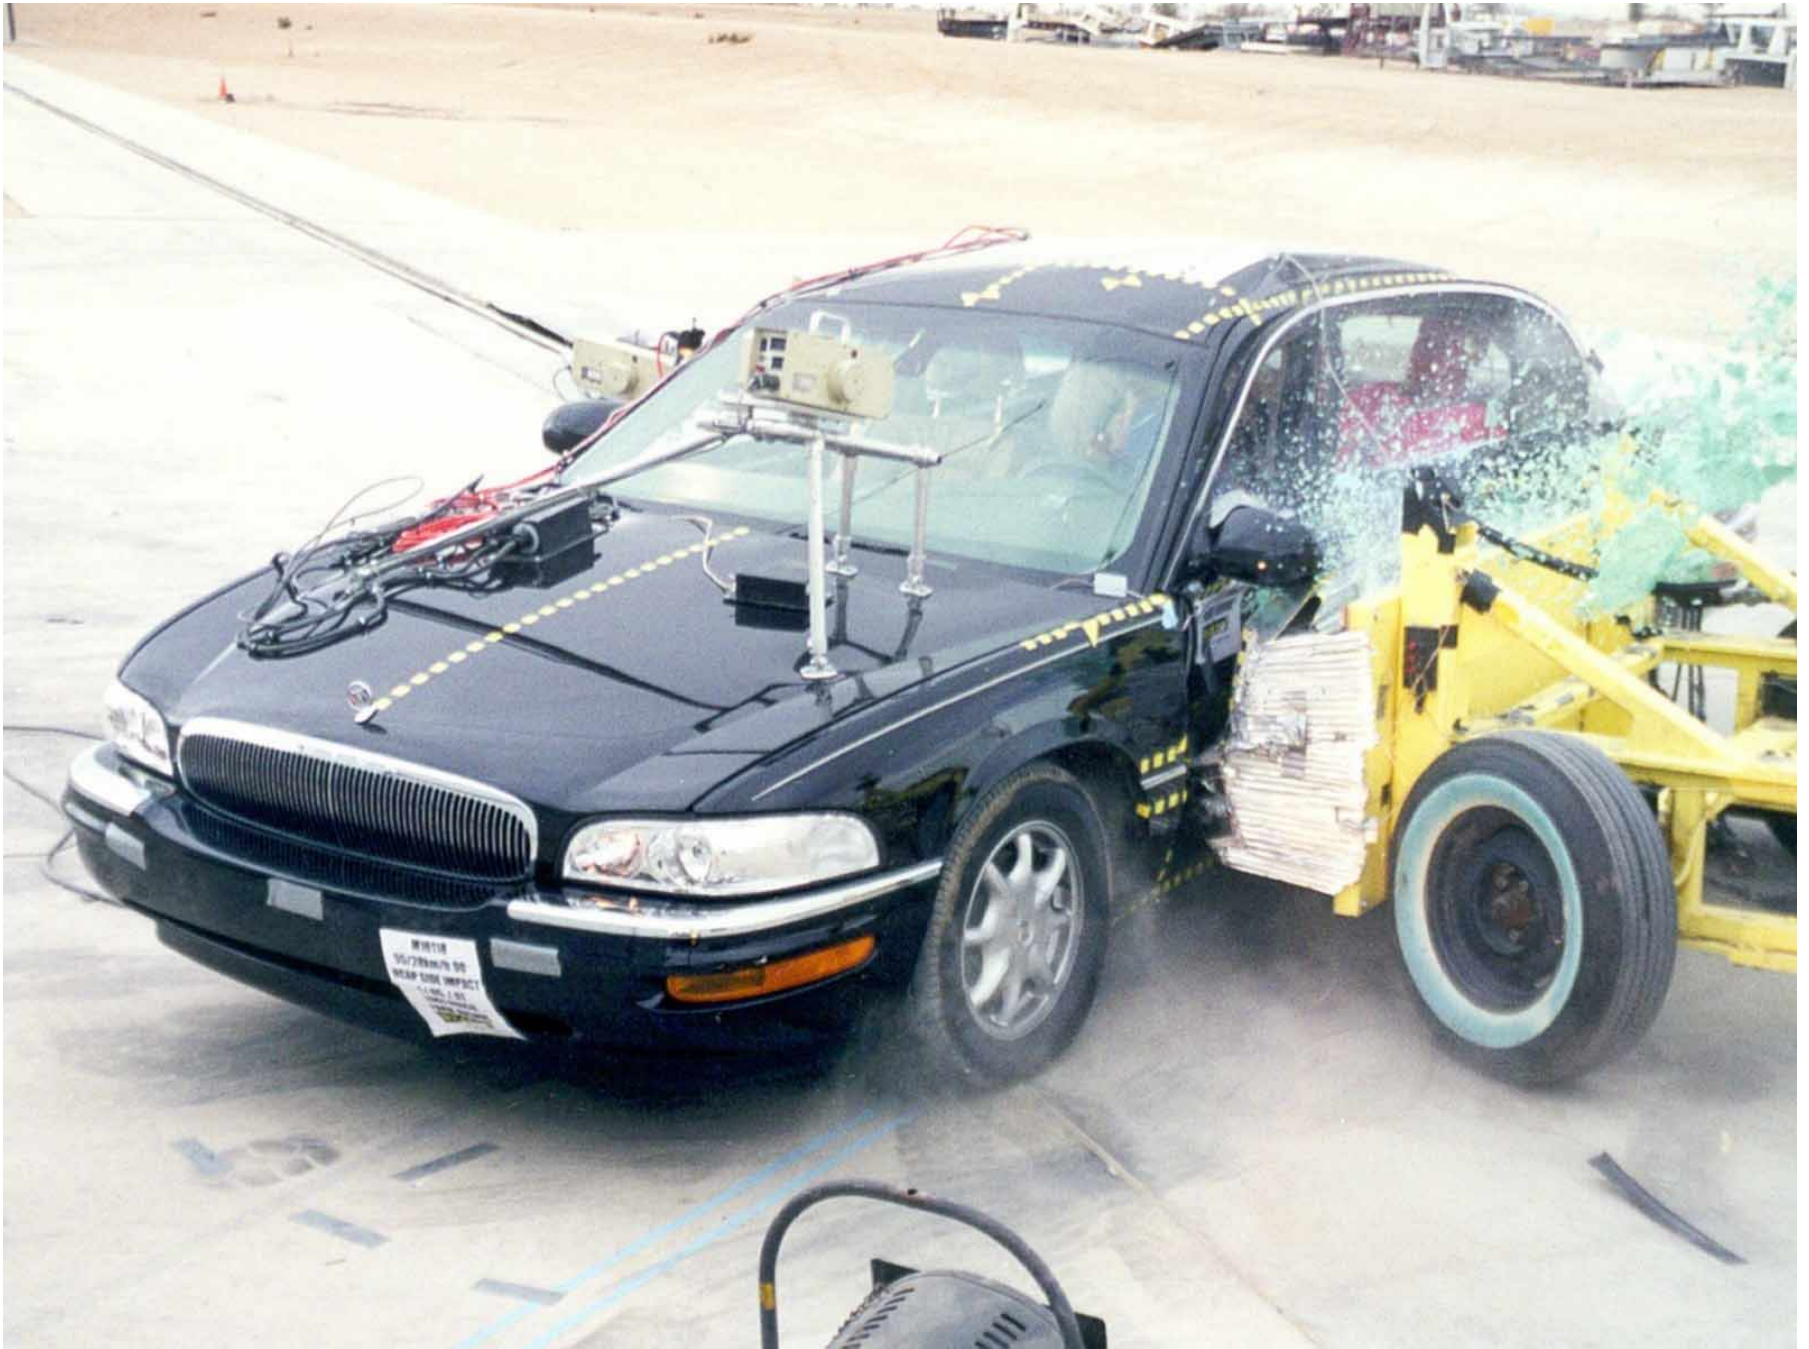
Figure A-45: Vehicle During Impact
