**REPORT NUMBER KAR21003-11**

**NEW CAR ASSESSMENT PROGRAM  
SIDE IMPACT TEST**

**MAZDA MOTOR CORPORATION  
2001 MAZDA MIATA  
TWO DOOR CONVERTIBLE  
NHTSA NUMBER: M15402**

**FINAL REPORT**

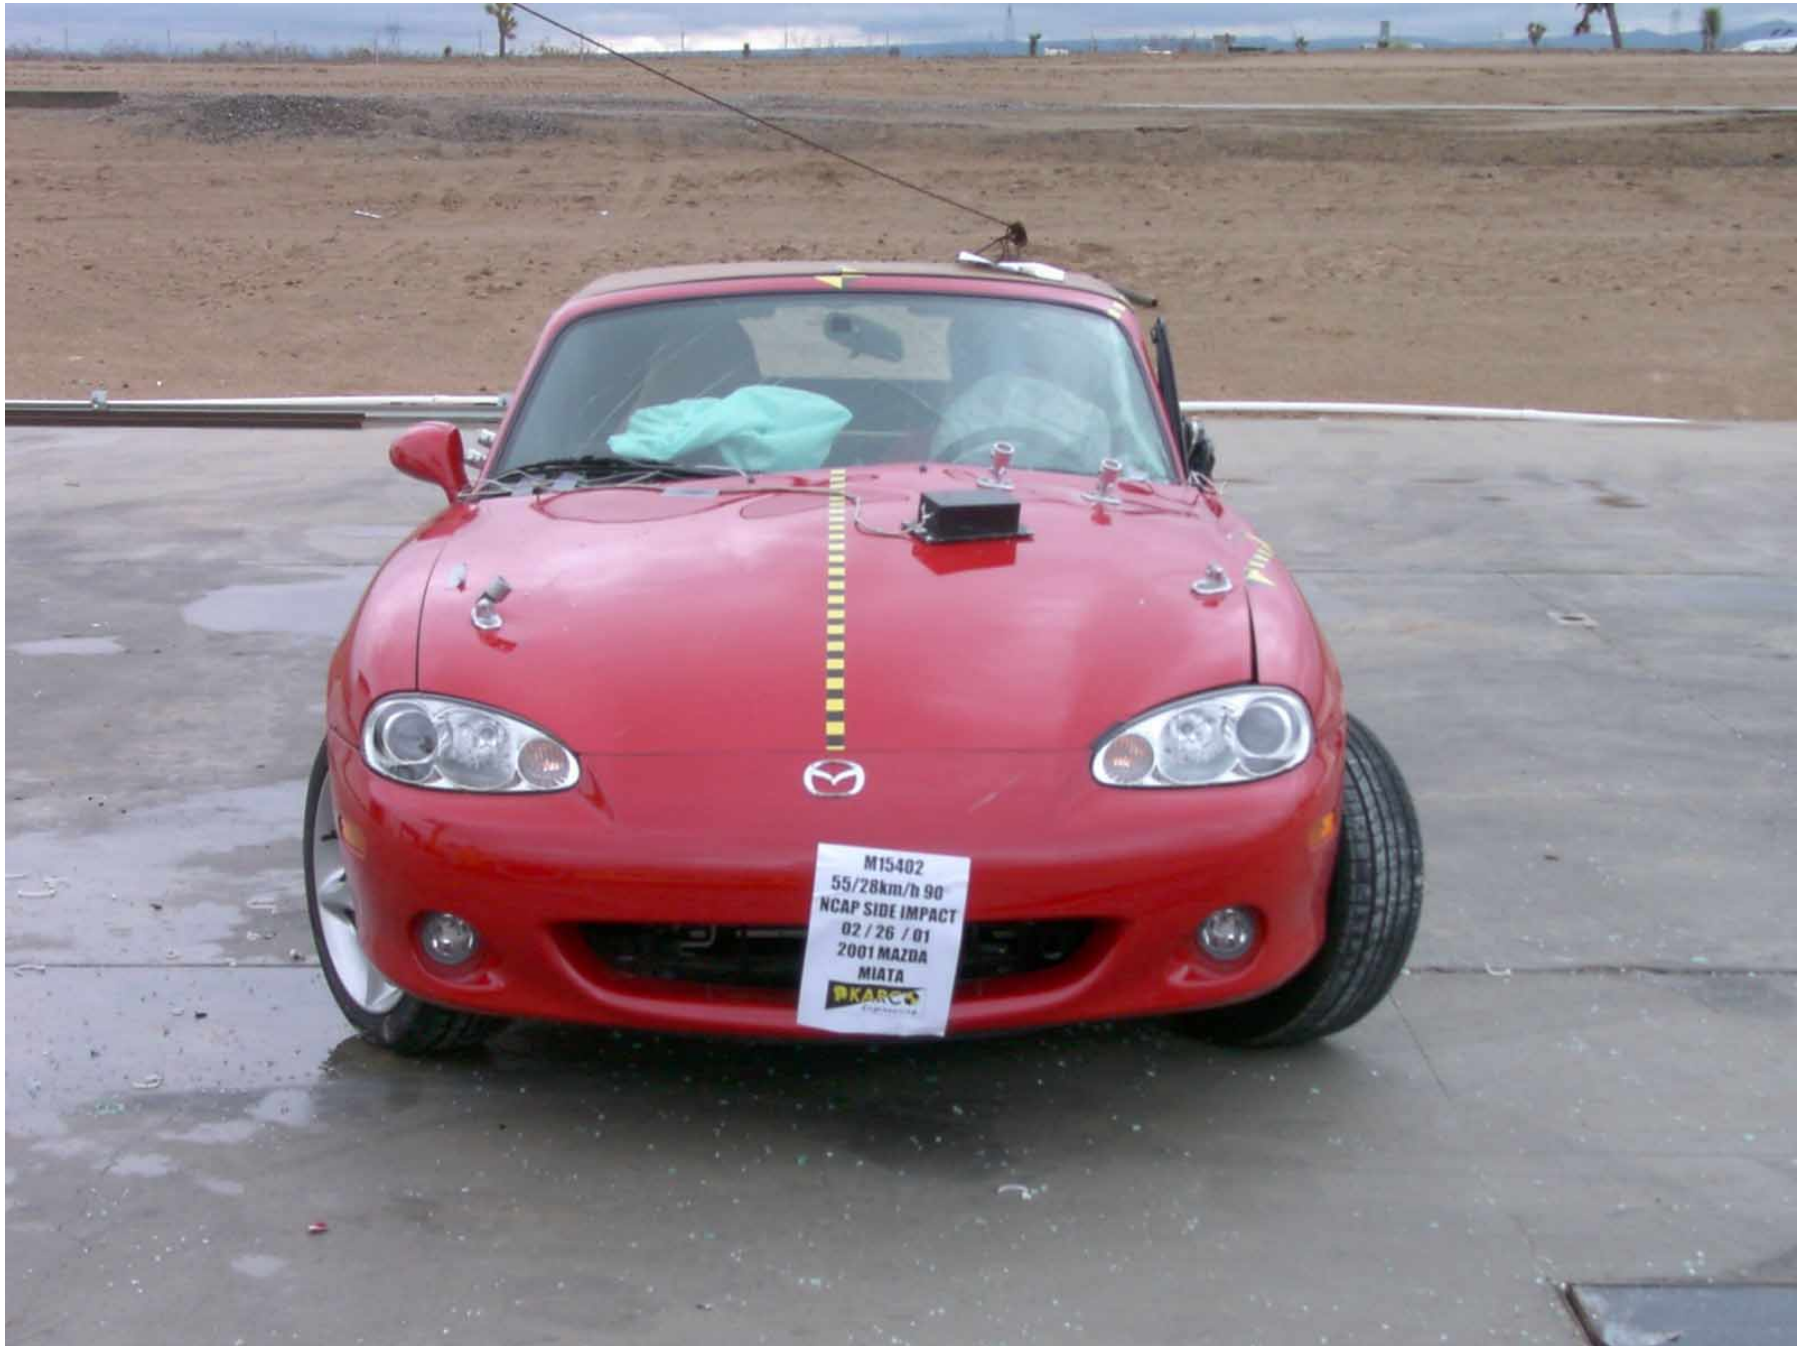
Figure A-6: Front View, Post-Test

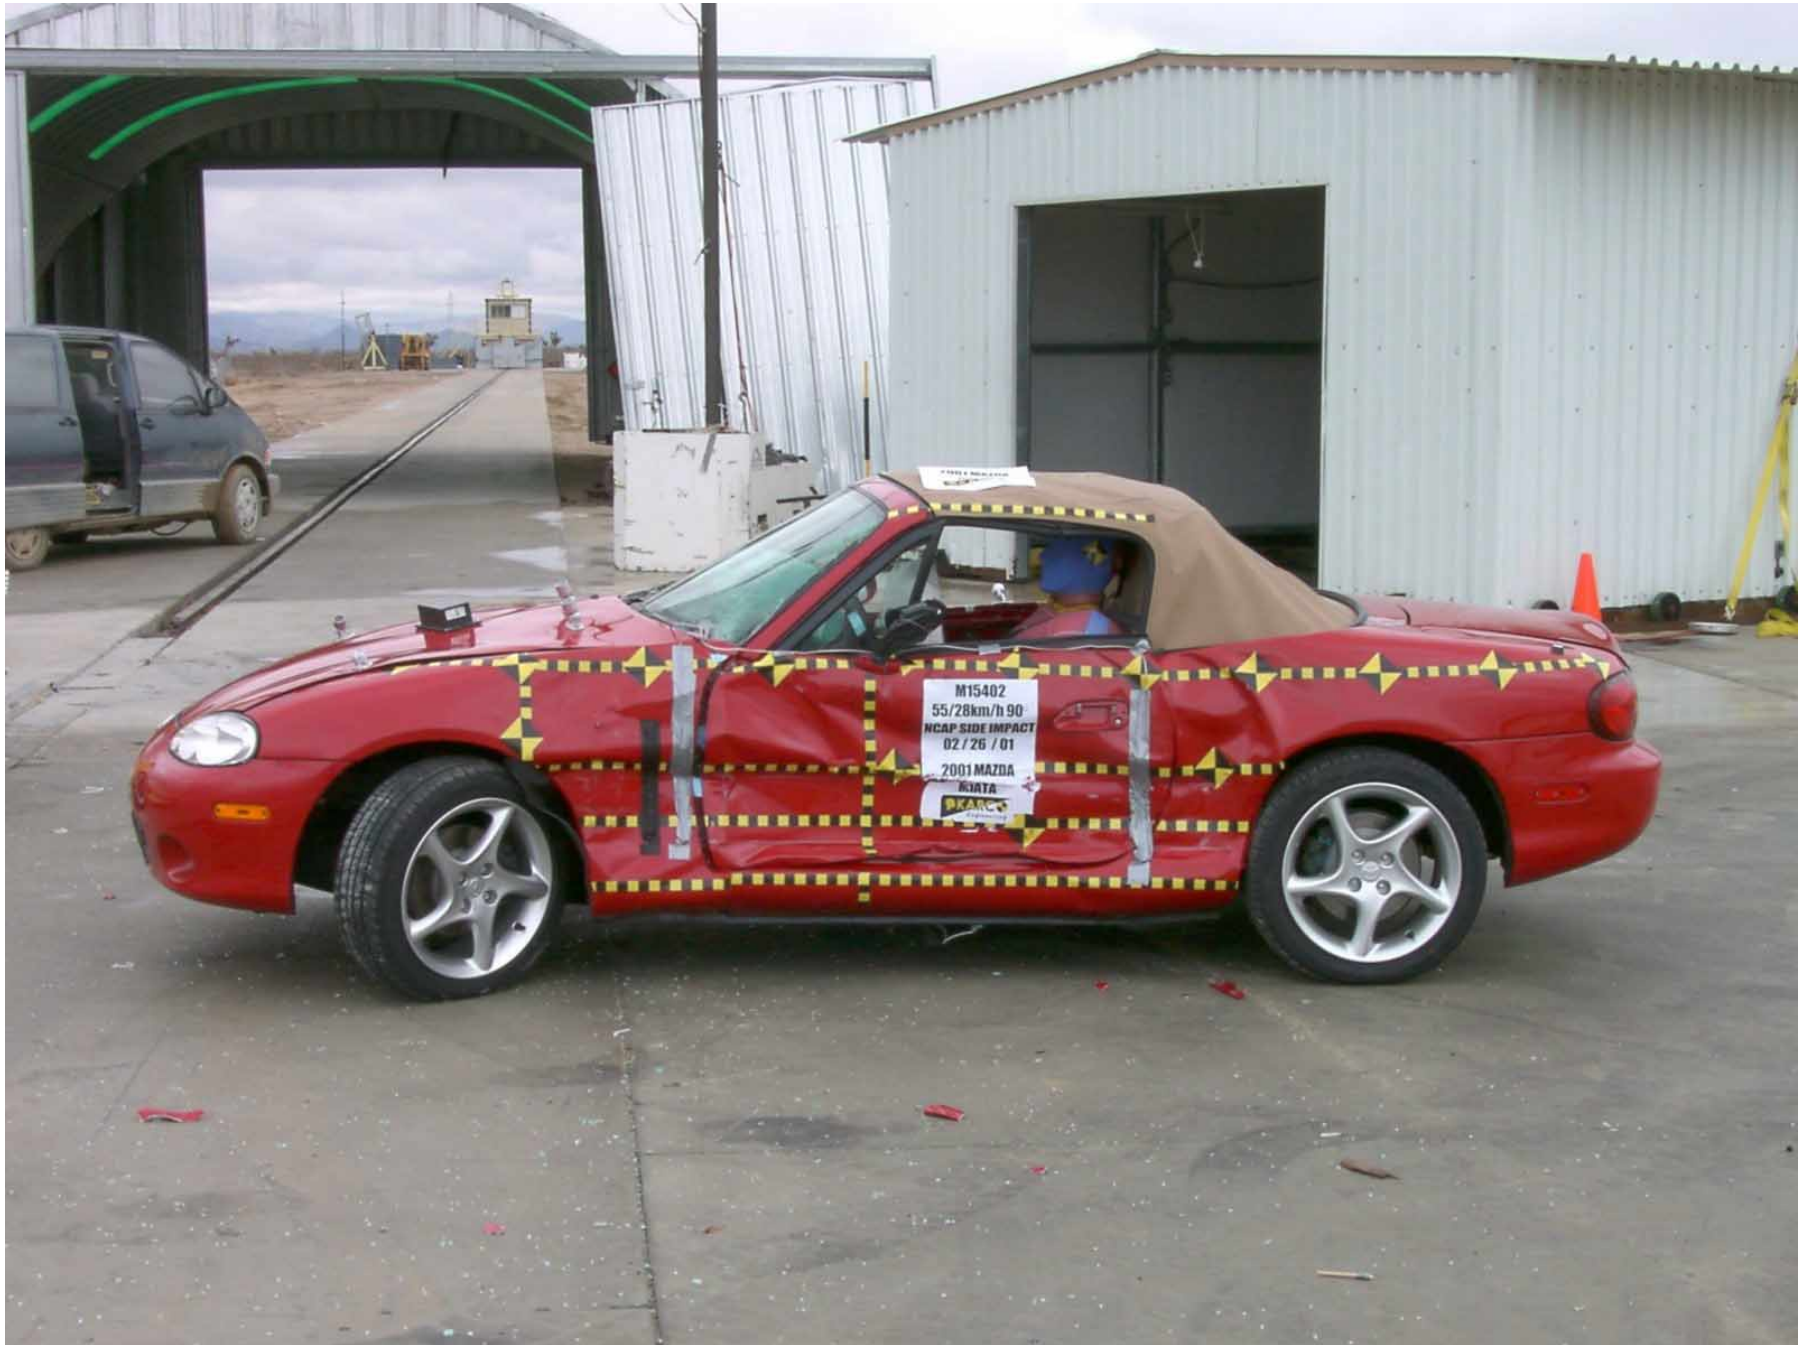
Figure A-10: Left (Impacted) Side View, Post-Test

The test vehicle sustained a maximum static crush of 189 mm at level 3, 1200mm rearward of the left vertical impact point. The driver SID, Serial No. 274 was calibrated just prior to this test. The SID injury criteria is summarized as follows:

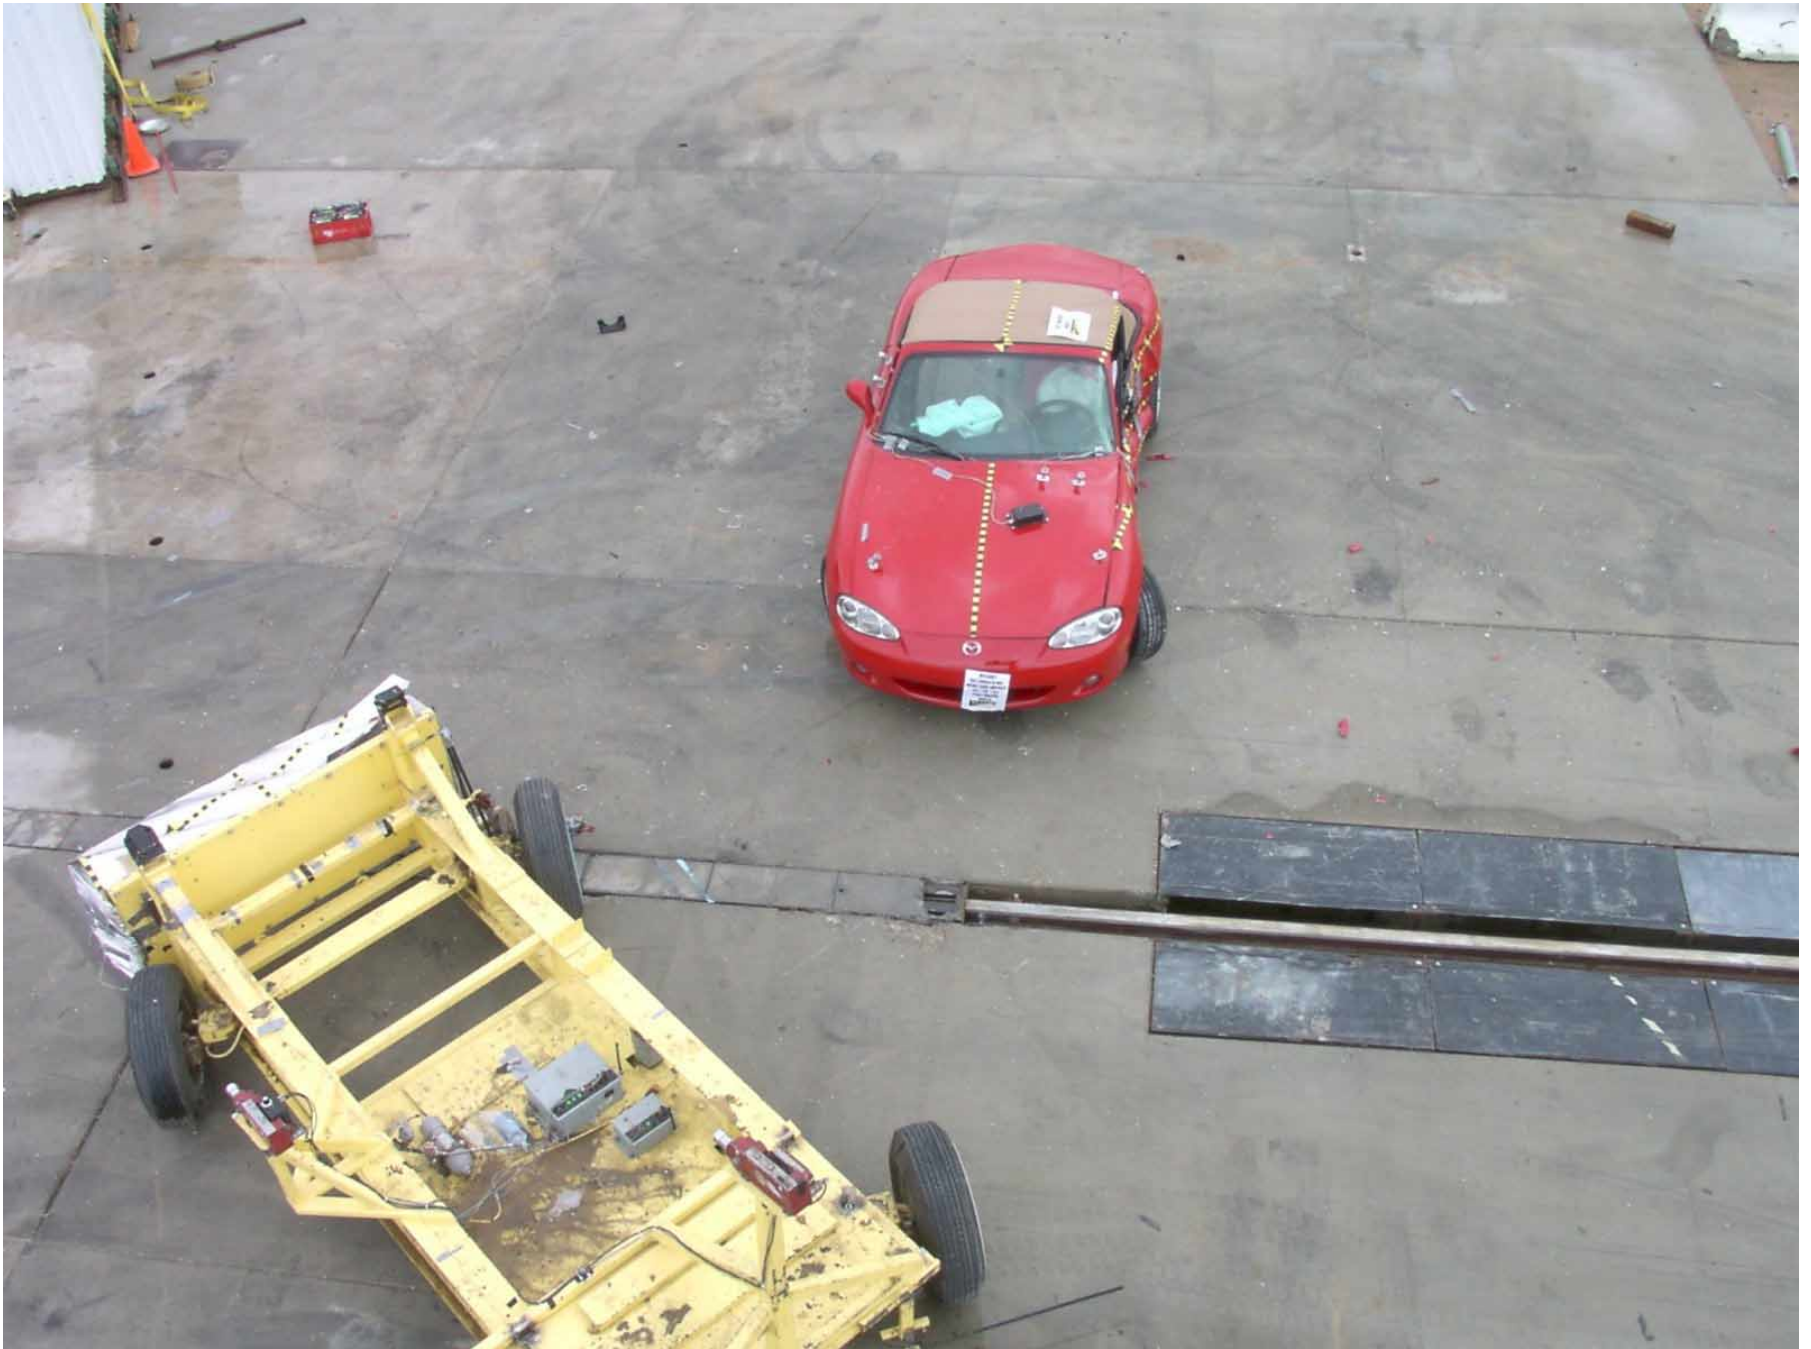
Figure A-13: Overall Overhead View, Post-Test

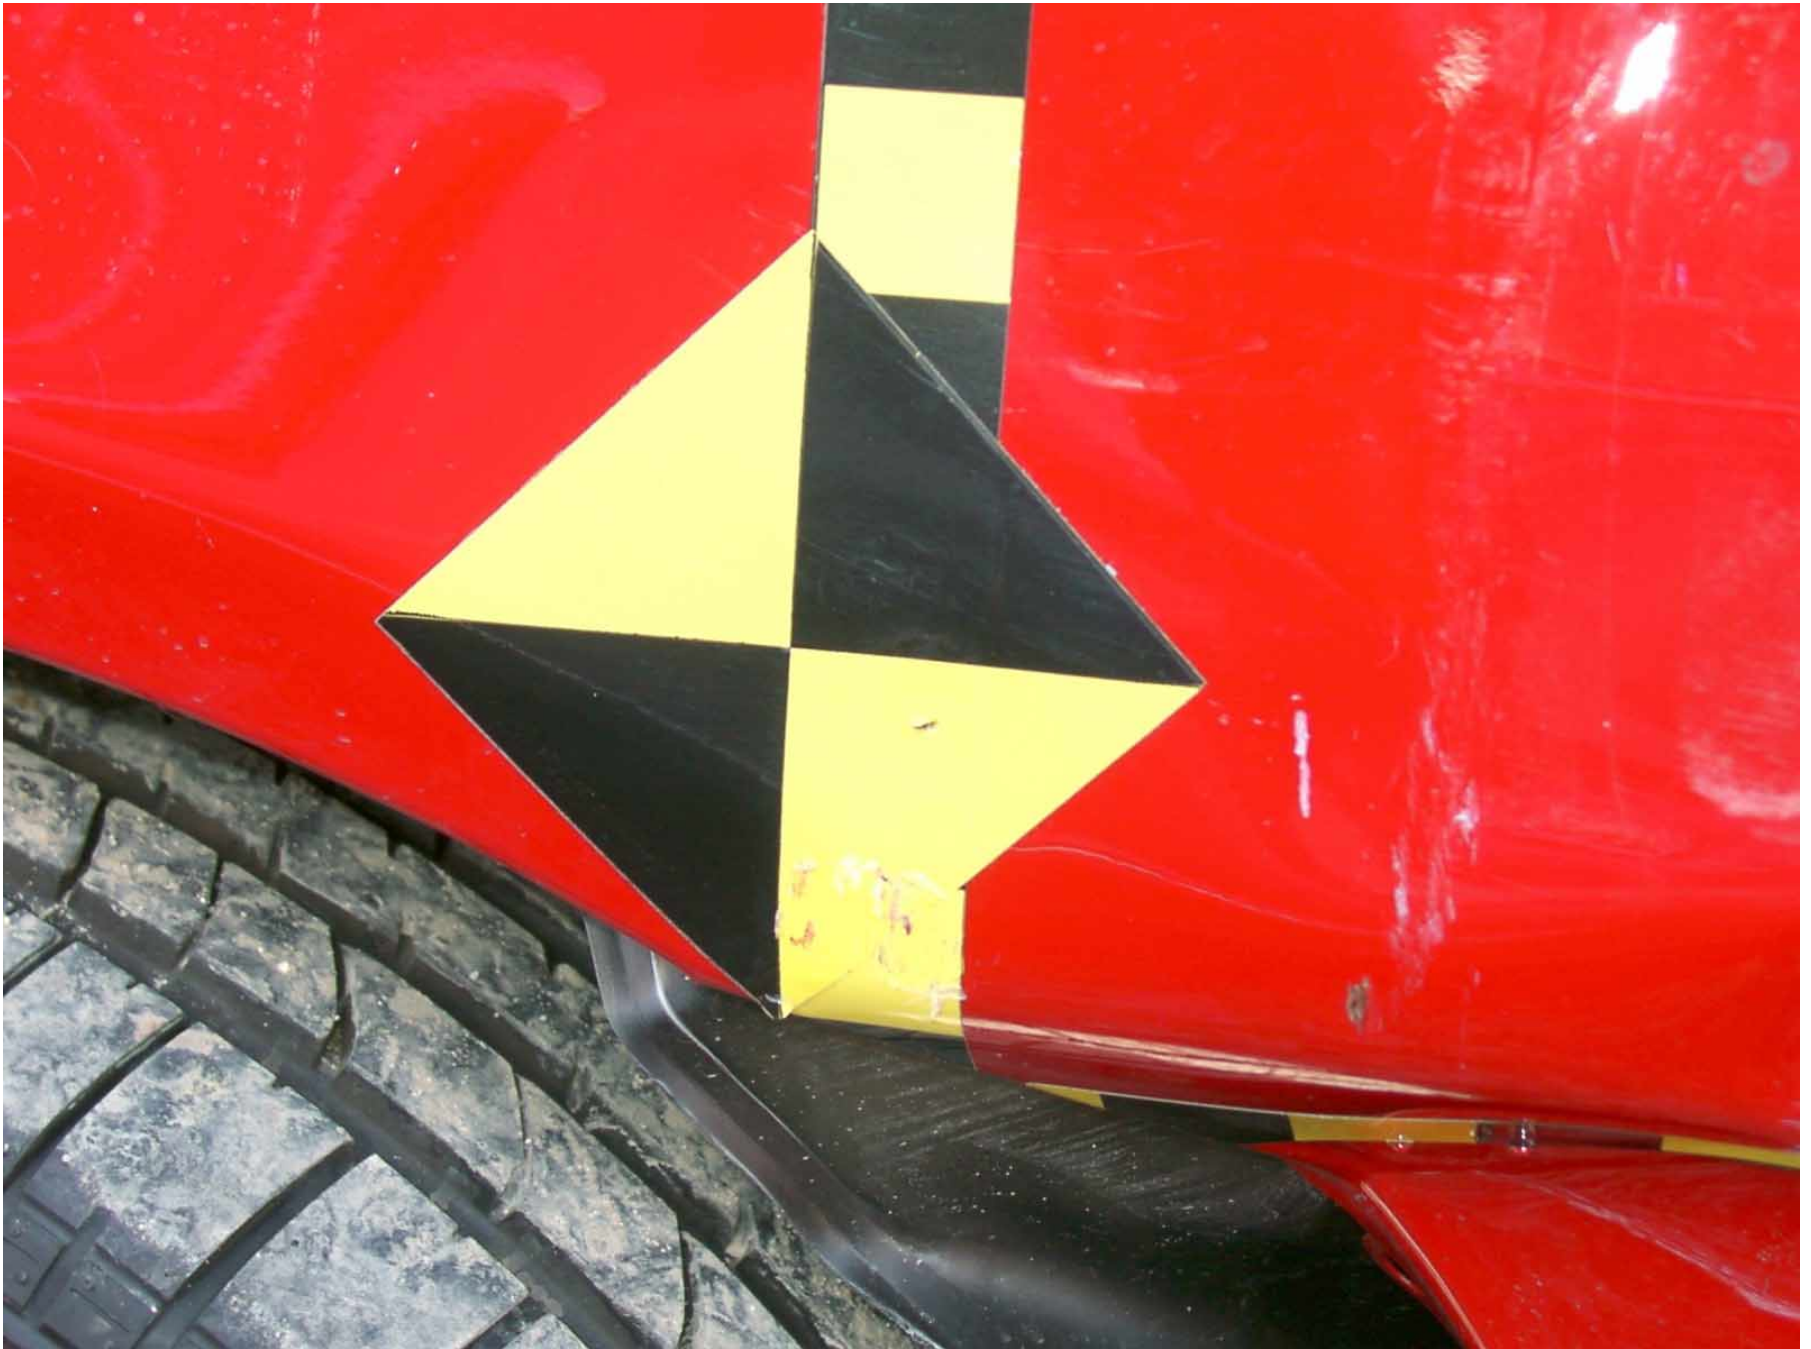
Figure A-17: Impact Point Target Close-up, Post-Test

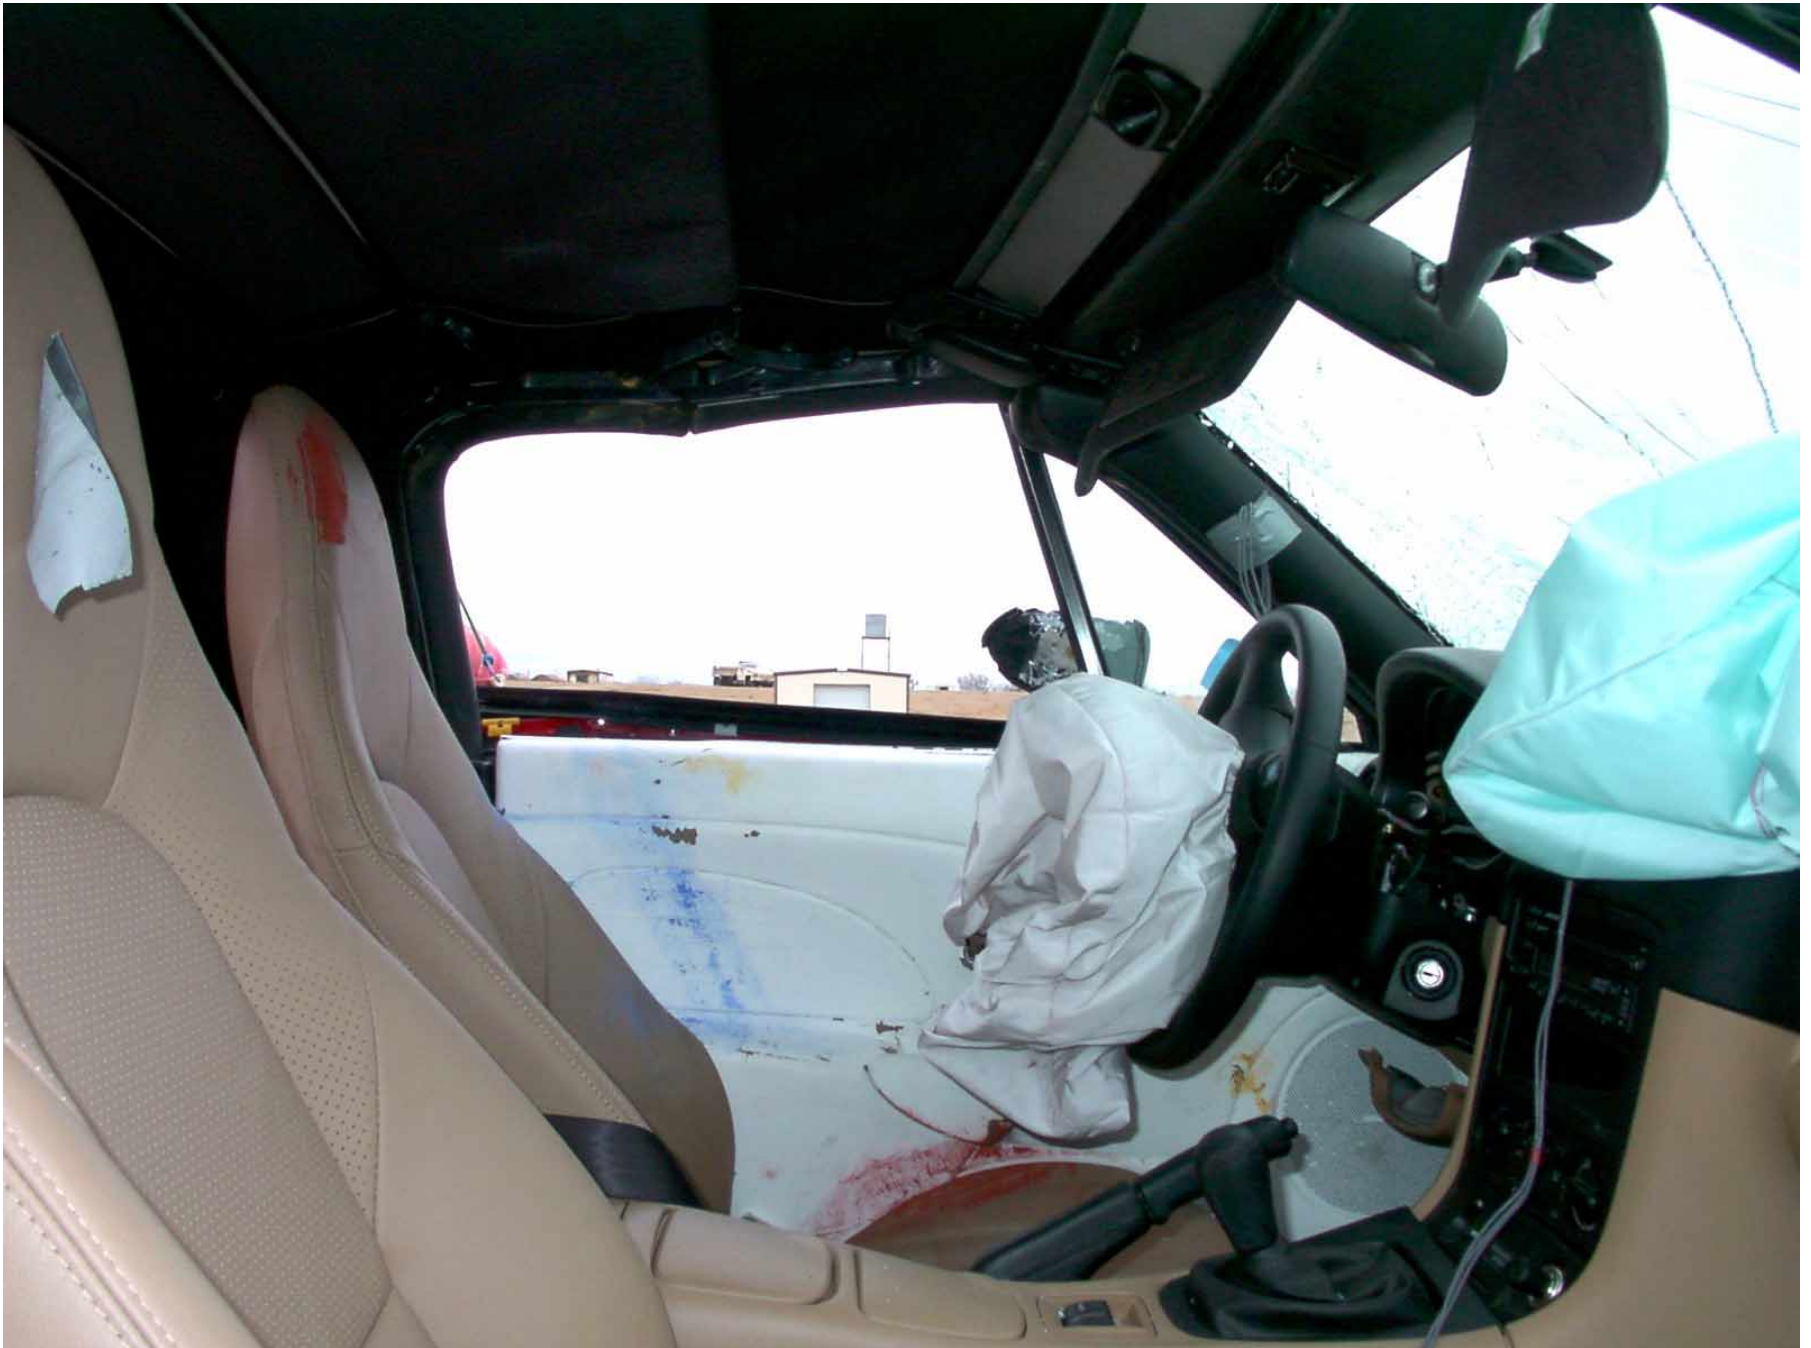
Figure A-26: Driver Dummy Contact Points (Inside View), Post-Test

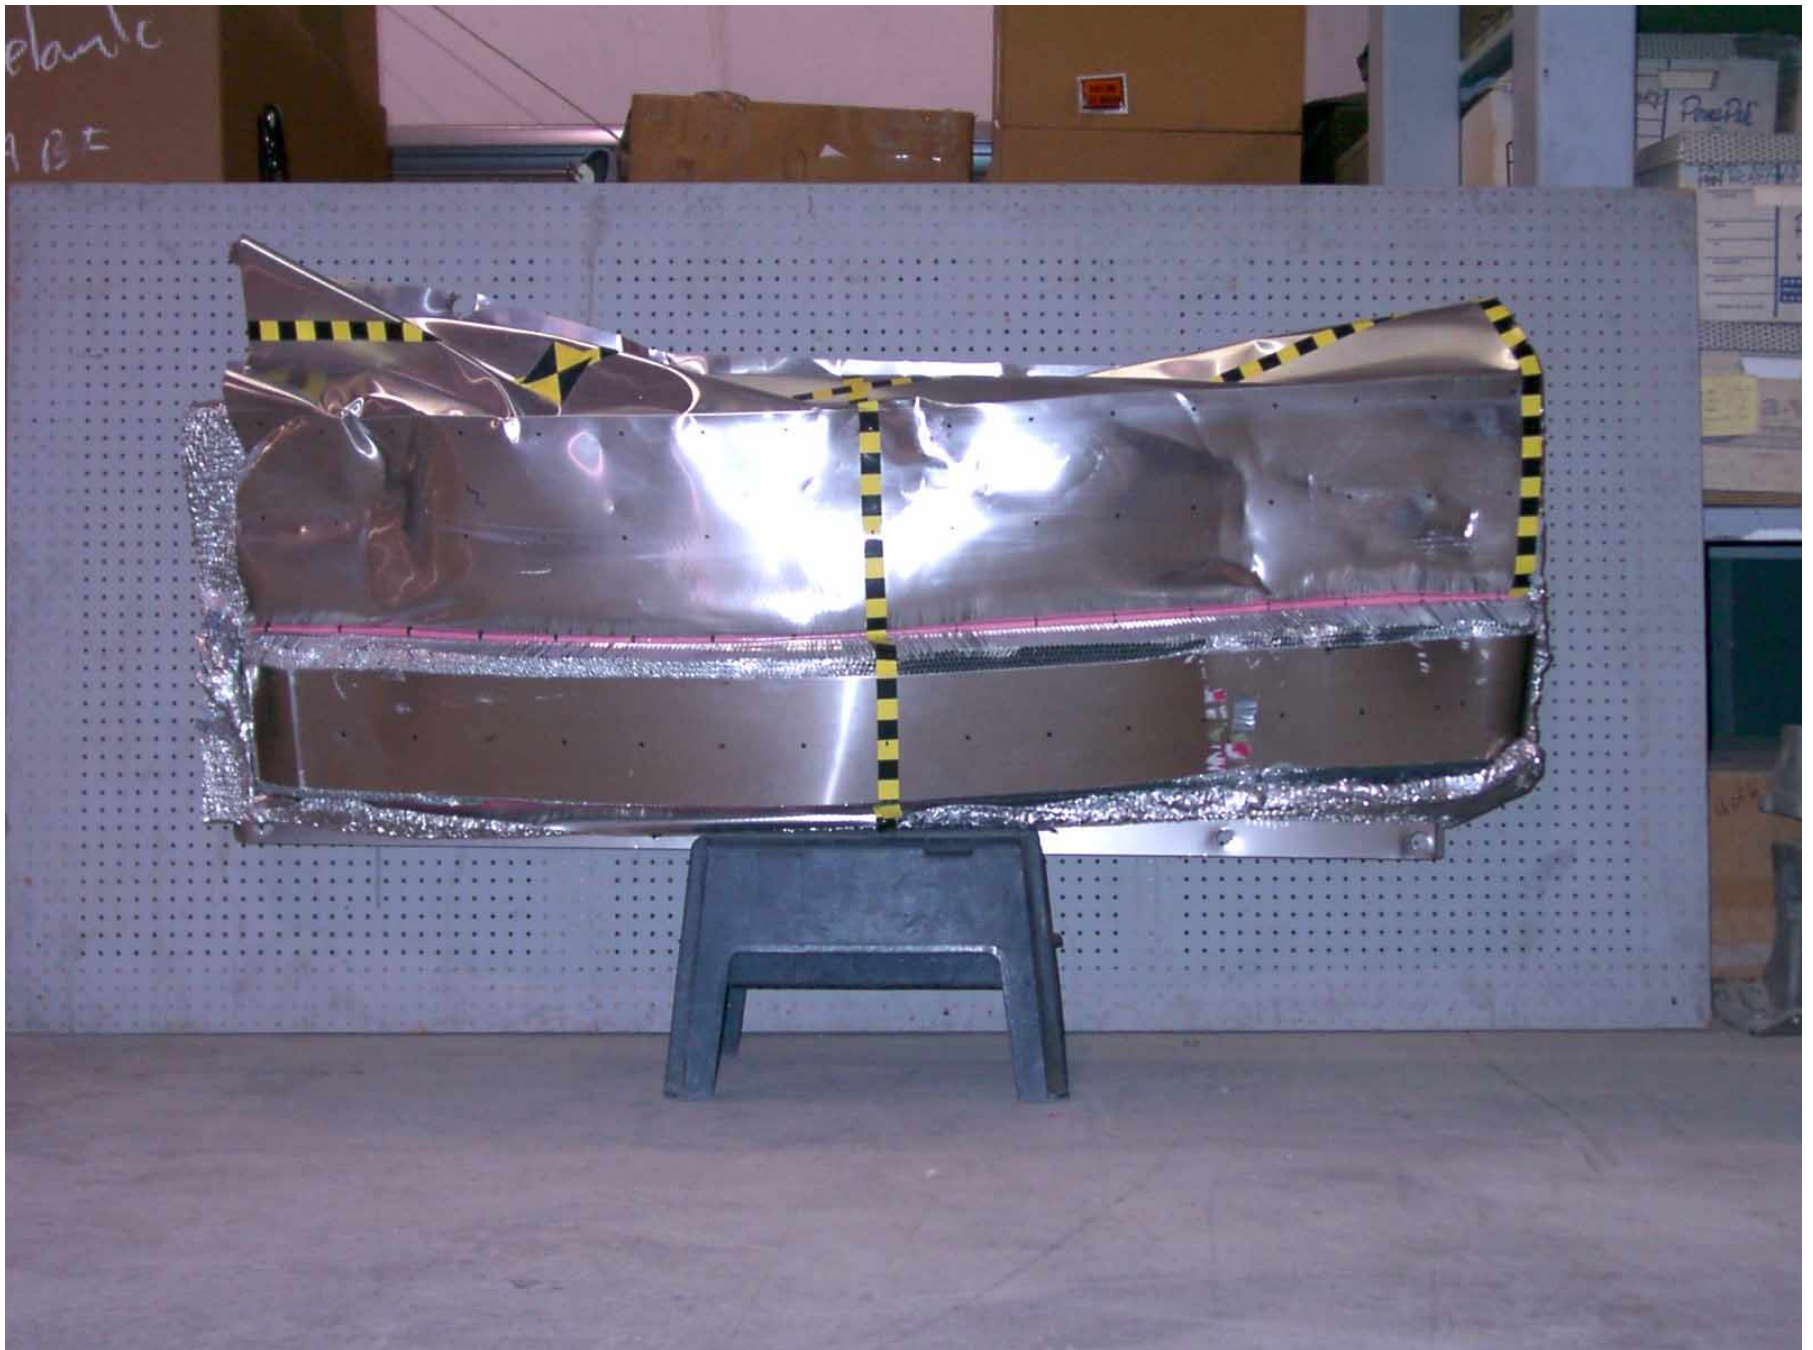
Figure A-28: Front View of Deformable Barrier, Post-Test
