**REPORT NUMBER KAR21049-01**

**NEW CAR ASSESSMENT PROGRAM  
FRONTAL BARRIER IMPACT TEST**

**TOYOTA MOTOR MANUFACTURING  
2001 TOYOTA TACOMA SR5 EXTENDED CAB PICKUP  
NHTSA NUMBER: TOY001**

**PREPARED BY:  
KARCO ENGINEERING  
9270 HOLLY ROAD  
ADELANTO, CALIFORNIA 92301**

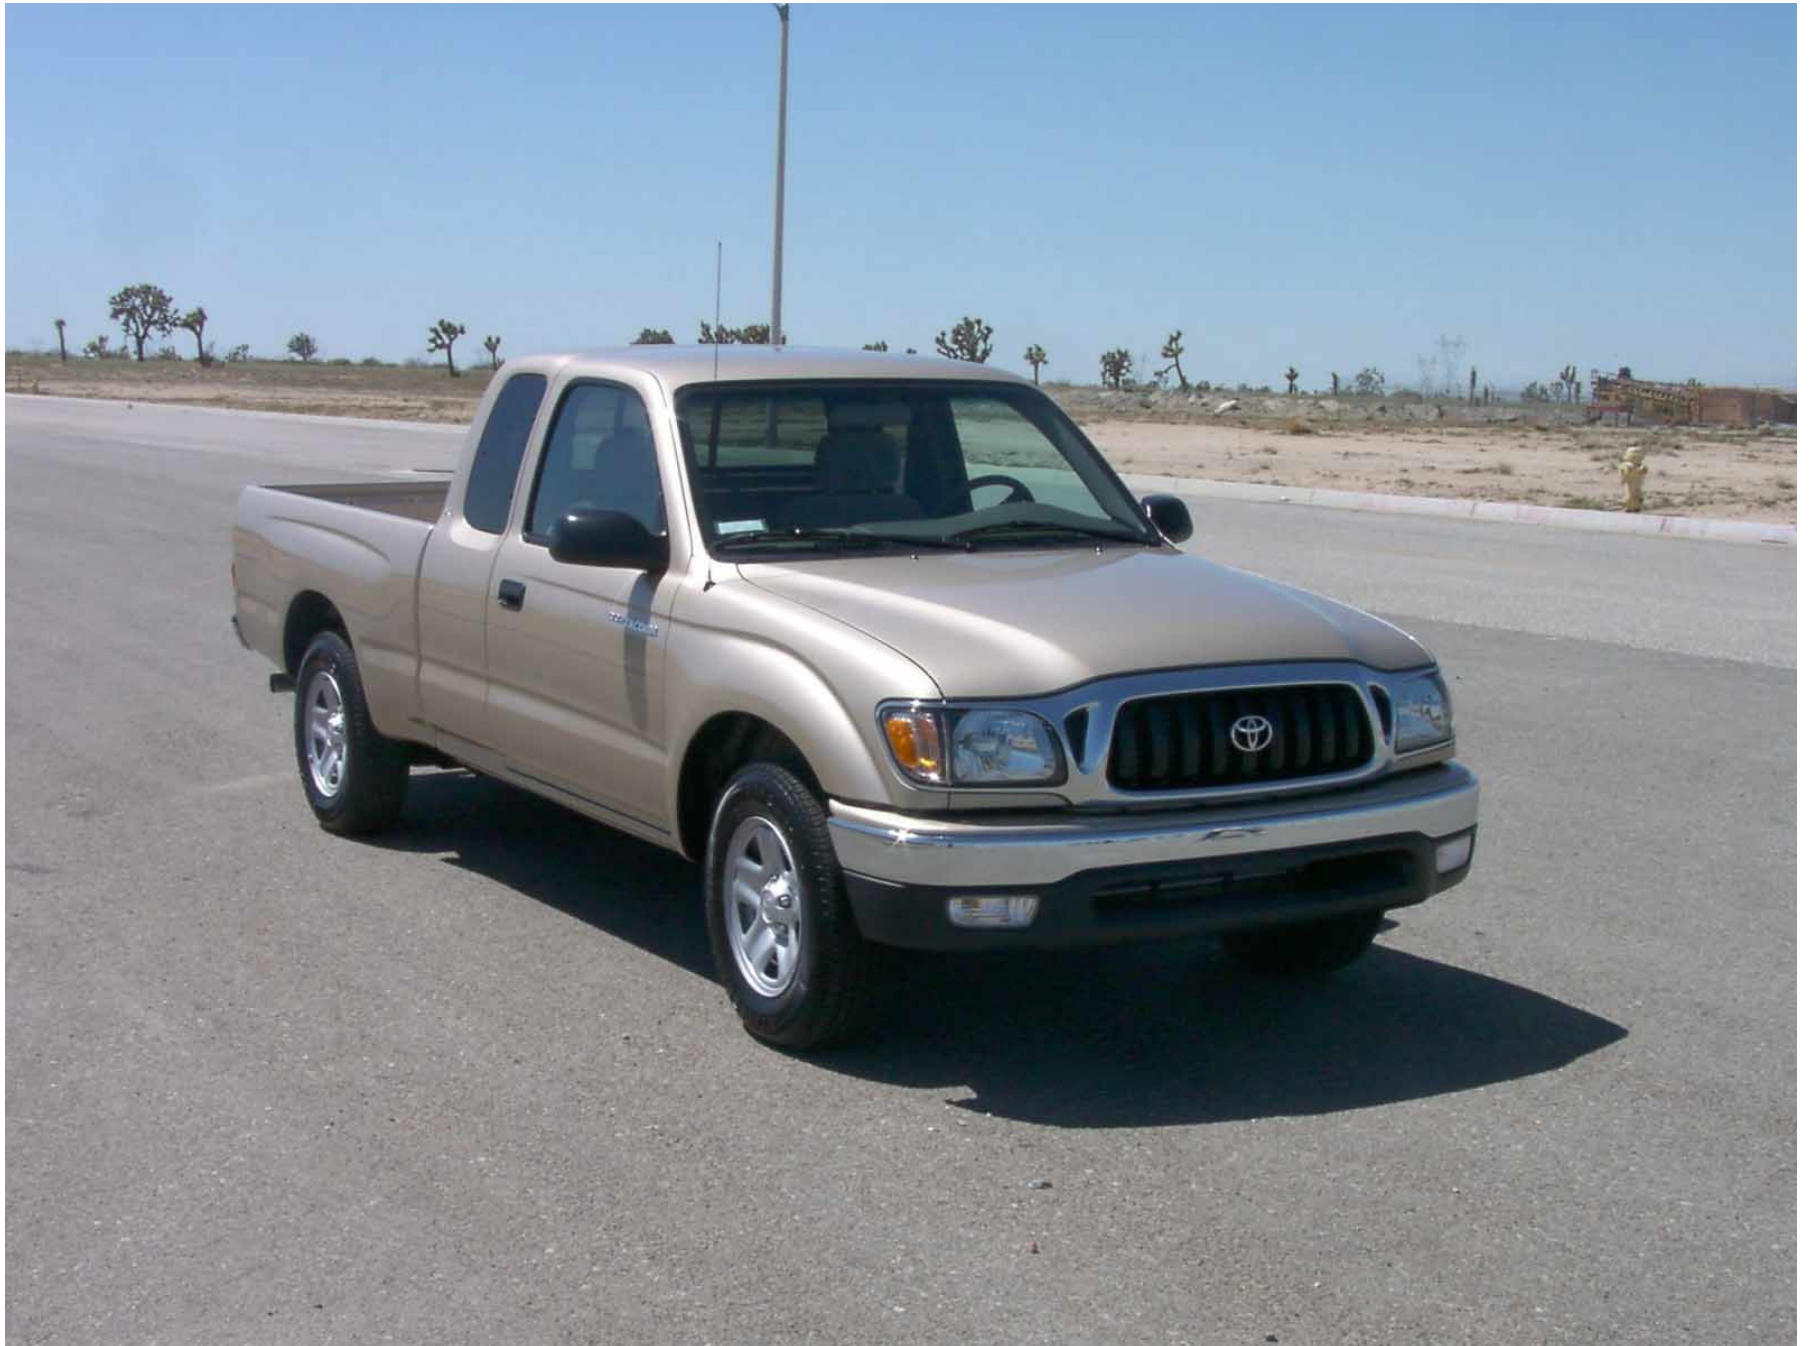
Figure A-1: Right Front, as Received

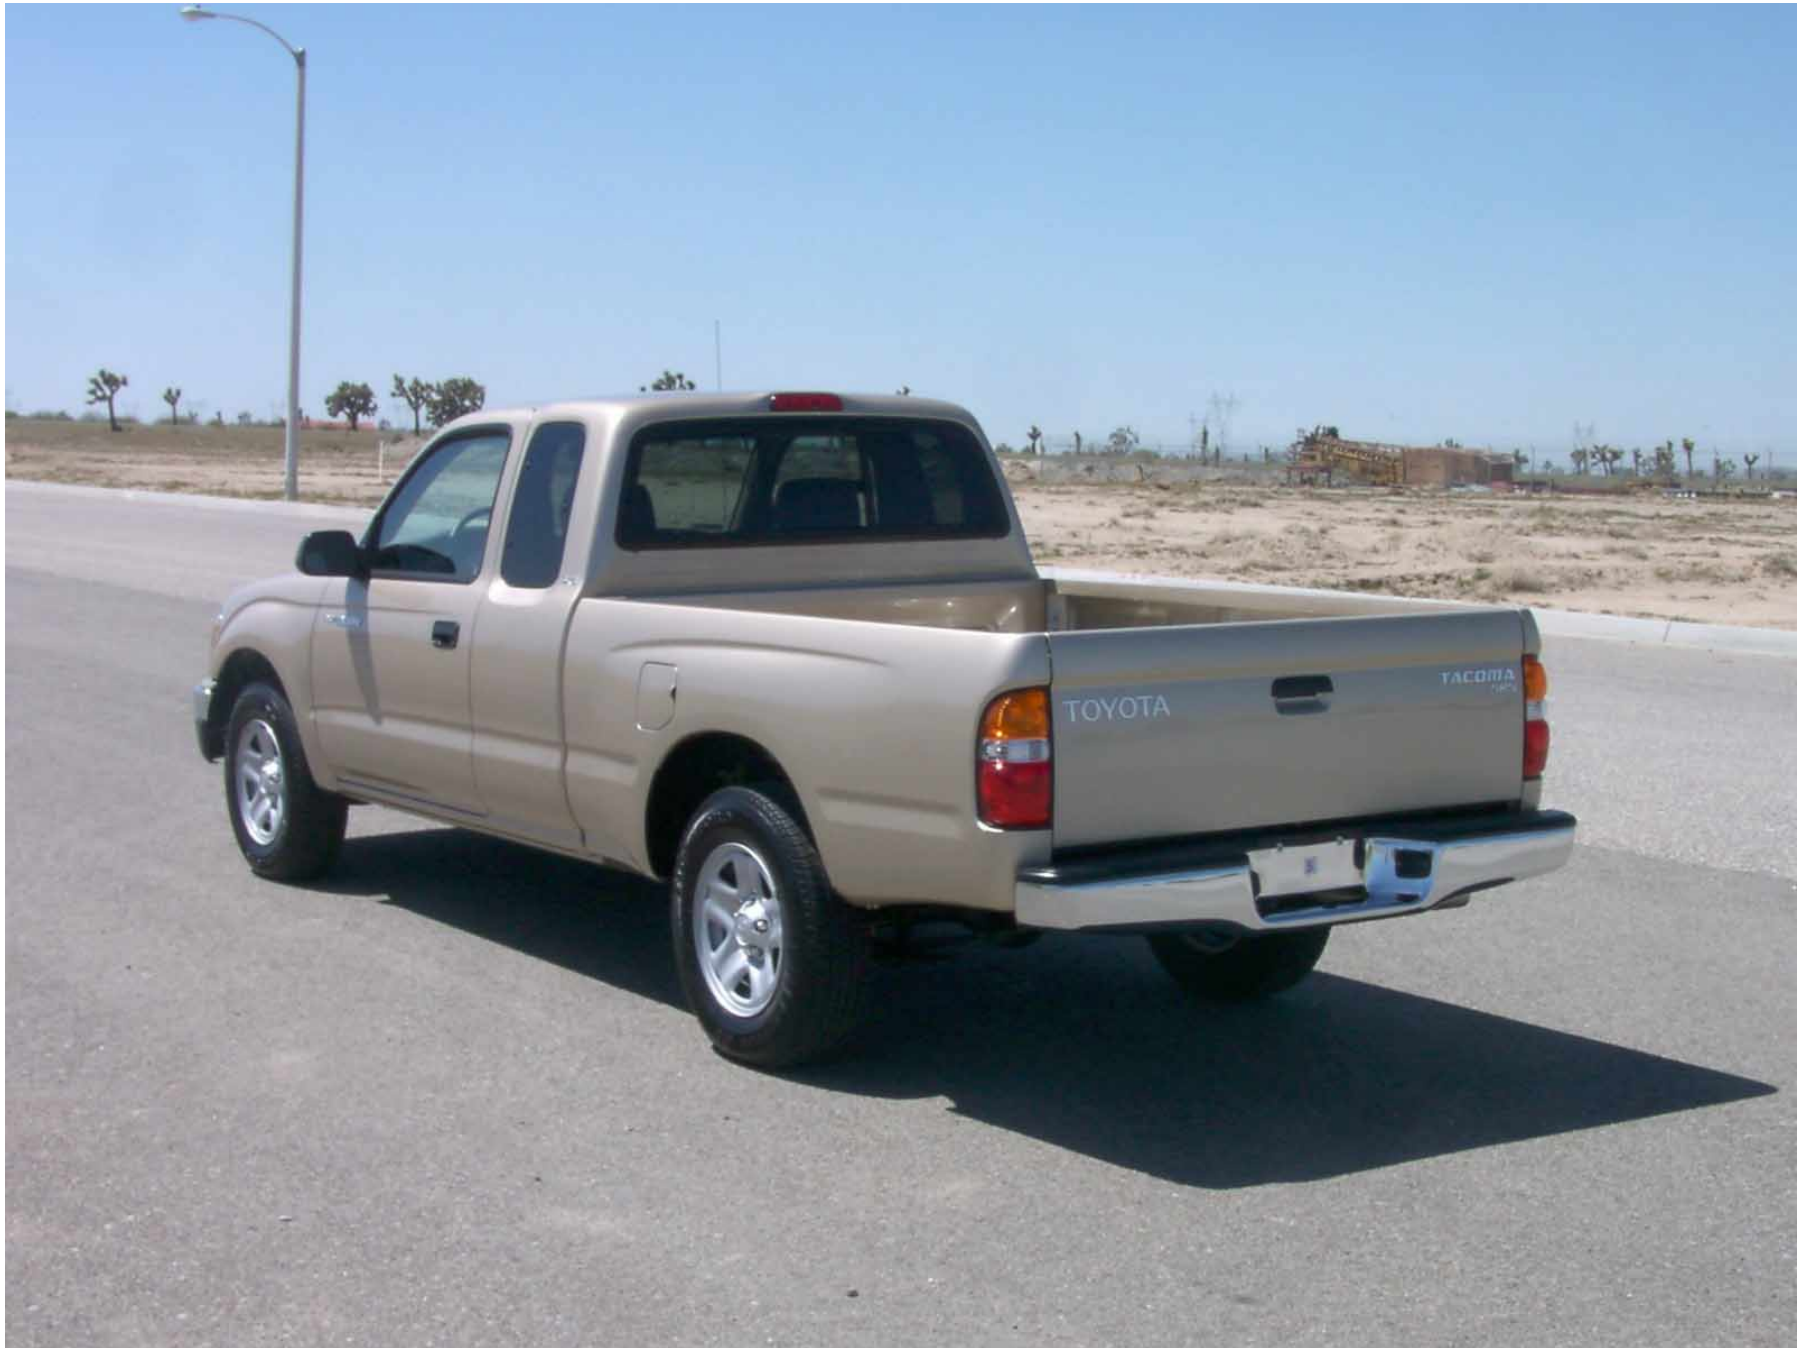
Figure A-2: Left Rear, as Received

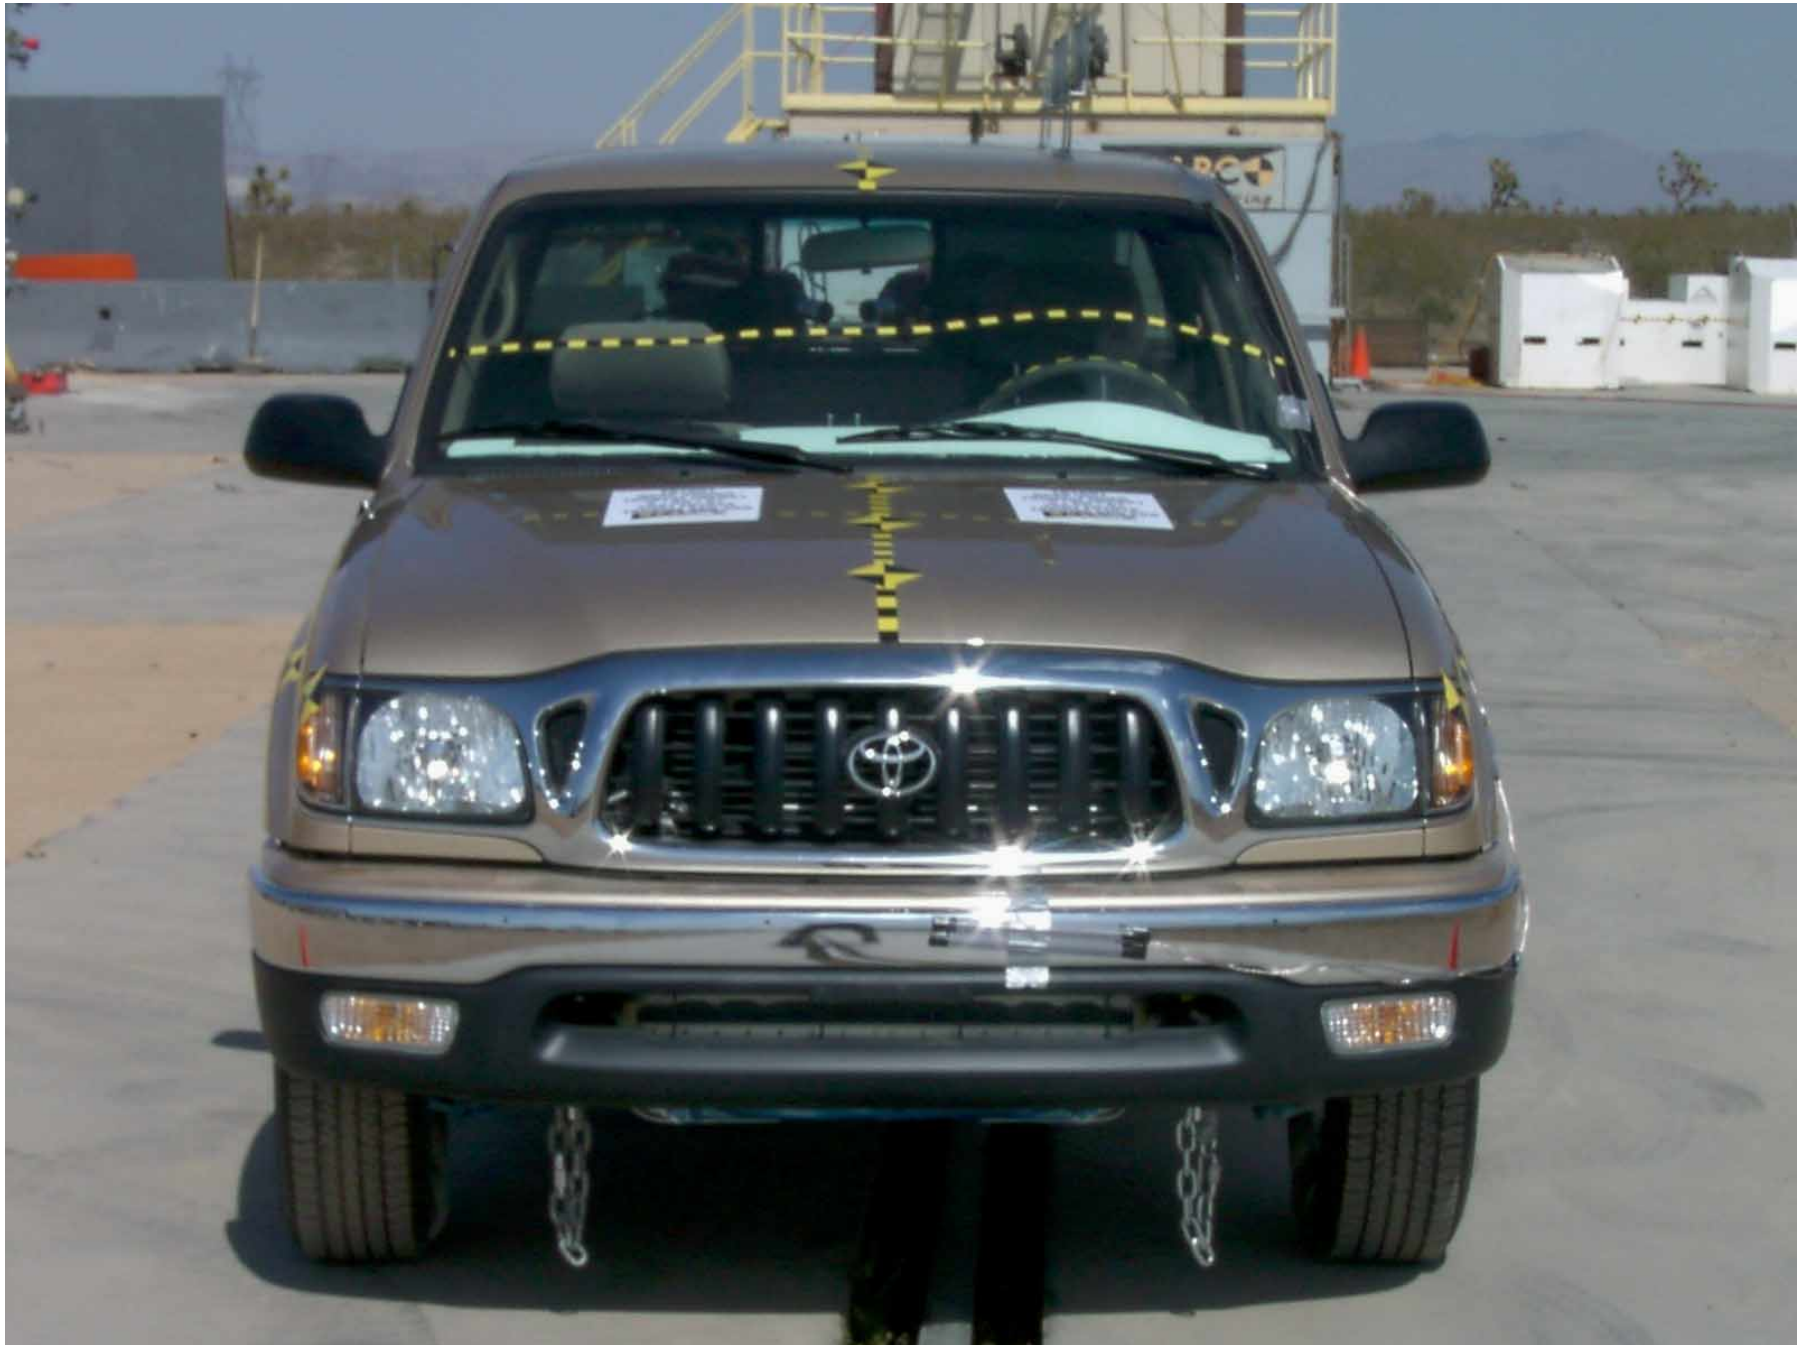
Figure A-5: Front View, Pre-Test

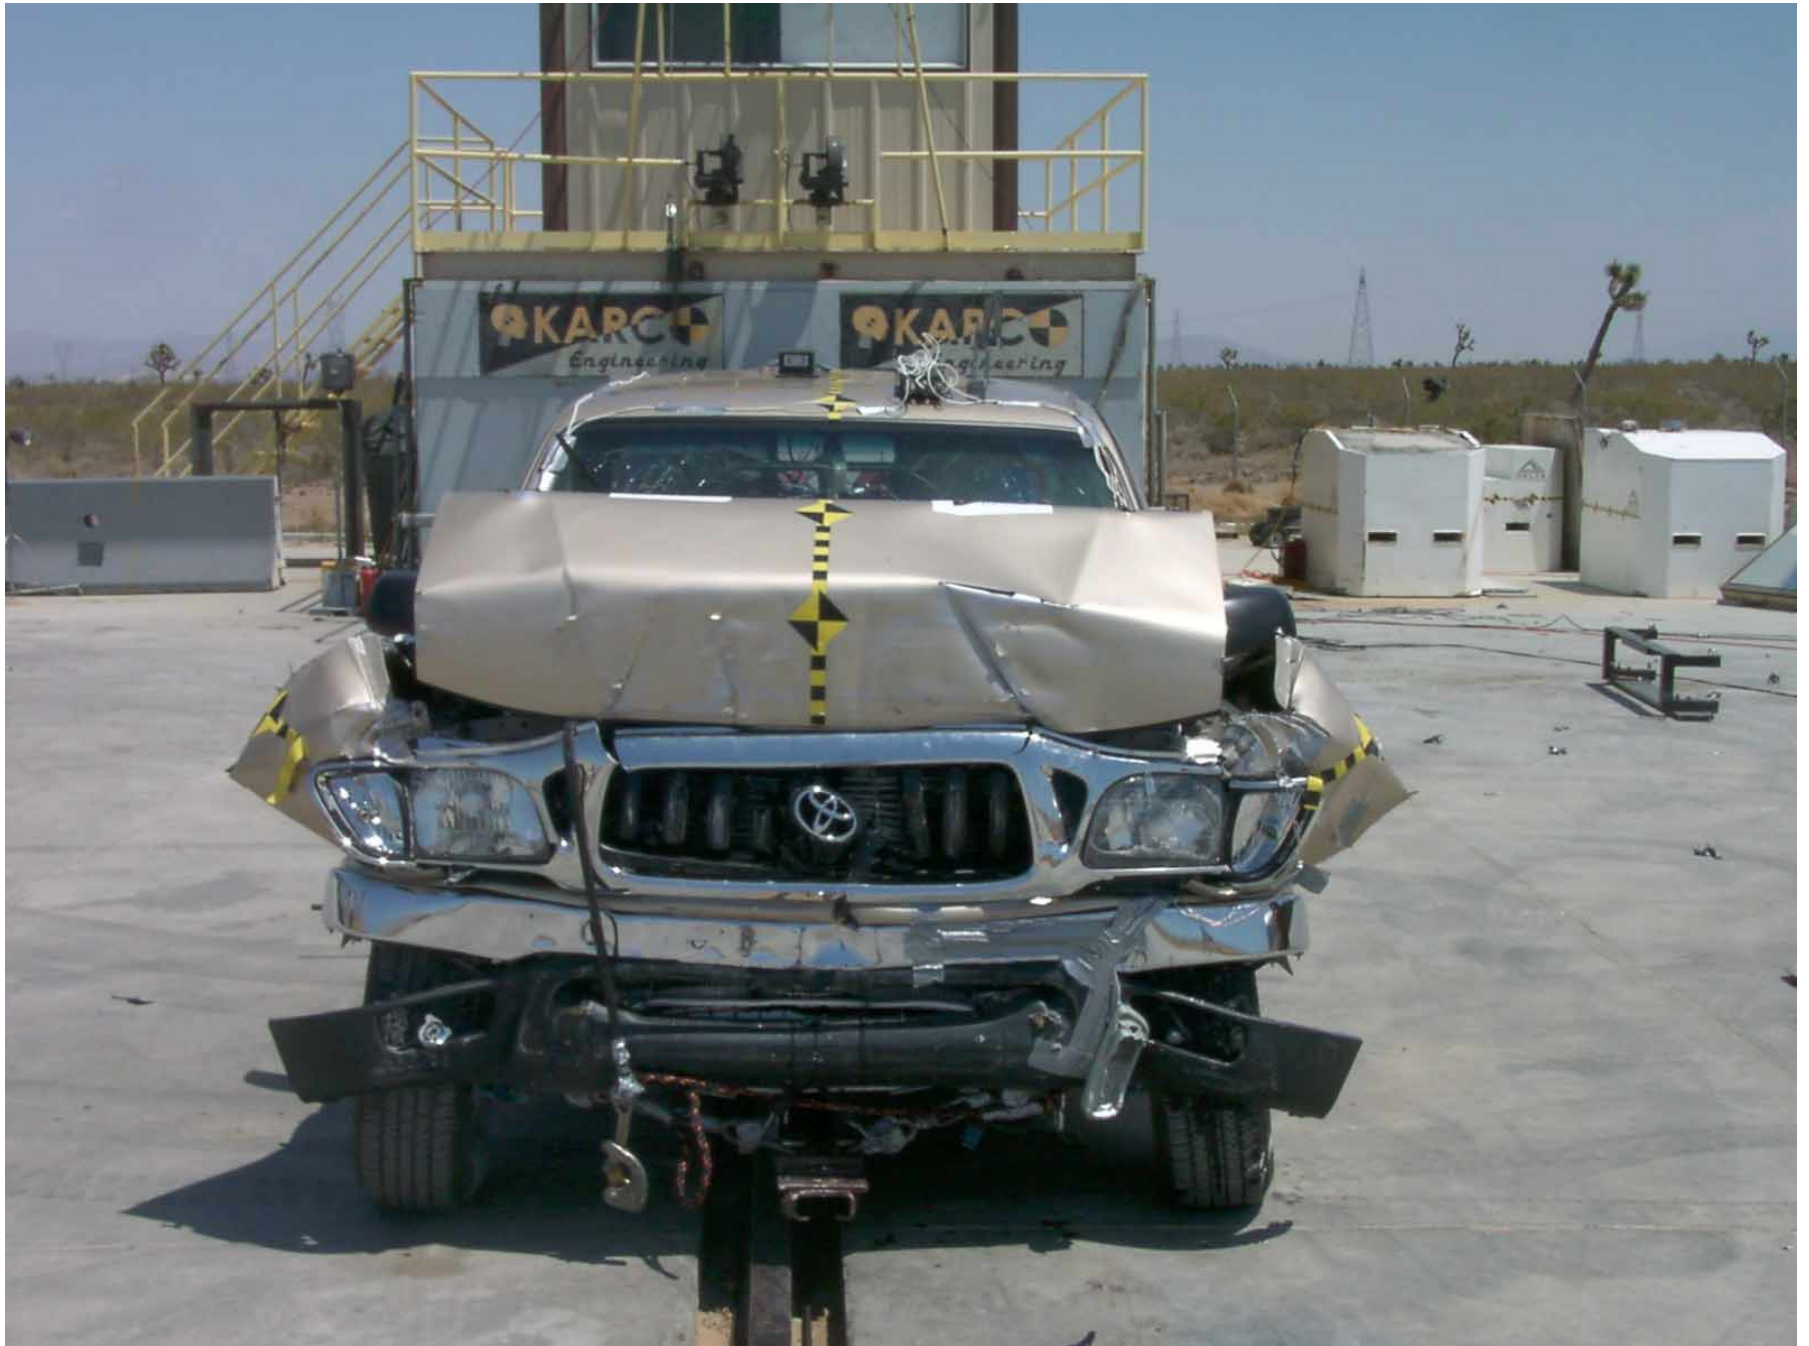
Figure A-6: Front View, Post-Test

Collision Deformation Classification: 12FDEW6 ; Midpoint of Damage: Vehicle Centerline  
Damage Region Length (mm): 1630 ; Impact Mode: Full Frontal

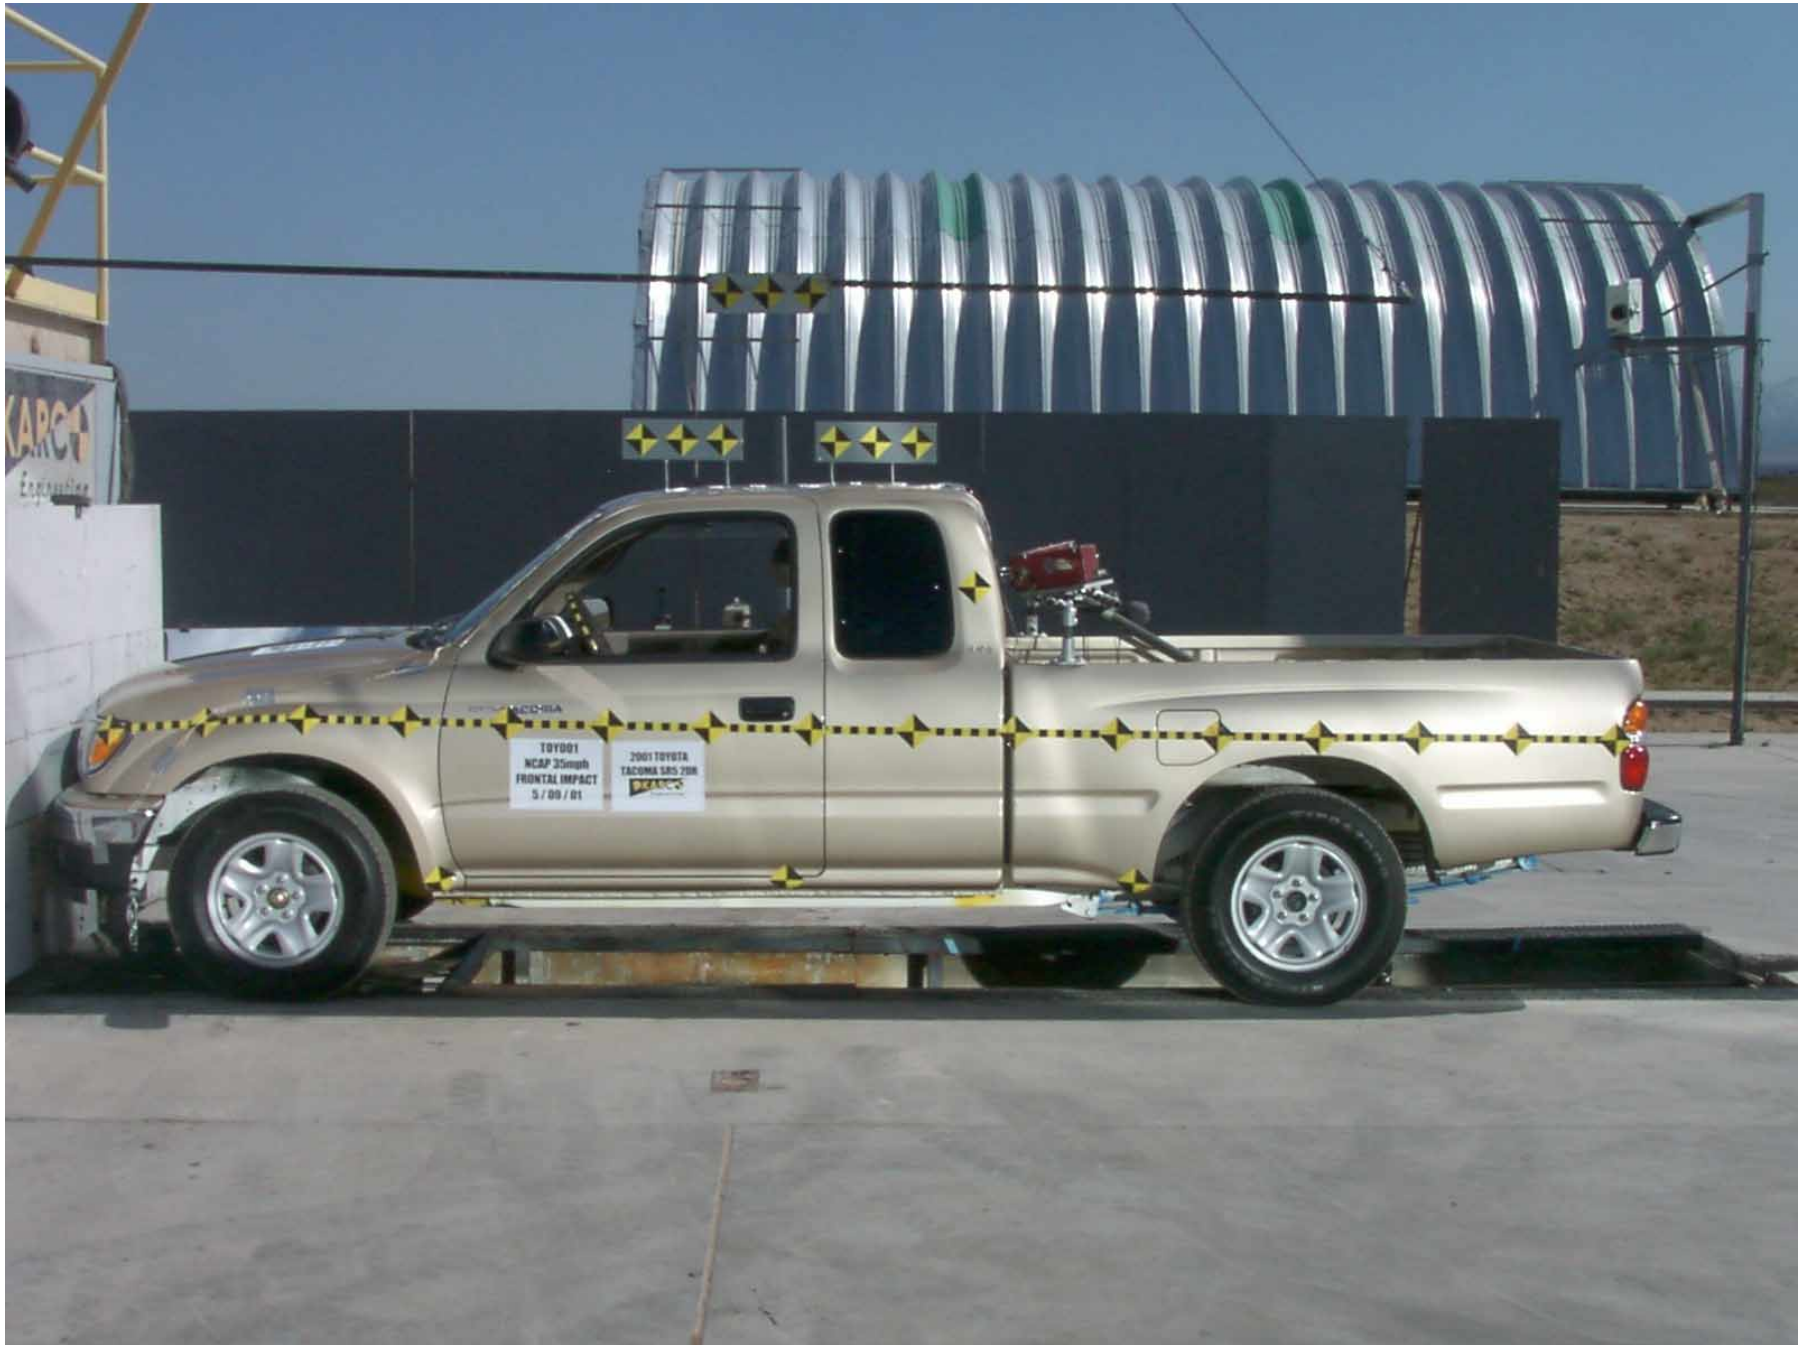
Figure A-7: Left Side View, Pre-Test

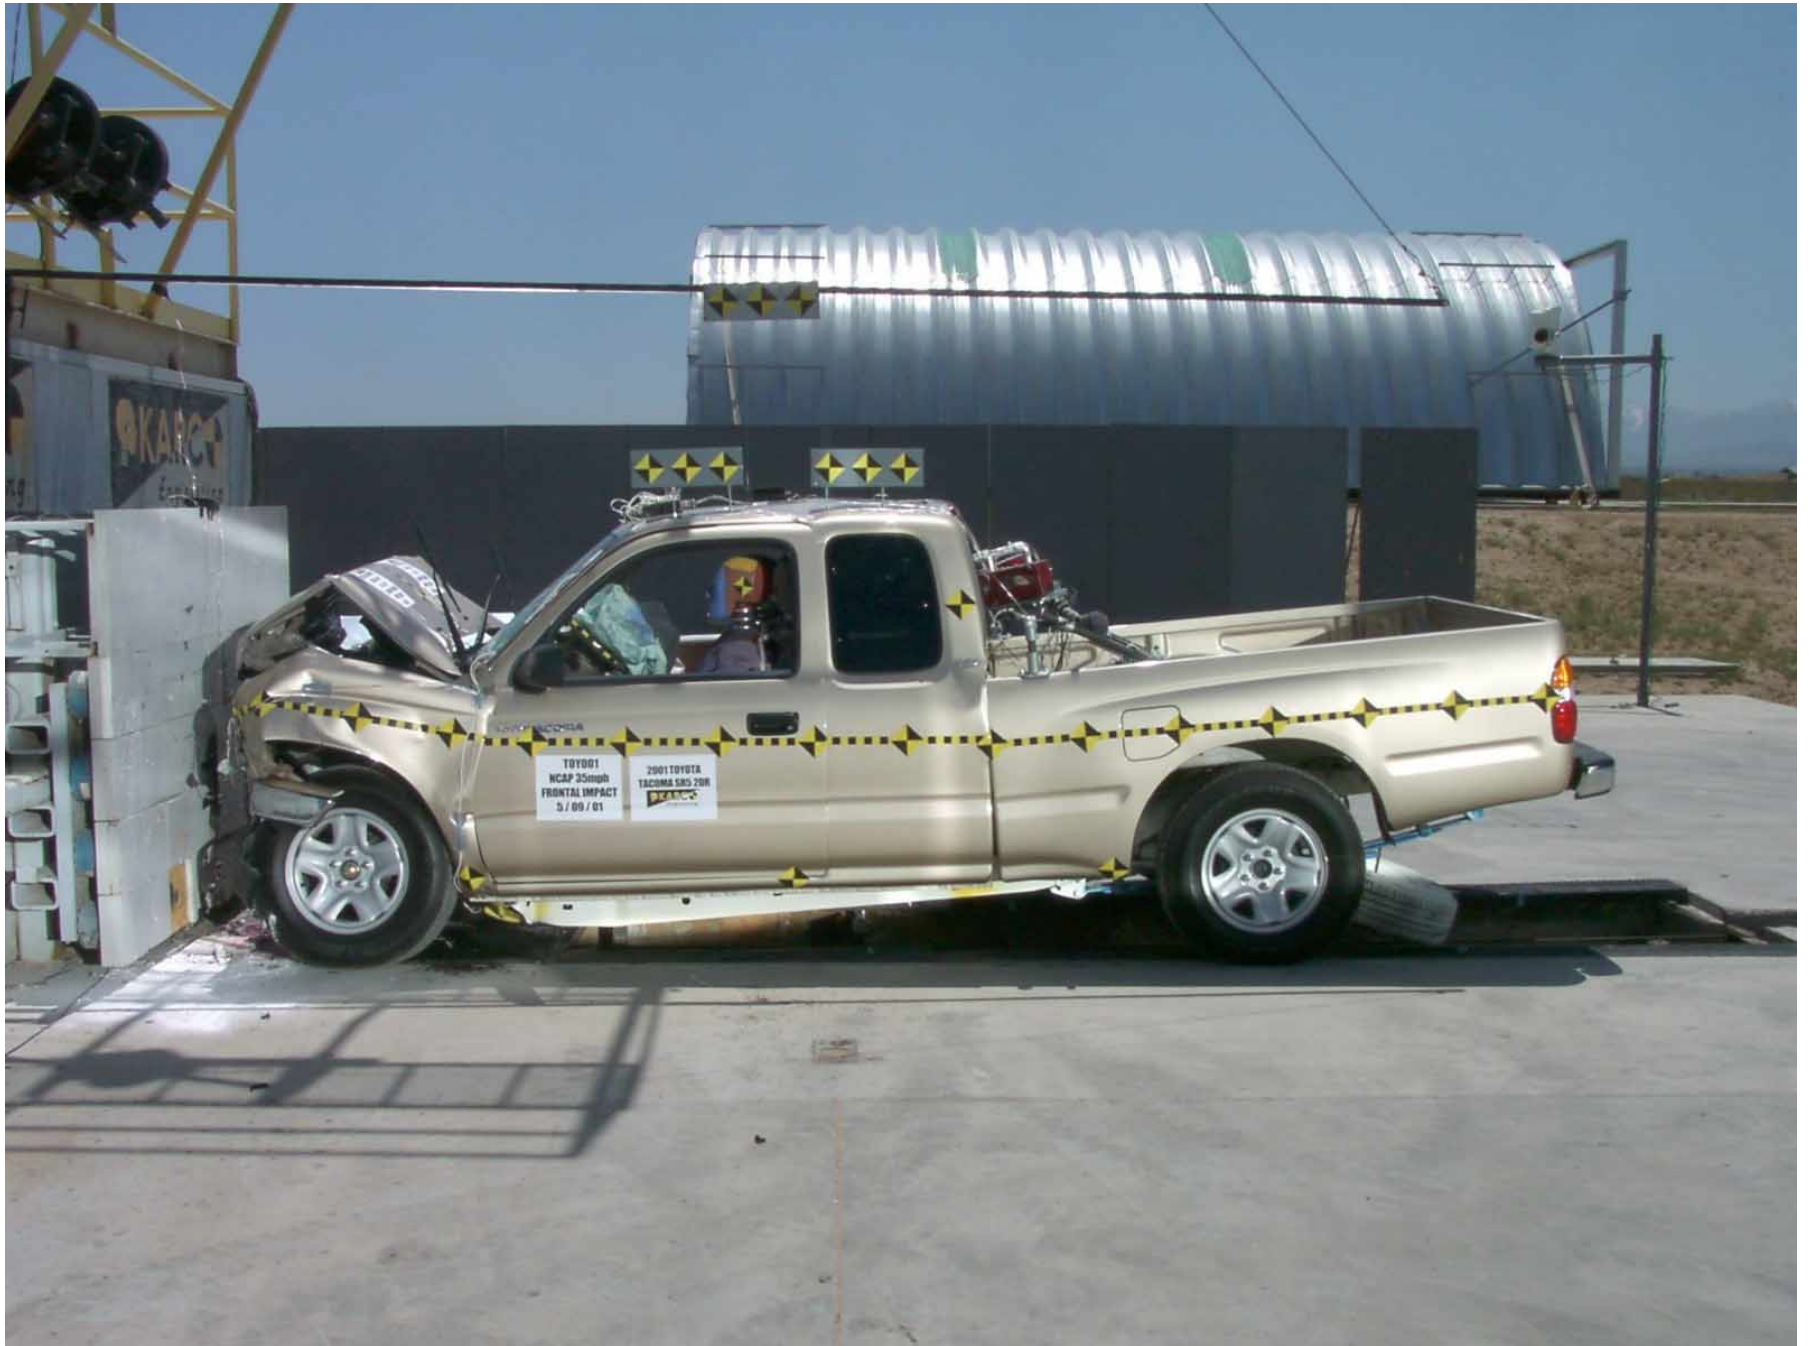
Figure A-8: Left Side View, Post-Test

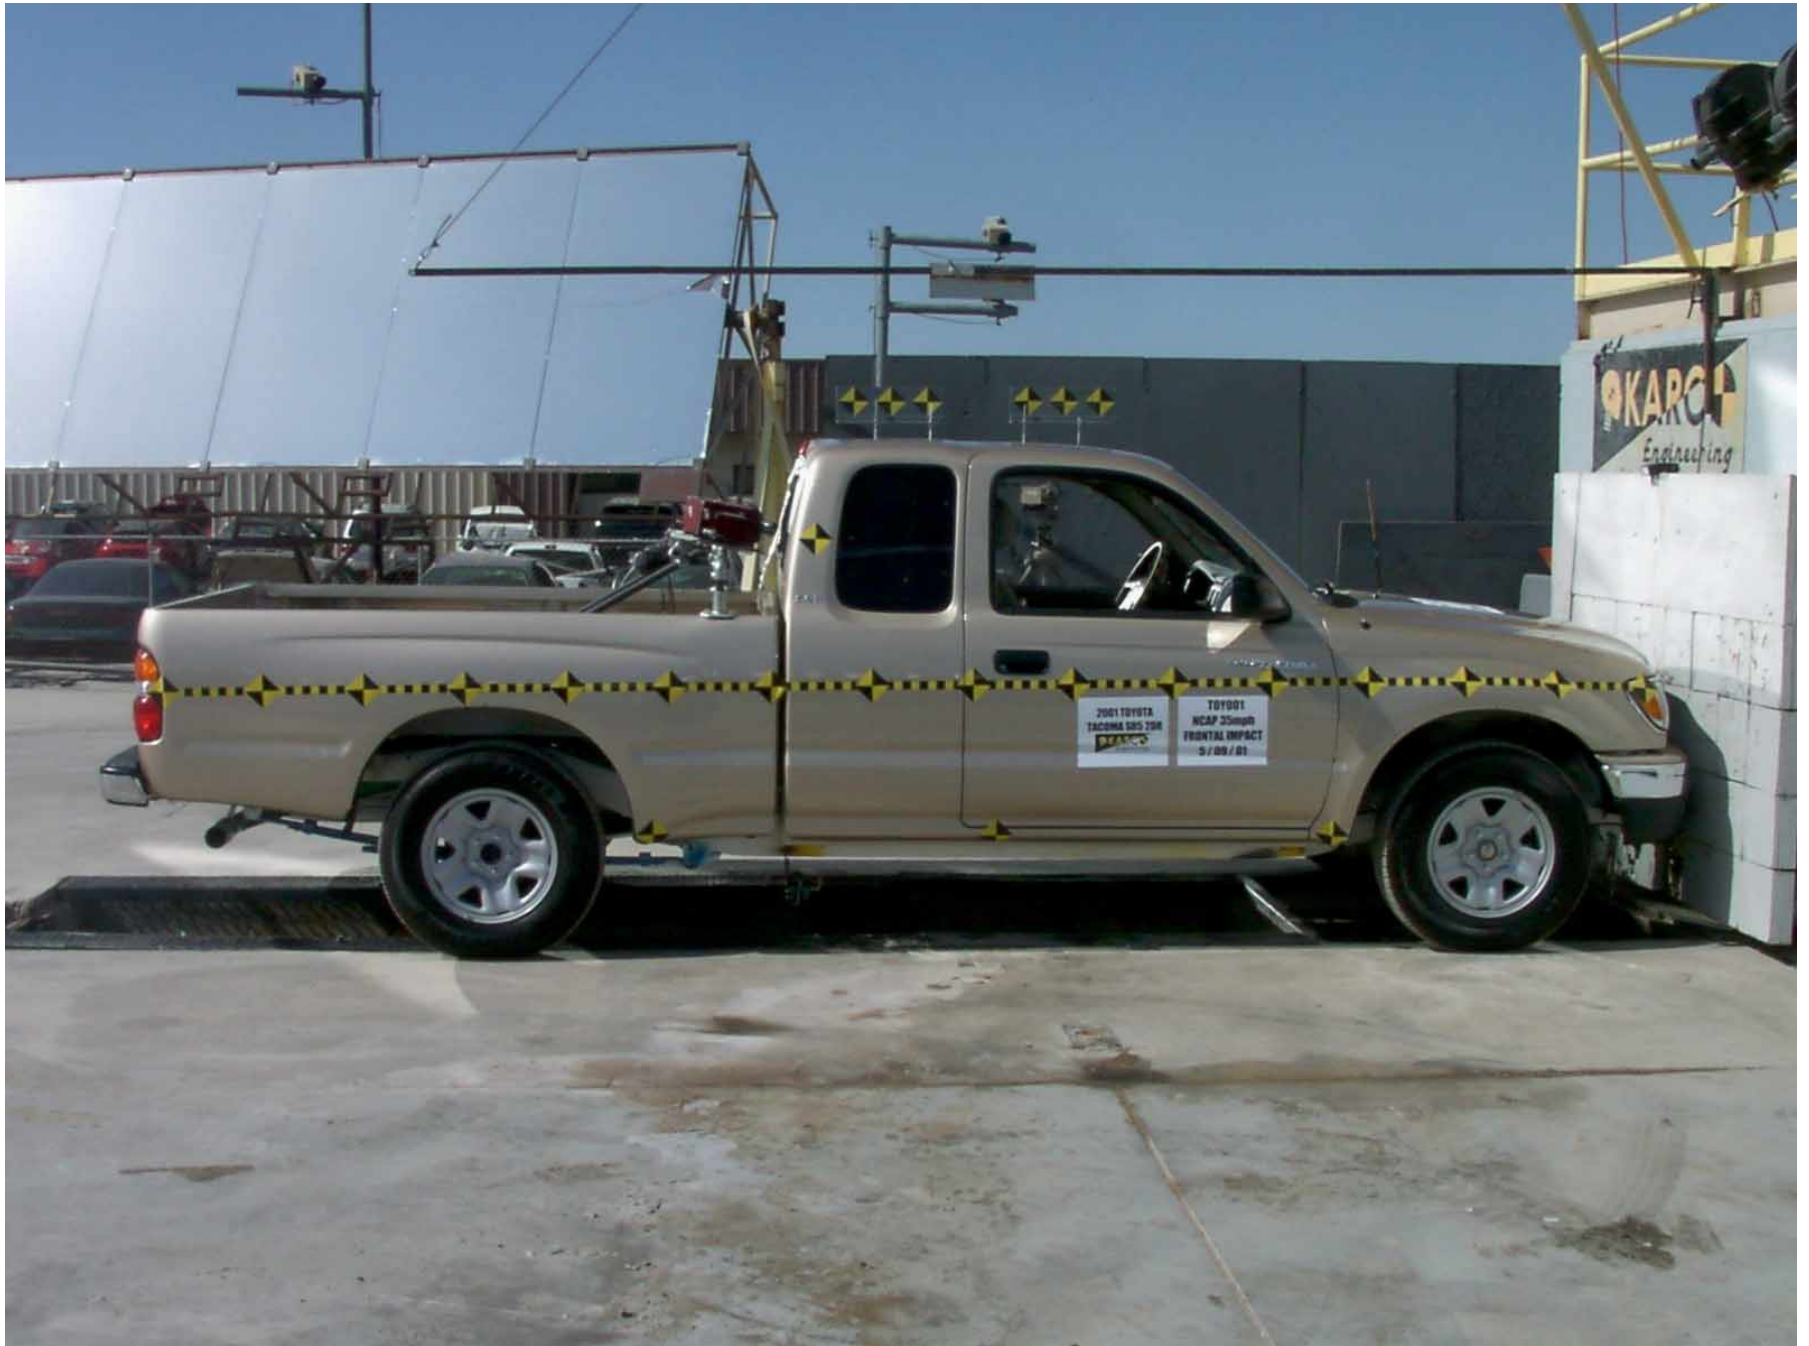
Figure A-9: Right Side View, Pre-Test

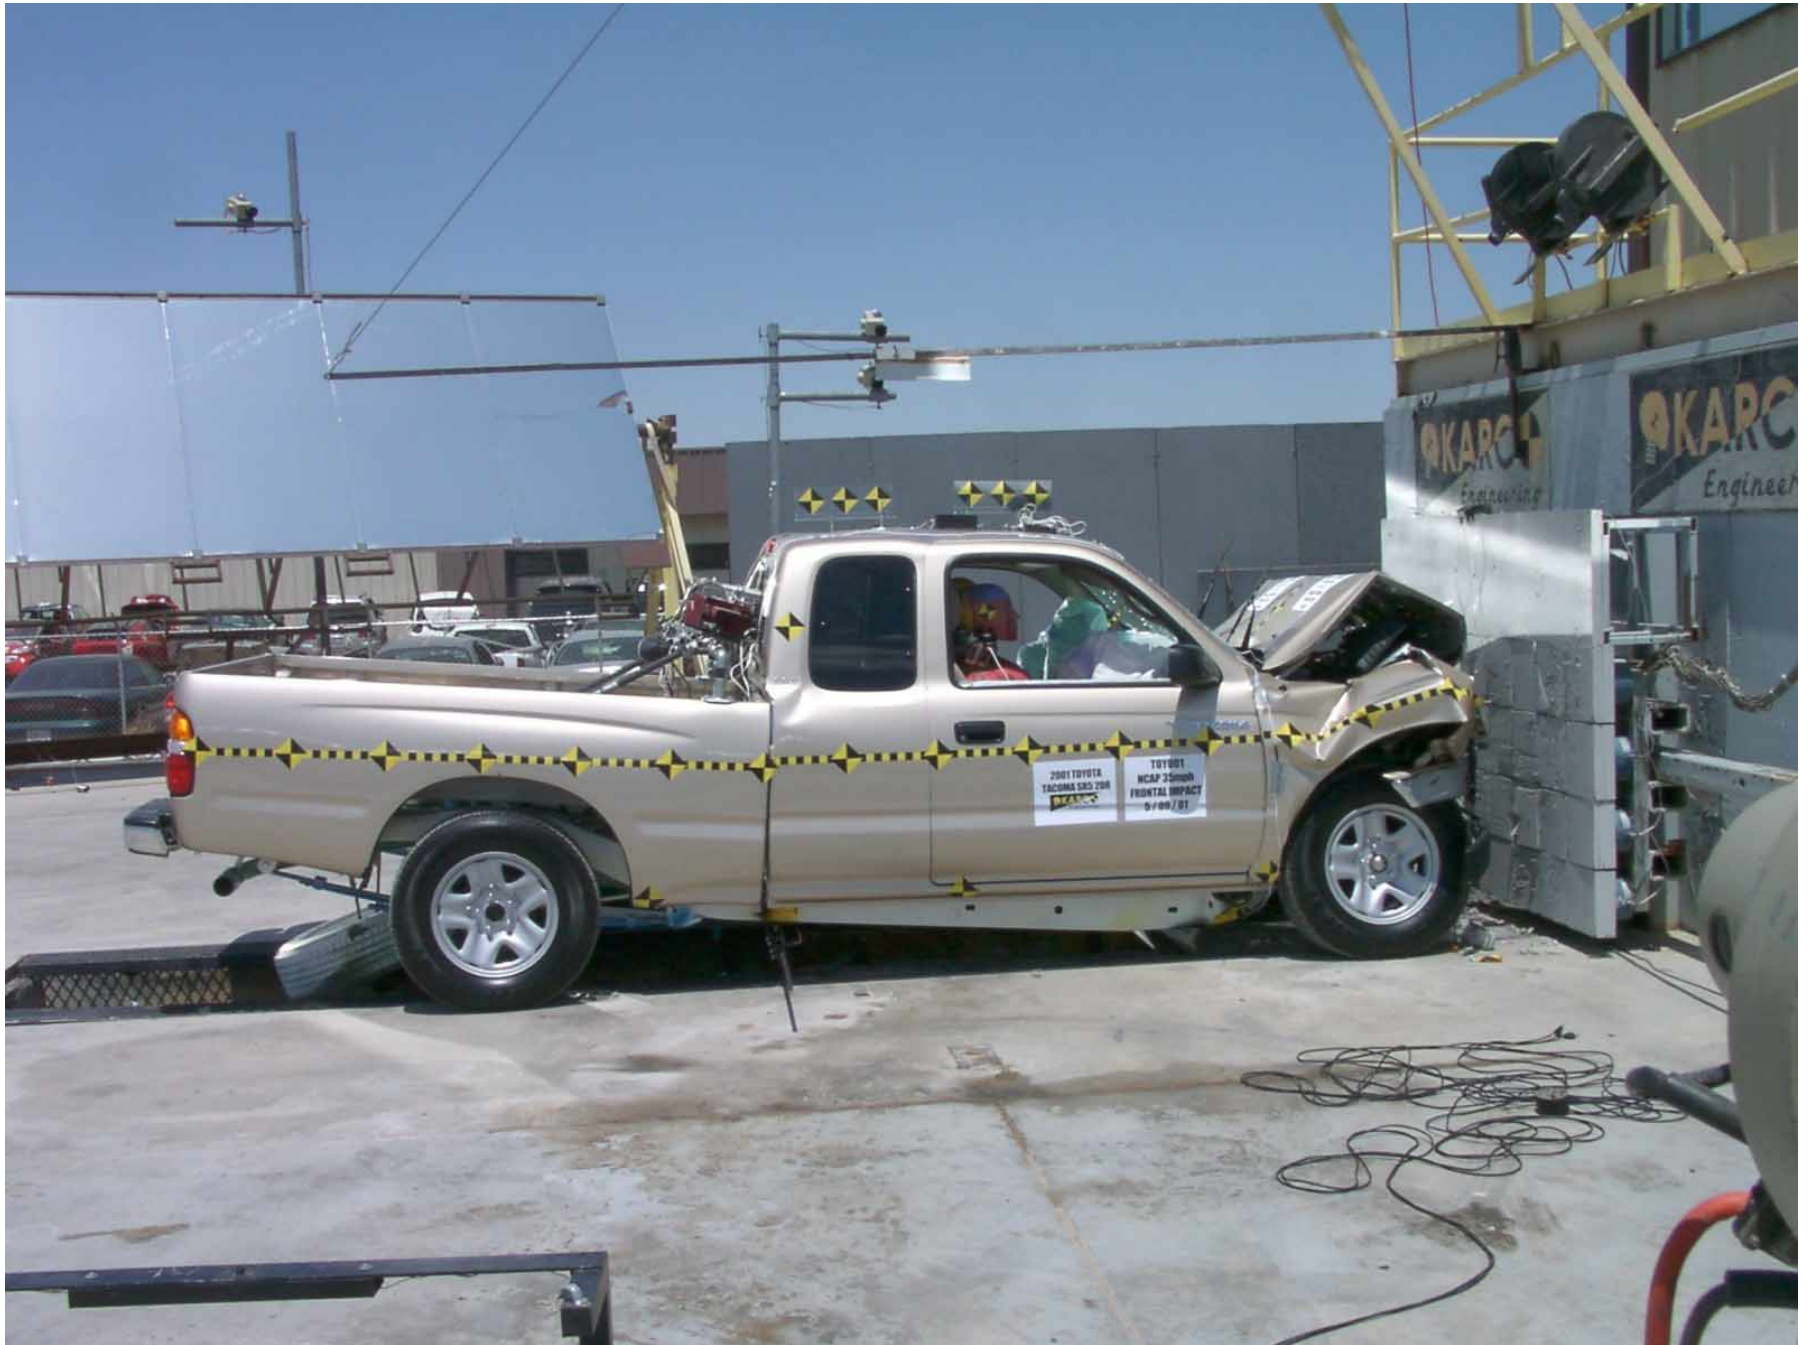
Figure A-10: Right Side View, Post-Test

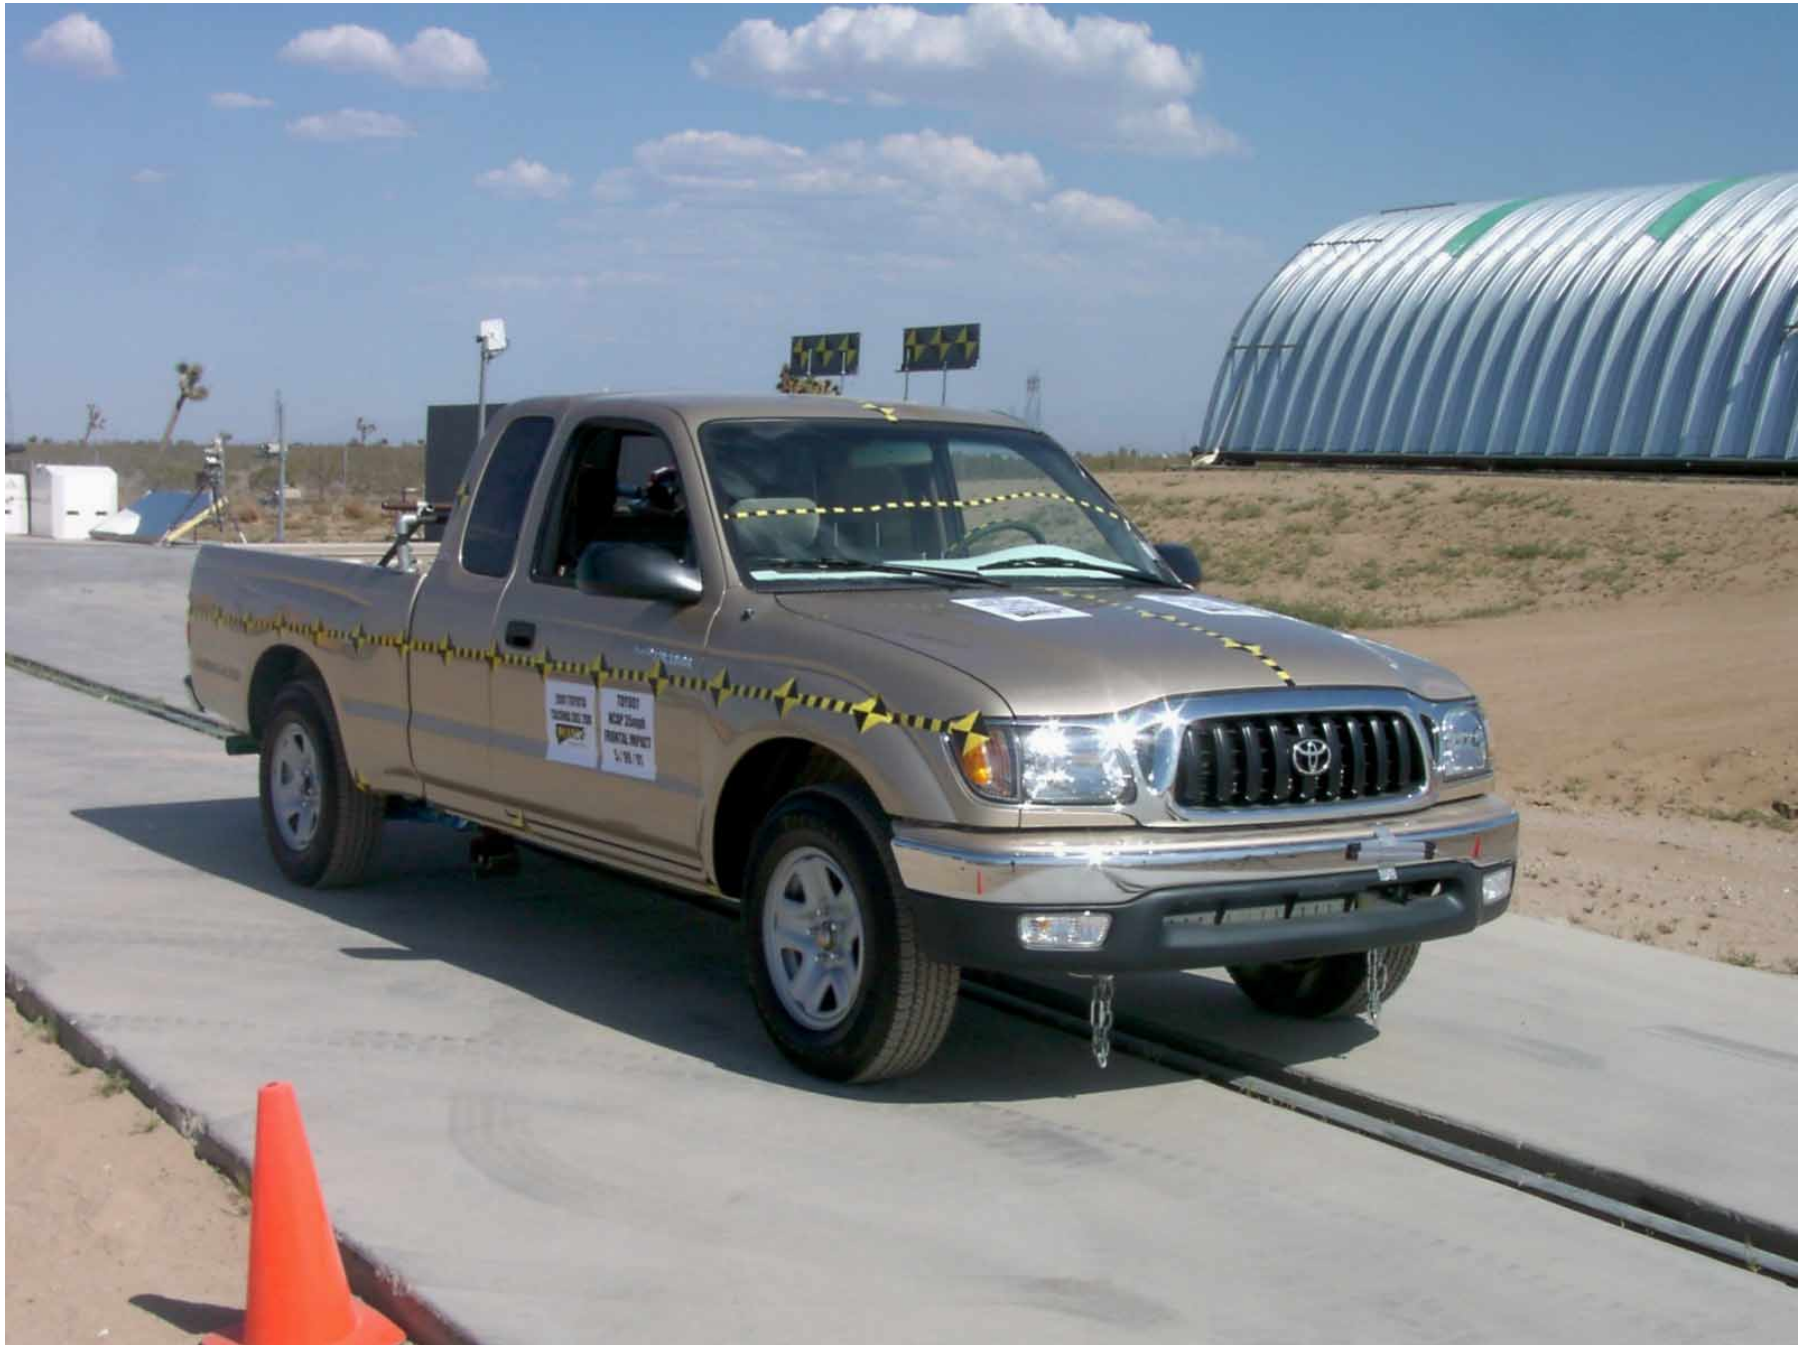
Figure A-11: Right Front View, Pre-Test
