**REPORT NUMBER KAR21049-01**

**NEW CAR ASSESSMENT PROGRAM  
FRONTAL BARRIER IMPACT TEST**

**TOYOTA MOTOR MANUFACTURING  
2001 TOYOTA TACOMA SR5 EXTENDED CAB PICKUP  
NHTSA NUMBER: TOY001**

**PREPARED BY:  
KARCO ENGINEERING  
9270 HOLLY ROAD  
ADELANTO, CALIFORNIA 92301**

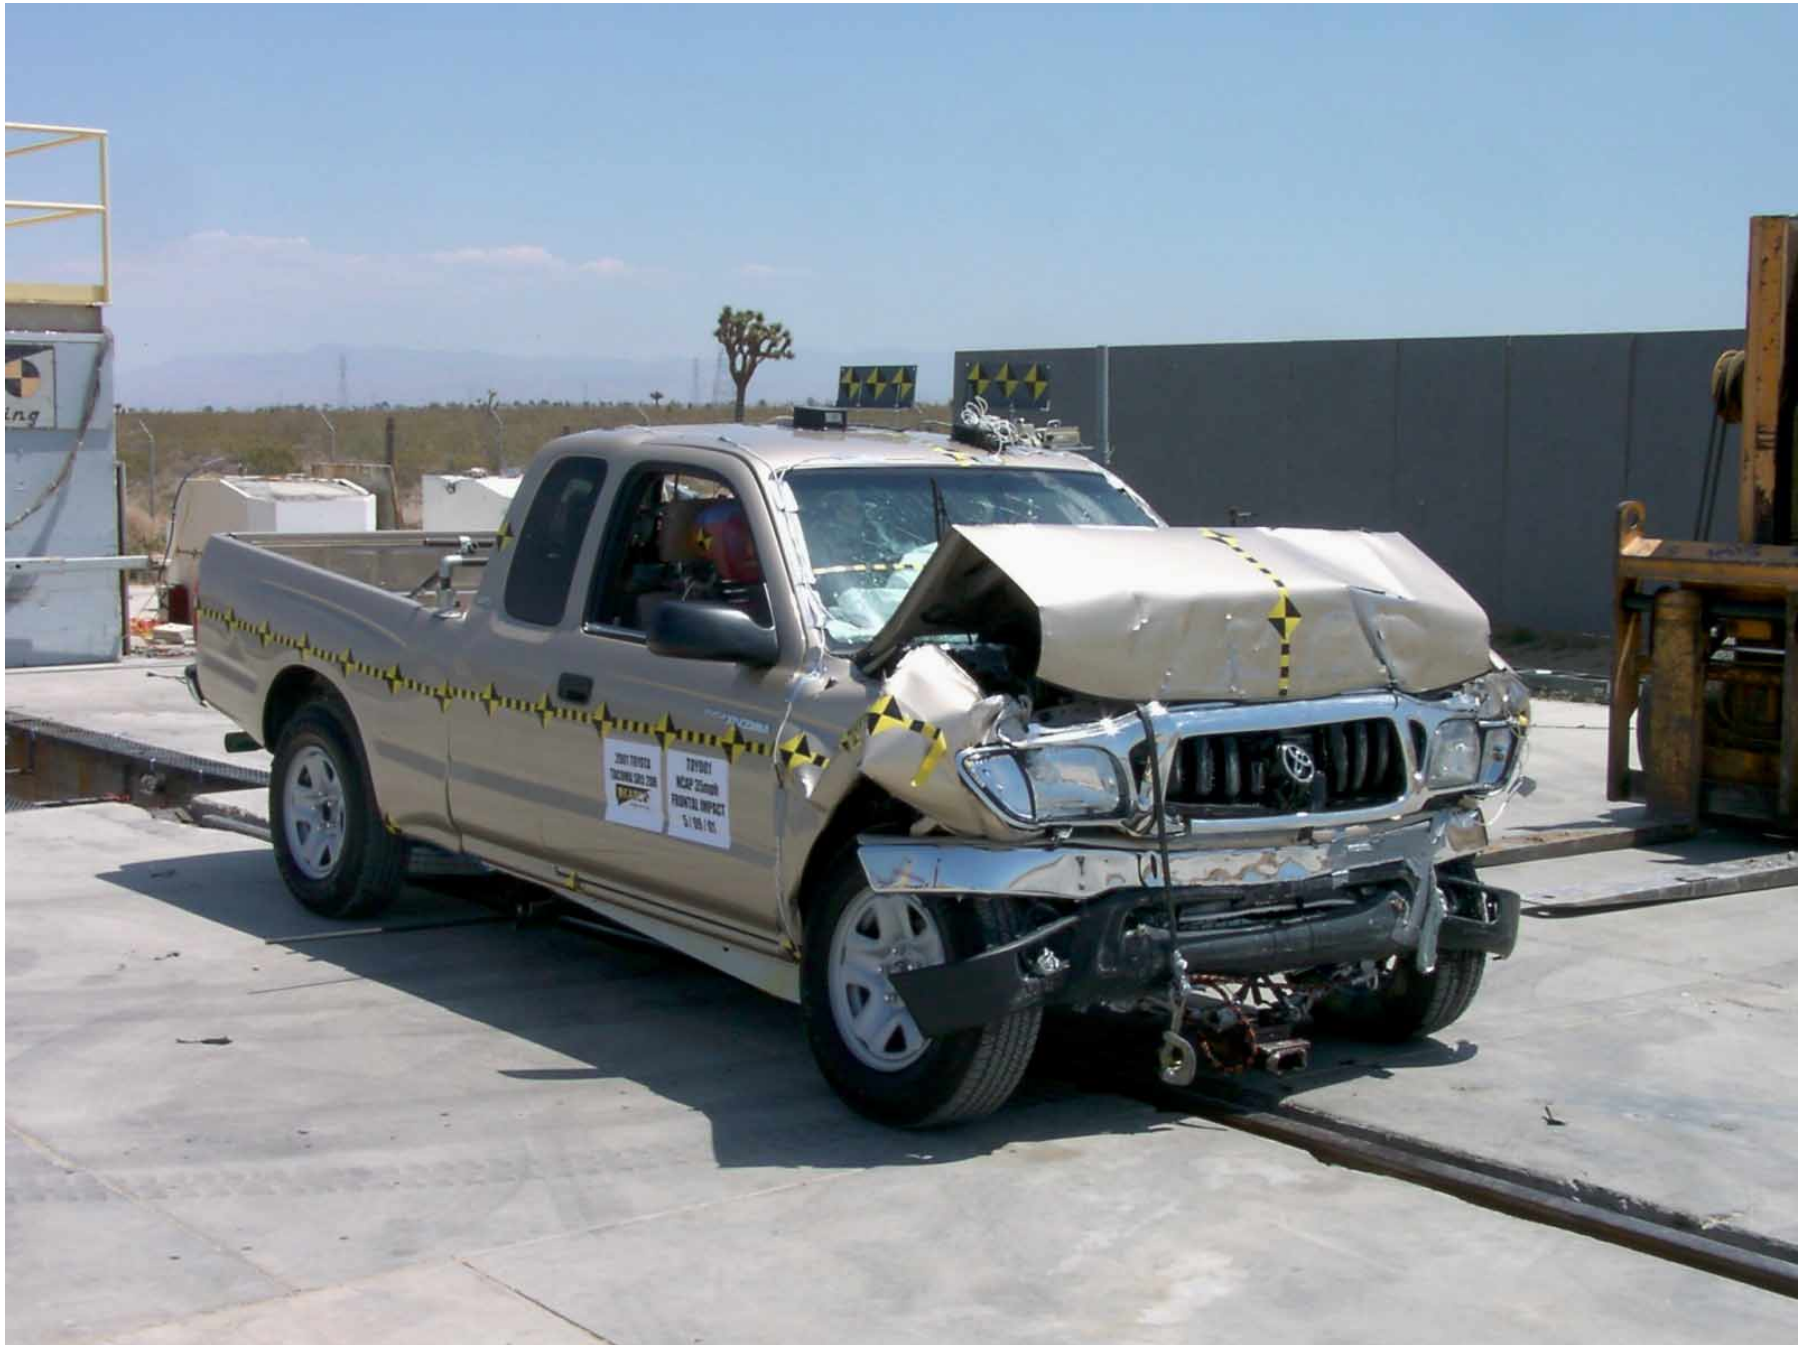
Figure A-12: Right Front View, Post-Test

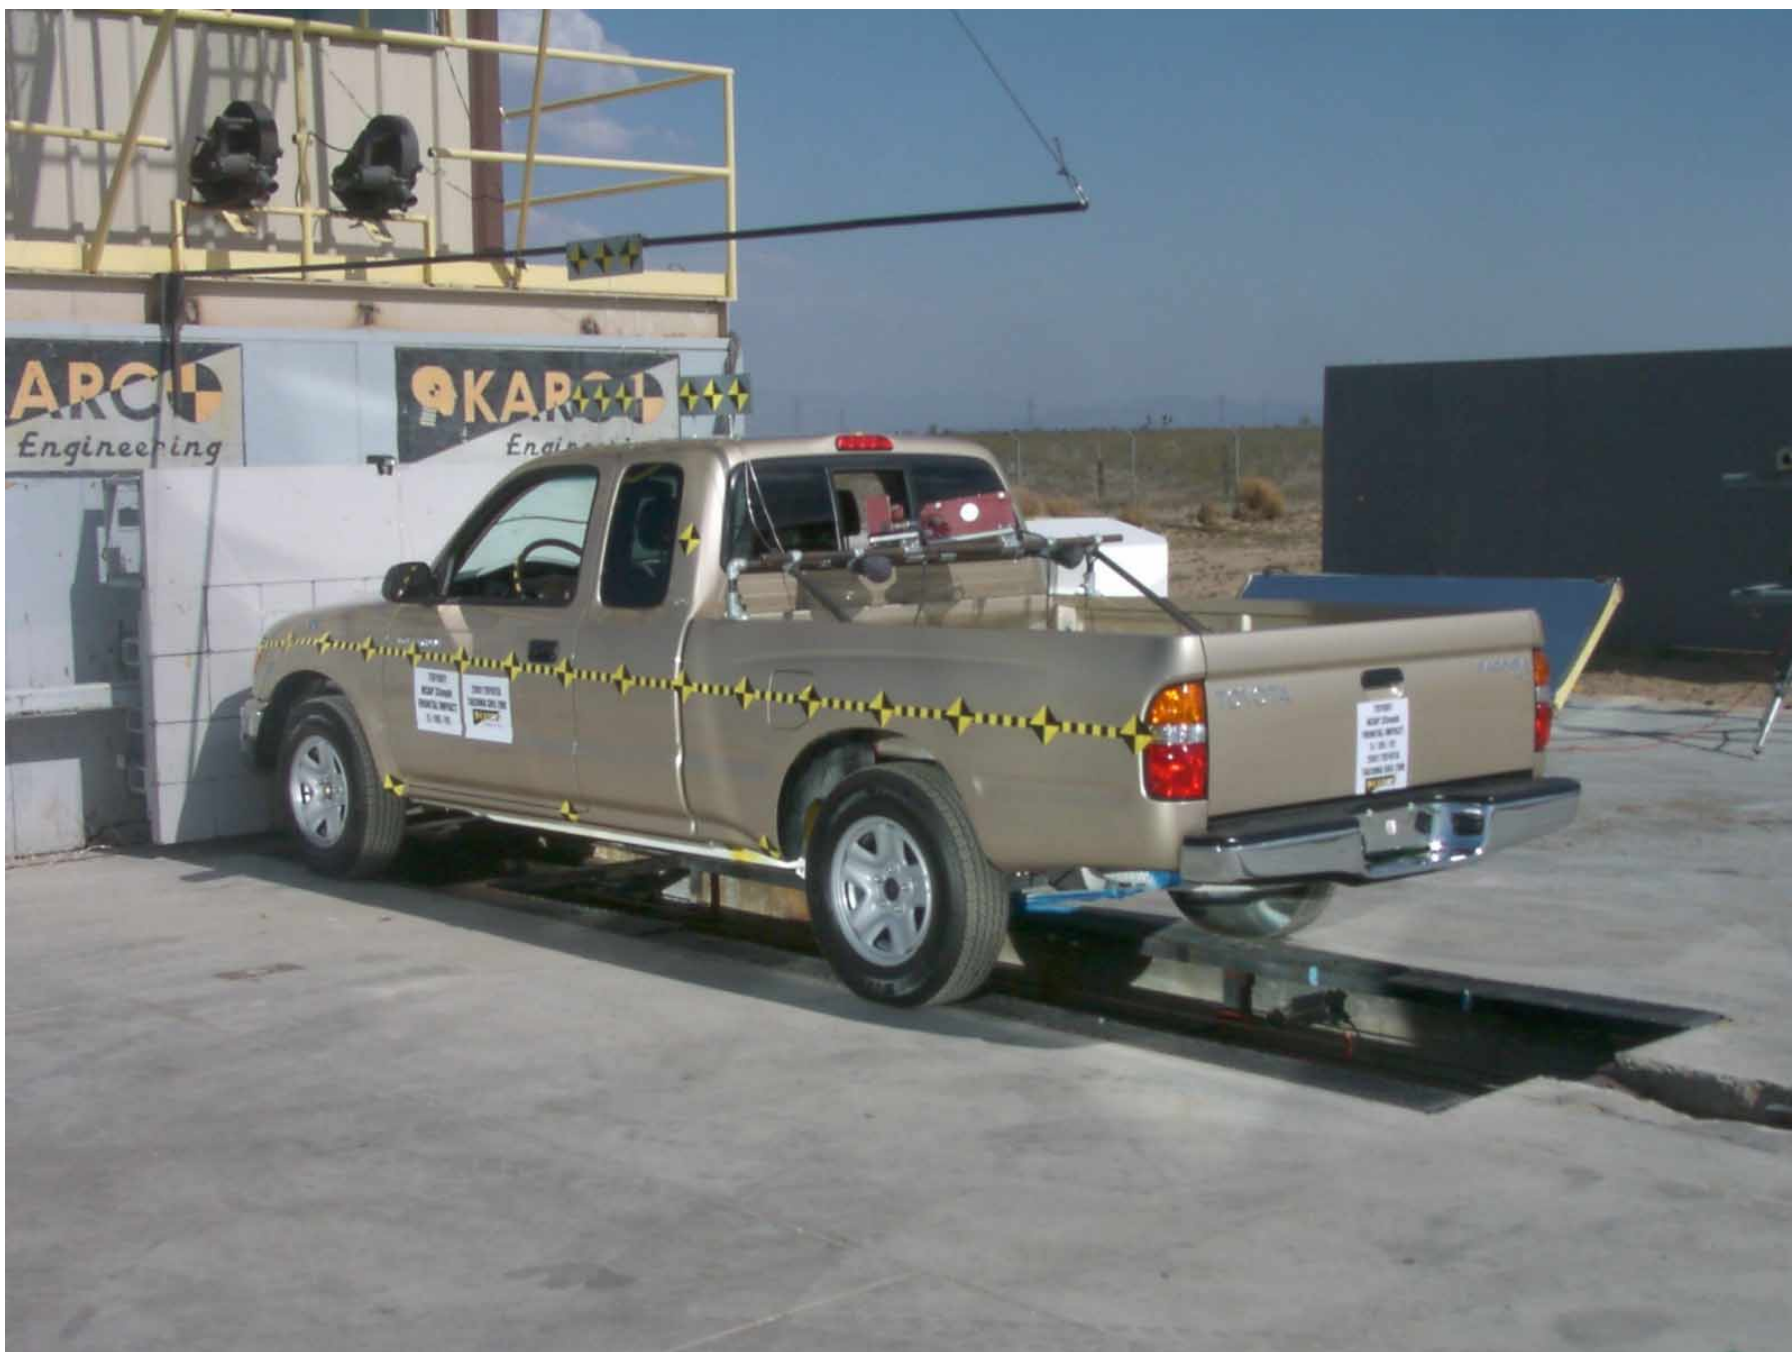
Figure A-13: Left Rear View, Pre-Test

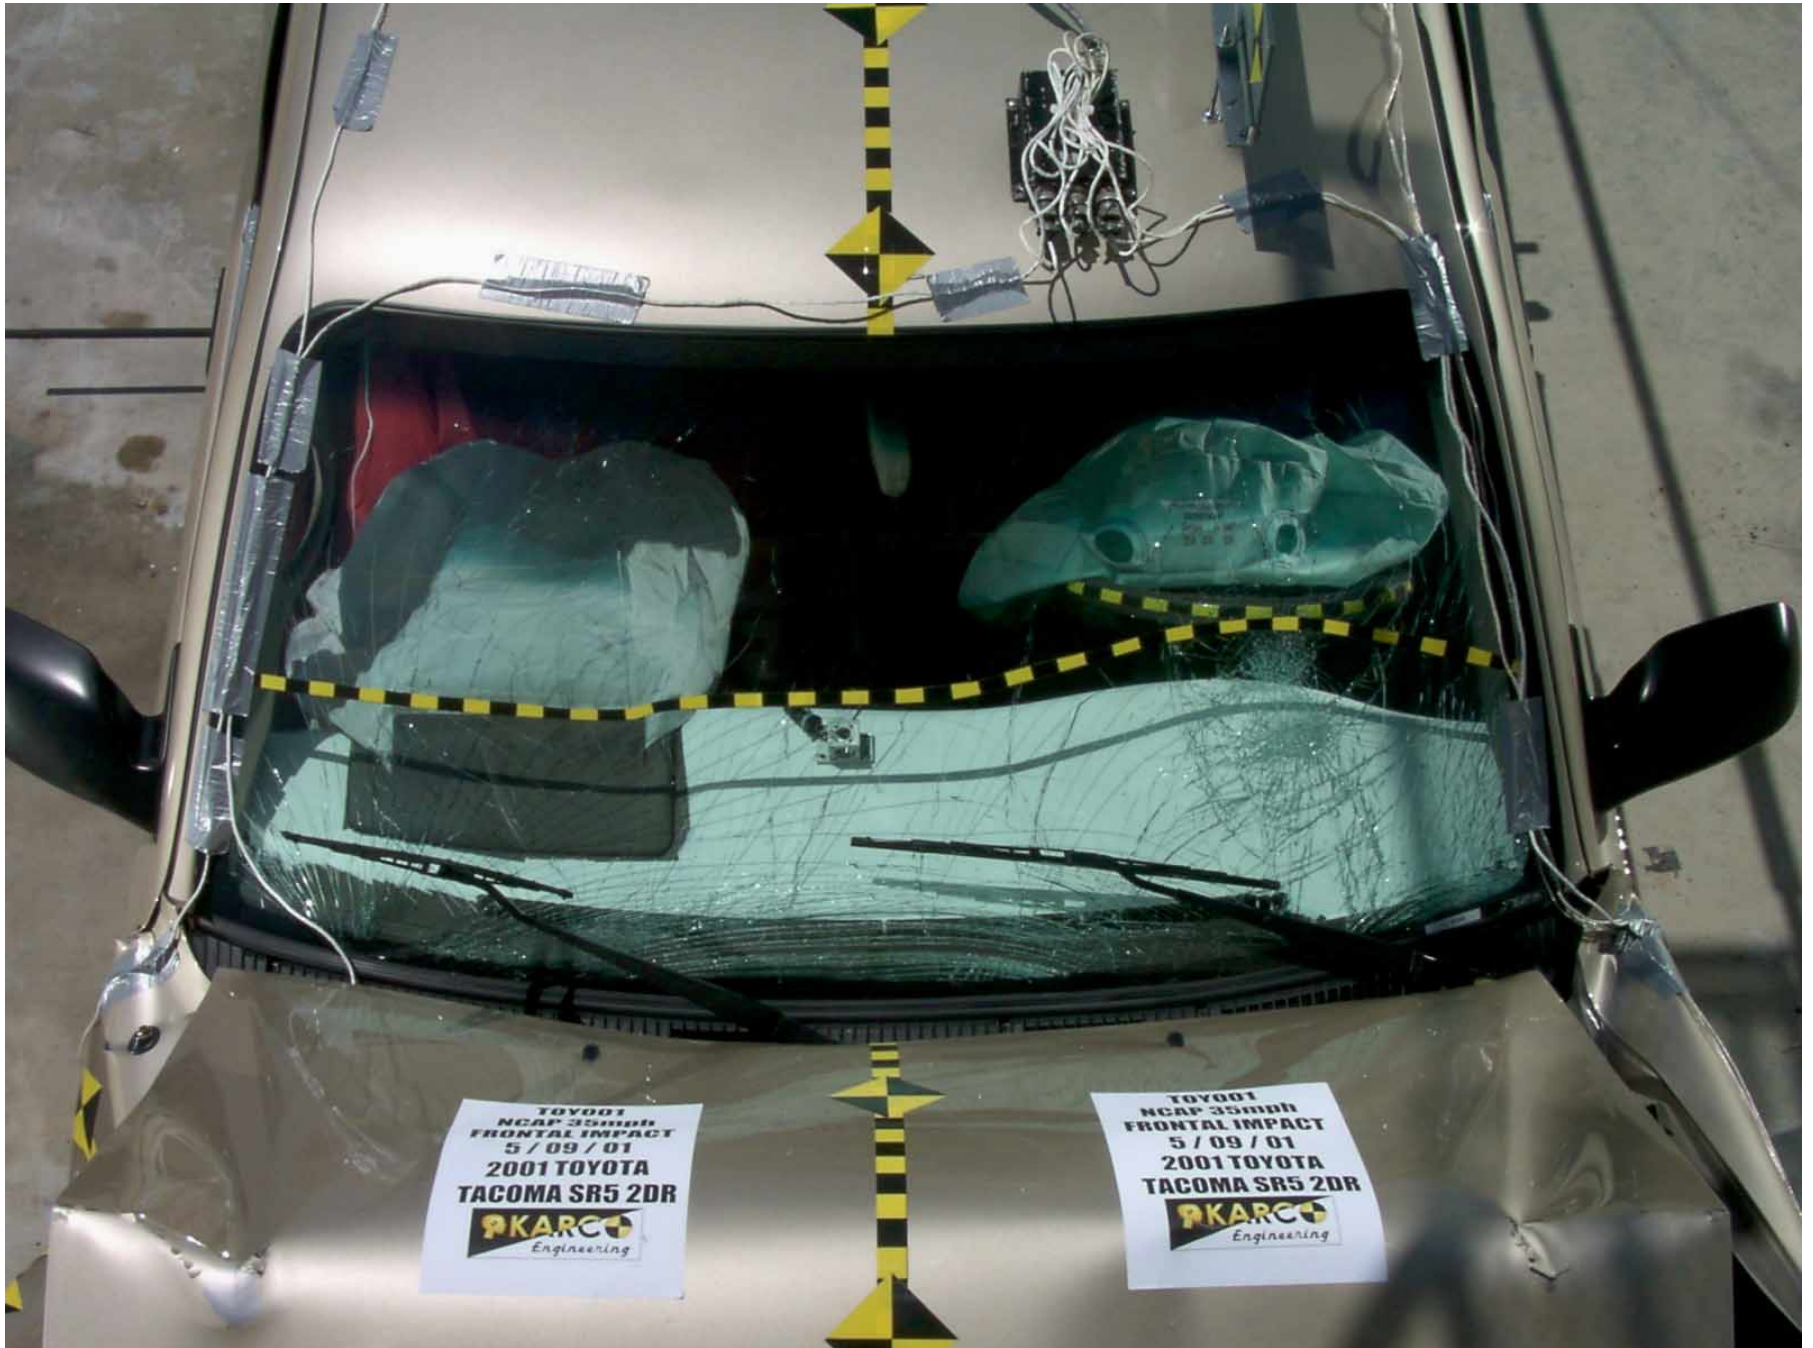
Figure A-16: Windshield, Post-Test

There was 100 percent windshield retention (minimum 50 percent required for passive restraint systems). No intrusion occurred into the protected or unprotected zone of the windshield. No Stoddard solvent leakage occurred after impact or during any phase of the rollover.

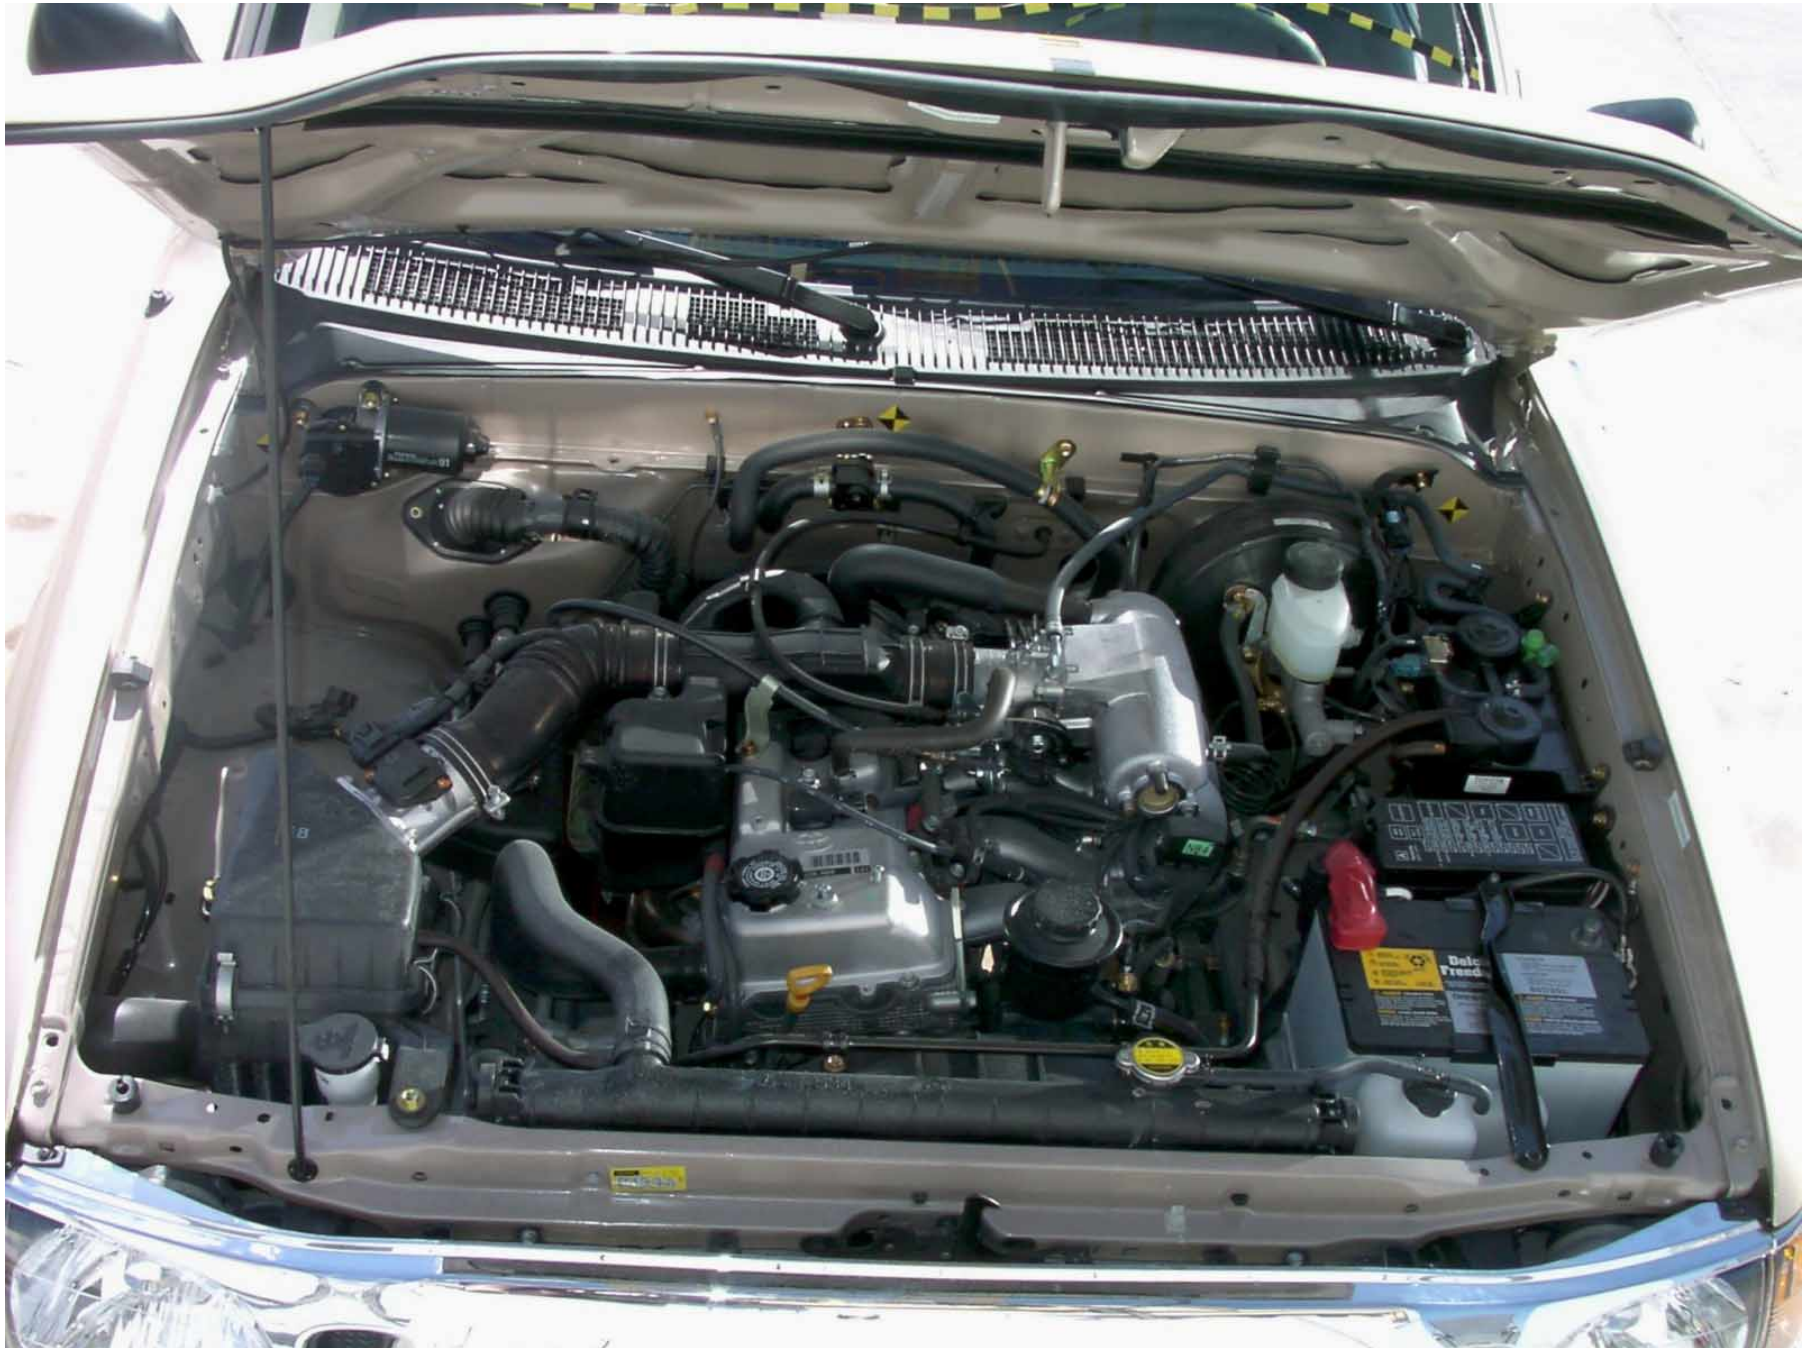
Figure A-17: Engine Compartment, Pre-Test

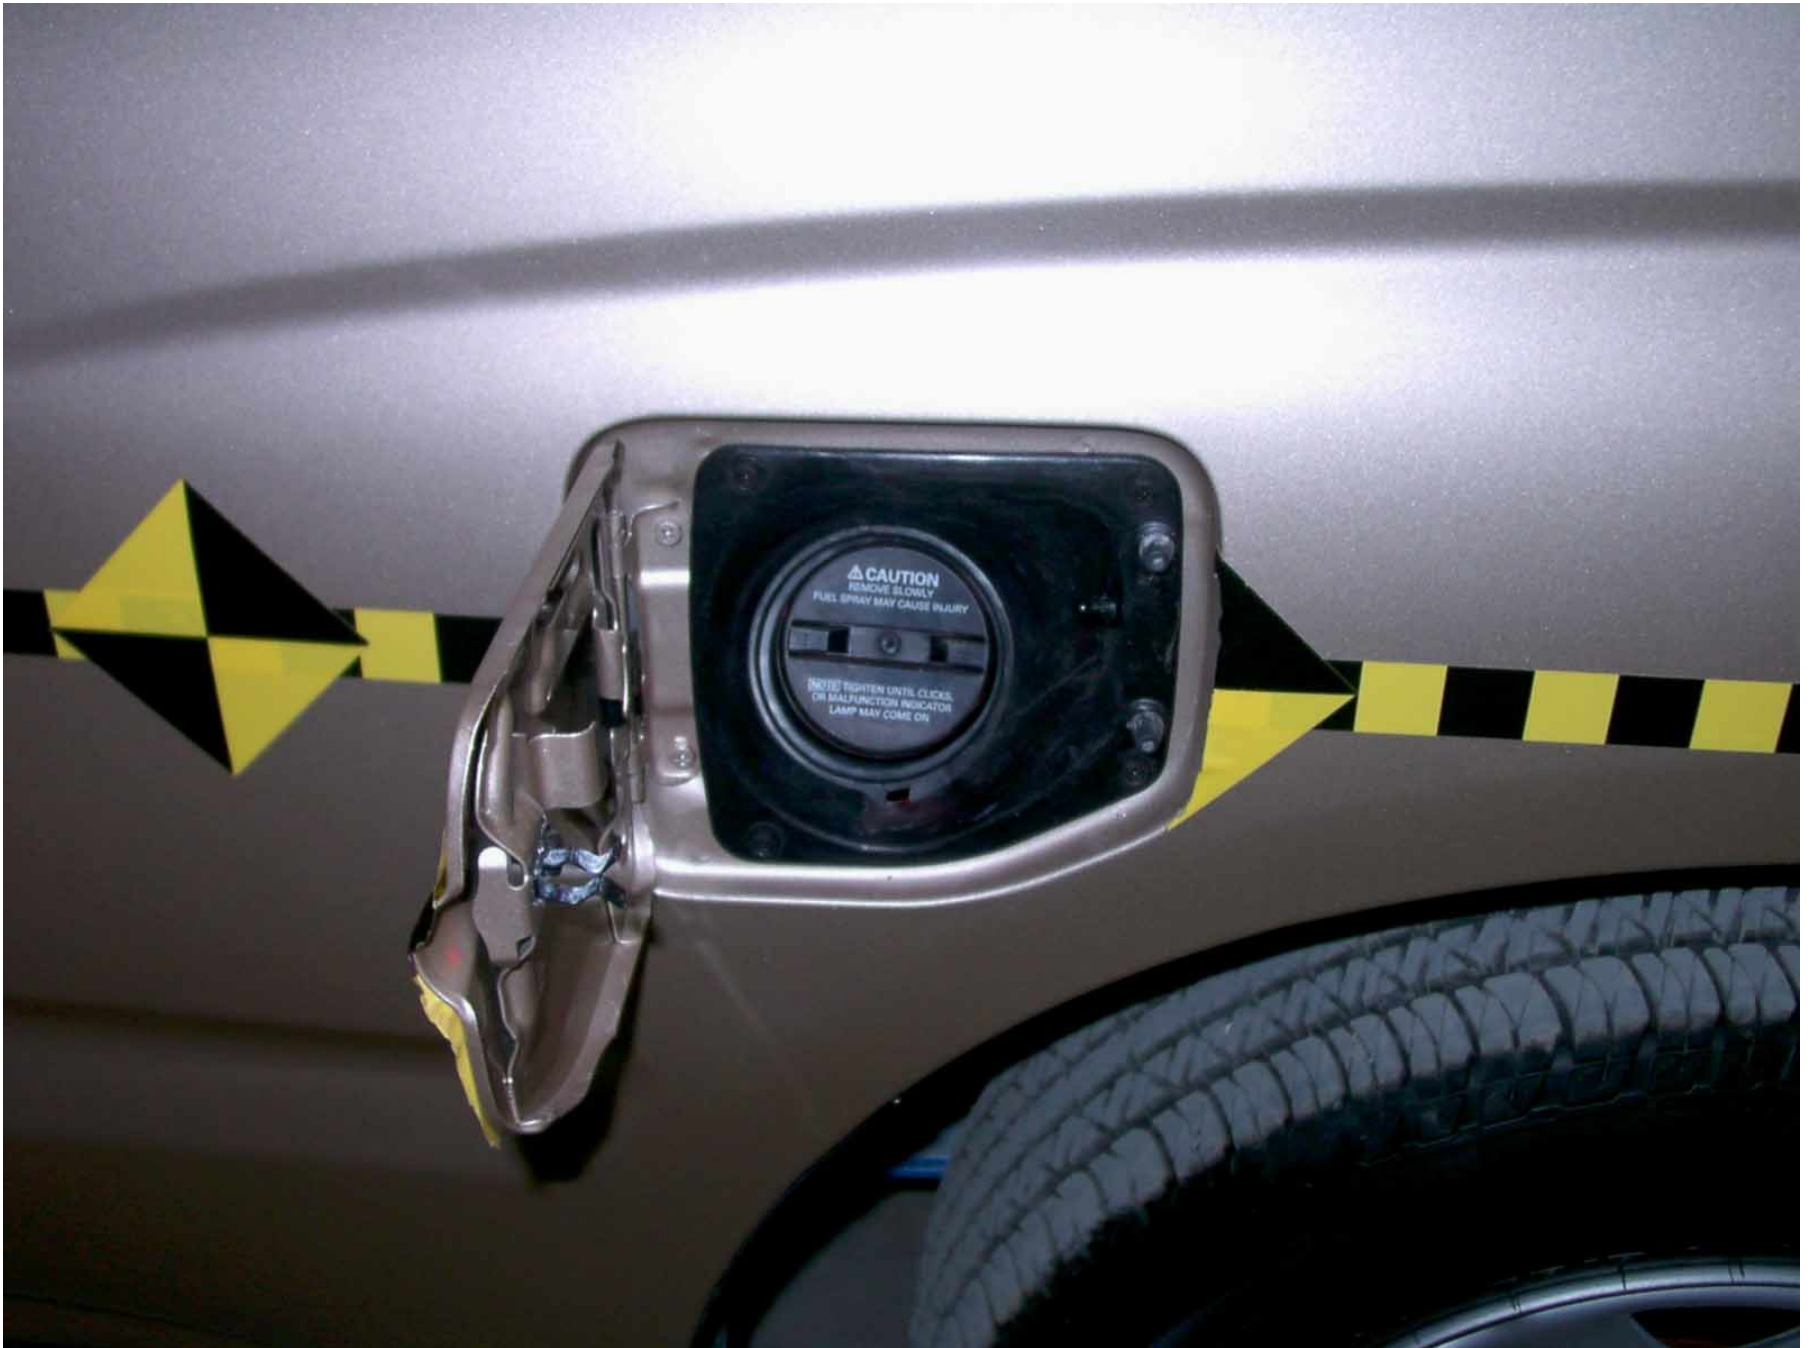
Figure A-19: Fuel Cap, Pre-test

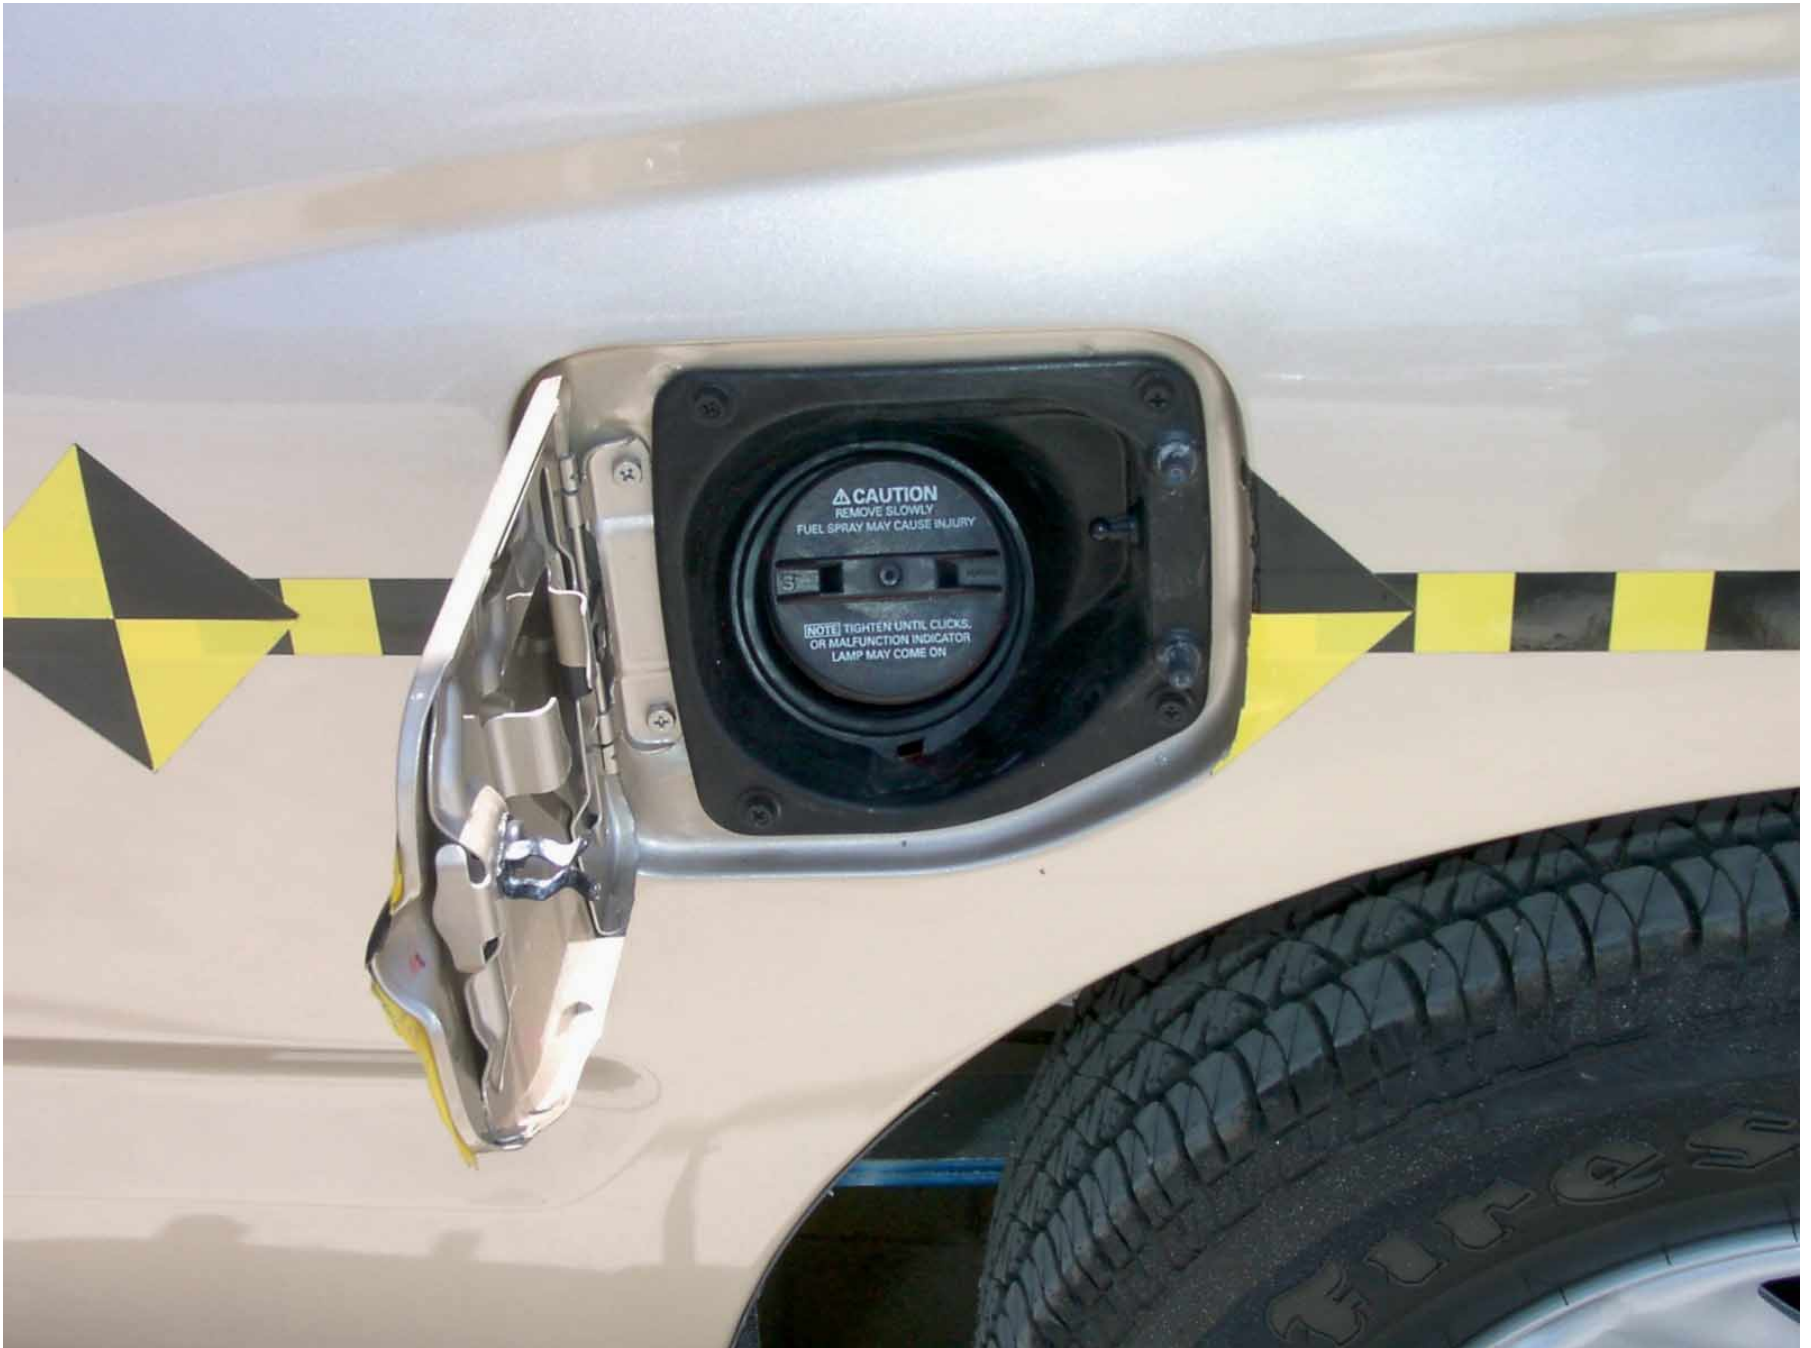
Figure A-20: Fuel Cap, Post-Test

- A. From impact until vehicle motion ceases: 0.0 oz.  
(Maximum Allowable = 1 ounce)
- B. For the 5 minute period after motion ceases: 0.0 oz.  
(Maximum Allowable = 5 ounces)
- C. For the following 25 minutes: 0.0 oz.  
(Maximum Allowable = 1 oz./minute)
- D. Spillage Details: No leakage occurred

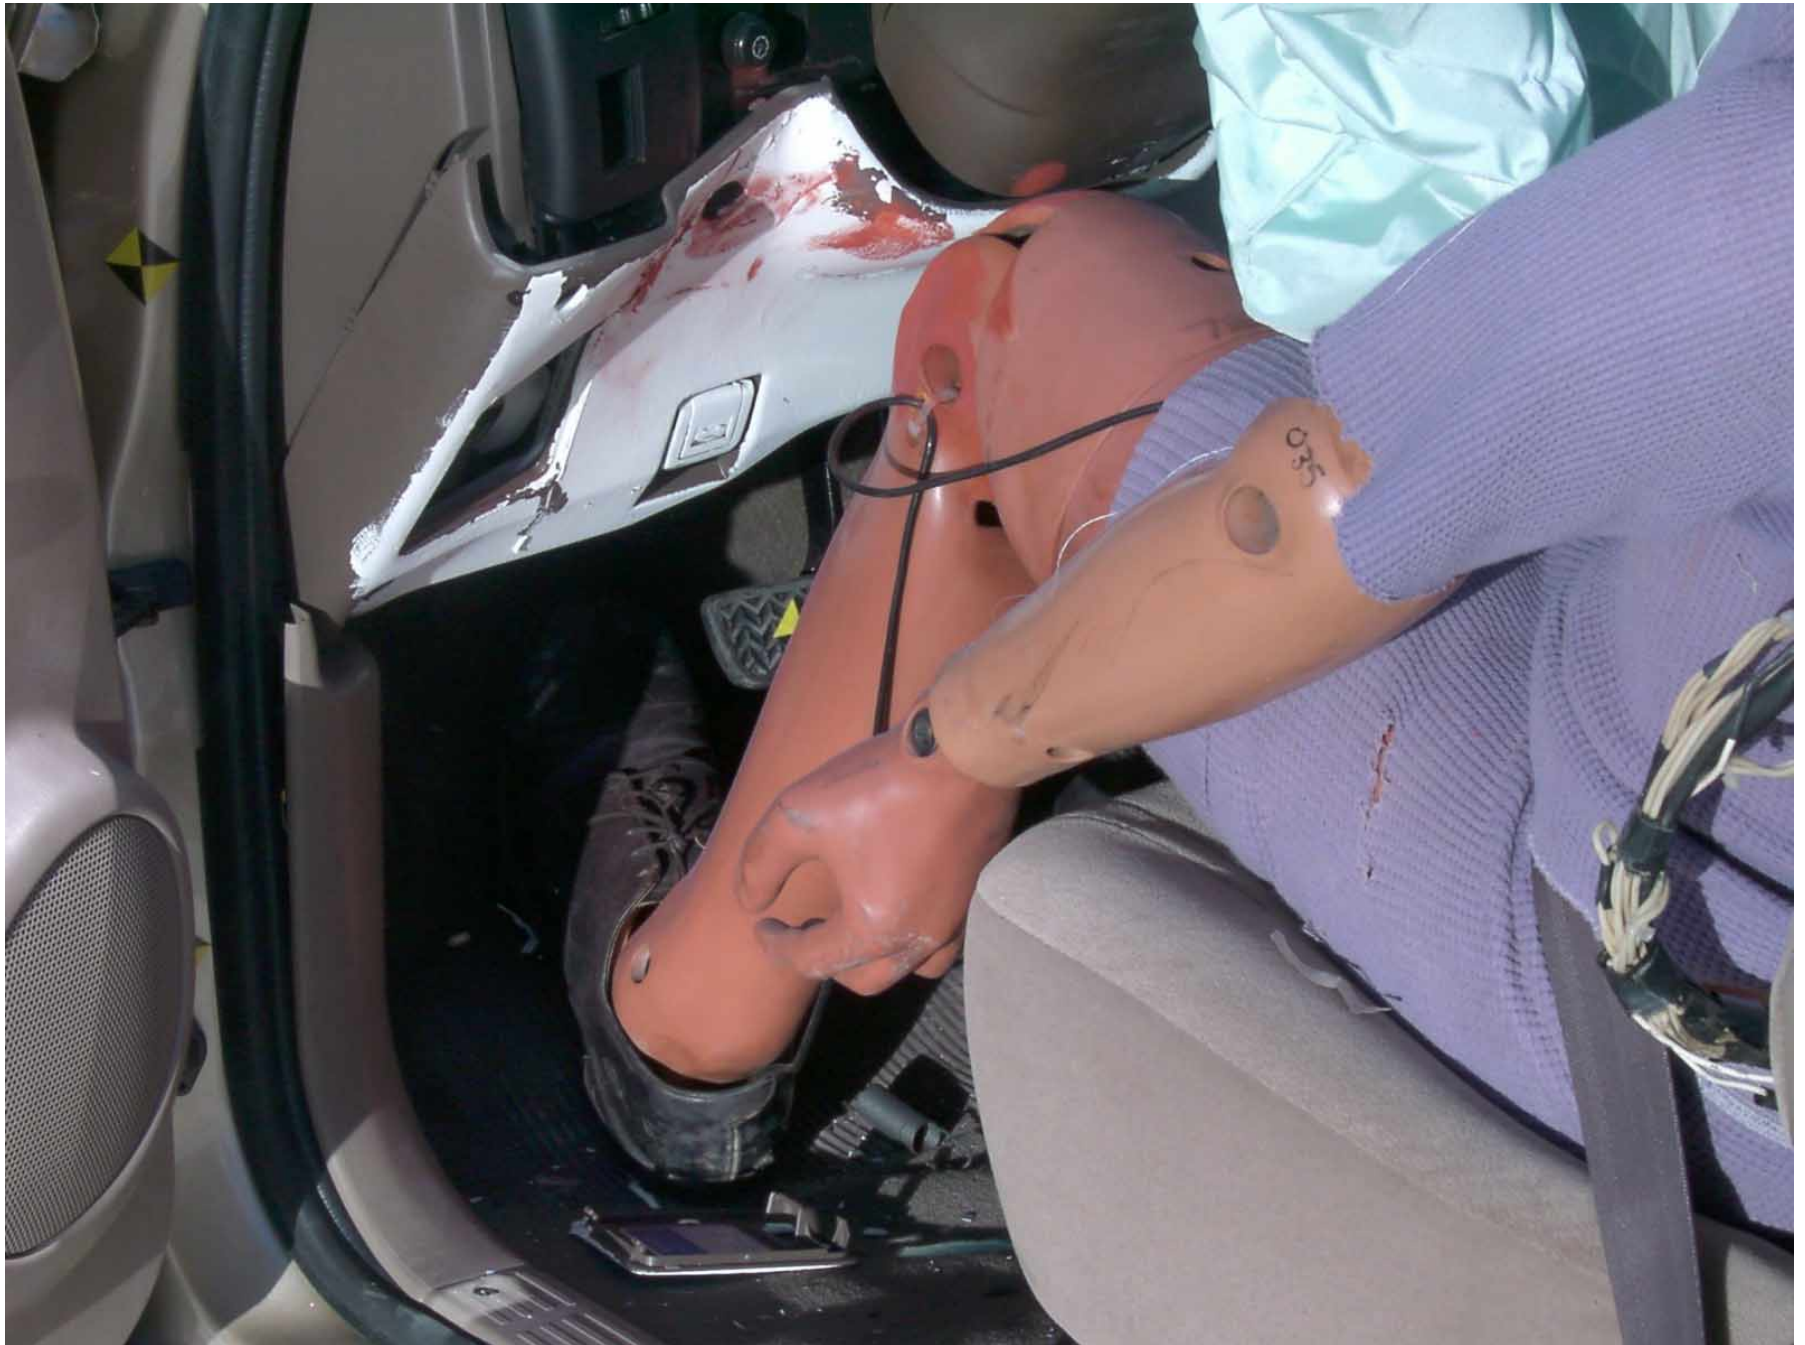
Figure A-34: Driver Dummy Feet and Knee Contact, Post-Test

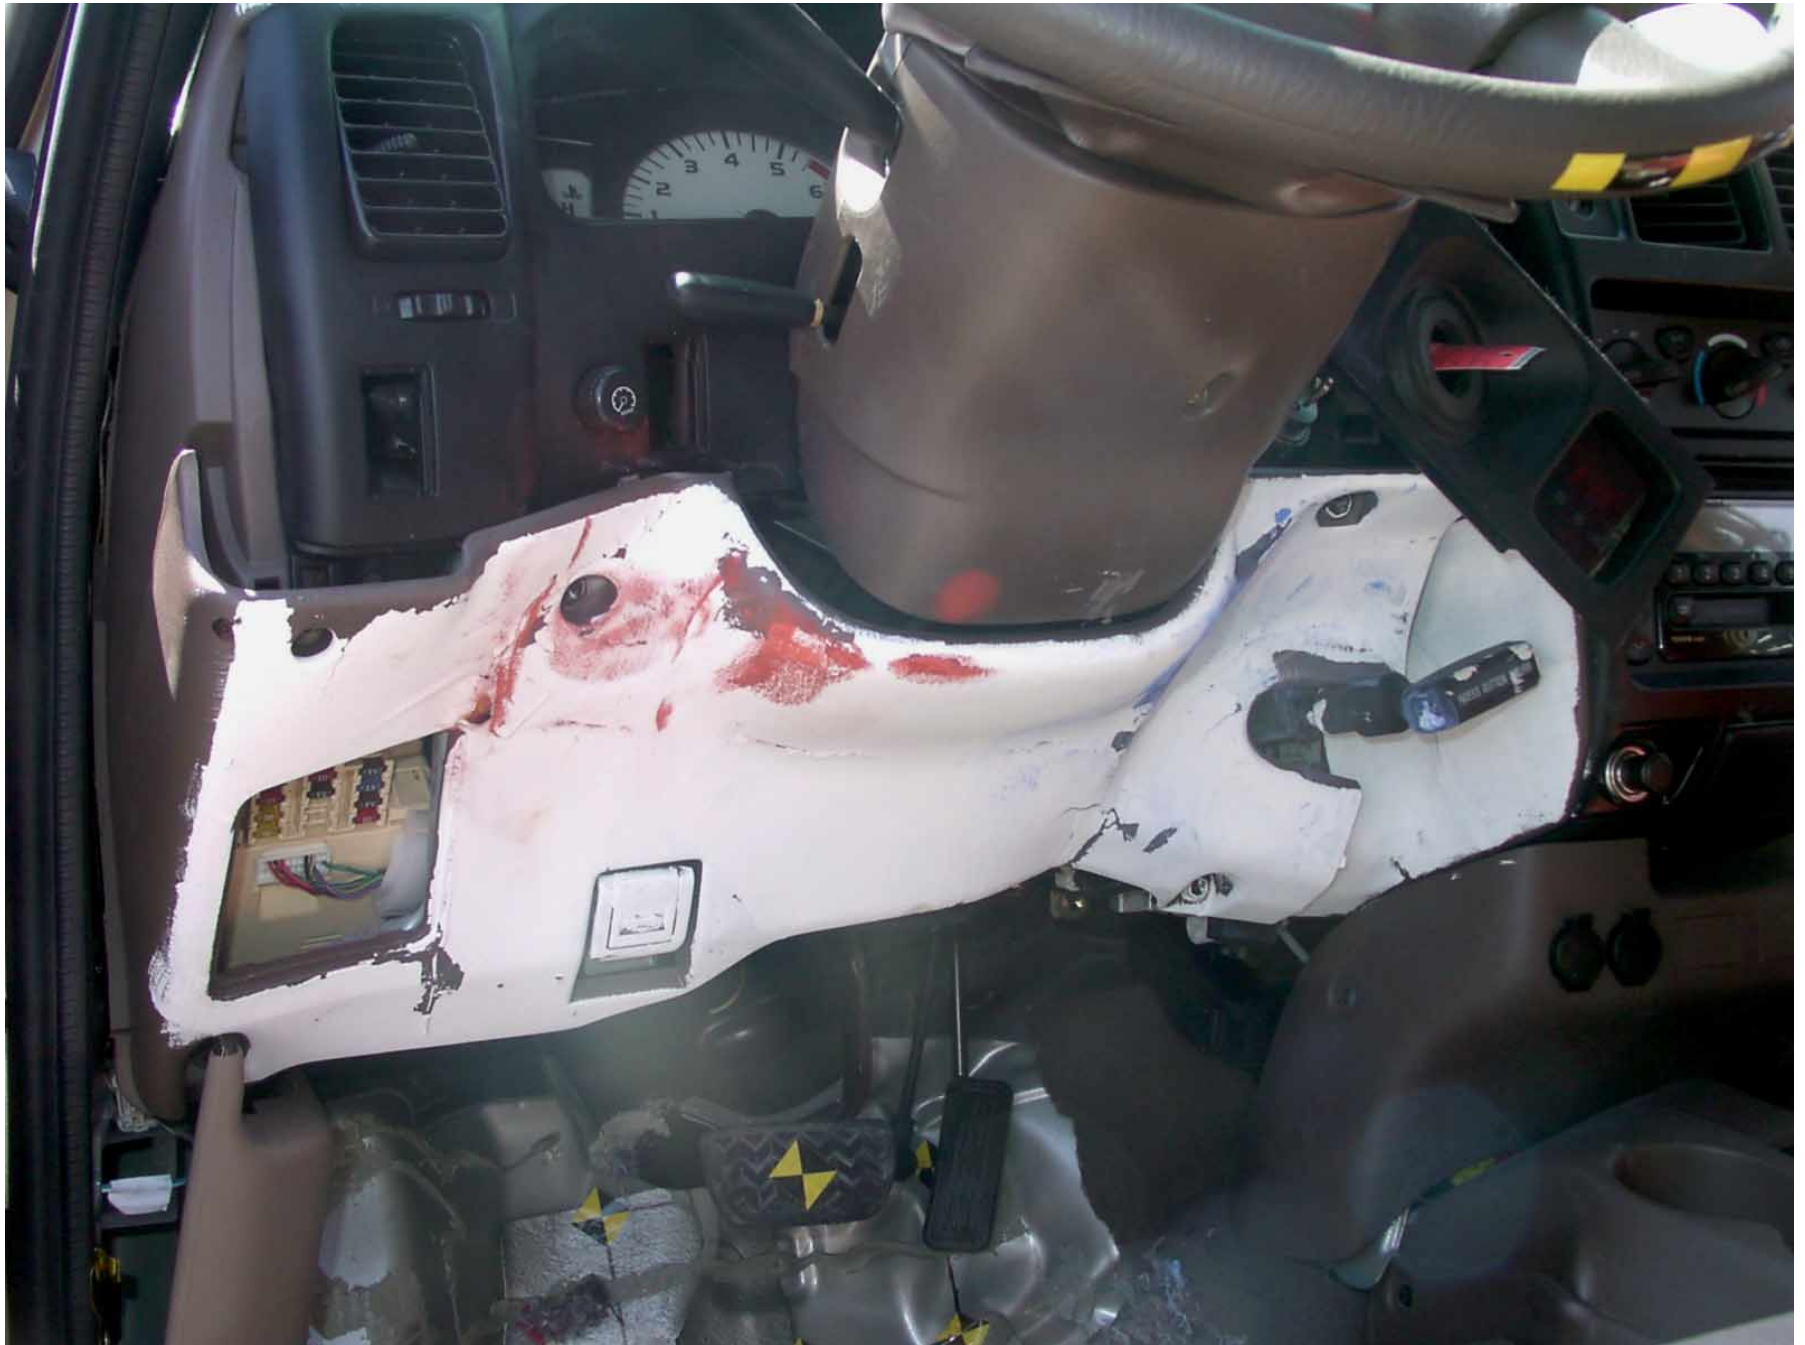
Figure A-36: Driver Side Knee Bolster, Post-Test

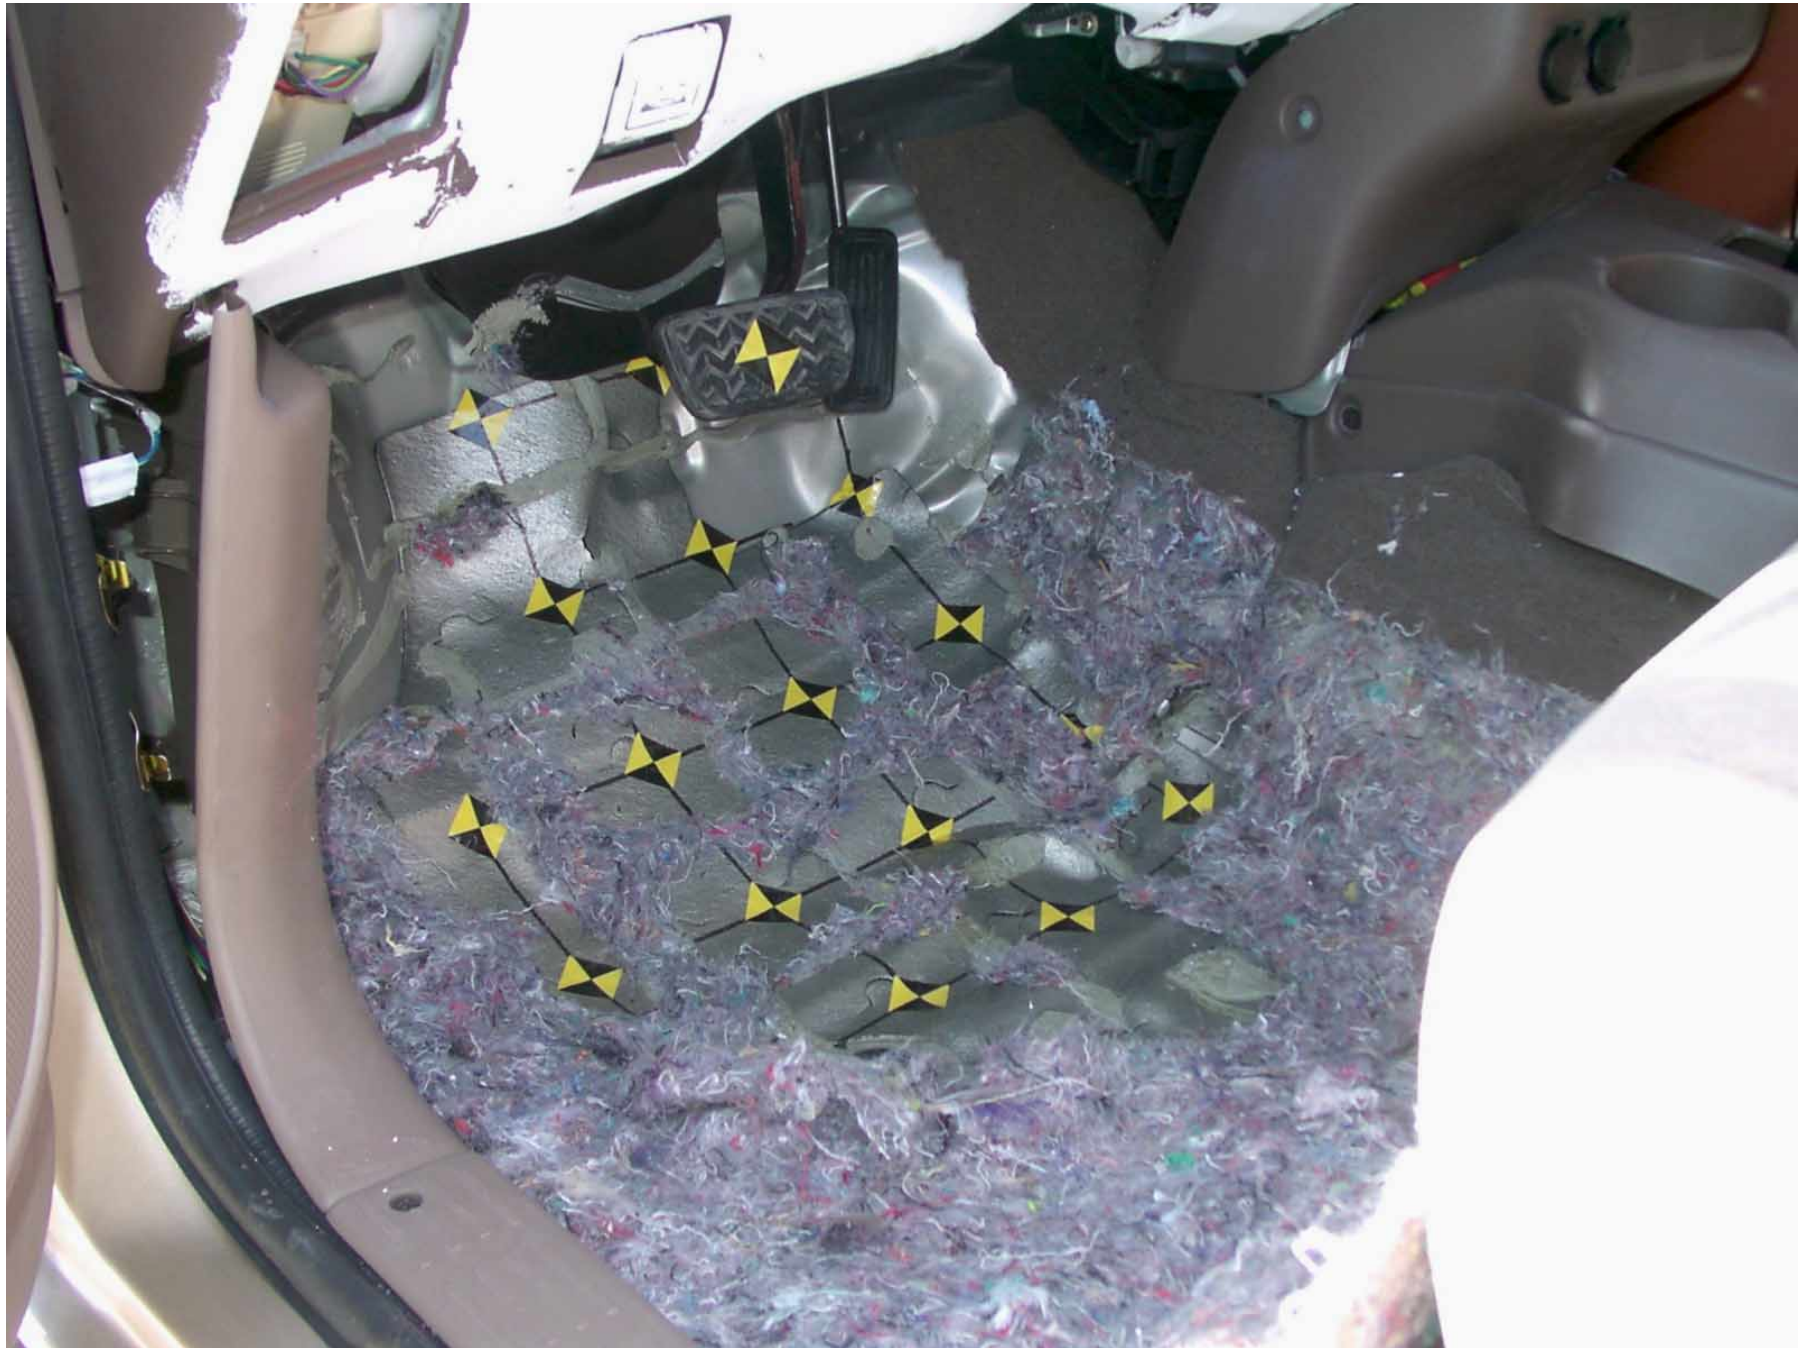
Figure A-38: Driver Side Floor Pan, Post-Test
