**REPORT NUMBER KAR21049-01**

**NEW CAR ASSESSMENT PROGRAM  
FRONTAL BARRIER IMPACT TEST**

**TOYOTA MOTOR MANUFACTURING  
2001 TOYOTA TACOMA SR5 EXTENDED CAB PICKUP  
NHTSA NUMBER: TOY001**

**PREPARED BY:  
KARCO ENGINEERING  
9270 HOLLY ROAD  
ADELANTO, CALIFORNIA 92301**

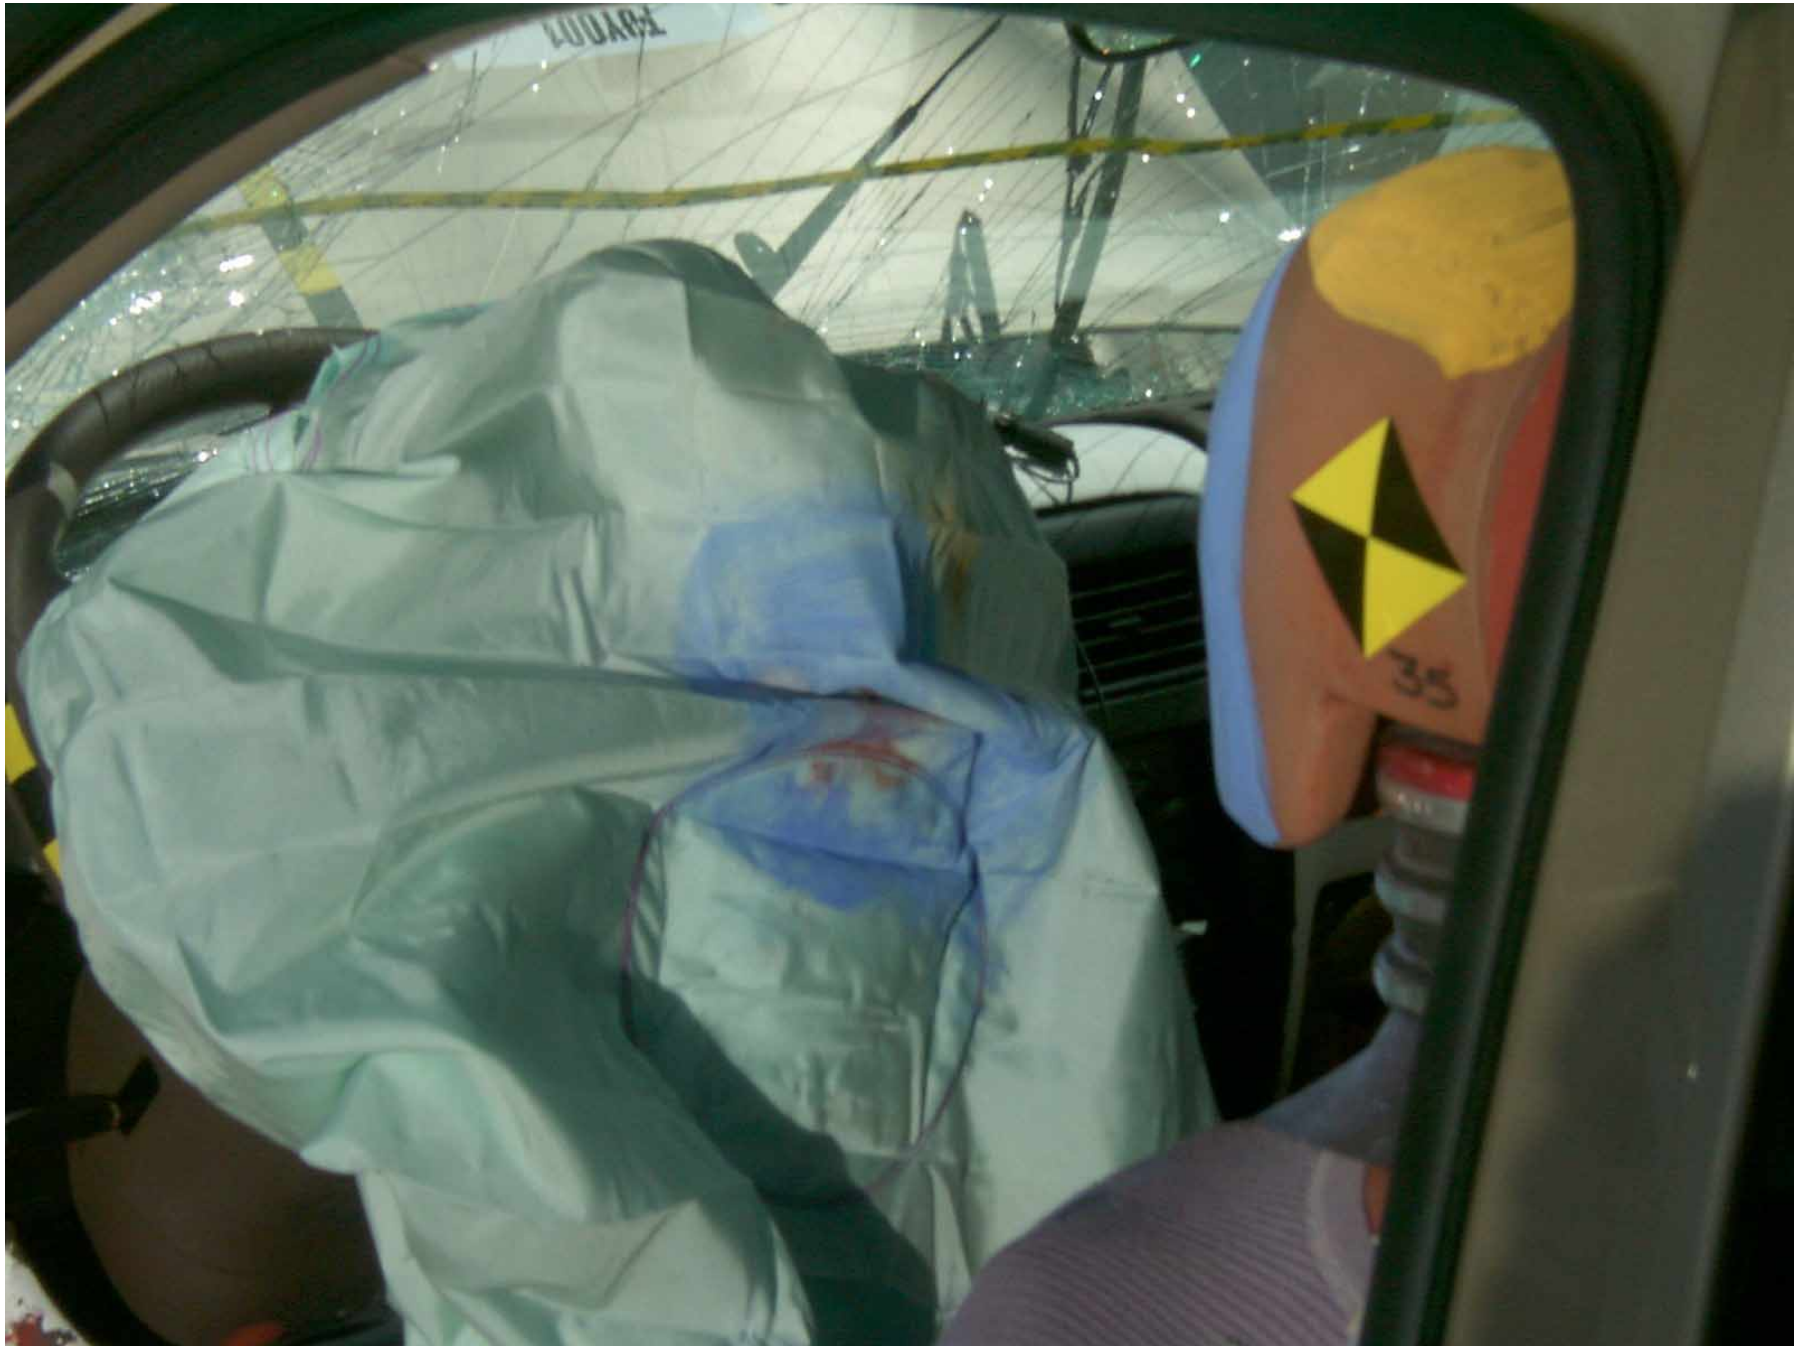
Figure A-40: Driver Dummy Contact, Post-Test

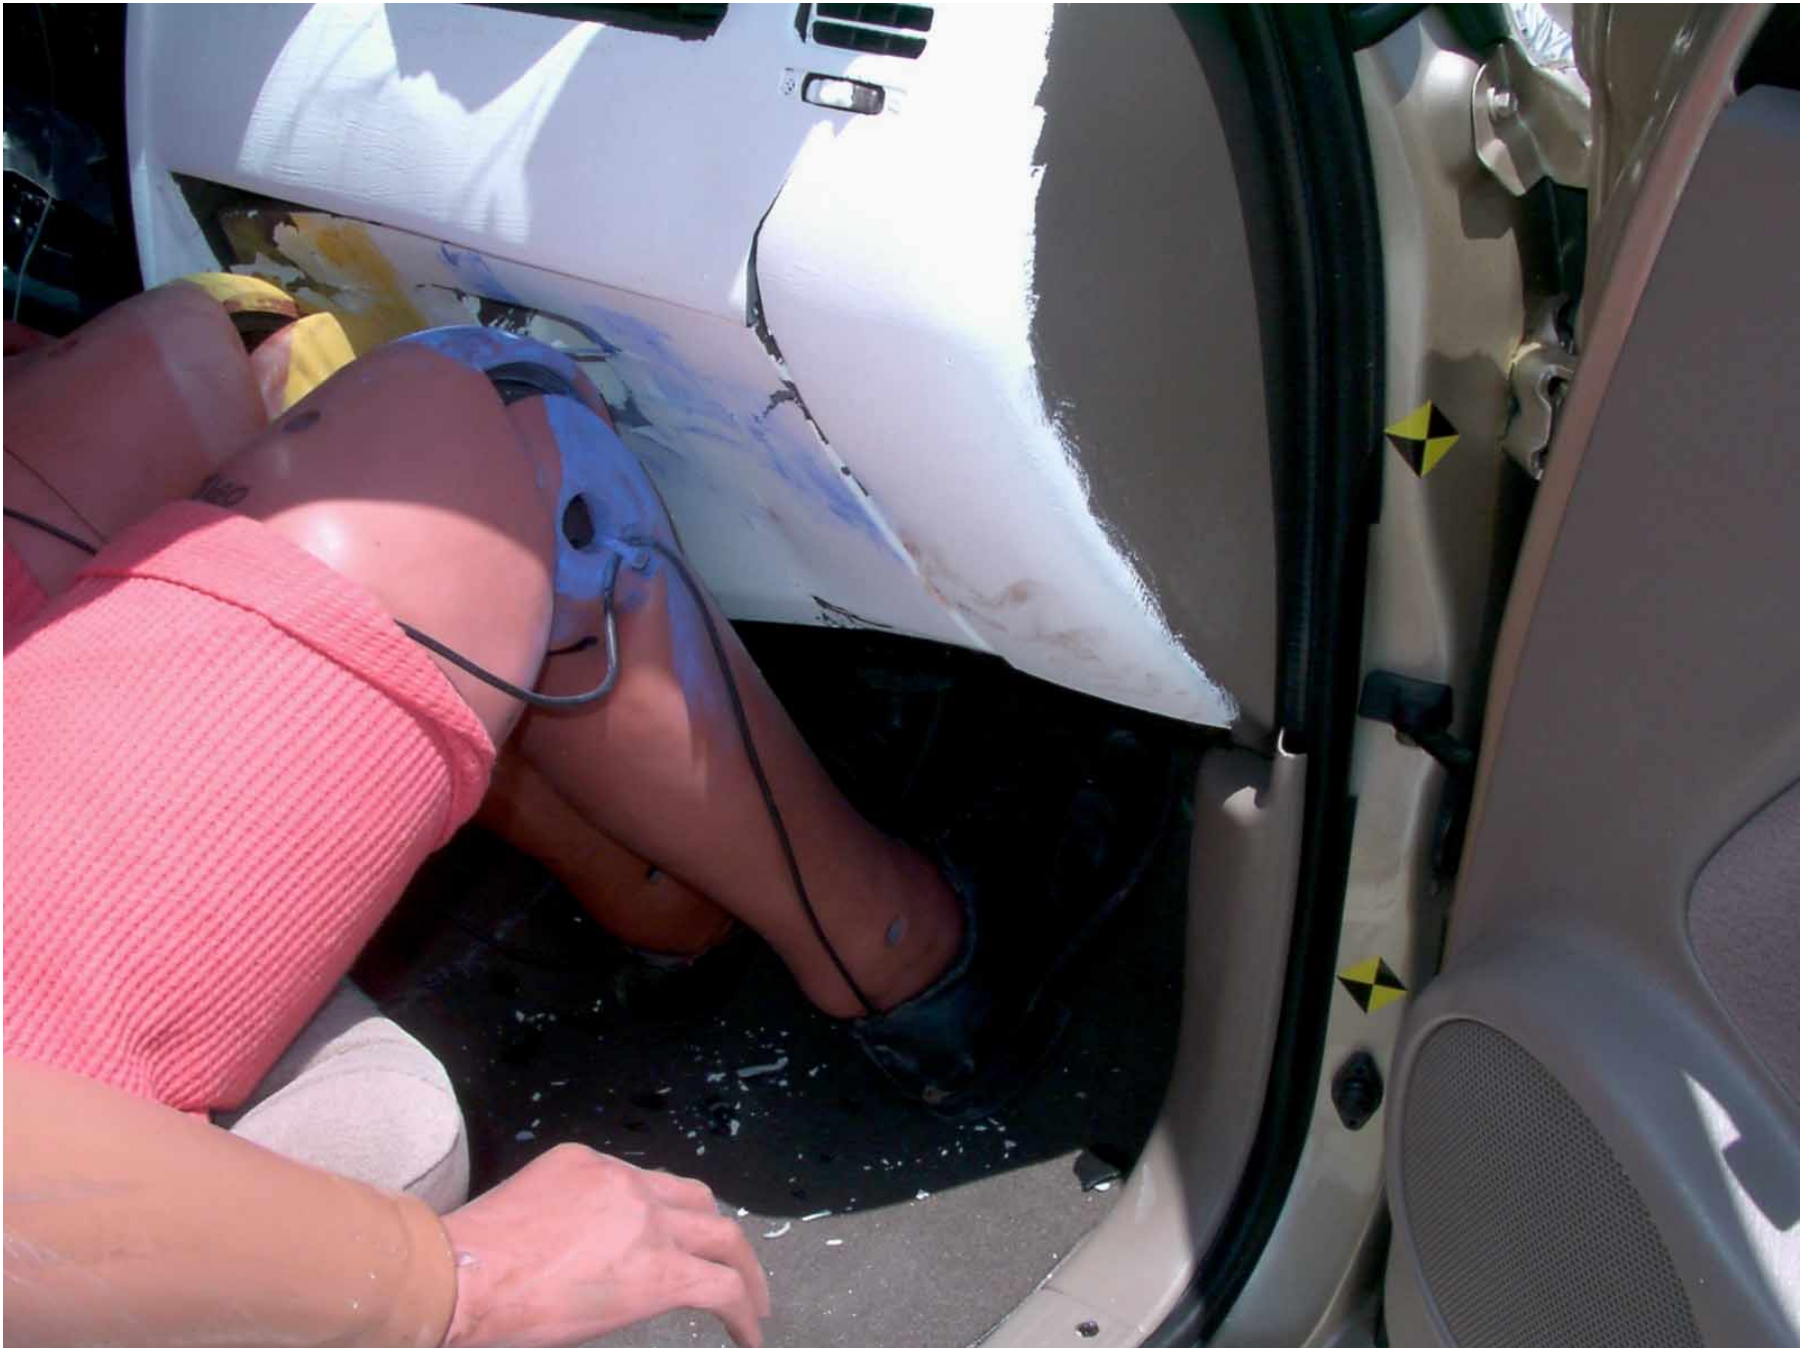
Figure A-50: Passenger Dummy Feet and Knee Contact, Post-Test

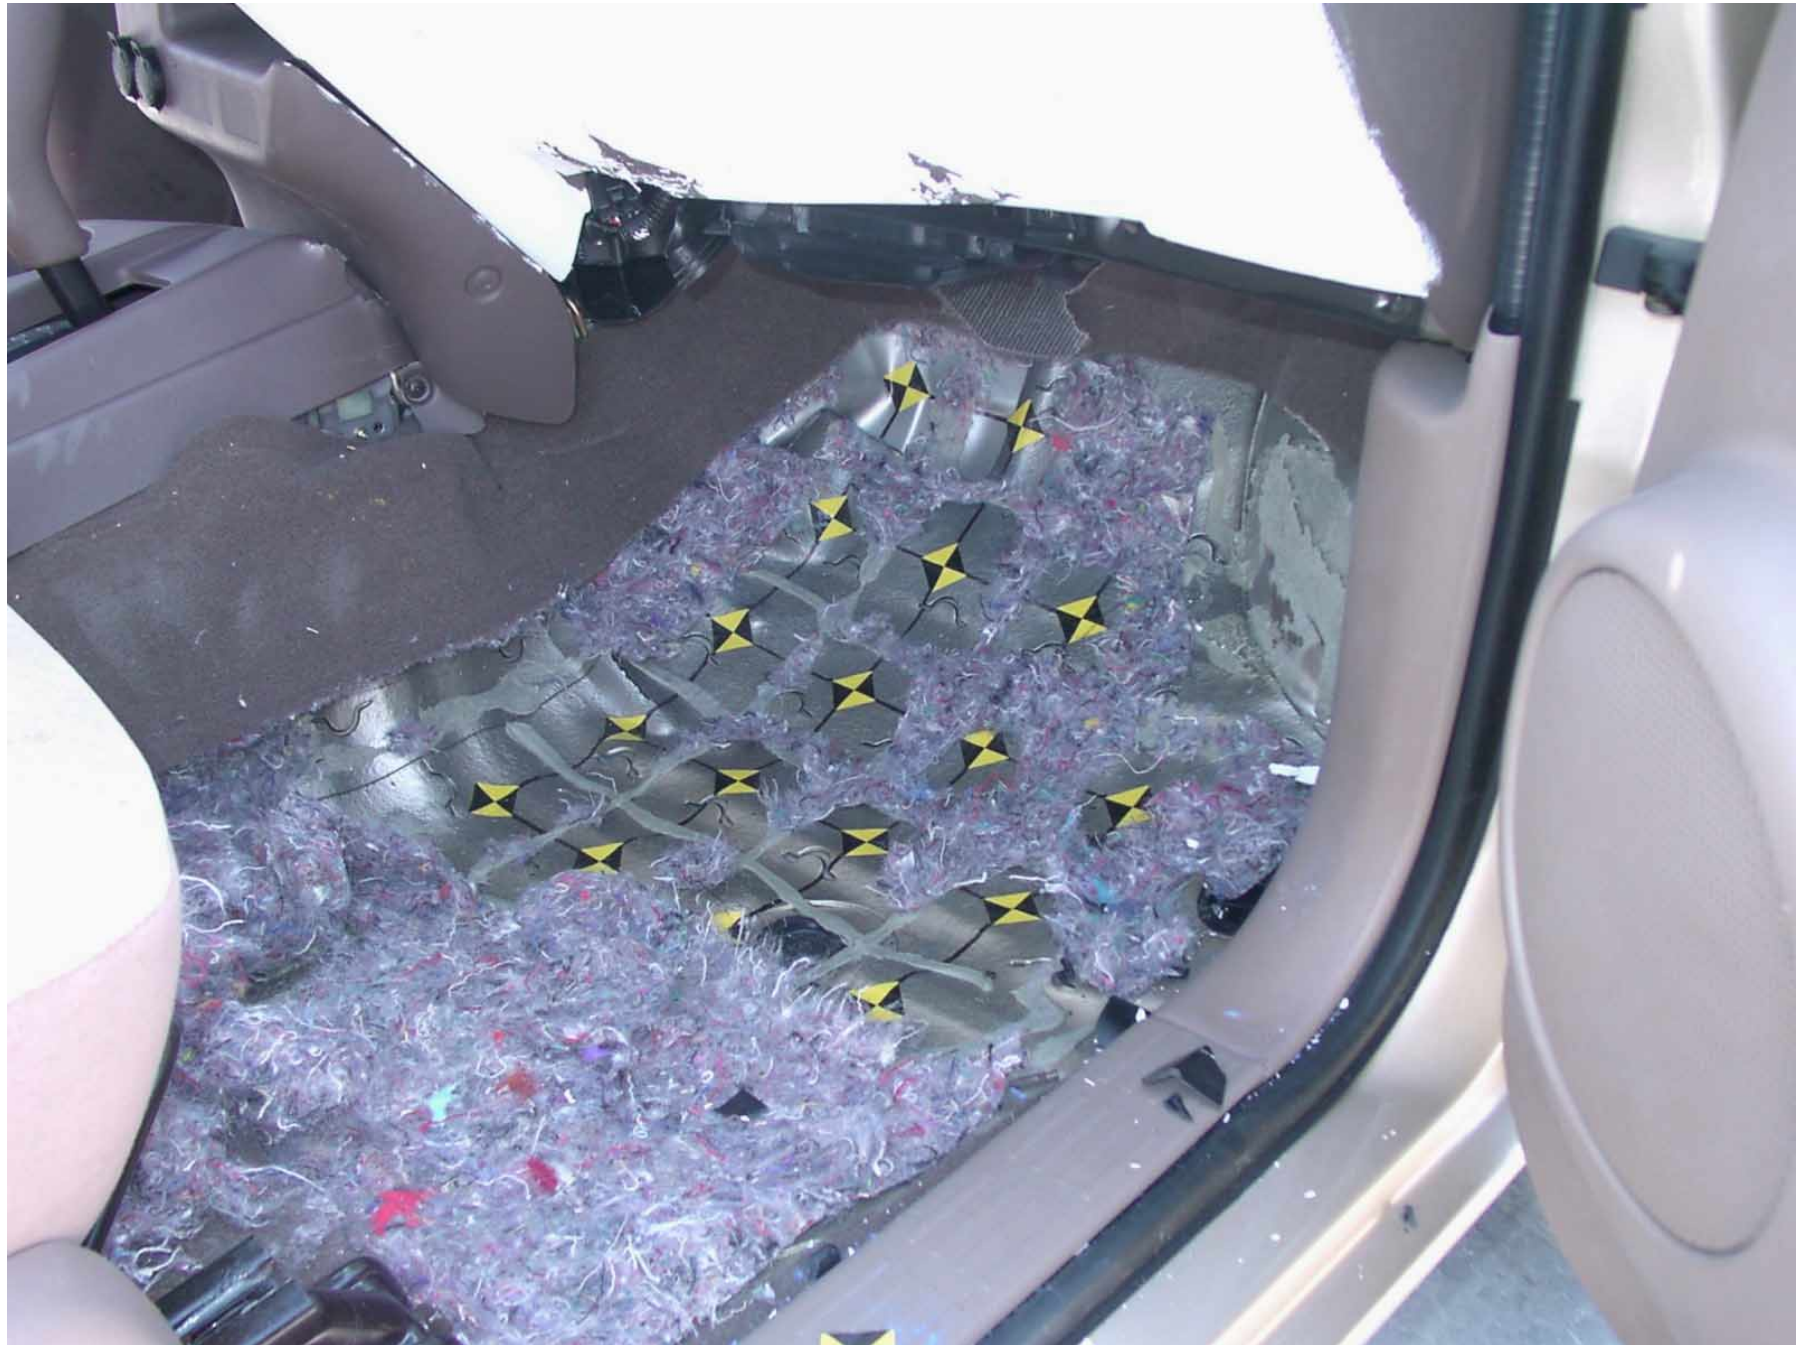
Figure A-52: Passenger Side Floor Pan, Post-Test

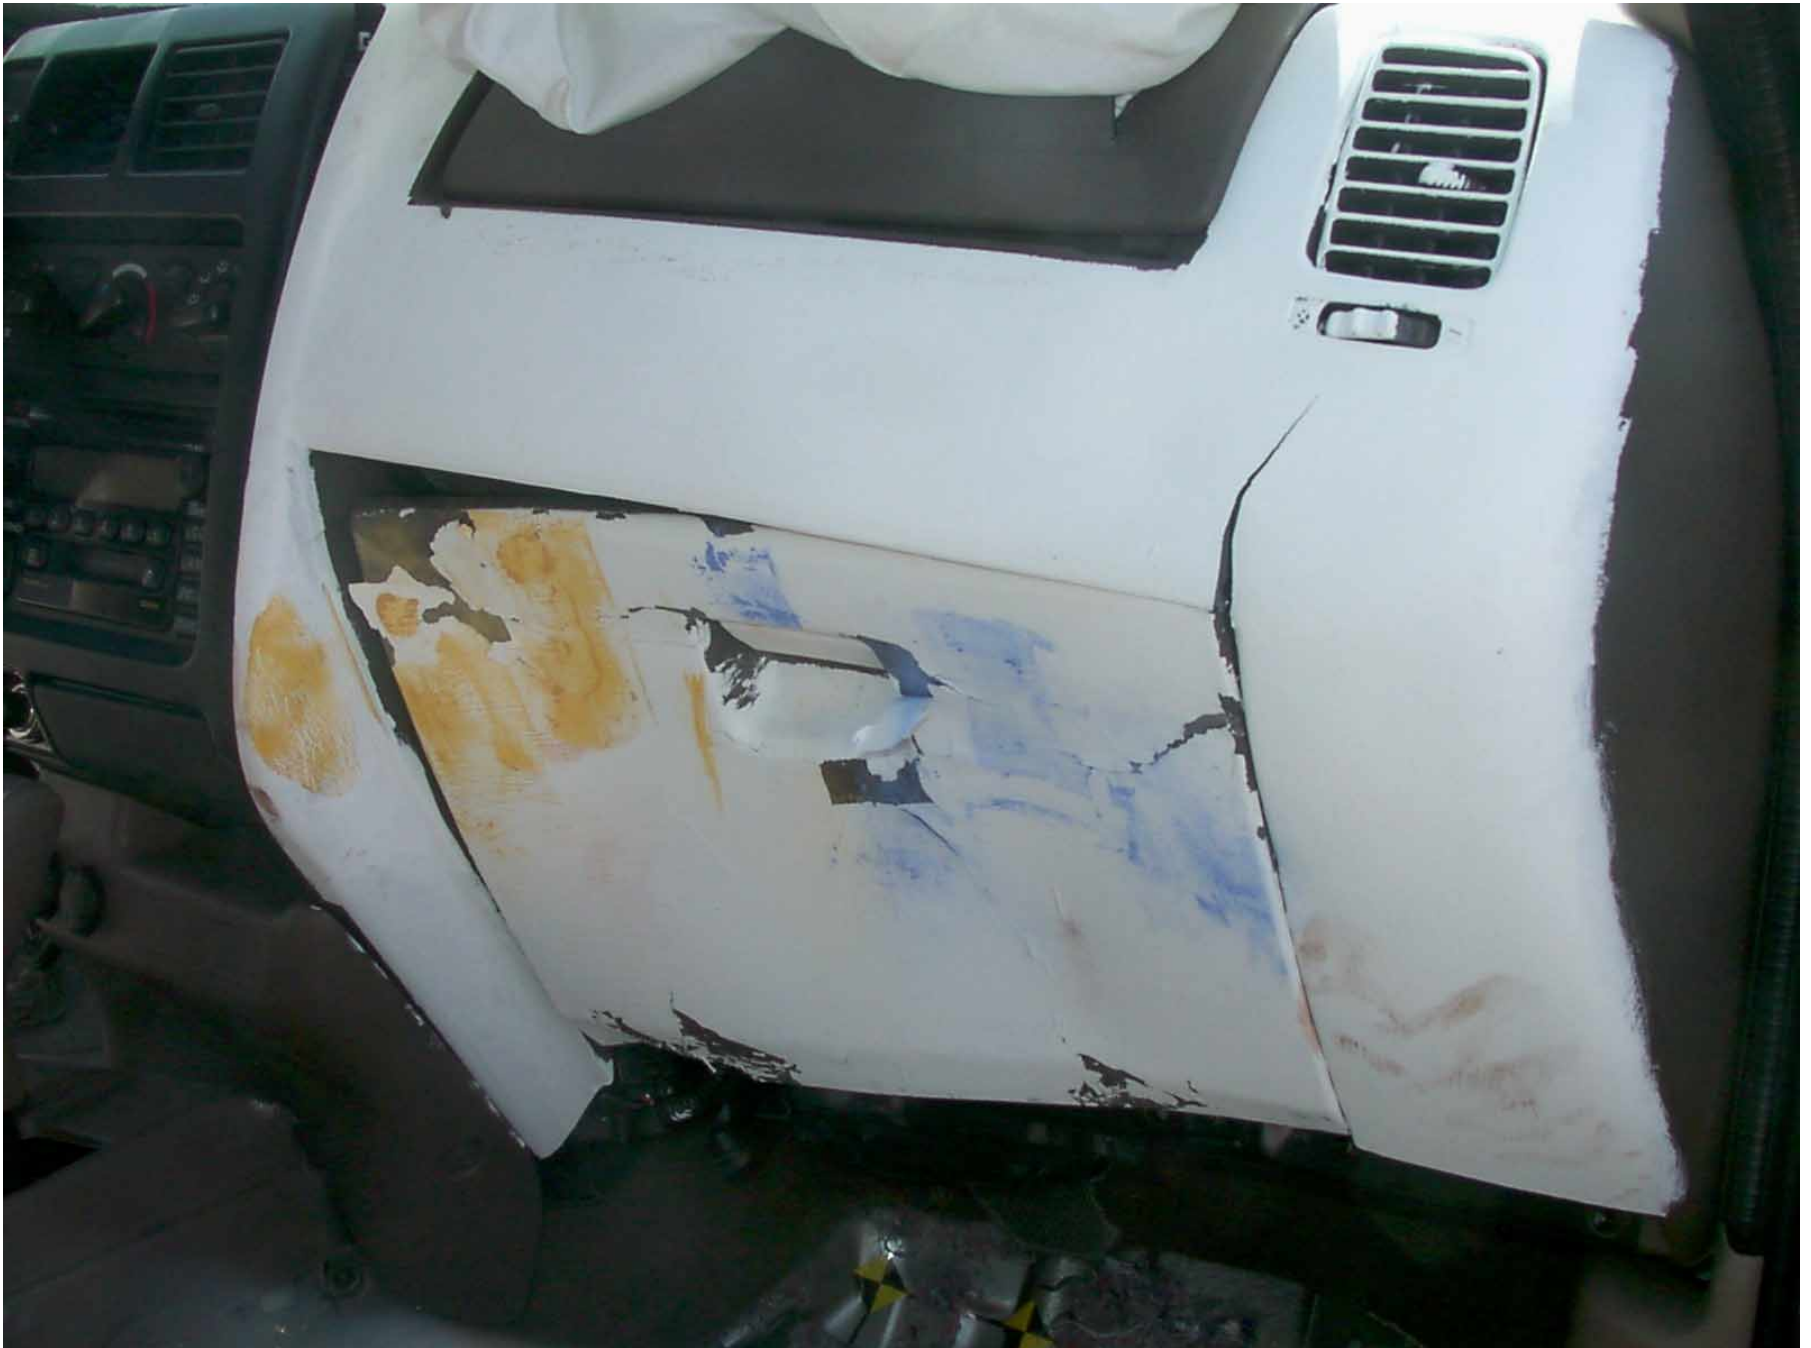
Figure A-54: Passenger Side Knee Bolster, Post-Test

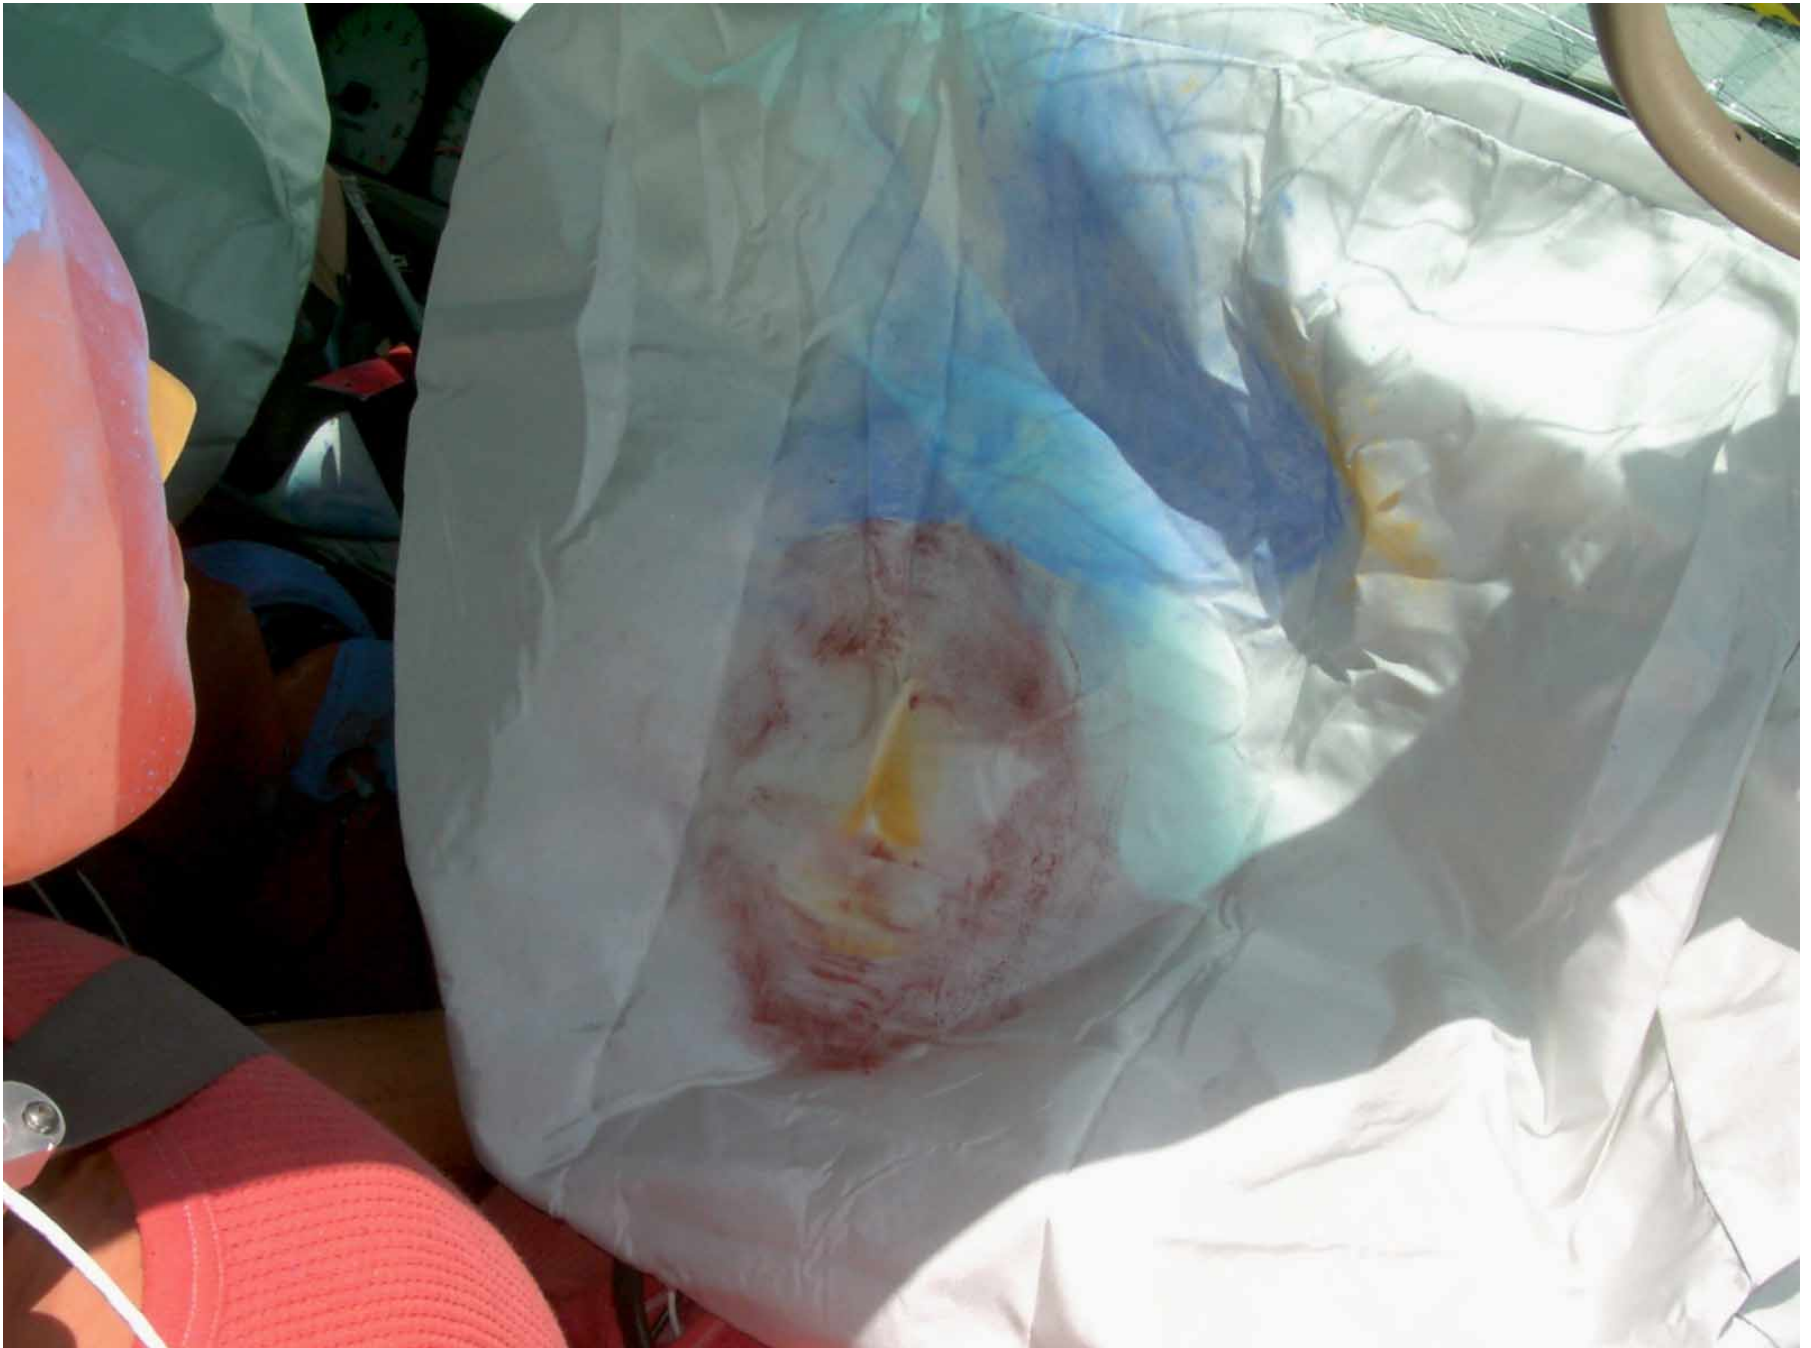
Figure A-56: Passenger Dummy Contact, Post-Test

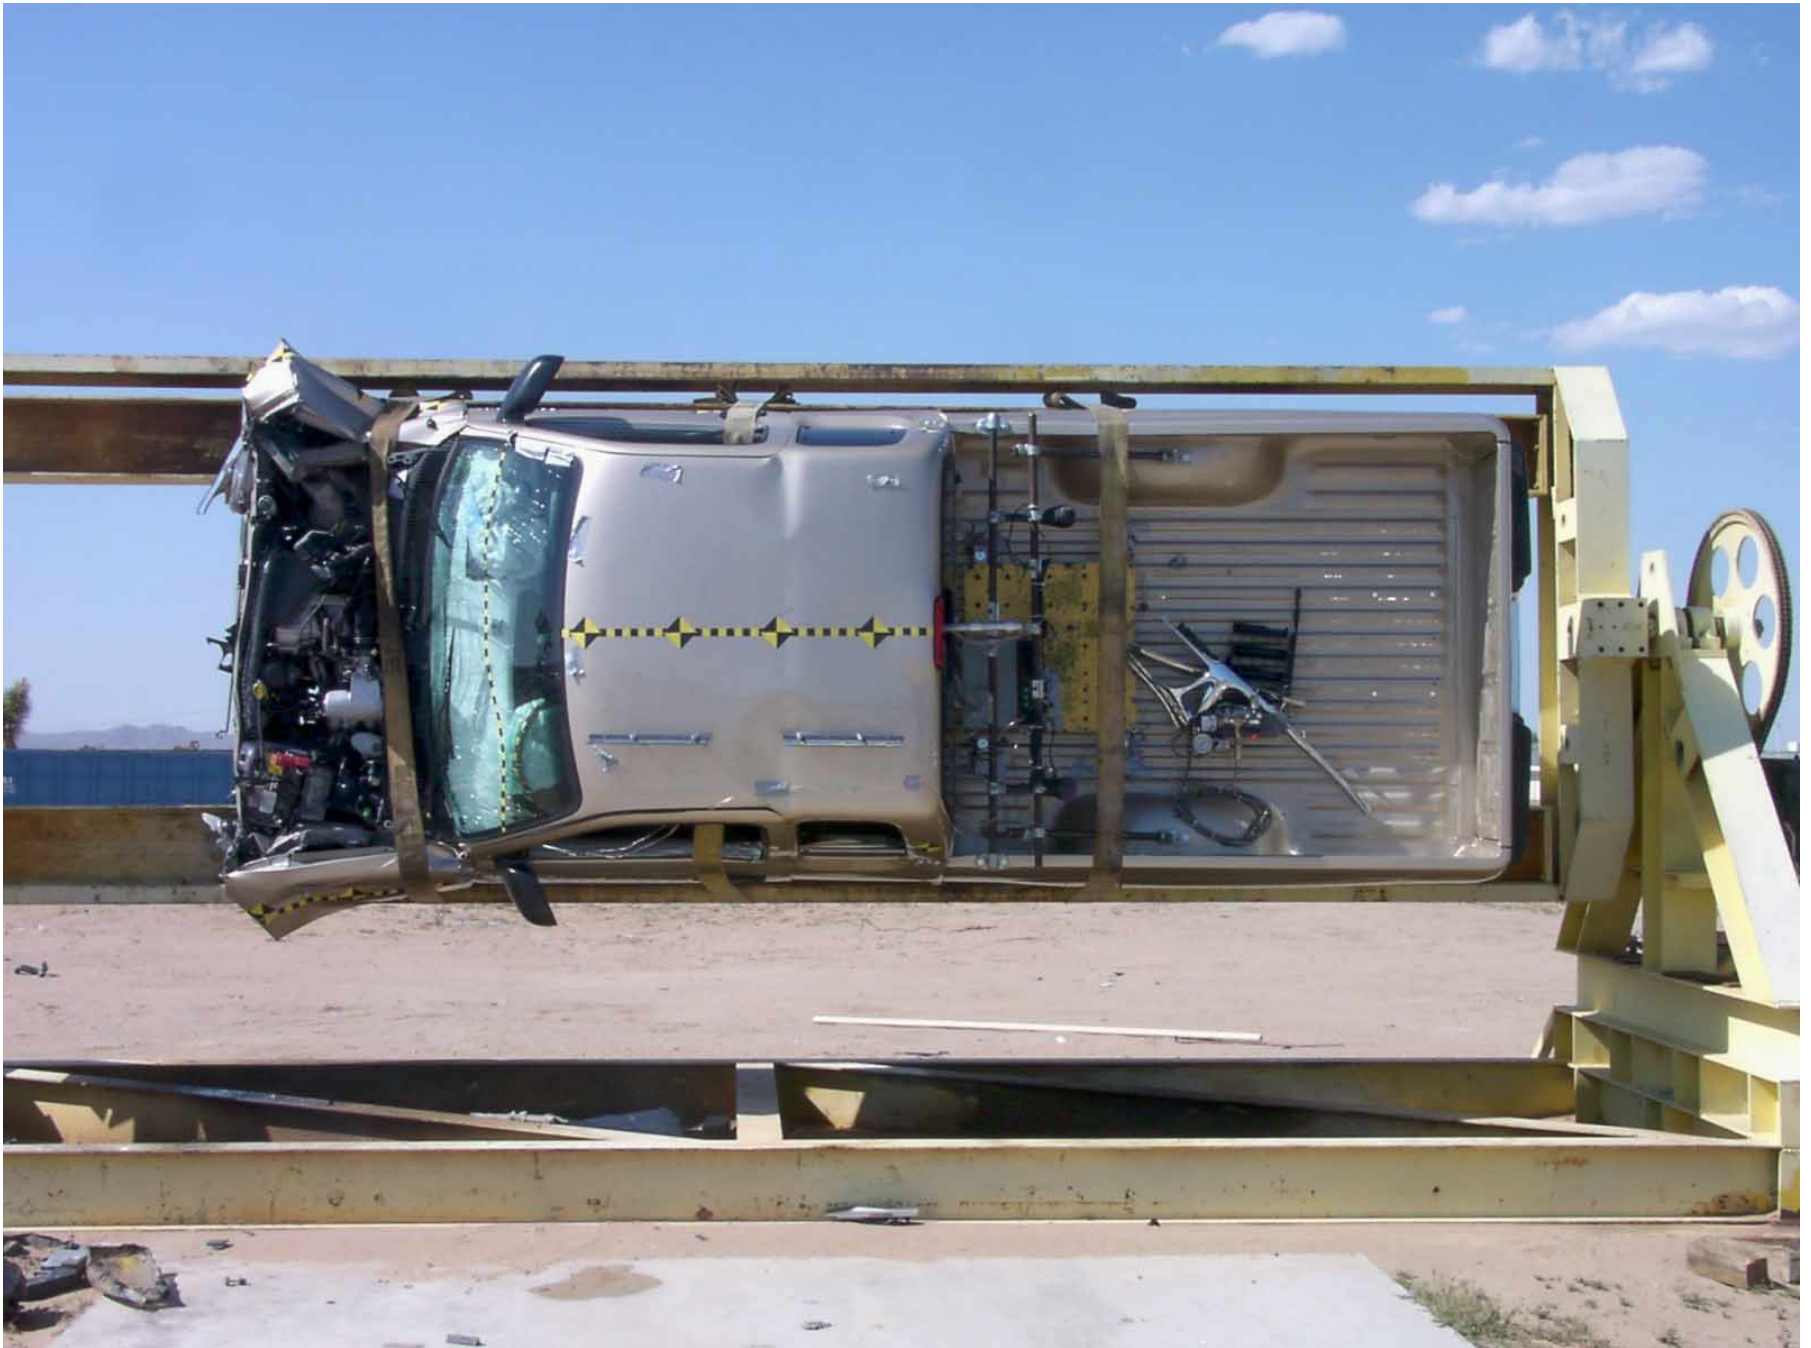
Figure A-57: Vehicle on Rollover Device
