REPORT NO. MCW-DOT-214-D3

**NEW CAR ASSESSMENT PROGRAM  
SIDE IMPACT TESTING**

GENERAL MOTORS CORPORATION  
2001 BUICK CENTURY SEDAN

FINAL REPORT

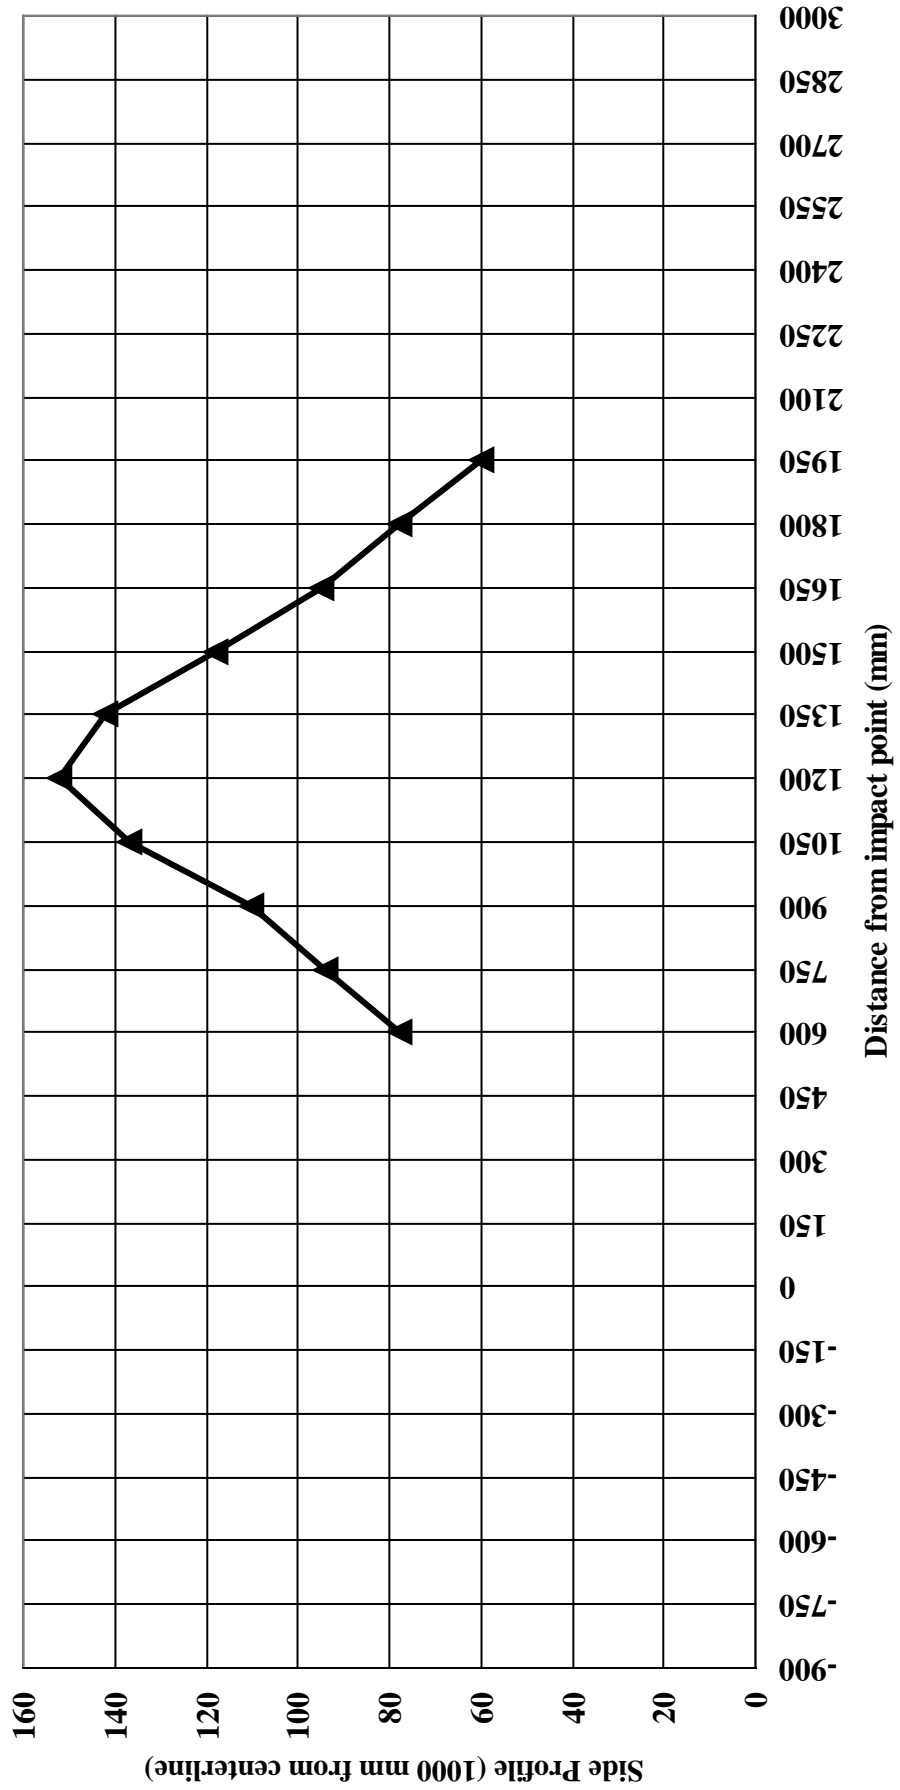
**SIDE PROFILE LEVEL 5**

234 mm above ground

1. LEVEL 1	(1311 mm above ground)	=	<u>348</u>	mm
2. LEVEL 2	(917 mm above ground)	=	<u>516</u>	mm
3. LEVEL 3	(587 mm above ground)	=	<u>462</u>	mm
4. LEVEL 4	(488 mm above ground)	=	<u>355</u>	mm
5. LEVEL 5	(234 mm above ground)	=	<u>152</u>	mm

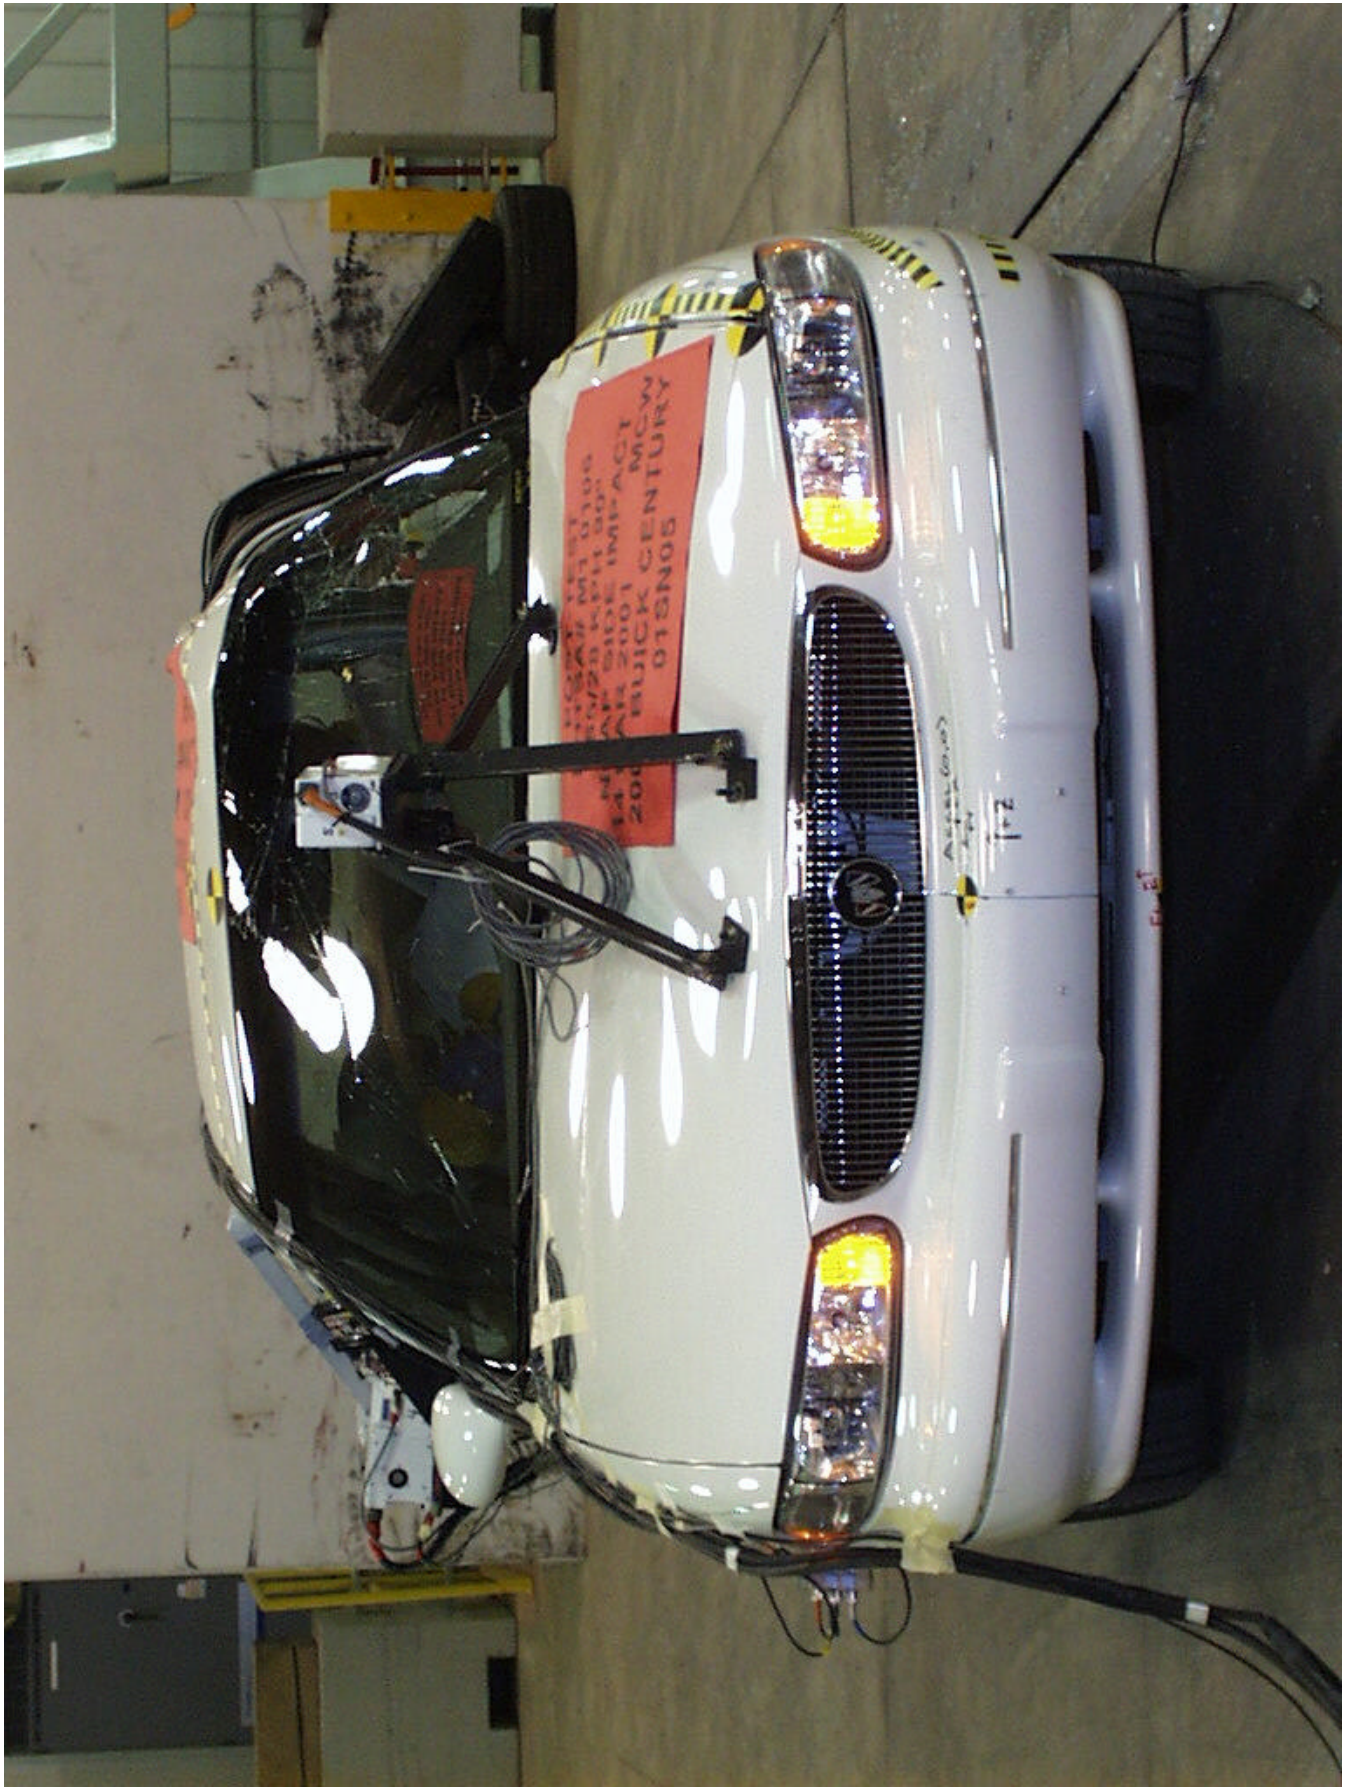
Figure A-2: POST-TEST FRONTAL VIEW OF TEST VEHICLE

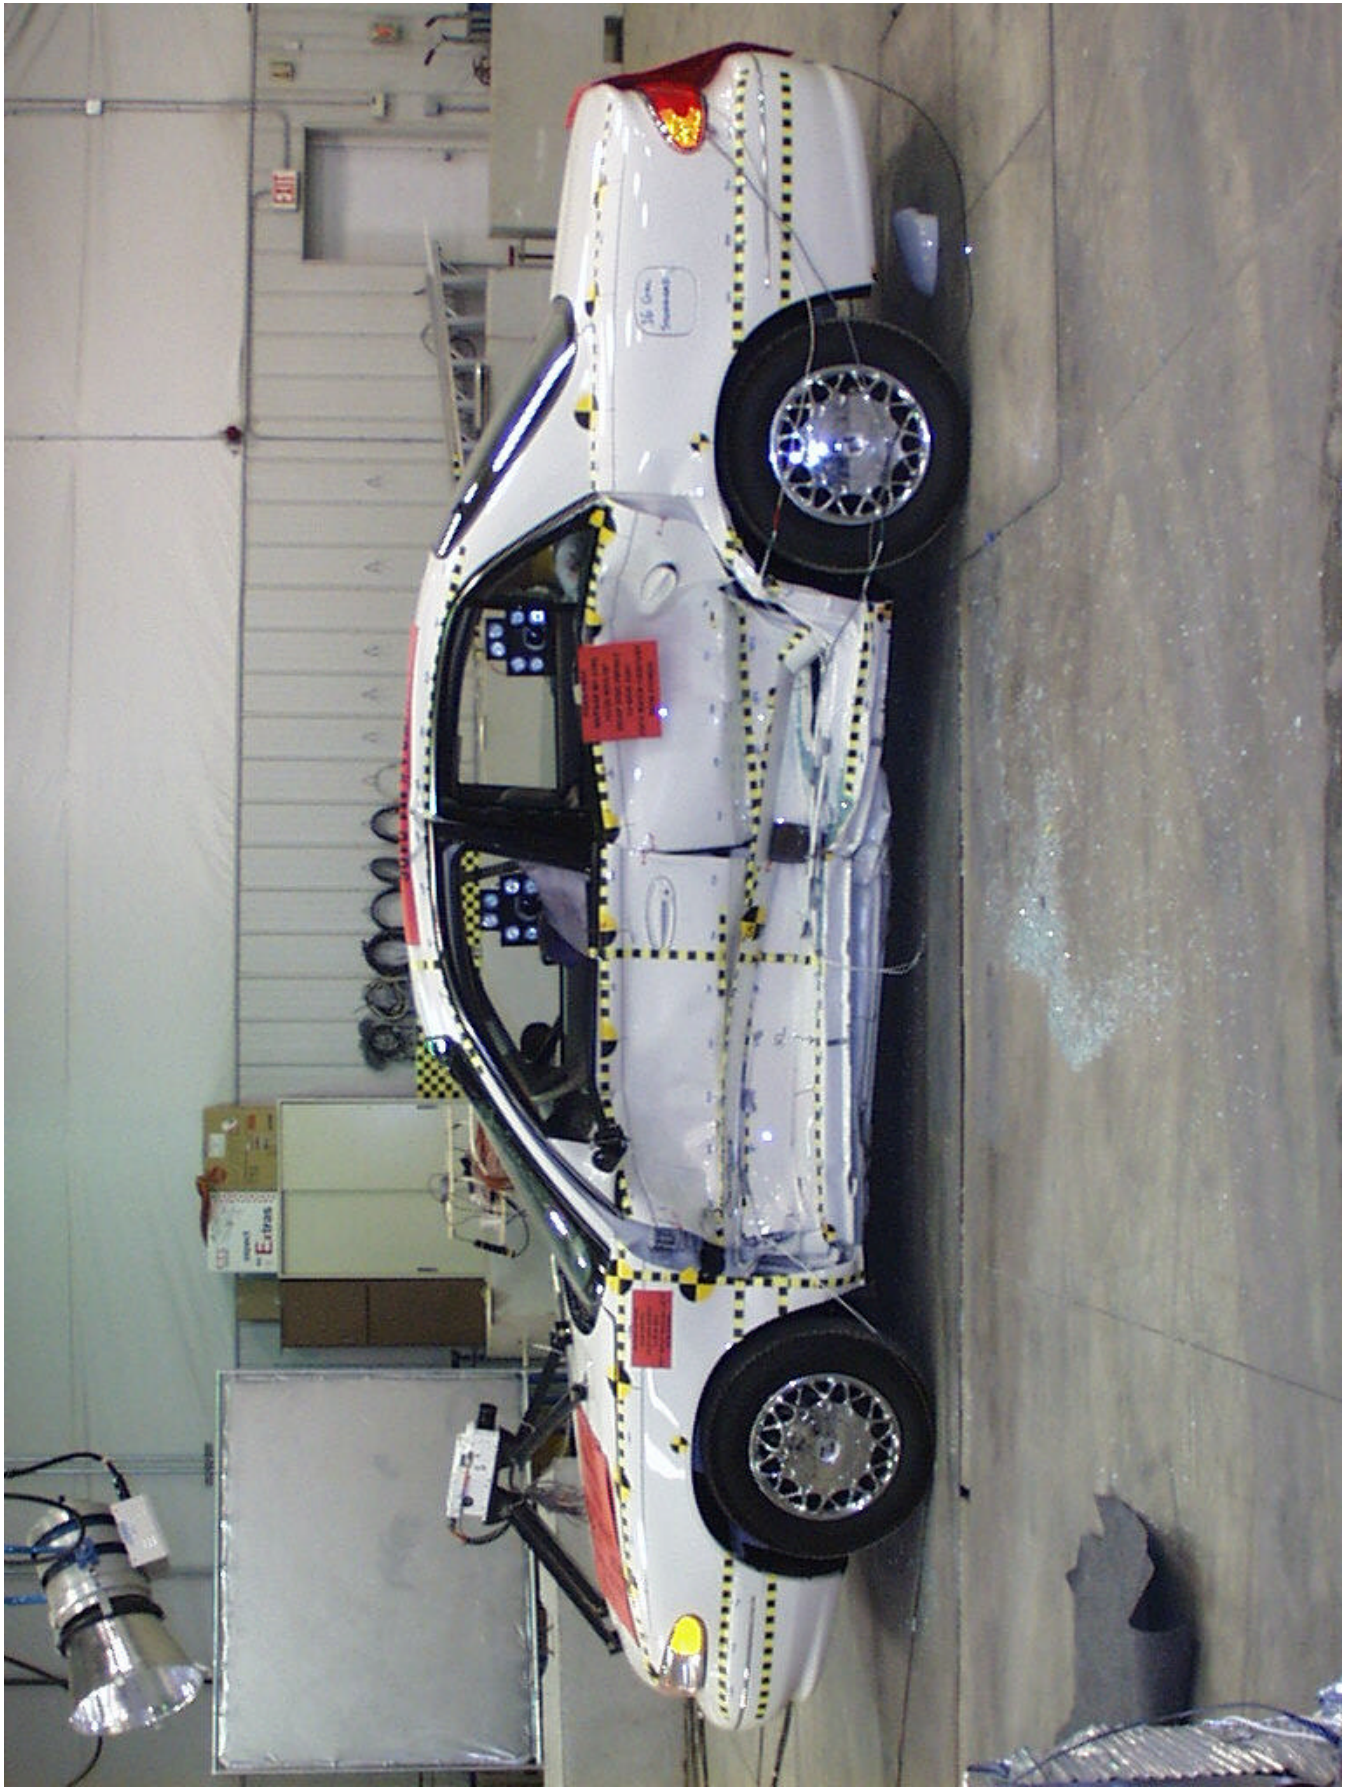
Figure A-6: POST-TEST IMPACTED SIDE VIEW OF TEST VEHICLE

MAXIMUM EXTERIOR STATIC CRUSH:

Maximum Post-Test intrusion at Level 2 is 516 mm

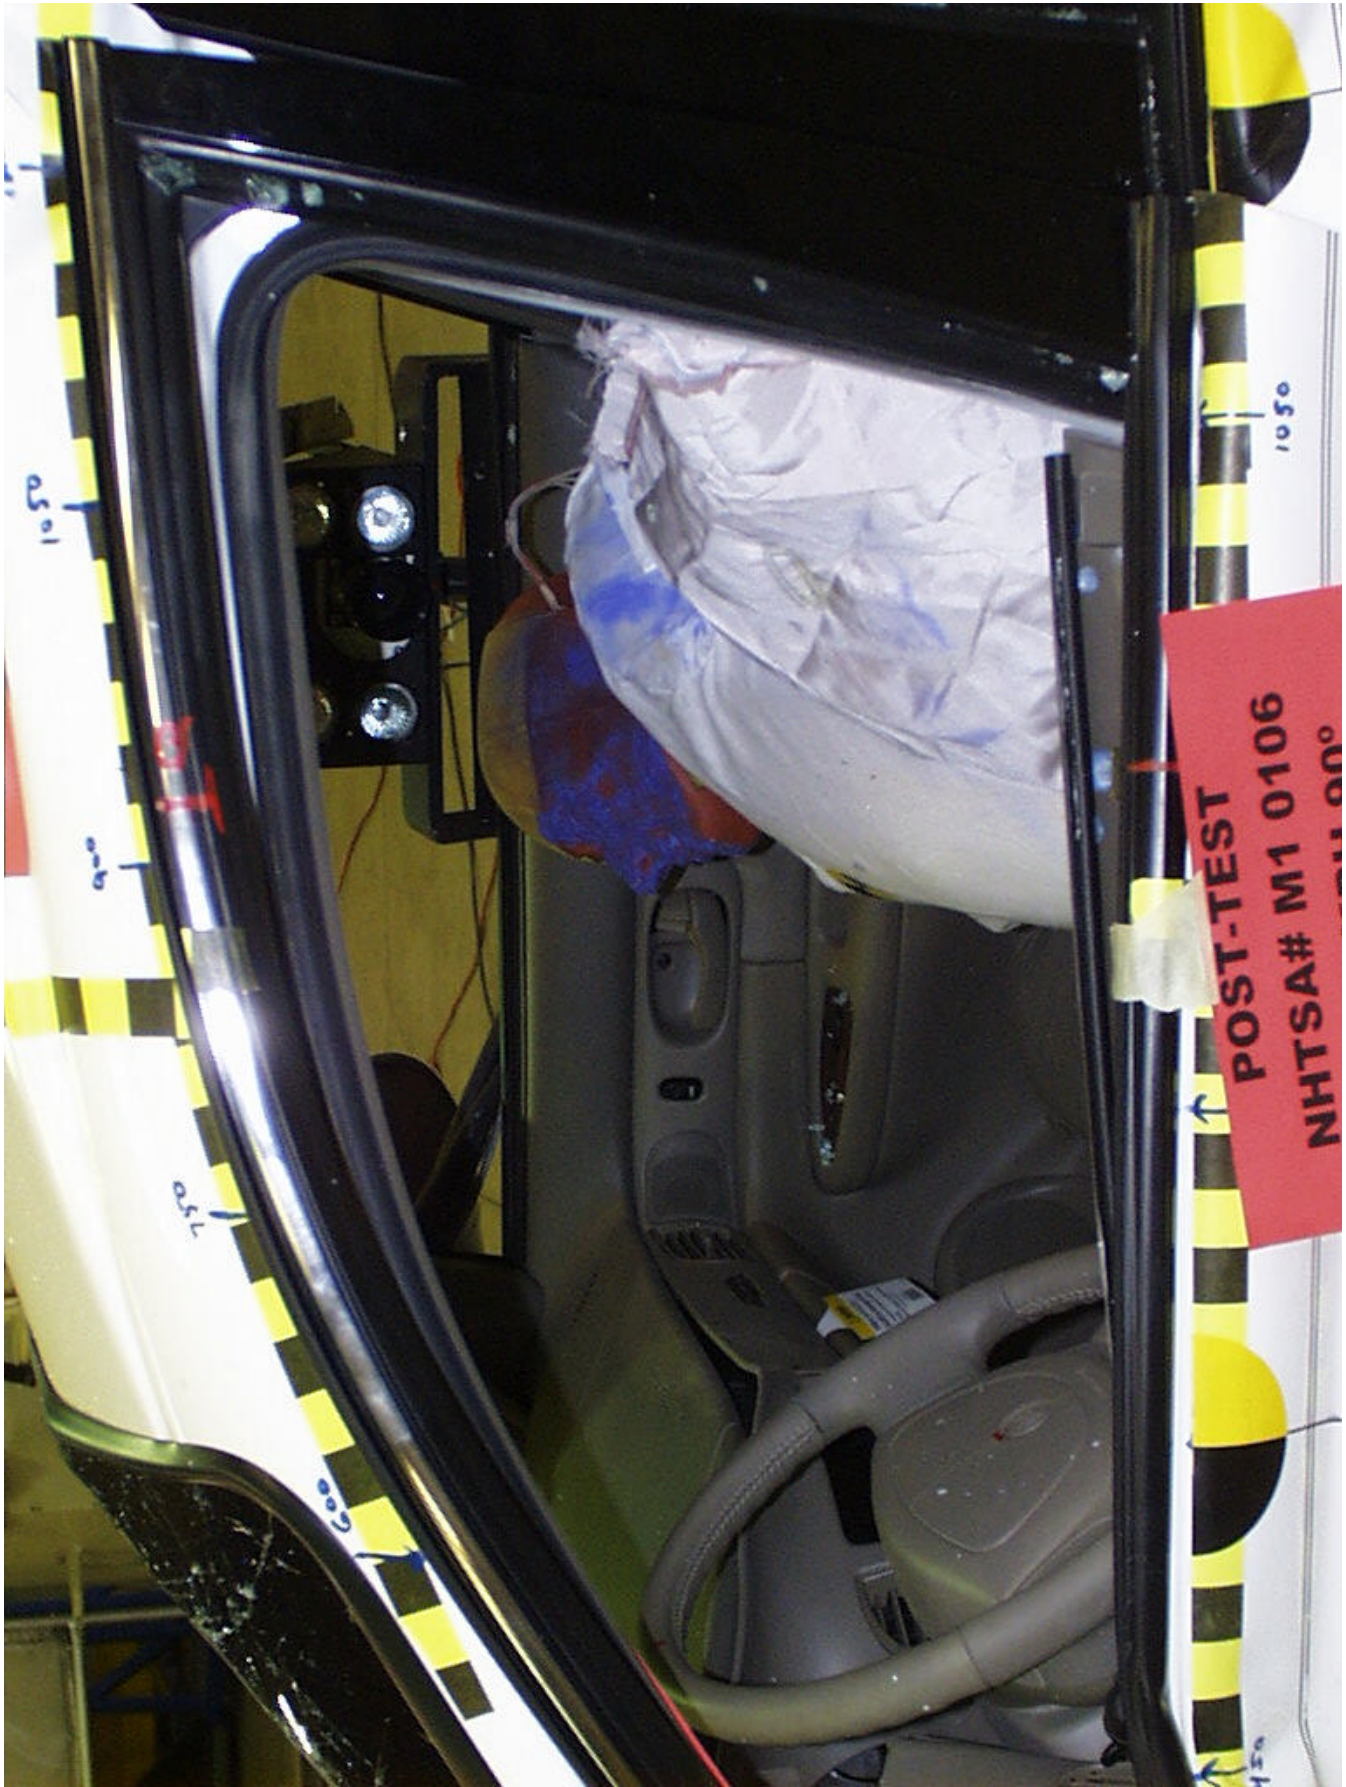
Figure A-14: POST-TEST LEFT OCCUPANT COMPARTMENT VIEW OF FRONT SID

Front	<u>Left front seat back was pushed inboard against center console</u>
Rear	<u>Left seat cushion was pushed upward and inboard by left rear door</u>

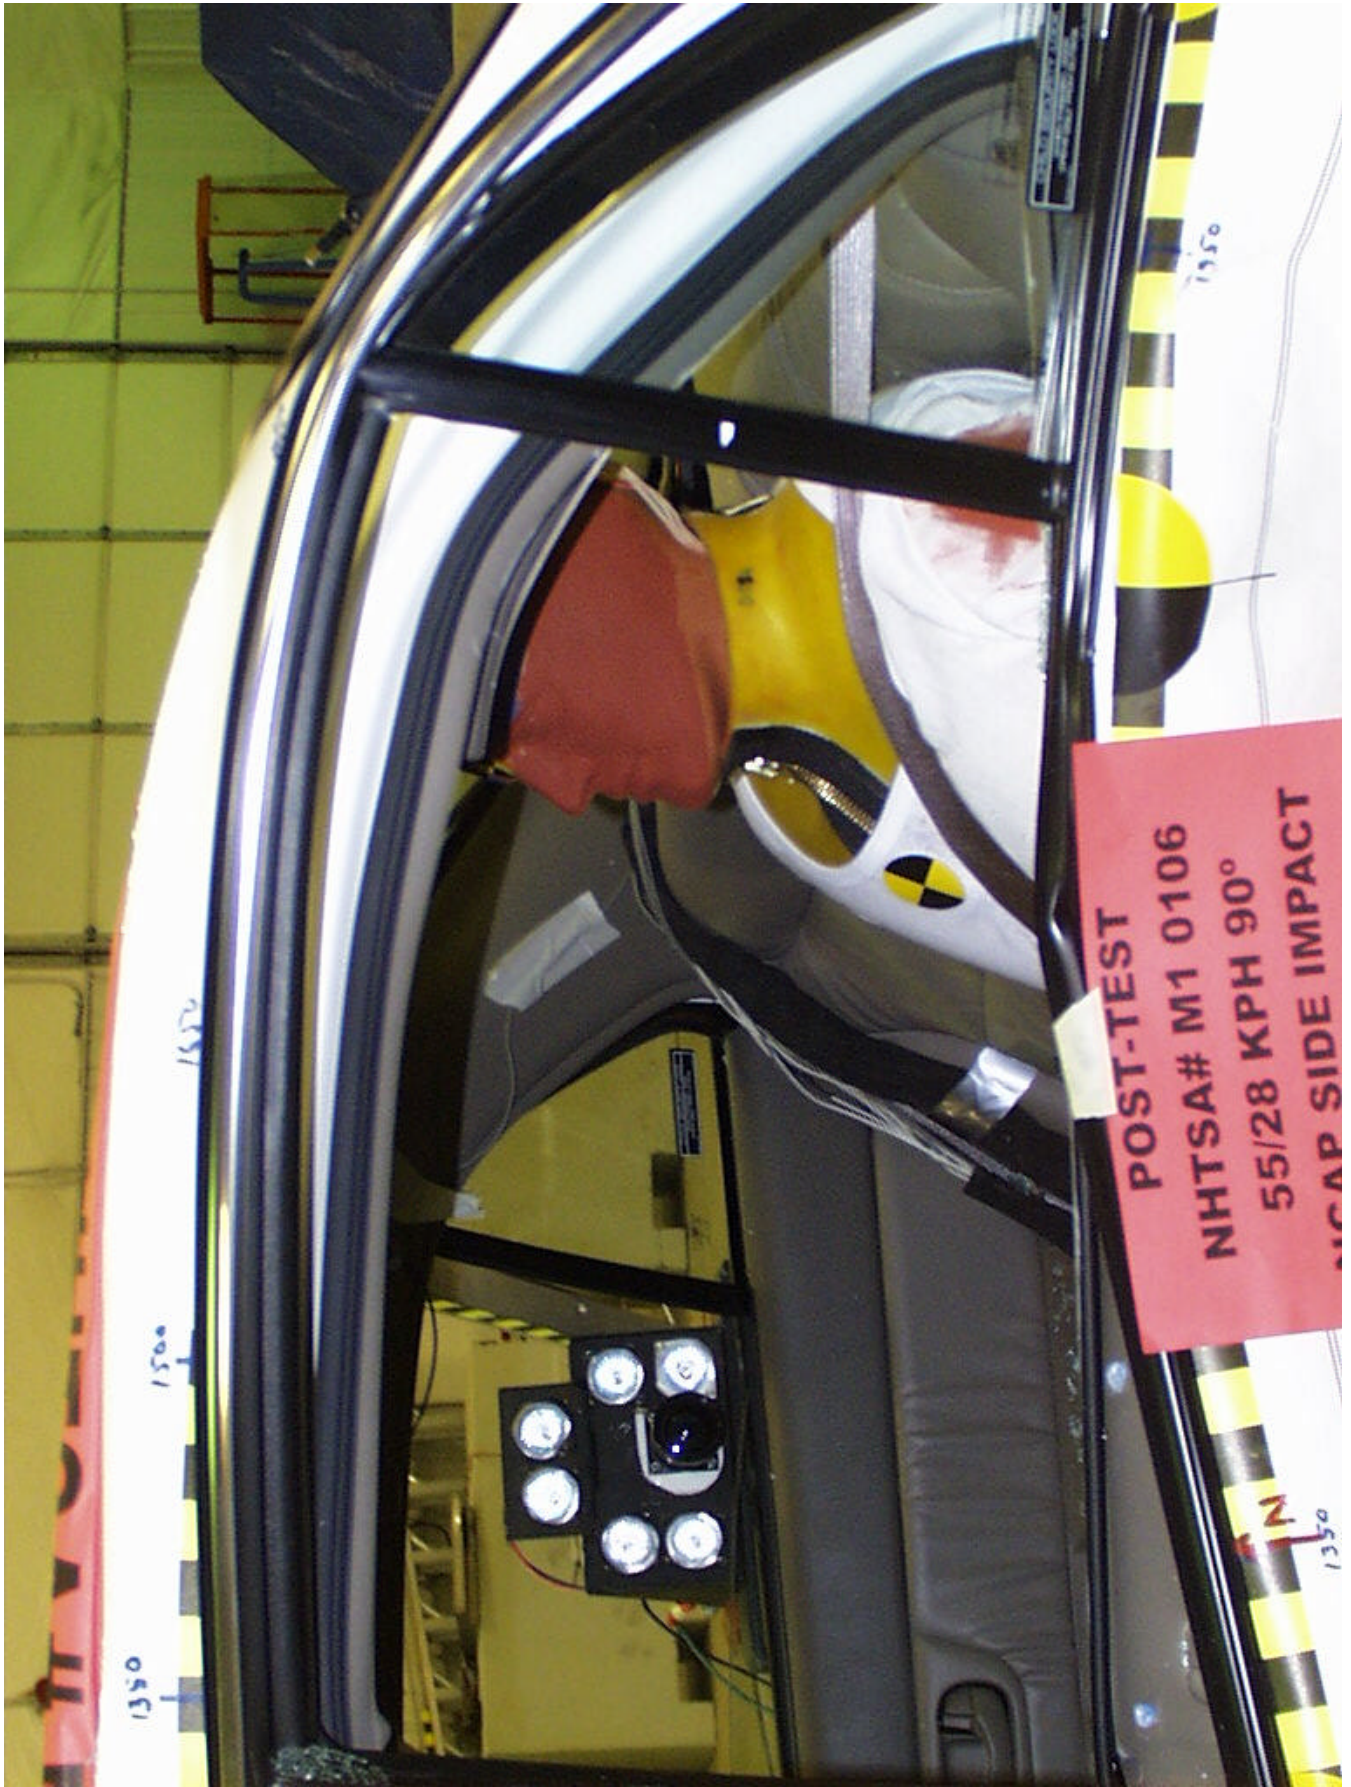
Figure A-16: POST-TEST LEFT OCCUPANT COMPARTMENT VIEW OF REAR SID

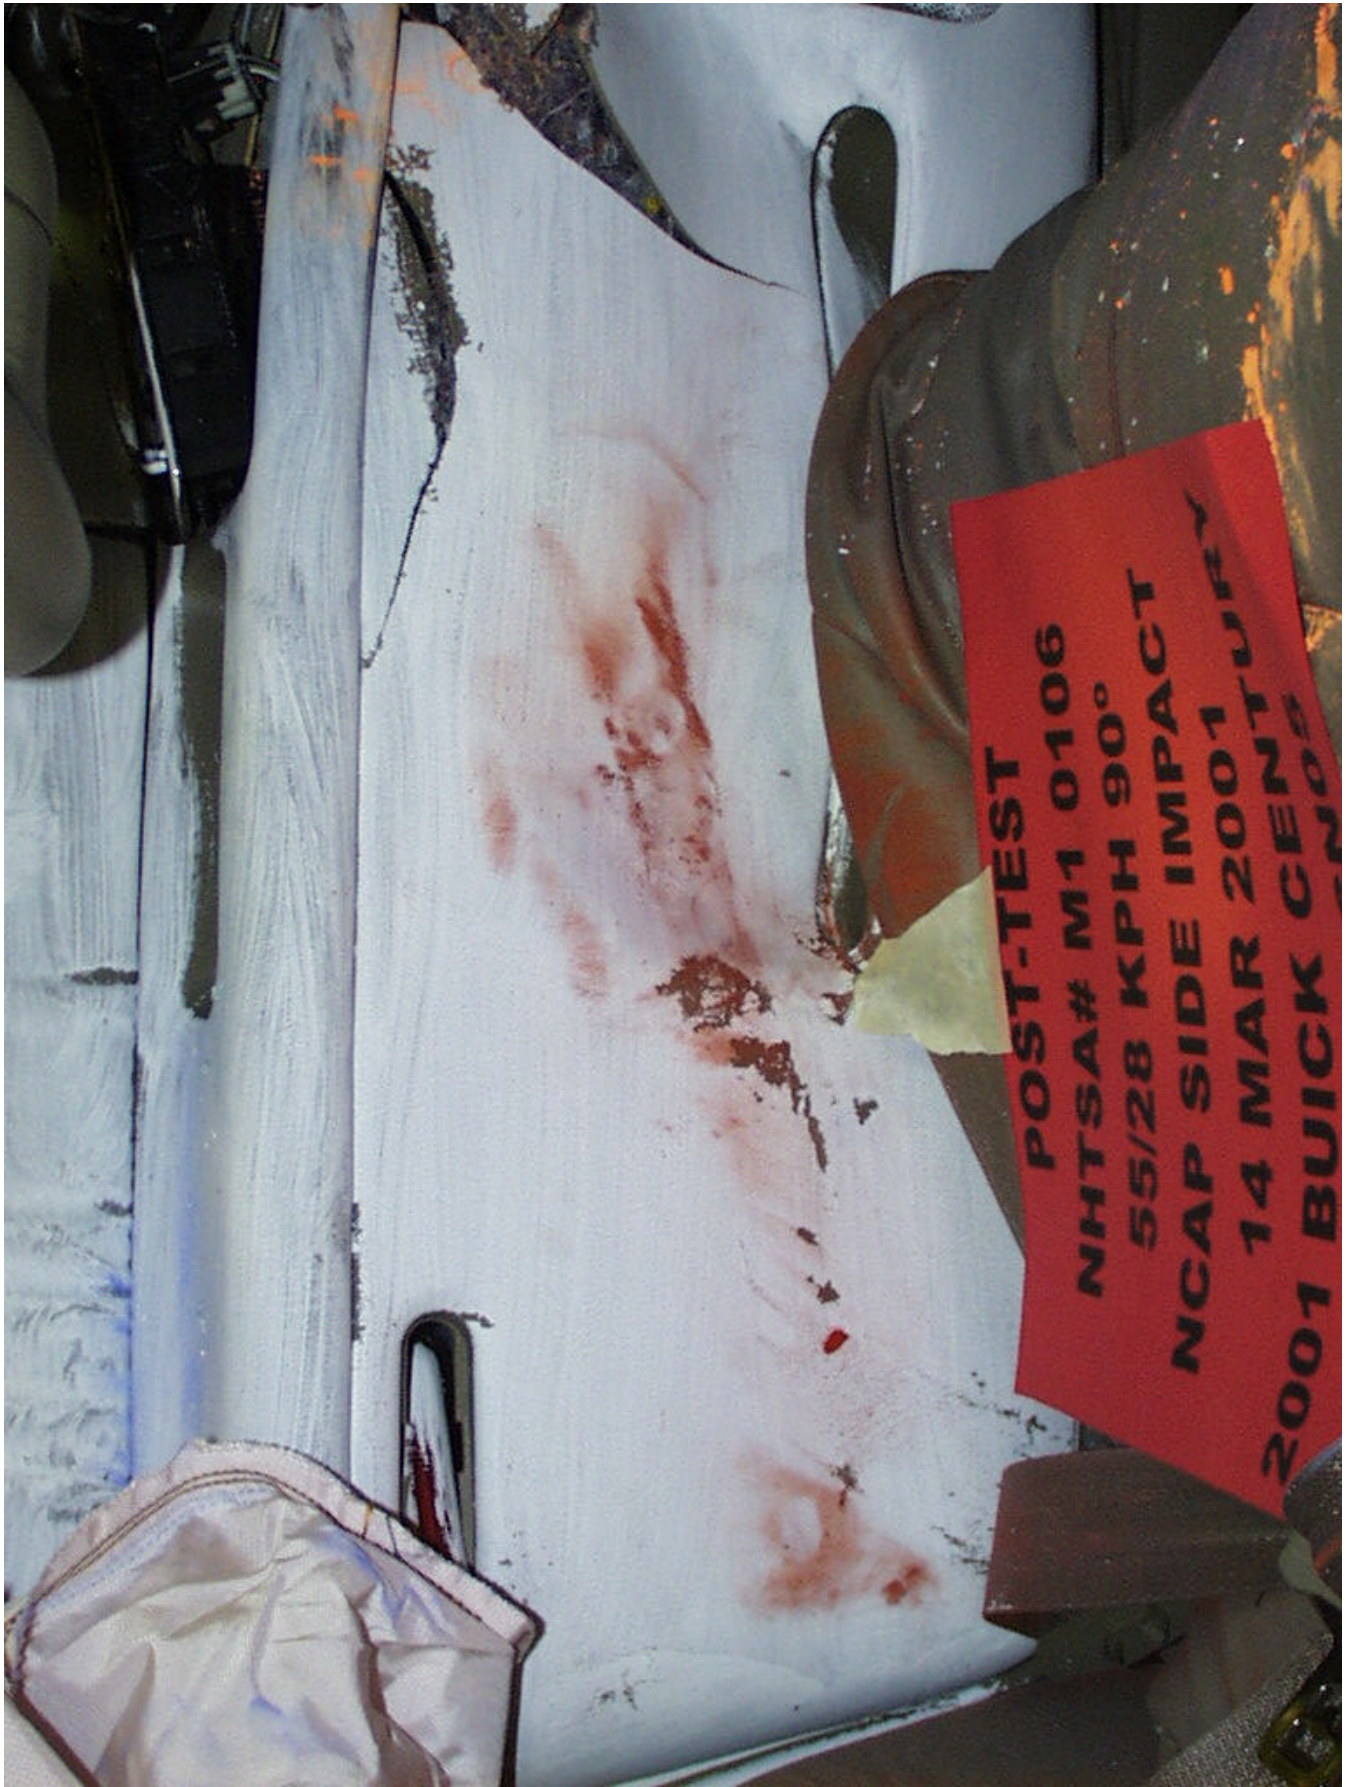
Figure A-18: POST-TEST INTERIOR OF FRONT DOOR SHOWING SID IMPACT LOCATIONS

<u>LEFT FRONT SID</u>	<u>LEFT REAR SID</u>
Head	<u>Left side of head to driver side airbag</u>	<u>Top of head to upper C-pillar trim panel</u>
Upper Torso	<u>Left side of upper torso to driver side airbag</u>	<u>Left side of upper torso to left rear door panel</u>
Lower Torso	<u>Left side of lower torso to arm rest</u>	<u>Left side of lower torso to left rear door panel</u>
Left Knee	<u>Left knee to left front door panel</u>	<u>Left knee to left lower rear door panel</u>
Right Knee	<u>Right knee to left knee</u>	<u>Right knee to left knee</u>

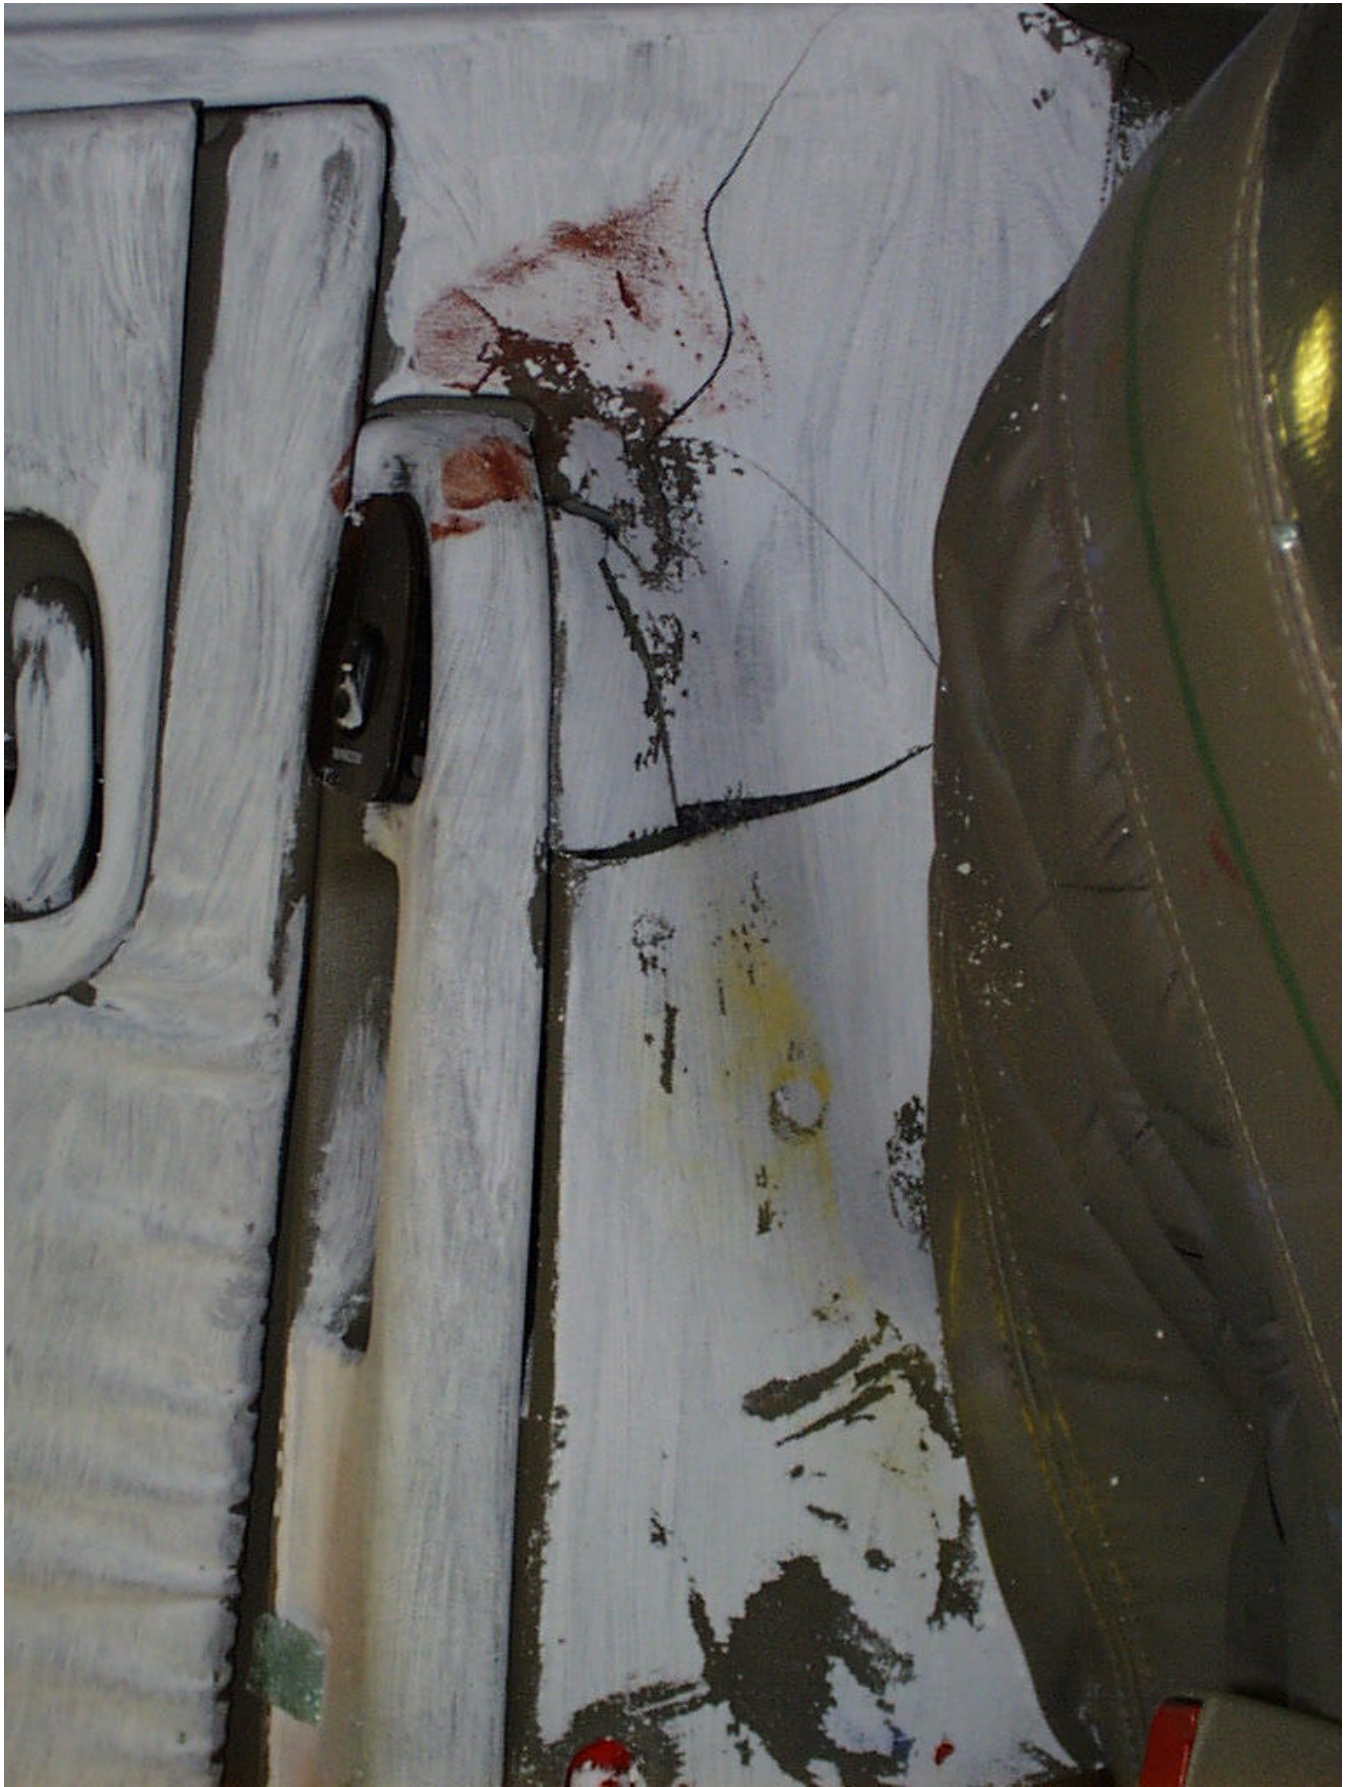
Figure A-20: POST-TEST INTERIOR OF REAR DOOR SHOWING SID IMPACT LOCATIONS

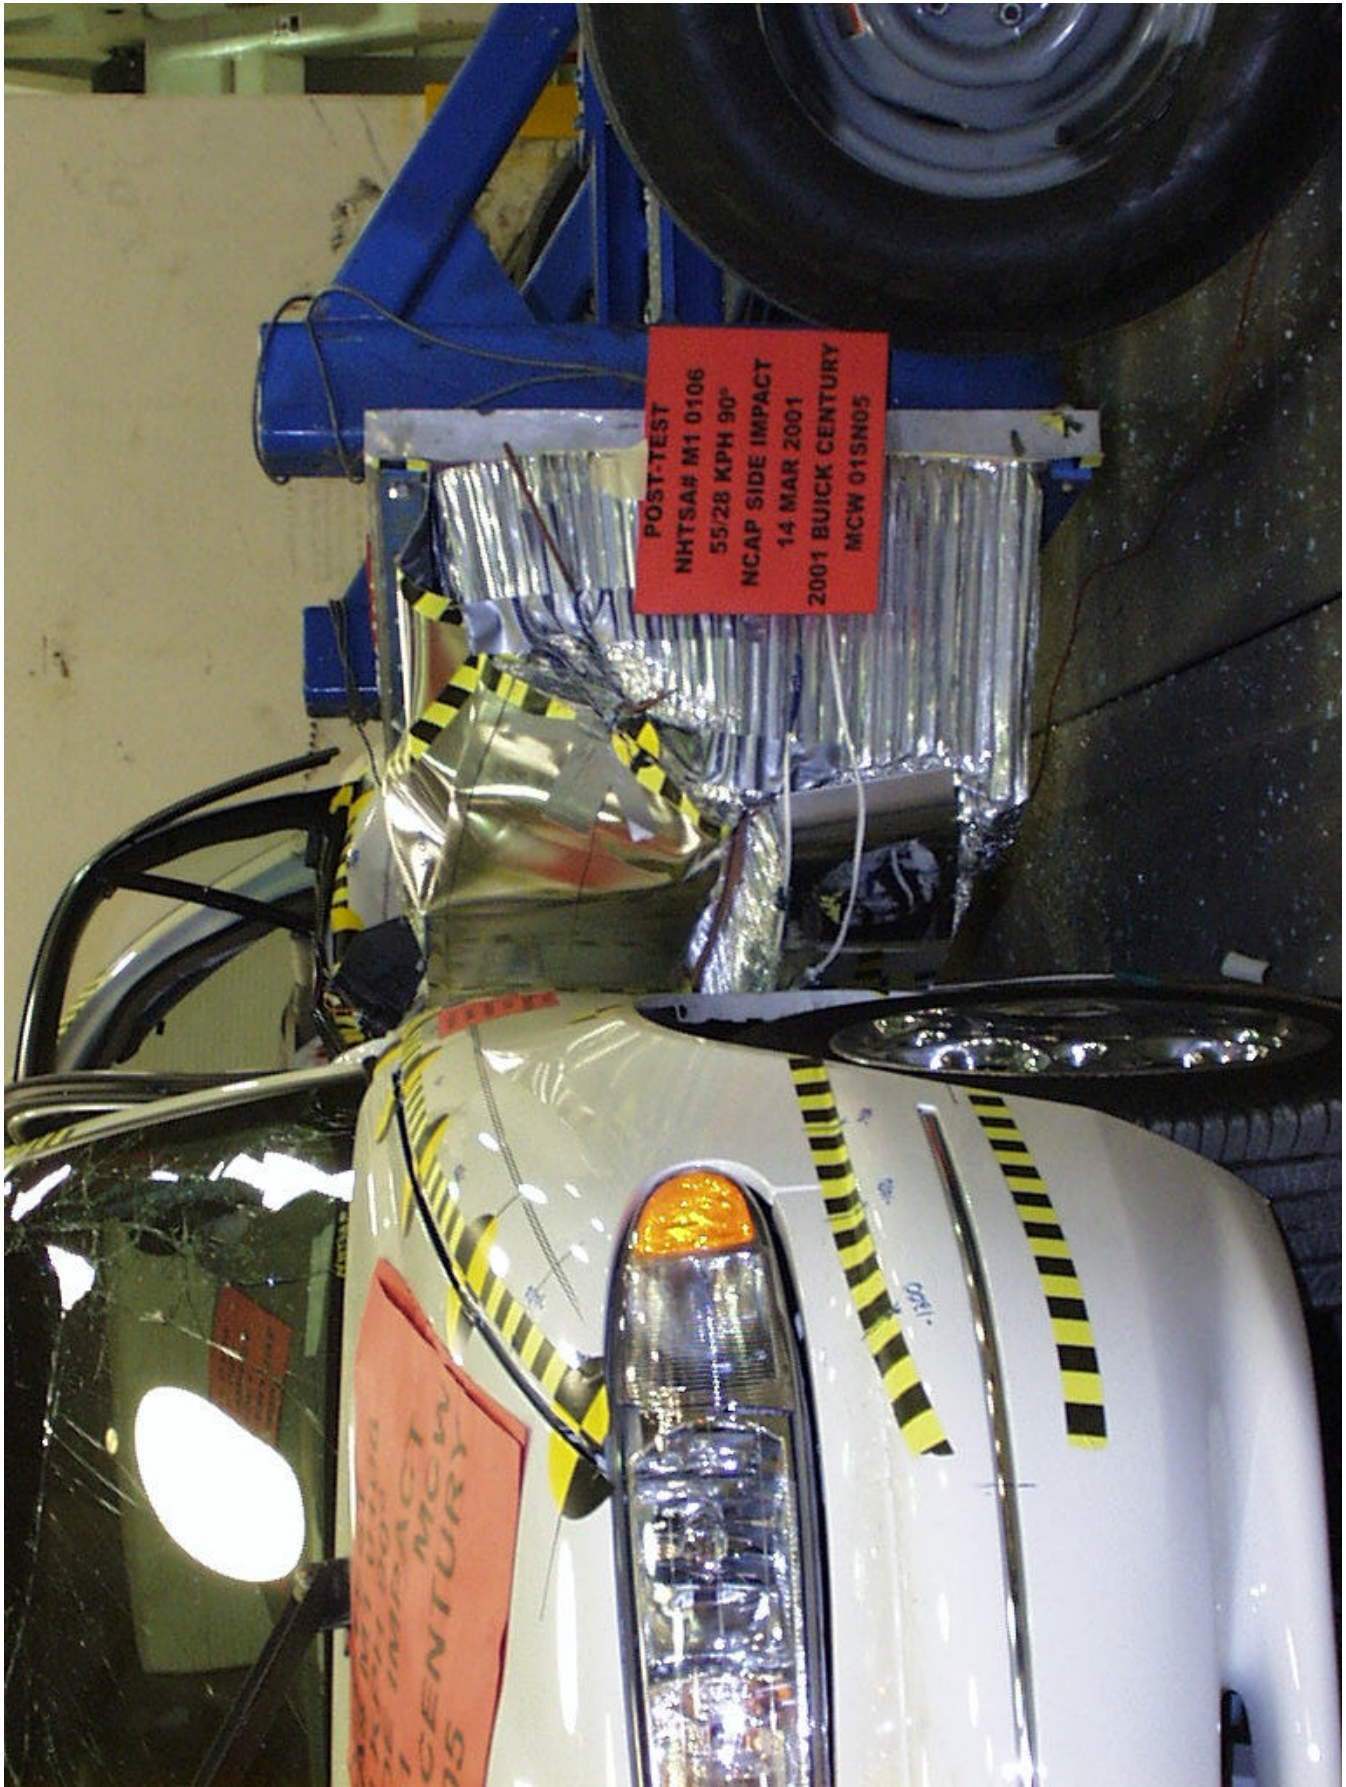
Figure A-22: POST-TEST LEFT SIDE VIEW OF MDB

MAXIMUM STATIC CRUSH OF HONEYCOMB IMPACT FACE:

1. Row A Center of Bumper	=	<u>97</u>	mm
2. Row B Top of Bumper	=	<u>50</u>	mm
3. Row C Mid-Level	=	<u>104</u>	mm
4. Row D Top of Stack	=	<u>177</u>	mm

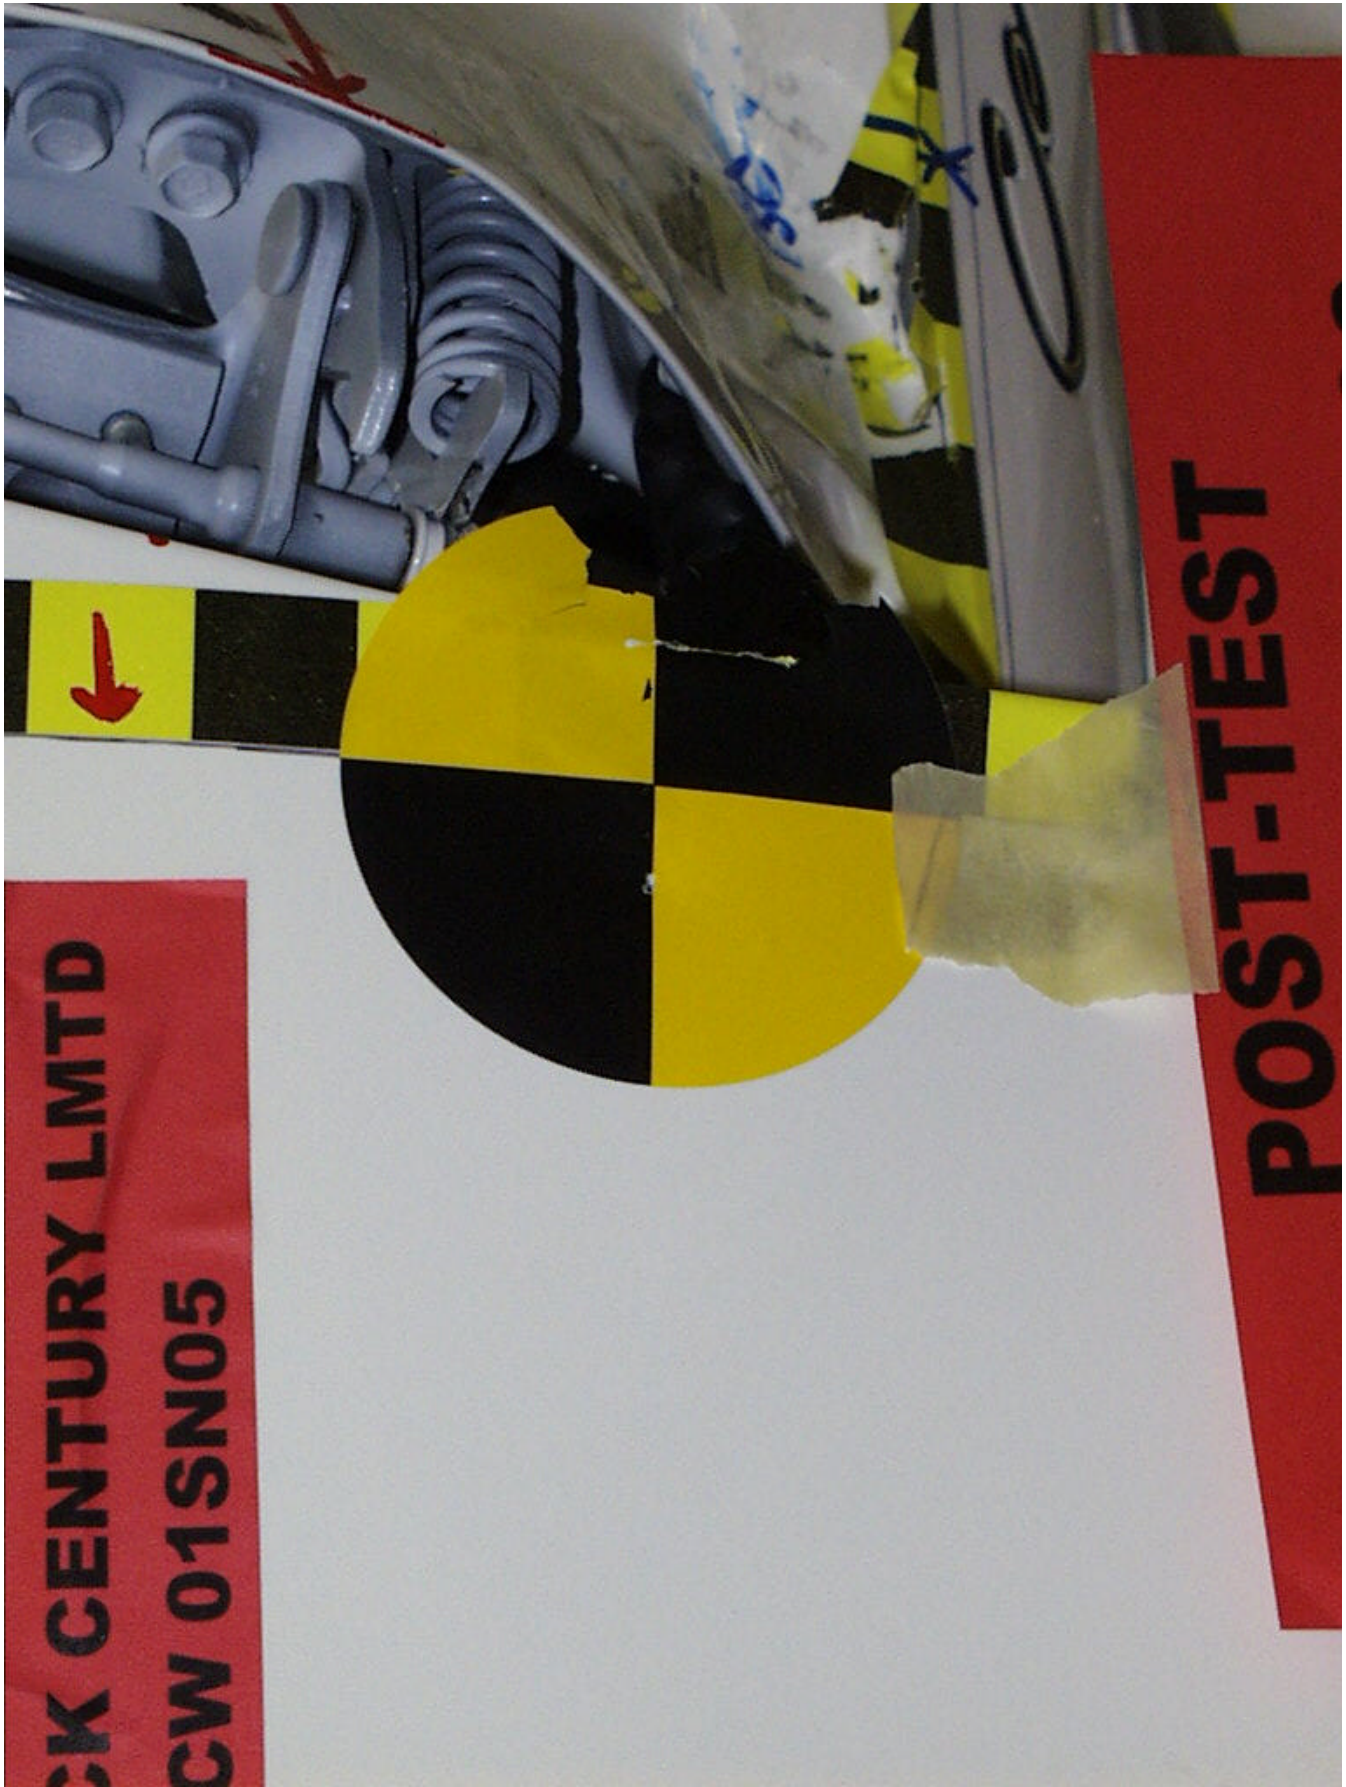
Figure A-28: POST-TEST CLOSE UP OF IMPACT POINT TARGET

Actual Impact Point is 16 mm forward of nominal impact reference line (lateral)

Actual Impact Point is 1 mm above nominal impact line (vertical)
