**REPORT NUMBER: 201-MGA-2001-002**

**SAFETY COMPLIANCE TESTING FOR FMVSS 201  
RIGID POLE SIDE IMPACT TEST**

**Volkswagen of Mexico  
2001 Volkswagen Jetta 4 Door  
NHTSA NUMBER: C15801**

**FINAL REPORT**

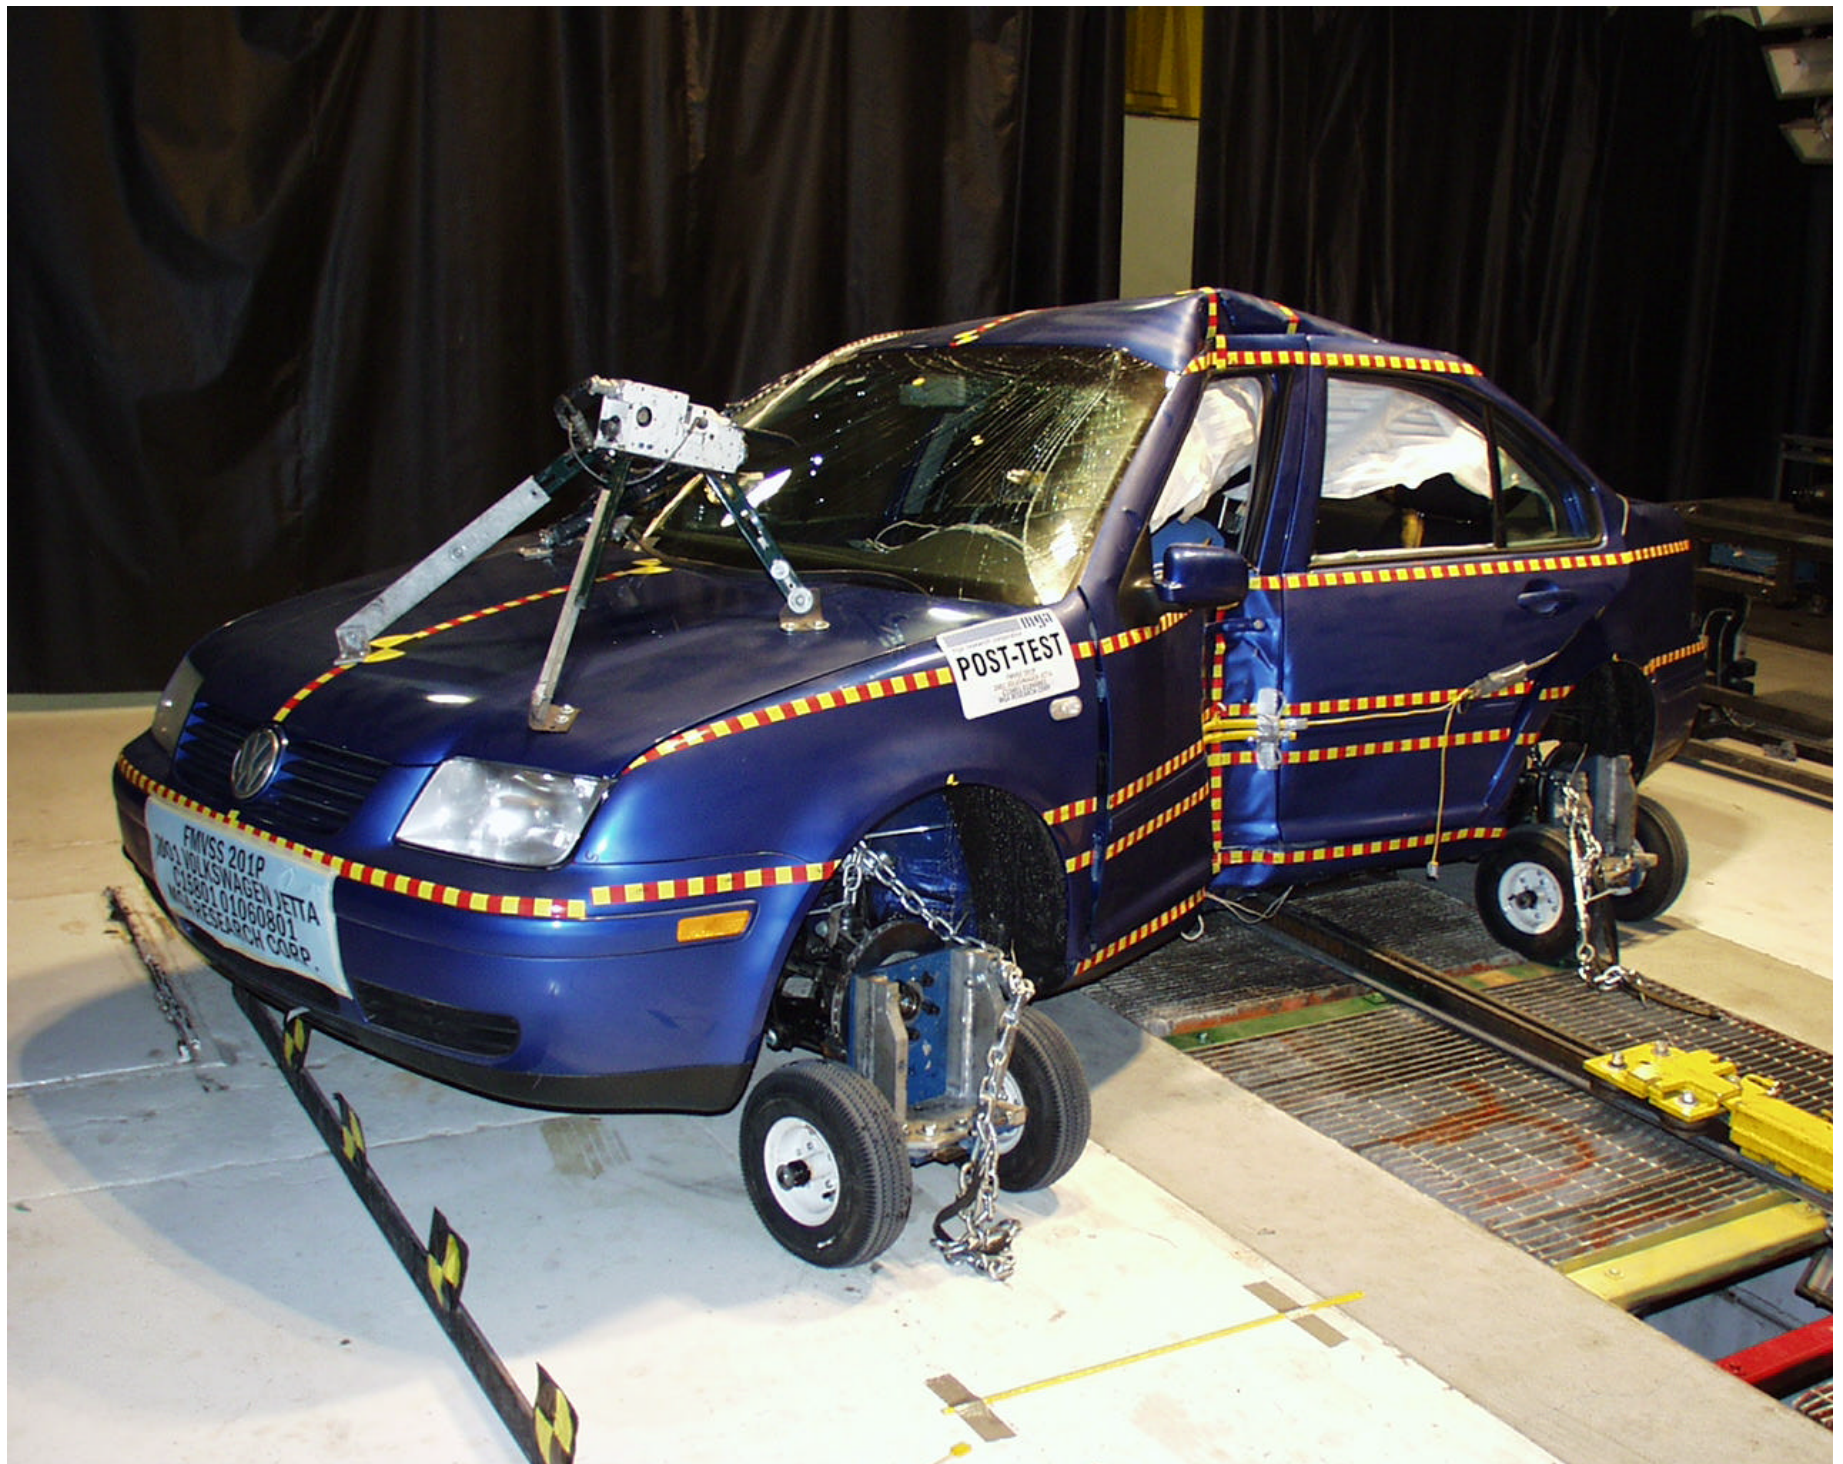
Photo No. A-8 - Post-Test Left Front View of Test Vehicle

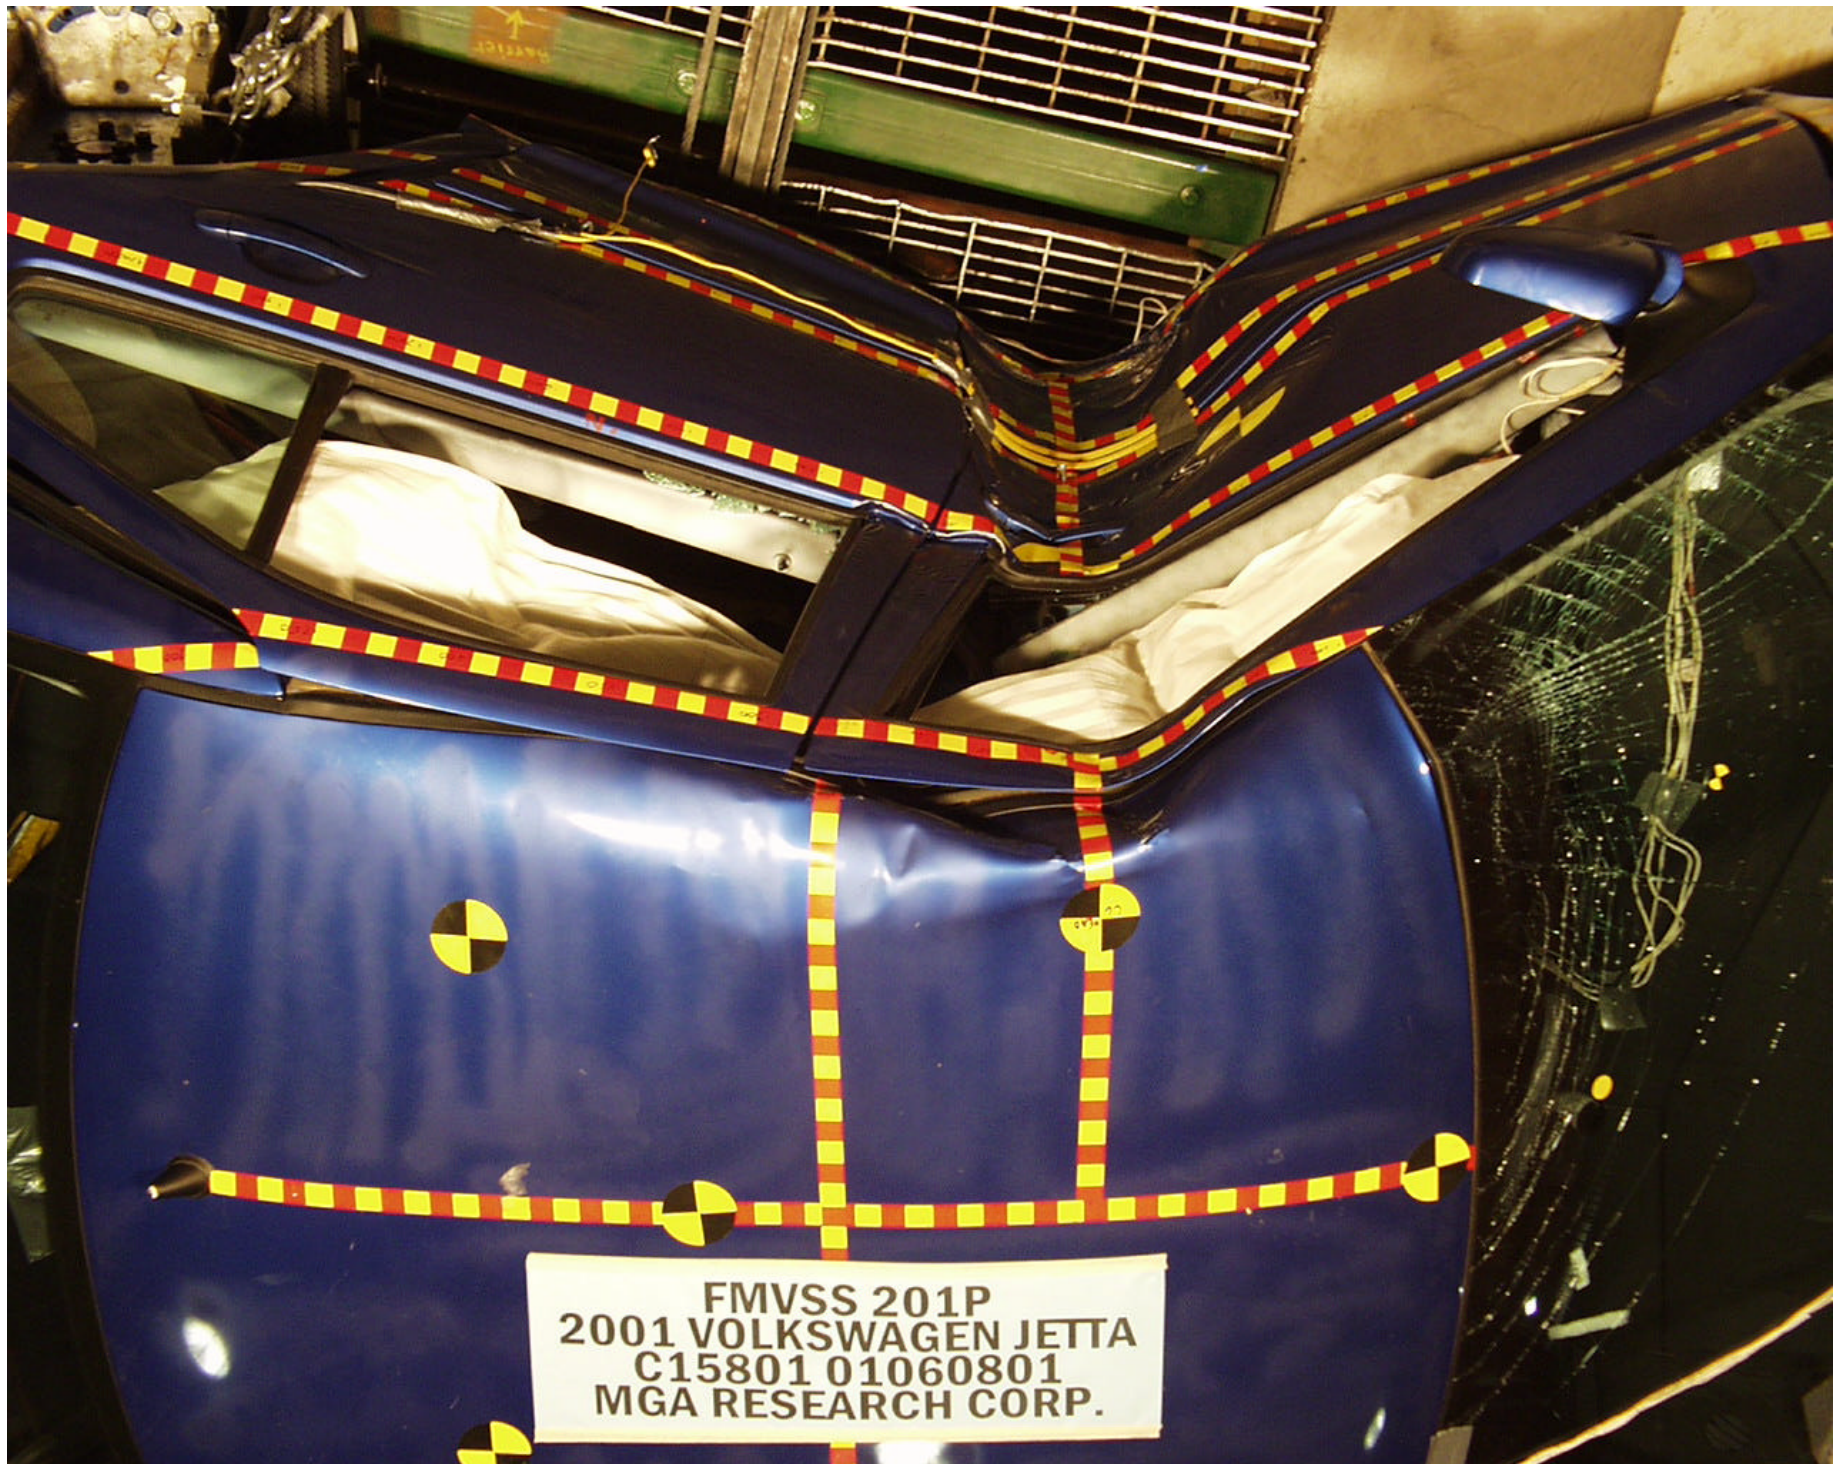
Photo No. A-14 - Post-Test Overhead View of Test Vehicle (Close-up)

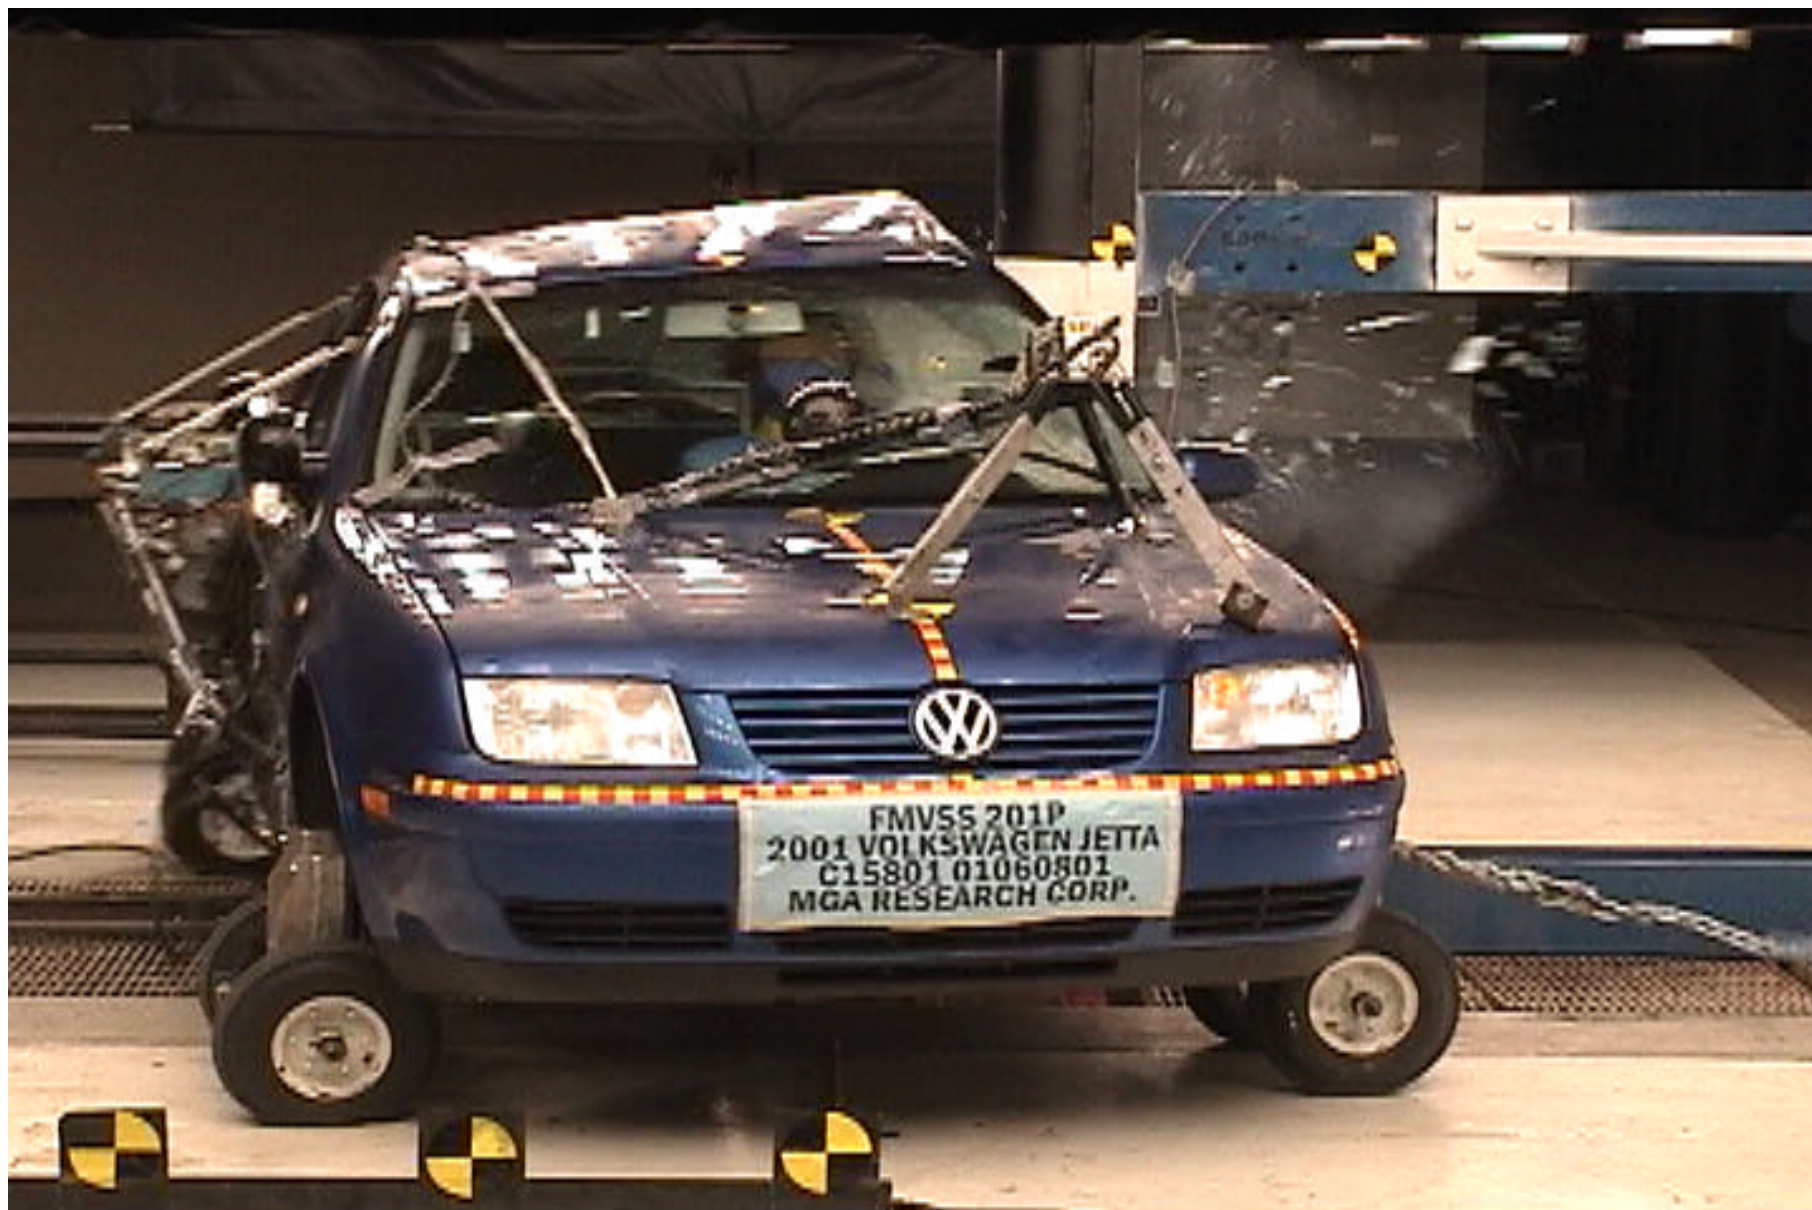
A rigid pole side impact test was performed on a model year 2001 Volkswagen Jetta 4 Door. The subject vehicle was towed into a rigid pole at a velocity of 28.6 km/h. The specified impact velocity range is from 27.1 to 28.9 km/h. The test vehicle was positioned at 90° to the line of forward motion. The weight of the vehicle as tested was 1451.5 kg. The test was conducted at MGA Research Corporation in Burlington, Wisconsin, on June 8, 2001.

Photo No. A-22 – Impact

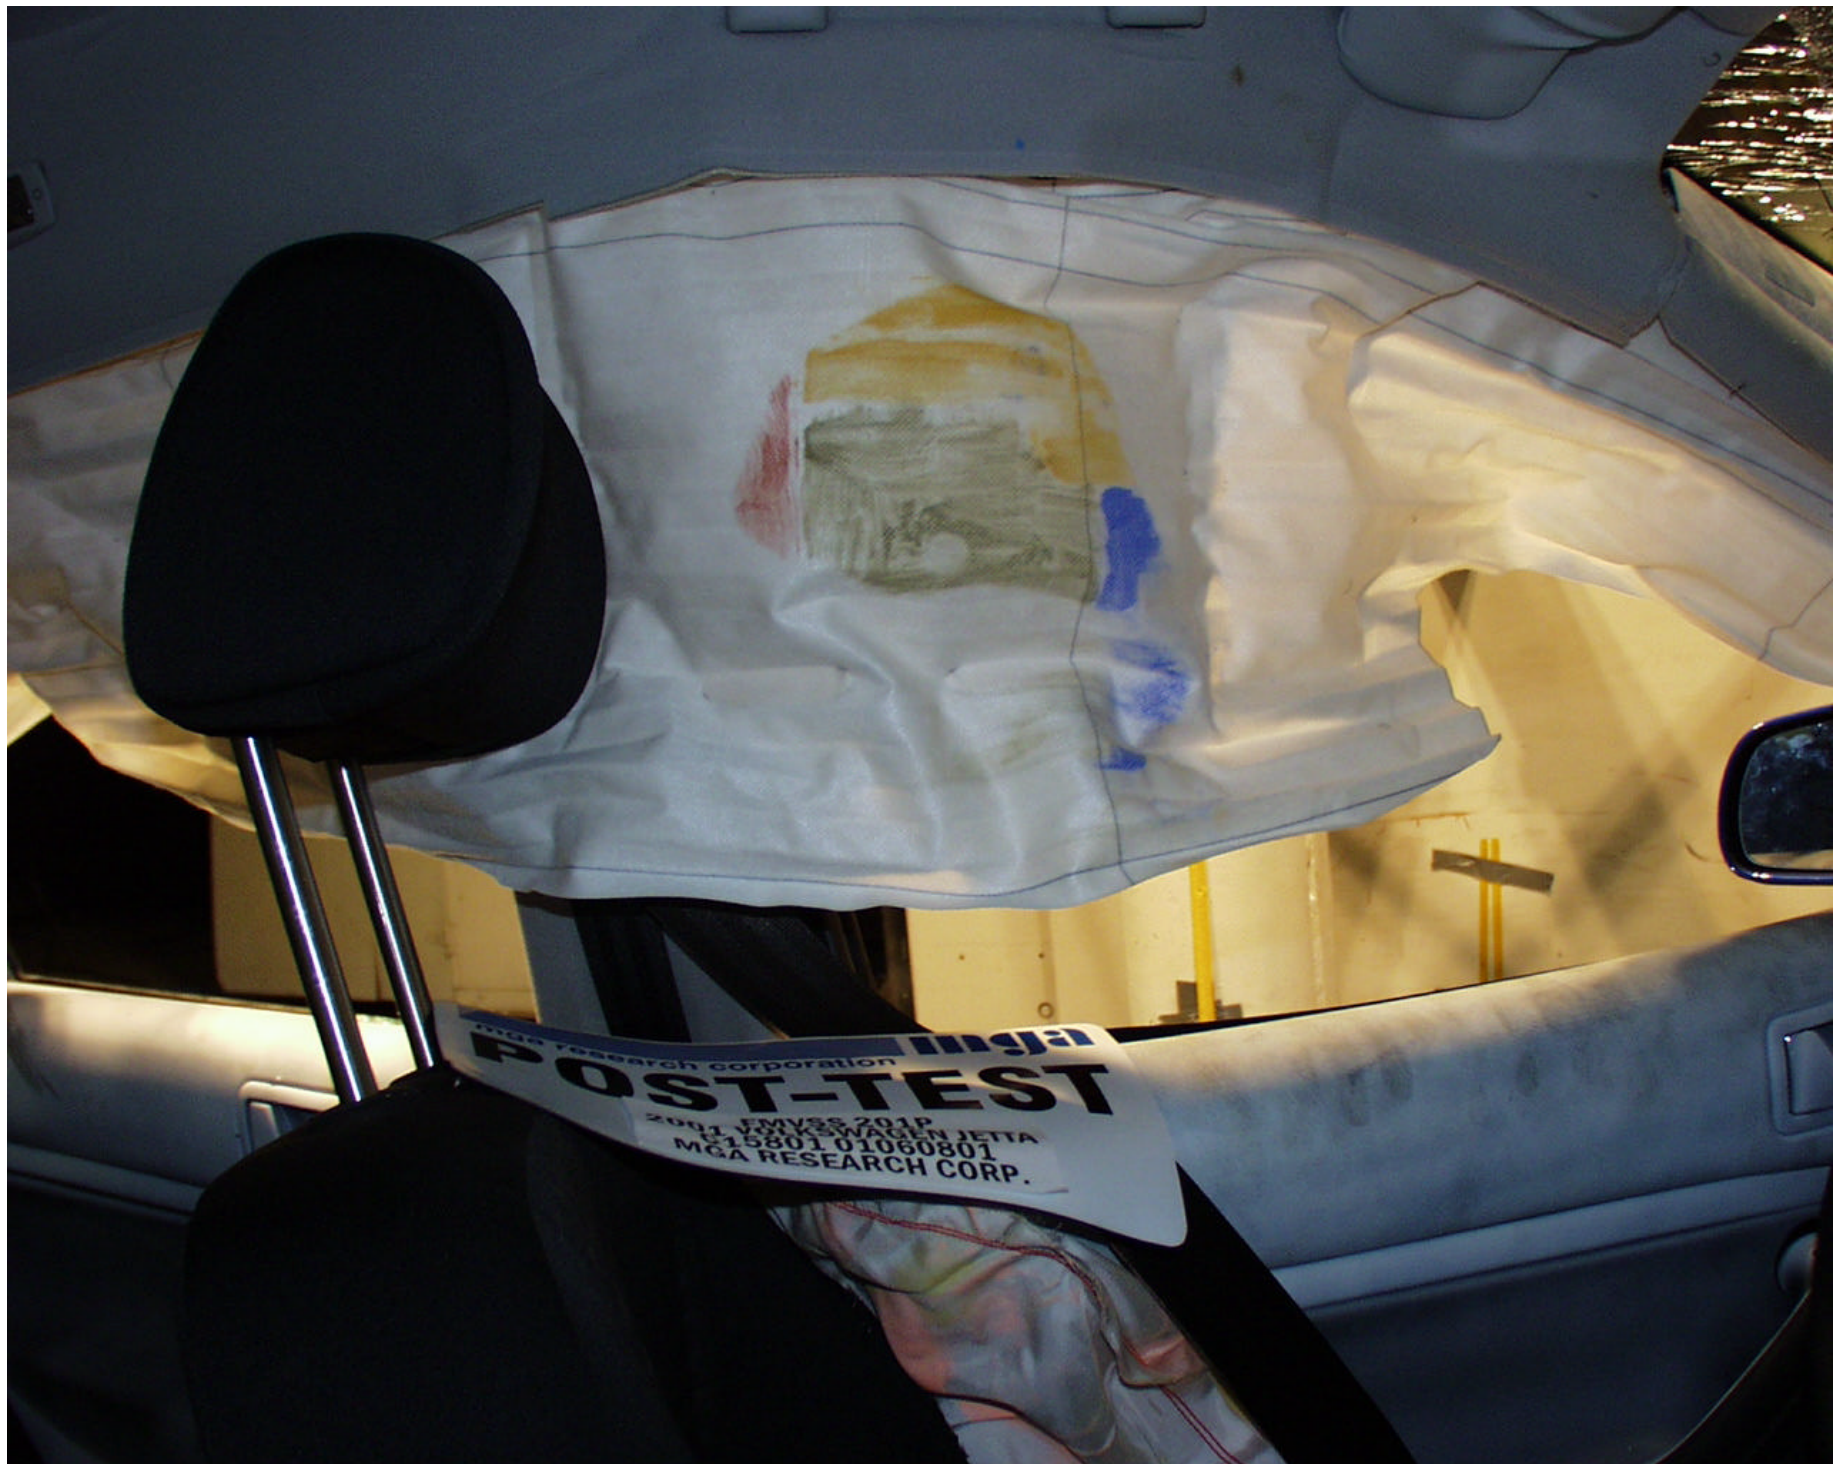
Photo No. A-23 - Post-Test Driver Dummy Head Contact

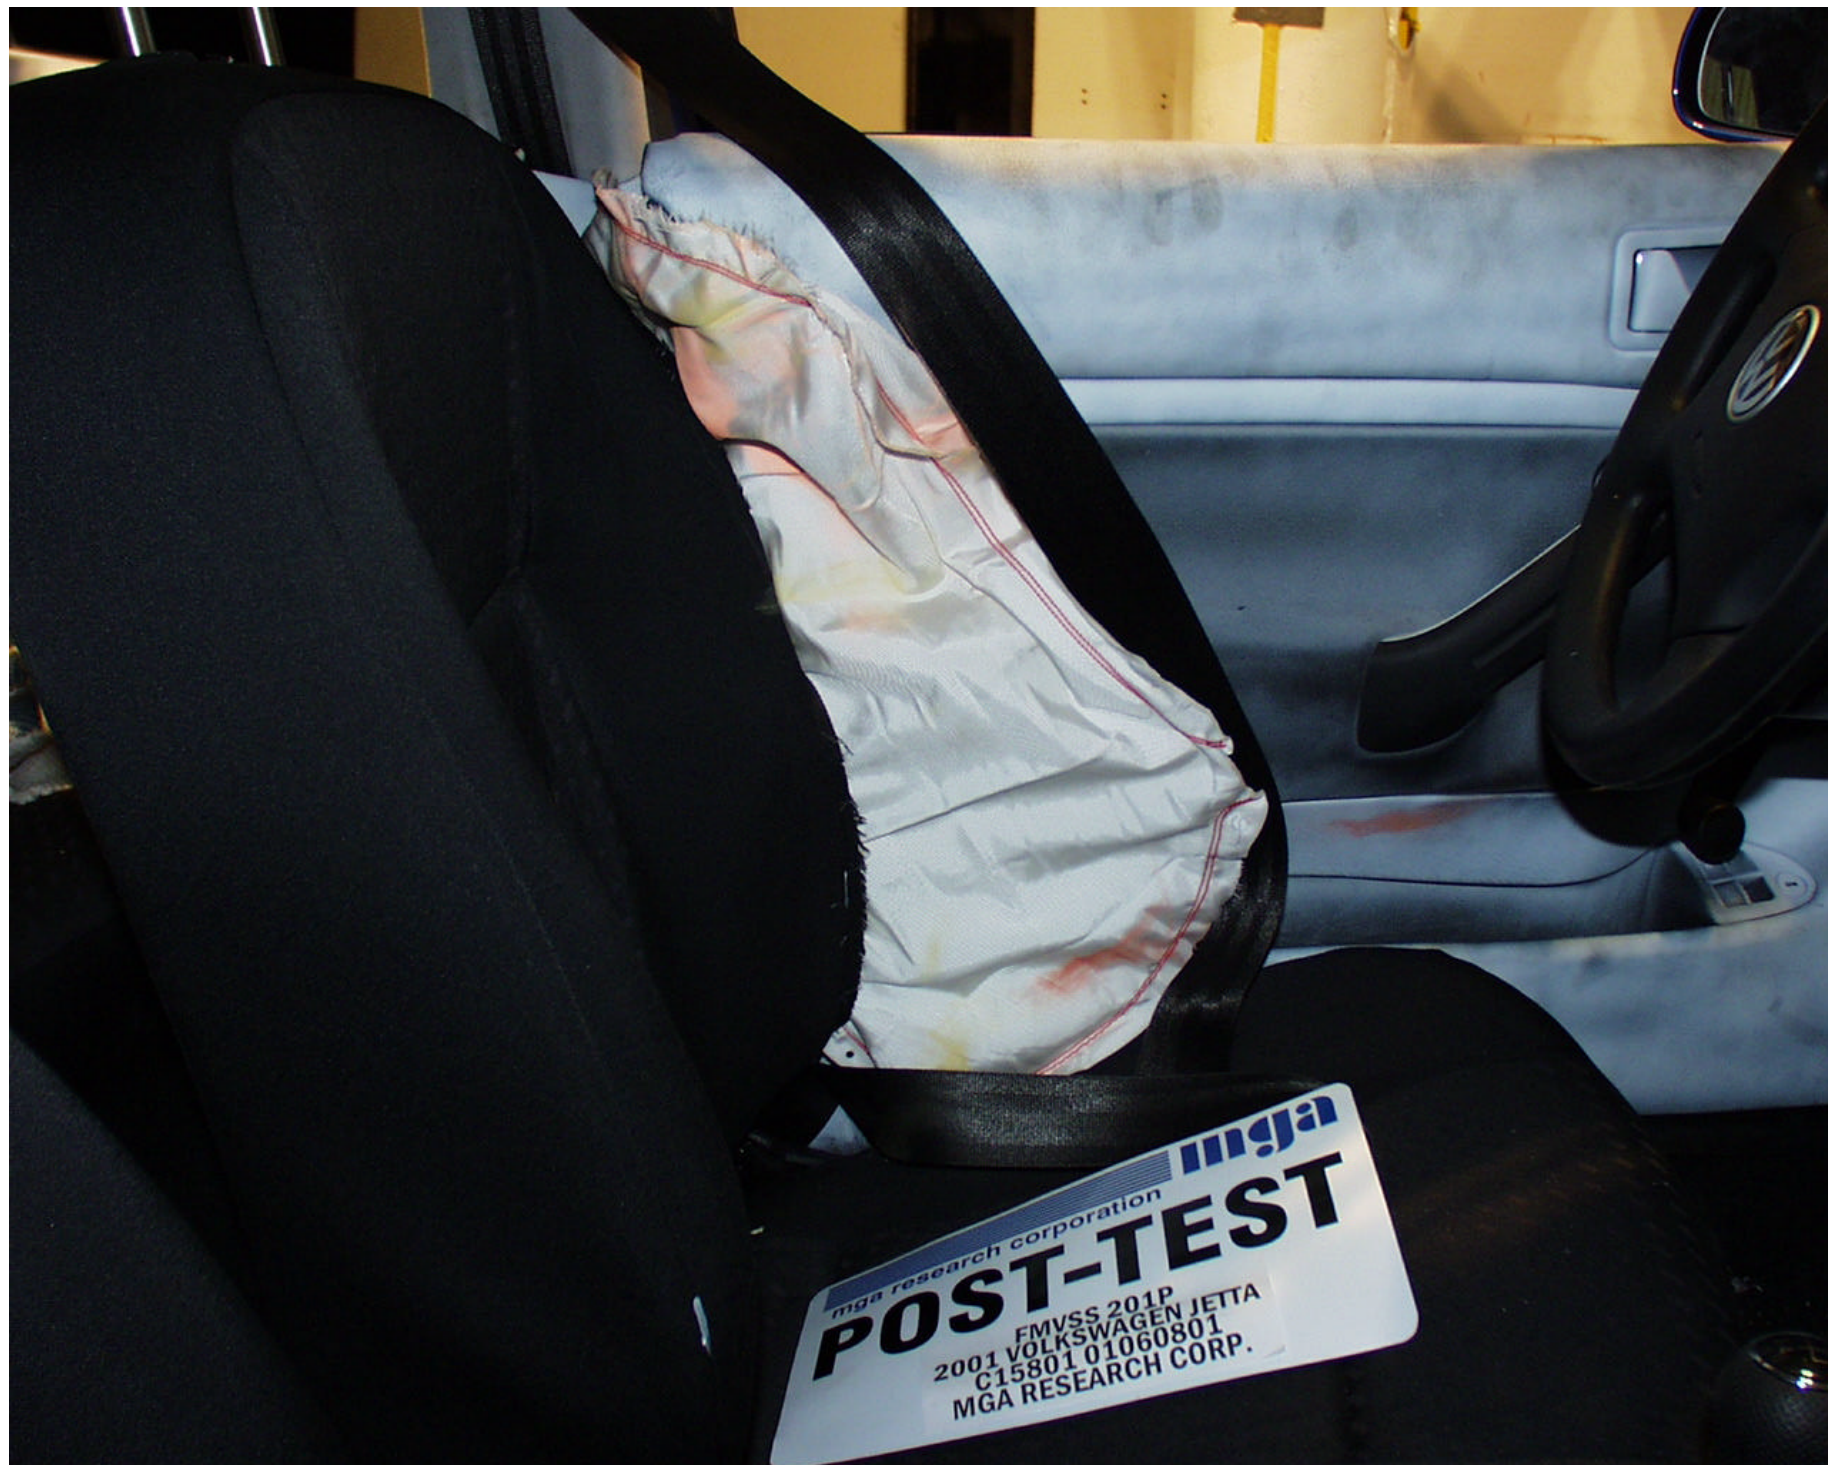
Photo No. A-24 - Post-Test Driver Dummy Thorax Contact

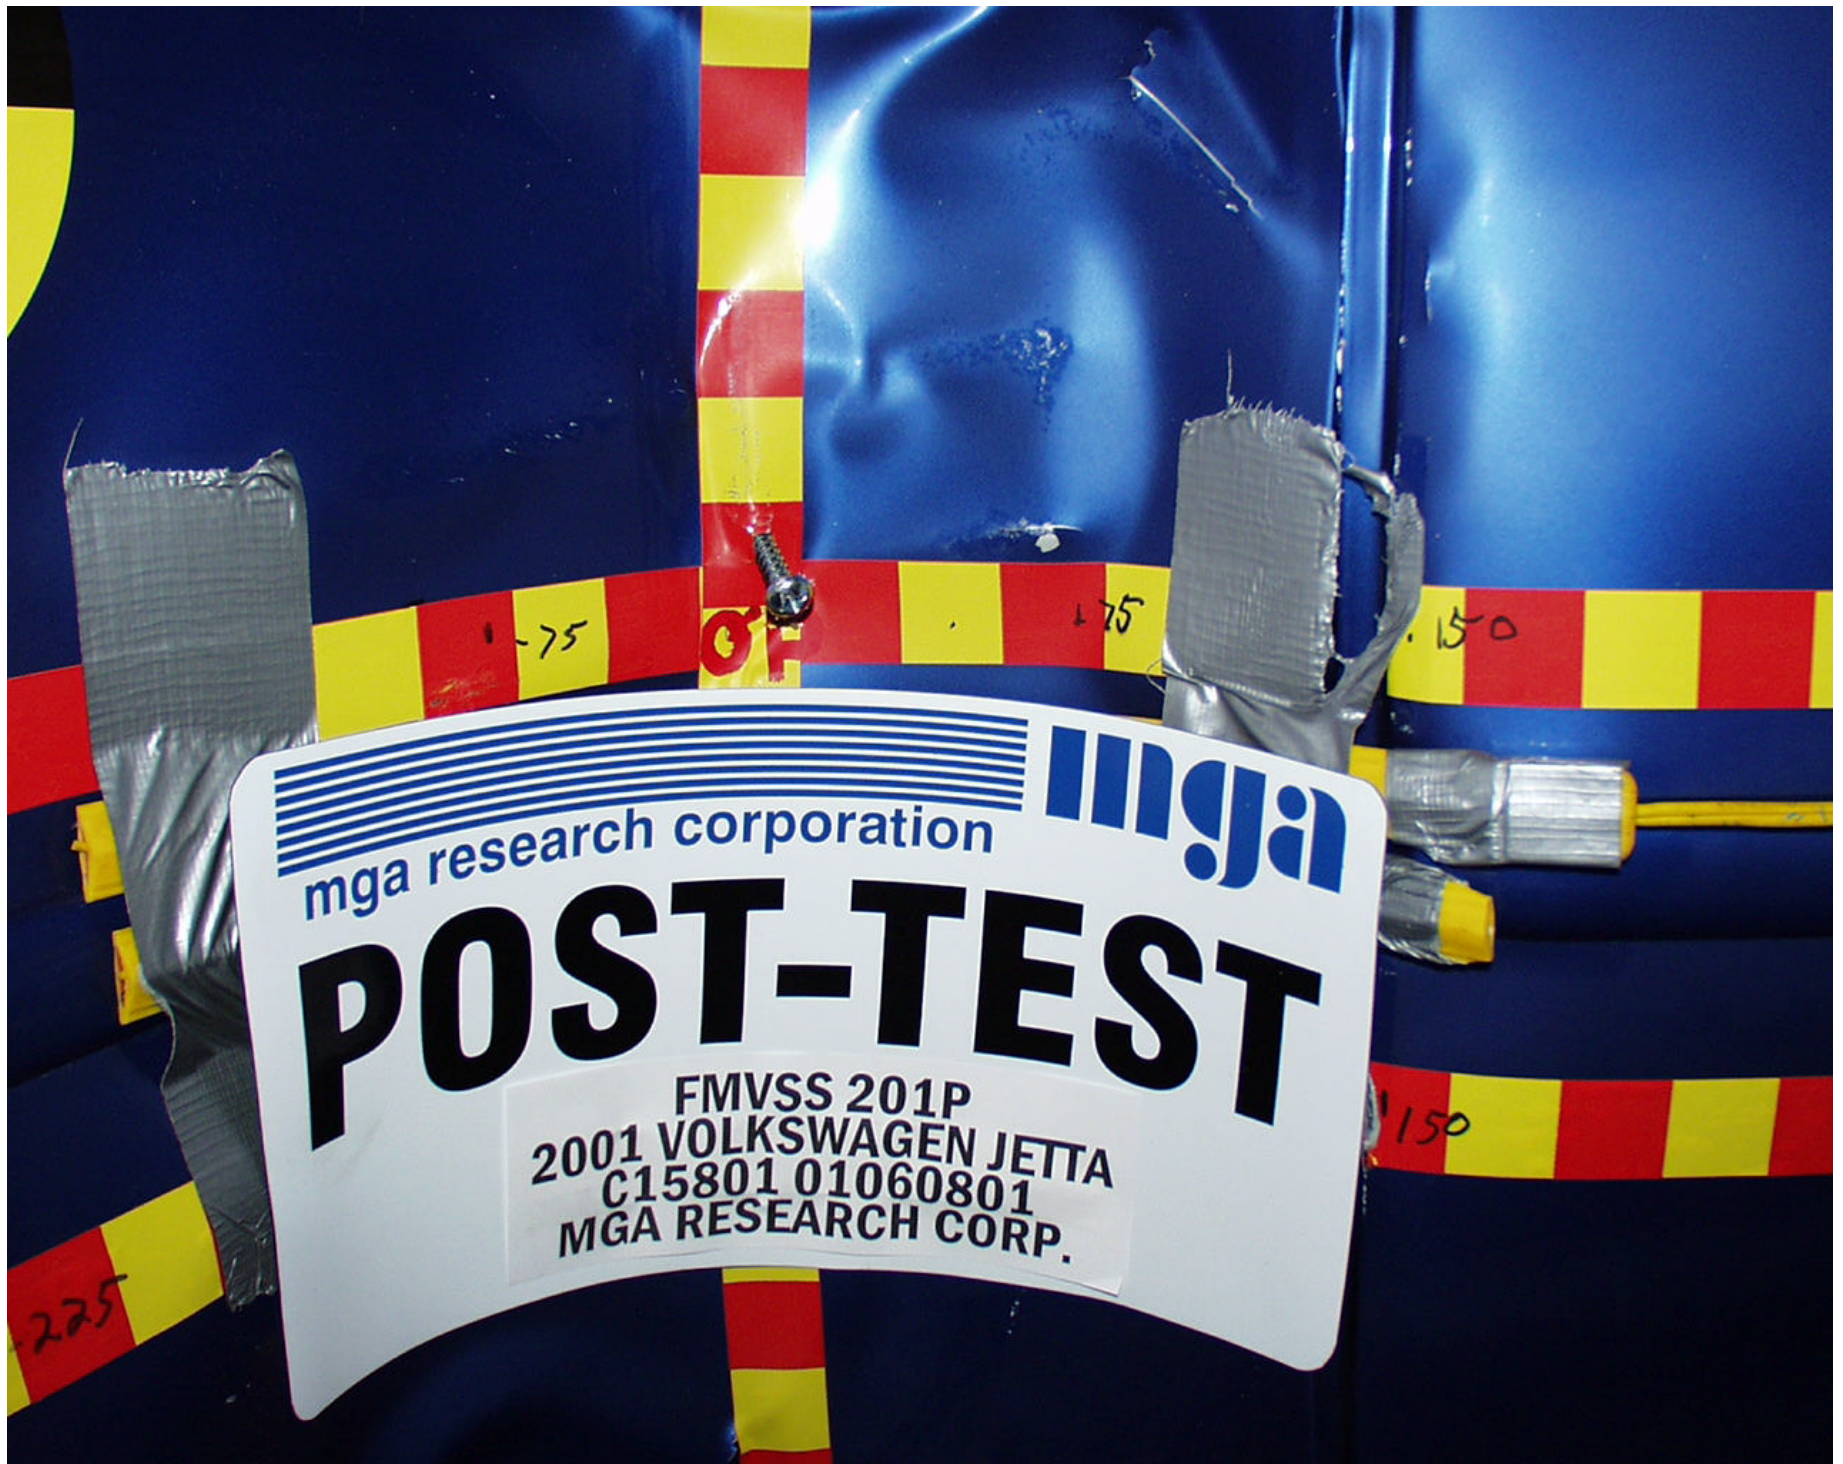
The test vehicle sustained a maximum static crush of 449 mm at level 3, at the impact point. The driver SID/HIII, Serial No. 037, was calibrated just prior to this test. The SID/HIII's injury criteria is summarized as follows:

Photo No. A-25 - Post-Test Impact Zone Side Close-up View
