**REPORT NUMBER: 201-MGA-2001-004**

**SAFETY COMPLIANCE TESTING FOR FMVSS 201  
RIGID POLE SIDE IMPACT TEST**

**DaimlerChrysler AG  
2001 Mercedes C240 4 Door  
NHTSA NUMBER: C10518**

**FINAL REPORT**

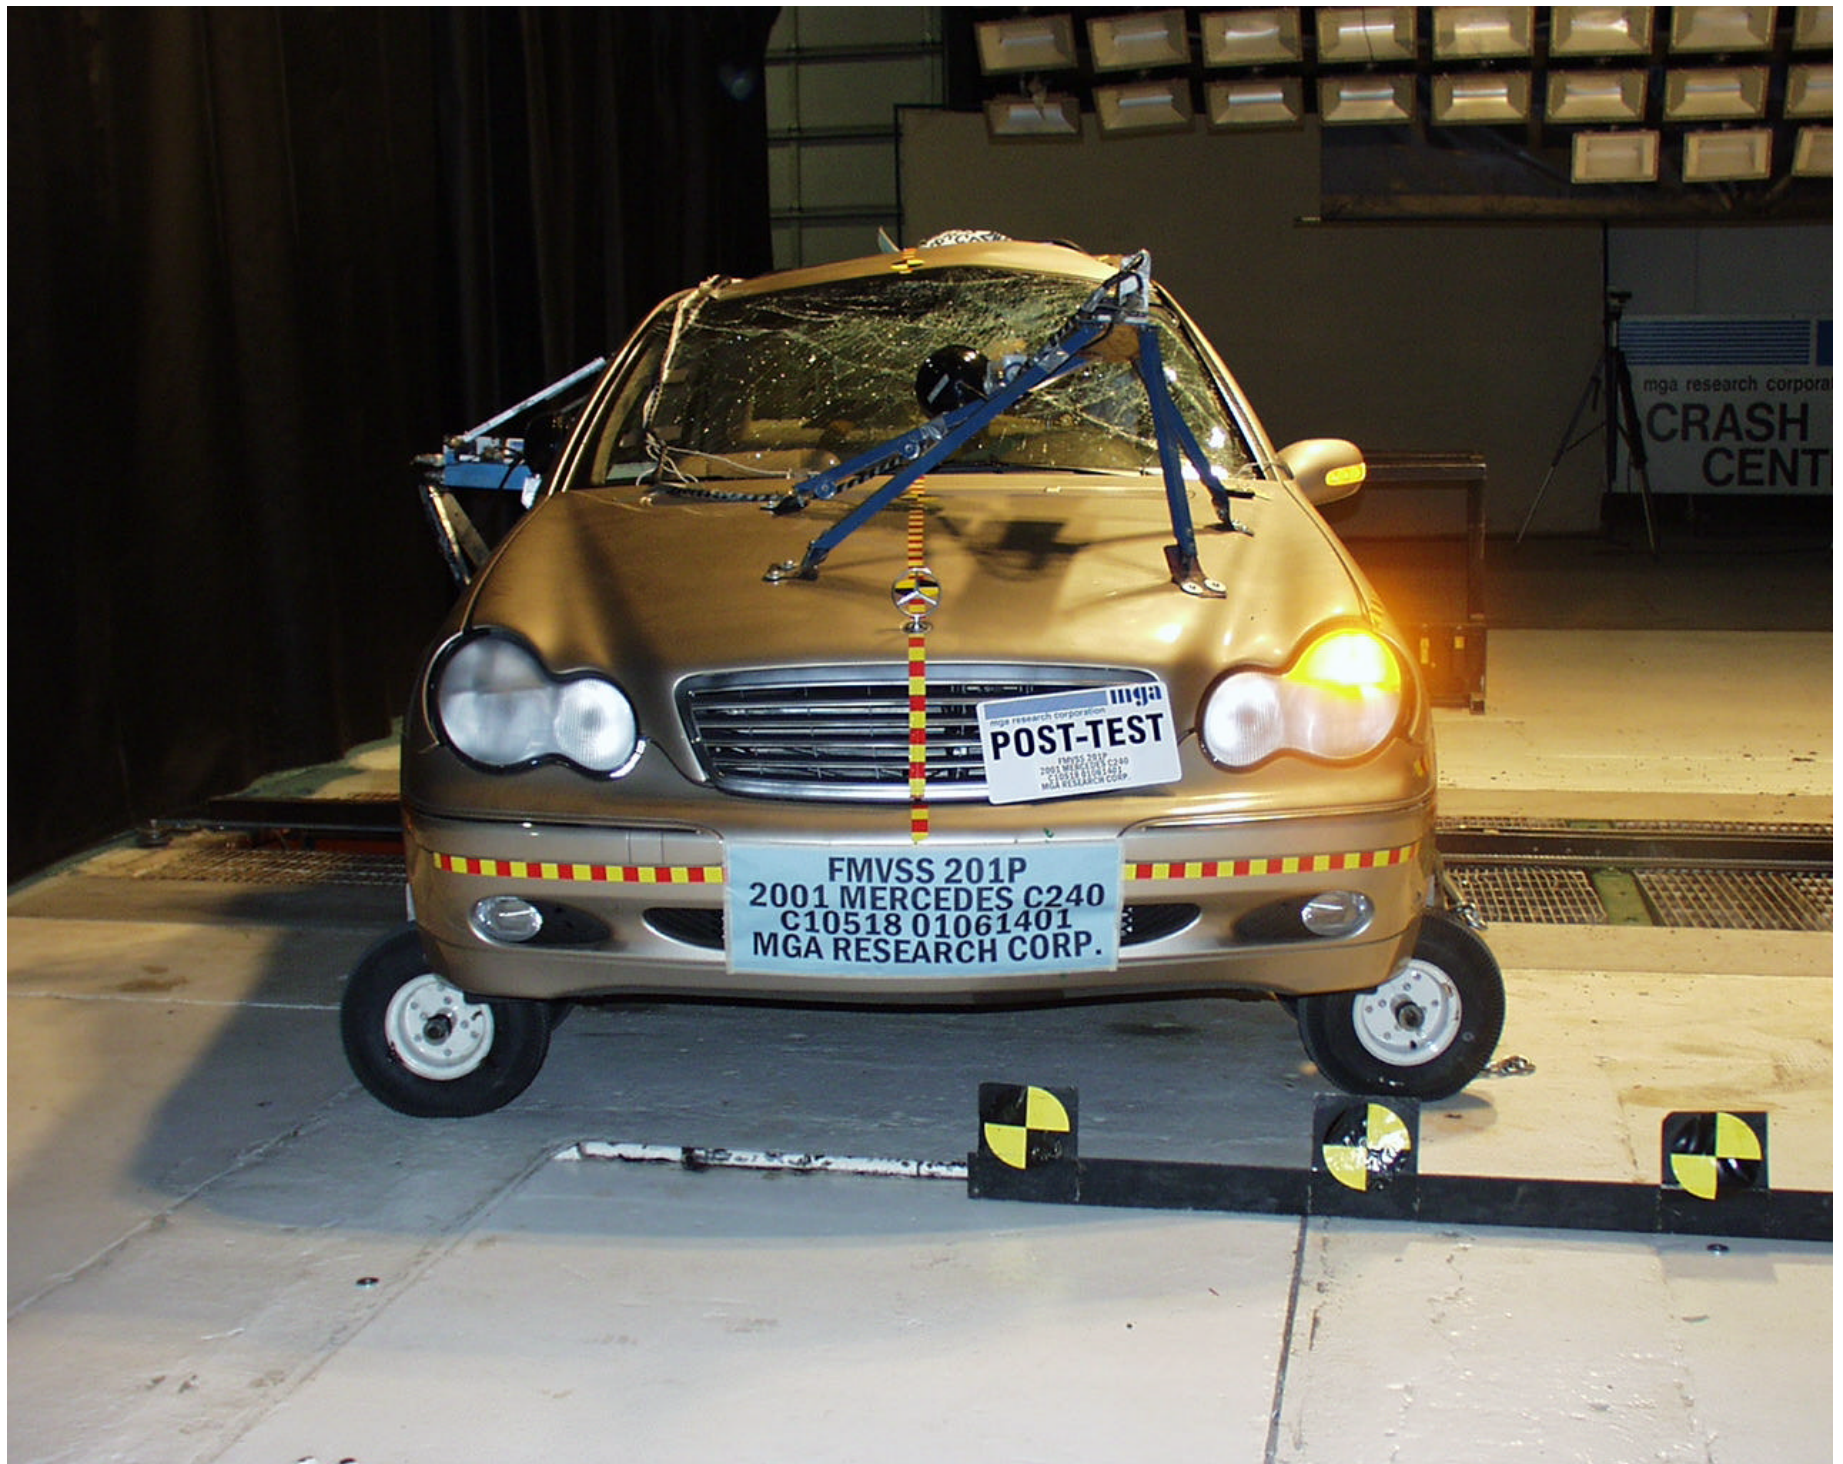
Photo No. A-2 - Post-Test Front View of Test Vehicle

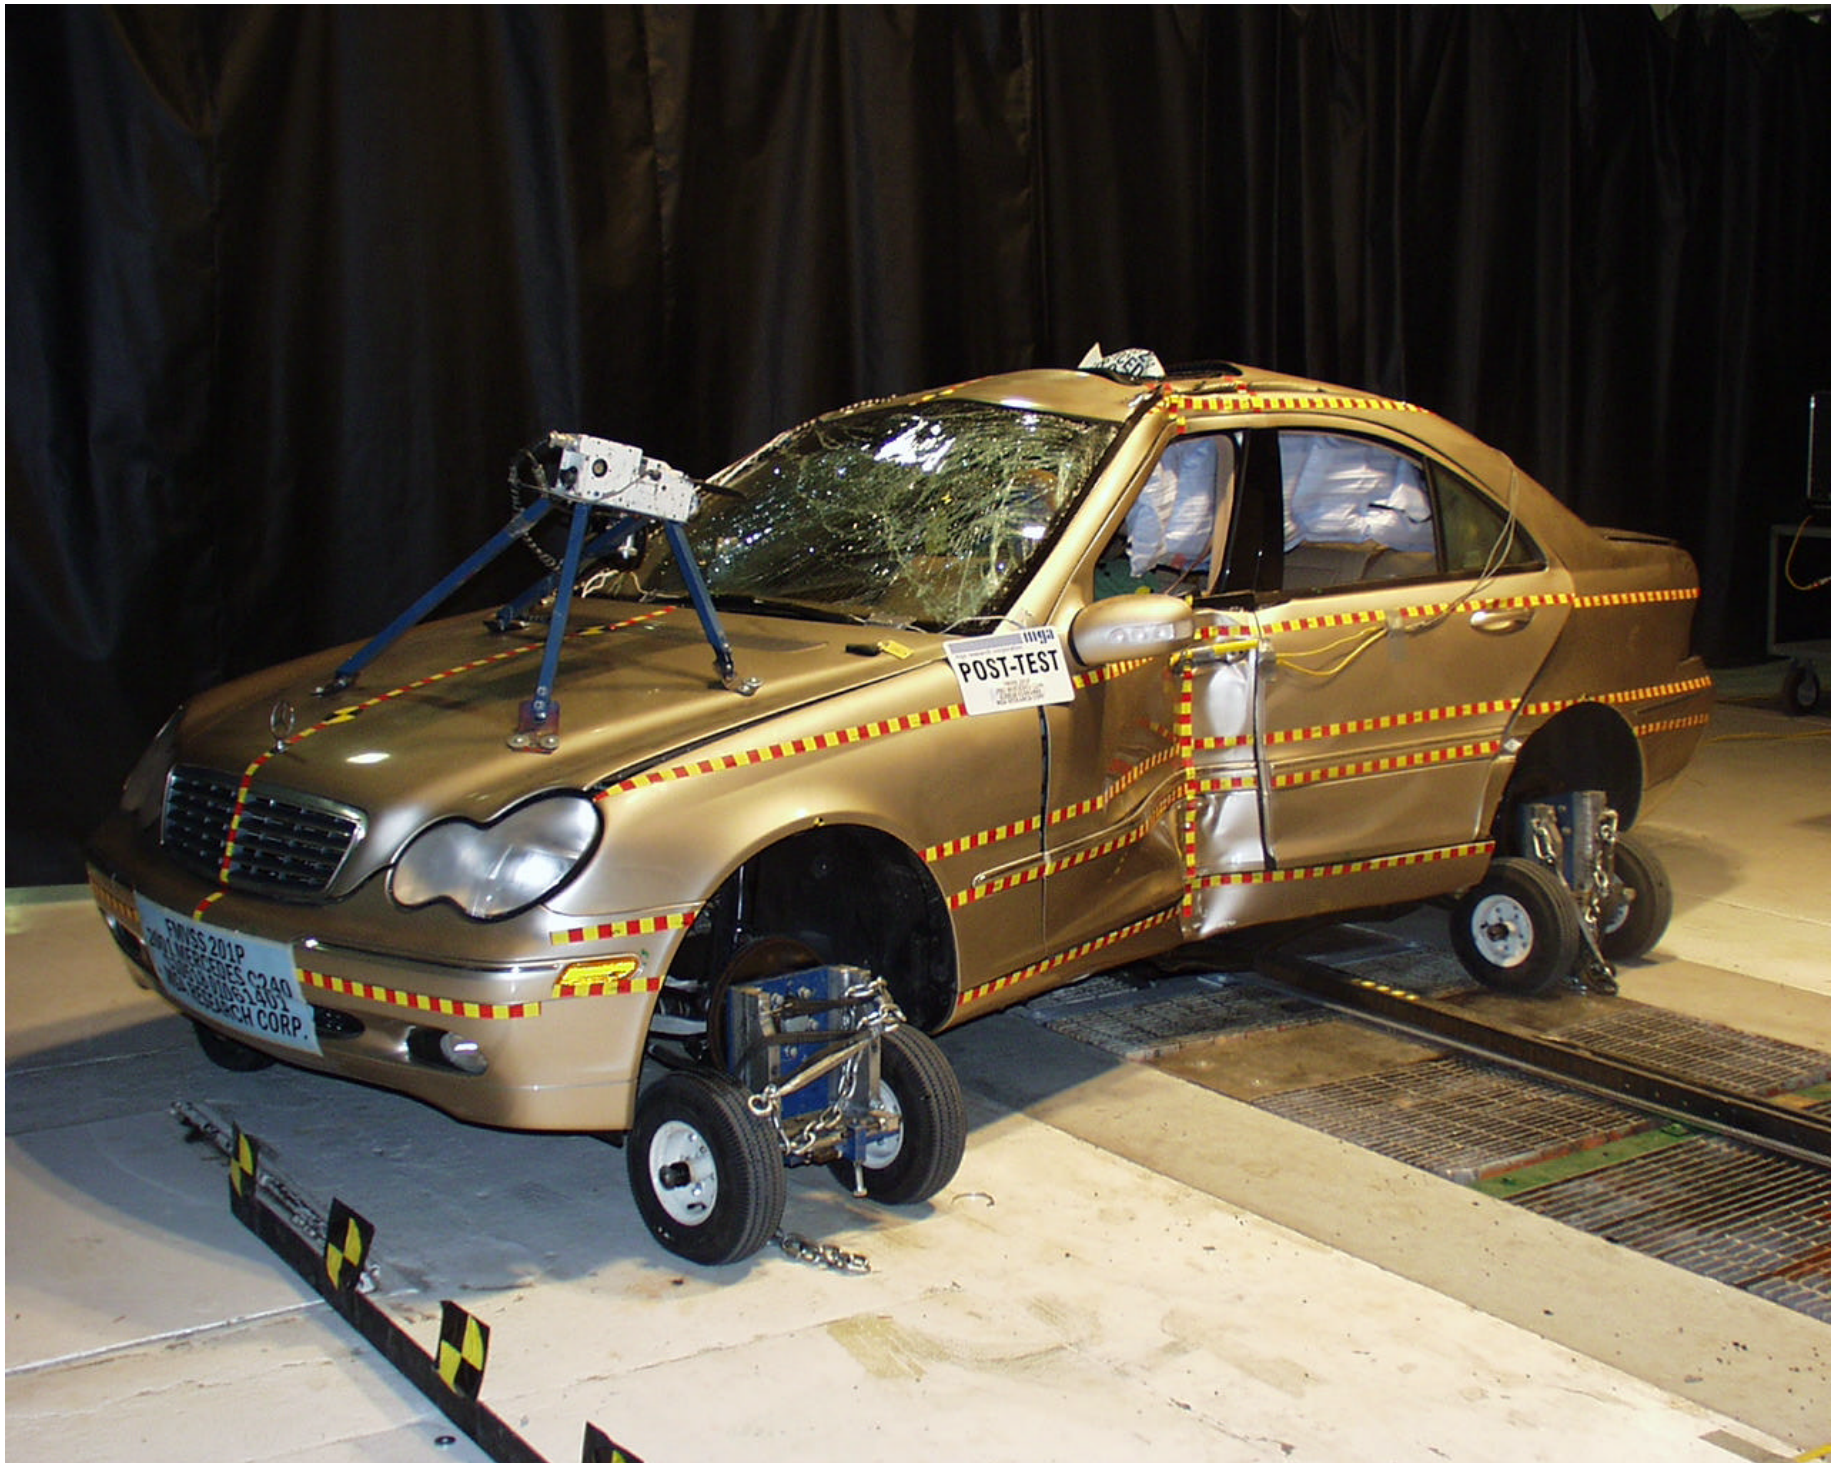
Photo No. A-8 - Post-Test Left Front View of Test Vehicle

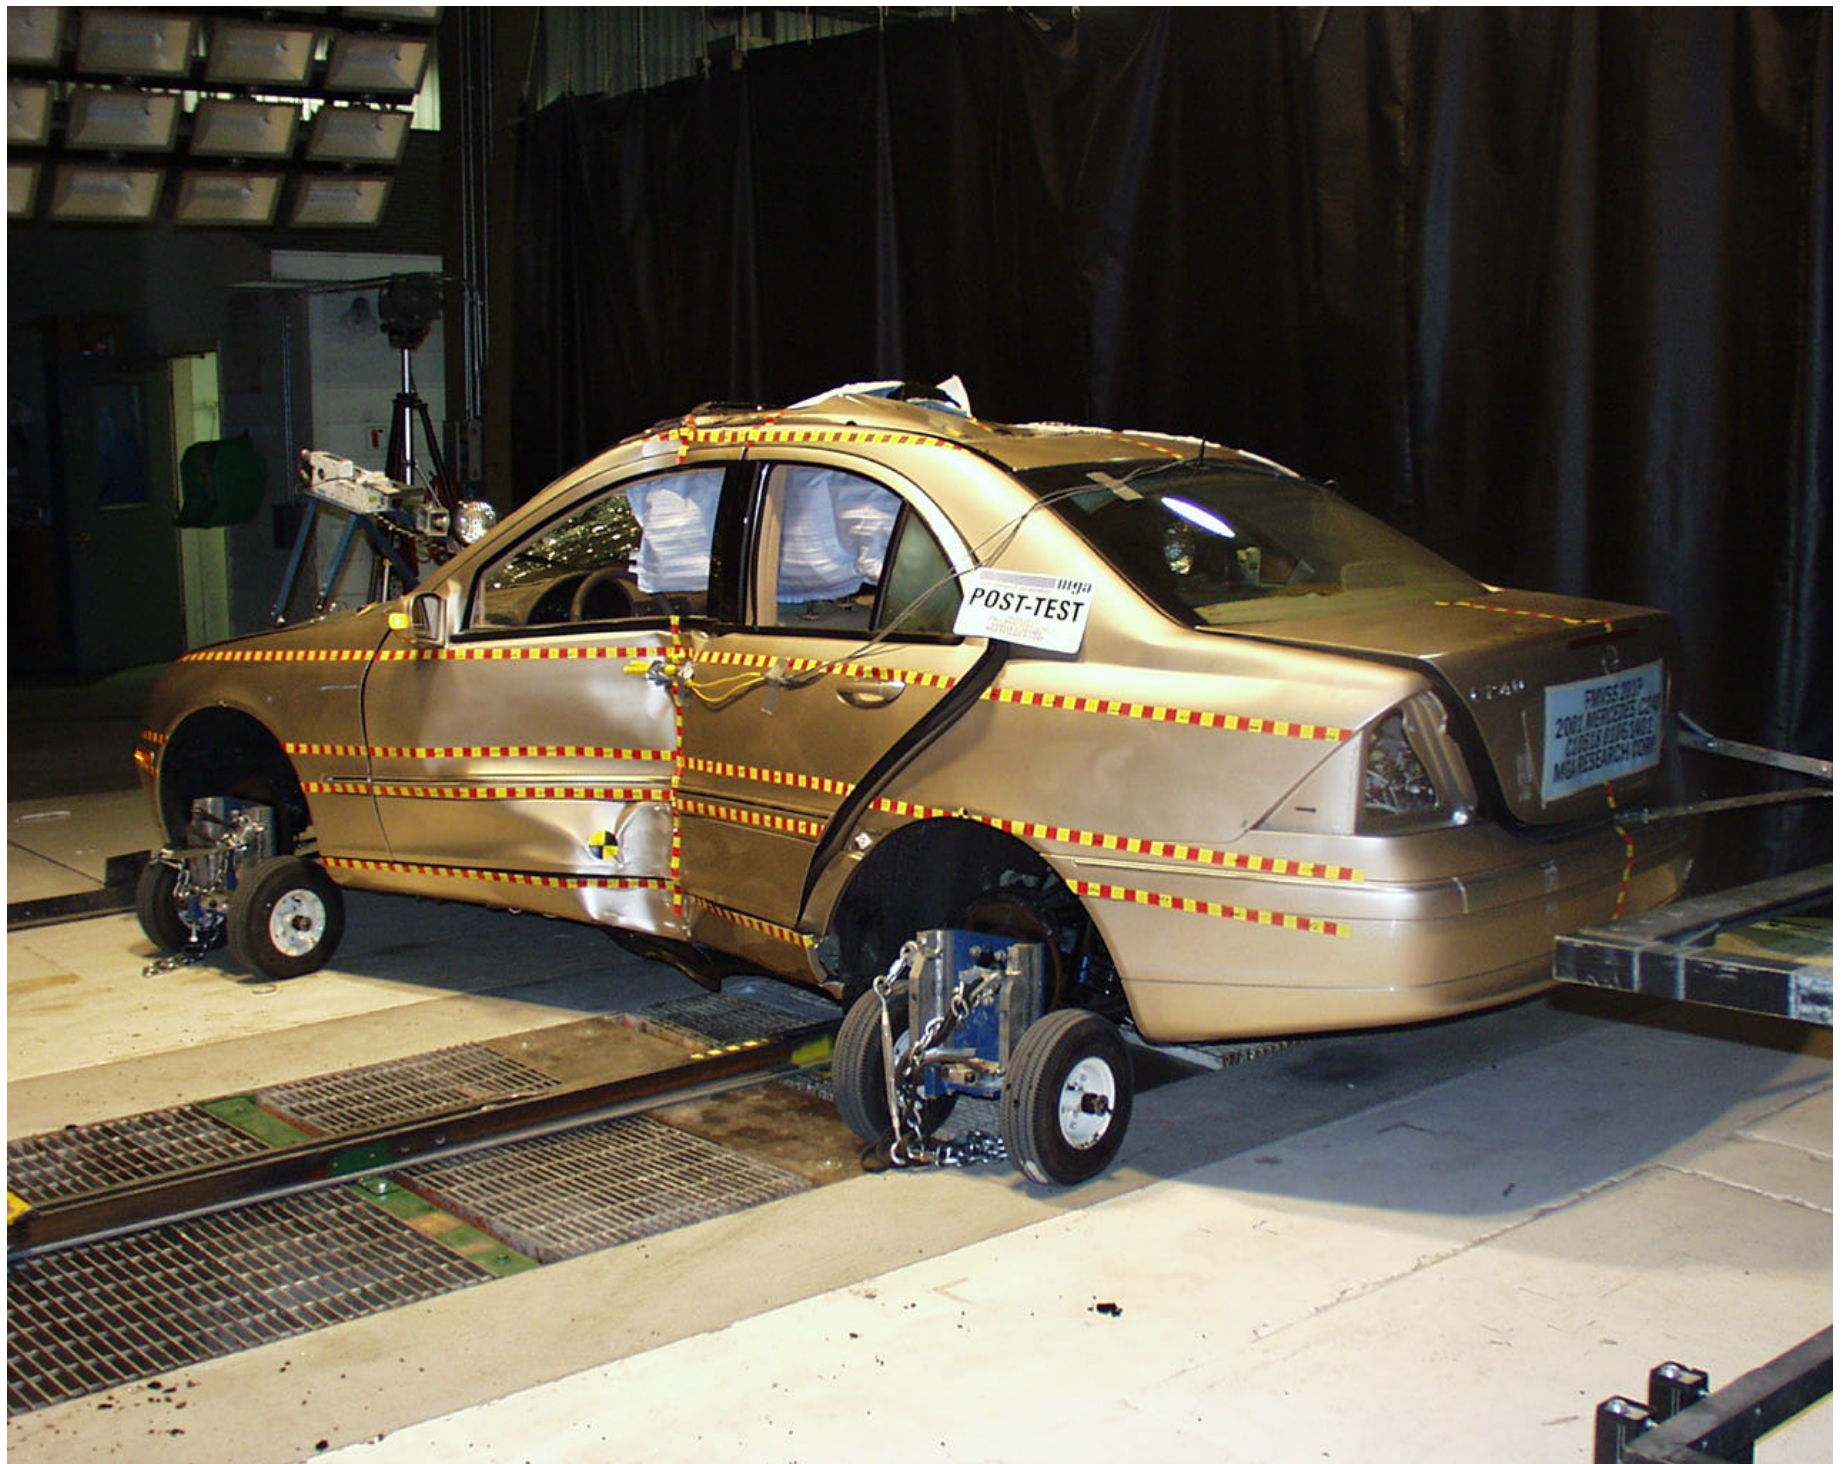
A-9

Photo No. A-10 - Post-Test Left Rear View of Test Vehicle

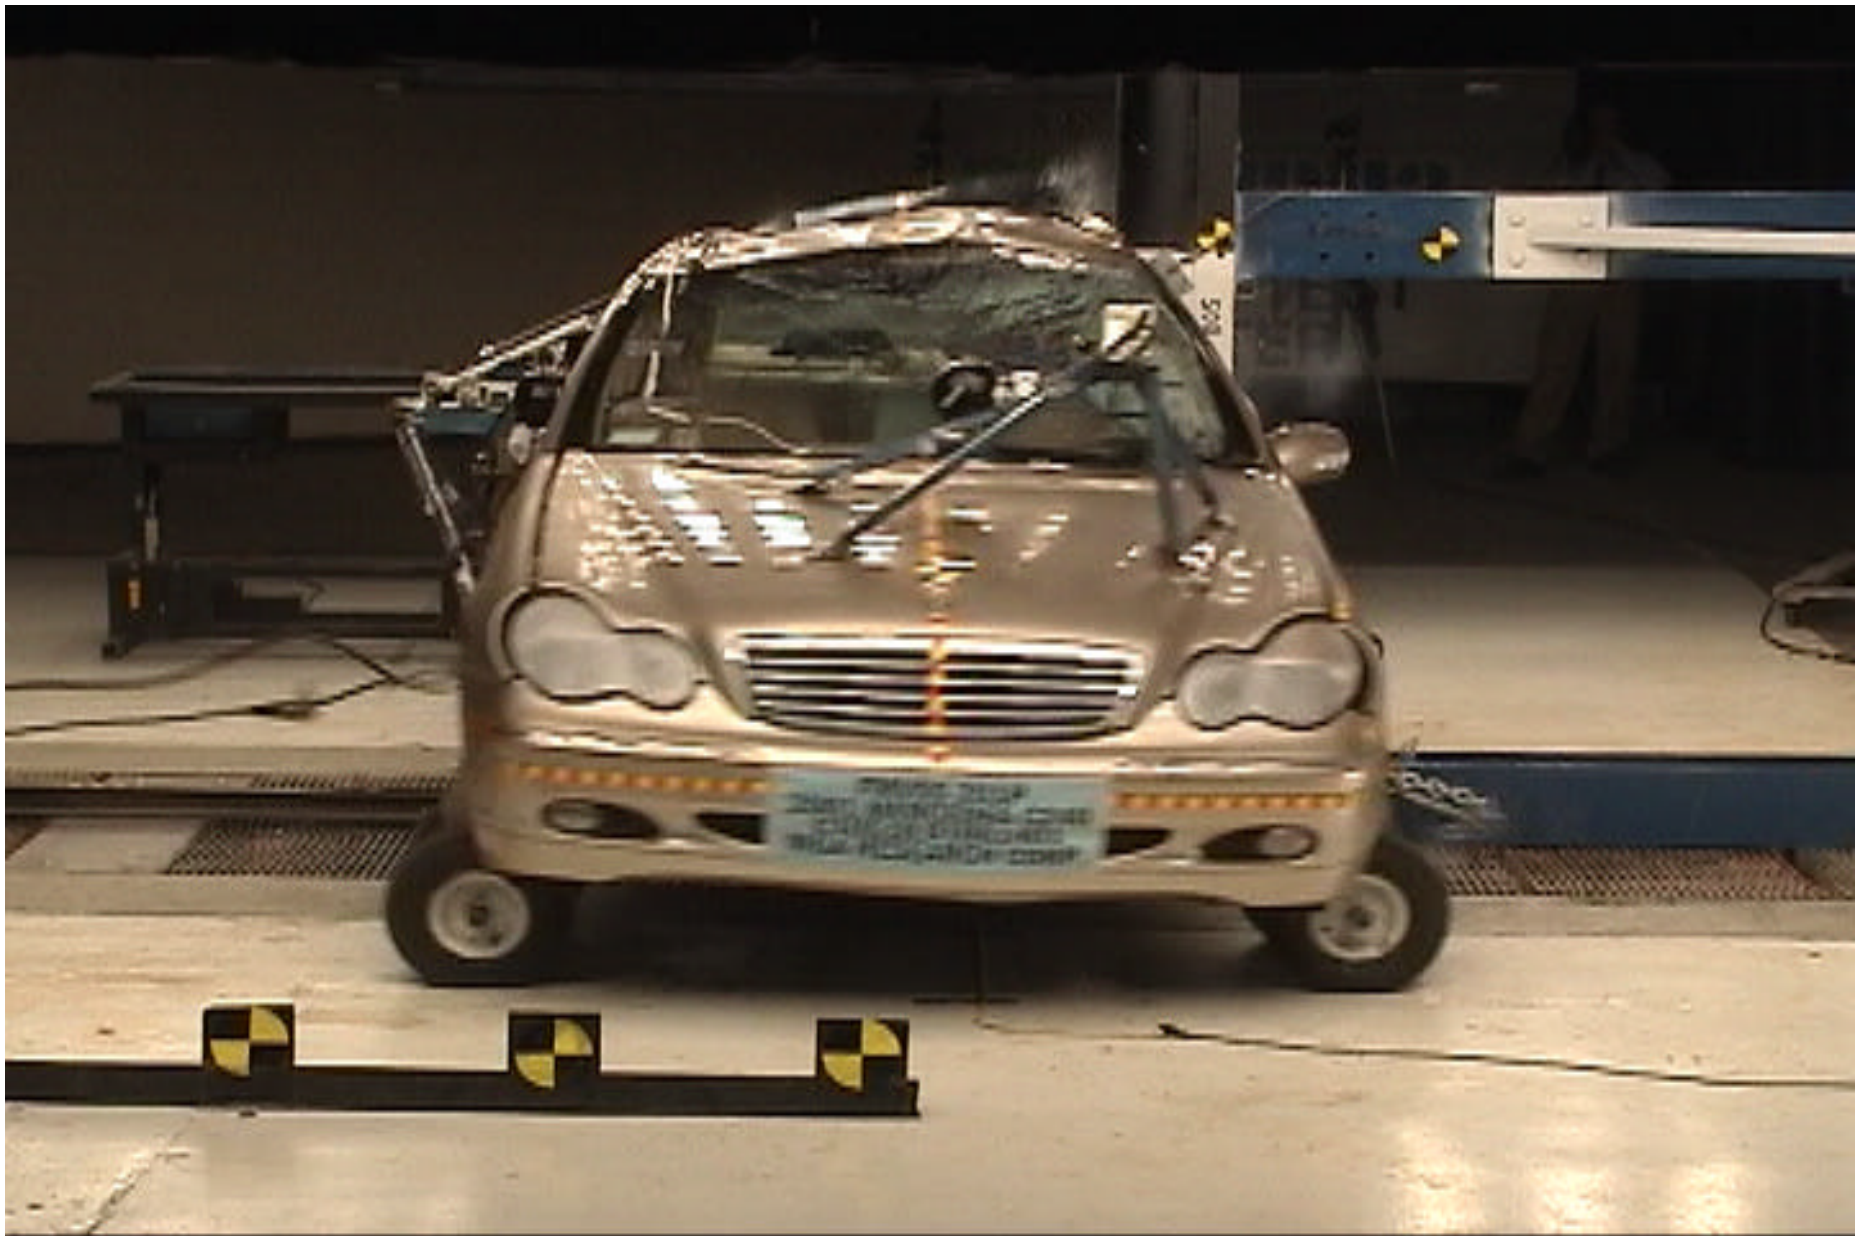
Photo No. A-21 – Impact

A rigid pole side impact test was performed on a model year 2001 Mercedes C240 4 Door. The subject vehicle was towed into a rigid pole at a velocity of 28.3 km/h. The specified impact velocity range is from 27.2 to 28.8 km/h. The test vehicle was positioned 90° to the line of forward motion. The weight of the vehicle as tested was 1679 kg. The test was conducted at MGA Research Corporation in Burlington, Wisconsin, on June 14, 2001.

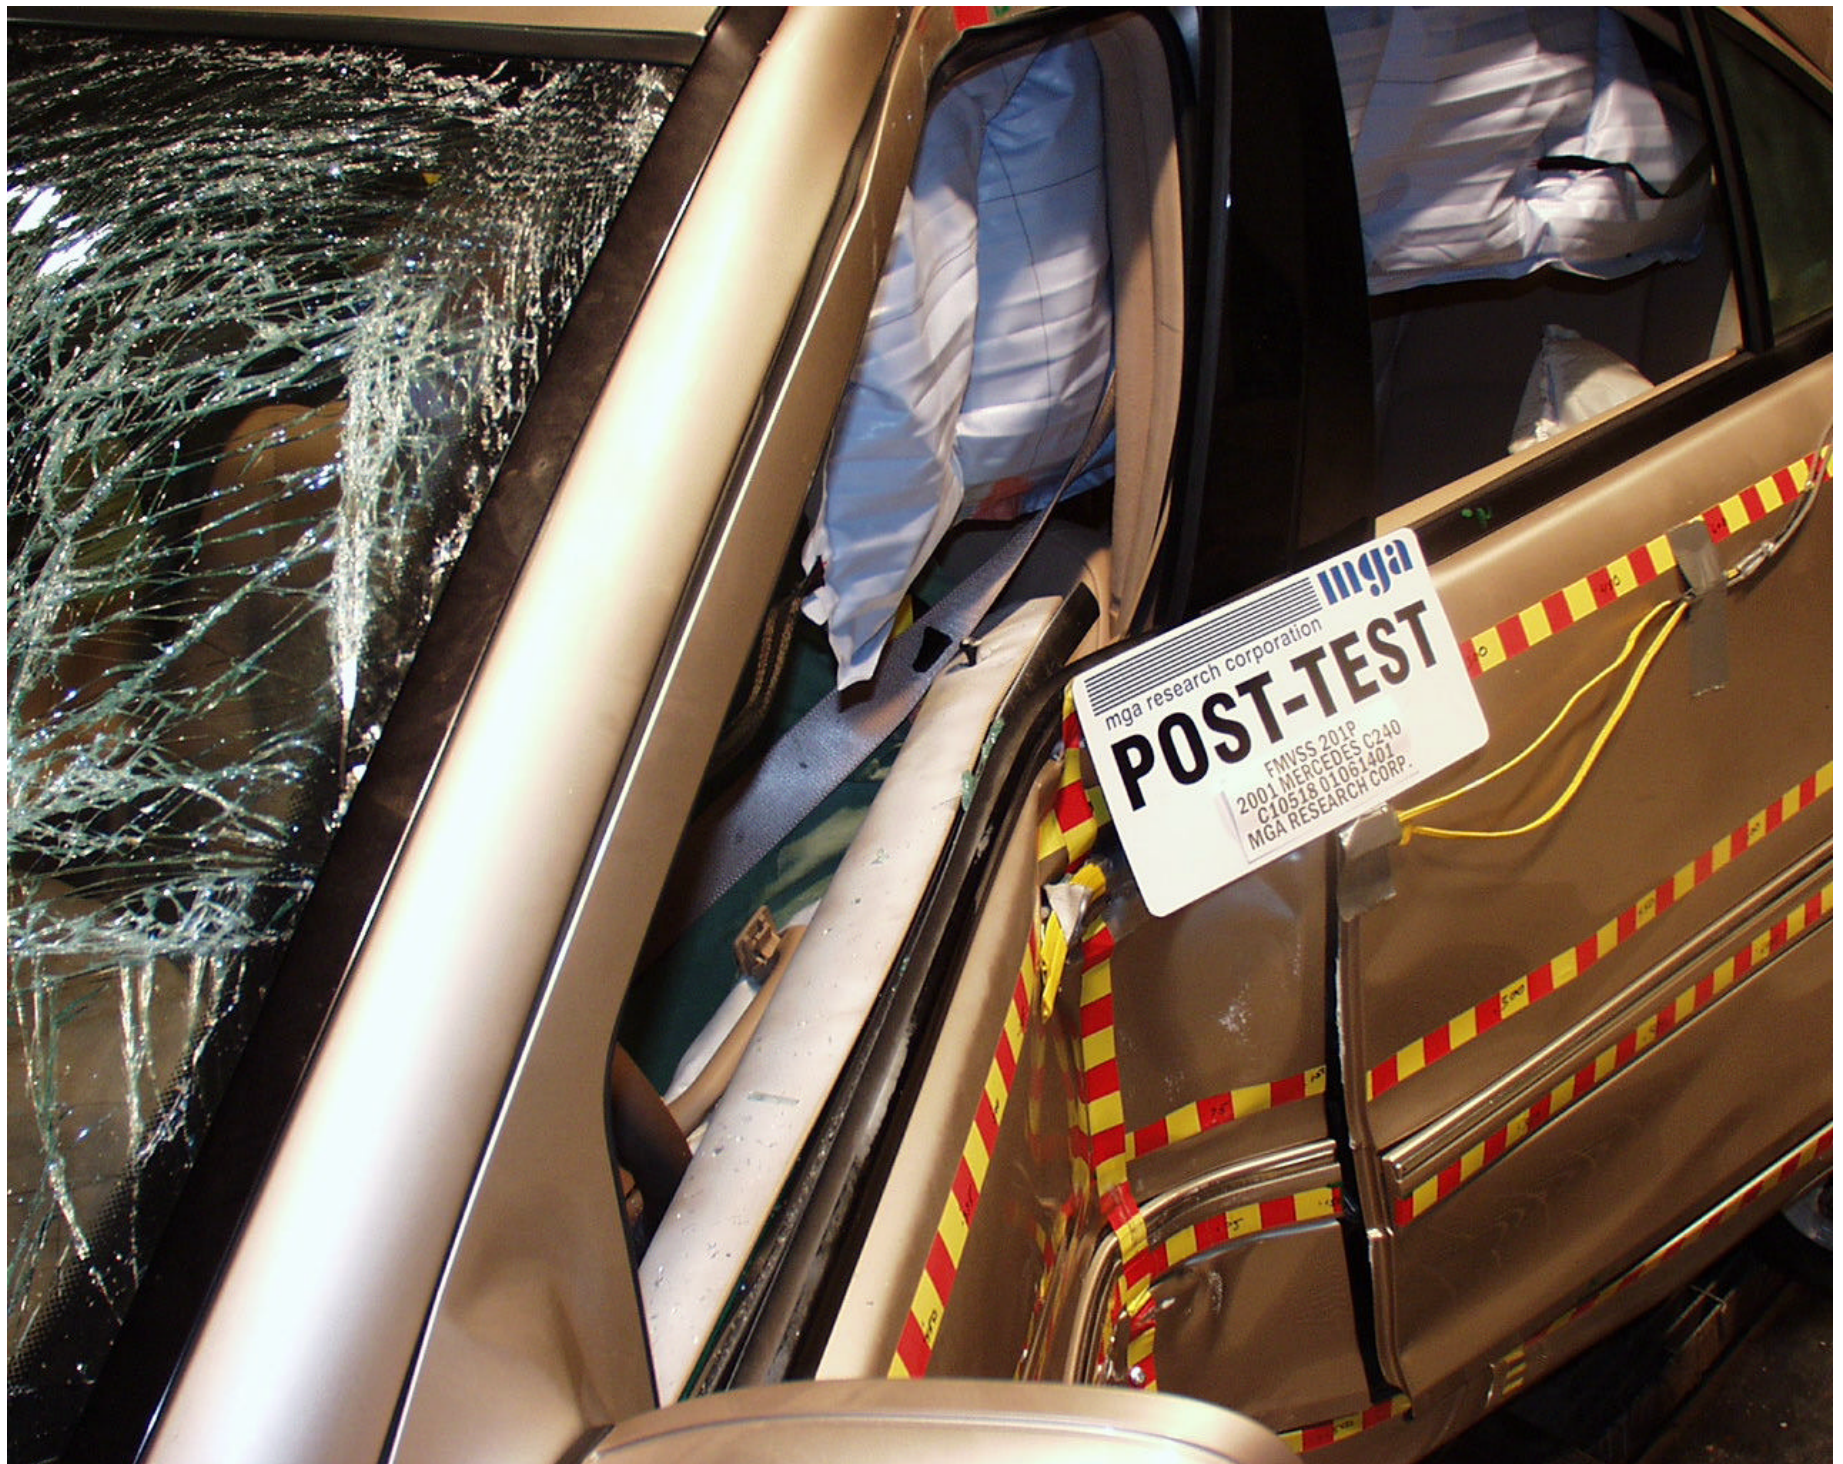
Photo No. A-23 - Post-Test Driver Shoulder and Door Top View

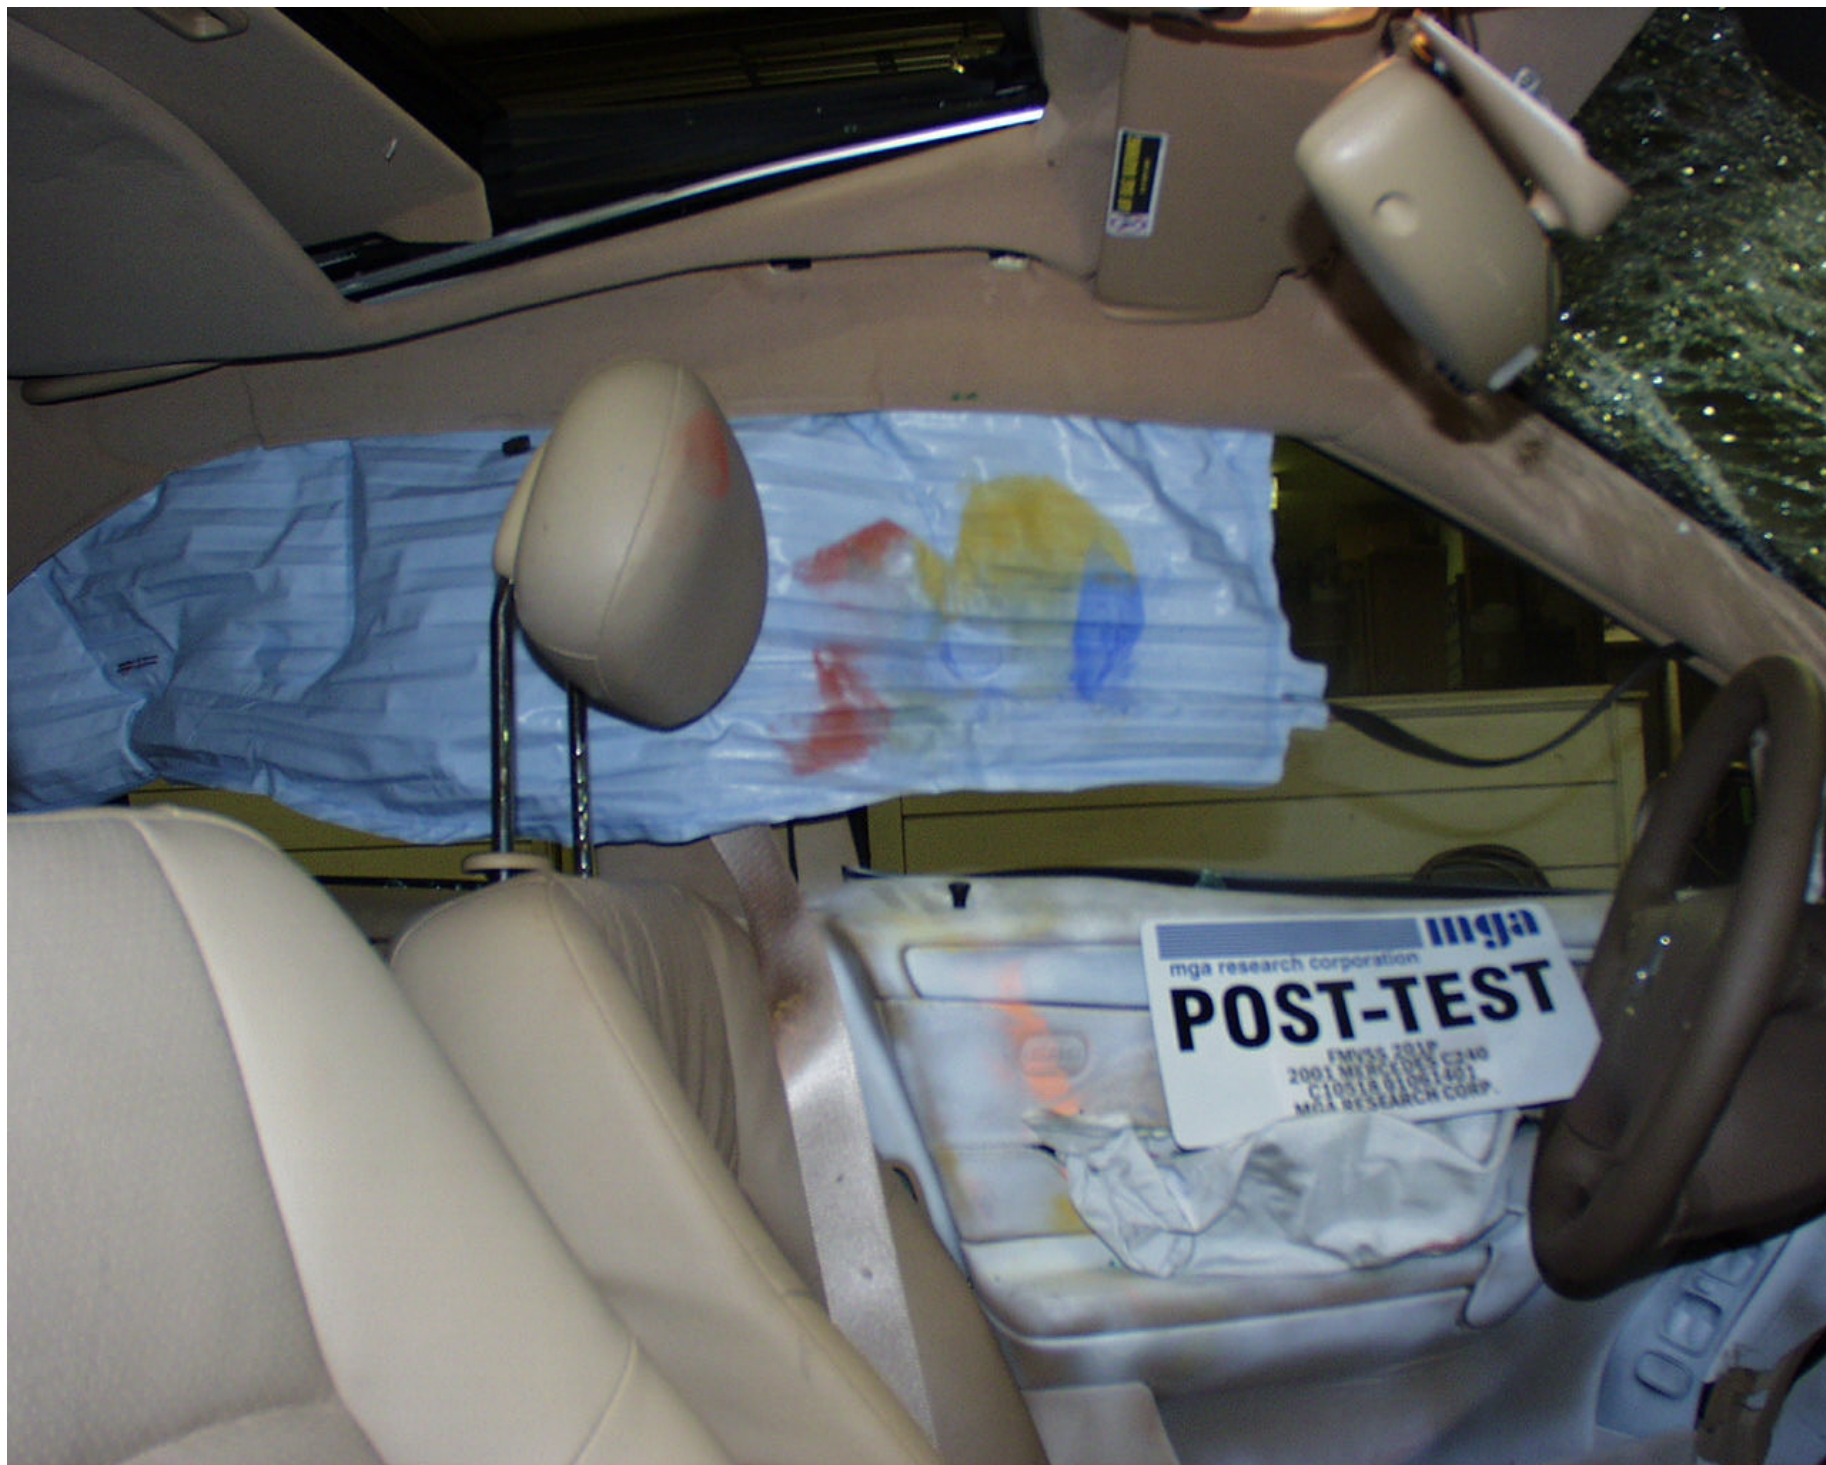
Photo No. A-24 - Post-Test Driver Dummy Head Contact

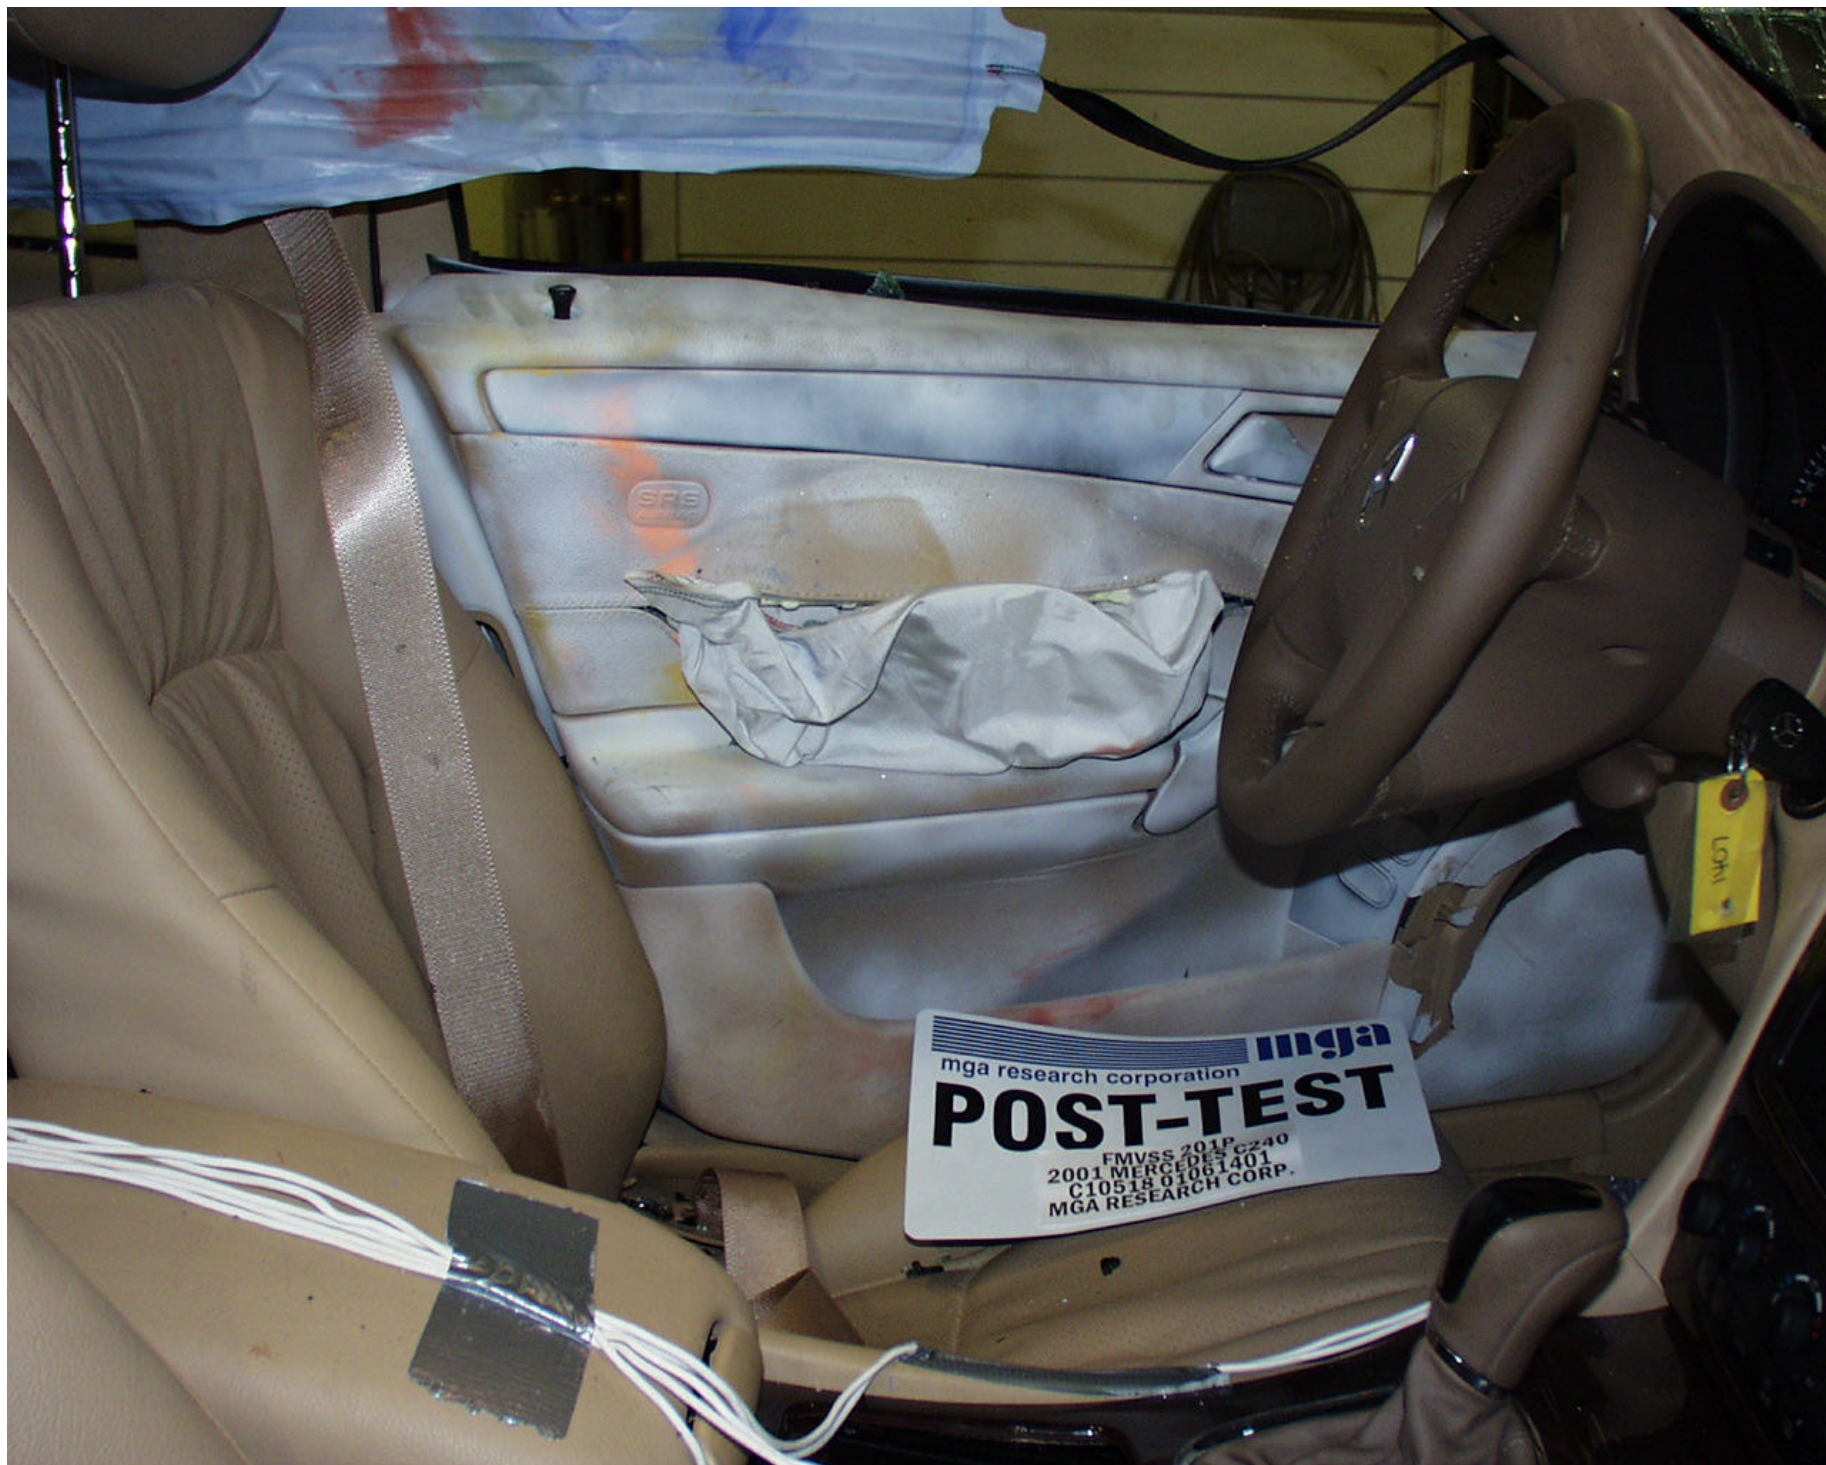
Photo No. A-25 - Post-Test Driver Dummy Thorax Contact

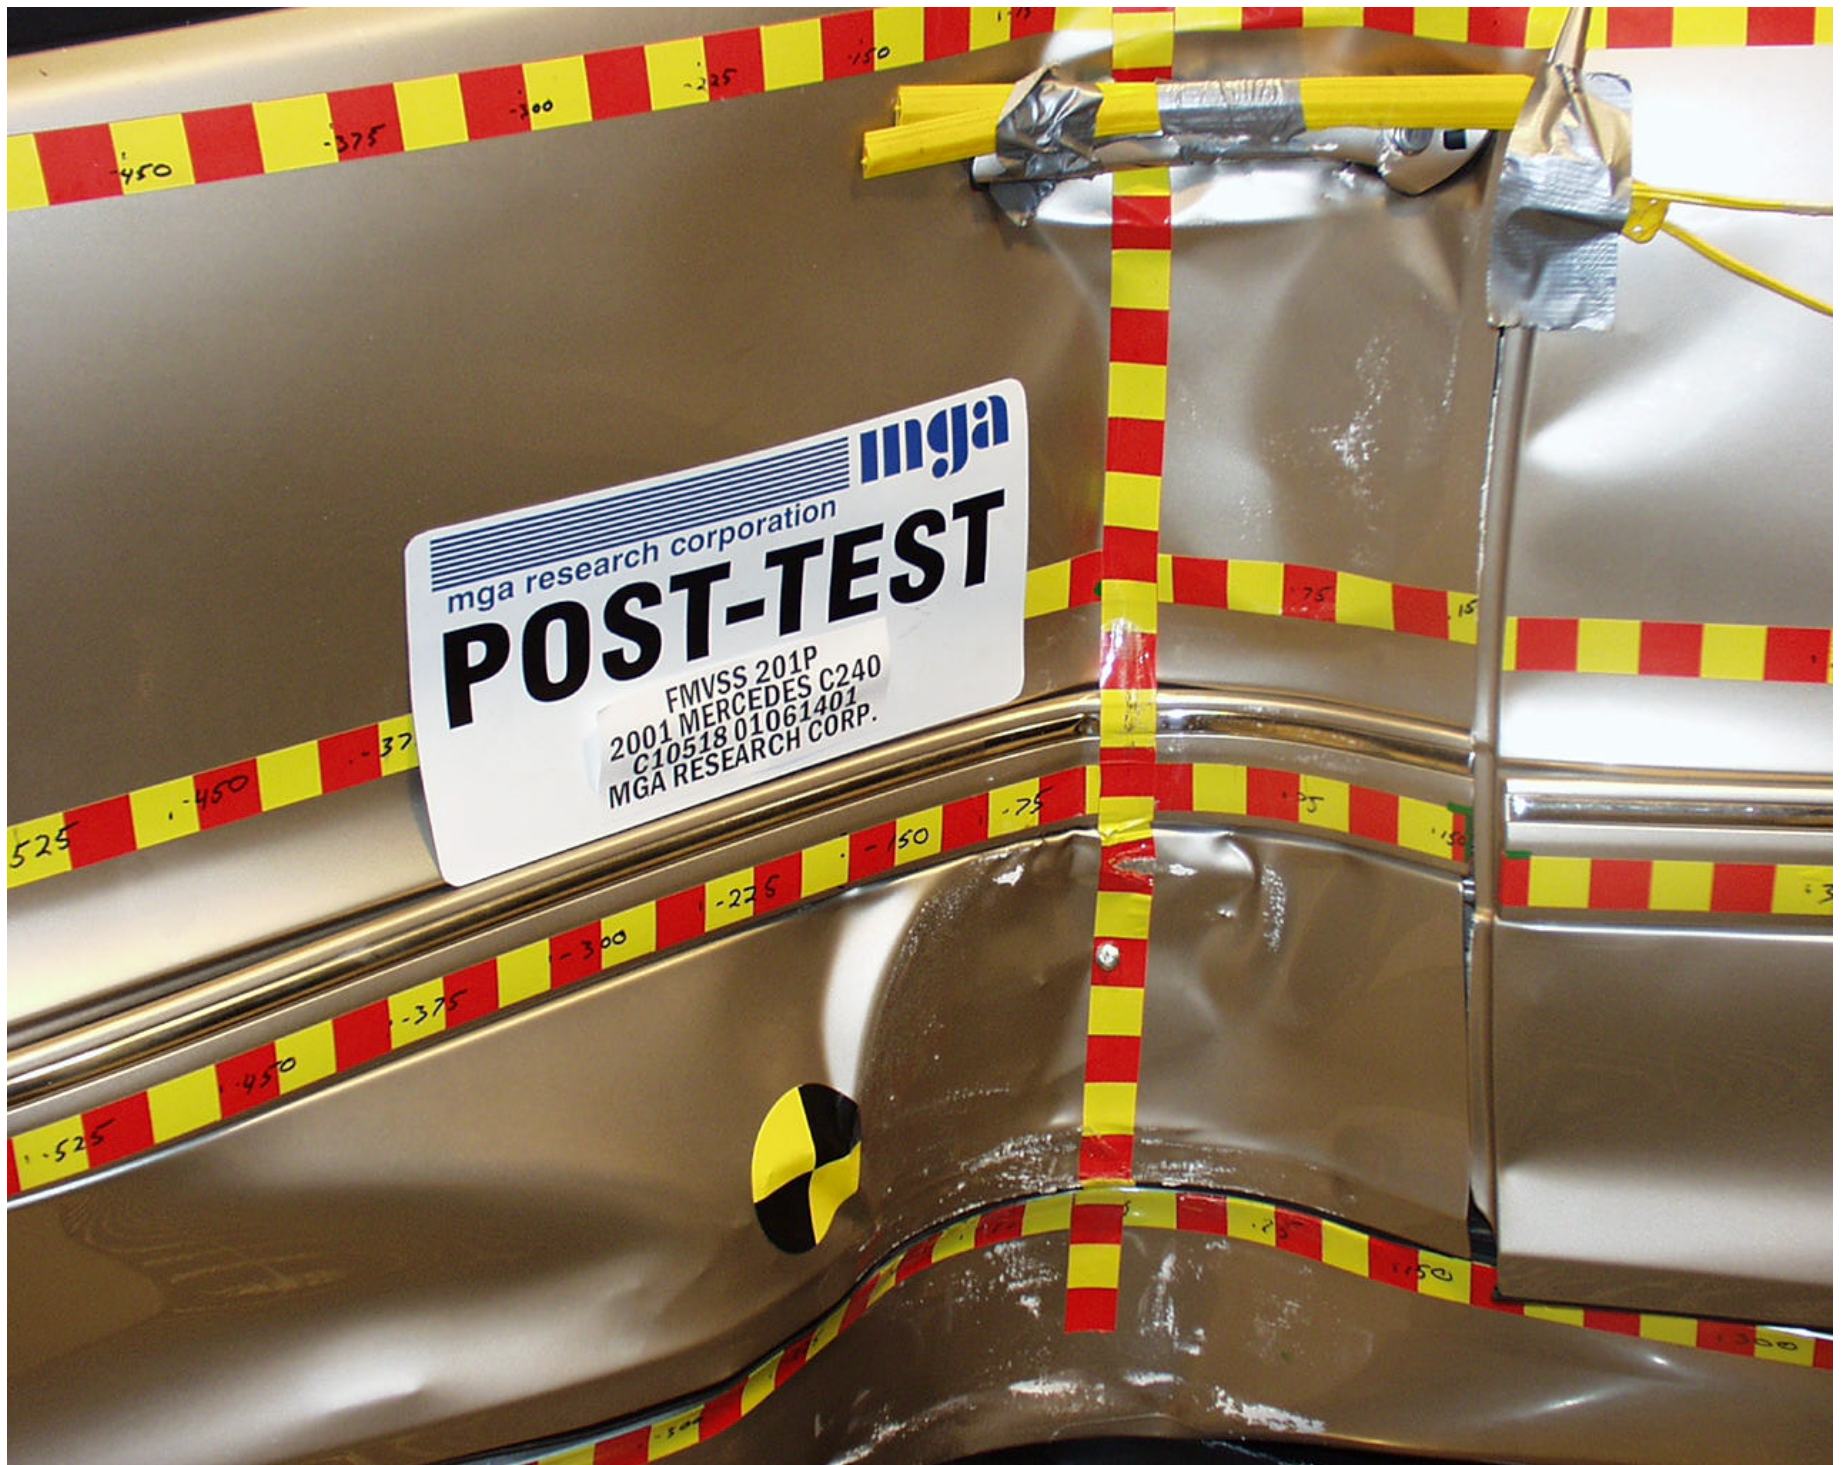
Photo No. A-26 - Post-Test Impact Zone Side Close-up View

The test vehicle sustained a maximum static crush of 382 mm at level 3, at the vertical impact line. The driver SID/HIII, Serial No. 037, was calibrated just prior to this test. The SID/HIII's injury criteria is summarized as follows:
