REPORT NUMBER: 301-CAL-01-03
SAFETY COMPLIANCE TESTING FOR FMVSS 301
FUEL SYSTEM INTEGRITY

GENERAL MOTORS DE MEXICO
2001 PONTIAC
AZTEK MPV

NHTSA NUMBER: C10105

VERIDIAN TEST NUMBER: 8606-3

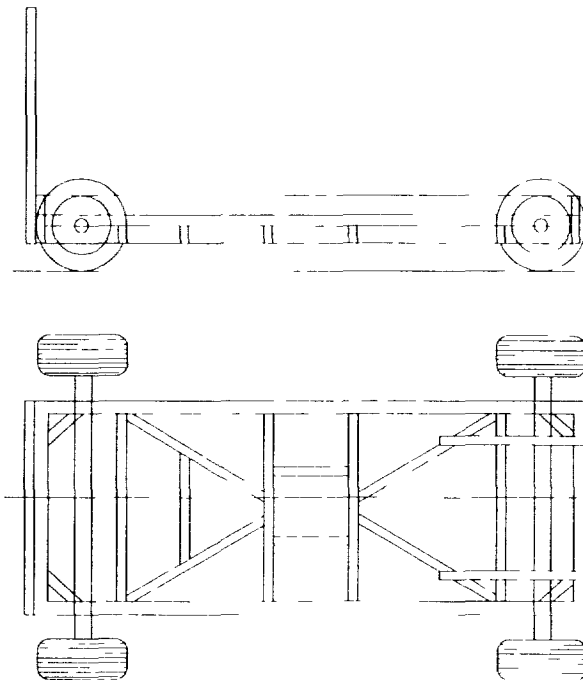
MOVING BARRIER DIMENSIONS

Barrier Face Height	<u>60 0</u>	in
Barrier Face Width	<u>78 0</u>	in
Barrier Face		
Ground Clearance	<u>5 0</u>	in
Tread Width	<u>59 5</u>	in
Wheel Base	<u>120 0</u>	in
Location of C G	X	<u>52 9</u> inches rearward of front wheel center
	Y	<u>0 0</u> inches from longitudinal vertical plane of symmetry
	Z	<u>16 3</u> inches above ground

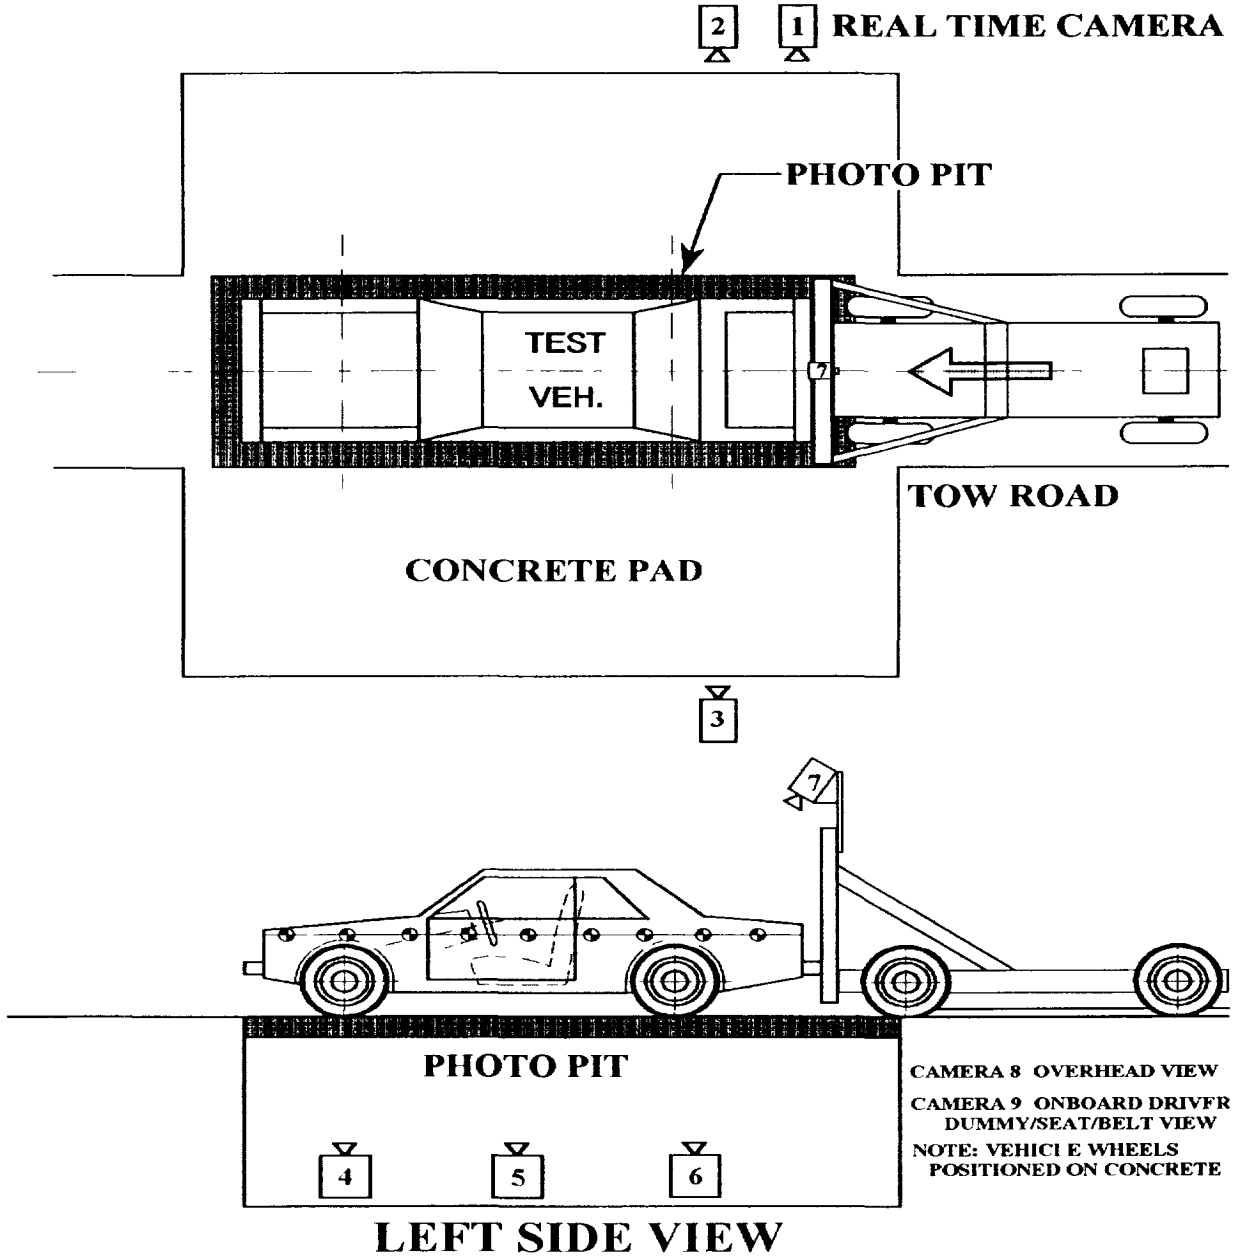
Figure 2

CAMERA POSITIONS FOR REAR IMPACTS

CAMERA NO	VIEW	CAMERA POSITIONS (inches)*			ANGLE** (degrees)	LENS (mm)	SPEED (fps)
		X	Y	Z			
1	Real-Time Camera	-	-	-	-	-	24
2	Right Side View	-539.7	70.0	43.5	0	13	1000
3	Left Side View	536.5	94.7	49.8	0	13	1000
4	Vehicle Front Underbody View	0	140.2	-77.0	90	13	1000
5	Vehicle Mid-Section Underbody View	0	83.0	-77.0	90	13	950
6	Vehicle Rear Underbody View	0	36.5	-77.0	90	13	750
7	Moving Barrier View	0	0	99.0	-105	13	1000
8	Overhead Overall View	-20.0	0	386.0	-90	13	990
9	Onboard Driver Dummy/Seat/Belt View	-	-	-	-	8	1000

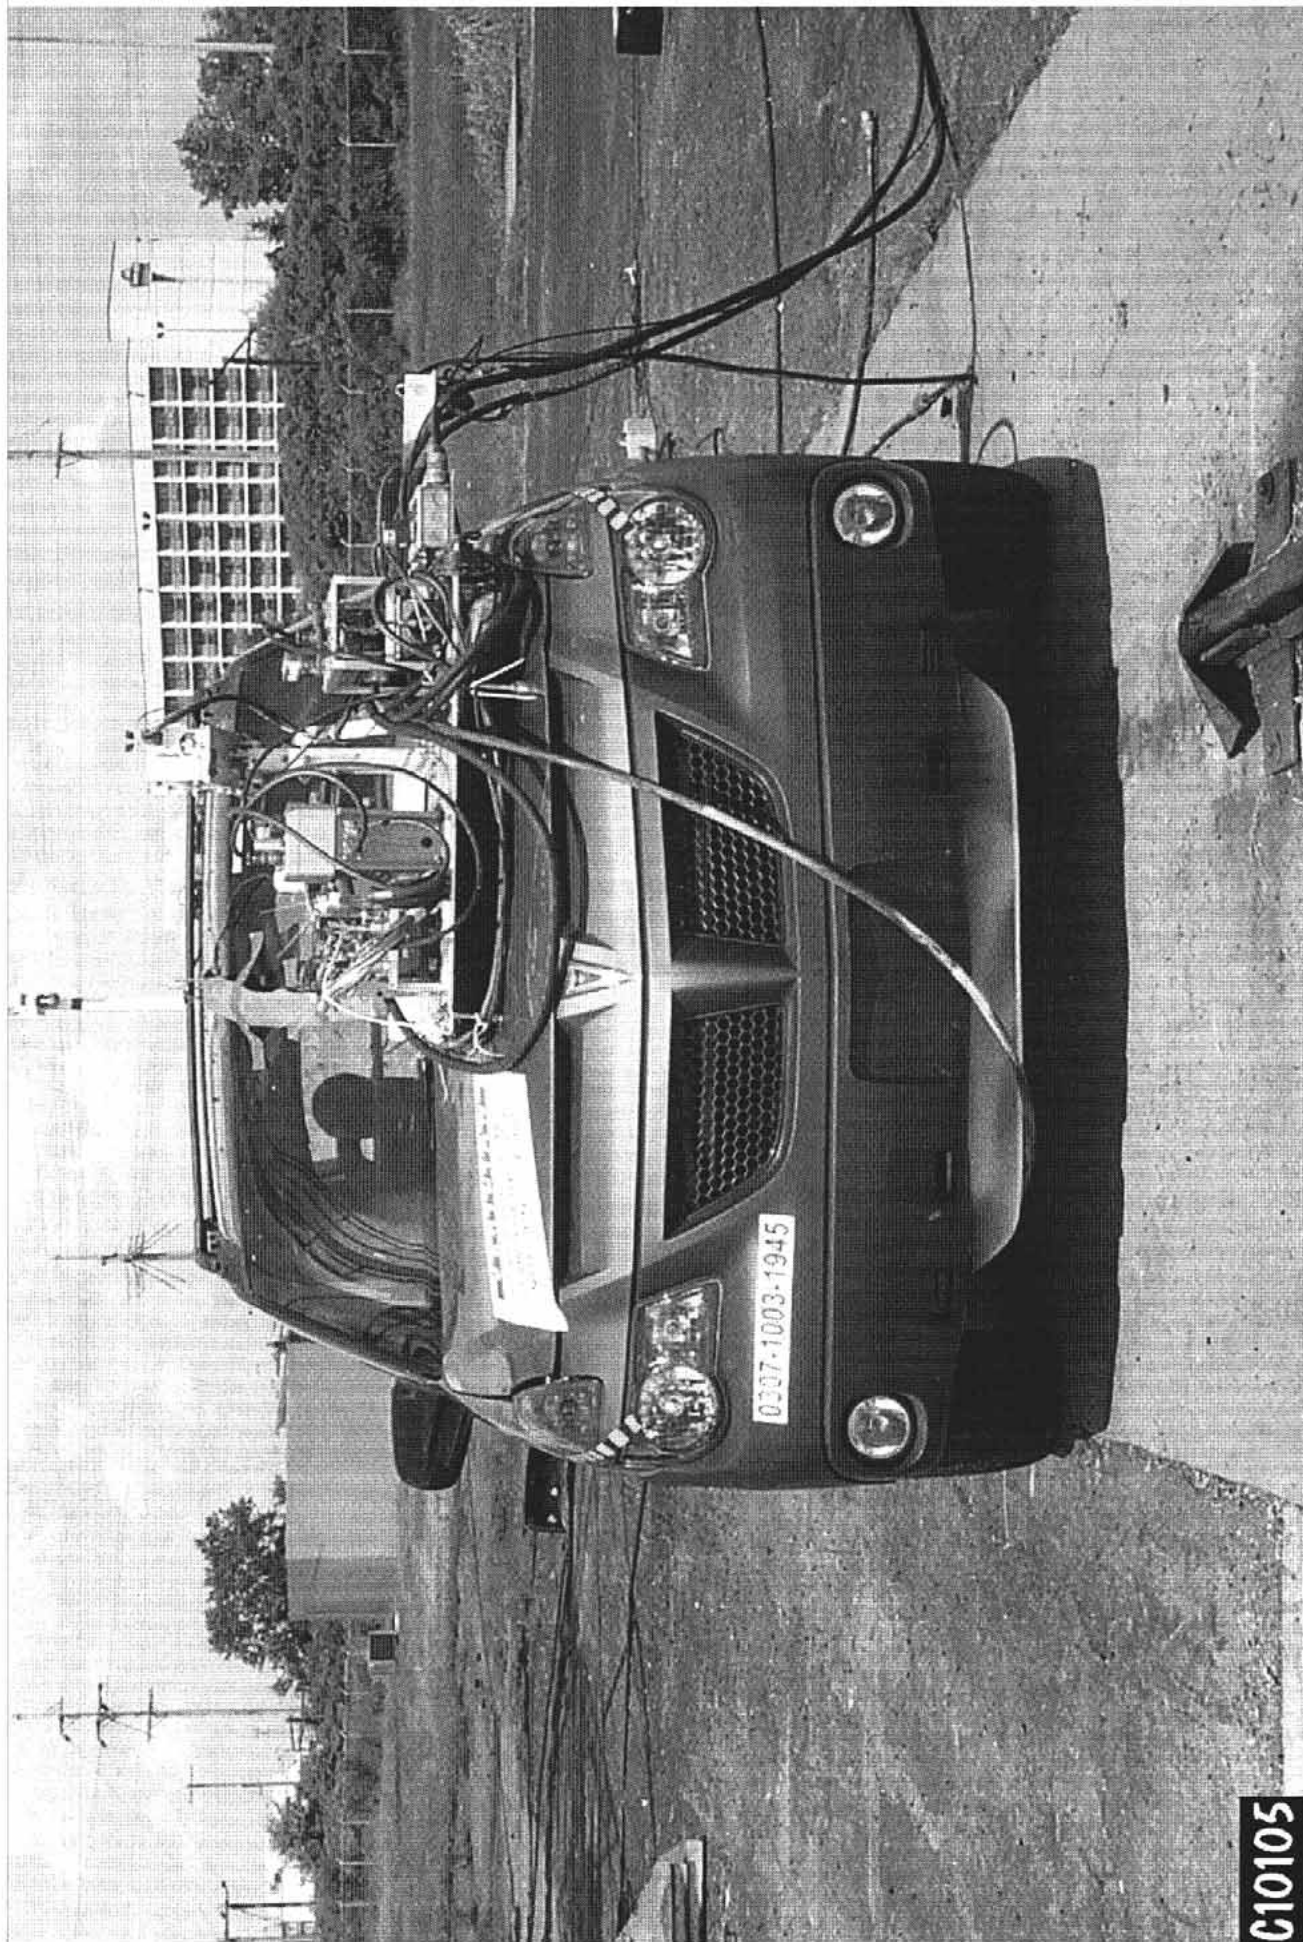
Figure A-2: POST-TEST FRONT VIEW

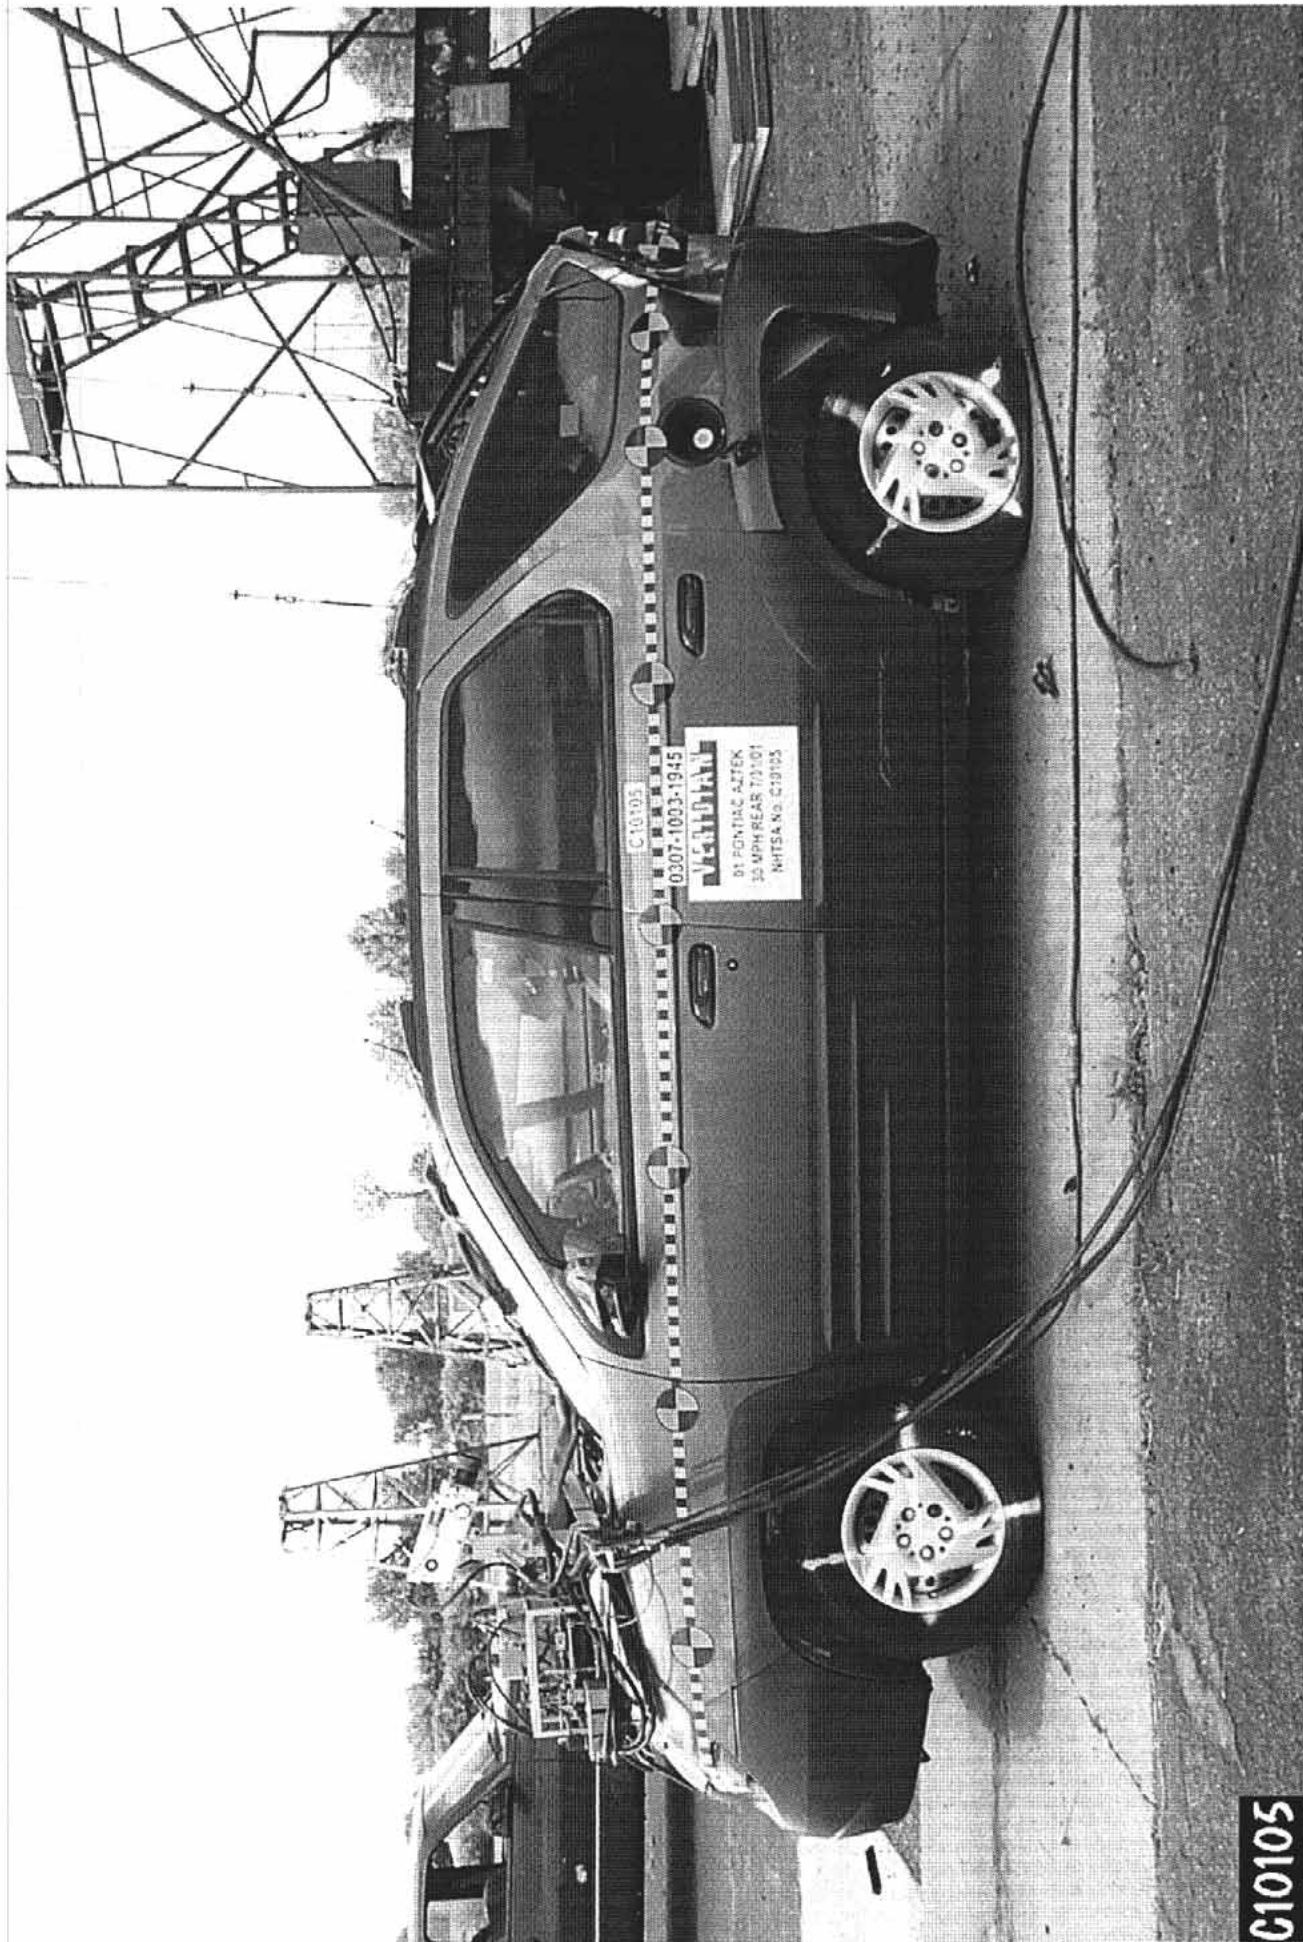
Figure A-4: POST-TEST LEFT SIDE VIEW

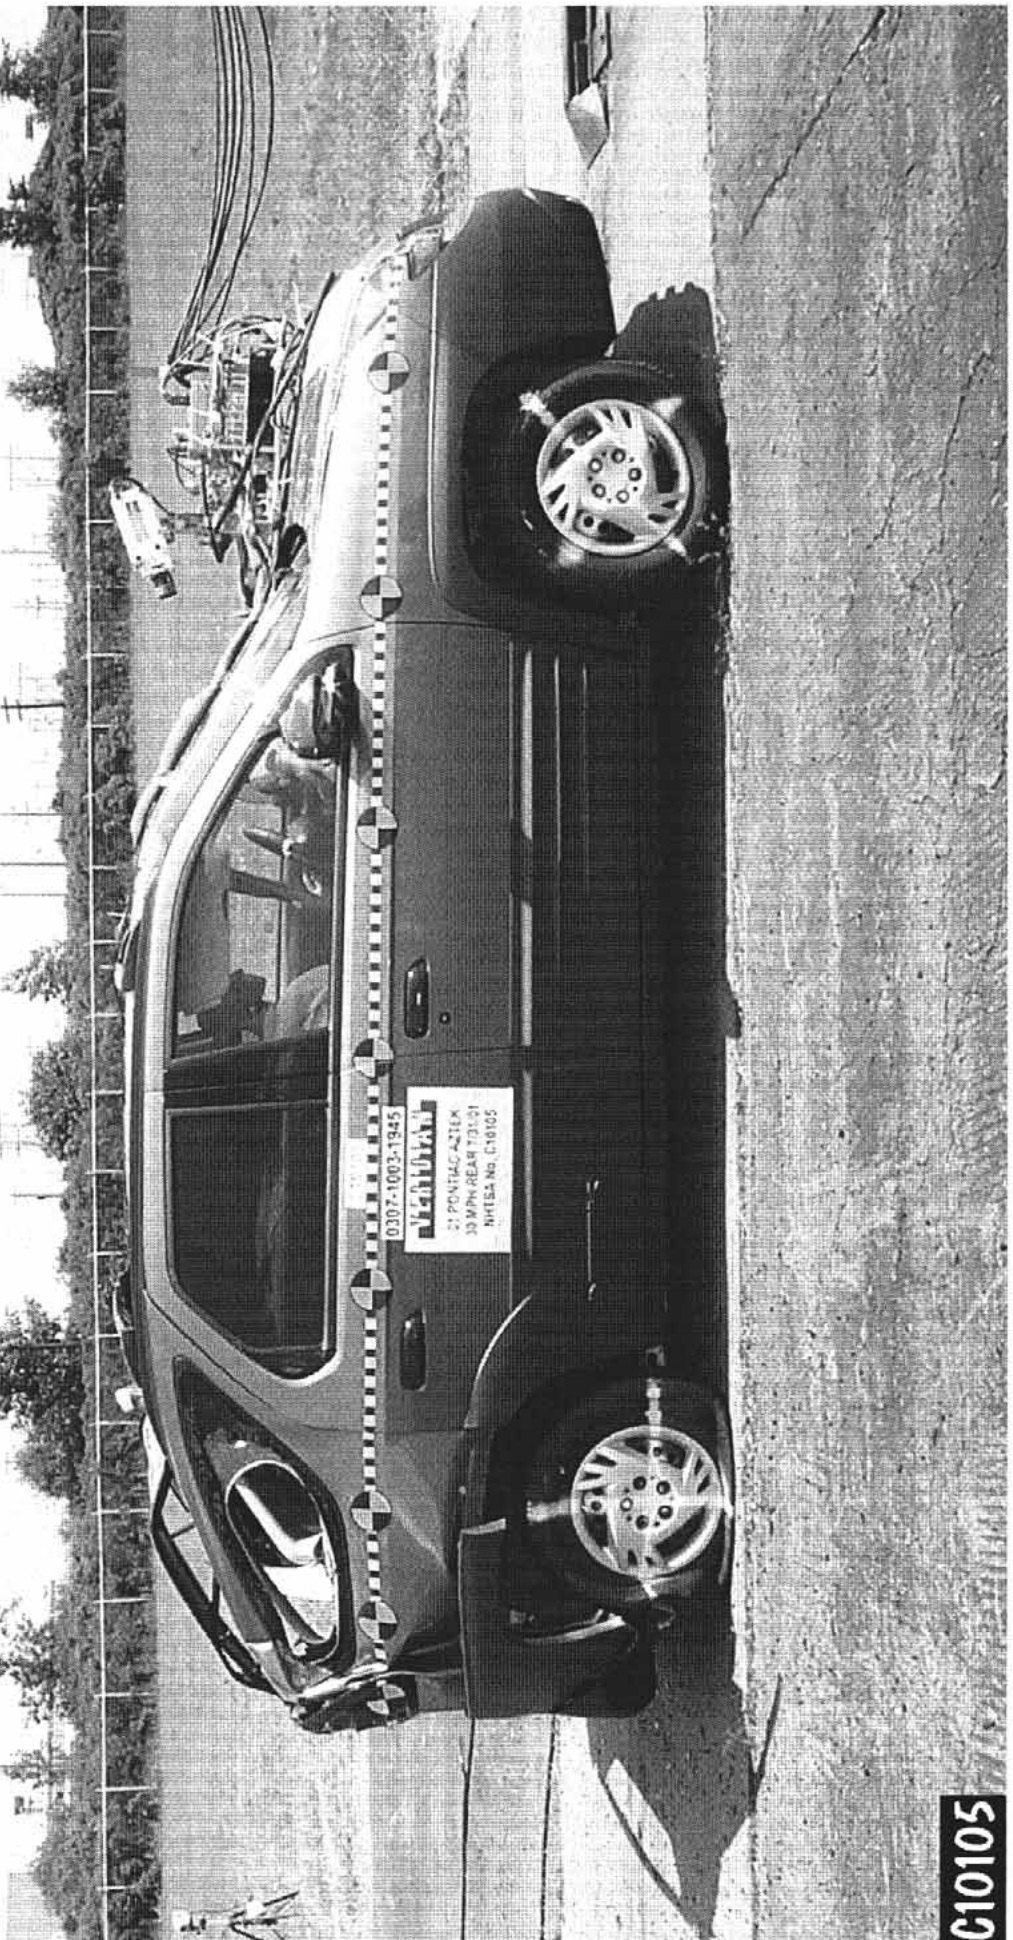
Figure A-6: POST-TEST RIGHT SIDE VIEW

Remarks The rear window and right rear quarter window shattered during the impact. The driver and passenger seatbacks reclined approximately 10 degrees during the impact.

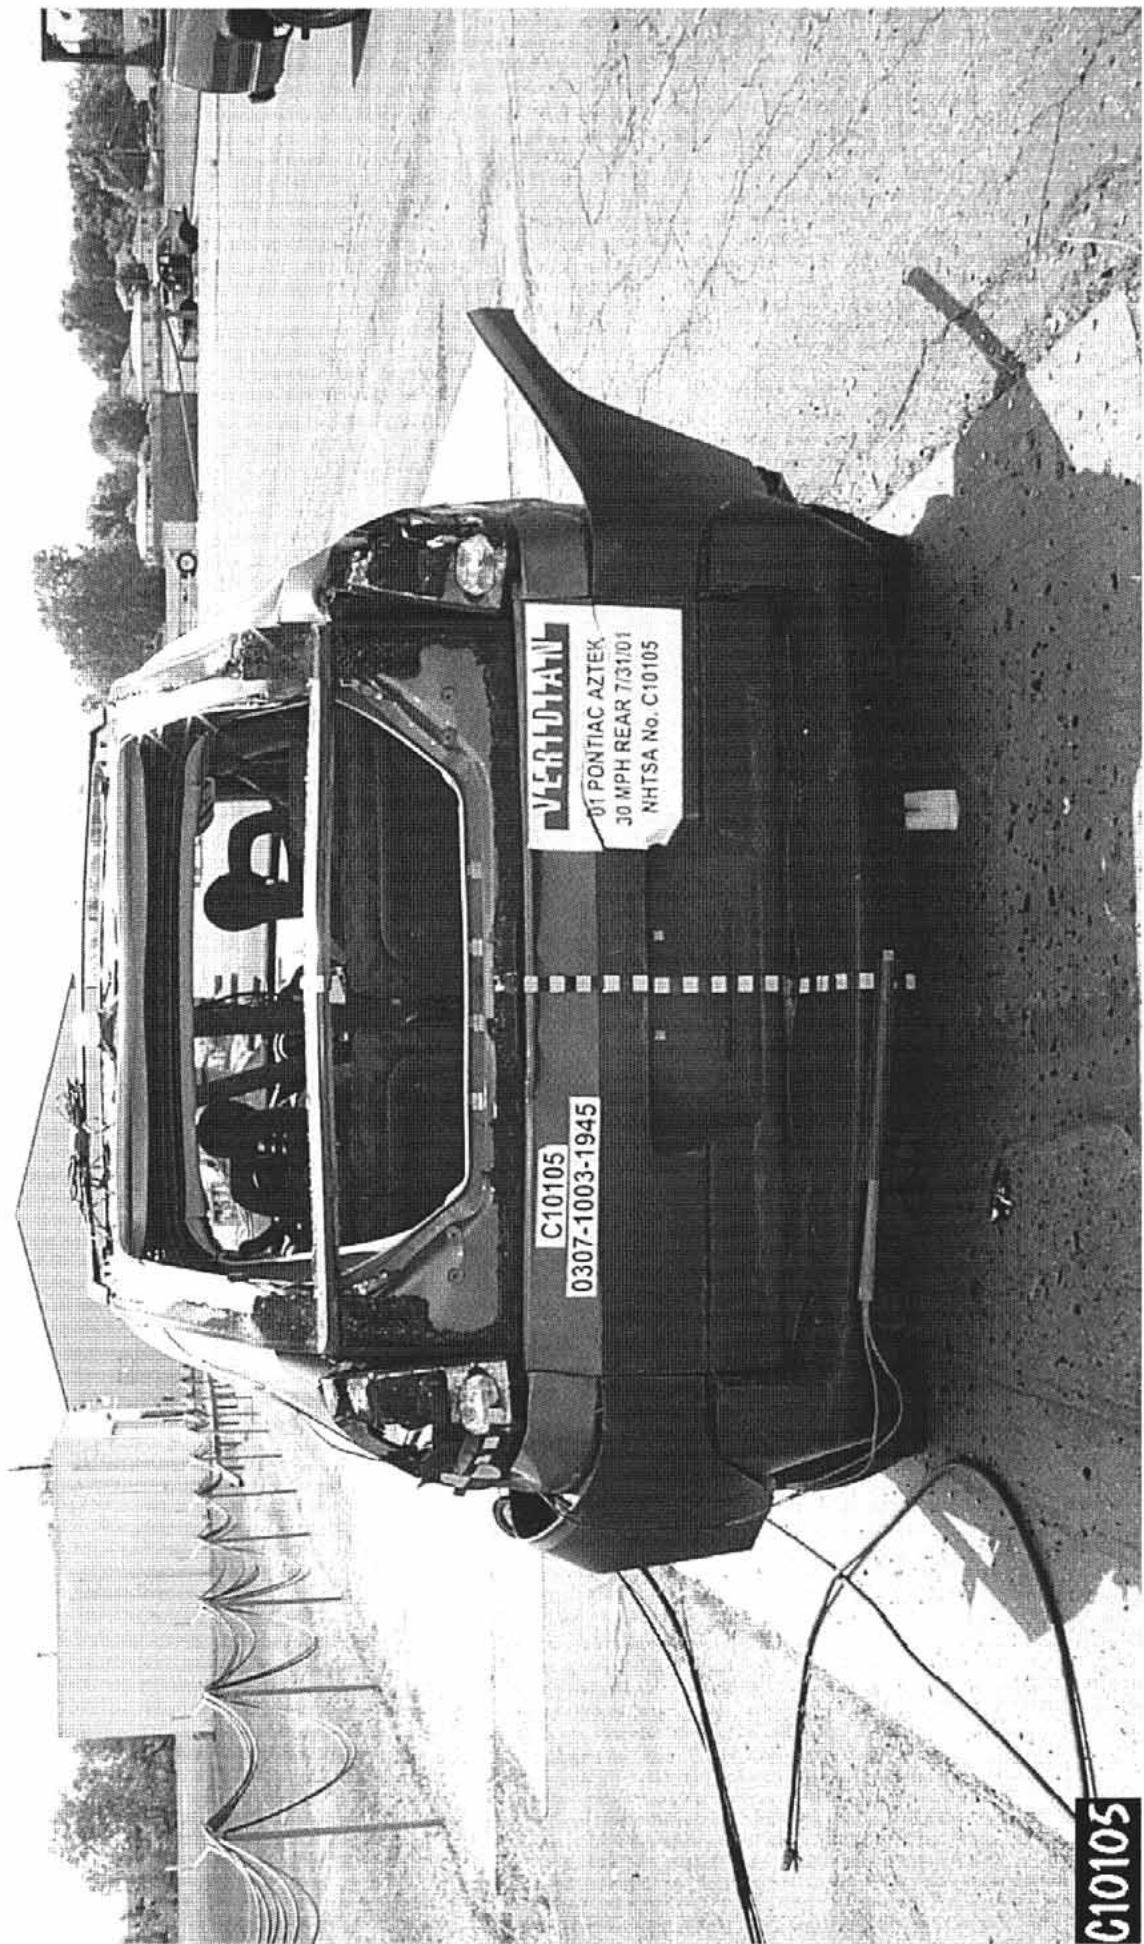
Figure A-8: POST-TEST REAR VIEW

Pre-Test Left = 177 2, C/L = 182 1 Right = 177 2
 Post-Test Left = 168 9, C/L = 174 4 Right = 169 3
 Crush Left = 8 3, C/L = 7 7 Right = 7 9
 AVERAGE = 7 97 inches

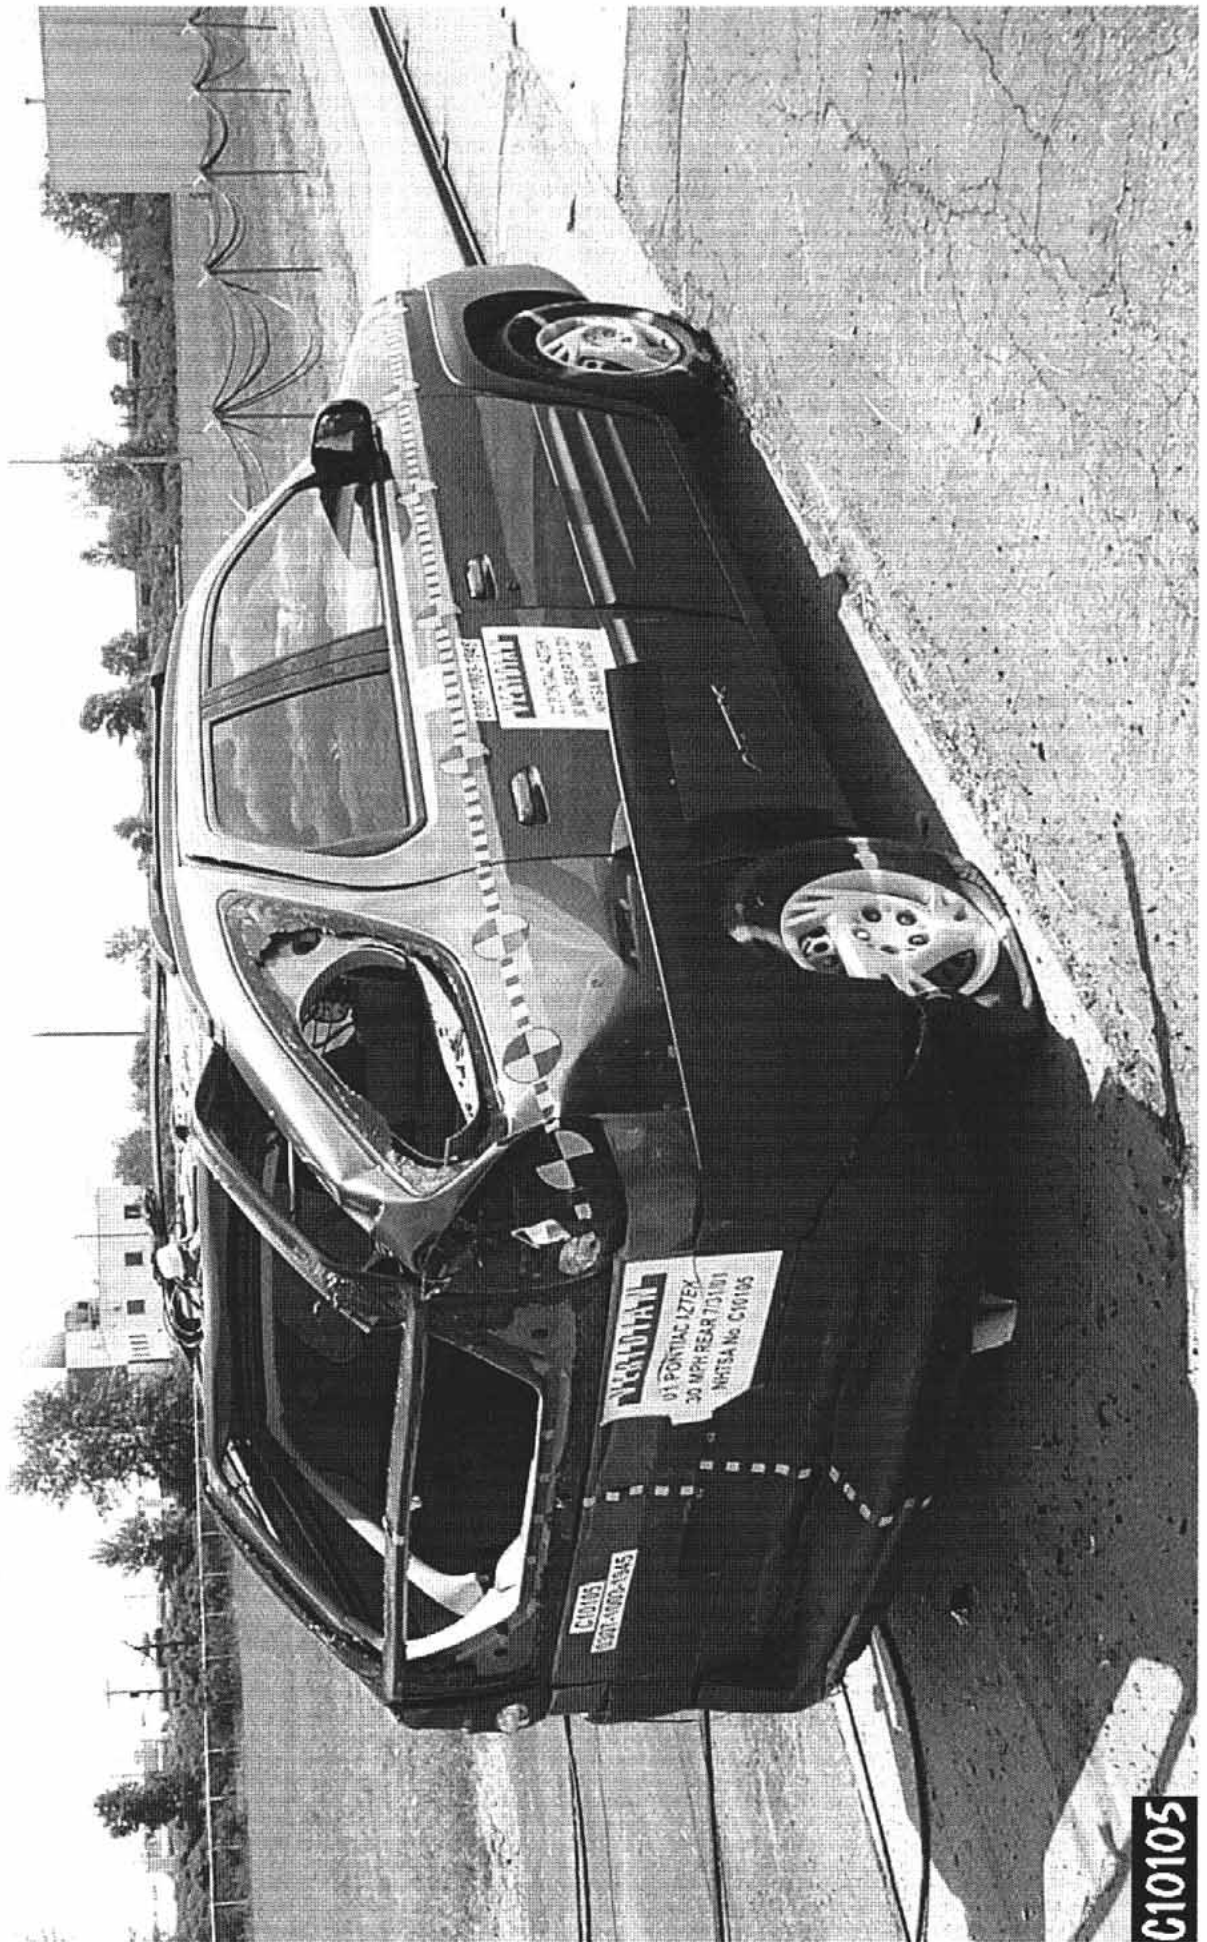
Figure A-12: POST-TEST RIGHT REAR THREE-QUARTER VIEW

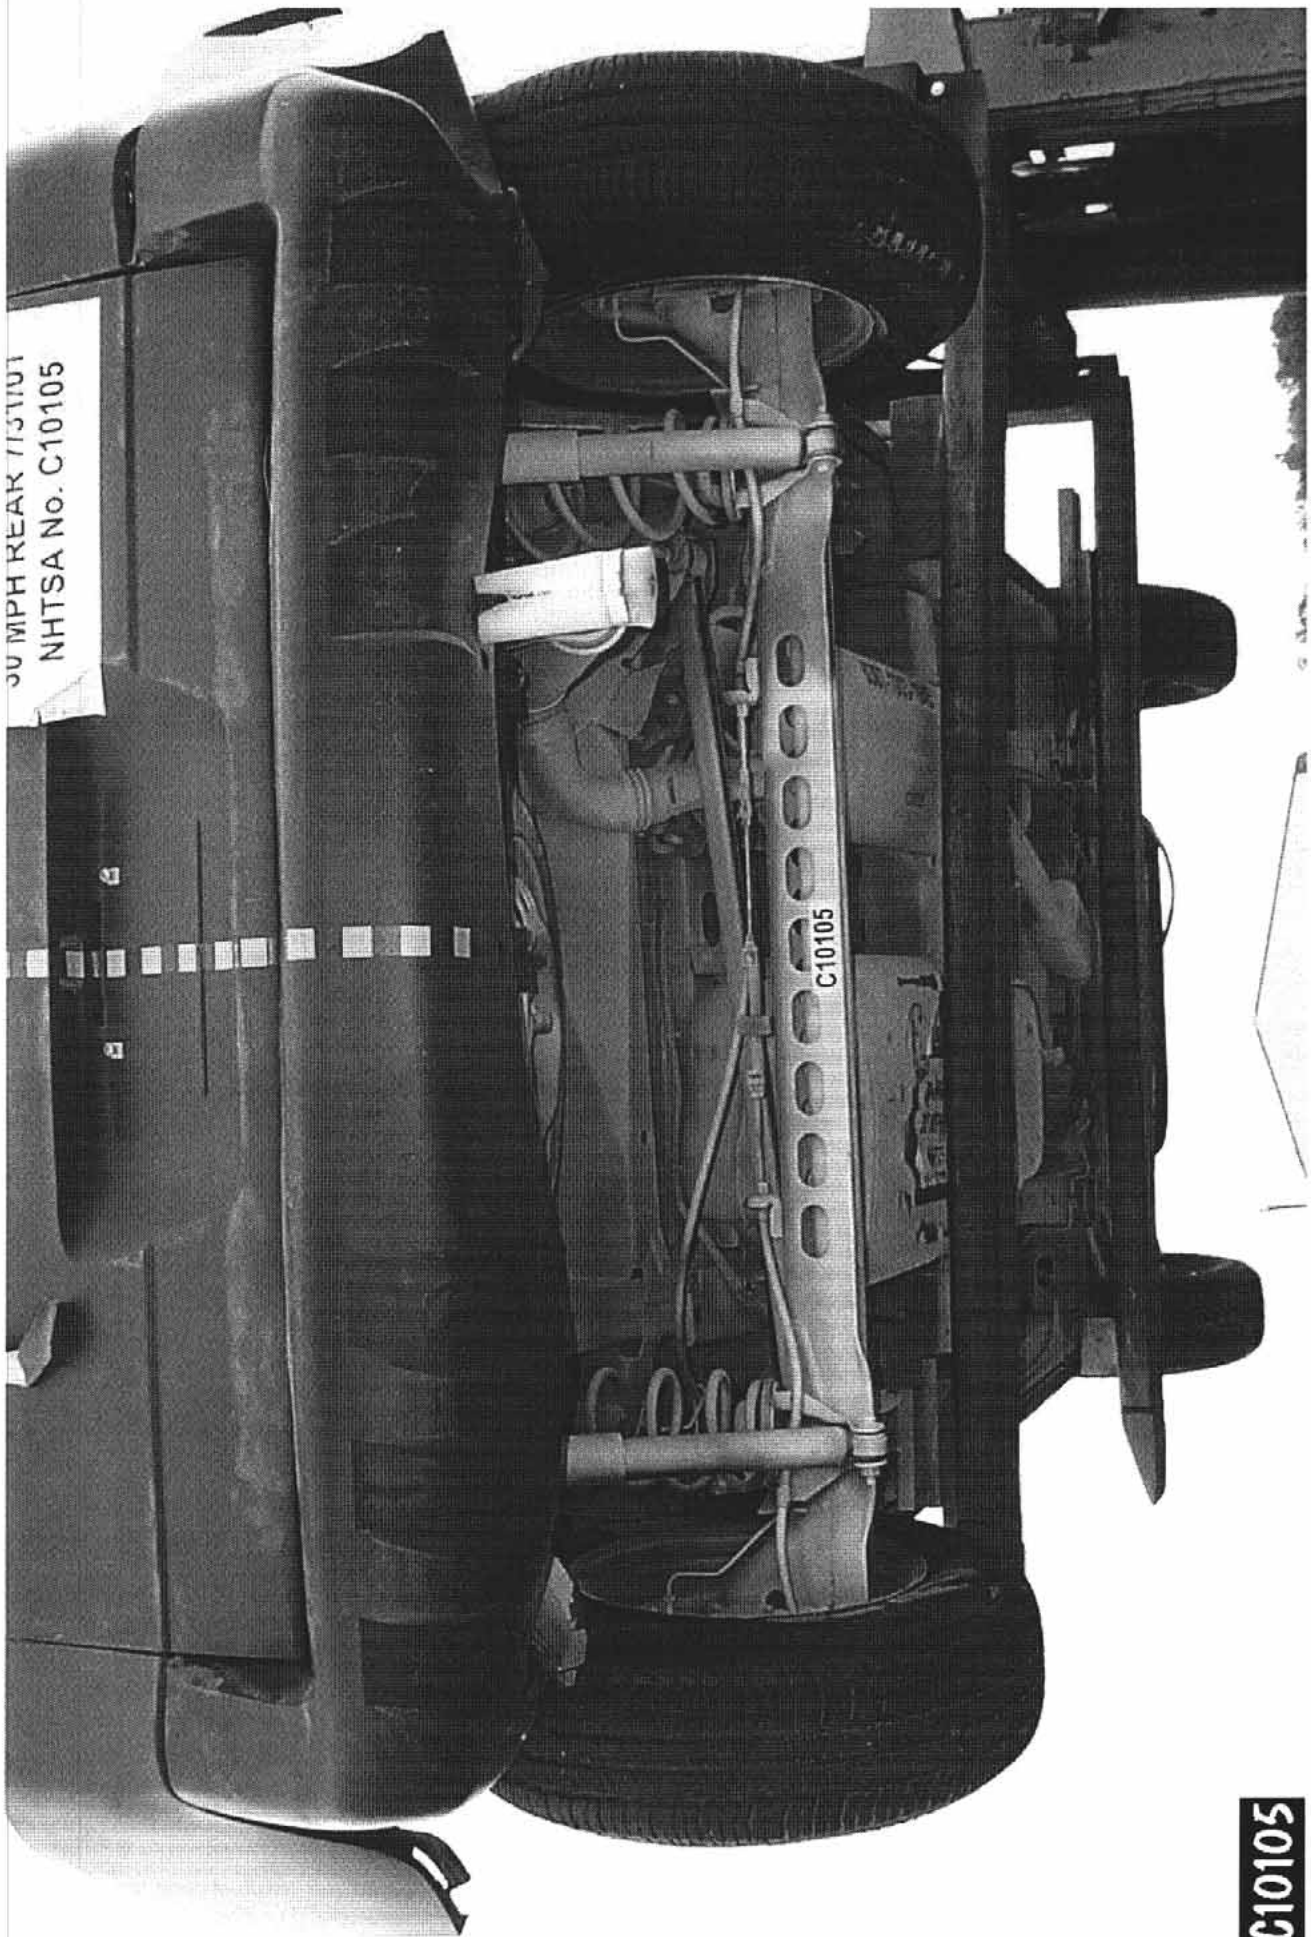
Figure A-16: POST-TEST REAR UNDERBODY VIEW

Stoddard Solvent Spillage from Vehicle's Fuel System None

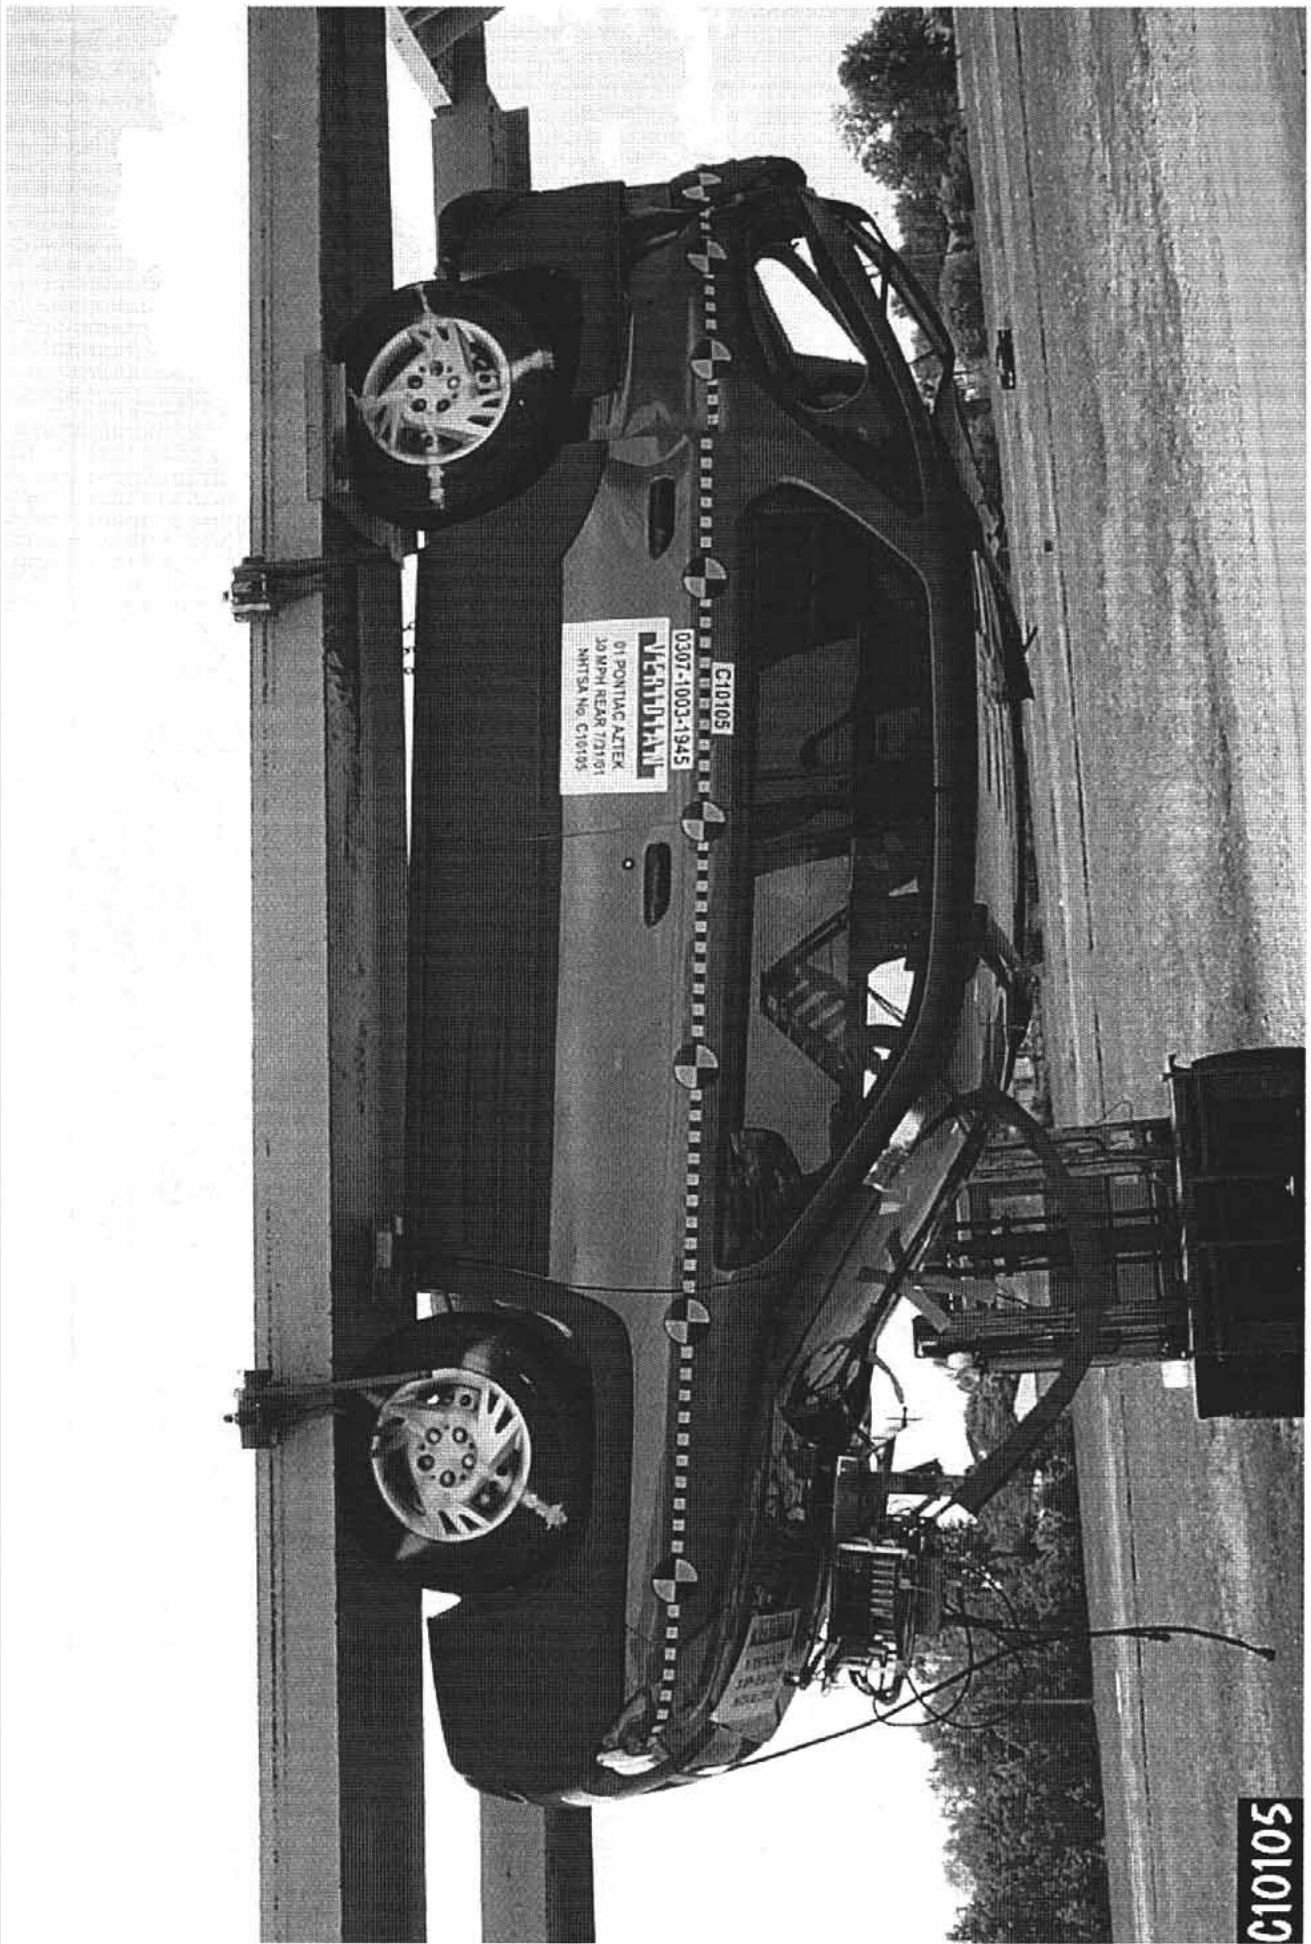
Figure A-20: ROLLOVER 180°

Rollover Stage	First 5 minutes from onset of rotation (oz)	6th min (oz)	7th min (oz)	8th min (if required) (oz)
0° - 90°	0	0	0	N/A
90° - 180°	0	0	0	N/A
180°-270°	0	0	0	N/A
270°-360°	0	0	0	N/A

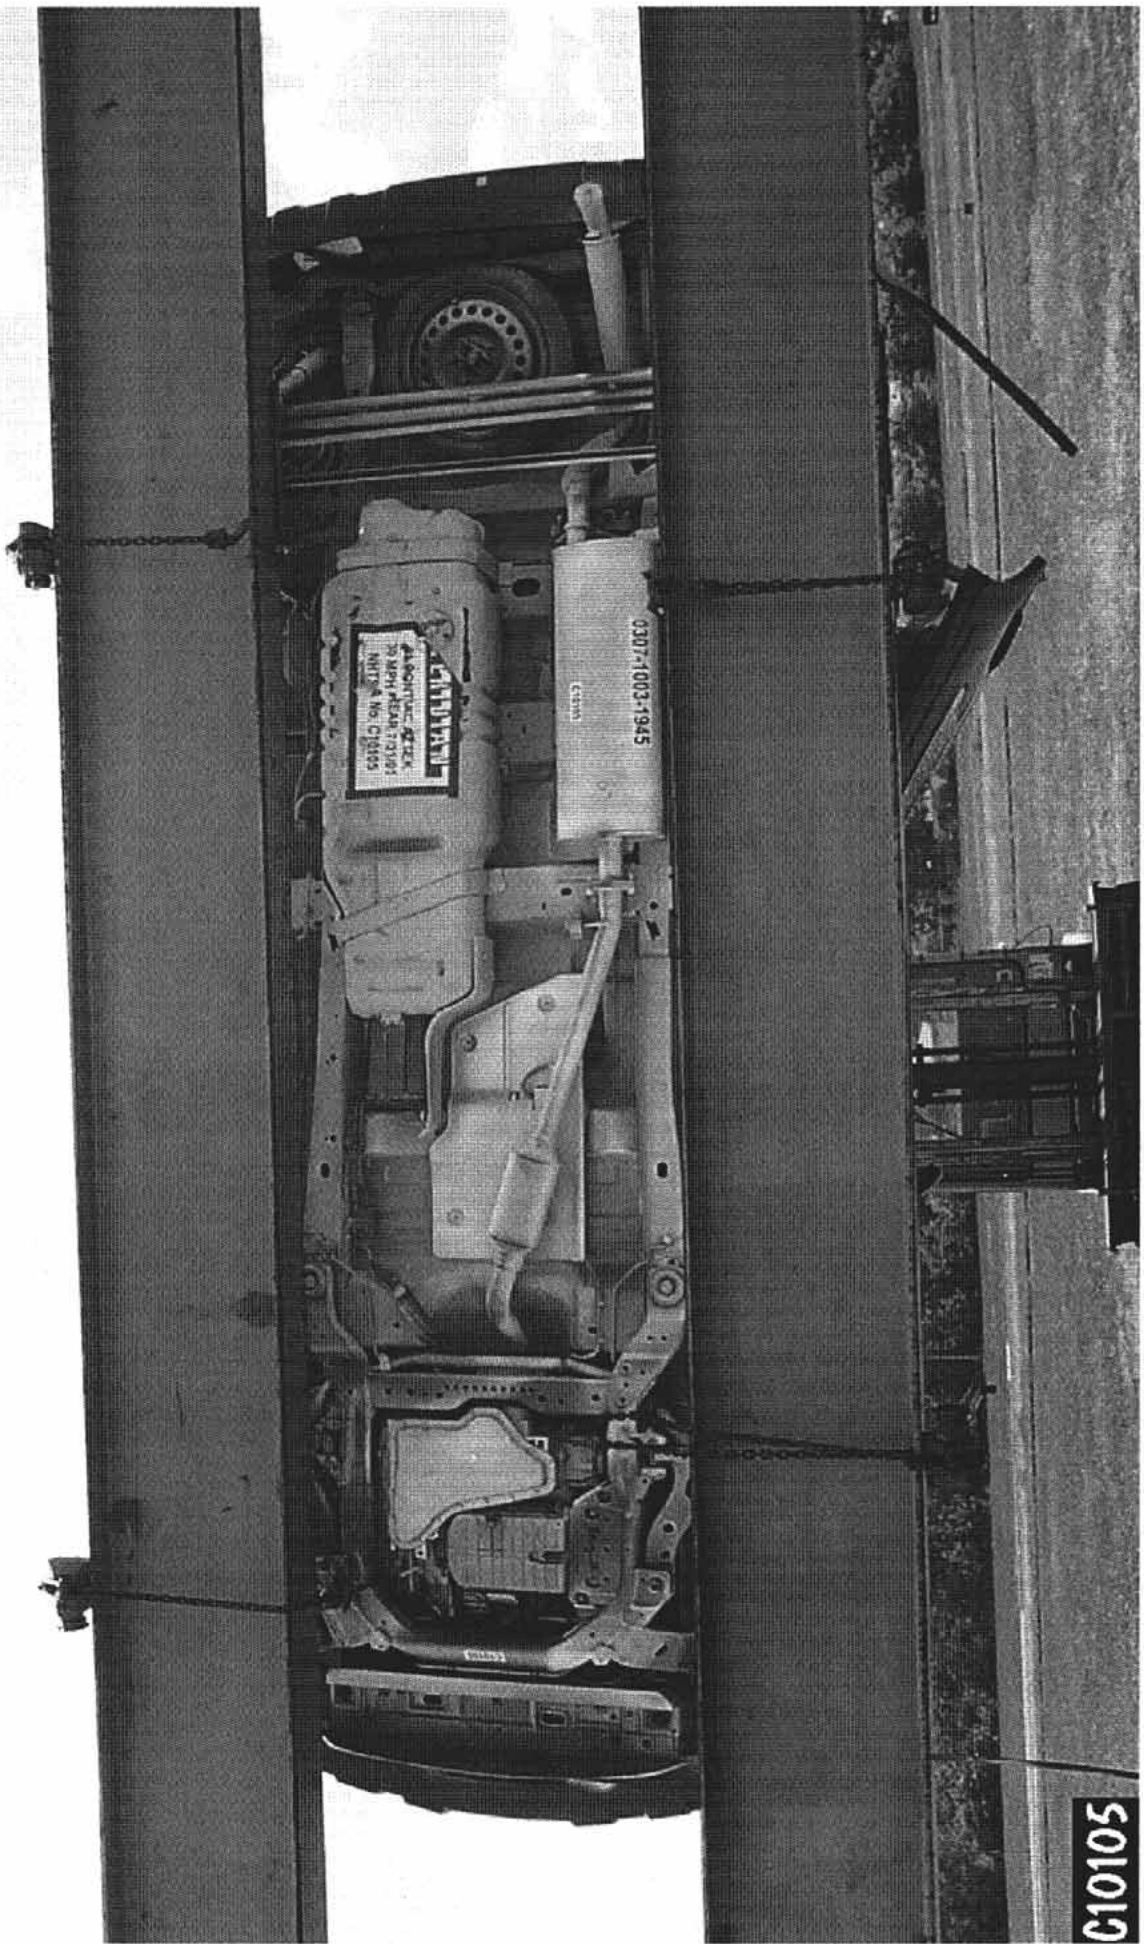
Figure A-21: ROLLOVER 270°
