REPORT NUMBER: 301-CAL-01-03
SAFETY COMPLIANCE TESTING FOR FMVSS 301
FUEL SYSTEM INTEGRITY

GENERAL MOTORS DE MEXICO
2001 PONTIAC
AZTEK MPV

NHTSA NUMBER: C10105

VERIDIAN TEST NUMBER: 8606-3

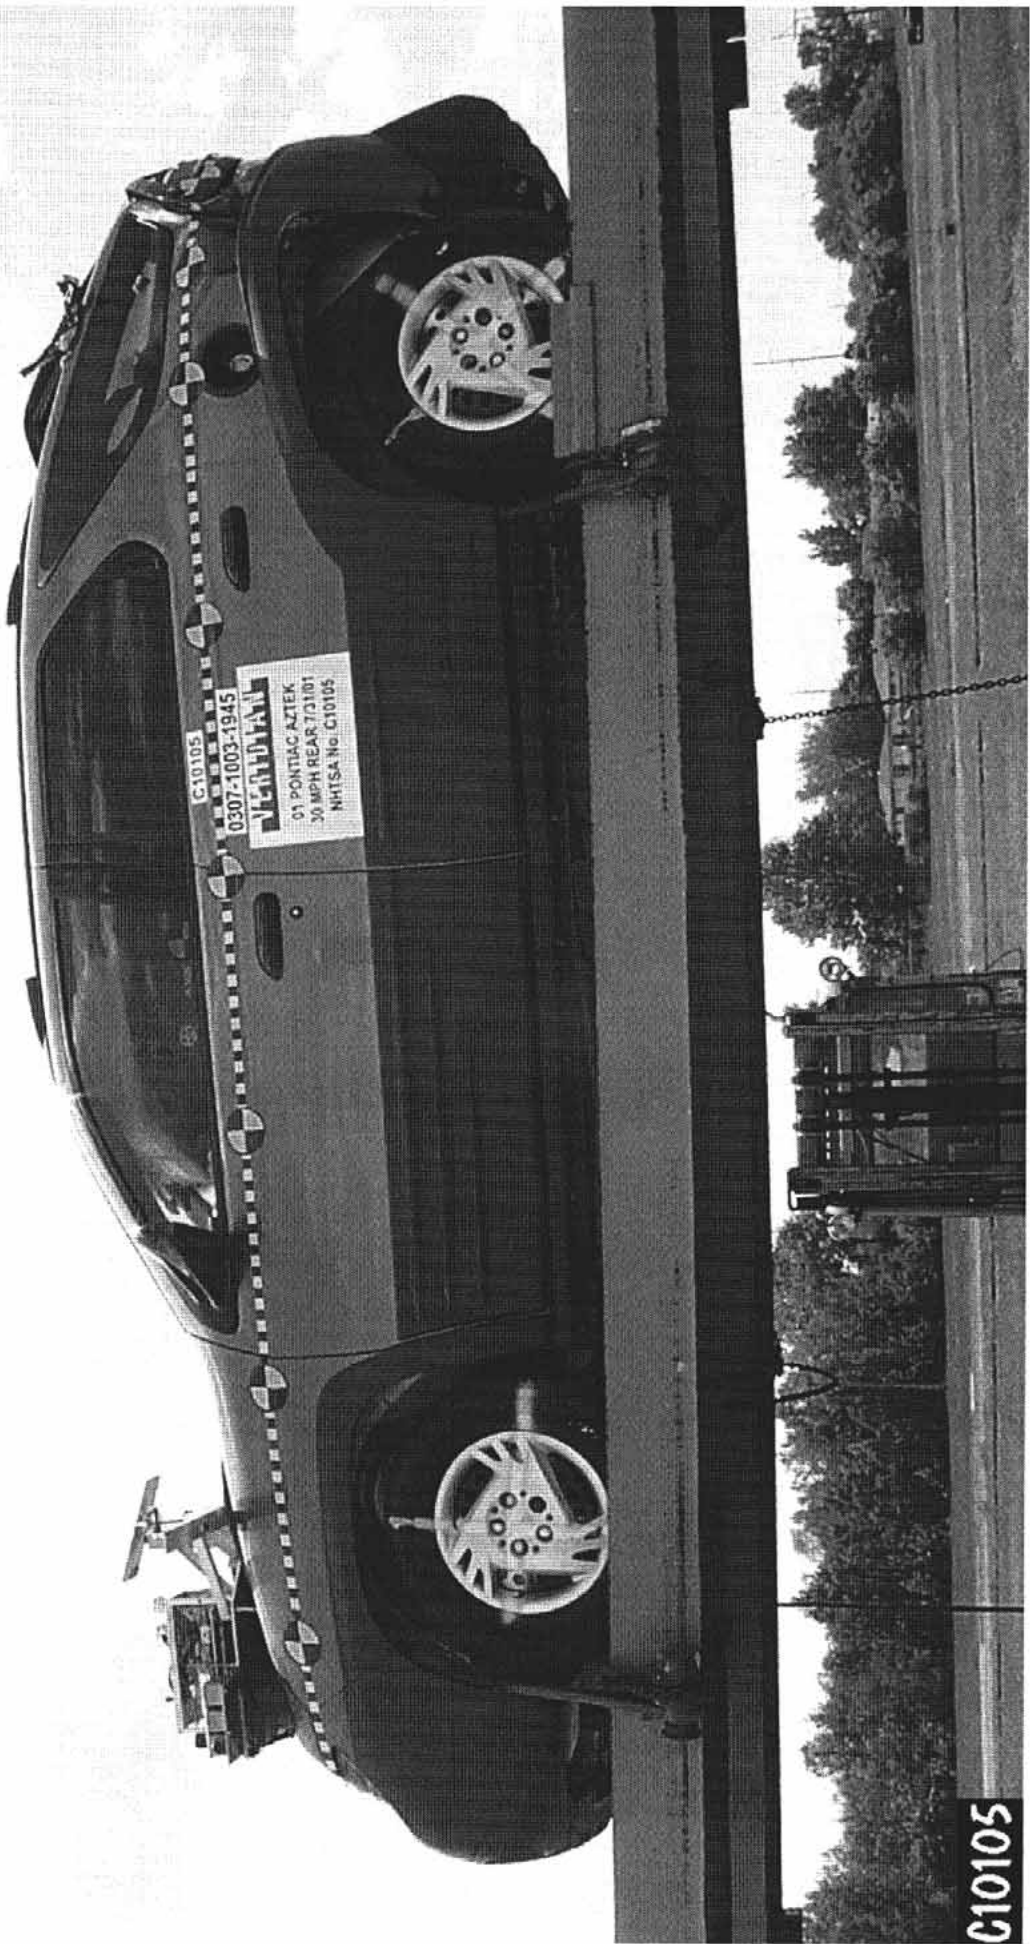
Figure A-22: ROLLOVER 360°

Rollover Stage	First 5 minutes from onset of rotation (oz)	6th min (oz)	7th min (oz)	8th min (if required) (oz)
0° - 90°	0	0	0	N/A
90° - 180°	0	0	0	N/A
180°-270°	0	0	0	N/A
270°-360°	0	0	0	N/A

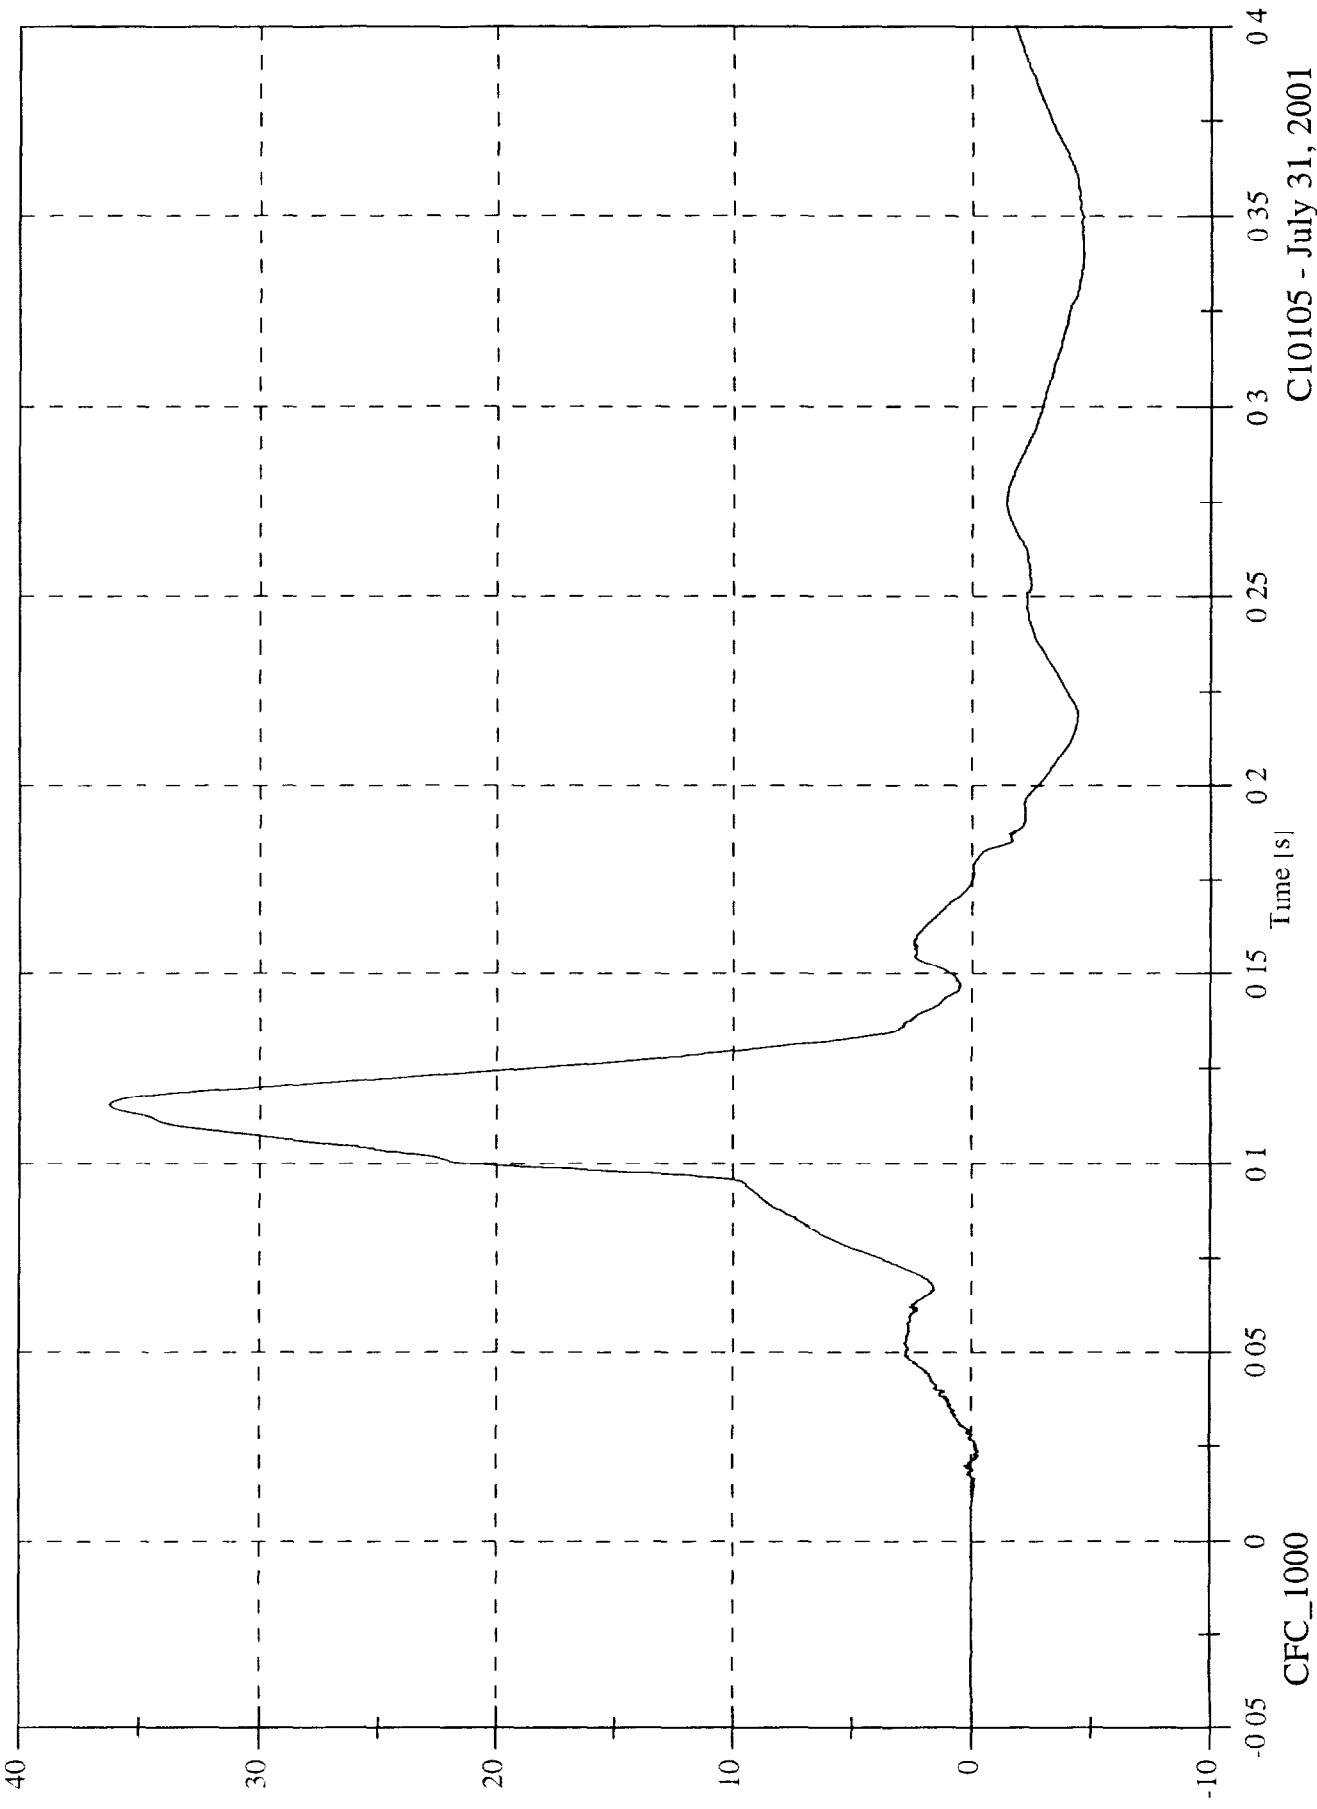
P1 Head x

Max: 36.3 [g] at 0.115 [s]
Min: -4.7 [g] at 0.340 [s]

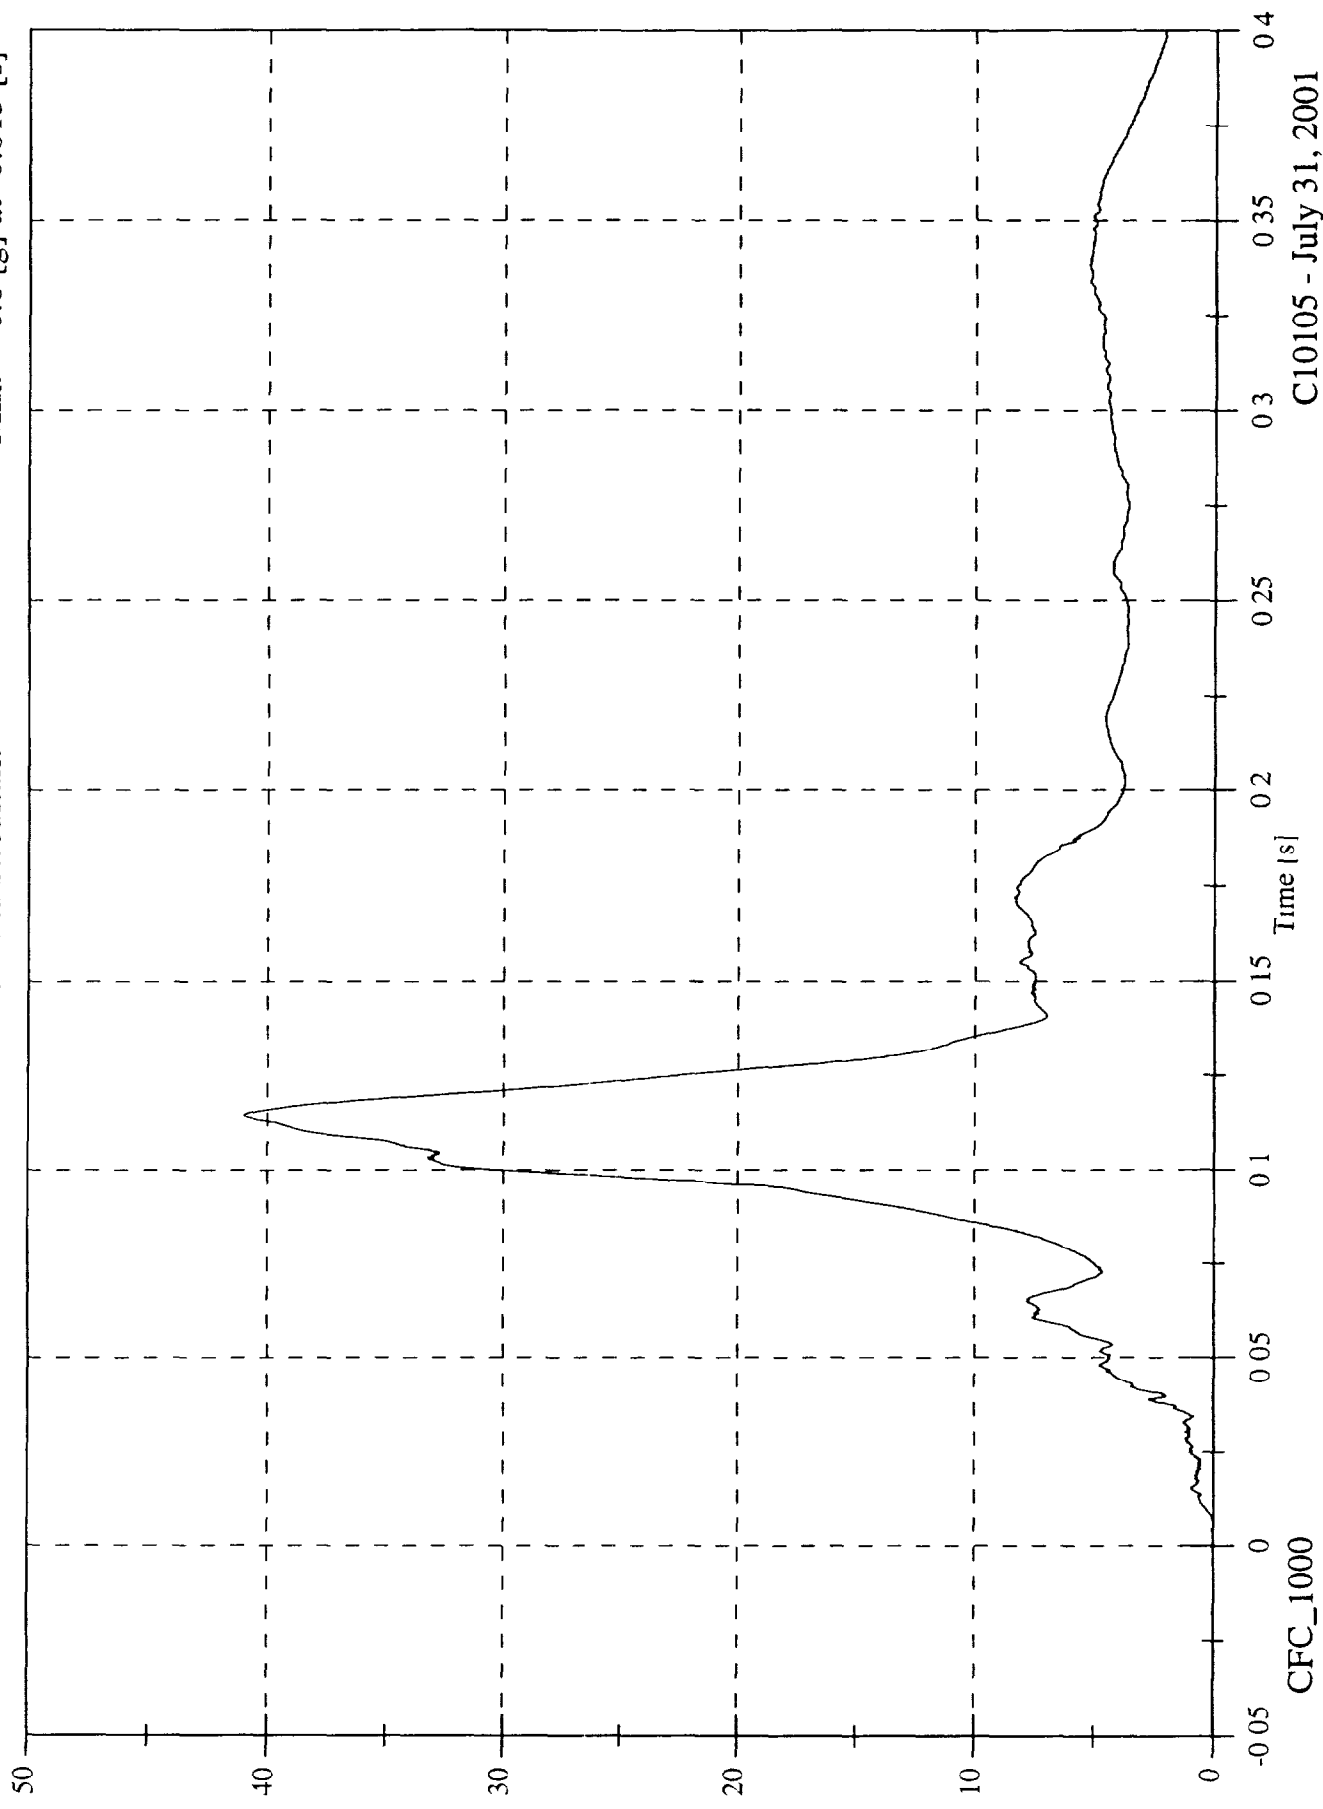
P1 Head Resultant

Max: 41.0 [g] at 0.114 [s]
Min: 0.0 [g] at -0.013 [s]

P1 HIC(36 ms) 184.3
 t1 95.9 msec
 t2 126.7 msec
 Duration 30.7 msec
 Average Acceleration 32.4 g

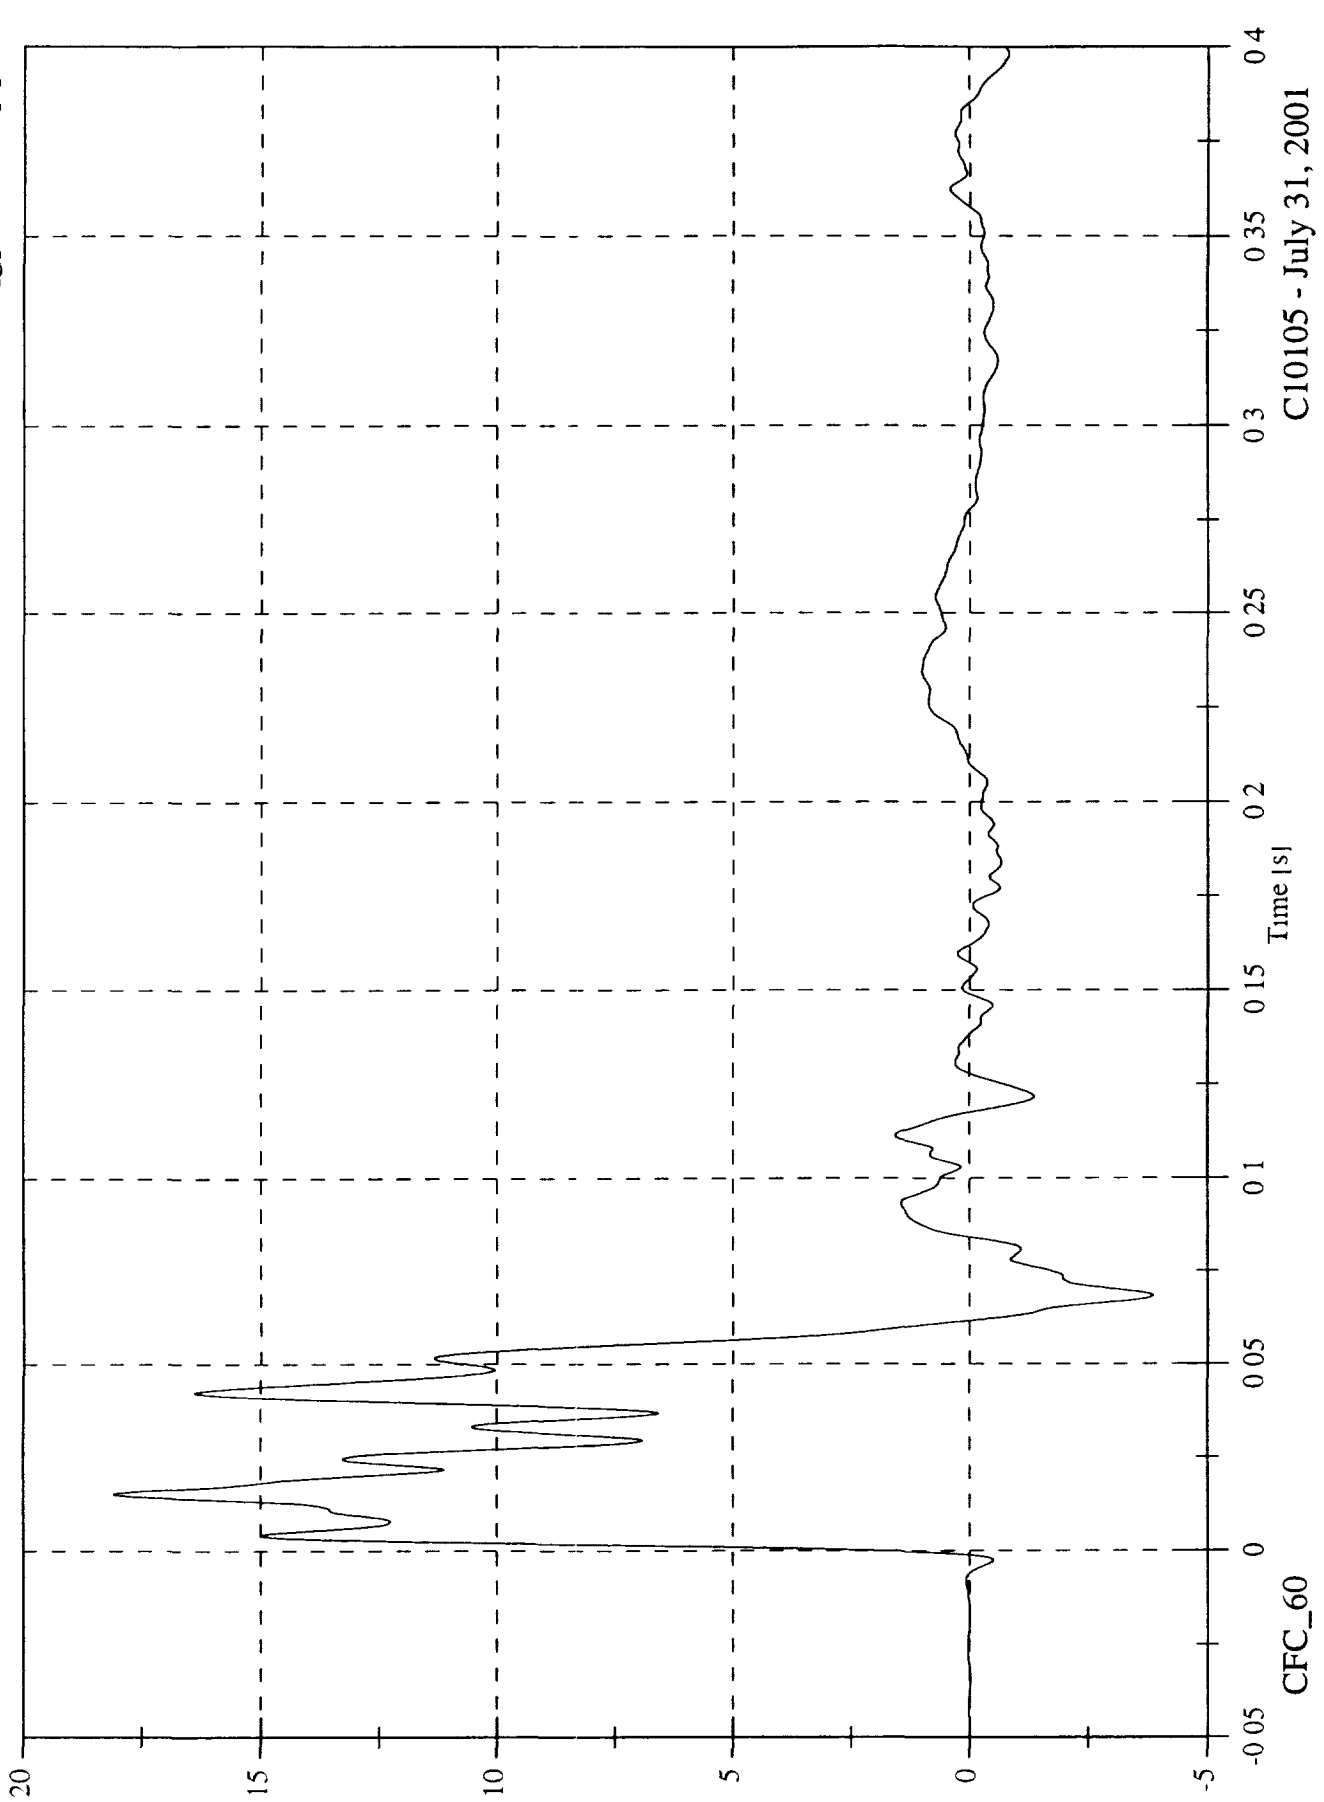
Acc #1 Left Rear Xmember X

Max: 18.1 [g] at 0.015 [s]

Min: -3.9 [g] at 0.068 [s]

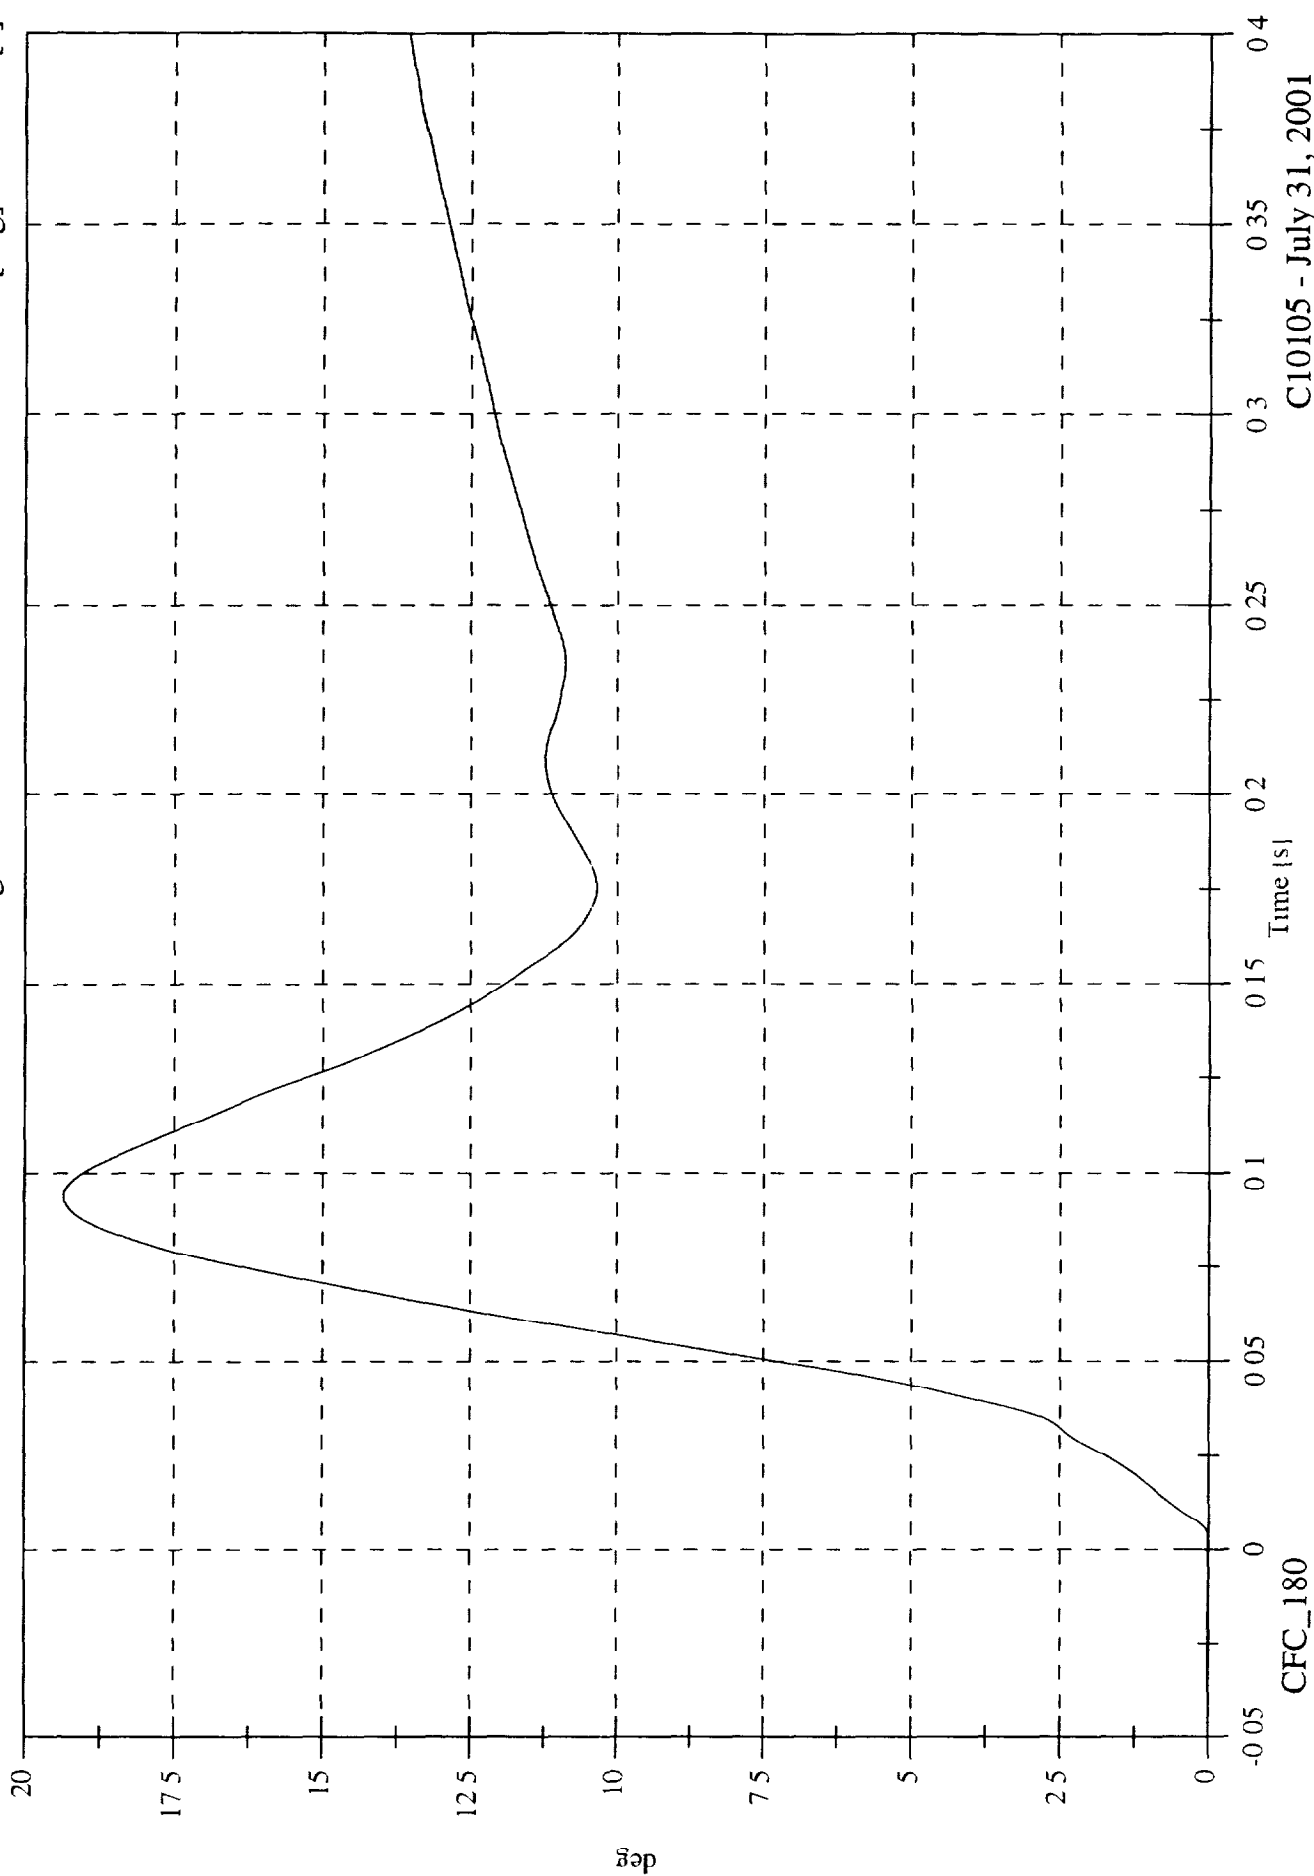
Seatback Angular Position

Max: 19.3 [deg] at 0.094 [s]

Min: 0.0 [deg] at -0.050 [s]

Note Angular seatback position is measured in degrees of rotation from the initial (design) position
