REPORT NUMBER: CAL-01-24

**NEW CAR ASSESSMENT PROGRAM (NCAP)  
FRONTAL BARRIER IMPACT TEST**

VOLVO GOTHENBURG SWEDEN  
2001 VOLVO S60  
4-DOOR SEDAN

NHTSA NUMBER: V15900

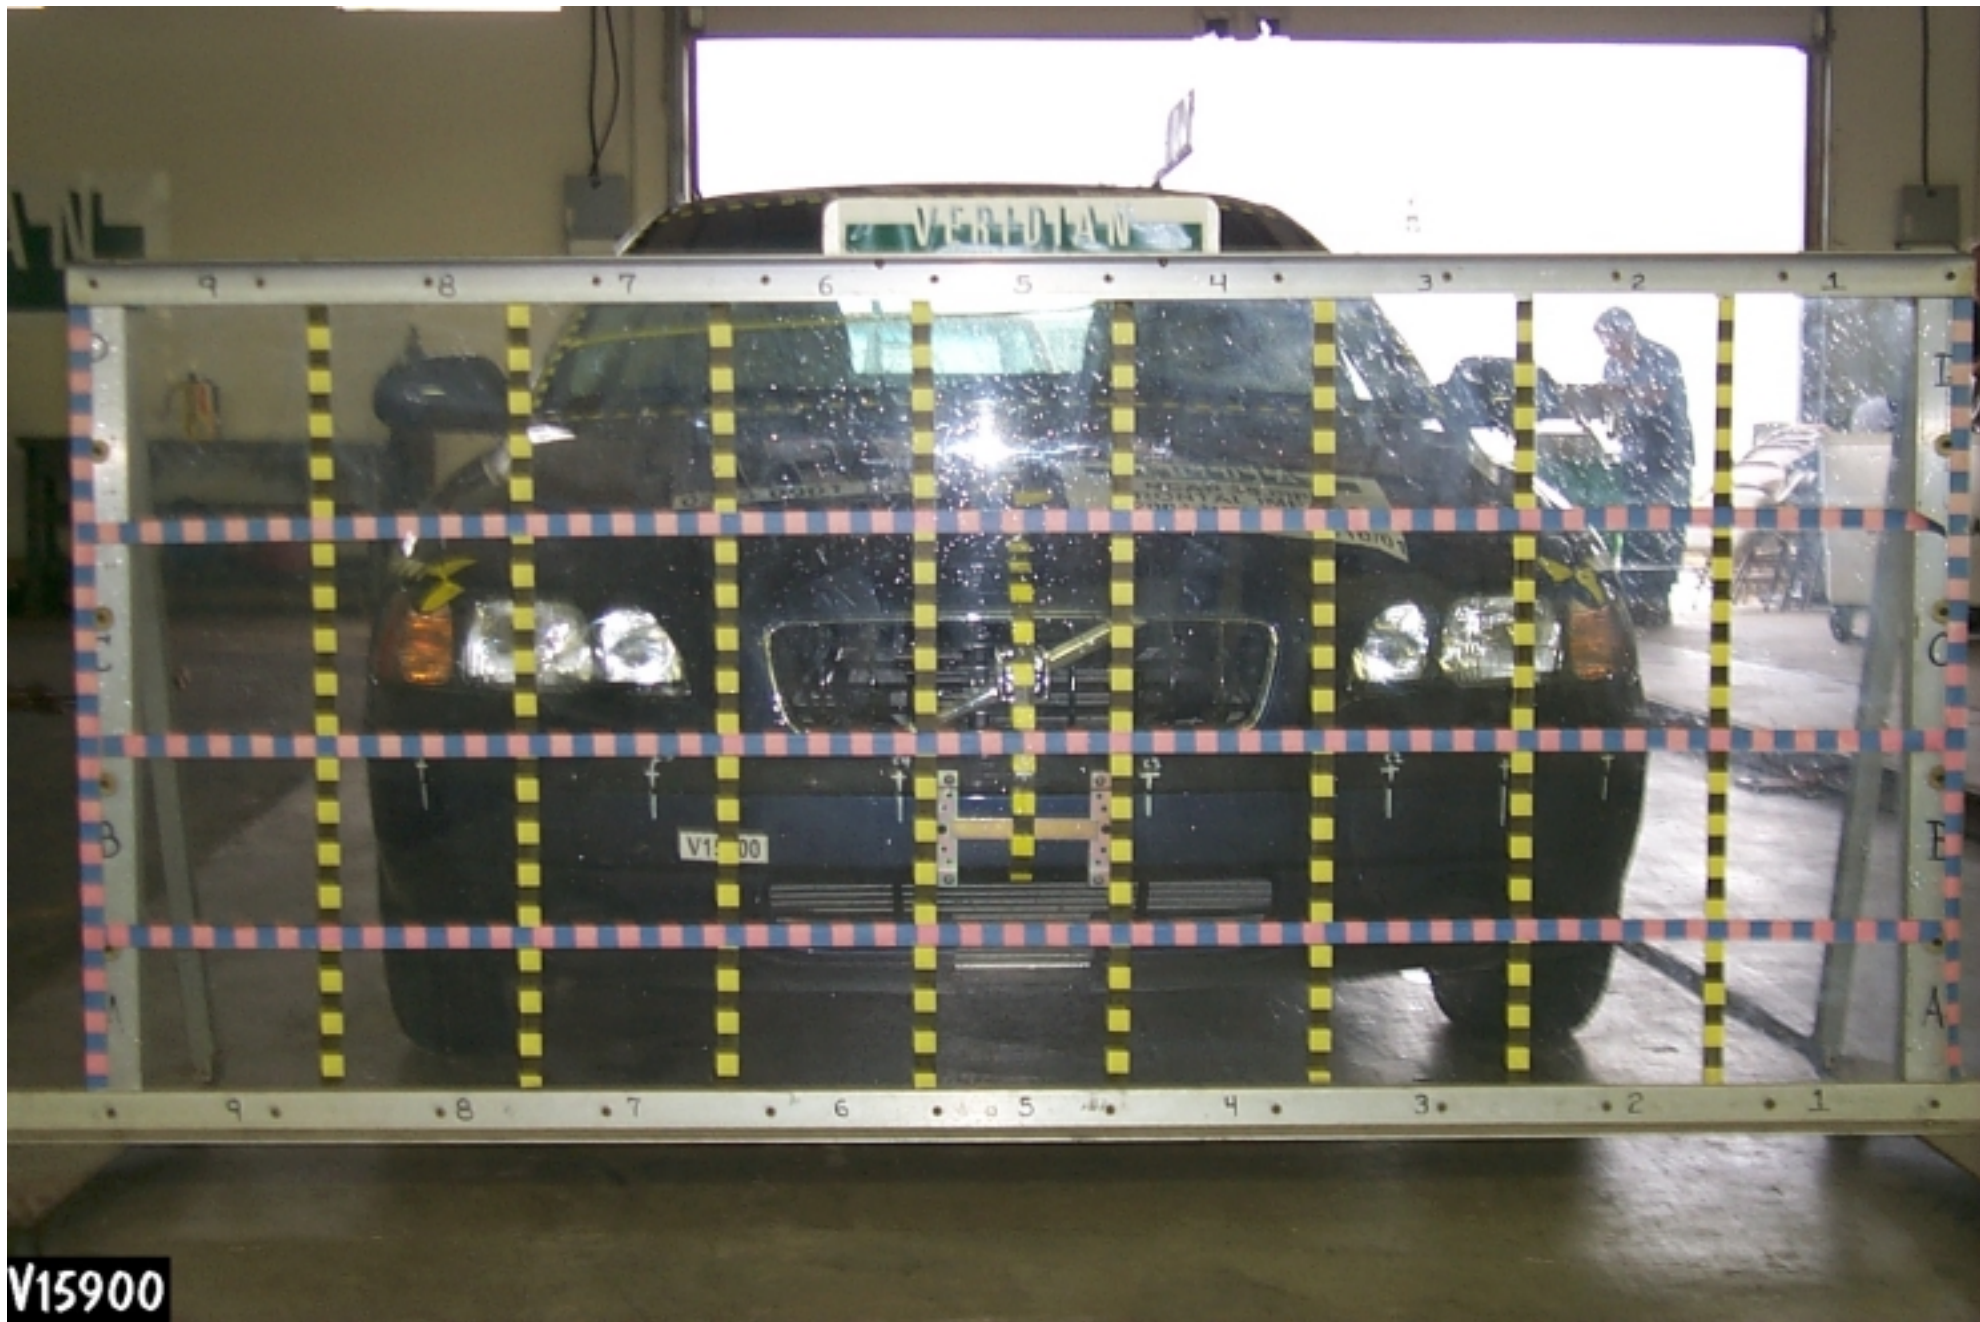
Figure A-1: LOAD CELL LOCATIONS.

A load cell barrier consisting of 36 load cells was impacted by a 2001 Volvo S60 4-Door Sedan at a velocity of 56.49 kph. The test was performed at Veridian Engineering on September 10, 2001. Pre- and post-test photographs of the vehicle and dummies can be found in Appendix A.

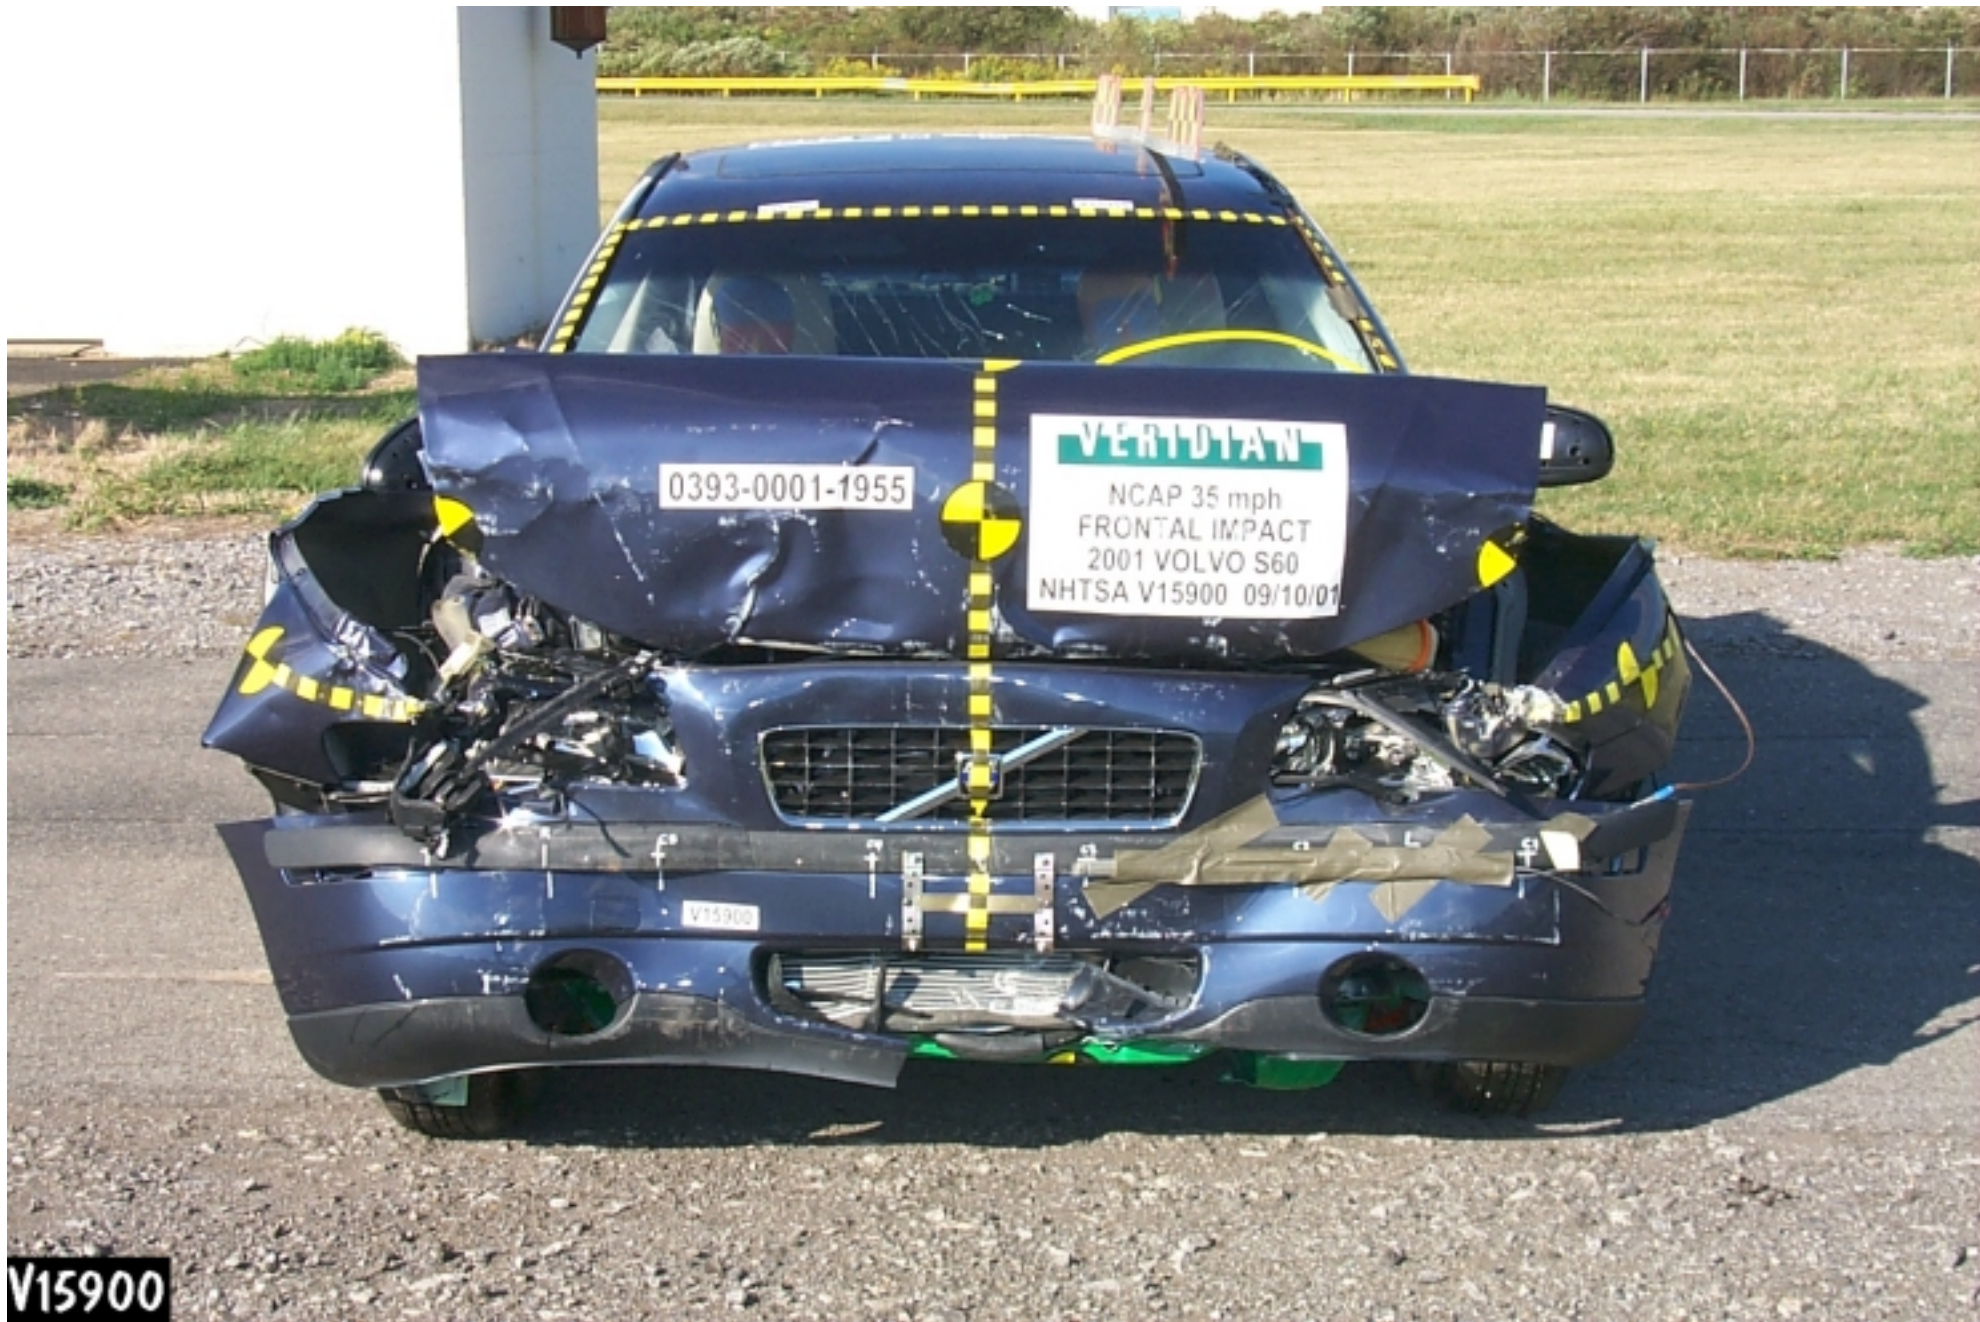
Figure A-3: POST-TEST FRONT VIEW.

The maximum static crush of the vehicle was 536 mm and both the driver and passenger side doors remained closed during the impact event and were operable after the impact.

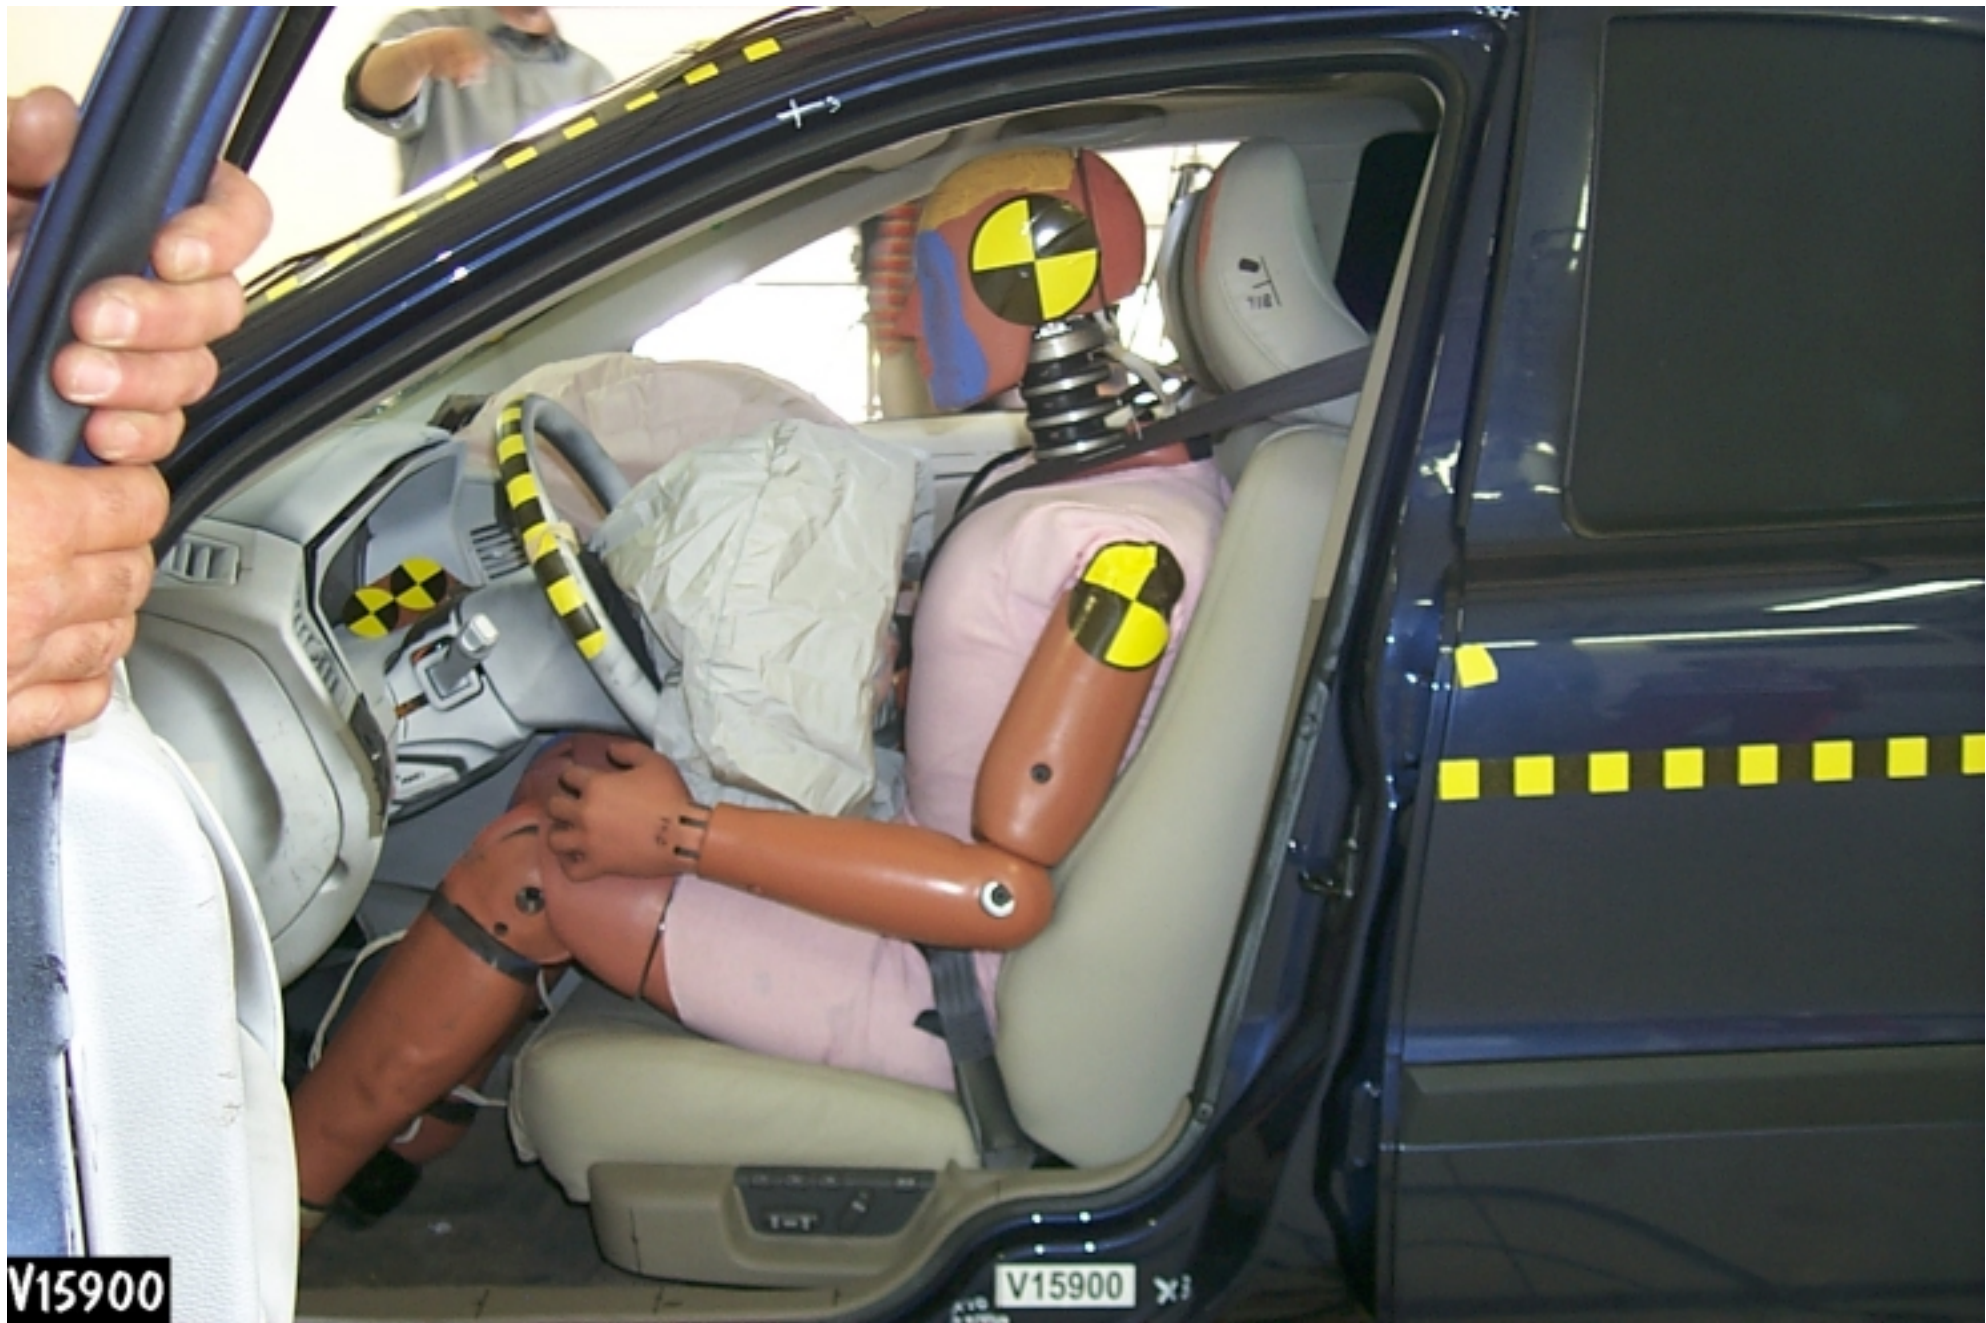
Figure A-23: POST-TEST DRIVER POSITION VIEW

The driver's visible contact points were as follows: Face to the upper centerline of the airbag, back of head to the outboard half of head restraint, chest to the lower half of the airbag, left knee to the knee bolster left of the steering column, and right knee to the knee bolster right of the steering column.

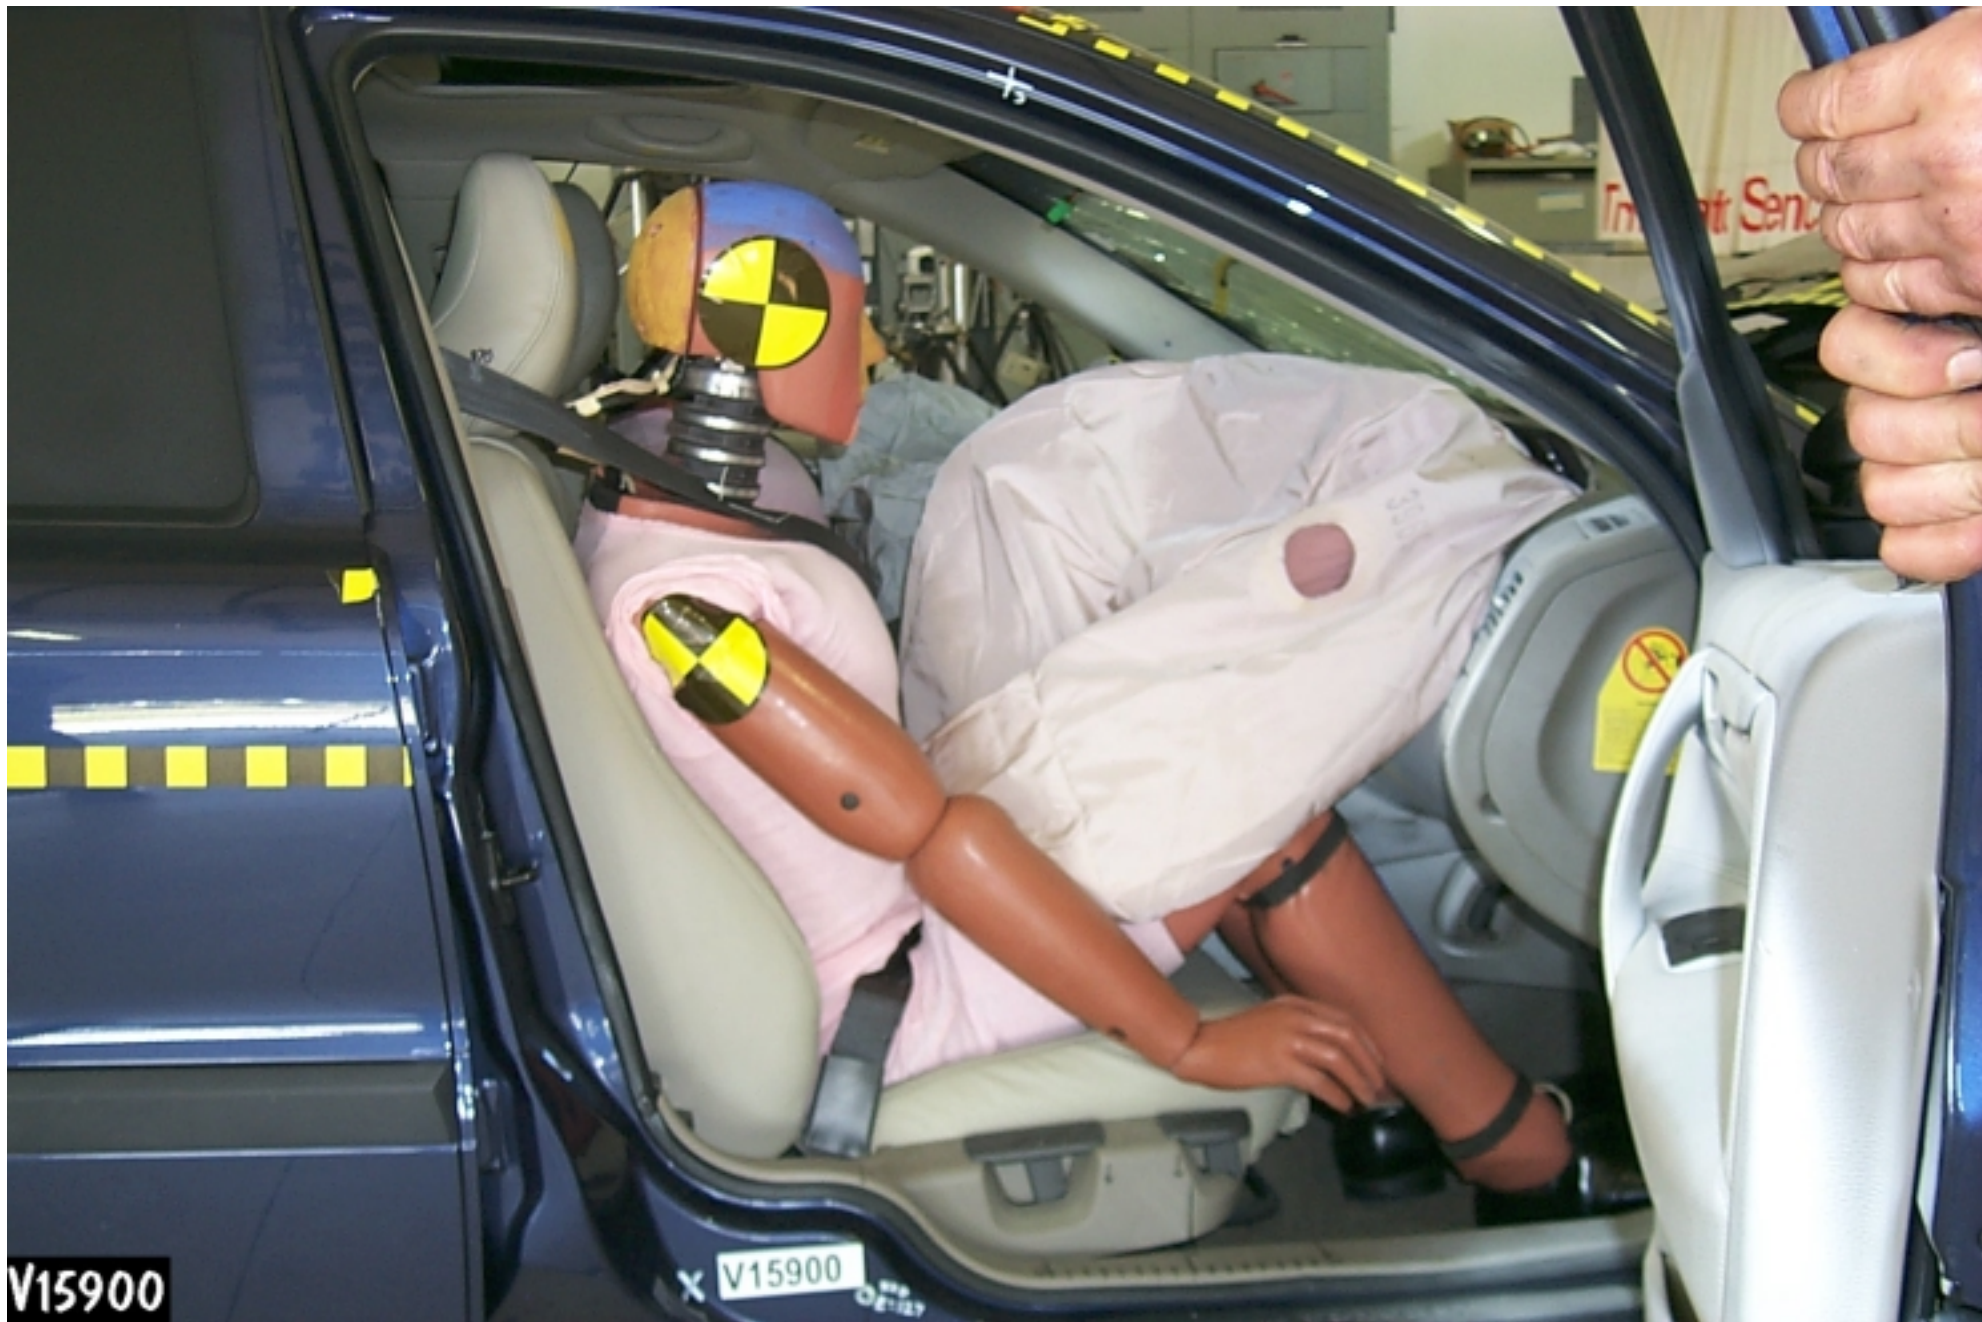
Figure A-25: POST-TEST PASSENGER POSITION VIEW

The passenger's visible contact points were as follows: Face to the right half of the airbag, back of head to the outboard half of the head restraint, chest to the lower half of the airbag, left knee to the left quarter of the glove compartment door, and right knee to the right third of the glove compartment door.
