REPORT NUMBER: SNCAP-CAL-01-9

**NEW CAR ASSESSMENT PROGRAM  
SIDE IMPACT TEST**

VOLVO GOTHENBERG SWEDEN  
2001 VOLVO S60  
4-DOOR SEDAN

VERIDIAN ENGINEERING TEST NUMBER: 8629-2

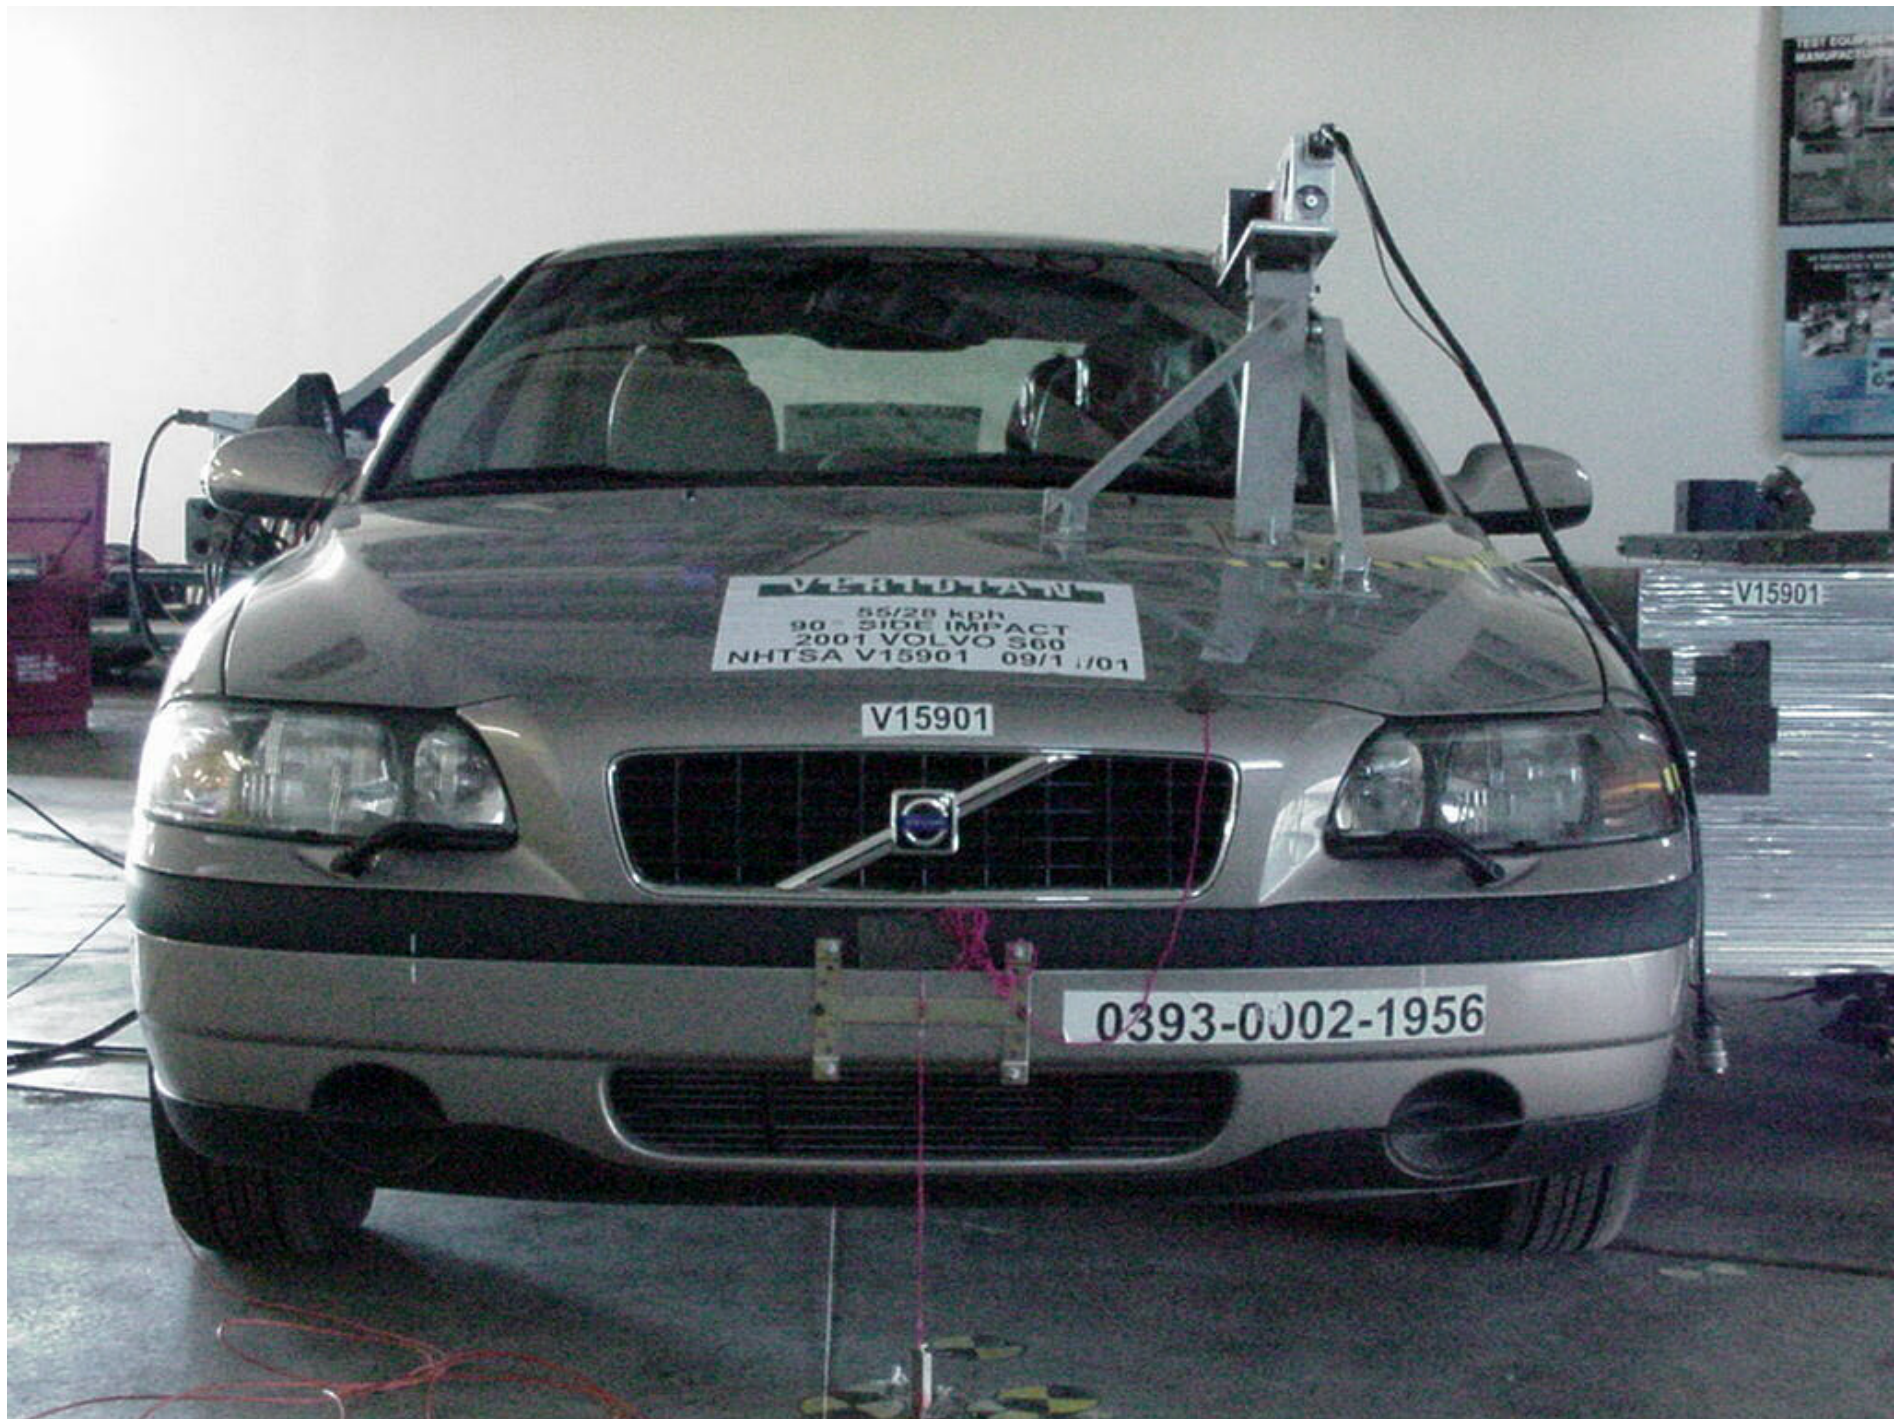
Figure A-1 PRE-TEST FRONTAL VIEW OF TEST VEHICLE

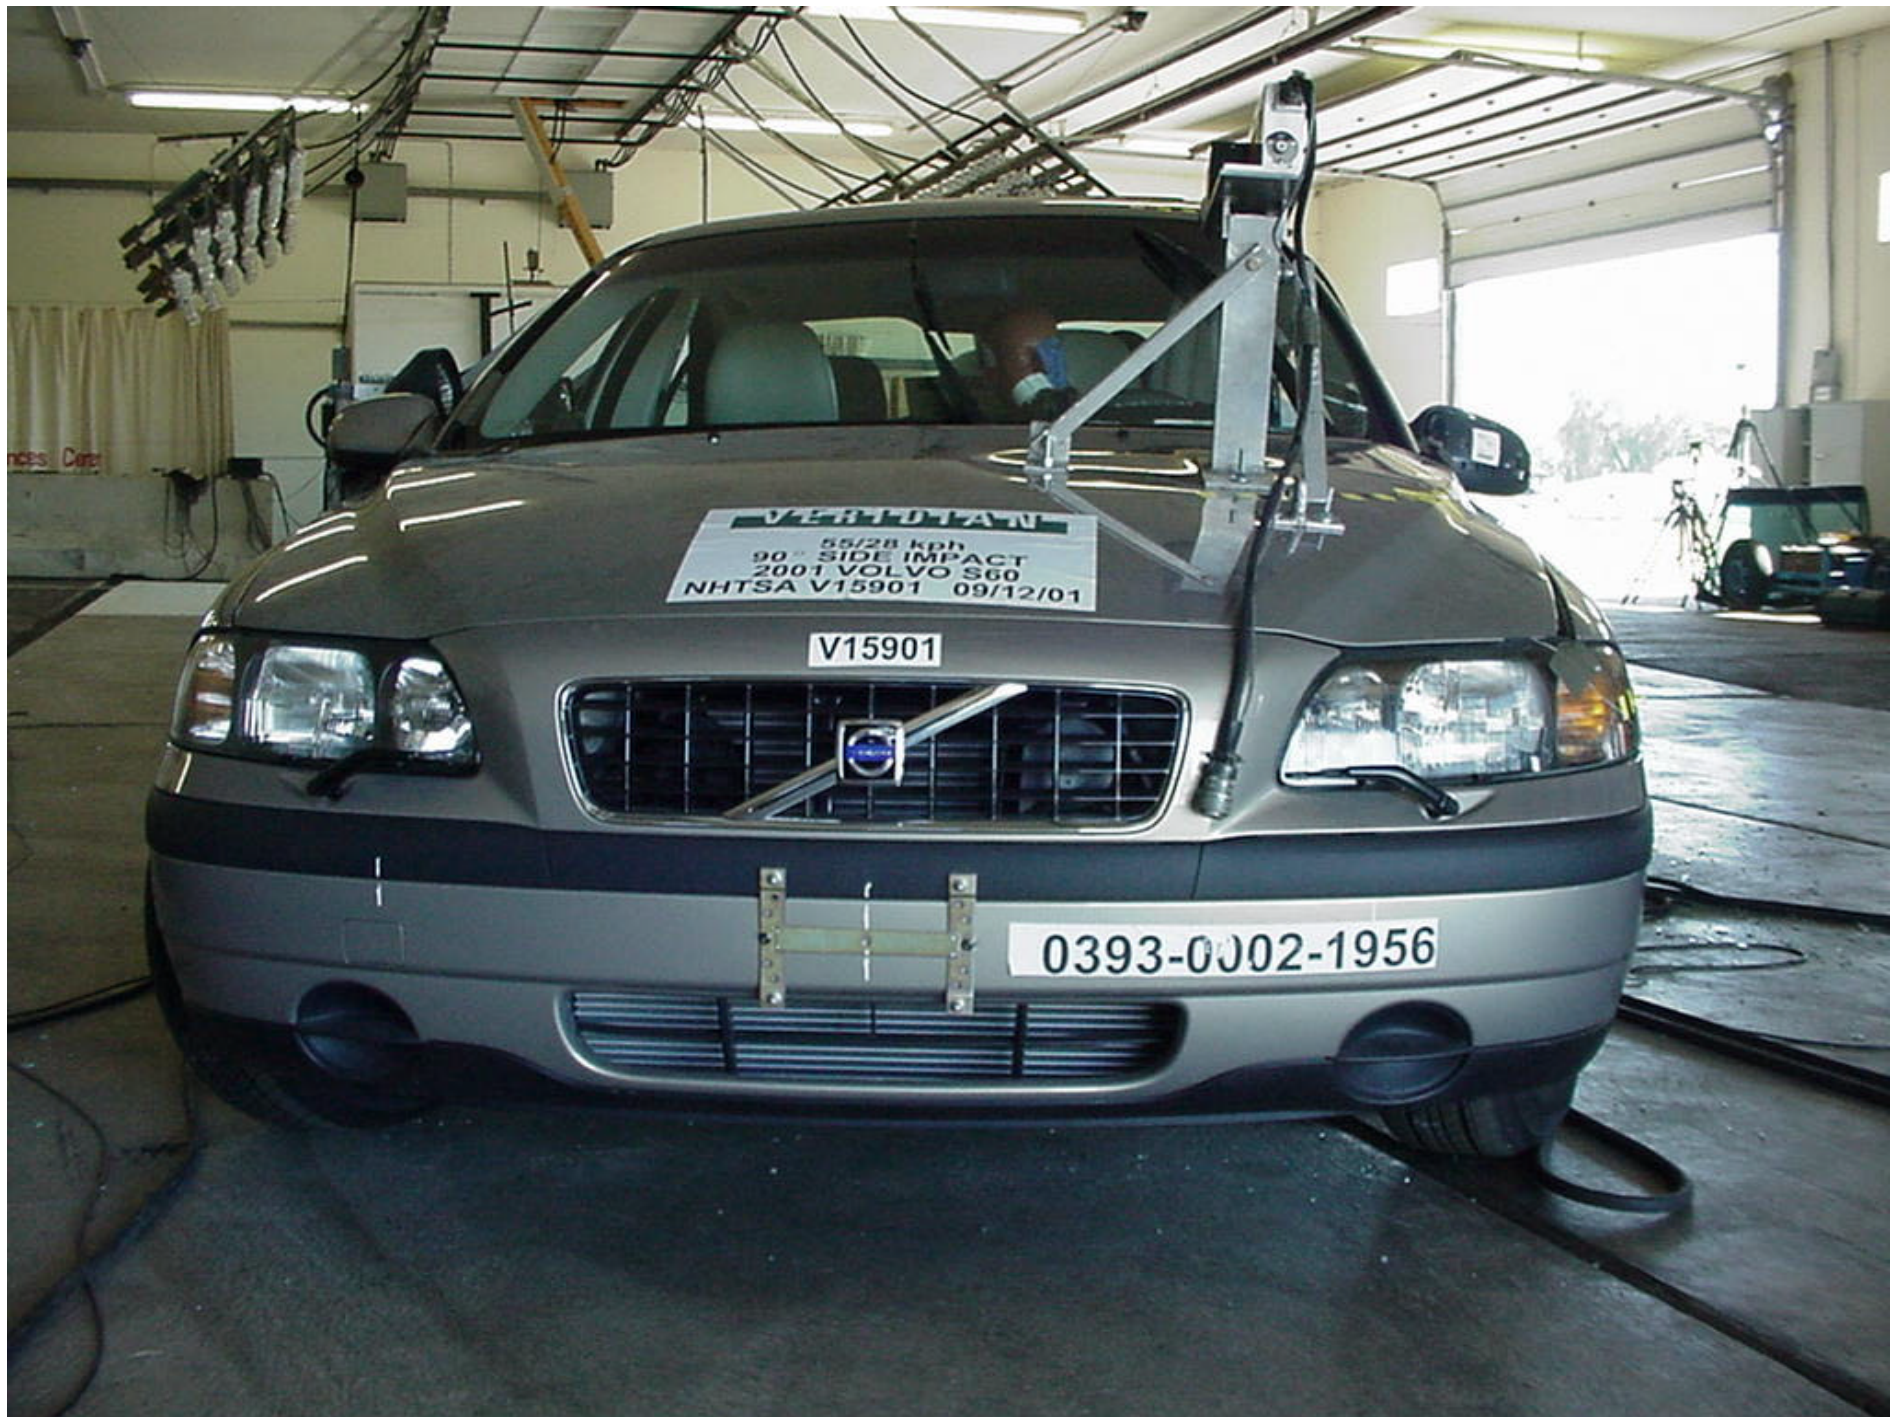
Figure A-2 POST-TEST FRONTAL VIEW OF TEST VEHICLE

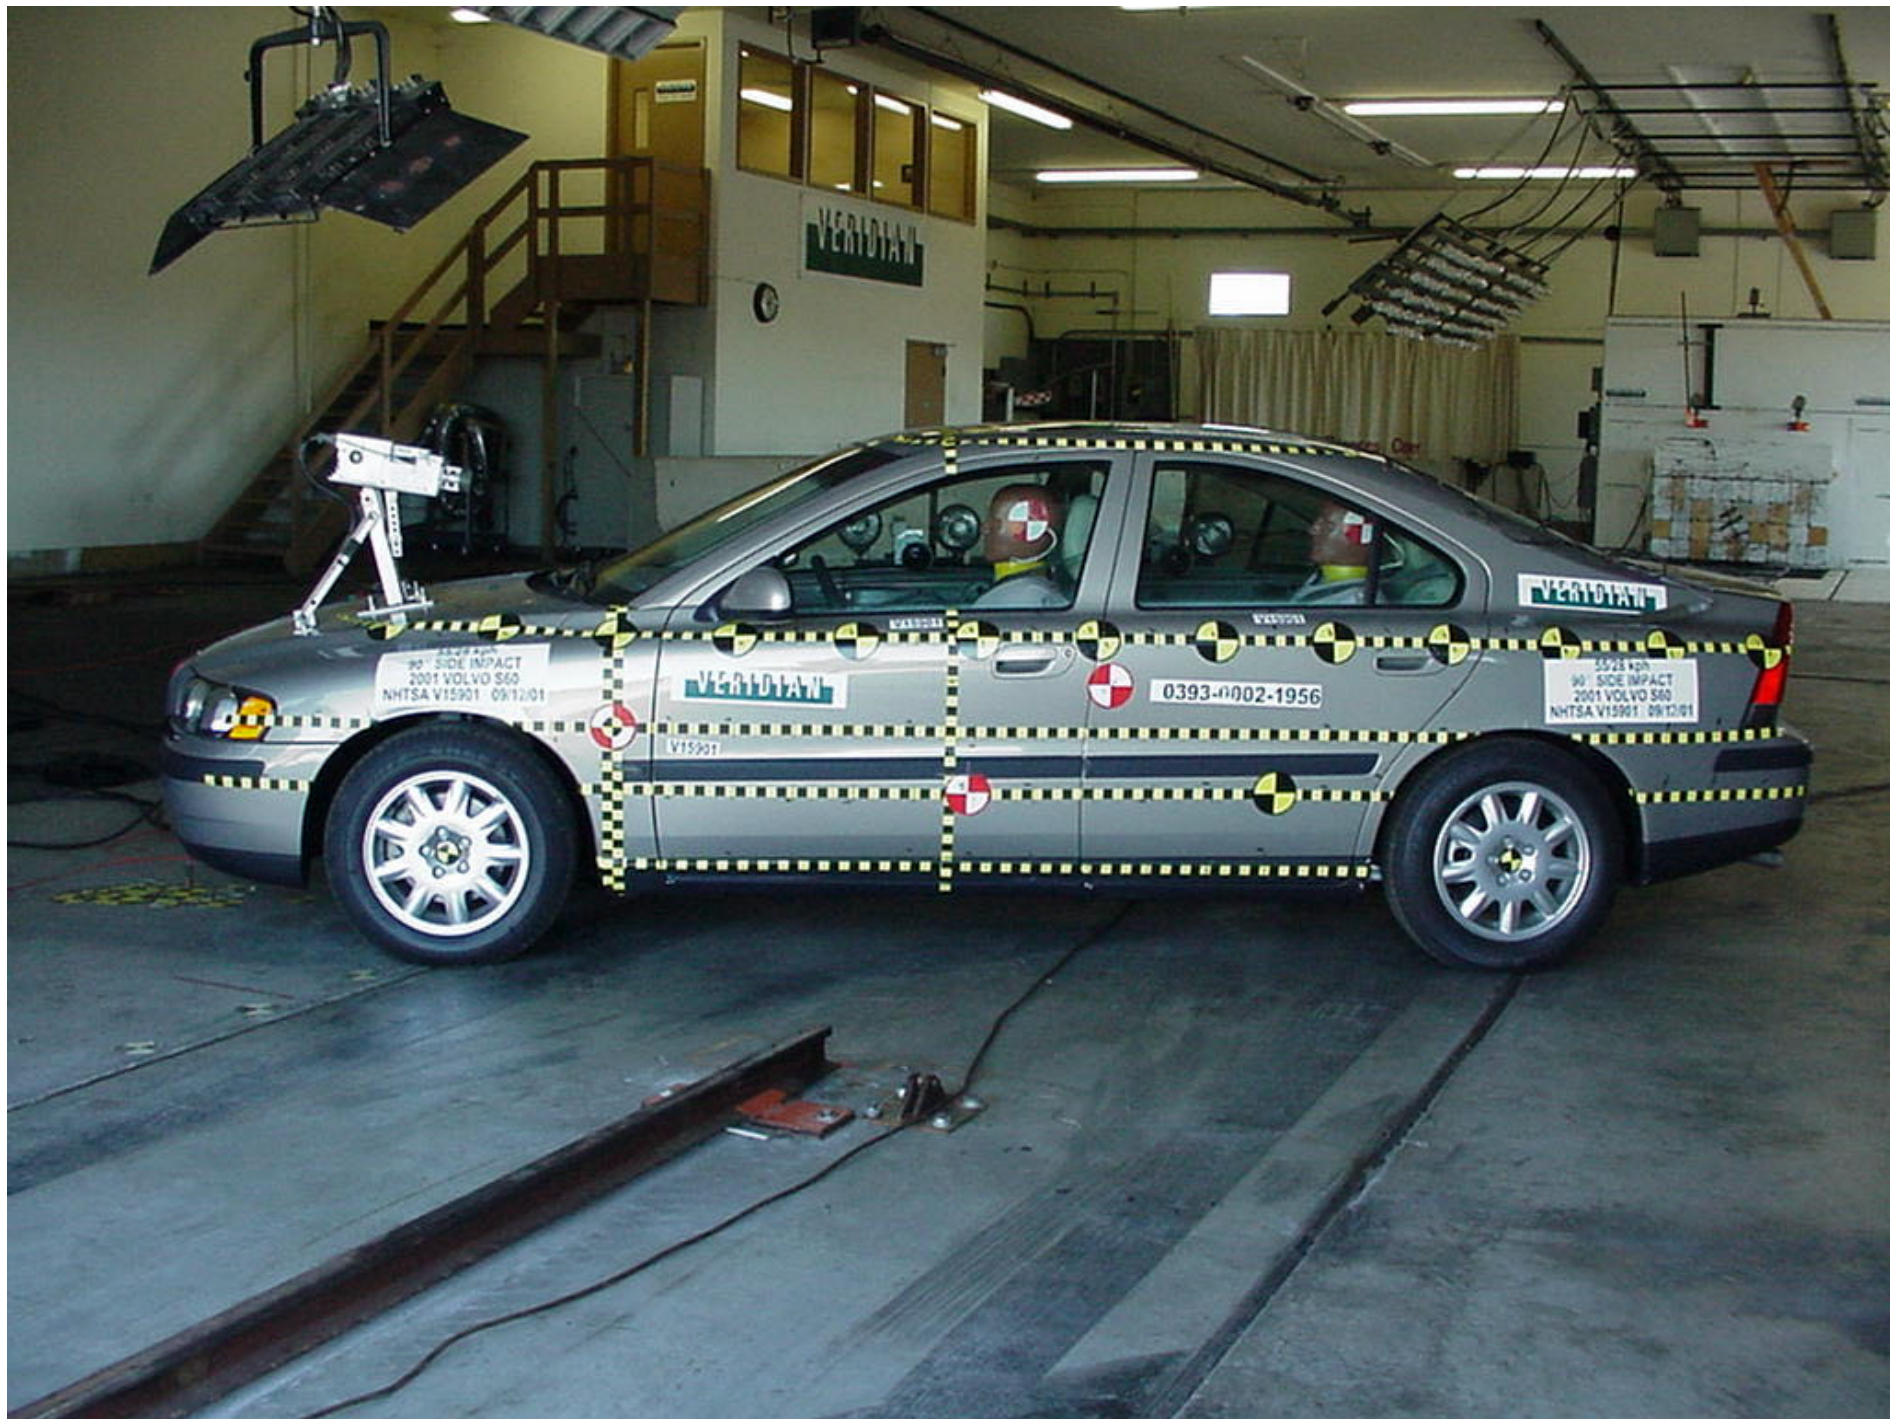
Figure A-5 PRE-TEST IMPACTED SIDE VIEW OF TEST VEHICLE

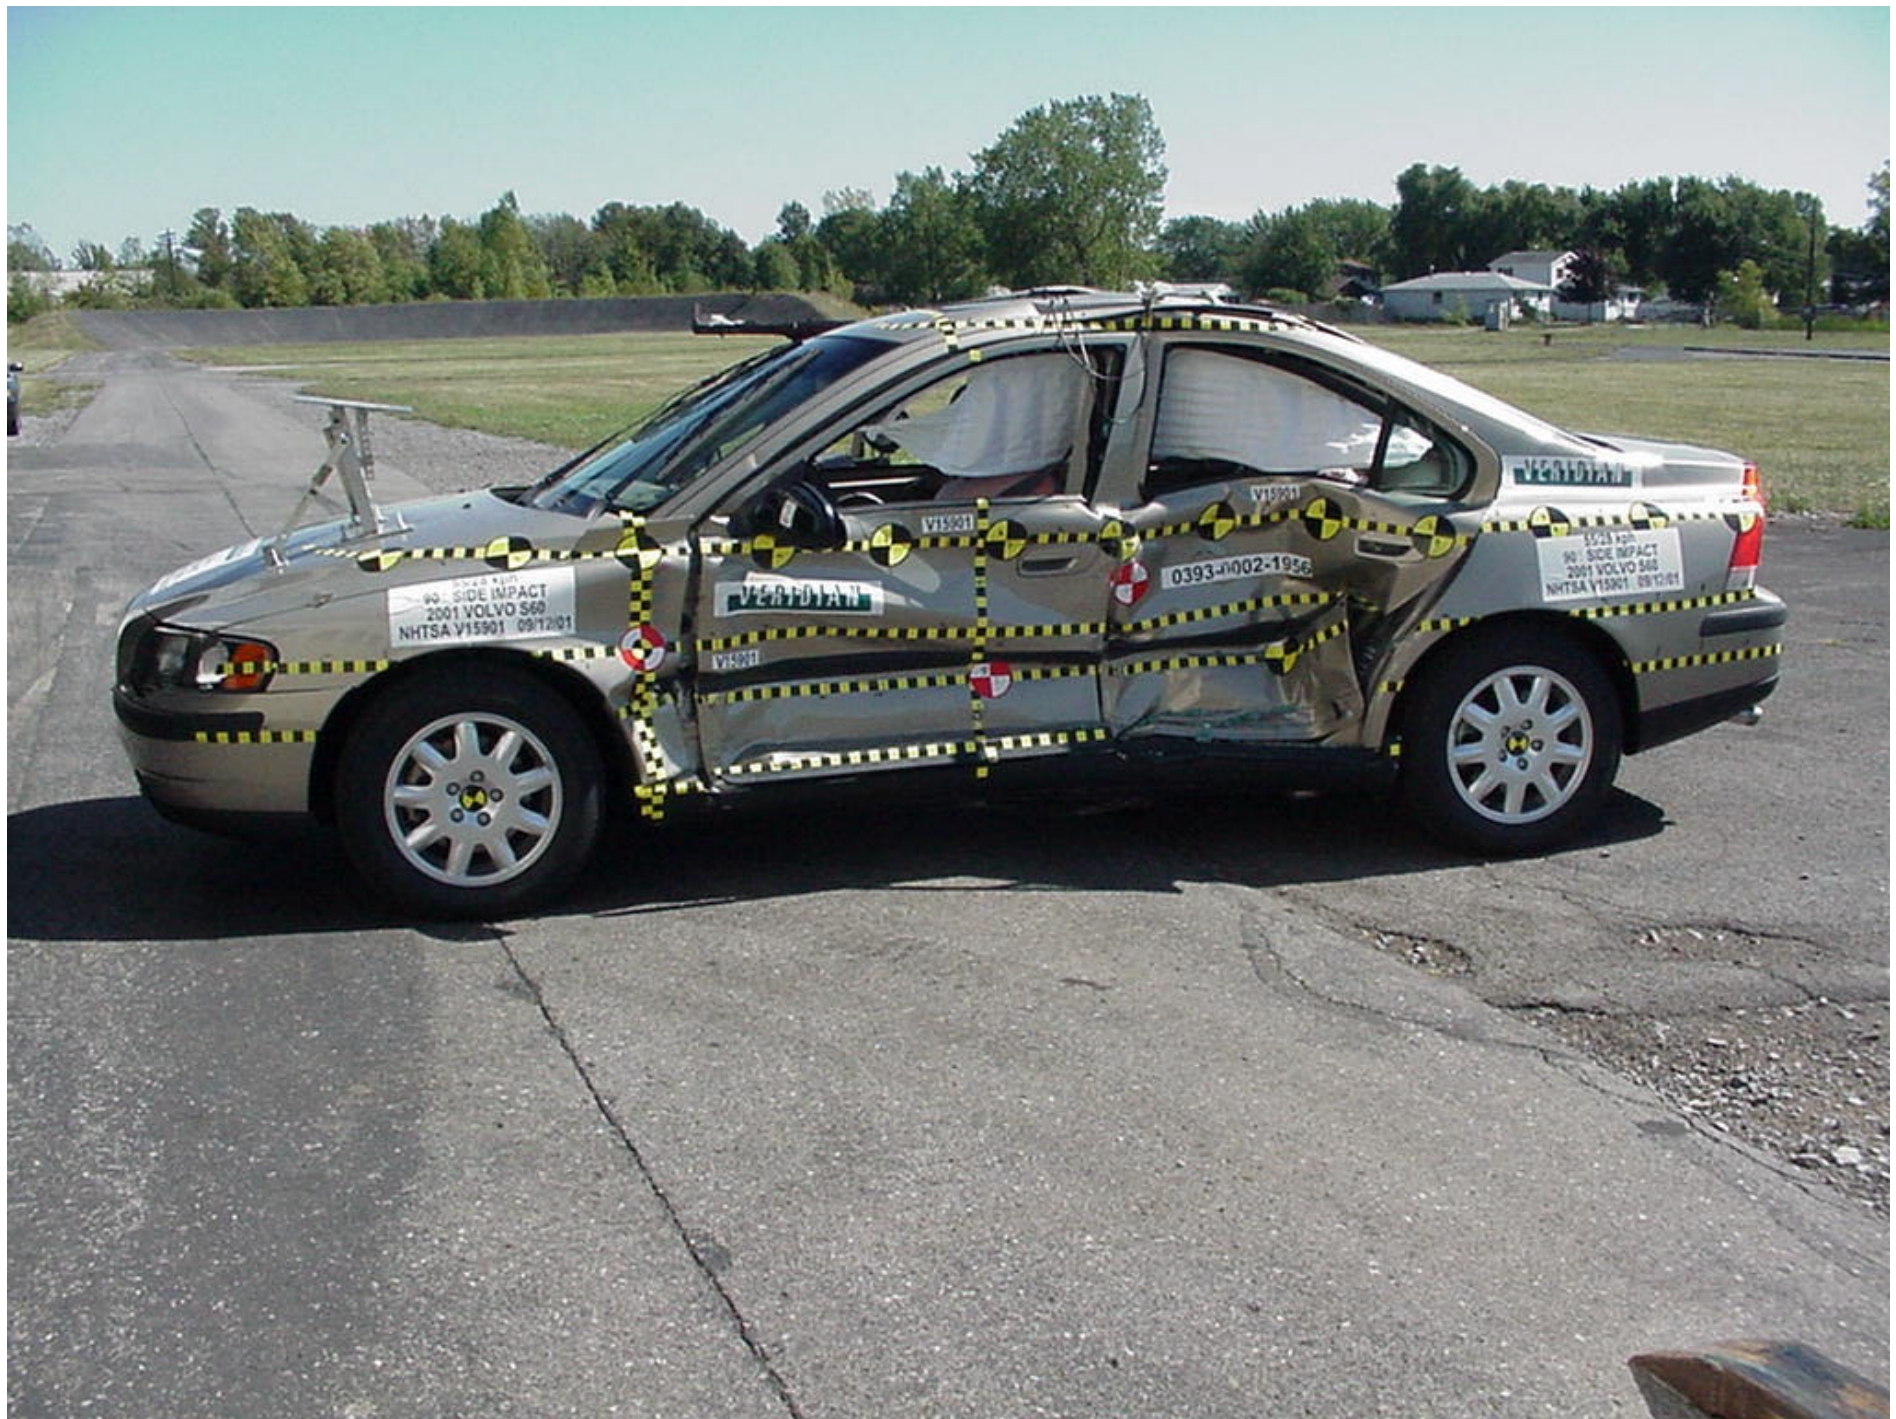
Figure A-6 POST-TEST IMPACTED SIDE VIEW OF TEST VEHICLE

Windshield: Cracked along lower A-Pillar  
Window: Side glass shattered upon impact

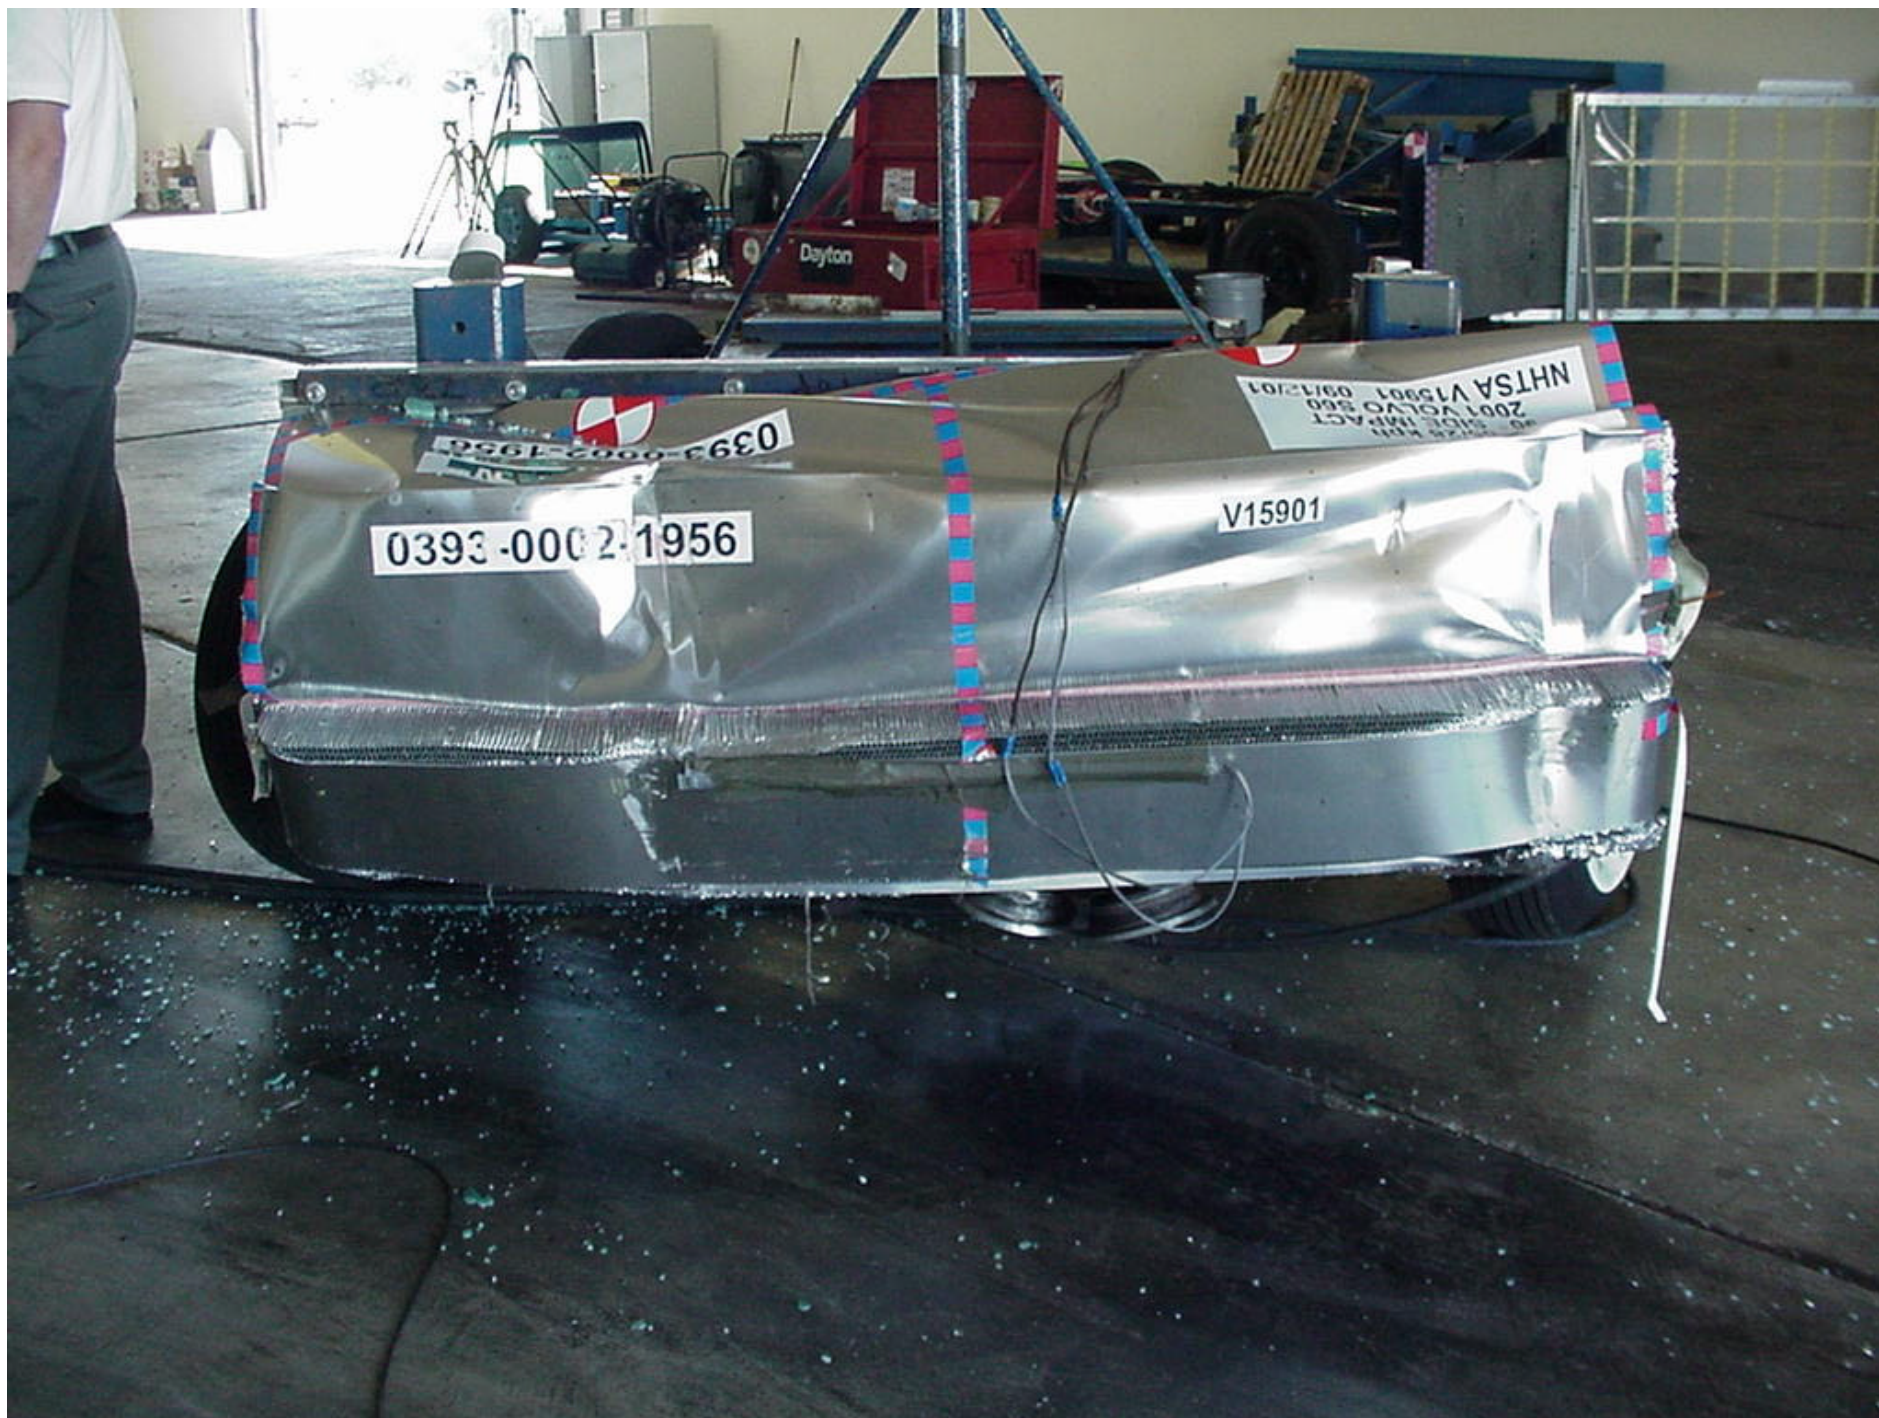
Figure A-8 POST-TEST FRONTAL VIEW OF IMPACTOR FACE

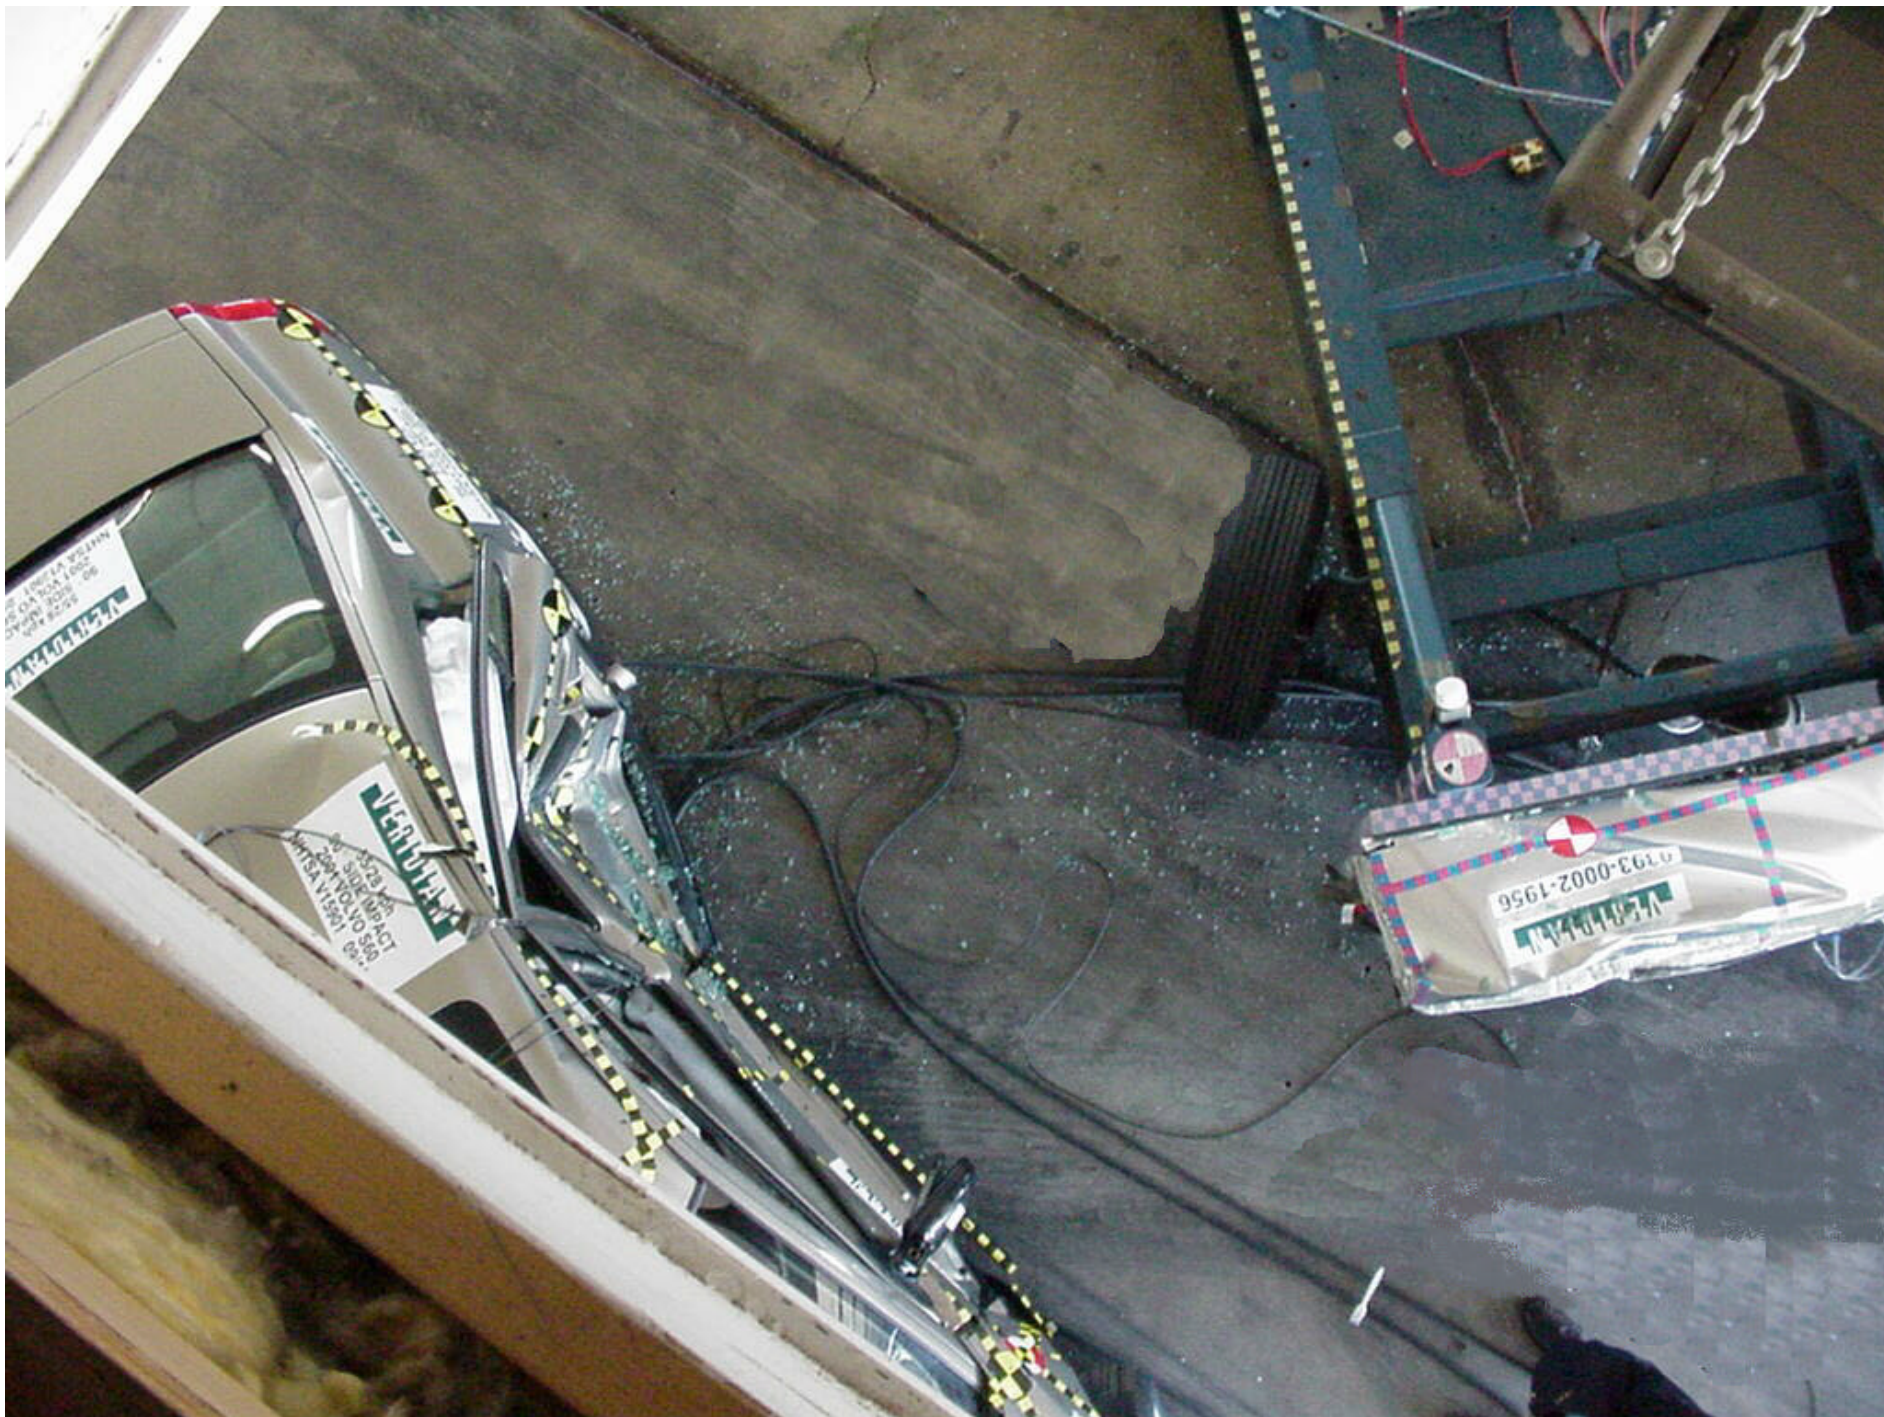
Figure A-16 POST-TEST OVERHEAD VIEW OF MDB AND VEHICLE

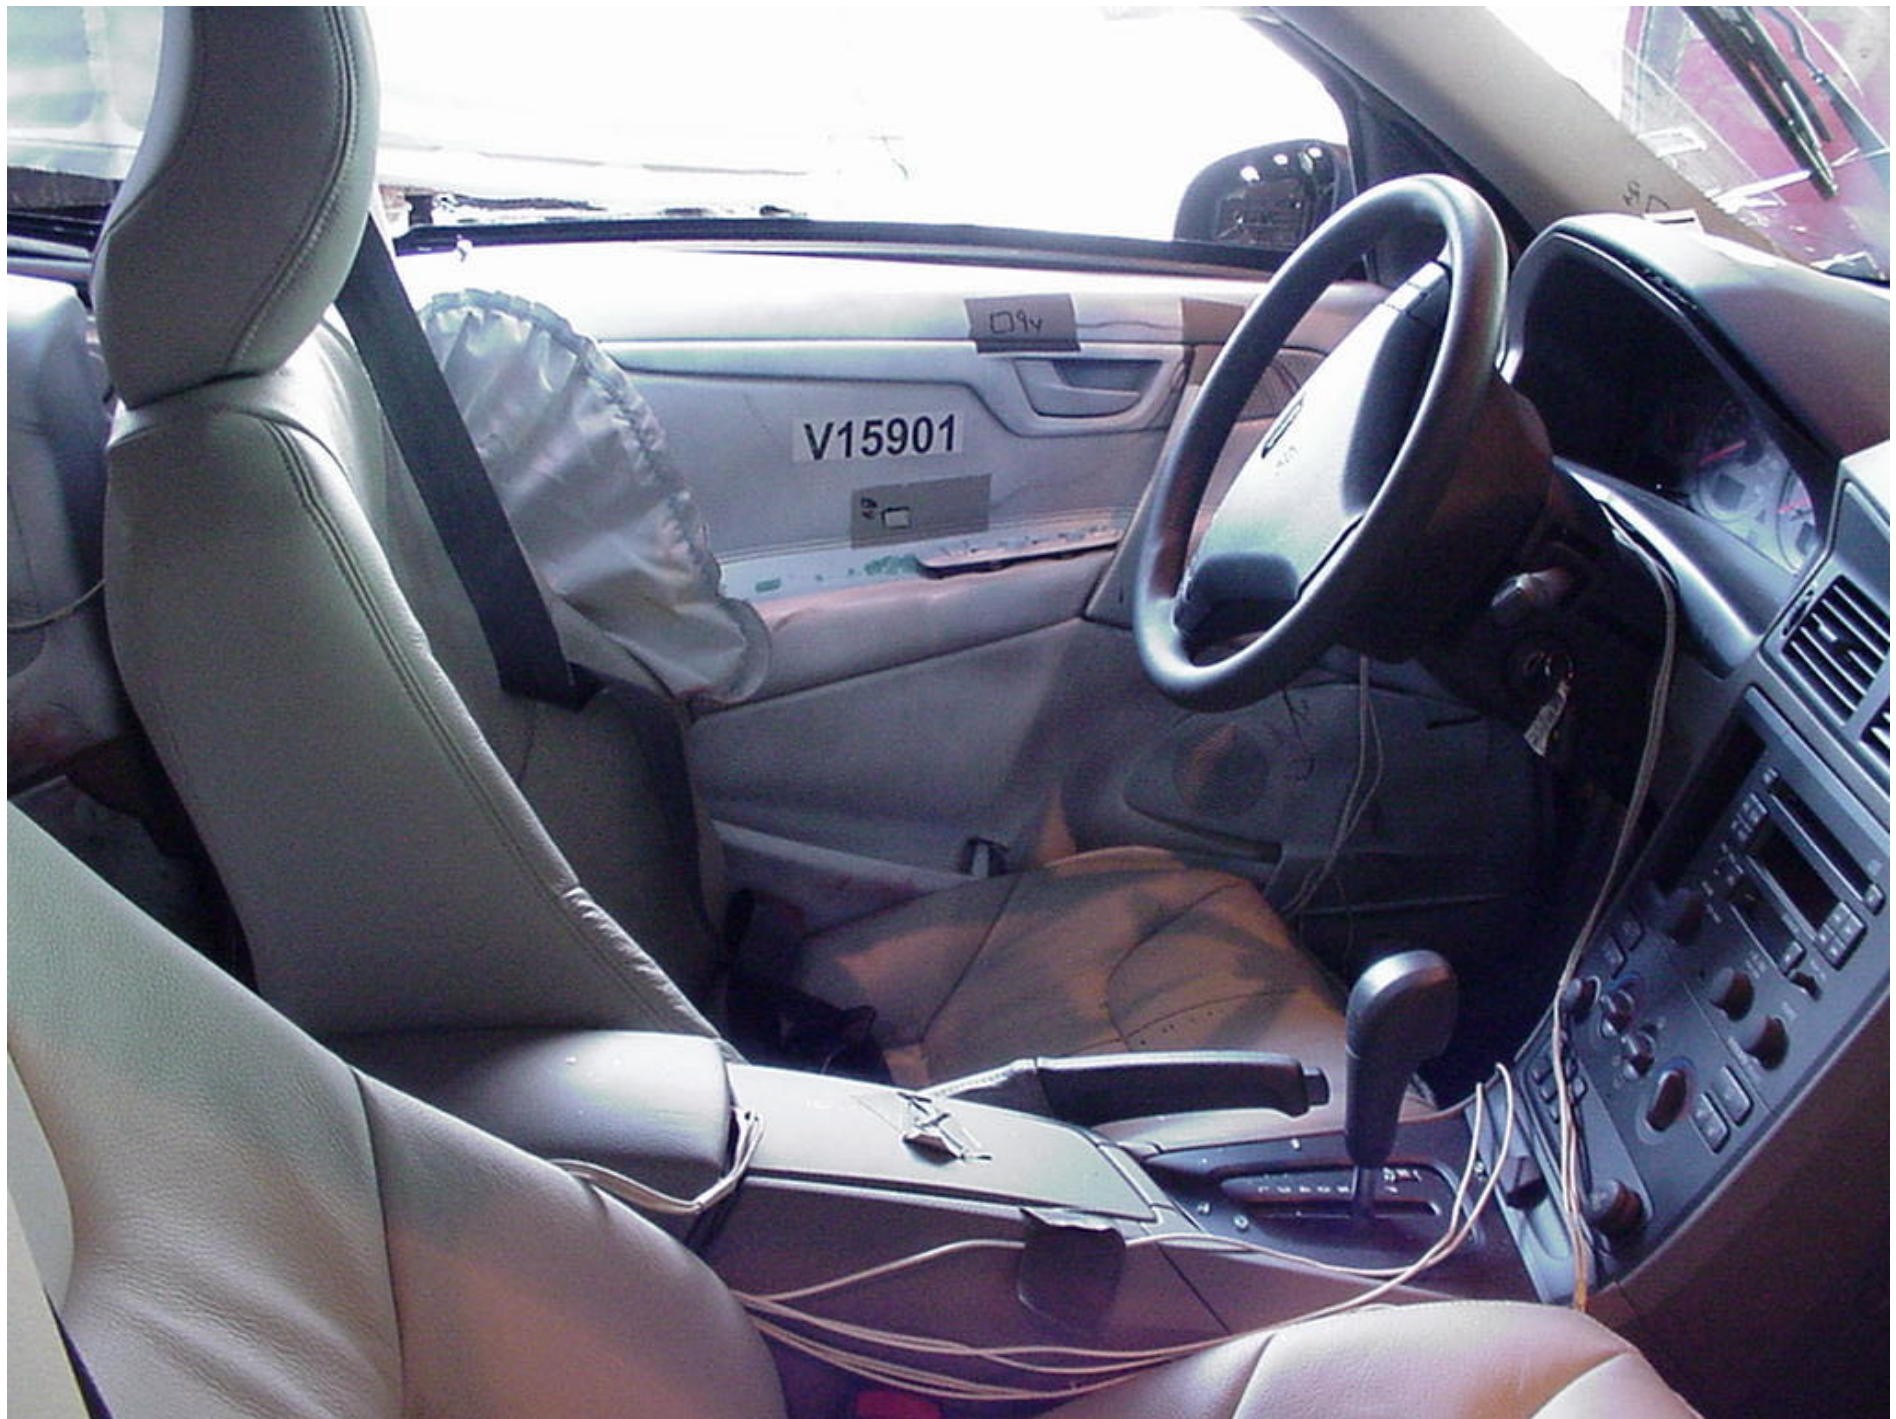
Figure A-26 POST-TEST INTERIOR OF FRONT DOOR SHOWING SID IMPACT LOCATIONS

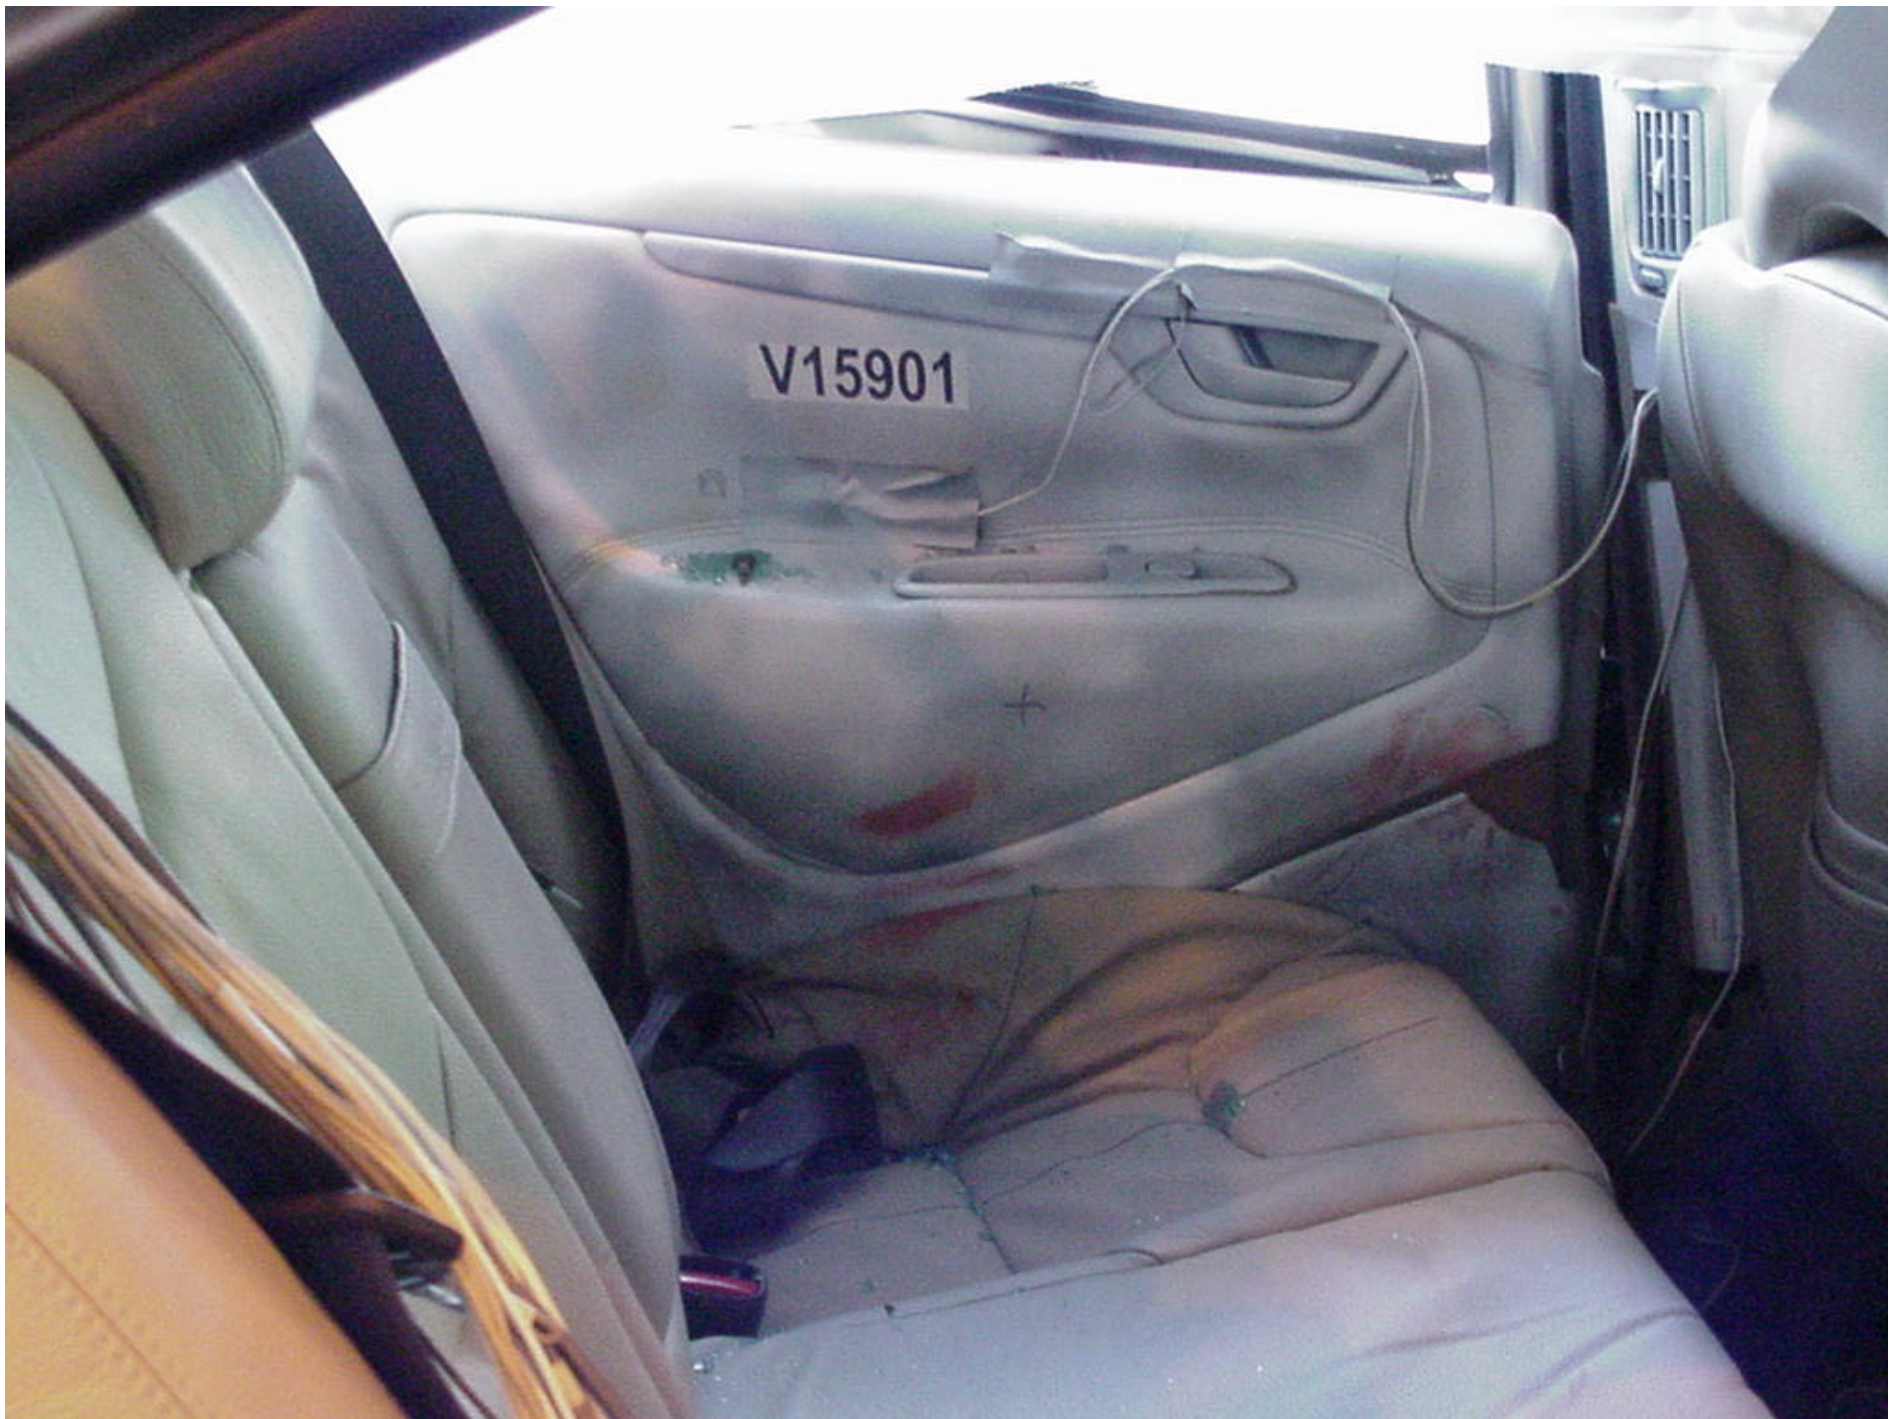
Figure A-28 POST-TEST INTERIOR OF REAR DOOR SHOWING SID IMPACT LOCATIONS
