REPORT NUMBER: SNCAP-CAL-01-9

**NEW CAR ASSESSMENT PROGRAM  
SIDE IMPACT TEST**

VOLVO GOTHENBERG SWEDEN  
2001 VOLVO S60  
4-DOOR SEDAN

VERIDIAN ENGINEERING TEST NUMBER: 8629-2

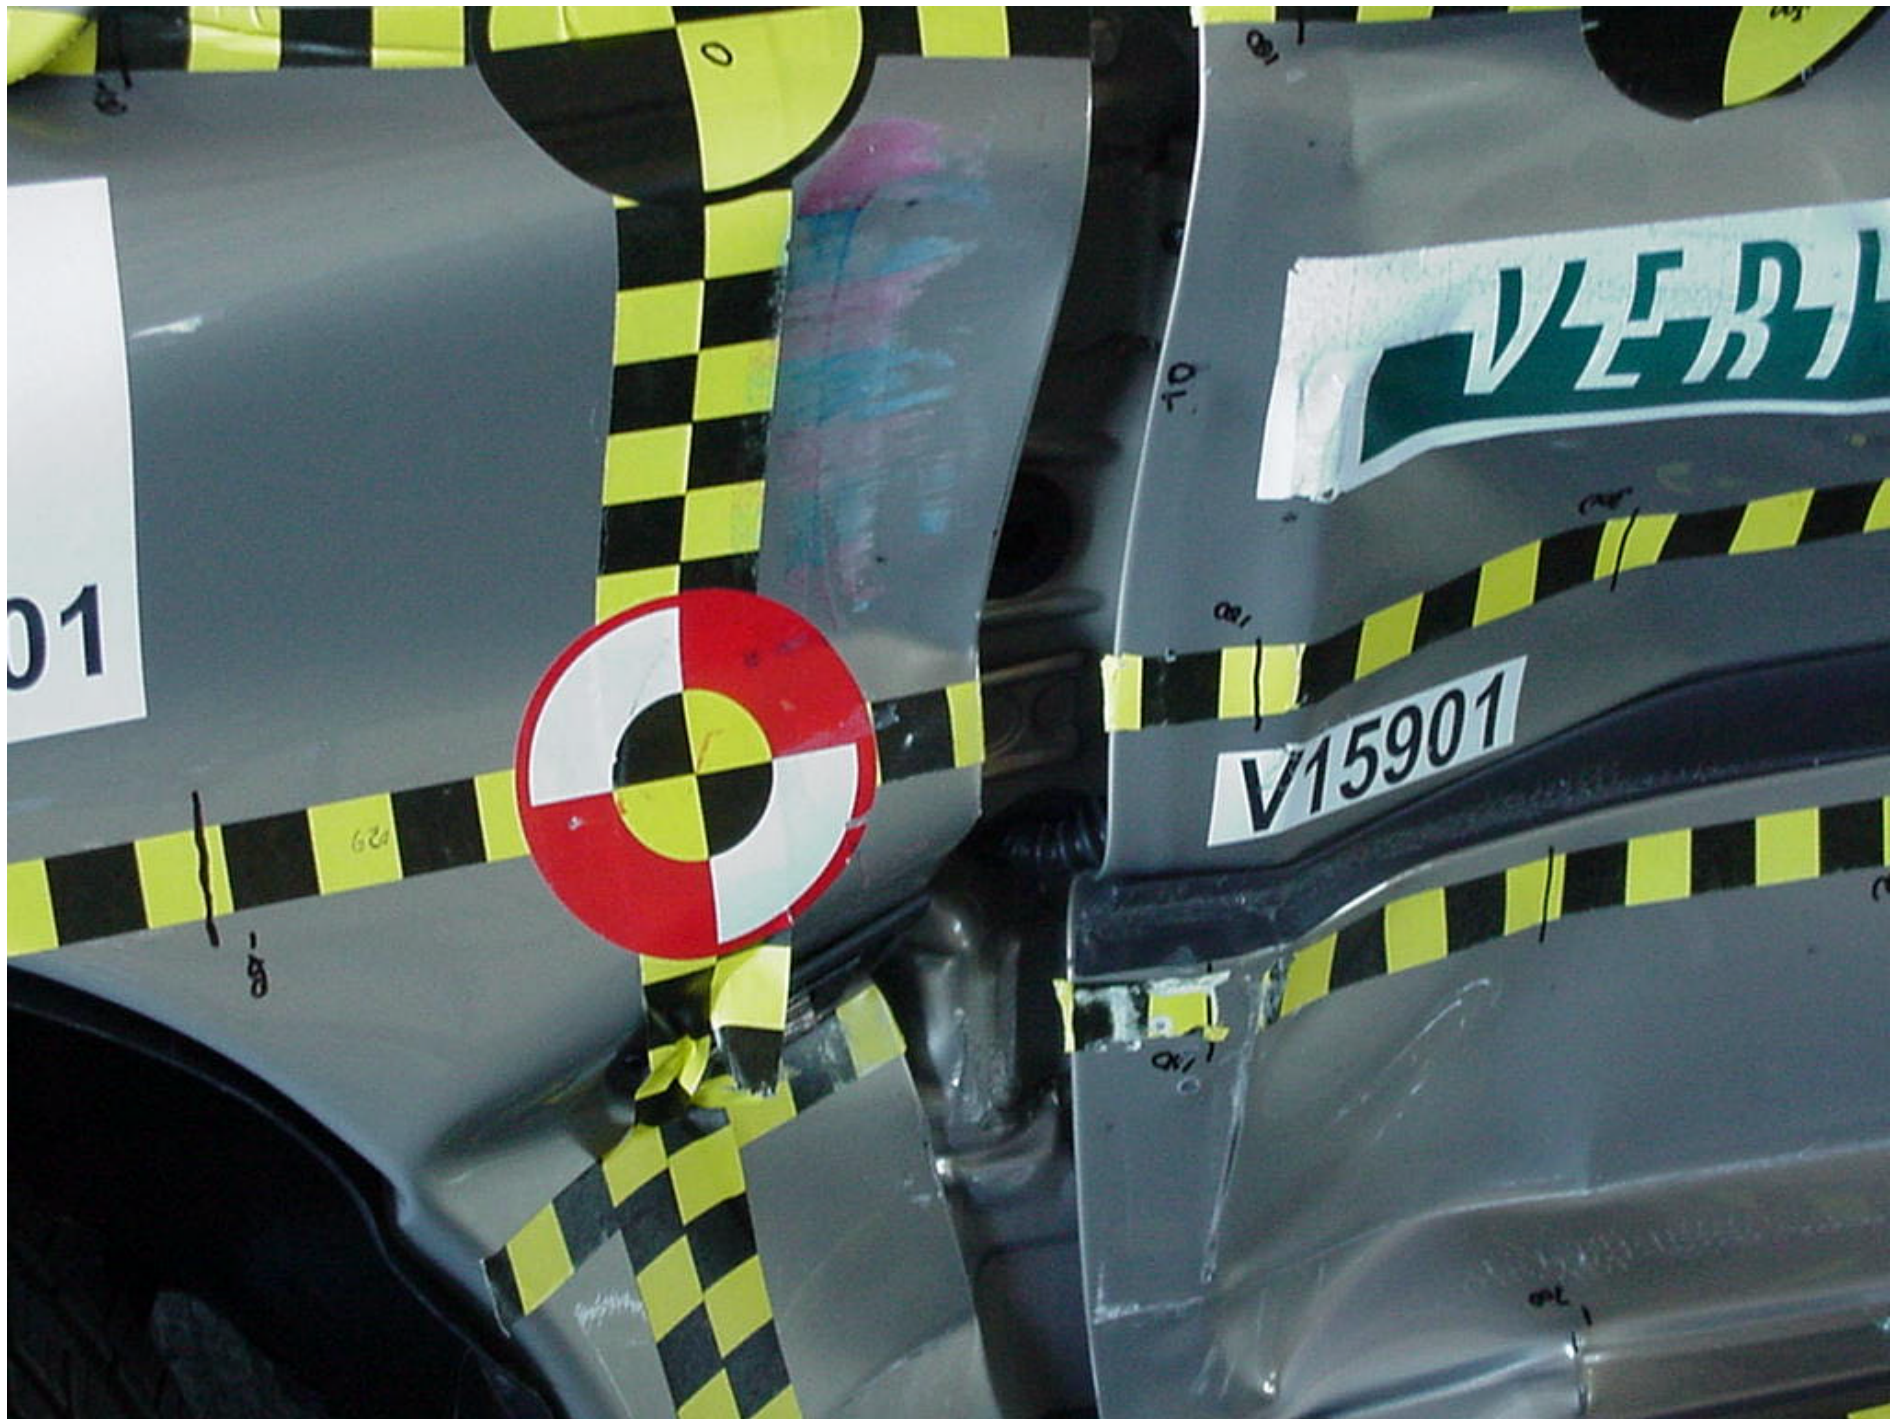
Figure A-31 POST-TEST CLOSE-UP VIEW OF IMPACT POINT TARGET

Actual Impact Point is 40 mm Forward of nominal impact ref. line (Lateral)

Actual Impact Point is 7 mm Below nominal impact point (Vertical)

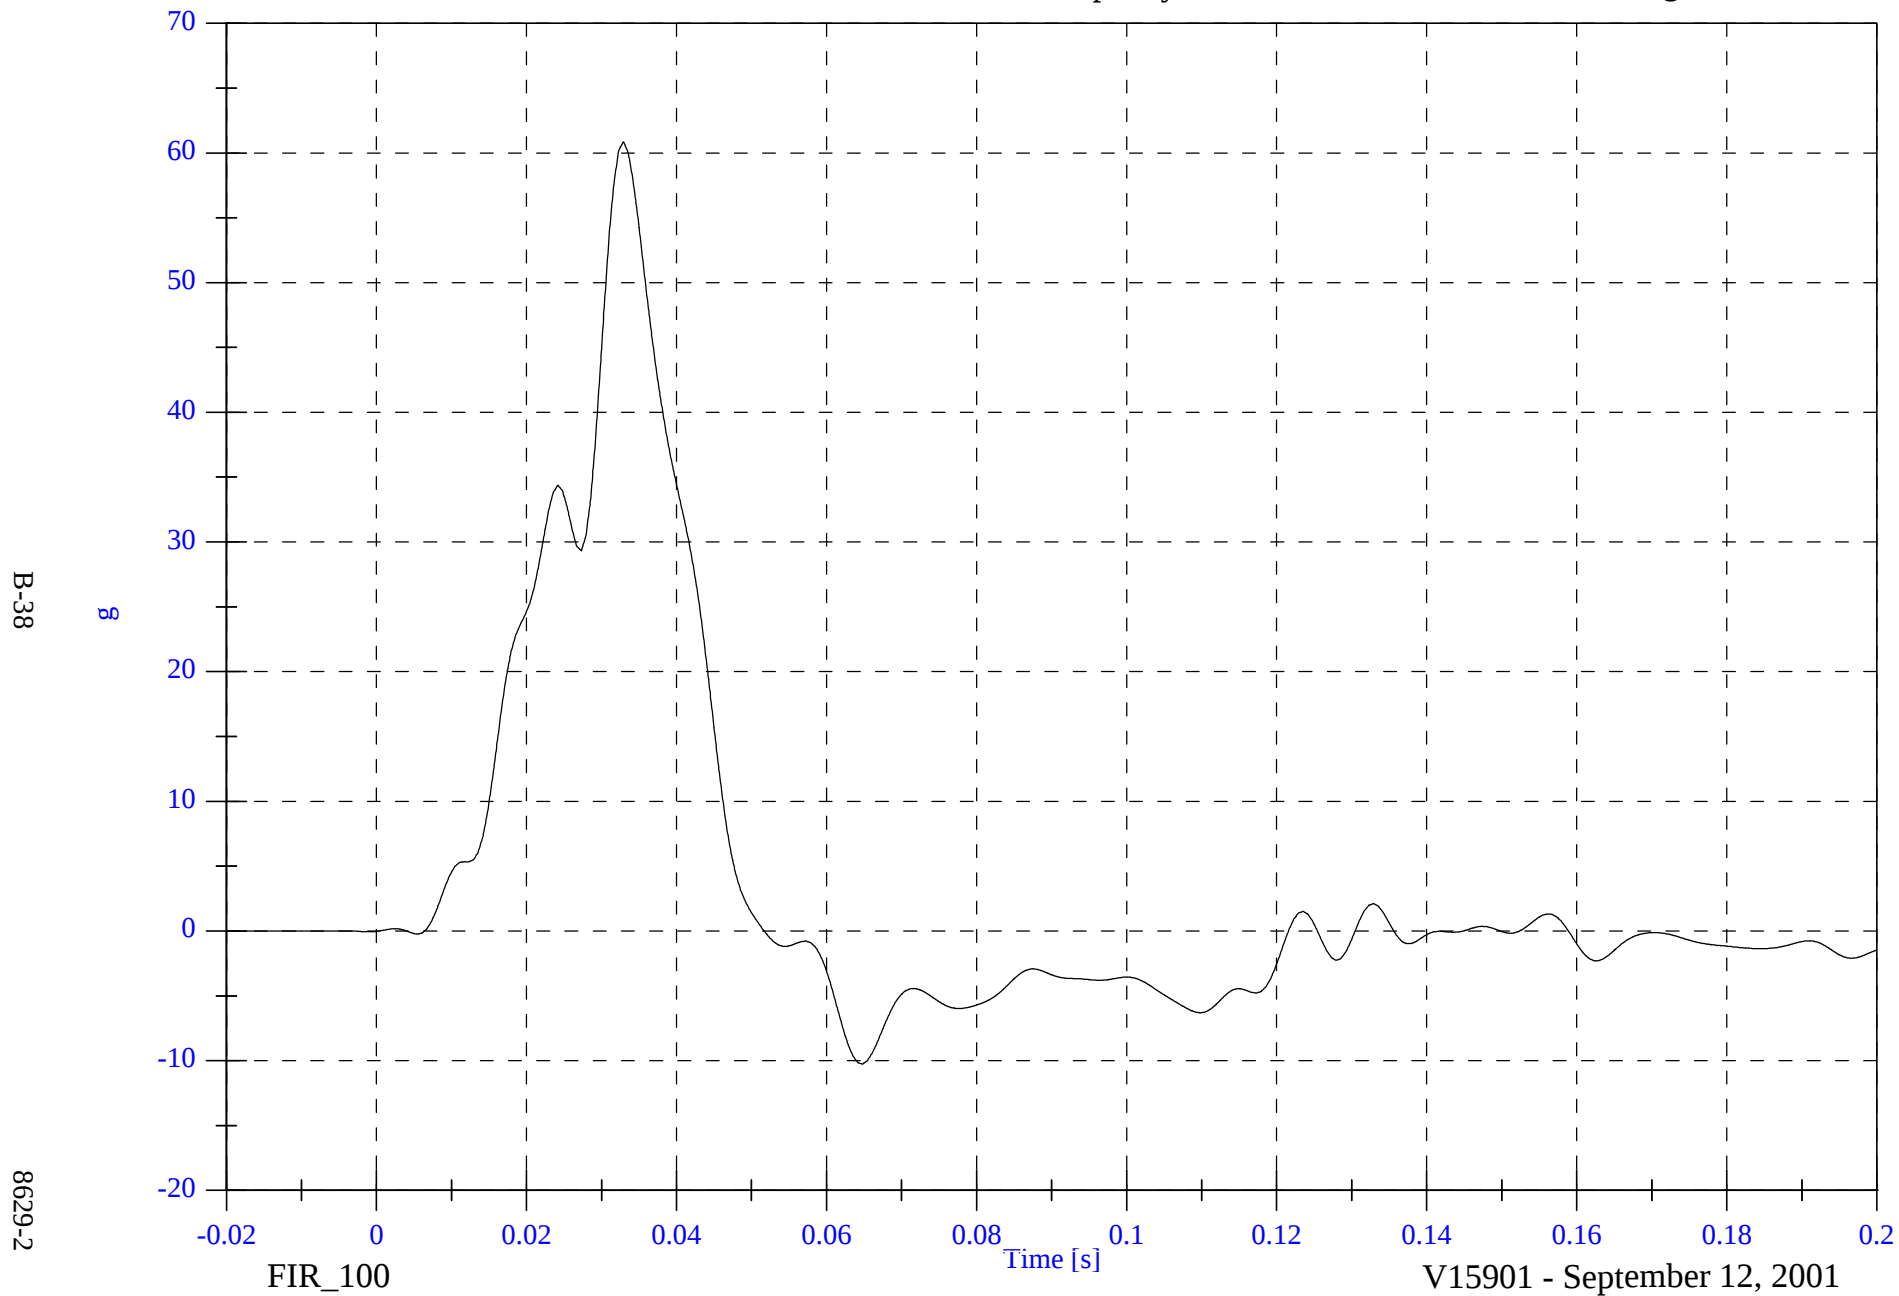
Optional SNCAP 2001 Volvo S60

P1 Pelvic y

Max: 67.4 [g] at 0.025 [s]

Min: -15.0 [g] at 0.064 [s]

<table><tr> <th></th> <th align="center"><u>Front SID</u></th> <th></th> <th align="center"><u>Rear SID</u></th> <th></th> </tr><tr> <td>Pelvis Acceleration (PEV):</td> <td align="center">67</td> <td align="center">g's</td> <td align="center">73</td> <td align="center">g's</td> </tr></table>
