**REPORT NUMBER KAR22003-01**

**NEW CAR ASSESSMENT PROGRAM  
SIDE IMPACT TEST**

**GENERAL MOTORS CORPORATION  
2002 CHEVROLET TRAILBLAZER LS  
4WD SUV**

**FINAL REPORT**

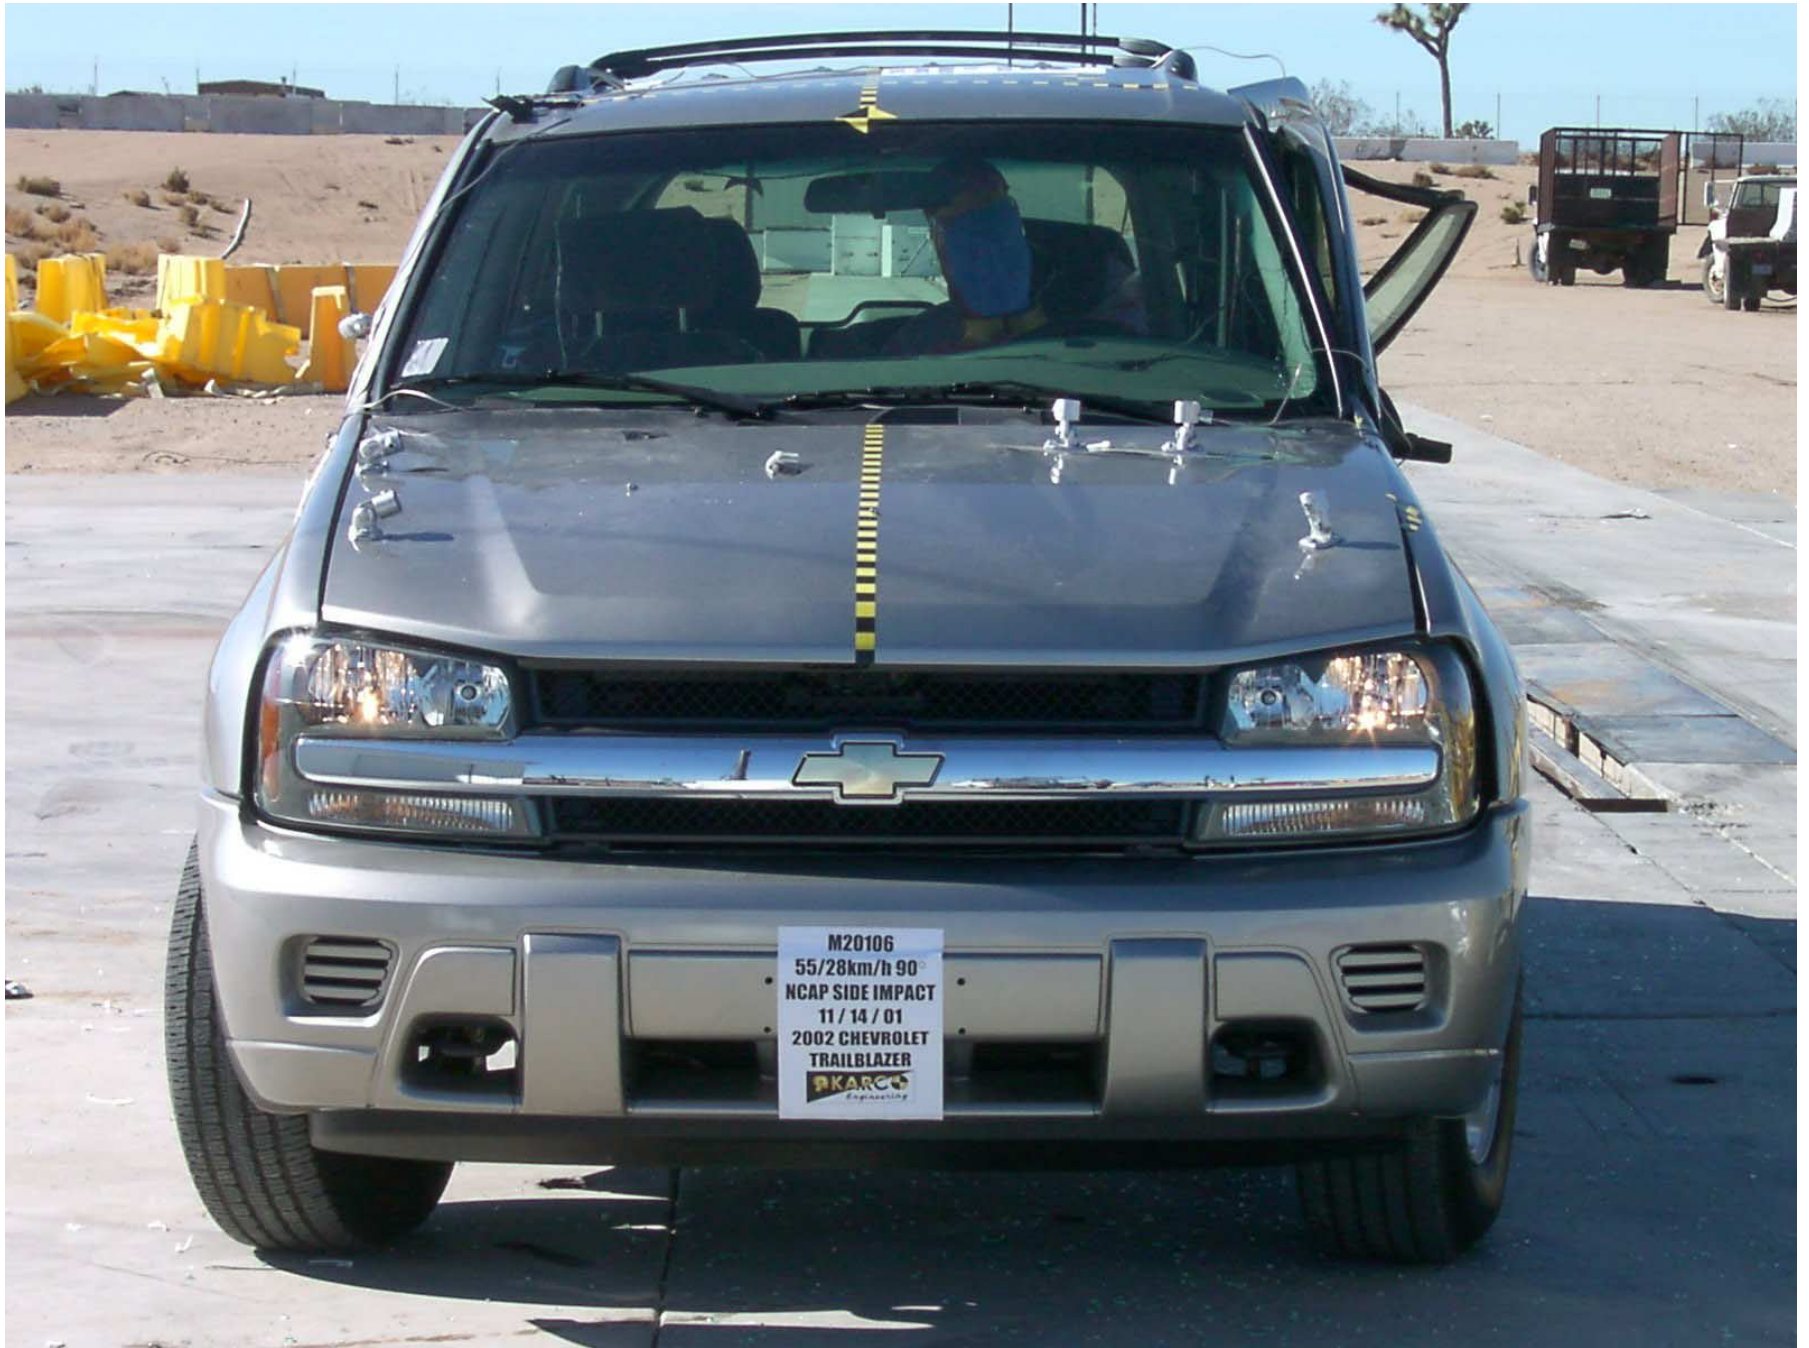
Figure A-6: Front View, Post-Test

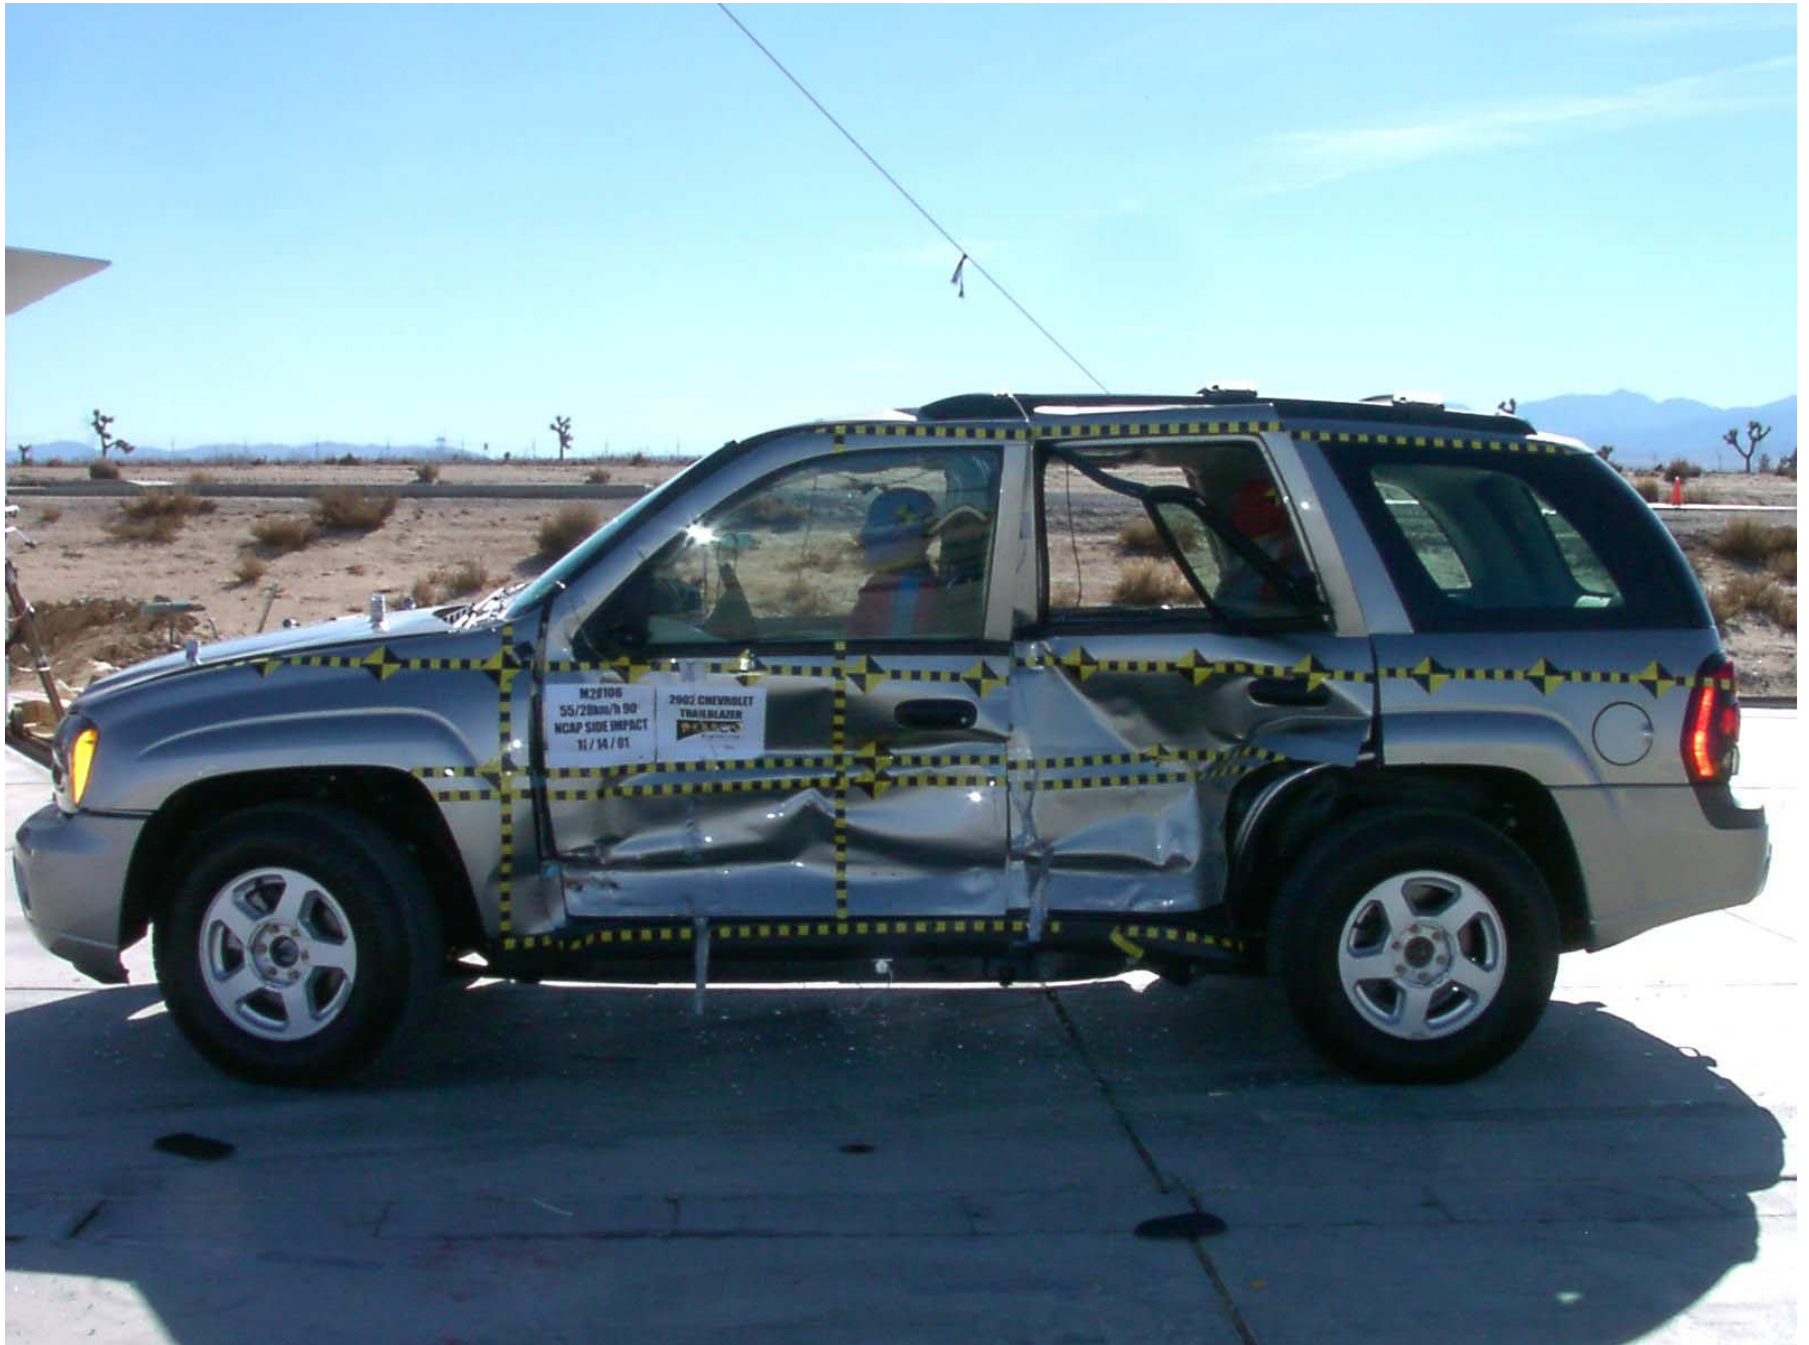
Figure A-10: Left (Impacted) Side View, Post-Test

The test vehicle sustained a maximum static crush of 285 mm at level 3, 1650mm rearward of the left vertical impact point. The driver SID, Serial No. 275 and the passenger SID, Serial No. 274 were calibrated just prior to this test. The SID injury criteria is summarized as follows:

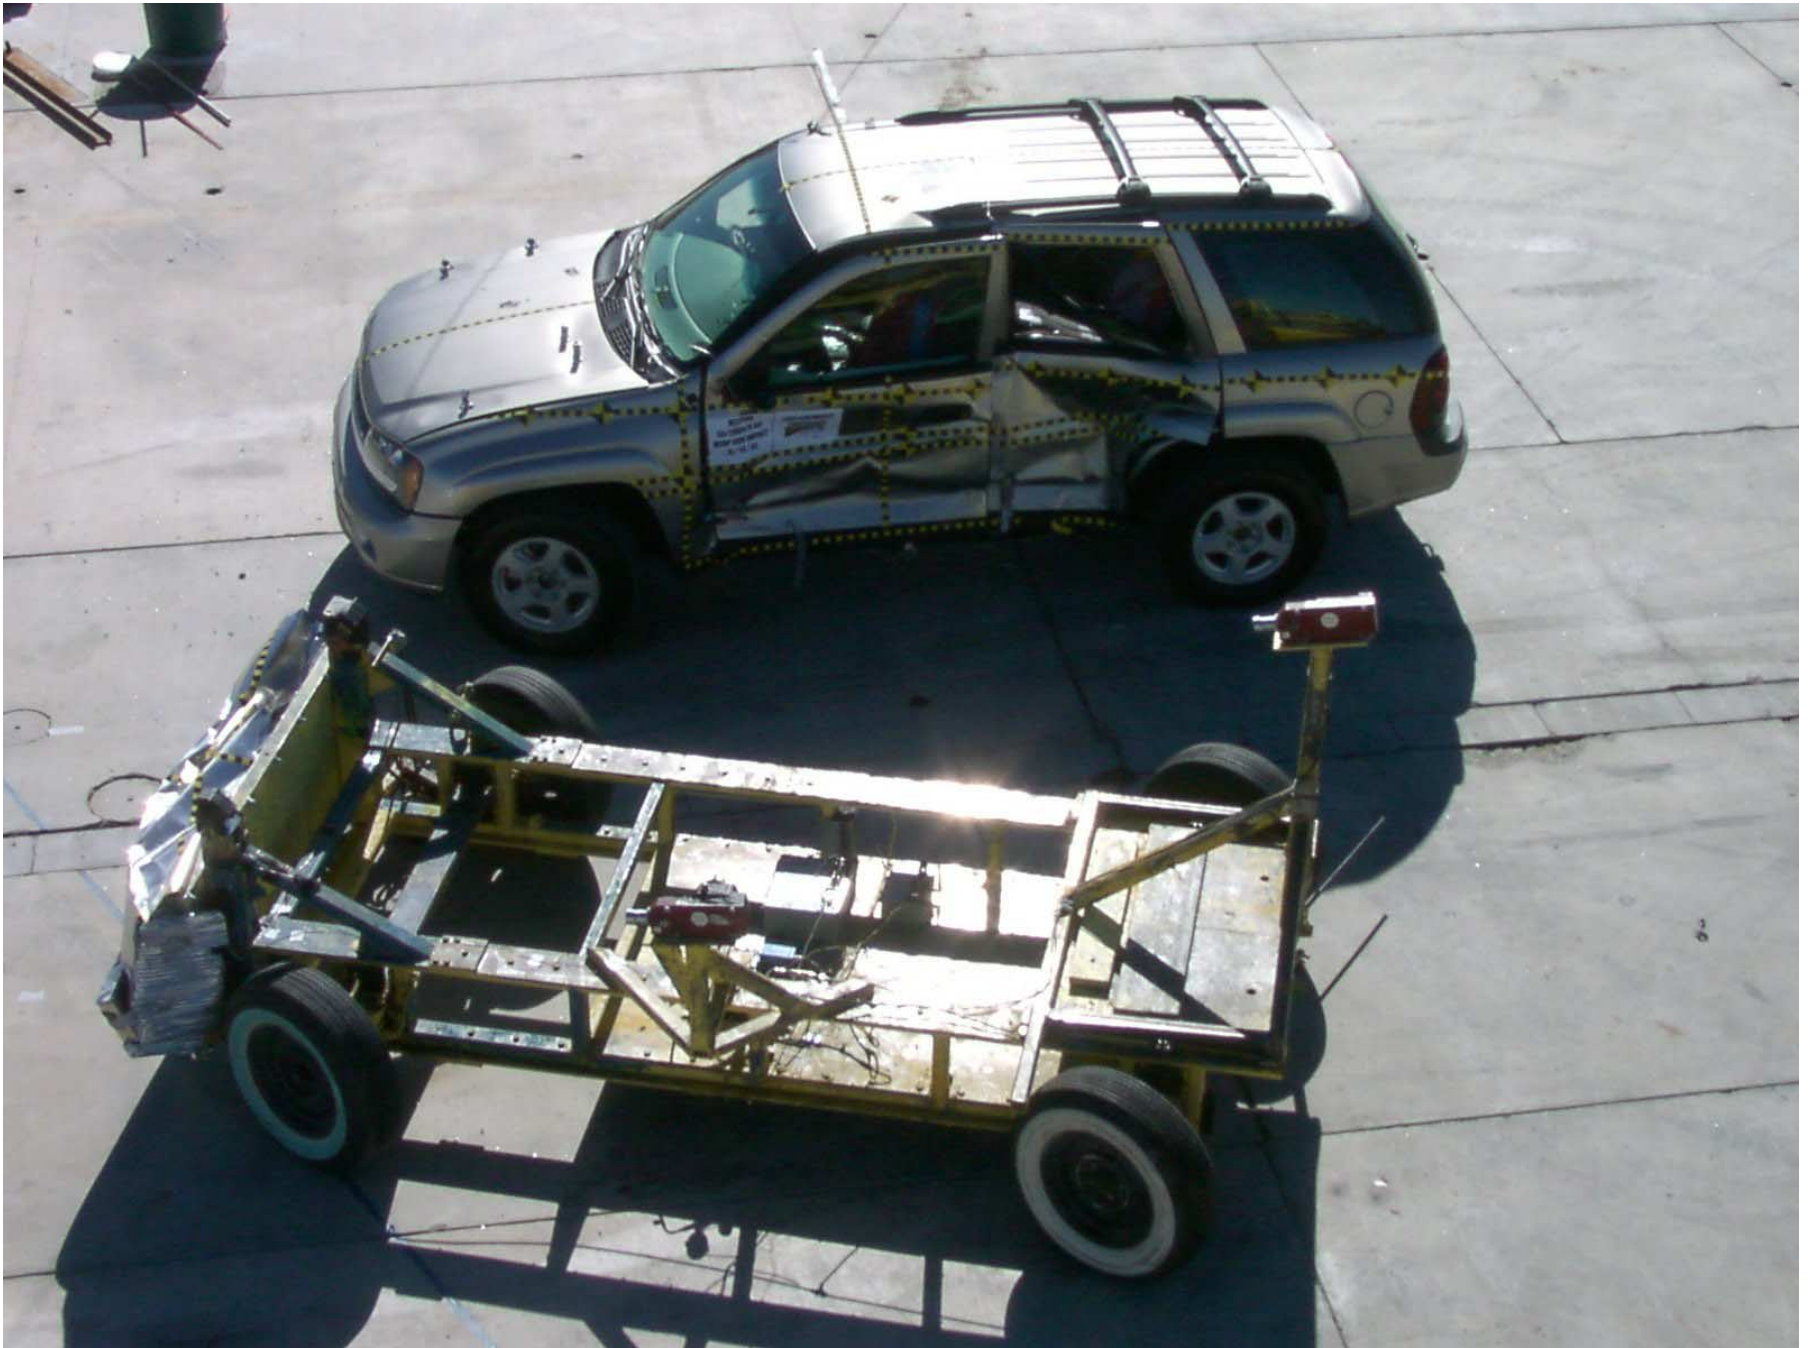
Figure A-13: Overhead Overall View, Post-Test

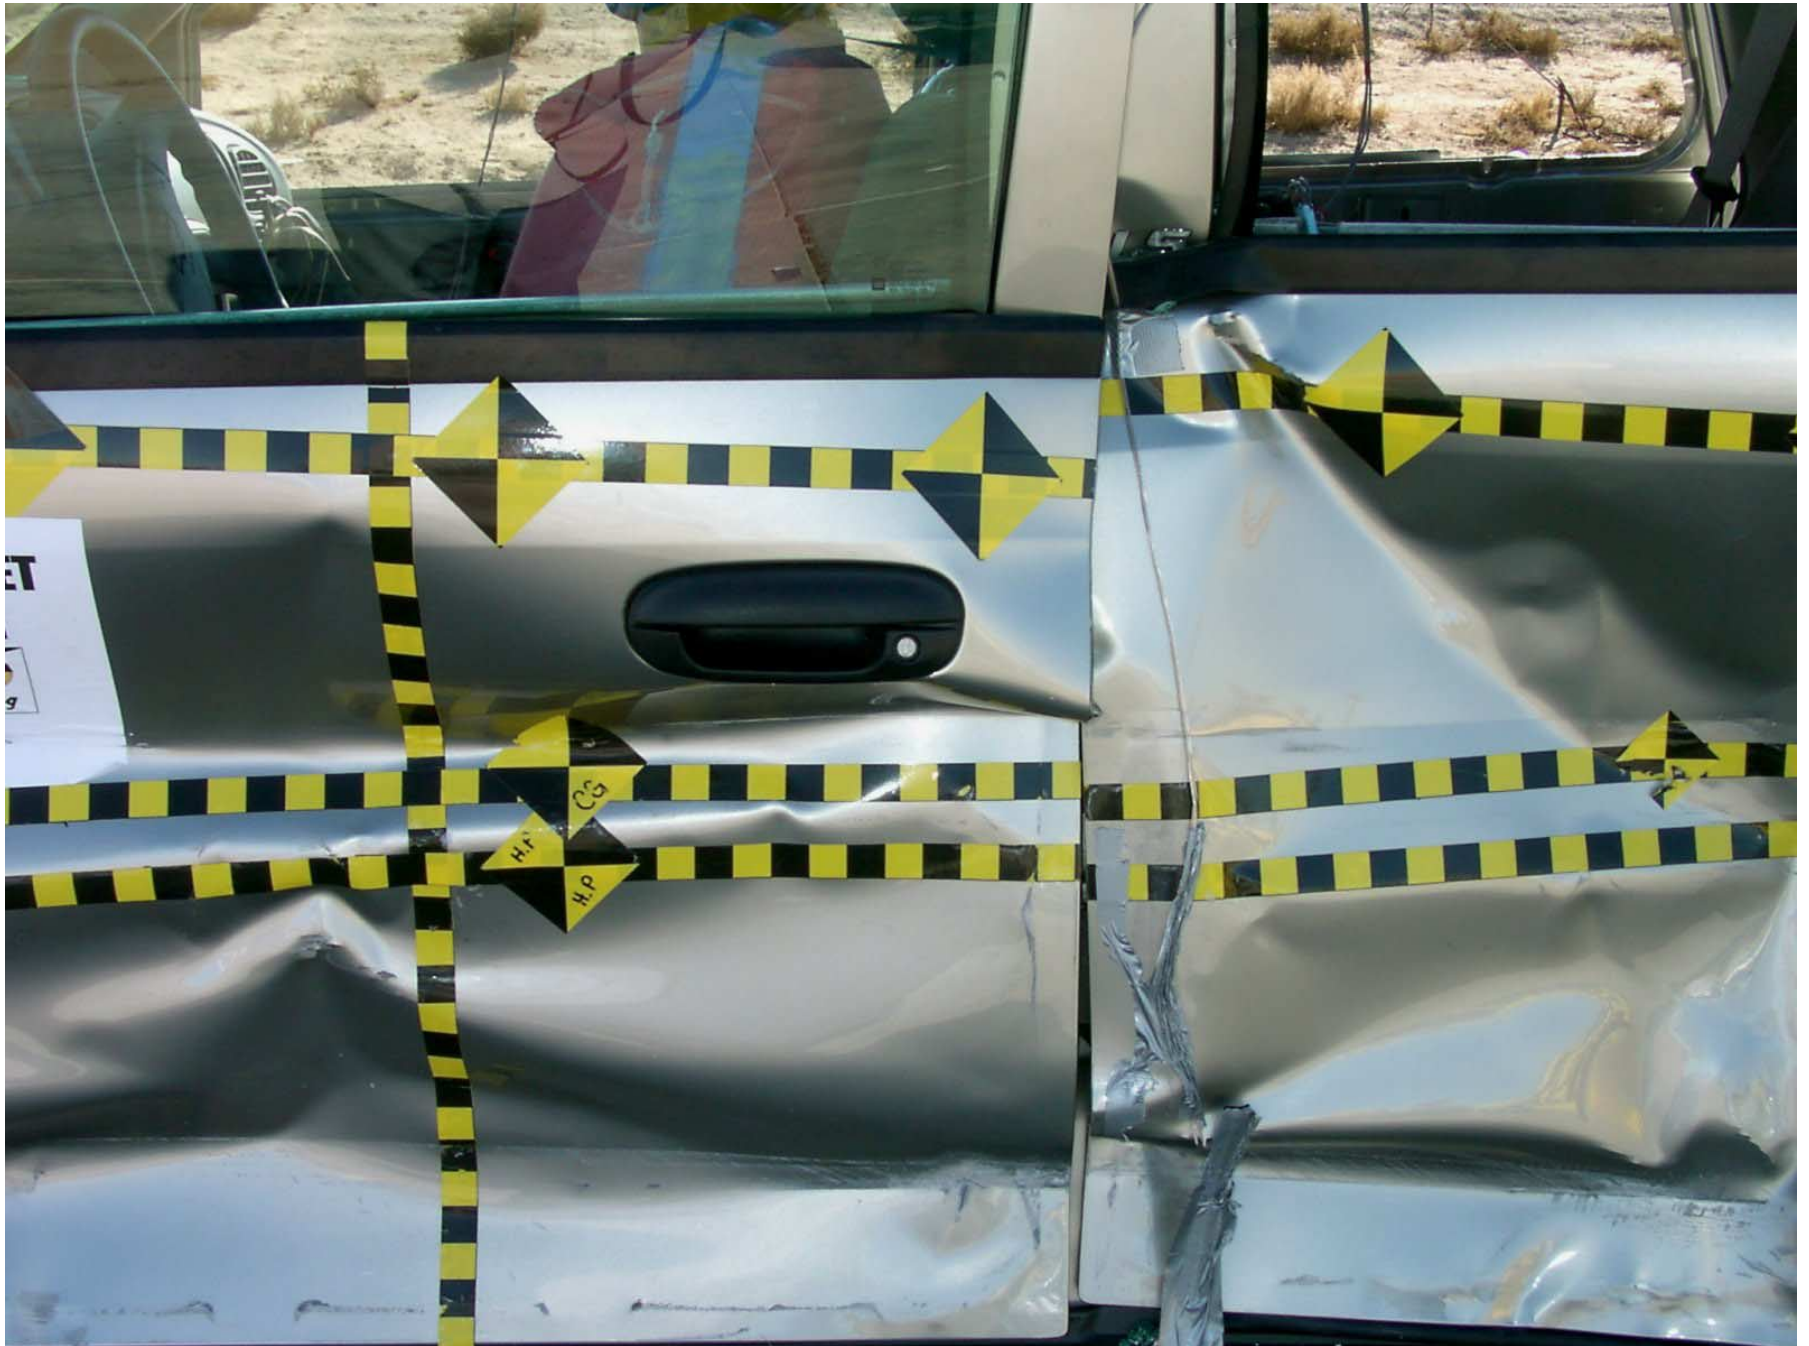
Figure A-19: Left Front Door Closed, Post-Test

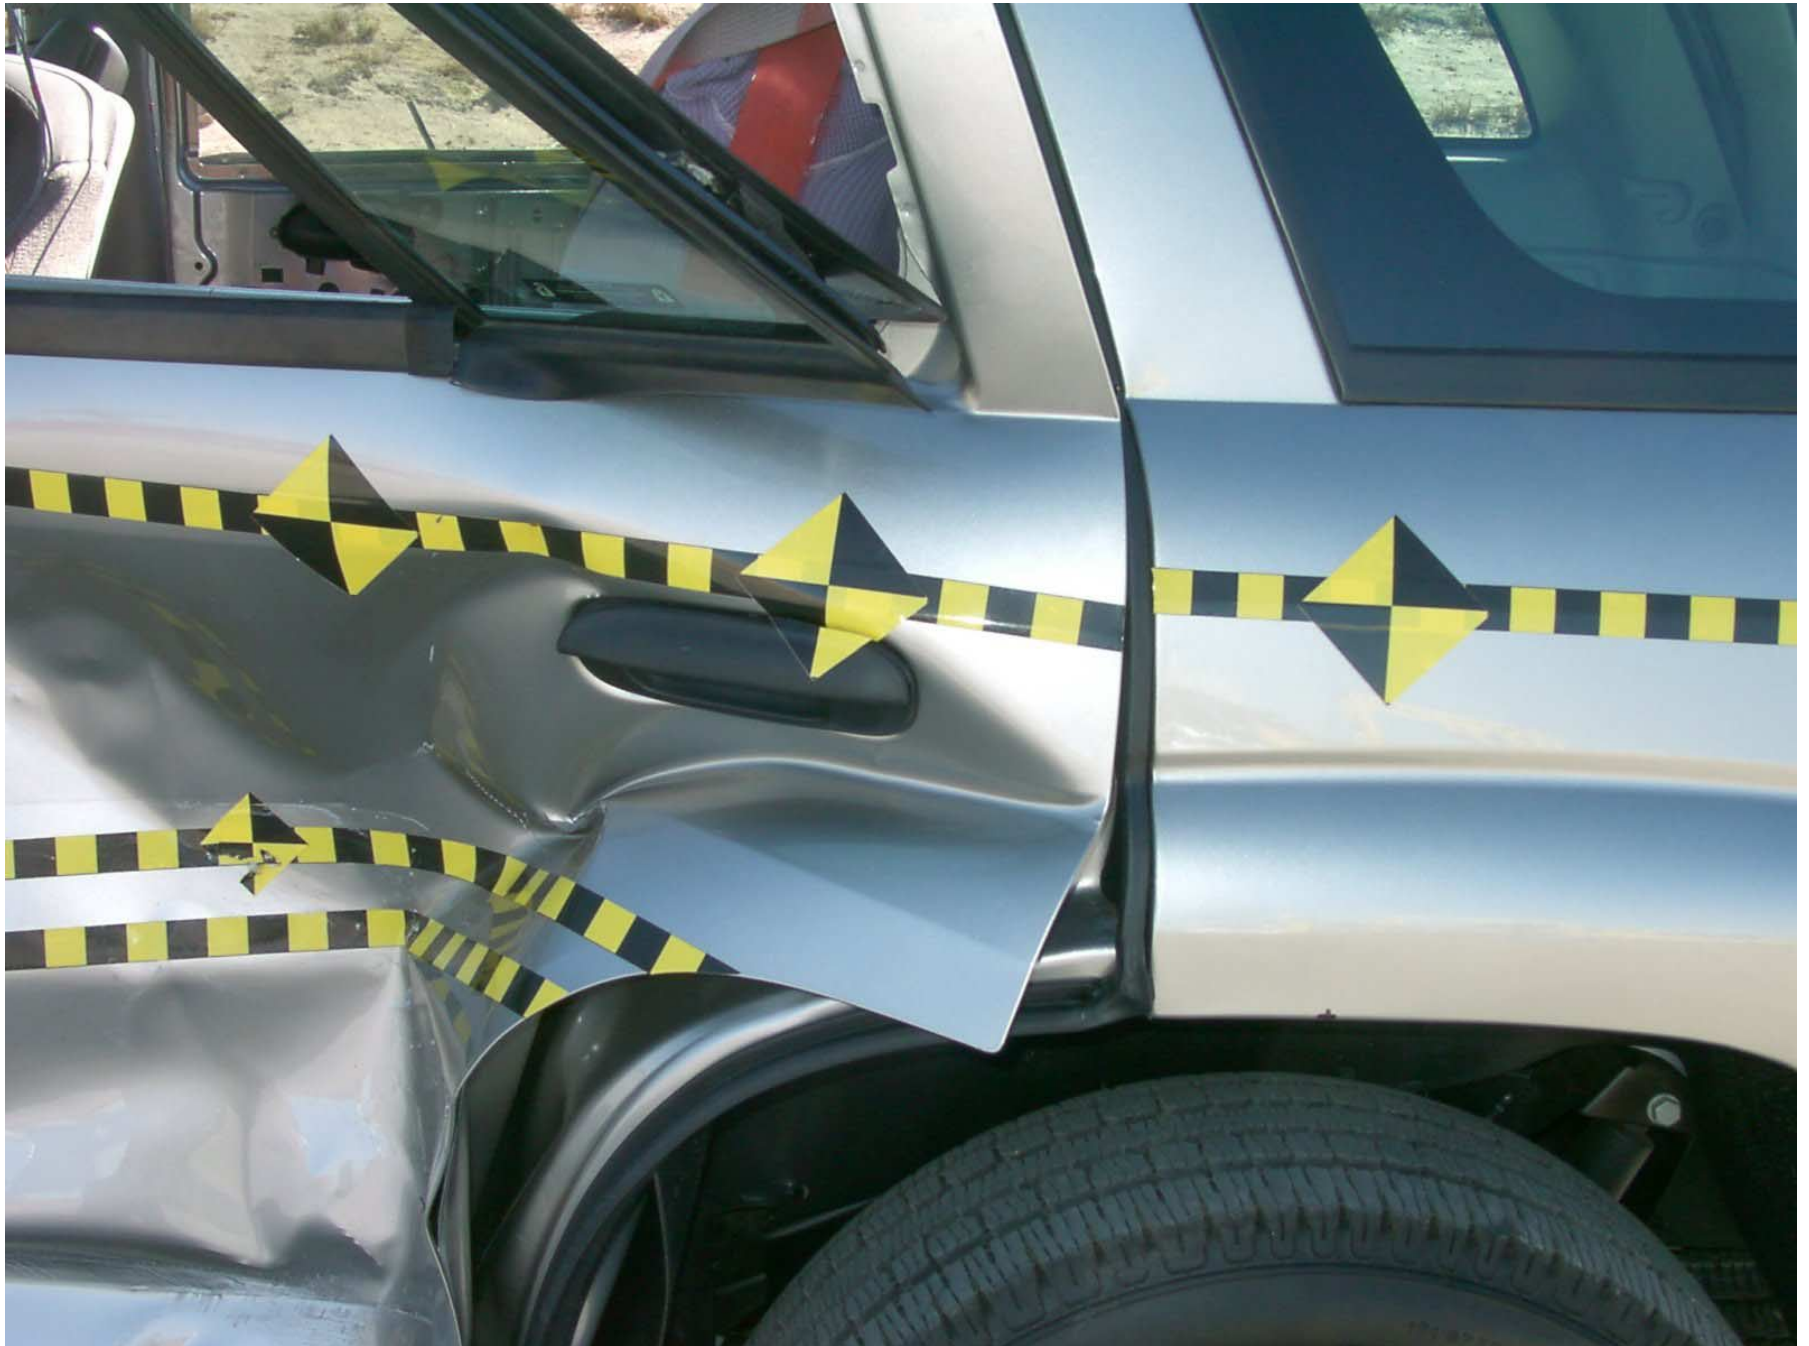
Figure A-21: Left Rear Door Closed, Post-Test

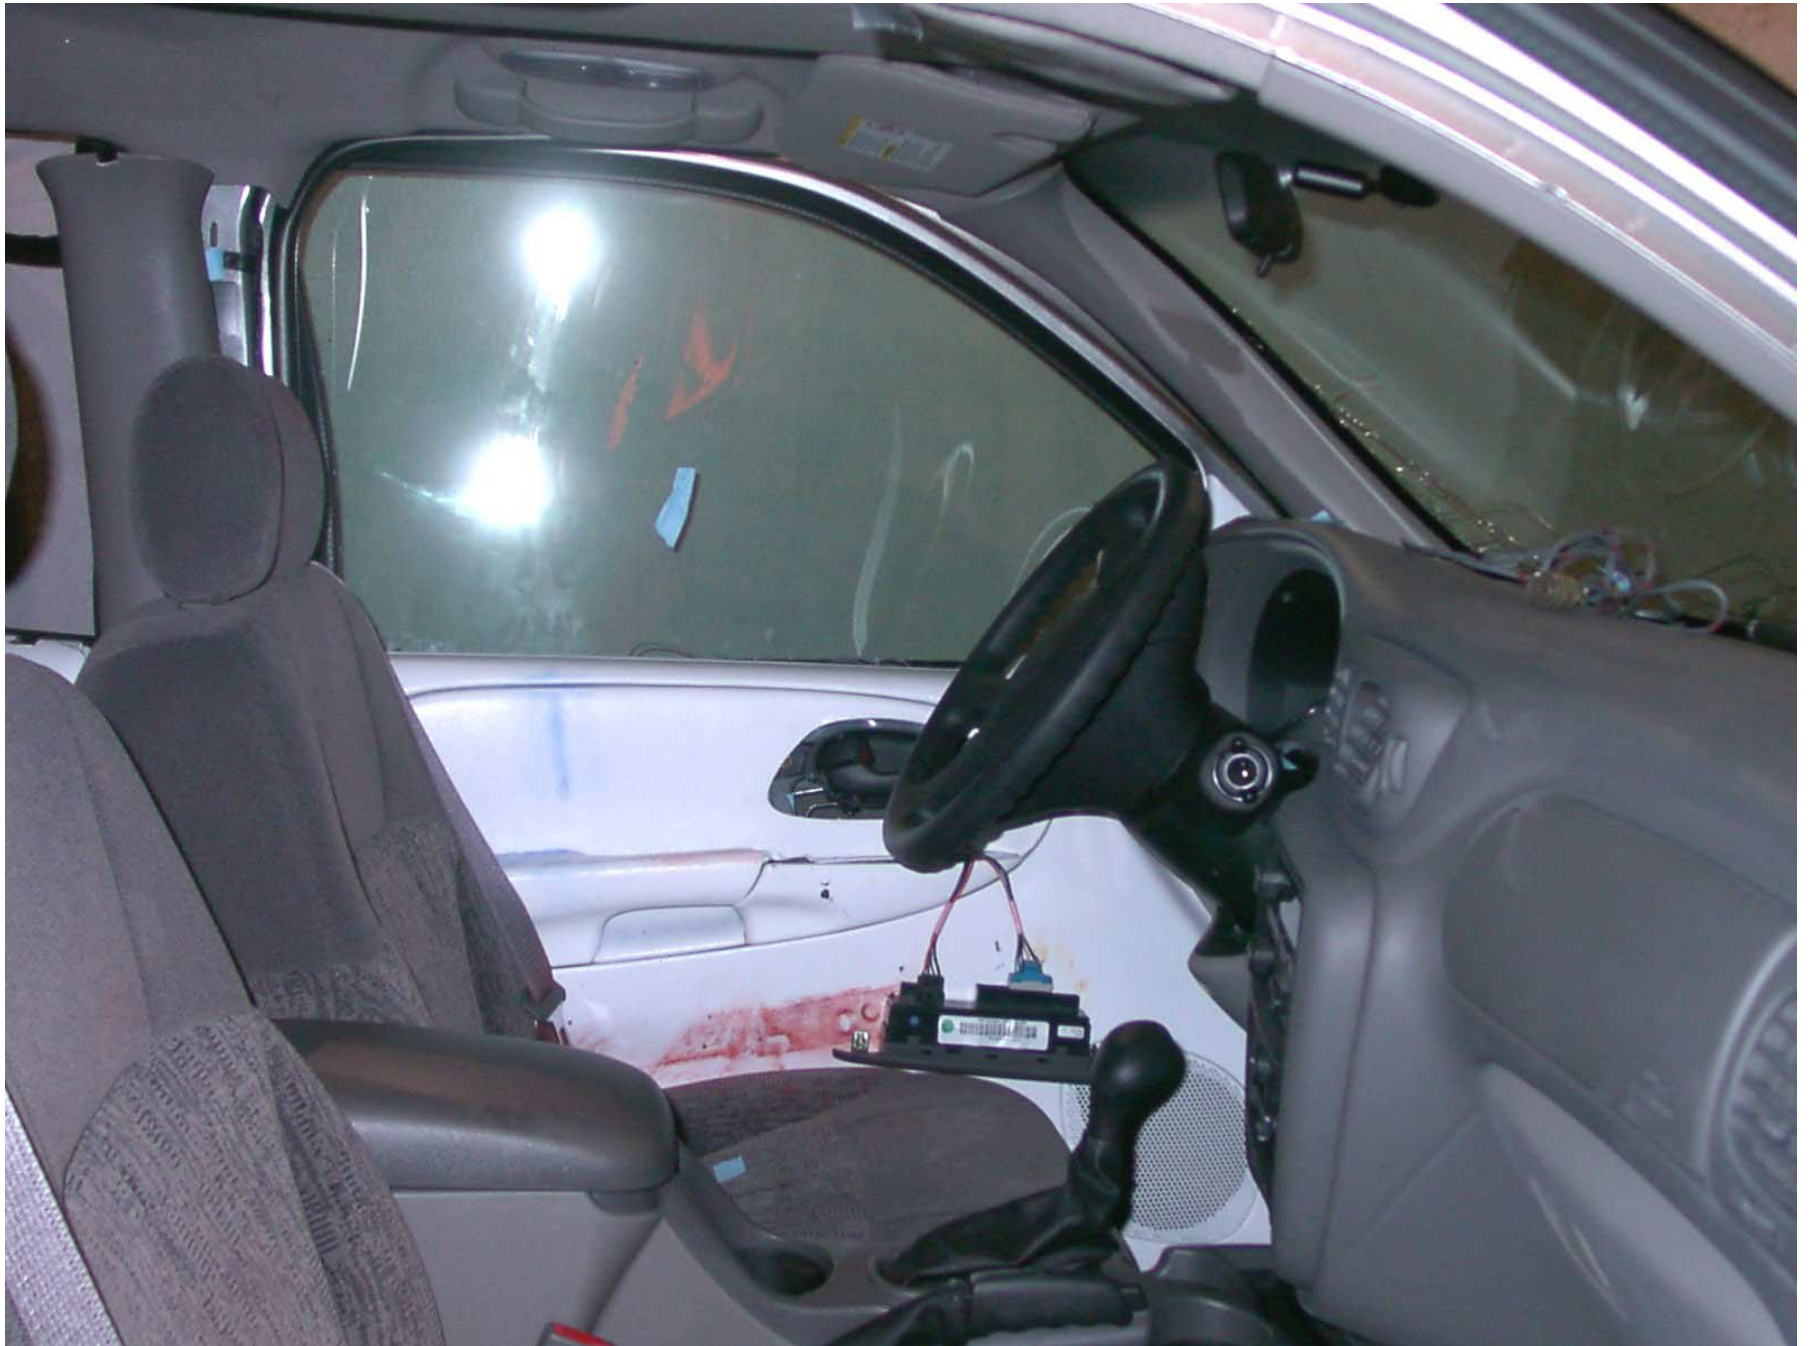
Figure A-30: Driver Dummy Contact Points Inside View, Post-Test

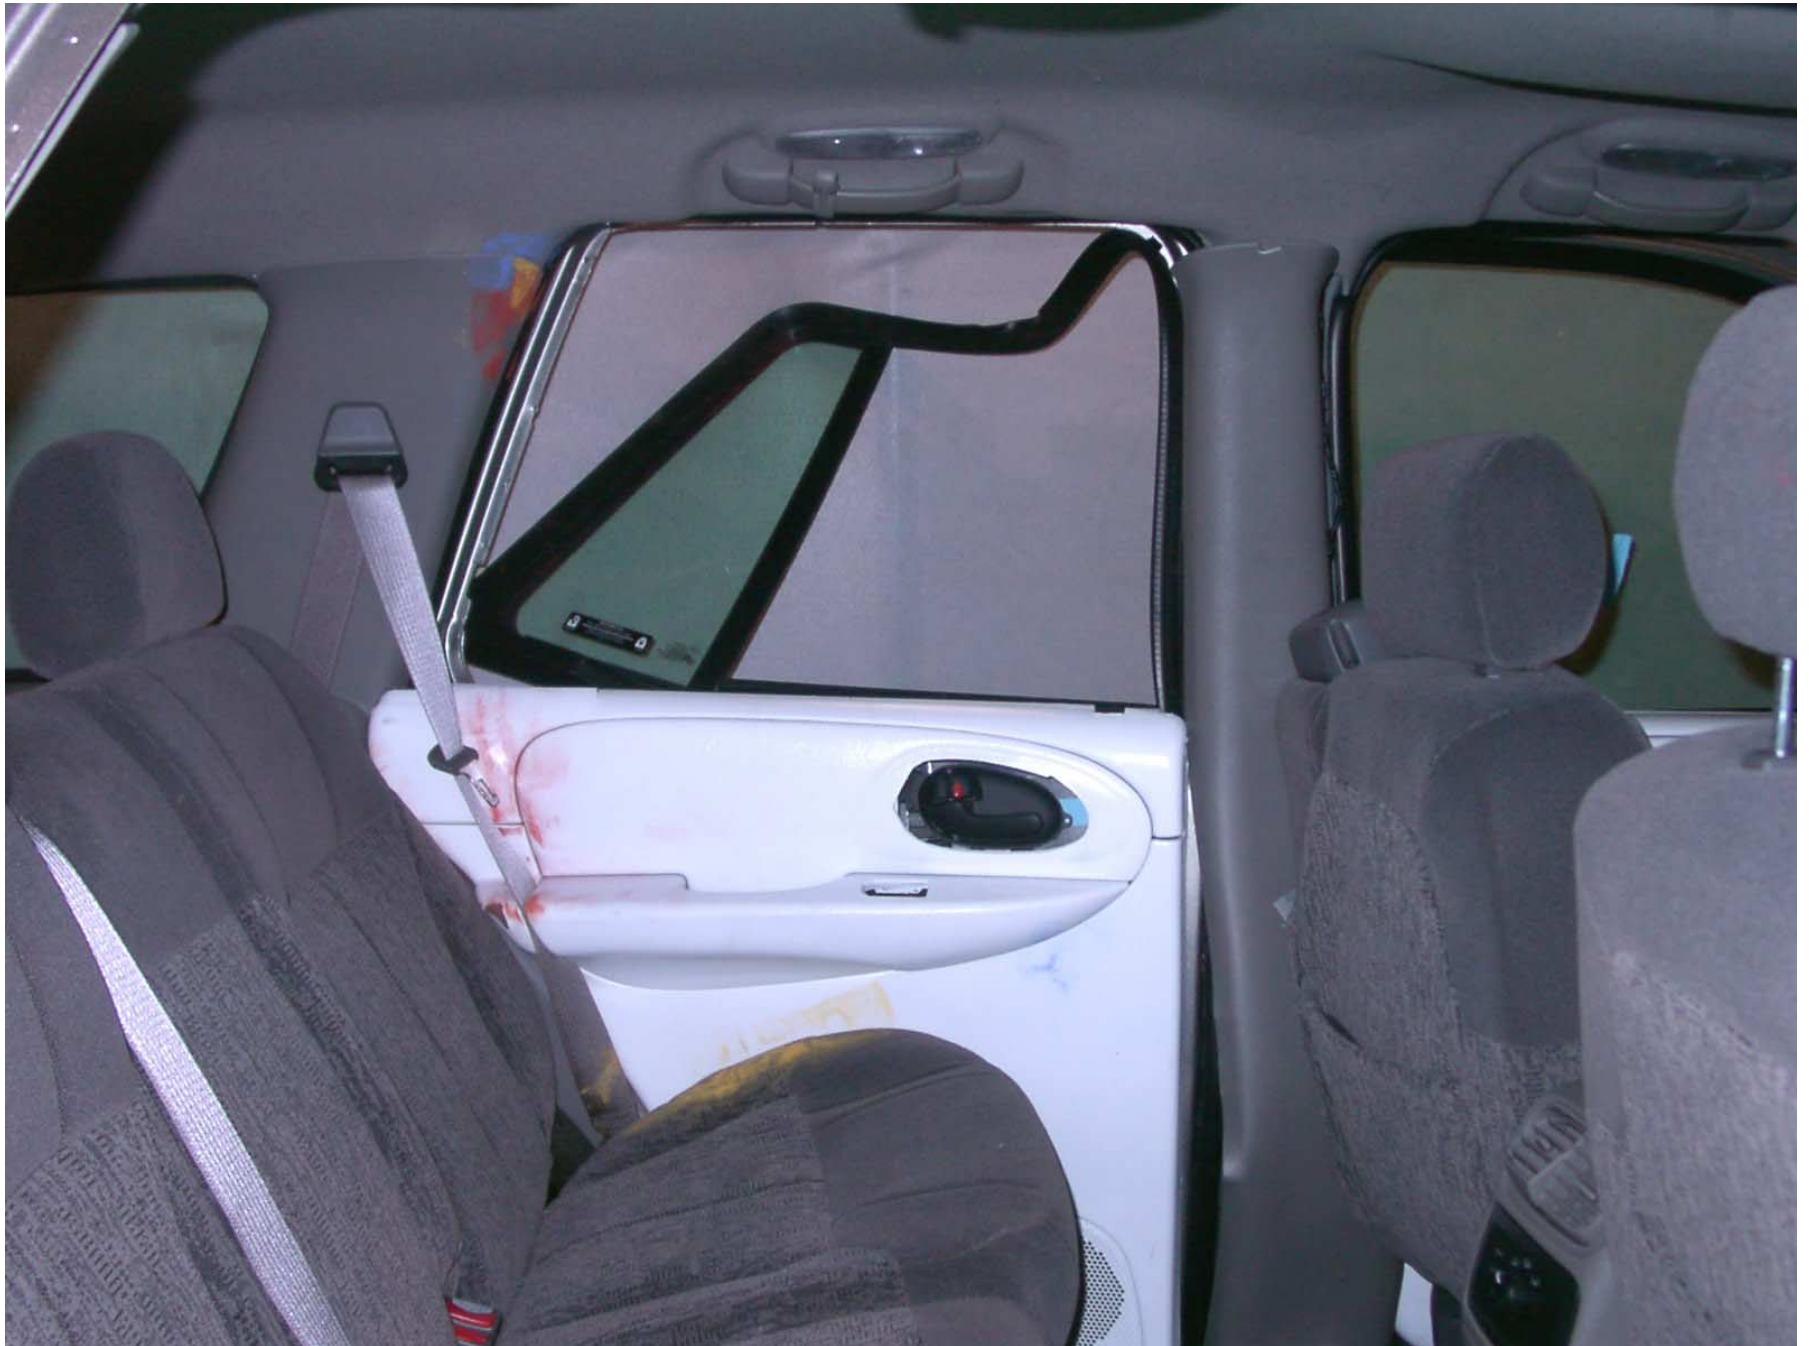
Figure A-39: Passenger Dummy Contact Points Inside View, Post-Test

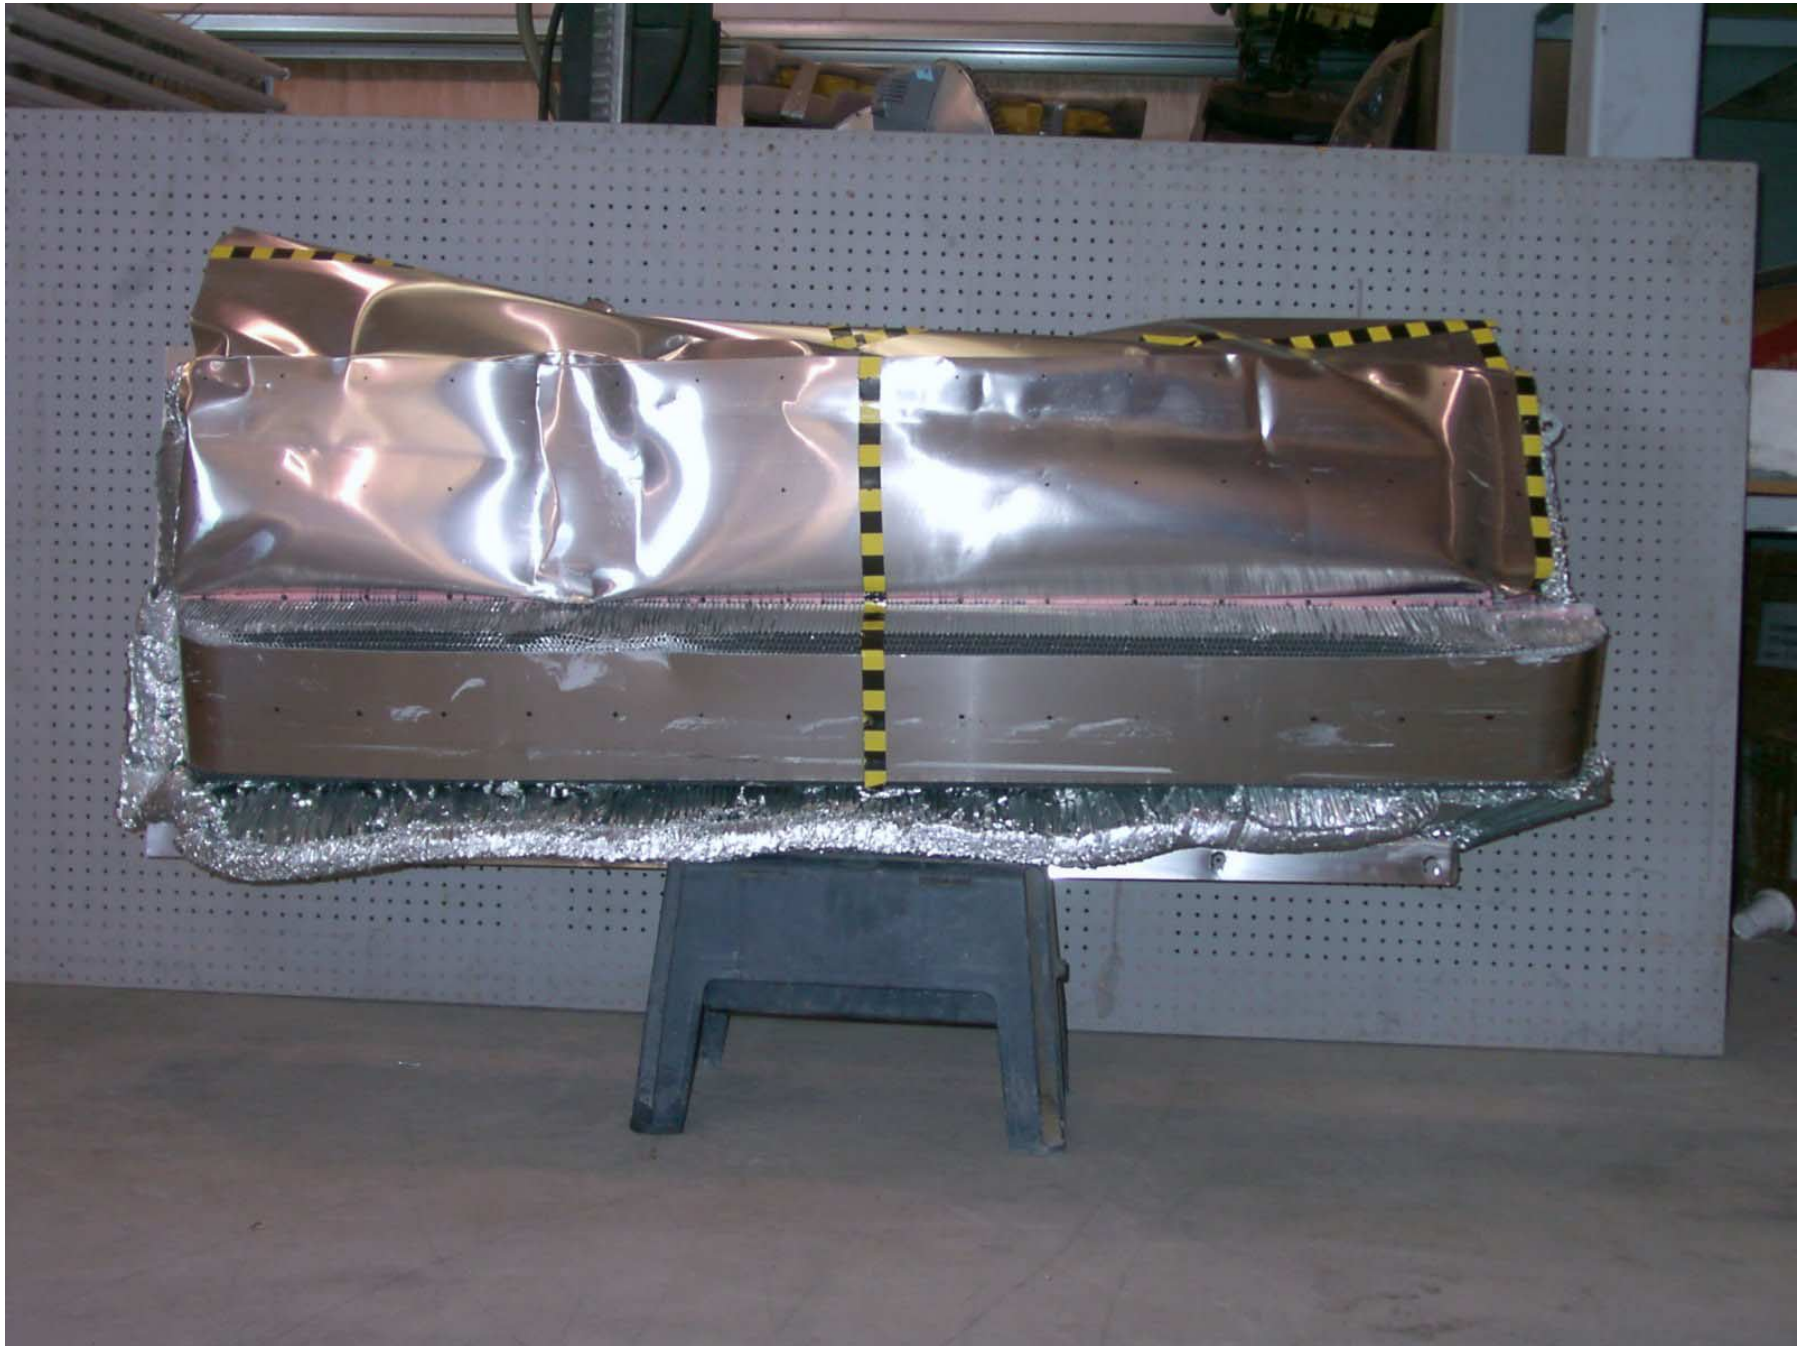
Figure A-41: Front View of Deformable Barrier, Post-Test

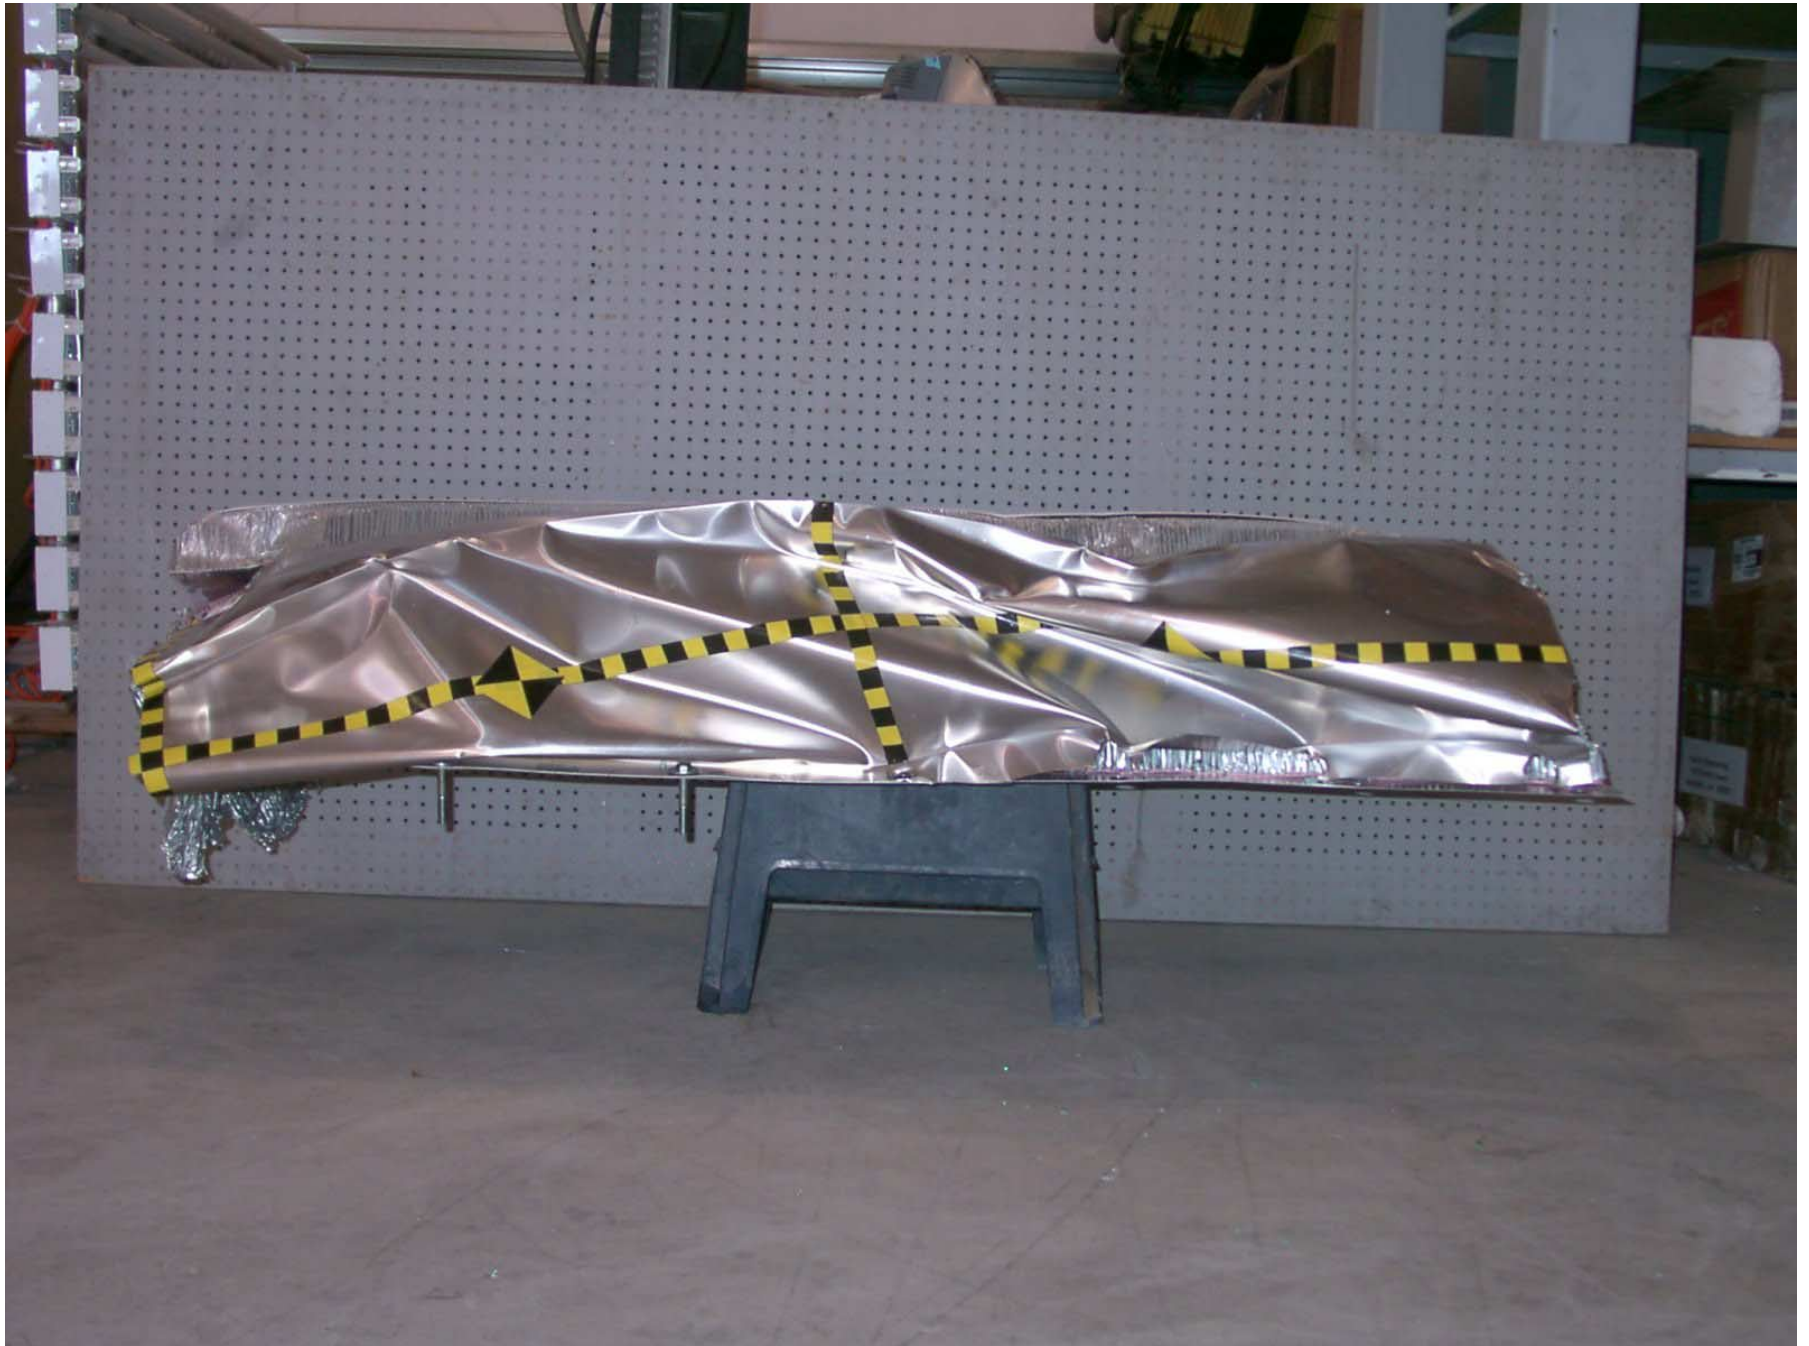
Figure A-43: Top View of Deformable Barrier, Post-Test
