**REPORT NUMBER KAR22003-01**

**NEW CAR ASSESSMENT PROGRAM  
SIDE IMPACT TEST**

**GENERAL MOTORS CORPORATION  
2002 CHEVROLET TRAILBLAZER LS  
4WD SUV**

**FINAL REPORT**

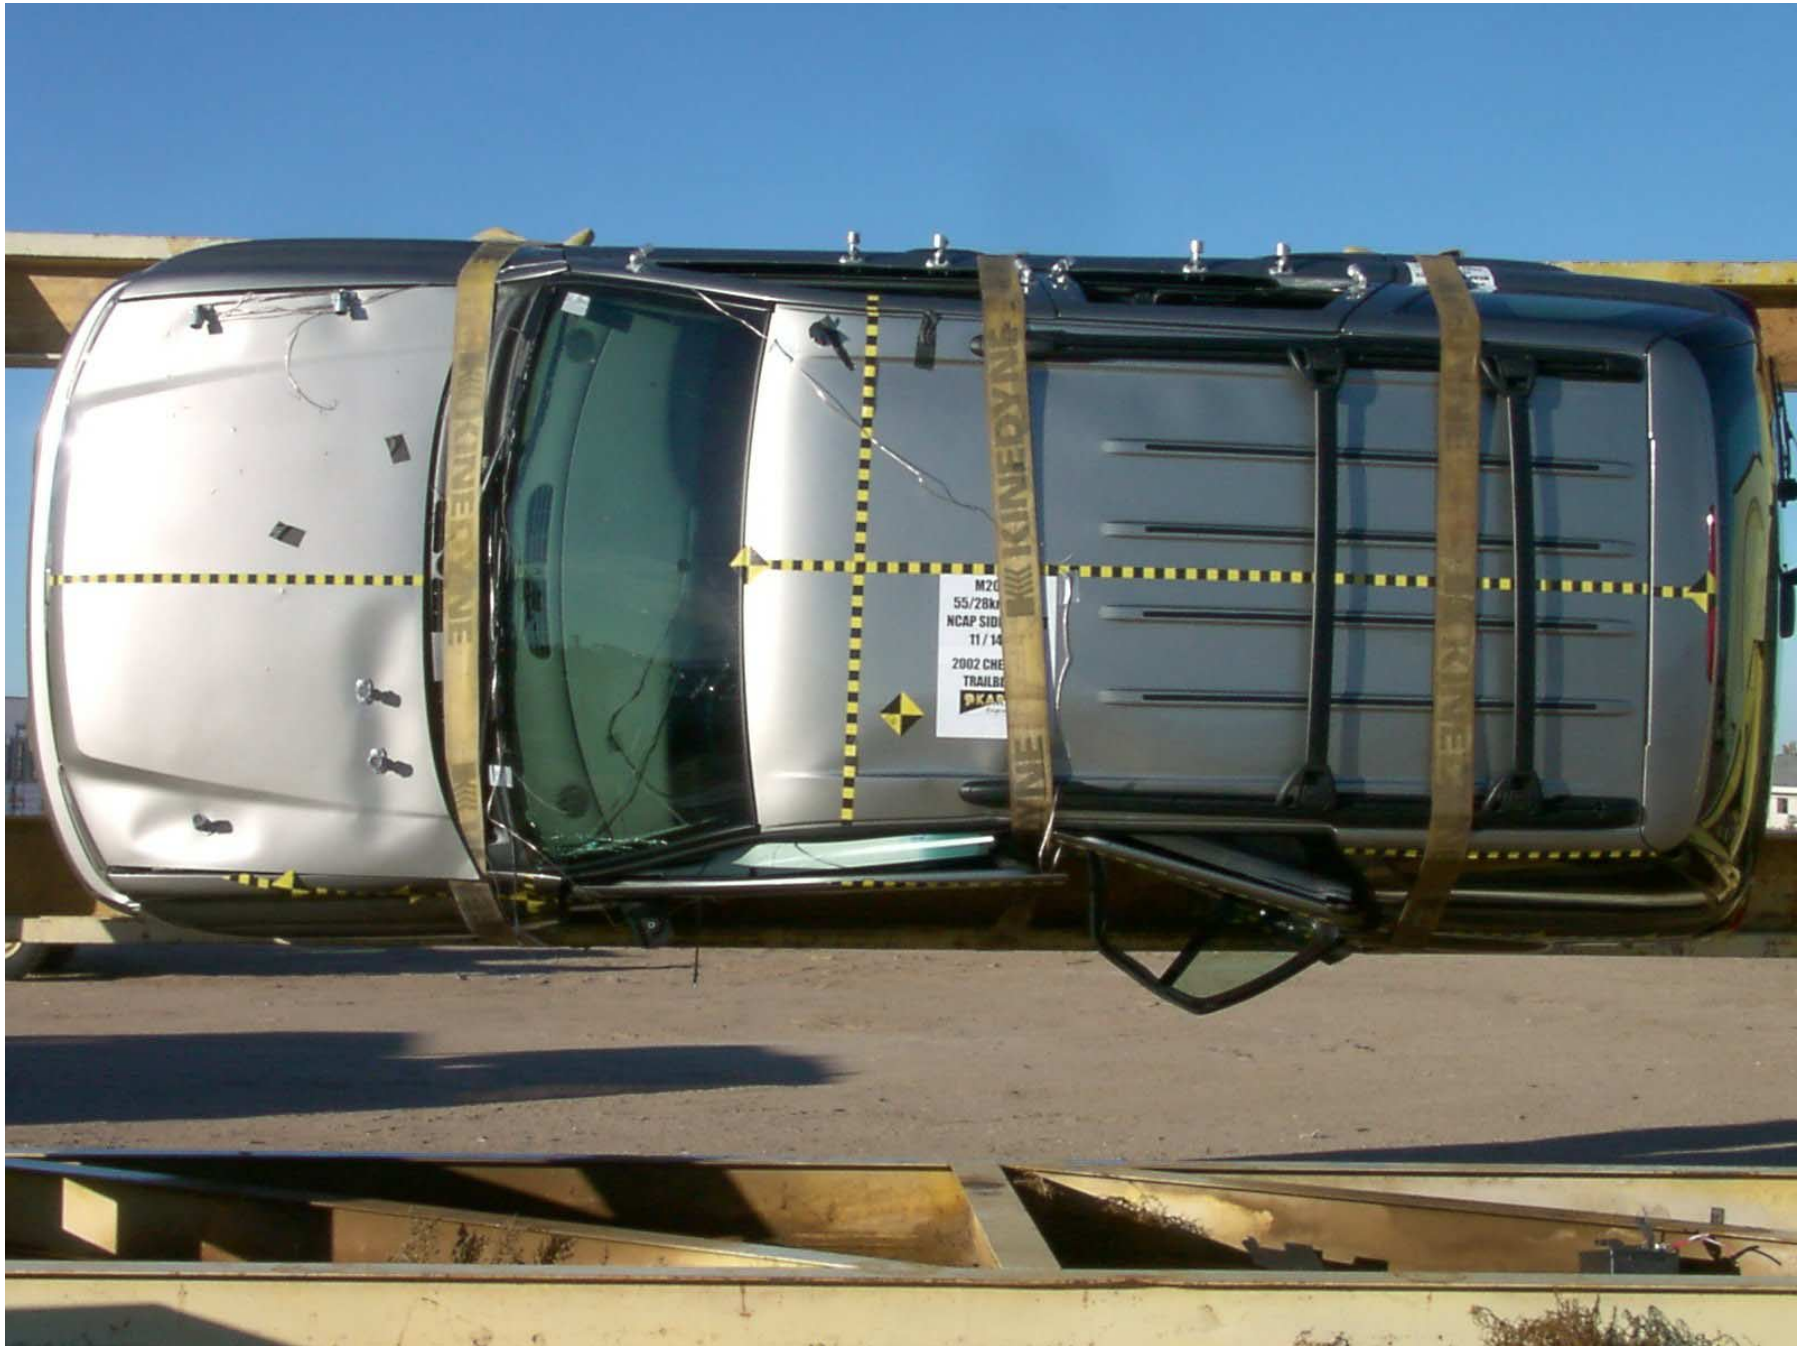
Figure A-48: Vehicle on Rollover Device, Top View

1. The specified fixture rollover rate for each 90° of rotation is 60 to 120 seconds.
2. The position hold time at each position is 300 seconds (minimum).
3. Details of Stoddard Solvent spillage locations.

No solvent leakage occurred during static rollover testing.

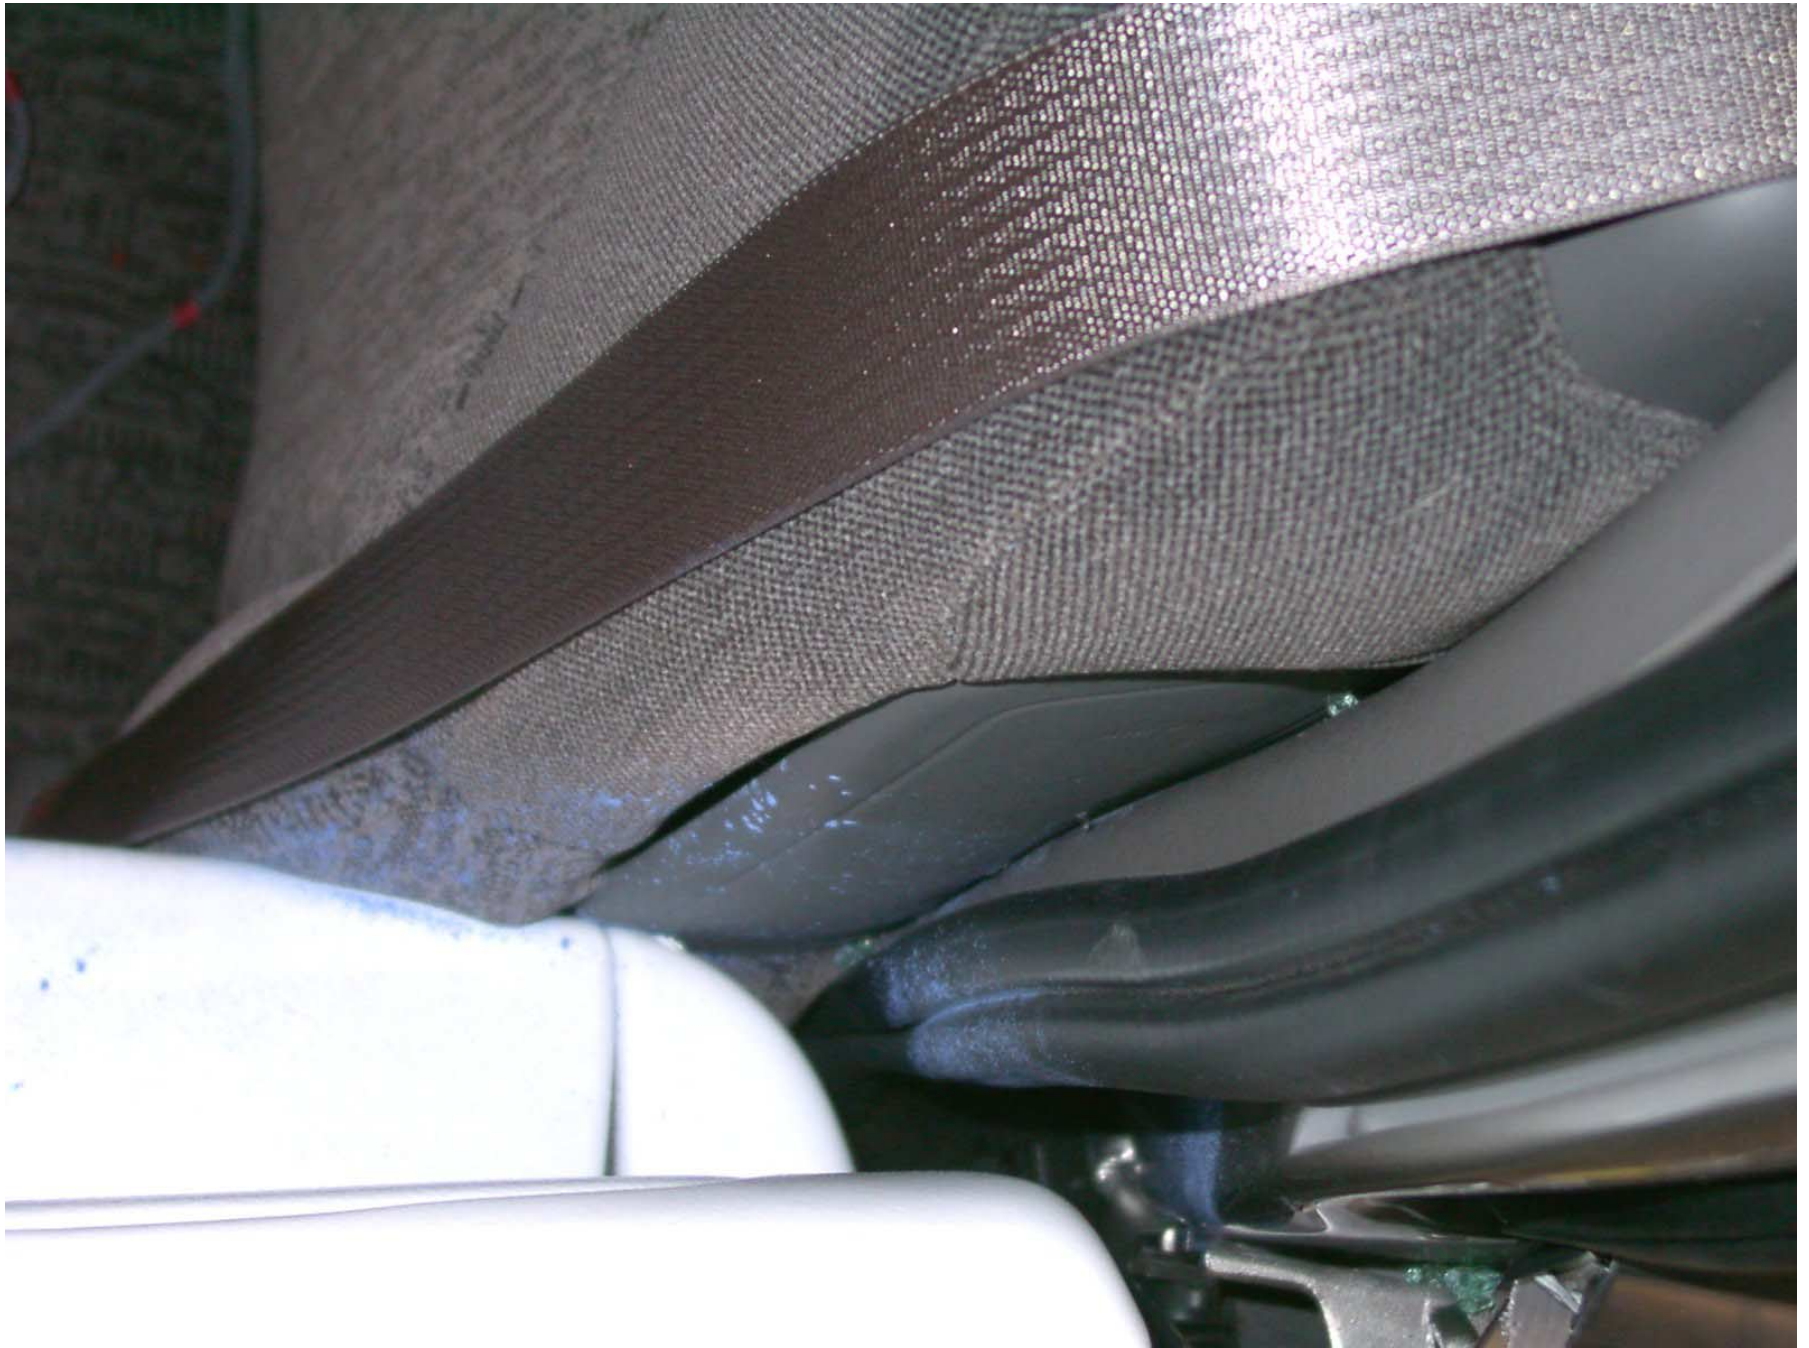
Figure A-50: Post-test Driver Side Airbag
