**REPORT NUMBER KAR21113-01**

**NEW CAR ASSESSMENT PROGRAM  
SIDE IMPACT TEST**

**GENERAL MOTORS CORPORATION  
2002 CHEVROLET MALIBU  
4 DOOR SEDAN**

**NHTSA NUMBER: GM0006**

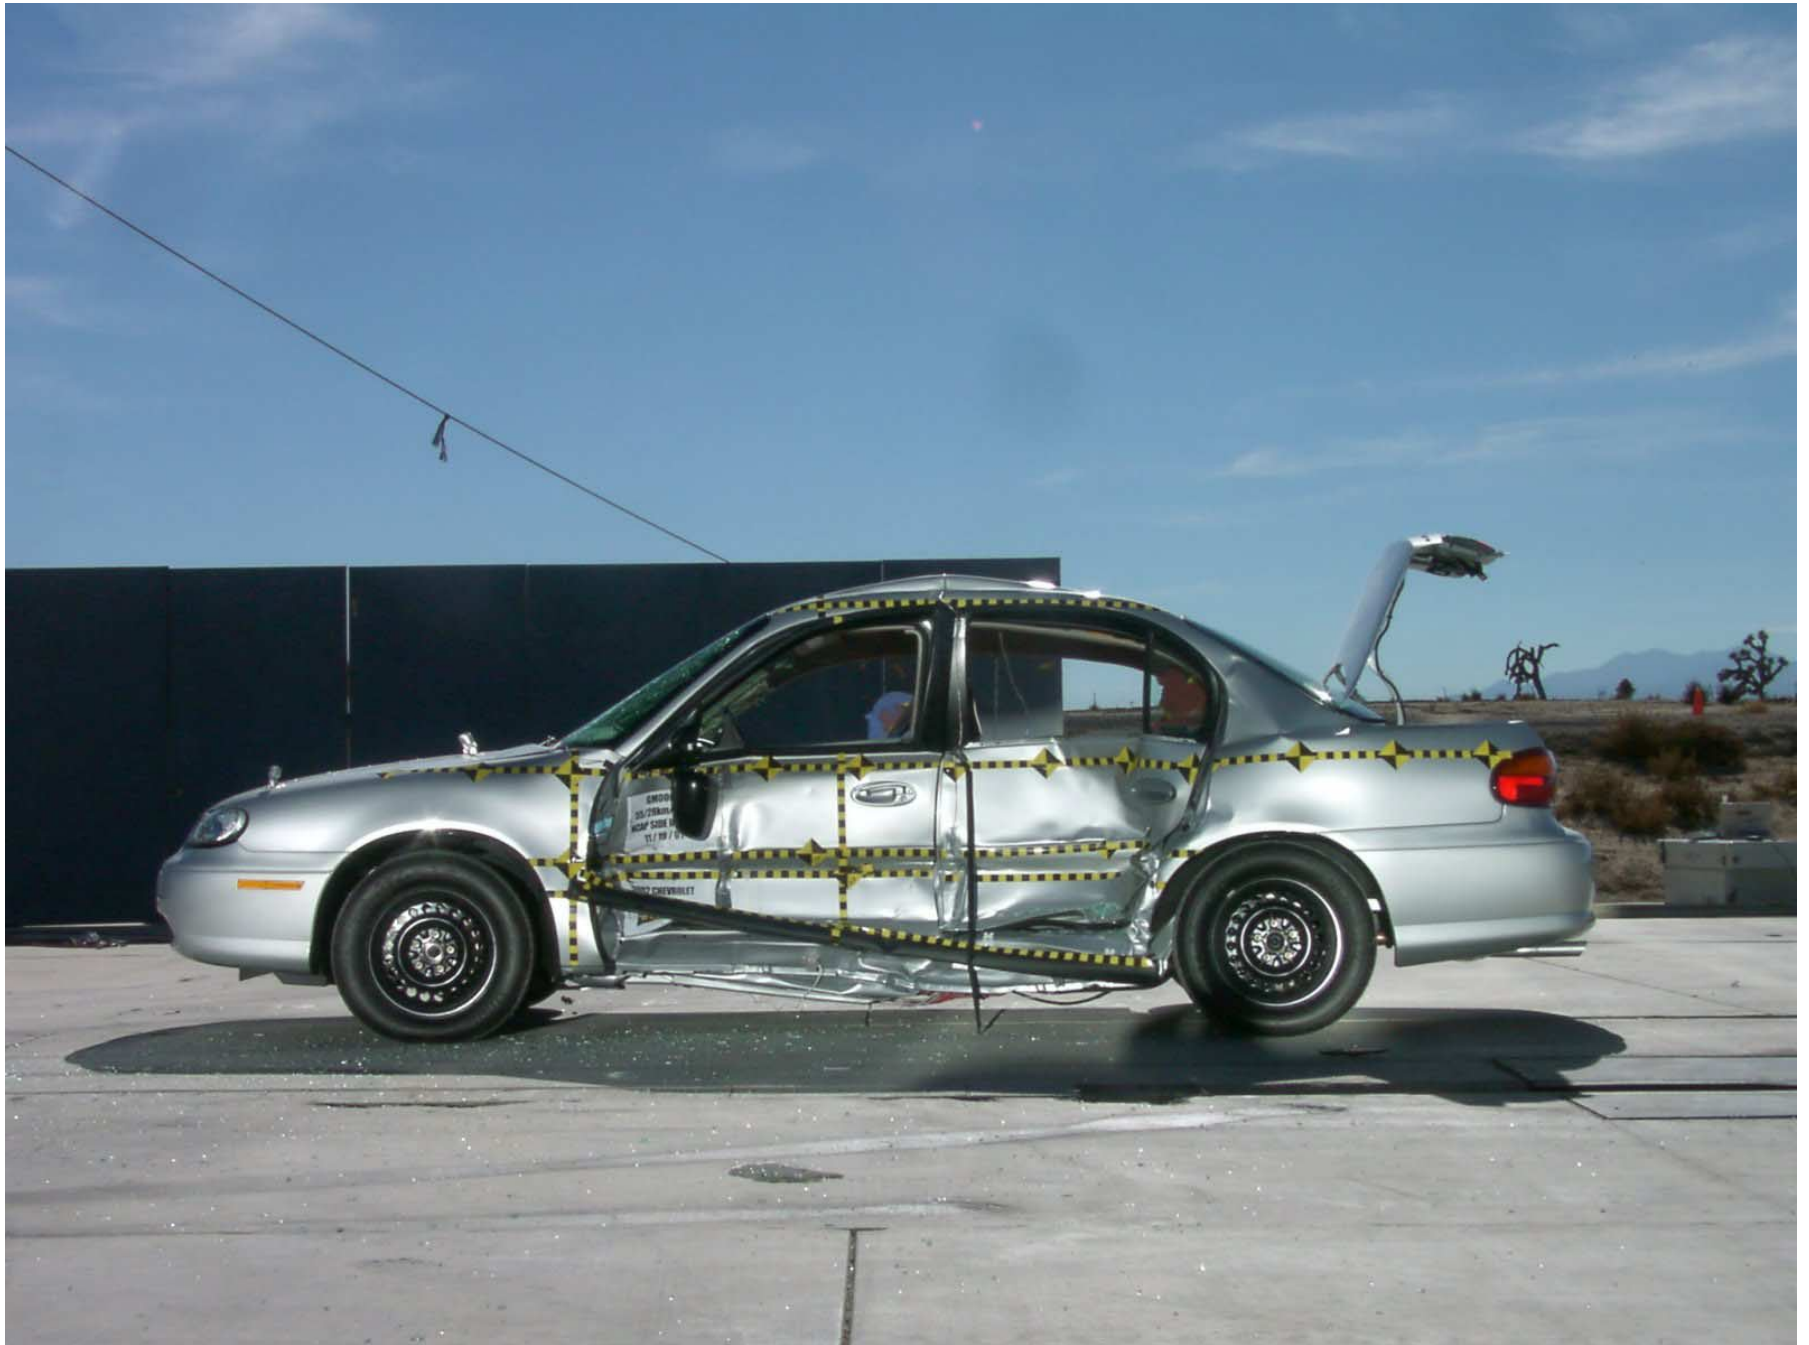
Figure A-10: Left (Impacted) Side View, Post-Test

The test vehicle sustained a maximum static crush of 459 mm at level 2, 1200mm rearward of the left vertical impact point. The driver SID, Serial No. 275 and the passenger SID, Serial No. 274 were calibrated just prior to this test. The SID injury criteria is summarized as follows:

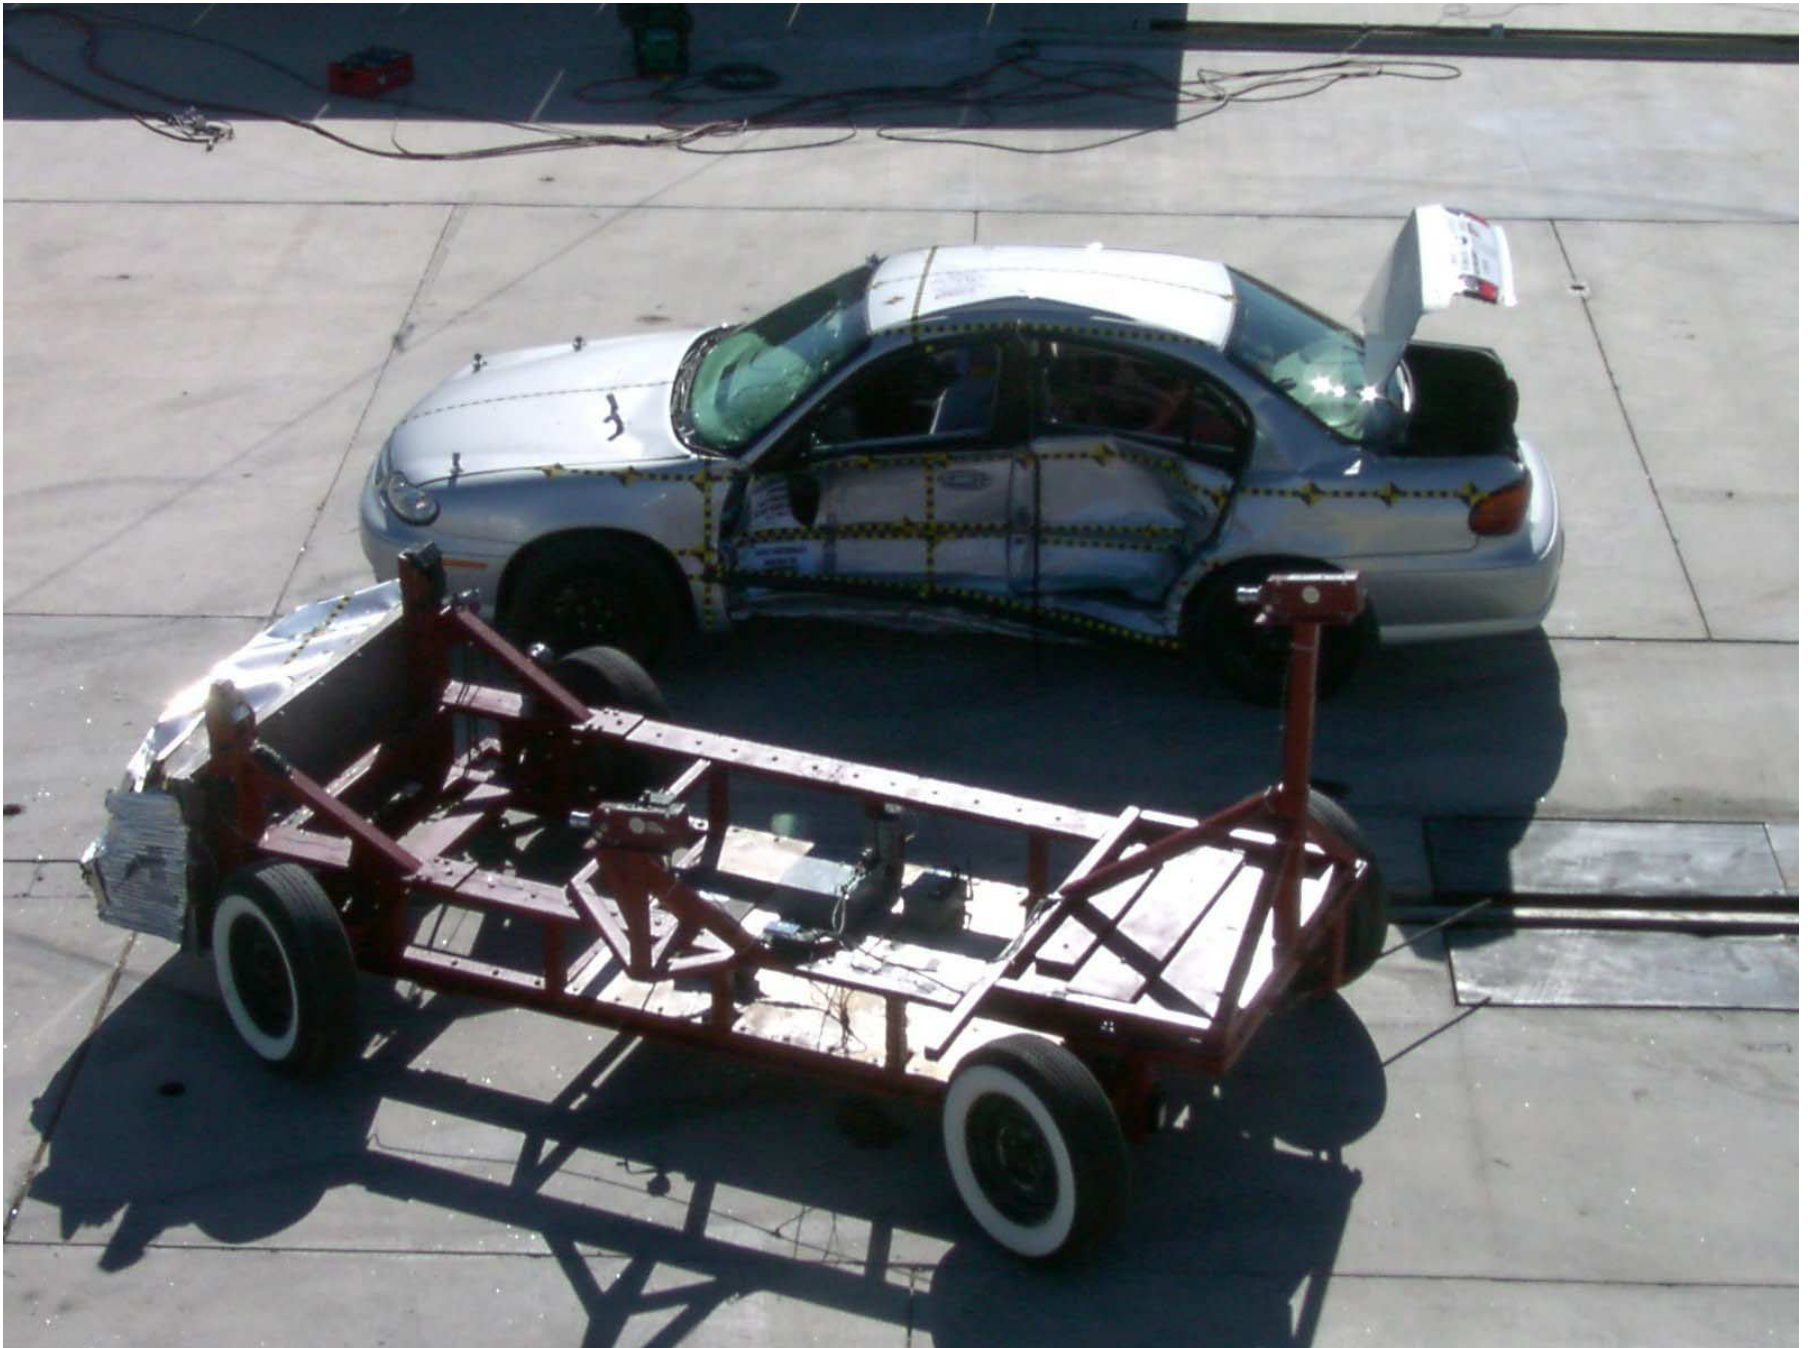
Figure A-13: Overhead Overall View, Post-Test

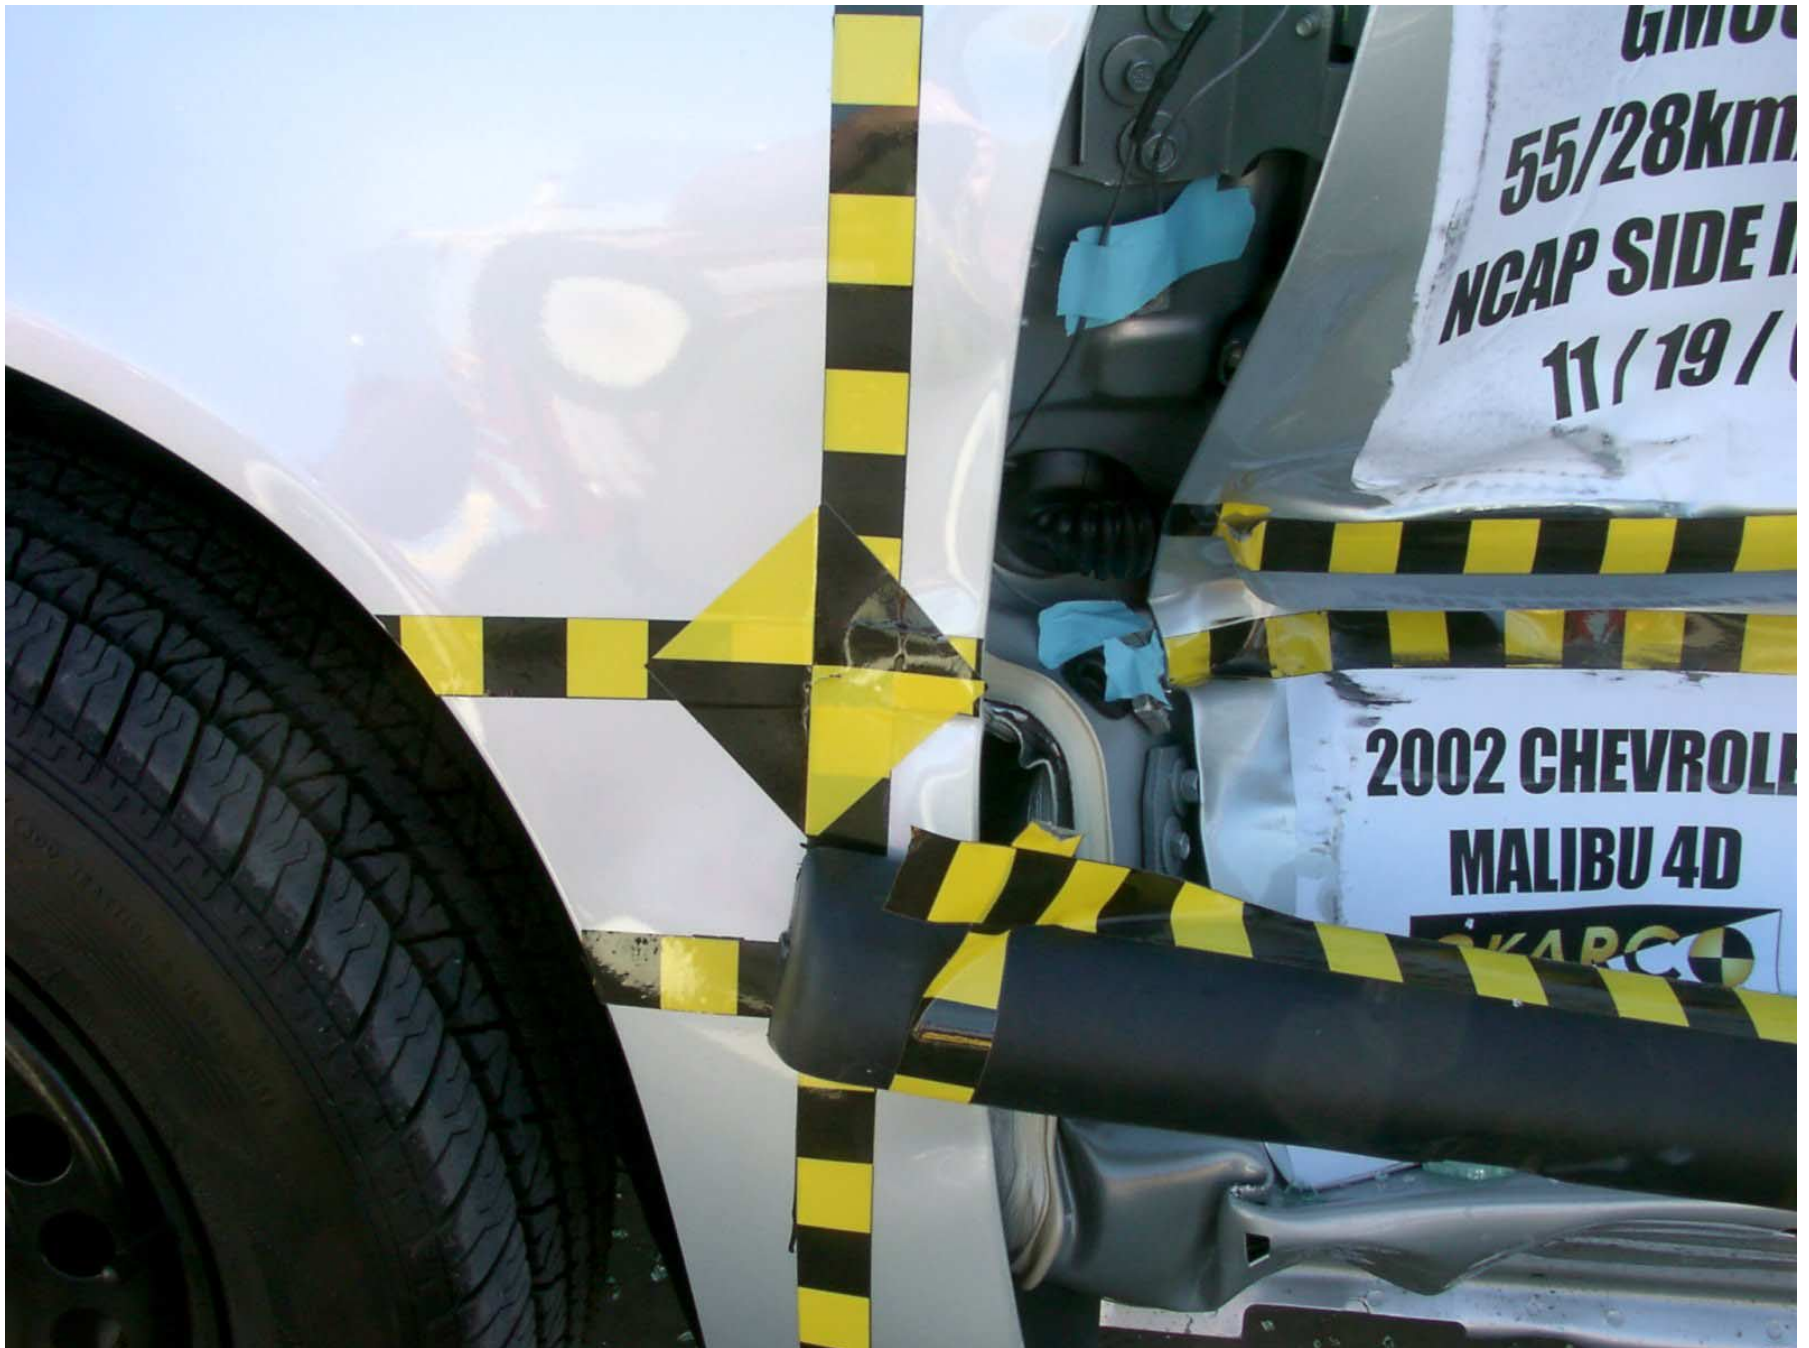
Figure A-17: Impact Point Target Close-up, Post-Test

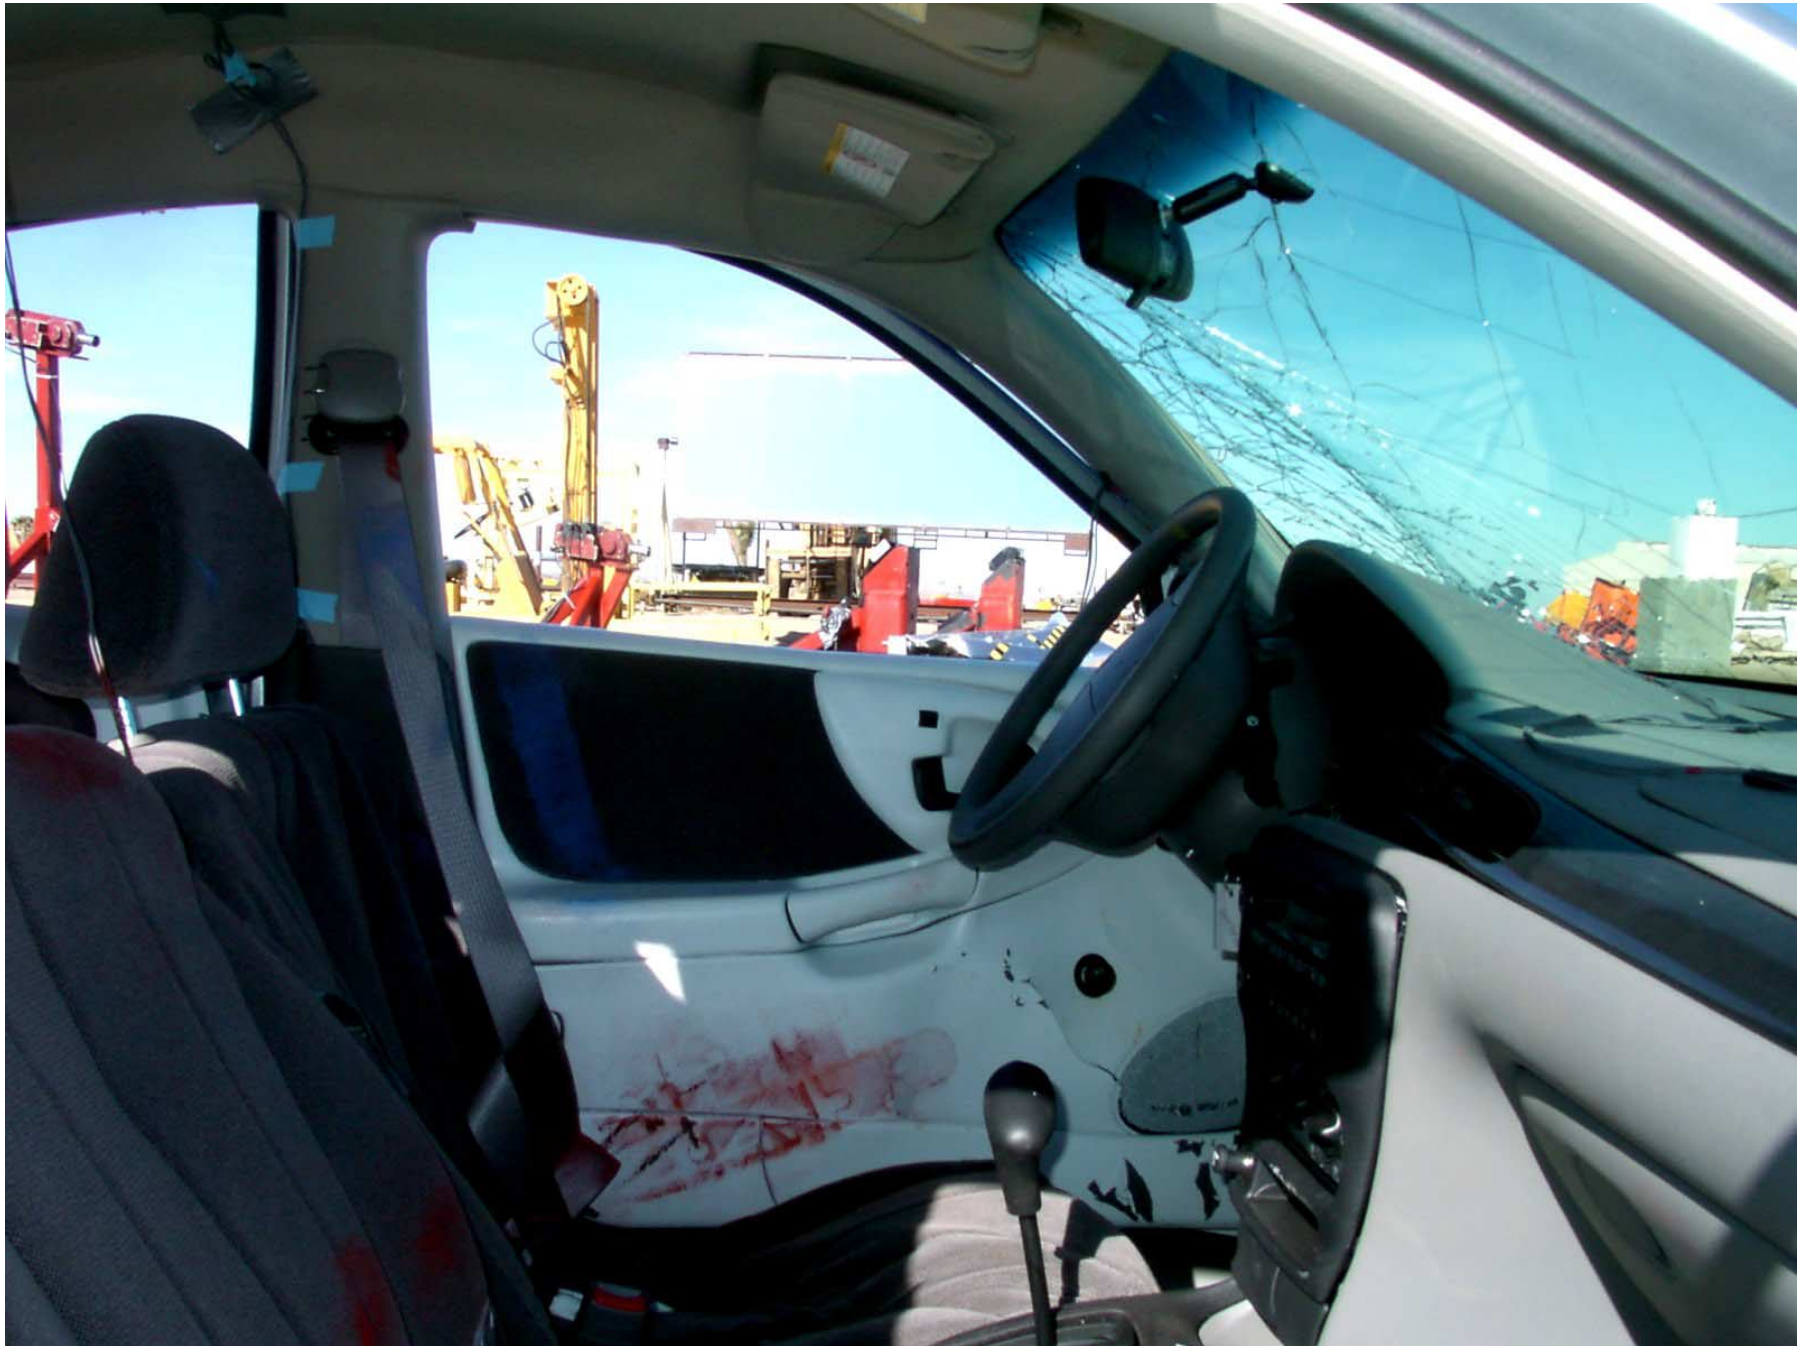
Figure A-30: Driver Dummy Contact Points Inside View, Post-Test

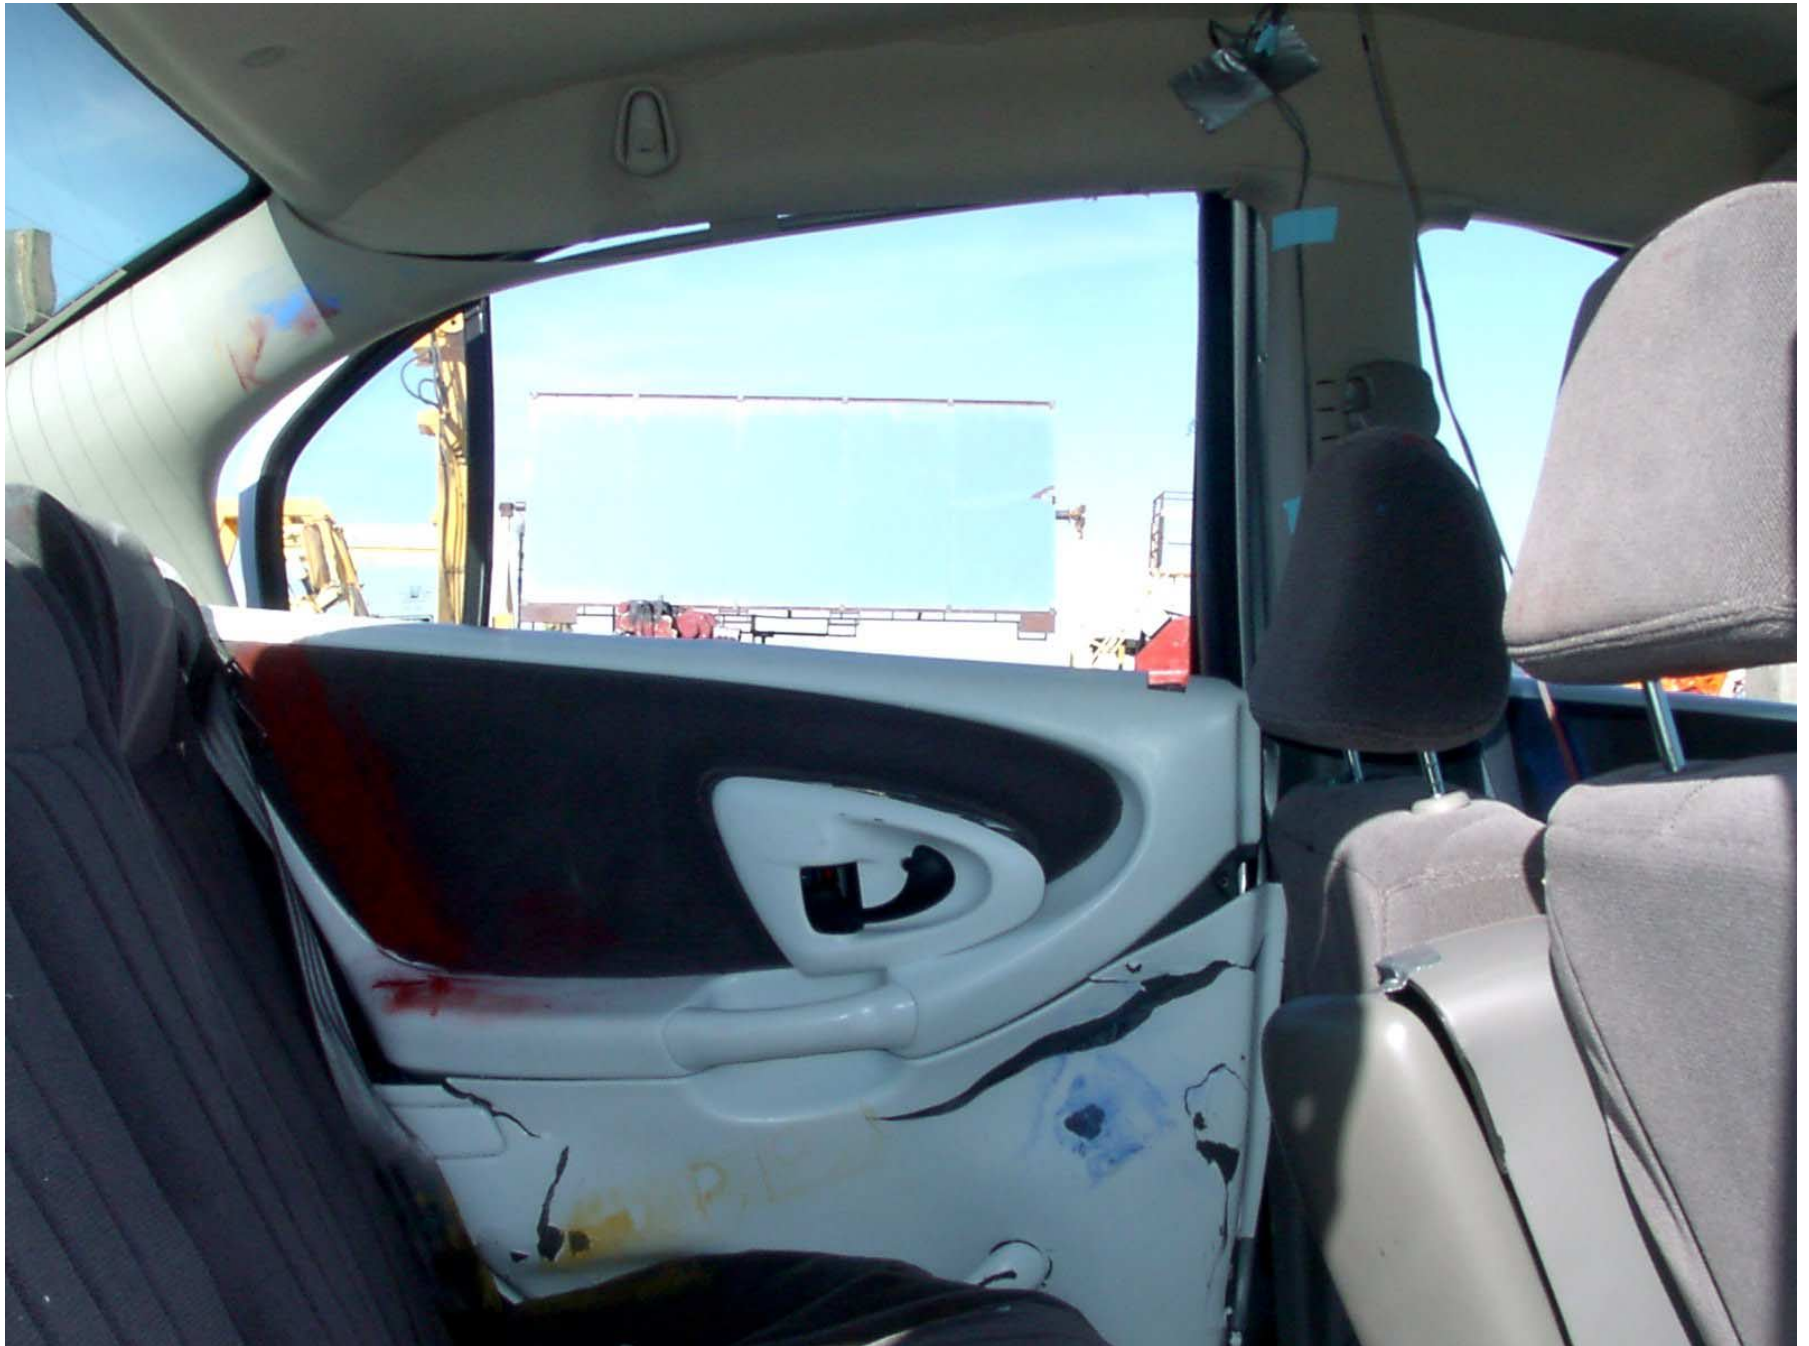
Figure A-39: Passenger Dummy Contact Points Inside View, Post-Test

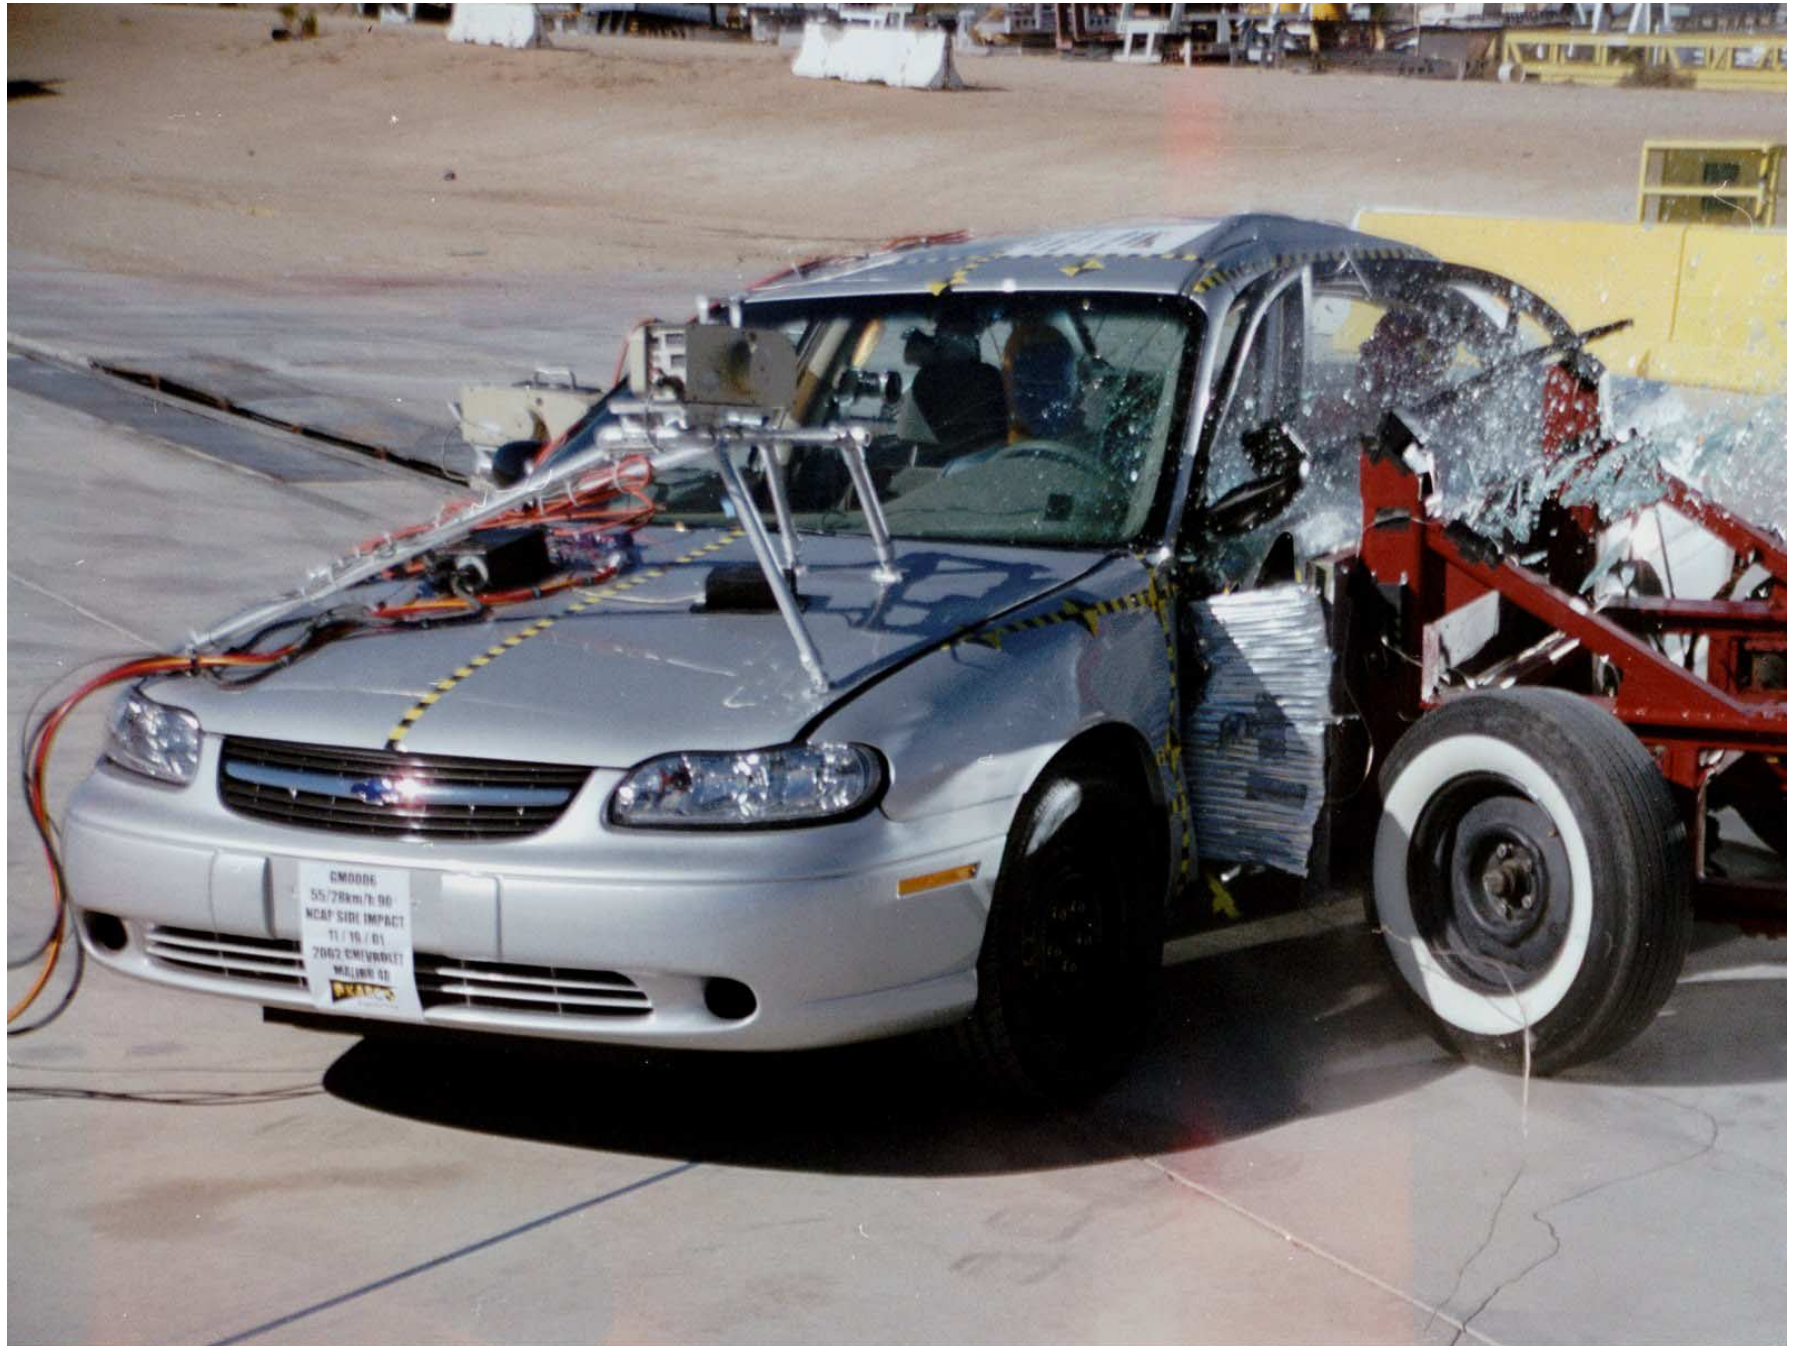
Figure A-49: Vehicle During Impact

A model year 2002 Chevrolet Malibu 4 Door Sedan was impacted on the left (driver's) side by a Moving Deformable Barrier (MDB) which was moving forward in a 27° crabbed position to the tow road guidance system at a velocity of 61.96 km/h. The specified impact velocity range is from 61.1 to 62.7 km/h. The test (target) vehicle was stationary and positioned 63° to the line of forward motion. The weight of the vehicle as tested was 1623 kg and the test weight of the MDB was 1361 kg. The test was conducted at KARCO Engineering in Adelanto, California, on November 19, 2001.
