# Insurance Institute for Highway Safety Crashworthiness Evaluation

## Crash Test Report 1999 Subaru Forester (CF98018)

**Vehicle identification number:** JF1SF6356XH701113  
**Body style:** Small four-door utility vehicle  
**Engine/transmission:** Longitudinal 2.5-liter 4-cylinder, 4-speed automatic, 4-wheel drive

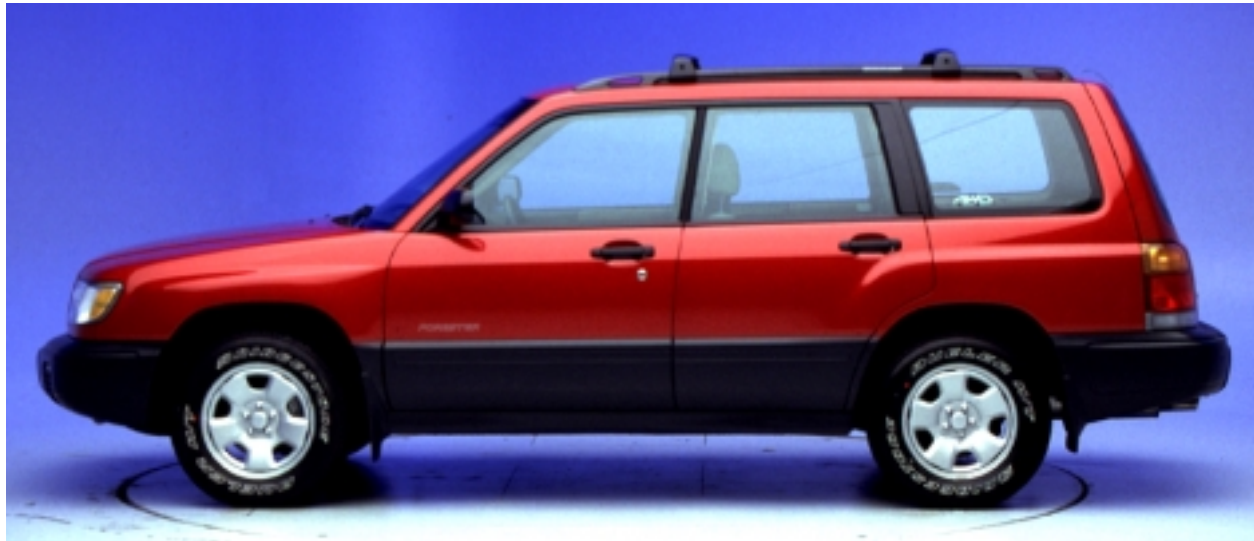
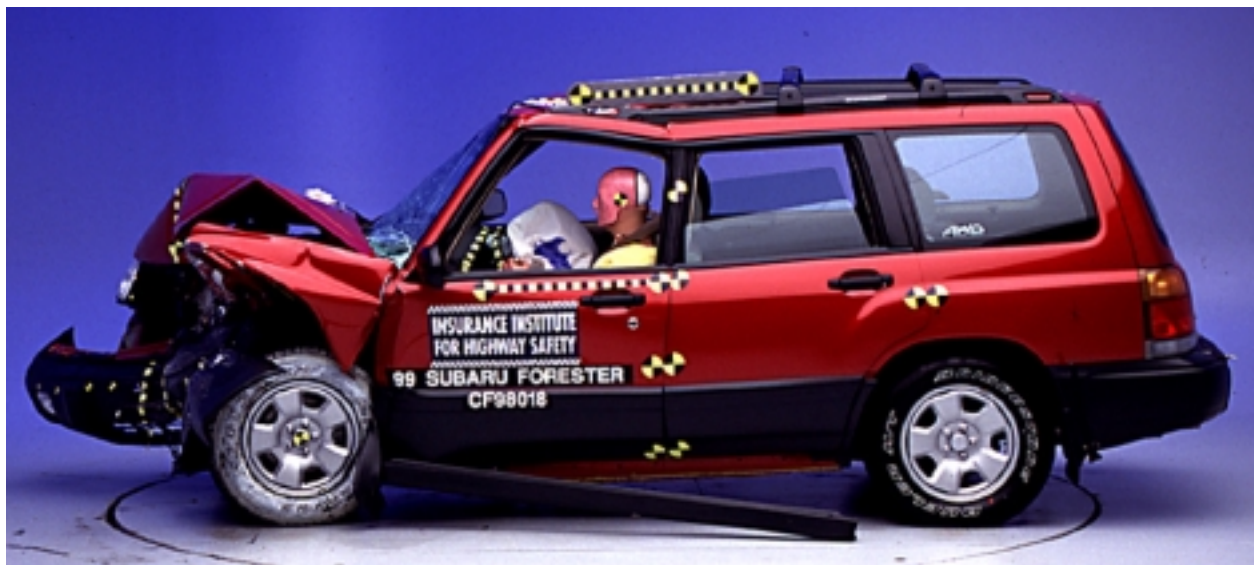
**Figure 1**  
**Precrash and Postcrash Side Views — 1999 Subaru Forester**

Measures of intrusion taken after the crash indicated the lower instrument panel in front of the dummy moved rearward 5-6 cm. Resultant intrusion in the driver footwell measured 14 cm at the footrest and 17-21 cm at other places on the toepan. All doors remained closed during the crash and opened with ease after the crash.

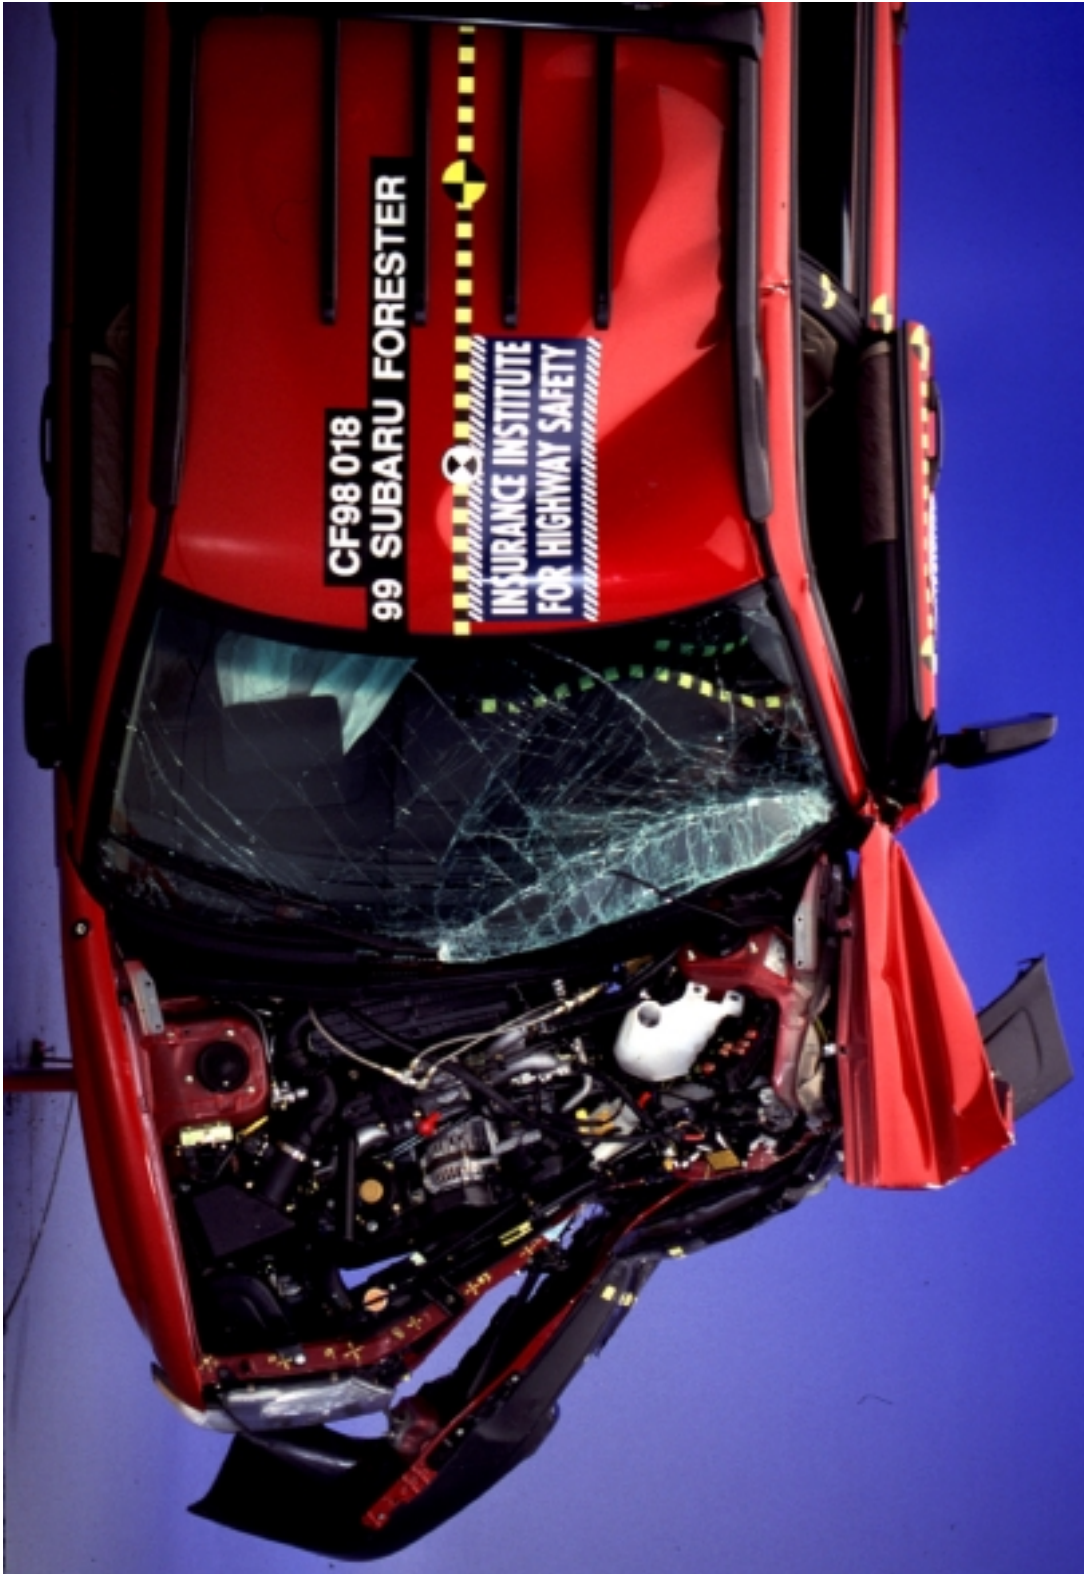
**Figure 2**  
**Overhead View of Crash Deformation — 1999 Subaru Forester**

Figure 2 shows the overhead view of the crash deformation. Figure 3 illustrates the precrash and postcrash contour measures of the front bumper cover and the resulting permanent crush. Figure 4 illustrates the corresponding measures of both the front bumper reinforcement bar and upper crossmember of the radiator support. Figure 5 shows the precrash and postcrash views from below. Figure 6 illustrates the deformation of the side rails, floor rails, and radiator and engine supports, which are visible in Figure 5.

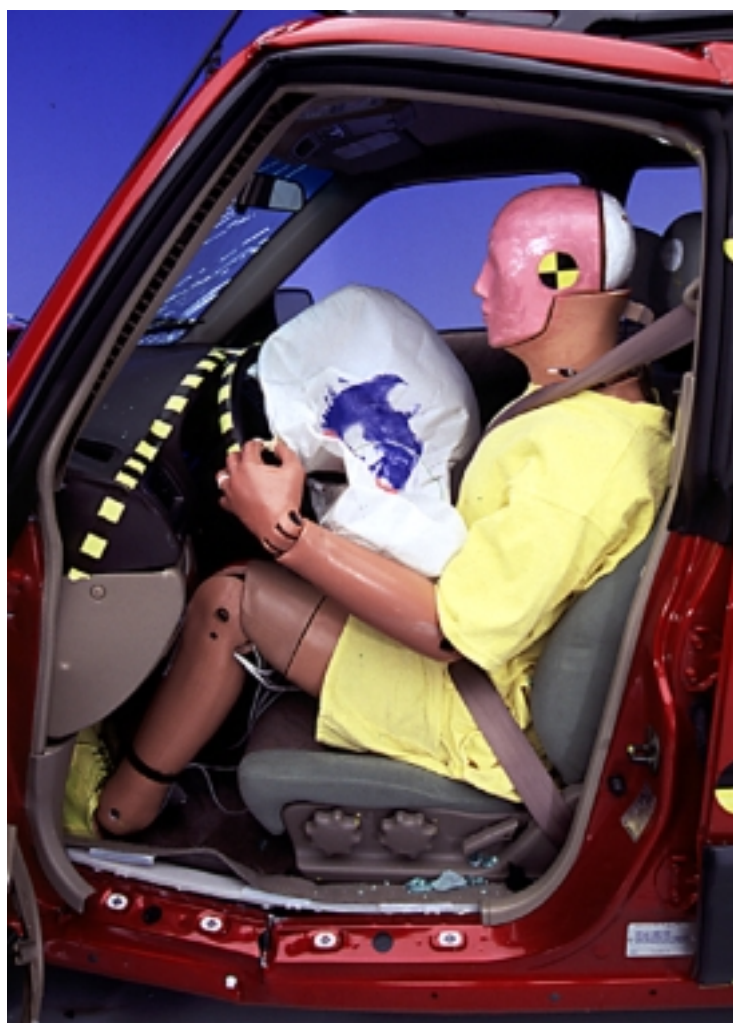
**Figure 7**  
**Dummy and Vehicle Interior, Postcrash — 1999 Subaru Forester**

**Left leg and foot:** Paint transferred from the dummy's left knee indicated the knee contacted the knee bolster just to the left of the steering column, about 3 cm above and 3 cm to the right of the left instrument panel intrusion reference point. The plastic bolster trim was cracked from this contact, and the U-shaped steel bracket supporting the bolster reinforcement plate on the left side of the steering column was crushed forward 3 cm. The medial edge of the knee contacted the tilt adjustment lever on the left side of the steering column. Paint transferred from the dummy's left shin indicated the shin contacted the knee bolster below and slightly to the left of the left knee impact location, extending outward to the right edge of the fuse panel door in the bolster. The left foot was found fully dorsiflexed, slightly everted, and internally rotated about 25 degrees, with the lateral sole against the intruded footrest and the back of the heel on the floorpan.

**Right leg and foot:** Paint transferred from the dummy's right knee indicated the knee contacted the knee bolster just below and to the right of the steering column, about 3 cm directly to the left of the right instrument panel intrusion reference point. The plastic bolster trim was cracked from this contact, and the U-shaped steel bracket supporting the bolster reinforcement plate on the right side of the steering column was crushed forward less than 1 cm. The knee also contacted the lower right side of the steering column trim just below the ignition switch. Paint transferred from the dummy's right shin indicated the shin contacted the knee bolster just below the right knee impact location. The right foot was found slightly dorsiflexed and considerably everted, with the medial sole from heel to toe pressed against the intruded toeplate to the left of the accelerator pedal. The back of the heel was pressed against the floorpan. (The brake pedal was located to the left and well behind the right foot.)
