**REPORT NUMBER KAR21130-01**

**NEW CAR ASSESSMENT PROGRAM  
SIDE IMPACT TEST**

**KIA MOTORS CORPORATION  
2002 KIA SEDONA LX  
MINIVAN**

**FINAL REPORT**

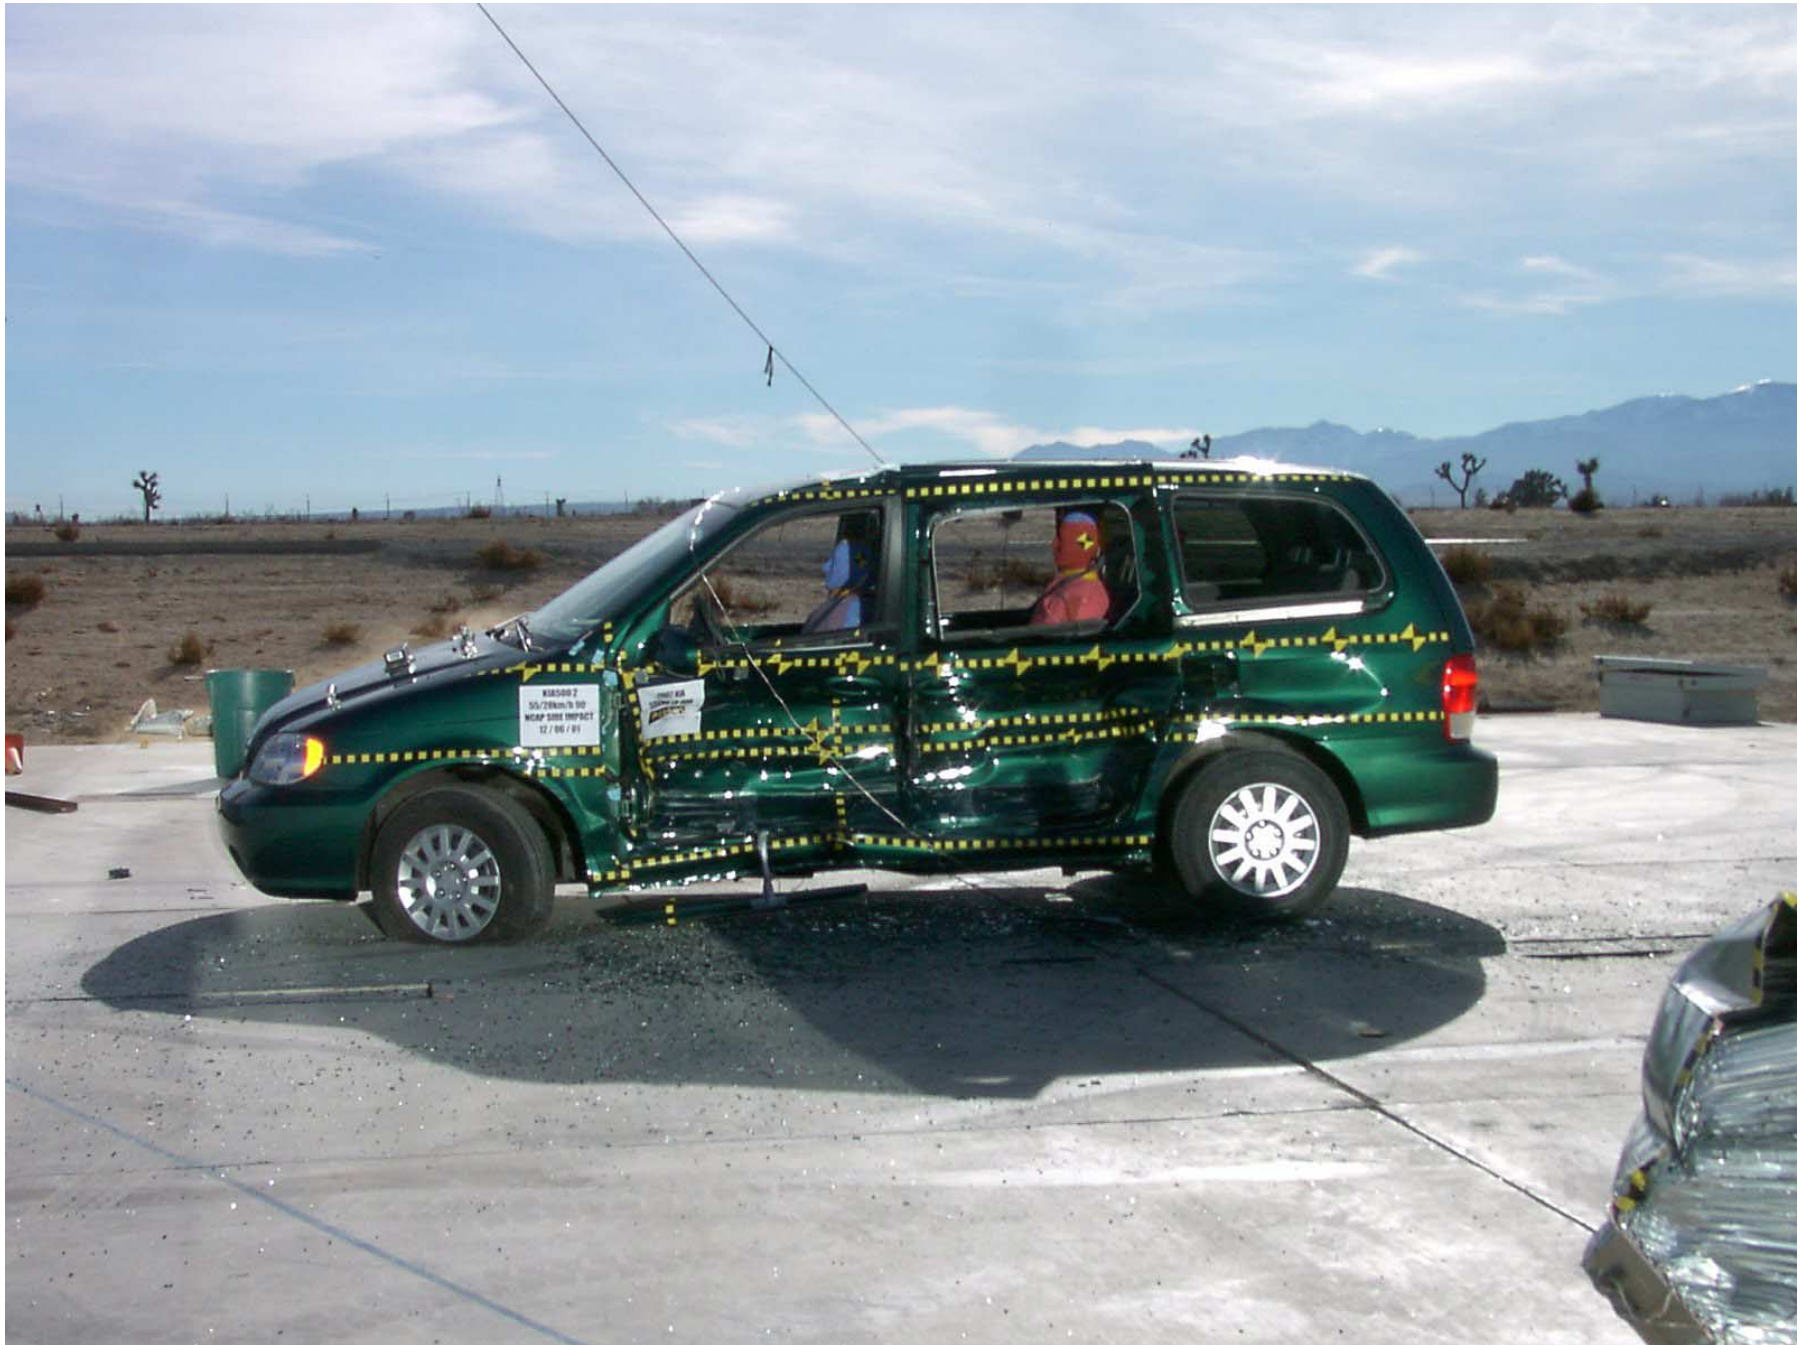
Figure A-10: Left (Impacted) Side View, Post-Test

The test vehicle sustained a maximum static crush of 368 mm at level 3, 1200 mm rearward of the left vertical impact point. The driver SID, Serial No. 274 and the passenger SID, Serial No. 275 were calibrated prior to this test. The SID injury criteria is summarized as follows:

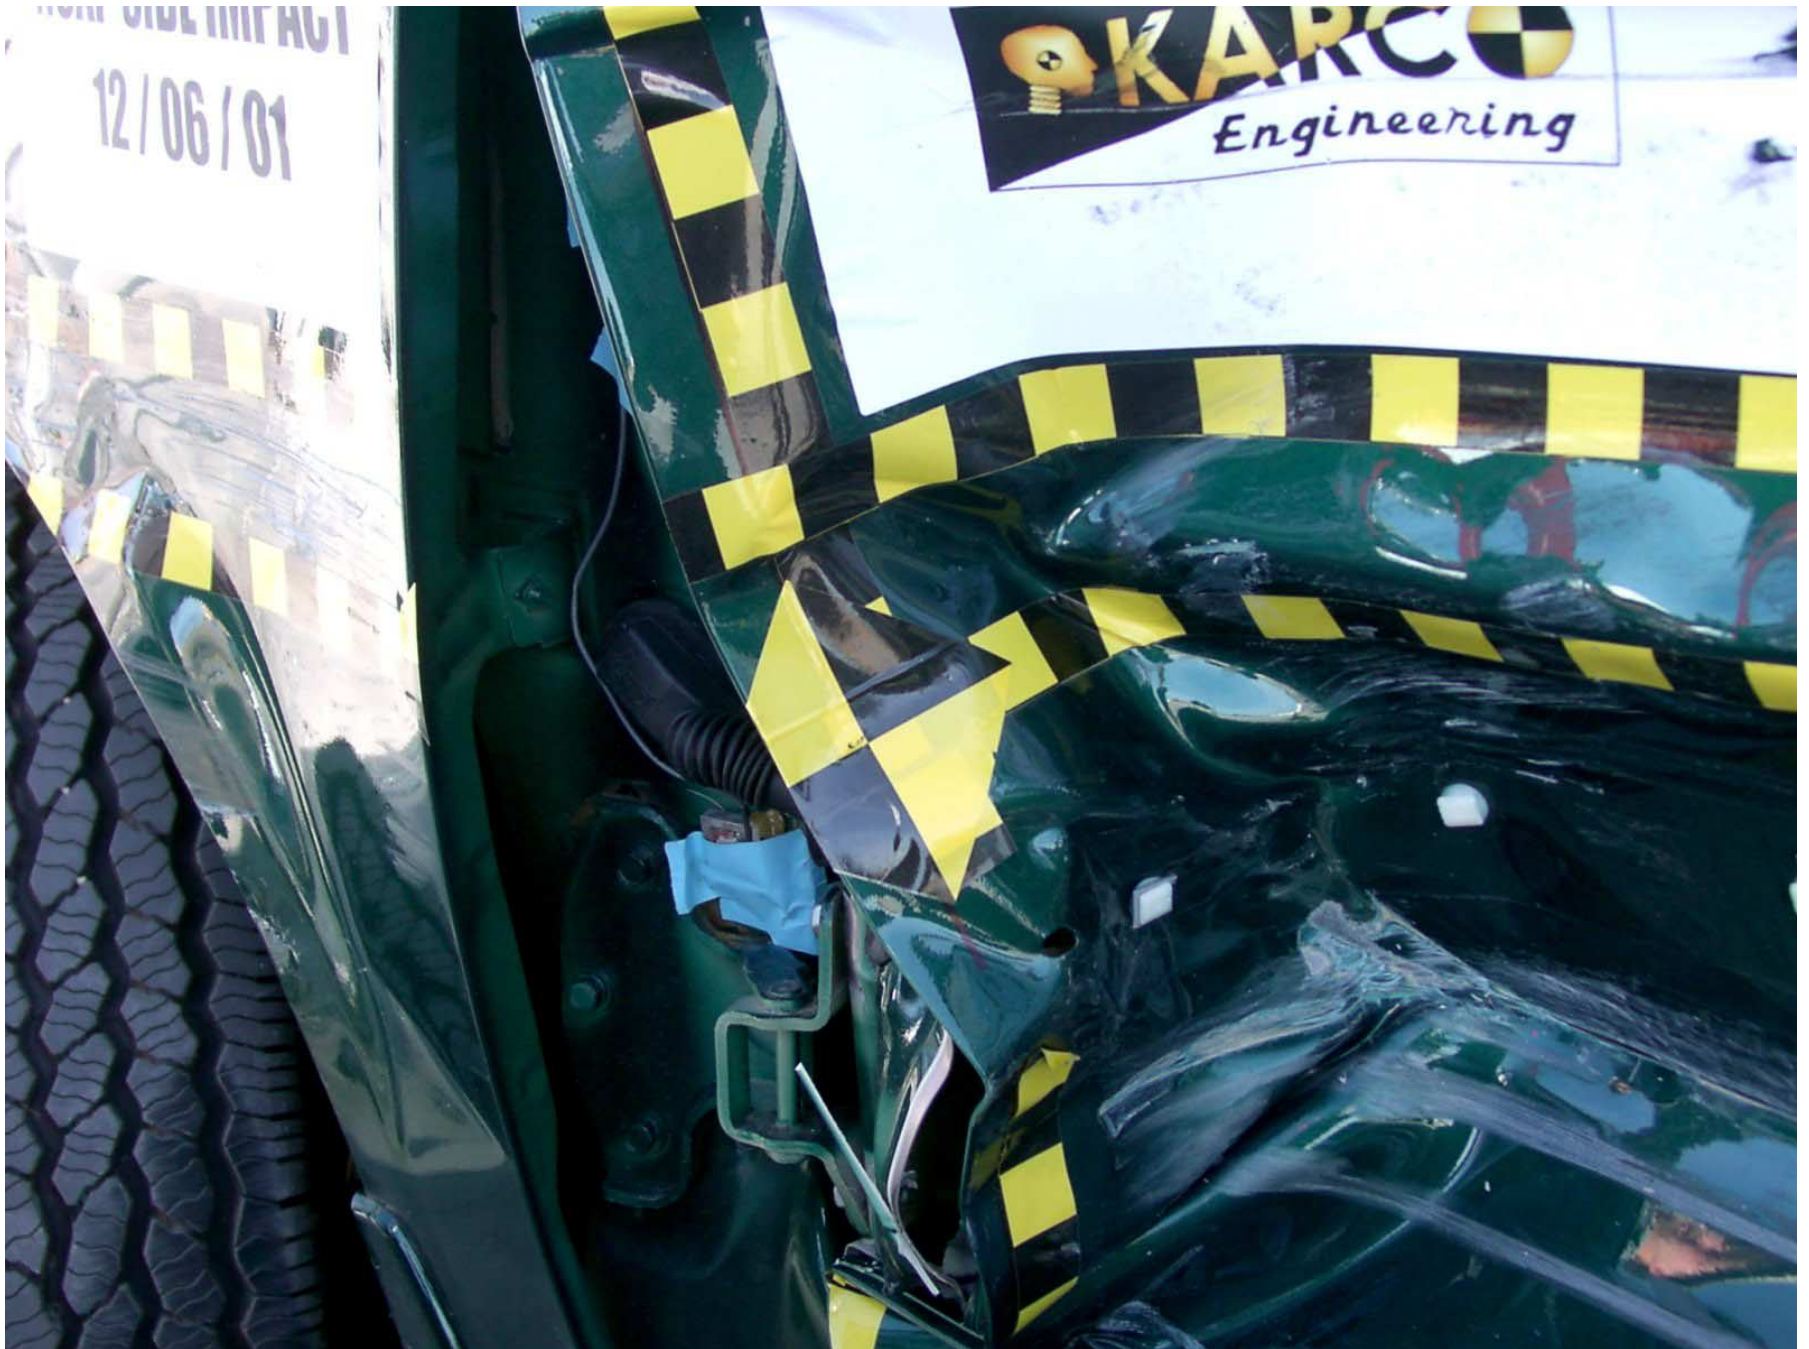
Figure A-17: Impact Point Target Close-up, Post-Test

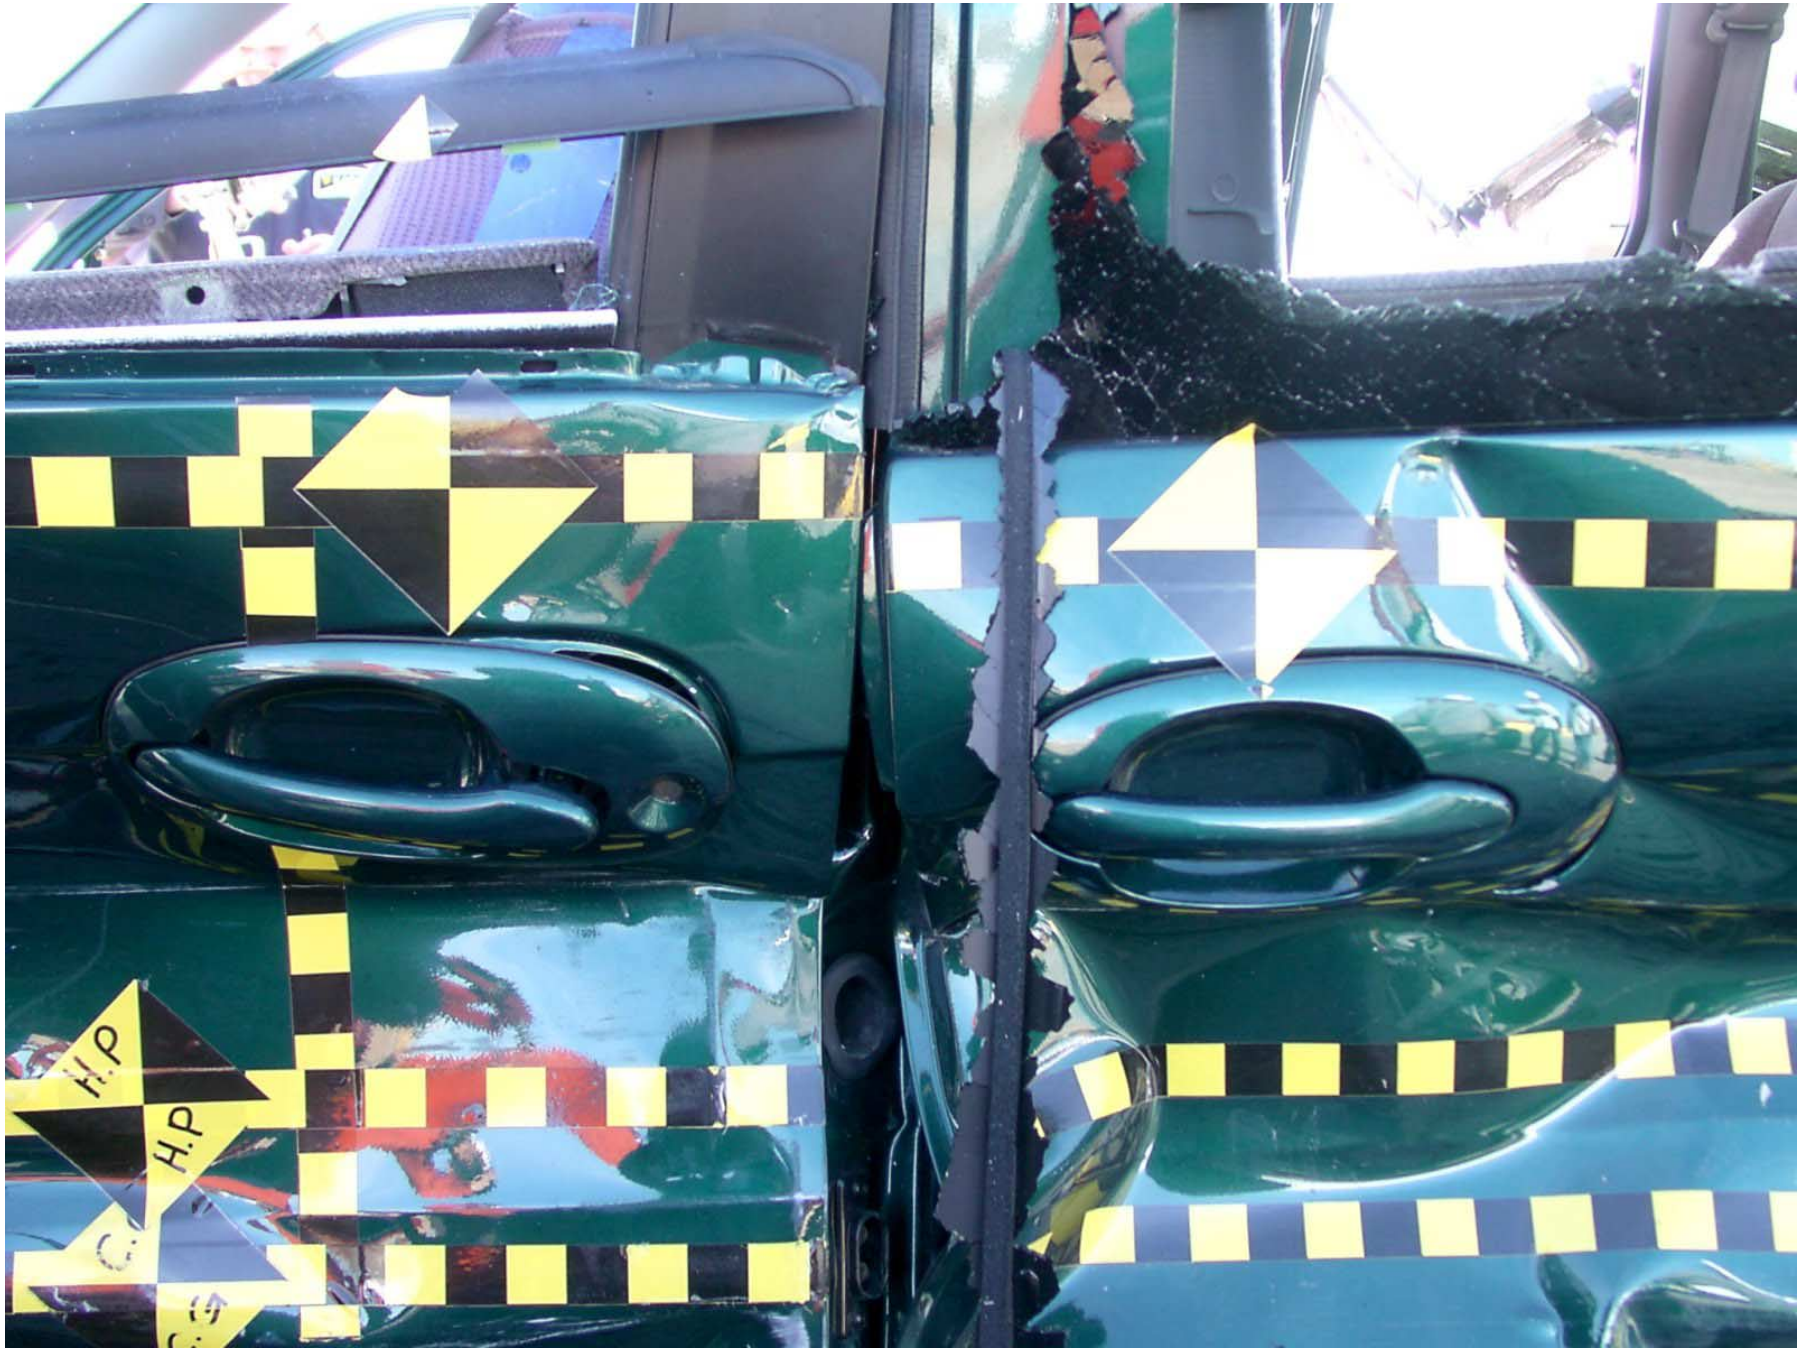
Figure A-19: Left Front Door Closed, Post-Test

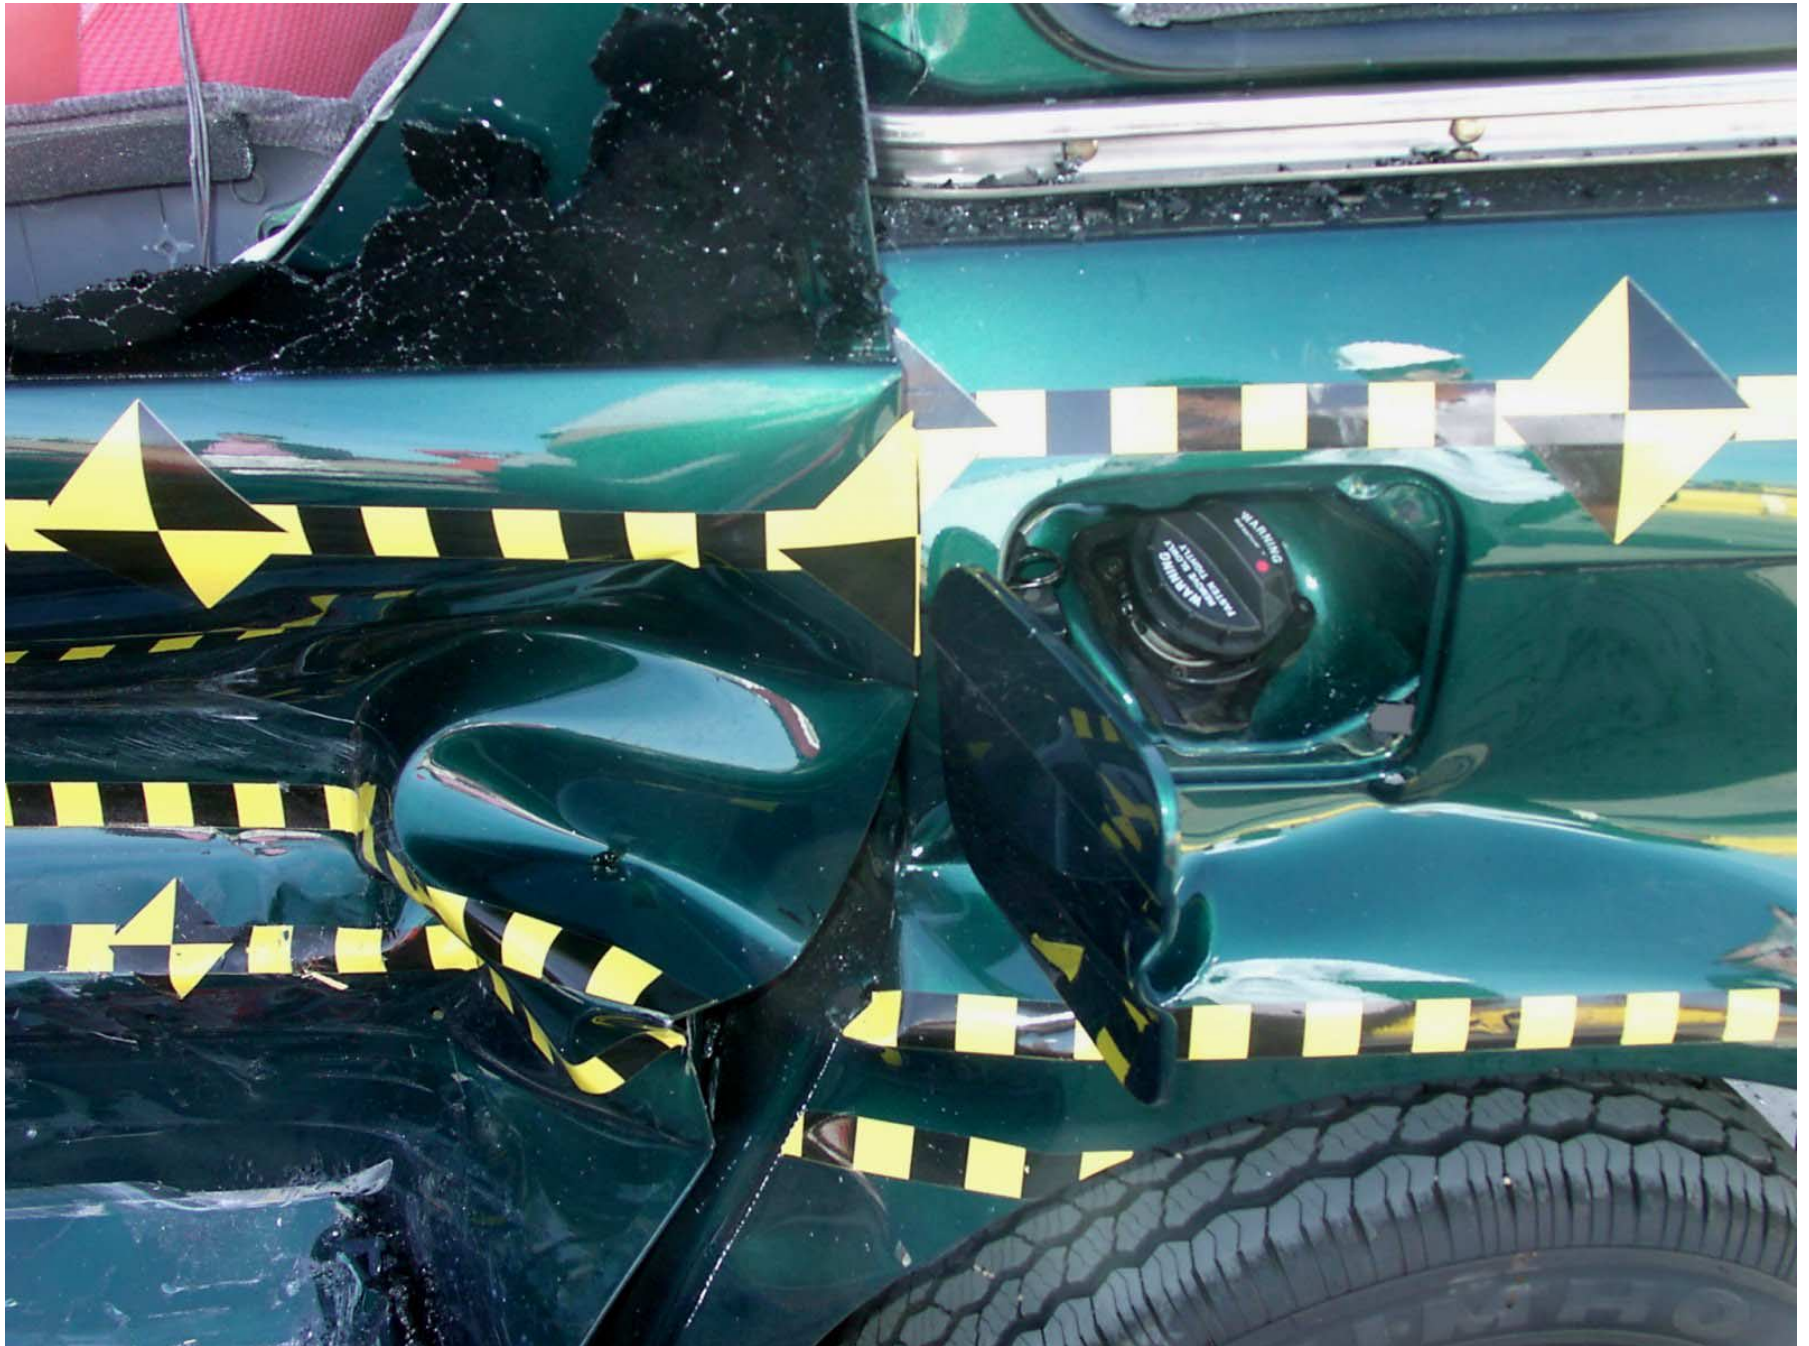
Figure A-21: Left Rear Door Closed, Post-Test

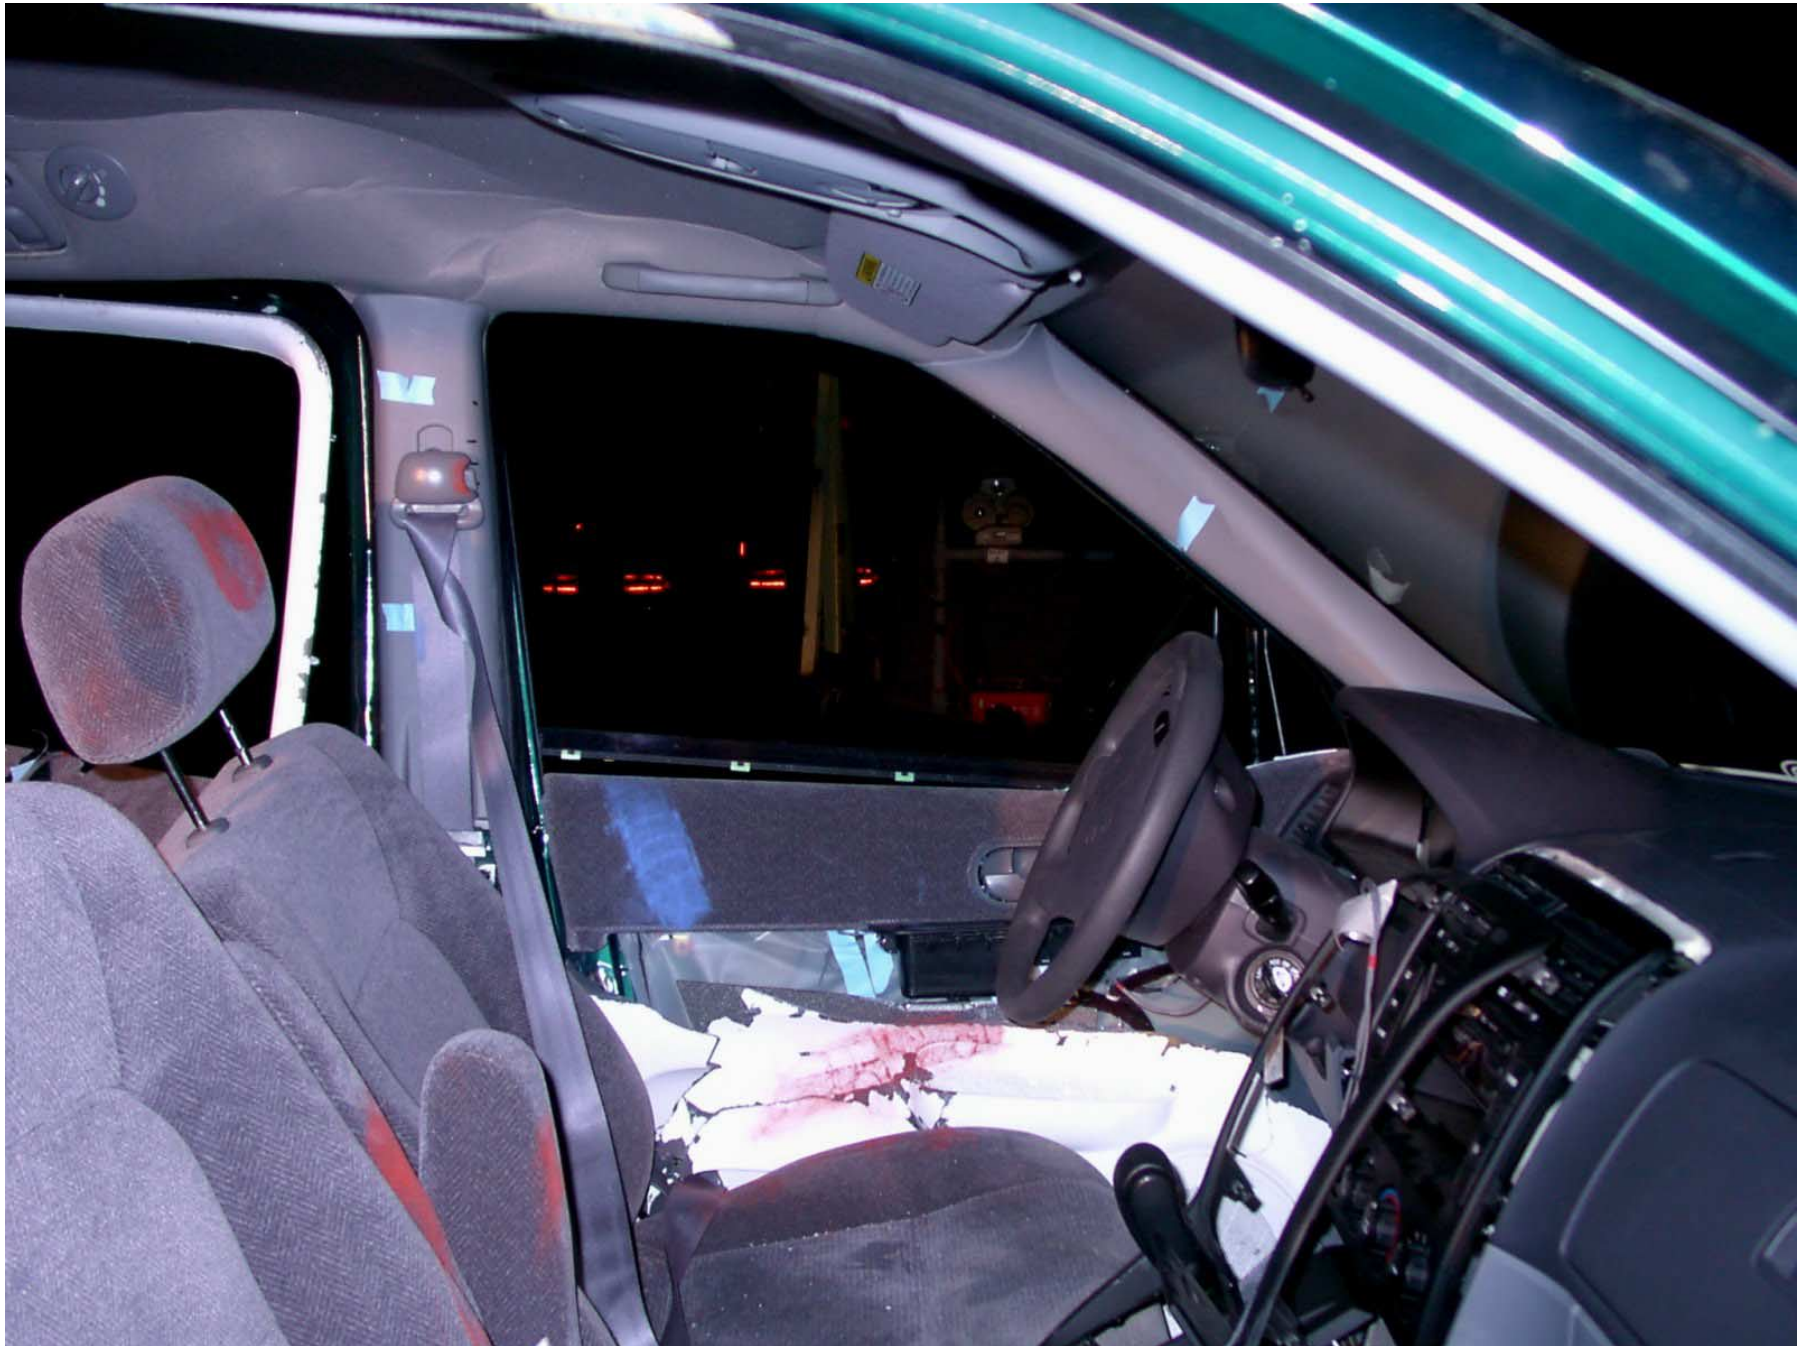
Figure A-30: Driver Dummy Contact Points Inside View, Post-Test

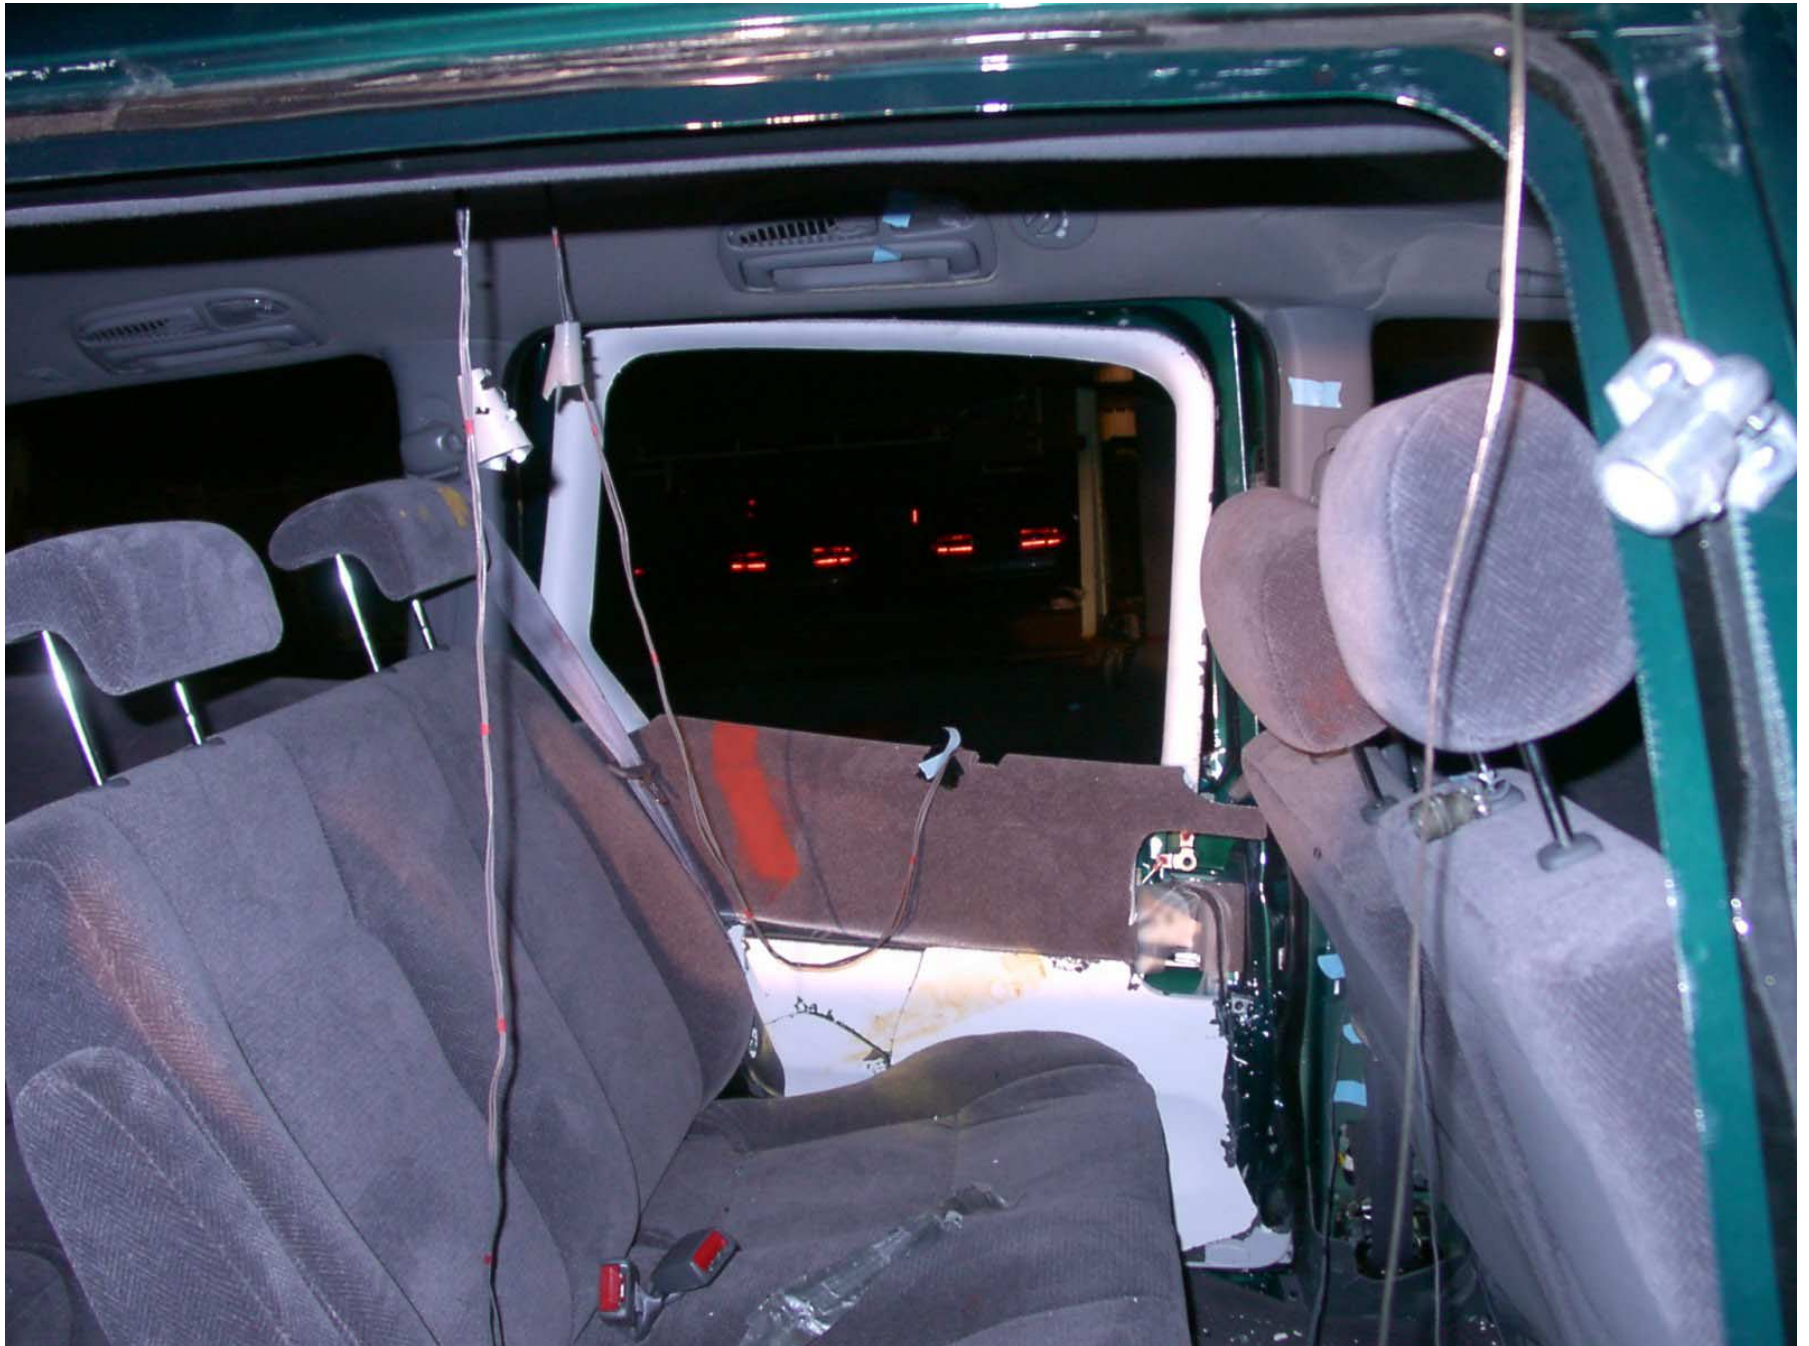
Figure A-39: Passenger Dummy Contact Points Inside View, Post-Test

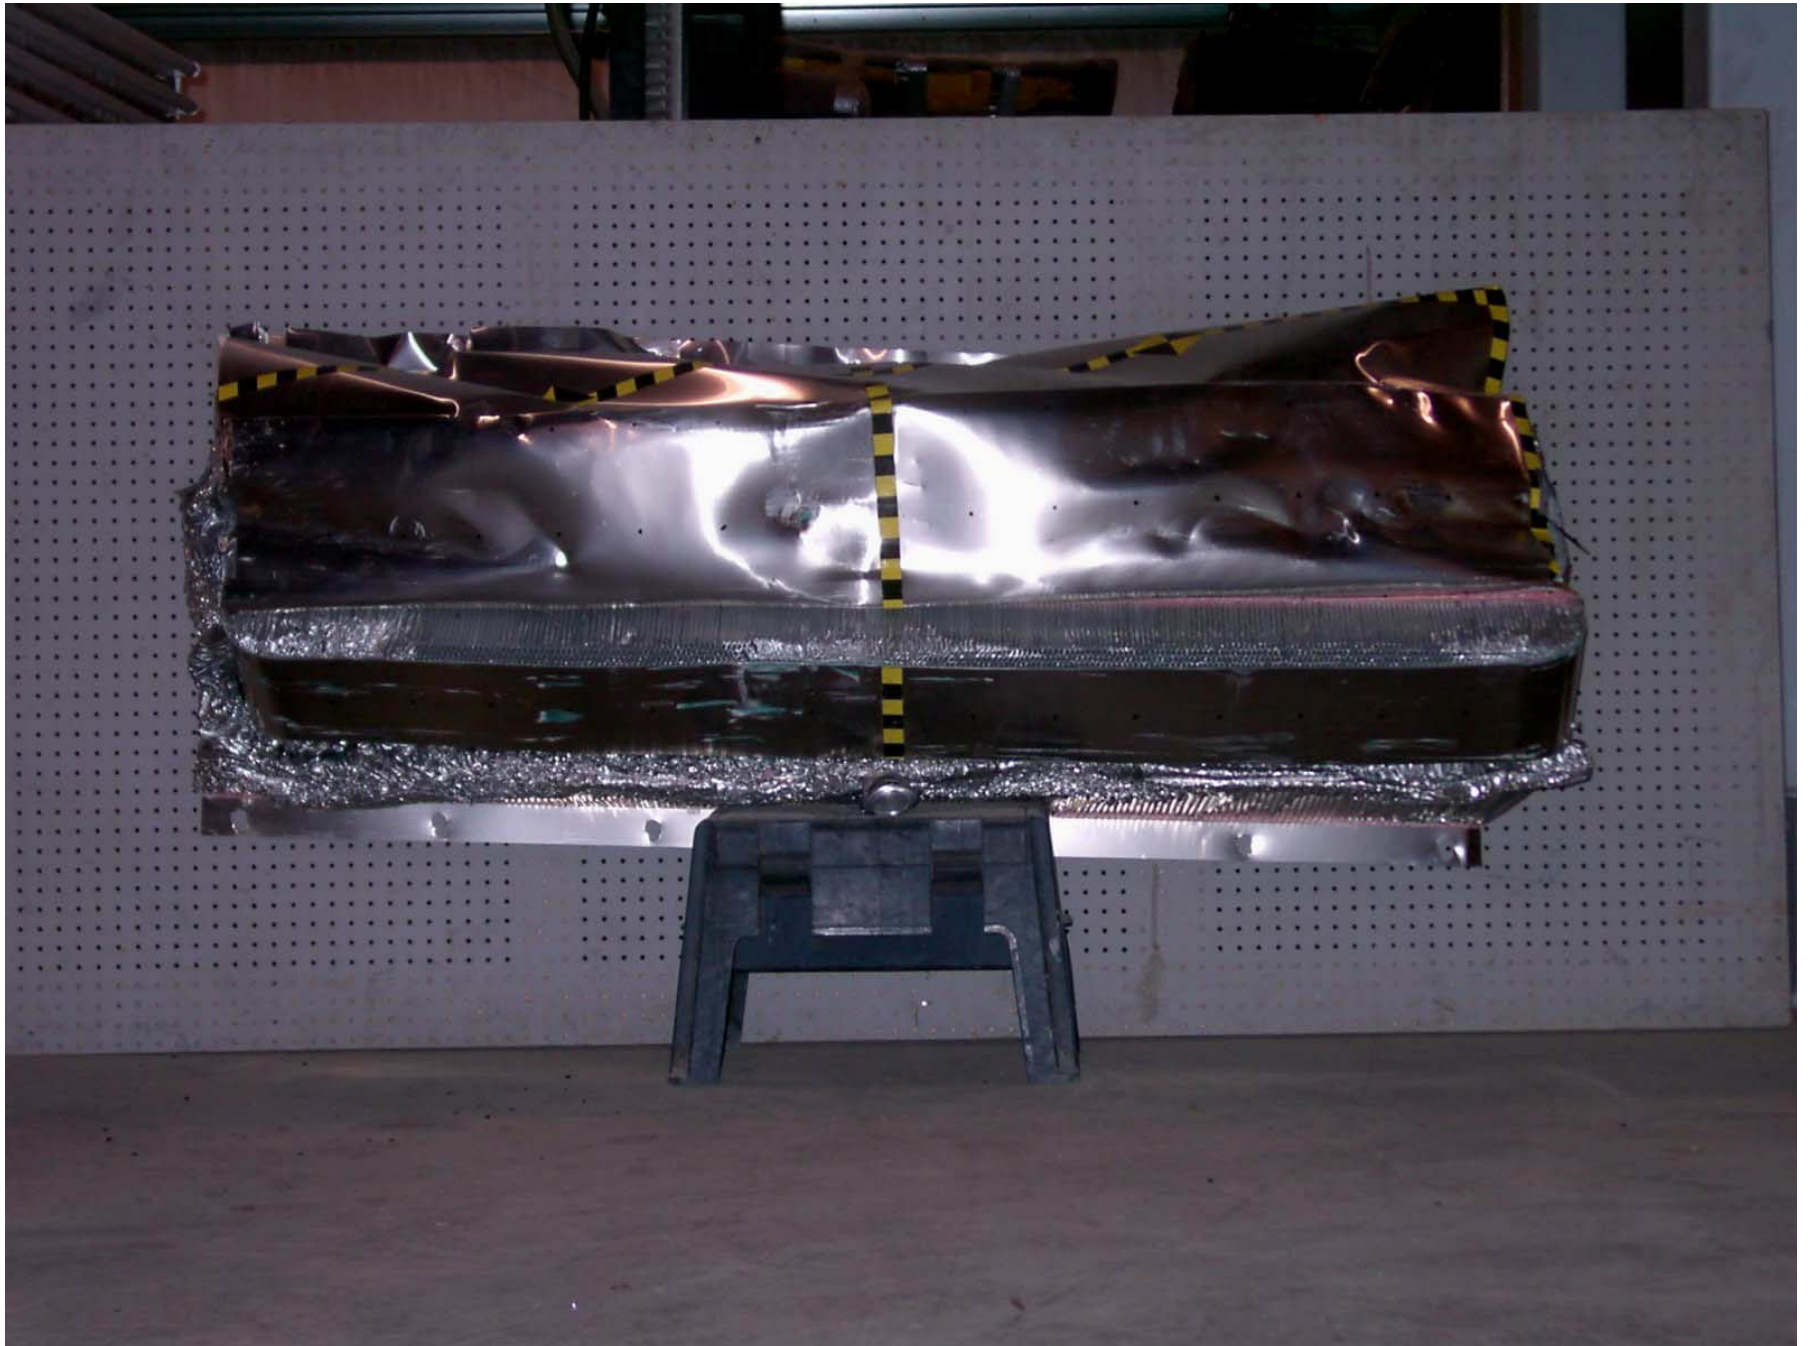
Figure A-41: Front View of Deformable Barrier, Post-Test

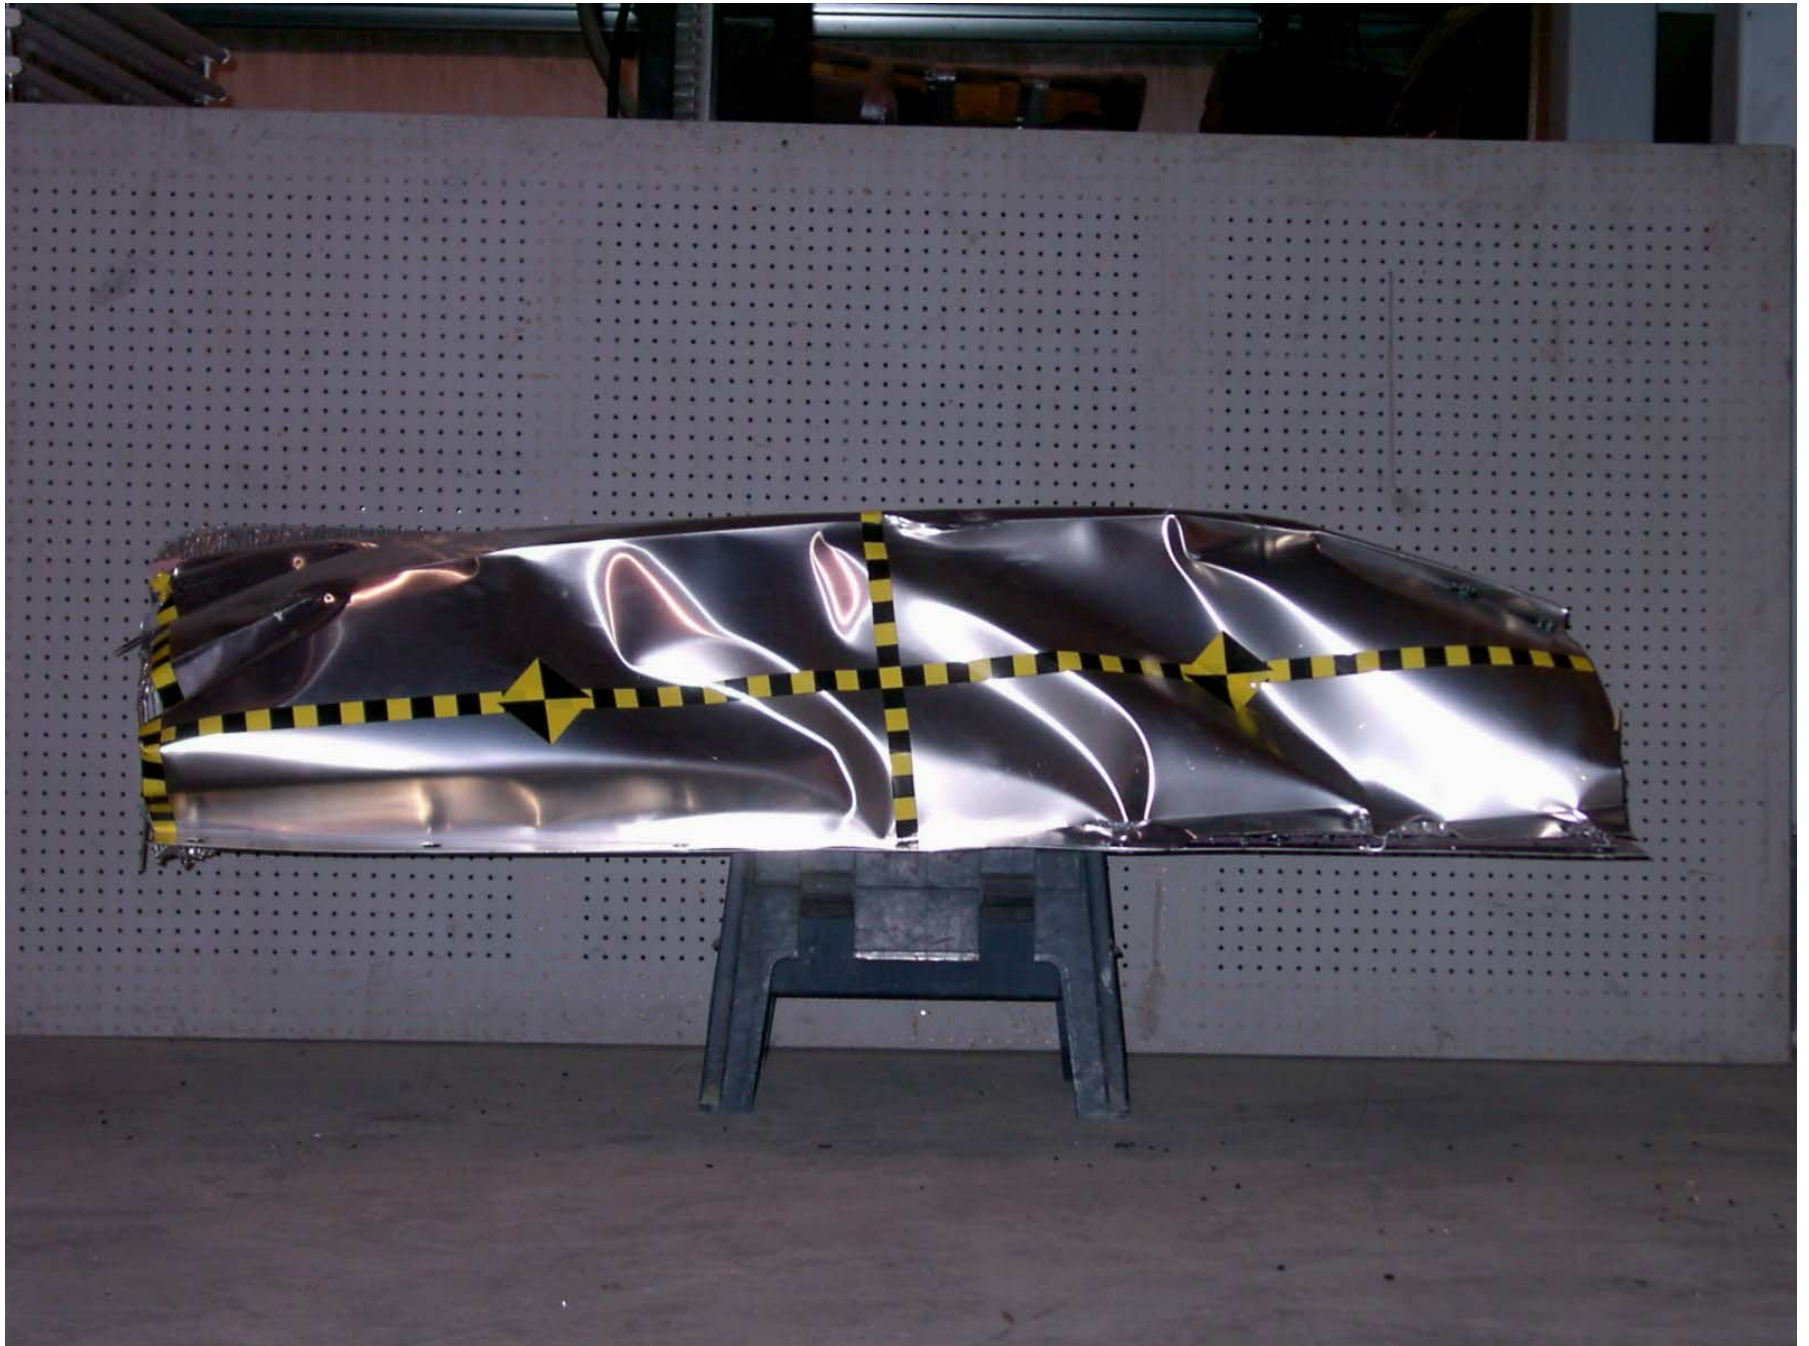
Figure A-43: Top View of Deformable Barrier, Post-Test

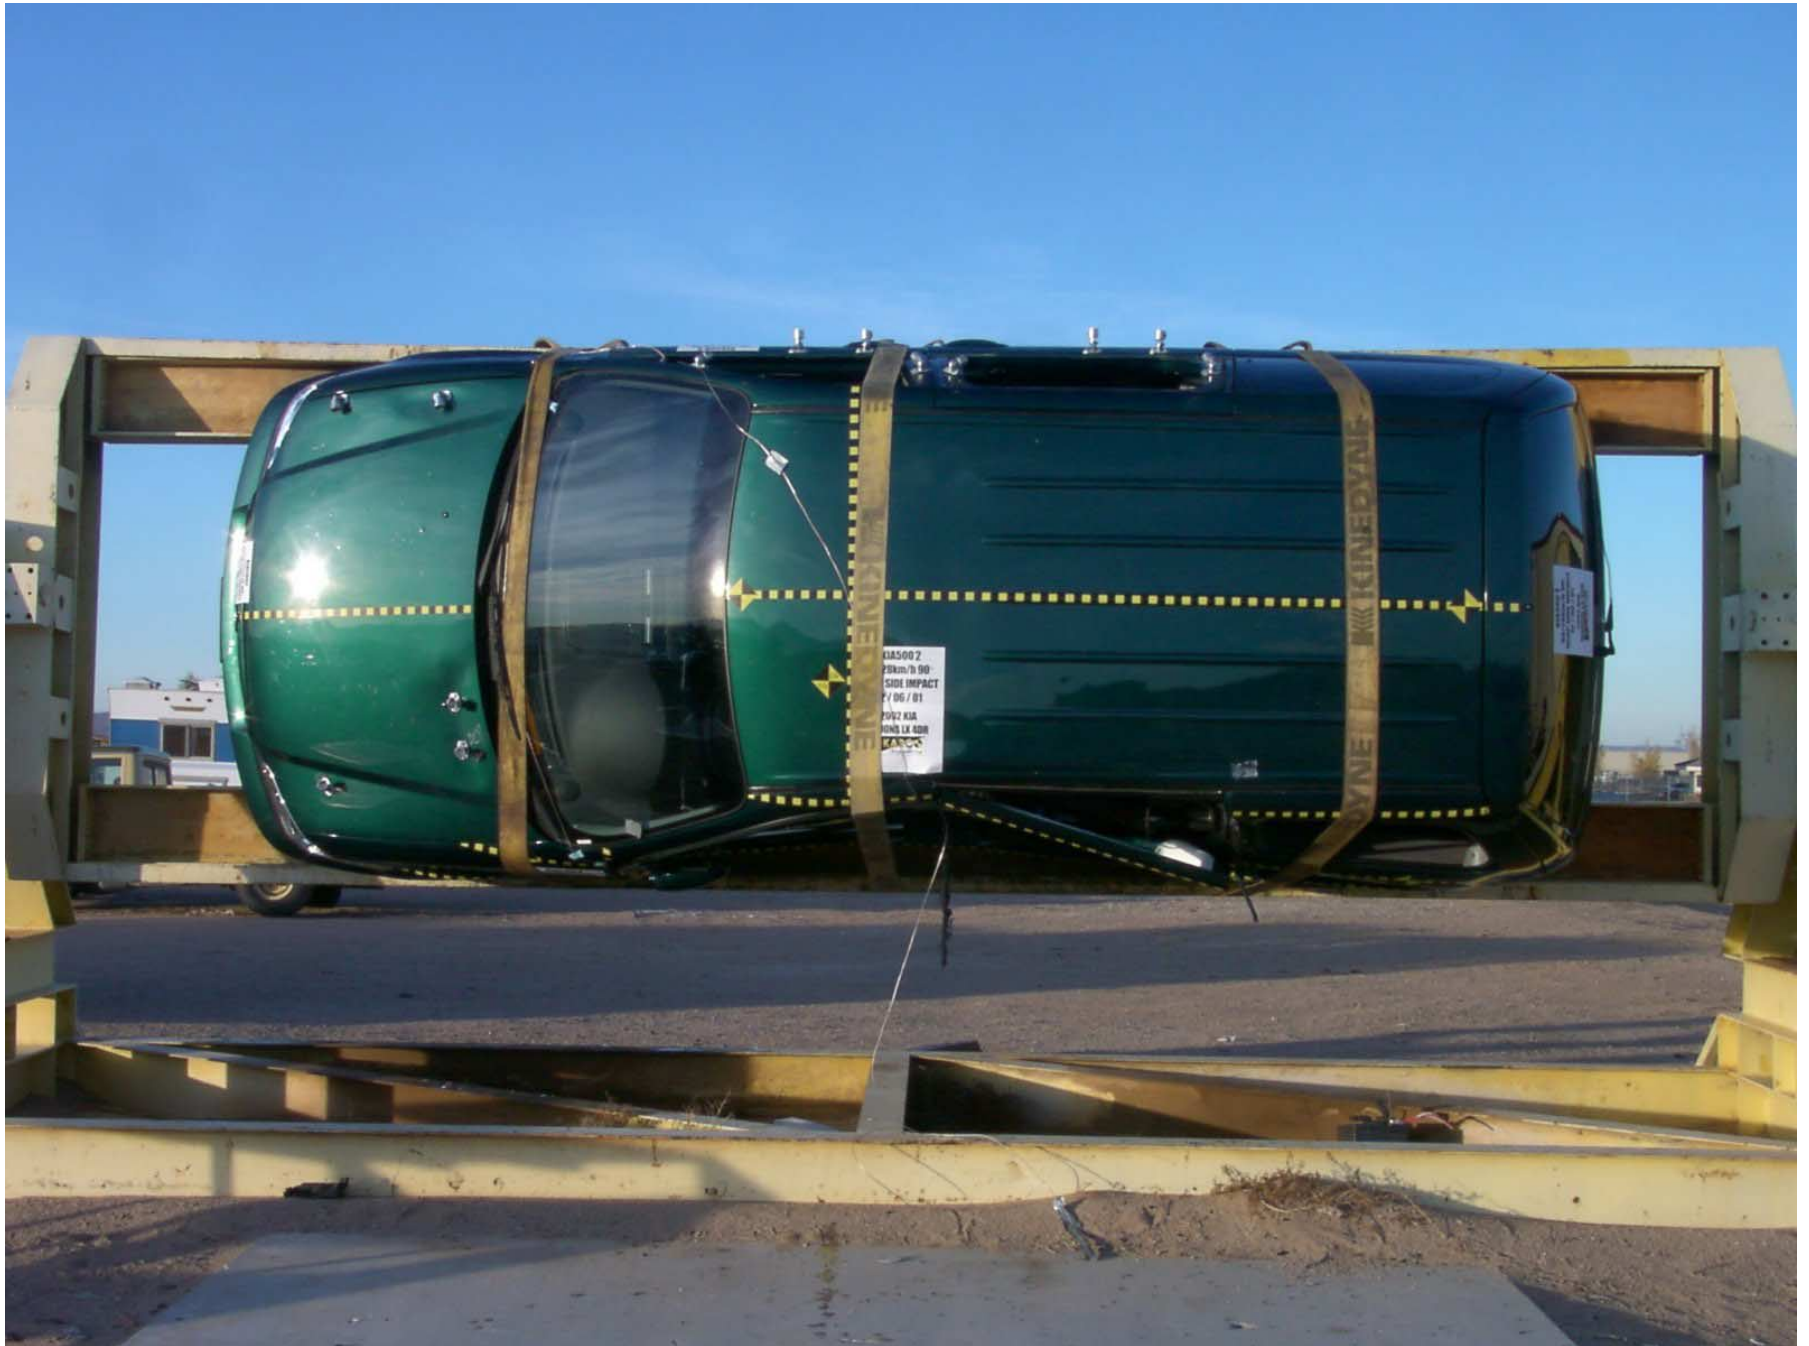
Figure A-48: Vehicle on Rollover Device, Top View

No solvent leakage occurred during static rollover testing.
