**REPORT NUMBER KAR21130-01**

**NEW CAR ASSESSMENT PROGRAM  
SIDE IMPACT TEST**

**KIA MOTORS CORPORATION  
2002 KIA SEDONA LX  
MINIVAN**

**FINAL REPORT**

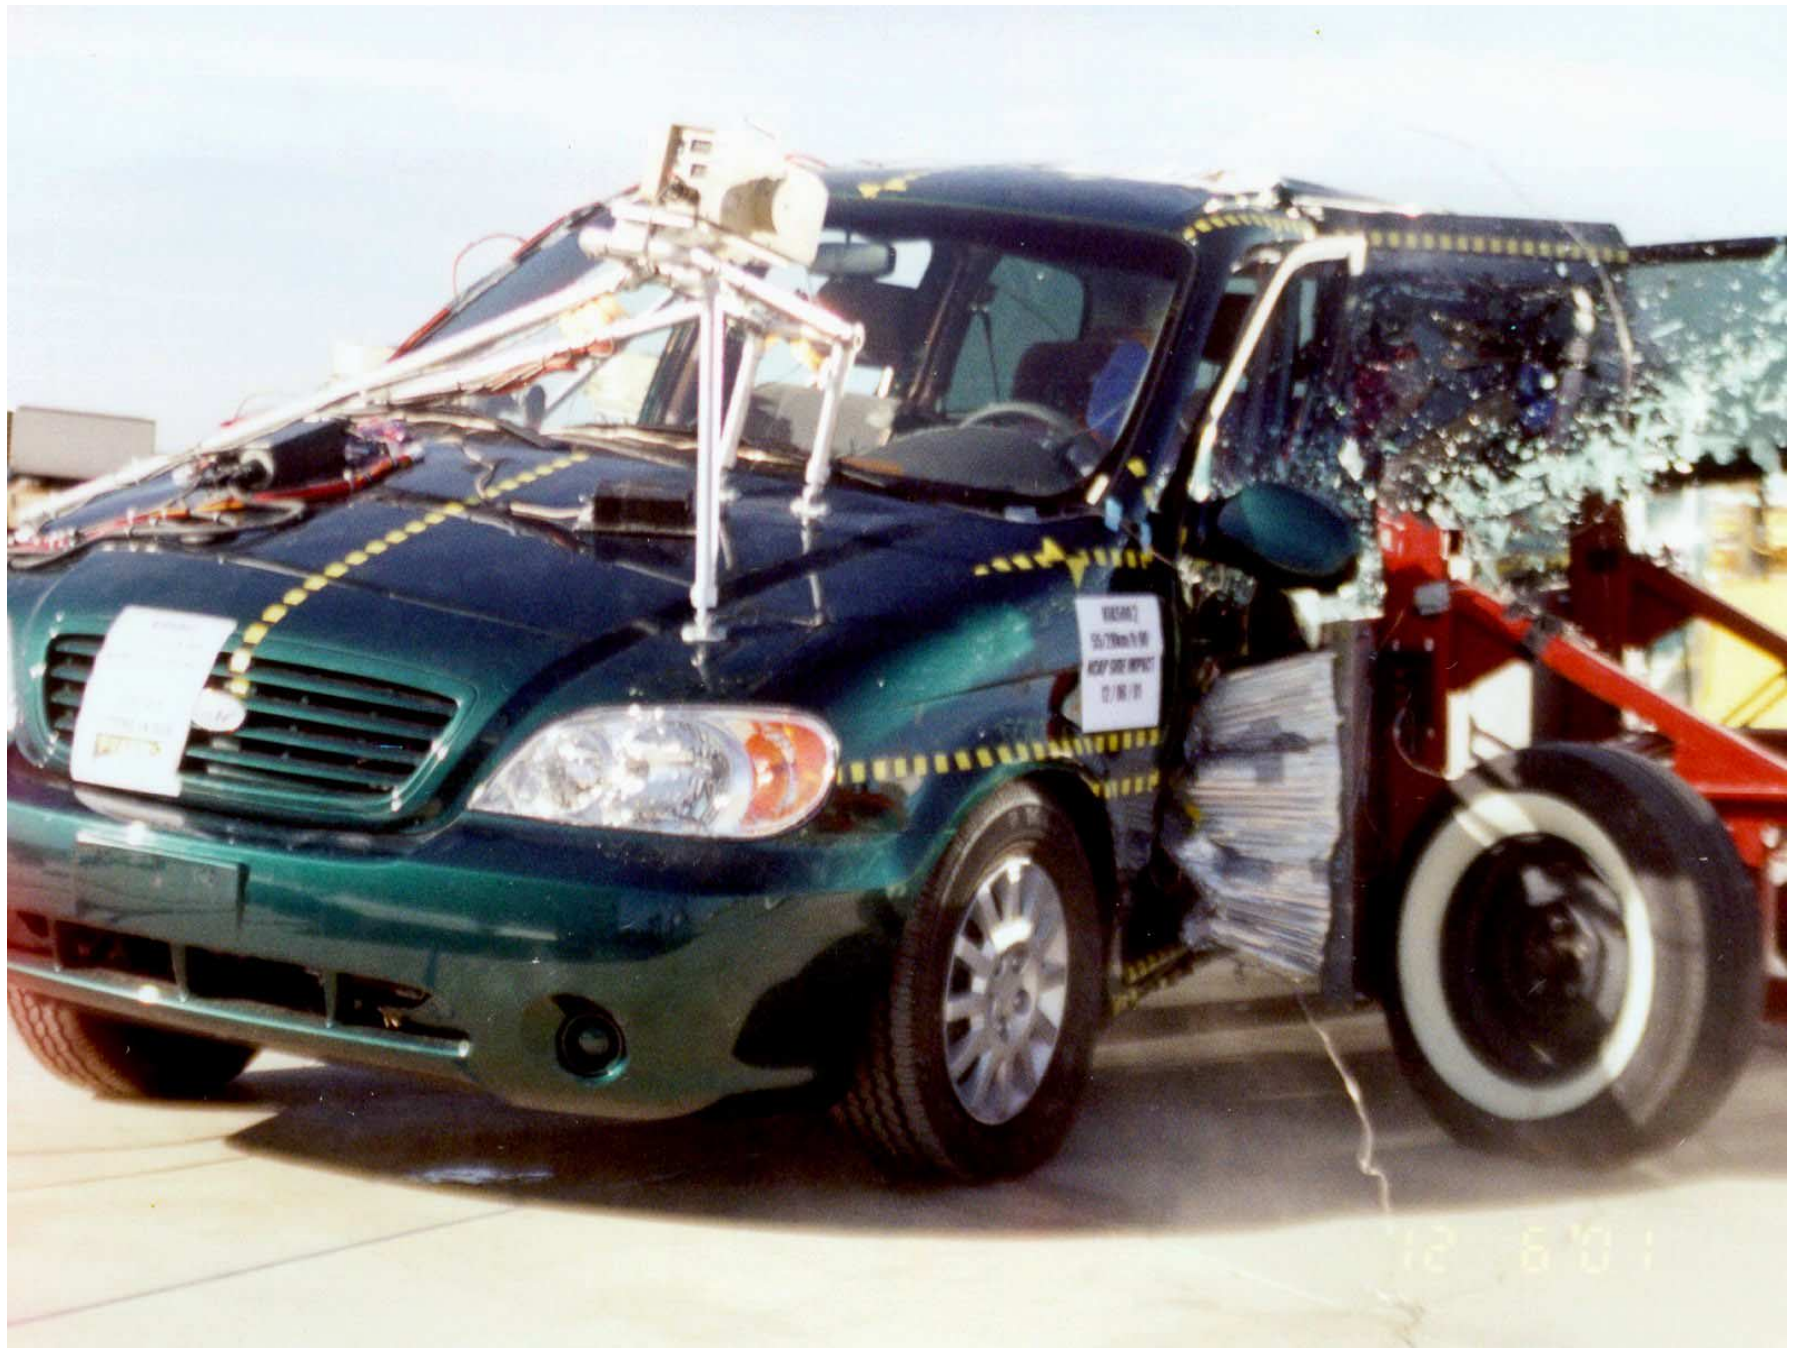
Figure A-49: Vehicle During Impact
