REPORT NUMBER: 214D-MGA-2002-004

**SAFETY COMPLIANCE TESTING FOR FMVSS 214
SIDE IMPACT PROTECTION
INDICANT**

Hyundai Motor Company
2002 Hyundai Sonata 4 door
NHTSA NUMBER: C20501

FINAL REPORT

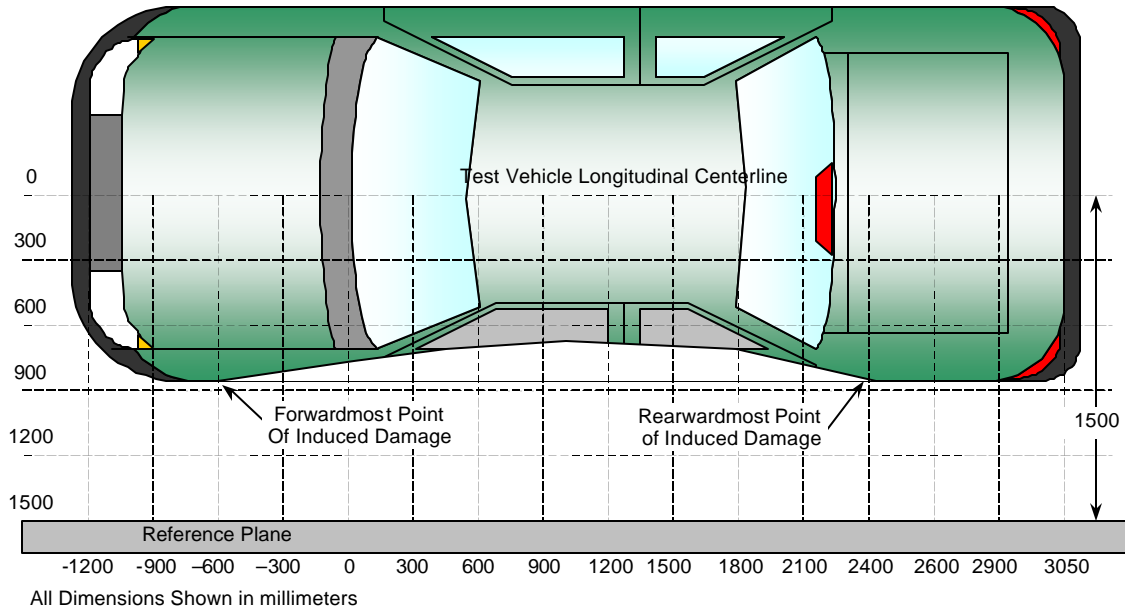
VEHICLE DAMAGE PROFILE DISTANCES

TOP VIEW

Damage Profile Distances

The test vehicle sustained a maximum static crush of 365 mm at level 2, 1350 mm rearward of the left vertical impact point. The driver and passenger SID's, Serial Nos. 049 and 048 respectively, were calibrated just prior to this test. The SID's injury criteria is summarized as follows:

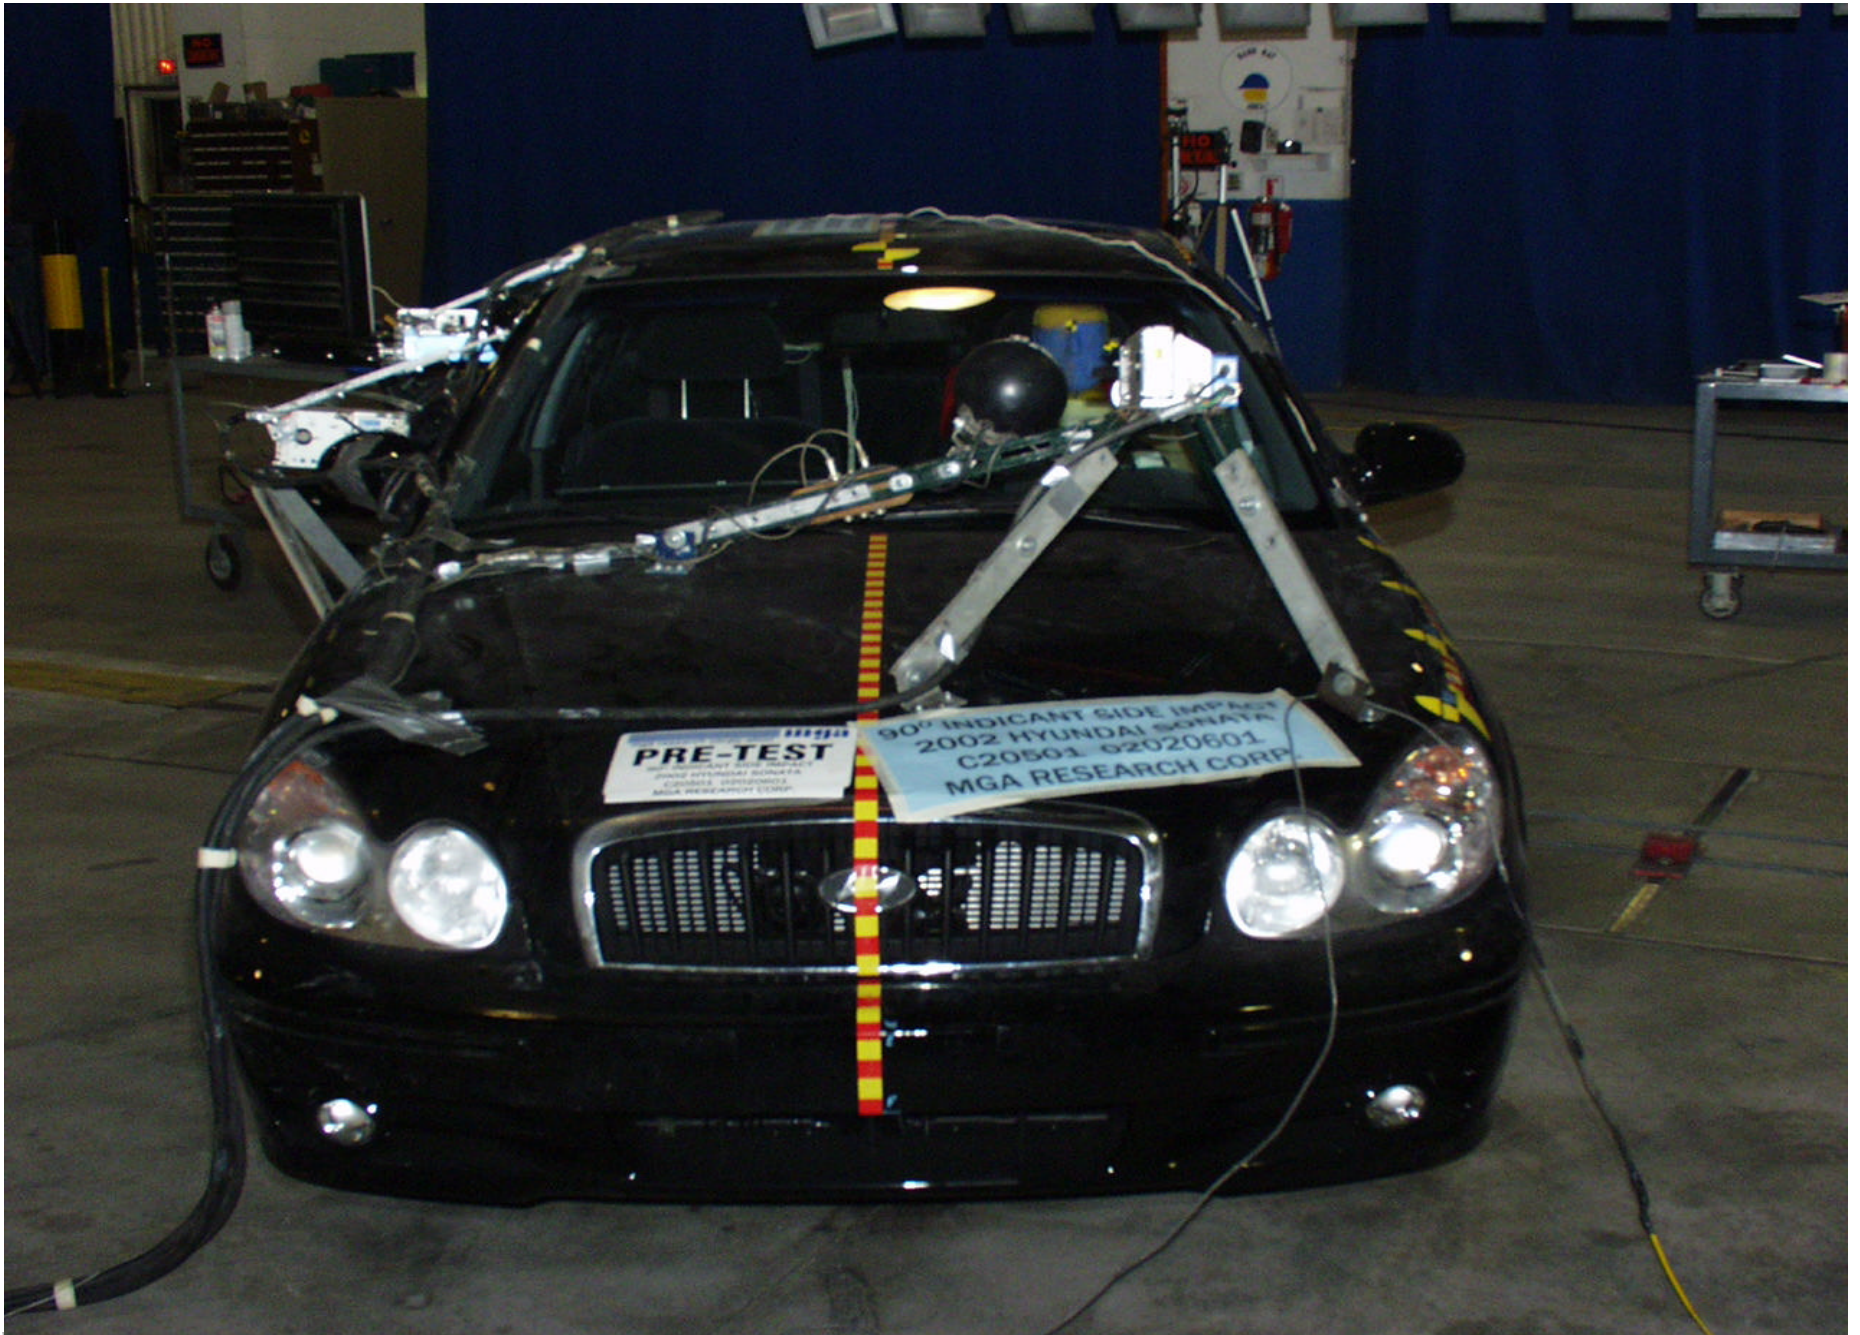
A-1.

Pre-Test Front View of Test Vehicle

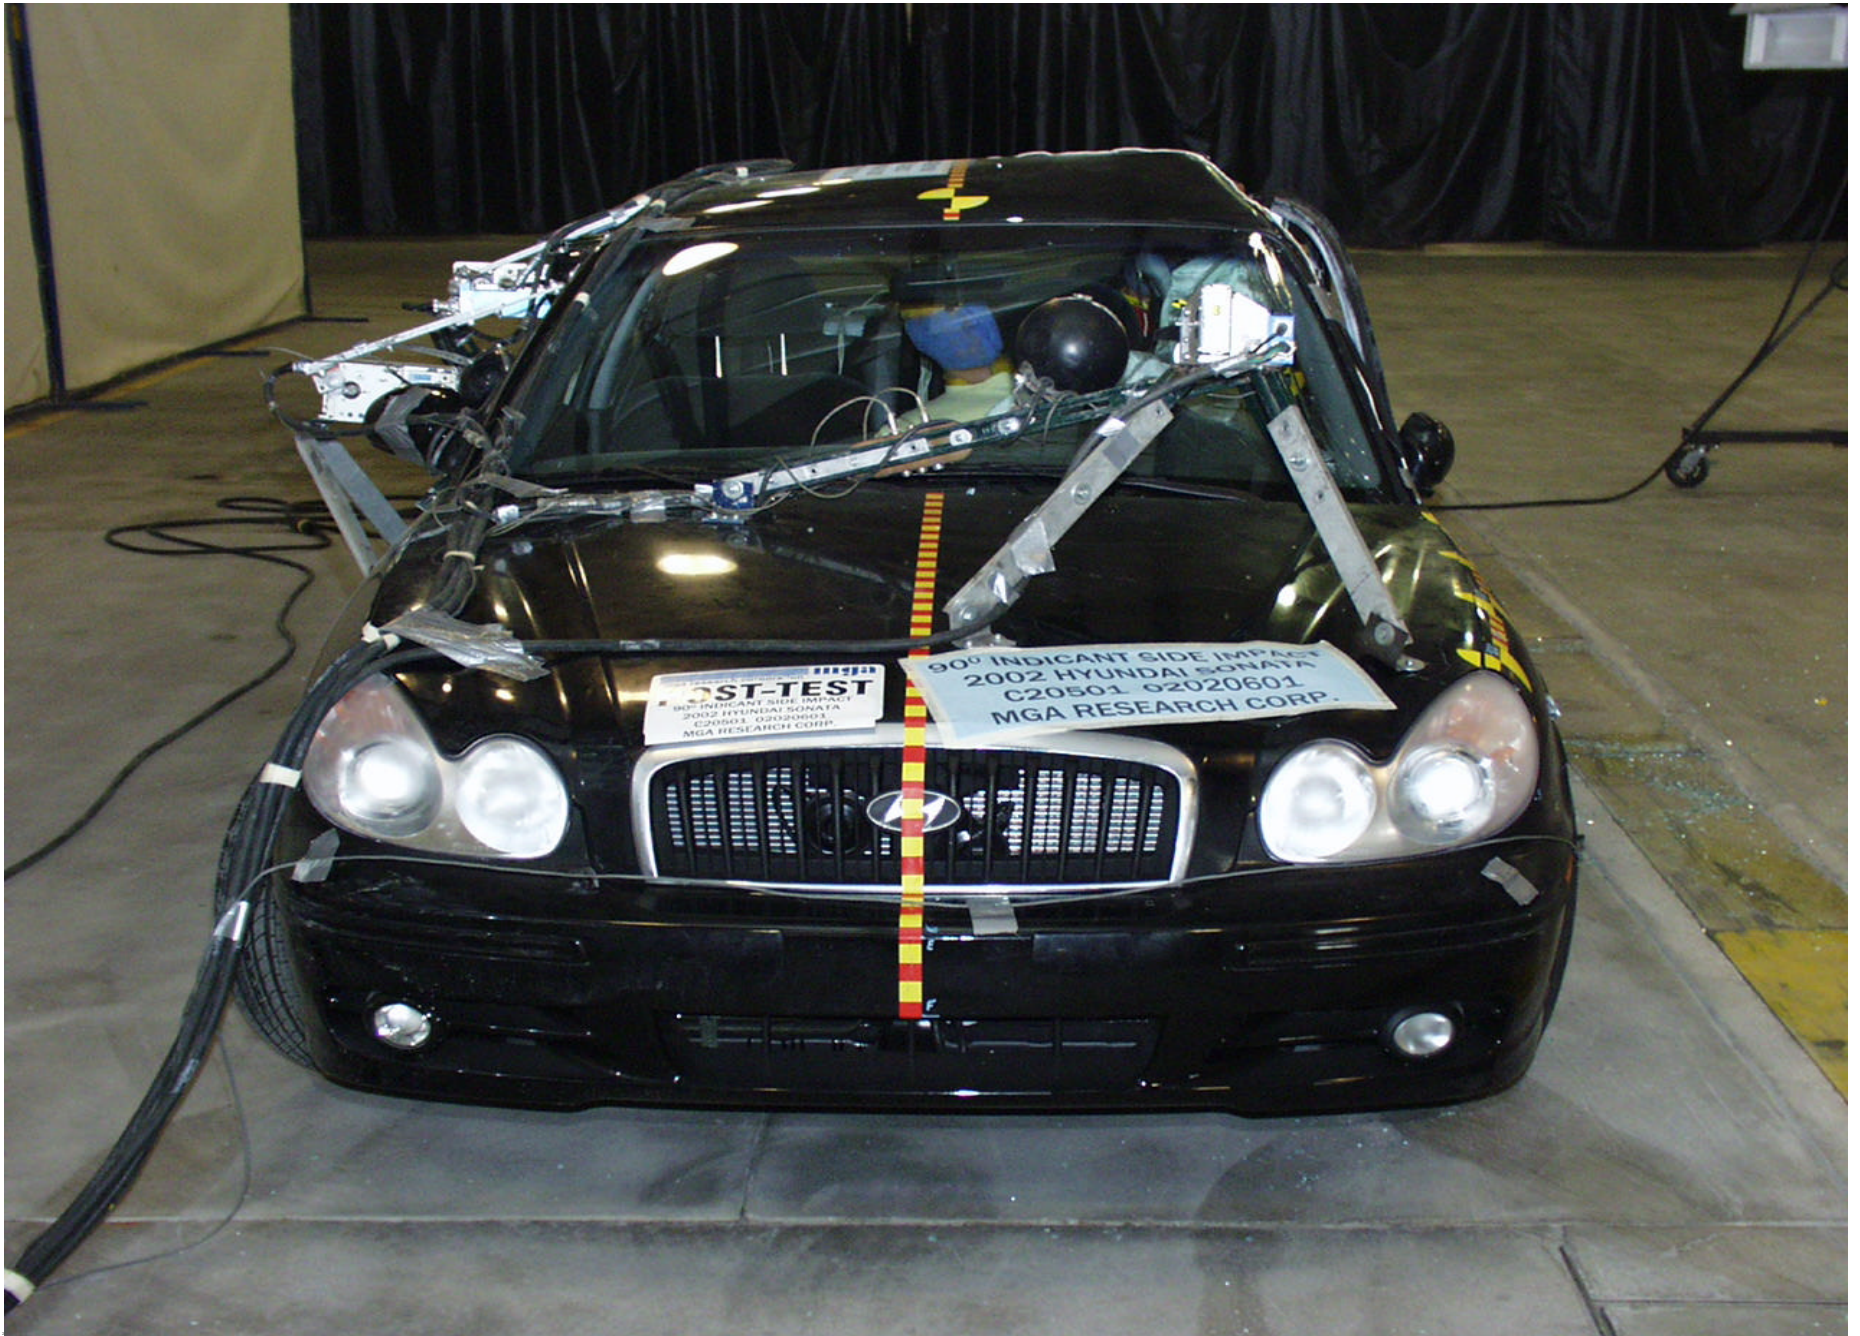
Post-Test Front View of Test Vehicle

Critical Areas of Performance	Observations and Conclusions
Pillar Performance	None
Sill Separation	None
Windshield Damage	Cracked
Window Damage	Both left side windows broke
Other Notable Effects	None

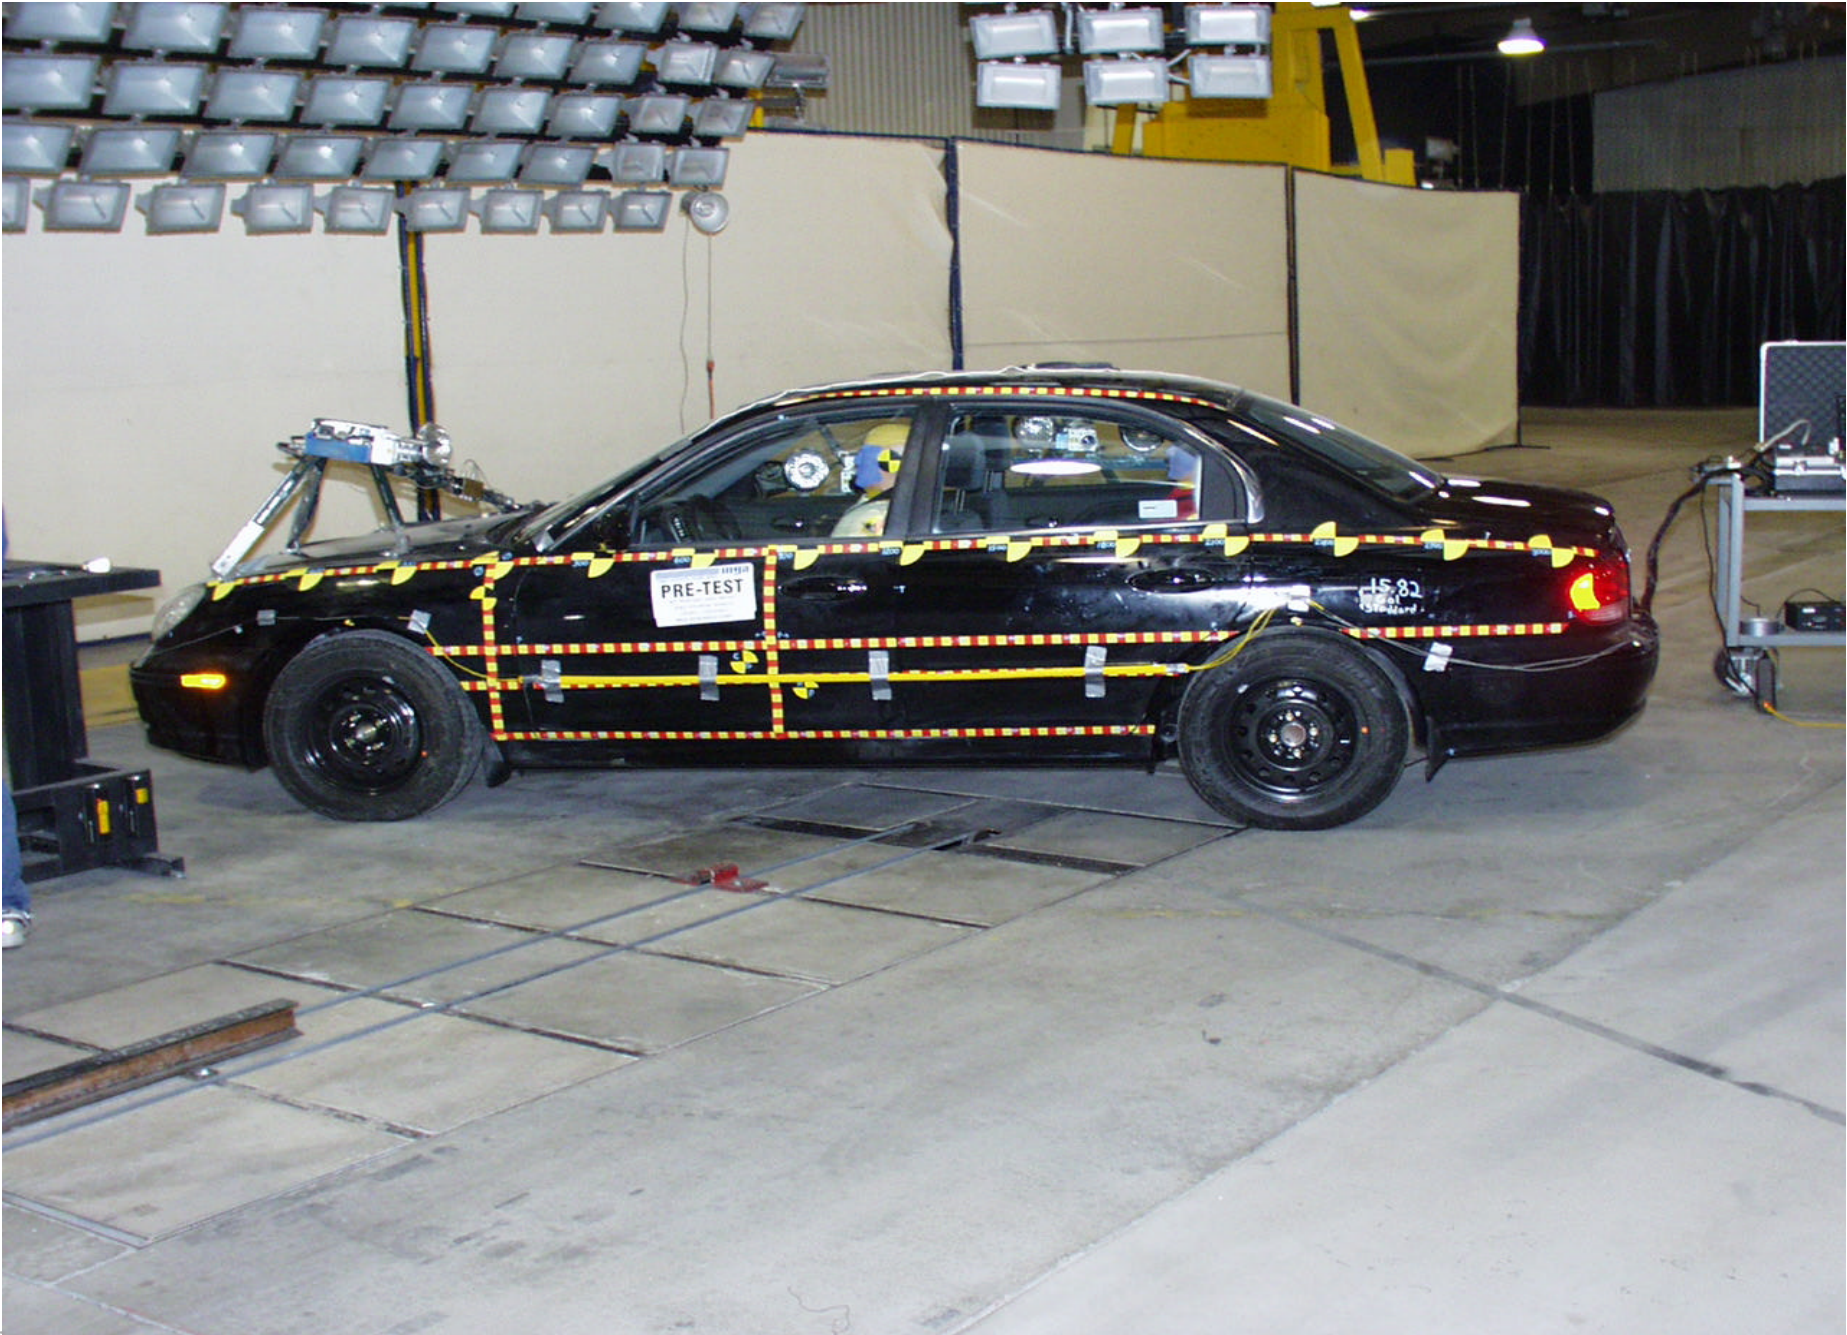
A-5.

Pre-Test Left Side View of Test Vehicle

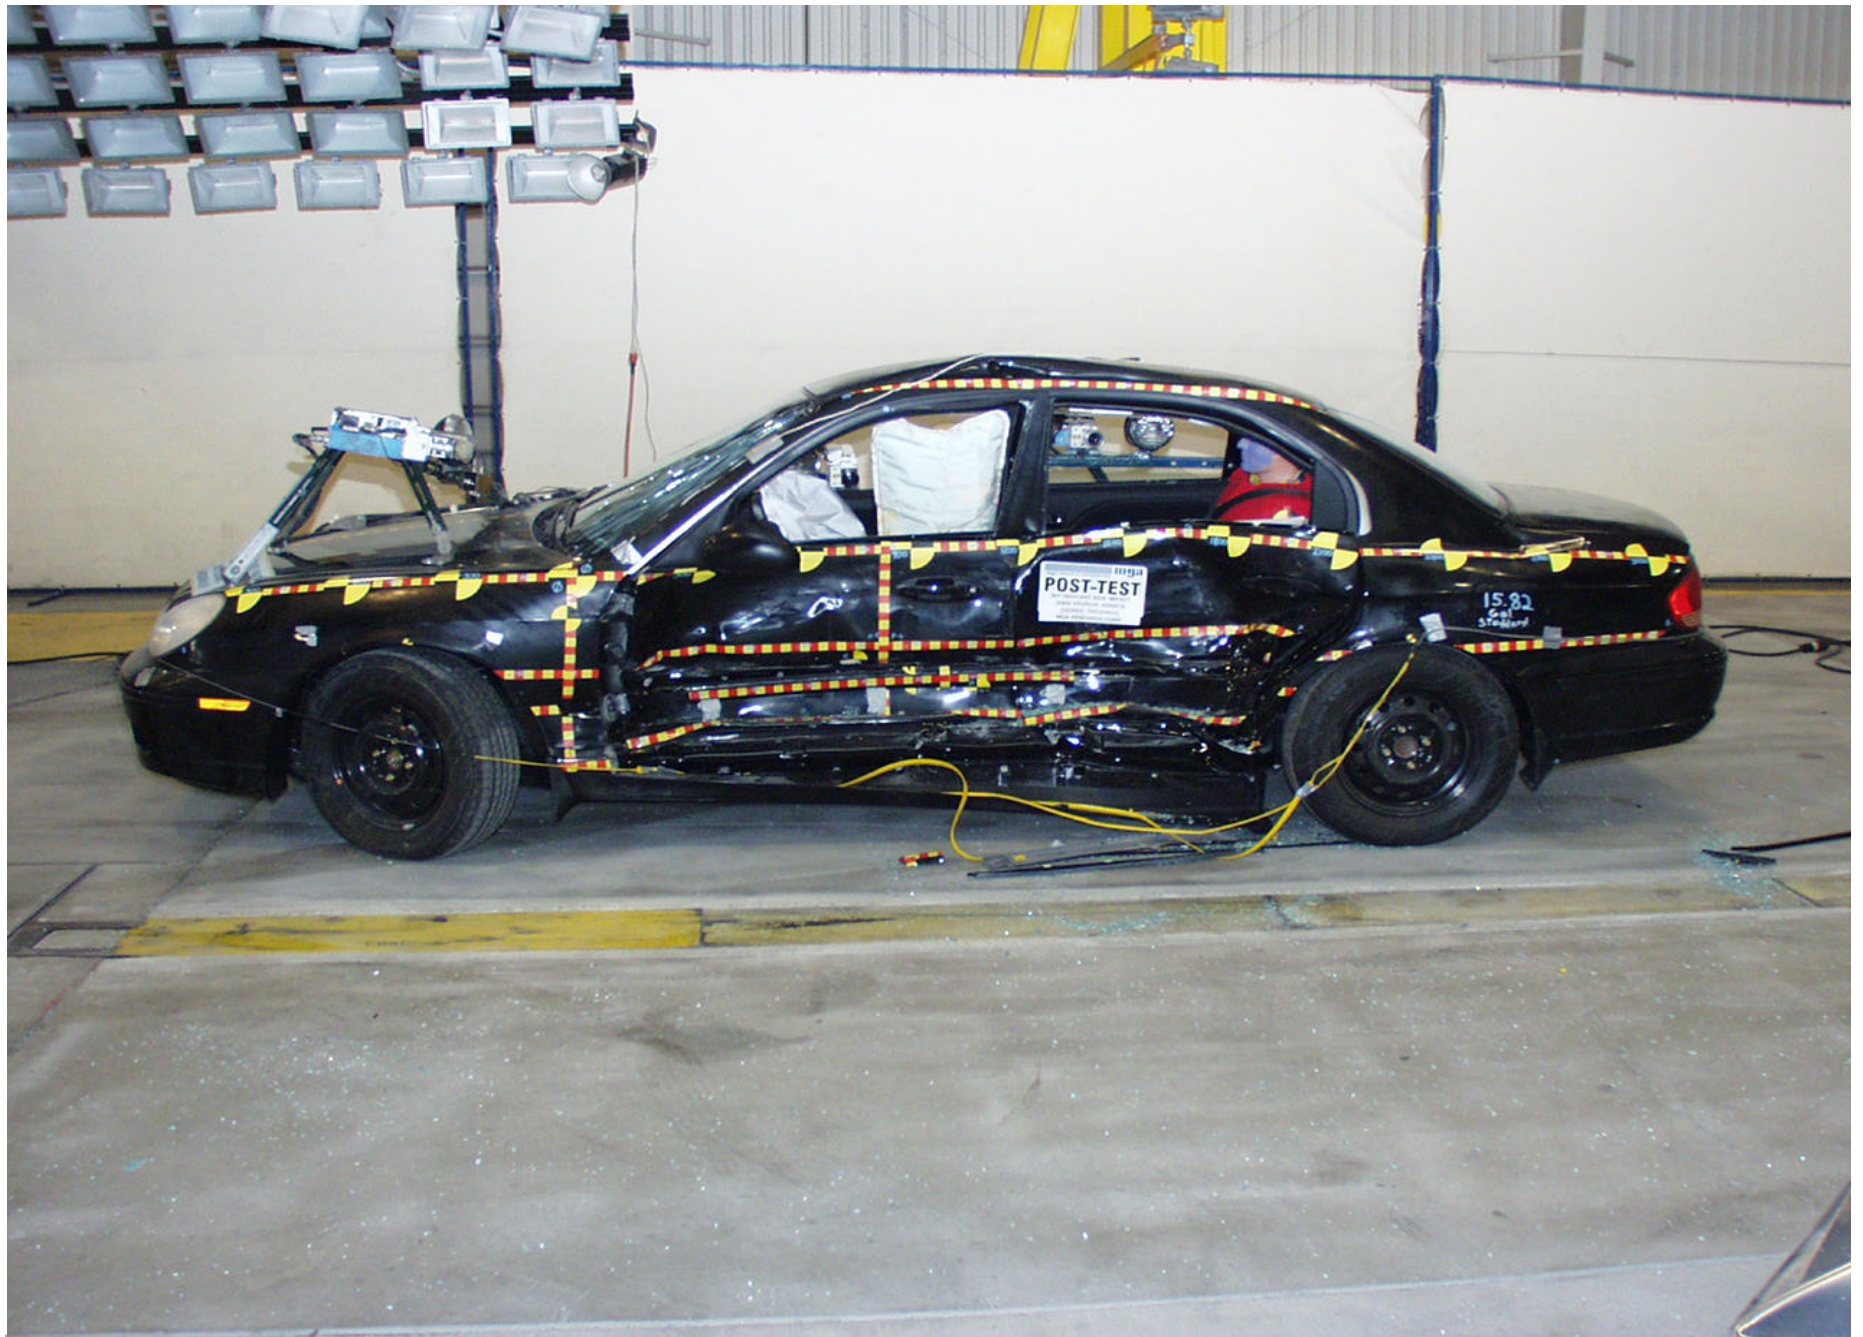
A-6.

Post-Test Left Side View of Test Vehicle

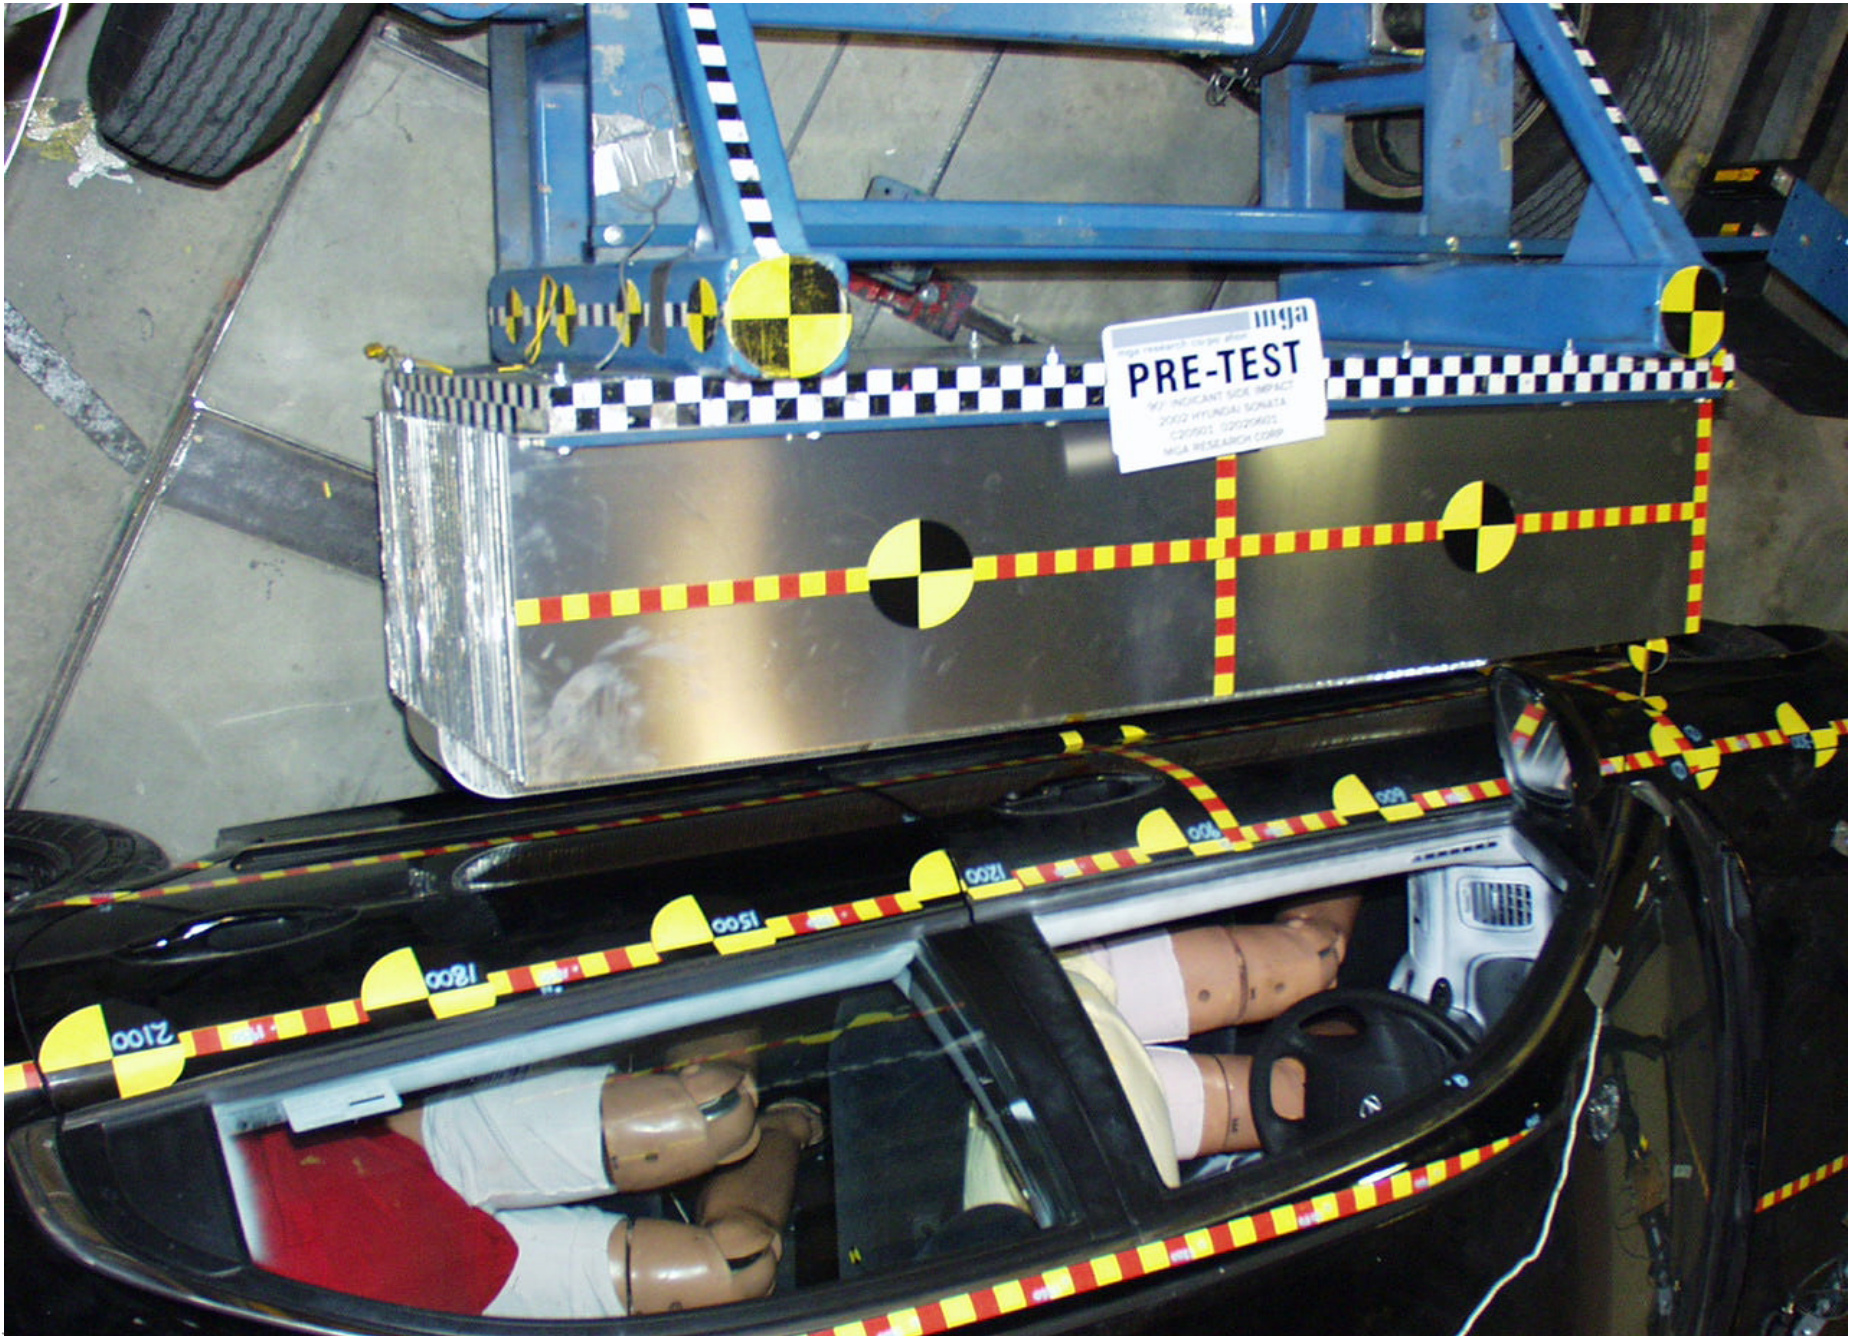
A-9.

Pre-Test MDB Positioned Against Vehicle Overhead View

A model year 2002 Hyundai Sonata 4 door was impacted on the left (driver's) side by a Moving Deformable Barrier (MDB) which was moving forward in a 27° crabbed position to the tow road guidance system at a velocity of 62.0 km/h. The specified impact velocity range is from 61.1 to 62.7 km/h. The test (target) vehicle was stationary and positioned 63° to the line of forward motion. The weight of the vehicle as tested was 1682.0 kg and the test weight of the MDB was 1362.0 kg. The test was conducted at MGA Research Corporation in Burlington, Wisconsin, on February 6, 2002.

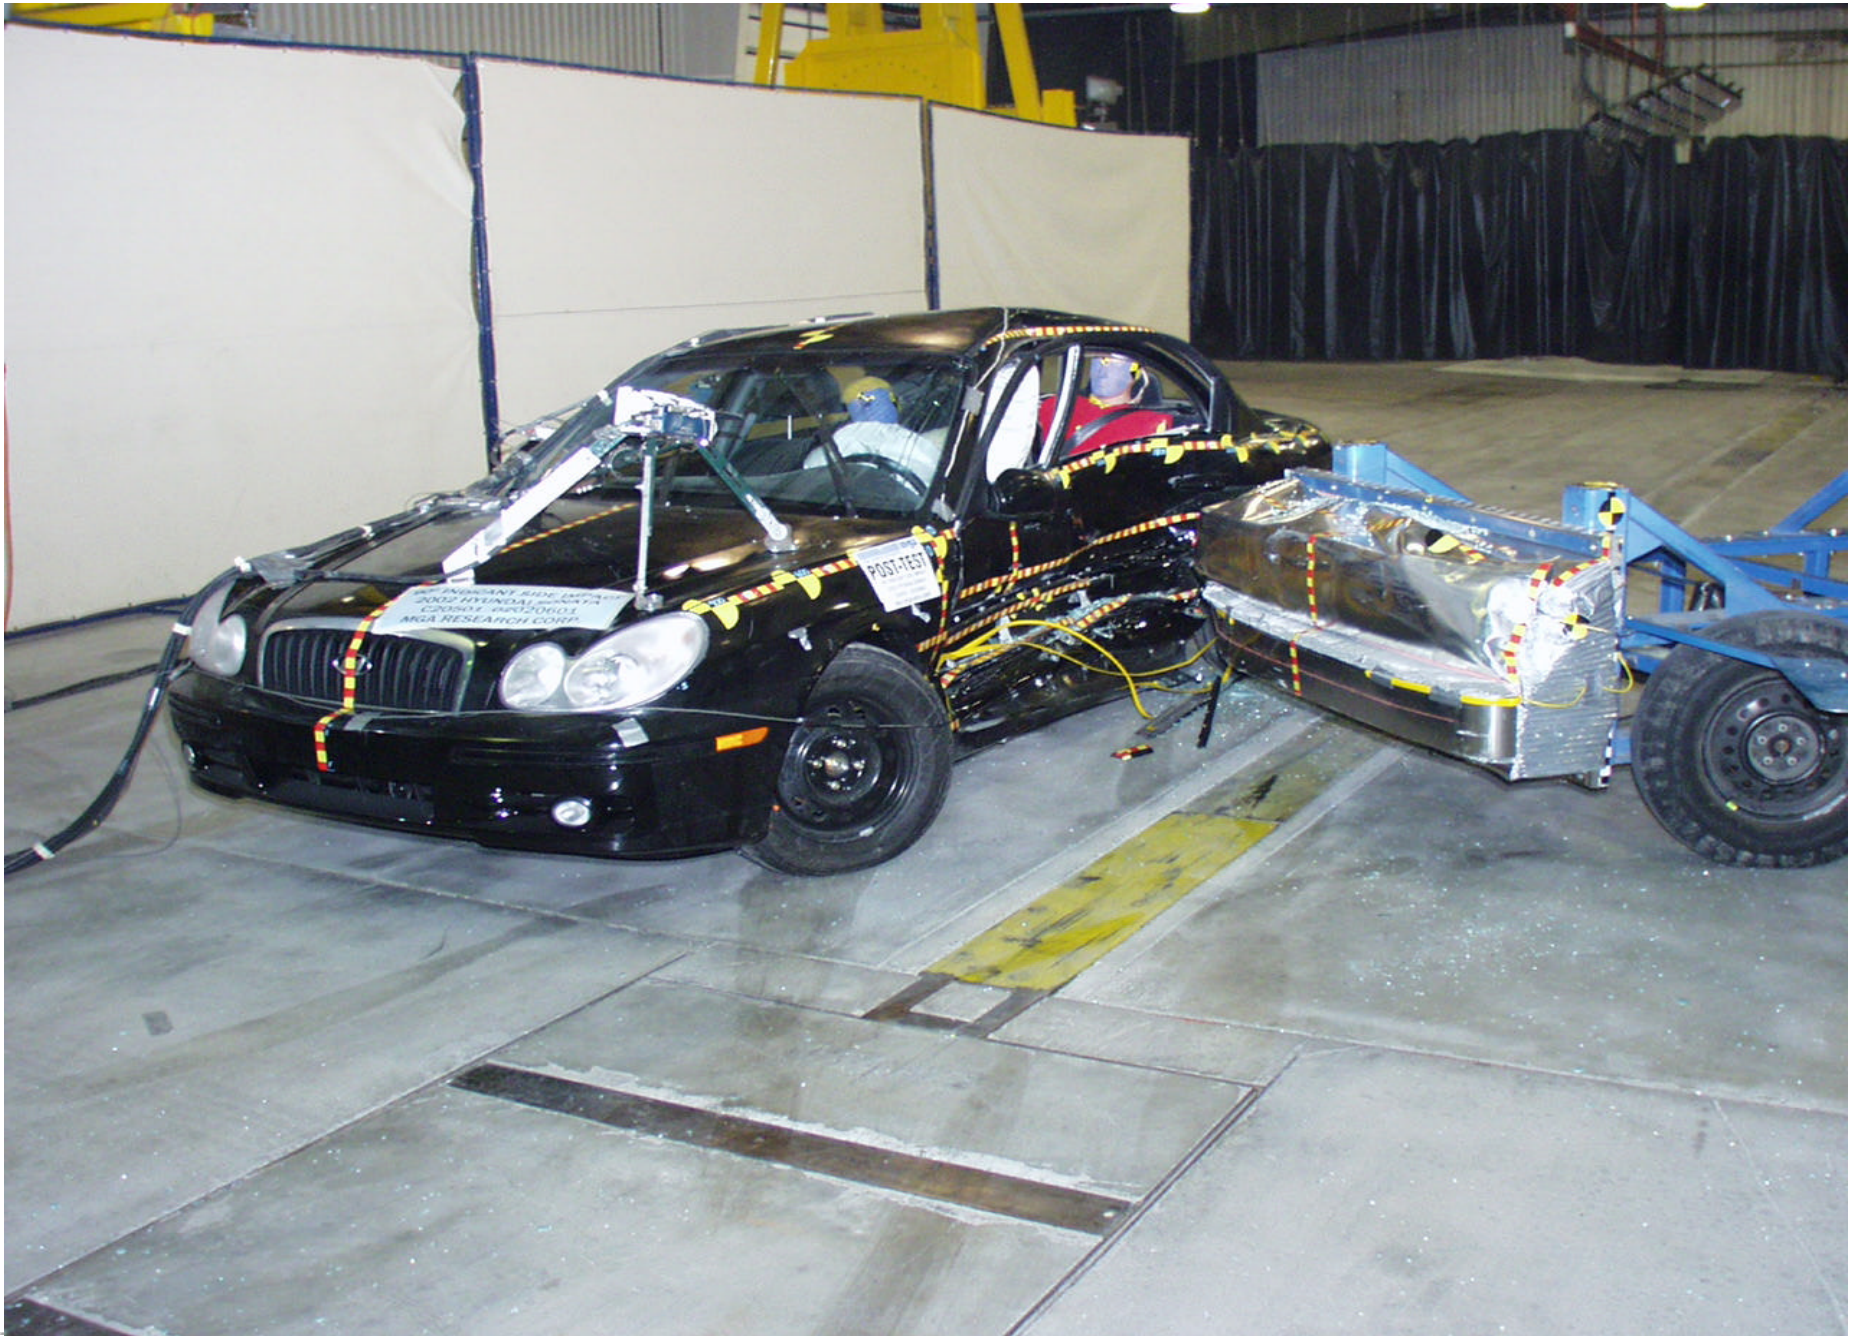
A-10.

Post-Test MDB and Vehicle (left side)

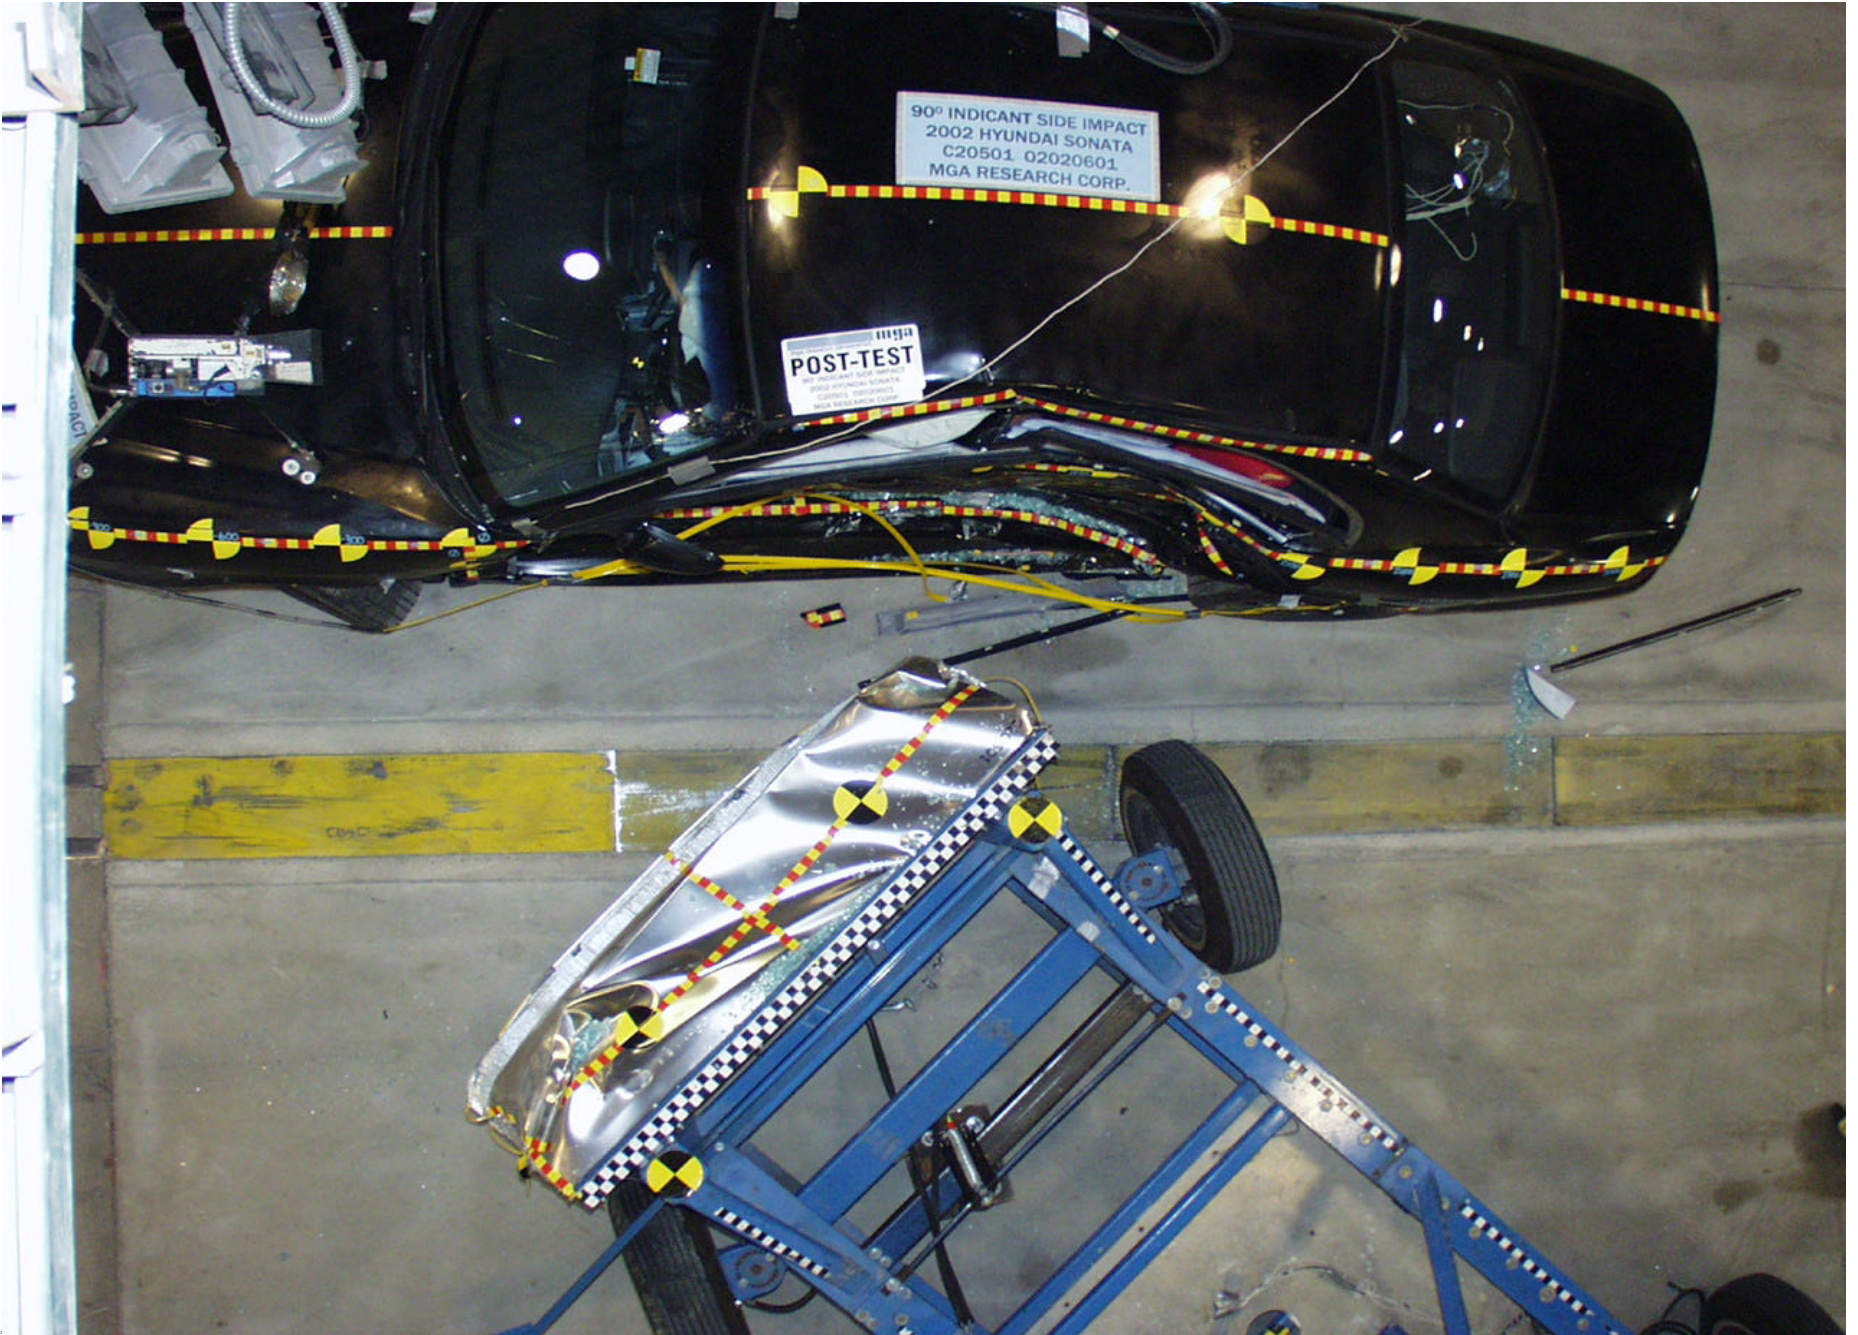
A-12.

Post-Test MDB and Vehicle Overhead View

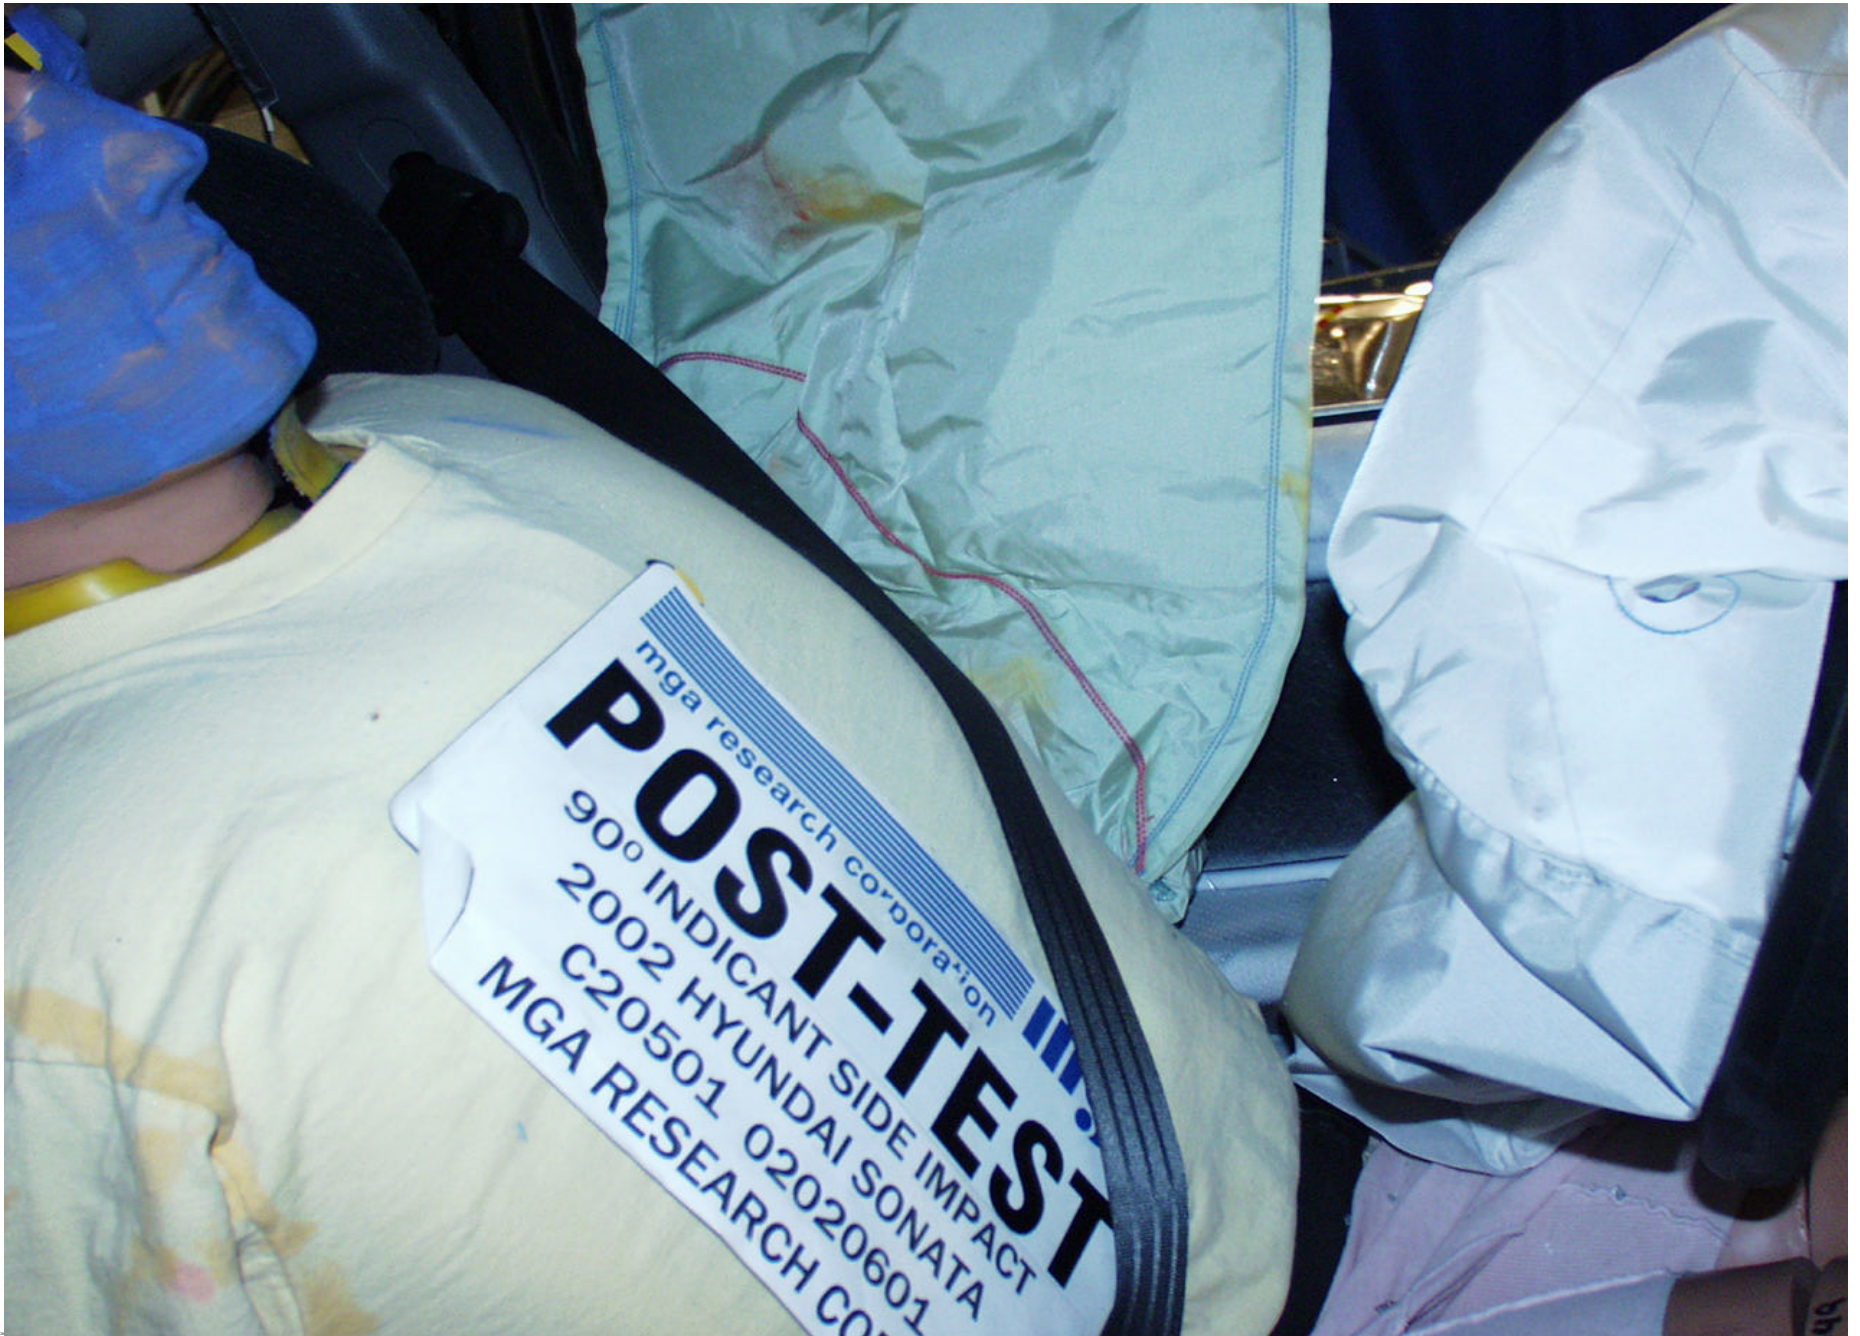
Post-Test Driver Dummy Contact
