REPORT NUMBER: 214D-MGA-2002-004

**SAFETY COMPLIANCE TESTING FOR FMVSS 214
SIDE IMPACT PROTECTION
INDICANT**

Hyundai Motor Company
2002 Hyundai Sonata 4 door
NHTSA NUMBER: C20501

FINAL REPORT

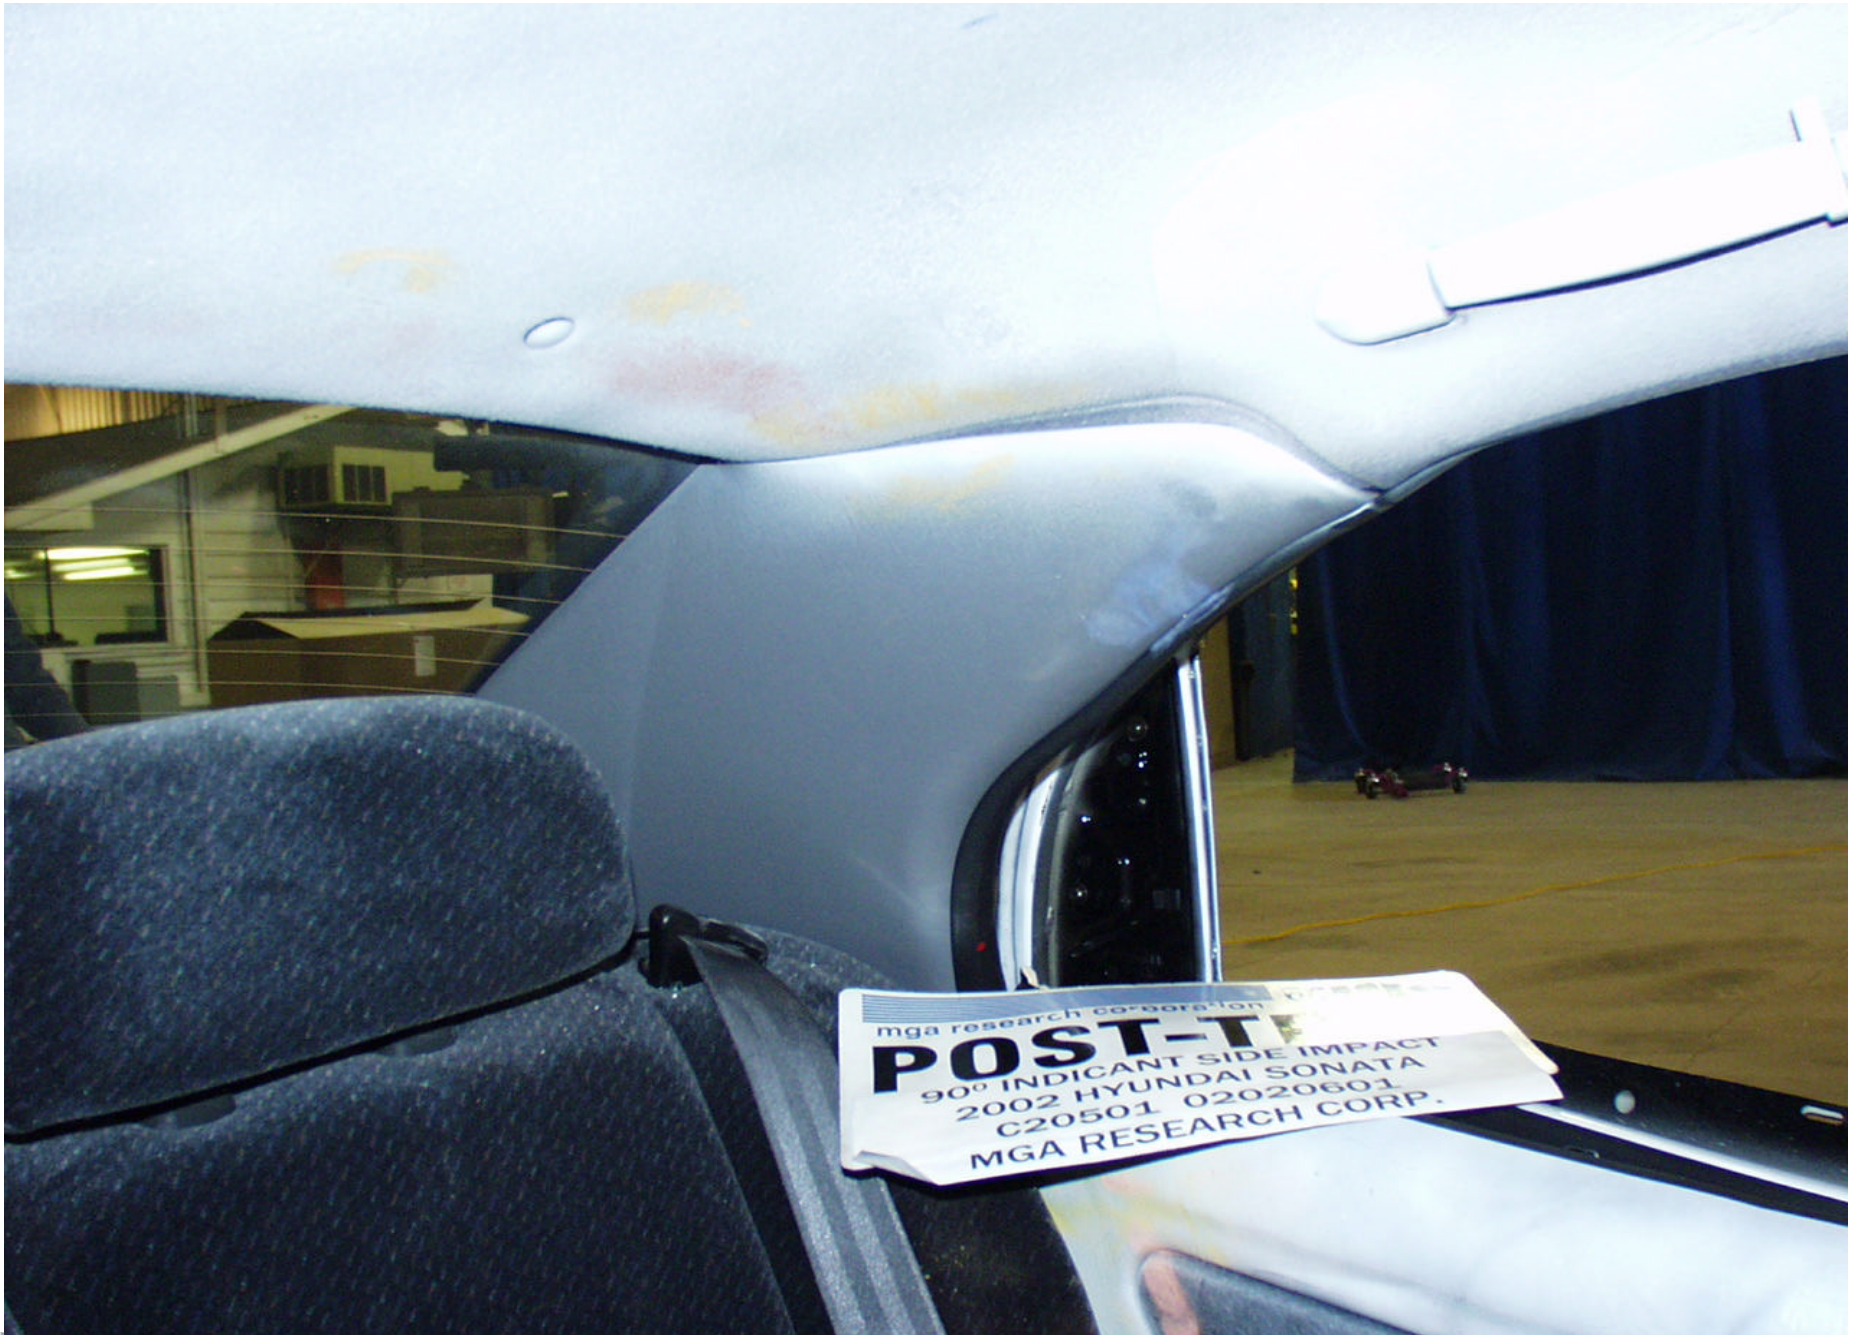
A-38.

Post-Test Passenger Dummy Head Contact

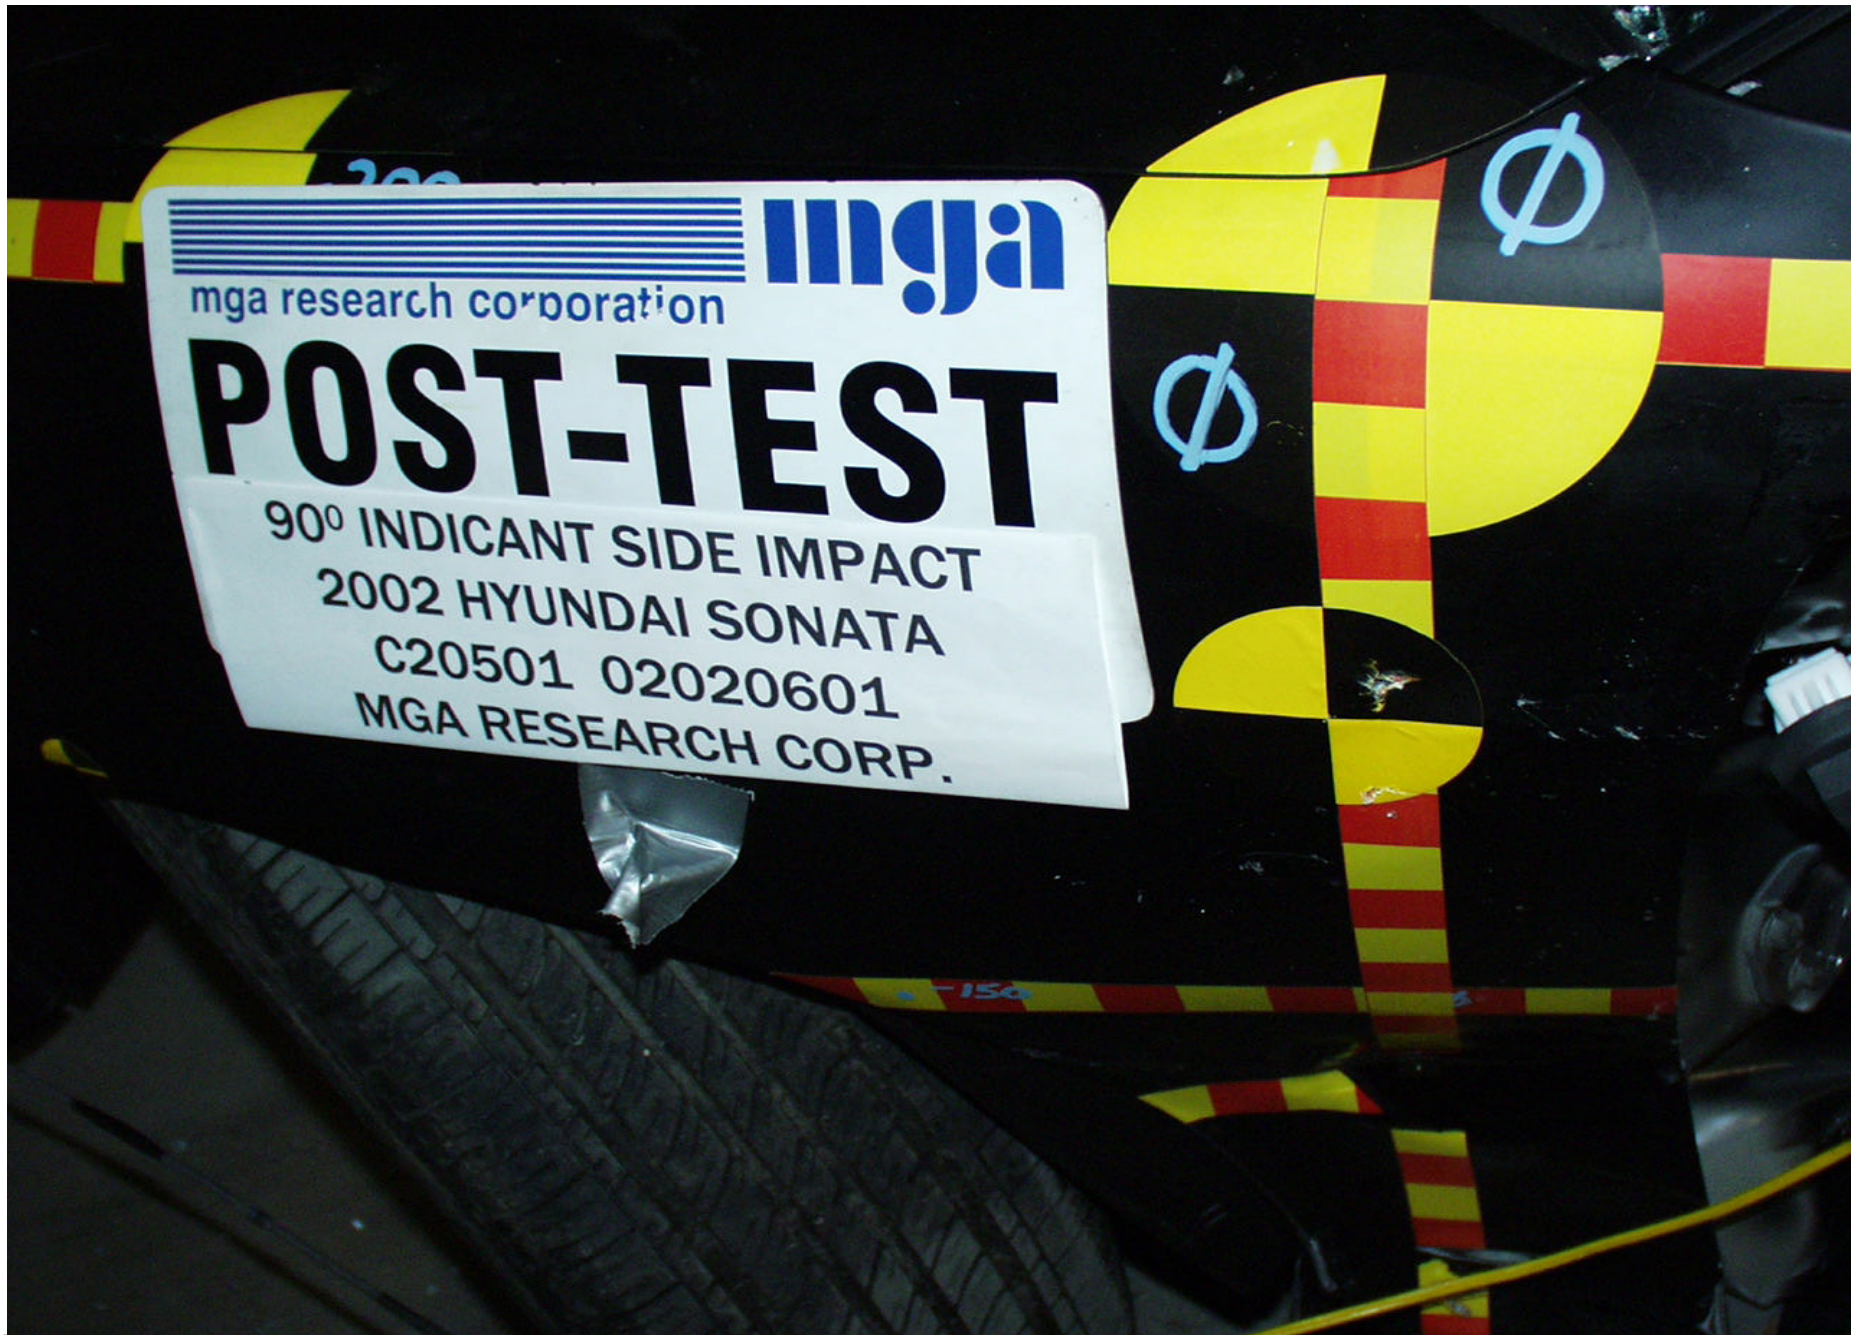
Post-Test Left Front Impact Point on Vehicle

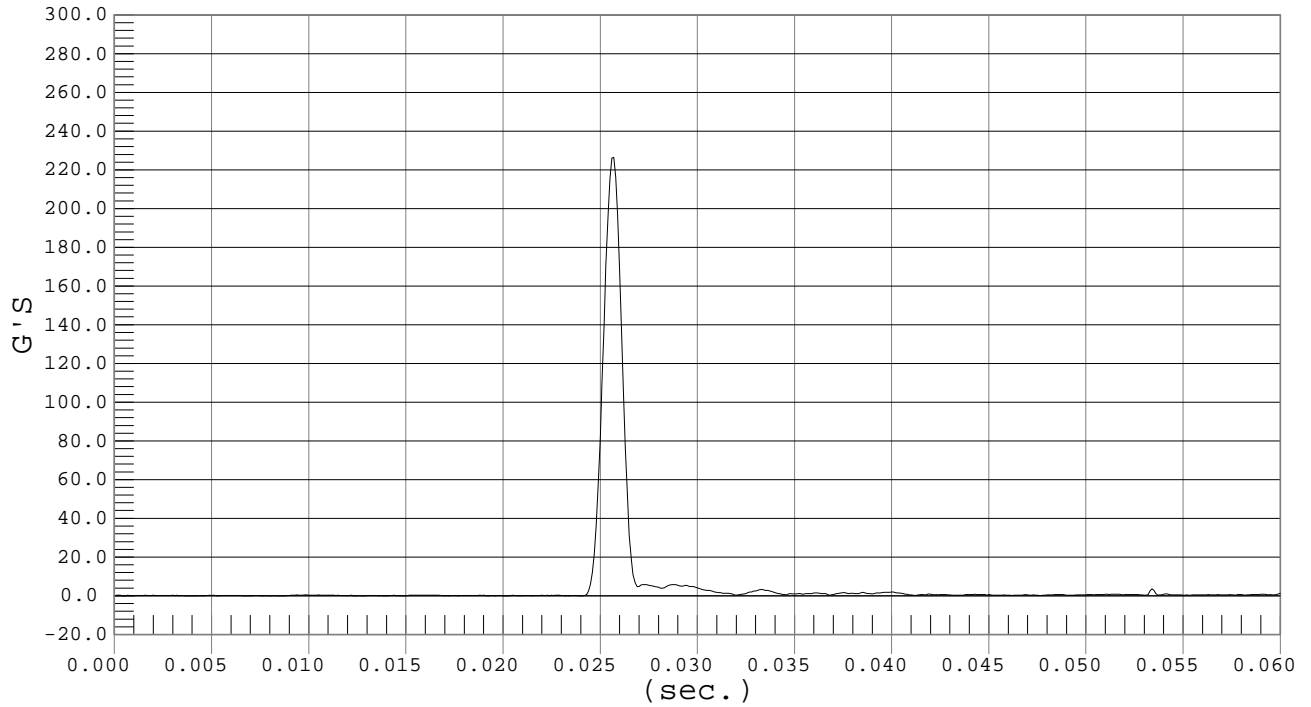
Test Date: 01-18-02
Speed: 0.0 fps, 0.00 M/s

Ymin = .06 G'S @ 0.0007 sec., Ymax = 226.5 G'S @ 0.0256 sec.

Tested Parameter	Units	Specification	Result	Pass/Fail
Laboratory Temperature	°C	18.9 to 25.5	20.5	Pass
Laboratory Relative Humidity	%	10 to 70	20	Pass
Peak Resultant Acceleration	G's	210 to 260	227	Pass
Peak Lateral Acceleration	G's	< 10	-4	Pass
Time Above 100 G	msec	0.9 – 1.5	1.2	Pass
Overall Test Results				Pass

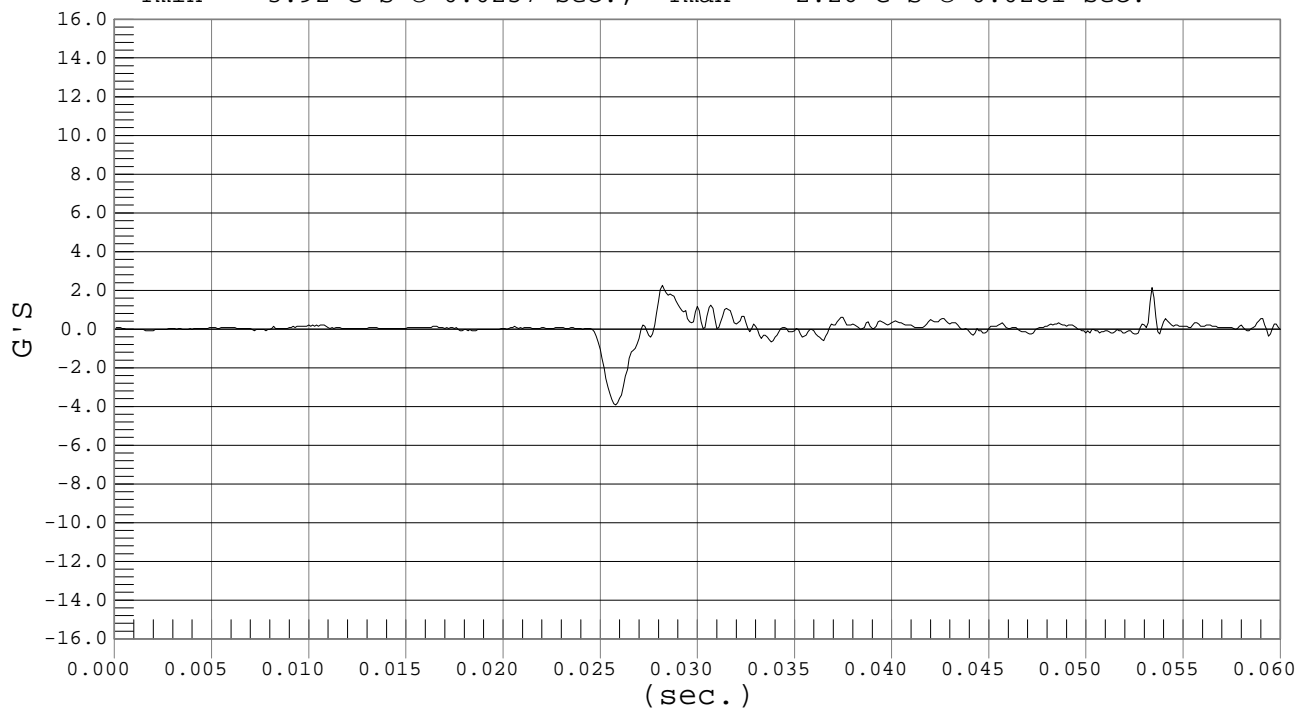
PEAK LATERAL ACCELERATION

Test Desc.: Head Drop
Component: Dummy #049

Test Date: 01-18-02
Speed: 0.0 fps, 0.00 M/s

Ymin = -3.92 G'S @ 0.0257 sec., Ymax = 2.26 G'S @ 0.0281 sec.

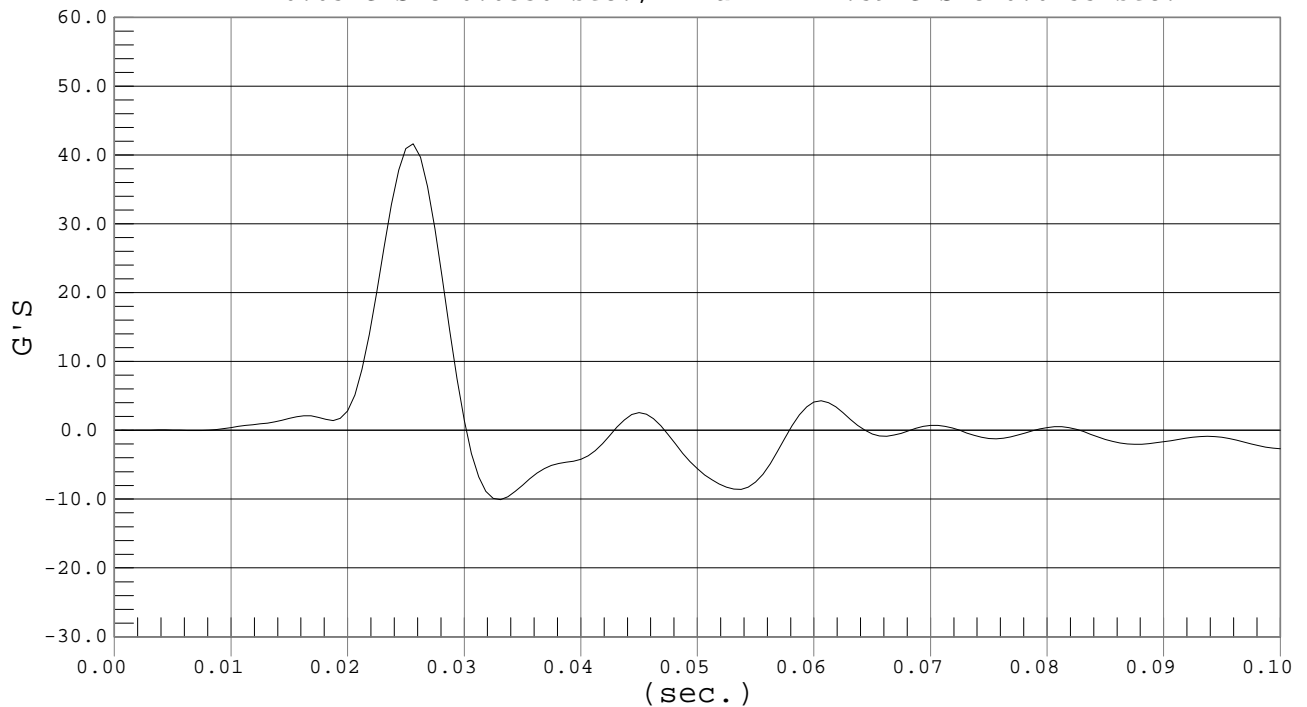
LOWER RIB ACCELERATION

Test Desc.: Thorax Impact
Component: Dummy #049

Test Date: 01-23-02
Speed: 14.1 fps, 4.29 M/s

Ymin = -10.05 G'S @ 0.0330 sec., Ymax = 41.59 G'S @ 0.0255 sec.

Tested Parameter	Units	Specification	Result	Pass/Fail
Laboratory Temperature	°C	18.9 – 25.5	21.1	Pass
Laboratory Relative Humidity	%	10 to 70	35	Pass
Probe Velocity	m/s	4.27 – 4.33	4.29	Pass
Upper Rib	G's	37 – 46	37	Pass
Lower Rib	G's	37 – 46	42	Pass
Lower Spine	G's	15 - 22	19	Pass
Overall Test Results				Pass

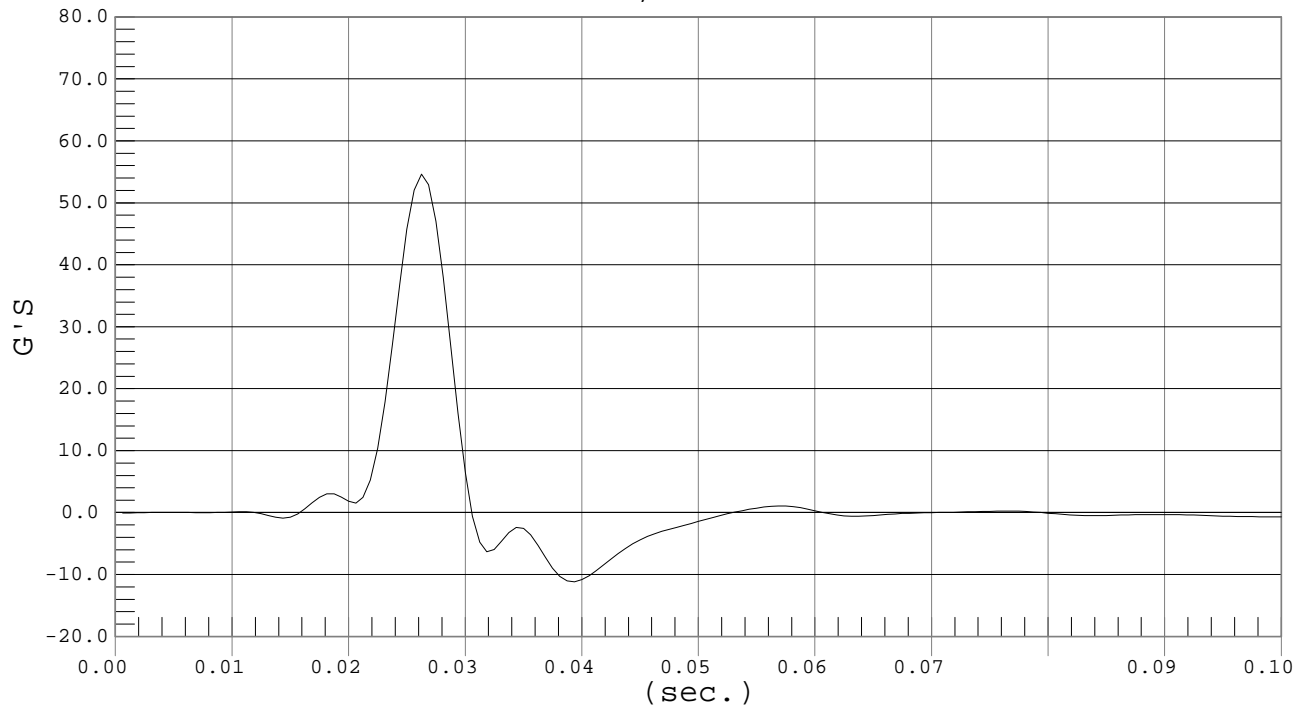
Test Date: 01-23-02
Speed: 14.1 fps, 4.30 M/s

Ymin = -11.16 G'S @ 0.0393 sec., Ymax = 54.66 G'S @ 0.0262 sec.

Tested Parameter	Units	Specification	Result	Pass/Fail
Laboratory Temperature	°C	18.9 – 25.5	21.1	Pass
Laboratory Relative Humidity	%	10 to 70	35	Pass
Probe Speed	m/s	4.27 – 4.33	4.30	Pass
Pelvis Acceleration	G's	40 - 60	55	Pass
Overall Test Results				Pass

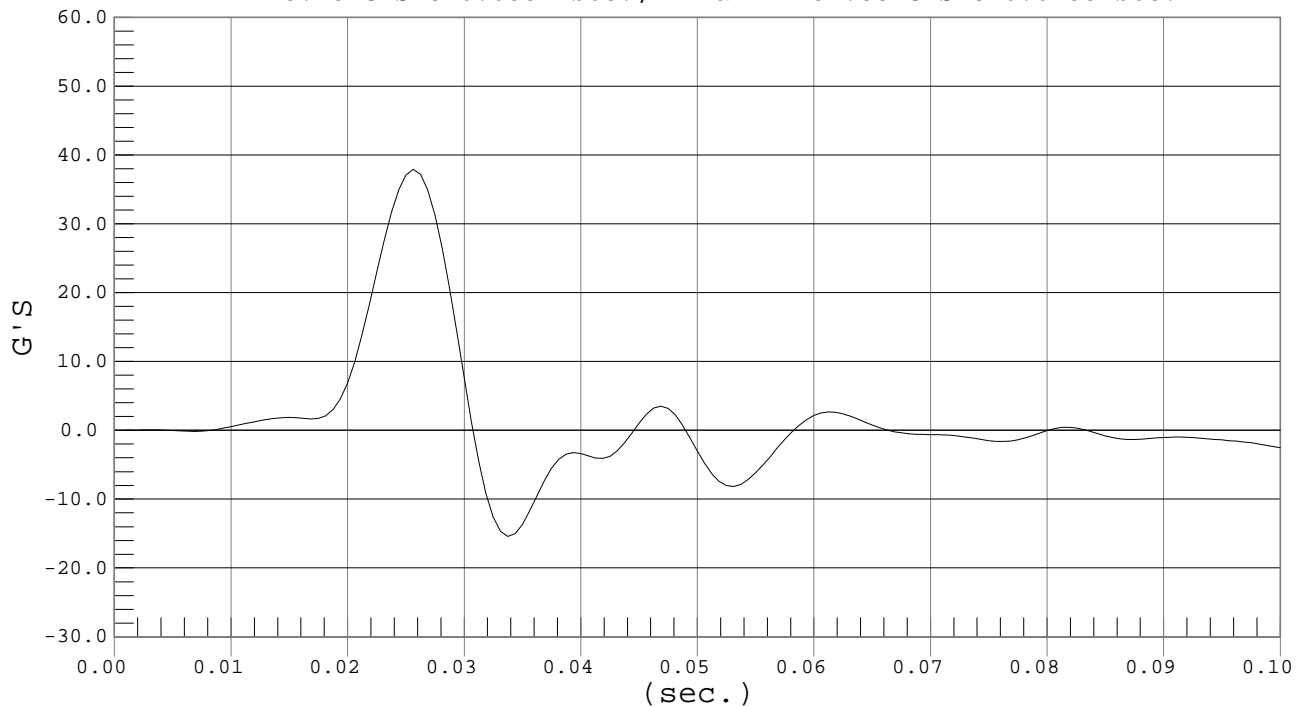
LOWER RIB ACCELERATION

Test Desc.: Thorax Impact
Component: Dummy #048

Test Date: 01-18-02
Speed: 14.1 fps, 4.30 M/s

Ymin = -15.43 G'S @ 0.0337 sec., Ymax = 37.88 G'S @ 0.0255 sec.

Tested Parameter	Units	Specification	Result	Pass/Fail
Laboratory Temperature	°C	18.9 – 25.5	20.7	Pass
Laboratory Relative Humidity	%	10 to 70	21	Pass
Probe Velocity	m/s	4.27 – 4.33	4.30	Pass
Upper Rib	G's	37 – 46	38	Pass
Lower Rib	G's	37 – 46	38	Pass
Lower Spine	G's	15 - 22	17	Pass
Overall Test Results				Pass

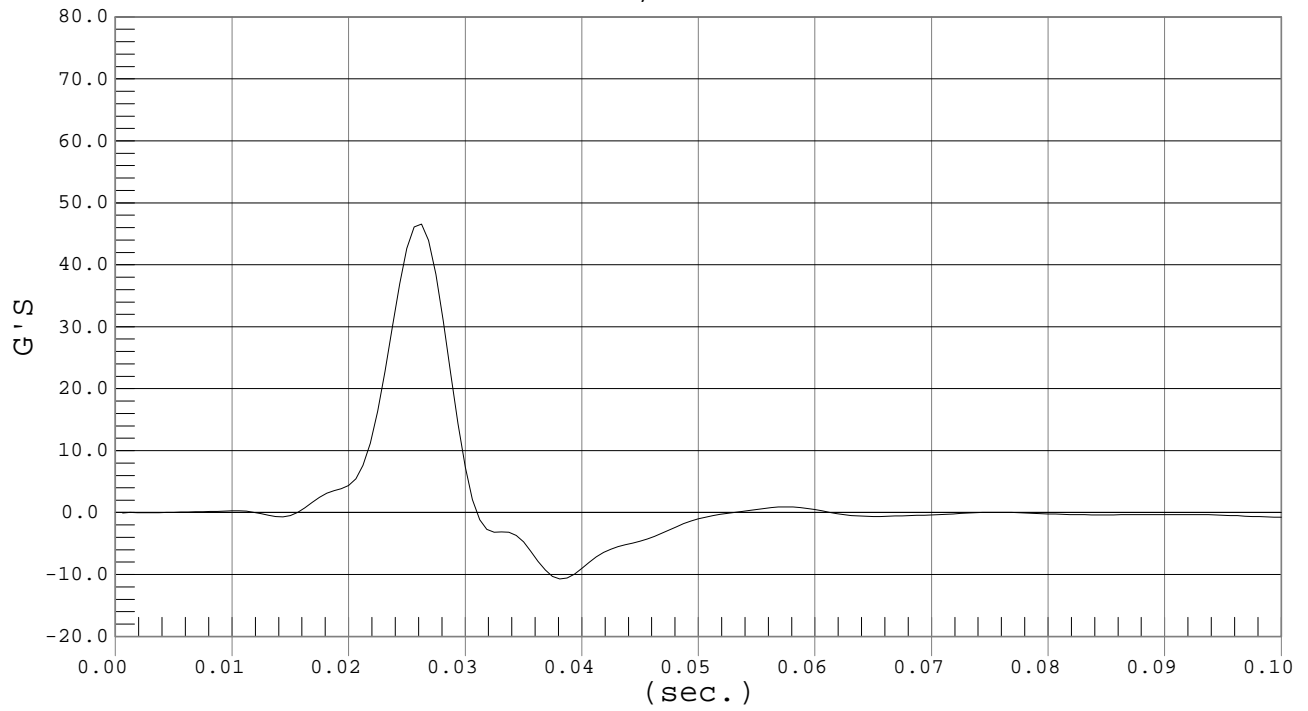
Test Date: 01-18-02
Speed: 14.1 fps, 4.30 M/s

Ymin = -10.71 G'S @ 0.0380 sec., Ymax = 46.59 G'S @ 0.0262 sec.

Tested Parameter	Units	Specification	Result	Pass/Fail
Laboratory Temperature	°C	18.9 – 25.5	20.7	Pass
Laboratory Relative Humidity	%	10 to 70	21	Pass
Probe Speed	m/s	4.27 – 4.33	4.30	Pass
Pelvis Acceleration	G's	40 - 60	47	Pass
			Overall Test Results	Pass

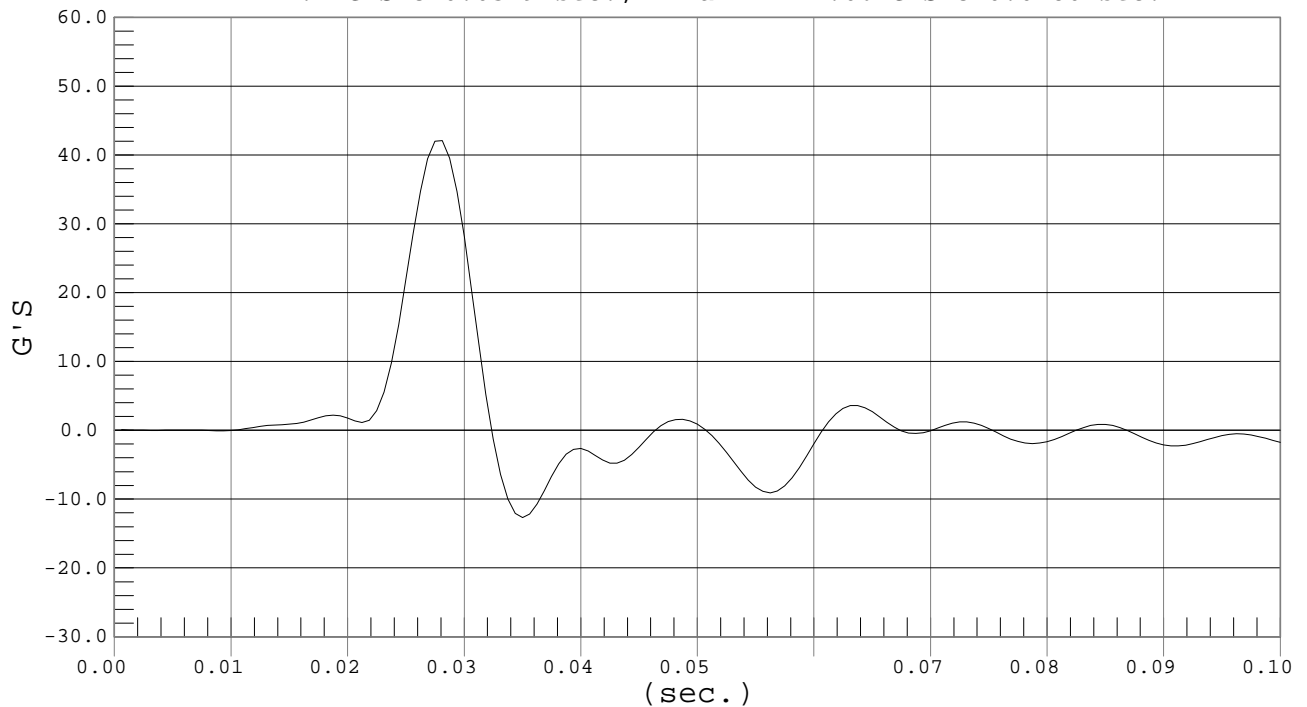
LOWER RIB ACCELERATION

Test Desc.: Thorax Impact
Component: Dummy #049

Test Date: 02-06-02
Speed: 14.0 fps, 4.27 M/s

Ymin = -12.7 G'S @ 0.0349 sec., Ymax = 42.06 G'S @ 0.0280 sec.

Tested Parameter	Units	Specification	Result	Pass/Fail
Laboratory Temperature	°C	18.9 – 25.5	21.7	Pass
Laboratory Relative Humidity	%	10 to 70	23	Pass
Probe Velocity	m/s	4.27 – 4.33	4.27	Pass
Upper Rib	G's	37 – 46	37	Pass
Lower Rib	G's	37 – 46	42	Pass
Lower Spine	G's	15 - 22	19	Pass
Overall Test Results				Pass

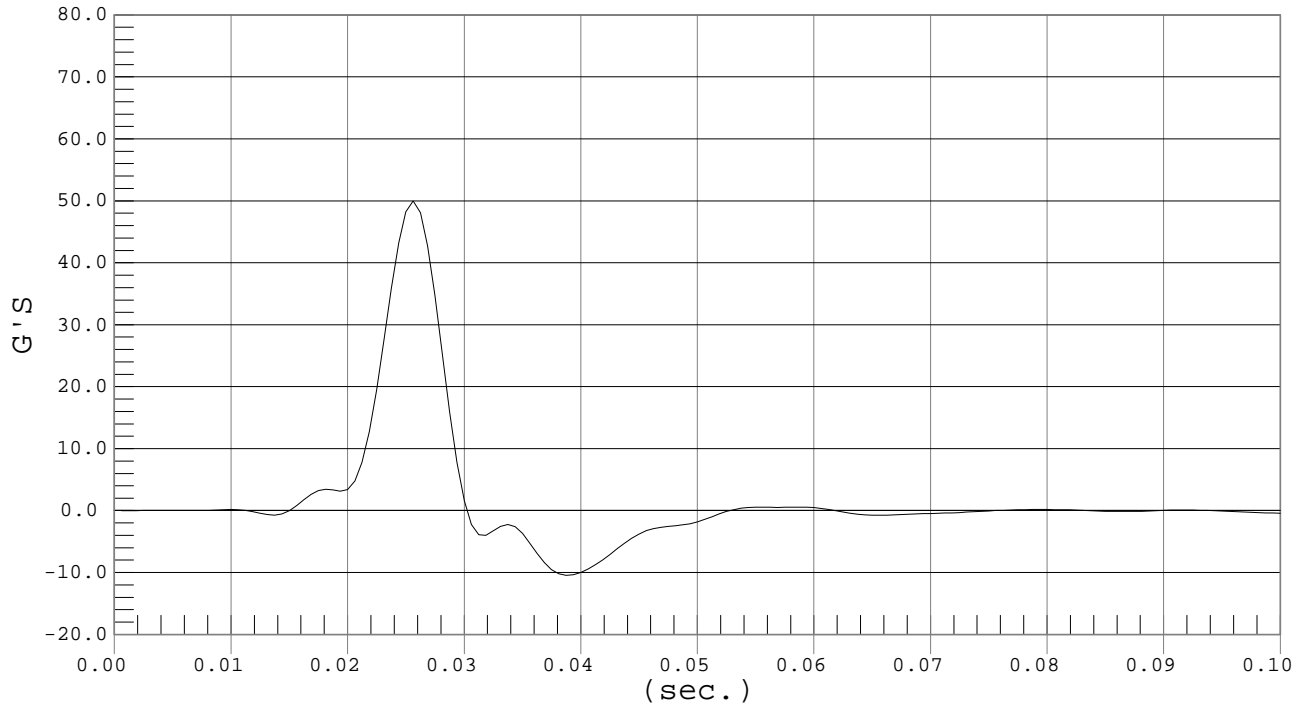
Test Date: 02-06-02
Speed: 14.0 fps, 4.28 M/s

Ymin = -10.47 G'S @ 0.0387 sec., Ymax = 50 G'S @ 0.0255 sec.

Tested Parameter	Units	Specification	Result	Pass/Fail
Laboratory Temperature	°C	18.9 – 25.5	21.7	Pass
Laboratory Relative Humidity	%	10 to 70	23	Pass
Probe Speed	m/s	4.27 – 4.33	4.28	Pass
Pelvis Acceleration	G's	40 - 60	50	Pass
Overall Test Results				Pass

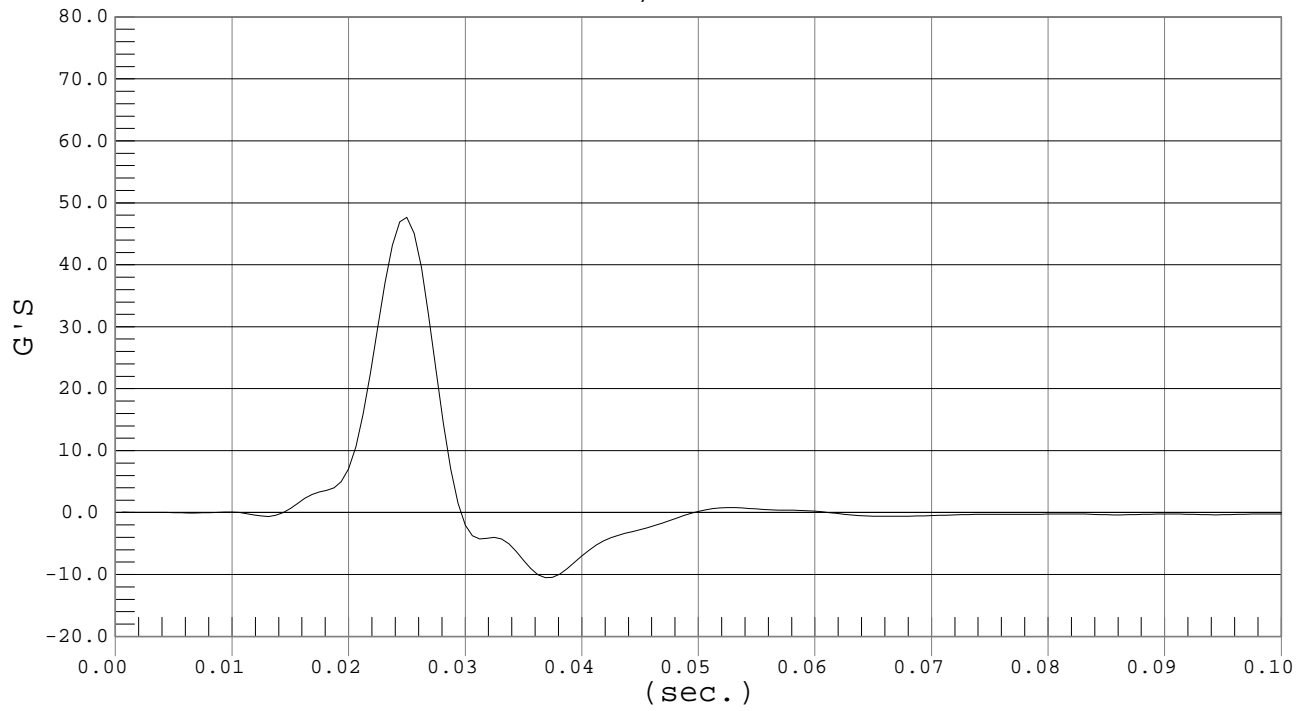
Test Date: 02-06-02
Speed: 14.0 fps, 4.28 M/s

Ymin = -10.51 G'S @ 0.0368 sec., Ymax = 47.66 G'S @ 0.0249 sec.

Tested Parameter	Units	Specification	Result	Pass/Fail
Laboratory Temperature	°C	18.9 – 25.5	21.8	Pass
Laboratory Relative Humidity	%	10 to 70	23	Pass
Probe Speed	m/s	4.27 – 4.33	4.28	Pass
Pelvis Acceleration	G's	40 - 60	48	Pass
			Overall Test Results	Pass
