**REPORT NUMBER: NCAP-MGA-2002-004**

**NEW CAR ASSESSMENT PROGRAM  
FRONTAL BARRIER IMPACT TEST**

**2002 JEEP LIBERTY SUV  
NHTSA NUMBER: M20303**

**PREPARED BY:  
MGA RESEARCH CORPORATION  
5000 WARREN ROAD  
BURLINGTON, WI 53105**

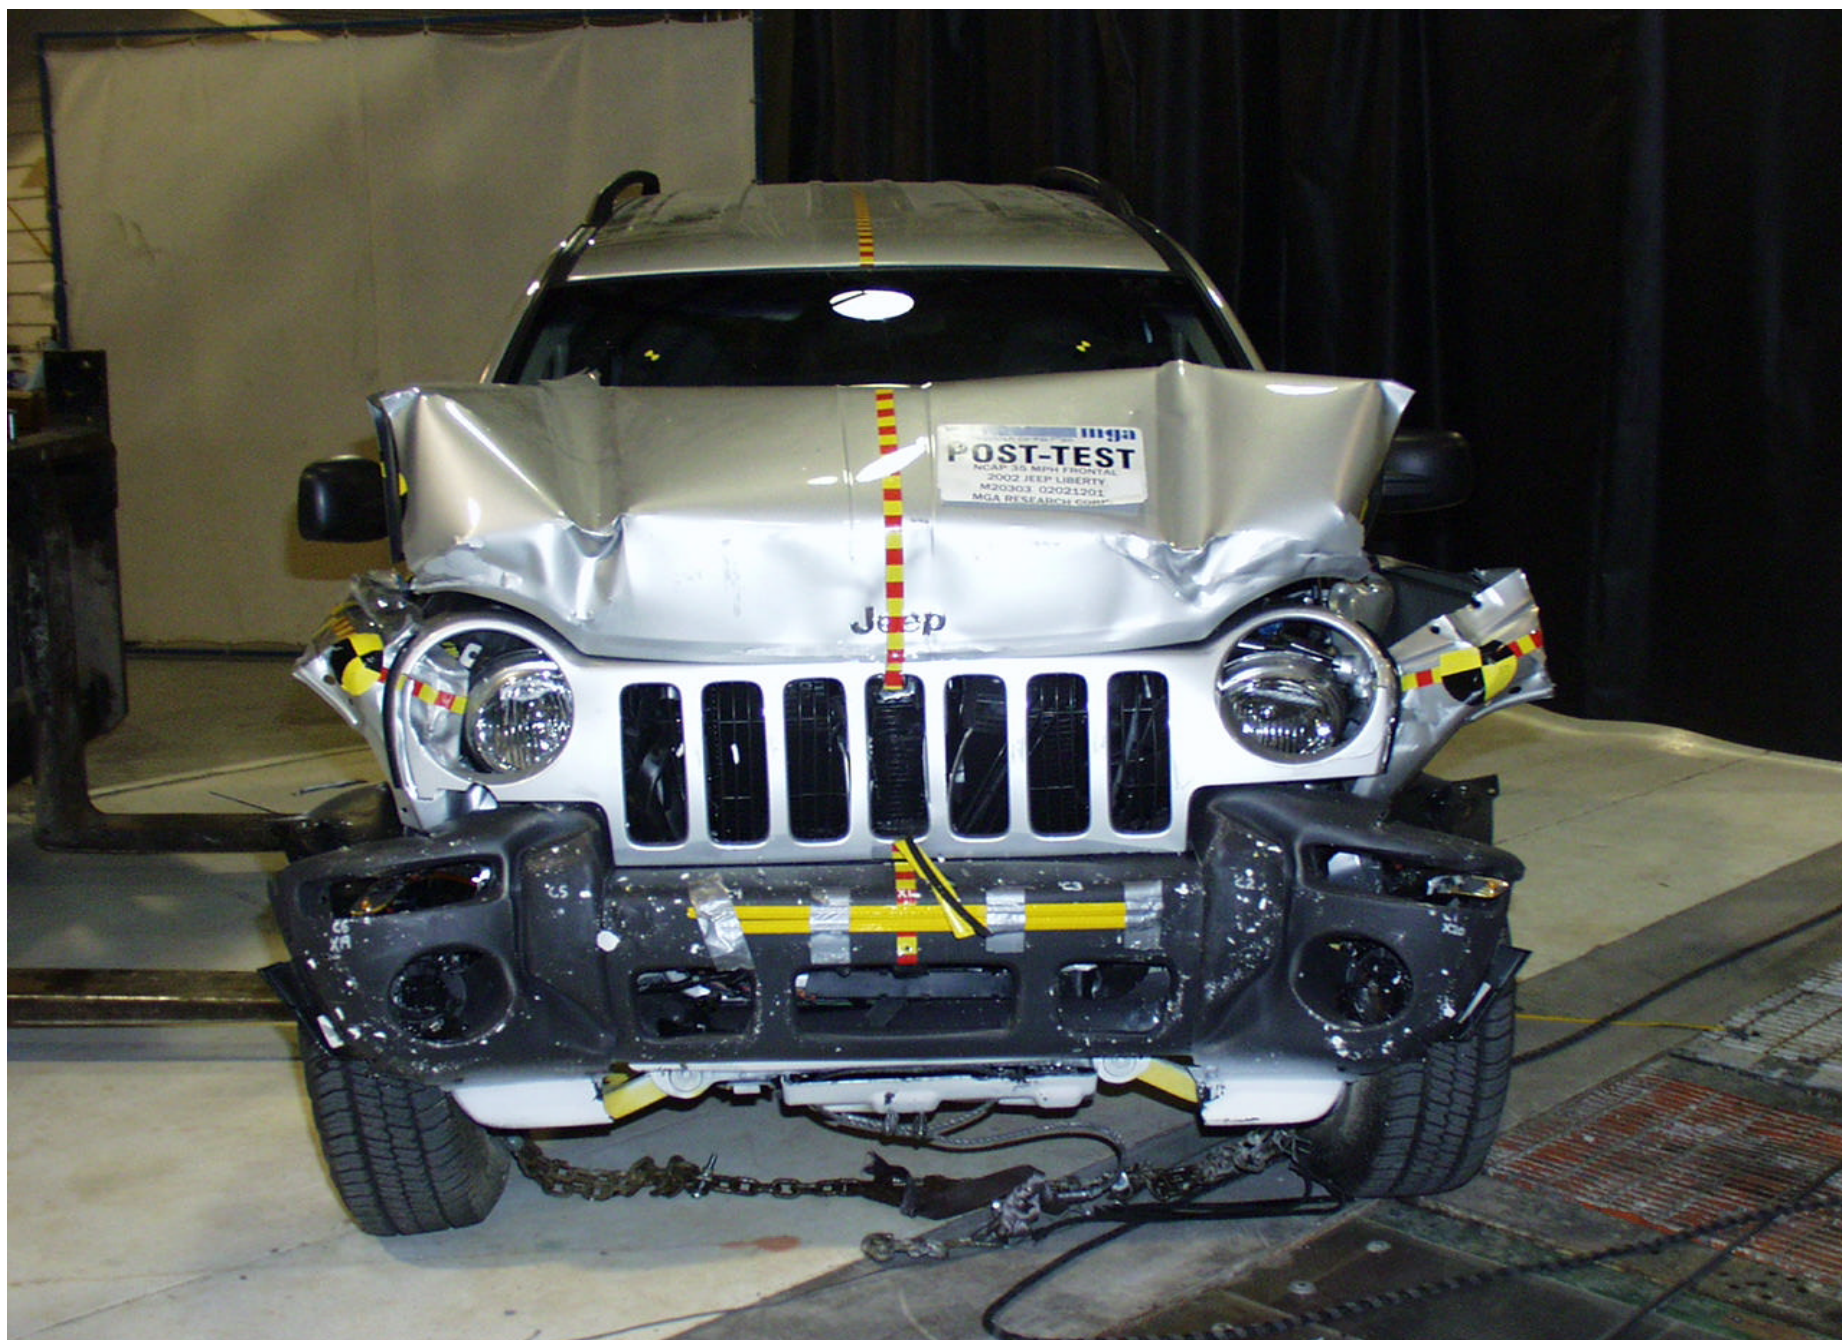
Post-Test Front View of Test Vehicle

The maximum static crush of the vehicle was 261 mm and both the driver and passenger side doors remained closed during the impact event and were operable after the impact.

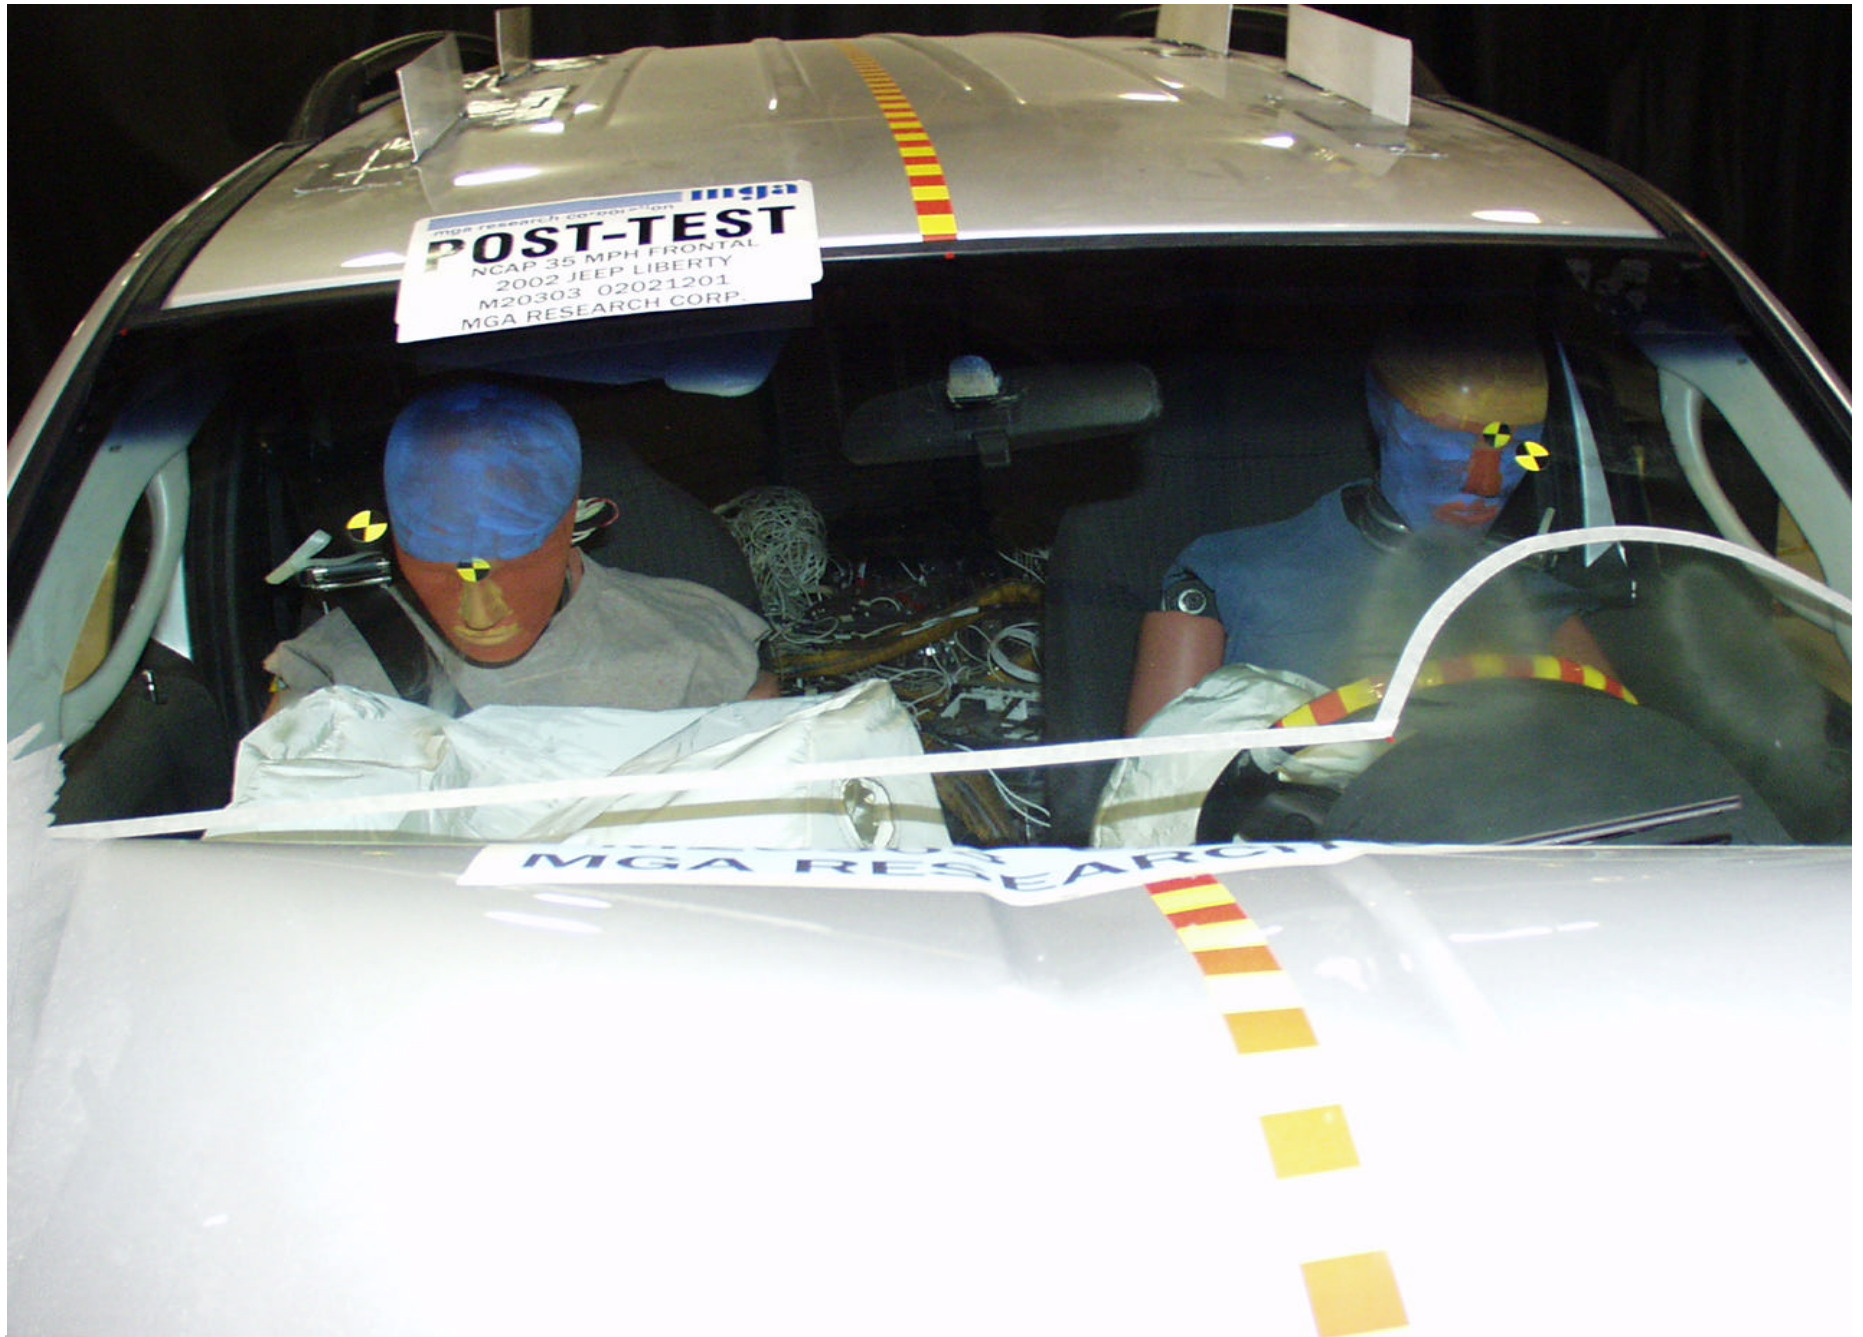
Post-Test Windshield View

There was 100 percent windshield retention and no intrusion into the protected zone of the windshield during the event. There was no Stoddard Solvent leakage after the event or during any phase of the static rollover.

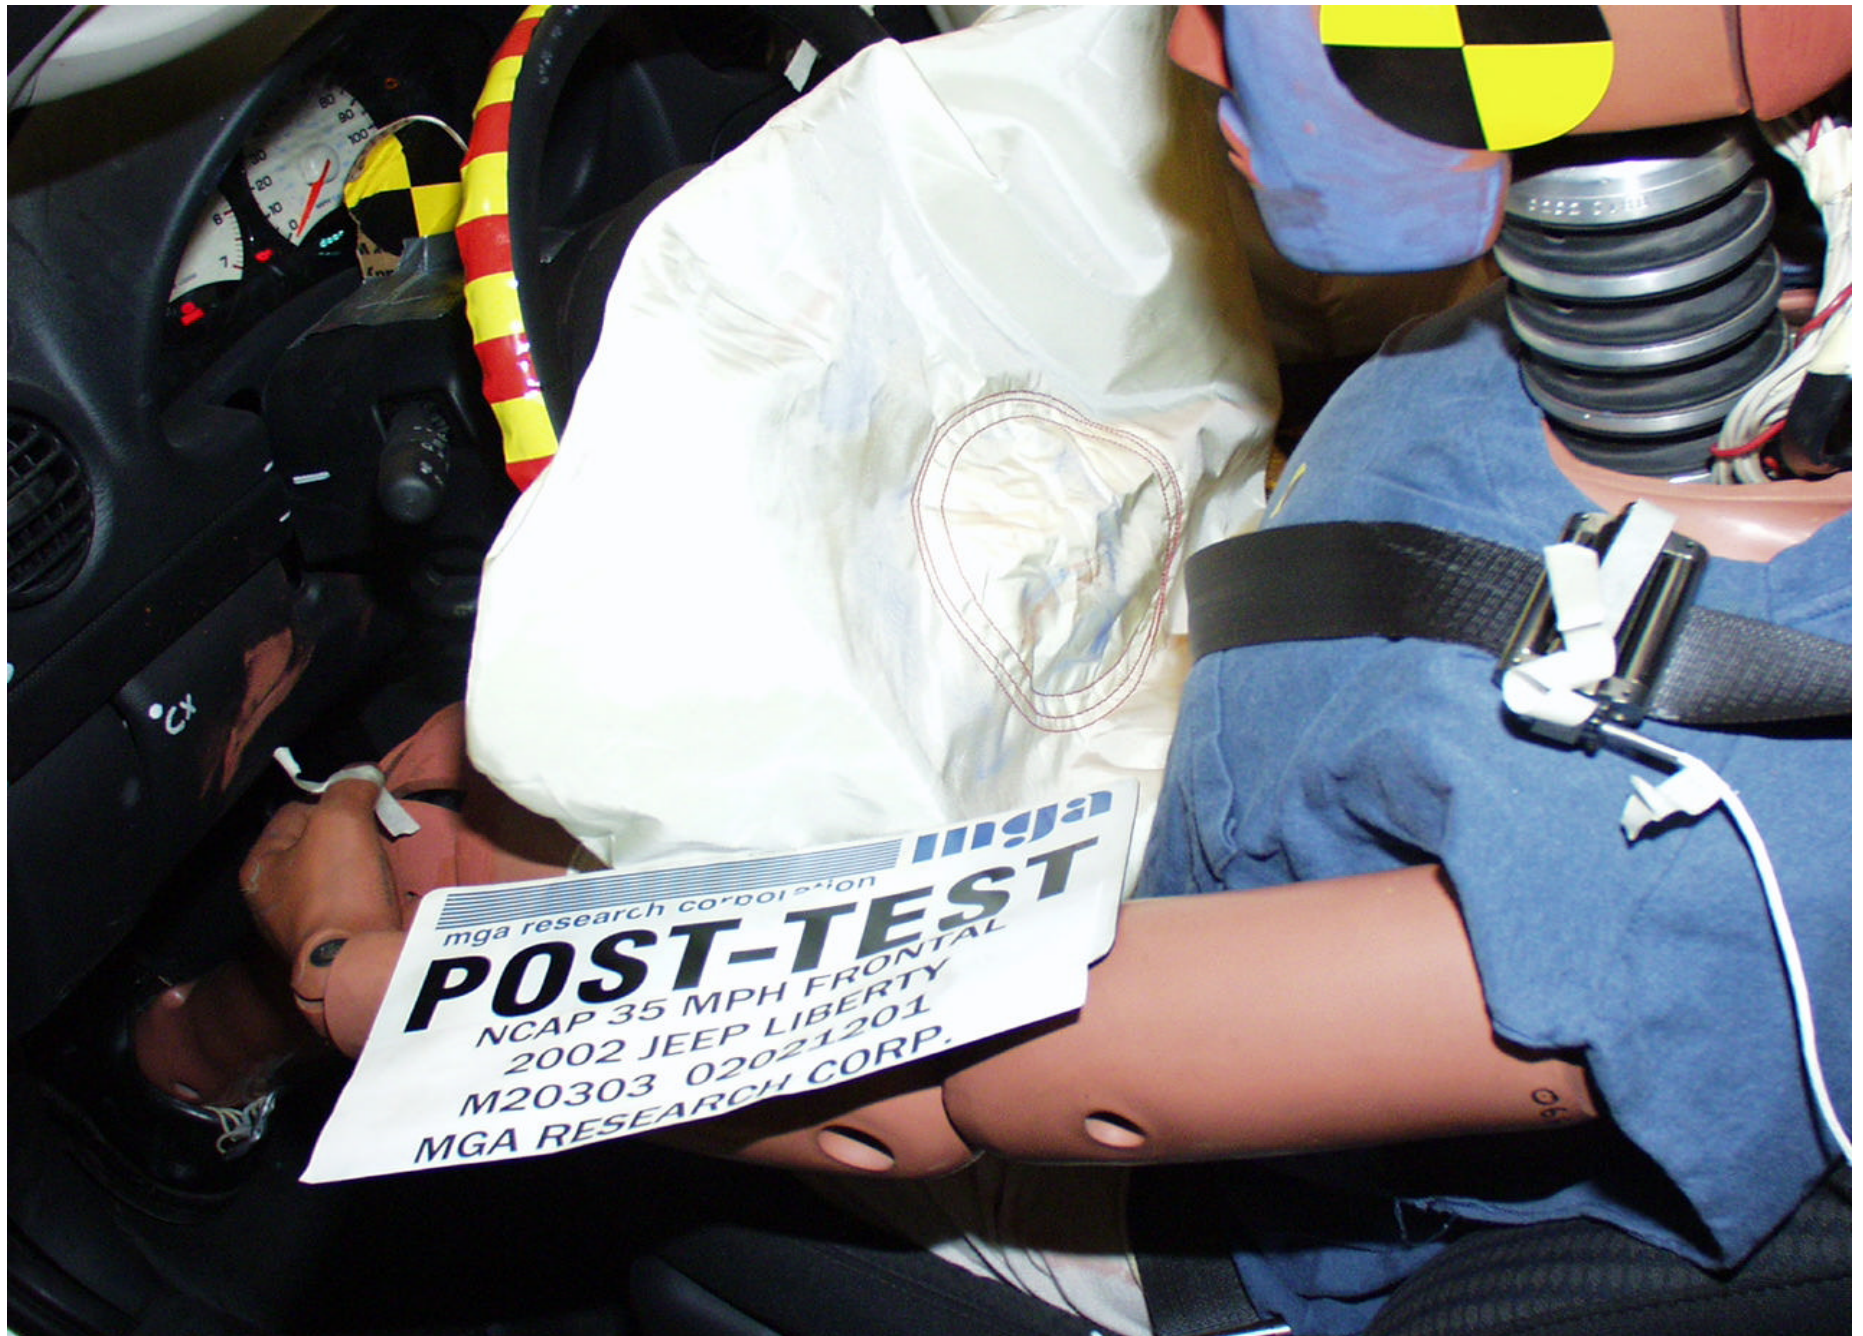
Post-Test Driver Airbag Contact

The driver's head, chest, and abdomen contacted the airbag. The driver's knees contacted the knee bolster. The passenger's head, chest, and abdomen contacted the airbag. The passenger head contacted the sunvisor. The passenger's knees contacted the glove box.

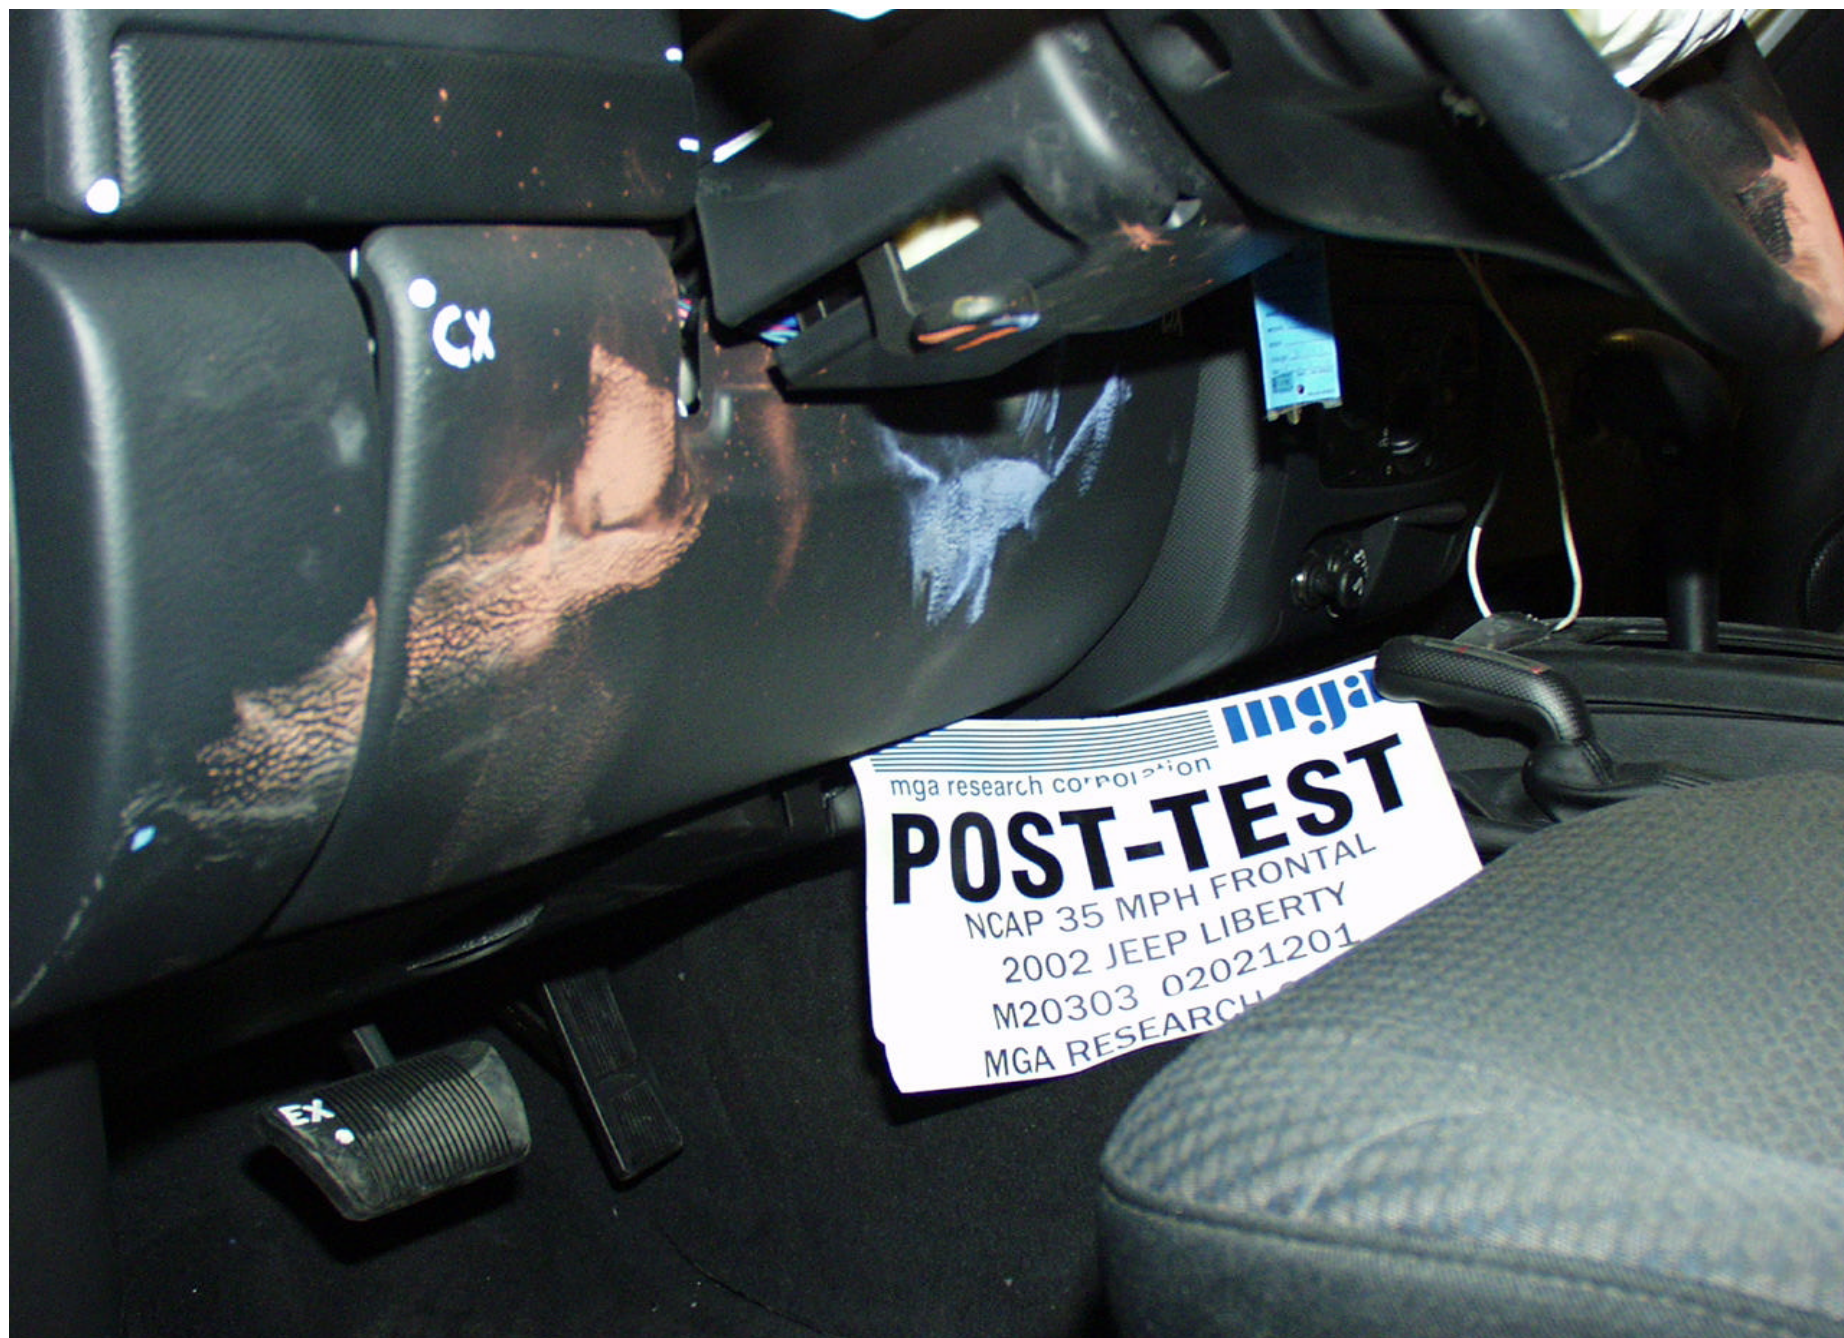
Post-Test Driver Knee Contact View

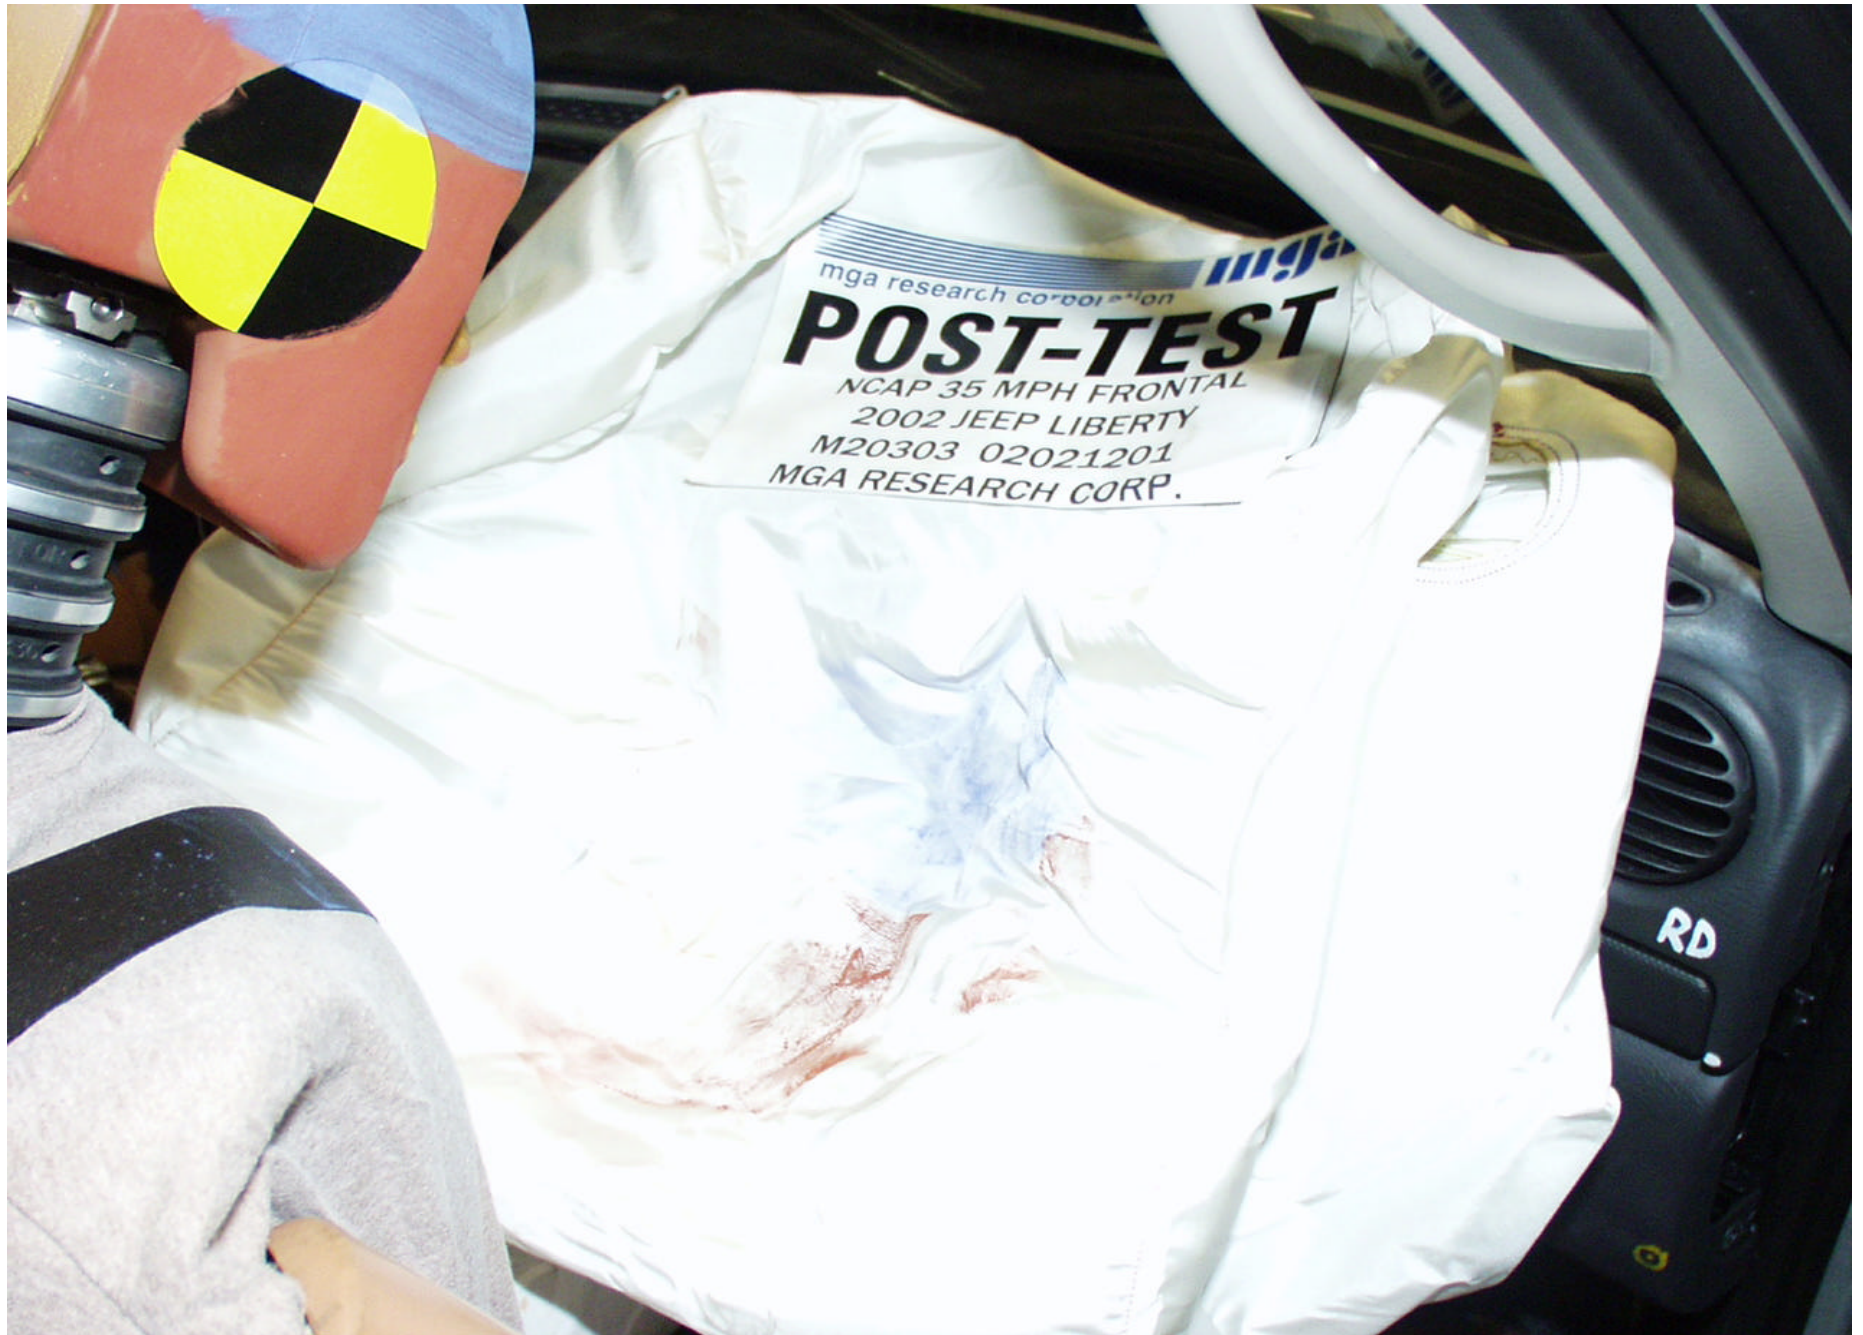
Post-Test Passenger Airbag Contact

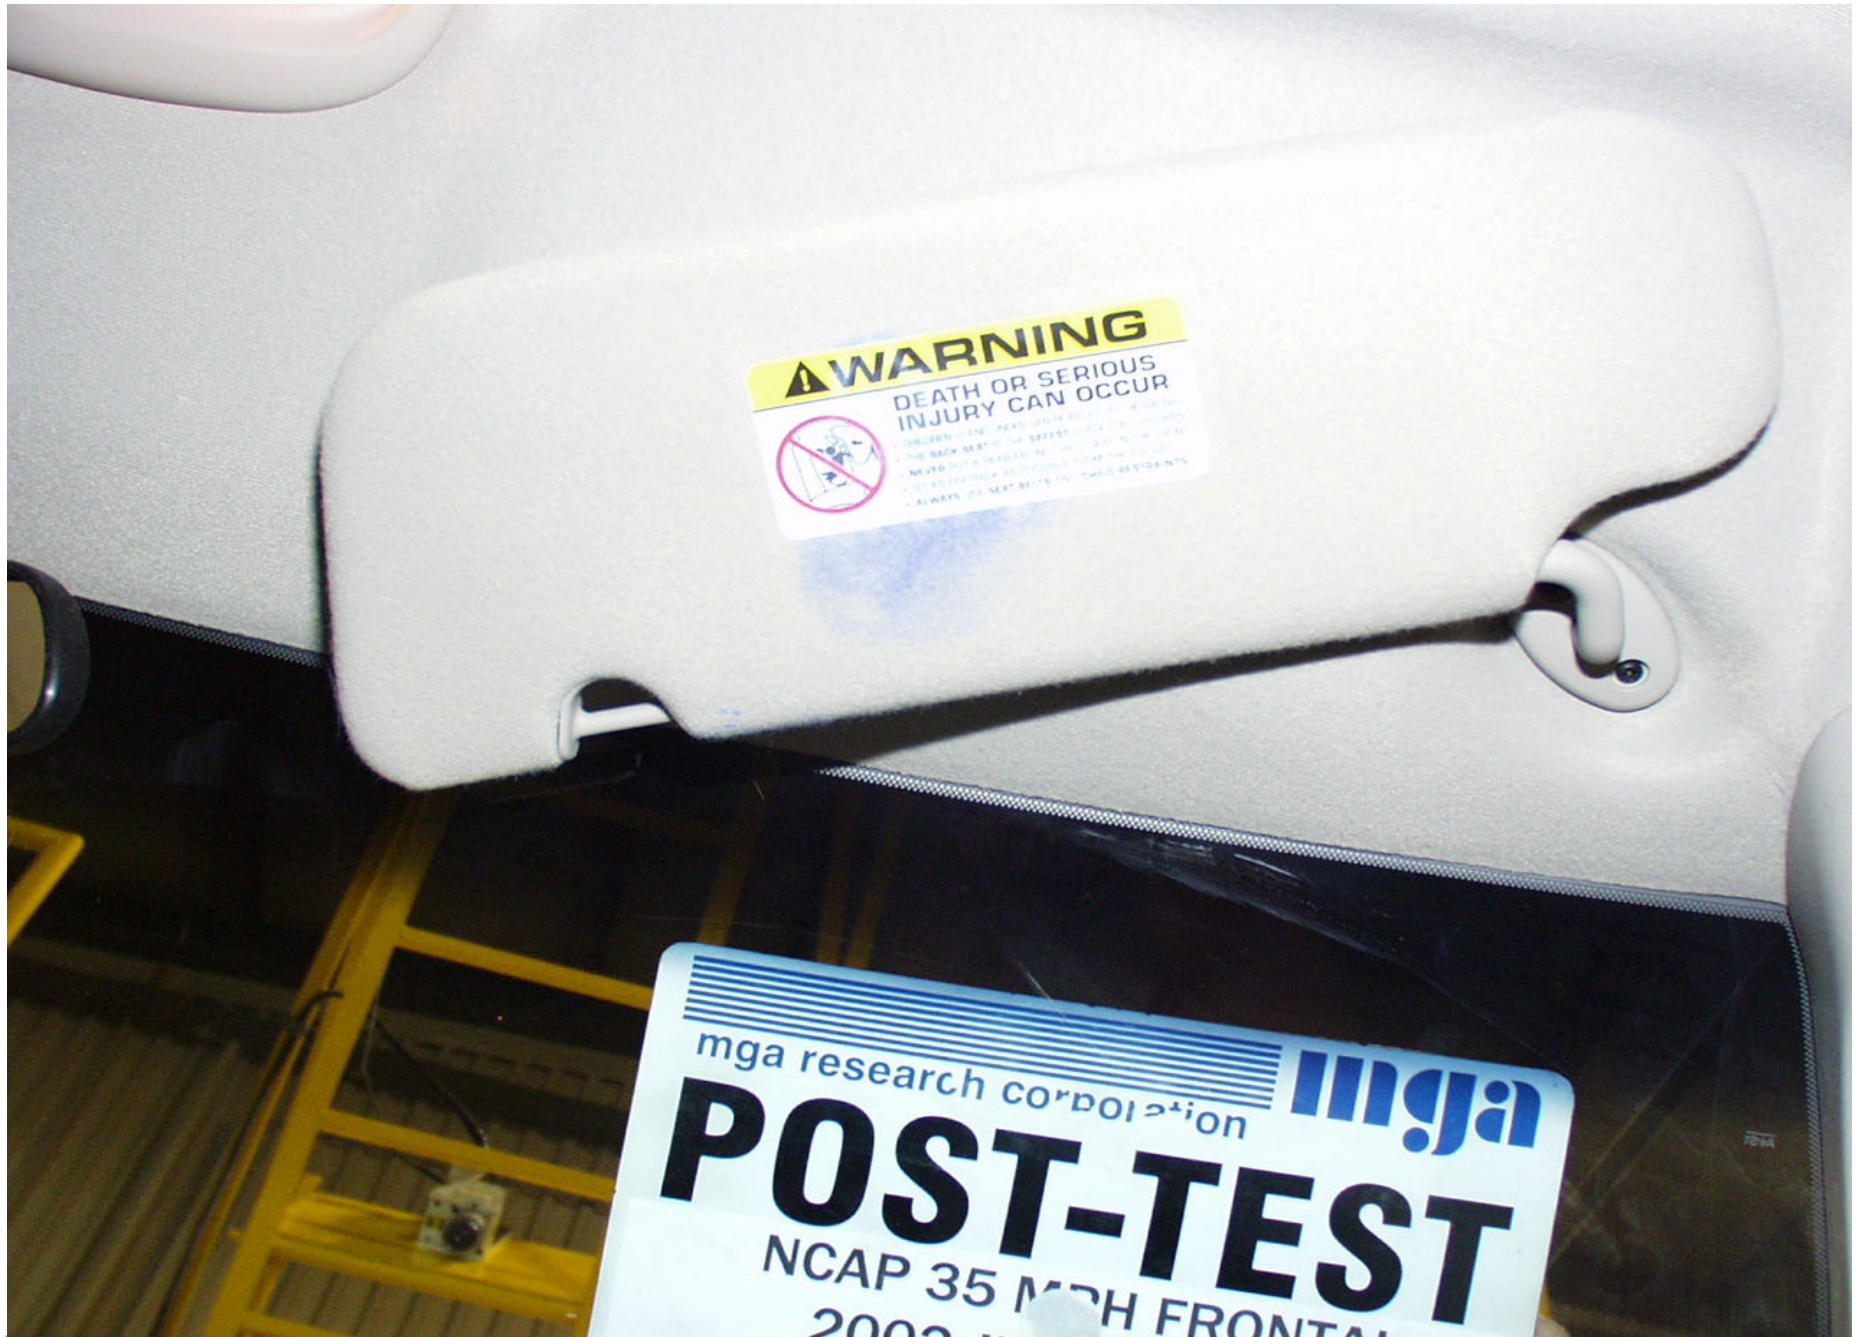
Post-Test Passenger Head Contact (Visor)

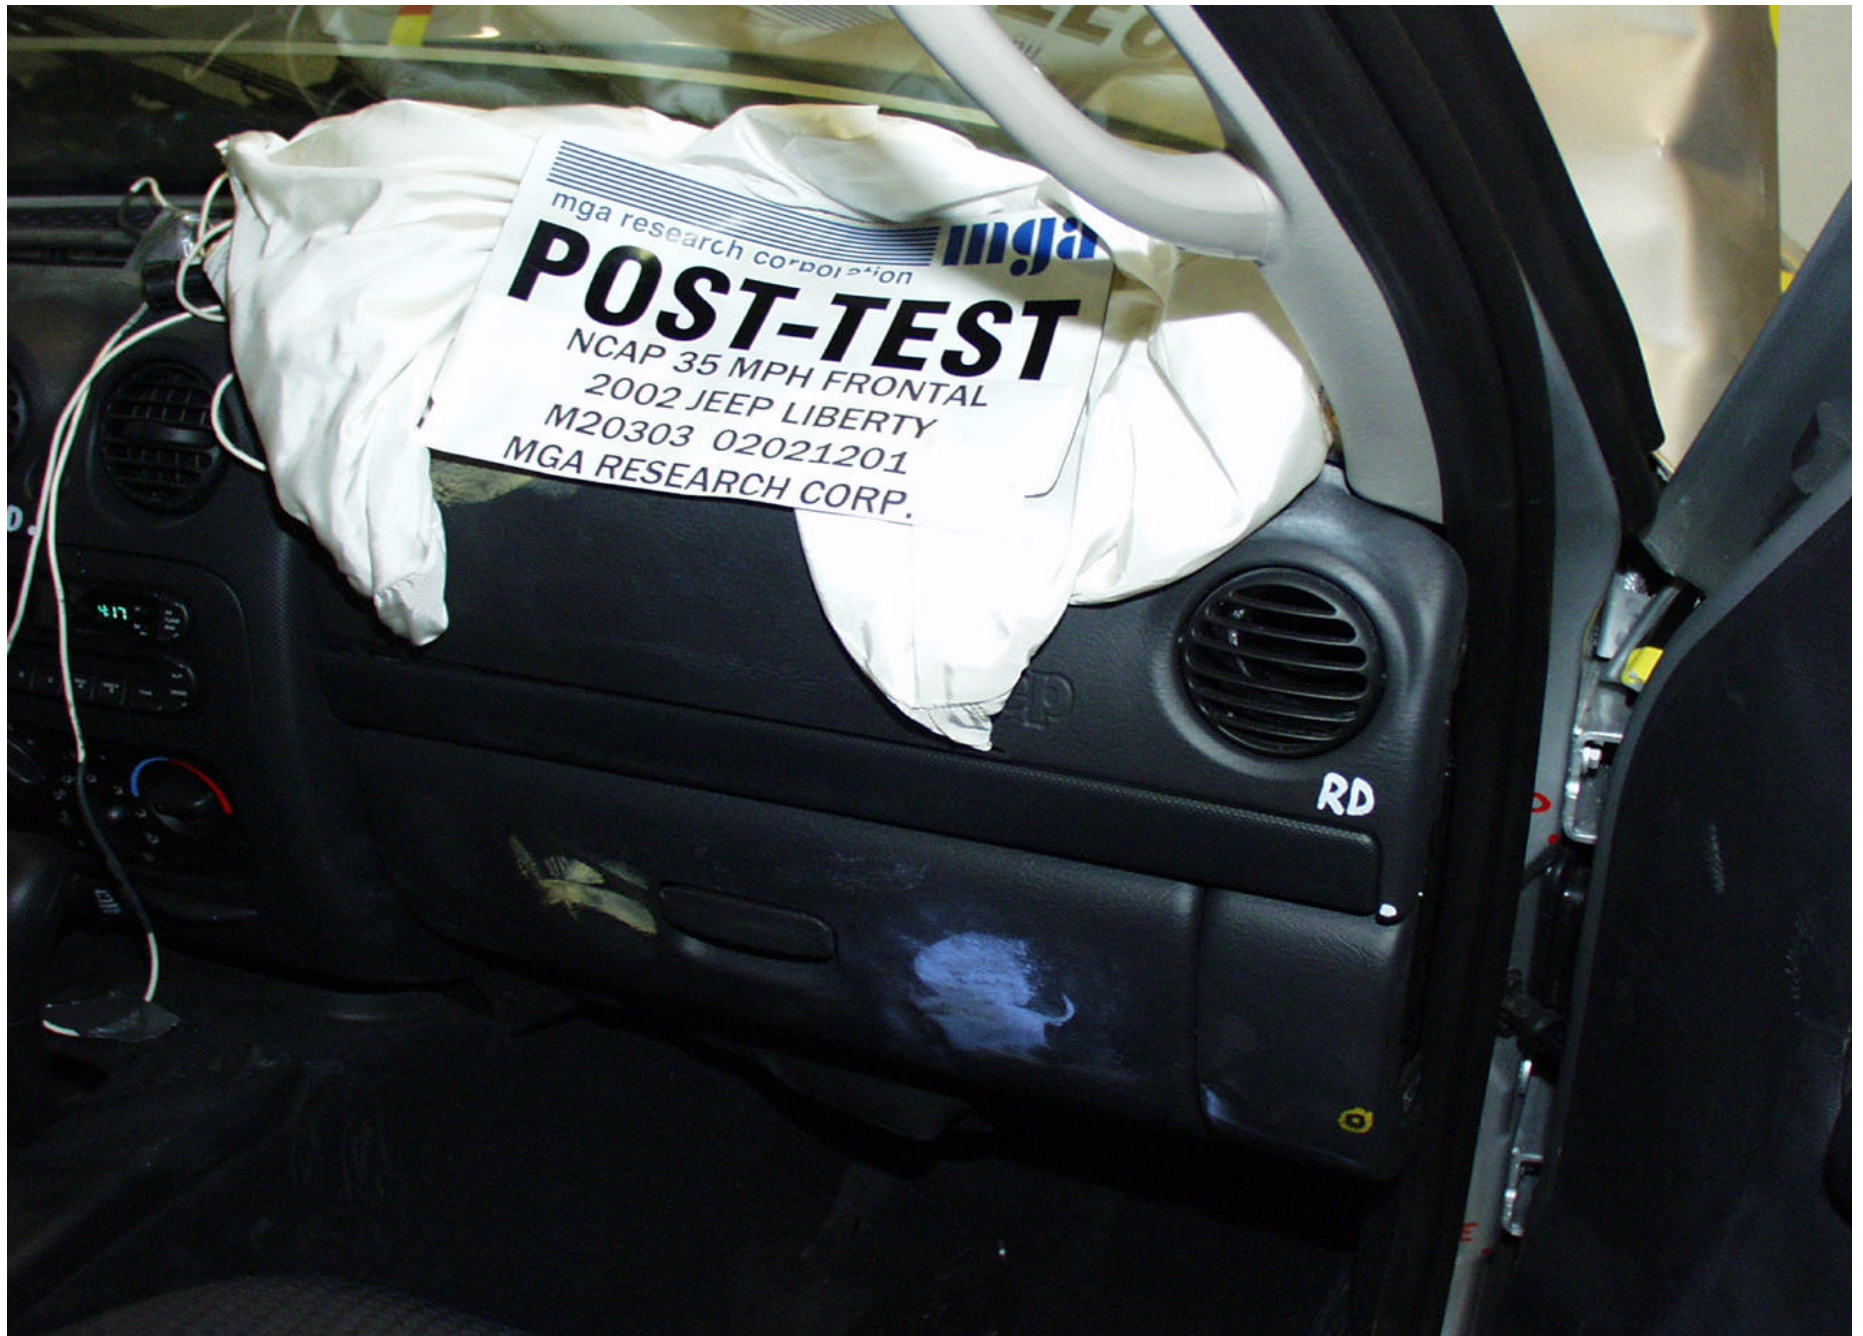
Post-Test Passenger Knee Contact View

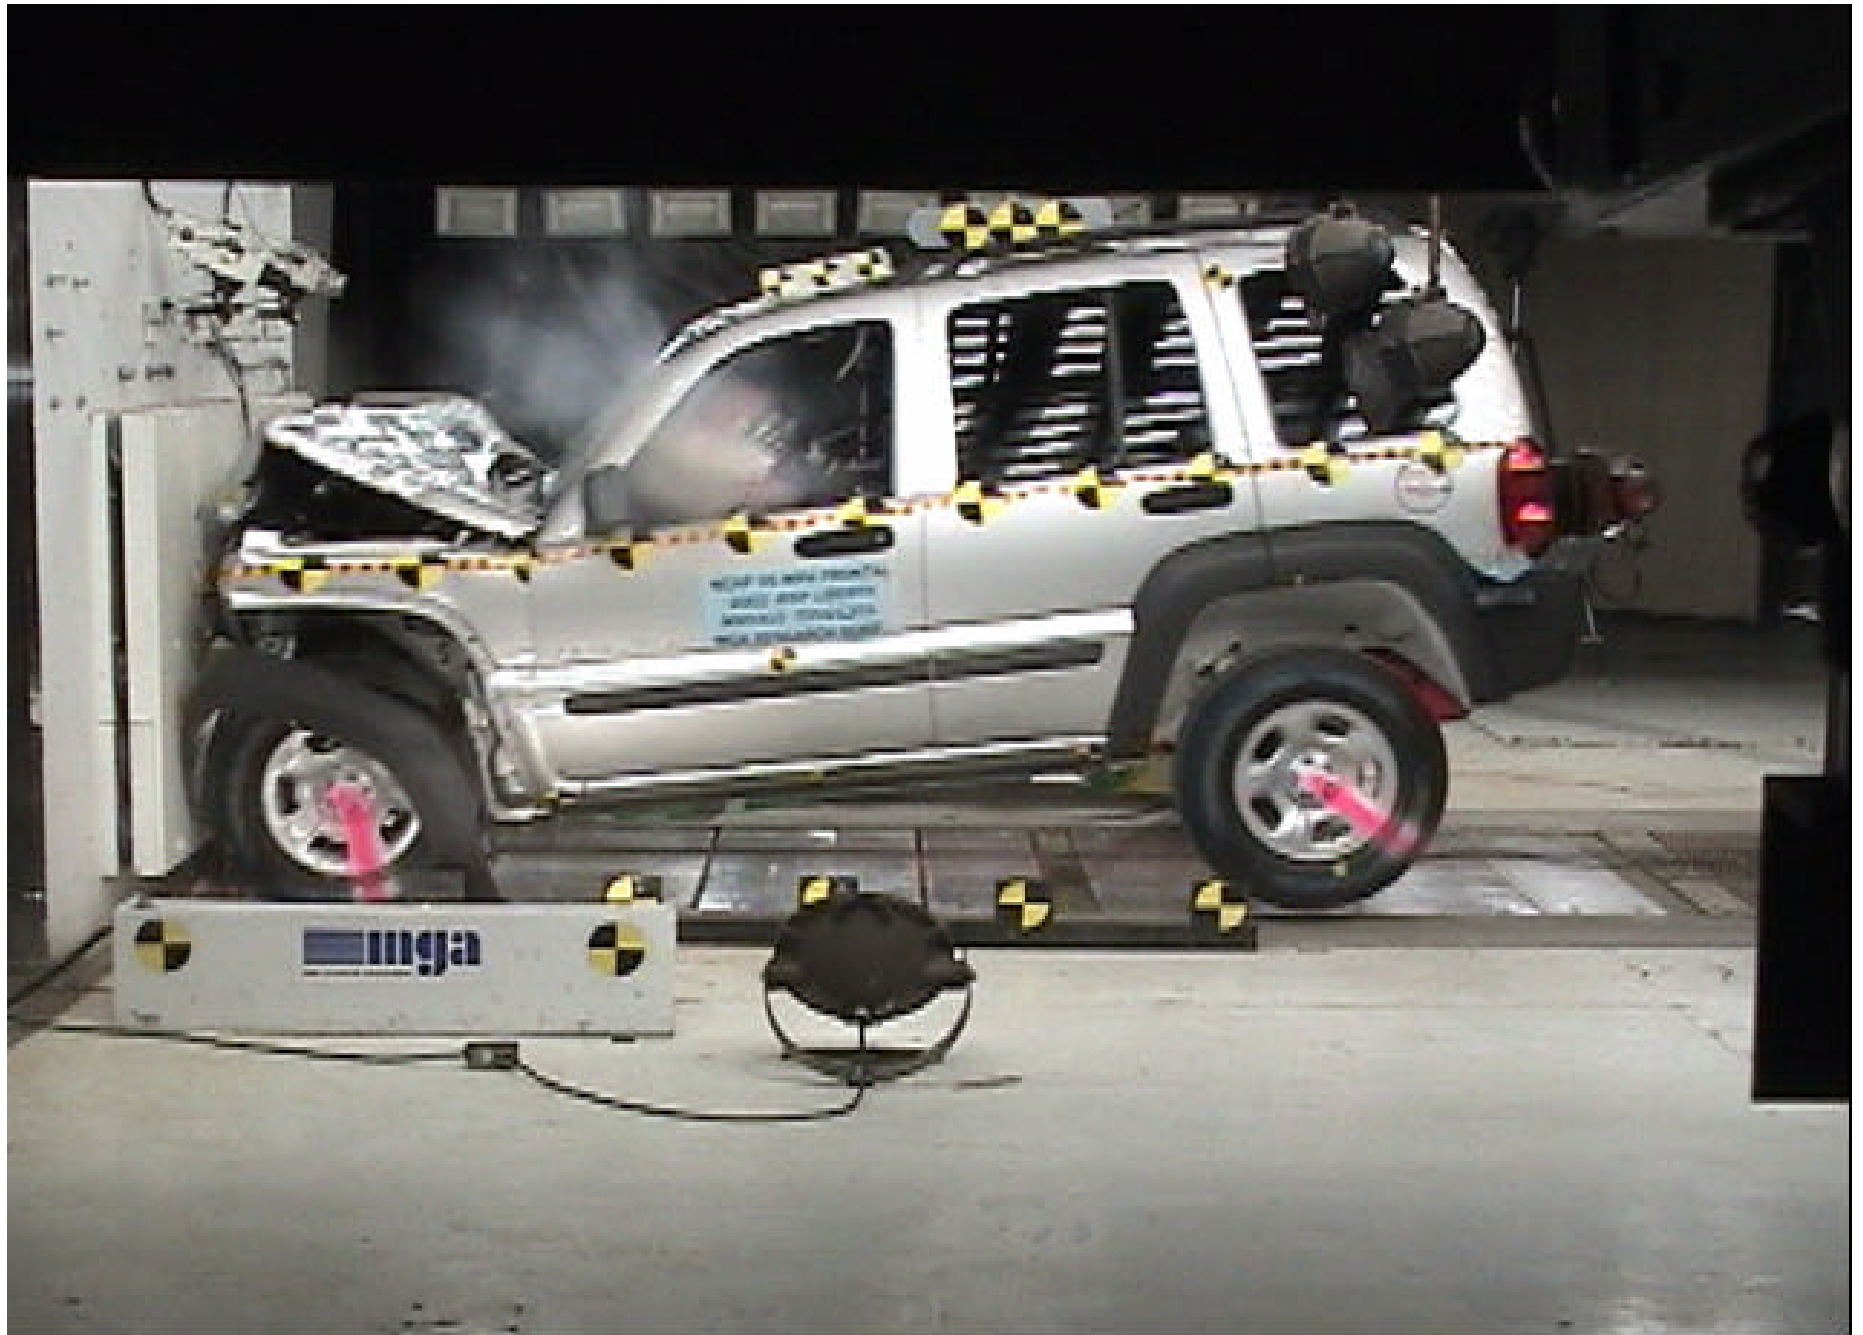
Vehicle Impact

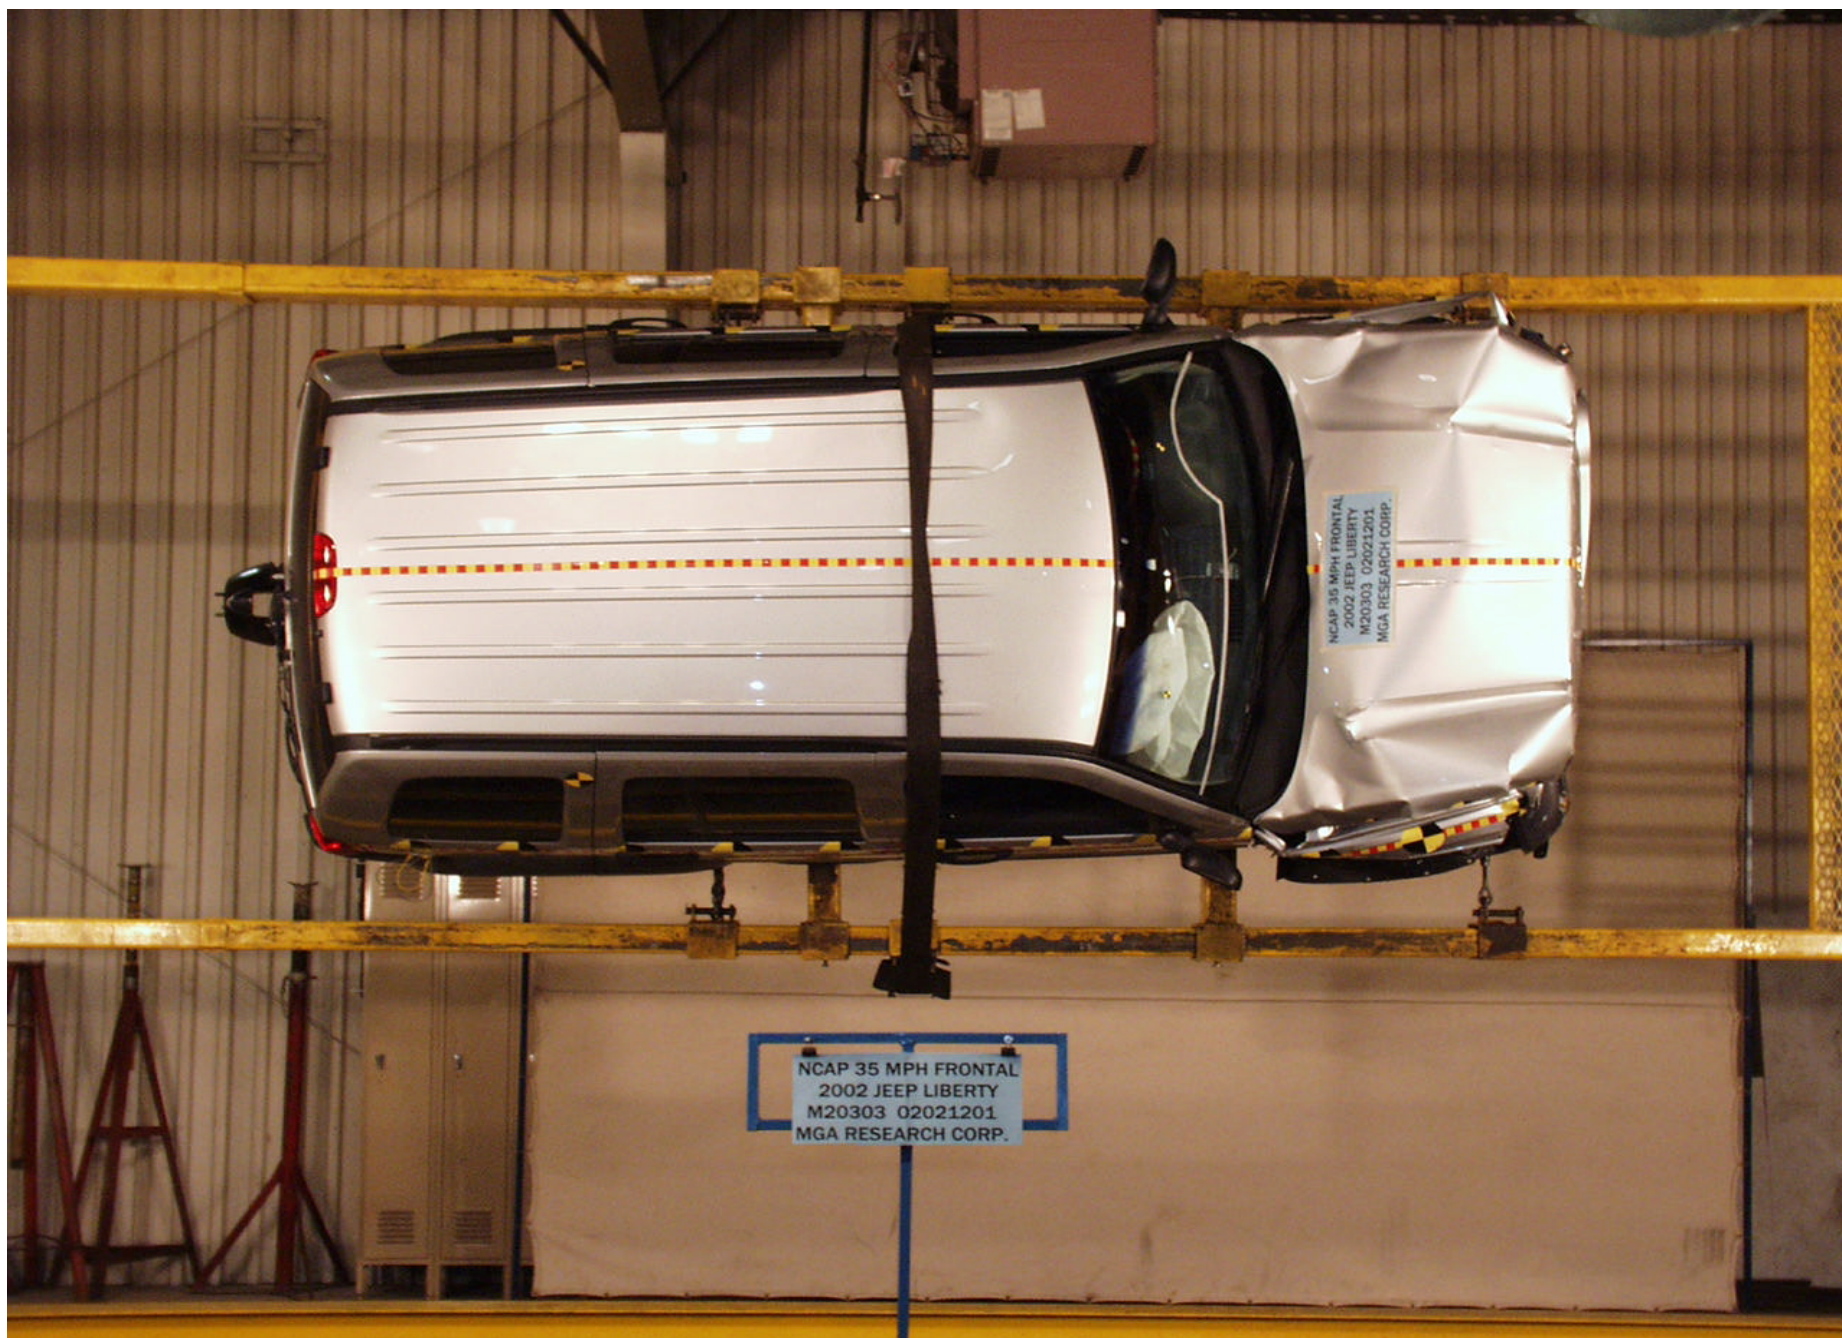
Rollover 270 Degrees
