**REPORT NUMBER: NCAP-MGA-2002-004**

**NEW CAR ASSESSMENT PROGRAM  
FRONTAL BARRIER IMPACT TEST**

**2002 JEEP LIBERTY SUV  
NHTSA NUMBER: M20303**

**PREPARED BY:  
MGA RESEARCH CORPORATION  
5000 WARREN ROAD  
BURLINGTON, WI 53105**

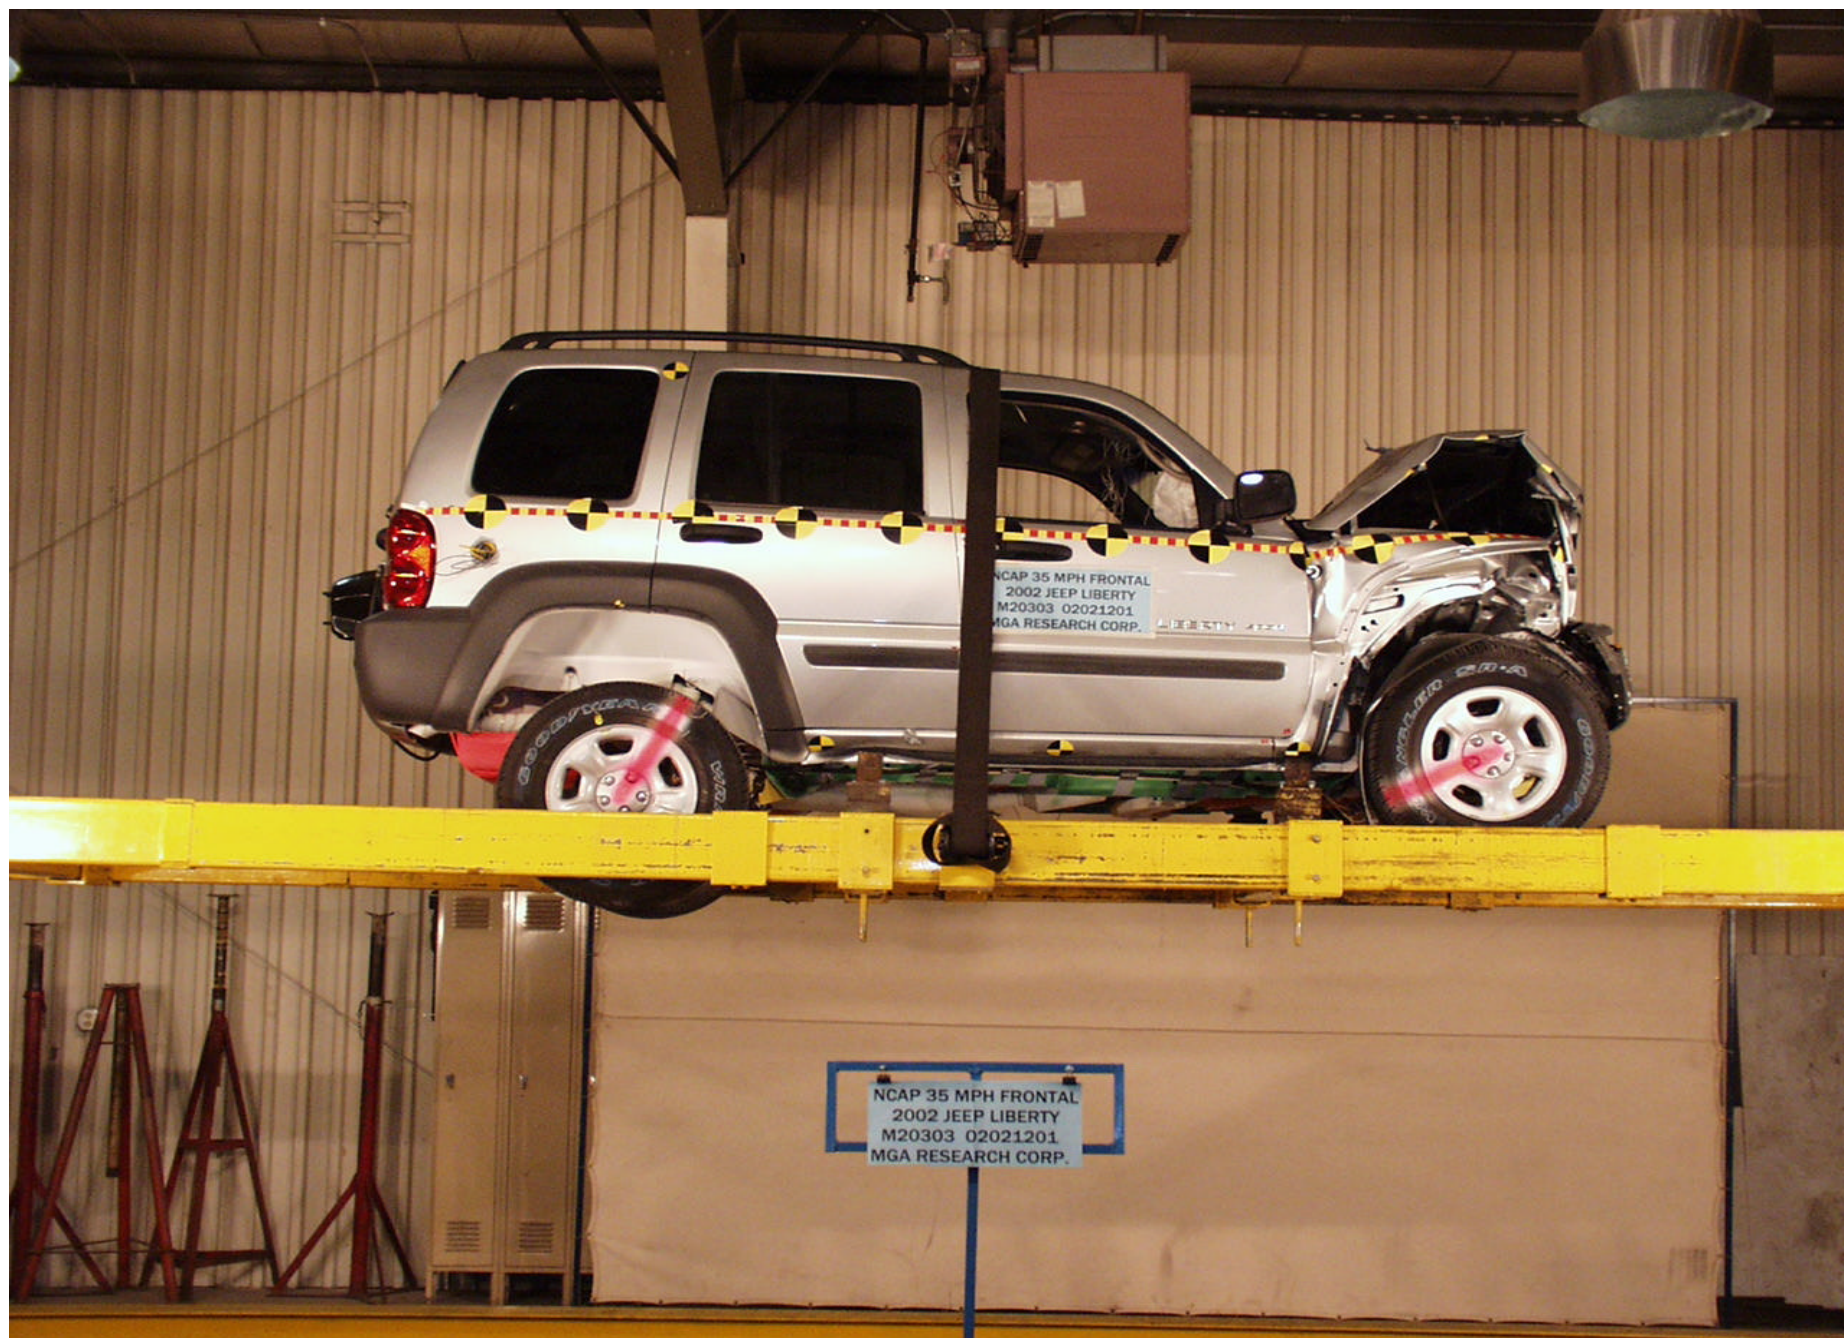
Rollover 360 Degrees

There was 100 percent windshield retention and no intrusion into the protected zone of the windshield during the event. There was no Stoddard Solvent leakage after the event or during any phase of the static rollover.
