REPORT NUMBER: 214D-MGA-2002-006

**SAFETY COMPLIANCE TESTING FOR FMVSS 214
SIDE IMPACT PROTECTION
INDICANT**

Audi AG
2002 Audi A4 4 Door
NHTSA NUMBER: C25800

**PREPARED BY:
MGA RESEARCH CORPORATION
5000 WARREN ROAD
BURLINGTON, WI 53105**

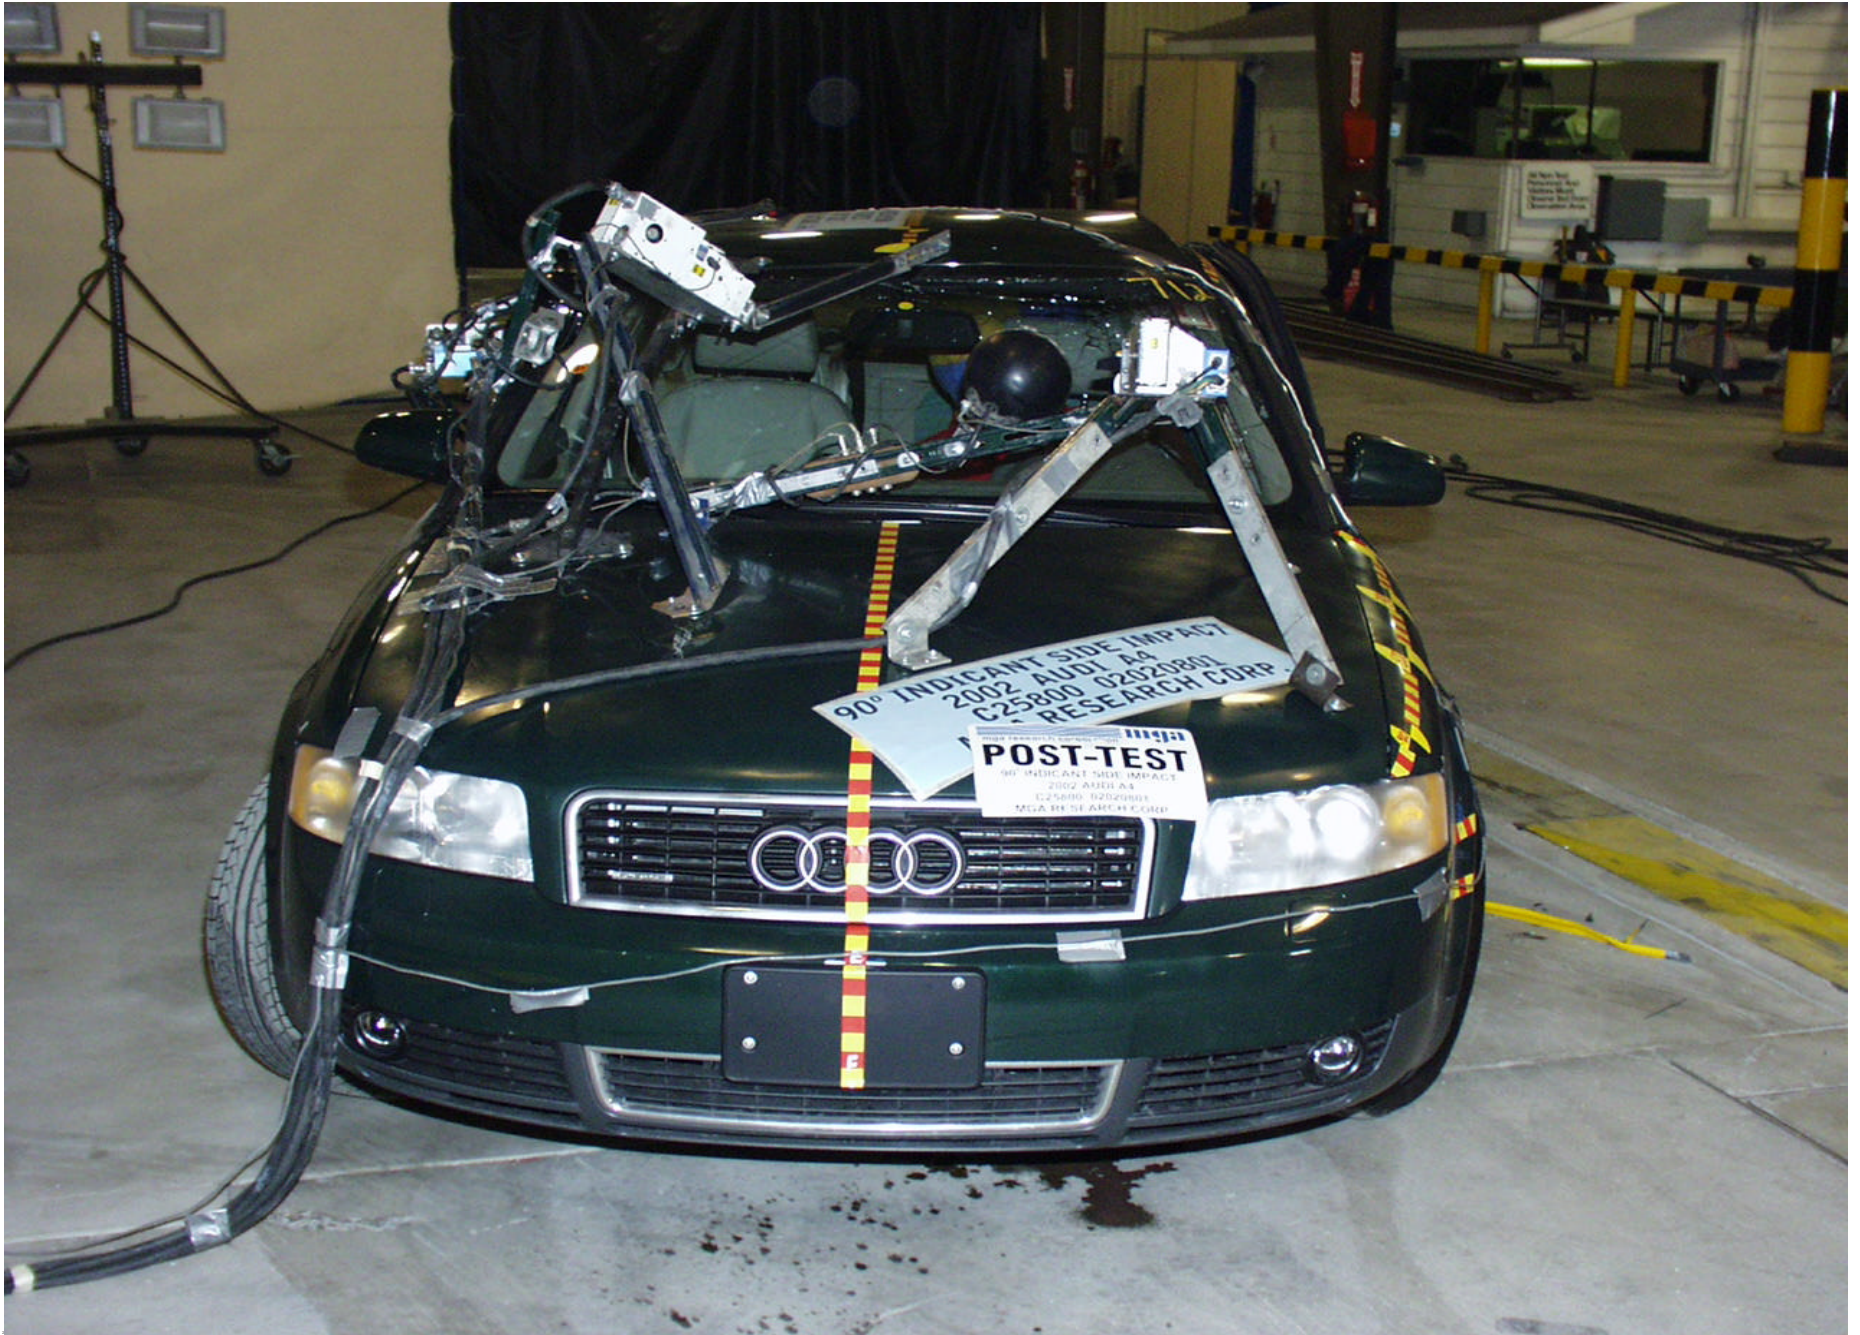
Post-Test Front View of Test Vehicle

Critical Areas of Performance	Observations and Conclusions
Pillar Performance	No separation
Sill Separation	None
Windshield Damage	Windshield cracked
Window Damage	Left rear side window broke
Other Notable Effects	None

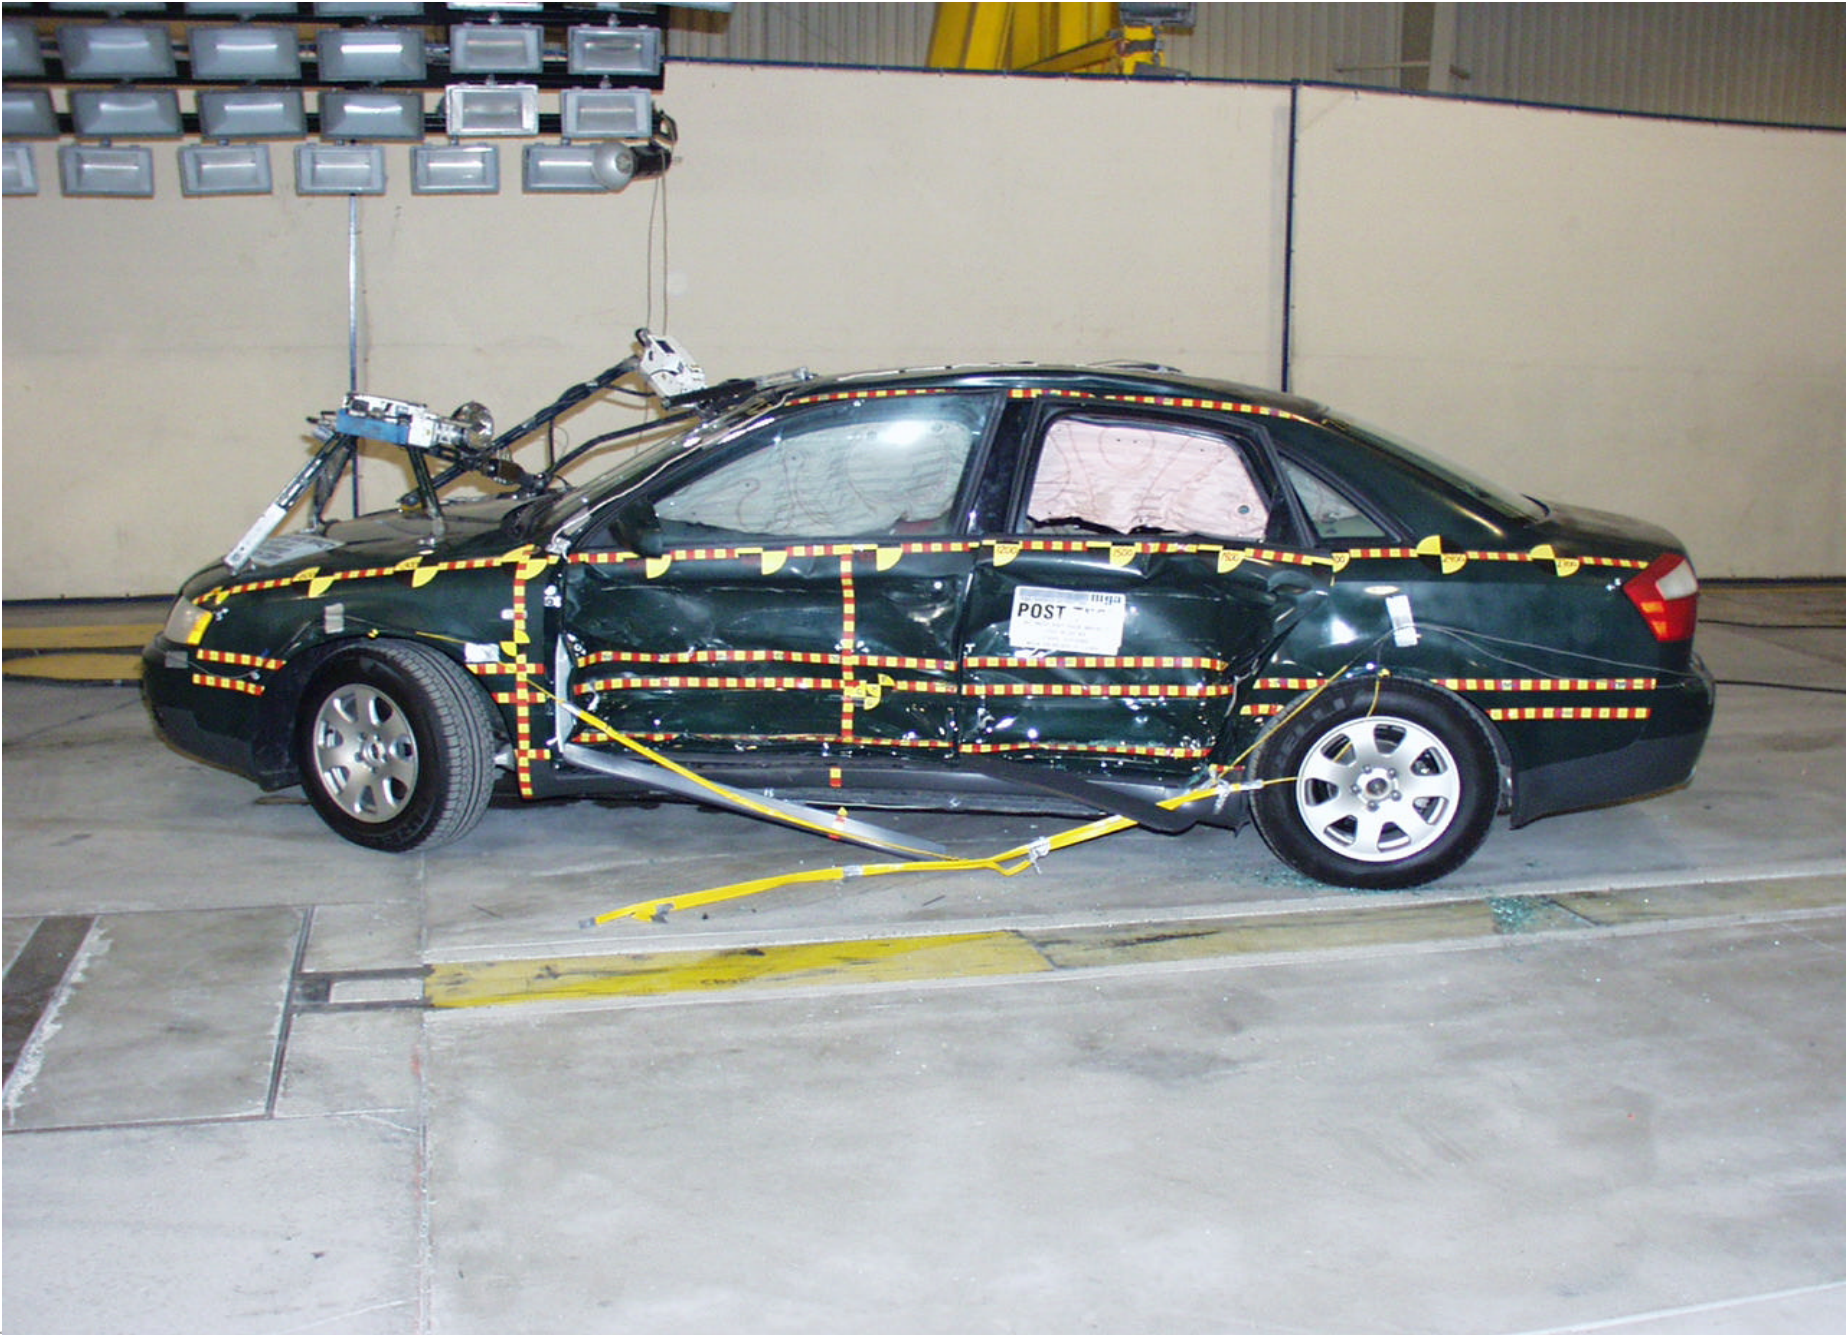
Post-Test Left Side View of Test Vehicle

The test vehicle sustained a maximum static crush of 270 mm at level 2, 750 mm rearward of the left vertical impact point. The driver and passenger SID's, Serial Nos. 48 and 49 respectively, were calibrated just prior to this test. The SID's injury criteria is summarized as follows:

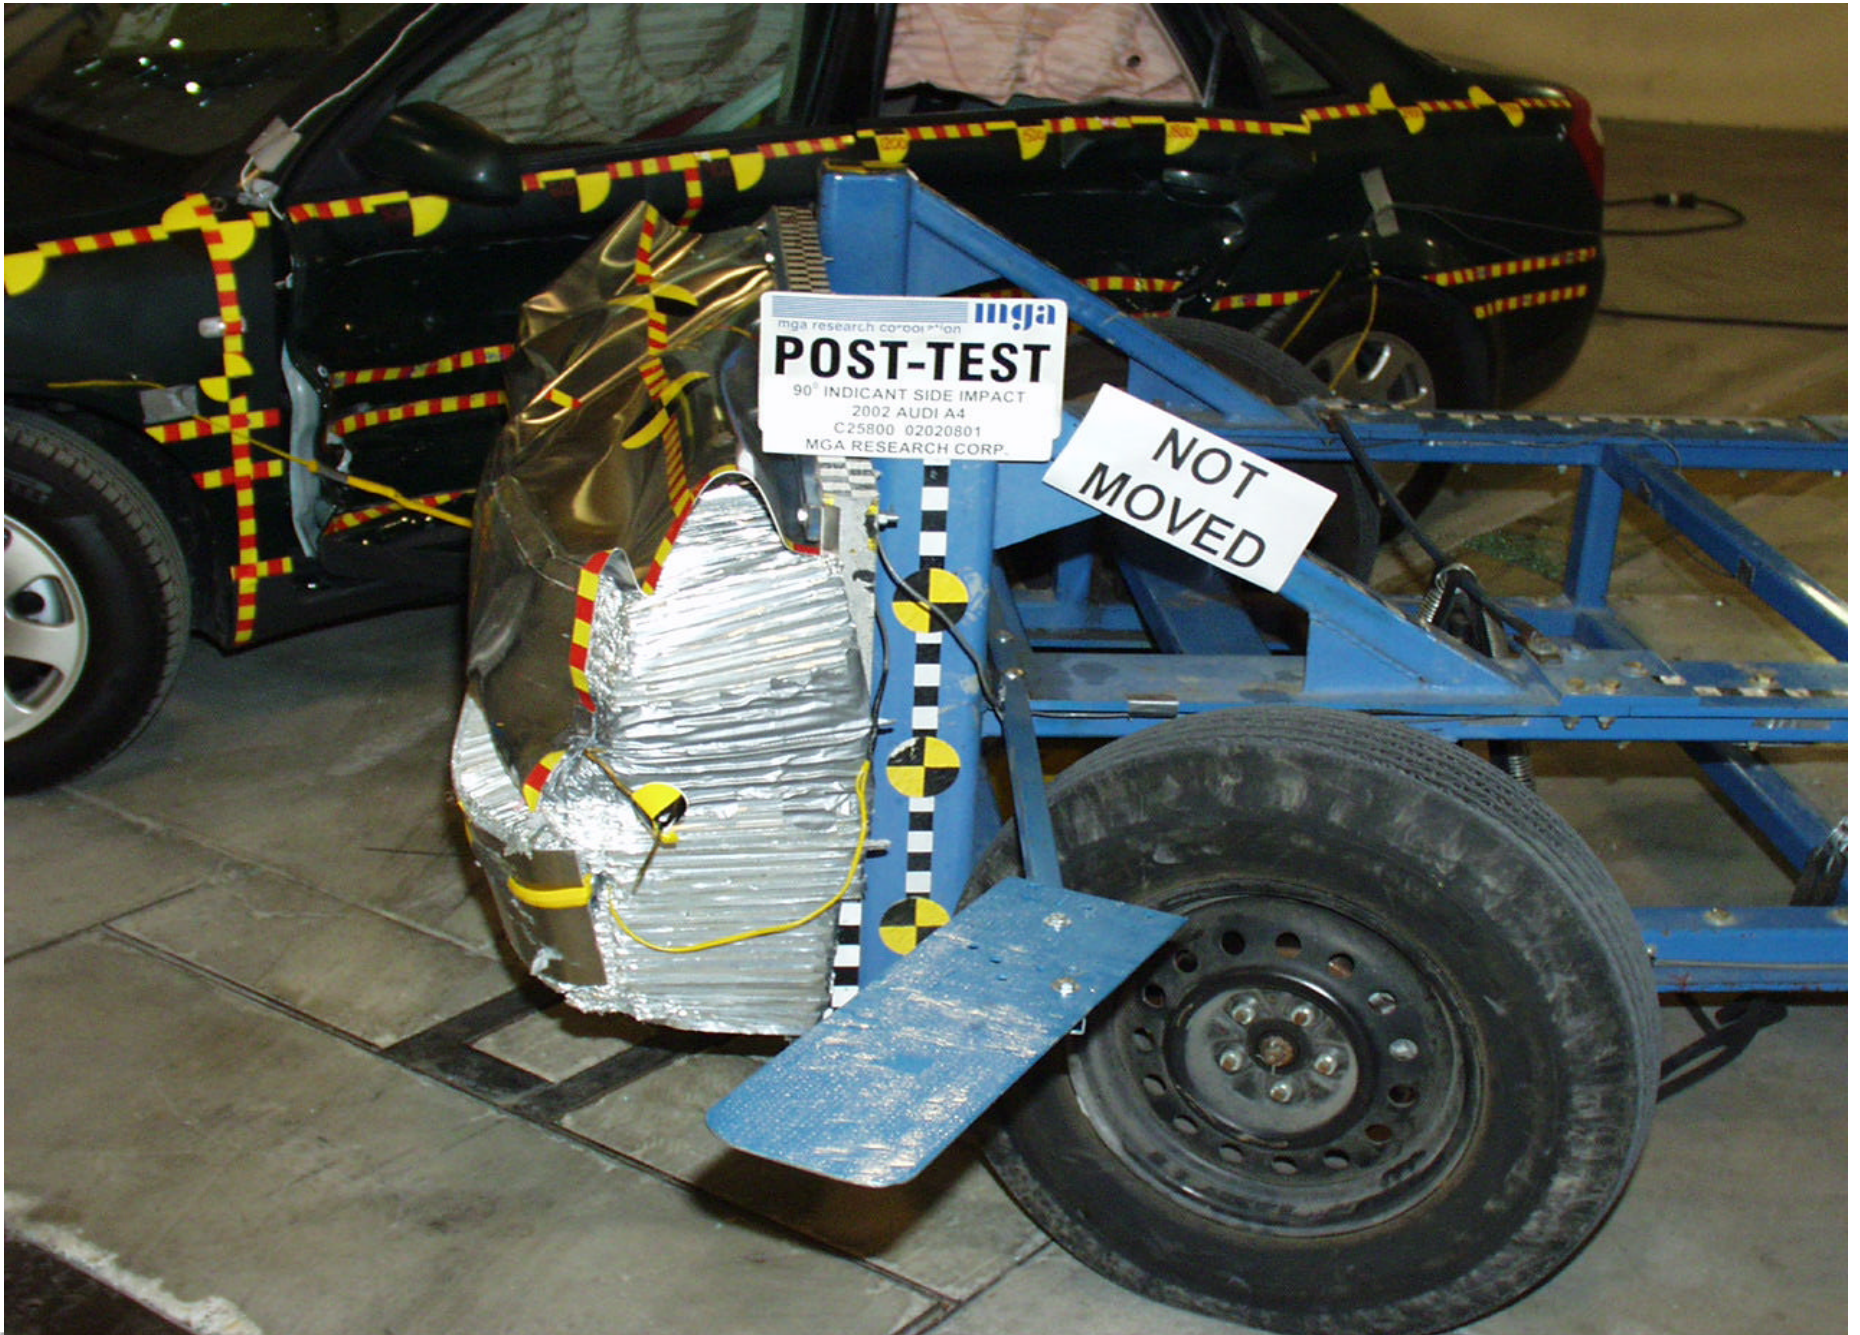
Post-Test MDB and Vehicle (left side)

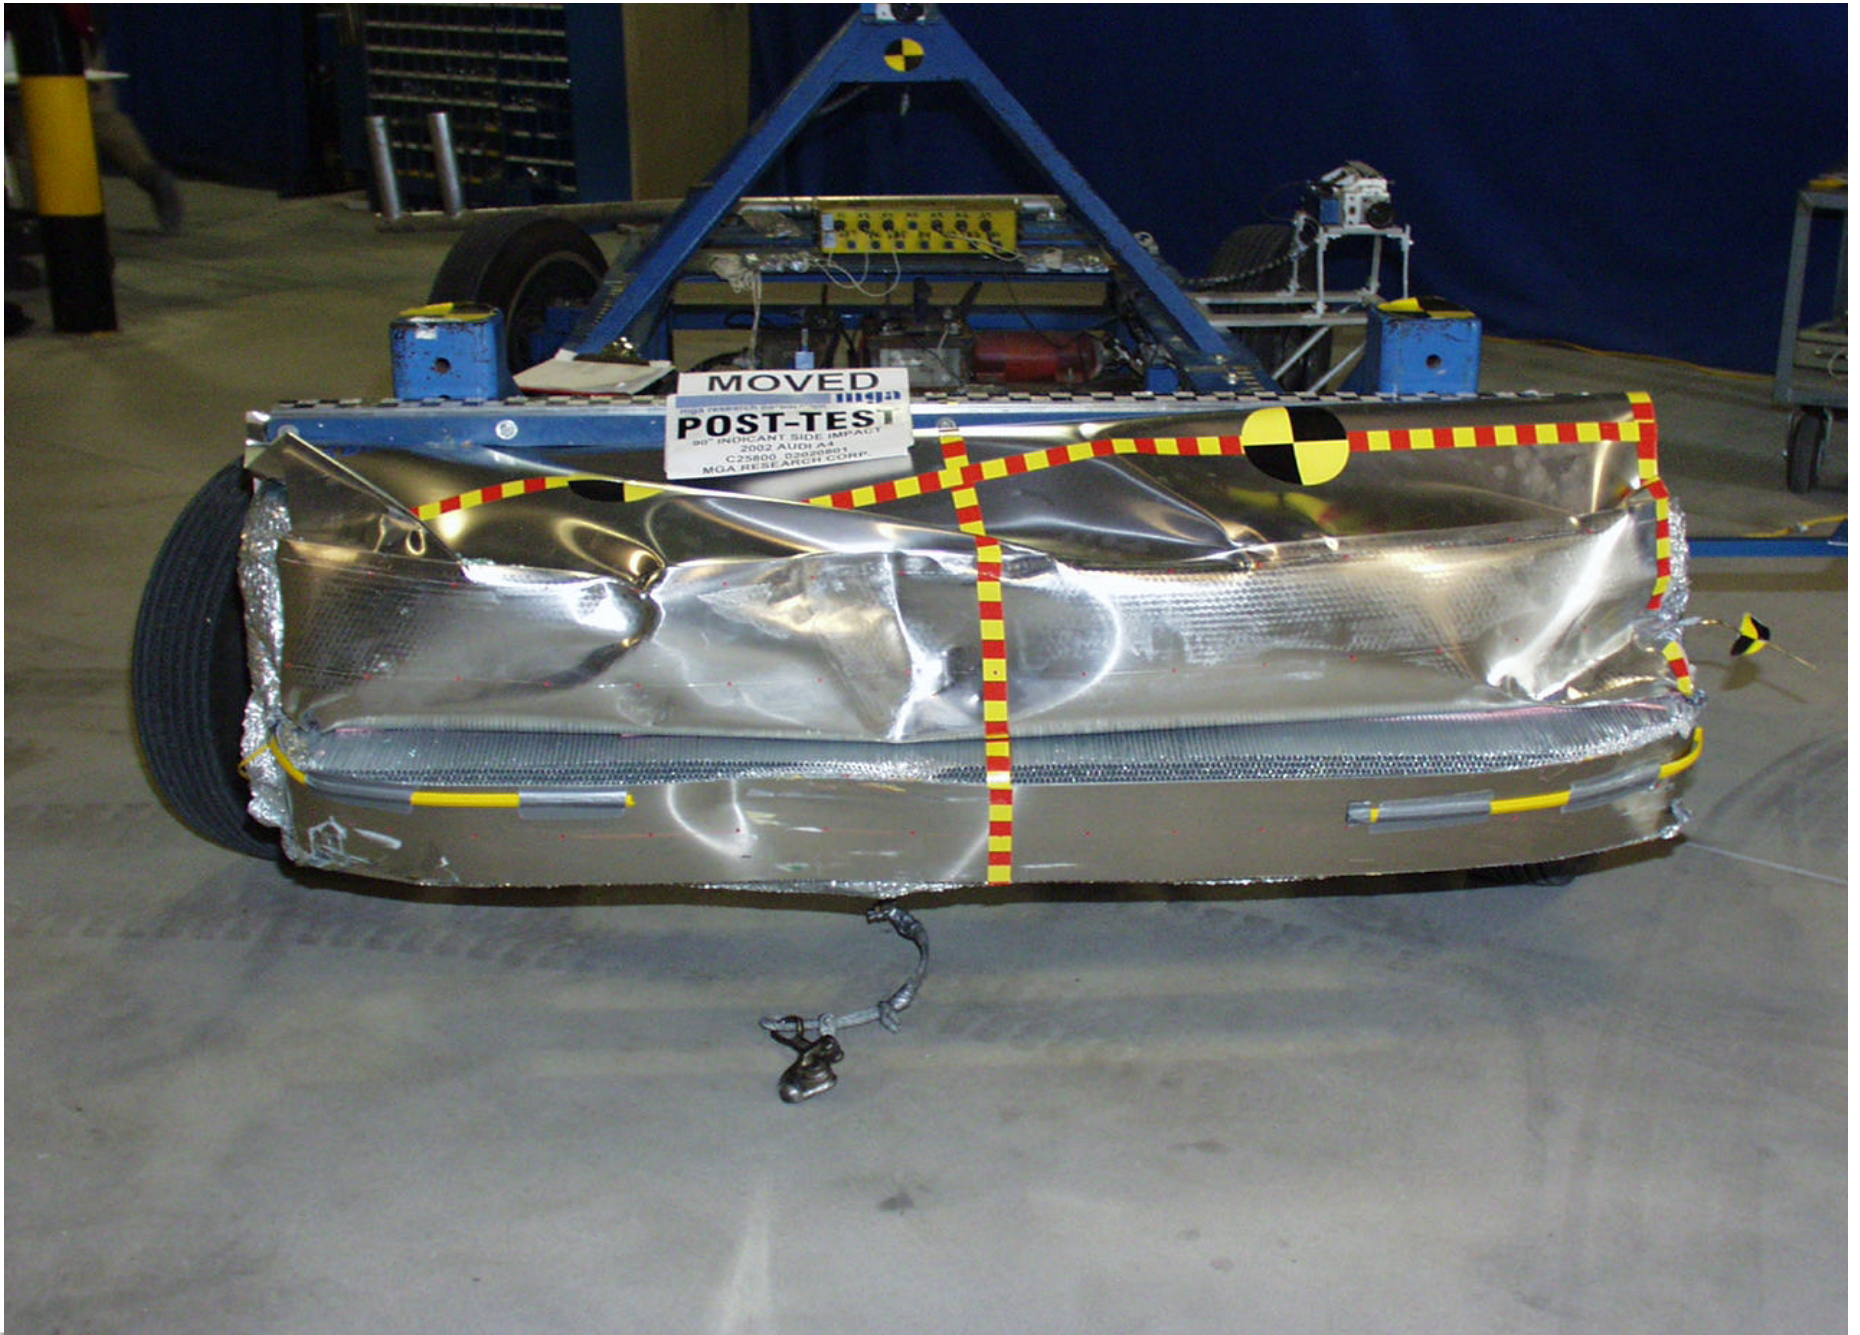
Post-Test MDB Front View

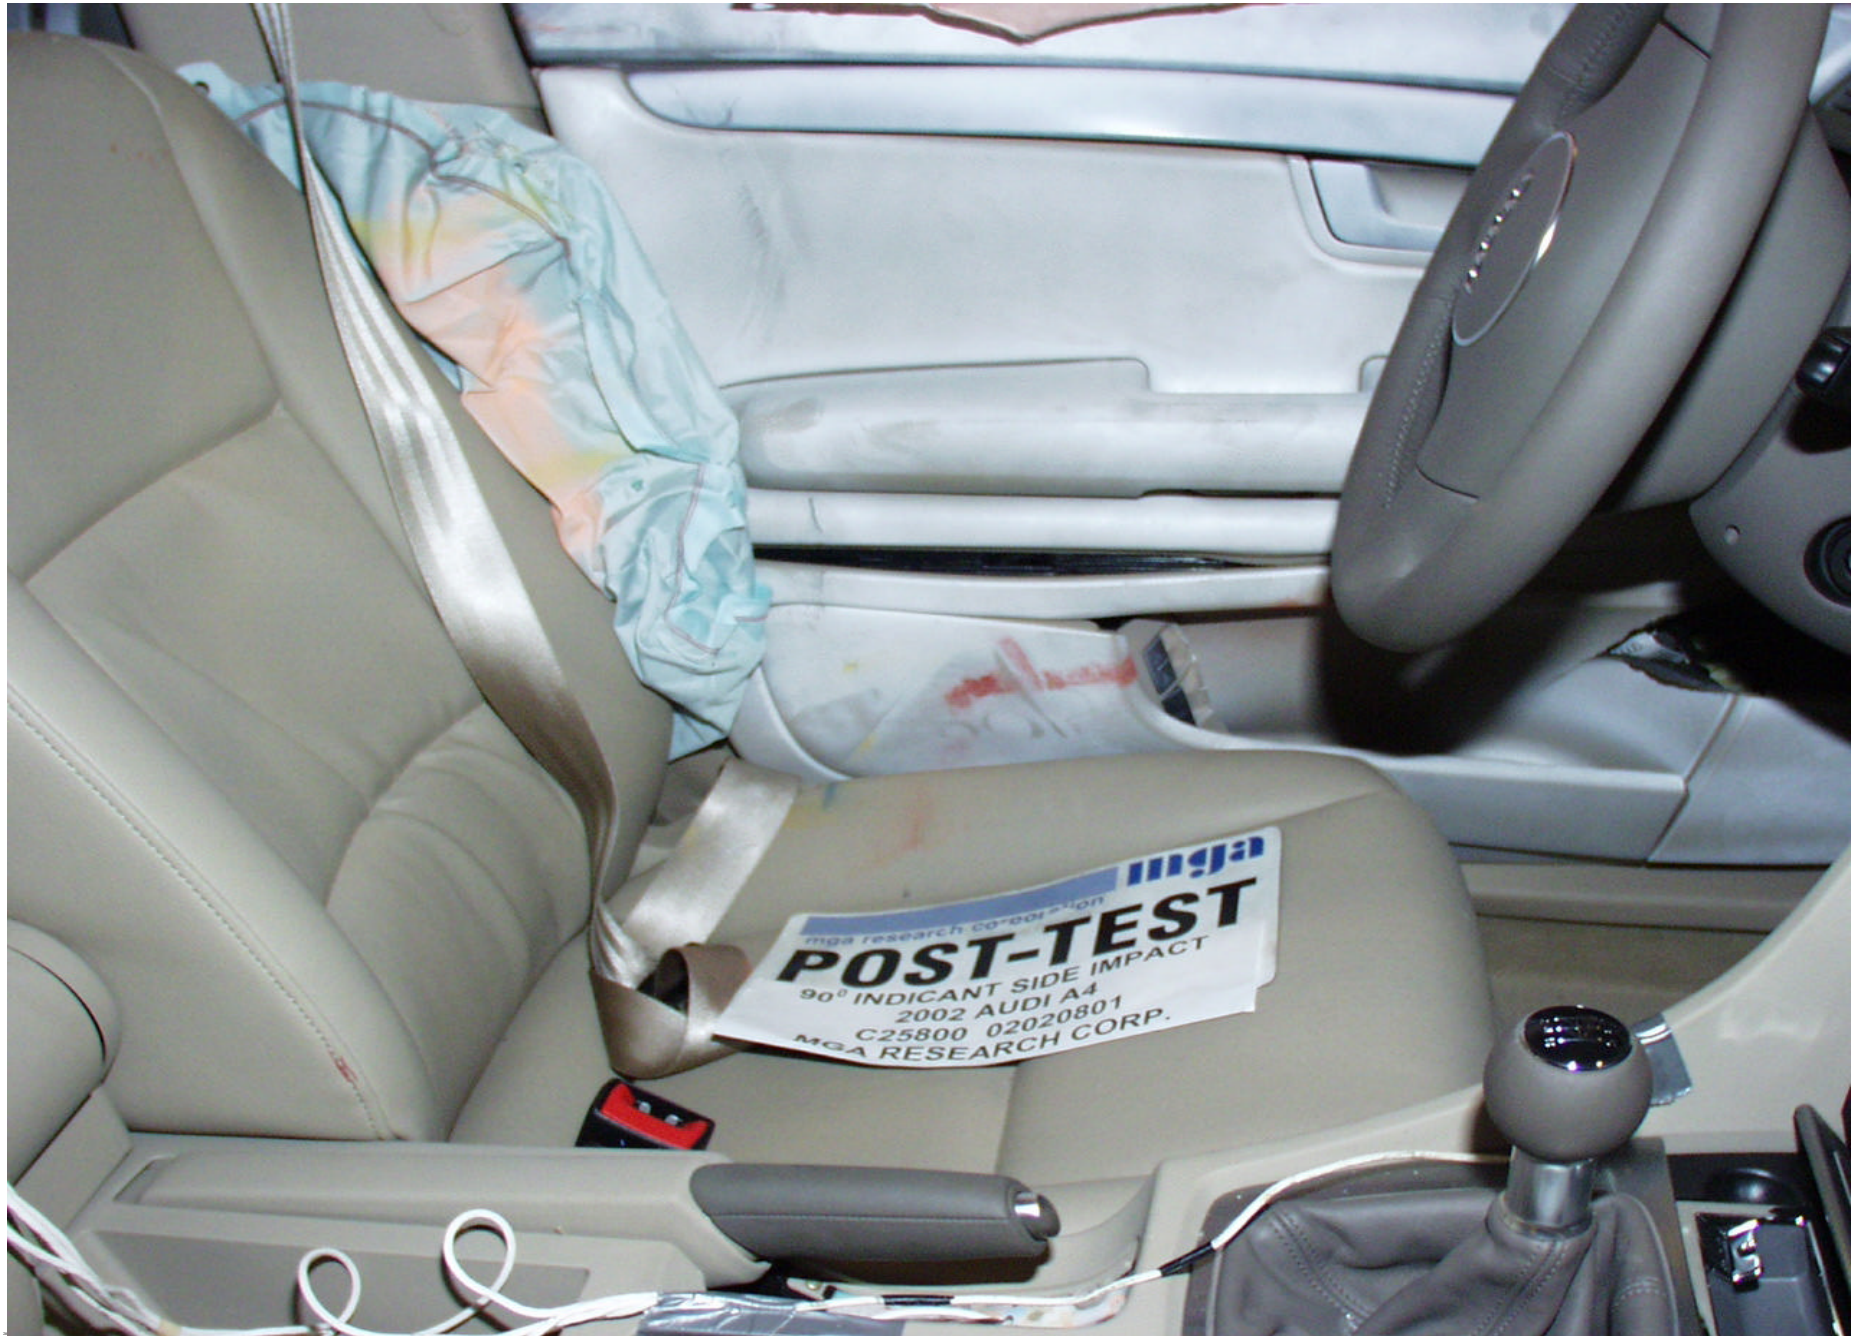
Post-Test Driver Dummy Contact

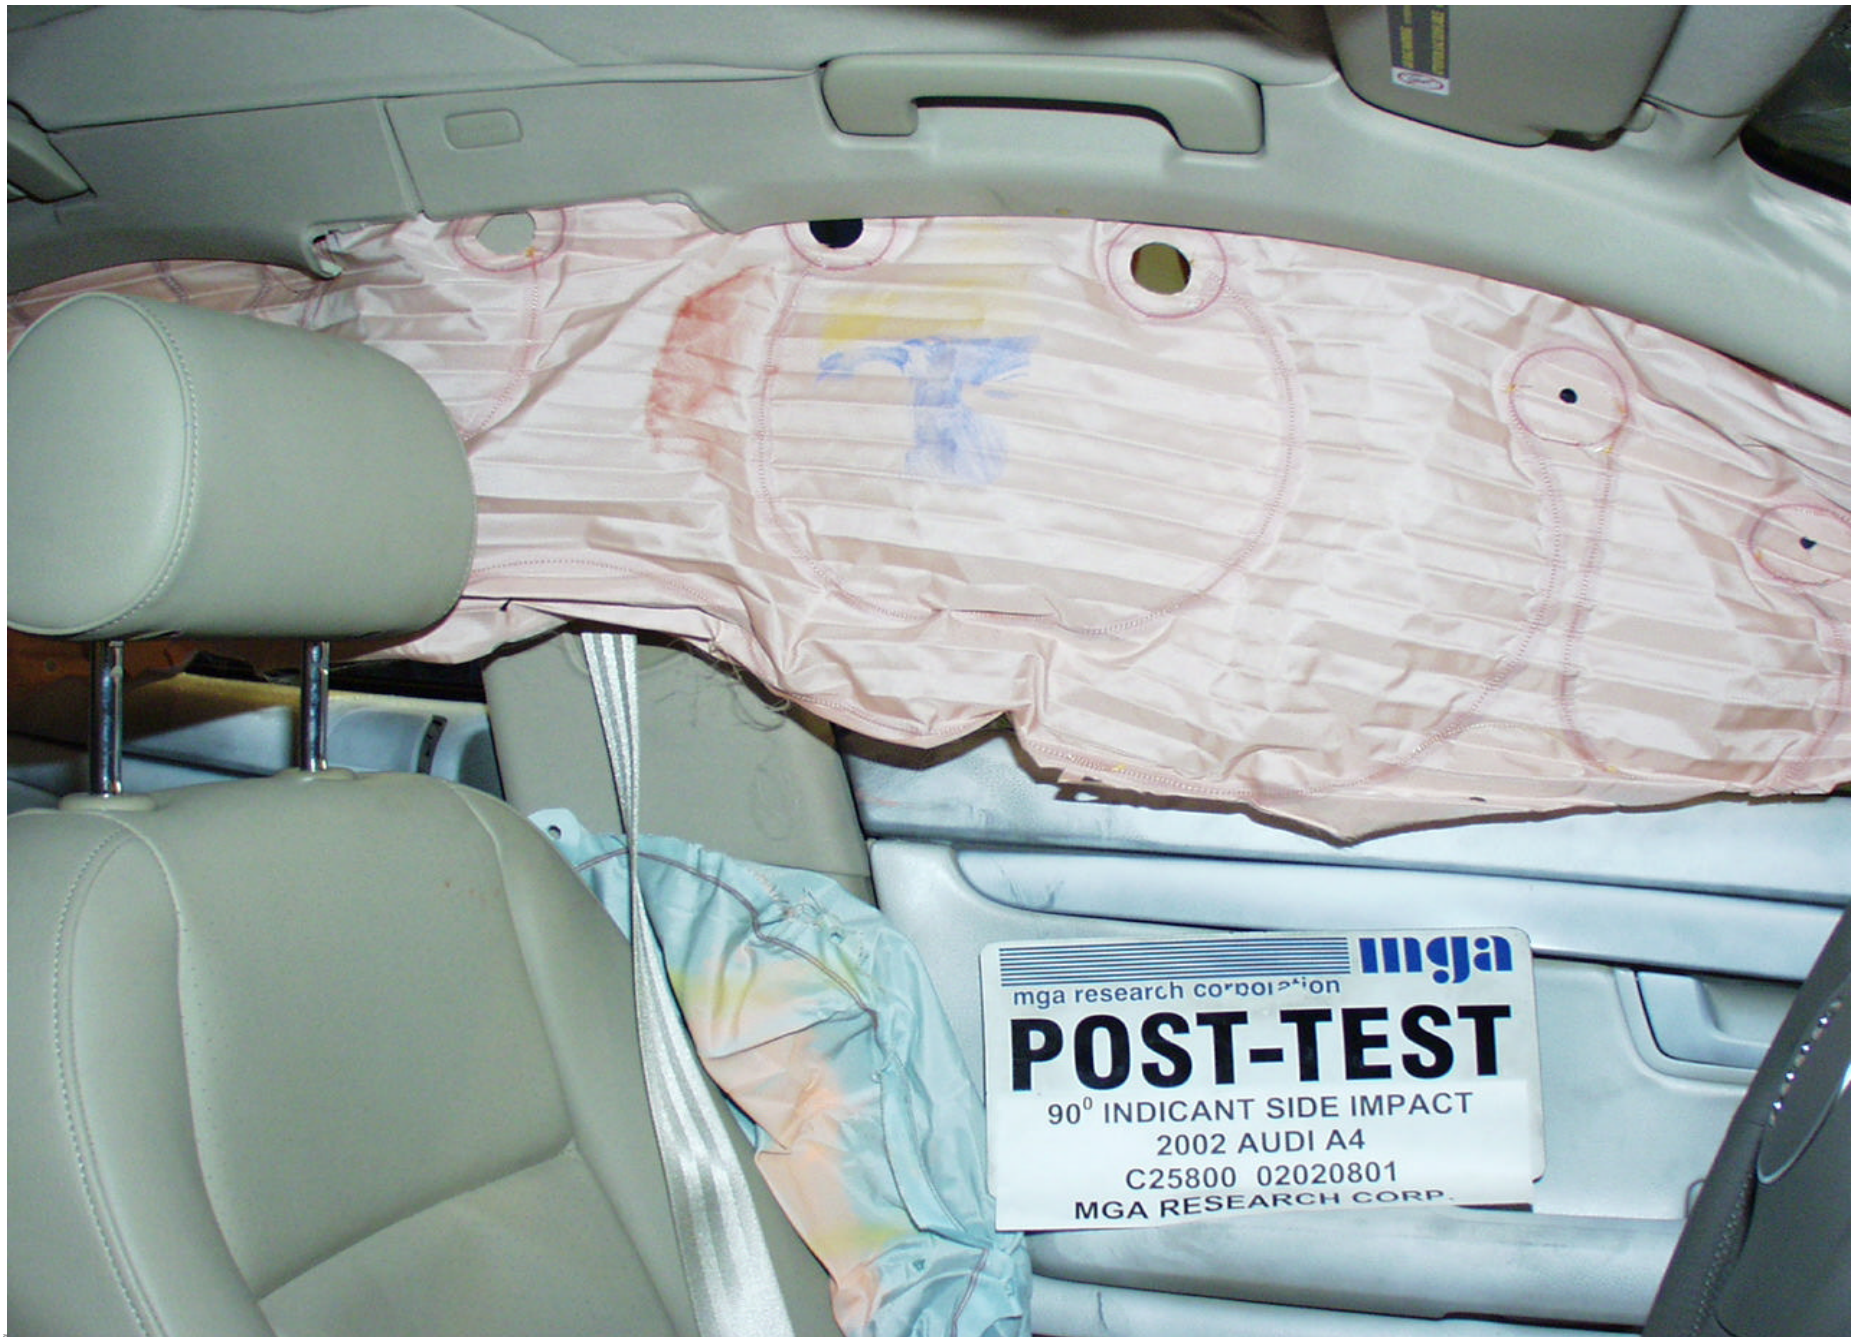
Post-Test Driver Dummy Head Contact

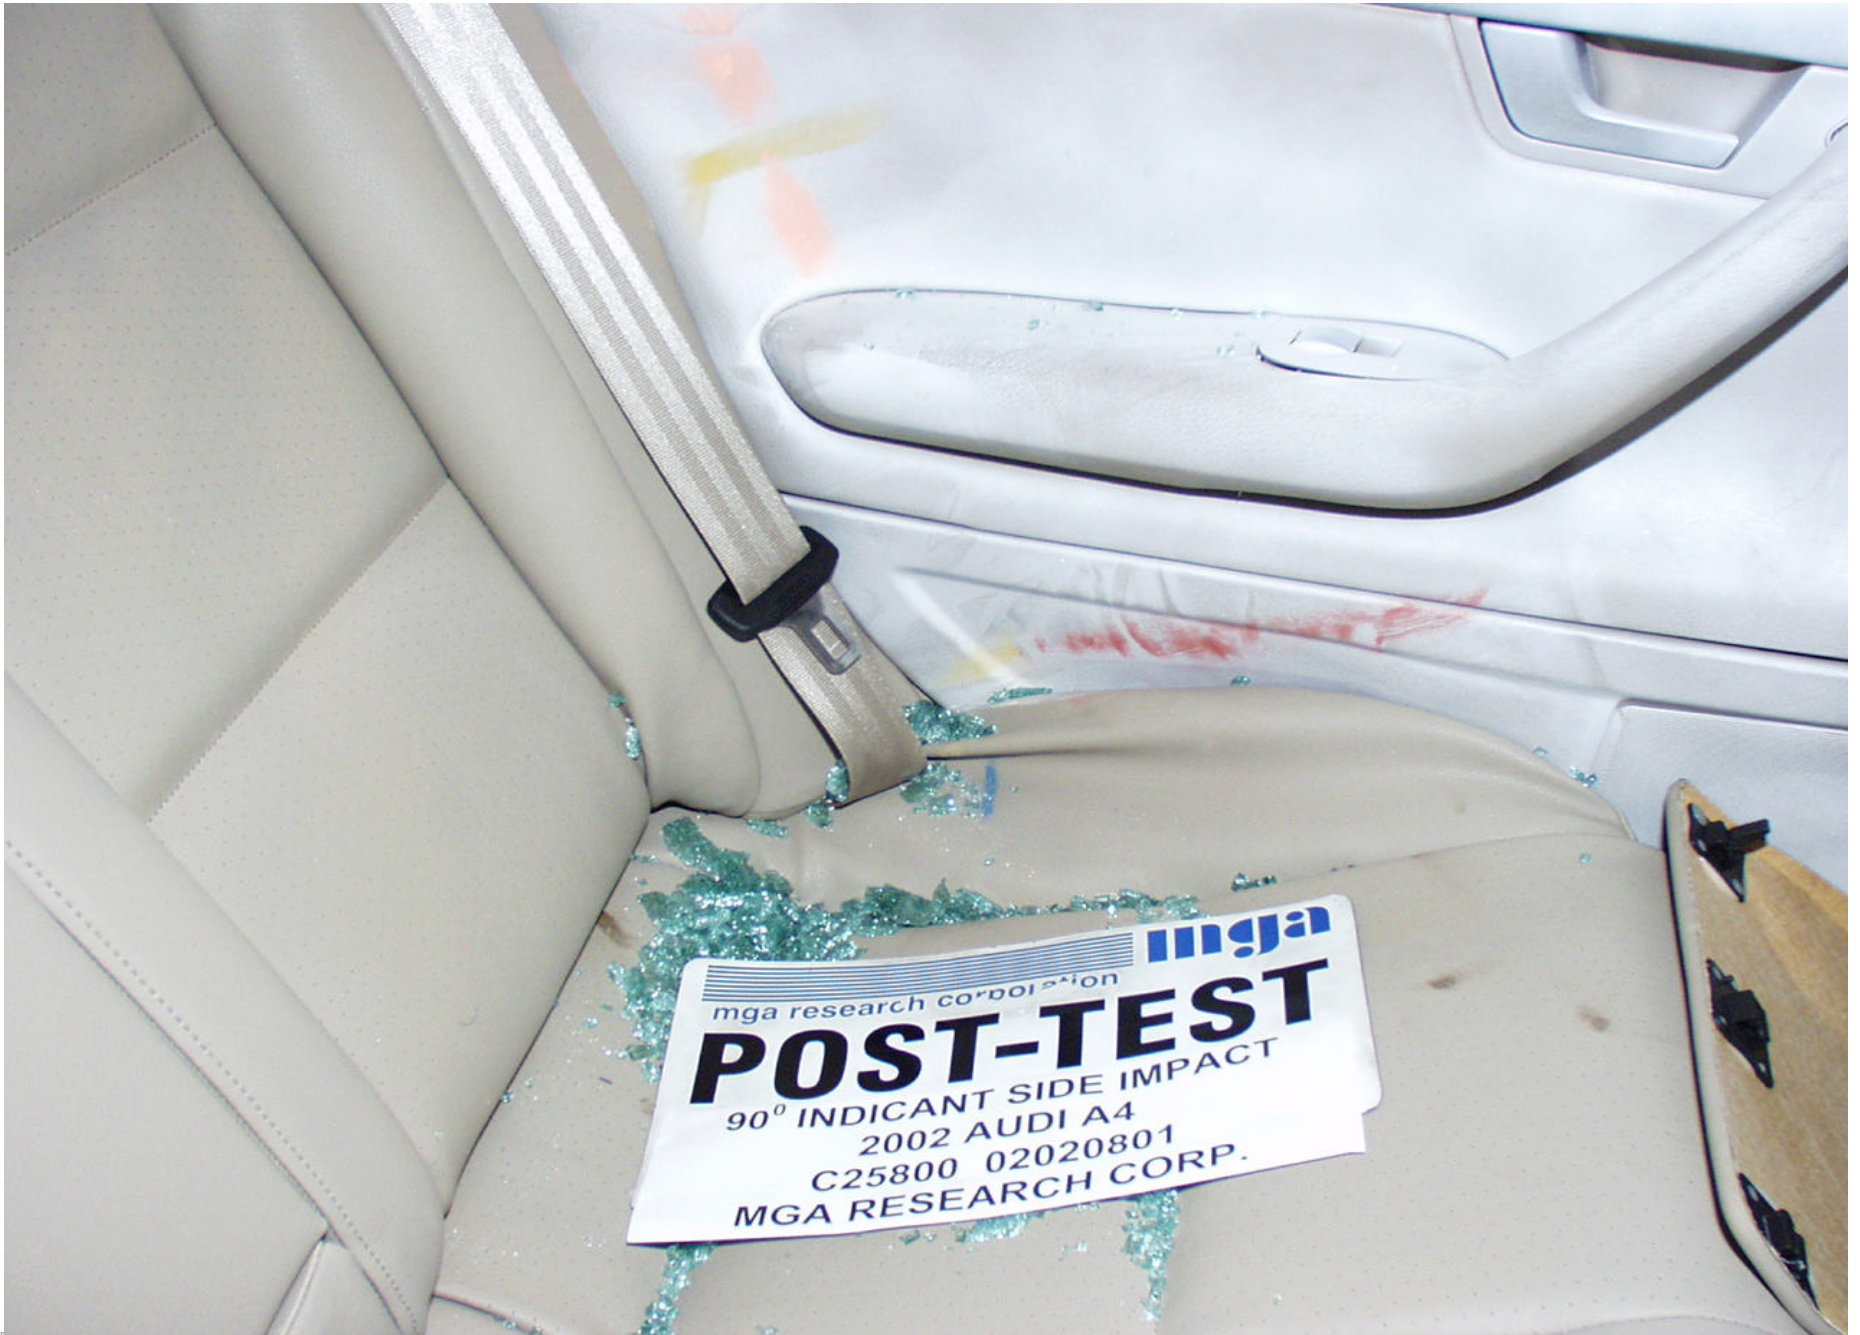
Post-Test Passenger Dummy Contact

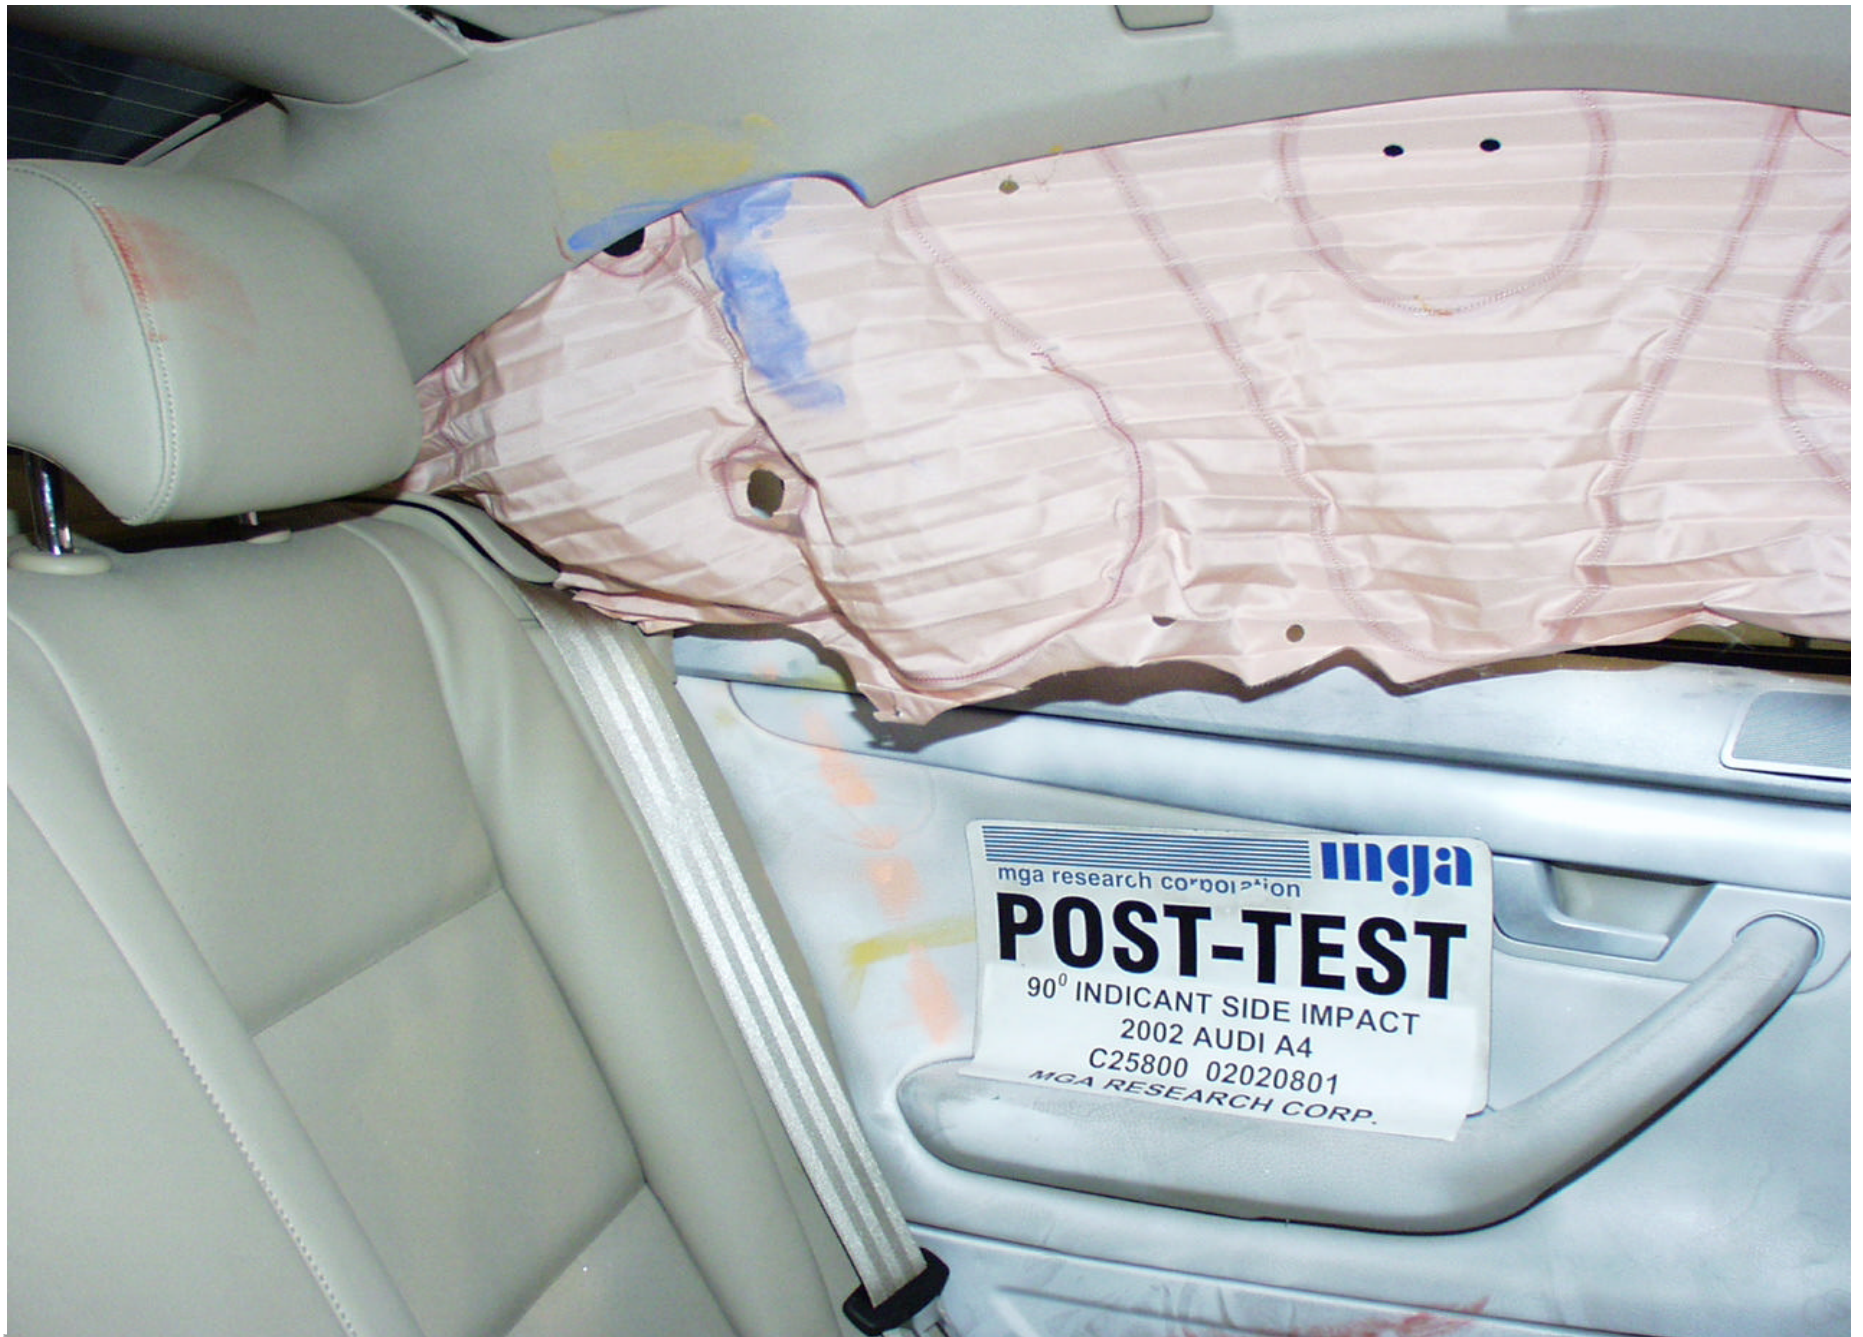
Post-Test Passenger Dummy Head Contact

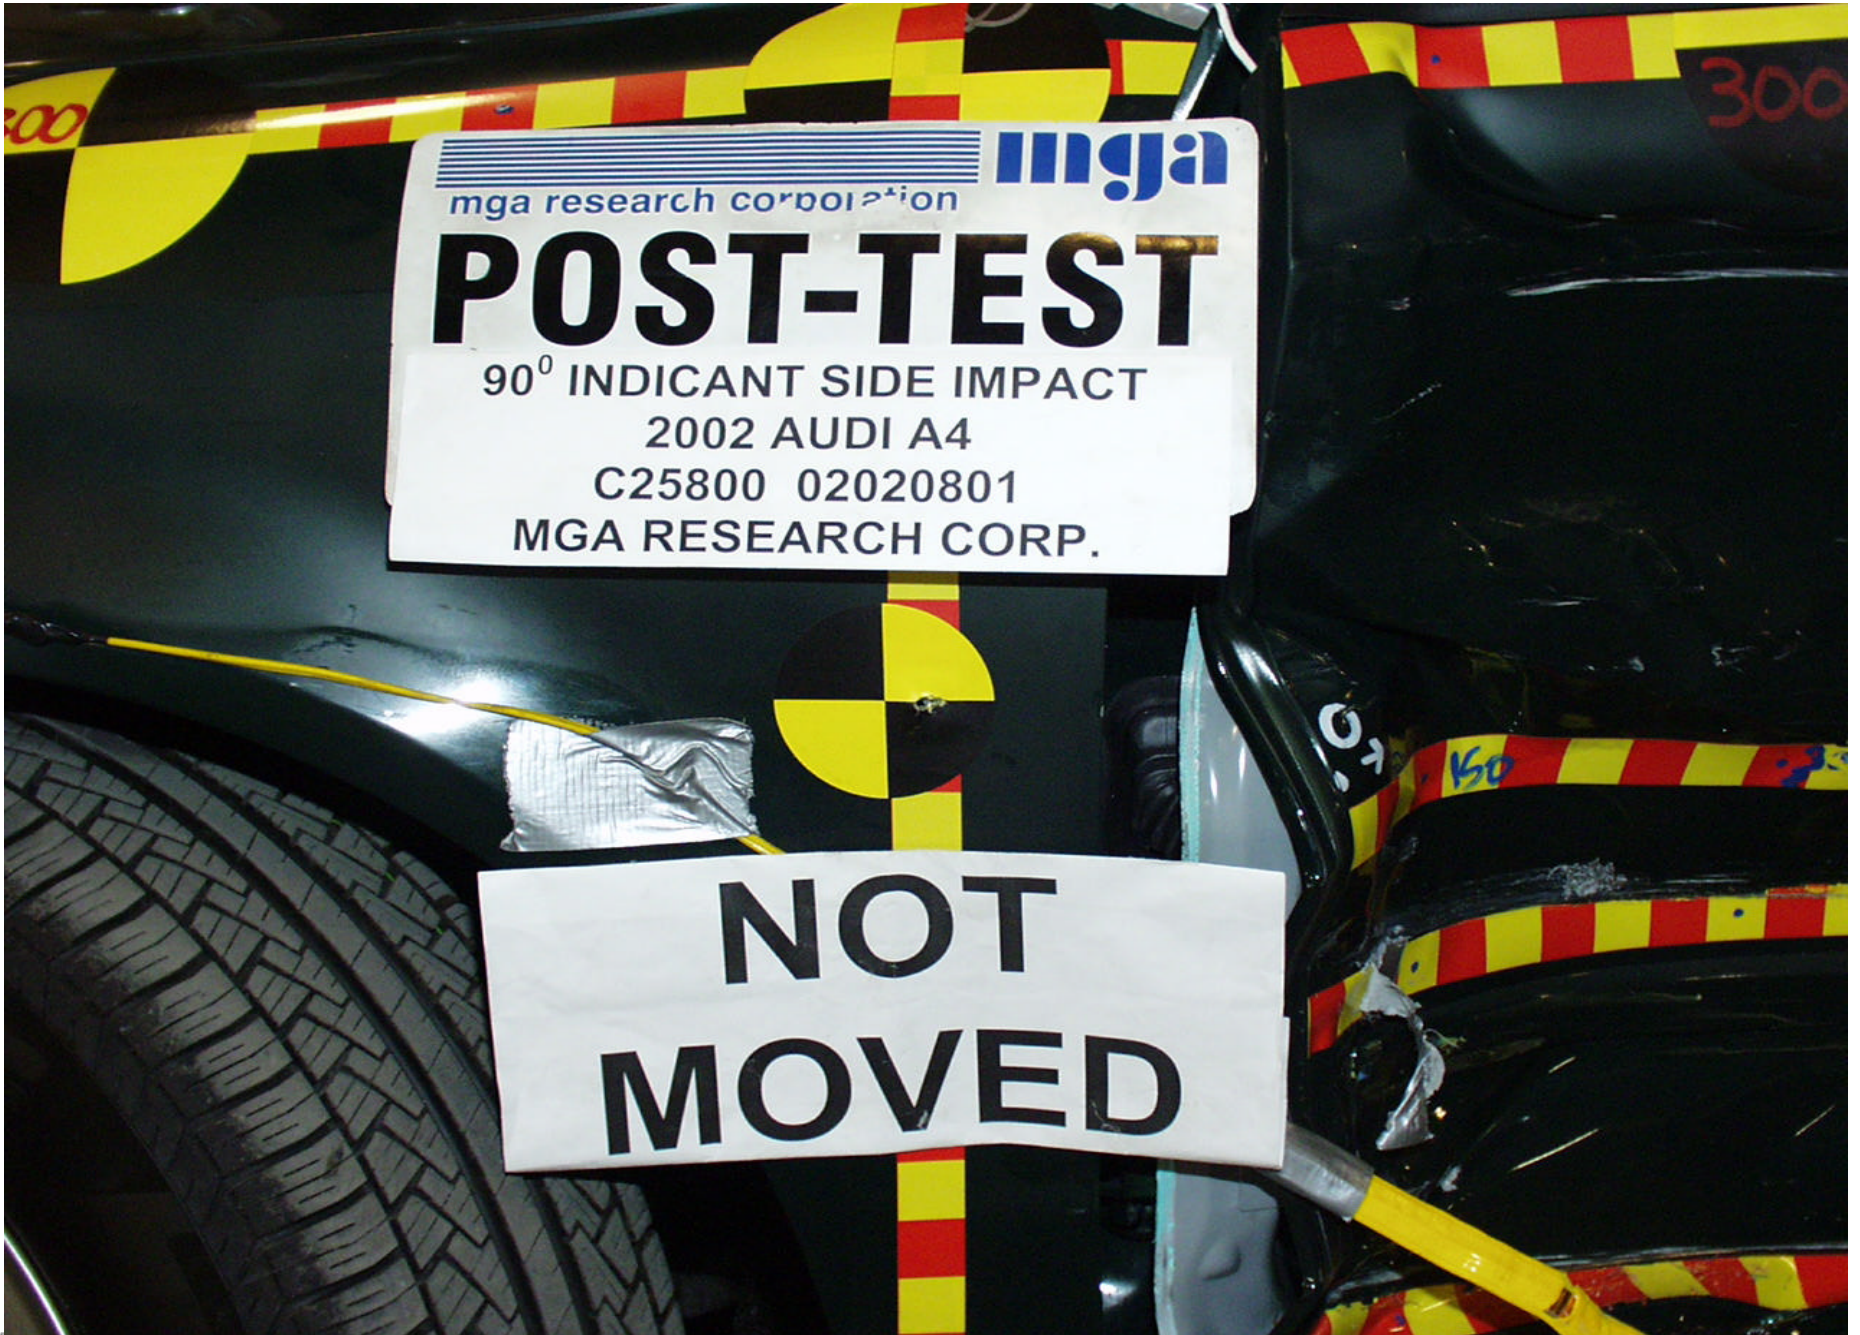
Post-Test Left Front Impact Point on Vehicle
