REPORT NUMBER: TO2-MGA-2001-001

35 MPH FRONTAL BARRIER IMPACT TEST

**1998 Audi A8 4 Door Sedan
NHTSA NUMBER: RW0511**

FINAL REPORT

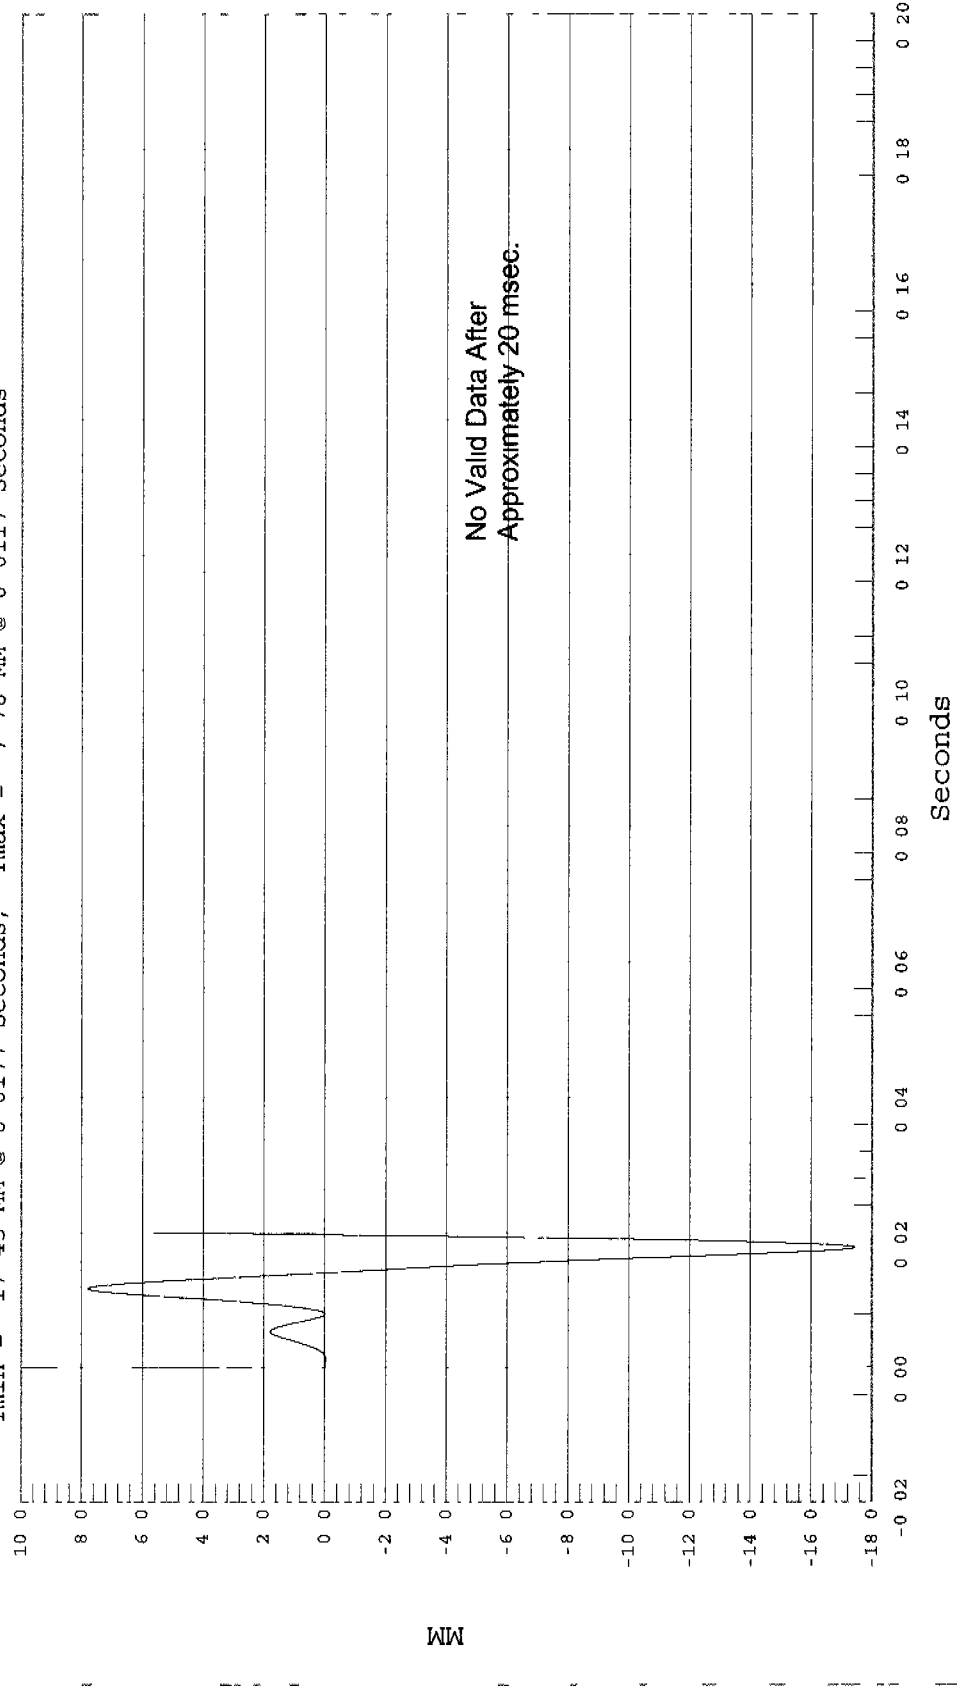
No Valid Data After
Approximately 20 msec.

RIGHT FRONT FRAME RAIL @ BUMPER Z ACCELERATION

⁴ Questionable Data After 20 msec.
