REPORT NUMBER: SNCAP-CAL-02-05

**NEW CAR ASSESSMENT PROGRAM
SIDE IMPACT TEST**

TOYOTA MOTOR MANUFACTURING, INDIANA, INC.
2002 TOYOTA TUNDRA
ACCESS CAB 4X2 PICKUP

VERIDIAN ENGINEERING TEST NUMBER: 8652-SNCAP-05

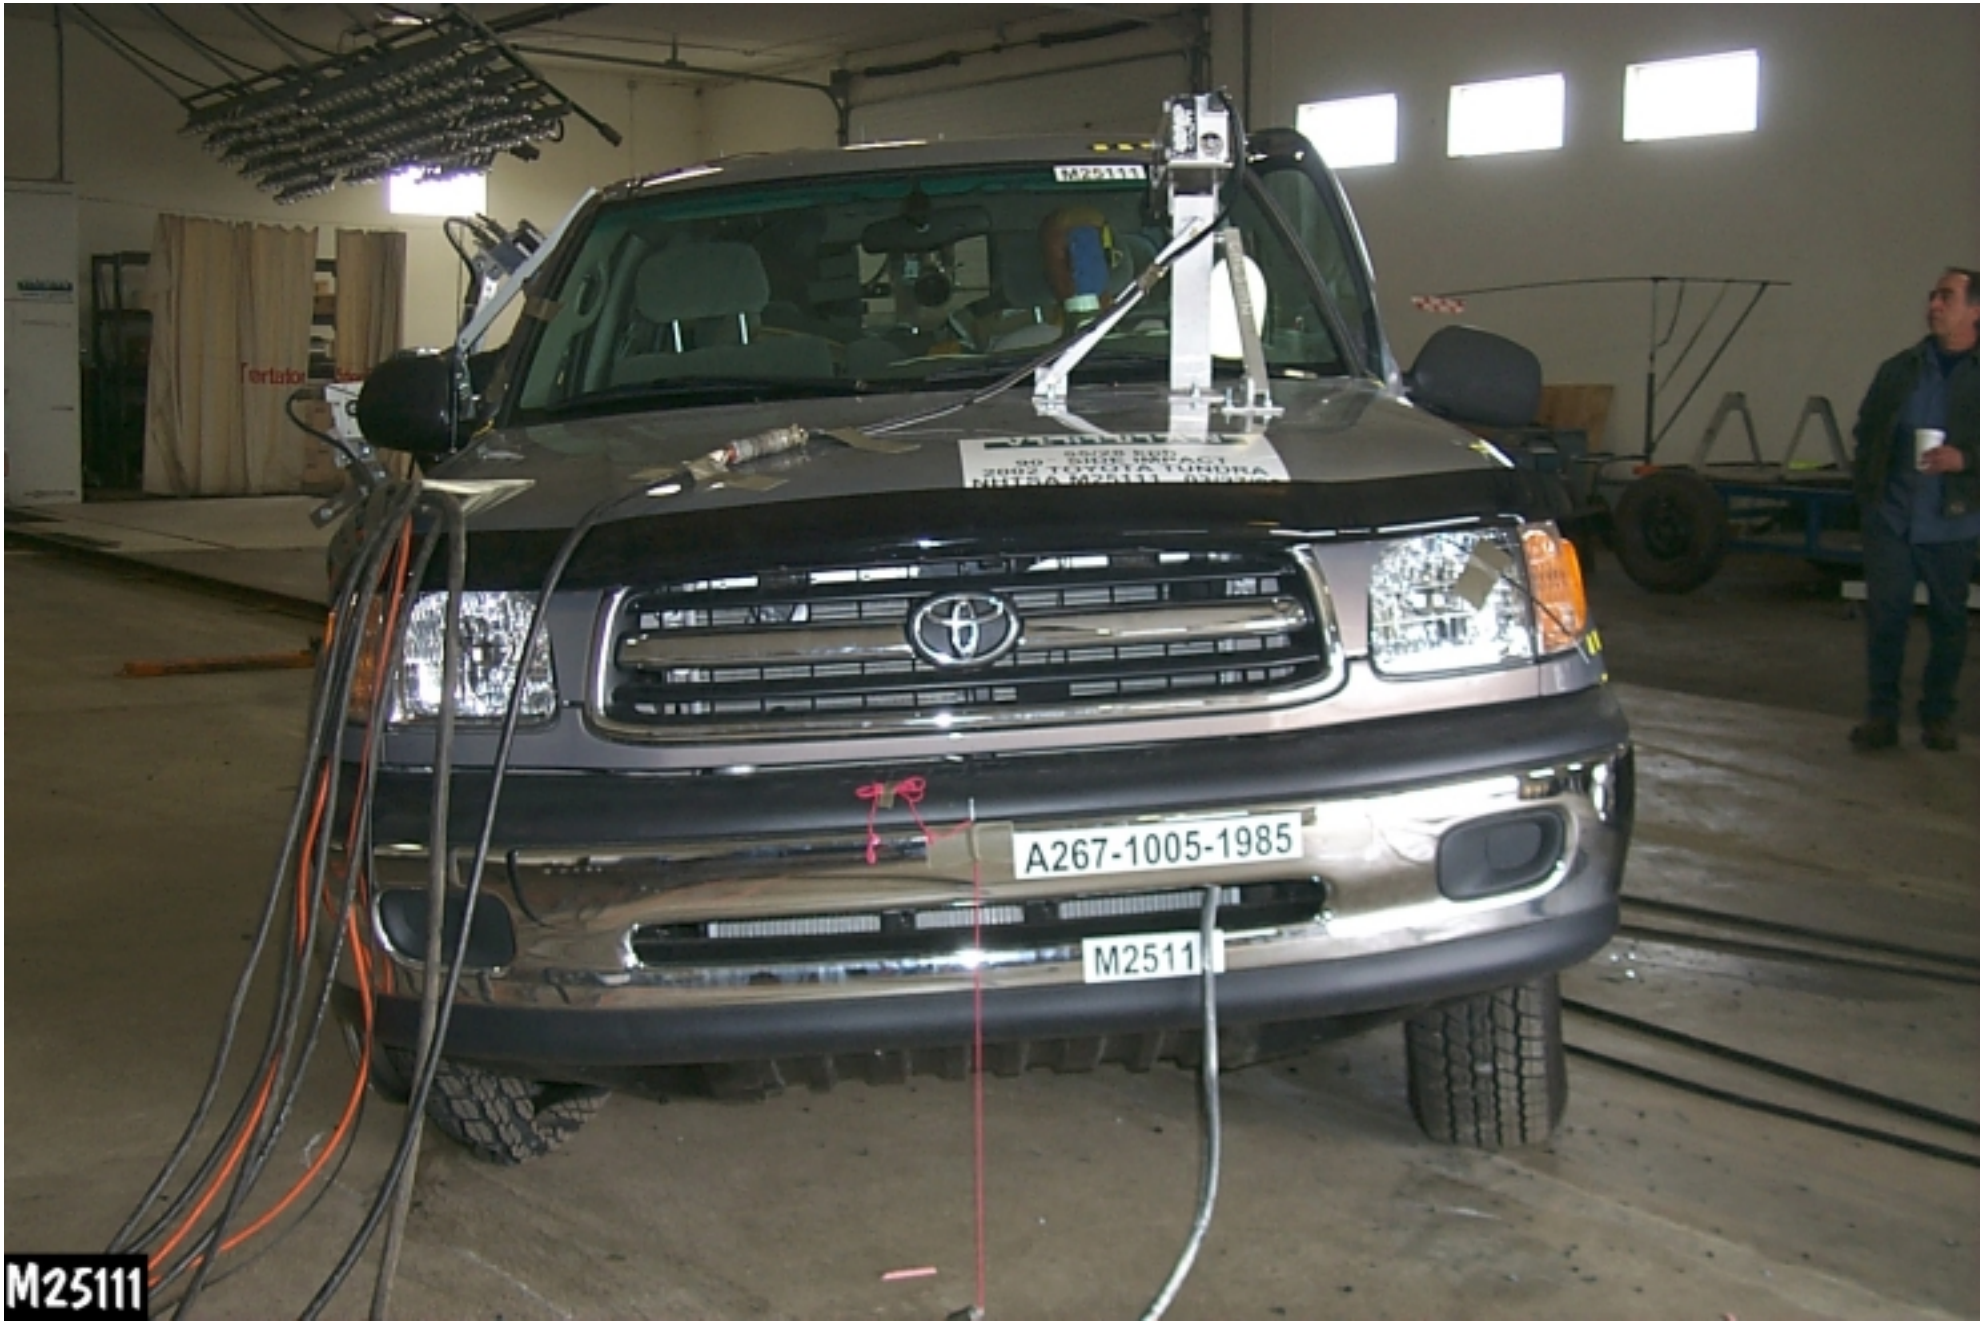
Figure A-2: POST-TEST FRONTAL VIEW OF TEST VEHICLE

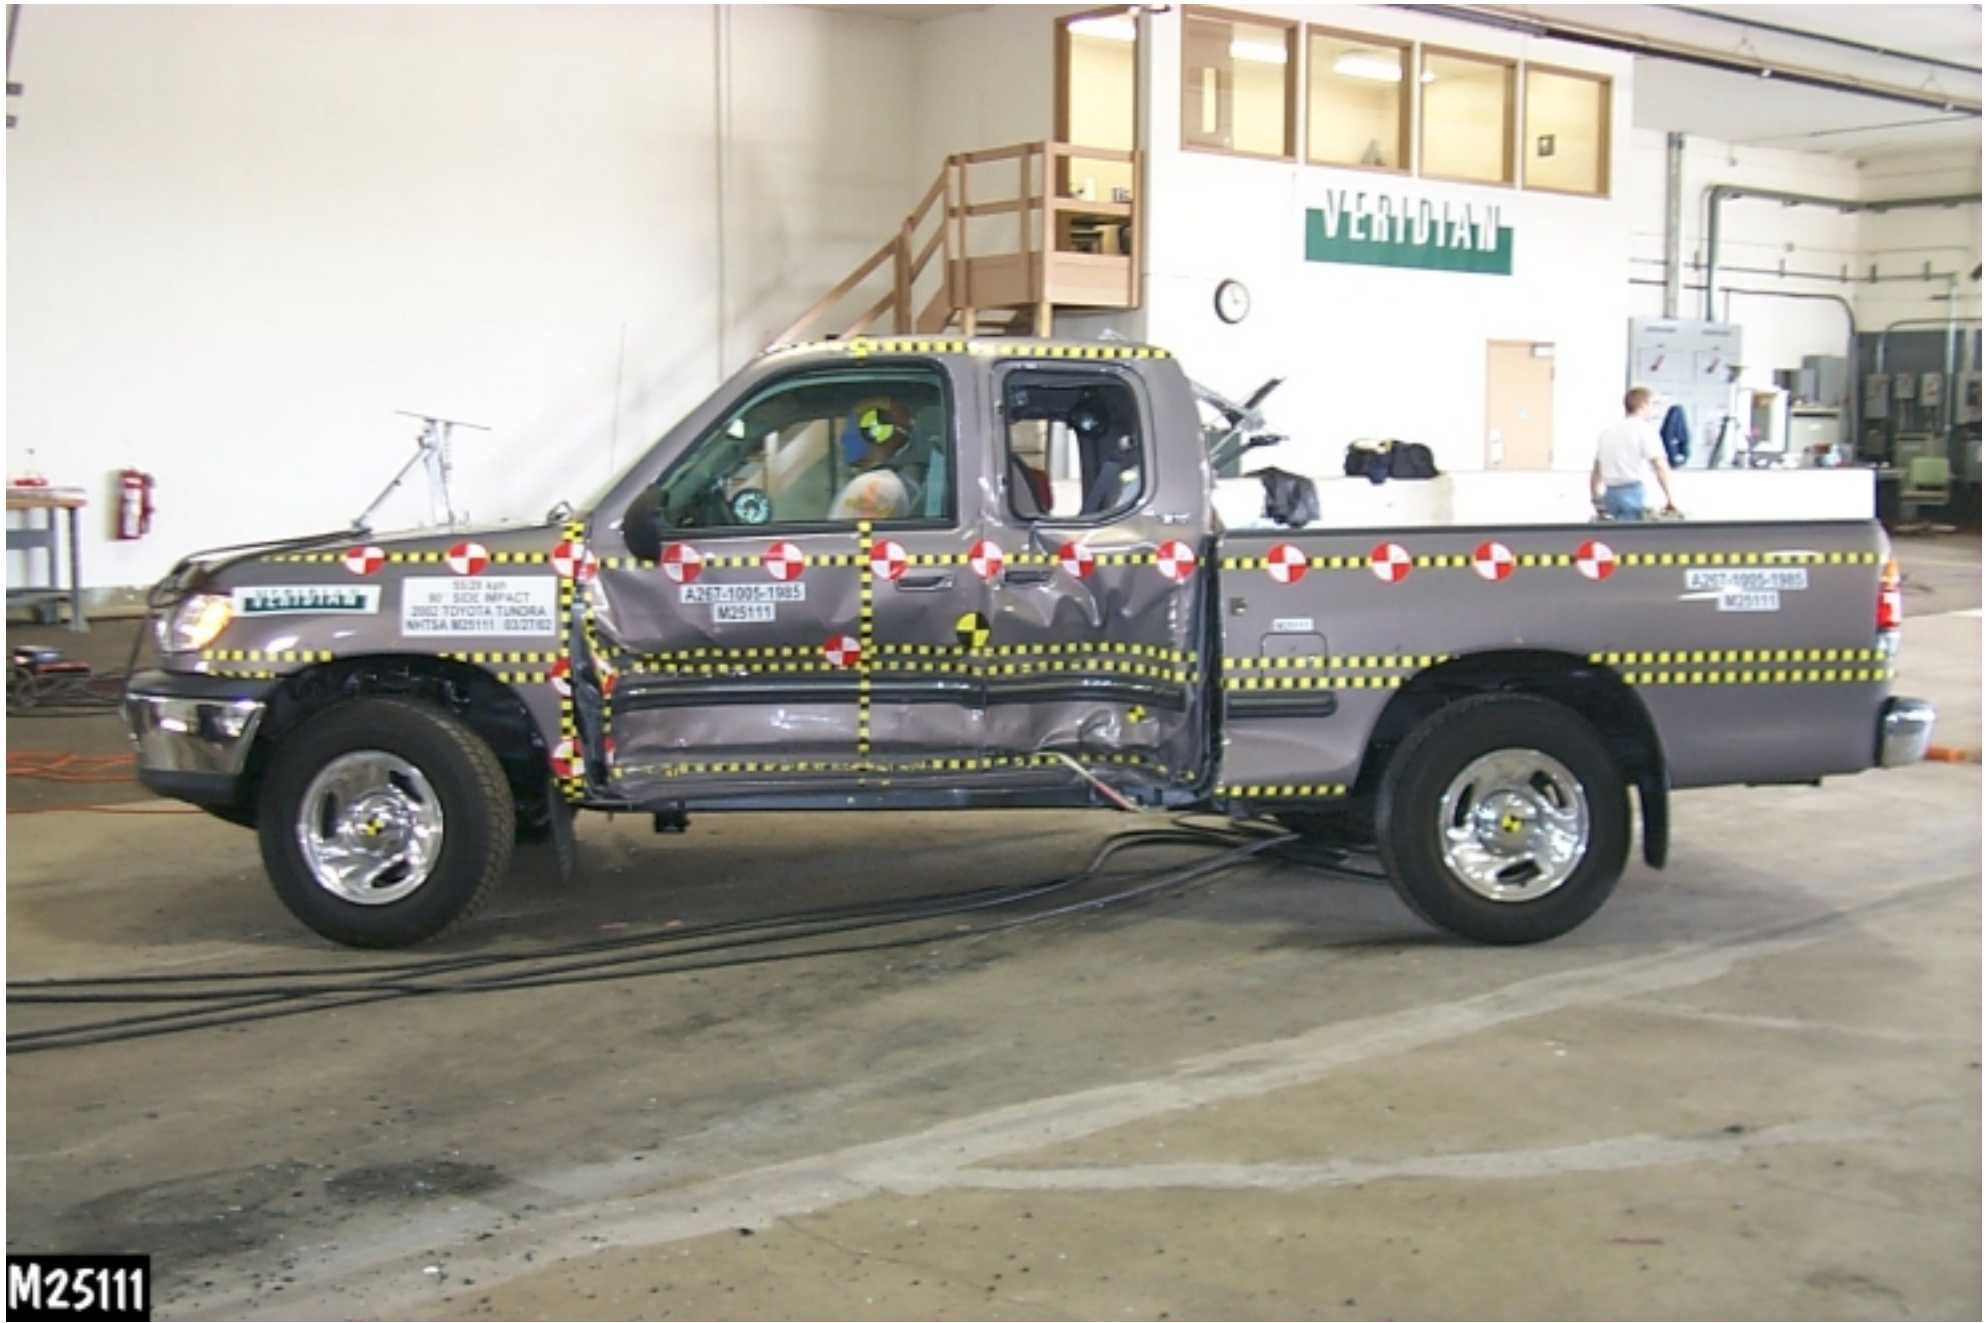
Figure A-6: POST-TEST IMPACTED SIDE VIEW OF TEST VEHICLE

MAXIMUM EXTERIOR STATIC CRUSH:

Maximum Post-Test Intrusion = 298 millimeters

CRITICAL AREAS OF PERFORMANCE	
Pillar Performance	No visible tears or separations
Sill Separation	None
Windshield Damage	None
Window Damage	Left rear quarter window shattered during the event
Other Notable Effects	Both right side tires deflated during the event

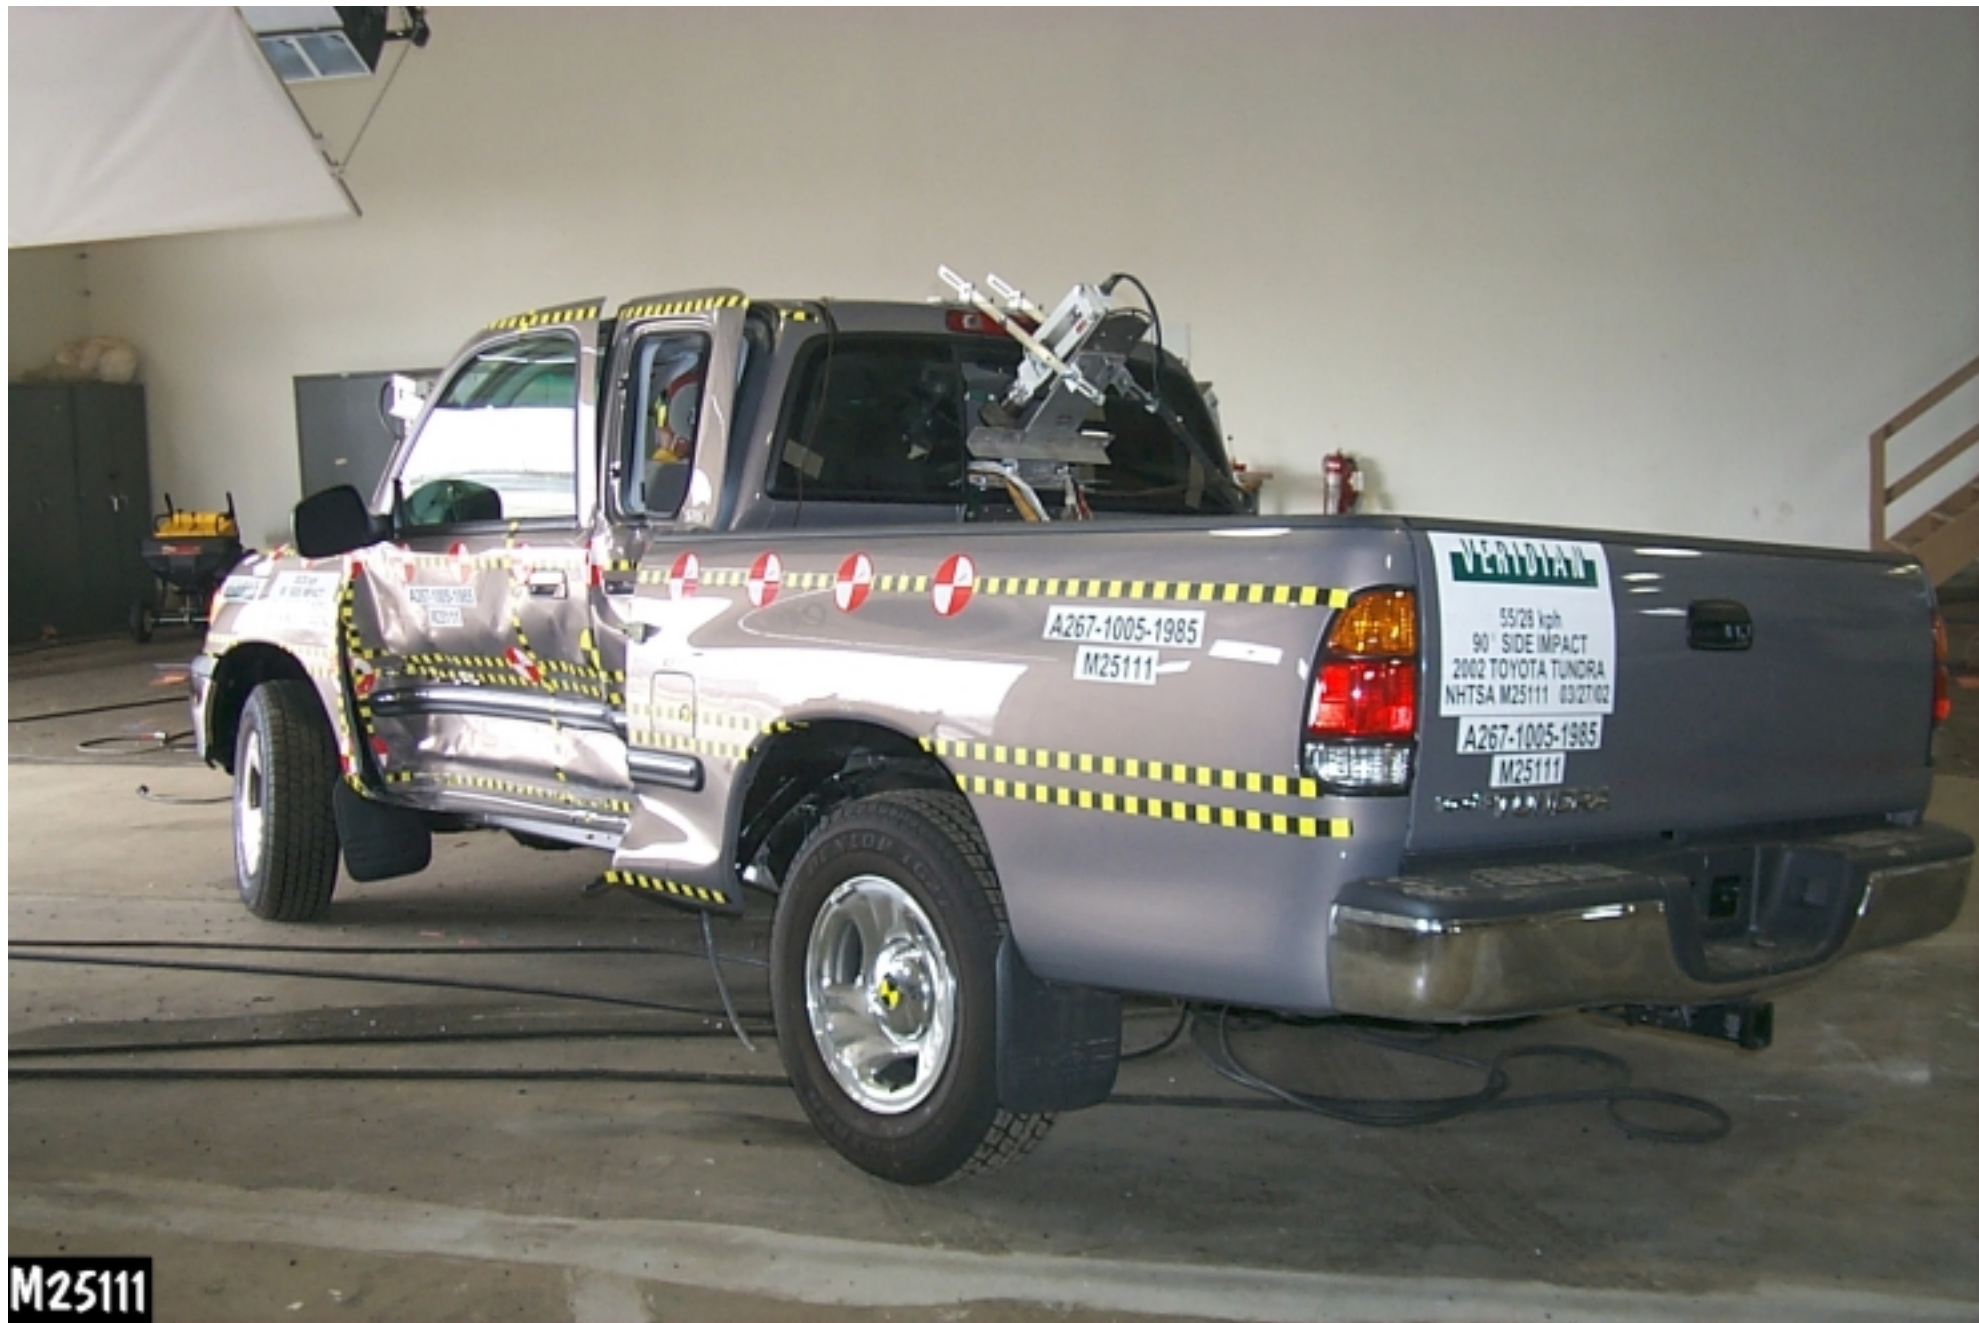
Figure A-10: POST-TEST LEFT REAR VIEW OF TEST VEHICLE

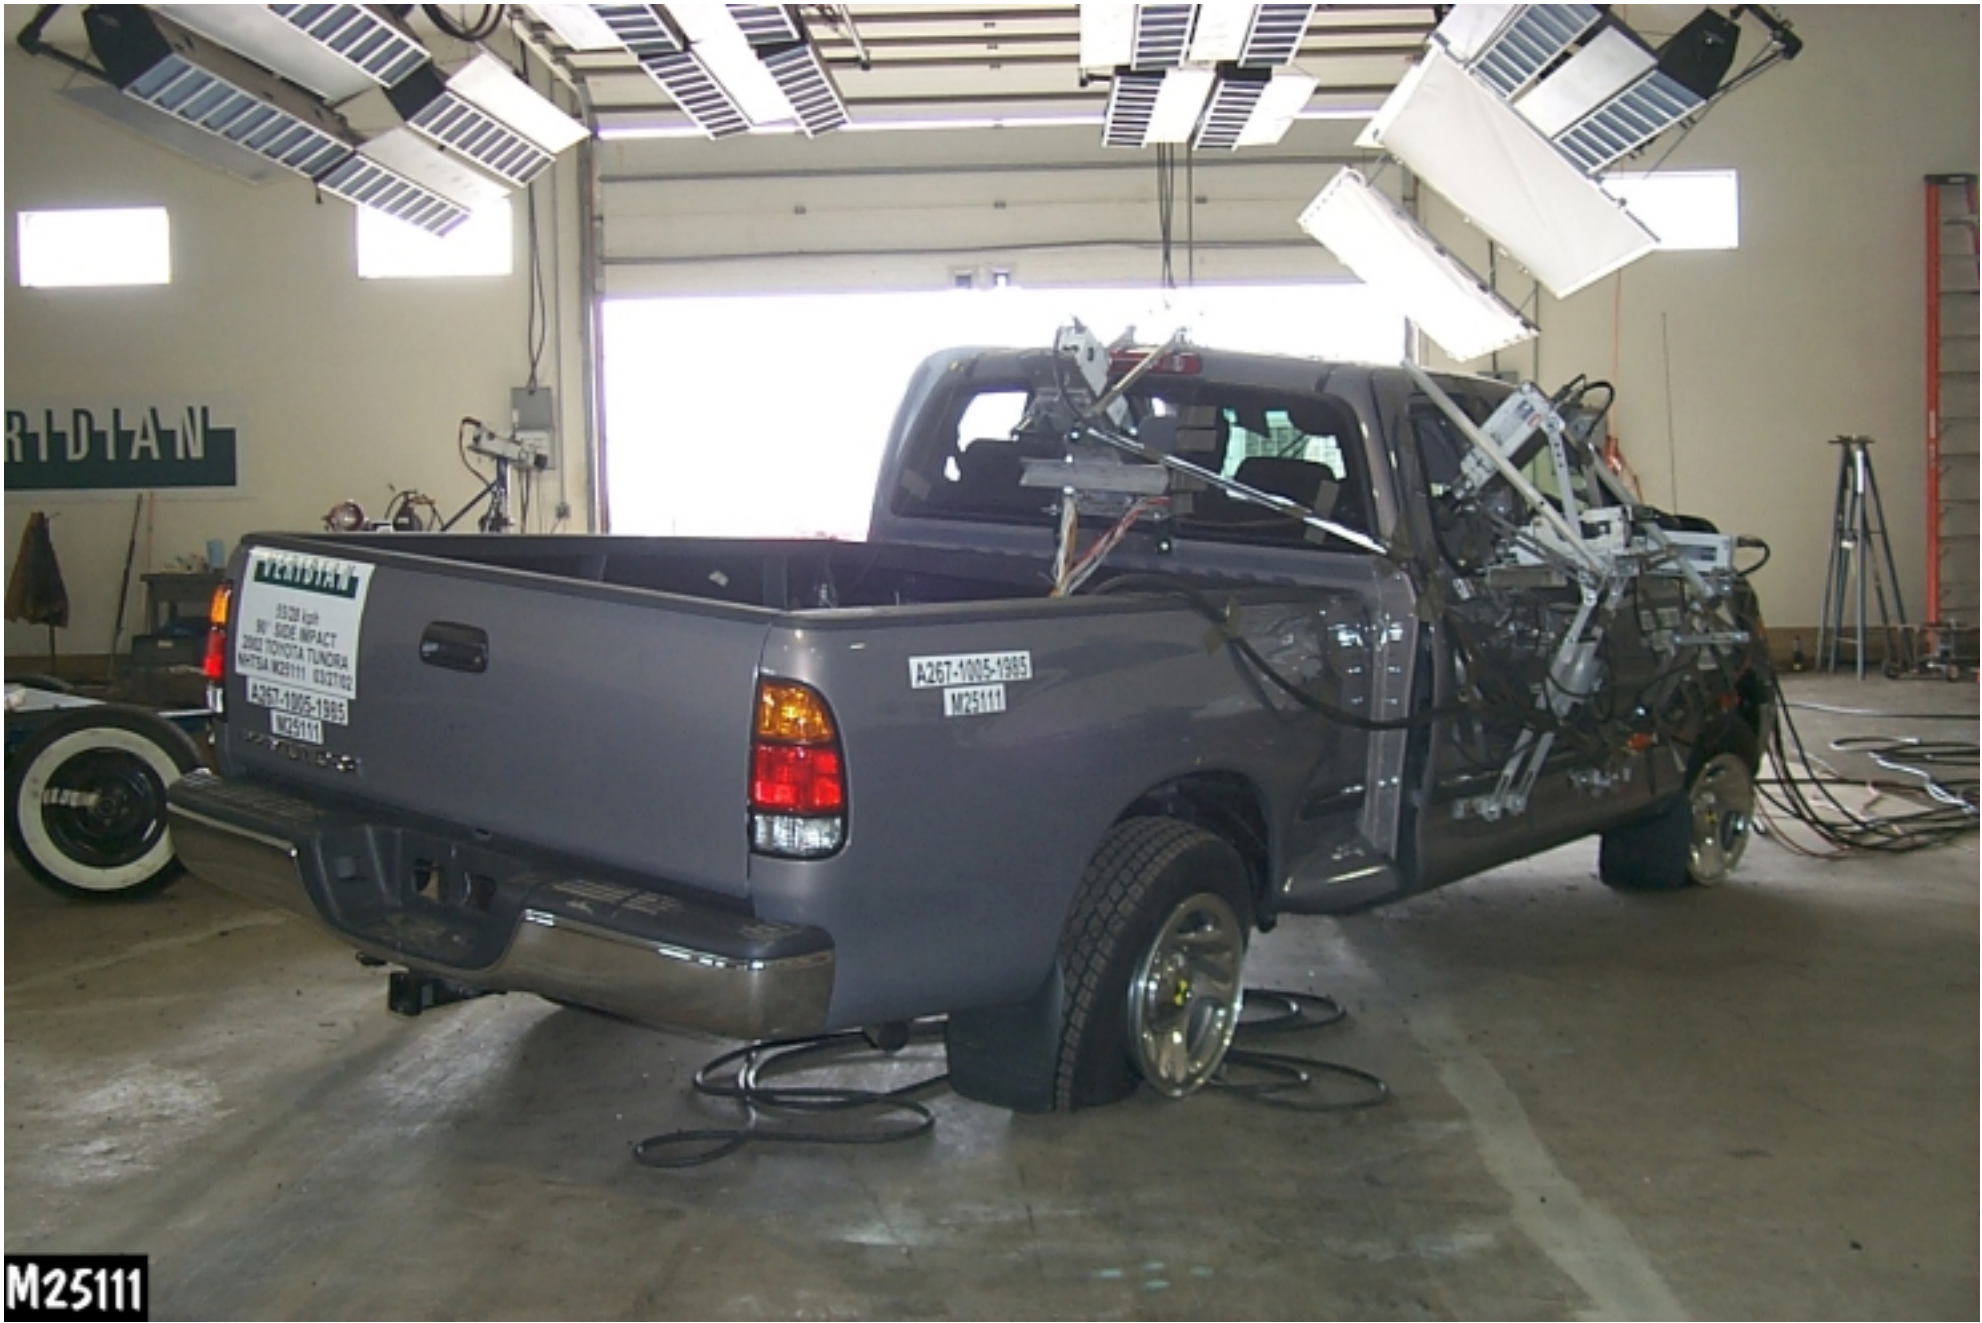
Figure A-14: POST-TEST RIGHT REAR VIEW OF TEST VEHICLE

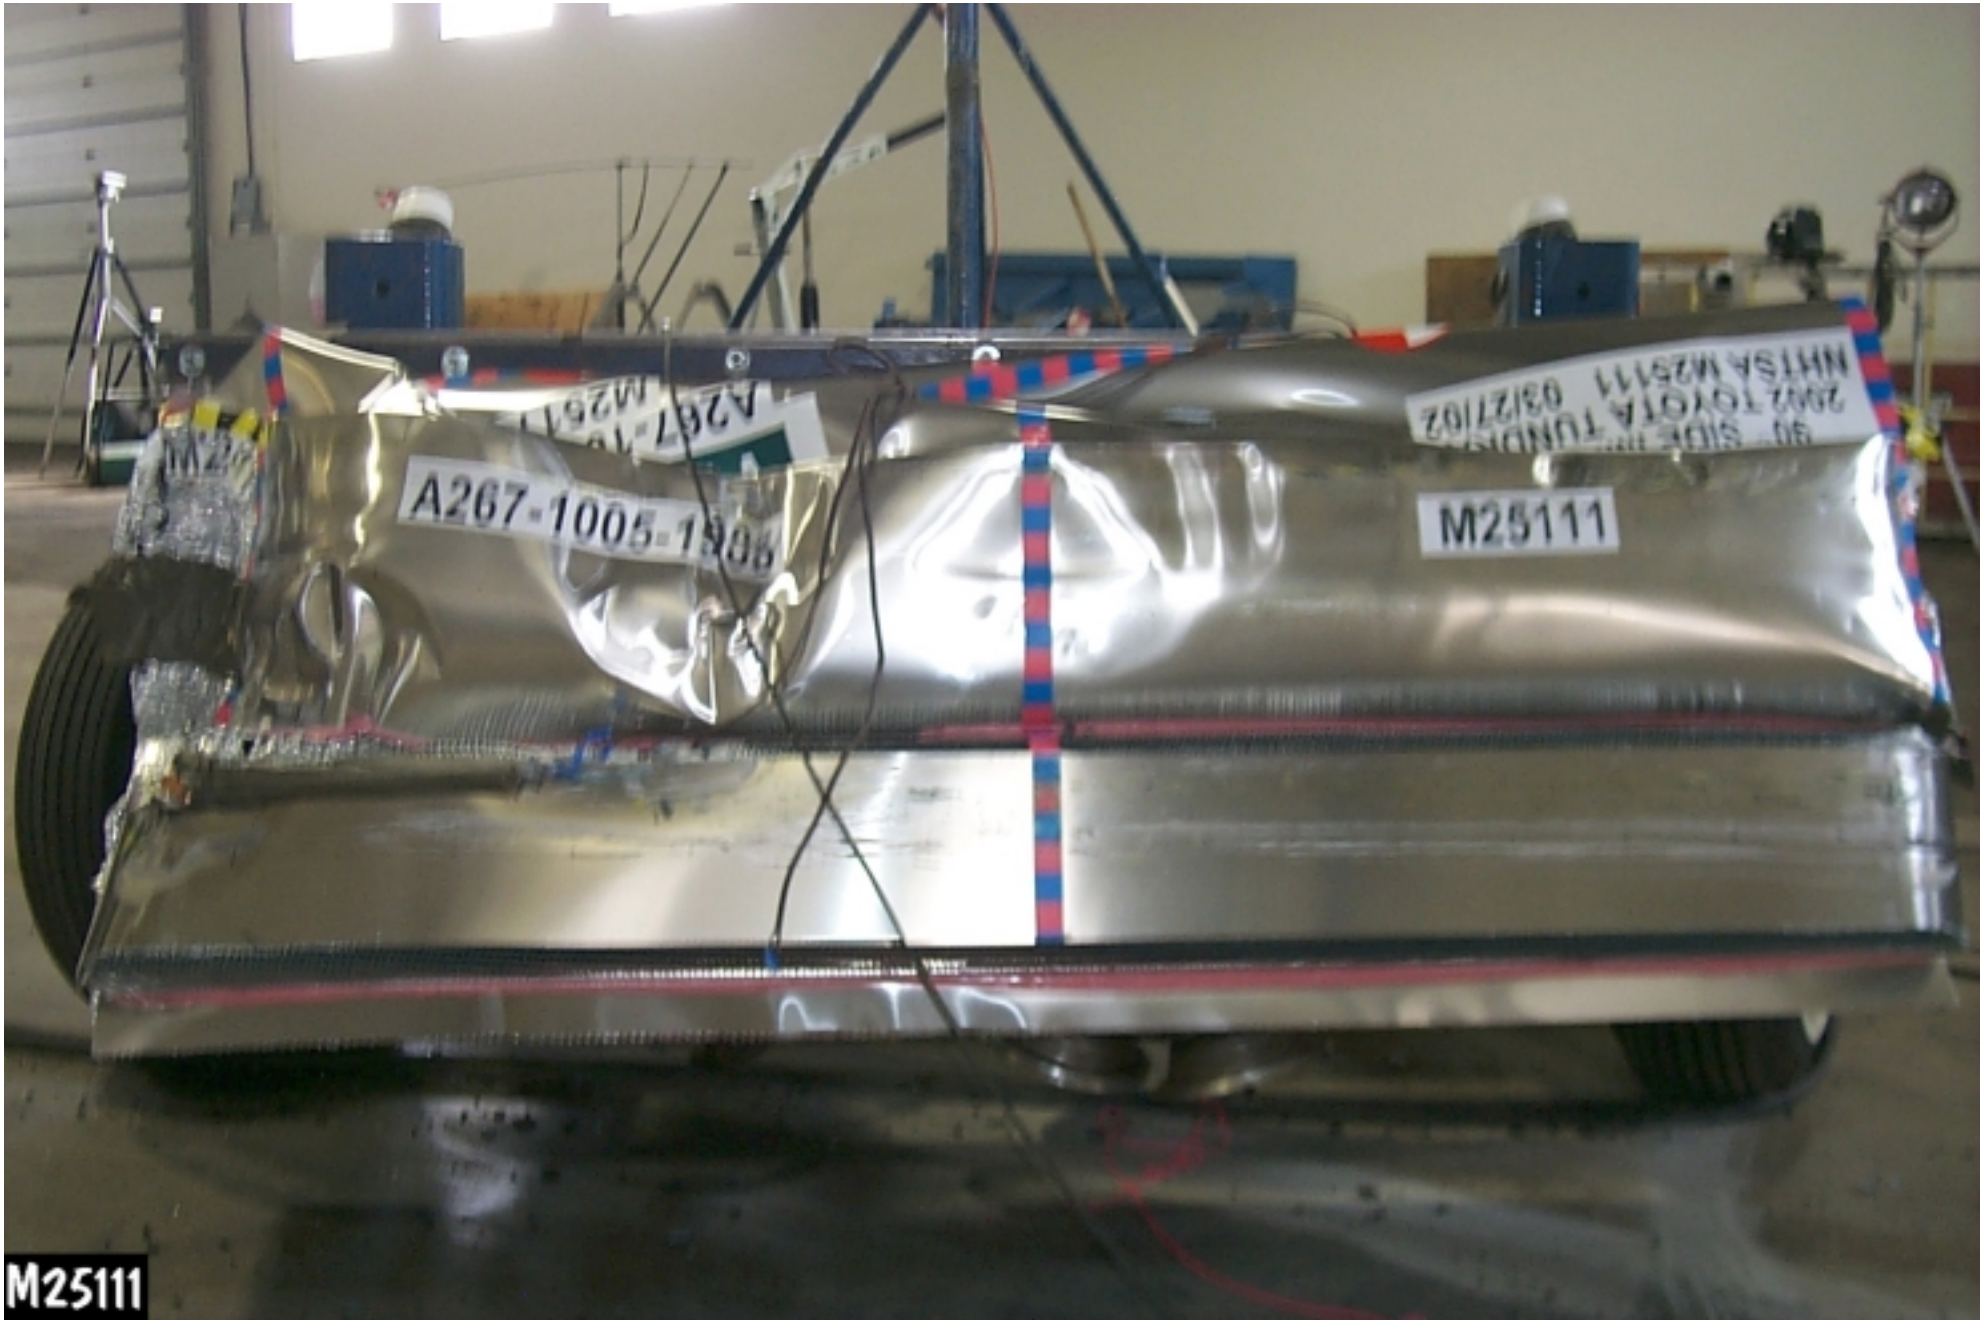
Figure A-16: POST-TEST FRONTAL VIEW OF IMPACTOR FACE

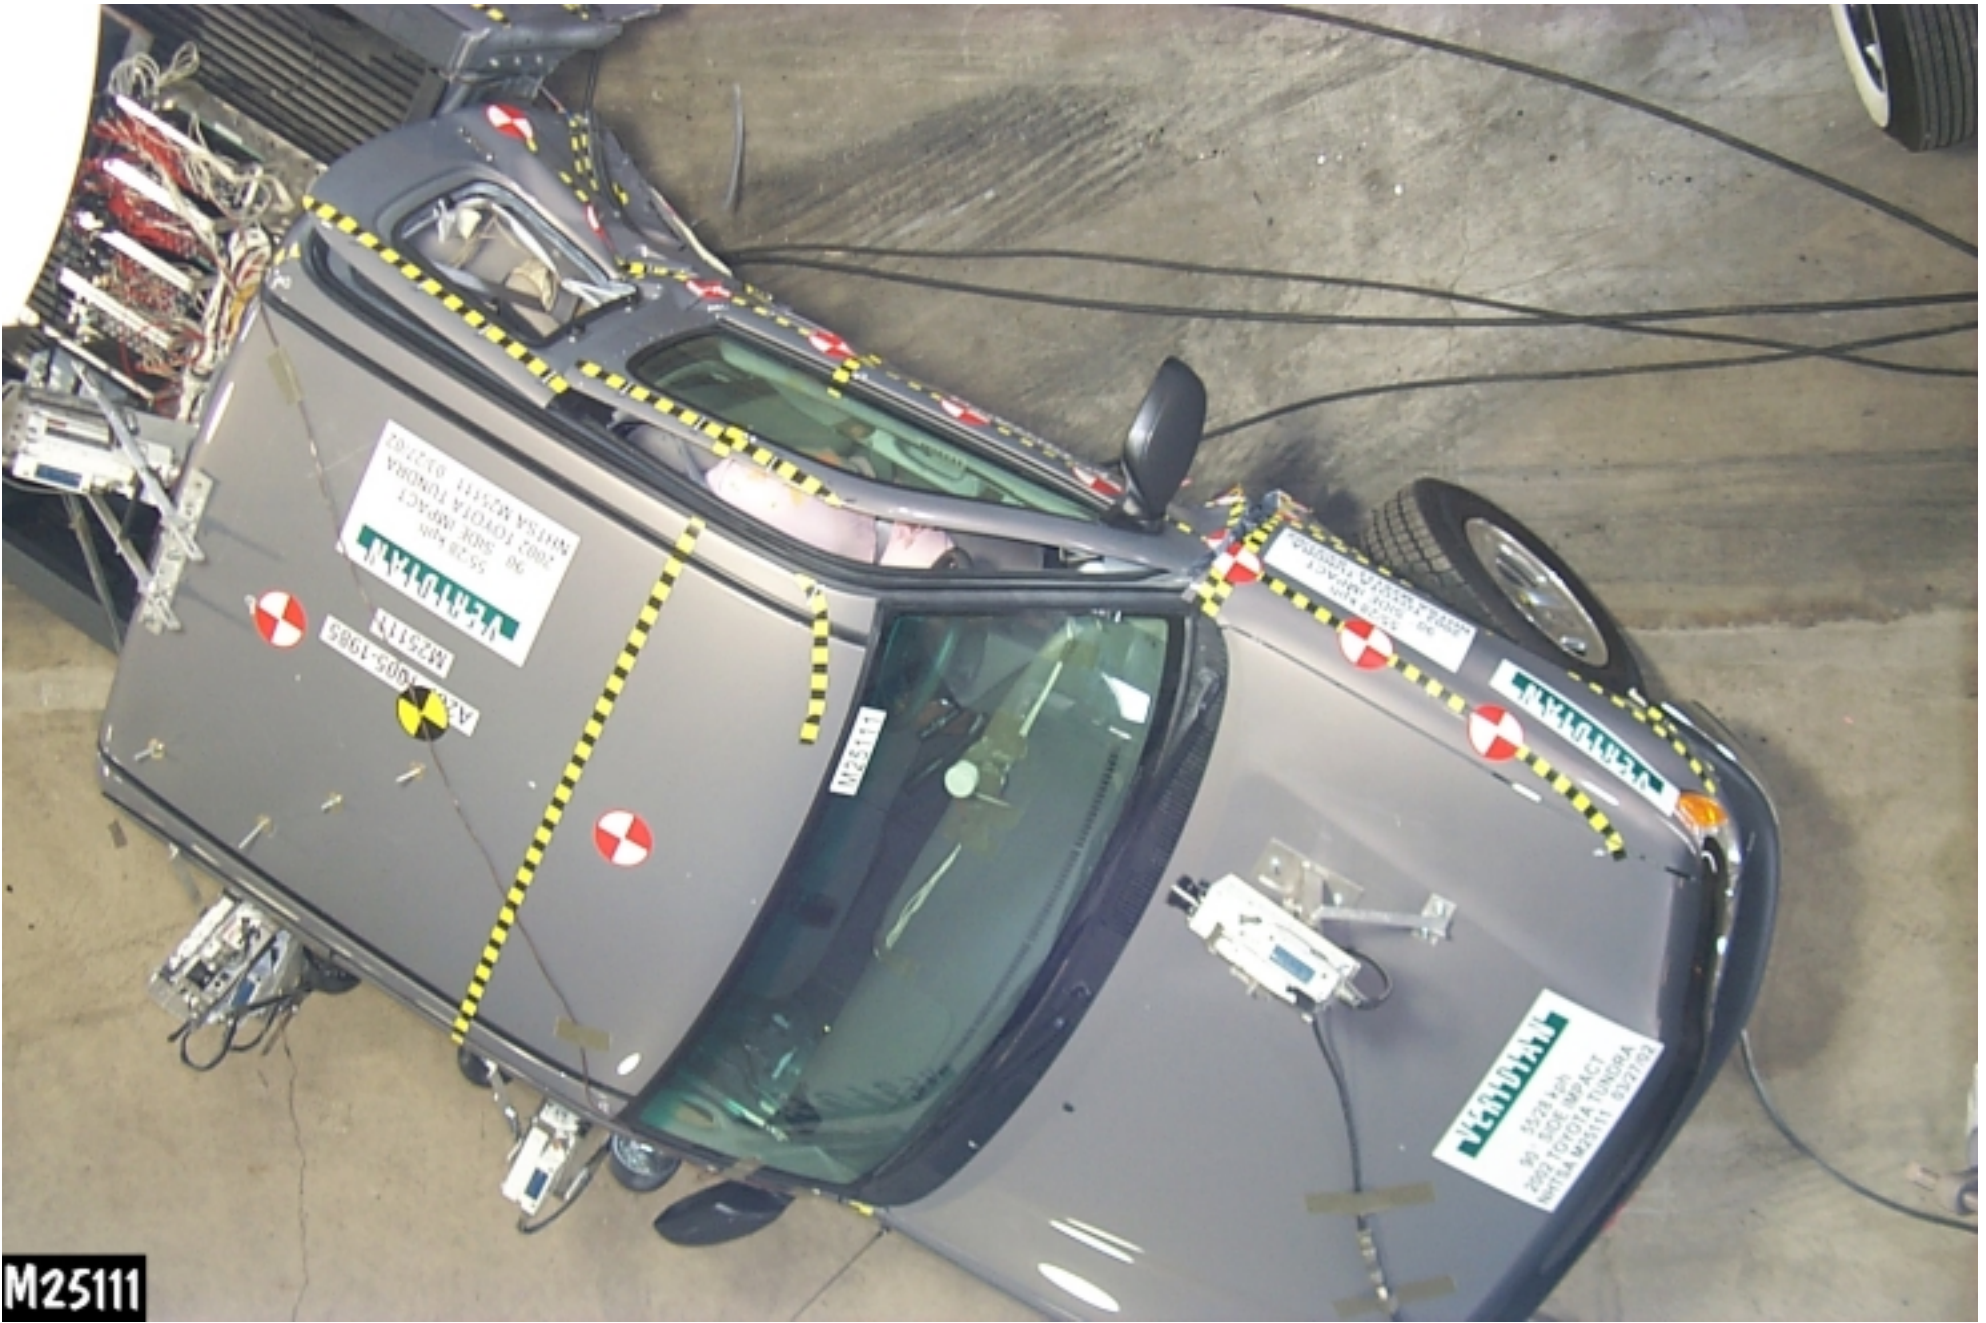
Figure A-24: POST-TEST OVERHEAD VIEW OF MDB AND VEHICLE

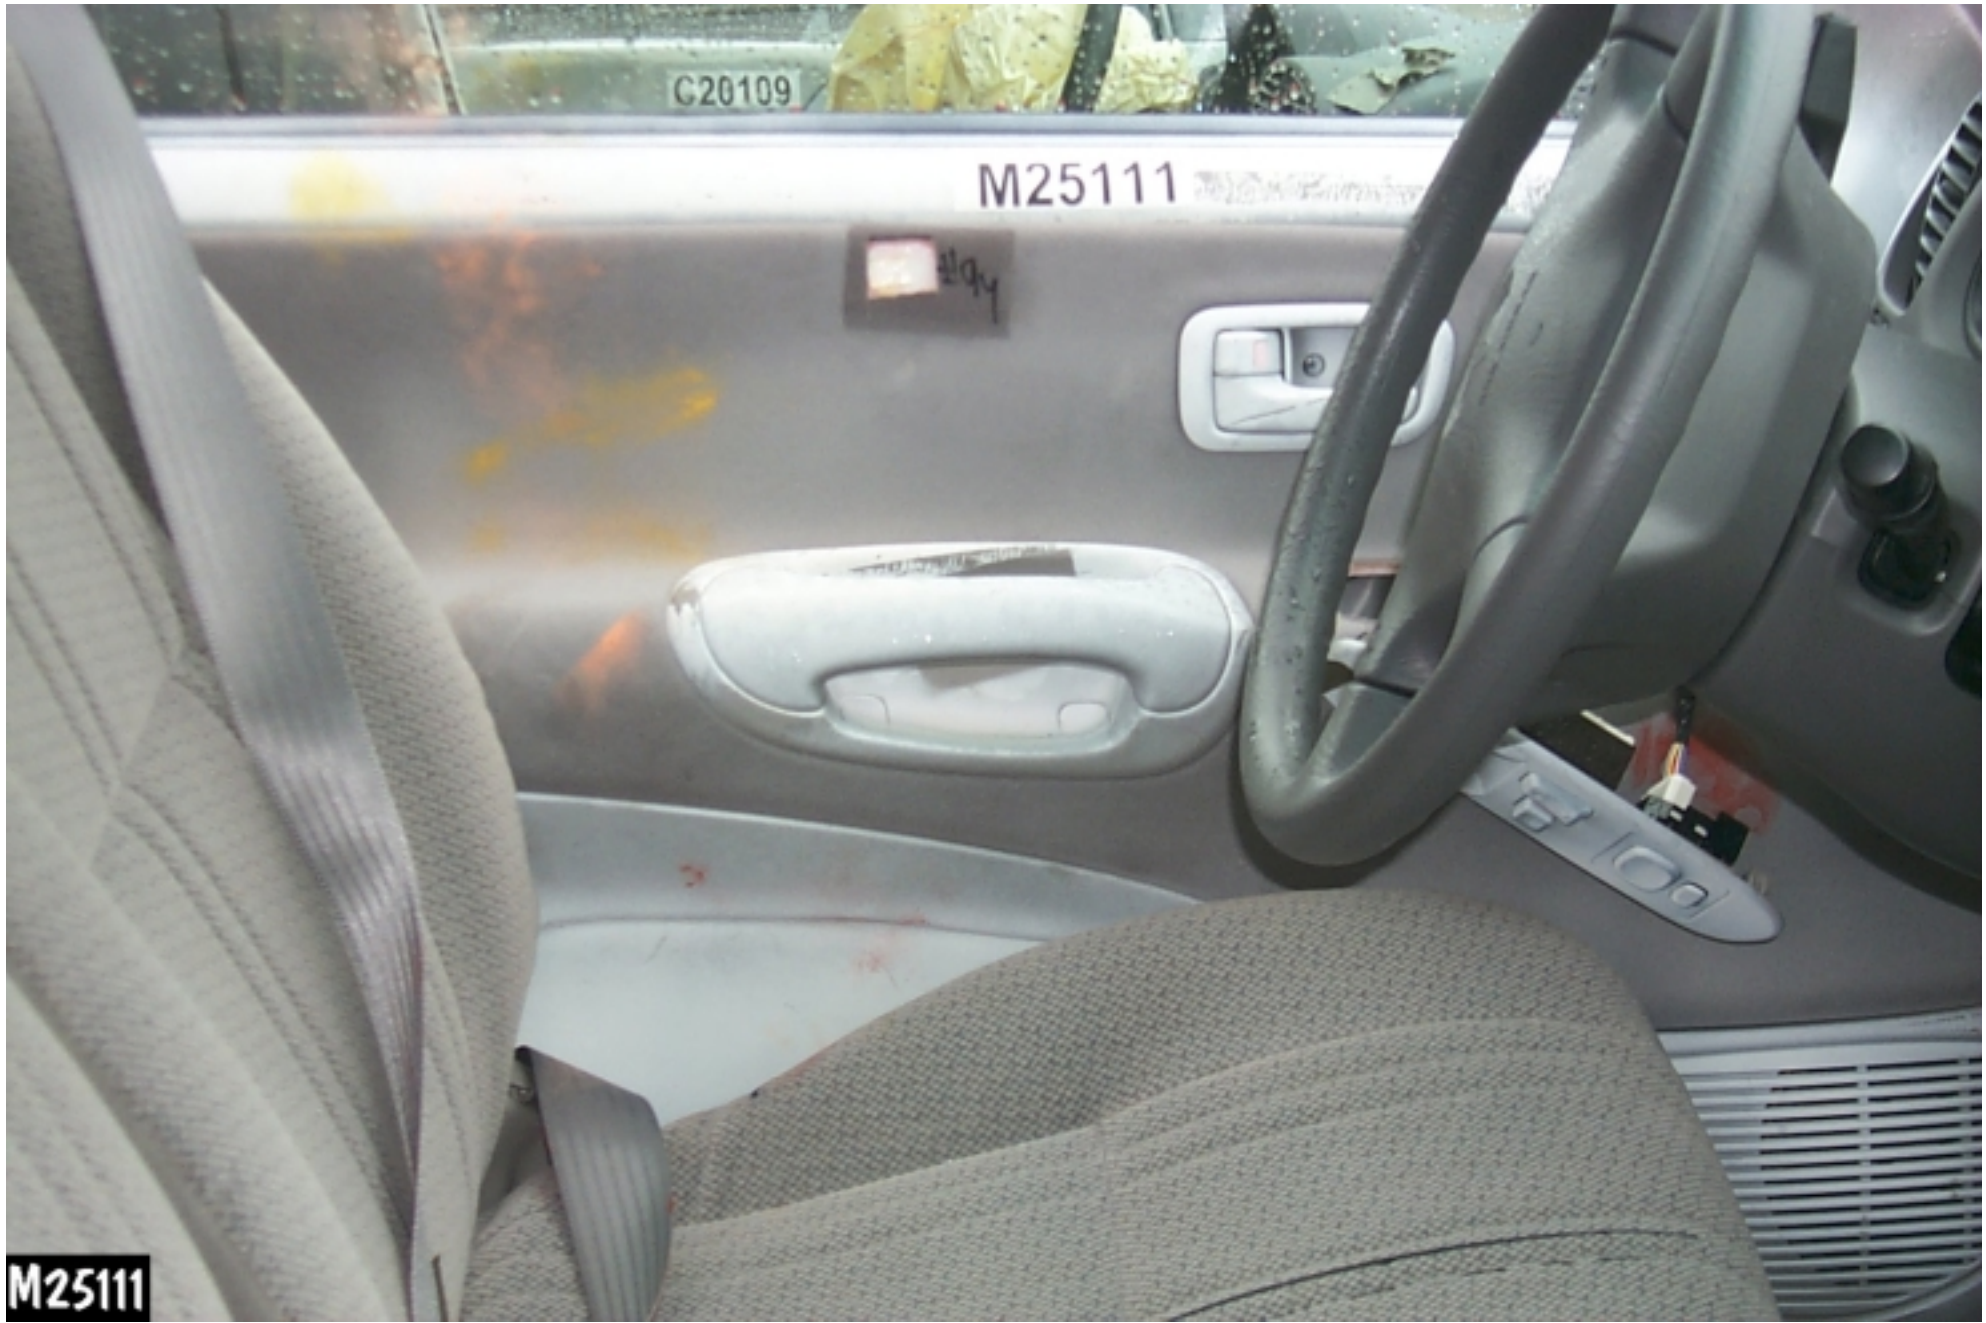
Figure A-30: POST-TEST INTERIOR OF FRONT DOOR SHOWING SID IMPACT LOCATIONS

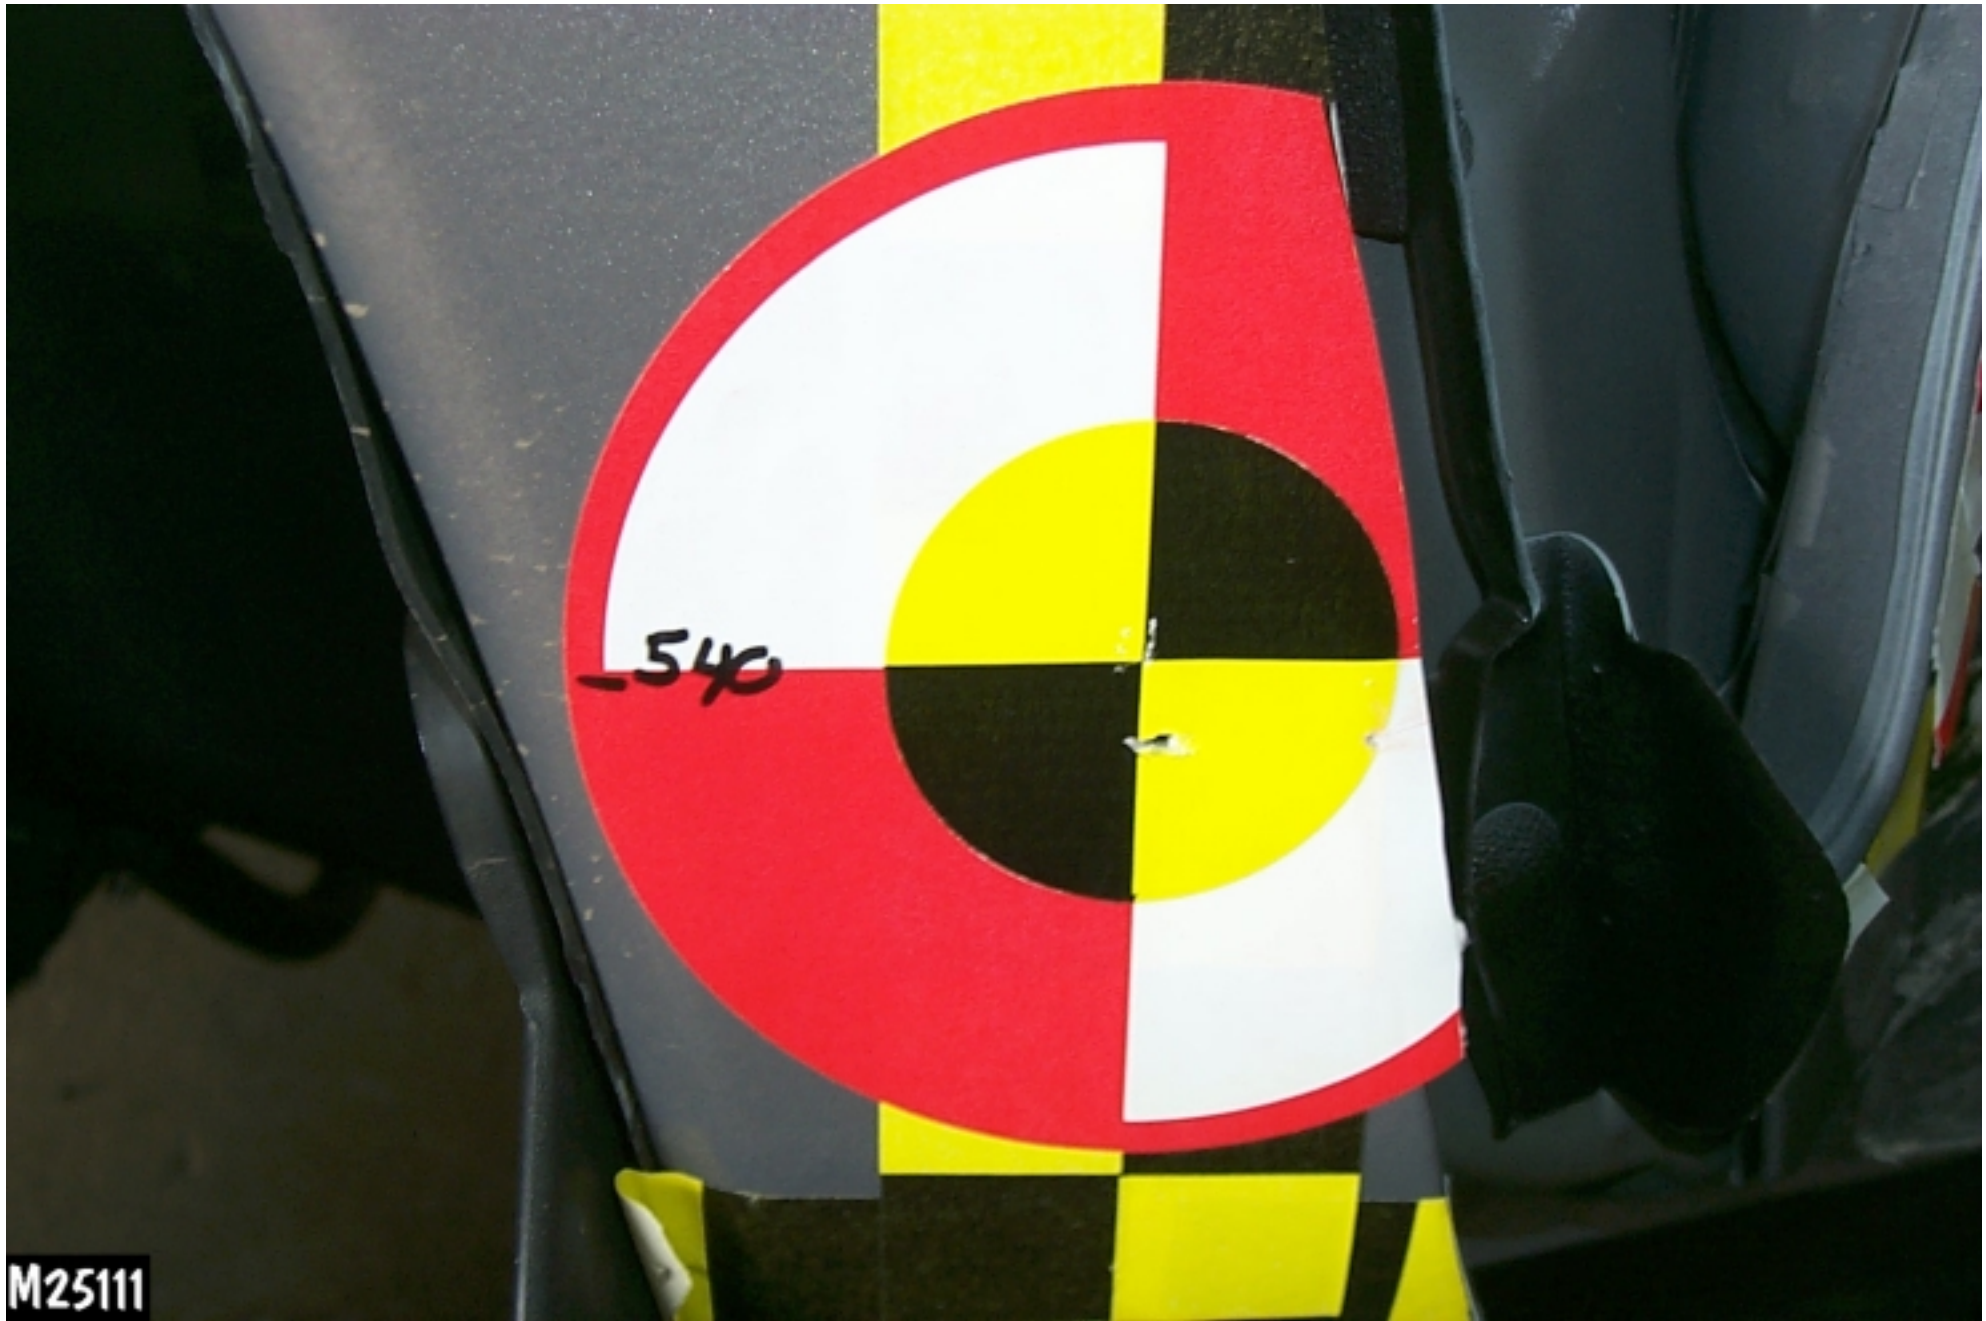
Figure A-33: POST-TEST CLOSE-UP VIEW OF IMPACT POINT TARGET

Actual Impact Point is 2 mm rearward of nominal impact ref. line (Lateral)

Actual Impact Point is 2 mm below nominal impact point (Vertical)
