REPORT NUMBER: SNCAP-CAL-02-05

**NEW CAR ASSESSMENT PROGRAM
SIDE IMPACT TEST**

TOYOTA MOTOR MANUFACTURING, INDIANA, INC.
2002 TOYOTA TUNDRA
ACCESS CAB 4X2 PICKUP

VERIDIAN ENGINEERING TEST NUMBER: 8652-SNCAP-05

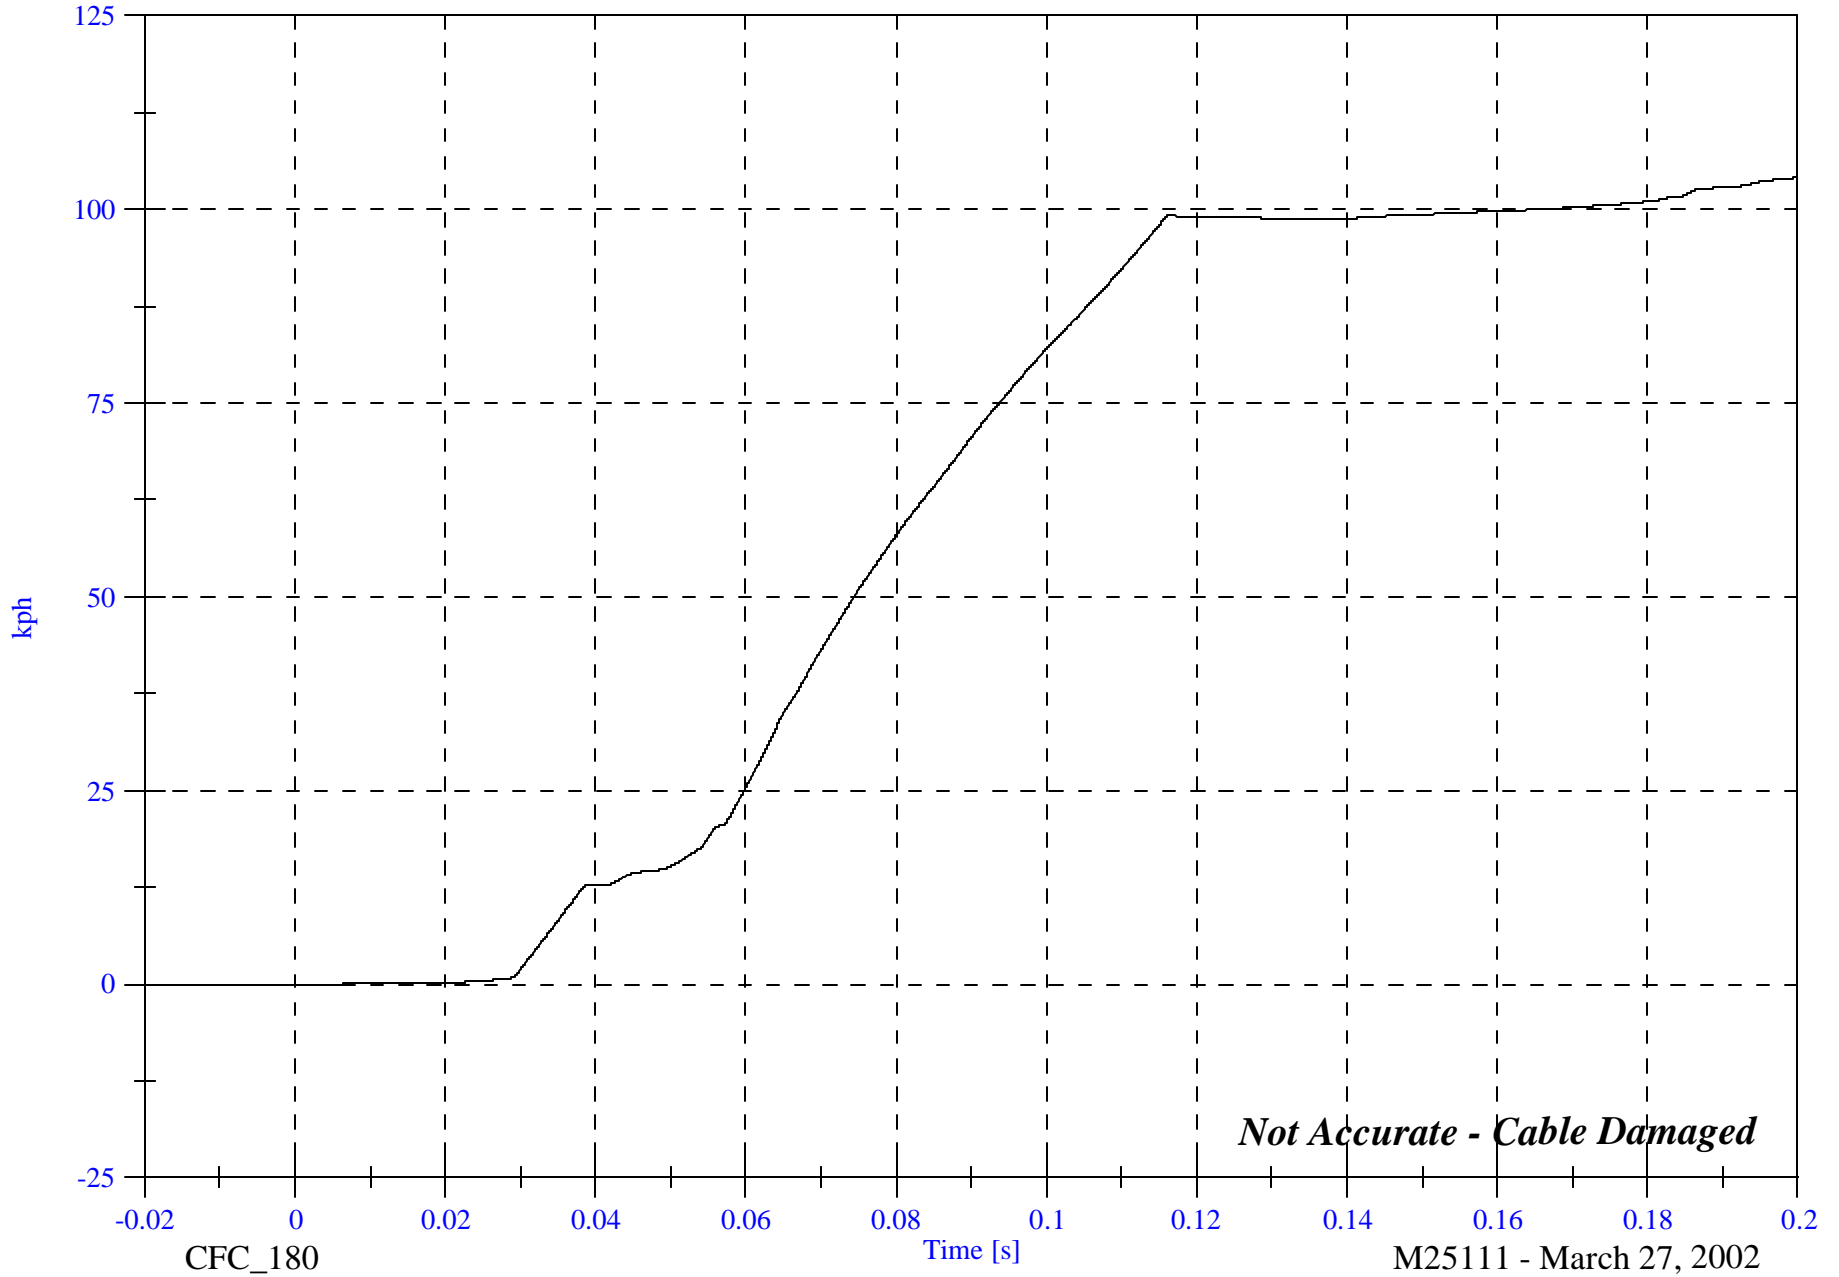
Not Accurate - Cable Damaged

† Data not accurate, cable was damaged during the event. TTI Calculated using Redundant Accelerometer.
