REPORT NO. MCW-DOT-02SN05

**NEW CAR ASSESSMENT PROGRAM  
SIDE IMPACT TESTING**

DAIMLER CHRYSLER MOTOR CORPORATION  
2002 CHRYSLER 300 M 4 DOOR SEDAN

FINAL REPORT

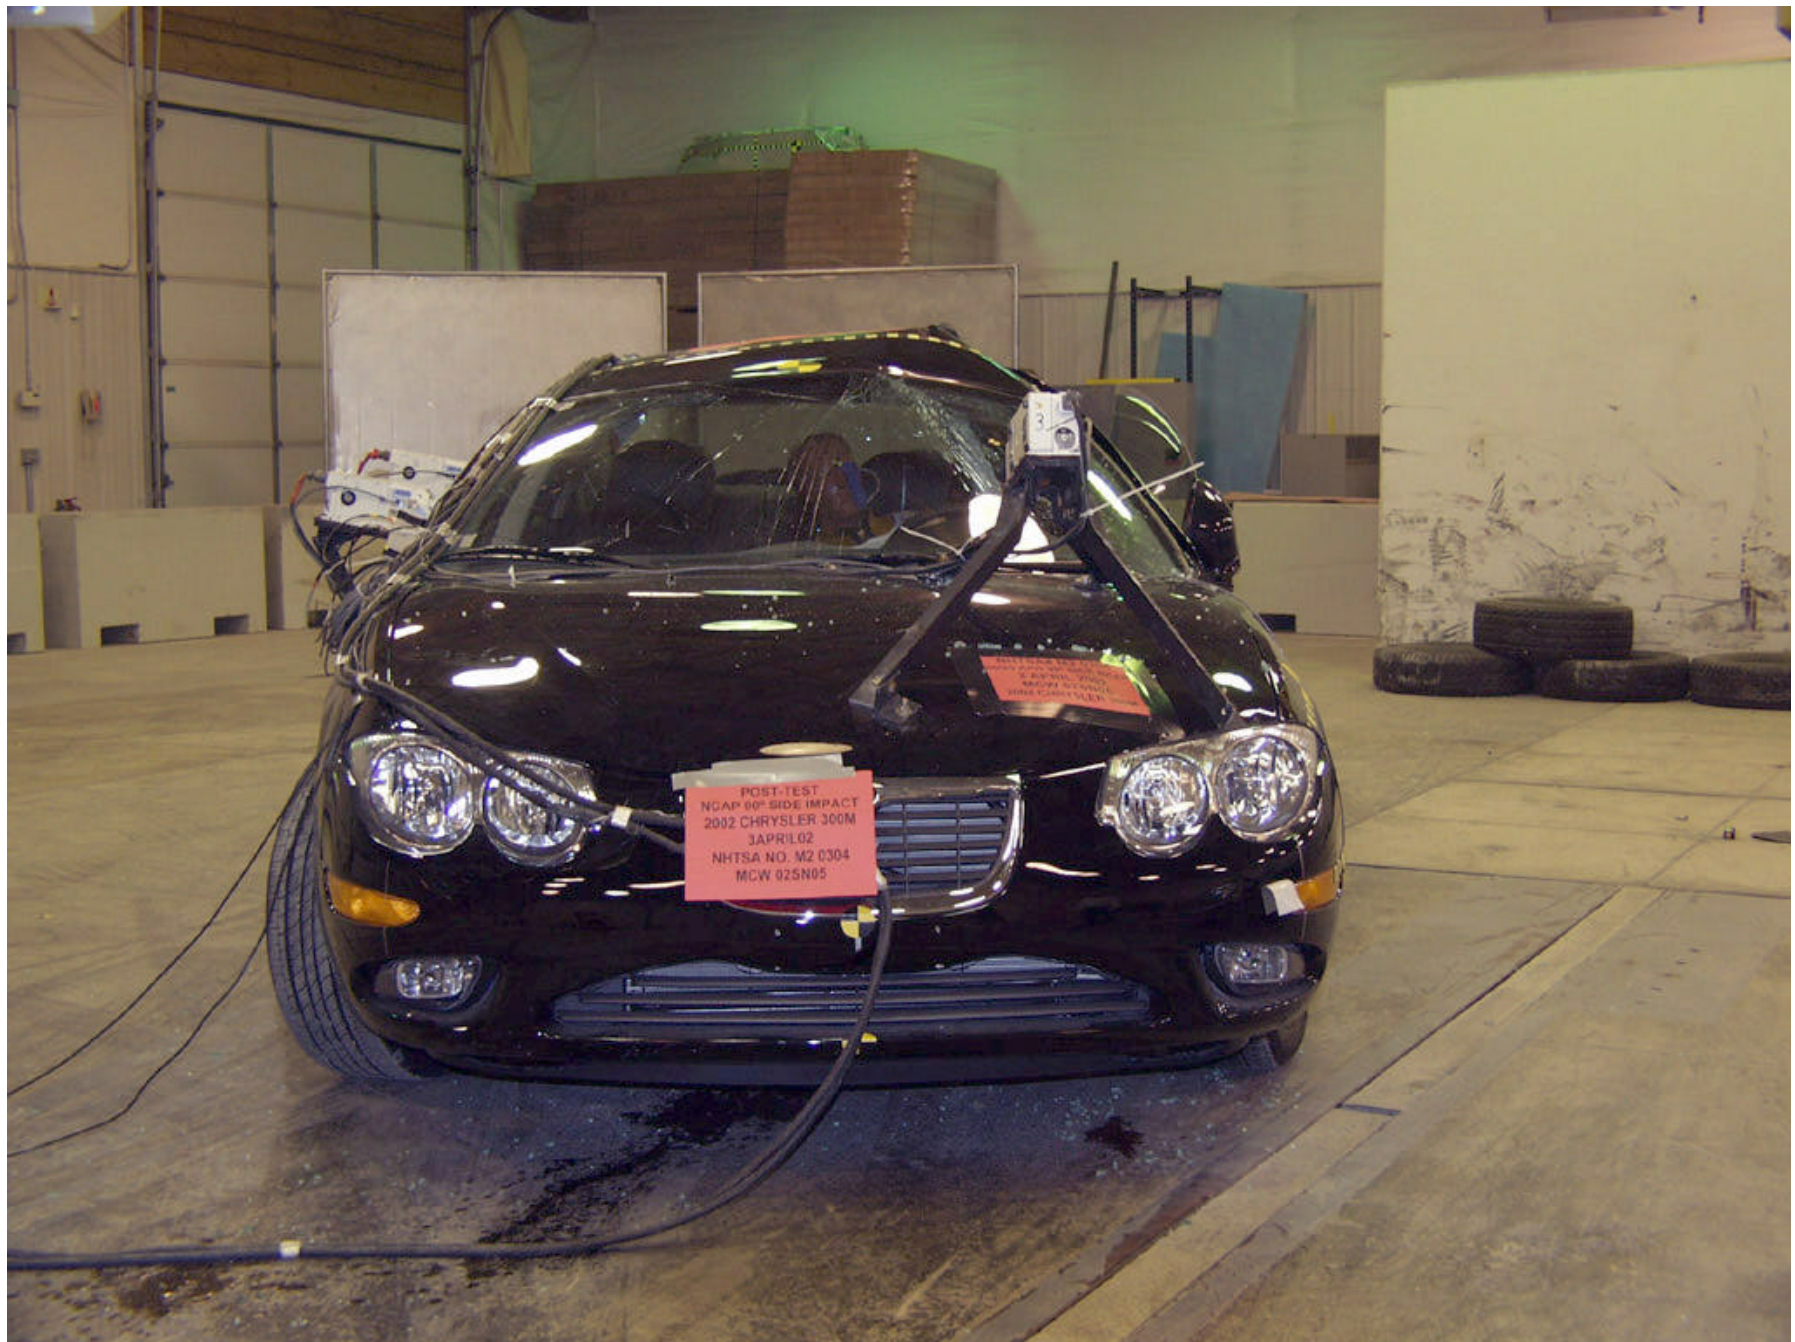
Figure A-2: POST-TEST FRONTAL VIEW OF TEST VEHICLE

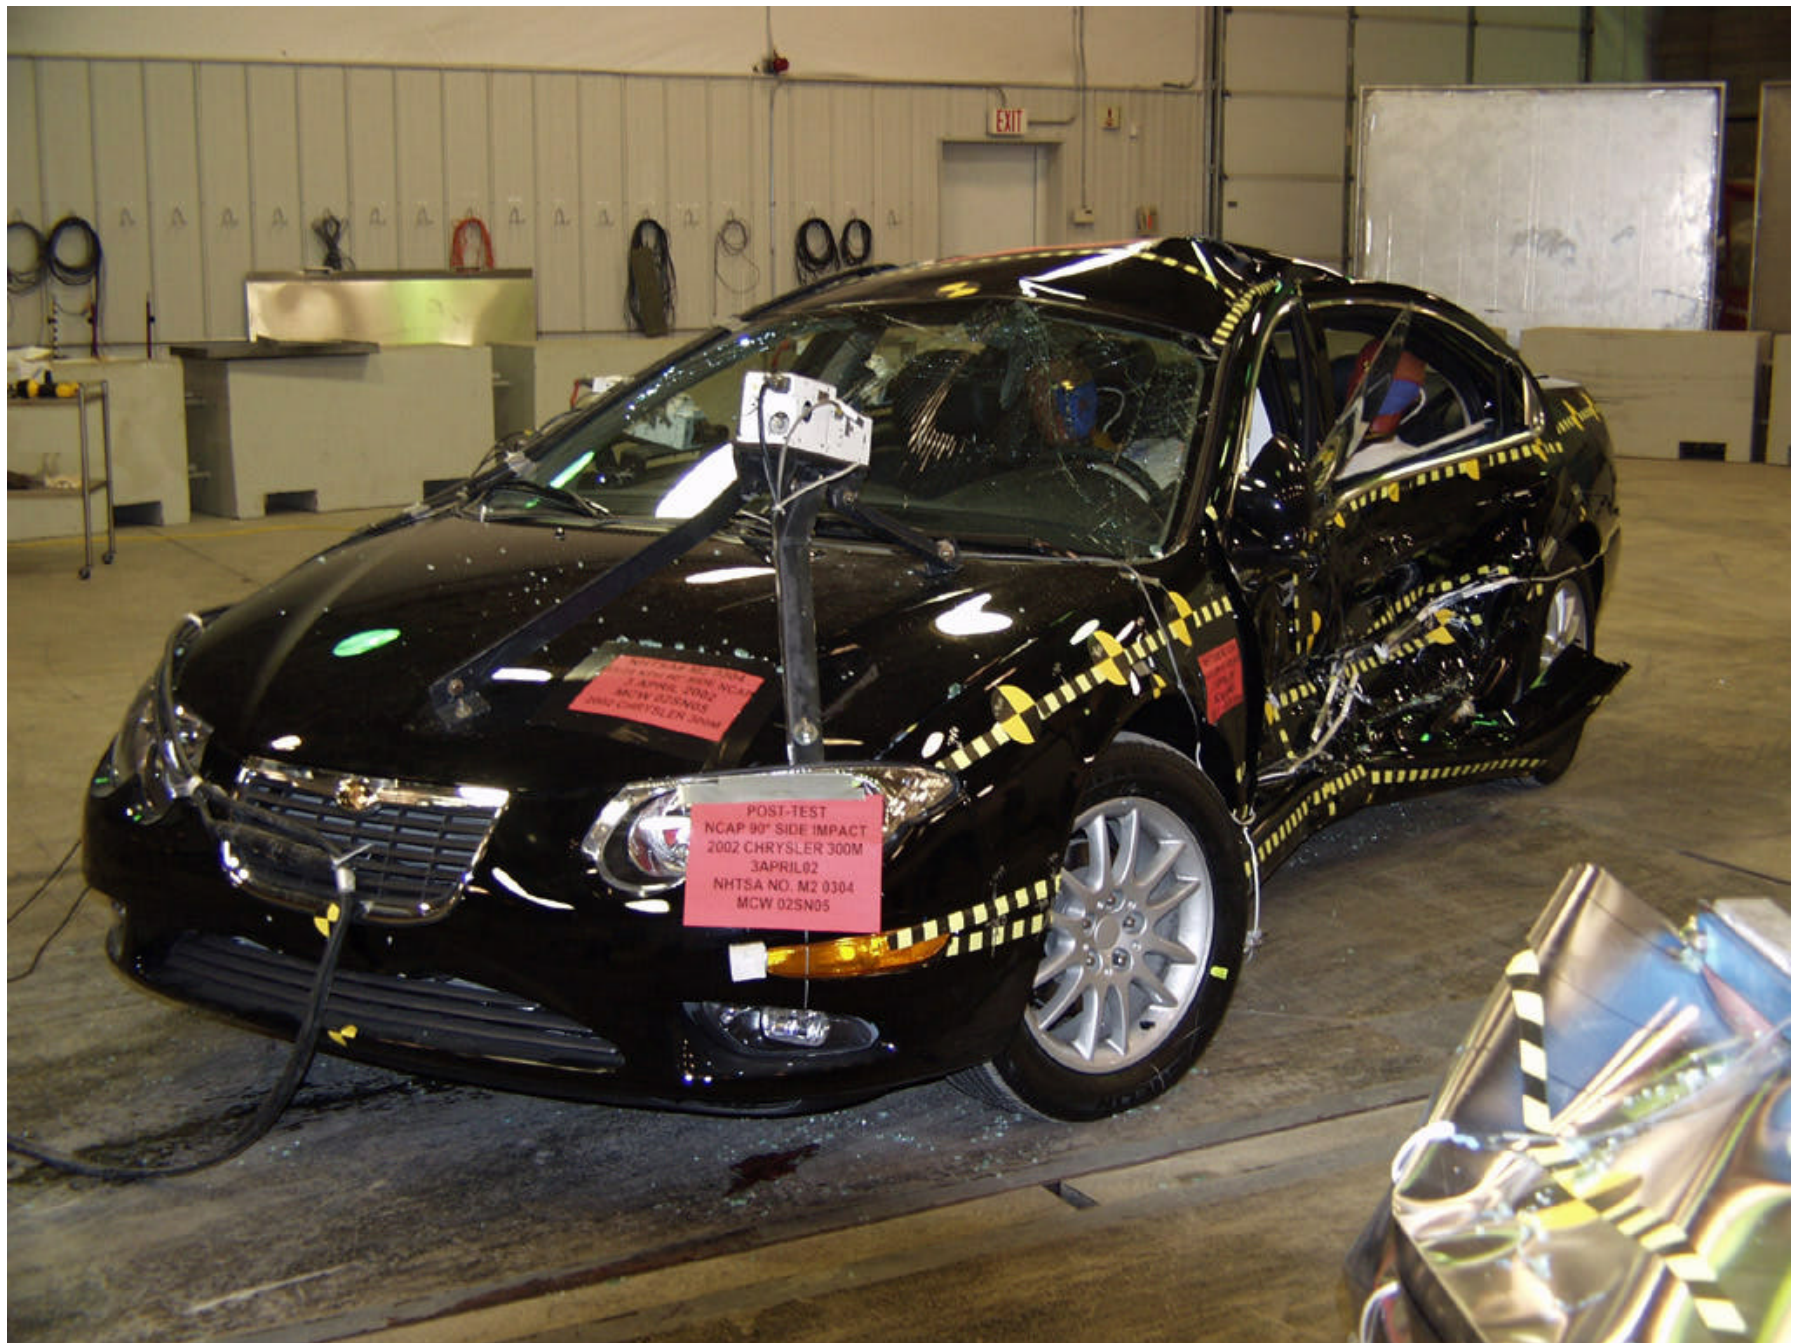
Figure A-4: POST-TEST LEFT FRONT VIEW OF TEST VEHICLE

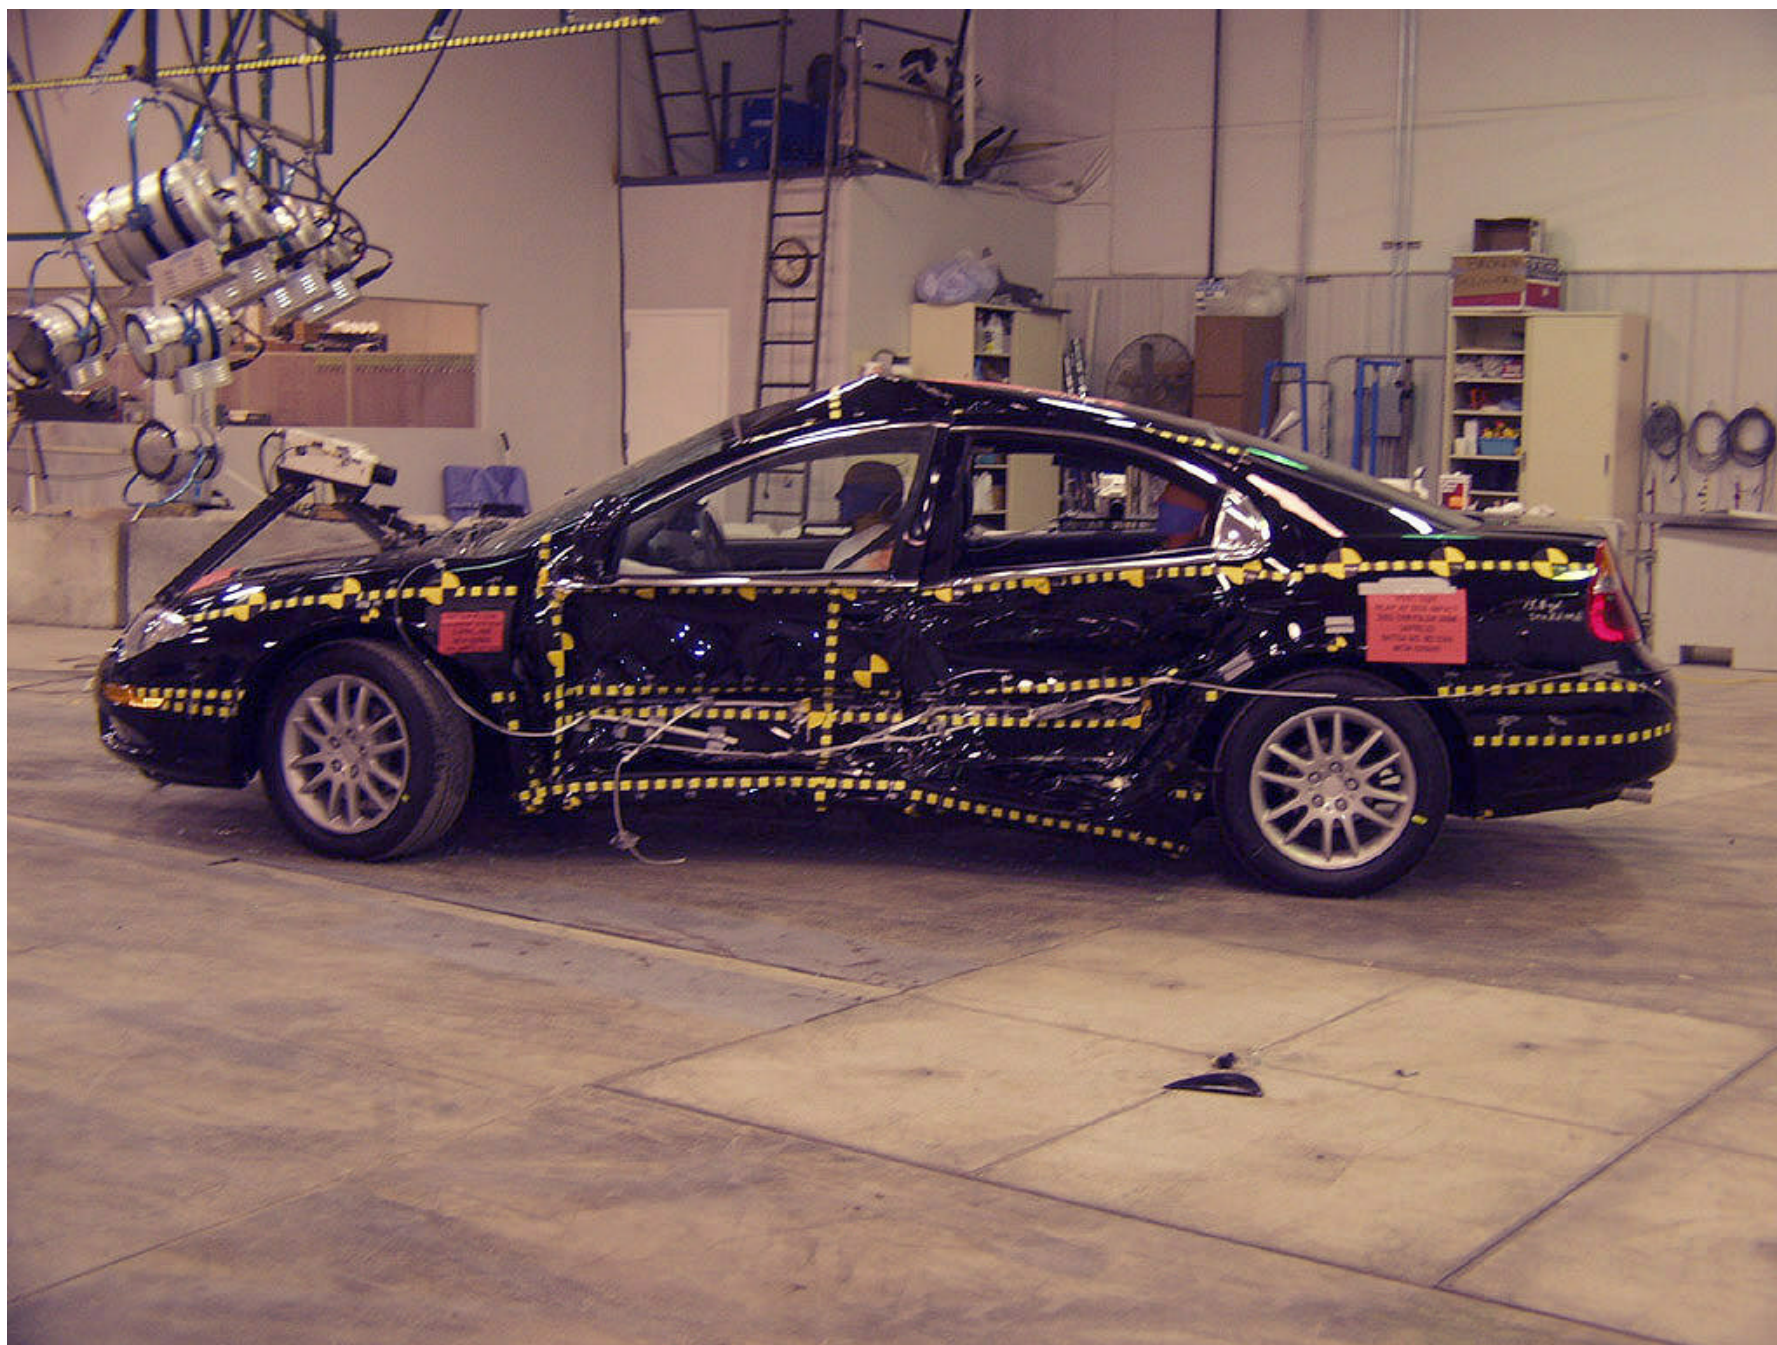
Figure A-6: POST-TEST LEFT SIDE VIEW OF VEHICLE

Maximum Post-Test intrusion at Level 2 is 351 mm

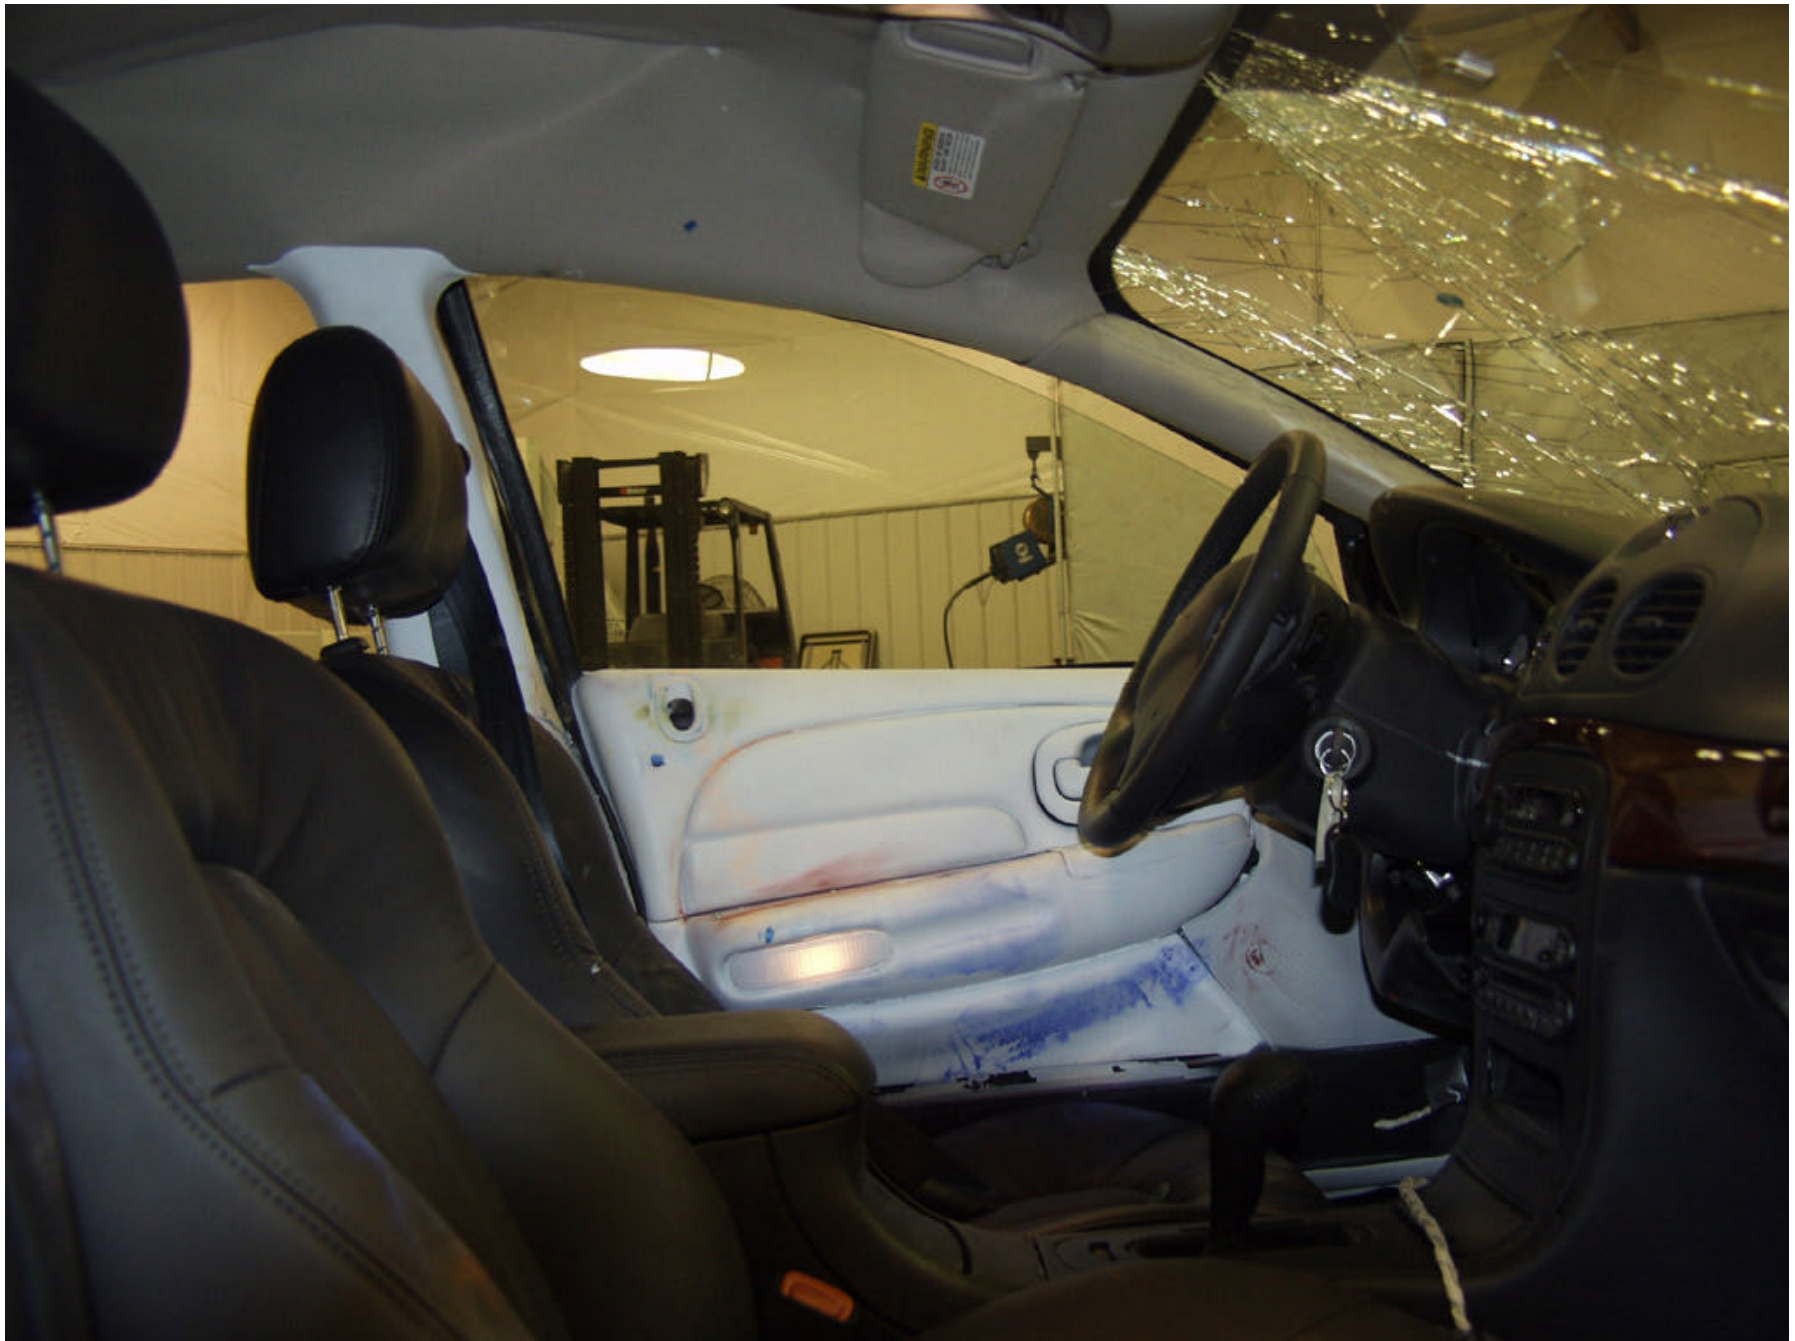
Figure A-26: POST-TEST INTERIOR OF FRONT DOOR SHOWING SID IMPACT LOCATIONS

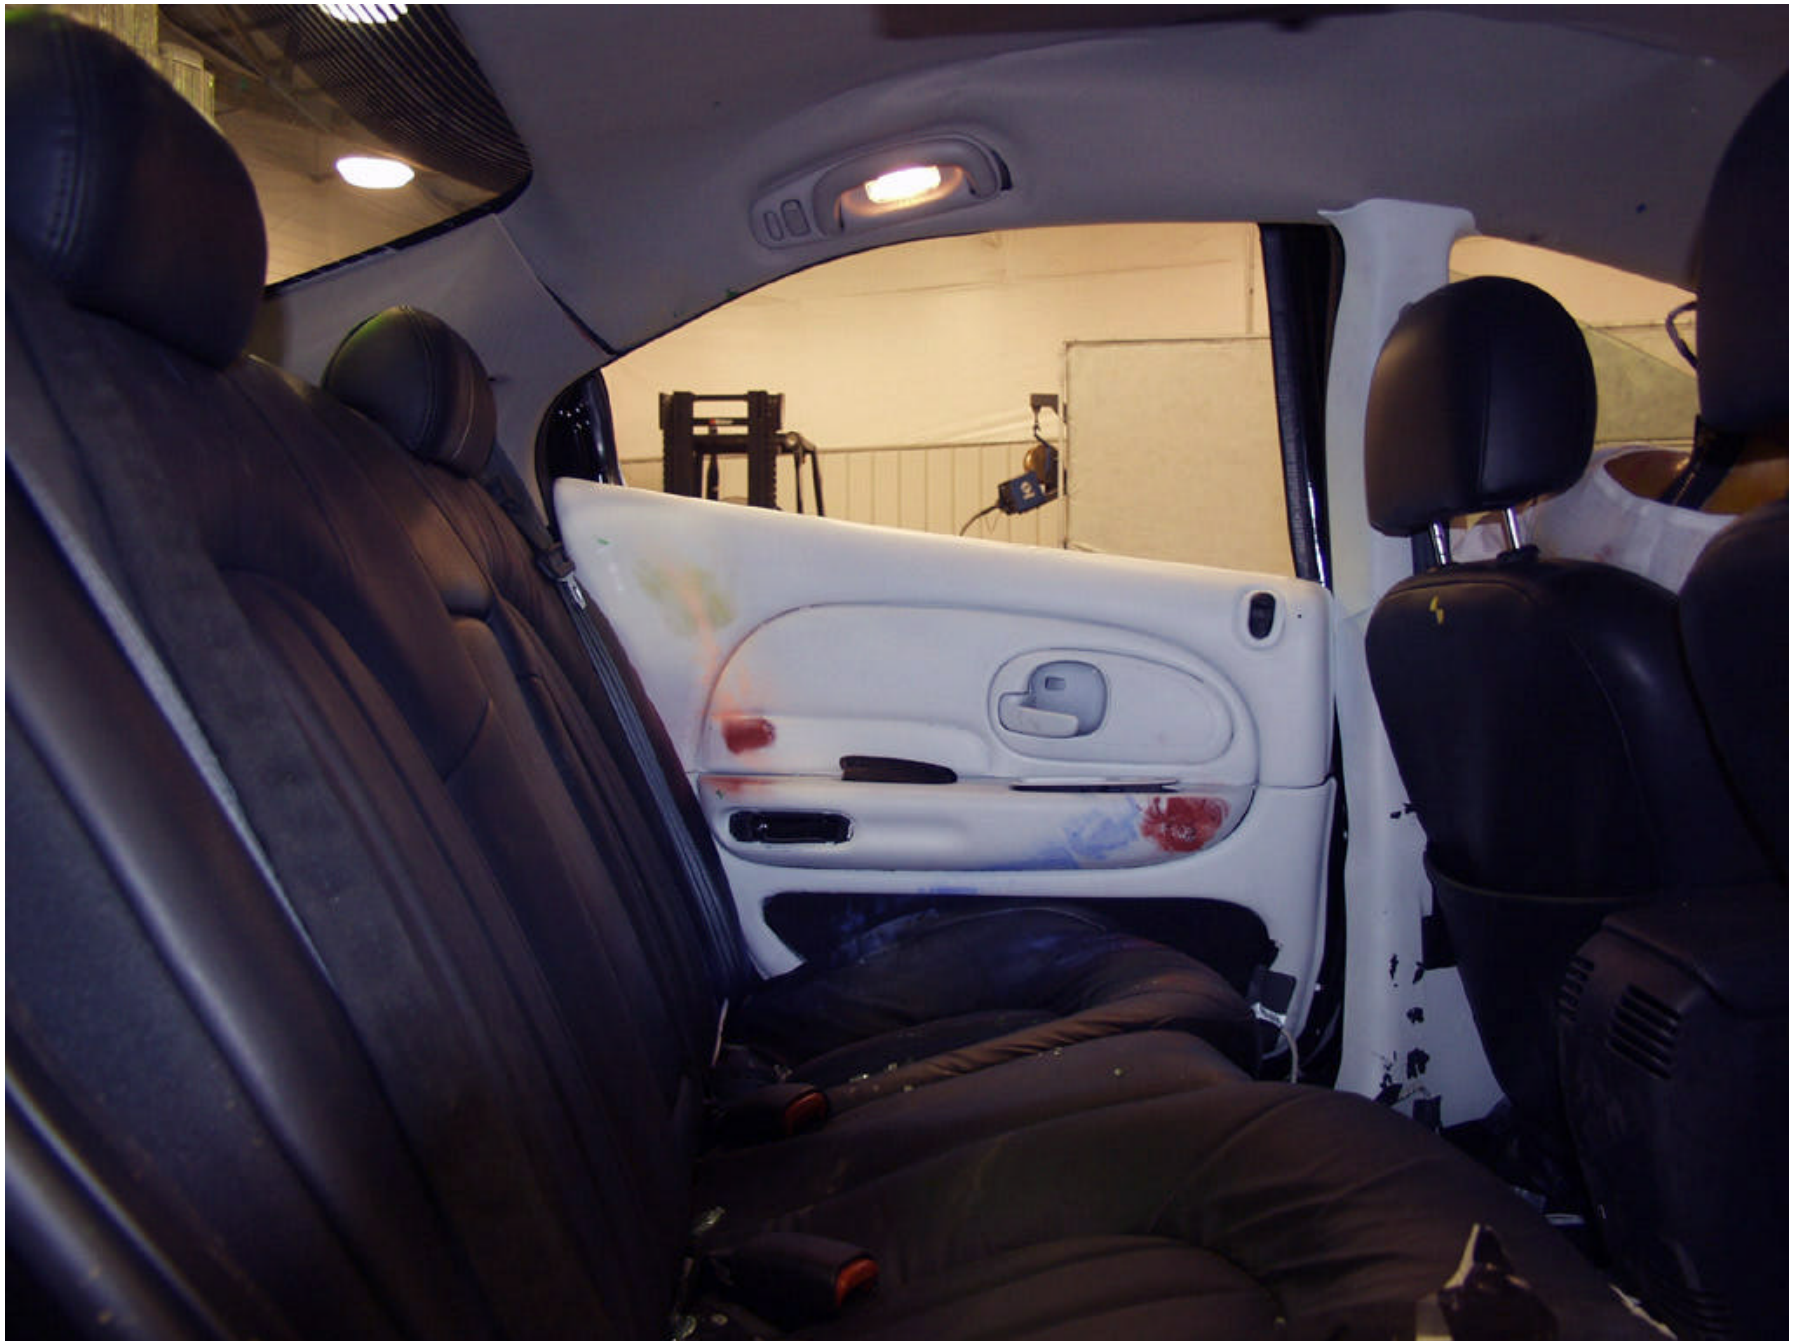
Figure A-28: POST-TEST INTERIOR OF REAR DOOR SHOWING SID IMPACT LOCATIONS

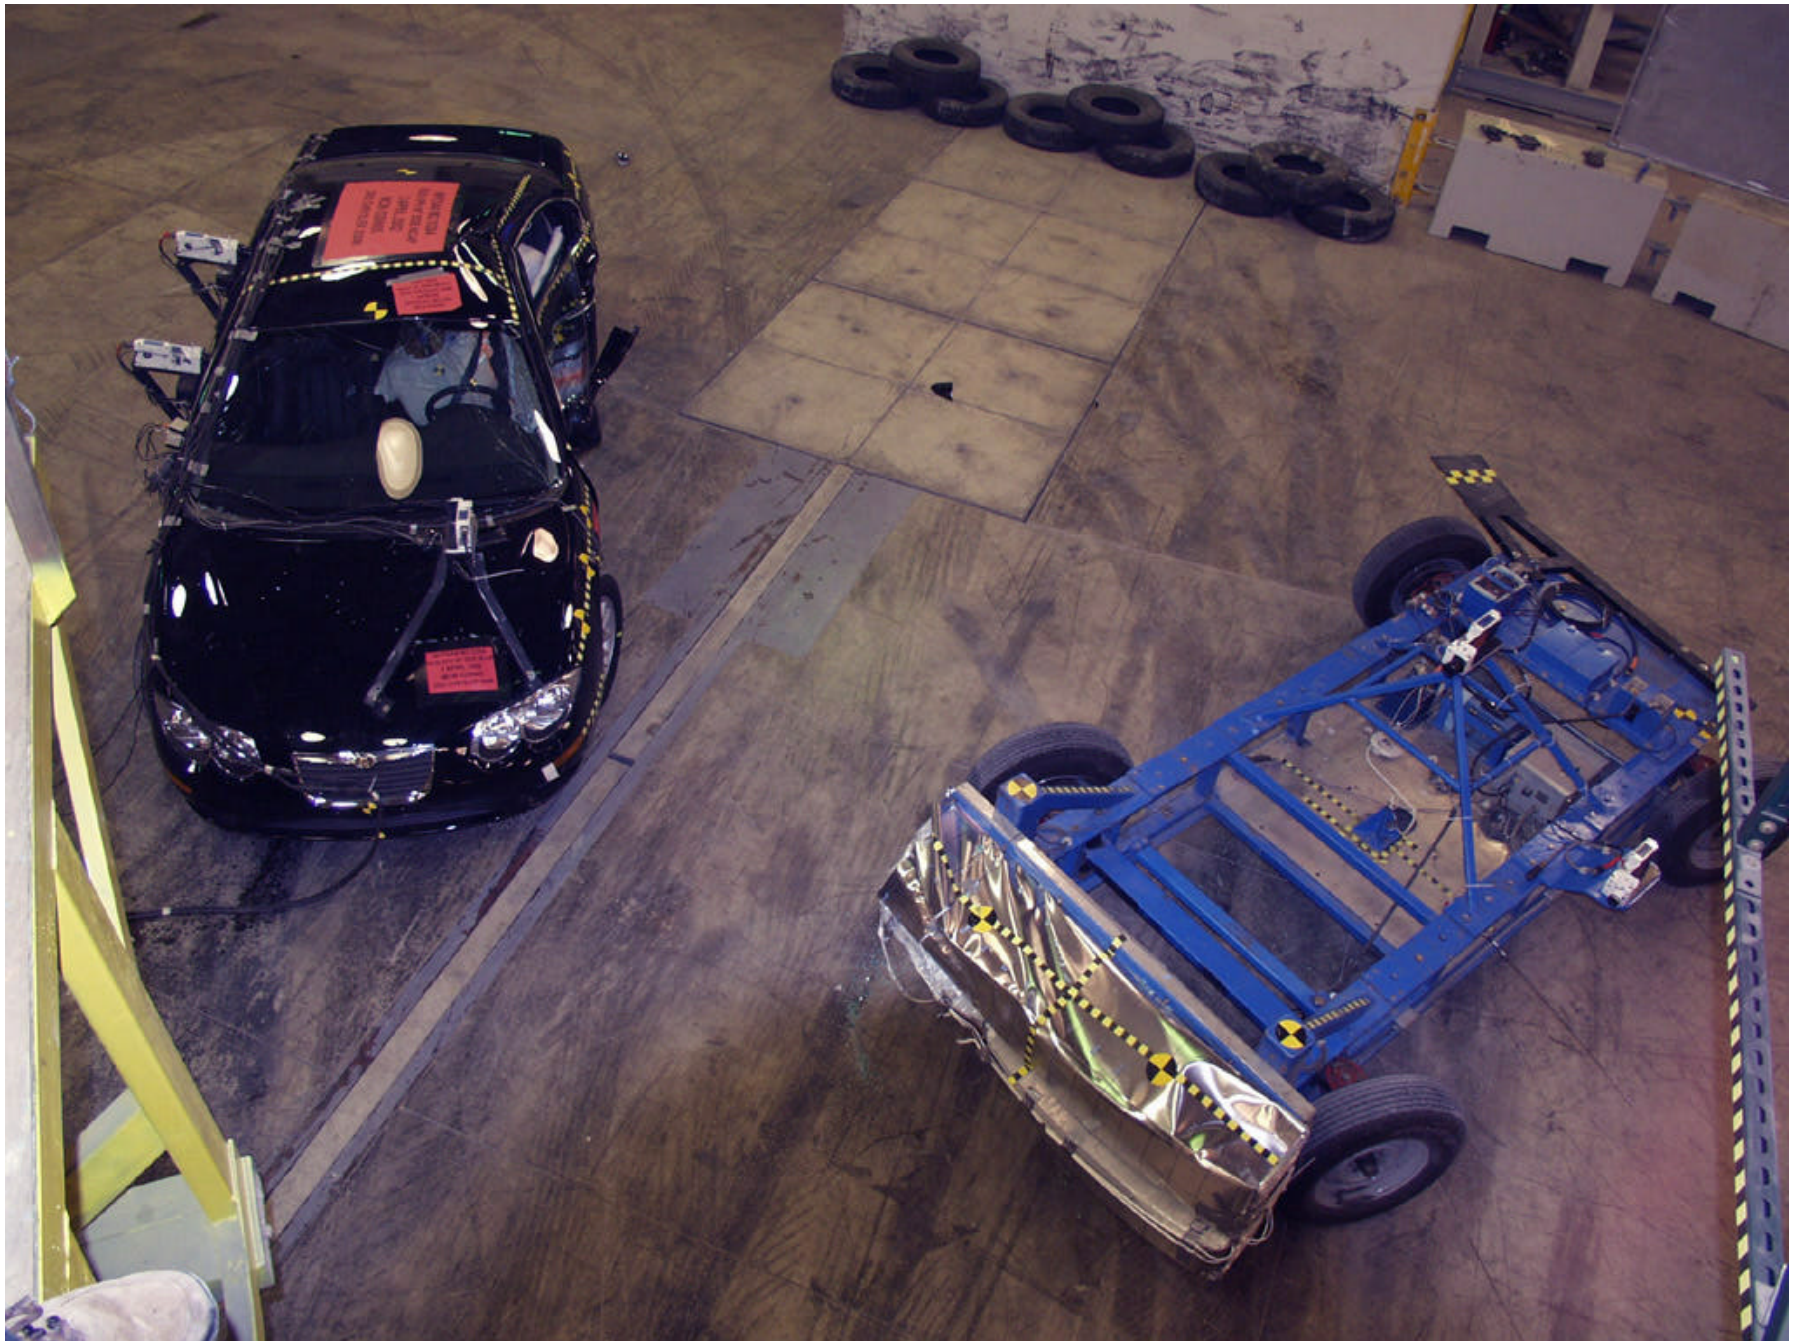
Figure A-34: POST-TEST OVERHEAD VIEW OF MDB

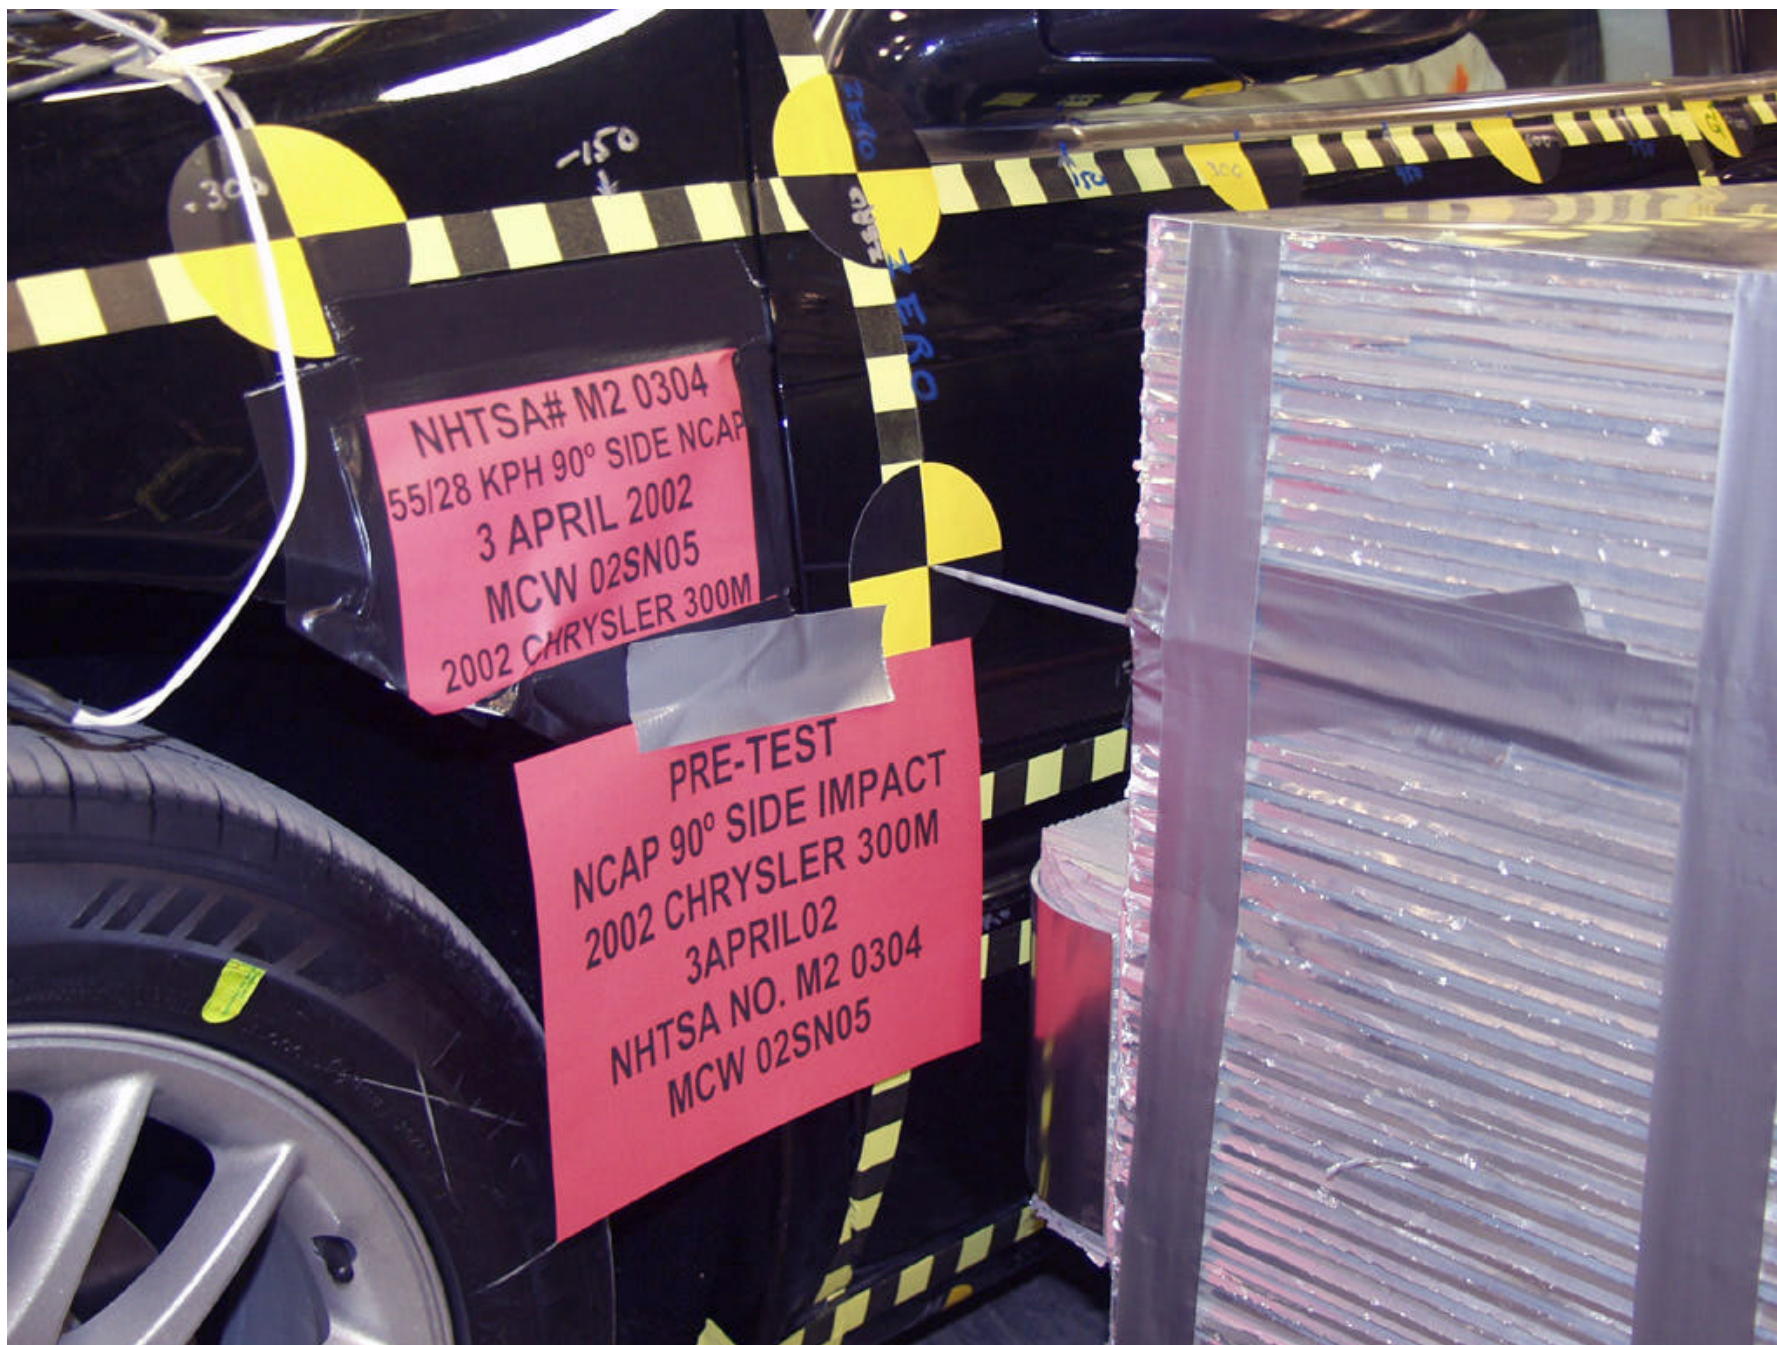
Figure A-35: PRE-TEST CLOSE-UP OF IMPACT POINT TARGET SHOWING WELDING ROD
