REPORT NO. MCW-DOT-02SN06

**NEW CAR ASSESSMENT PROGRAM  
SIDE IMPACT TESTING**

TOYOTA MOTOR CORPORATION  
2003 TOYOTA MATRIX 4-DOOR SEDAN

NHTSA NUMBER: M3 5106

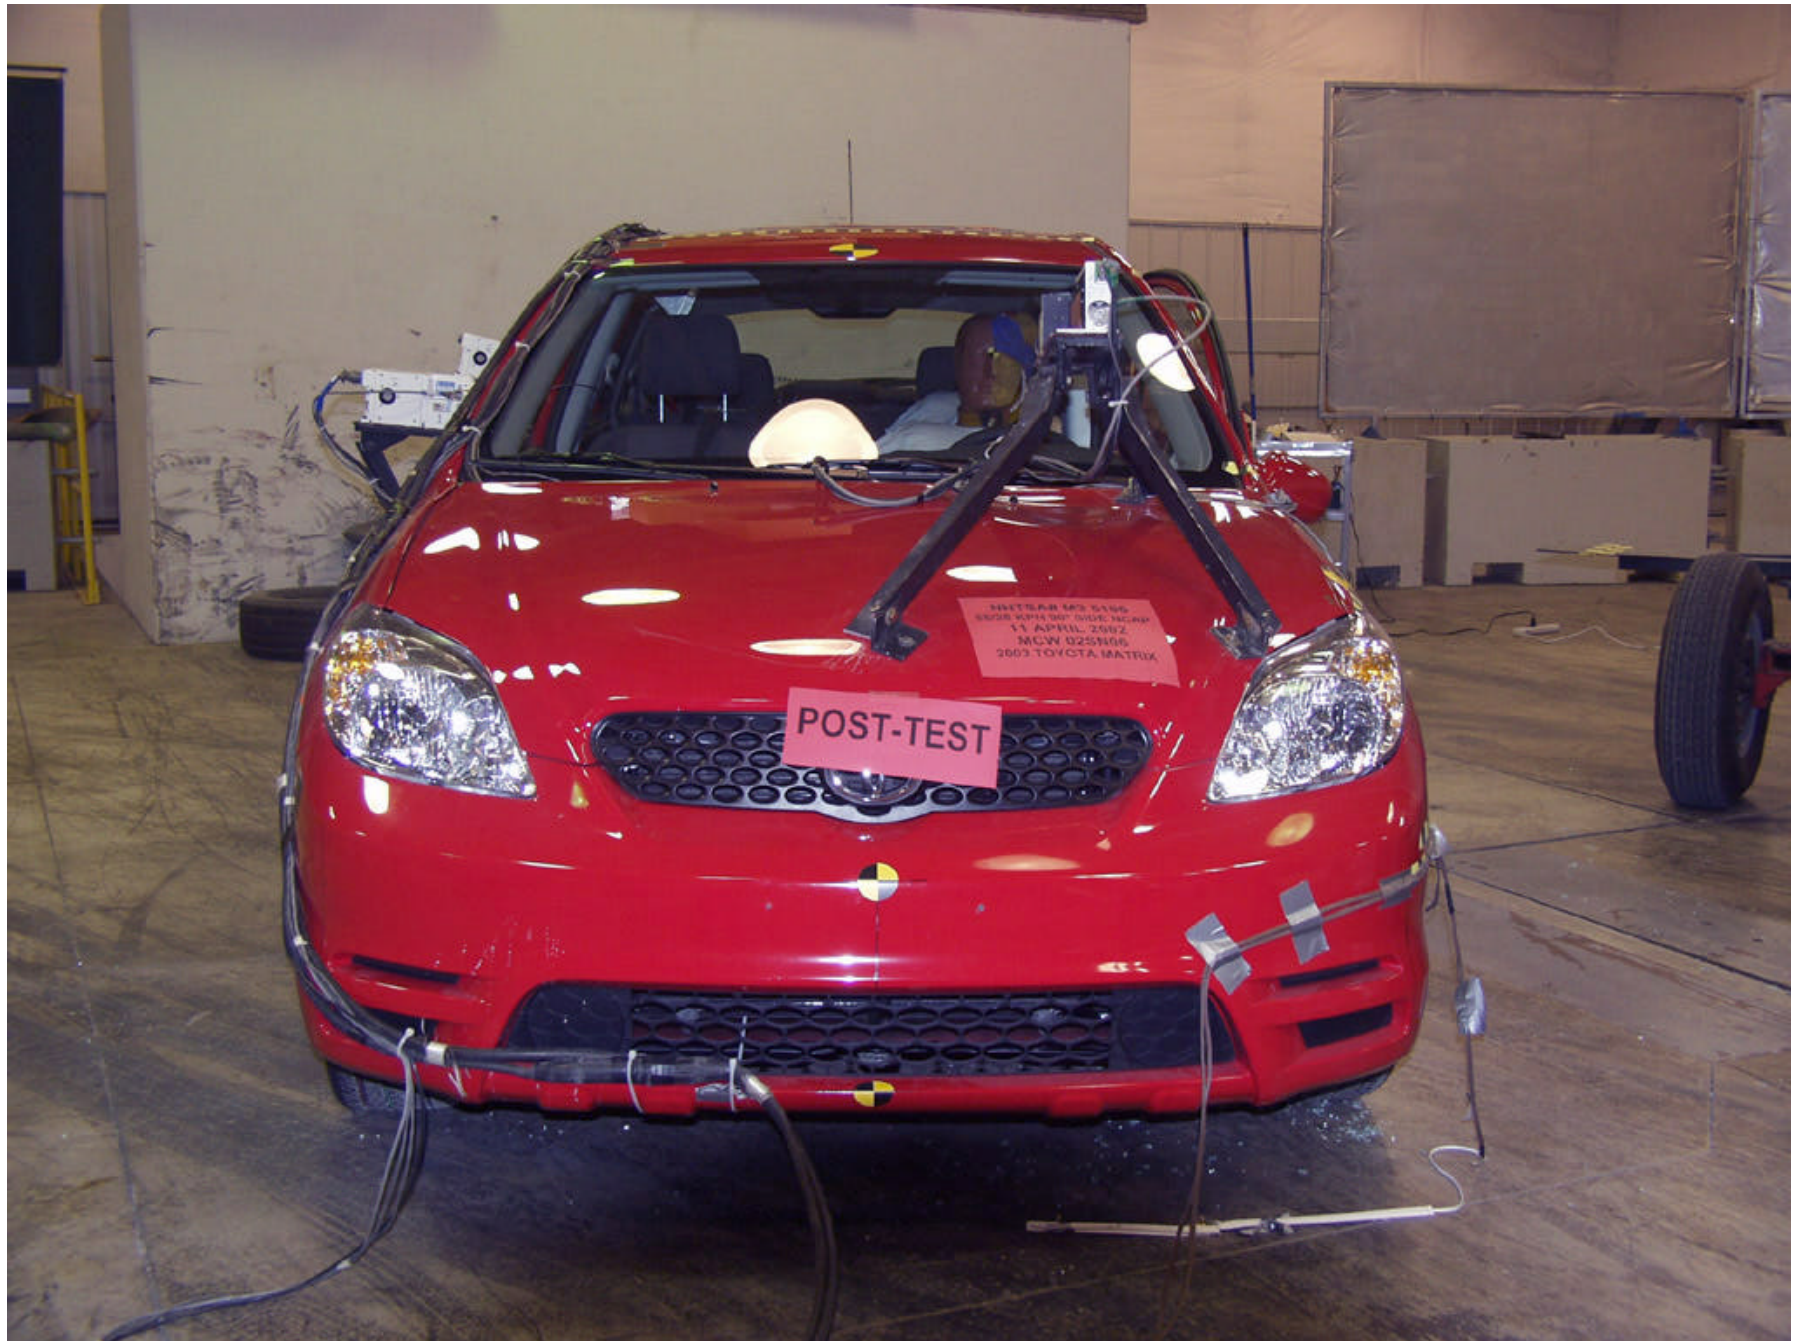
Figure A-2: POST-TEST FRONTAL VIEW OF TEST VEHICLE

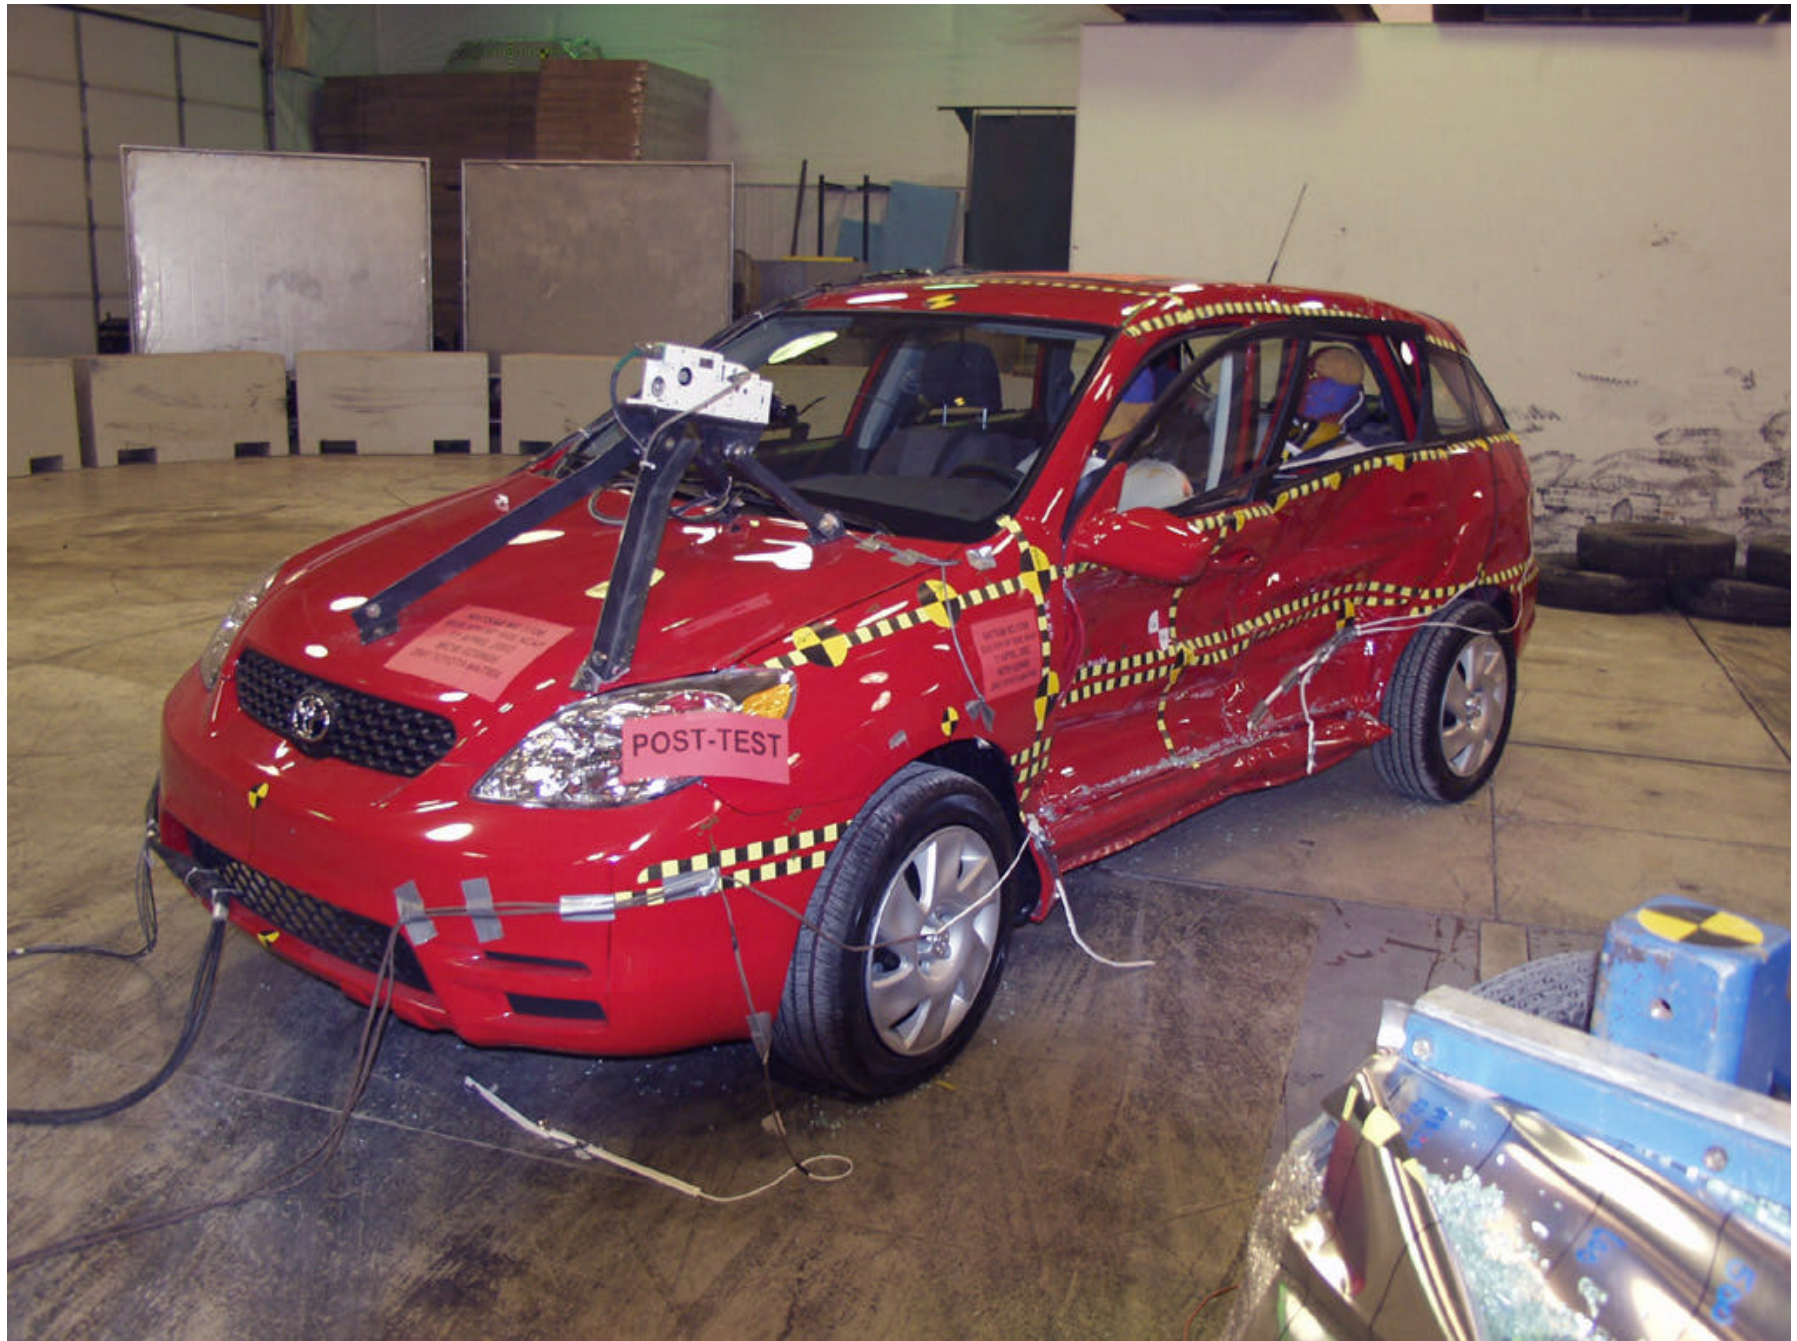
Figure A-4: POST-TEST LEFT FRONT VIEW OF TEST VEHICLE

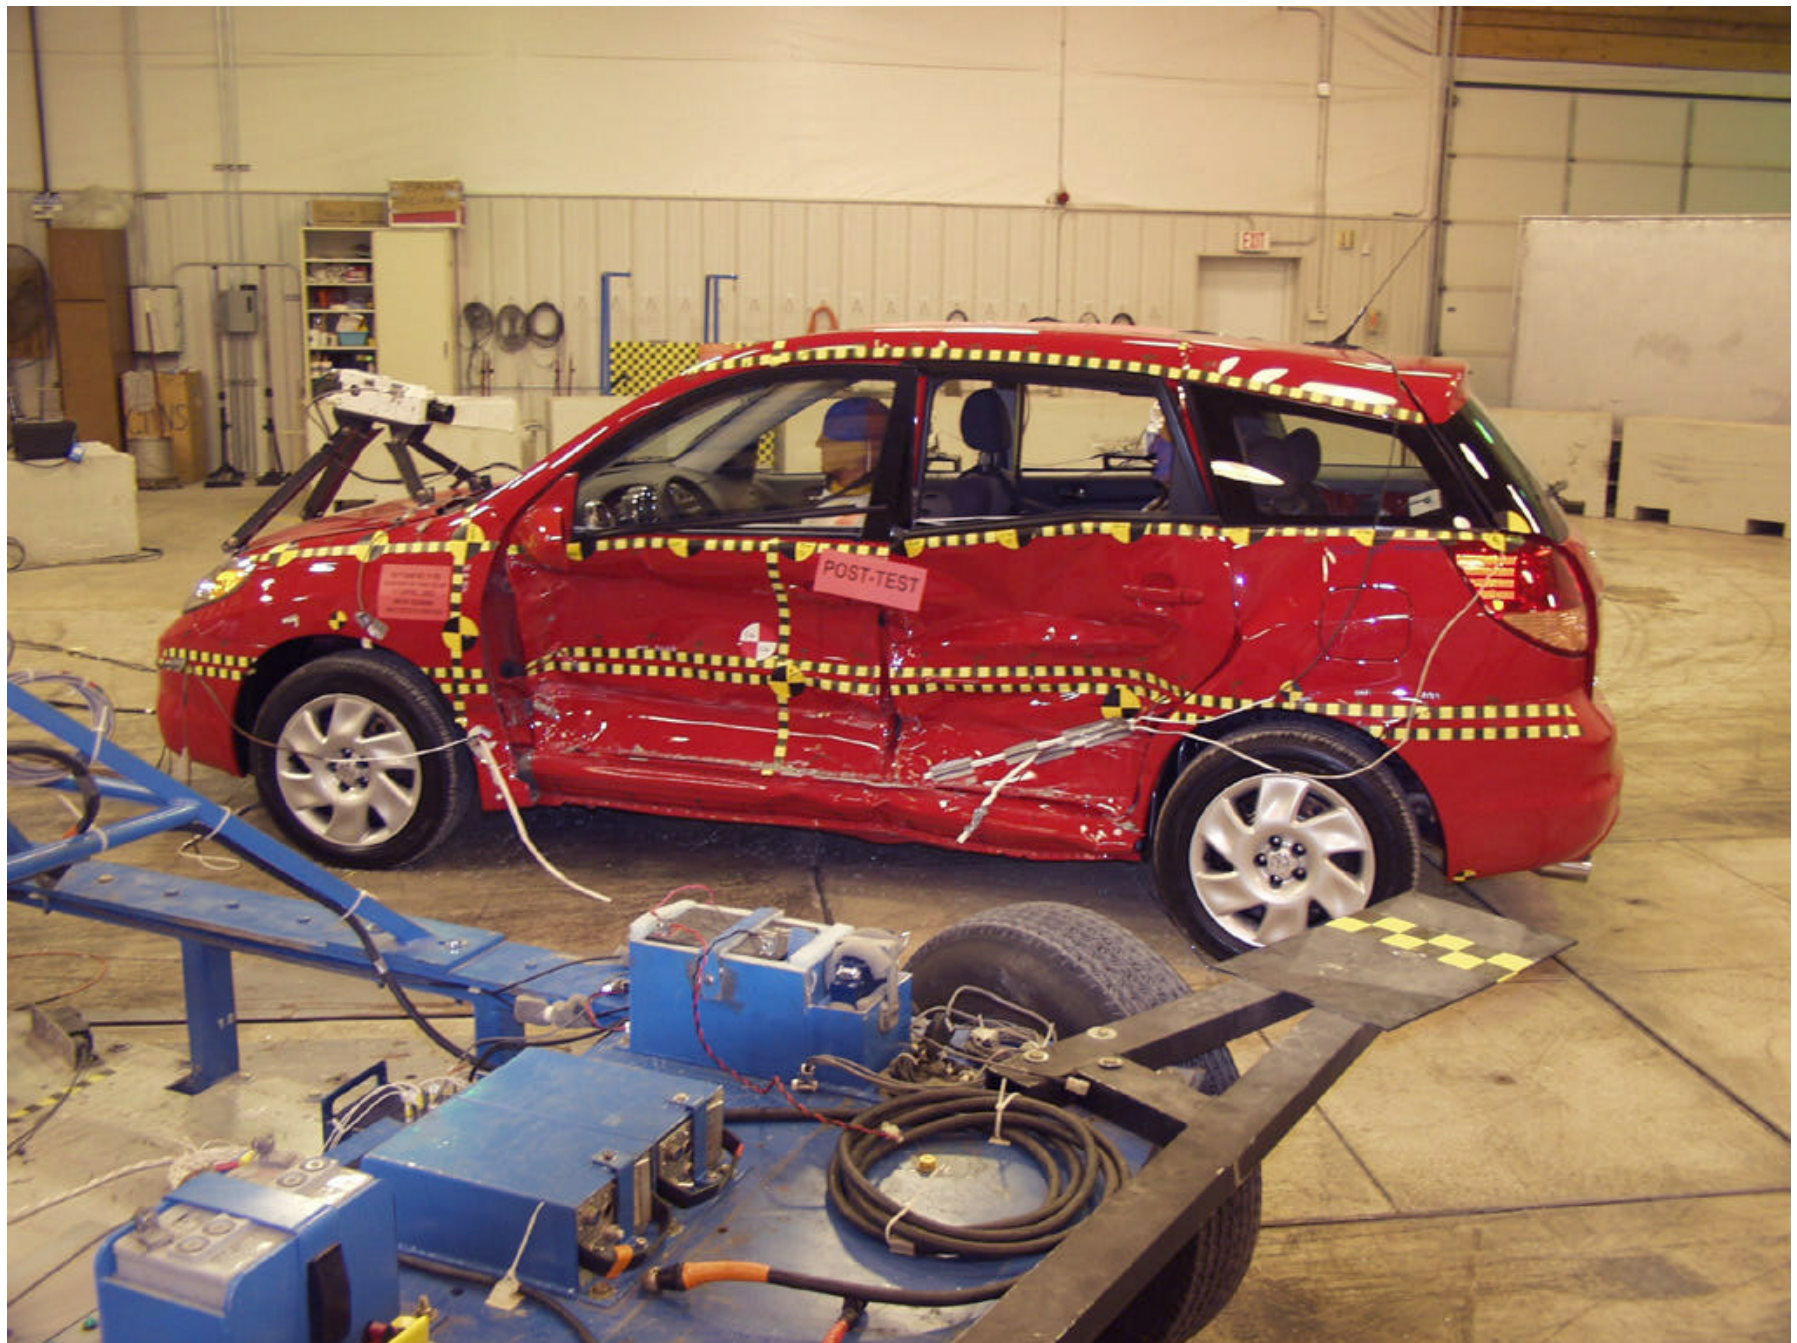
Figure A-6: POST-TEST LEFT SIDE VIEW OF TEST VEHICLE

Maximum Post-Test intrusion at Level 3 is 288 mm

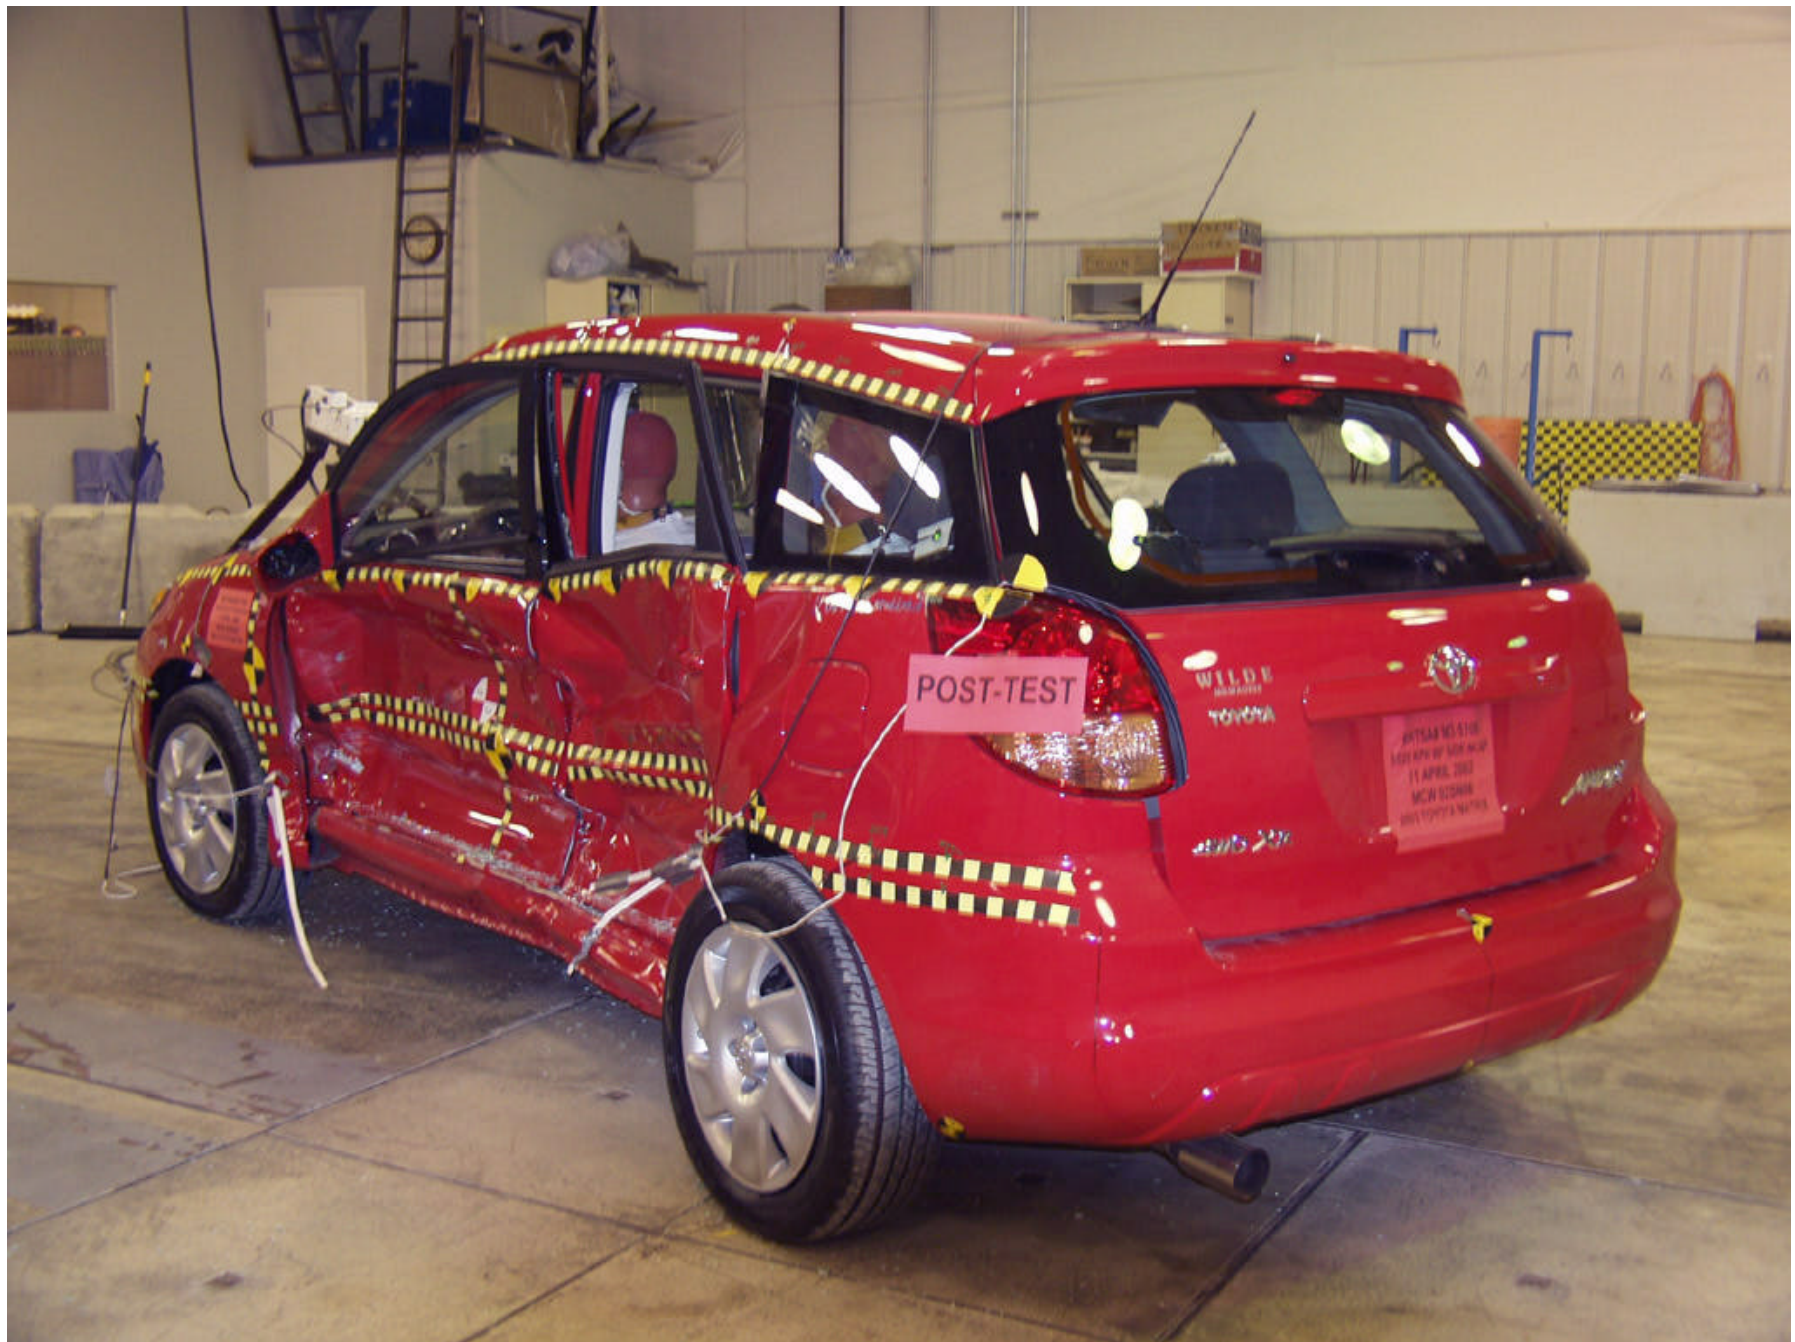
Figure A-8: POST-TEST LEFT REAR VIEW OF TEST VEHICLE

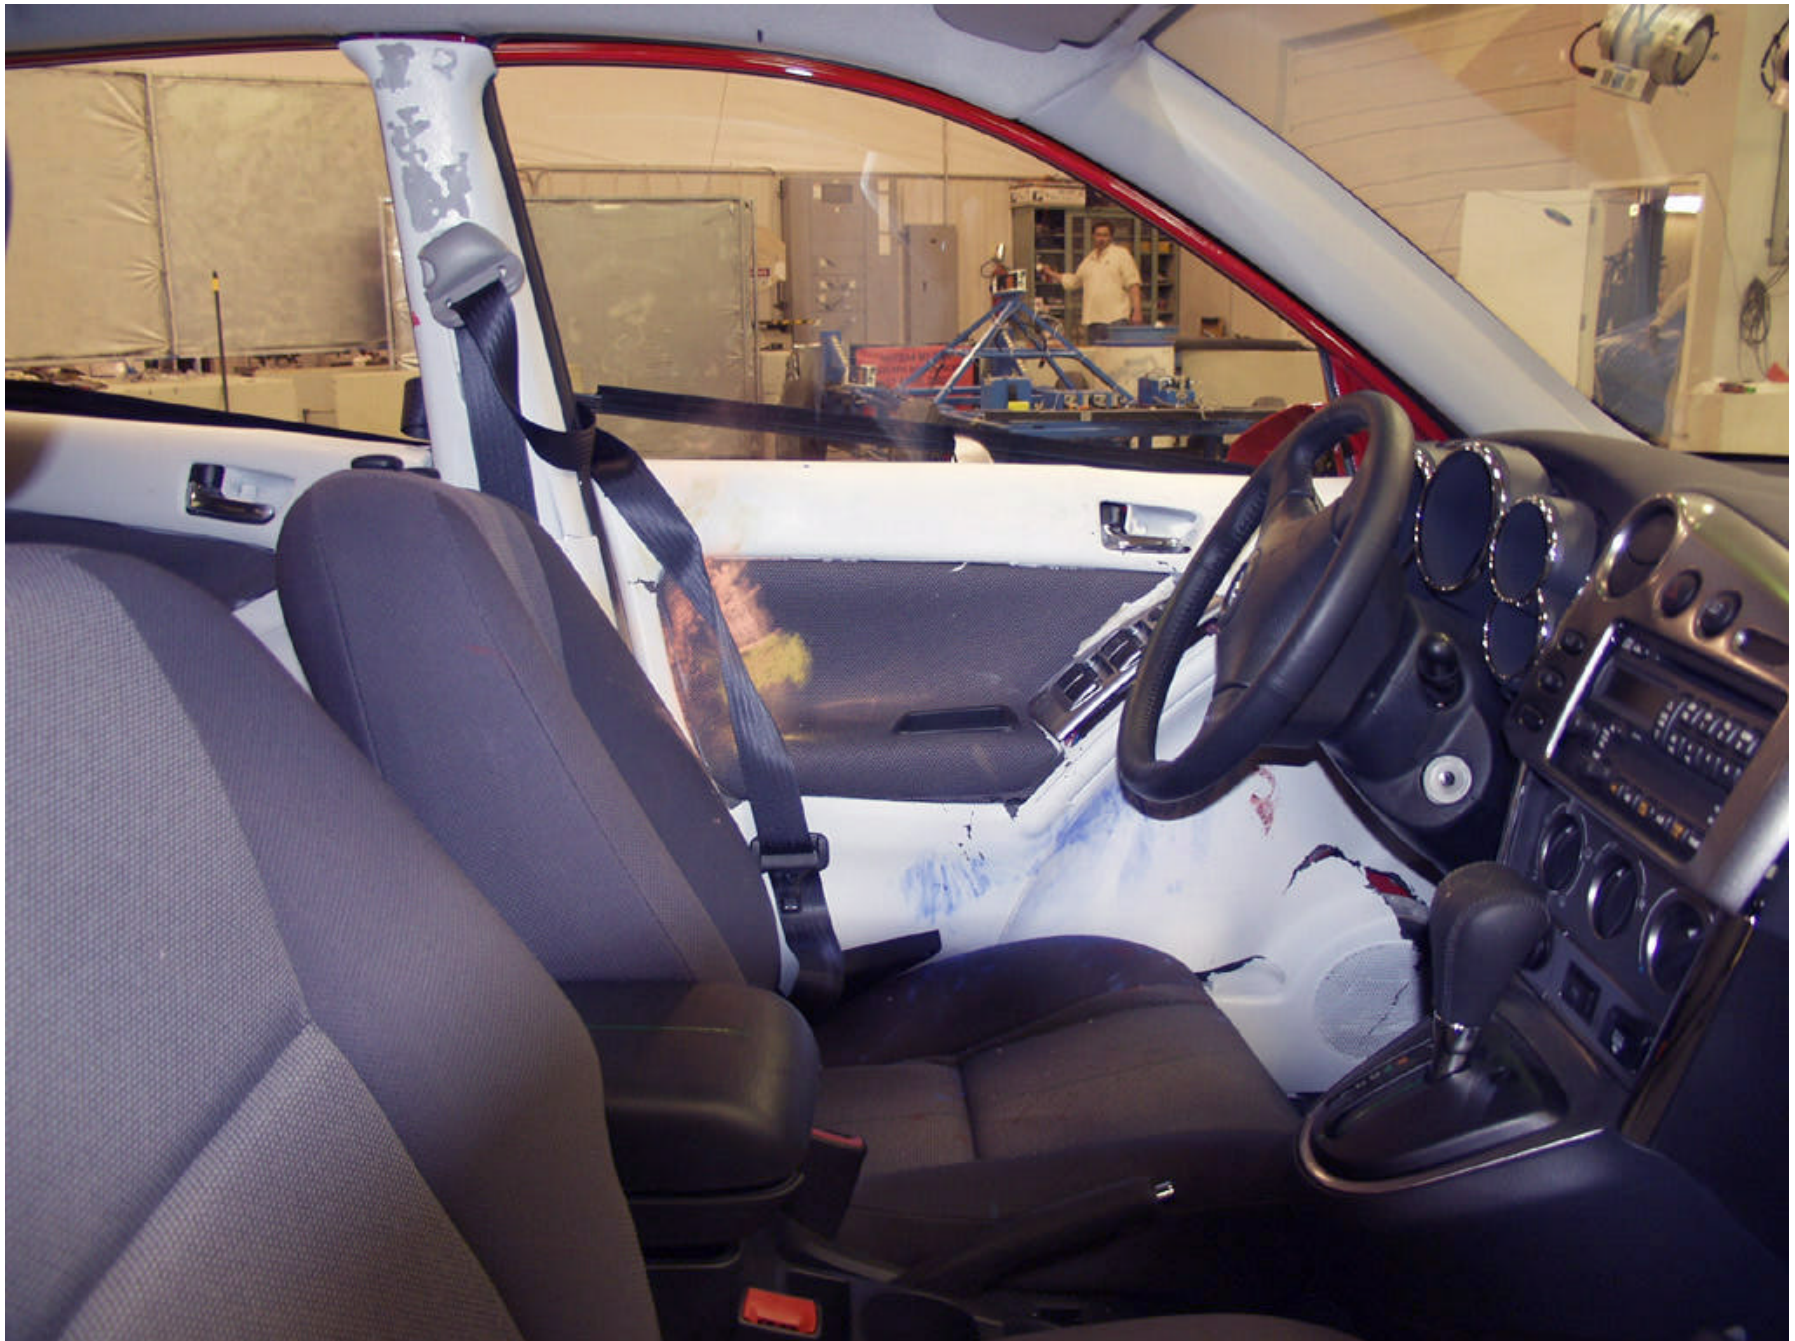
Figure A-26: POST-TEST INTERIOR OF FRONT DOOR SHOWING SID IMPACT LOCATIONS

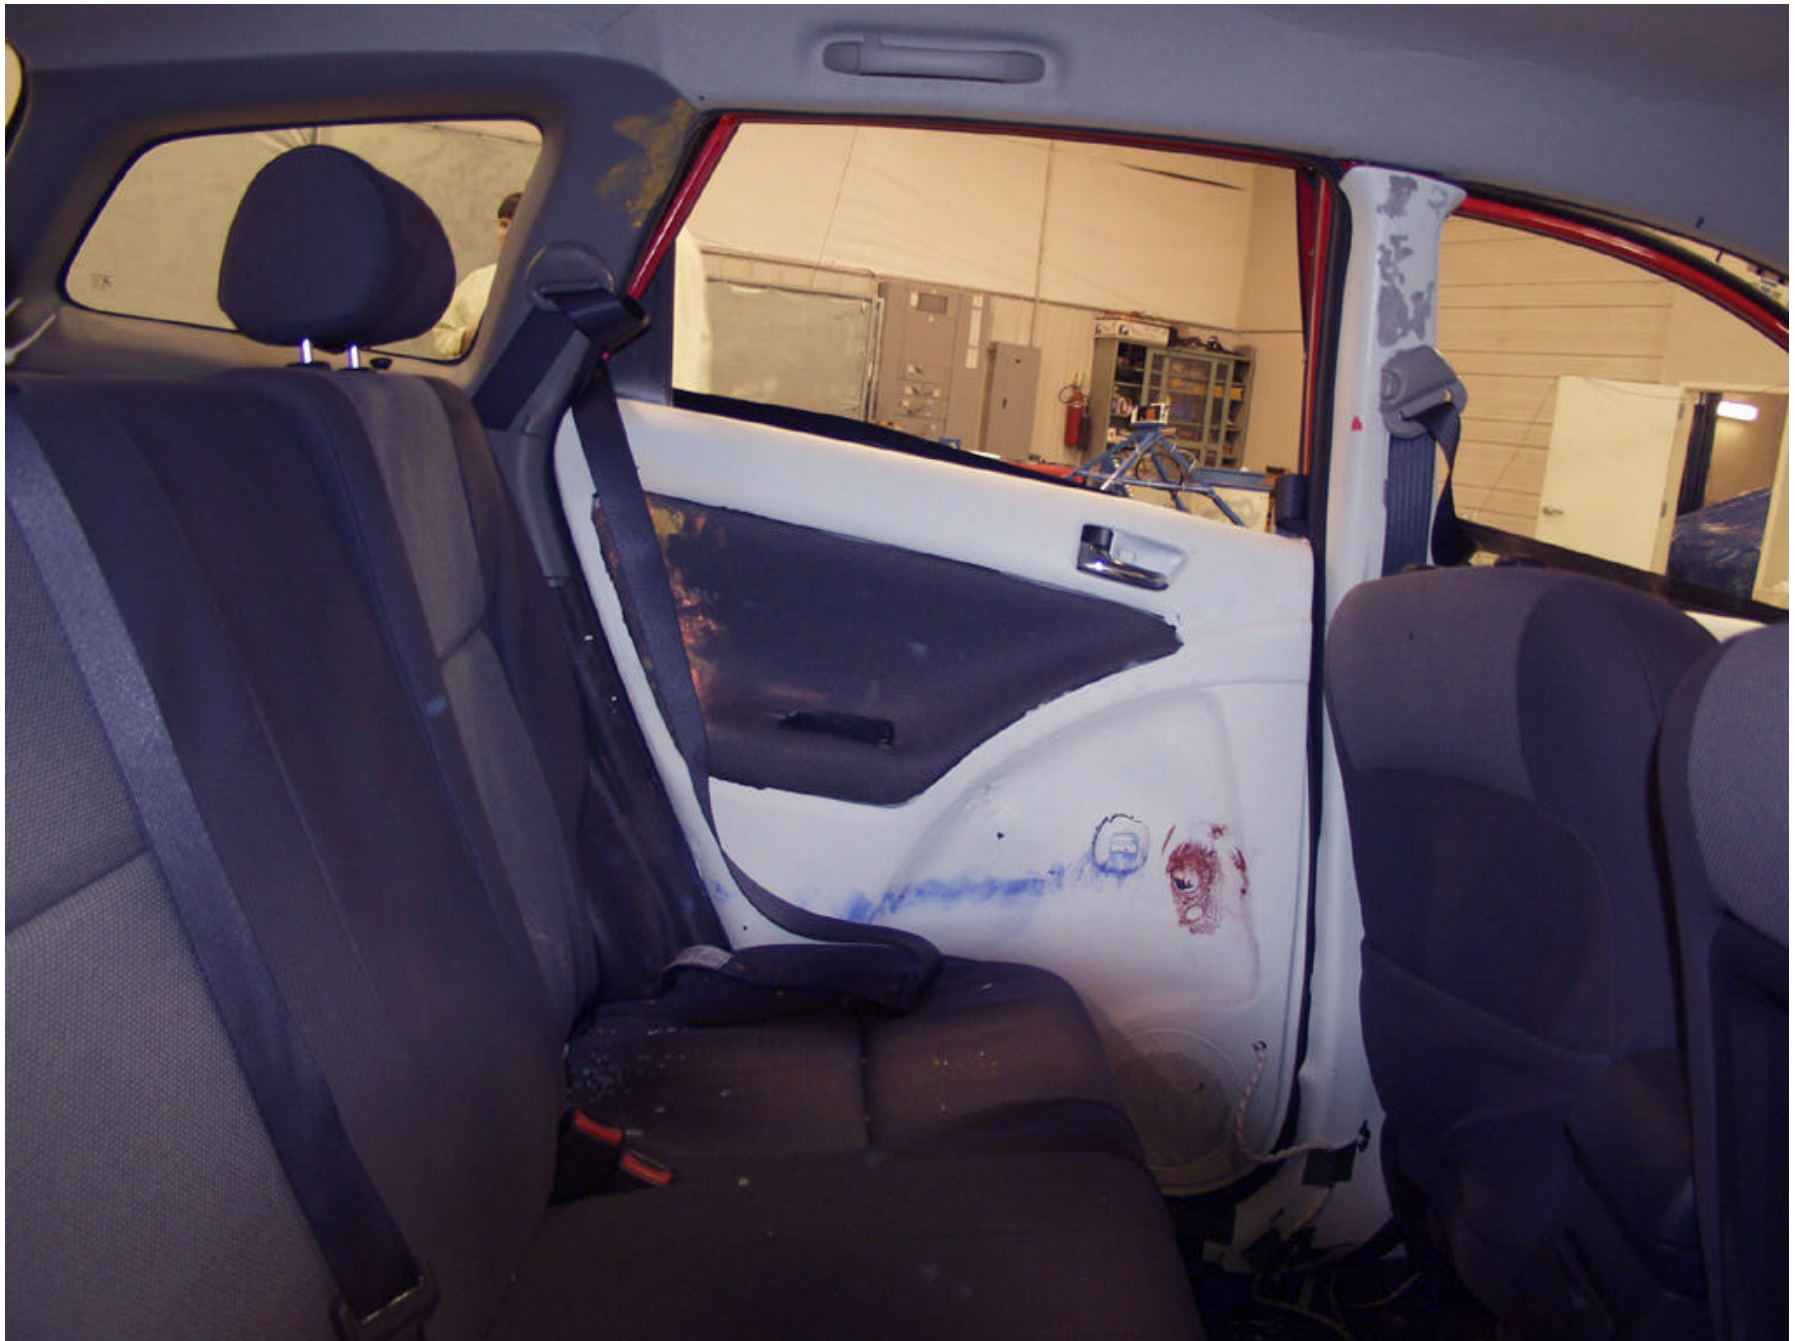
Figure A-28: POST-TEST INTERIOR OF REAR DOOR SHOWING SID IMPACT LOCATIONS

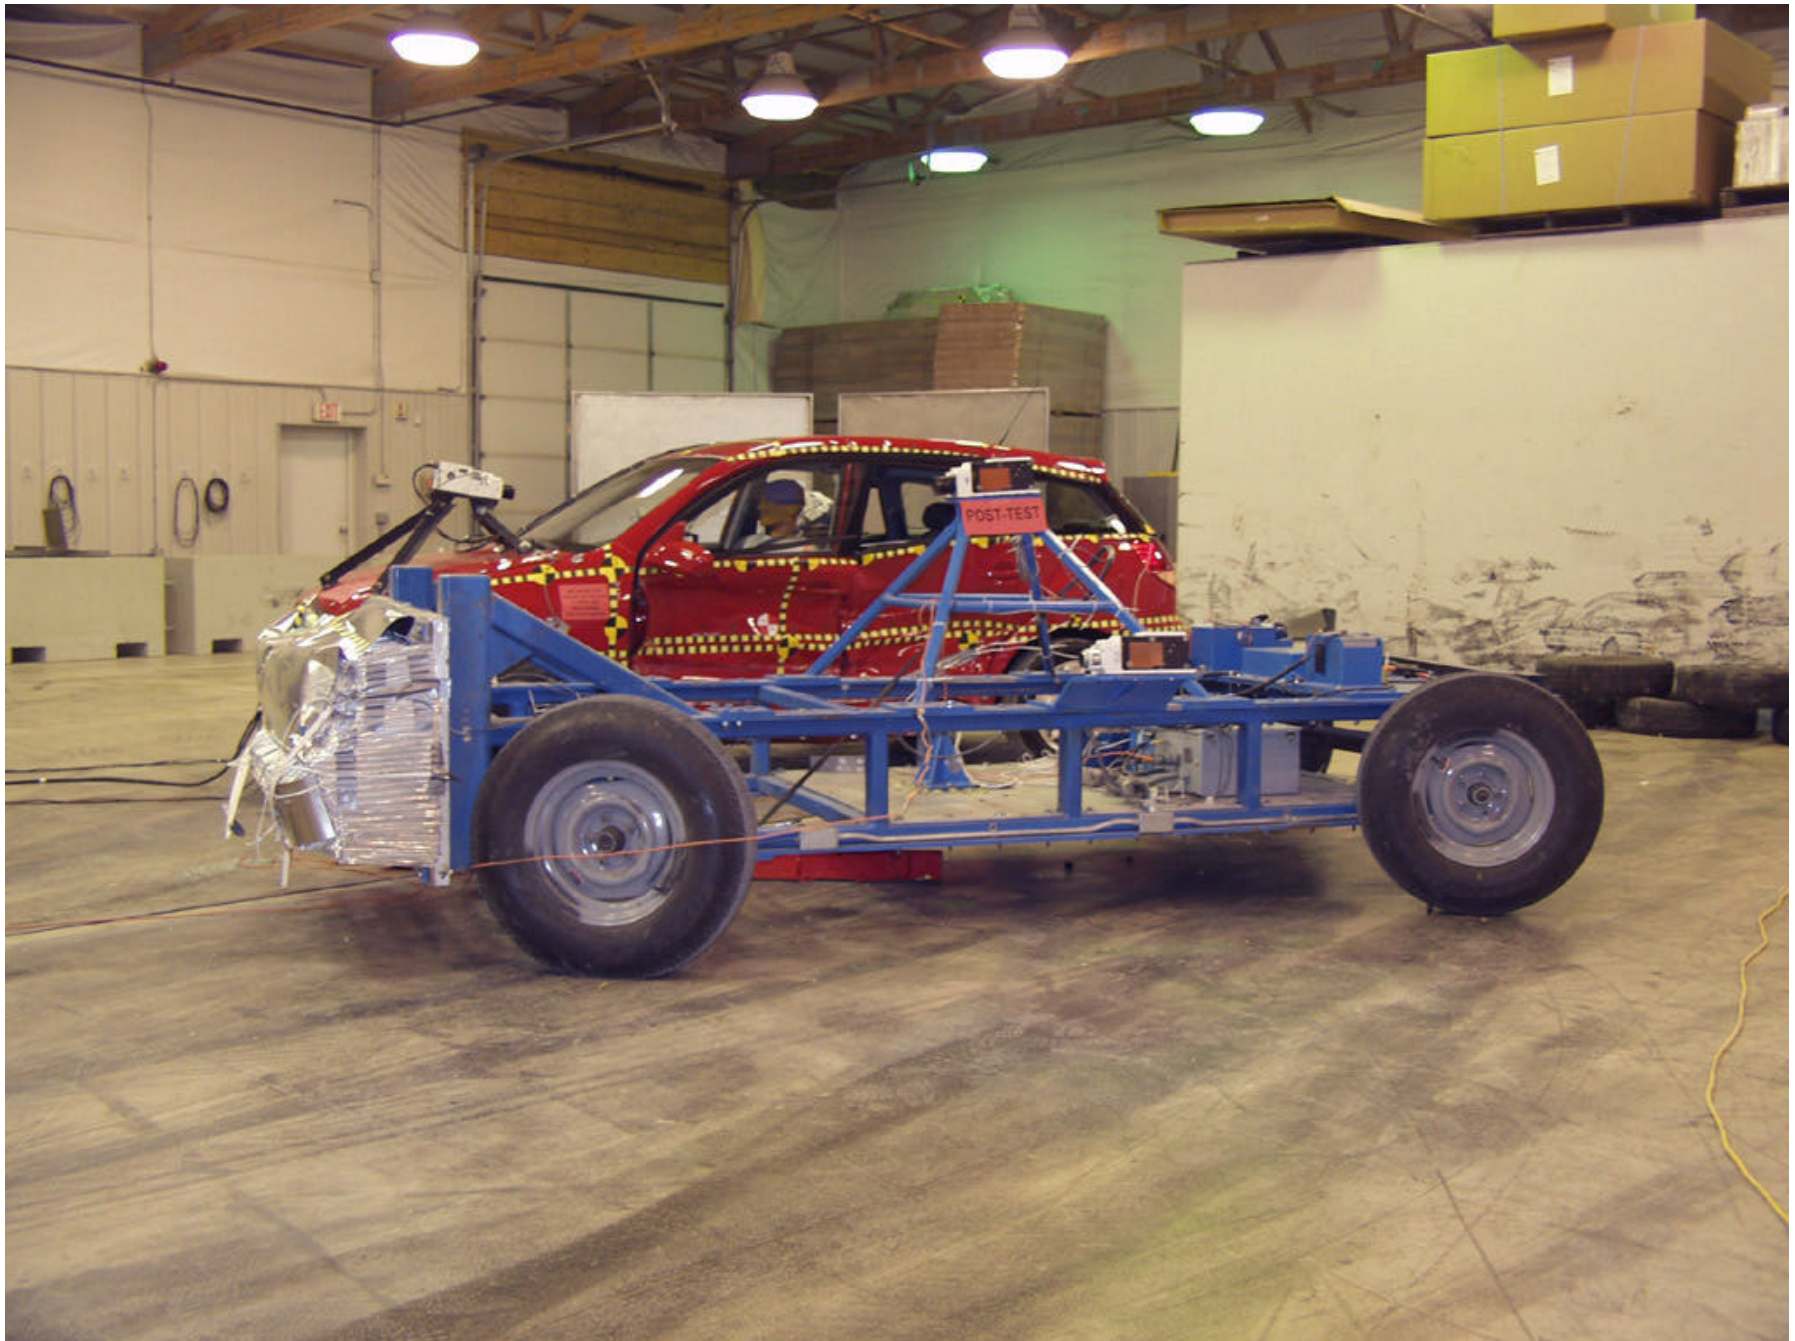
Figure A-30: POST-TEST LEFT SIDE VIEW OF MDB

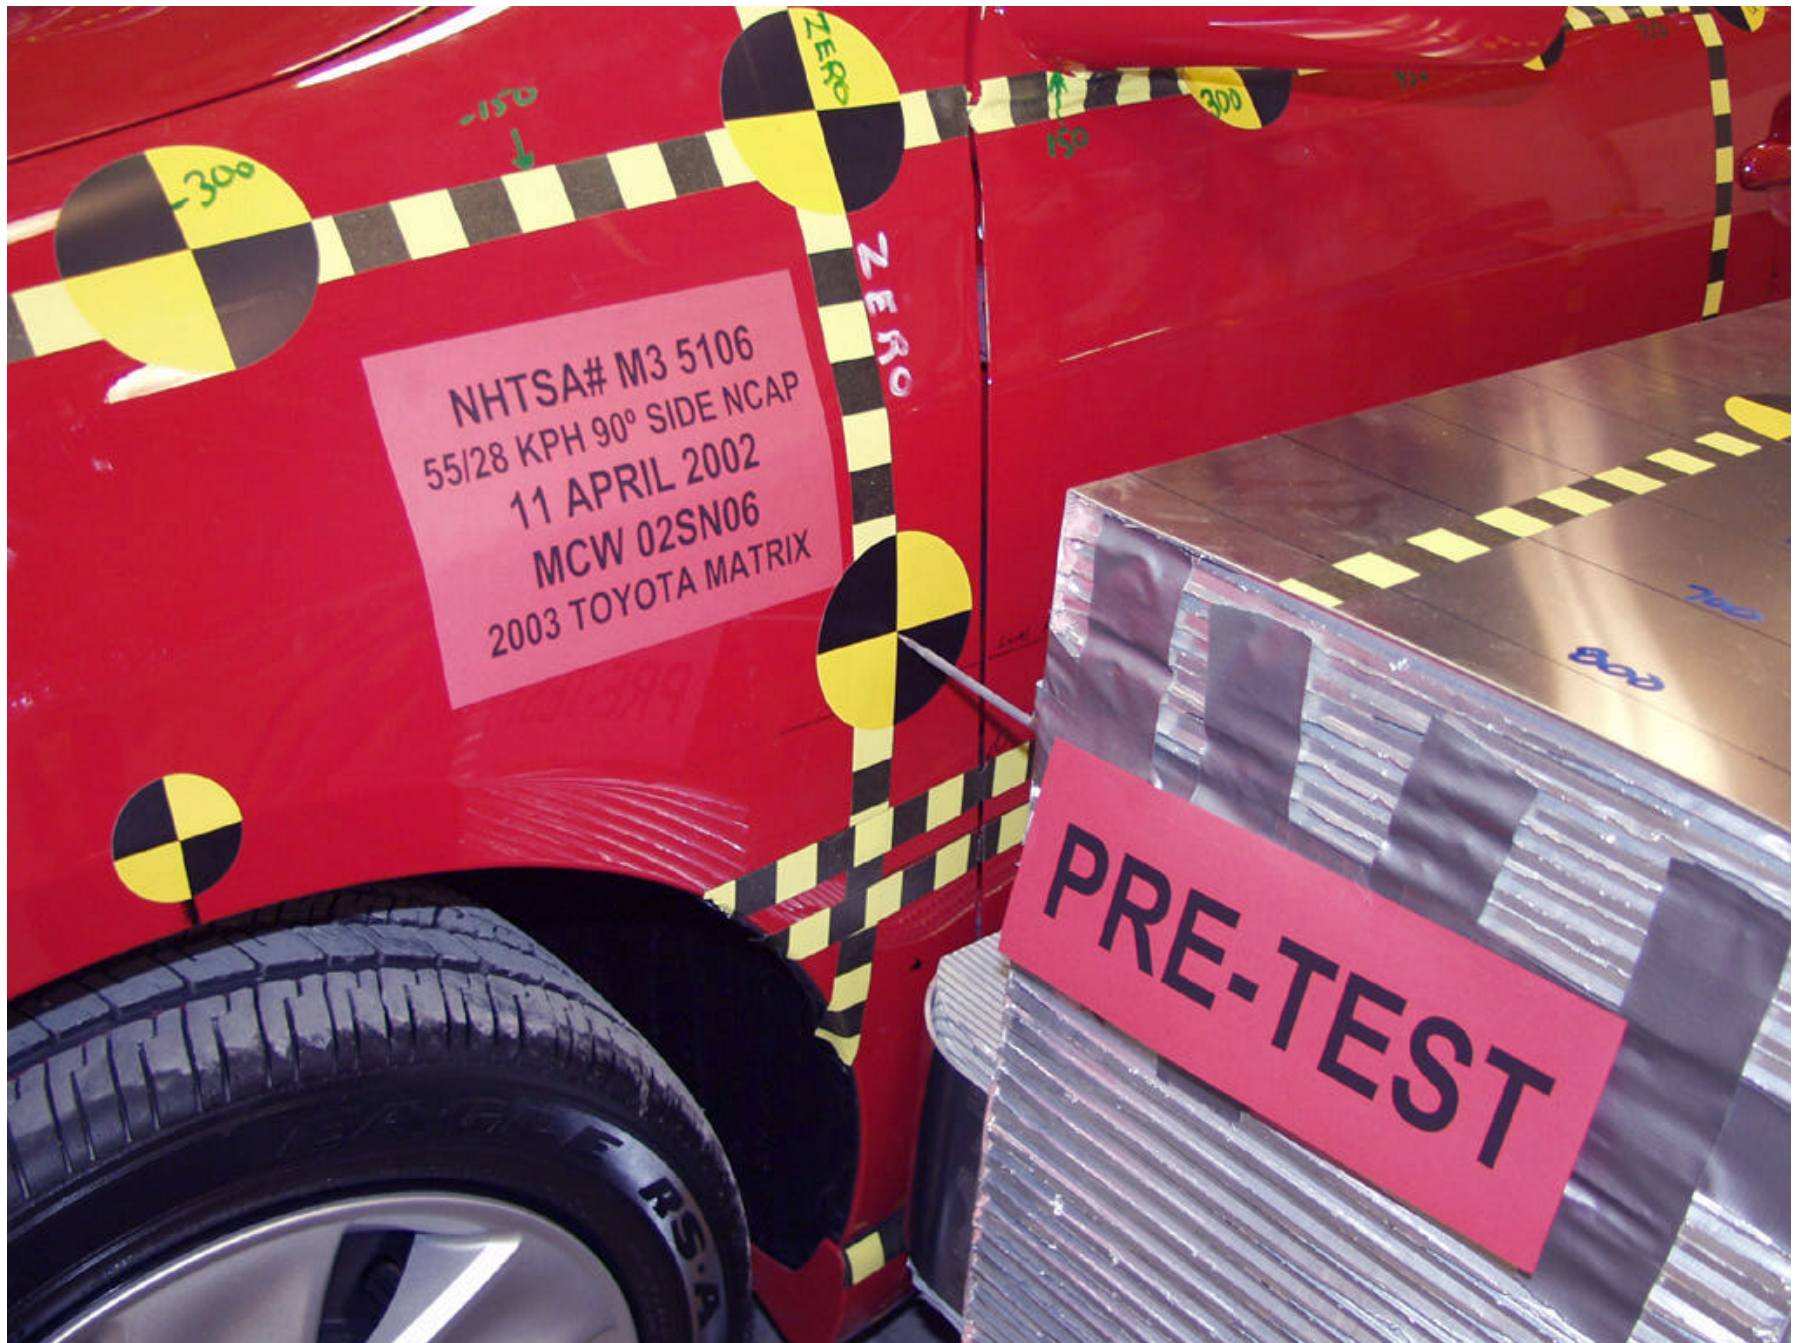
Figure A-35: PRE-TEST CLOSE-UP OF IMPACT POINT TARGET SHOWING WELDING ROD

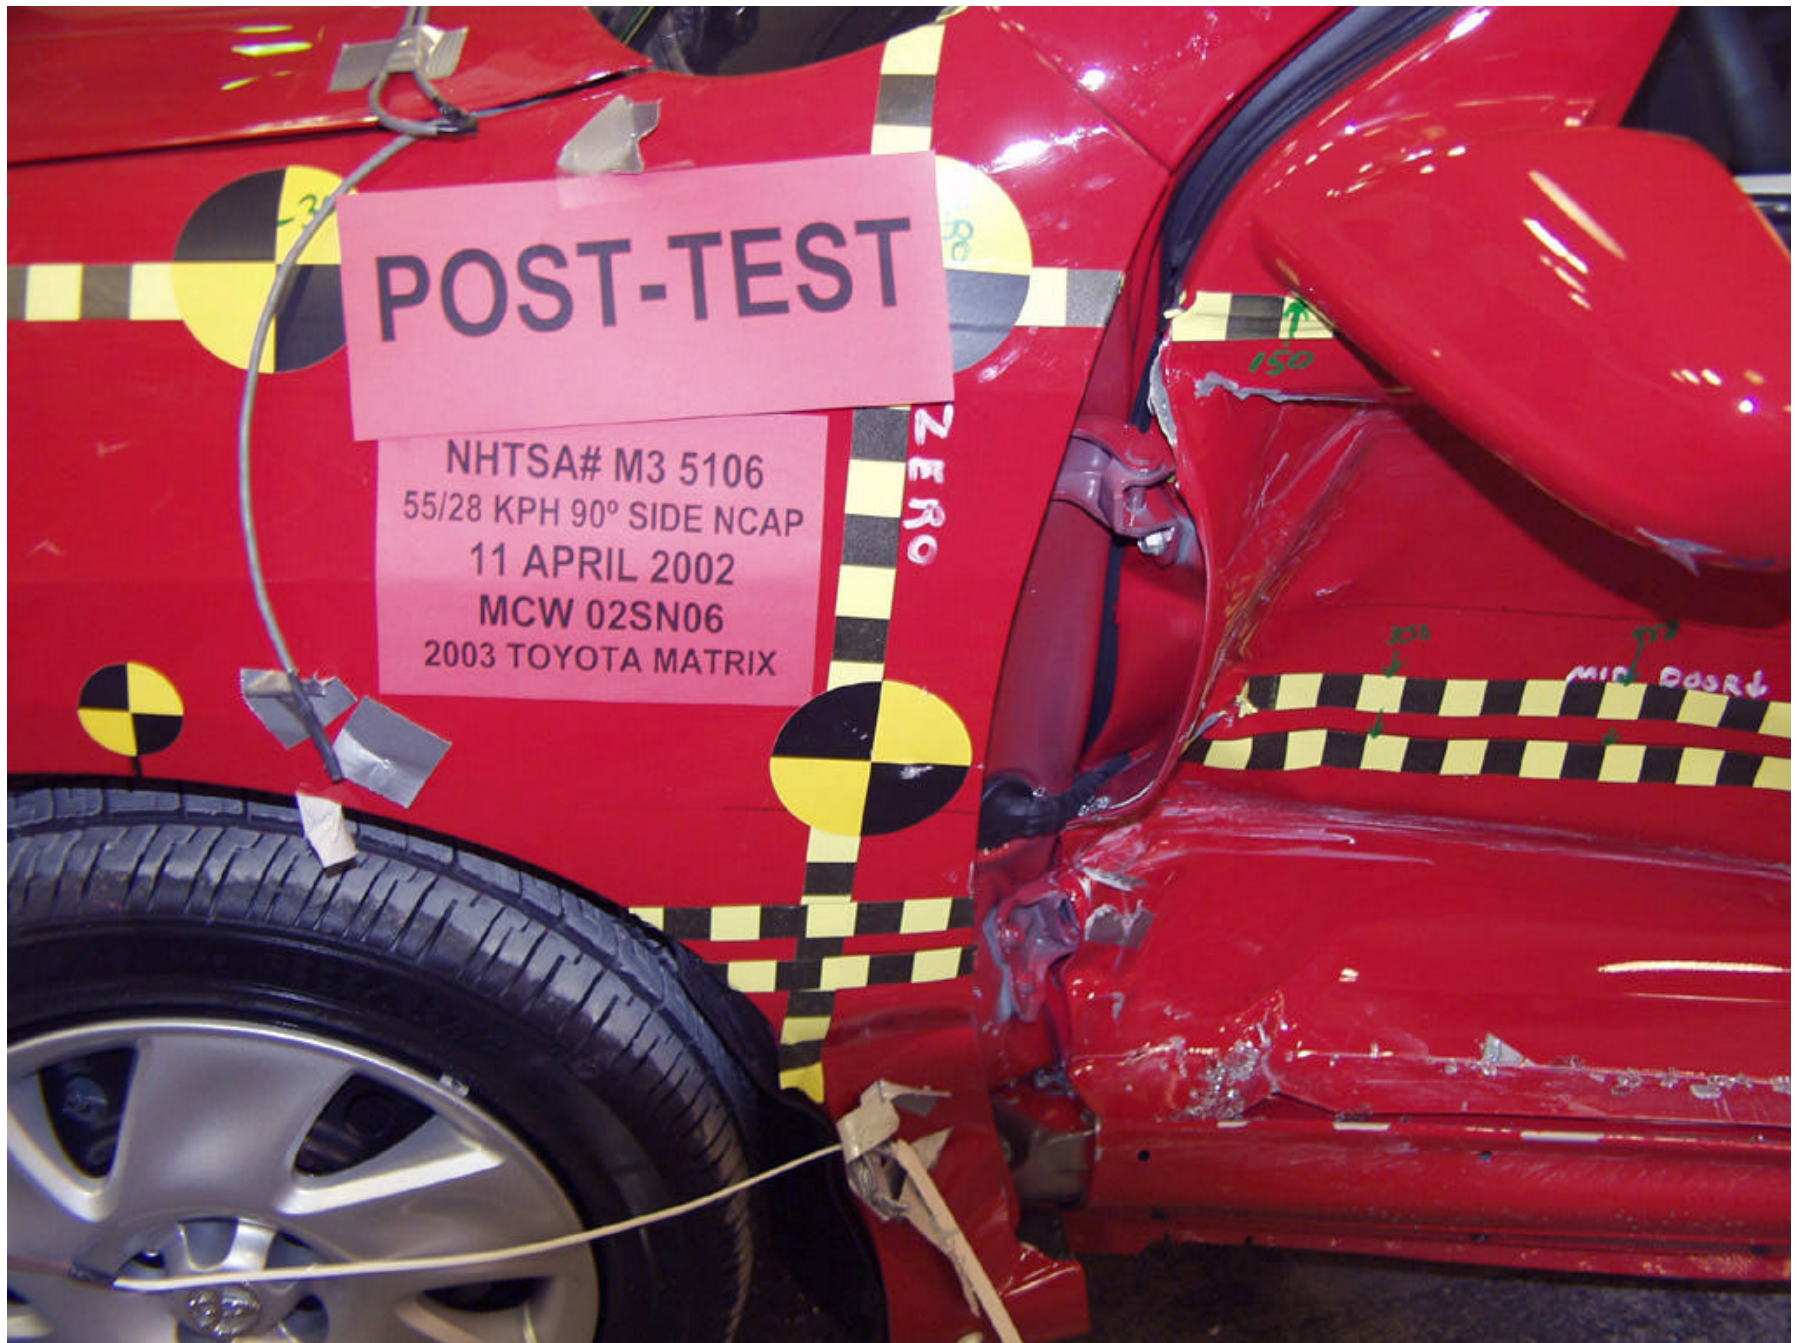
Figure A-36: POST-TEST CLOSE-UP OF IMPACT POINT TARGET

Actual Impact Point is 20 mm rearward of nominal impact reference line (lateral)

Actual Impact Point is 5 mm below nominal impact line (vertical)
