**REPORT NUMBER: TO11-MGA-2002-001**

**FULL SCALE SIDE IMPACT POLE TESTS OF BASELINE VEHICLES**

**Volvo  
1999 Volvo S80 Sedan  
NHTSA NUMBER: RX5904**

**FINAL REPORT**

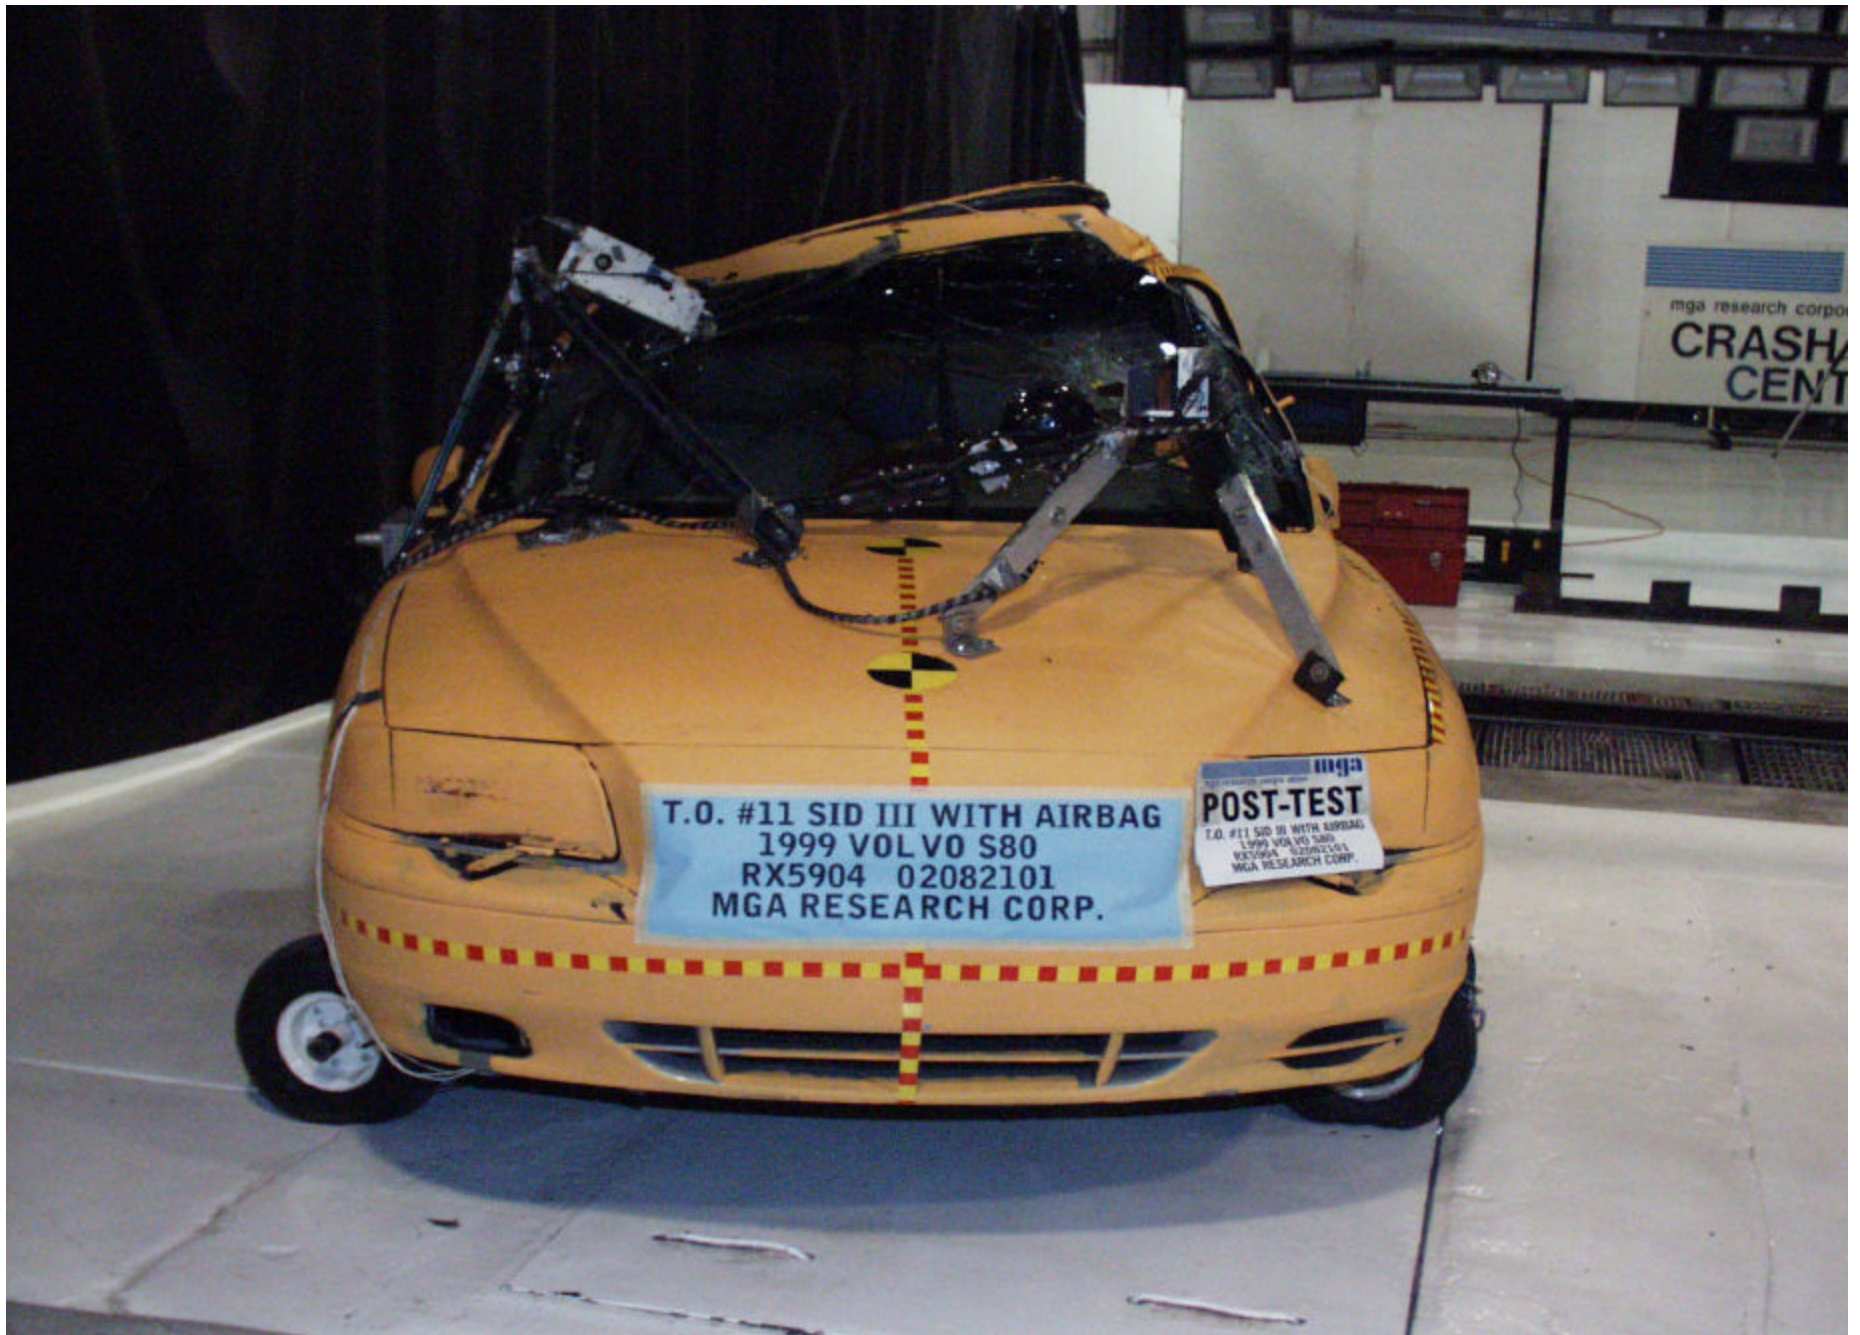
Post-Test Front View of Test Vehicle

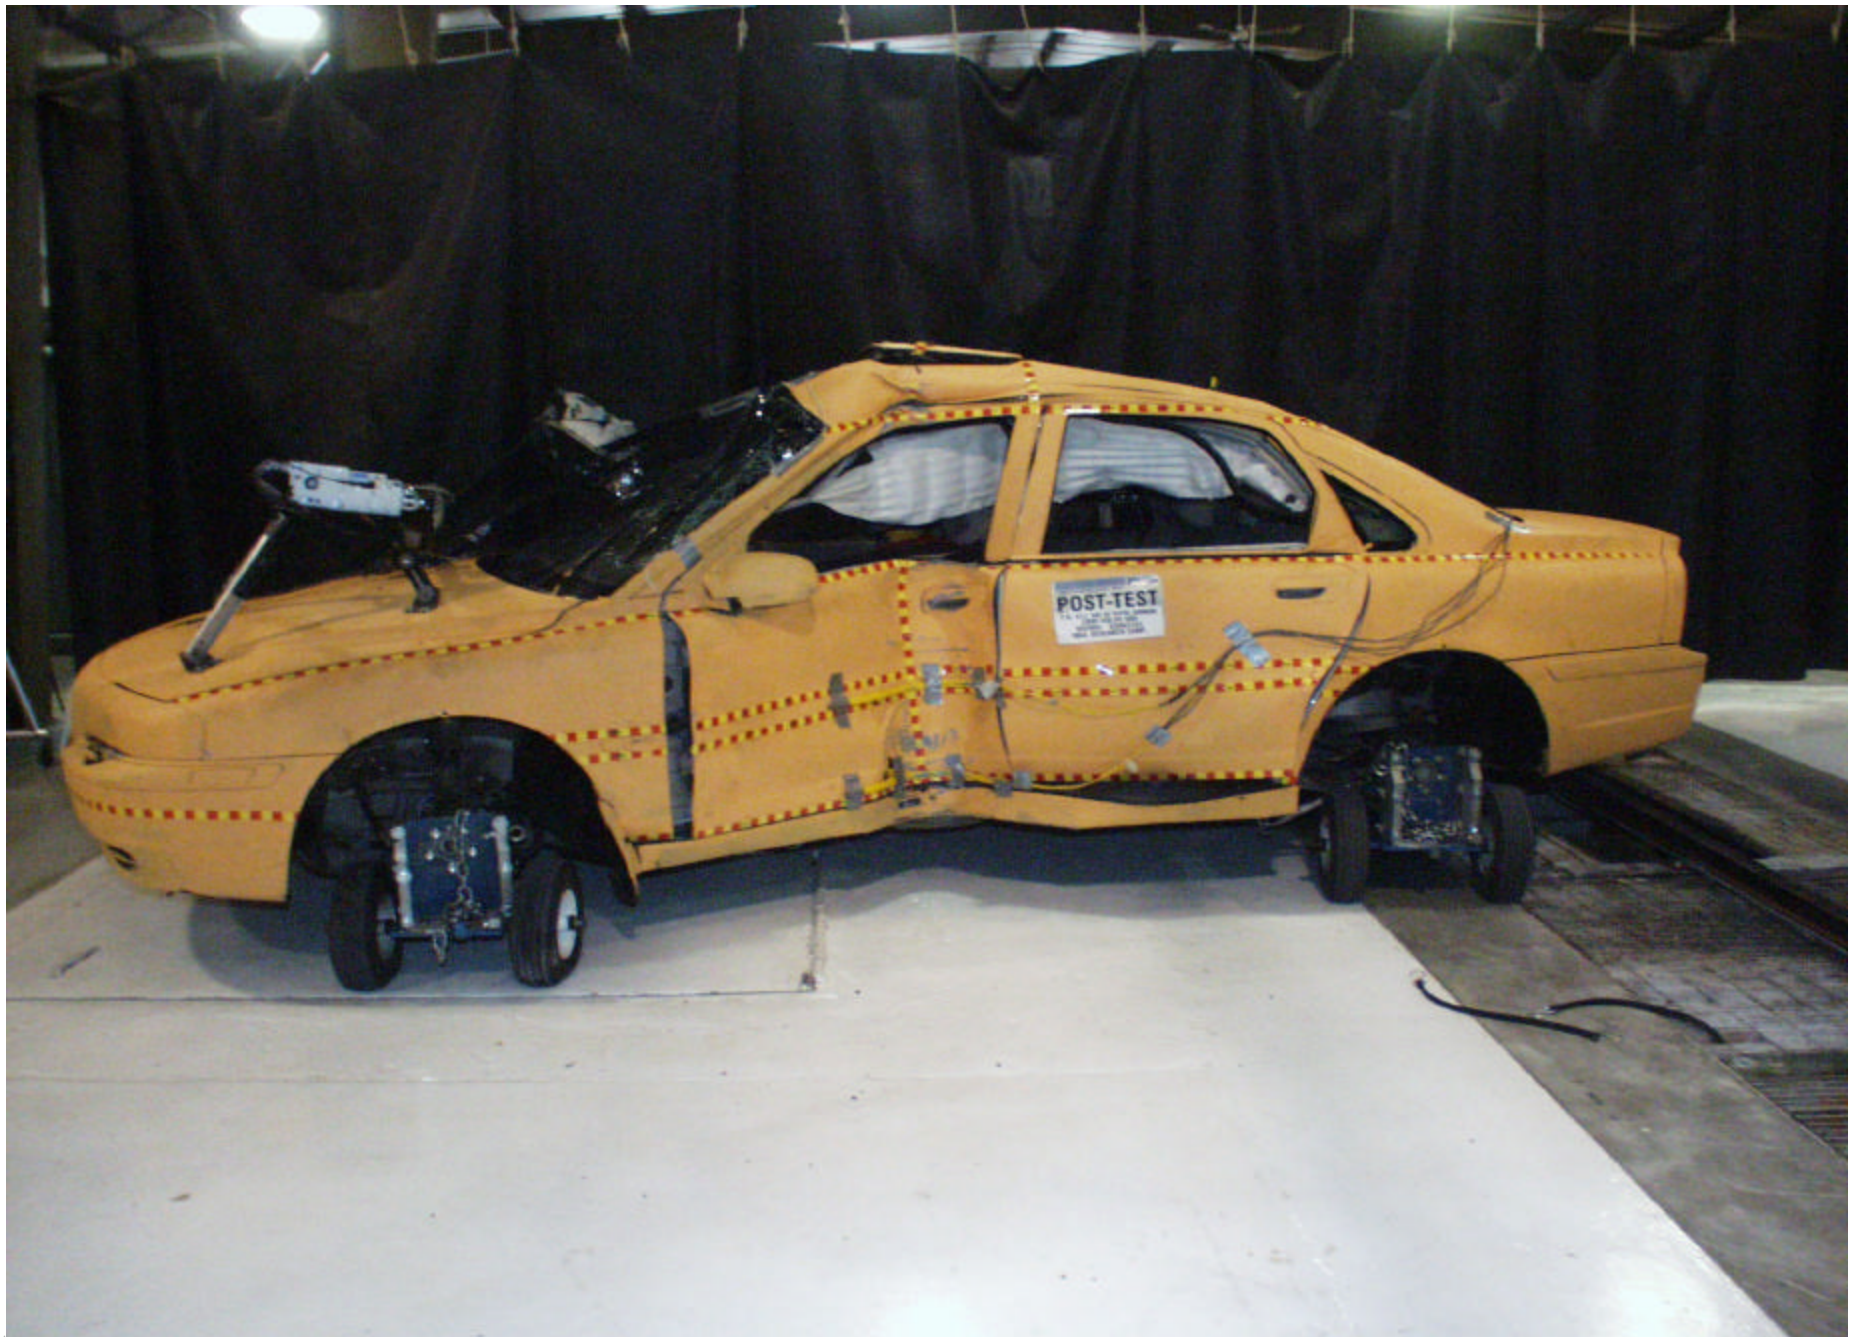
Post-Test Left Side View of Test Vehicle

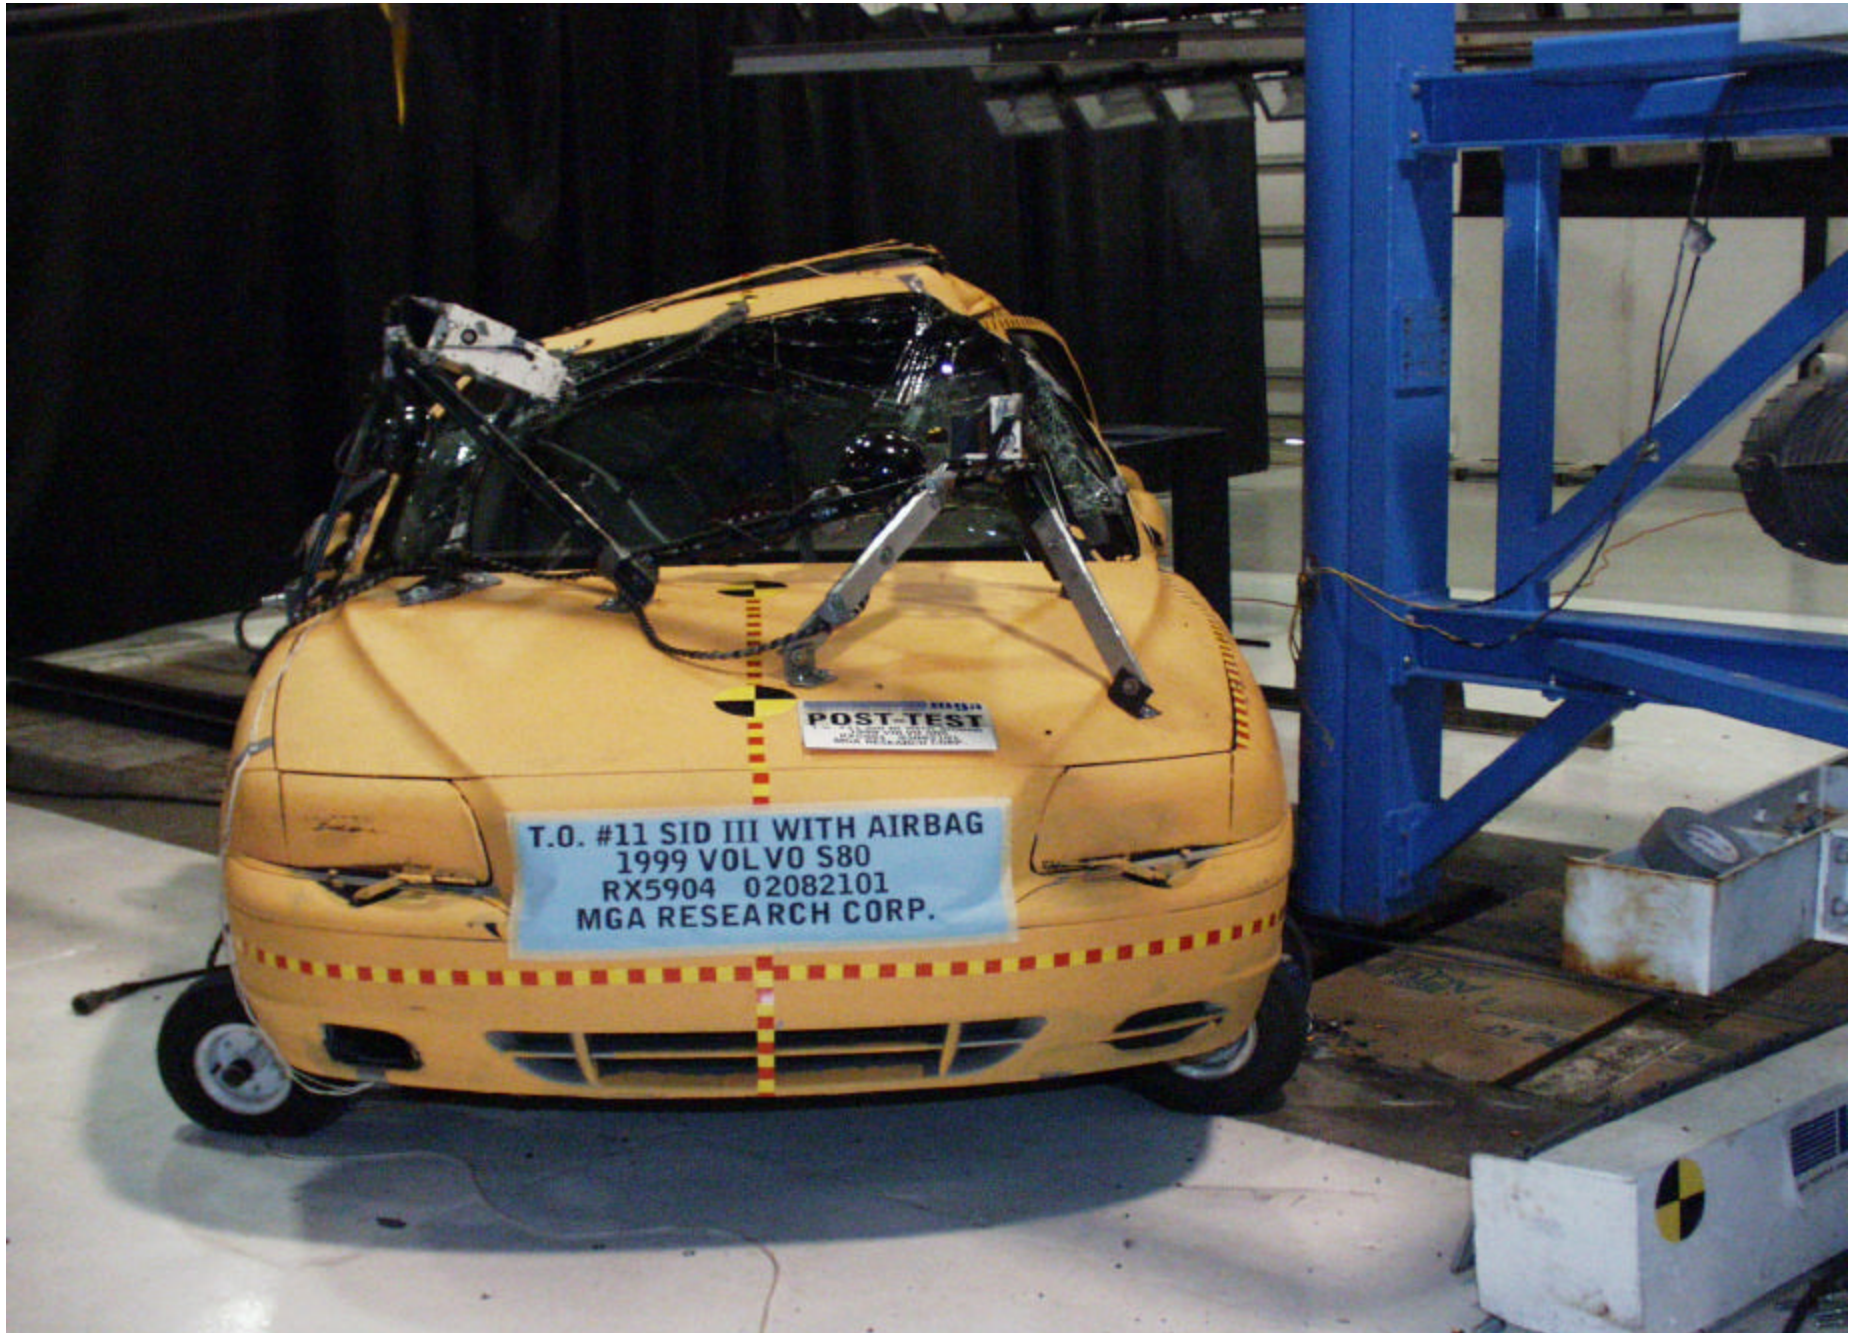
Post-Test Pole and Vehicle (left side)

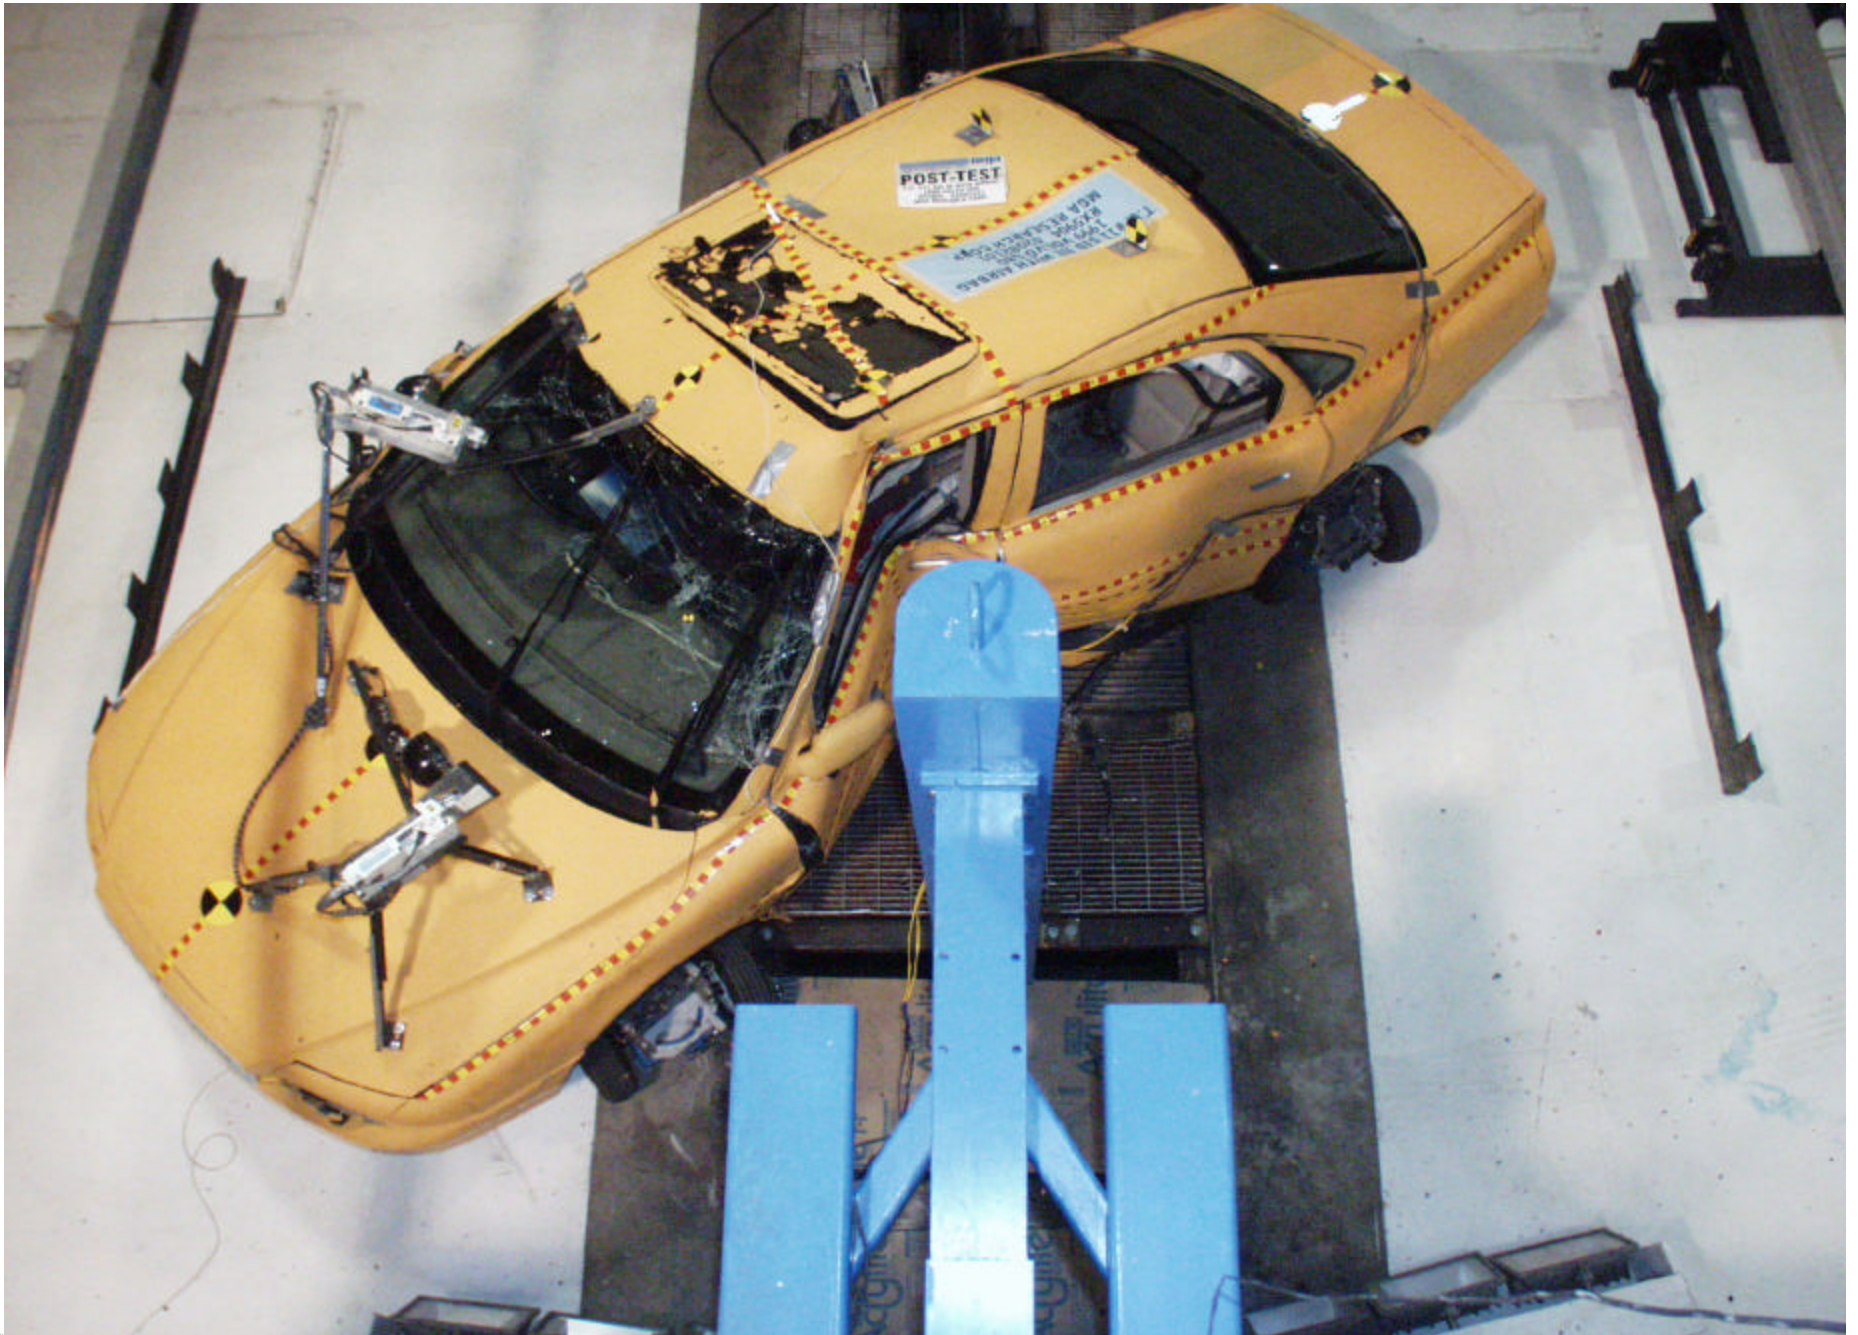
Post-Test Pole and Vehicle Overhead View

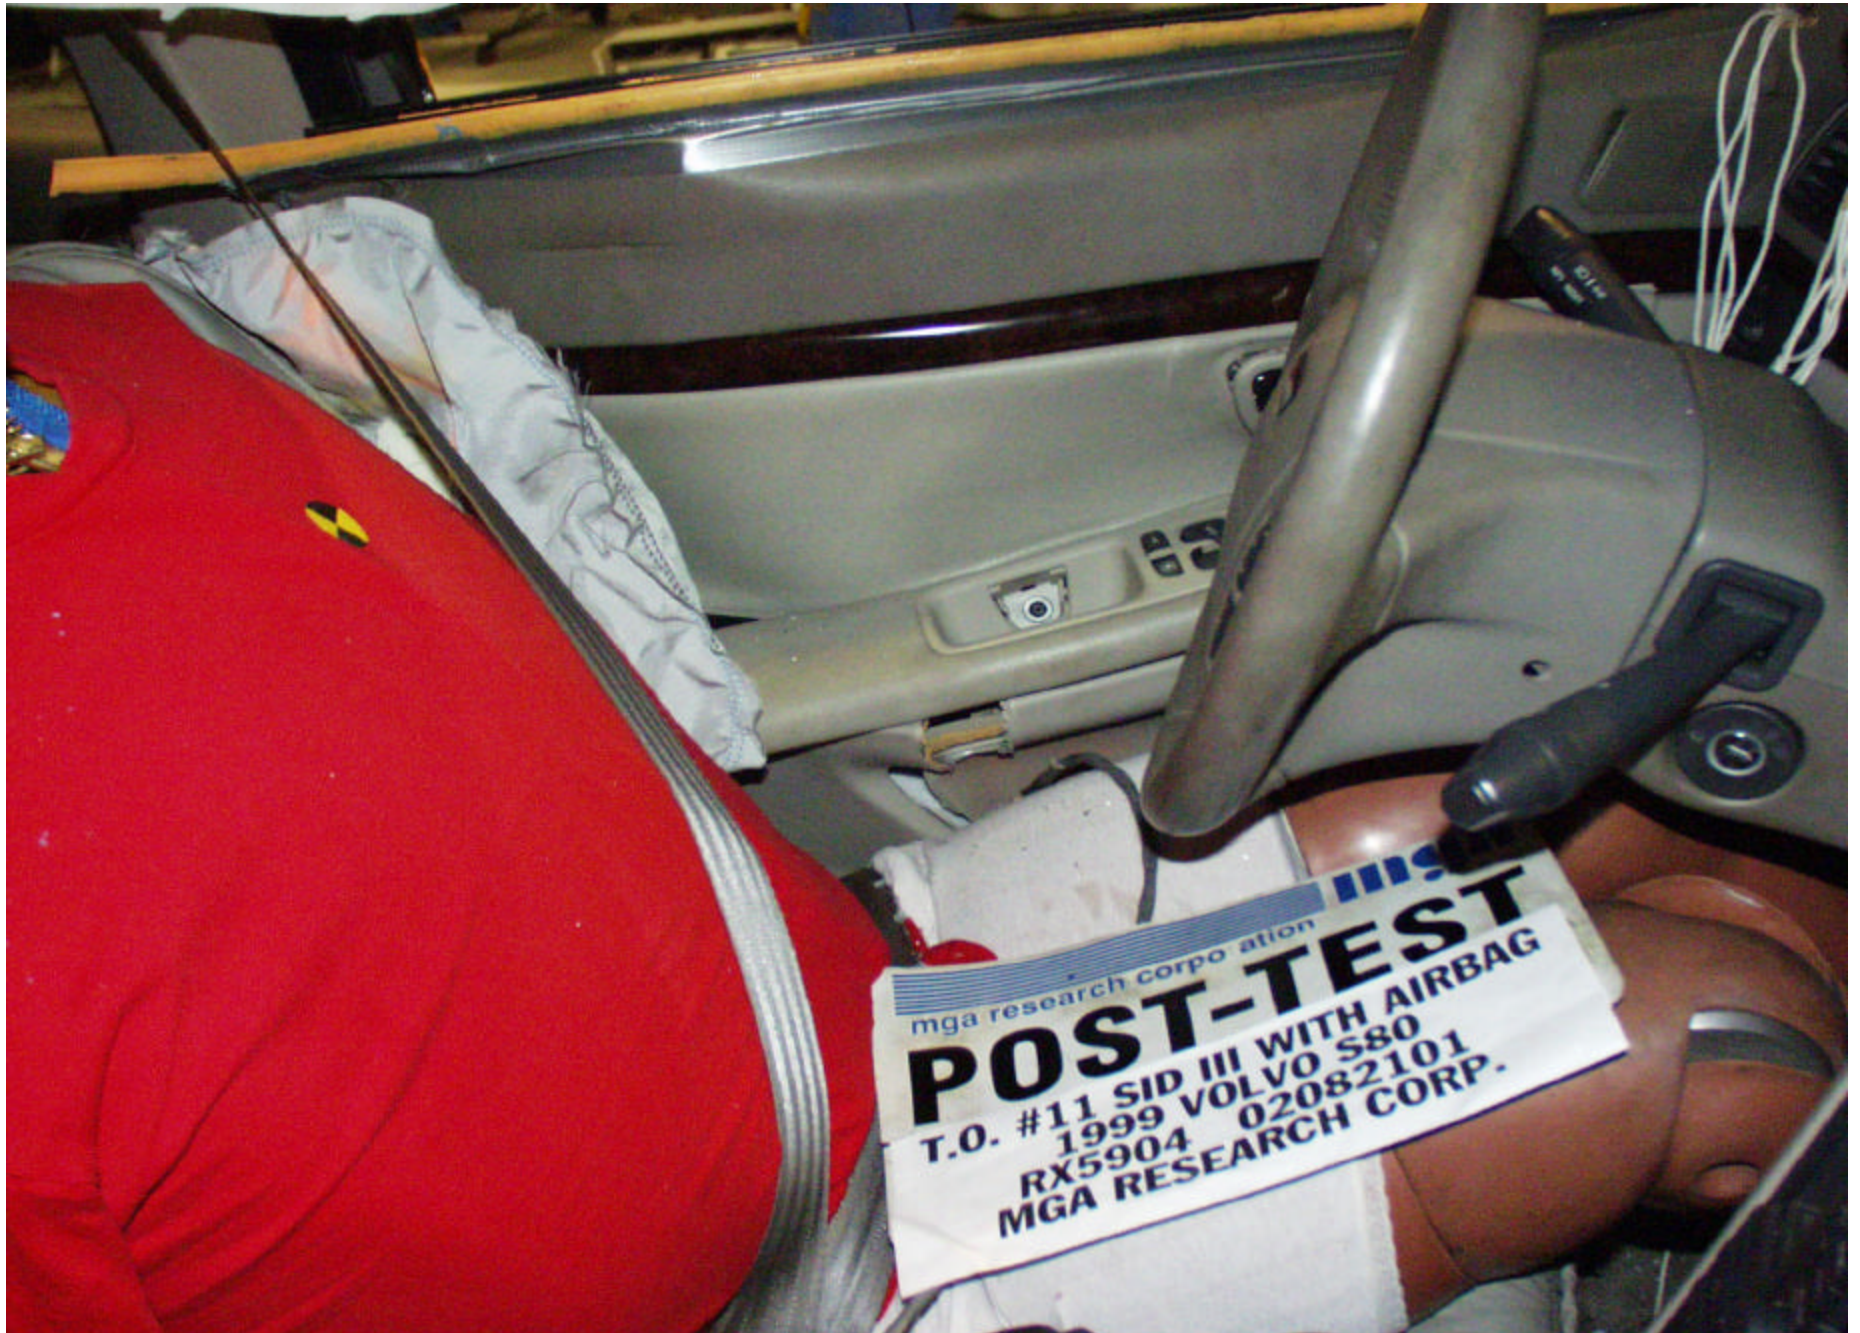
Post-Test Driver Dummy Contact

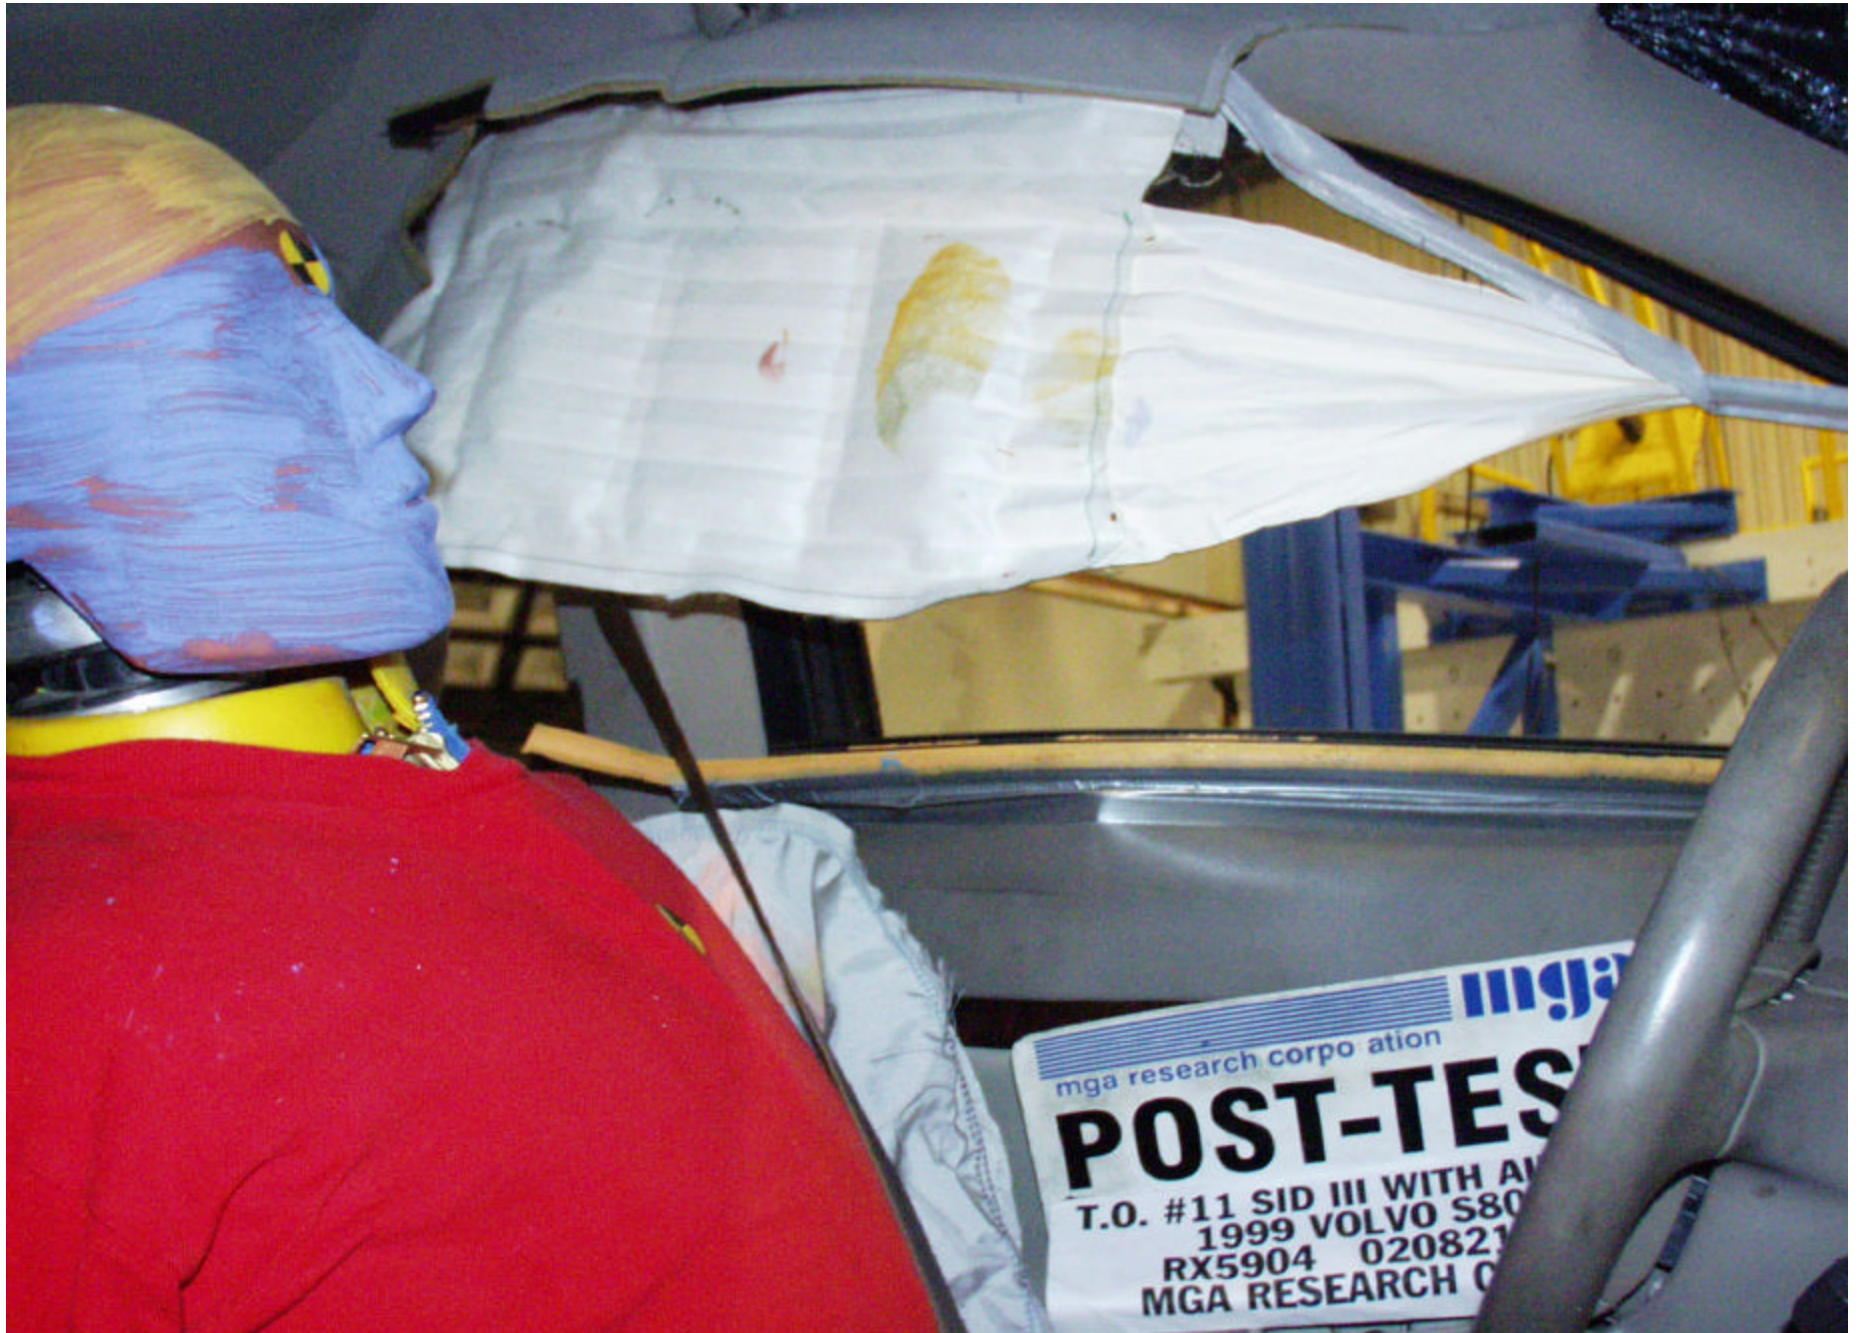
Post-Test Driver Dummy Head Contact

| Description | Left Front |
|---|---|
| Head Contact | Curtain airbag |

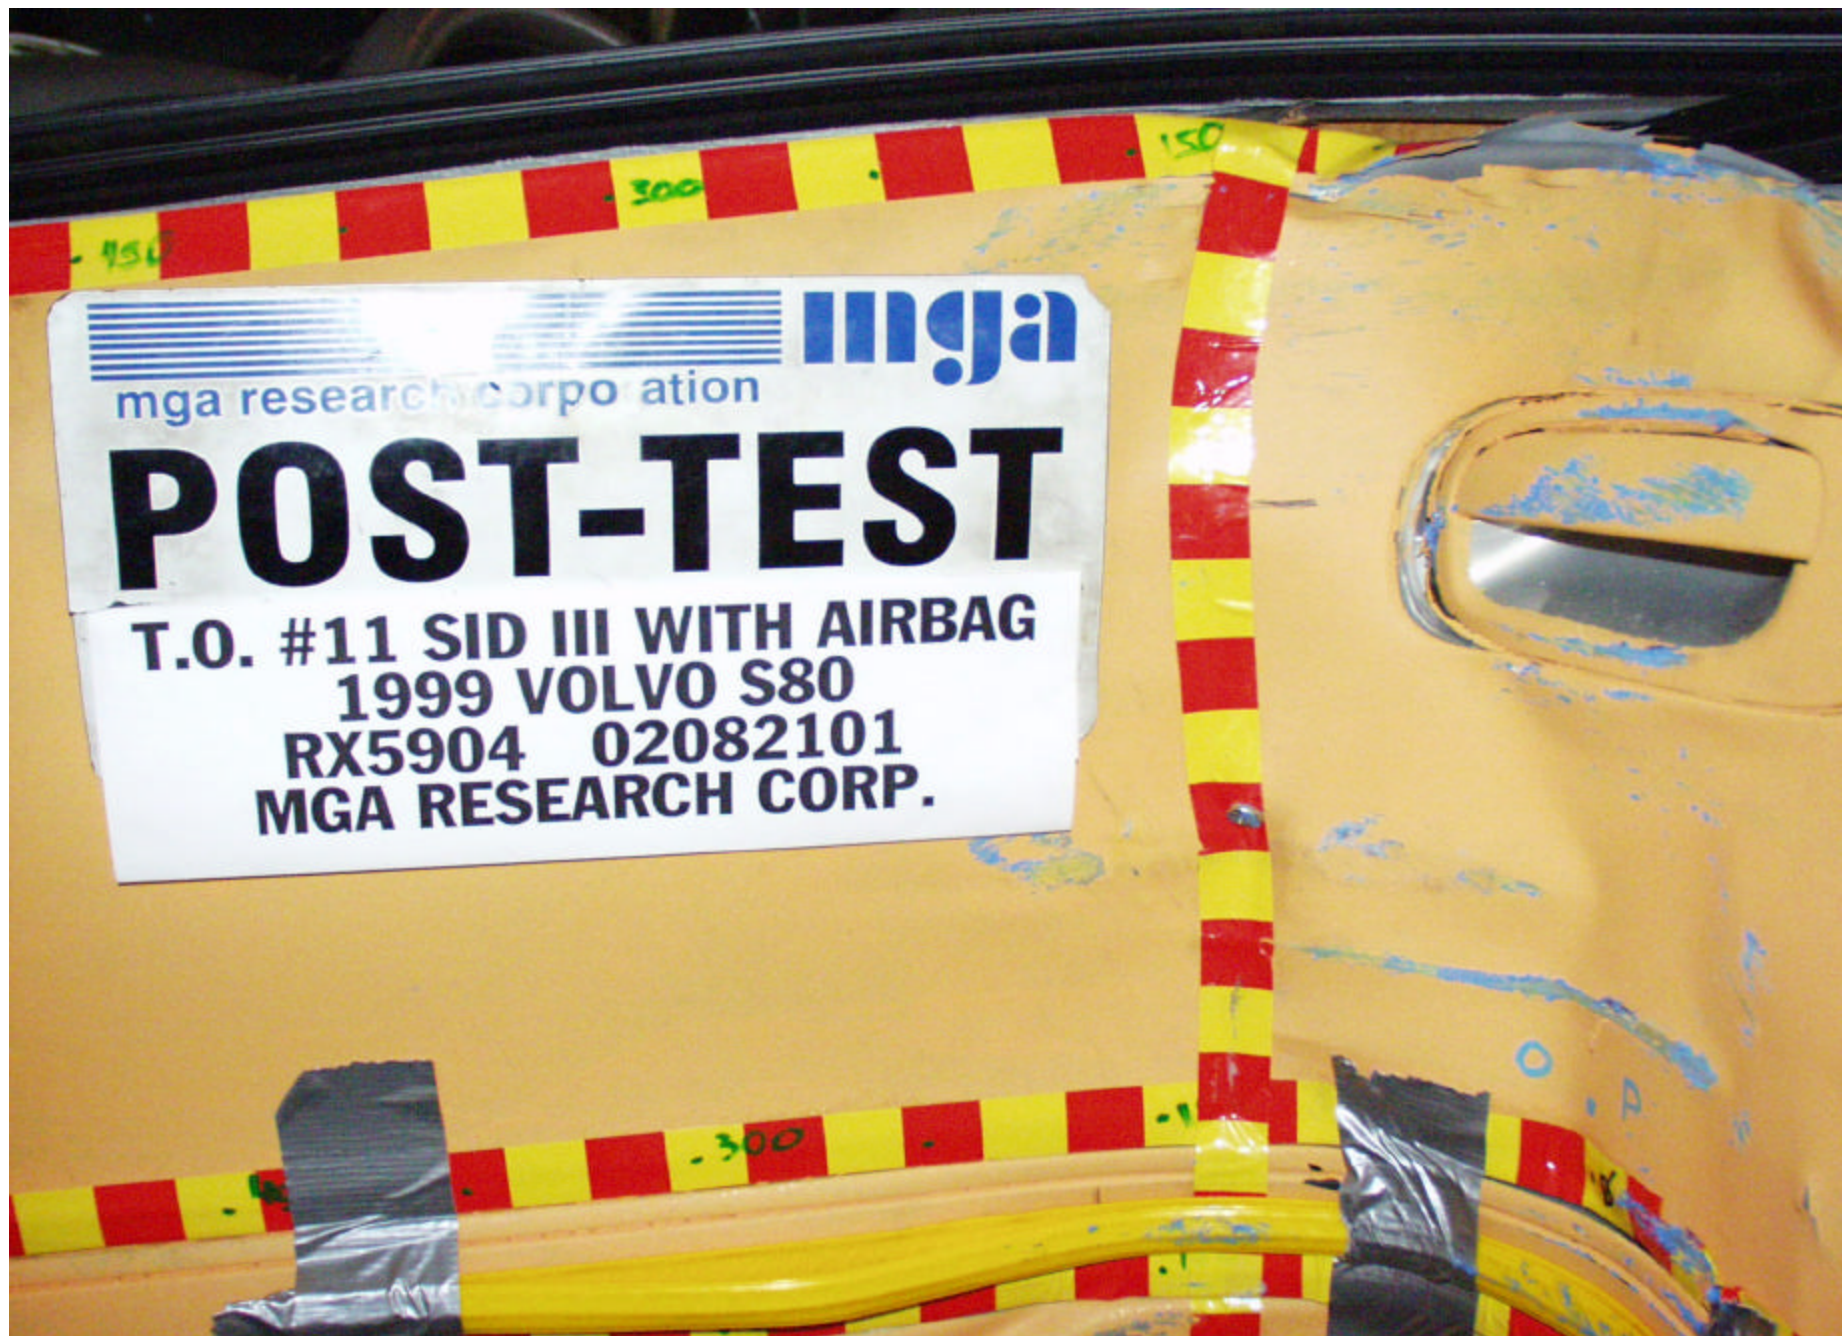
Post-Test Impact Point on Vehicle
