**Vehicle Research and Test Center**  
**2001 Mitsubishi Montero Sport into Left Front of**  
**1997 Honda Accord - 50% Offset - Oblique 30°**  
**TRC Inc. Test Number: 020921**

**Prepared By:**  
**Transportation Research Center Inc.**  
**10820 State Route 347**  
**East Liberty, OH 43319**

**Final Report**  
**October 2002**

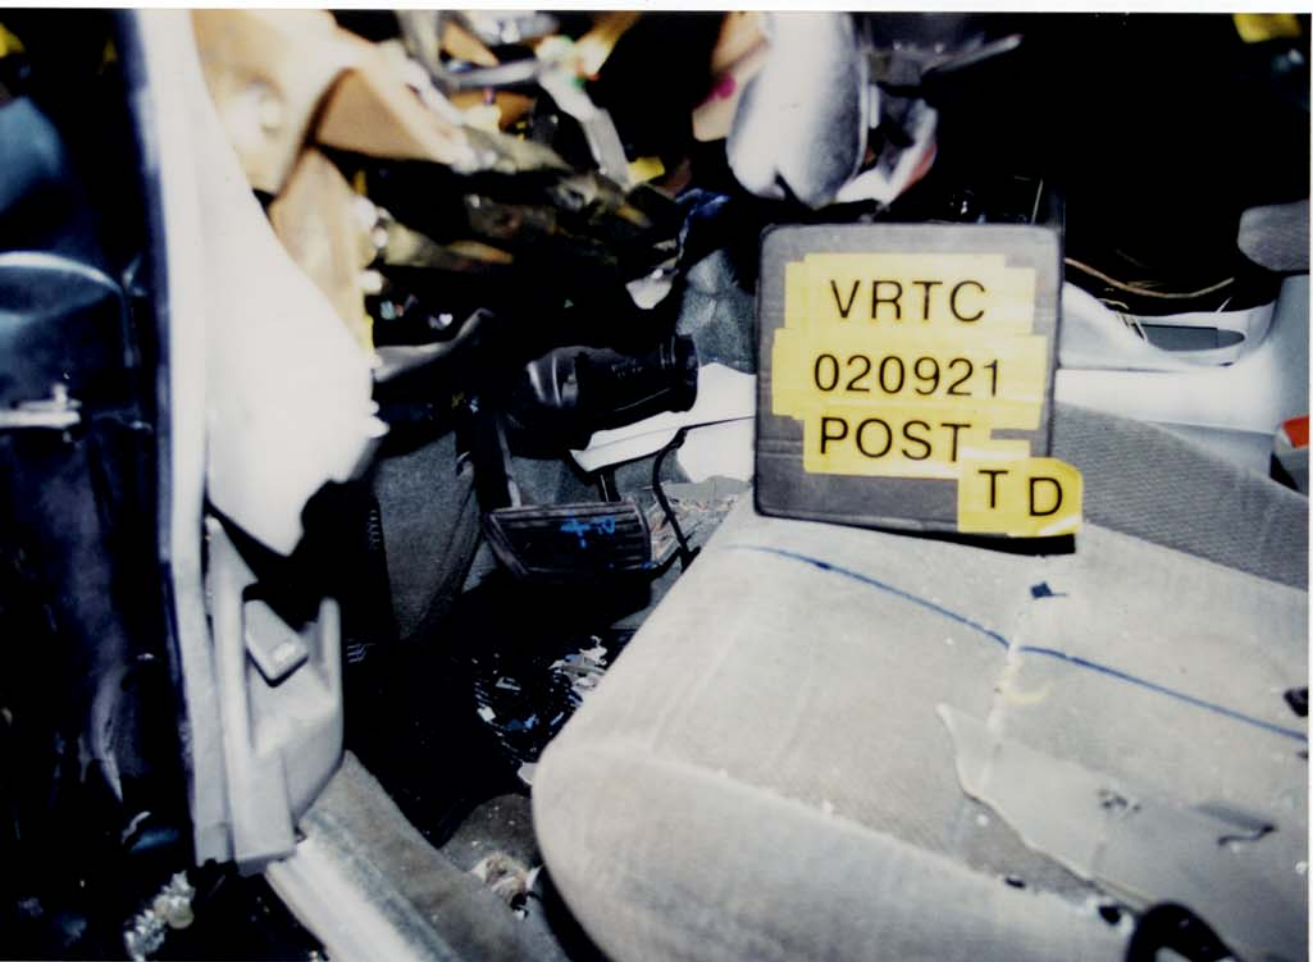
Figure A-90 Post-Test Target Vehicle Driver Floorpan Deformation

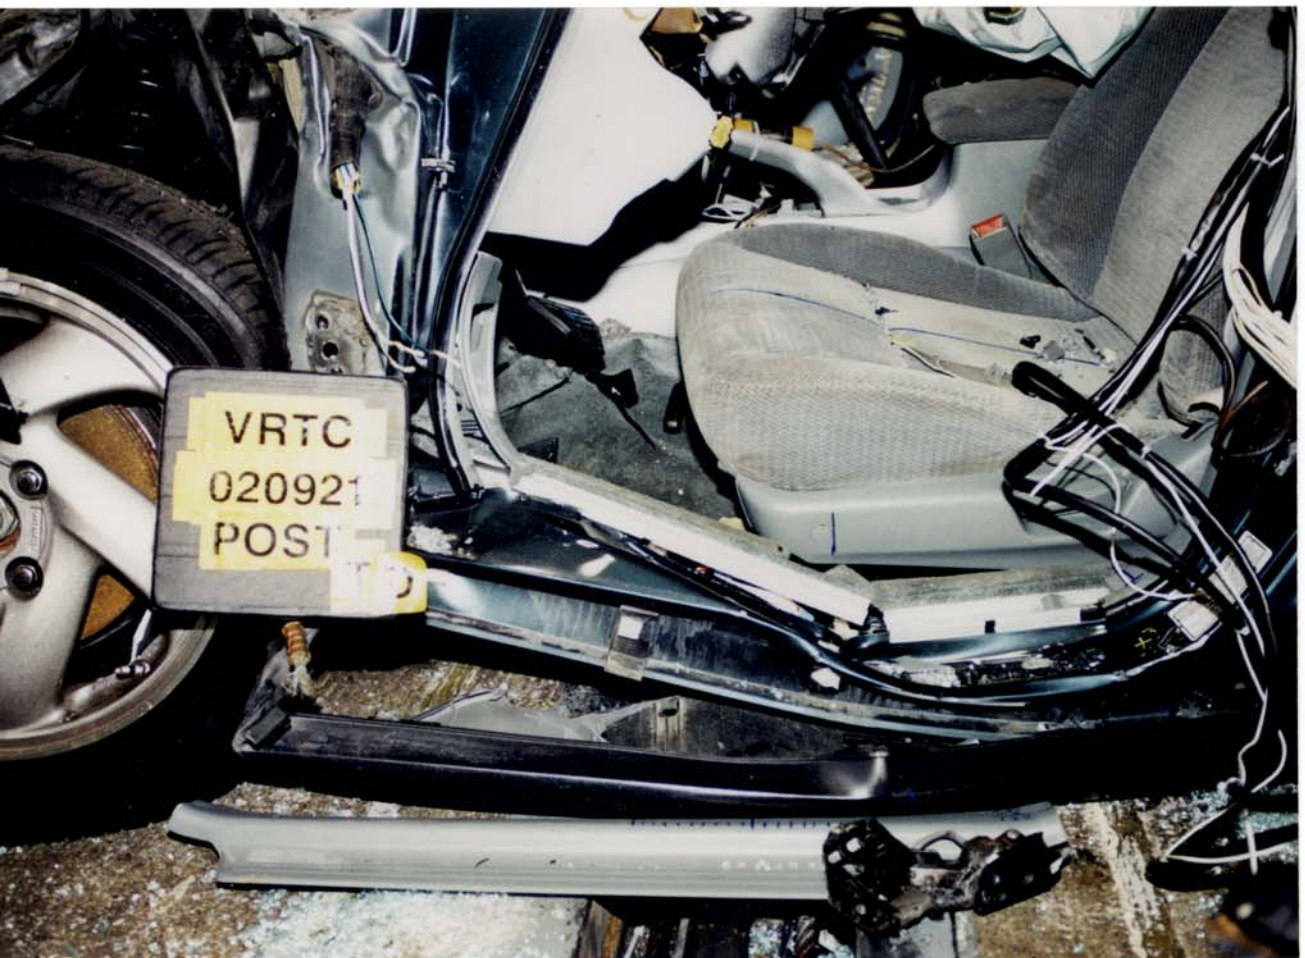
Figure A-92 Post-Test Target Vehicle Deformation - View 2
