**REPORT NUMBER: NCAP-MGA-2003-002**

**NEW CAR ASSESSMENT PROGRAM  
FRONTAL BARRIER IMPACT TEST**

**2003 FORD ESCORT ZX2 2 DOOR  
NHTSA NUMBER: M30206**

**PREPARED BY:  
MGA RESEARCH CORPORATION  
5000 WARREN ROAD  
BURLINGTON, WI 53105**

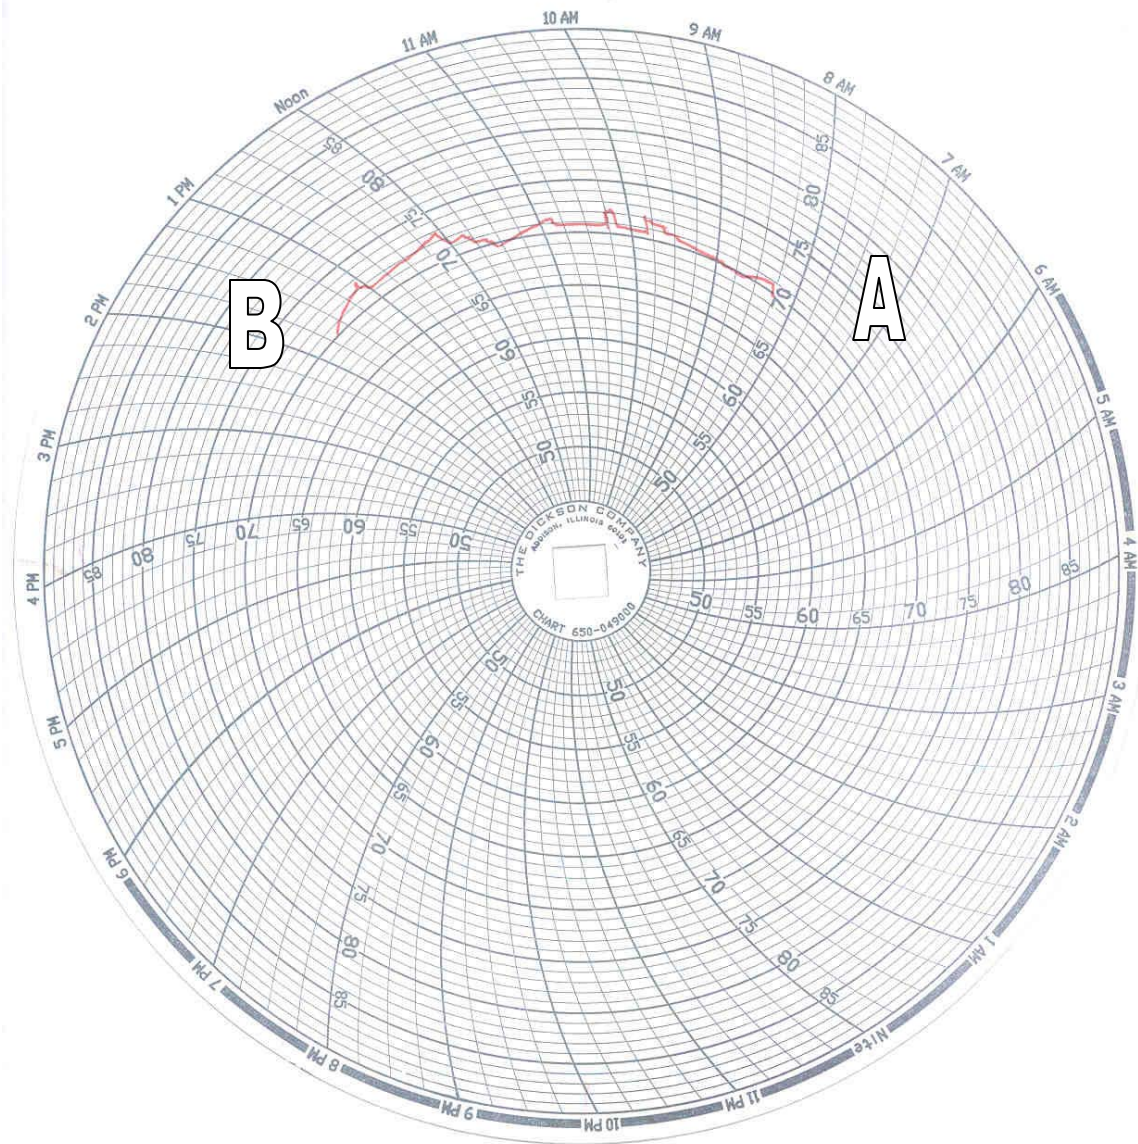
A = Dummies installed in vehicle at 8:00 a.m.

B = Test conducted at 1:58 p.m.

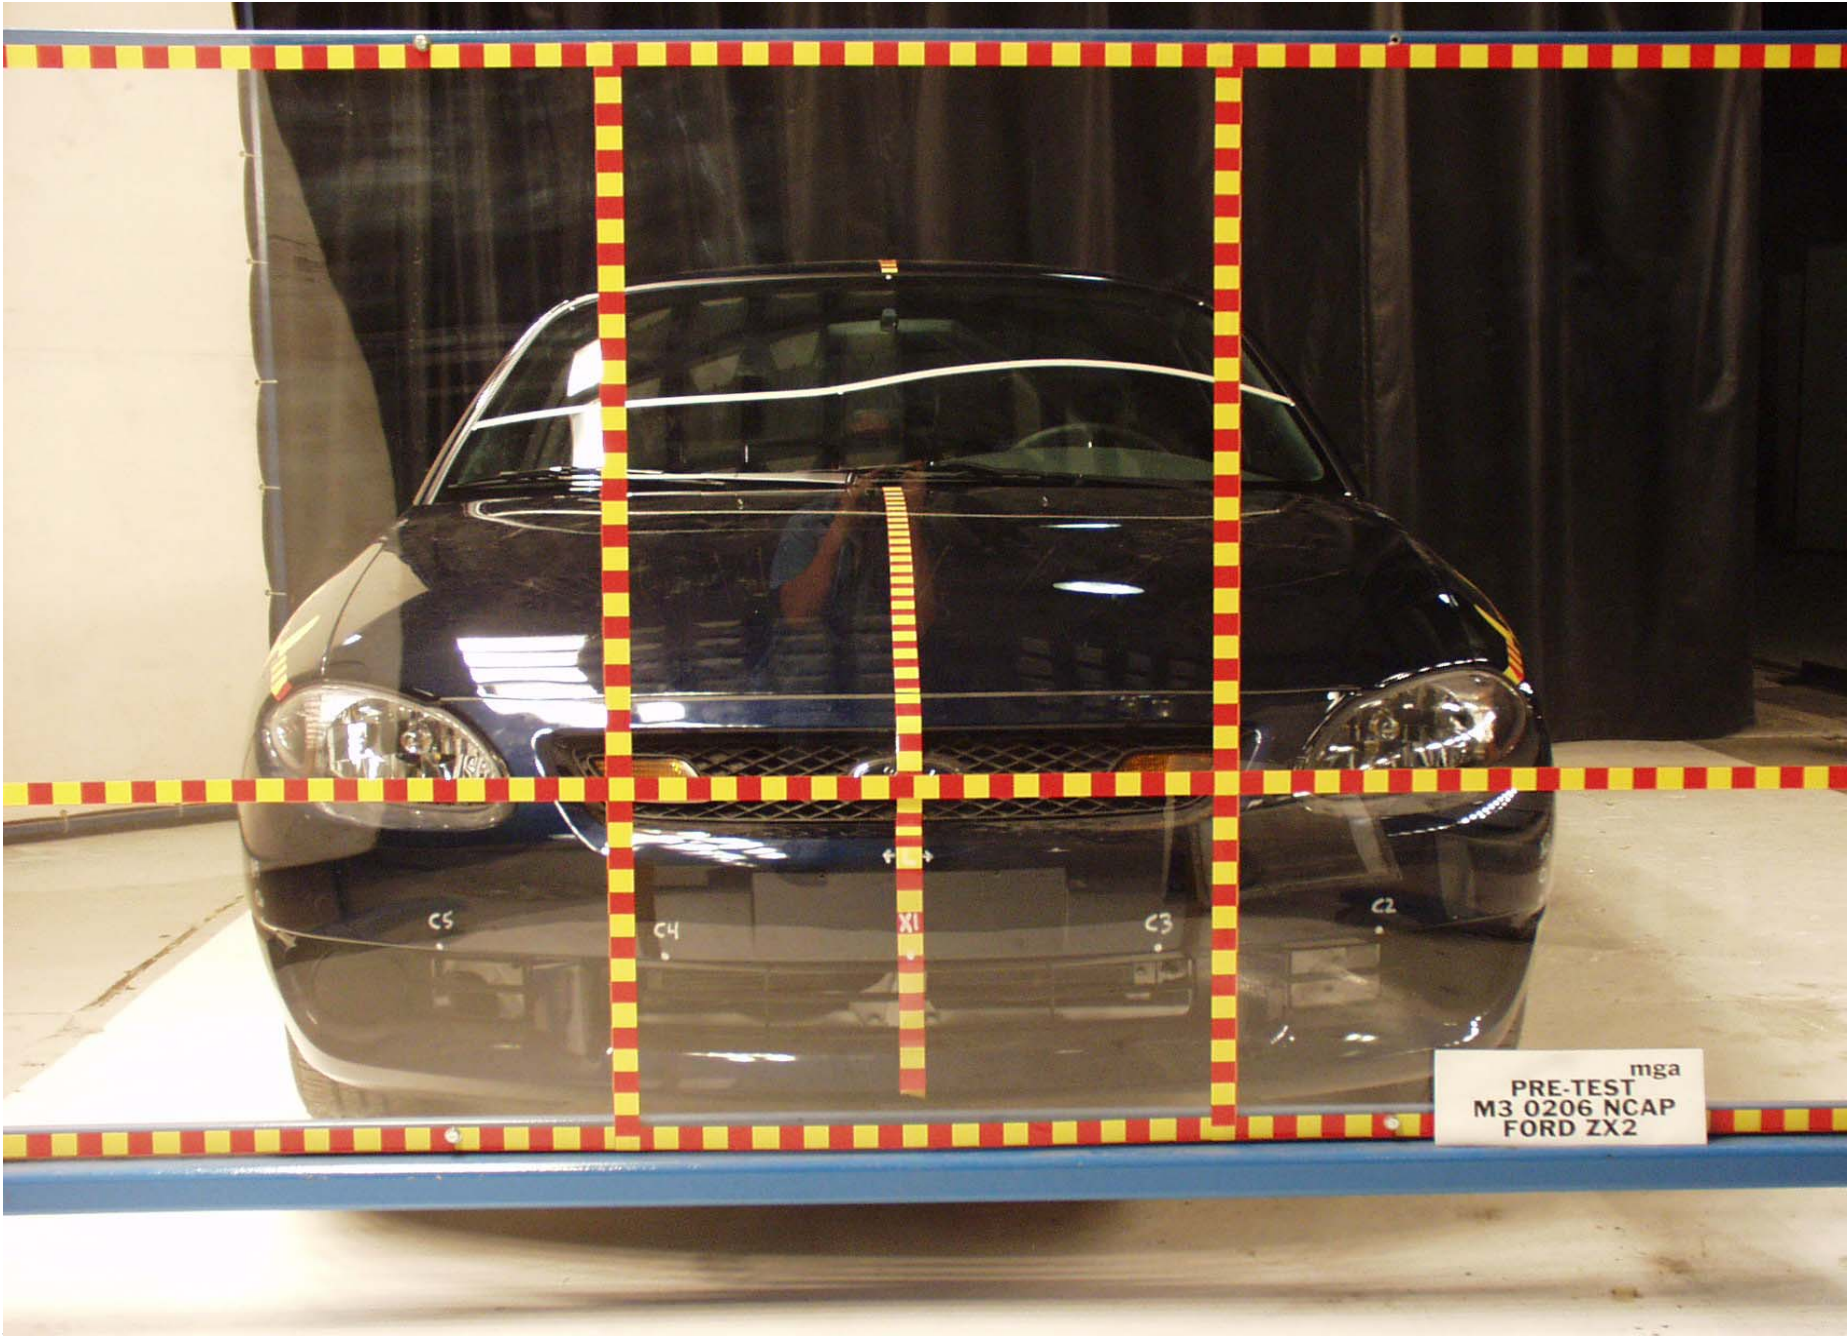
A-1.

Load Cell Location

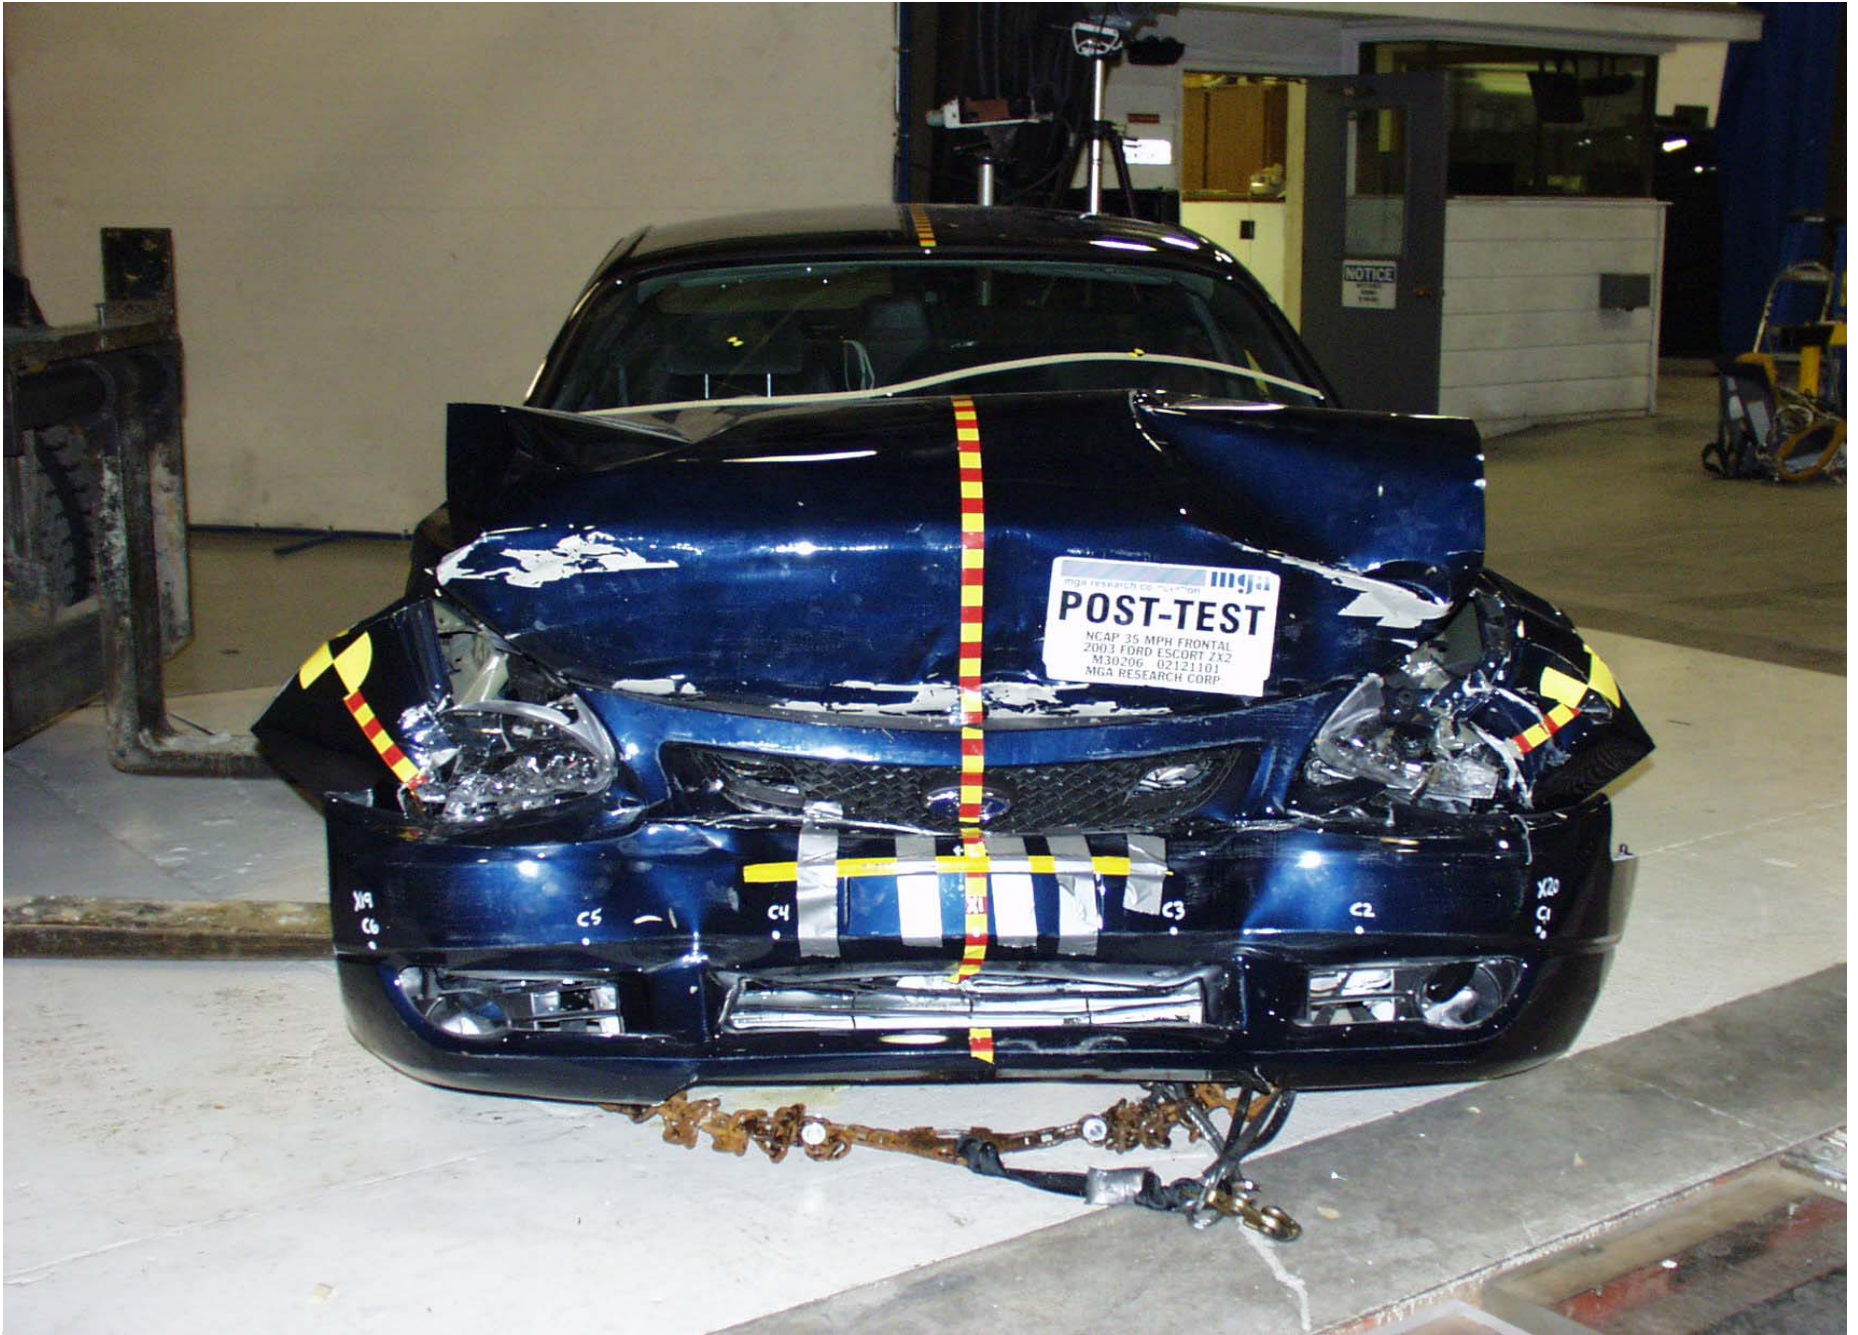
Post-Test Front View of Test Vehicle

The maximum static crush of the vehicle was 403 mm and both the driver and passenger side doors remained closed and latched during the impact event and were operable after the impact.

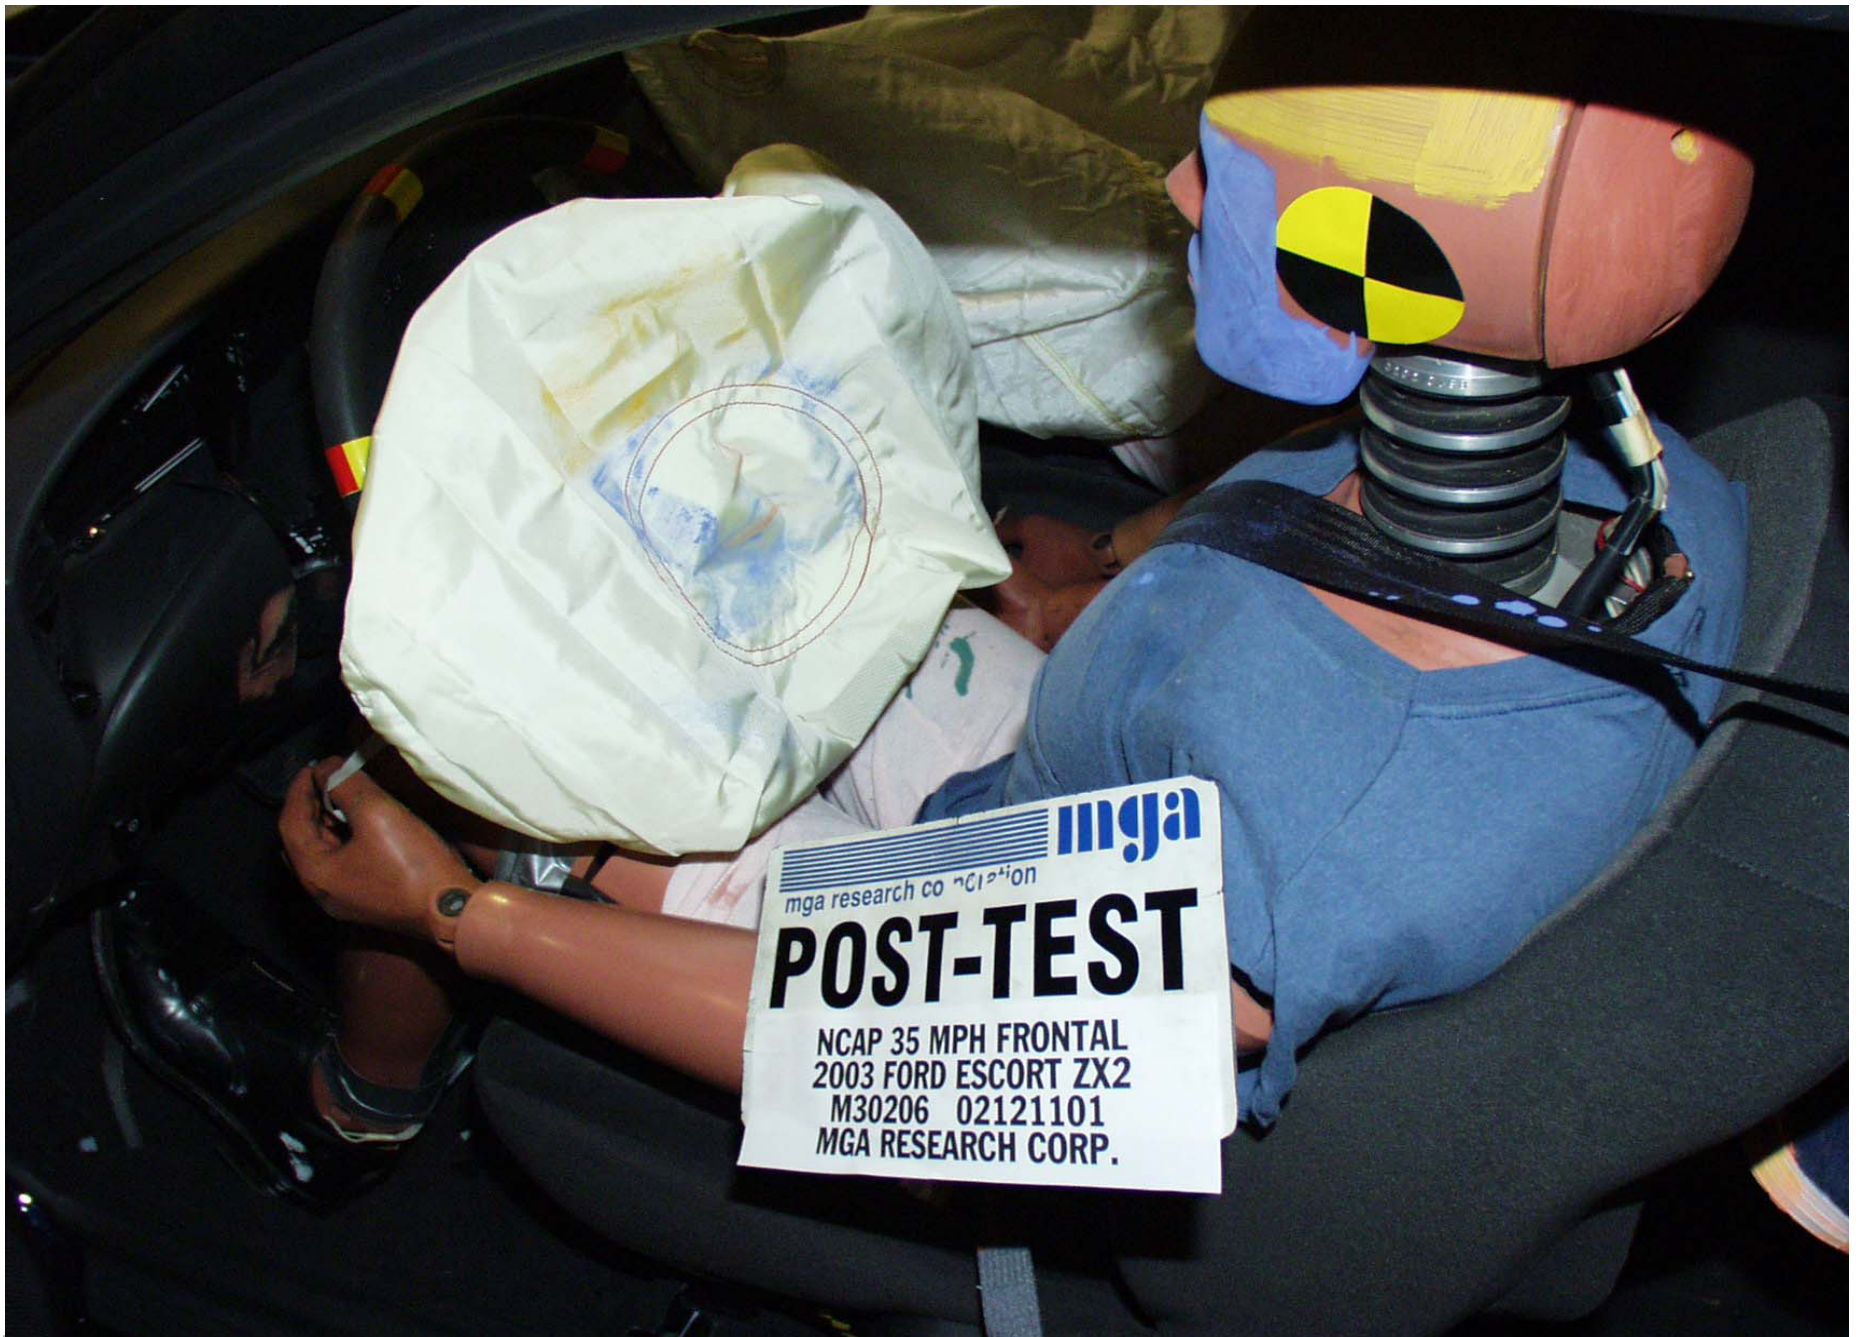
Post-Test Driver Dummy Airbag Contact

The driver's head and chest contacted the airbag. The driver's head also contacted the headrest. The driver's knees contacted the bolster and steering column. The passenger's head and chest contacted the airbag. The passenger's head also contacted the headrest. The passenger's knees contacted the glove box.

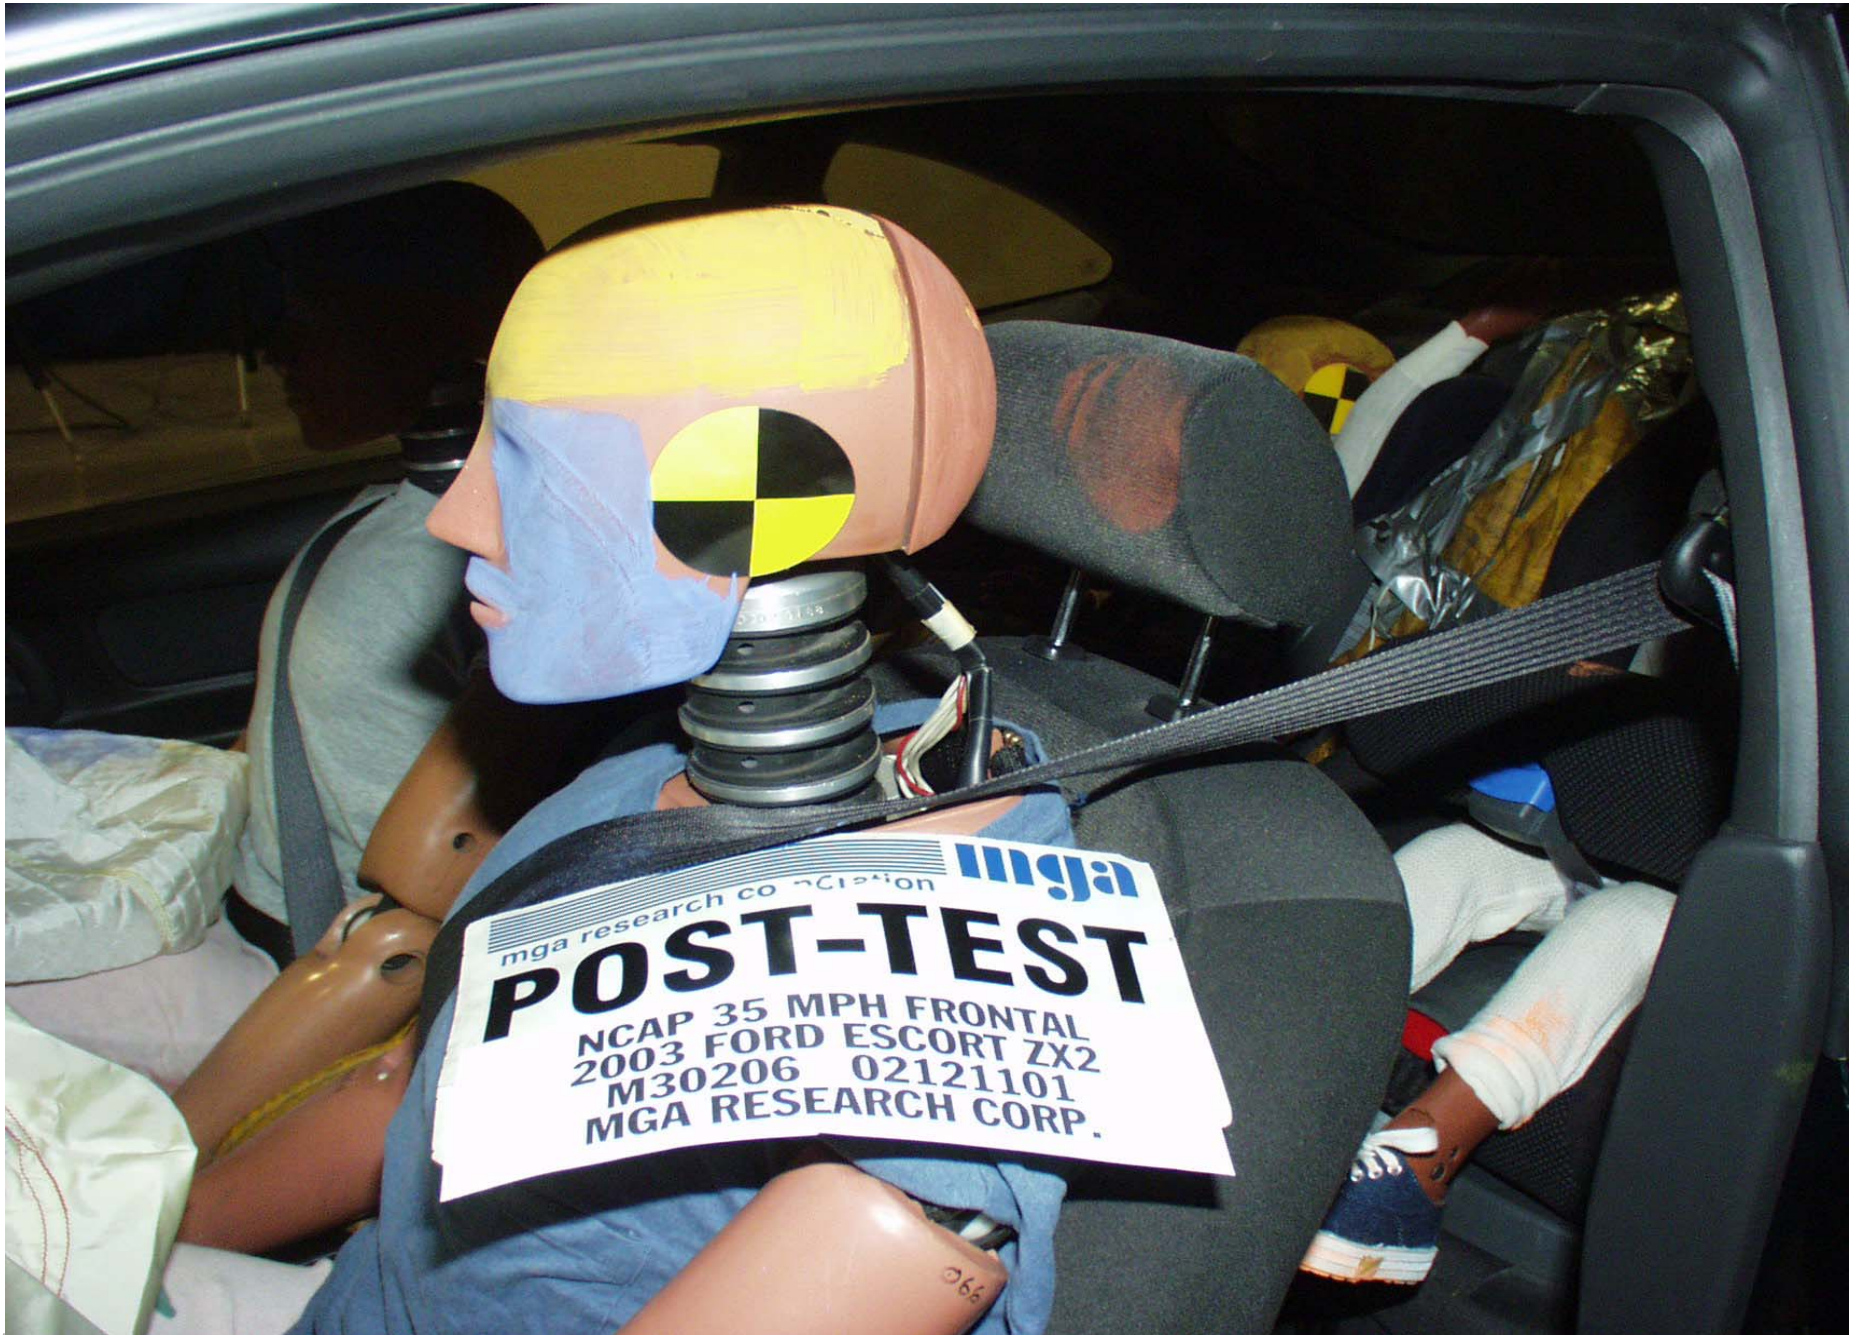
Post-Test Driver Dummy Head Contact

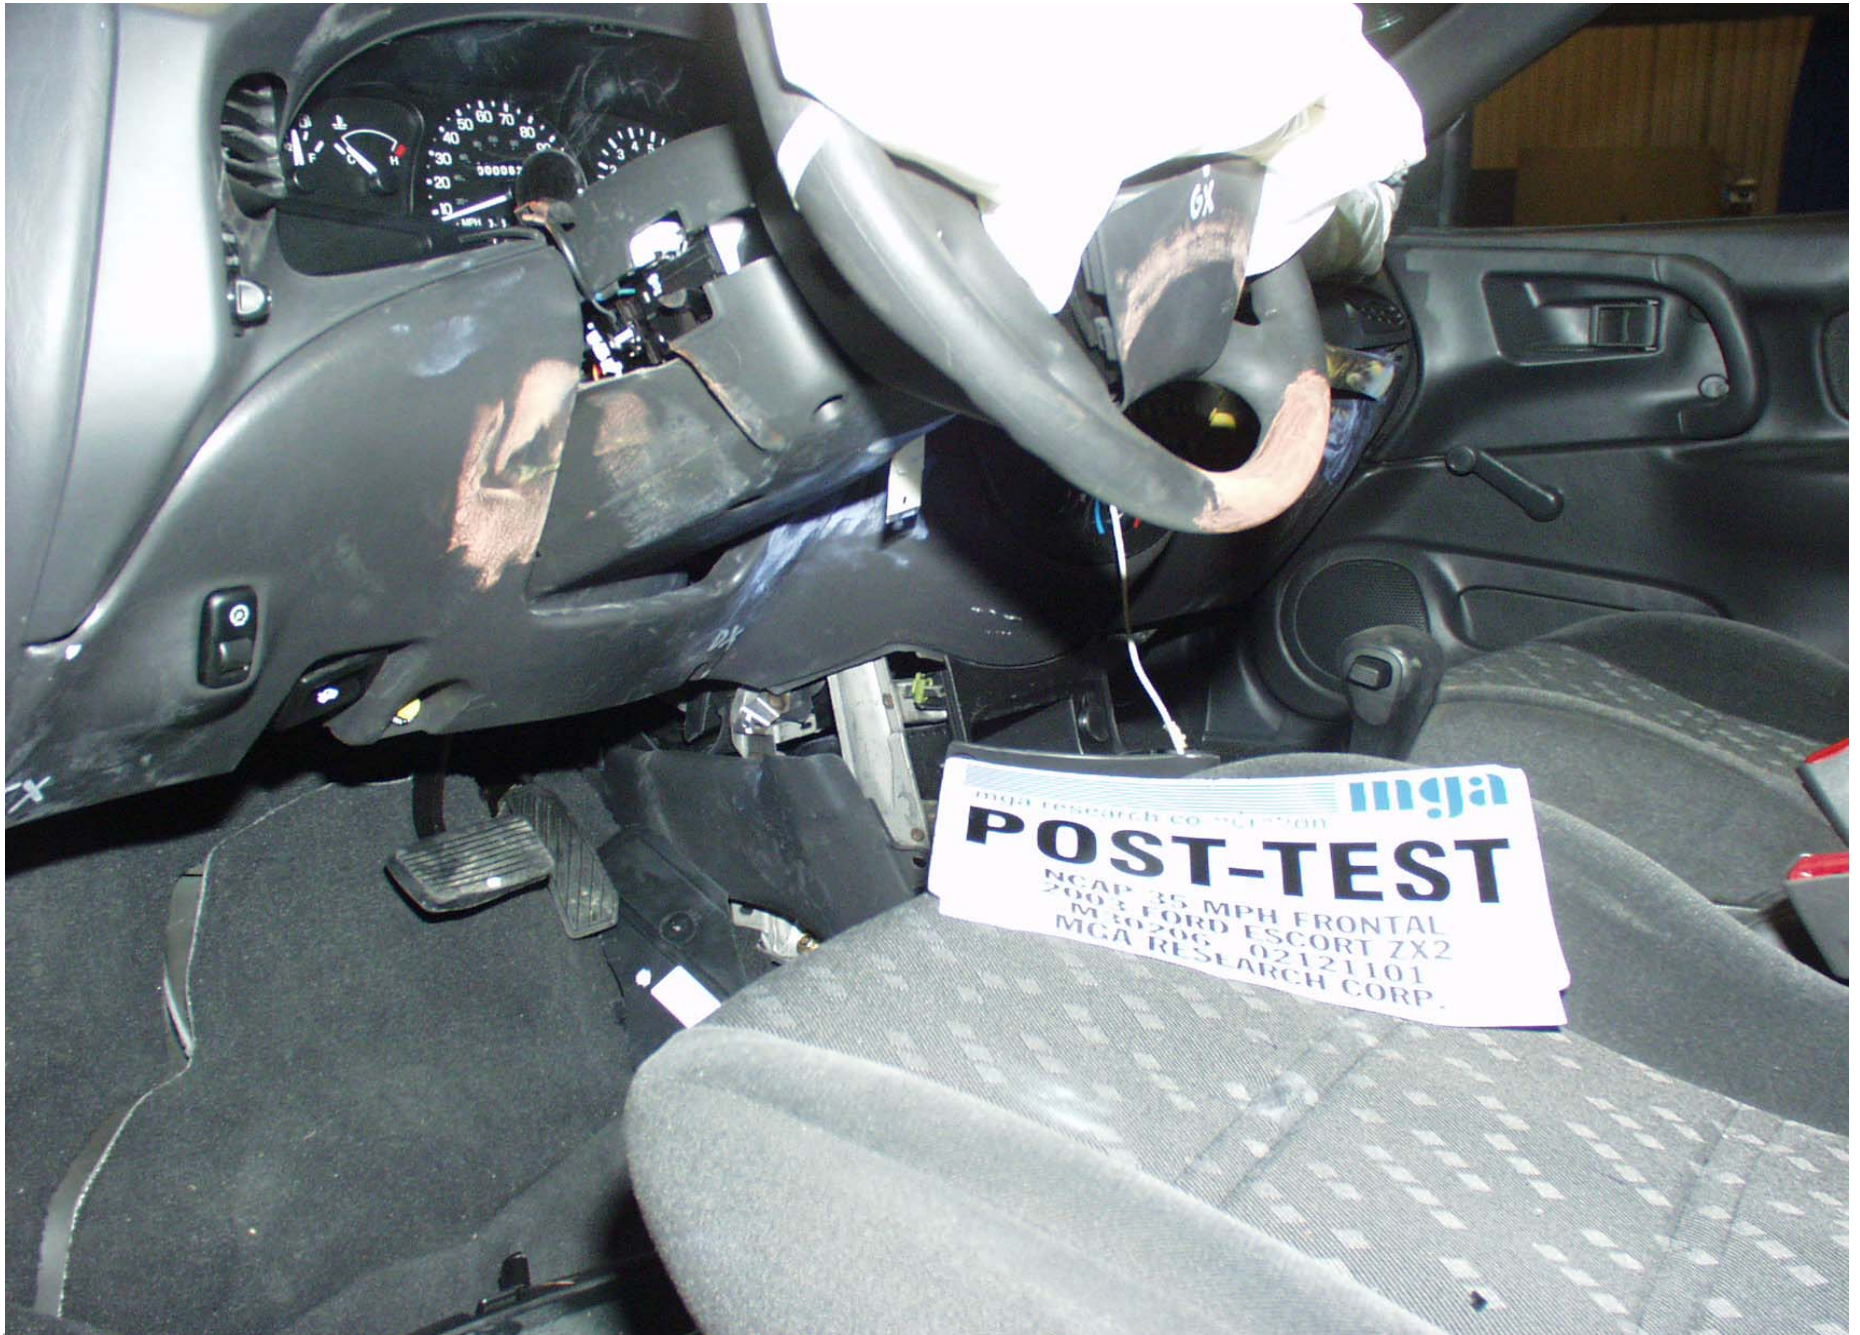
A-44.

Post-Test Driver Dummy Knee Contact

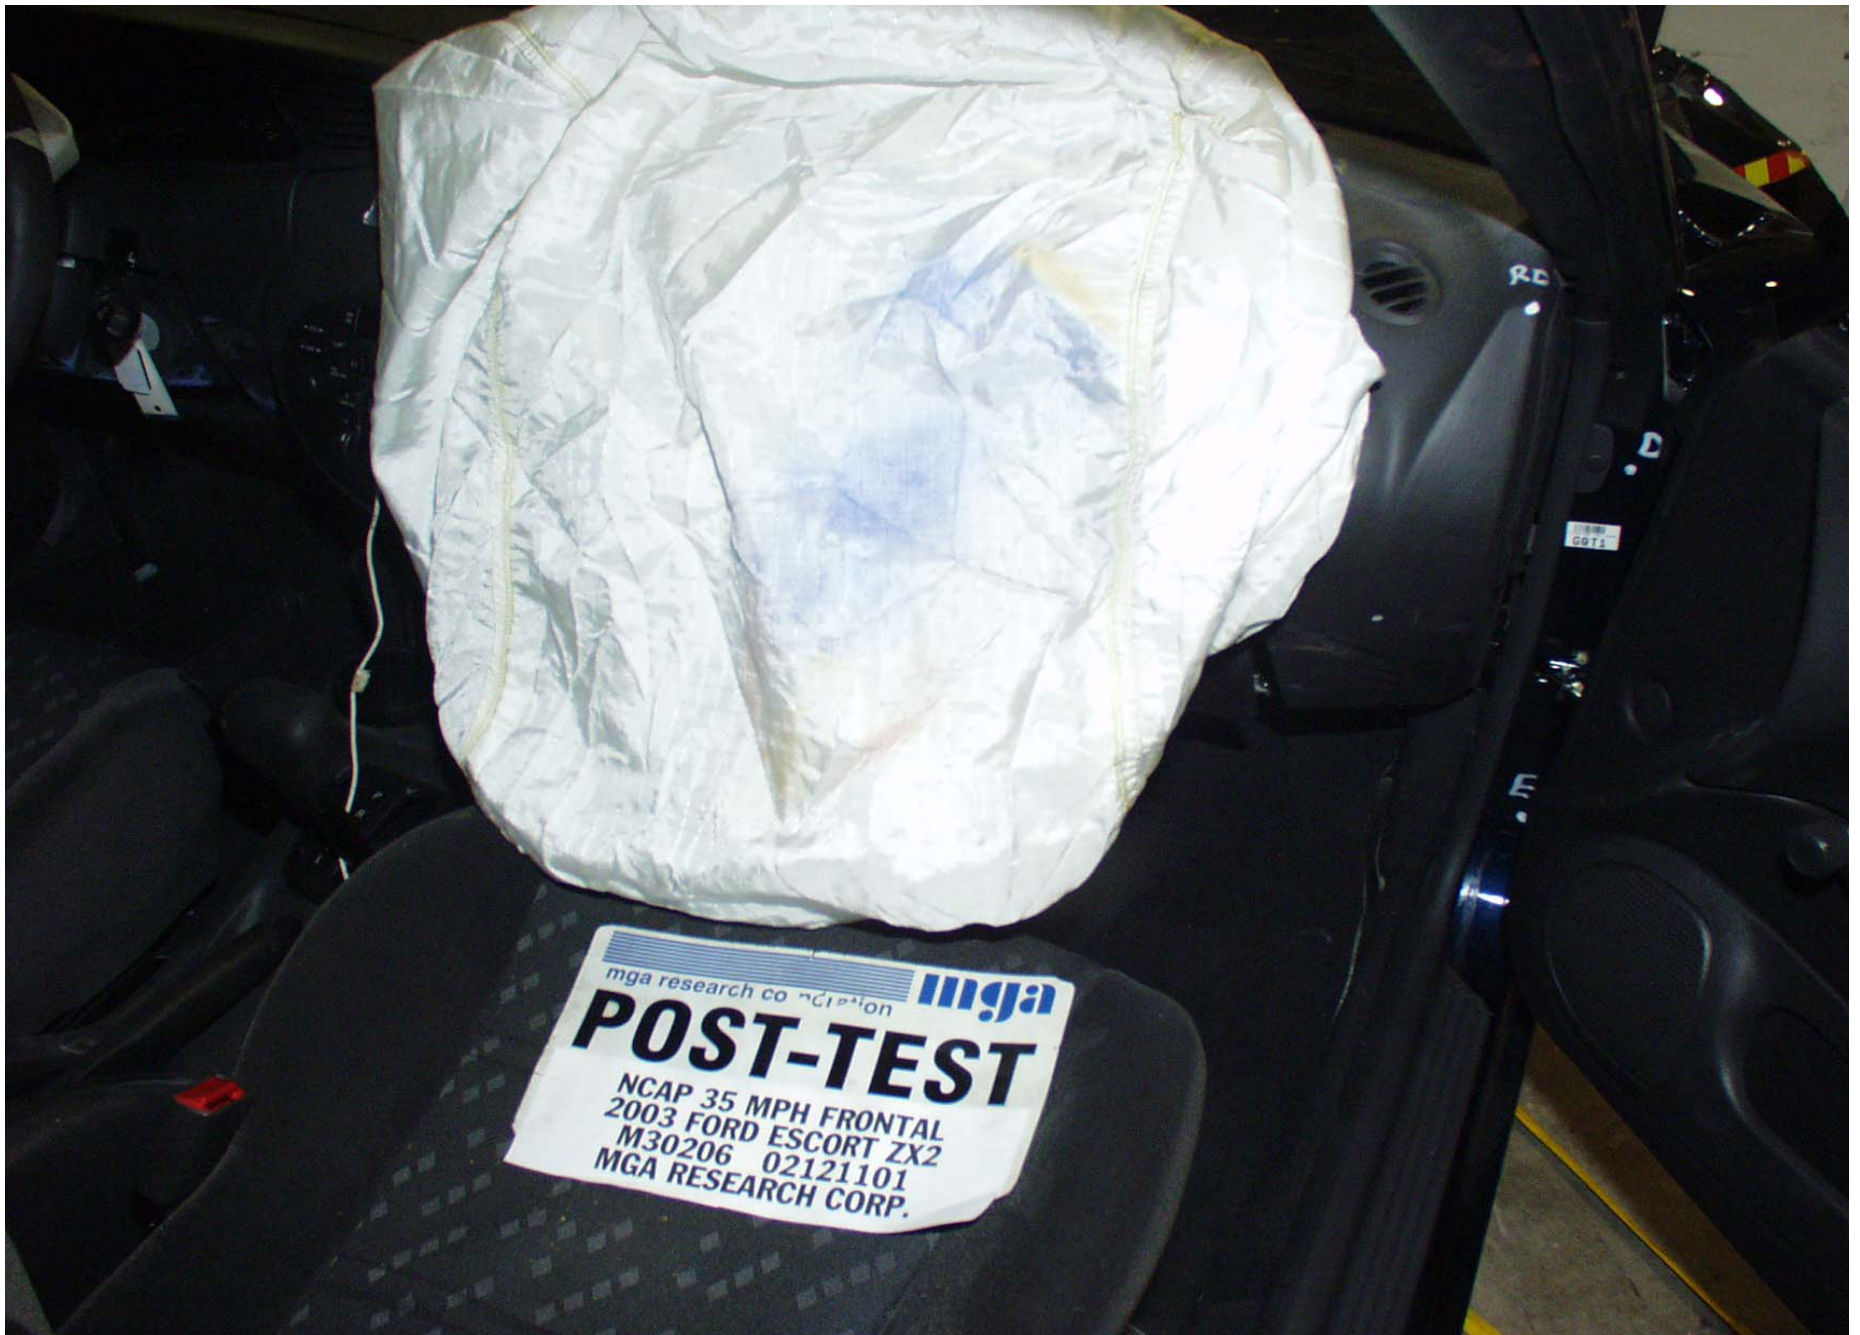
Post-Test Passenger Dummy Airbag Contact

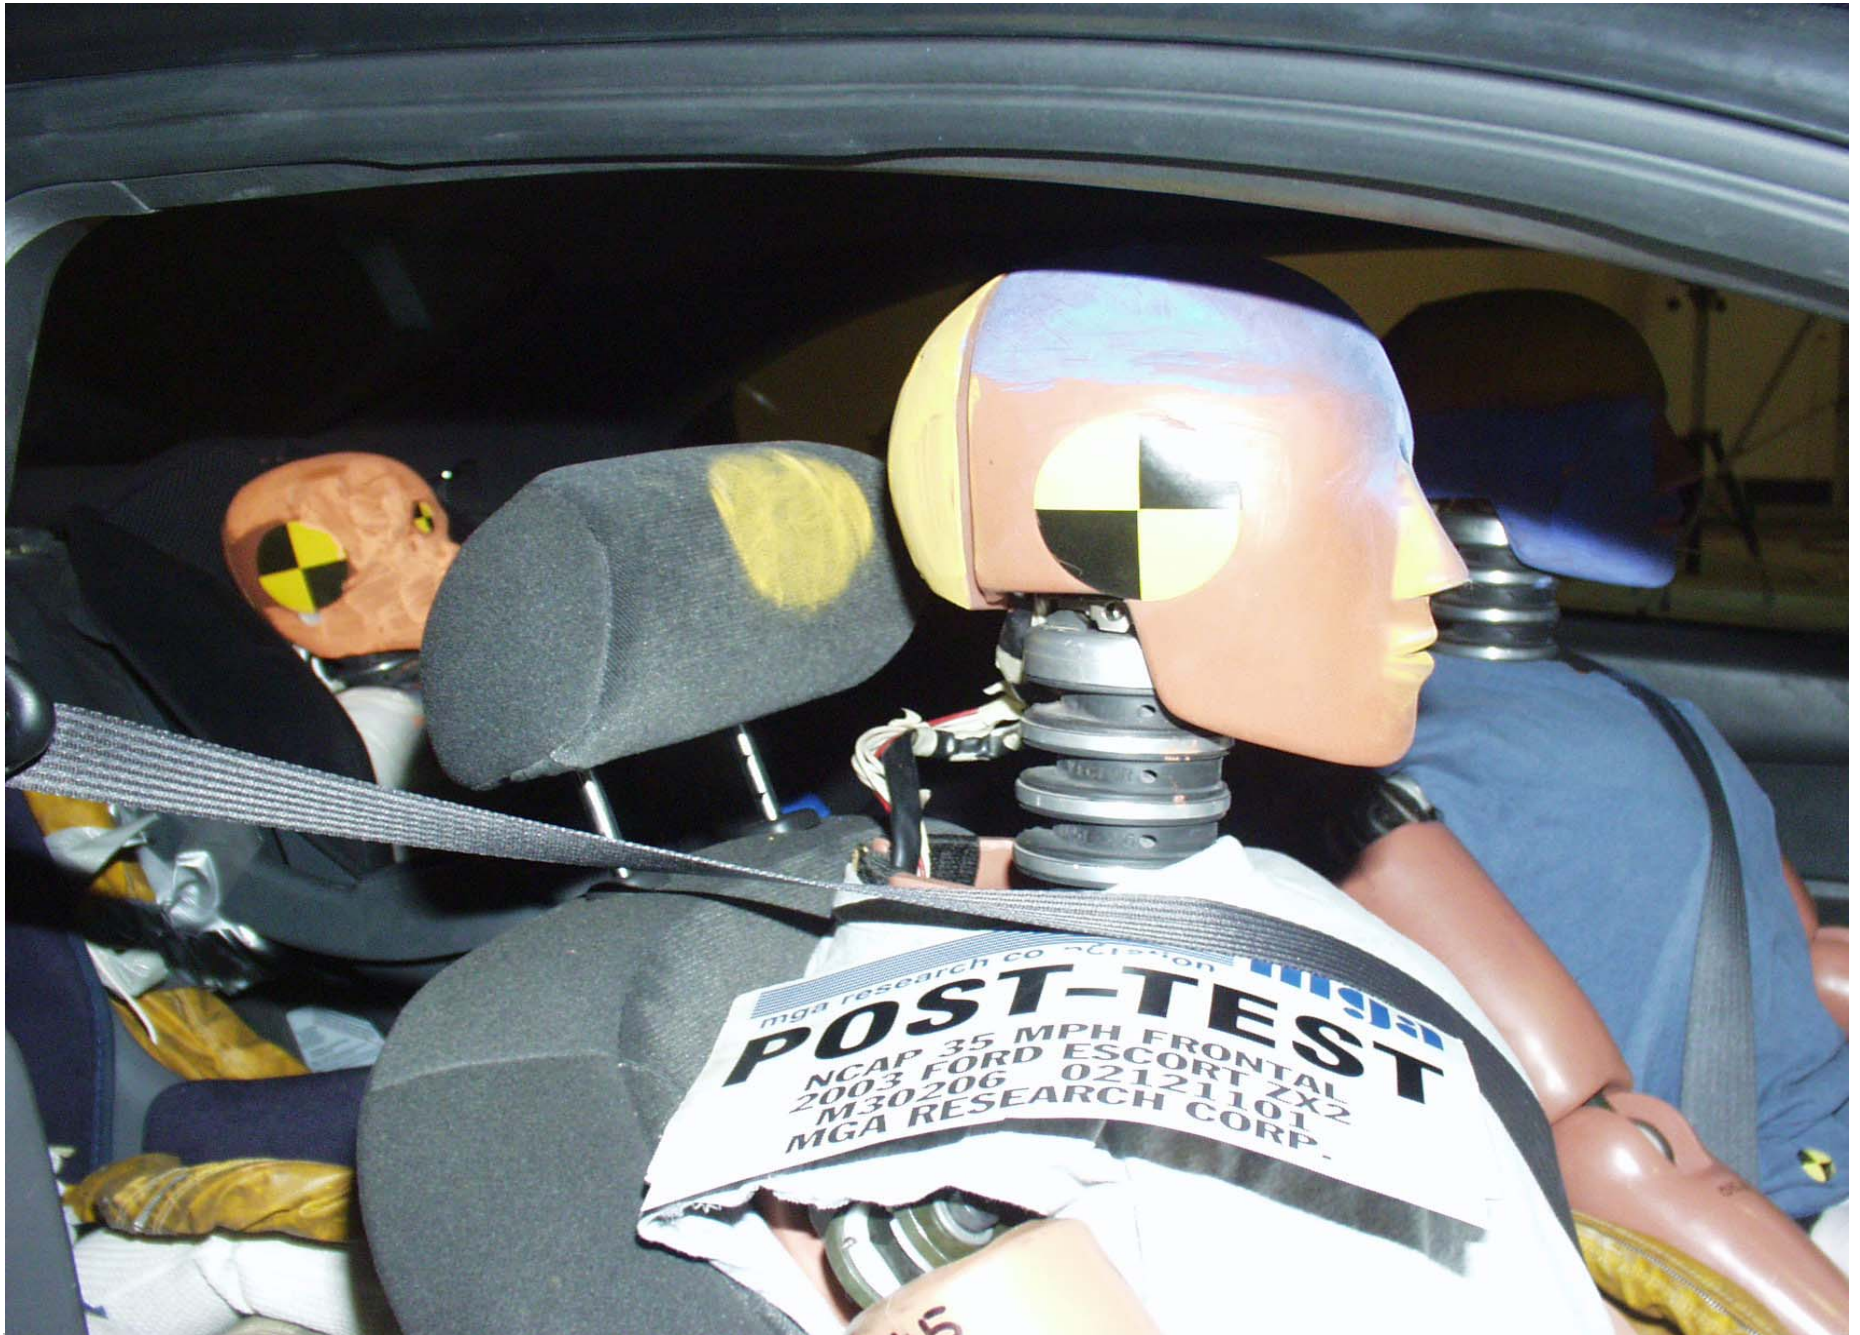
Post-Test Passenger Dummy Head Contact

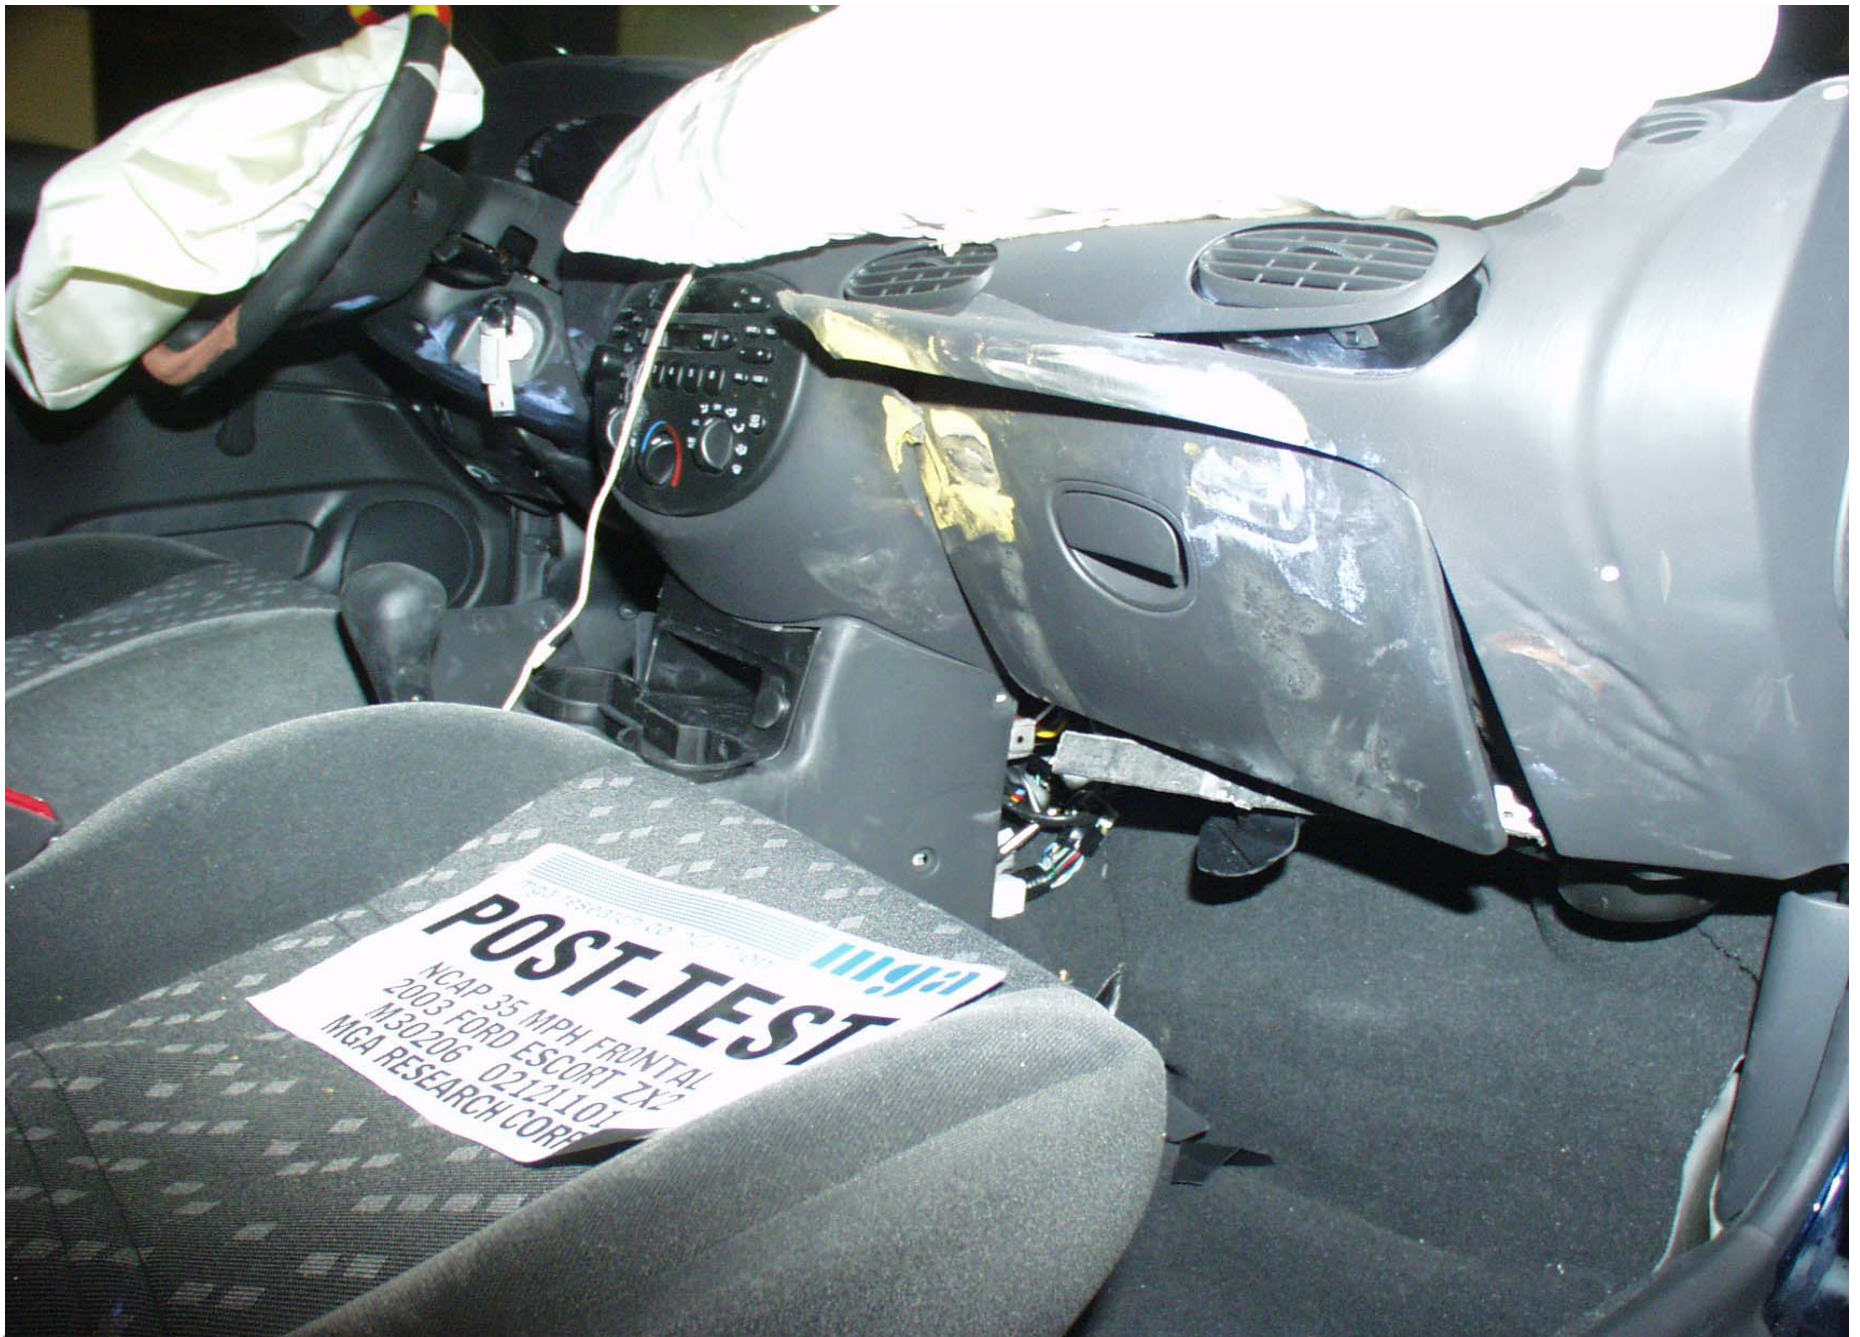
A-60.

Post-Test Passenger Dummy Knee Contact
