# Insurance Institute for Highway Safety Crashworthiness Evaluation

## Crash Test Report 2002 Suzuki Aerio (CEF0217)

**Vehicle identification number:** JS2RA41S525103342  
**Body style:** Small 4-door sedan  
**Engine/transmission:** Transverse 2.0-liter 4-cylinder, 4-speed automatic, front-wheel drive

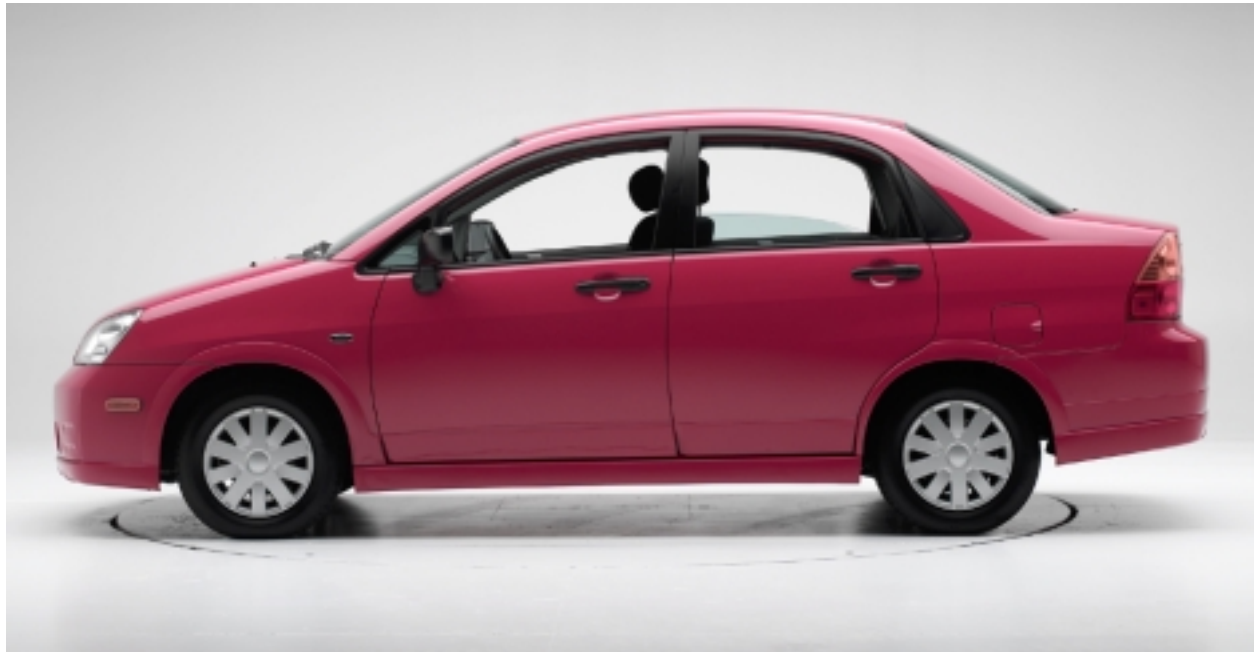
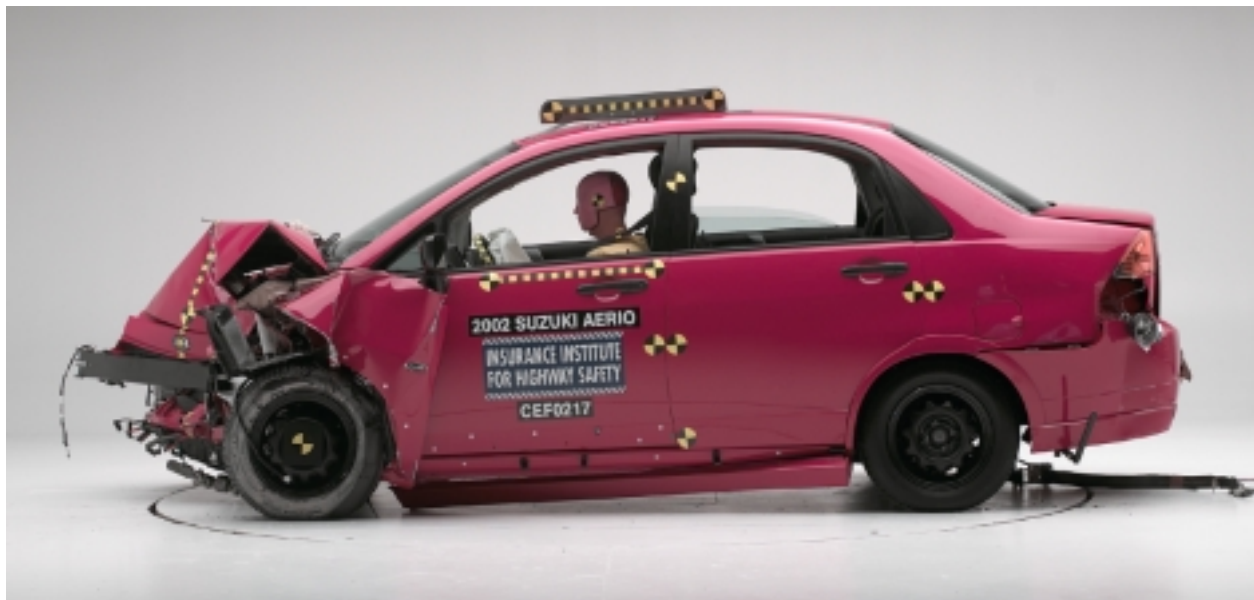
**Figure 1**  
**Precrash and Postcrash Side Views — 2002 Suzuki Aerio**

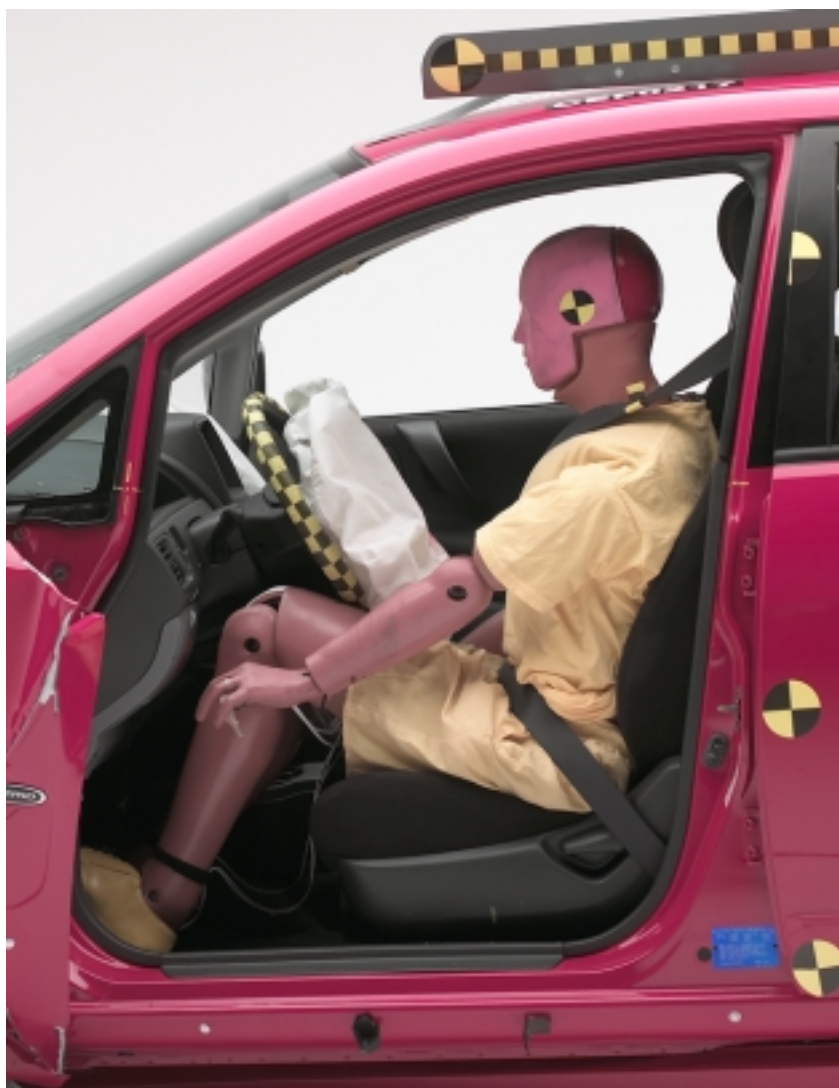
**Figure 3**  
**Dummy and Vehicle Interior, Postcrash — 2002 Suzuki Aerio**

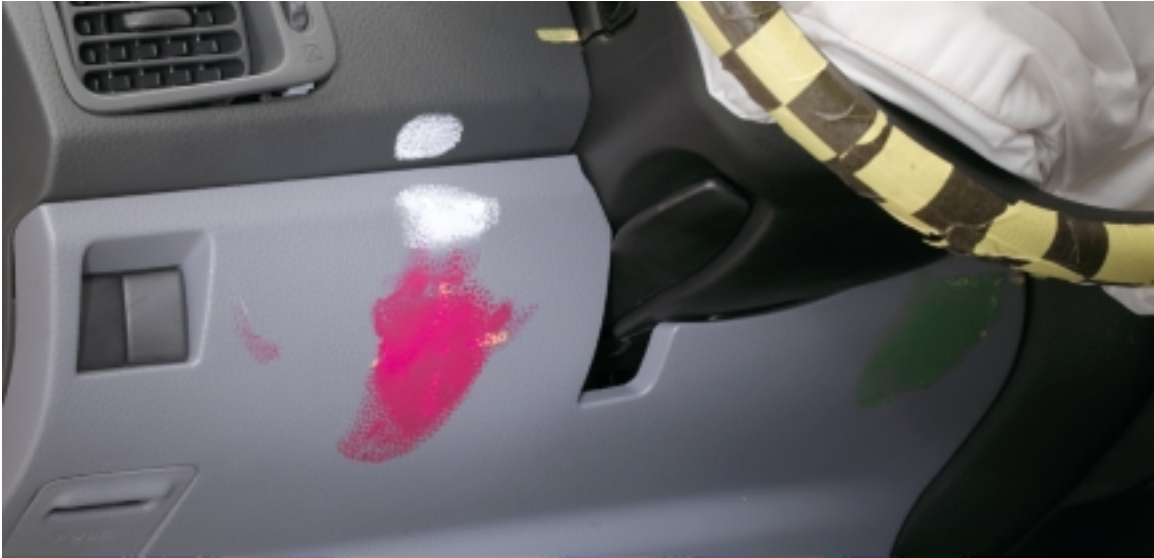
**Figure 4**  
**Dummy Left Knee/Shin Contacts, Postcrash — 2002 Suzuki Aerio**

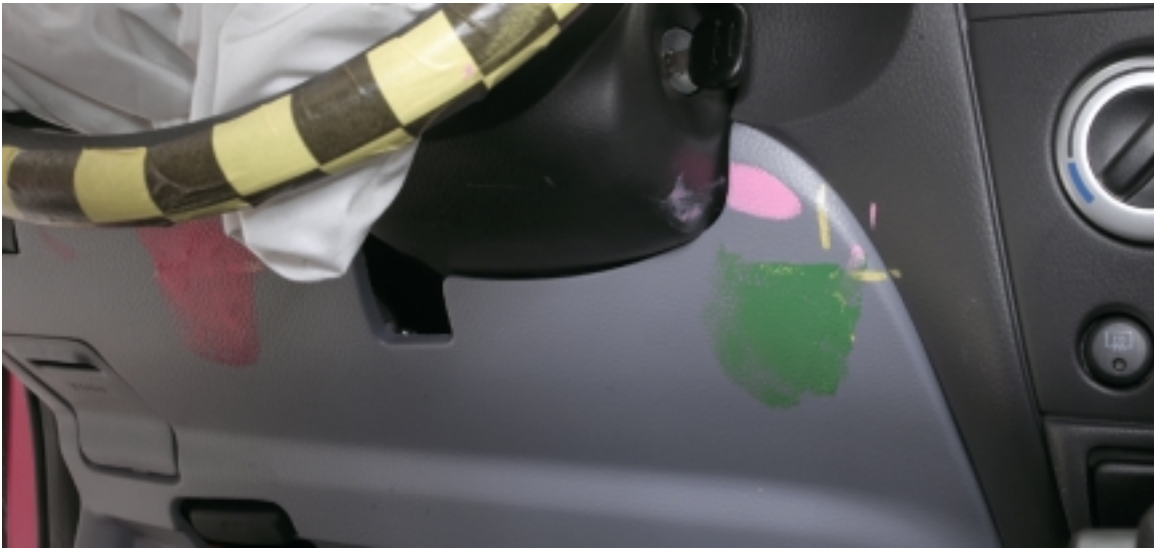
**Figure 5**  
**Dummy Right Knee/Shin Contacts, Postcrash — 2002 Suzuki Aerio**

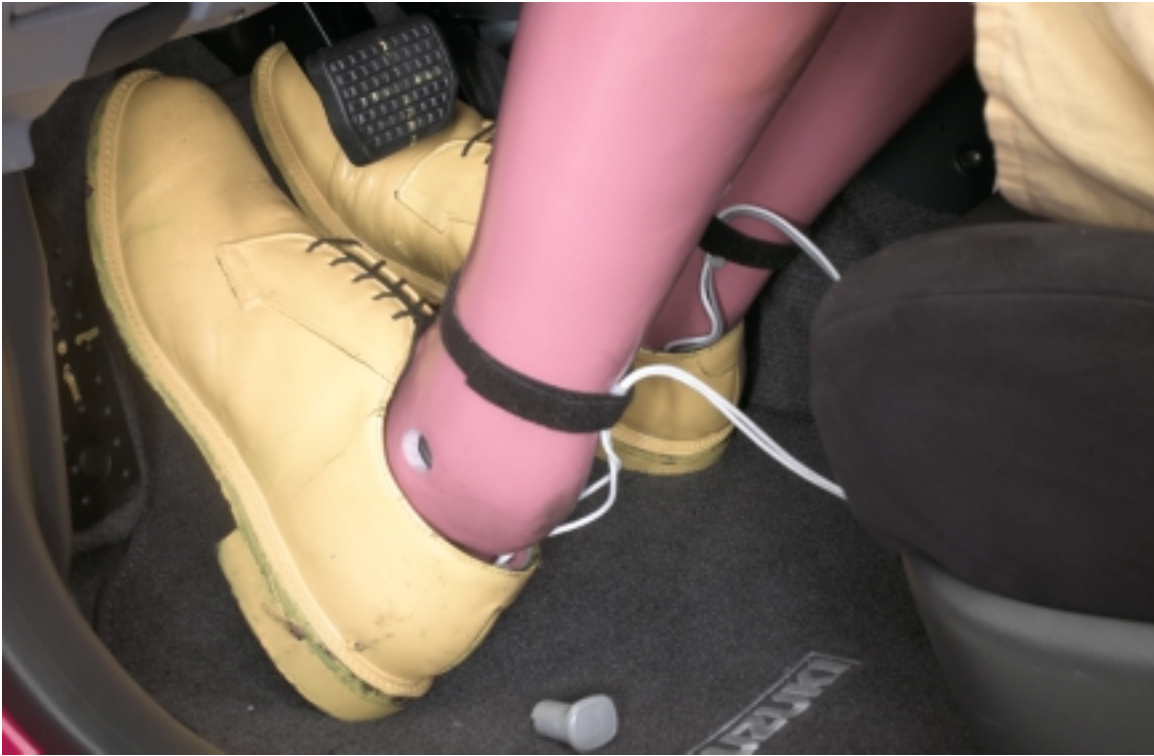
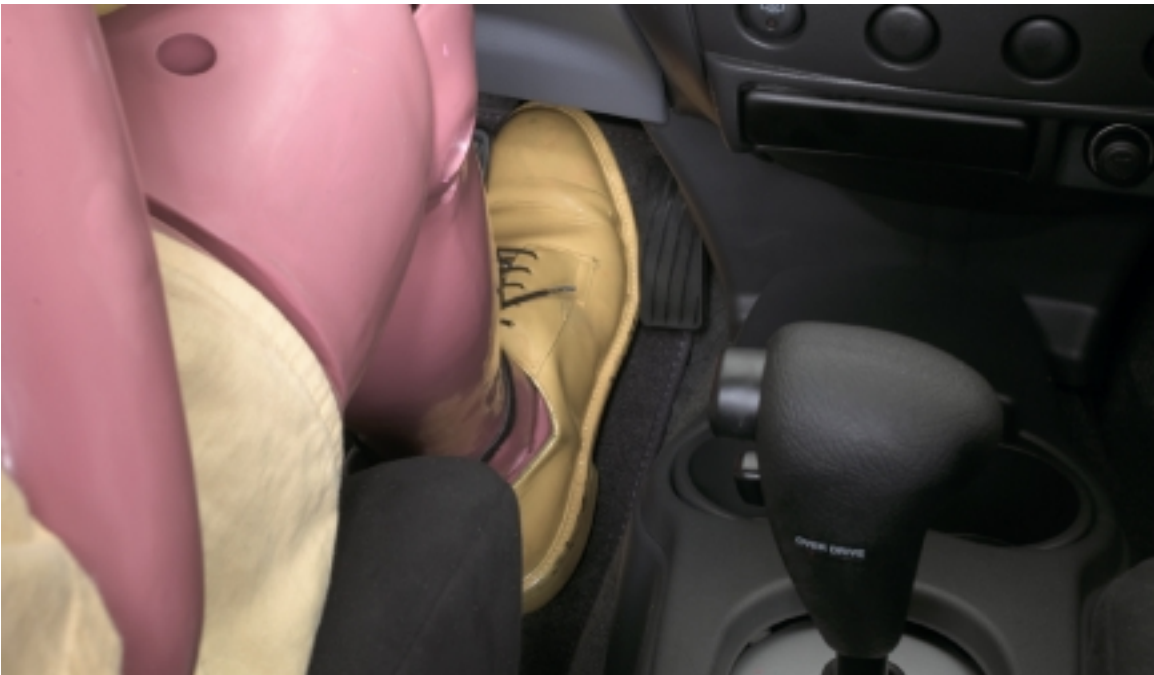
**Figure 6**  
**Dummy Feet Positions, Postcrash — 2002 Suzuki Aerio**
