# Insurance Institute for Highway Safety Crashworthiness Evaluation

## Crash Test Report 2002 Mini Cooper (CEF0222)

**Vehicle identification number:** WMWRC33422TC34141  
**Body style:** Small 2-door hatchback  
**Engine/transmission:** Transverse 1.6-liter 4-cylinder, 5-speed manual, front-wheel drive

40.0 mi/h (64.4 km/h), 40% overlap, deformable barrier face with slotted bumper

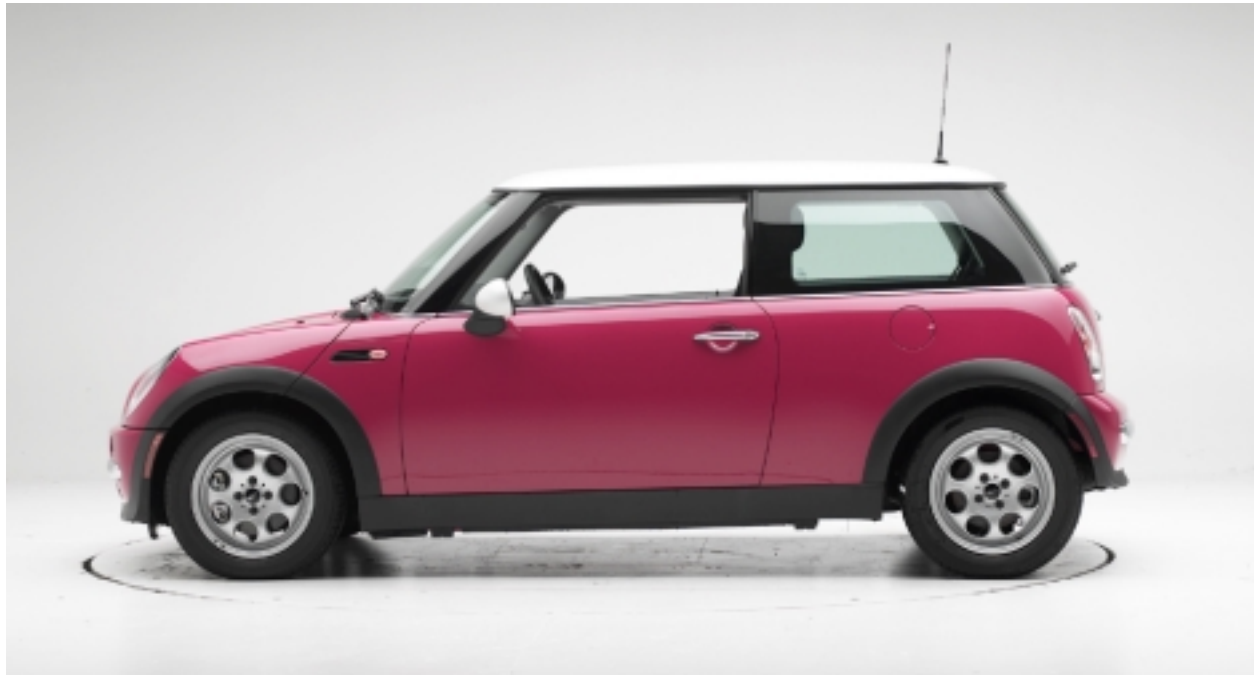
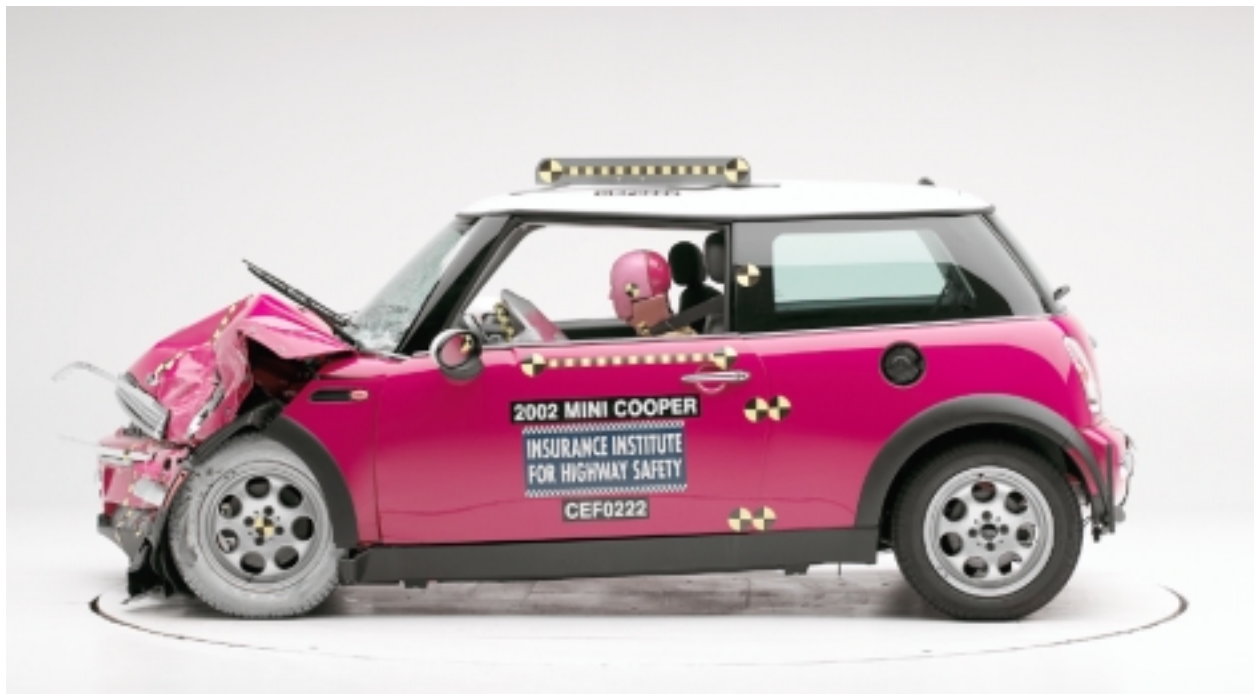
**Figure 1**  
**Precrash and Postcrash Side Views — 2002 Mini Cooper**

A 2002 Mini Cooper was crash tested on November 6, 2002 into a fixed deformable barrier at 40.0 mi/h (64.4 km/h) and a 40 percent overlap on the driver side. A Hybrid III 50th percentile male dummy was positioned in the driver seat with the lap/shoulder belt fastened.

Both doors remained closed during the crash. The driver door aperture shortened 5 cm, as measured at the lower edge of the window. After the crash, the driver door required some additional effort but no tools to open. The right door opened with ease.

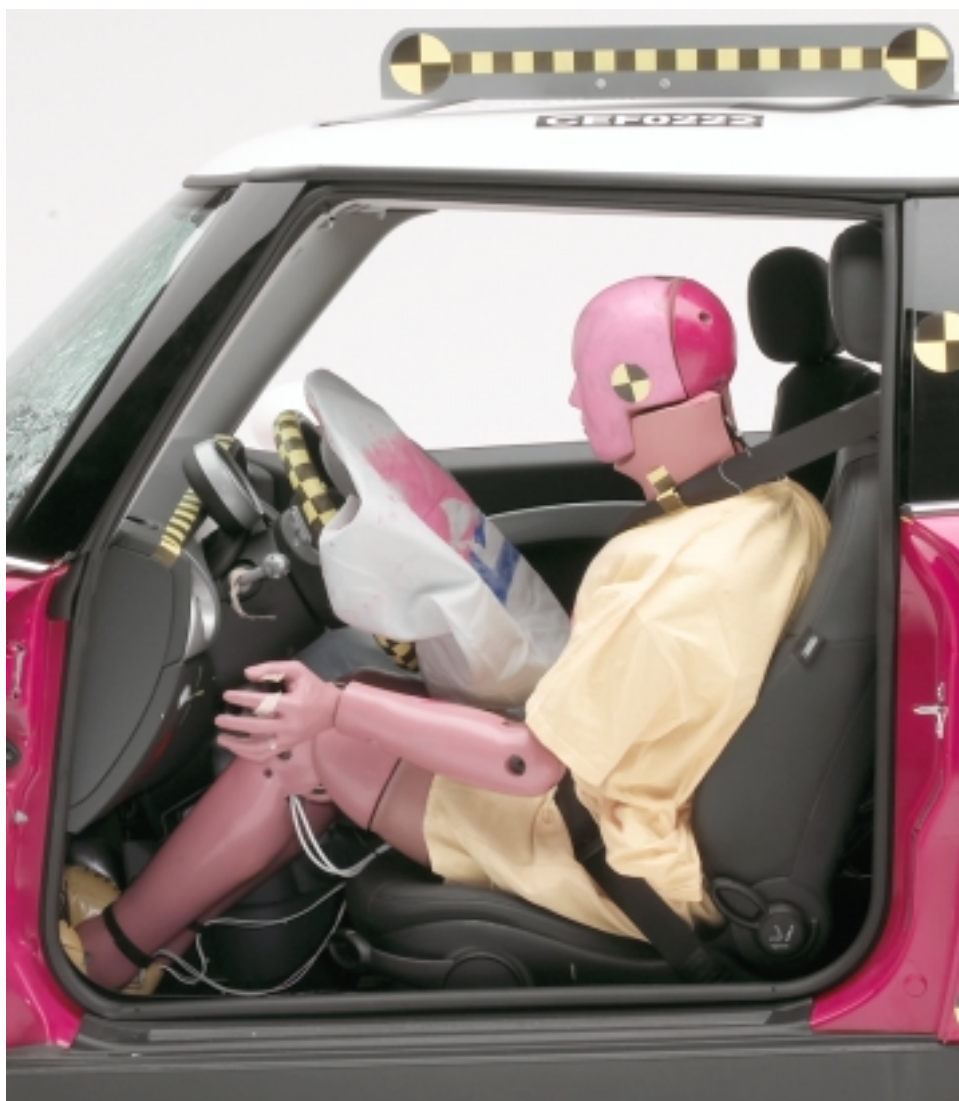
**Figure 3**  
**Dummy and Vehicle Interior, Postcrash — 2002 Mini Cooper**

Analysis of the high-speed film taken from camera position D indicated that the dummy's face began to load the airbag at 40 ms, 2 ms before the airbag became fully inflated. Paint transferred from the dummy's face indicated the nose loaded the airbag about 7 cm below and 1 cm to the left of its center. As the head loaded the airbag, it rolled around to the left. During rebound, the head moved downward, and the dummy's left forearm contacted the top left rear of the head at 122 ms, according to the head acceleration data. The head then leaned out partway beyond the precrash plane of the side glass as it moved rearward and upward. The head did not contact the B-pillar. Table 2 provides the timing of these events.
