REPORT NUMBER: NCAP-MGA-2003-003

**NEW CAR ASSESSMENT PROGRAM
FRONTAL BARRIER IMPACT TEST**

**2003 CHEVROLET AVALANCHE 4 DOOR
NHTSA NUMBER: M30100**

**PREPARED BY:
MGA RESEARCH CORPORATION
5000 WARREN ROAD
BURLINGTON, WI 53105**

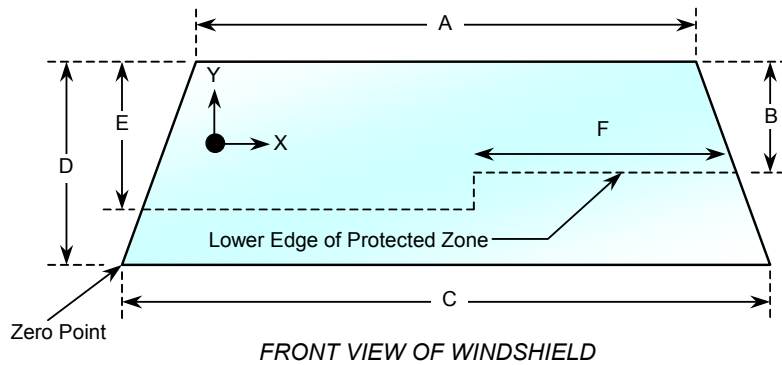
Item	Units	Value
A	mm	1390
B	mm	388
C	mm	1740
D	mm	667
E	mm	458
F	mm	1050

AREA OF PROTECTED ZONE FAILURES - NONE

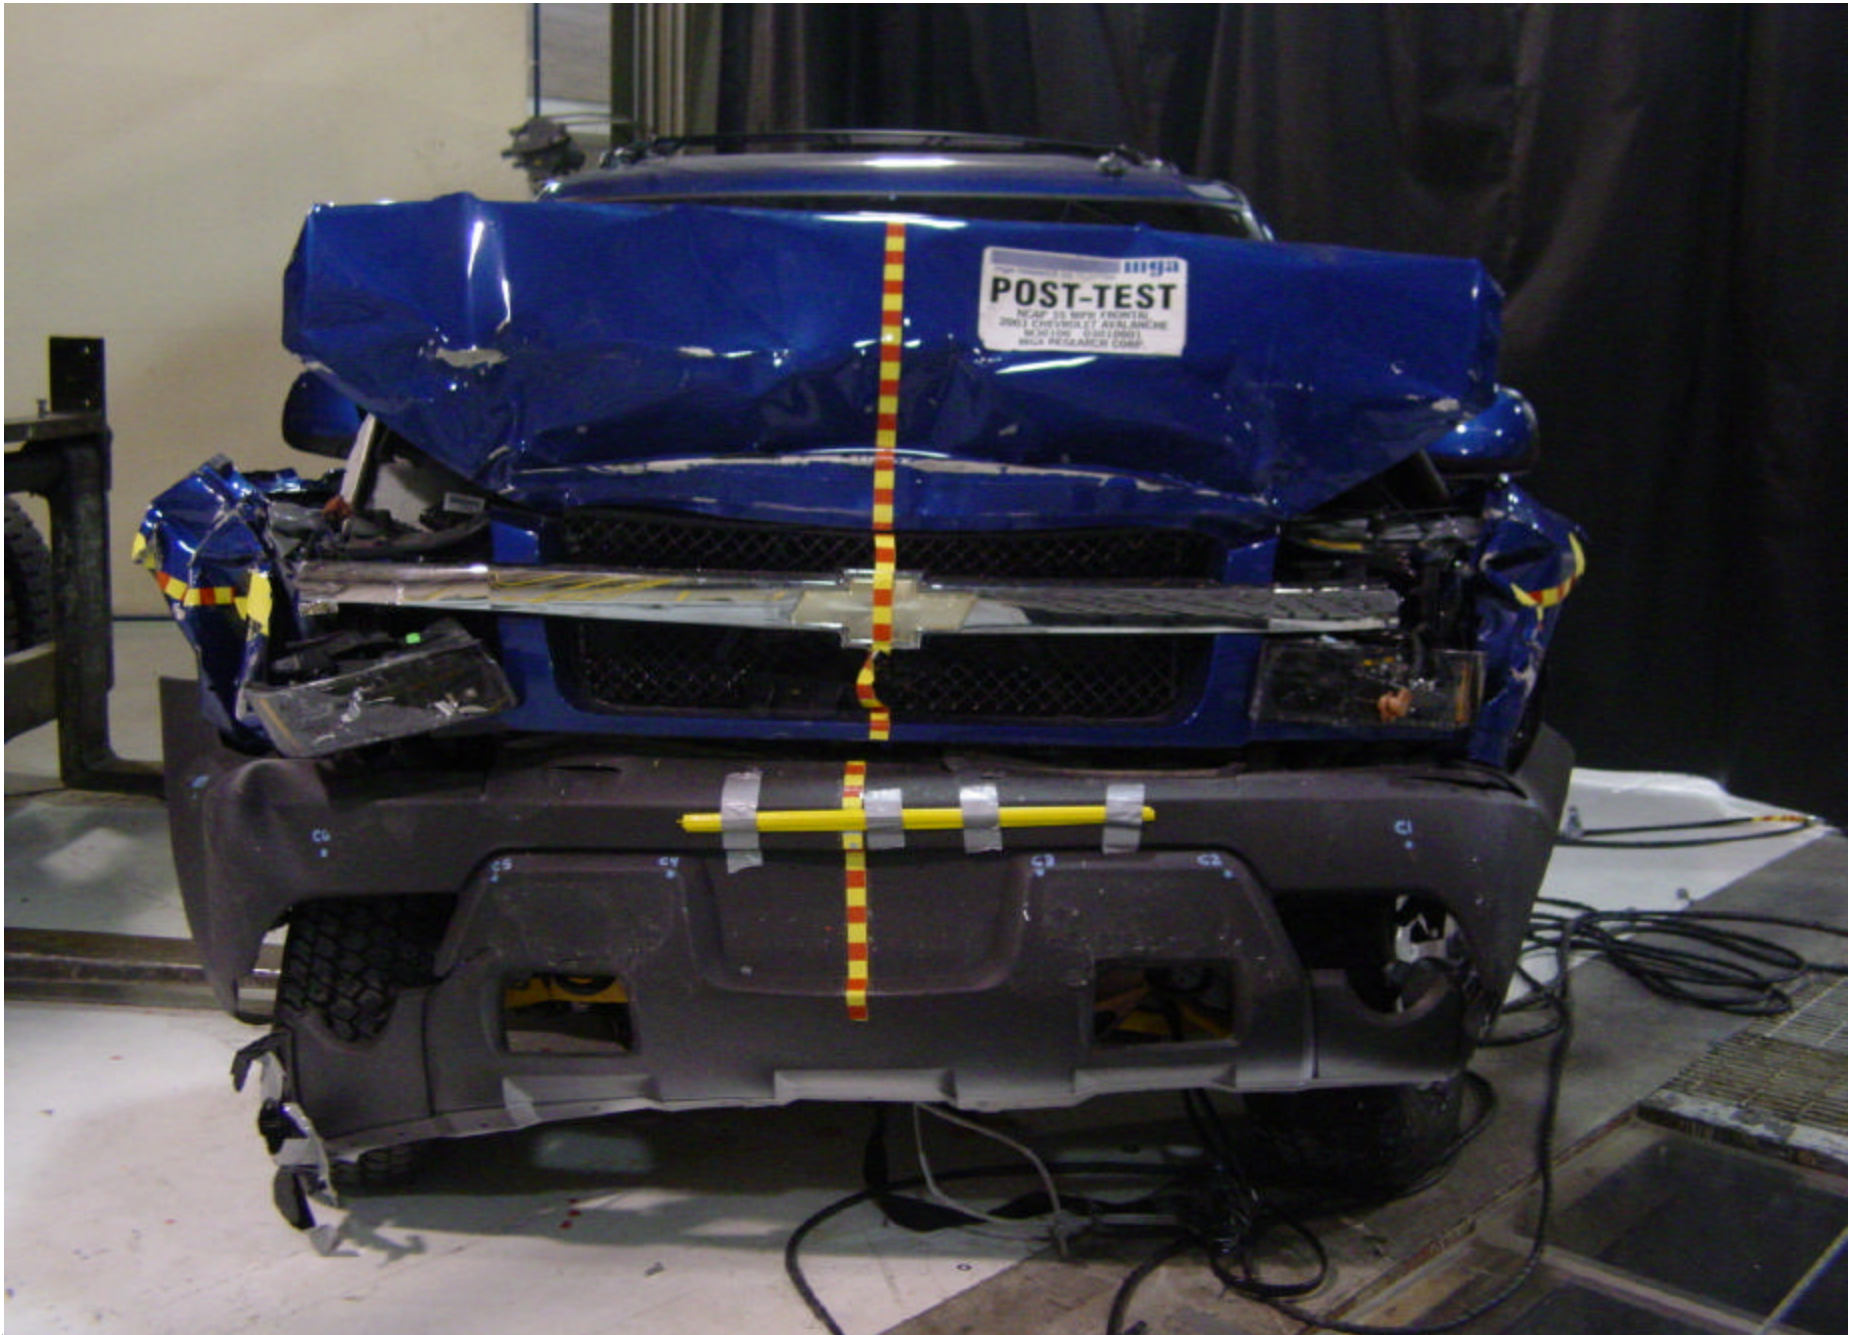
Post-Test Front View of Test Vehicle

The maximum static crush of the vehicle was 562 mm and both the driver and passenger side doors remained closed and latched during the impact event.

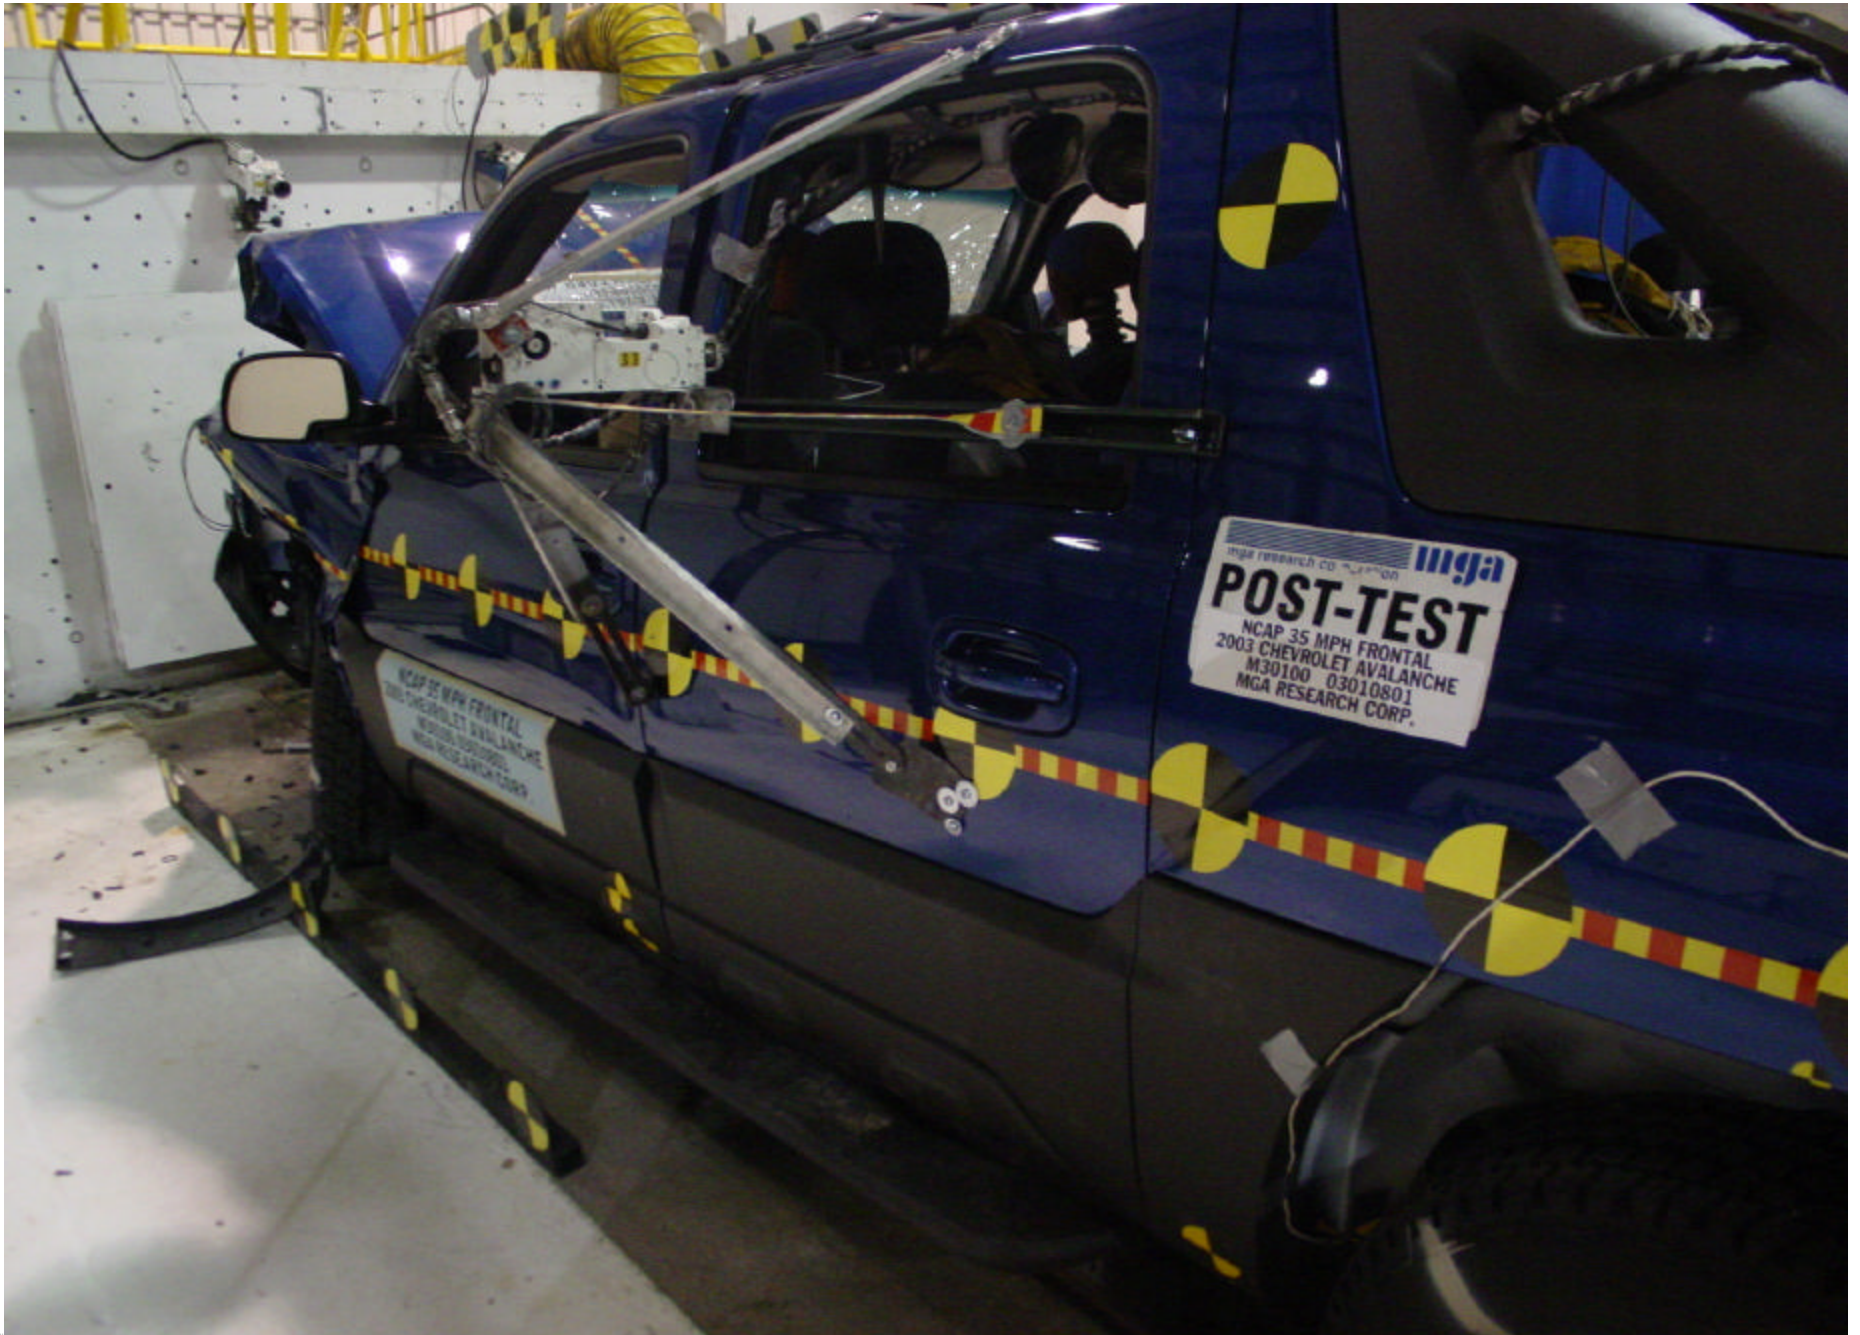
Post-Test Left Rear Three-Quarter View of Doors After Impact

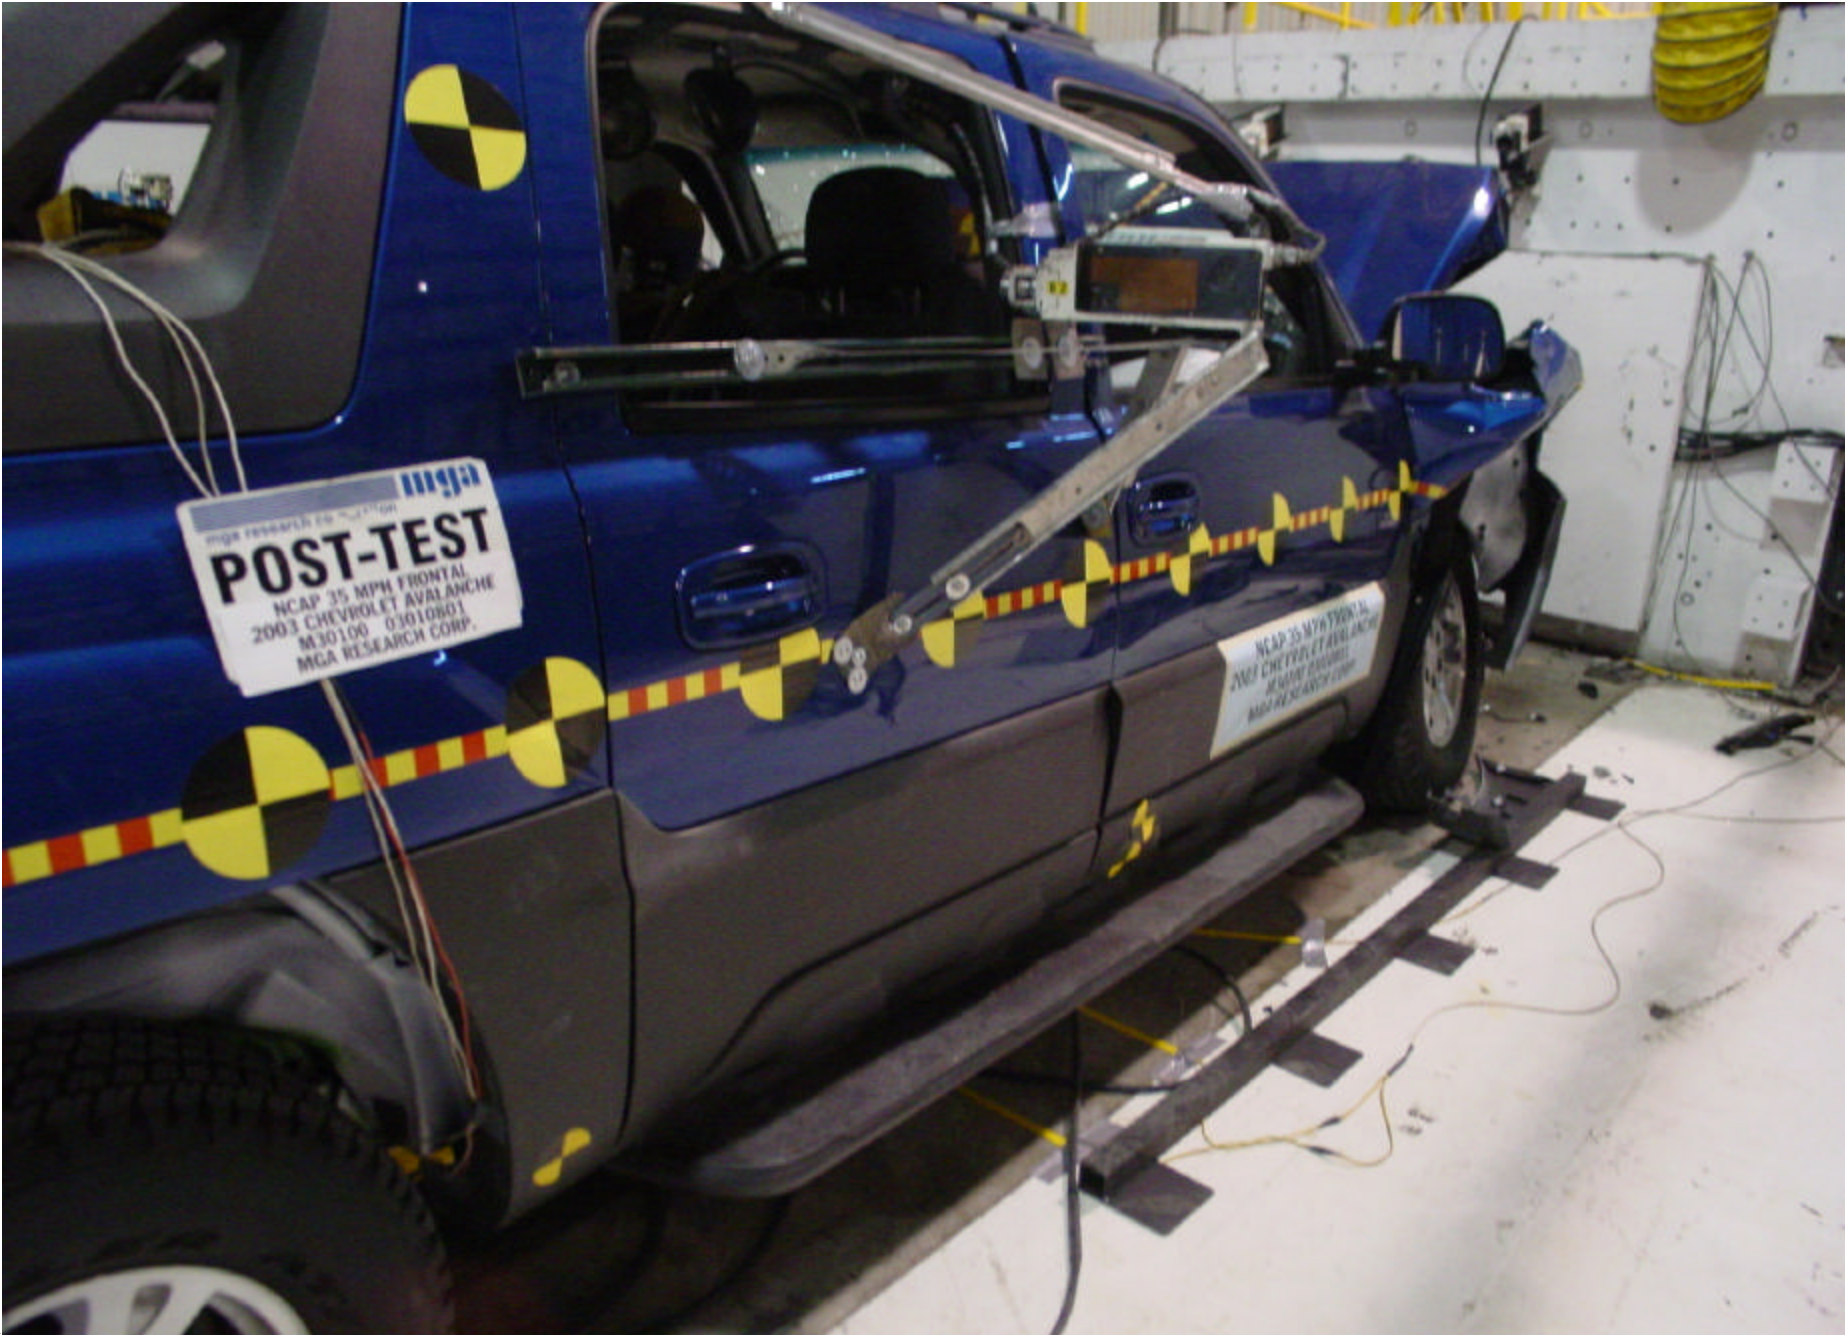
Post-Test Right Rear Three-Quarter View of Door After Impact

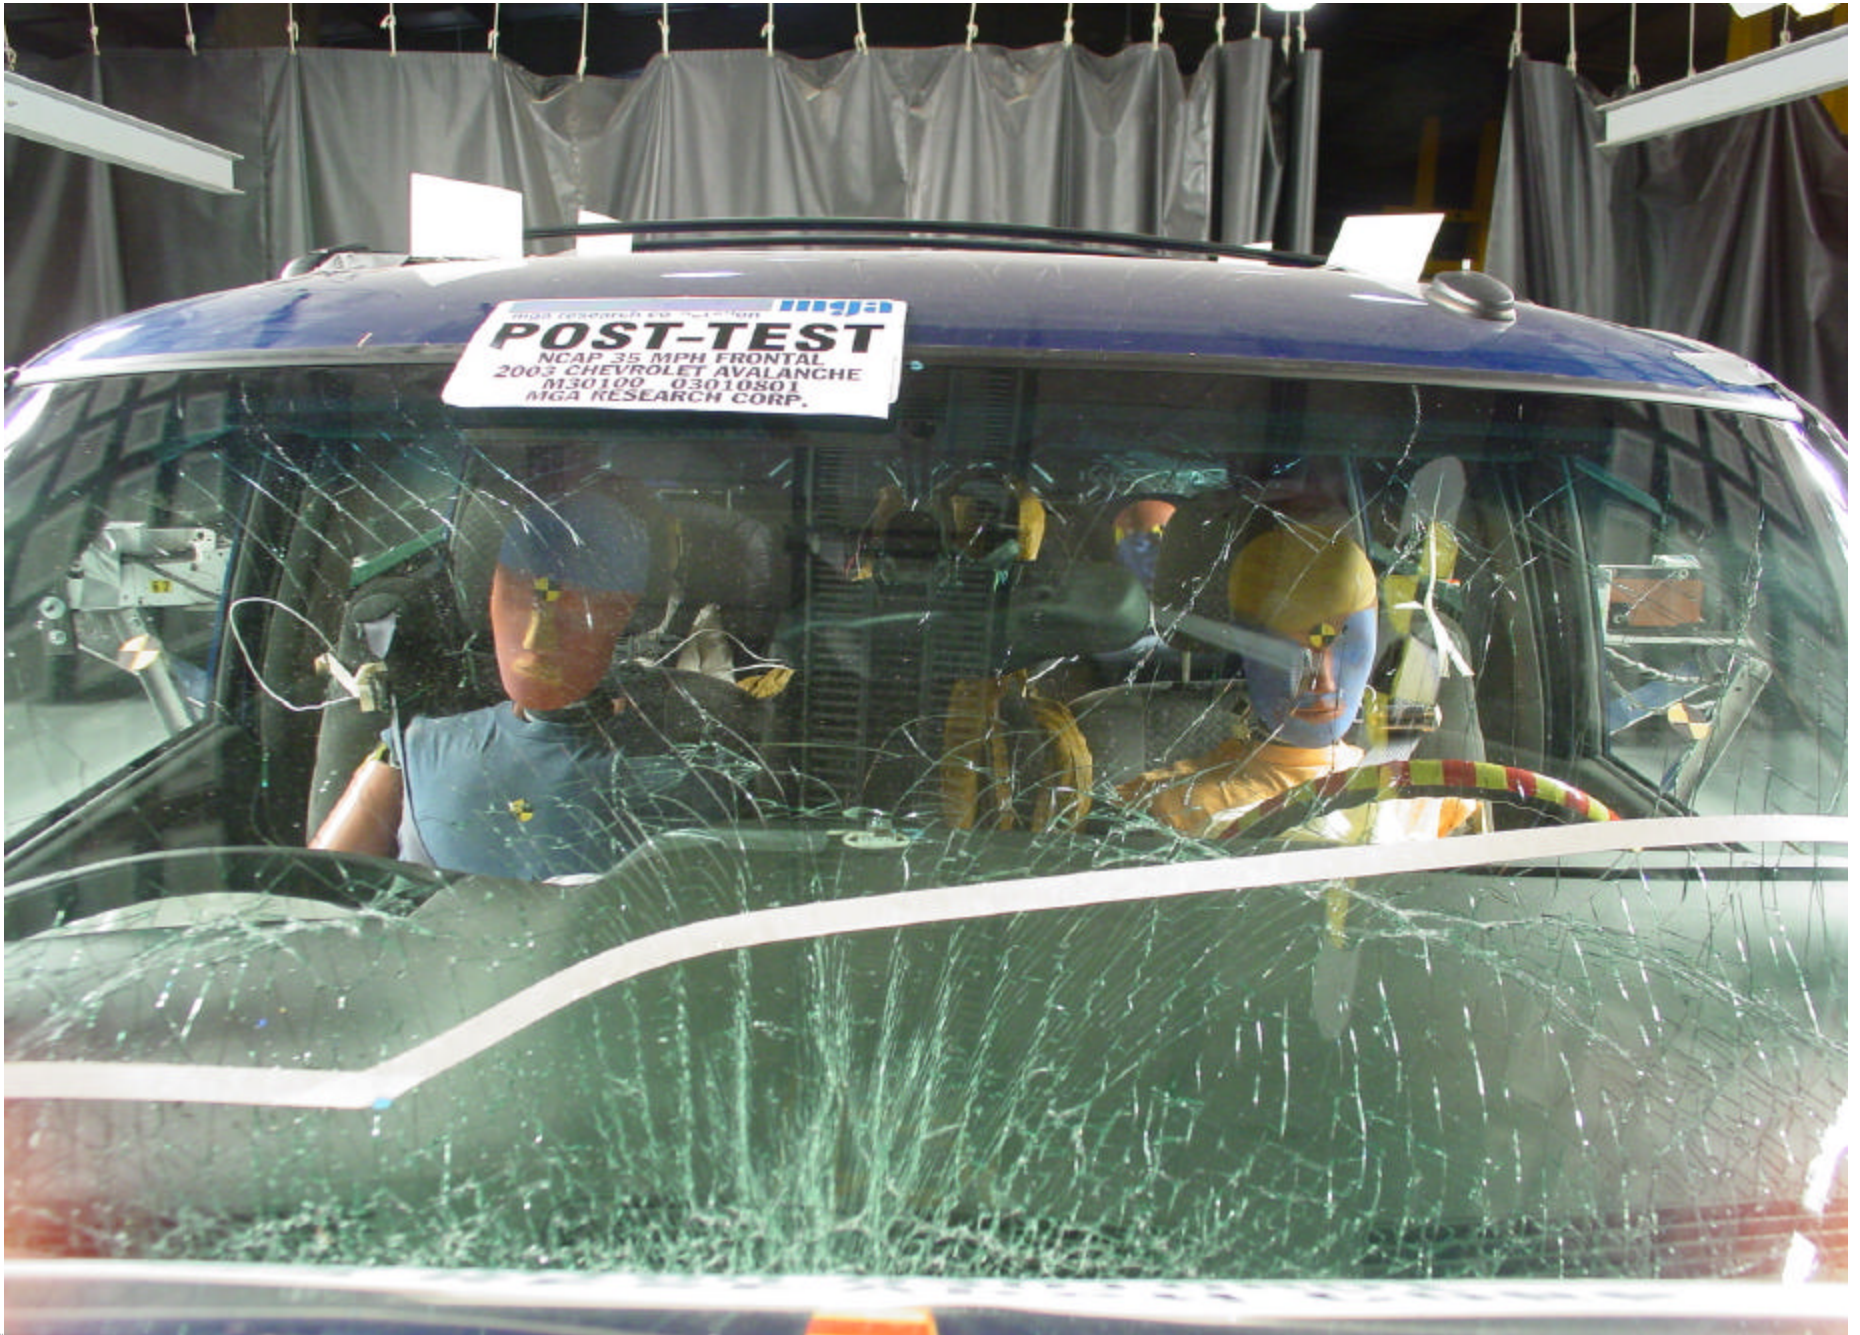
Post-Test Windshield View

There was 100 percent windshield retention and no intrusion into the protected zone of the windshield during the event. There was no Stoddard Solvent leakage after the event or during any phase of the static rollover.

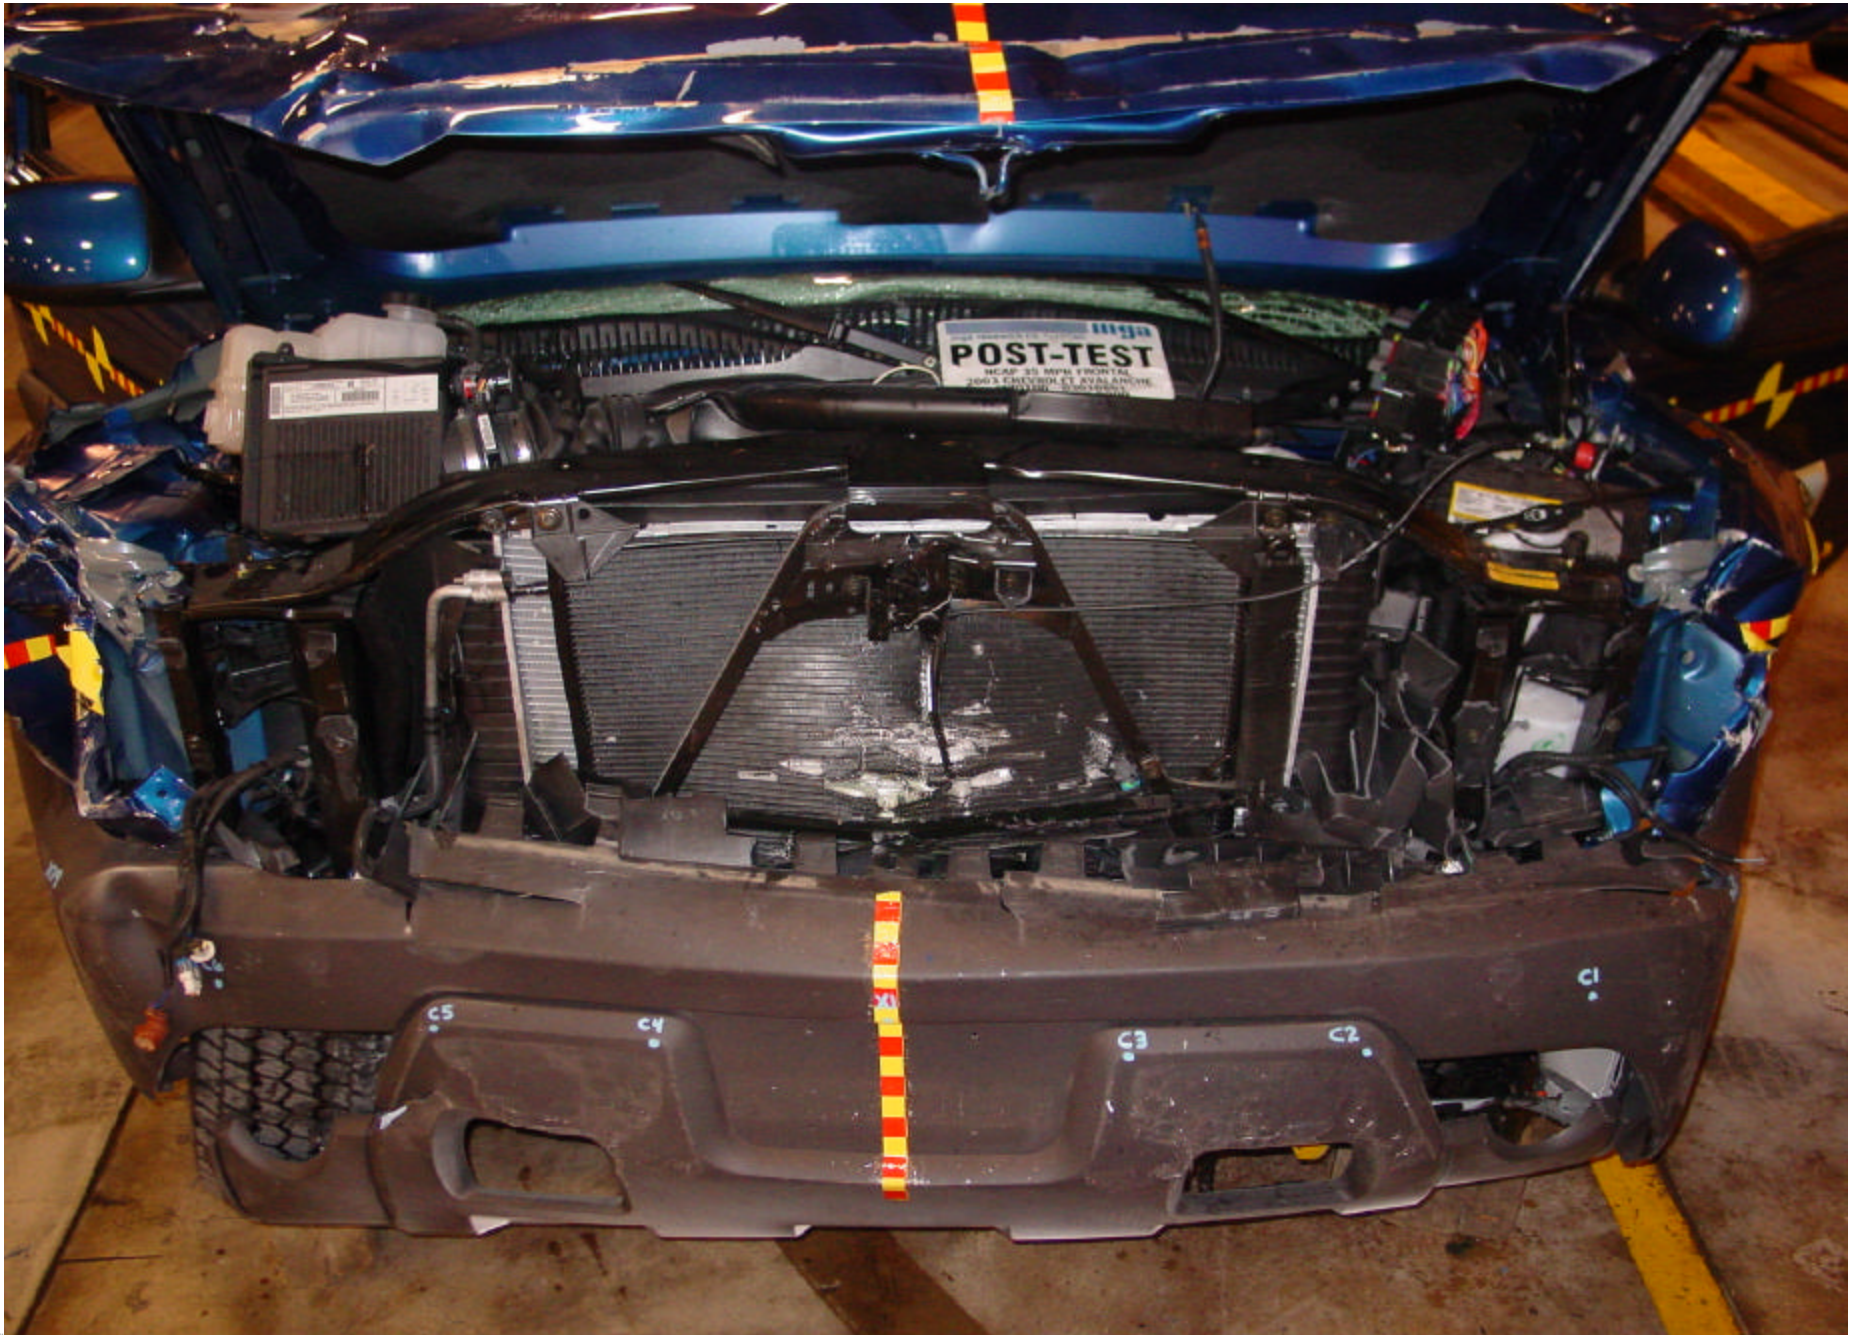
Post-Test Engine Compartment View

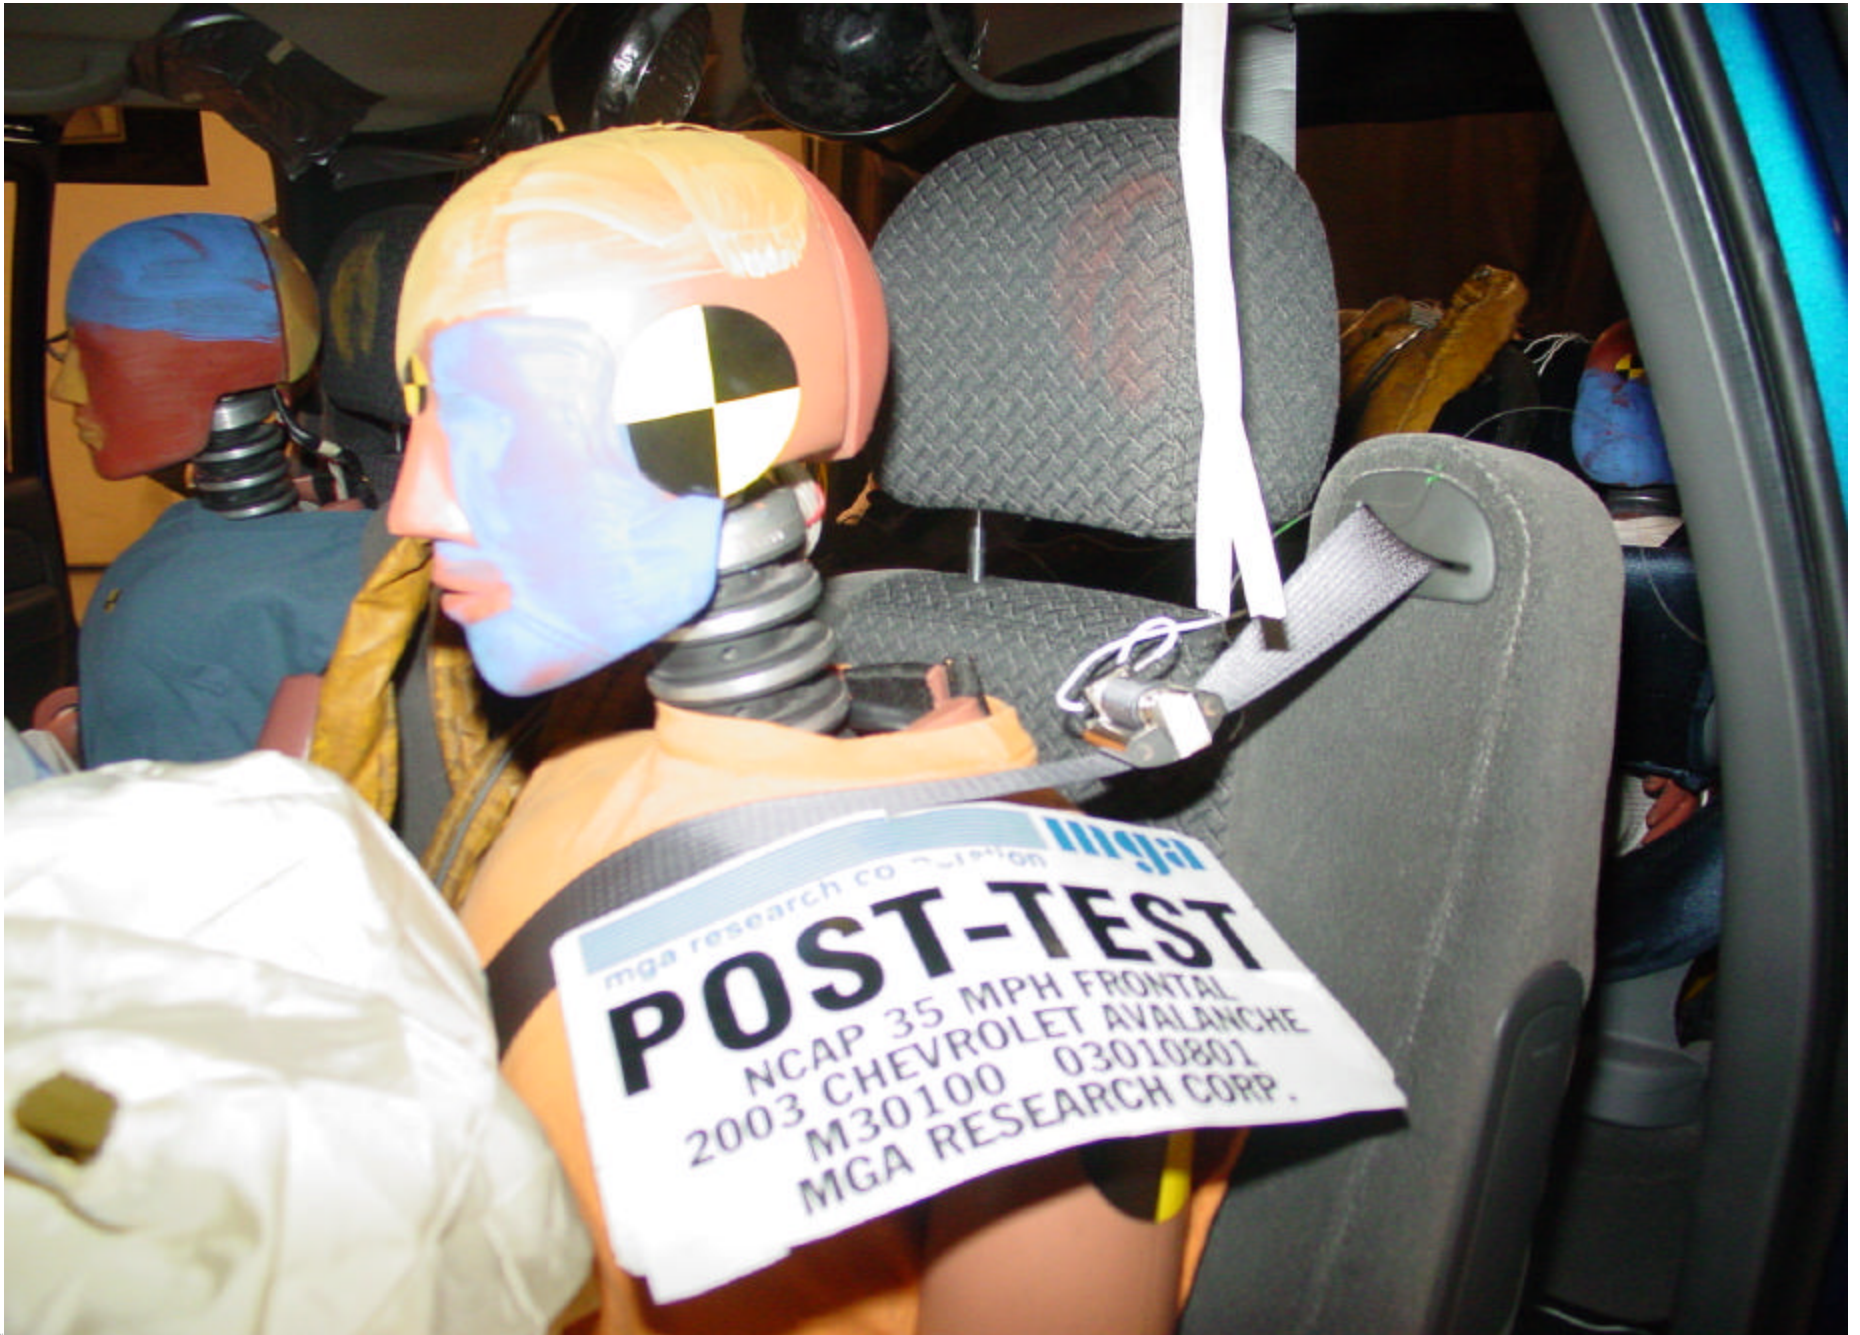
Post-Test Driver Dummy Head Contact

The driver's head and chest contacted the airbag. The driver's head also contacted the headrest. The driver's knees contacted the bolster. The passenger's head and chest contacted the airbag. The passenger's head also contacted the headrest. The passenger's knees contacted the glove box.

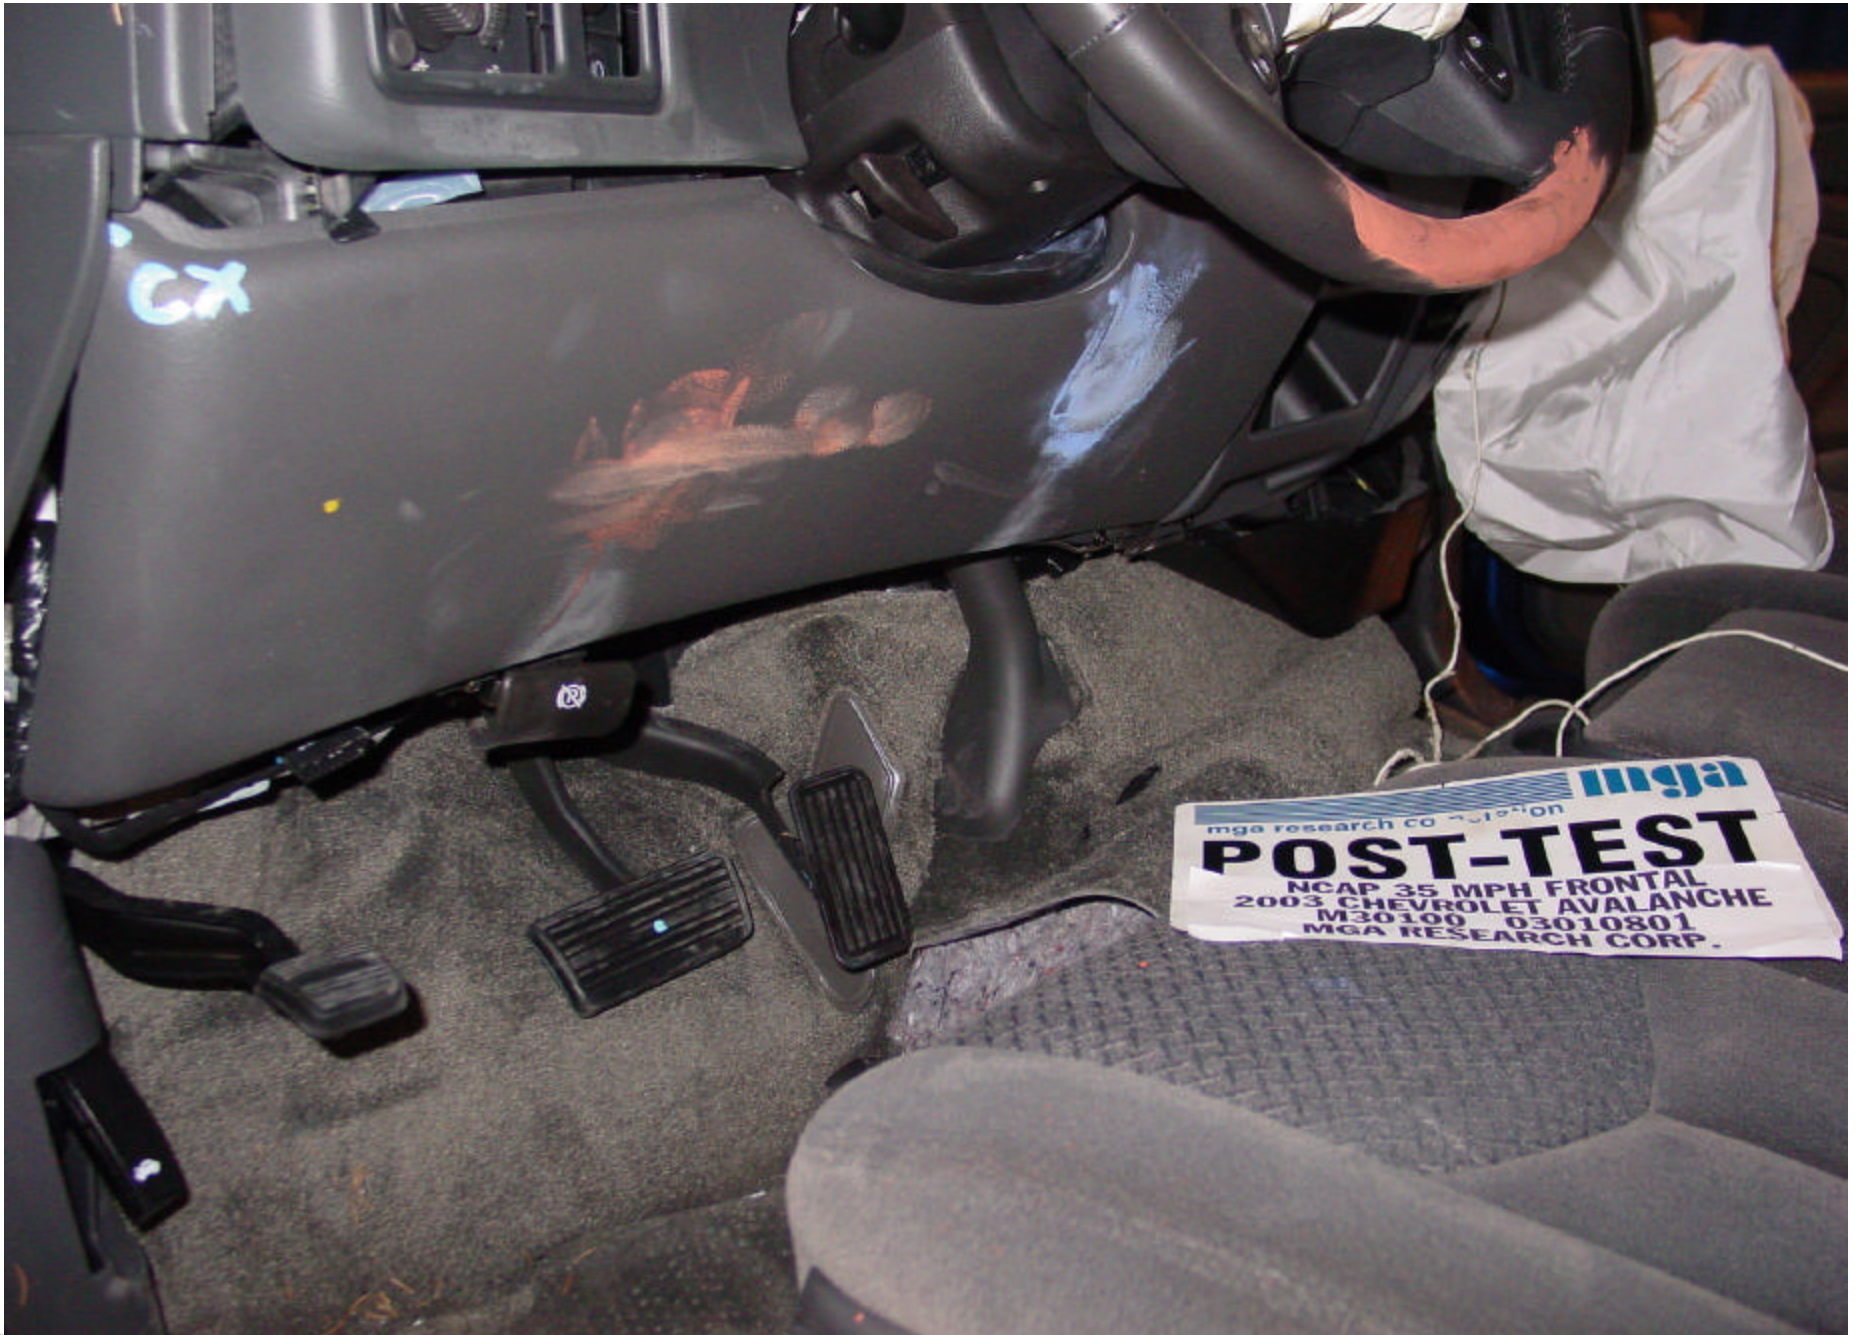
Post-Test Driver Dummy Knee Contact

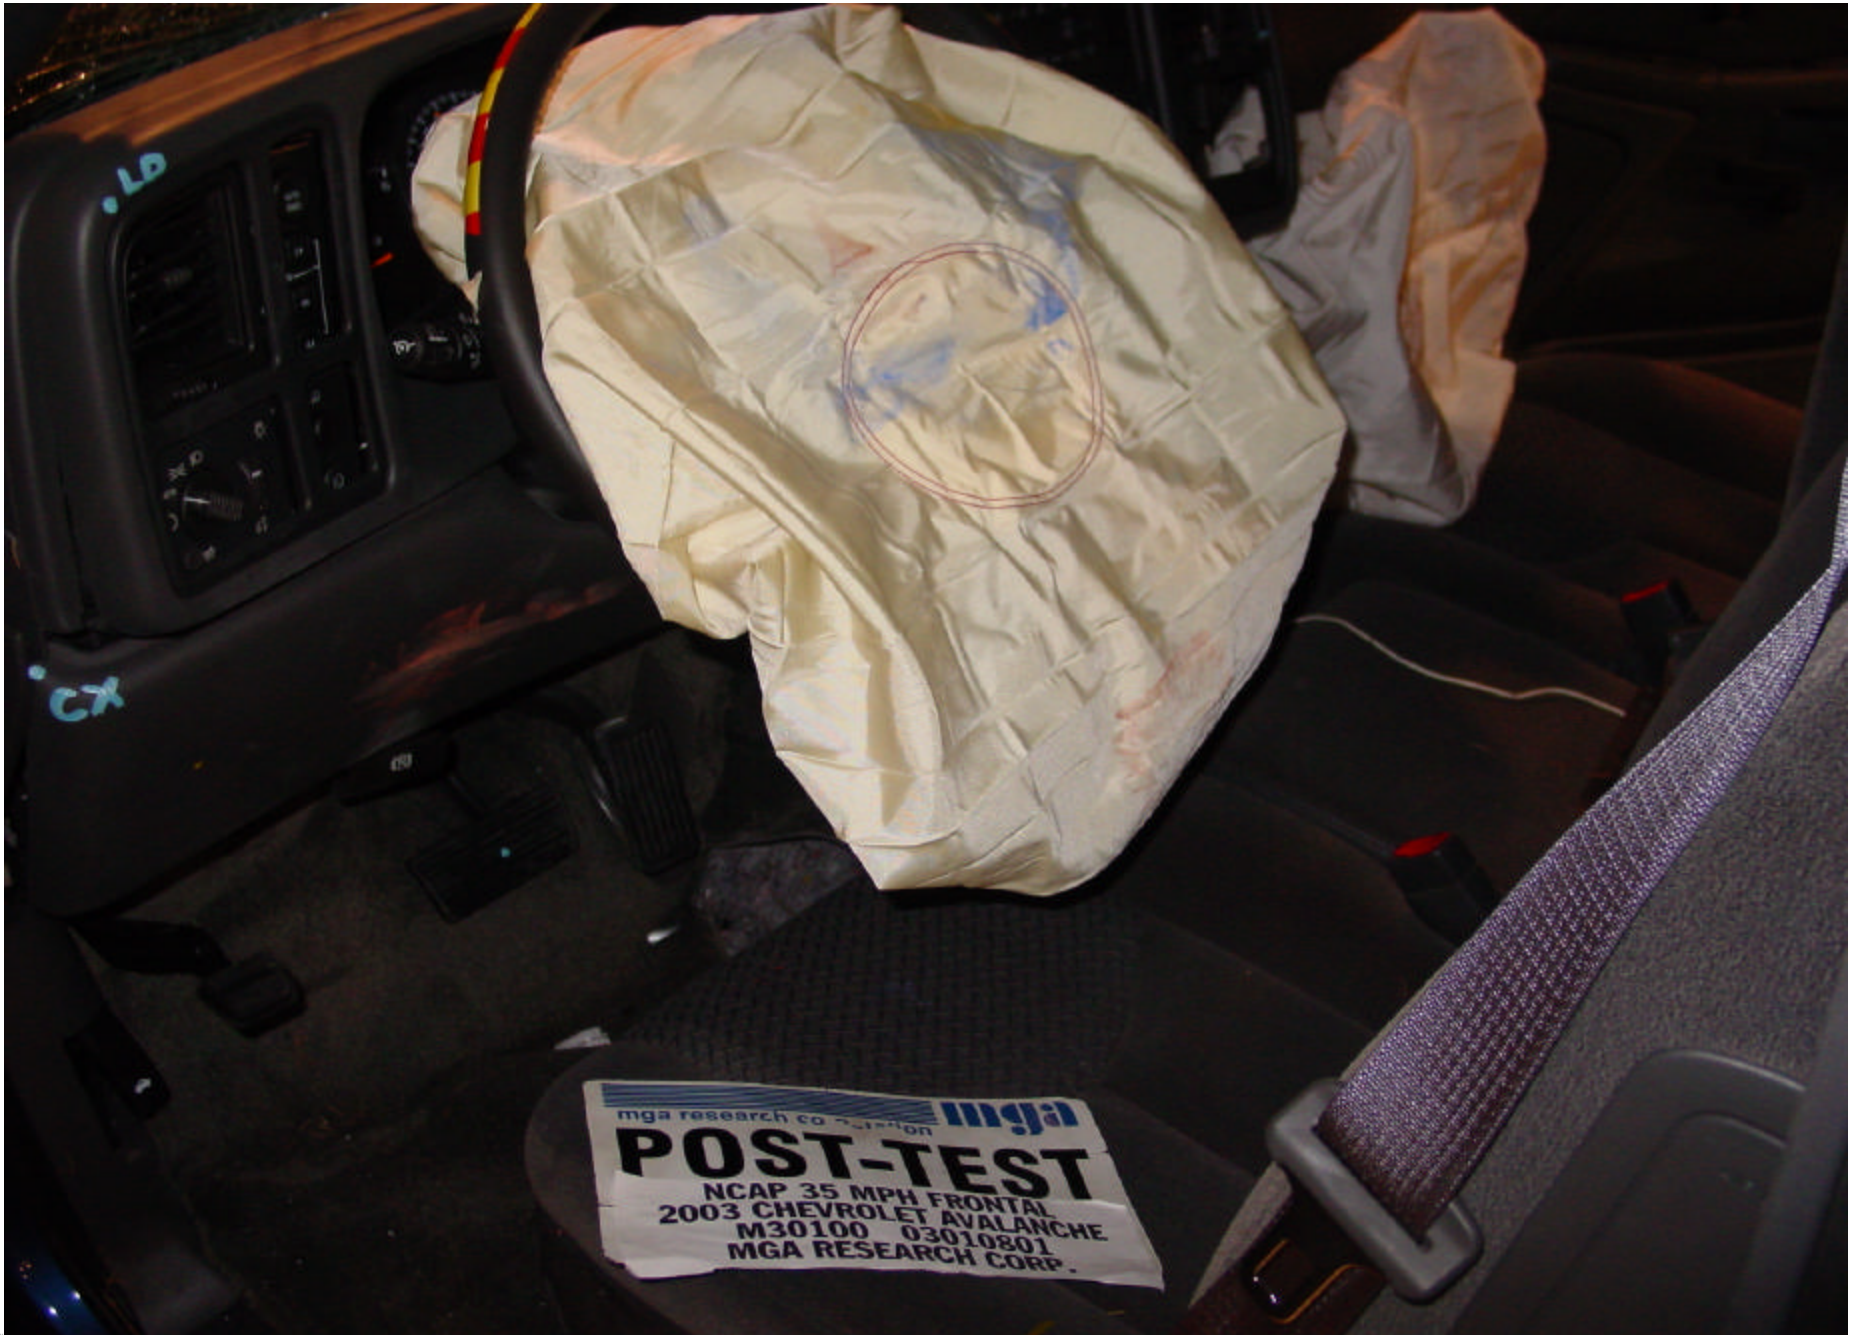
Post-Test Driver Dummy Airbag Contact

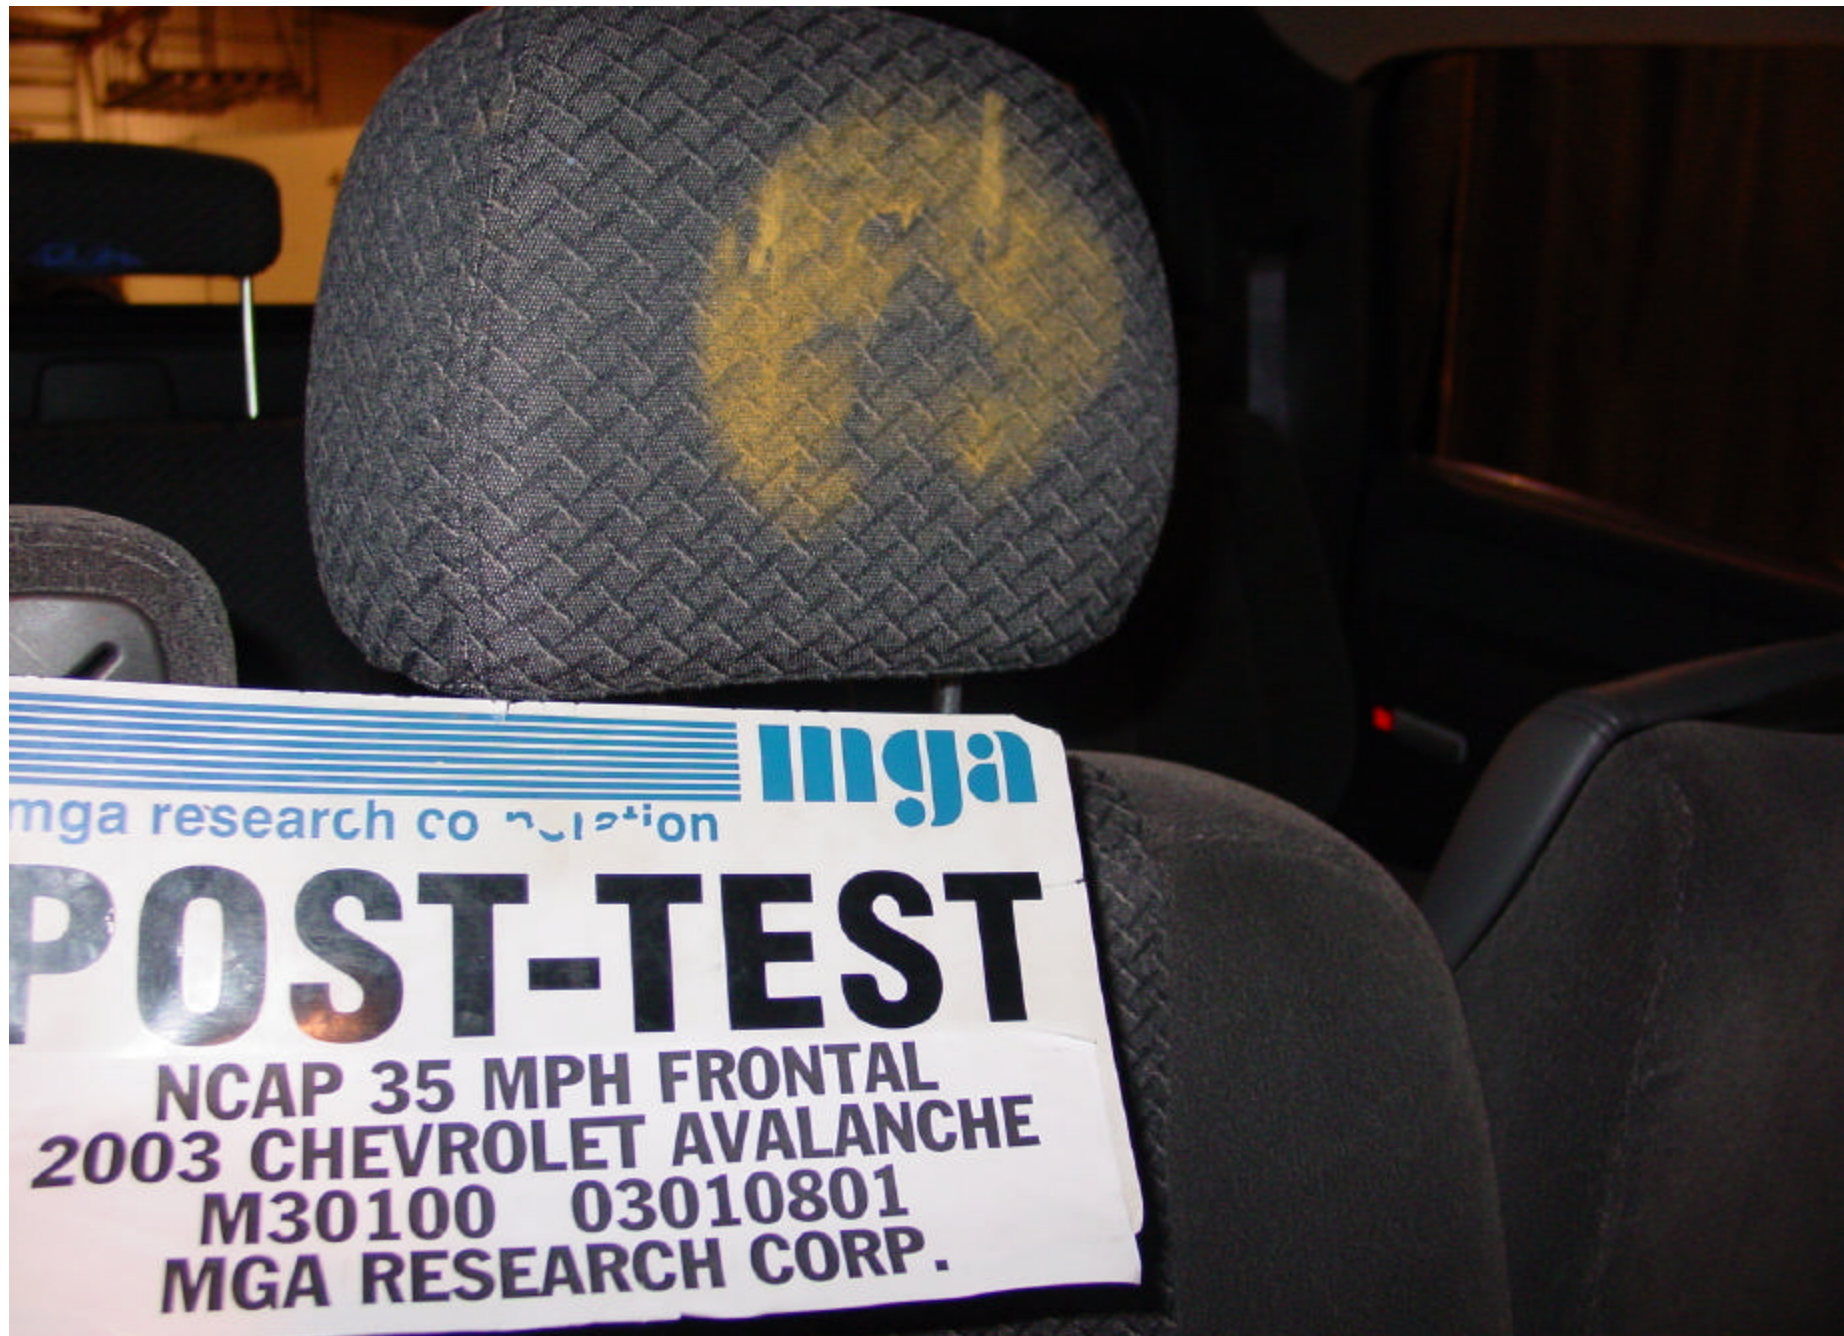
Post-Test Passenger Dummy Head Contact
