REPORT NUMBER: NCAP-MGA-2003-003

**NEW CAR ASSESSMENT PROGRAM
FRONTAL BARRIER IMPACT TEST**

**2003 CHEVROLET AVALANCHE 4 DOOR
NHTSA NUMBER: M30100**

**PREPARED BY:
MGA RESEARCH CORPORATION
5000 WARREN ROAD
BURLINGTON, WI 53105**

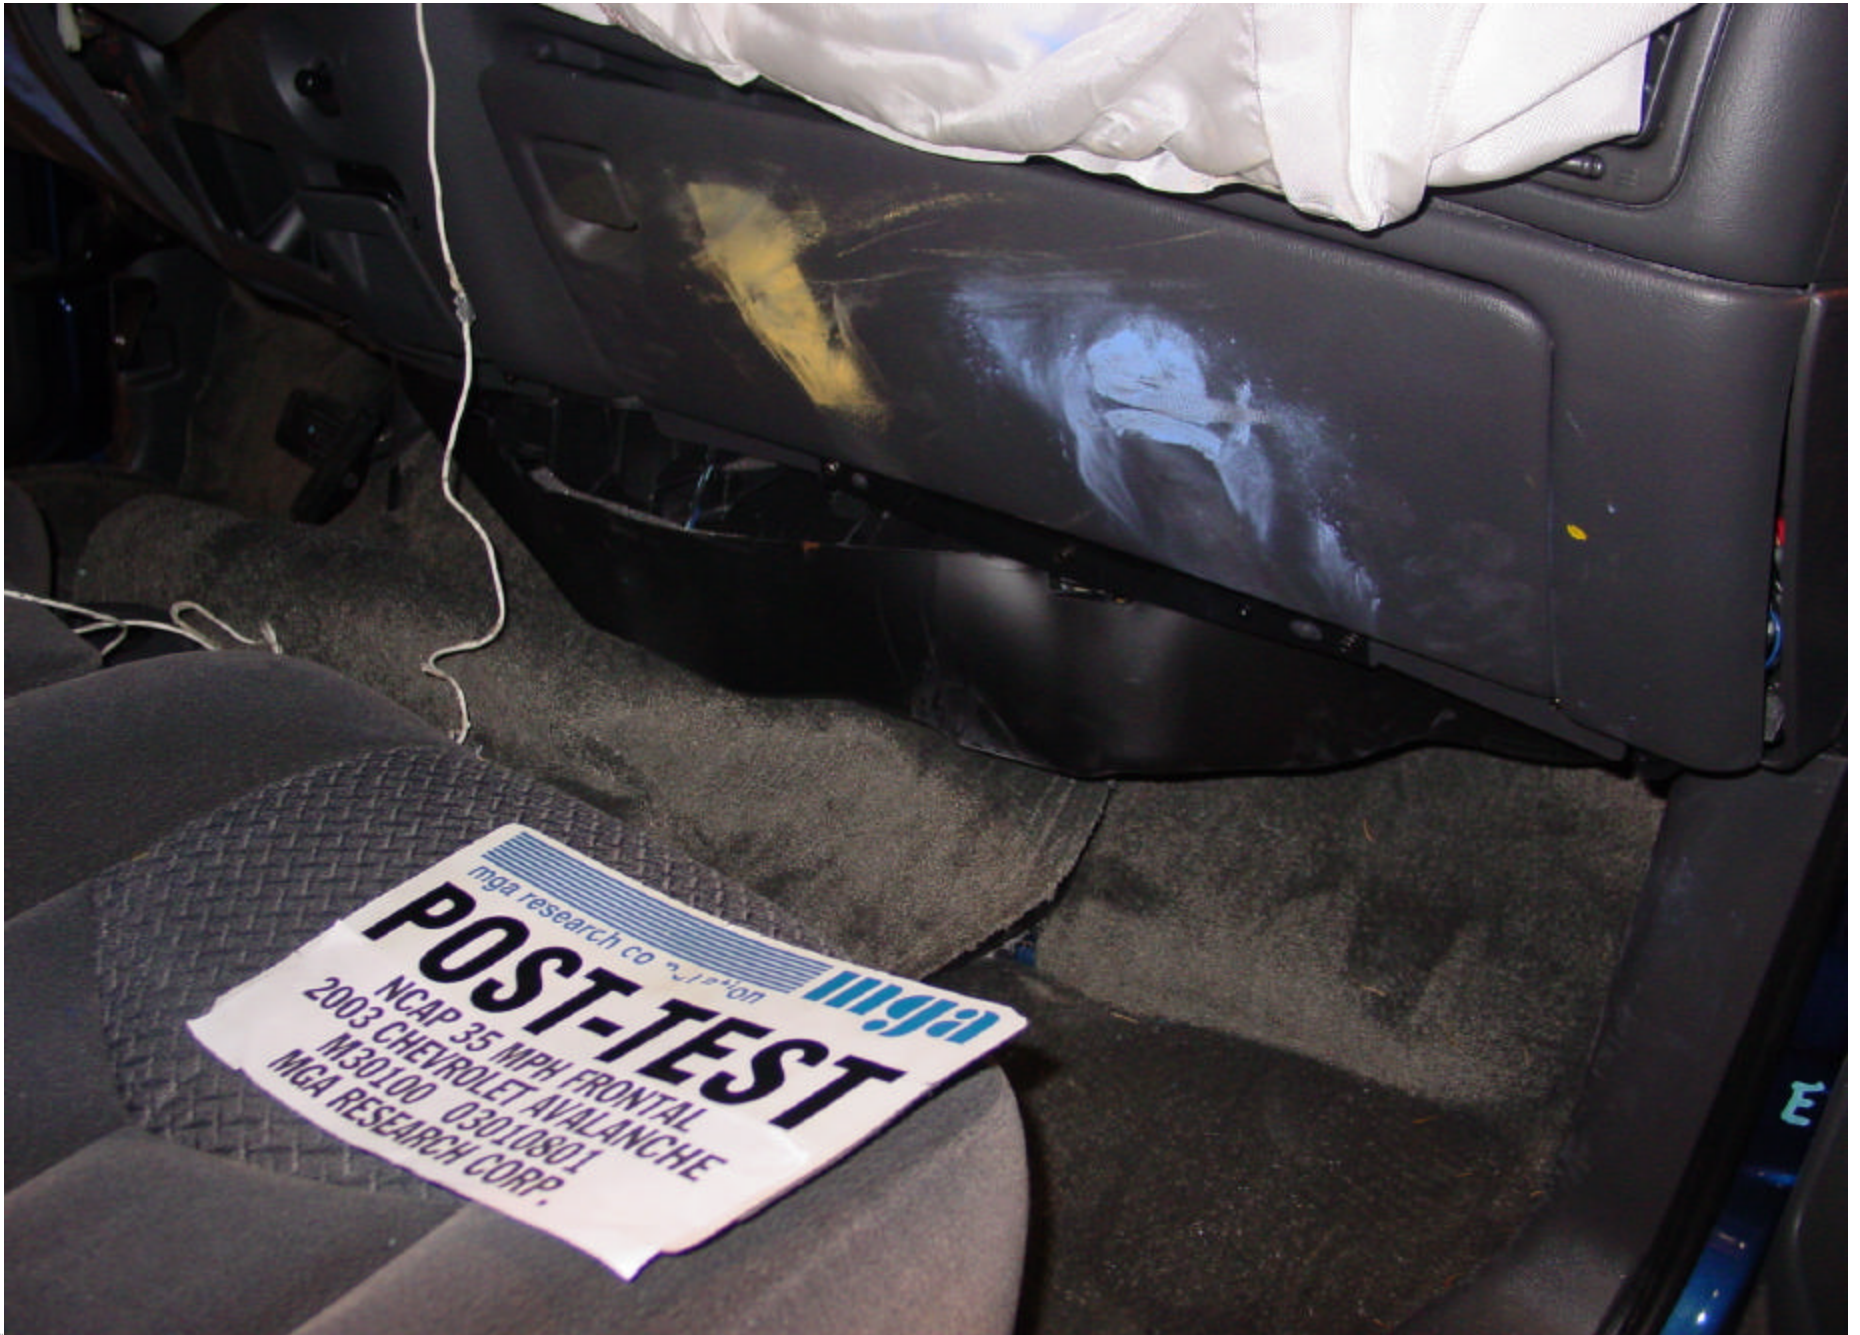
Post-Test Passenger Dummy Knee Contact

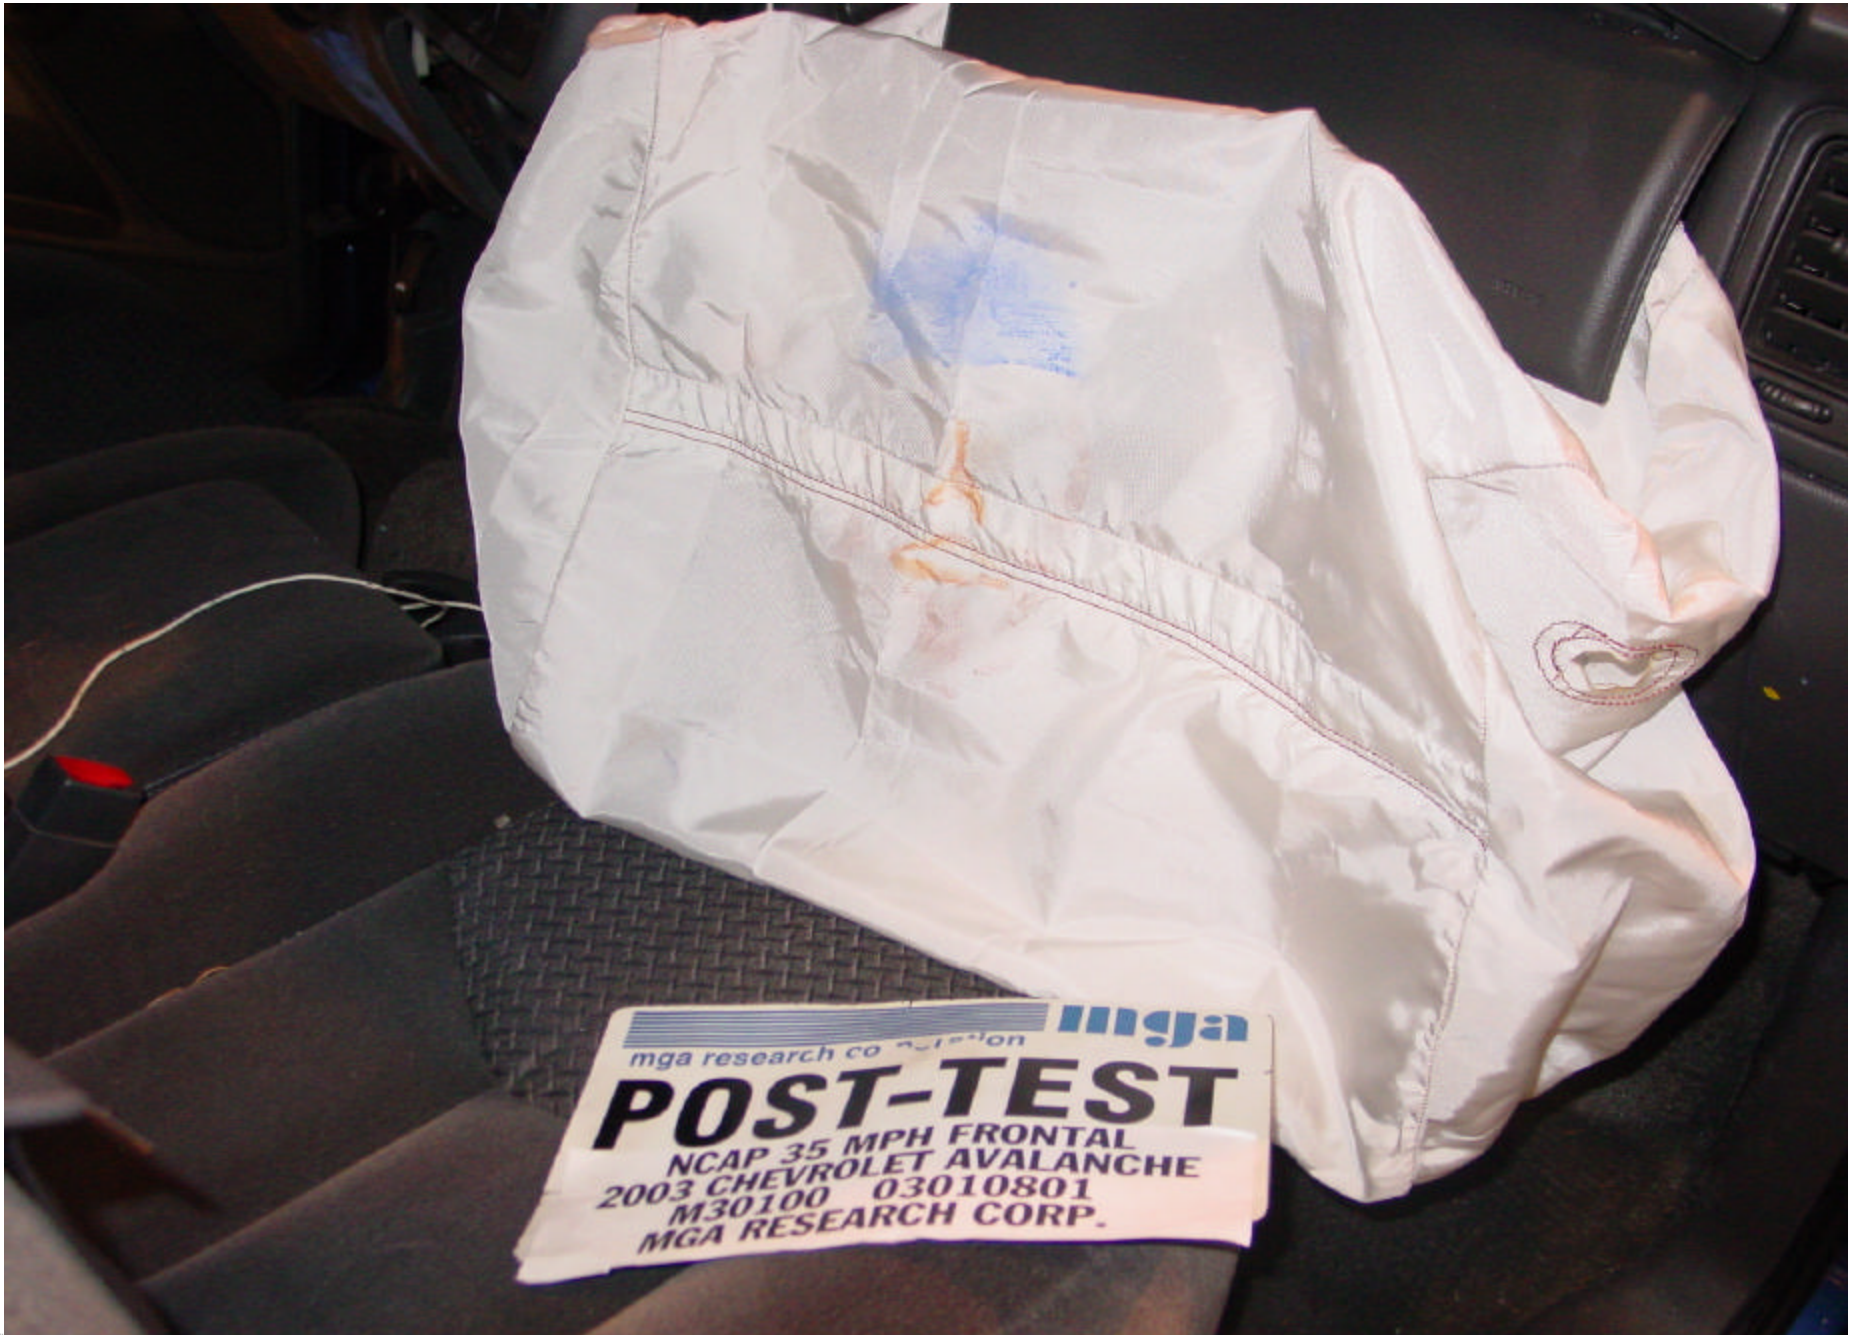
Post-Test Passenger Dummy Airbag Contact
