REPORT NUMBER: SNCAP-CAL-03-03

**NEW CAR ASSESSMENT PROGRAM  
SIDE IMPACT TEST**

HONDA OF AMERICA MFG. INC.  
2003 HONDA ACCORD  
2-DOOR COUPE

**FINAL REPORT**

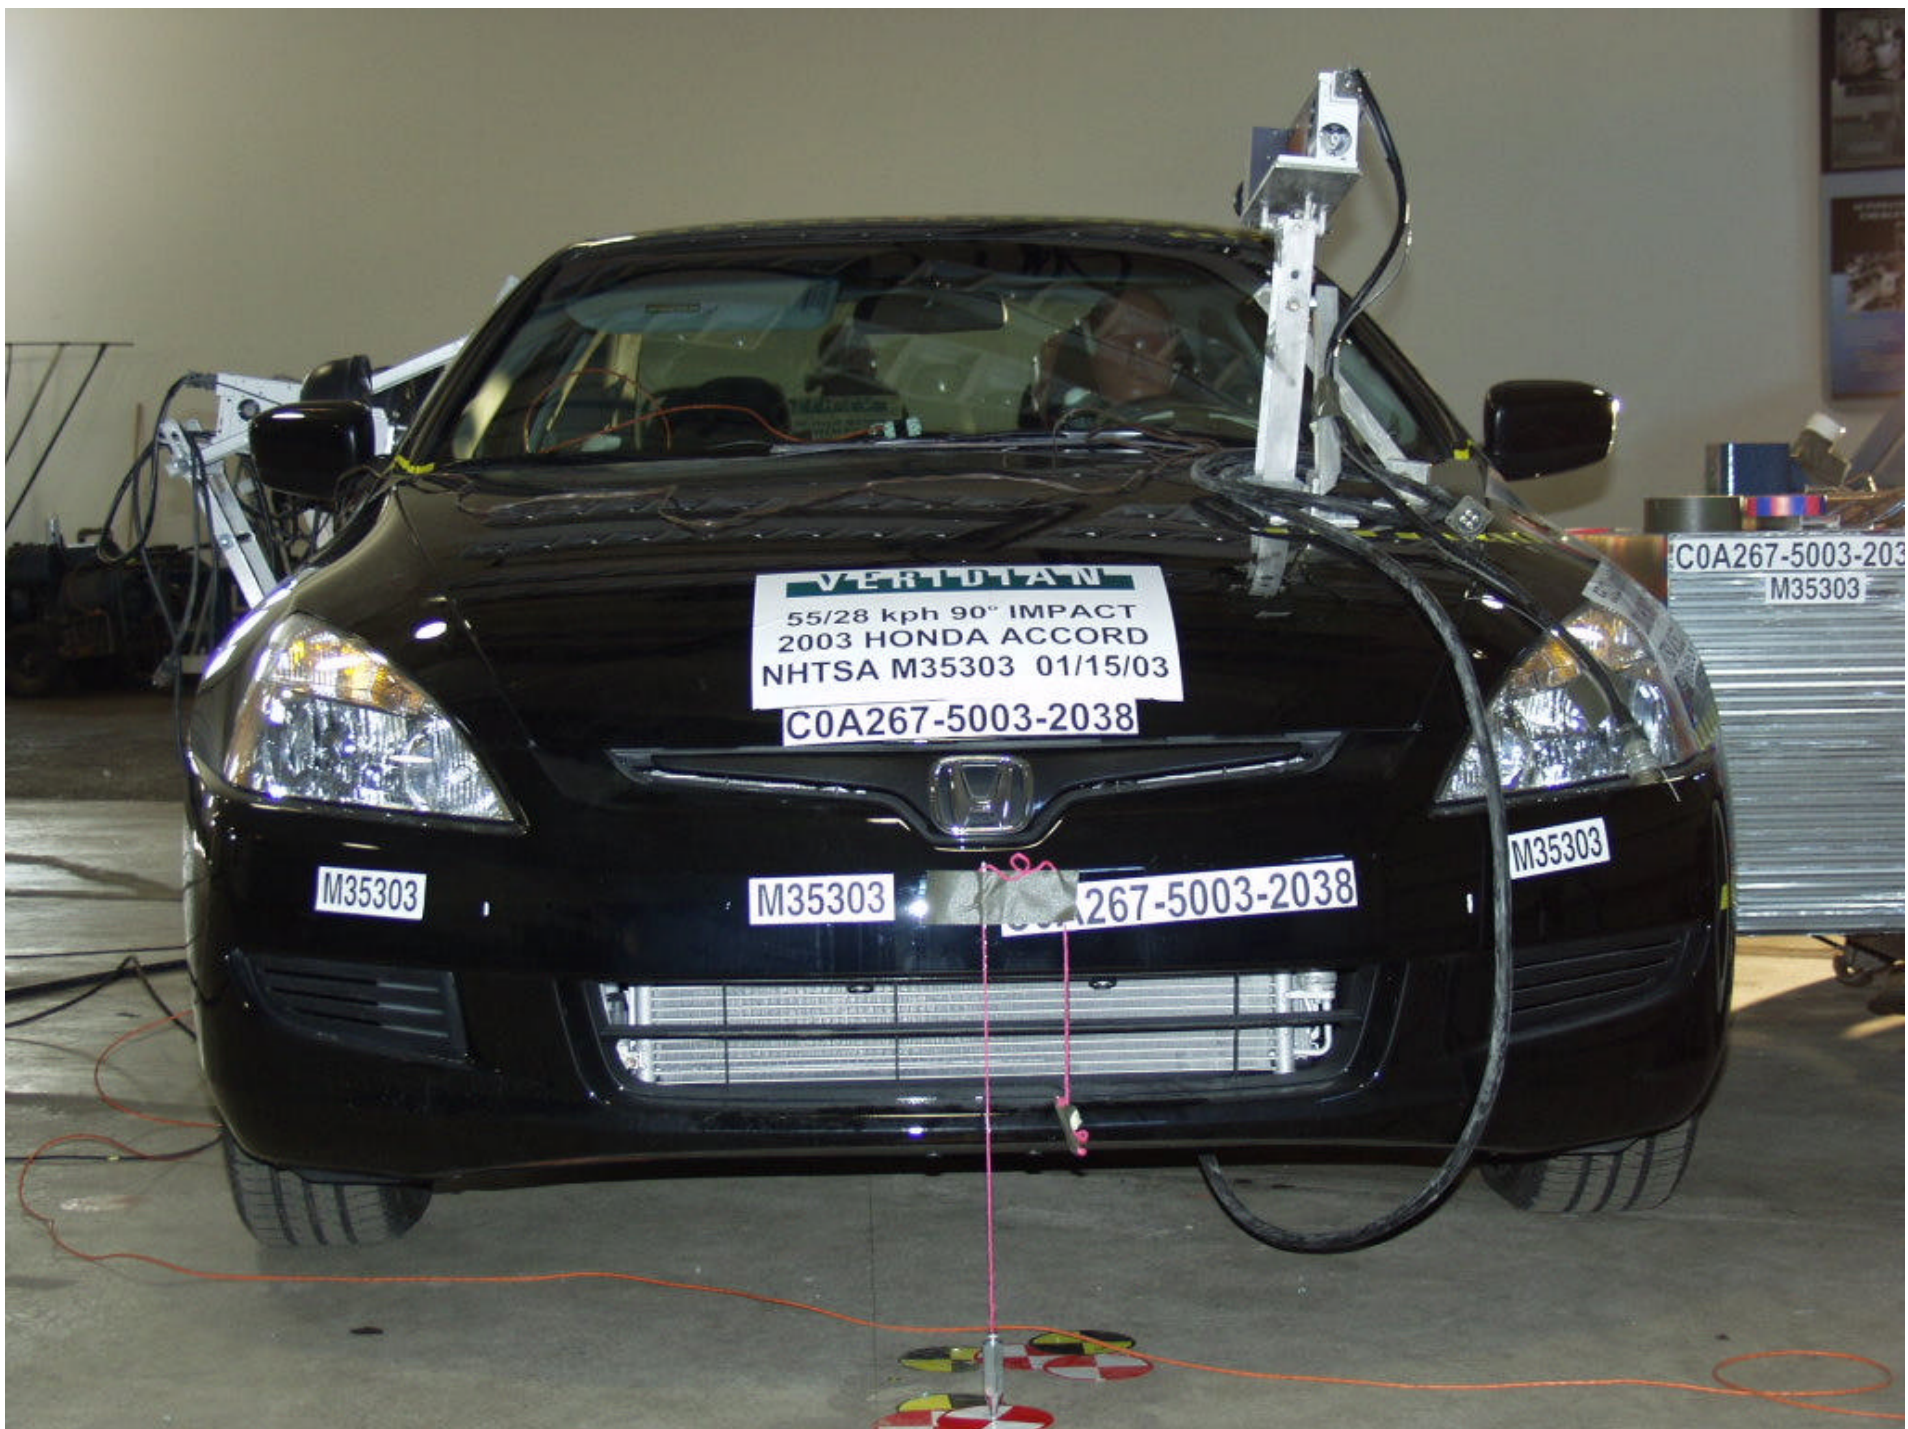
Figure A-1 PRE-TEST FRONTAL VIEW OF TEST VEHICLE

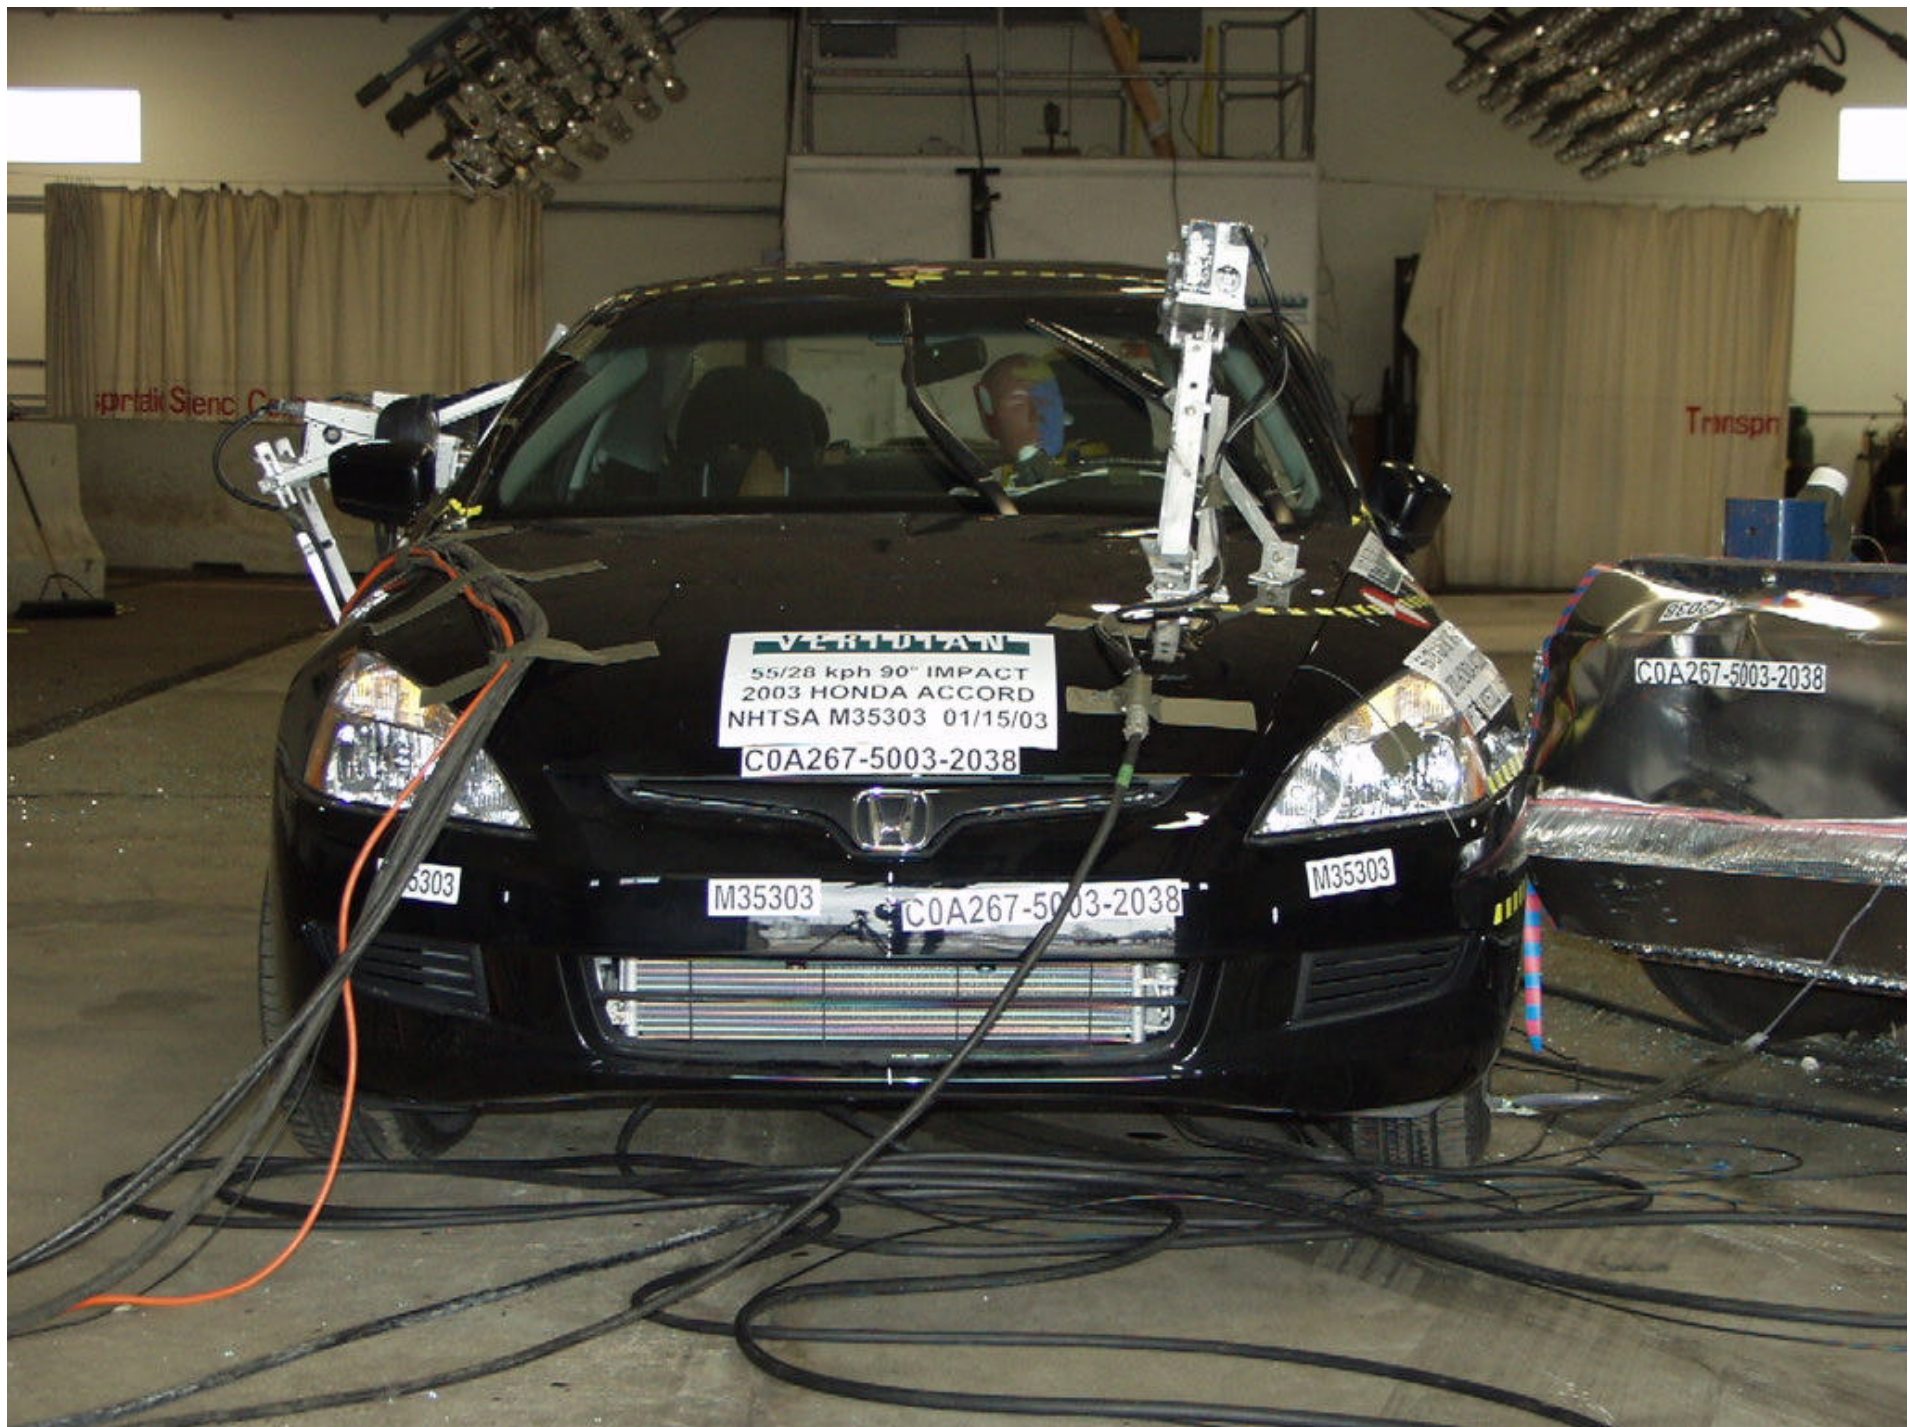
Figure A-2 POST-TEST FRONTAL VIEW OF TEST VEHICLE

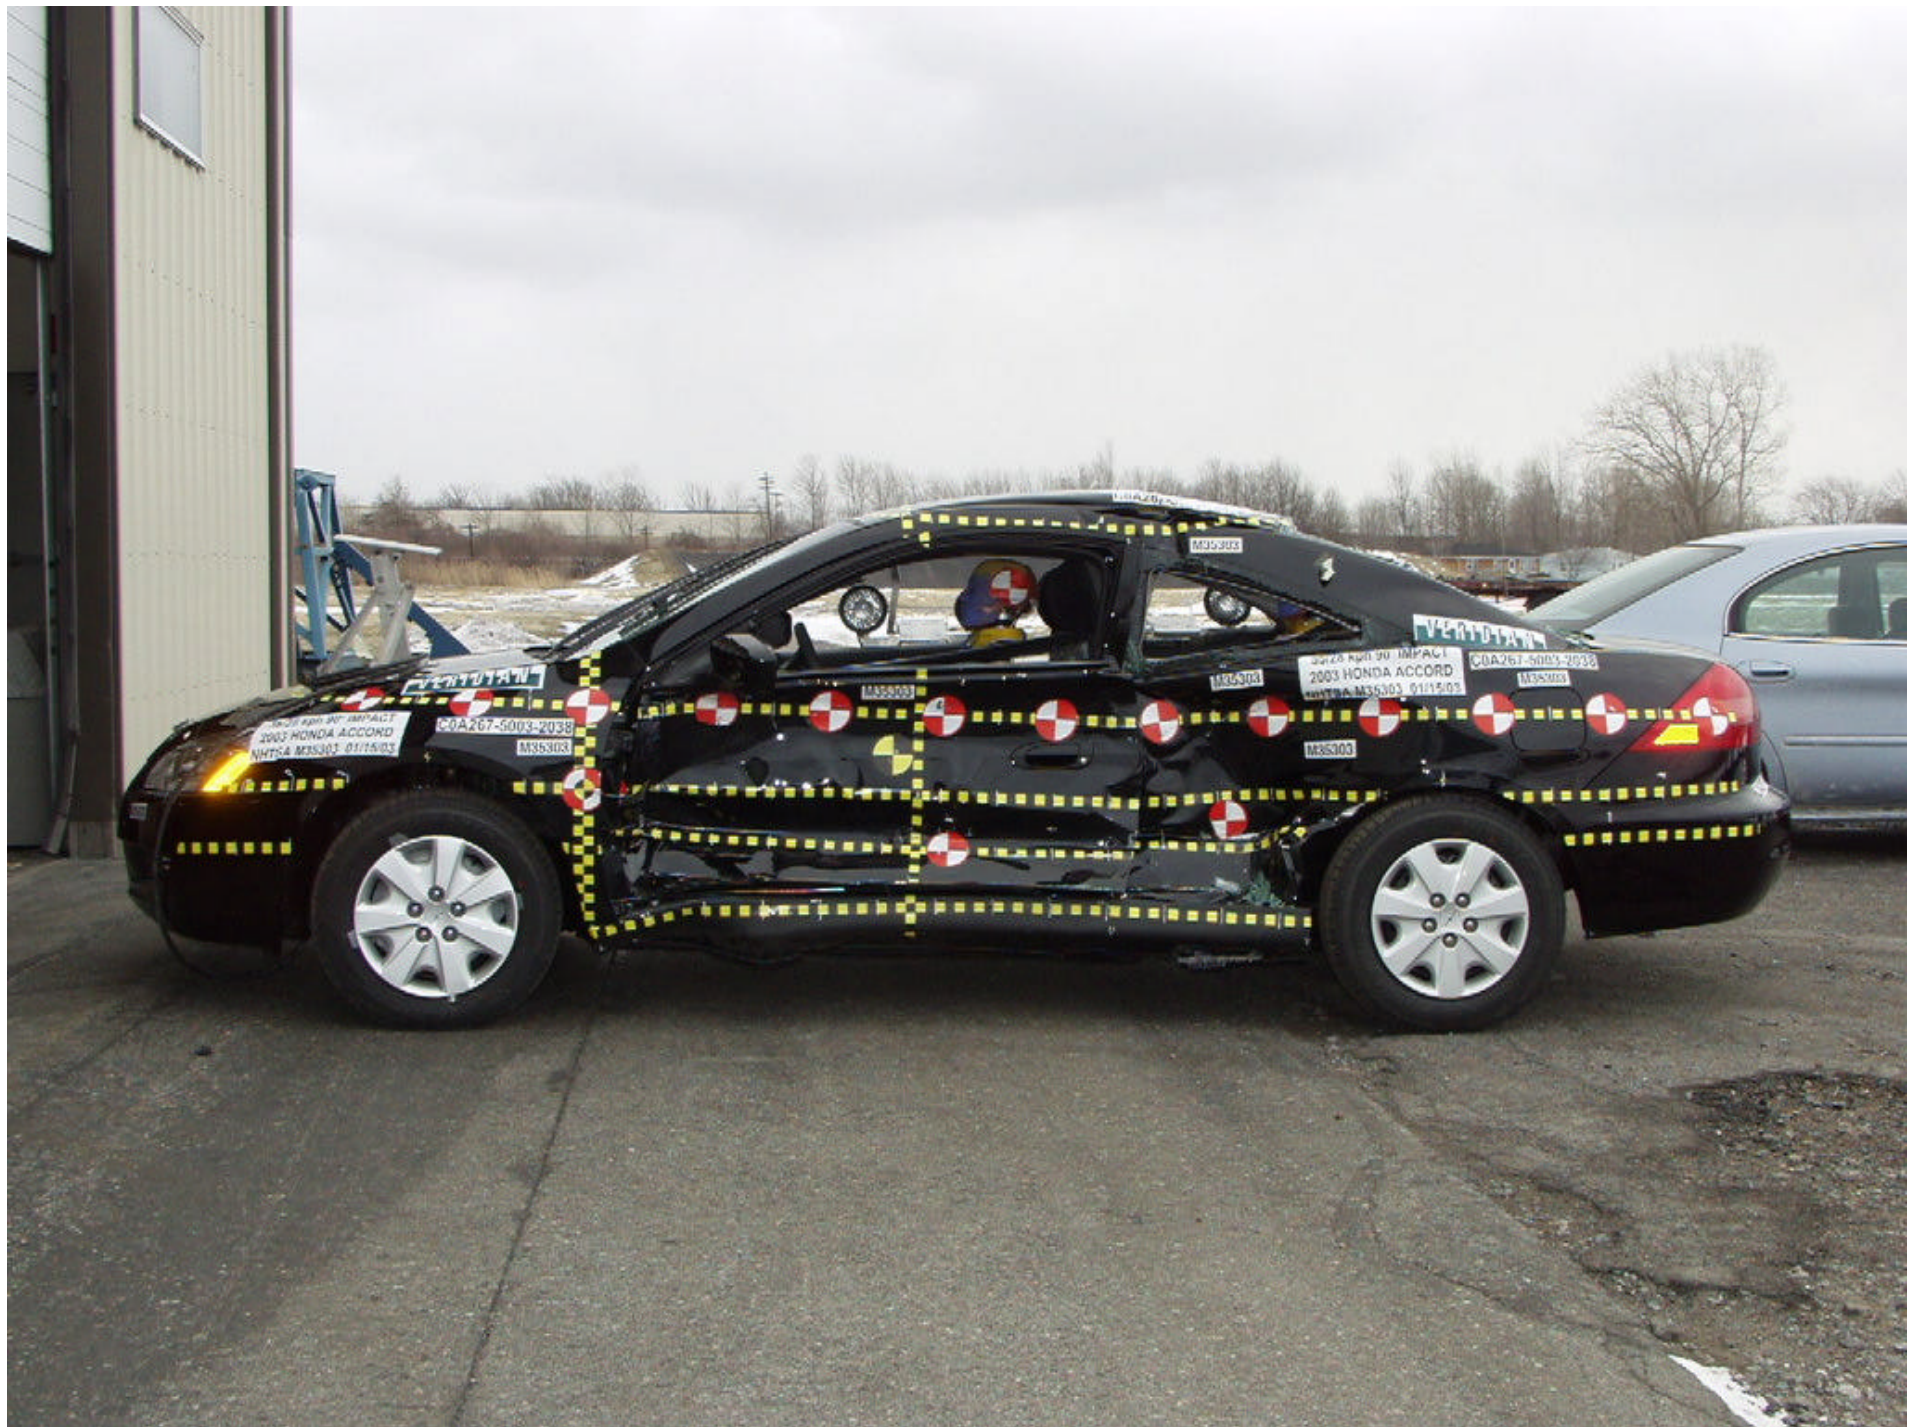
Figure A-6 POST-TEST IMPACTED SIDE VIEW OF TEST VEHICLE

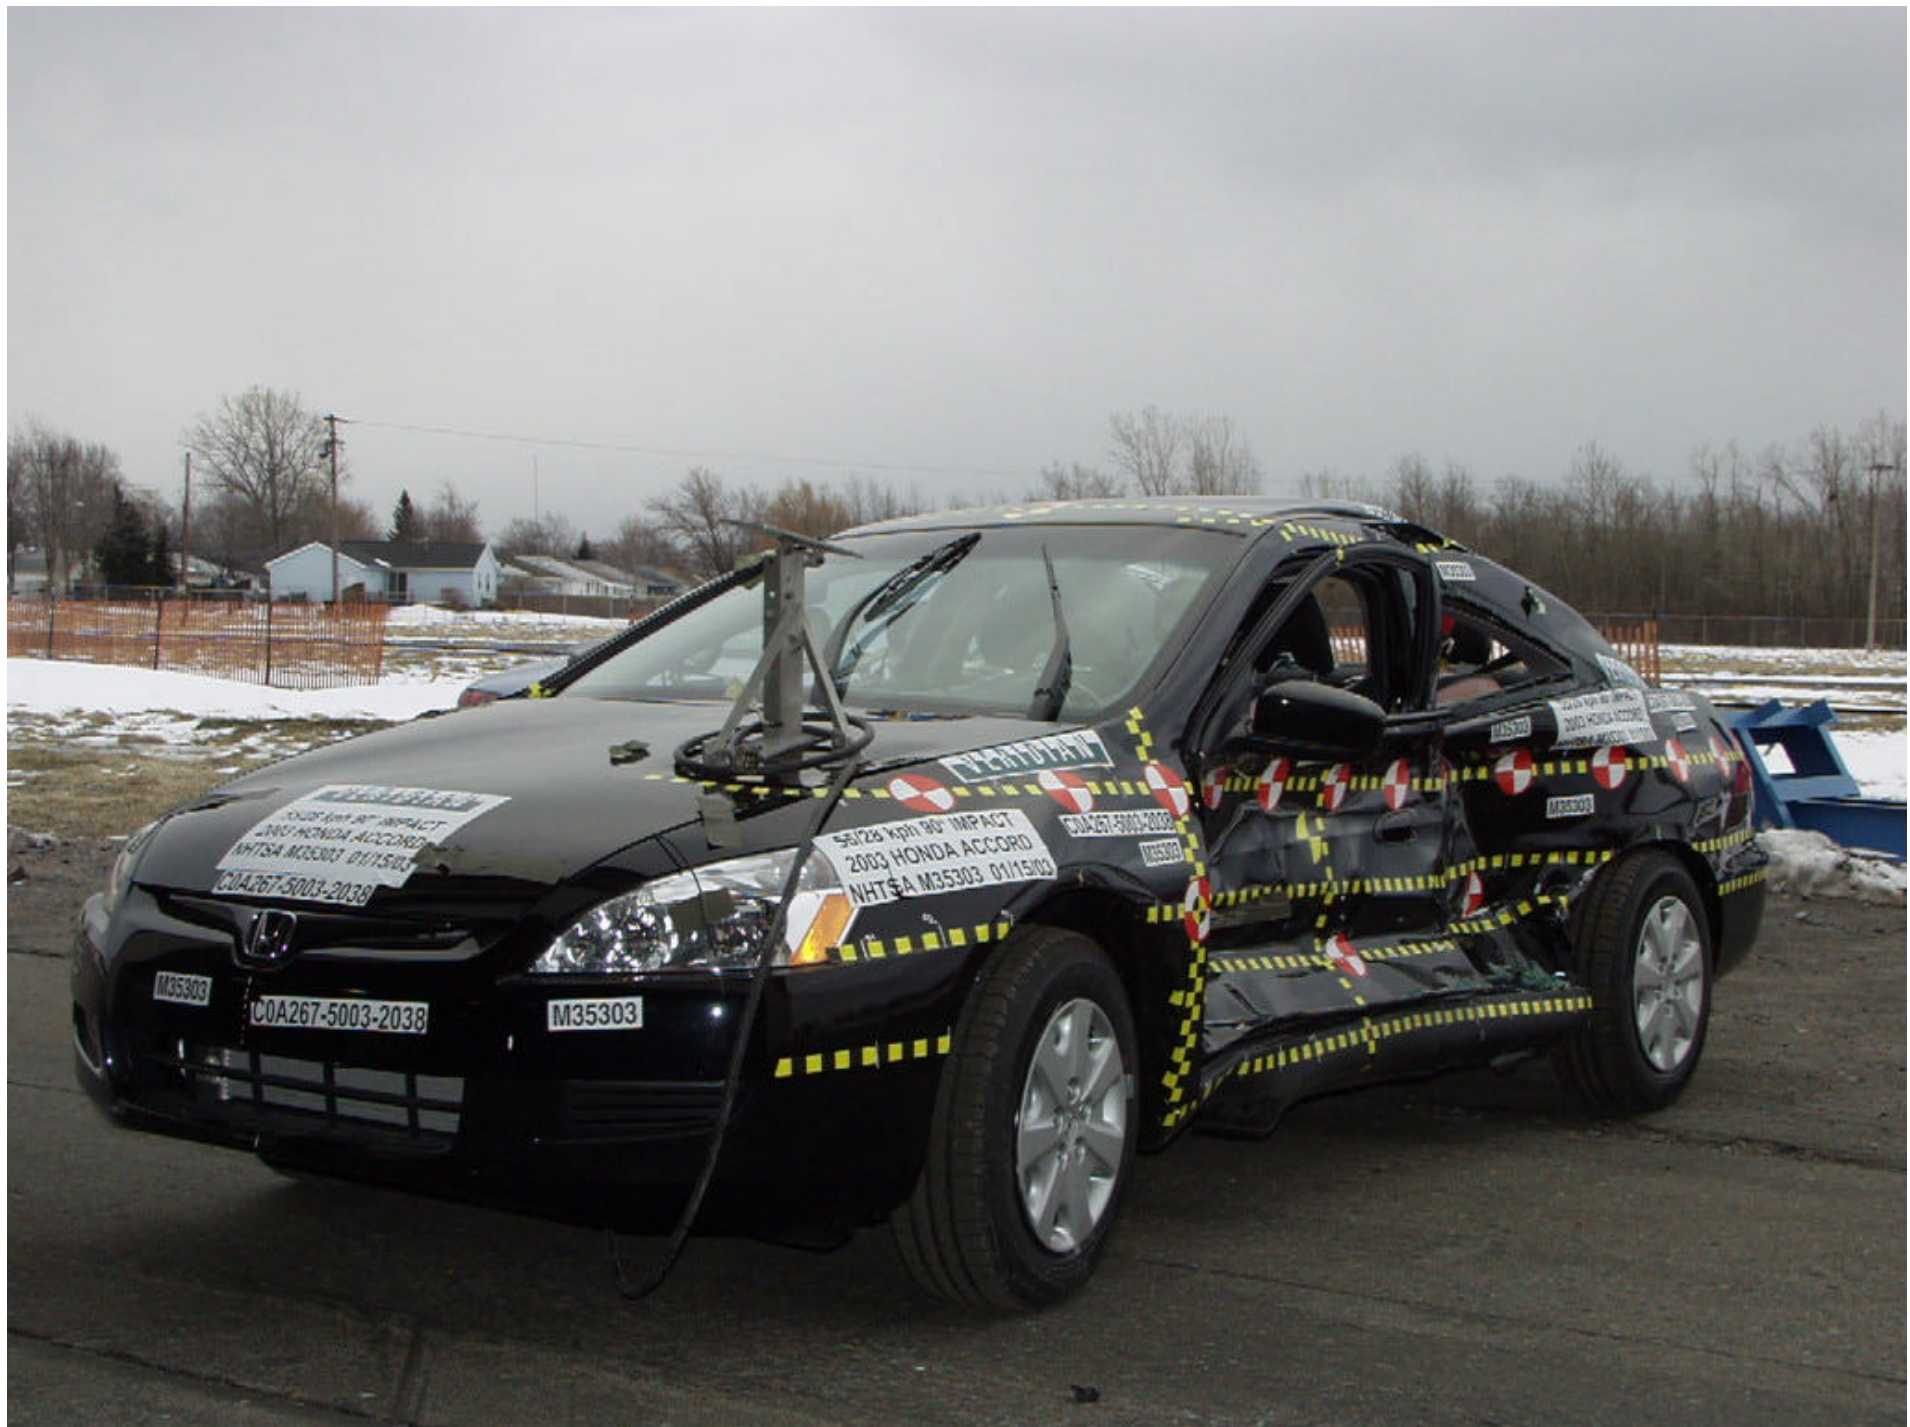
Figure A-8 POST-TEST LEFT FRONT VIEW OF TEST VEHICLE

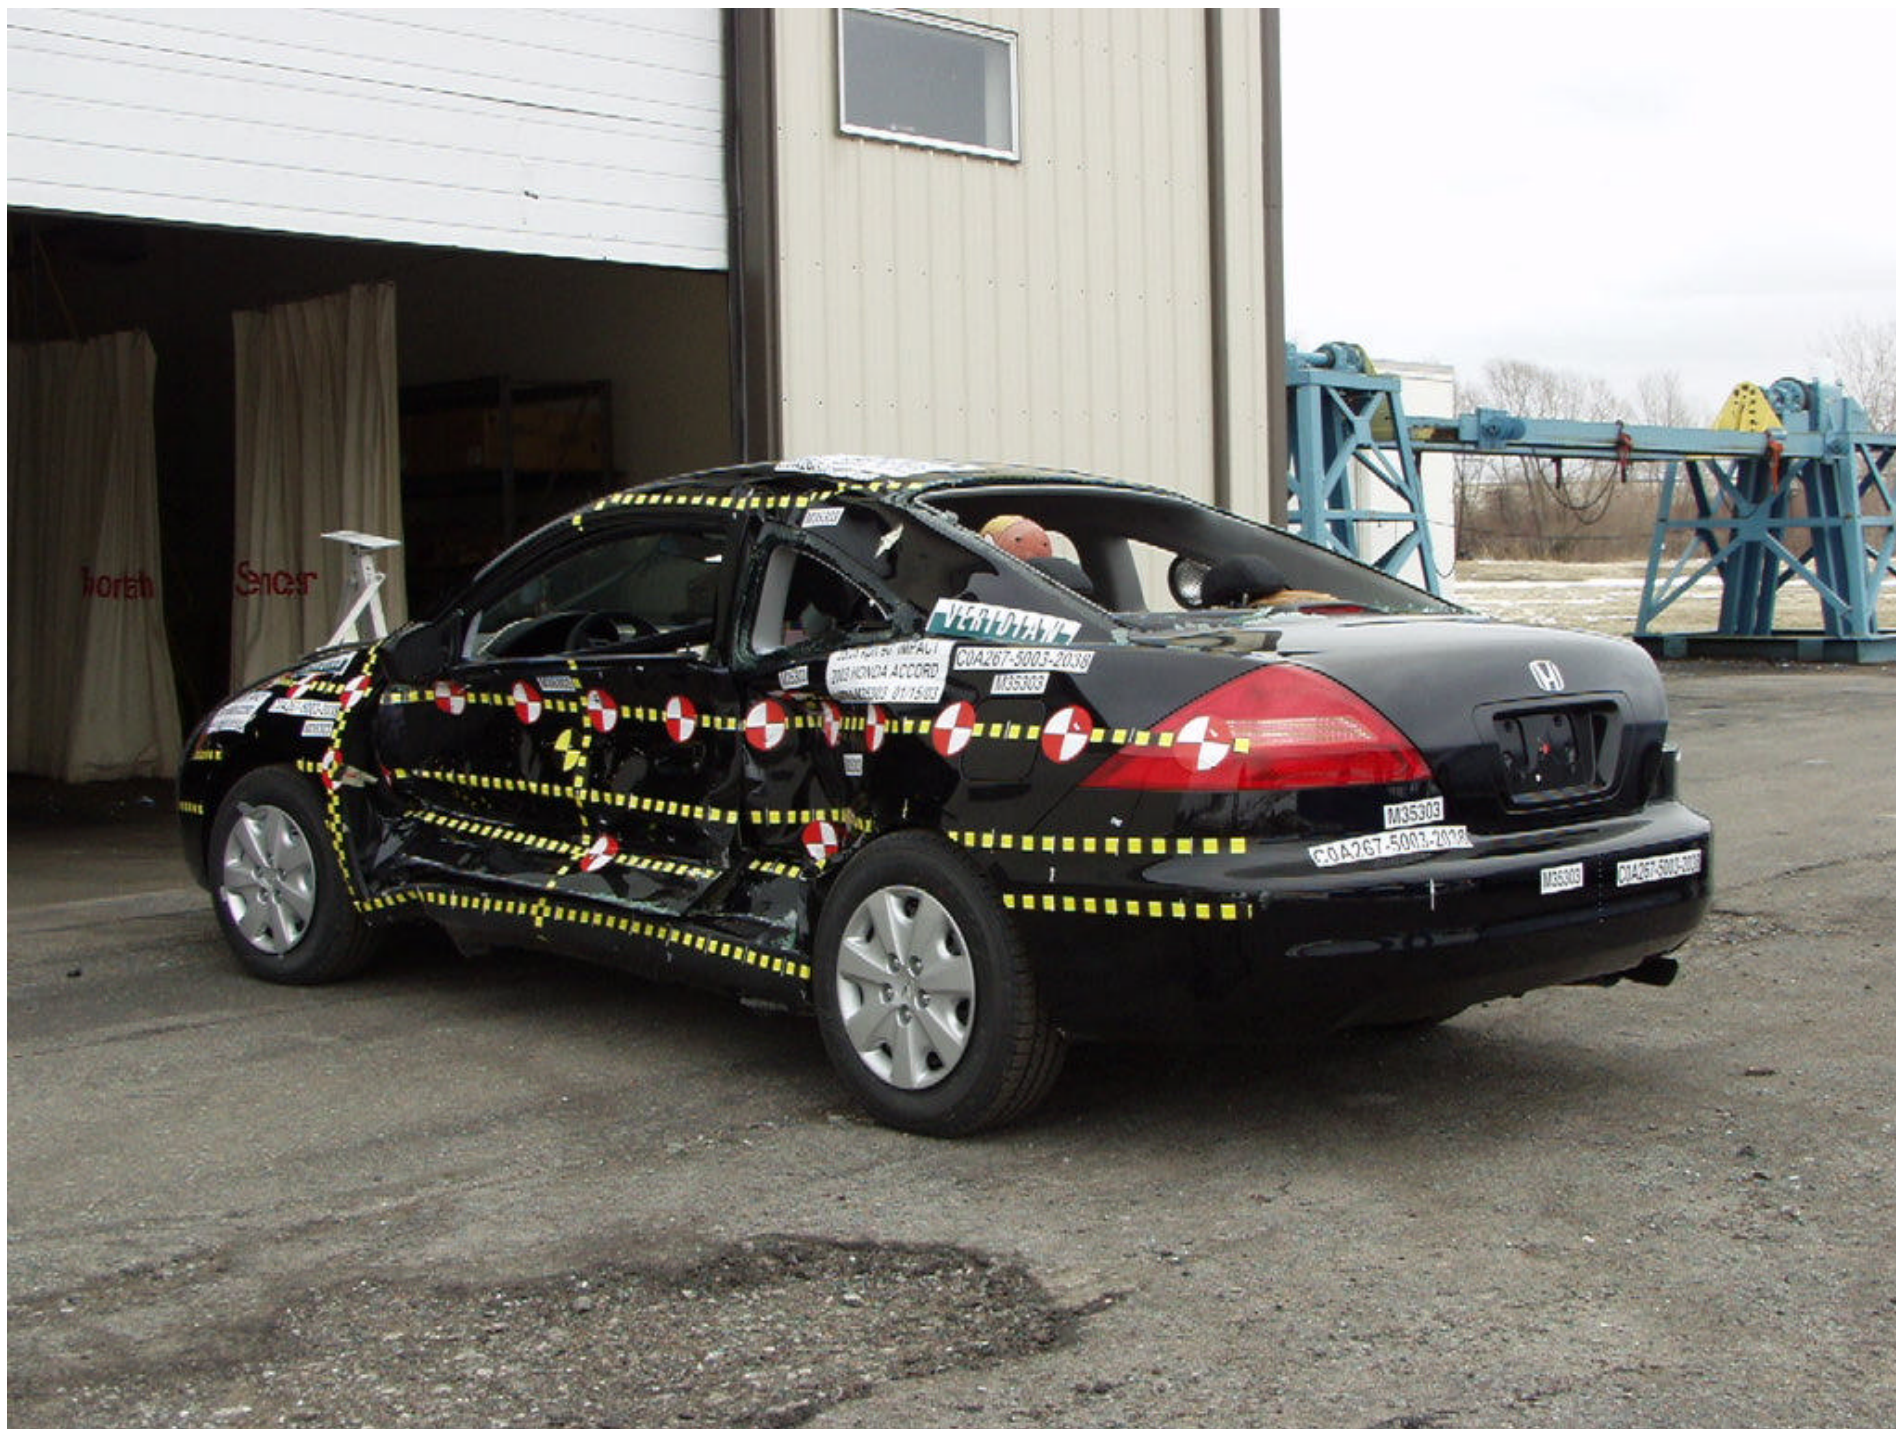
Figure A-10 POST-TEST LEFT REAR VIEW OF TEST VEHICLE

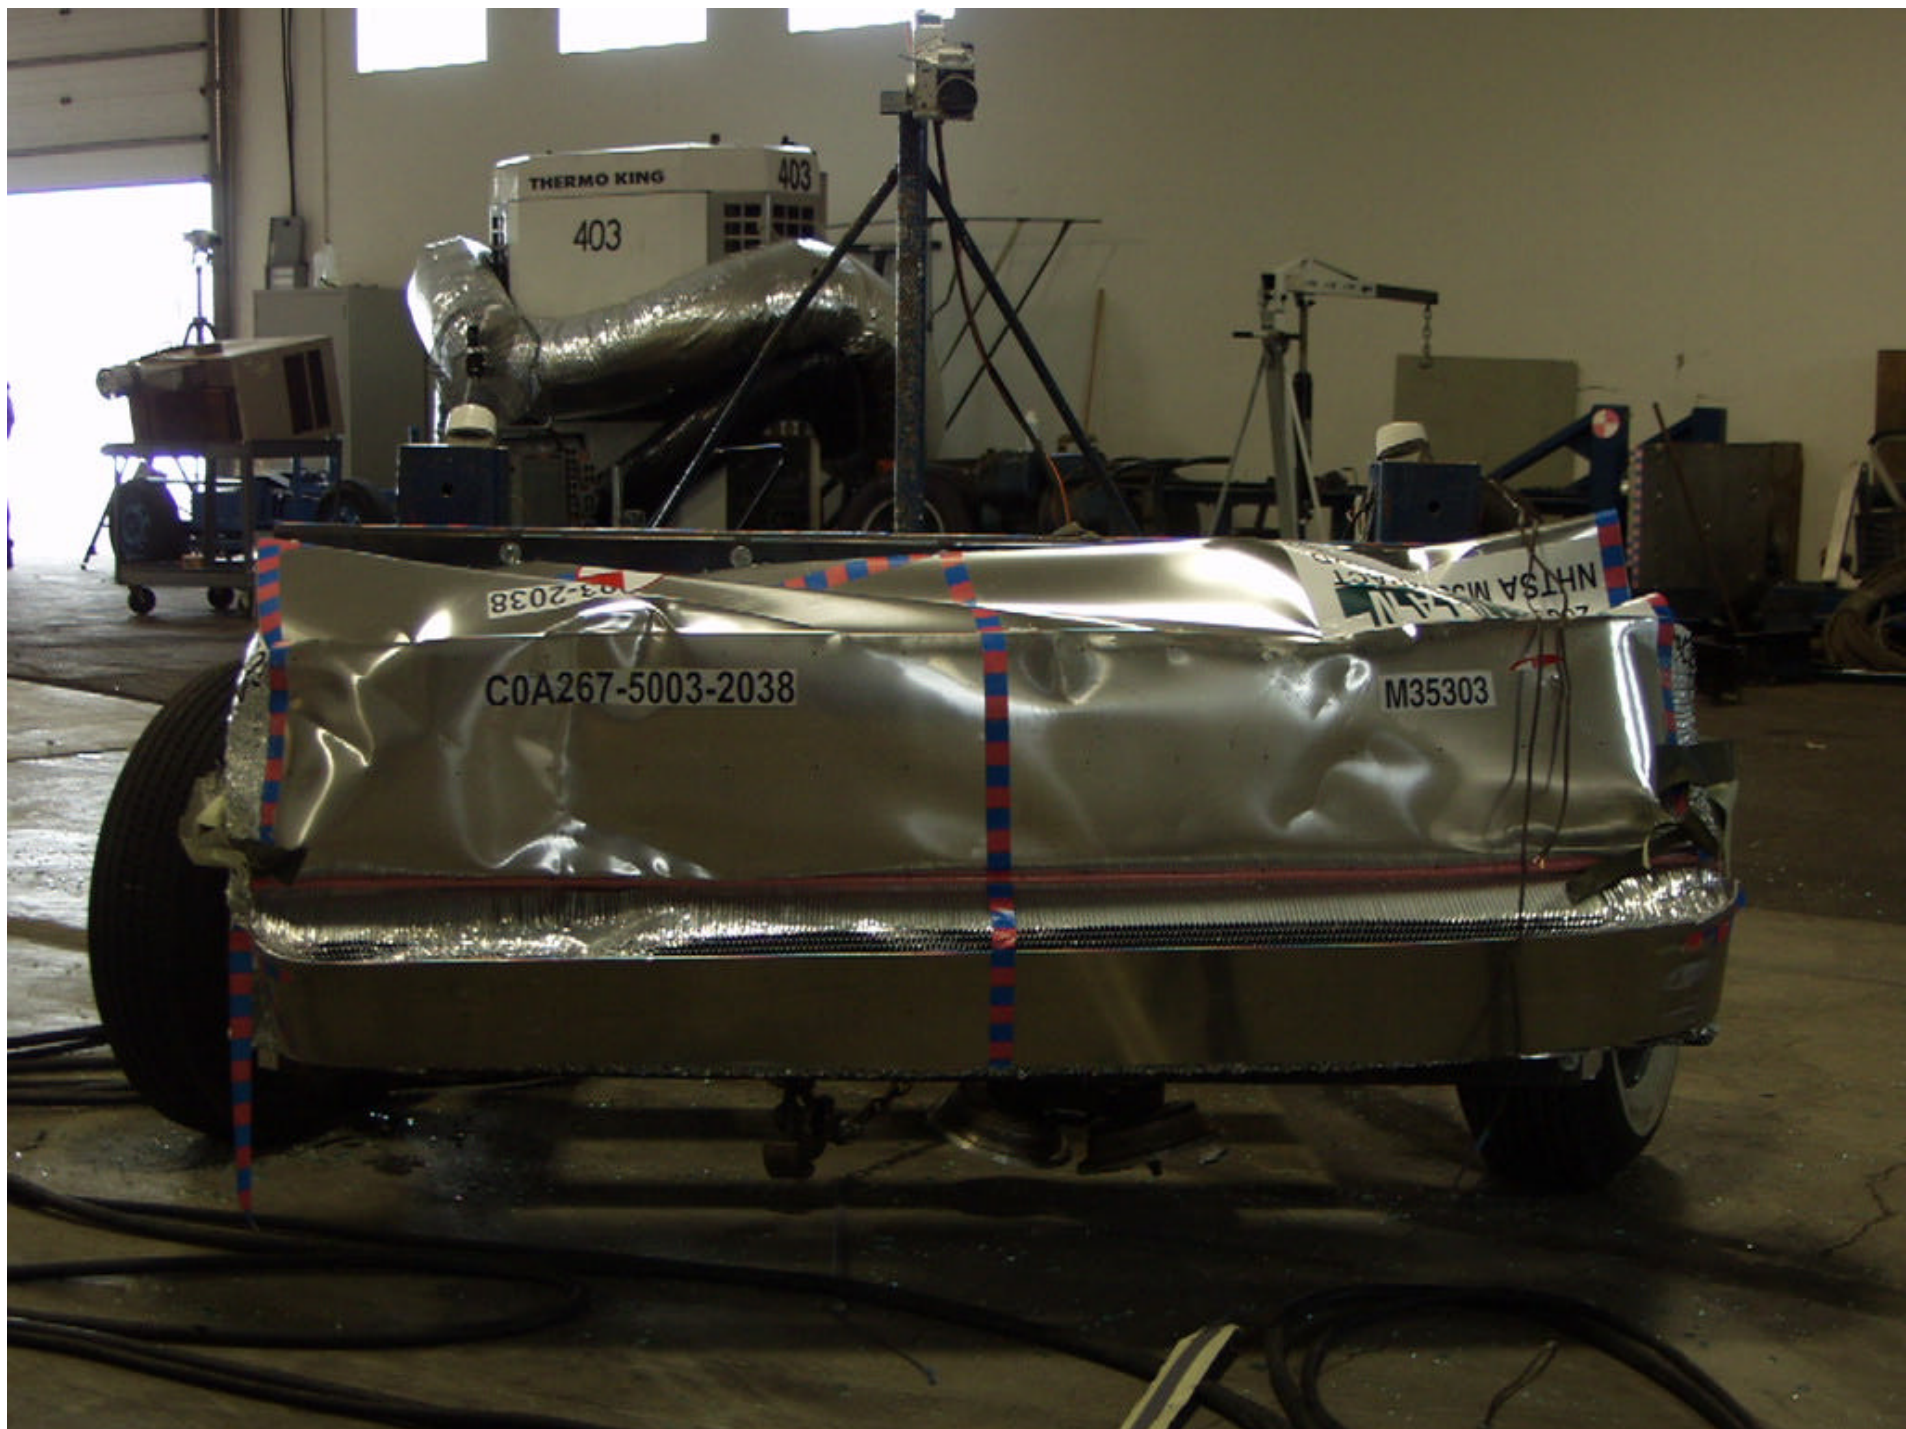
Figure A-16 POST-TEST FRONTAL VIEW OF IMPACTOR FACE

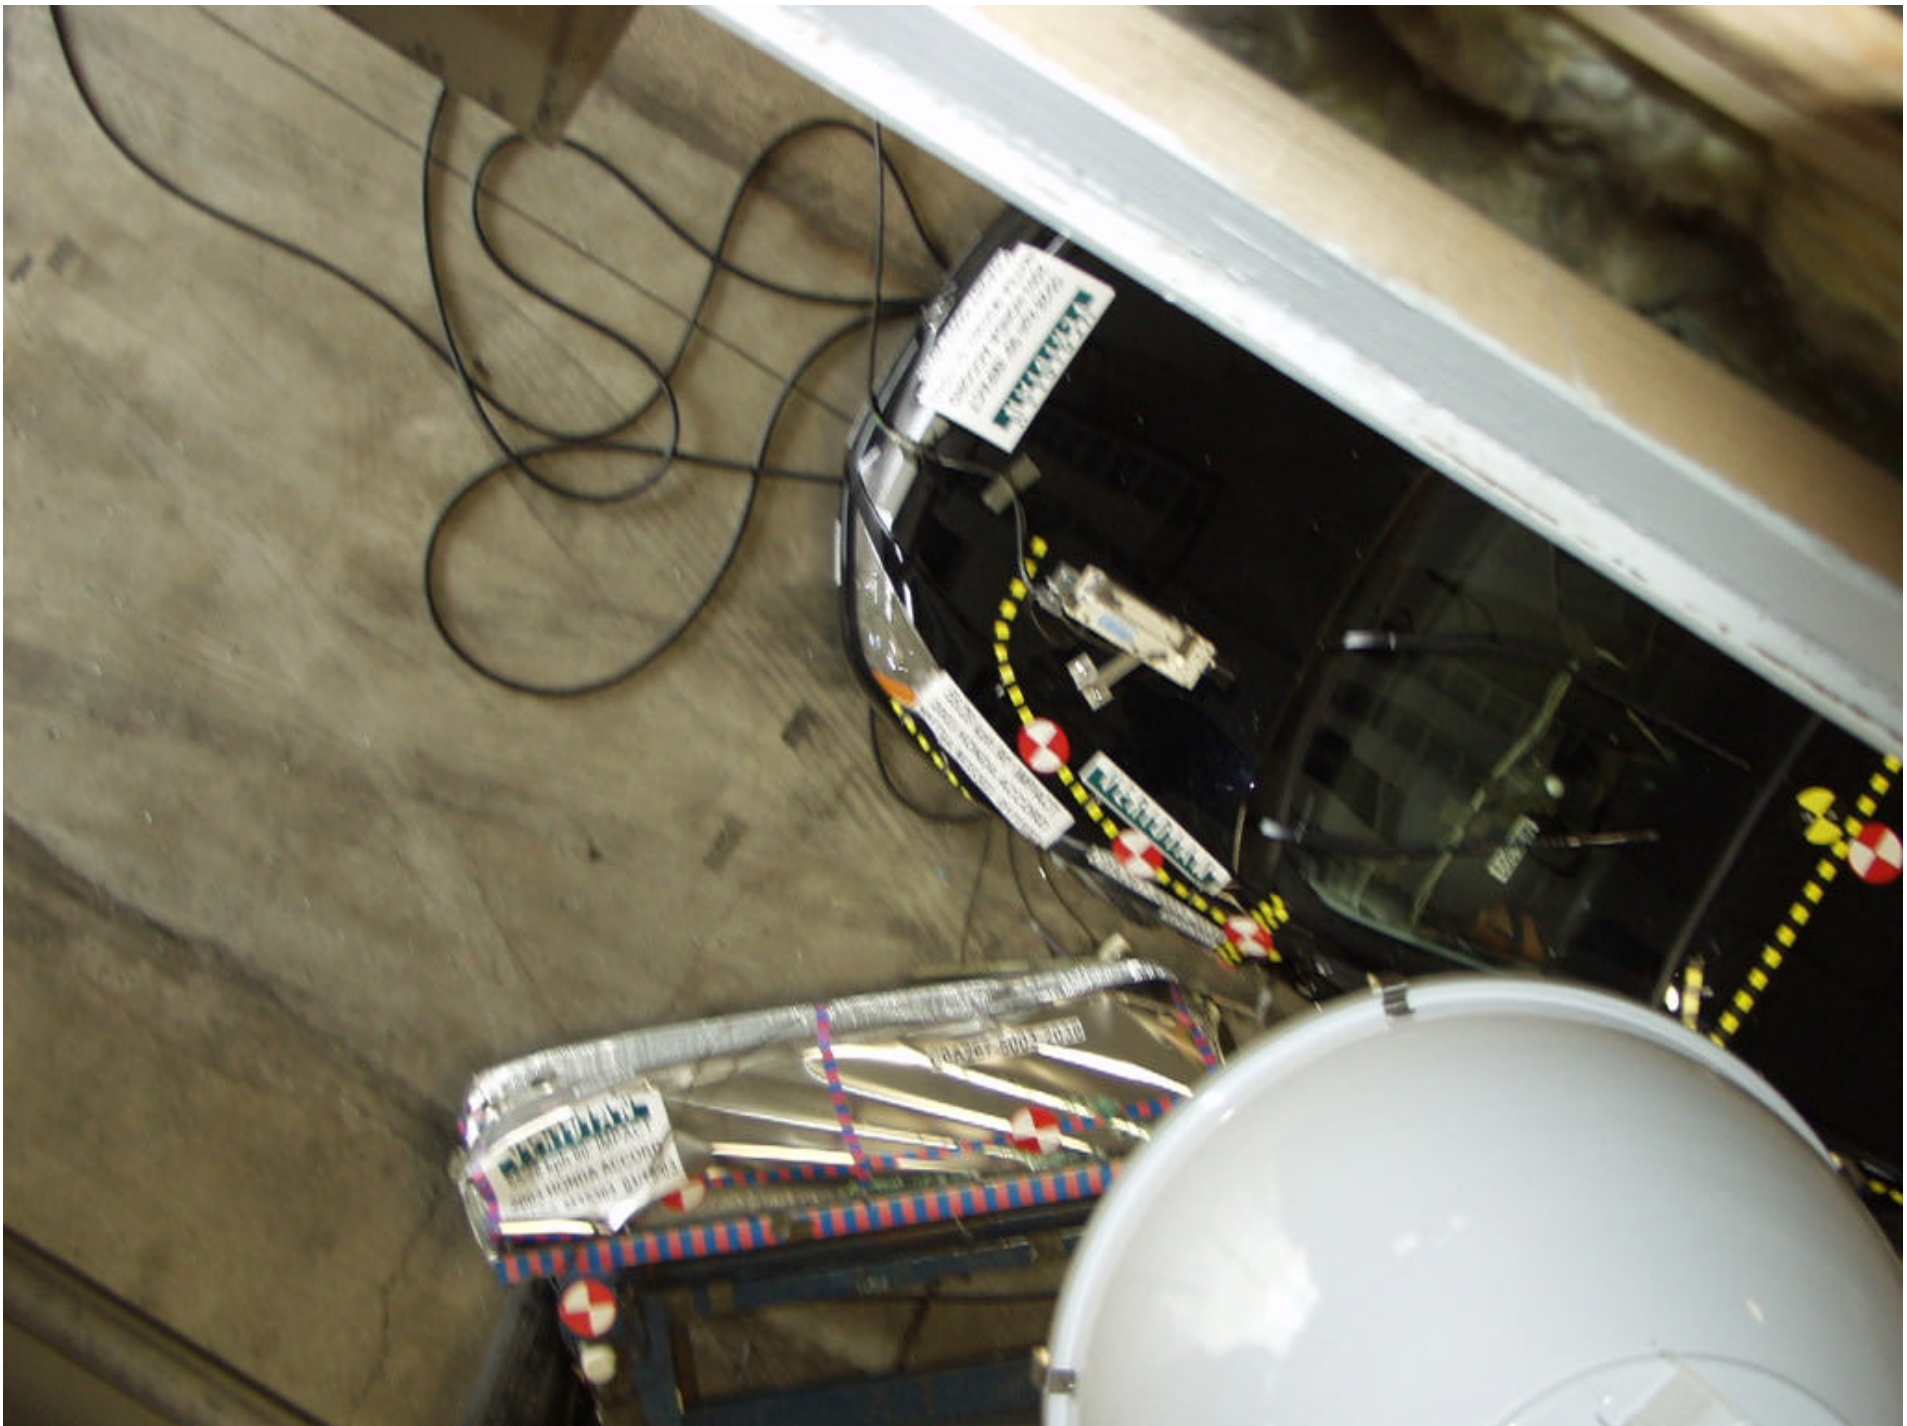
Figure A-24 POST-TEST OVERHEAD VIEW OF MDB AND VEHICLE

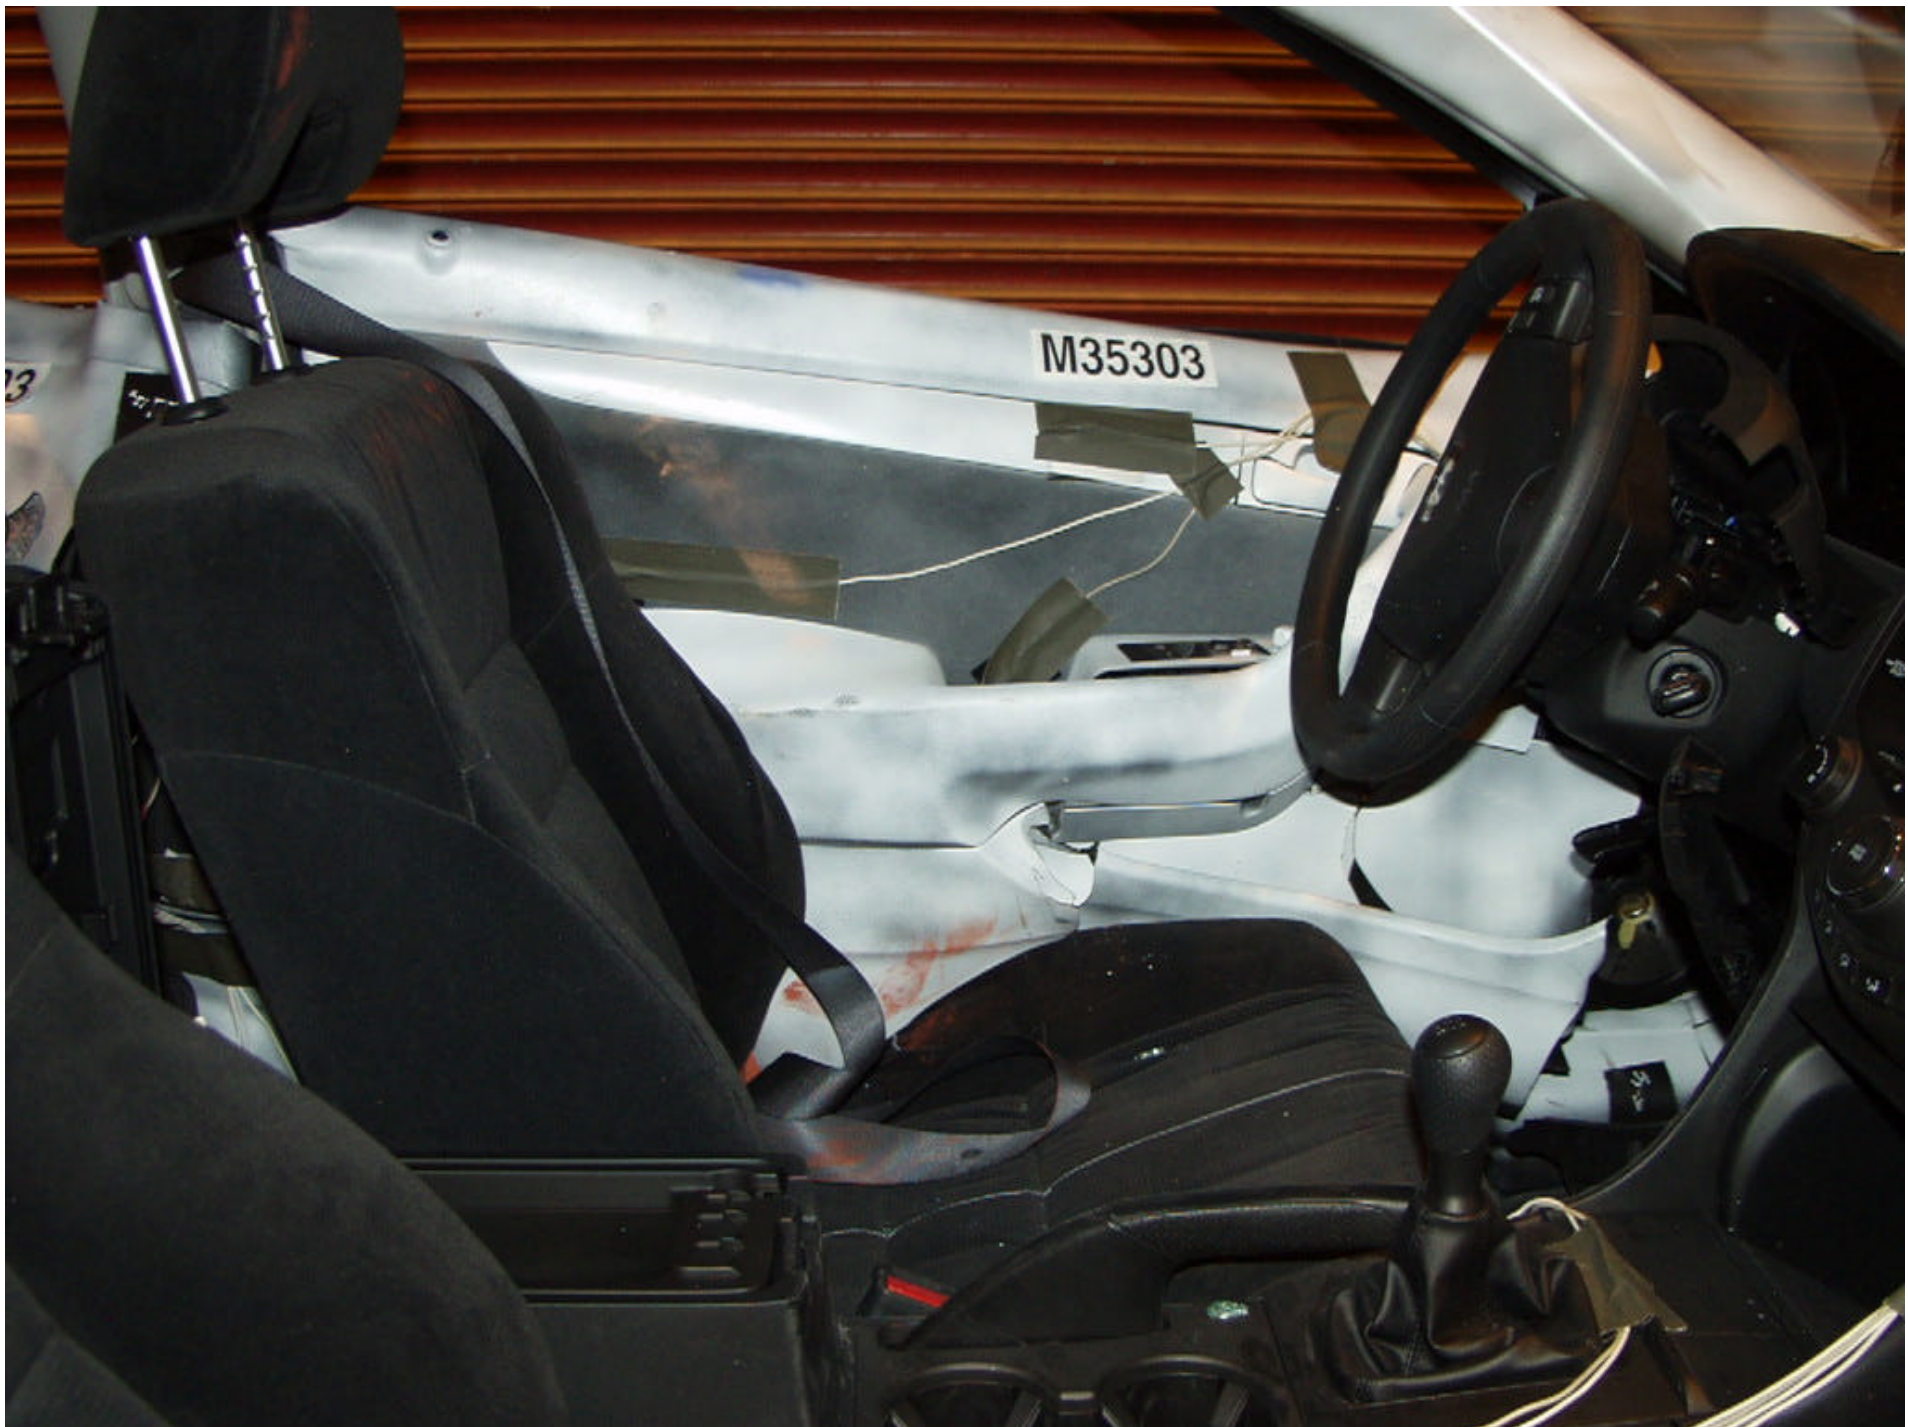
Figure A-34 POST-TEST INTERIOR OF FRONT DOOR SHOWING SID HIII IMPACT LOCATIONS
