REPORT NUMBER: SNCAP-CAL-03-03

**NEW CAR ASSESSMENT PROGRAM  
SIDE IMPACT TEST**

HONDA OF AMERICA MFG. INC.  
2003 HONDA ACCORD  
2-DOOR COUPE

**FINAL REPORT**

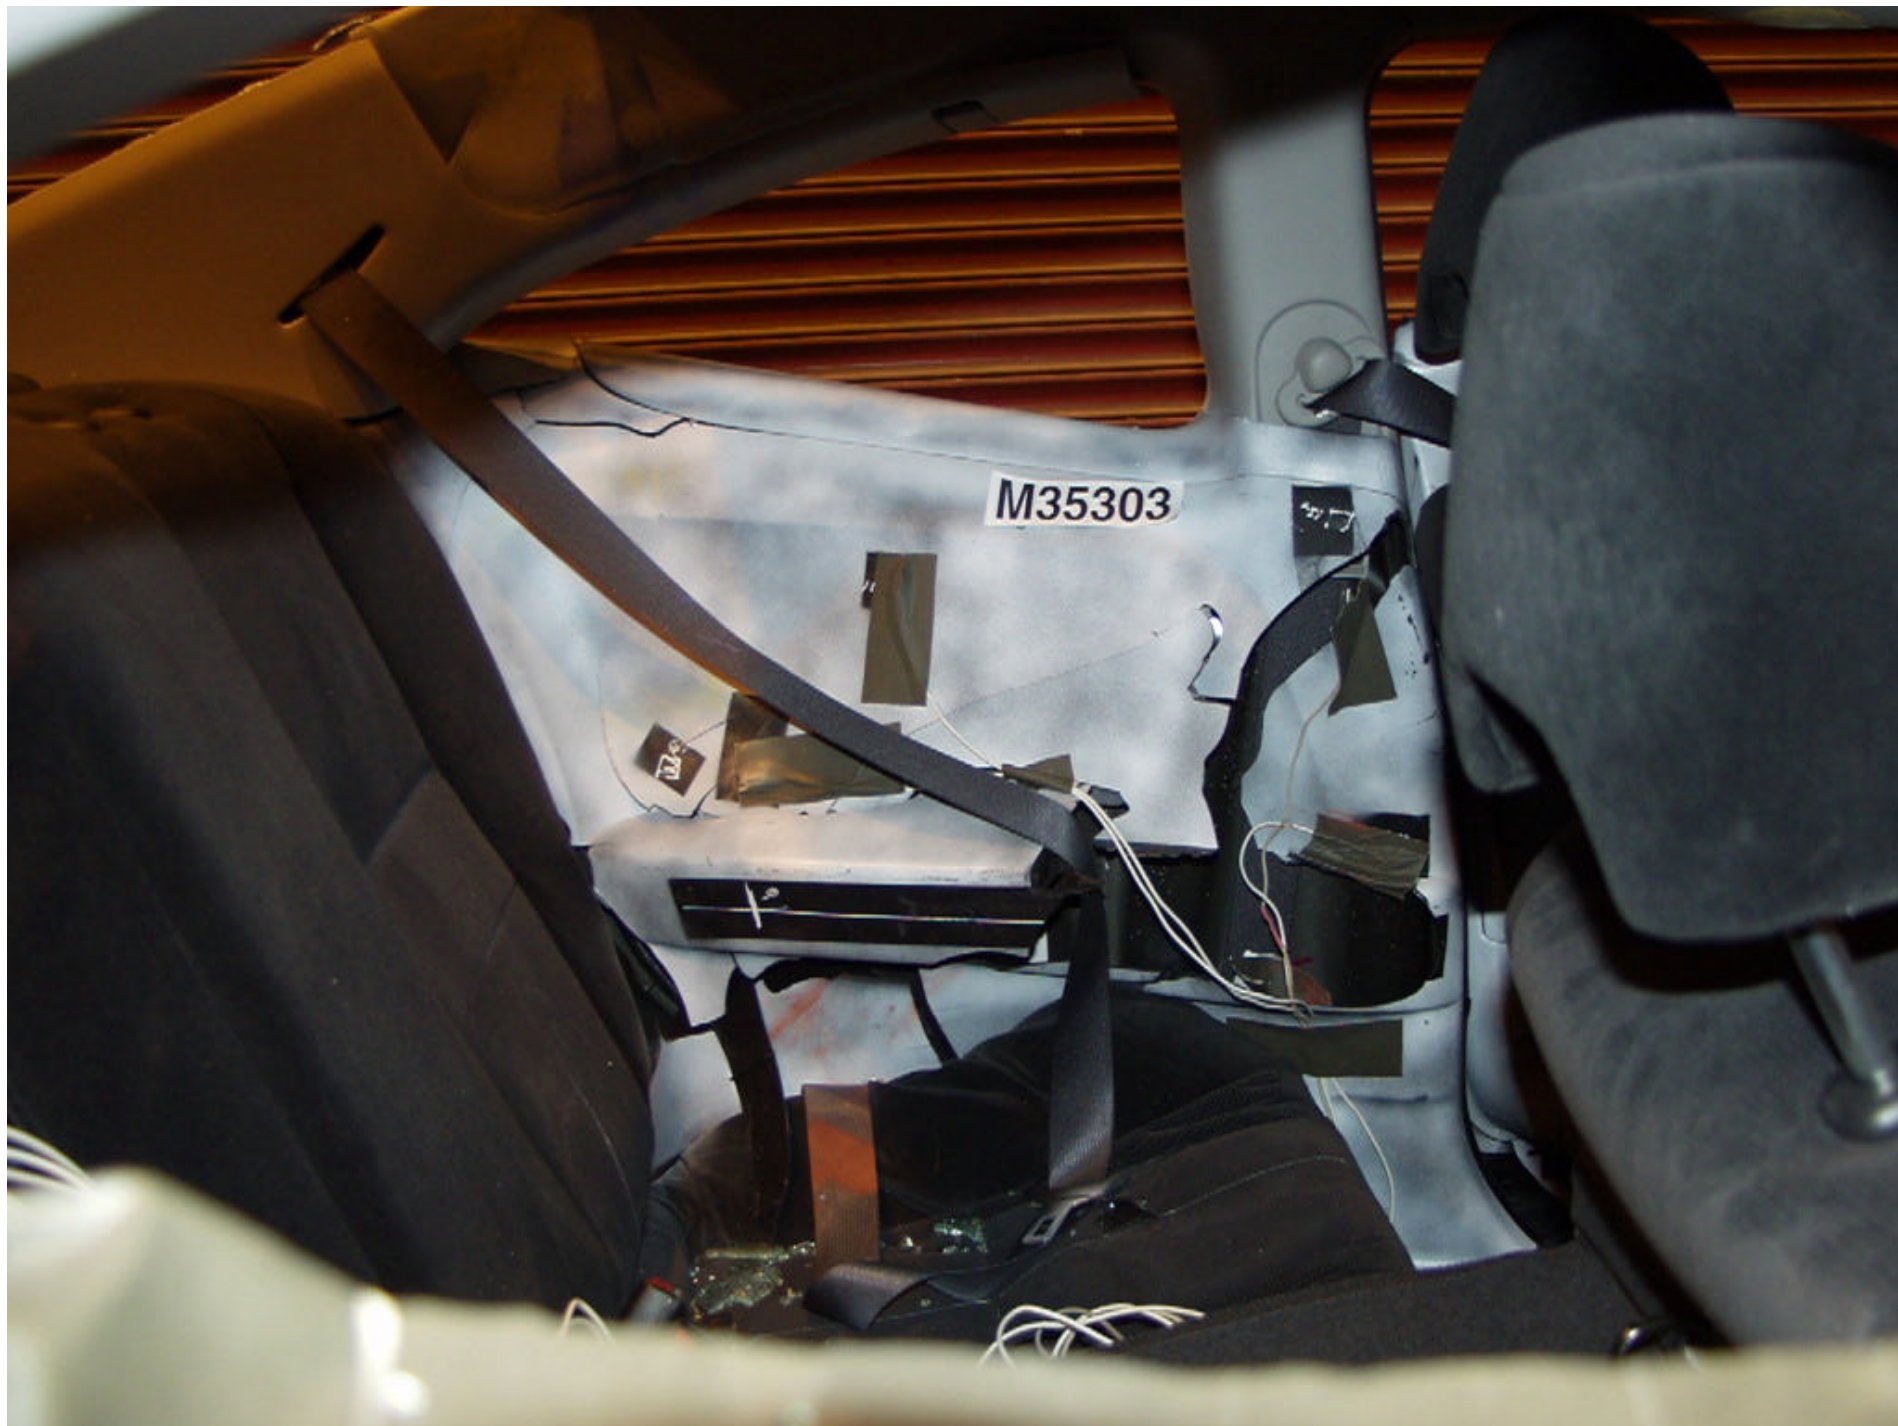
Figure A-36 POST-TEST INTERIOR OF REAR DOOR SHOWING SID HIII IMPACT LOCATIONS

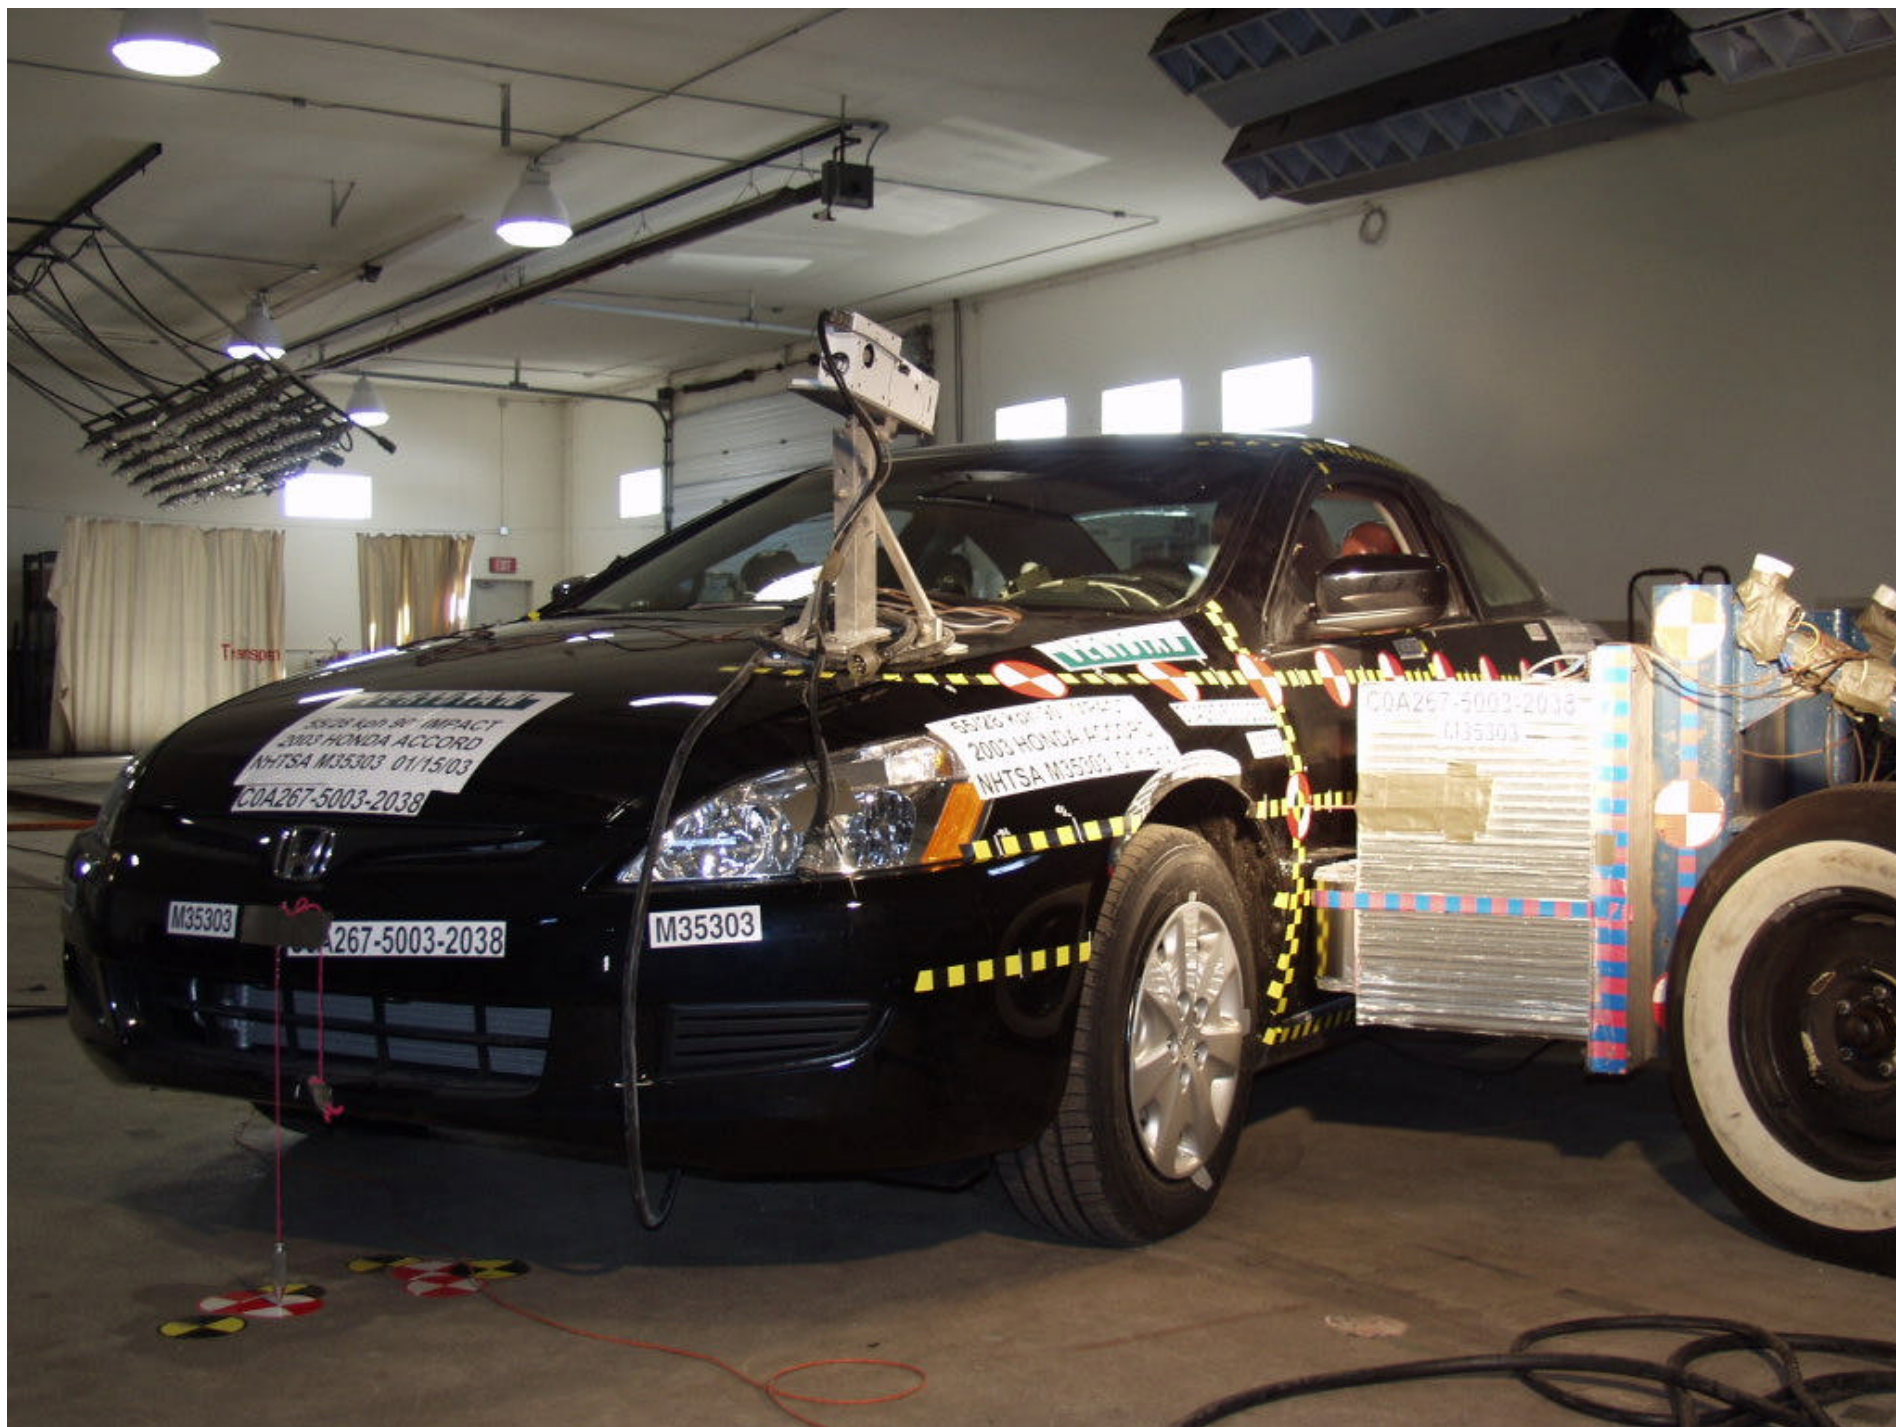
Figure A-37 PRE-TEST LEFT SIDE VIEW OF MDB WITH IMPACTOR FACE IN POSITION

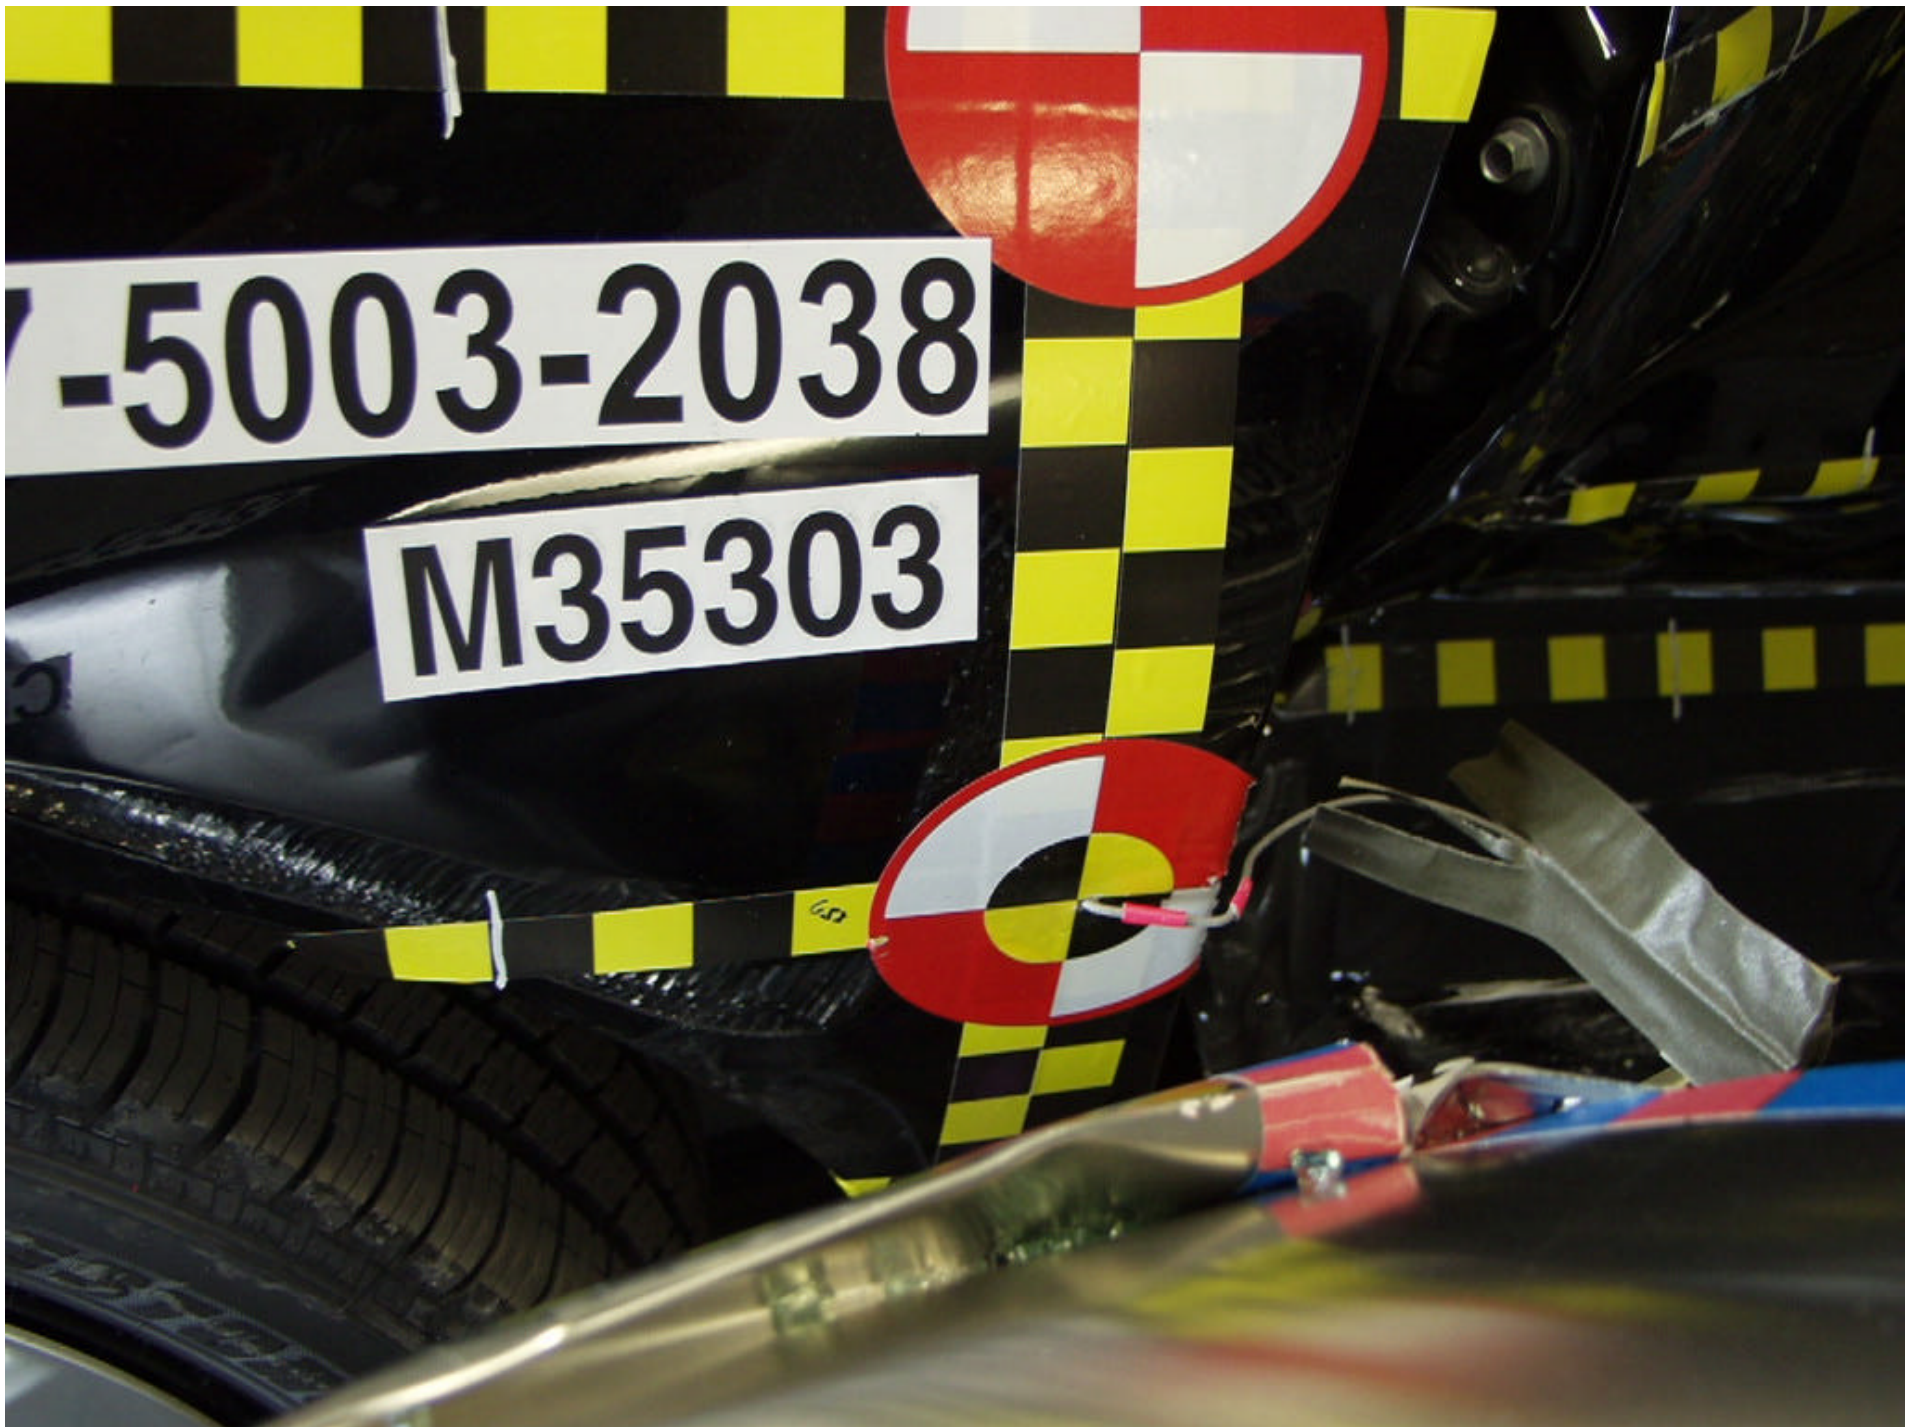
Figure A-39 POST-TEST CLOSE-UP VIEW OF IMPACT POINT TARGET

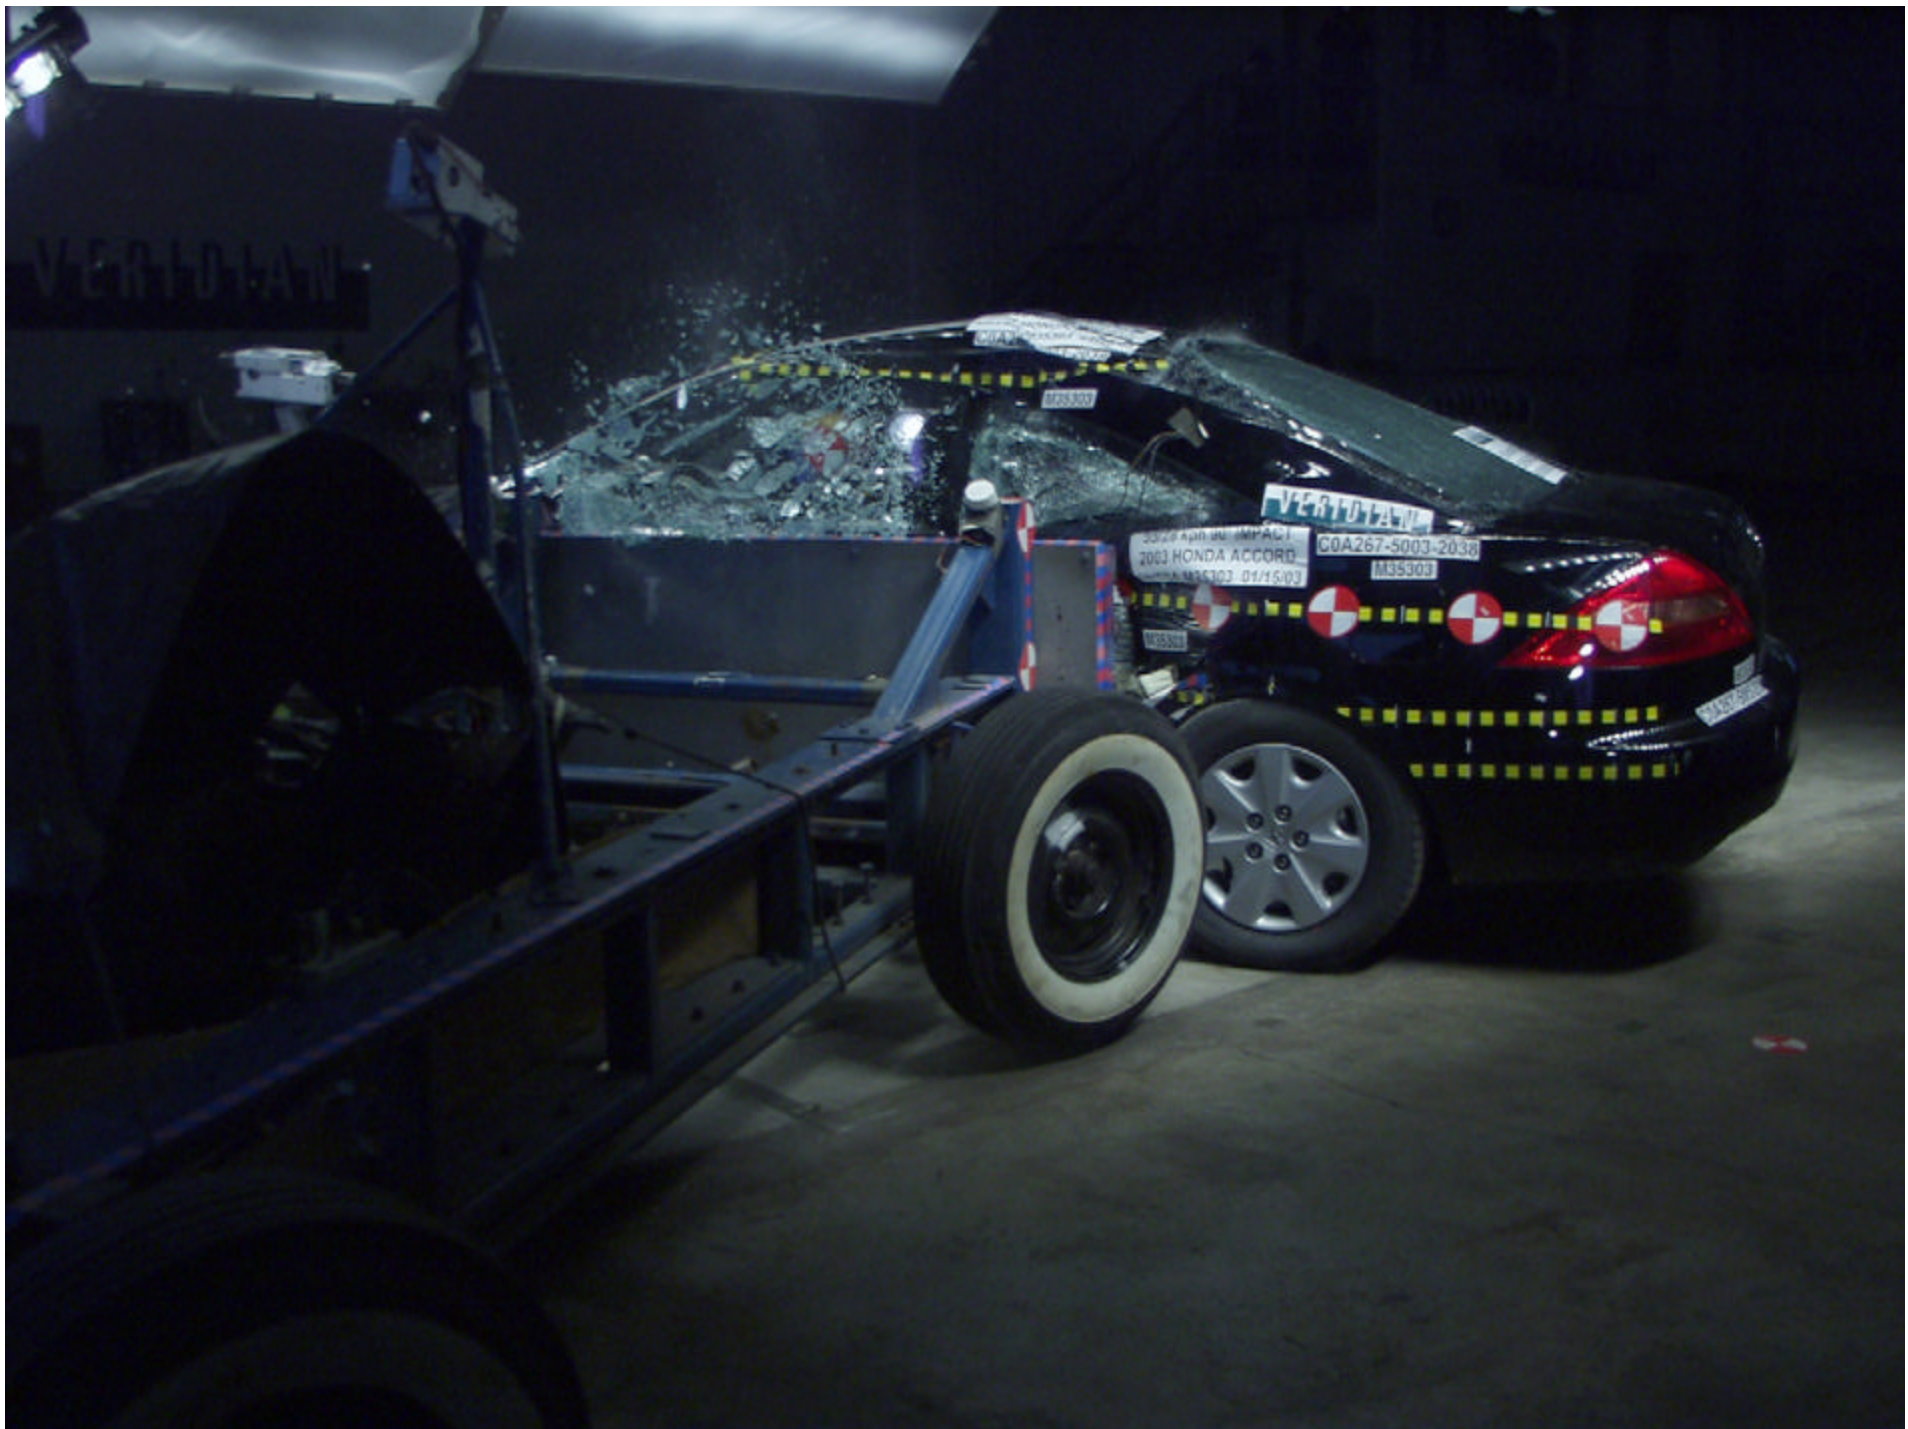
Figure A-42 IMPACT PHOTO
