**REPORT NUMBER: TO11-MGA-2003-003**

**FULL SCALE SIDE IMPACT POLE TESTS OF BASELINE VEHICLES**  
**Task Order #T0007 / RFP #0011**

**Volvo**  
**1999 Volvo S80 Sedan**  
**NHTSA NUMBER: RX5907**

**PREPARED BY:**  
**MGA RESEARCH CORPORATION**  
**5000 WARREN ROAD**  
**BURLINGTON, WI 53105**

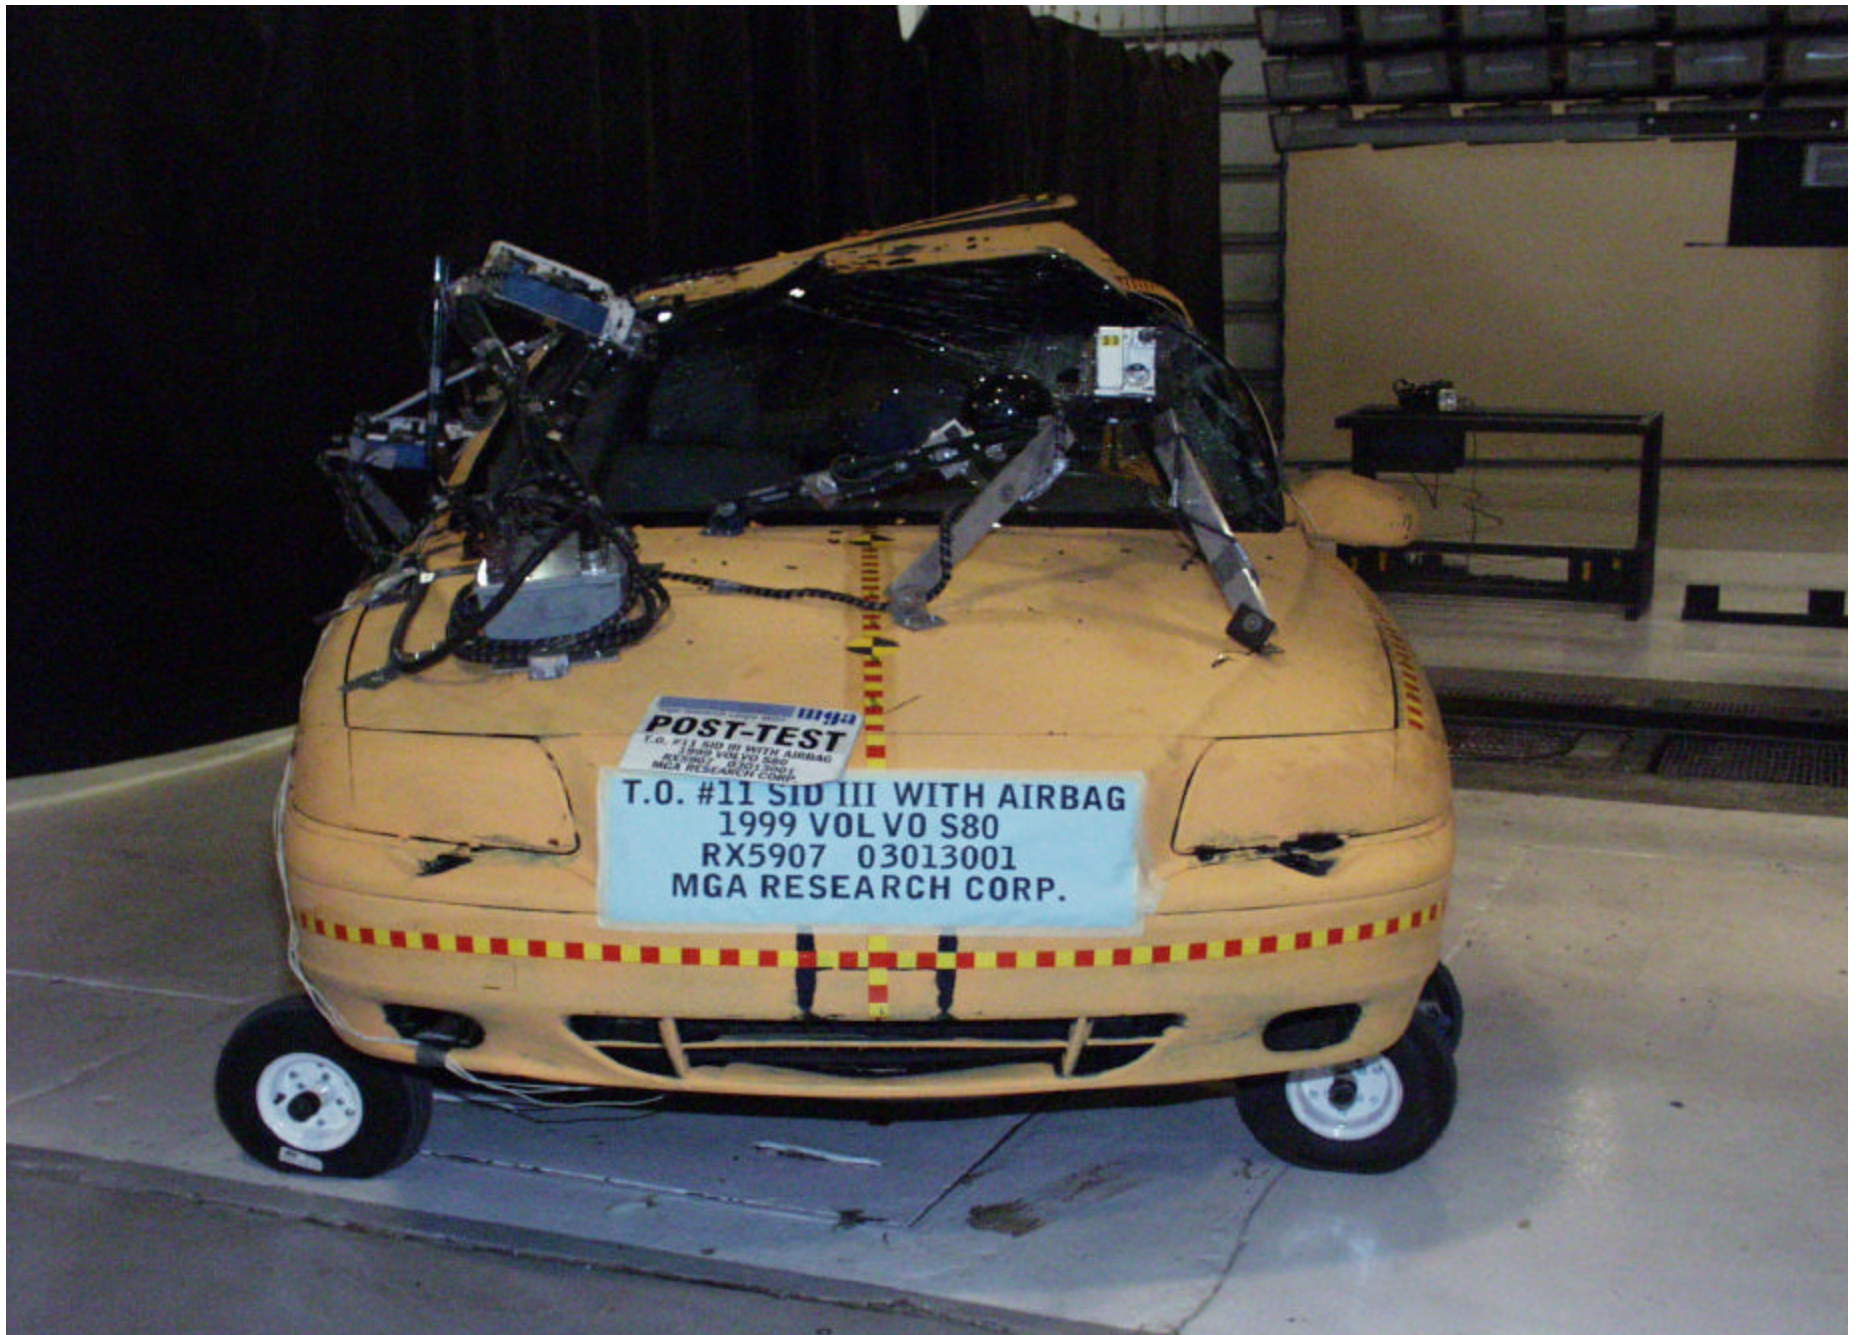
Post-Test Front View of Test Vehicle

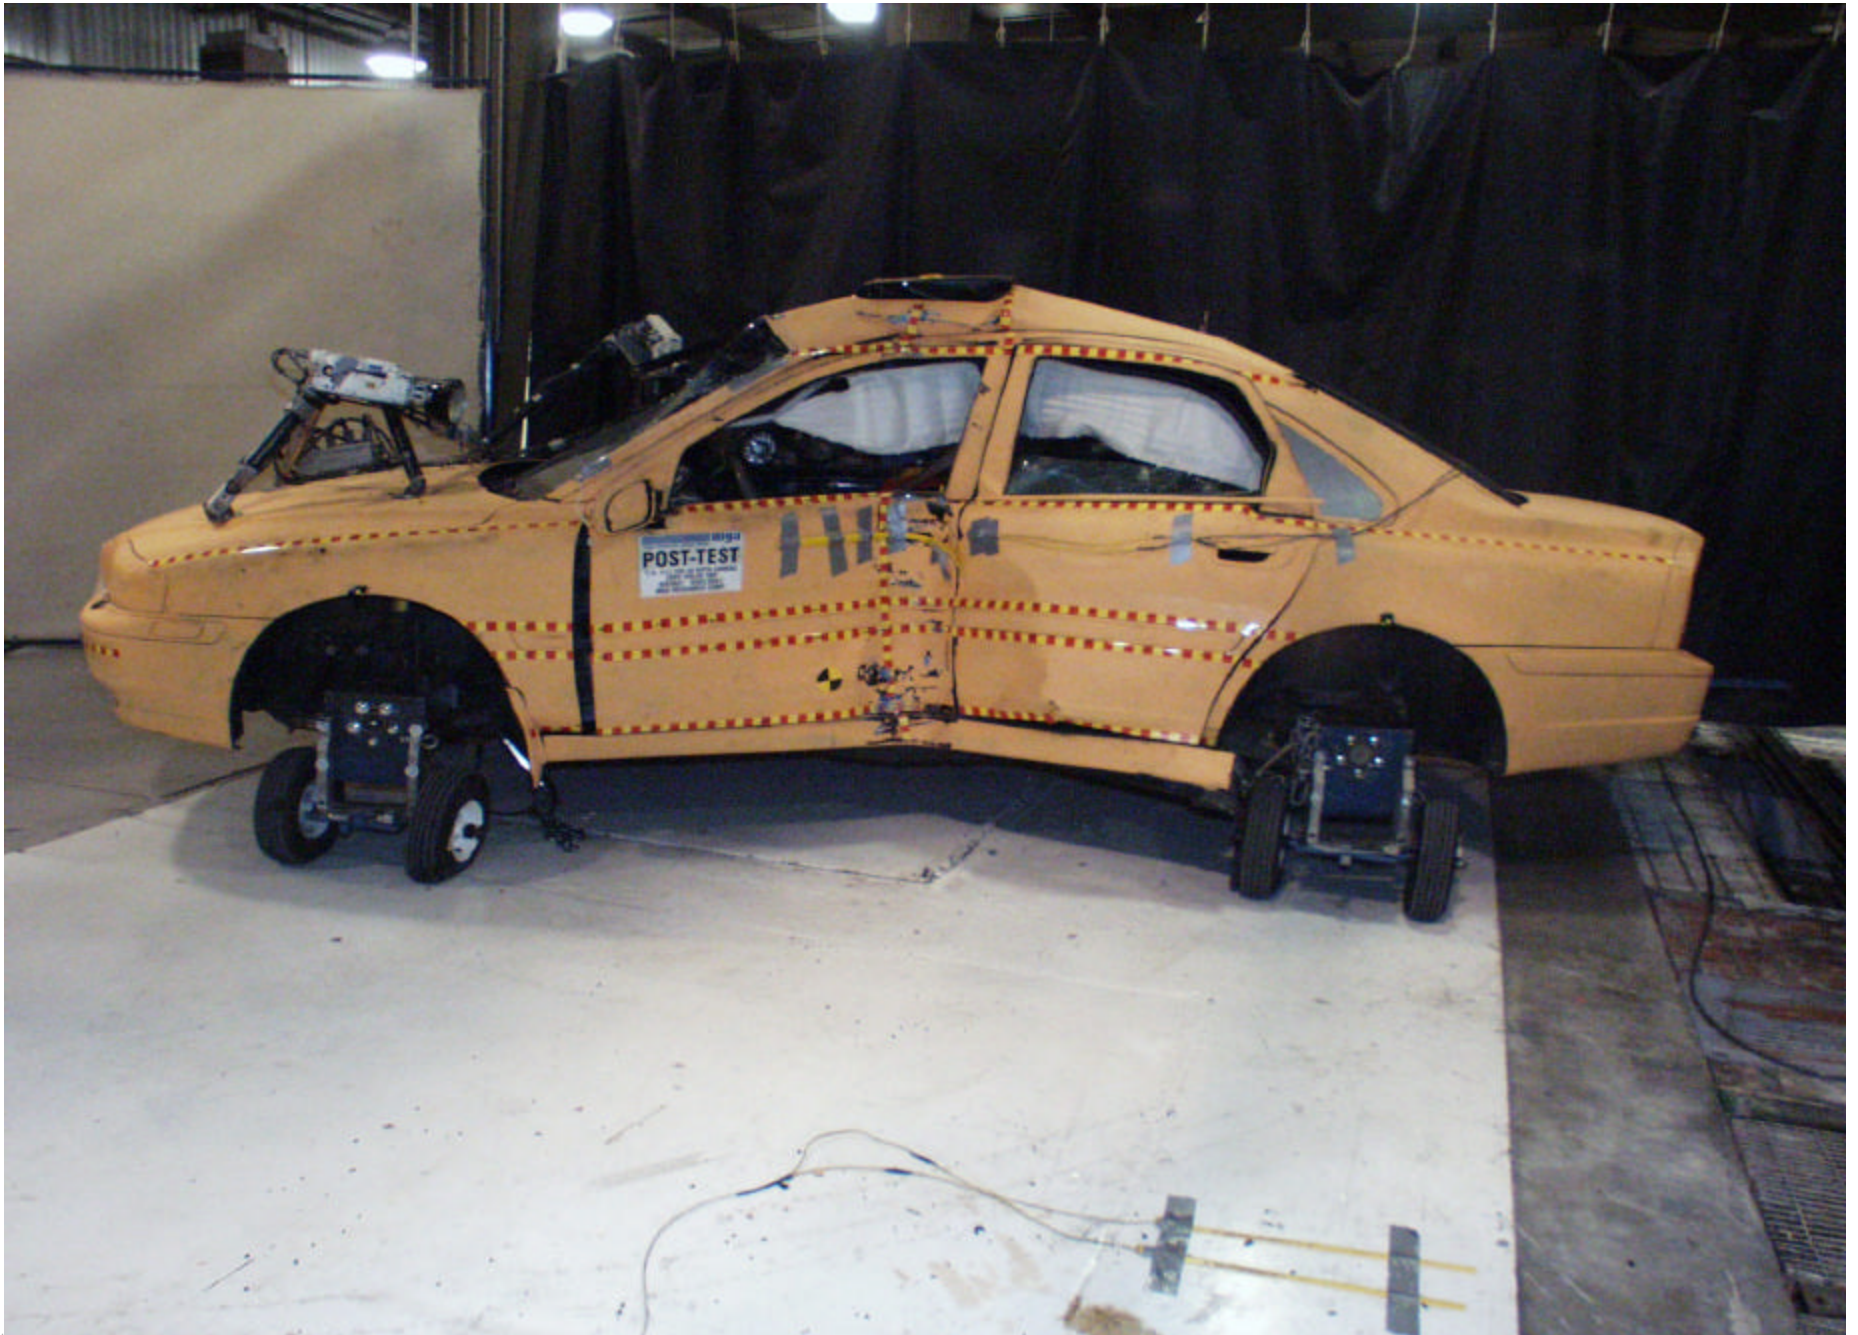
Post-Test Left Side View of Test Vehicle

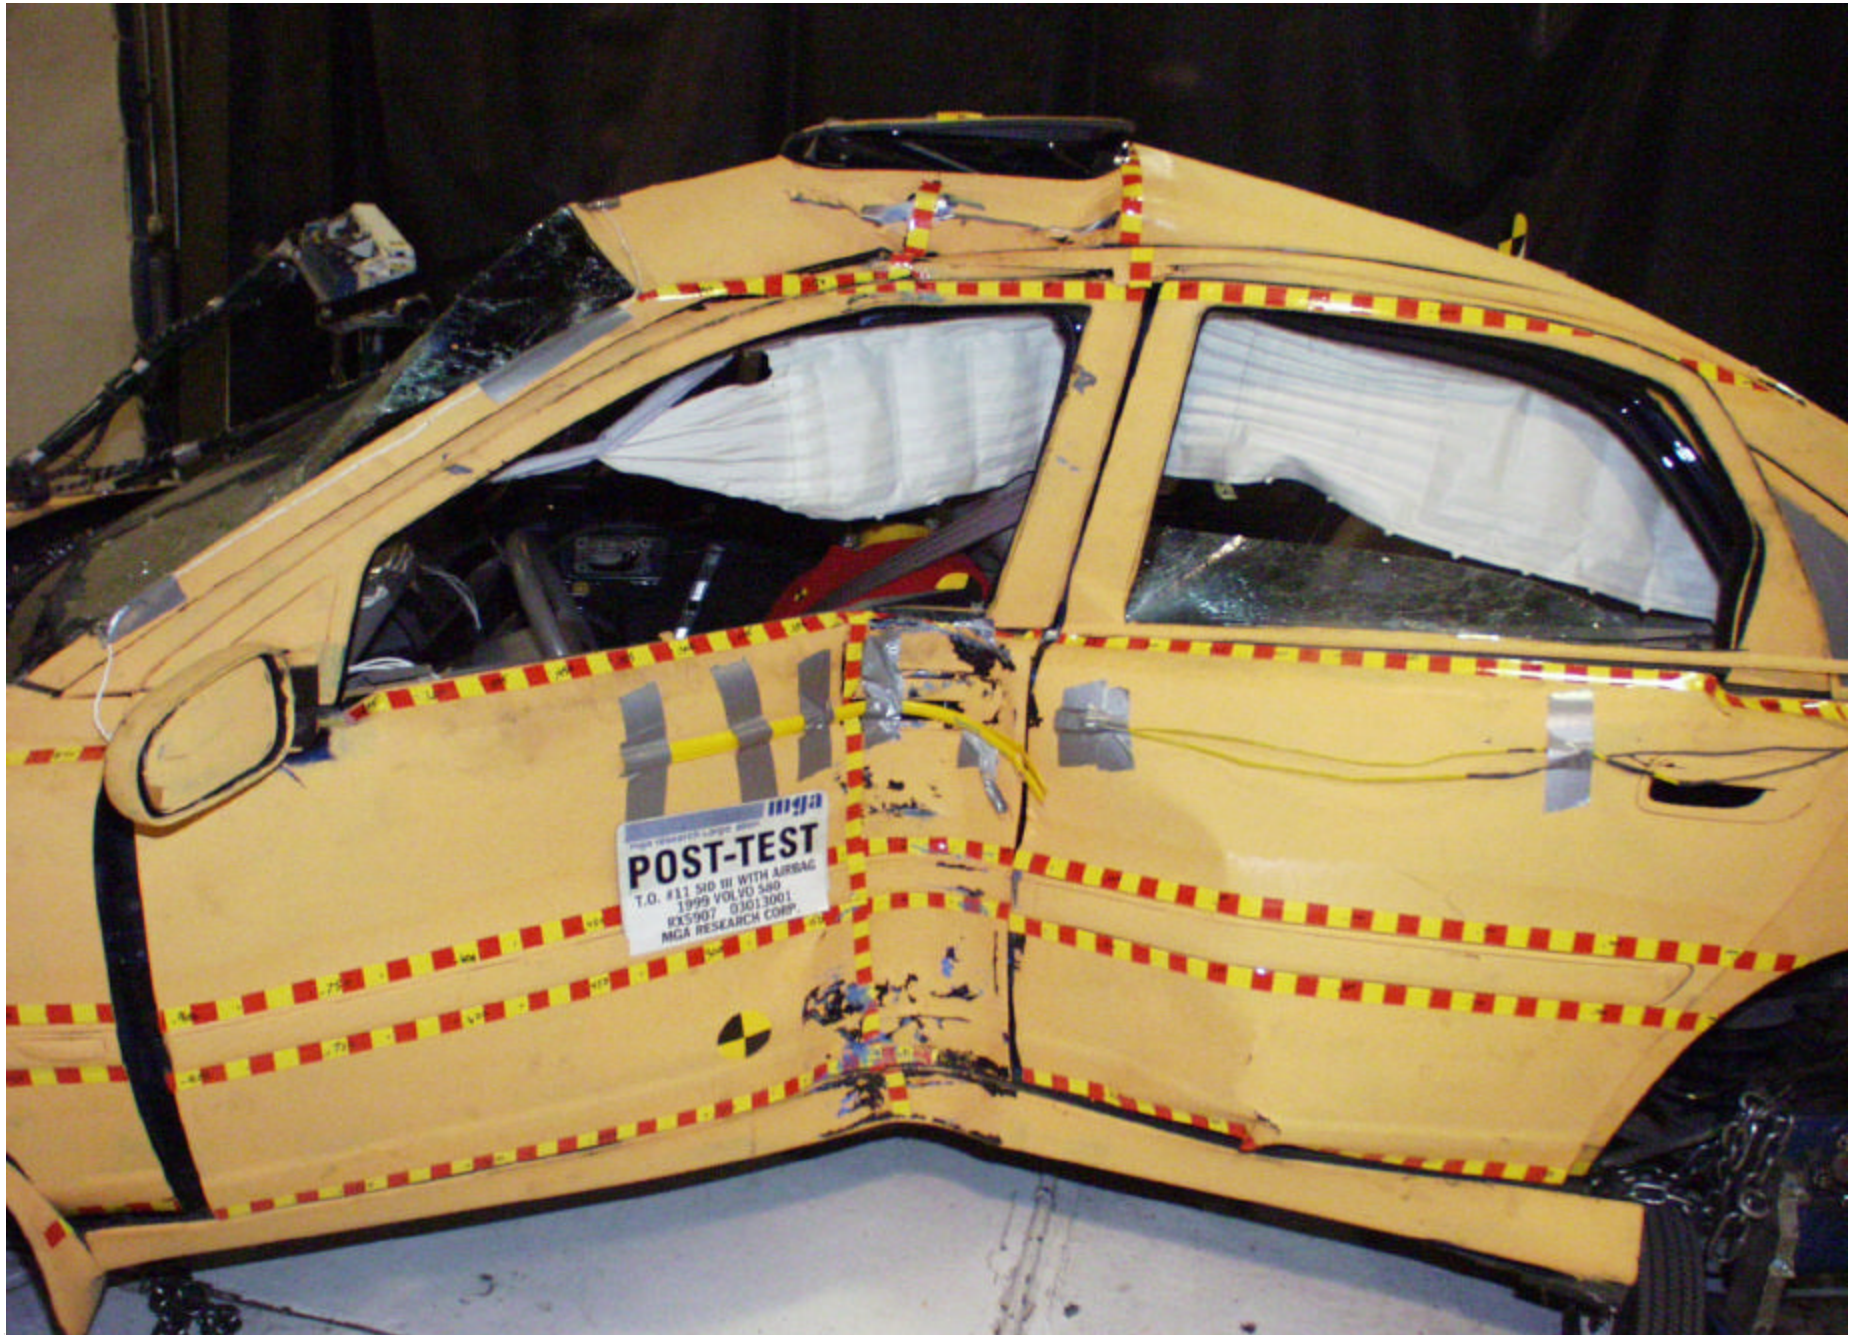
Post-Test Left Side View of Test Vehicle (Close-Up)

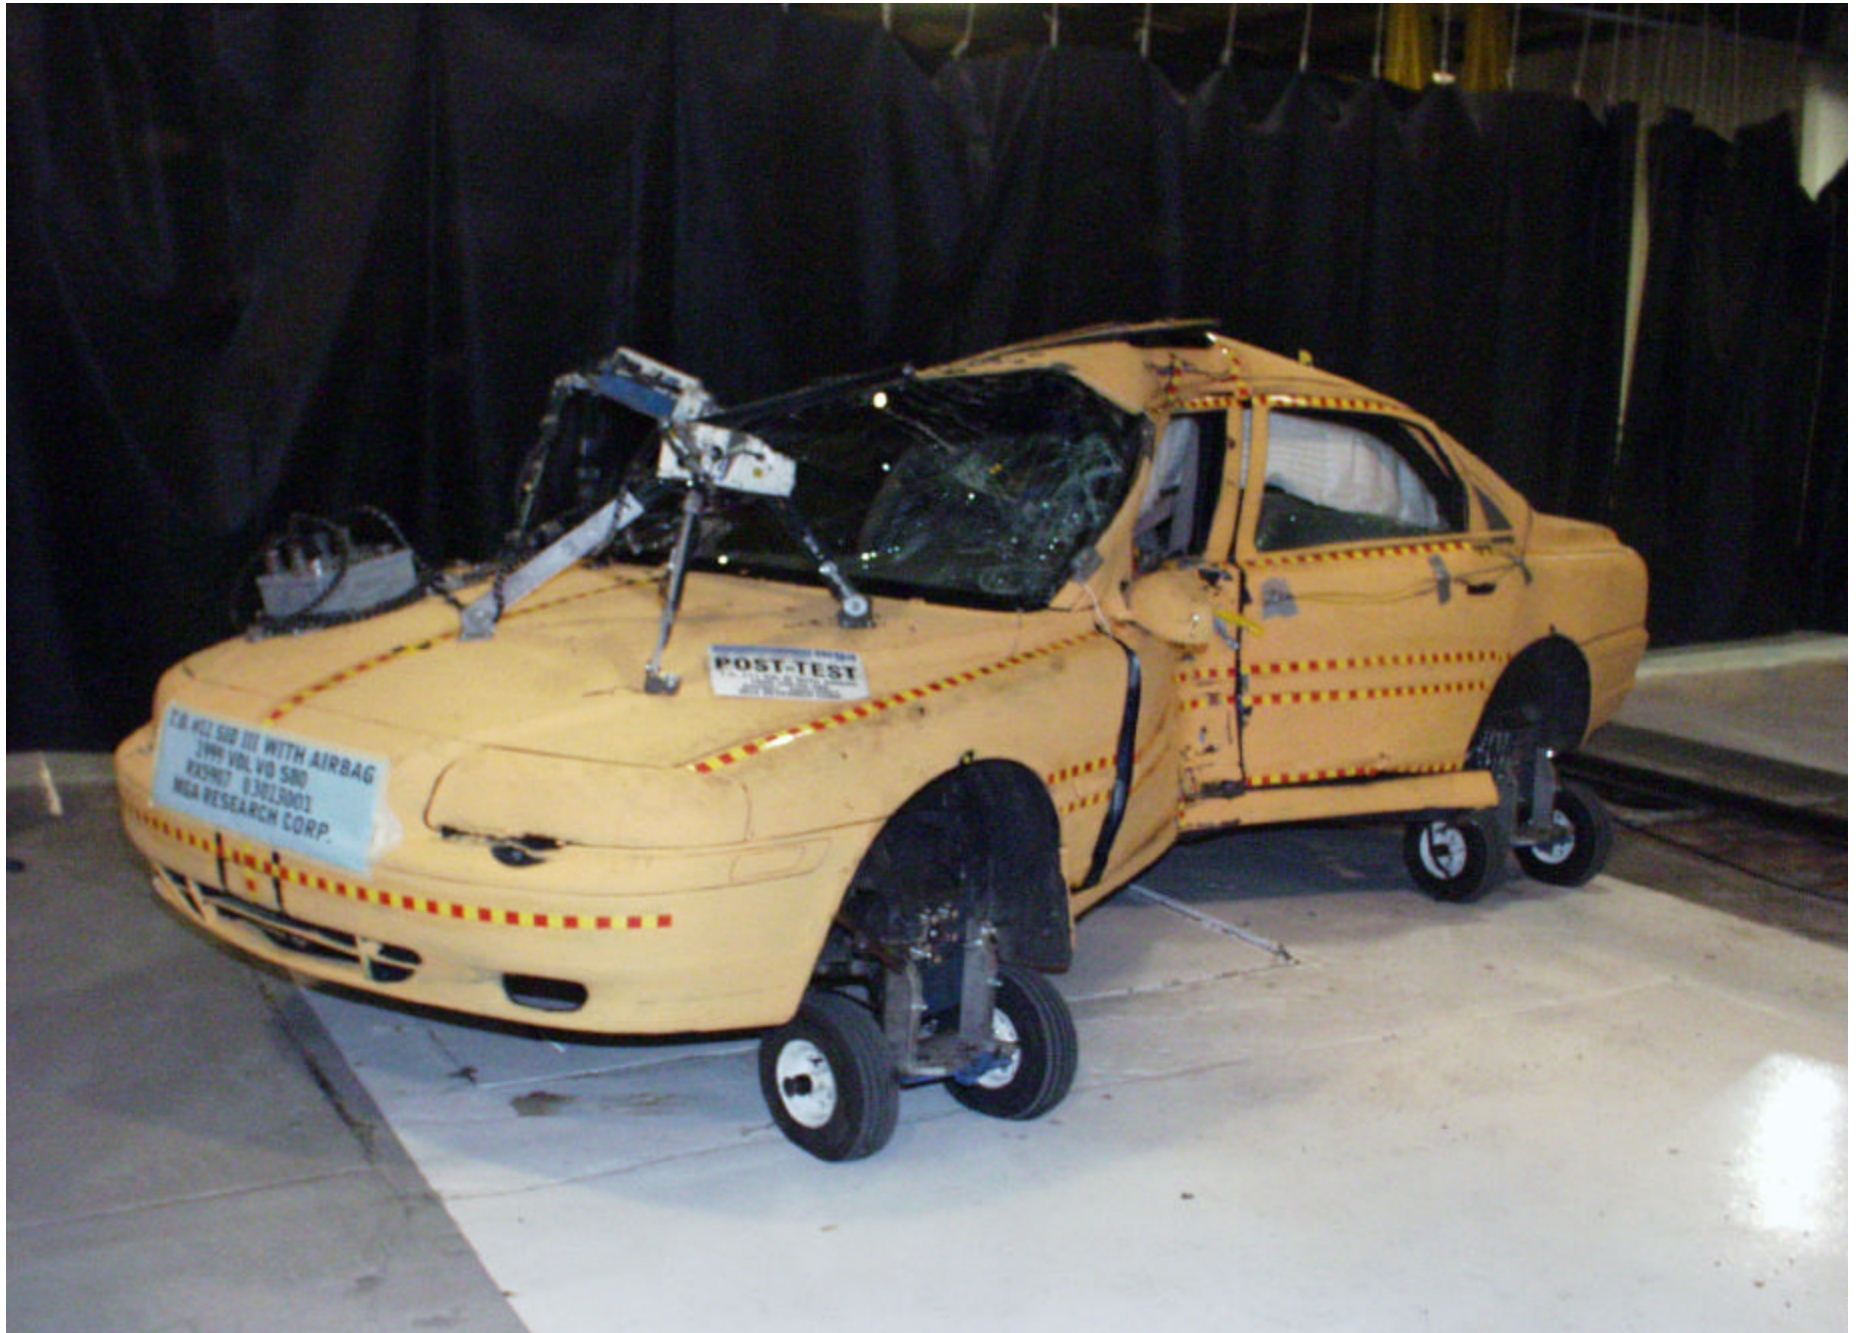
Post-Test Left  $\frac{3}{4}$  Front View of Test Vehicle

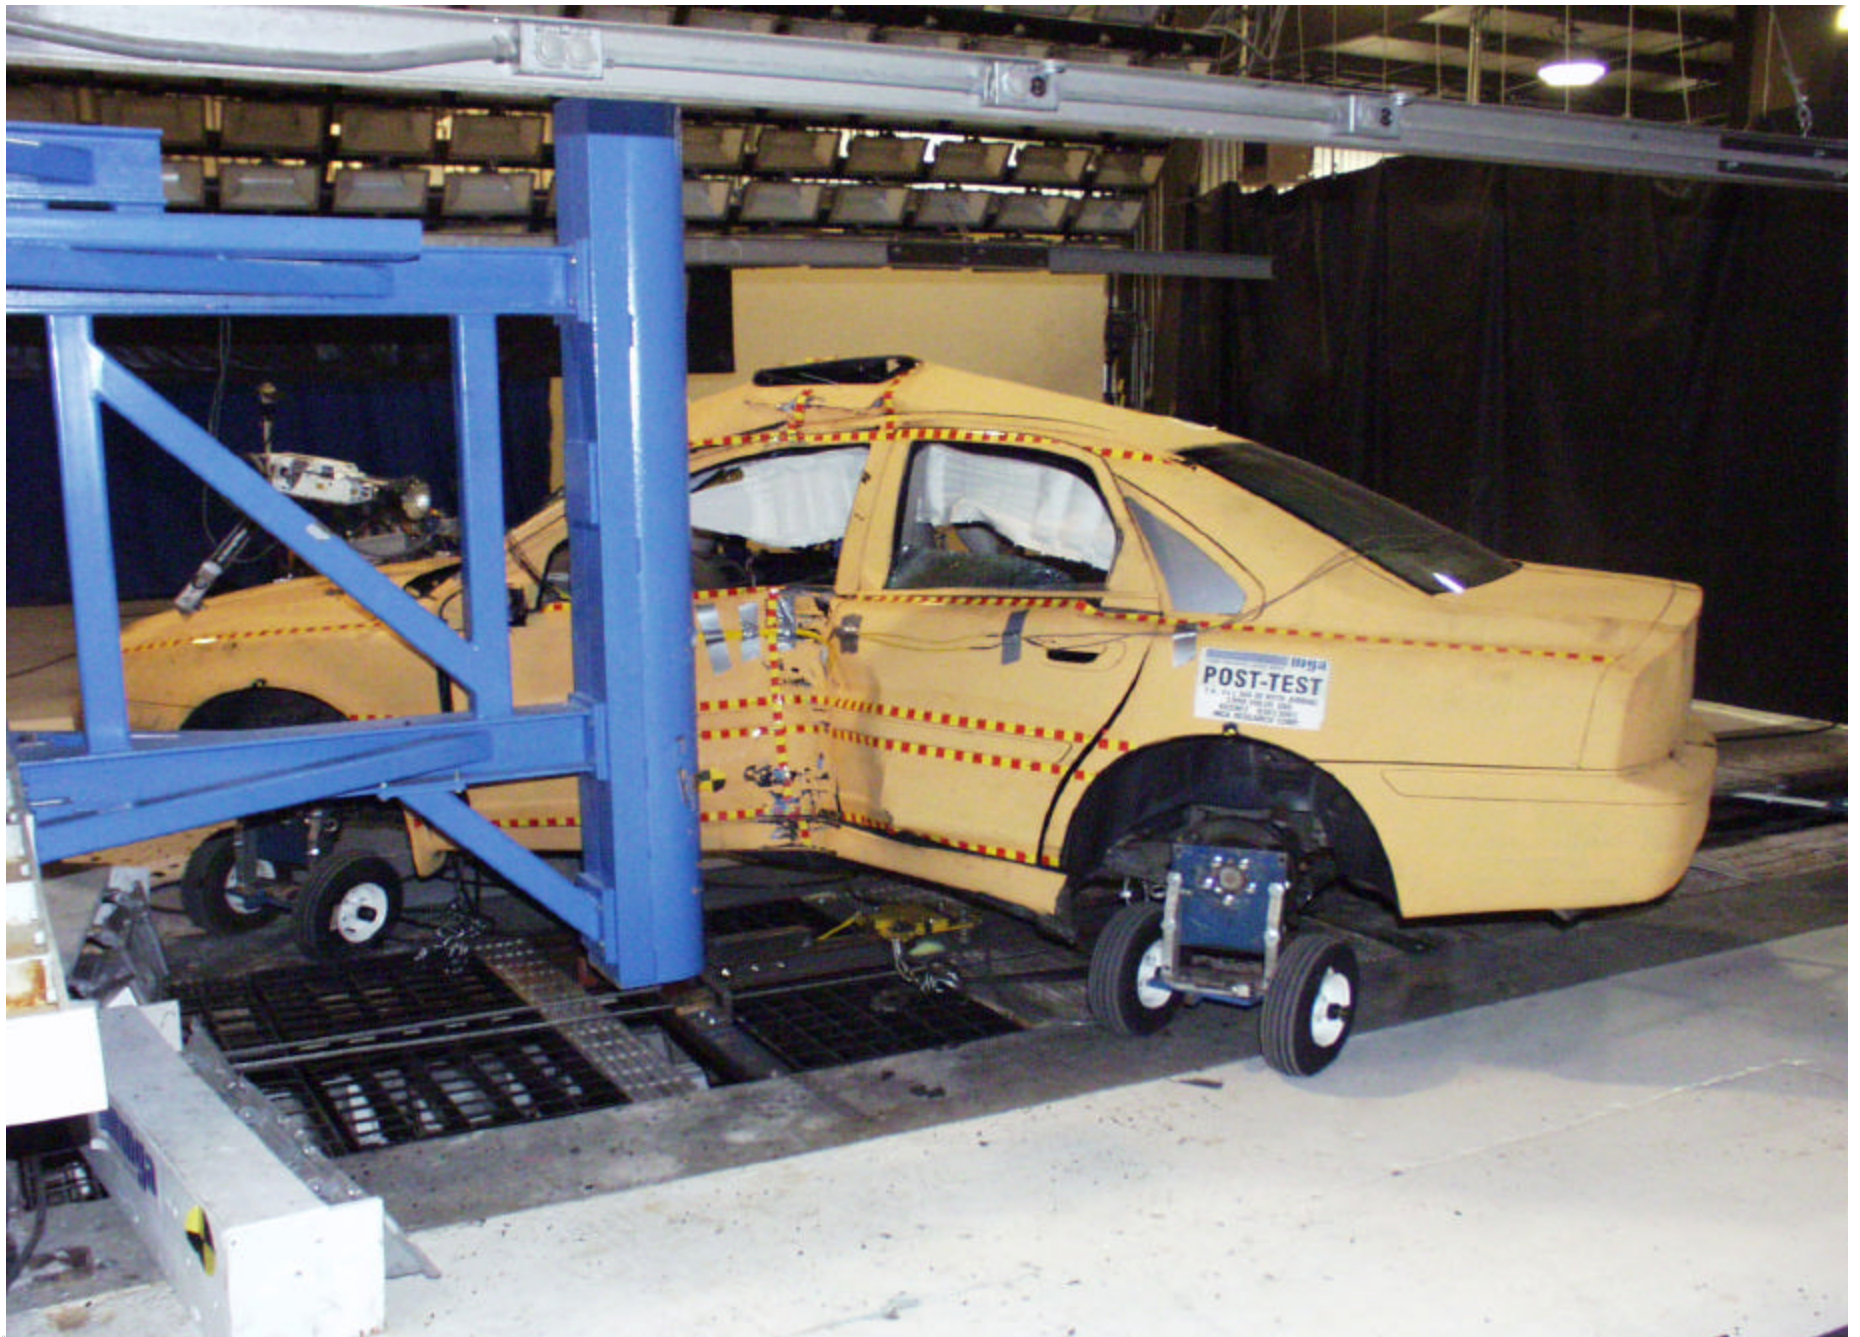
Post-Test Pole and Vehicle (left side)

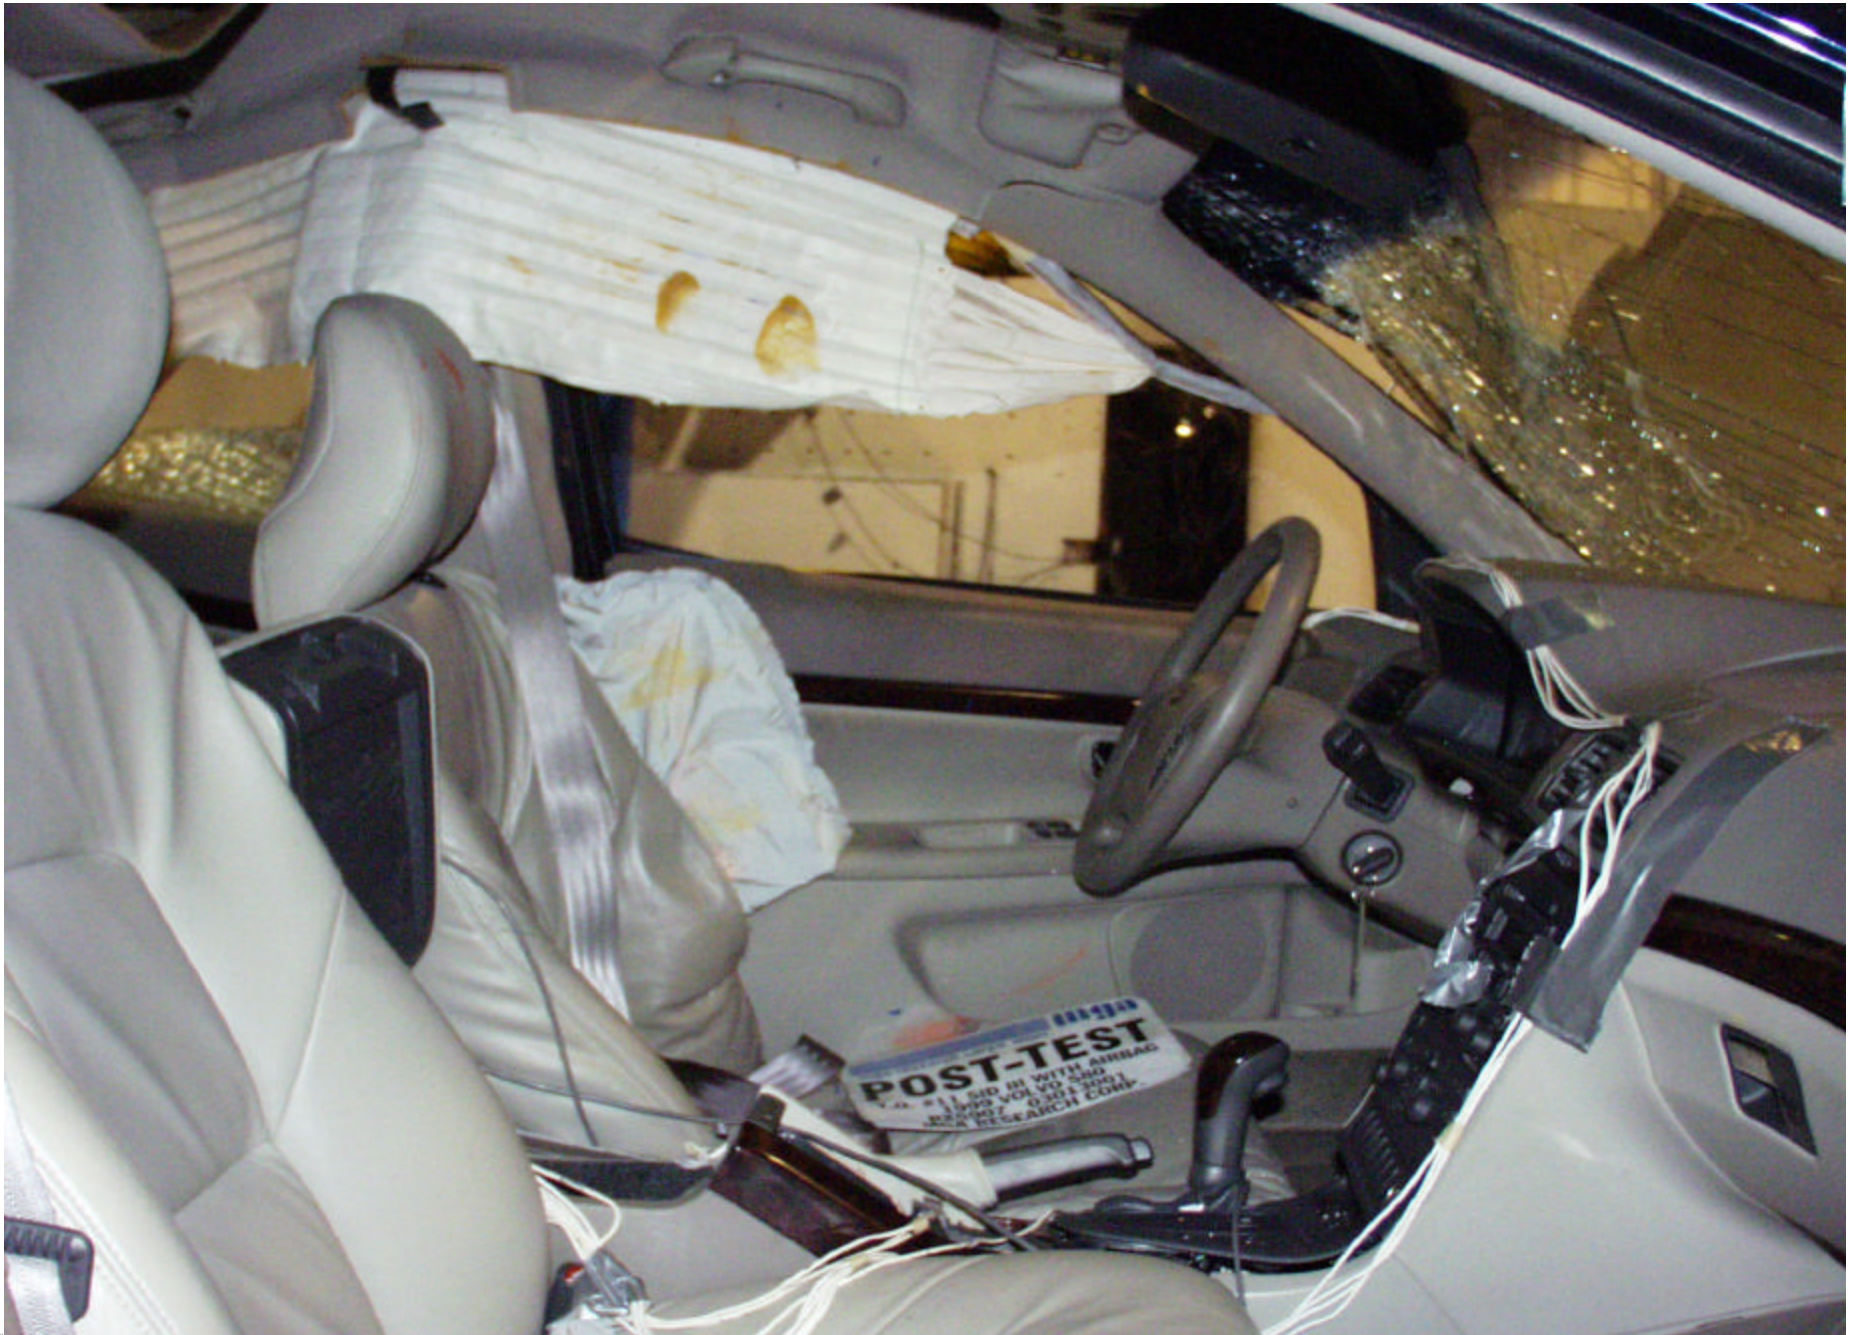
Post-Test Driver Dummy Contact

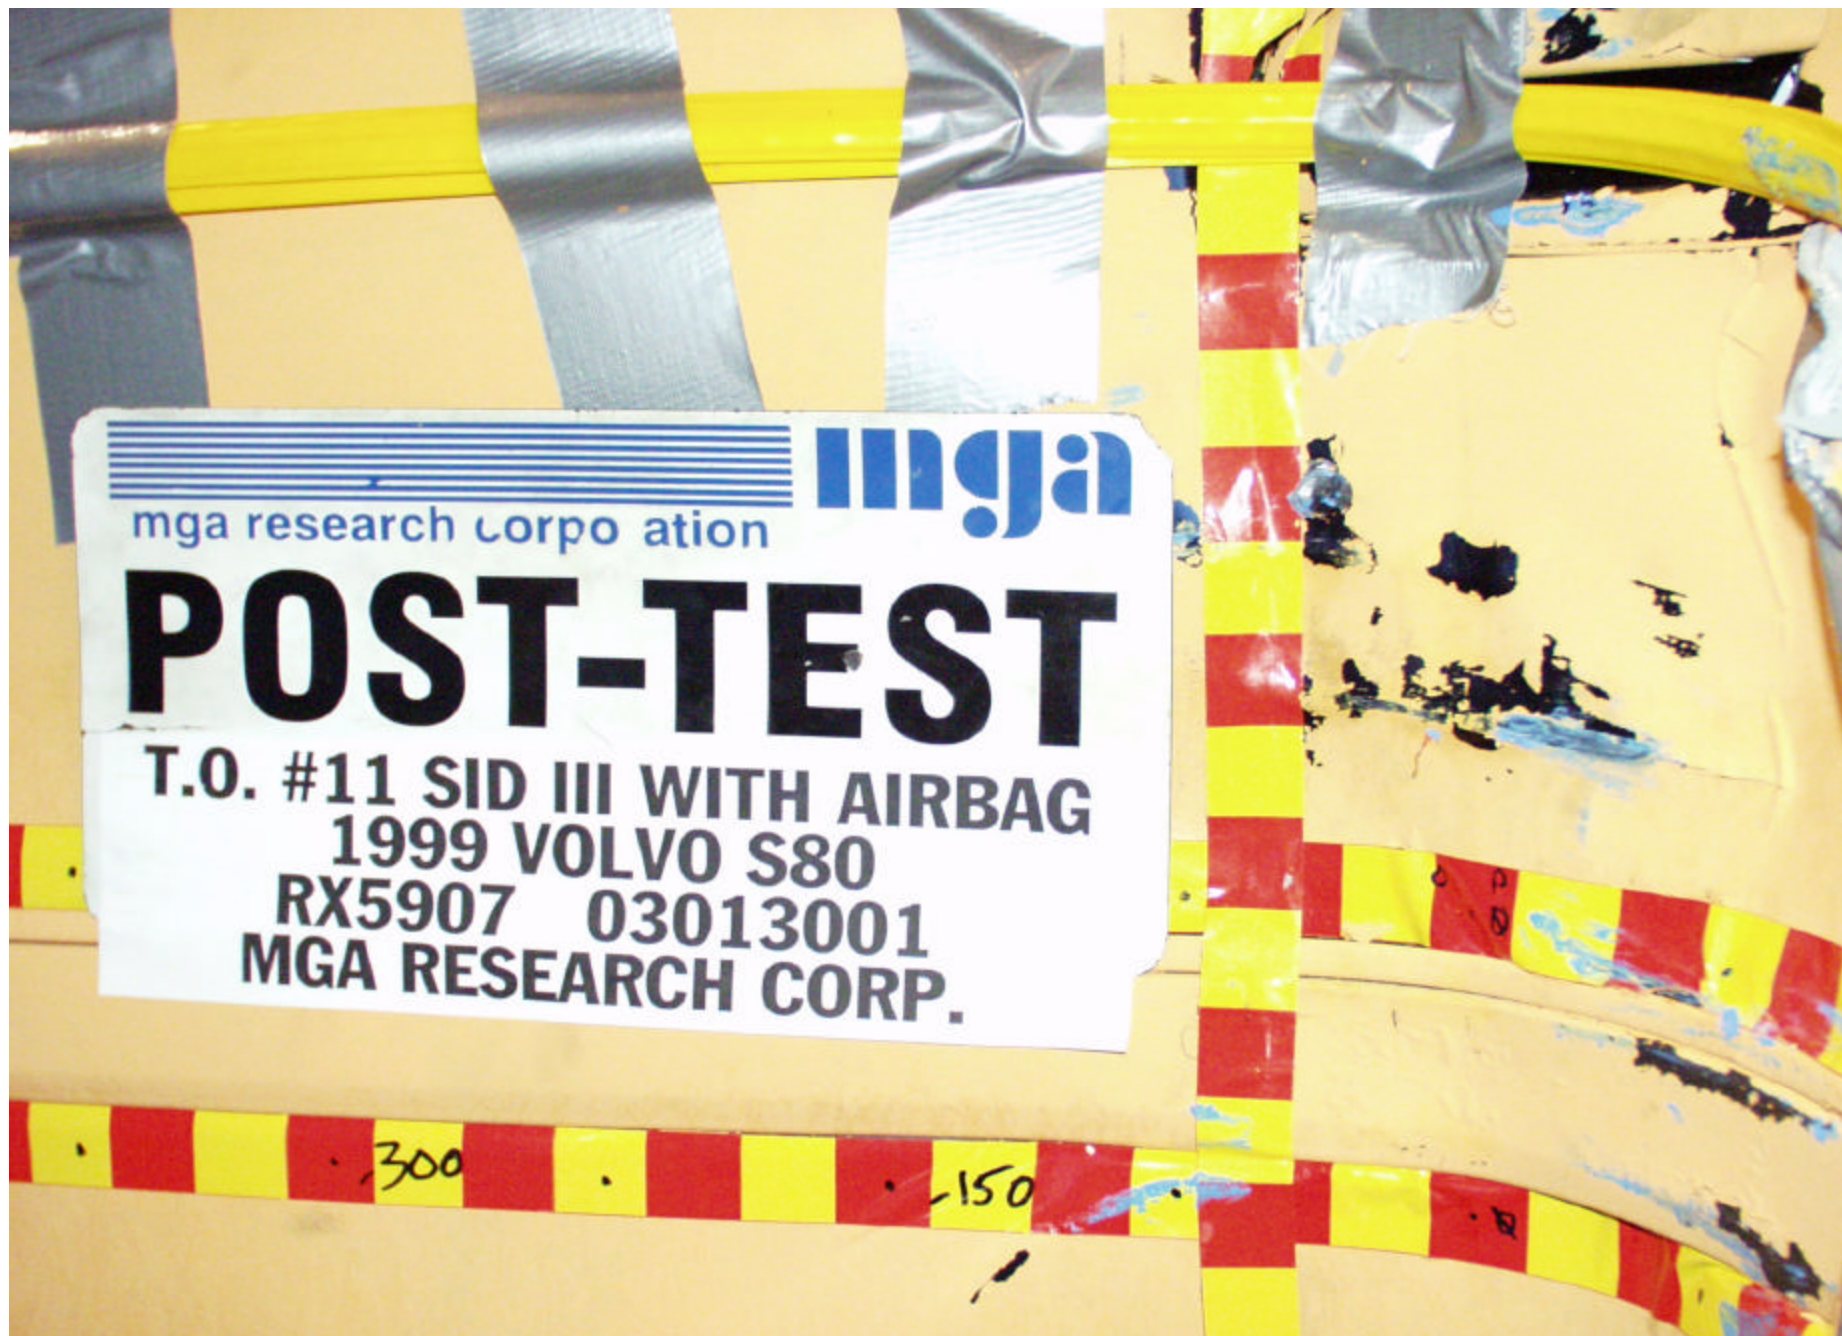
Post-Test Impact Point on Vehicle
