**NEW CAR ASSESSMENT PROGRAM
SIDE IMPACT TEST**

**BAYERISCHE MOTORENWERKE AG
2003 BMW X5 3.0i
SUV**

NHTSA NUMBER: M30502

**Prepared By:
KARCO ENGINEERING, LLC
9270 HOLLY ROAD
ADELANTO, CALIFORNIA 92301**

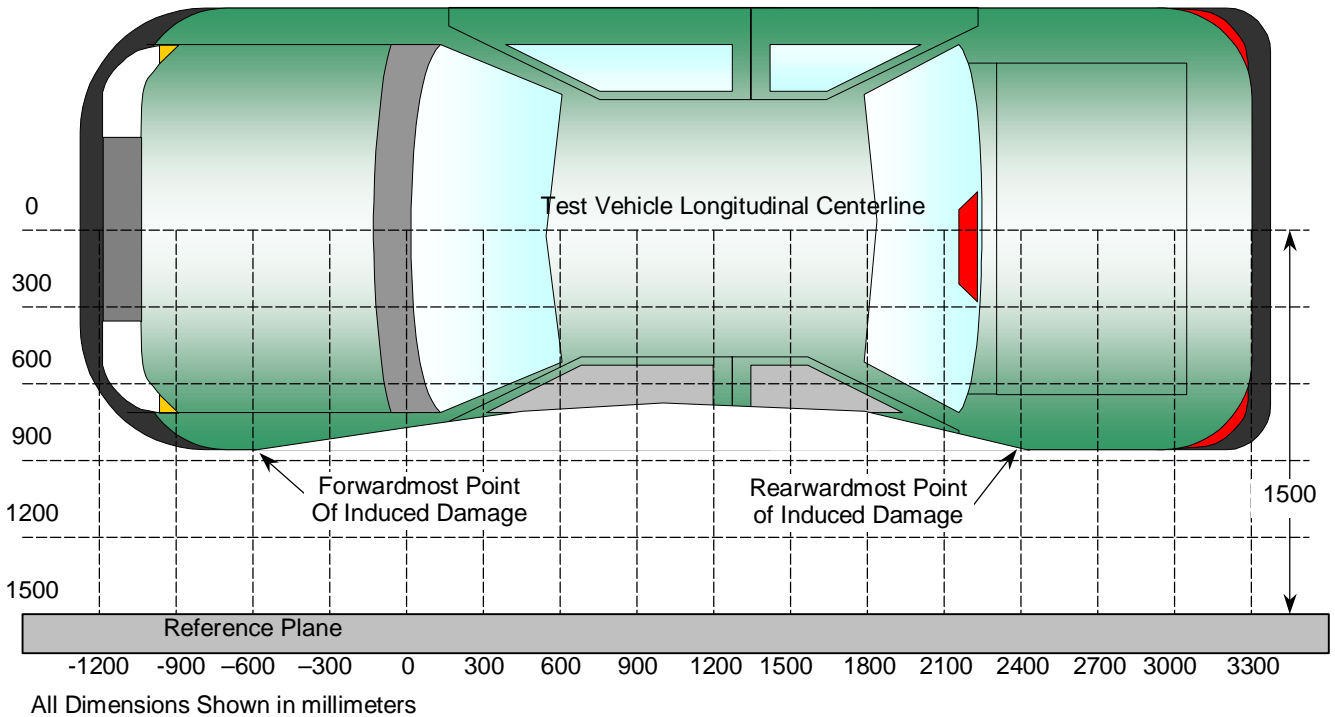
TOP VIEW

Damage Profile Distances

The test vehicle sustained a maximum static crush of 286 mm at level 2, 1650mm rearward of the left vertical impact point. The driver SID/Hybrid III, Serial No. 274 and the passenger SID/Hybrid III, Serial No. 275 were calibrated one test prior to this test. The SID/Hybrid III injury criteria is summarized as follows:

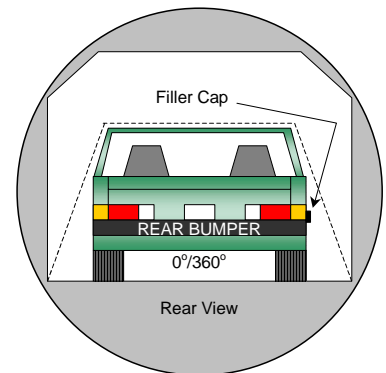
270° TO 360°

1. The specified fixture rollover rate for each 90° of rotation is 60 to 120 seconds.
2. The position hold time at each position is 300 seconds (minimum).
3. Details of Stoddard Solvent spillage locations.

No solvent leakage occurred during static rollover testing.

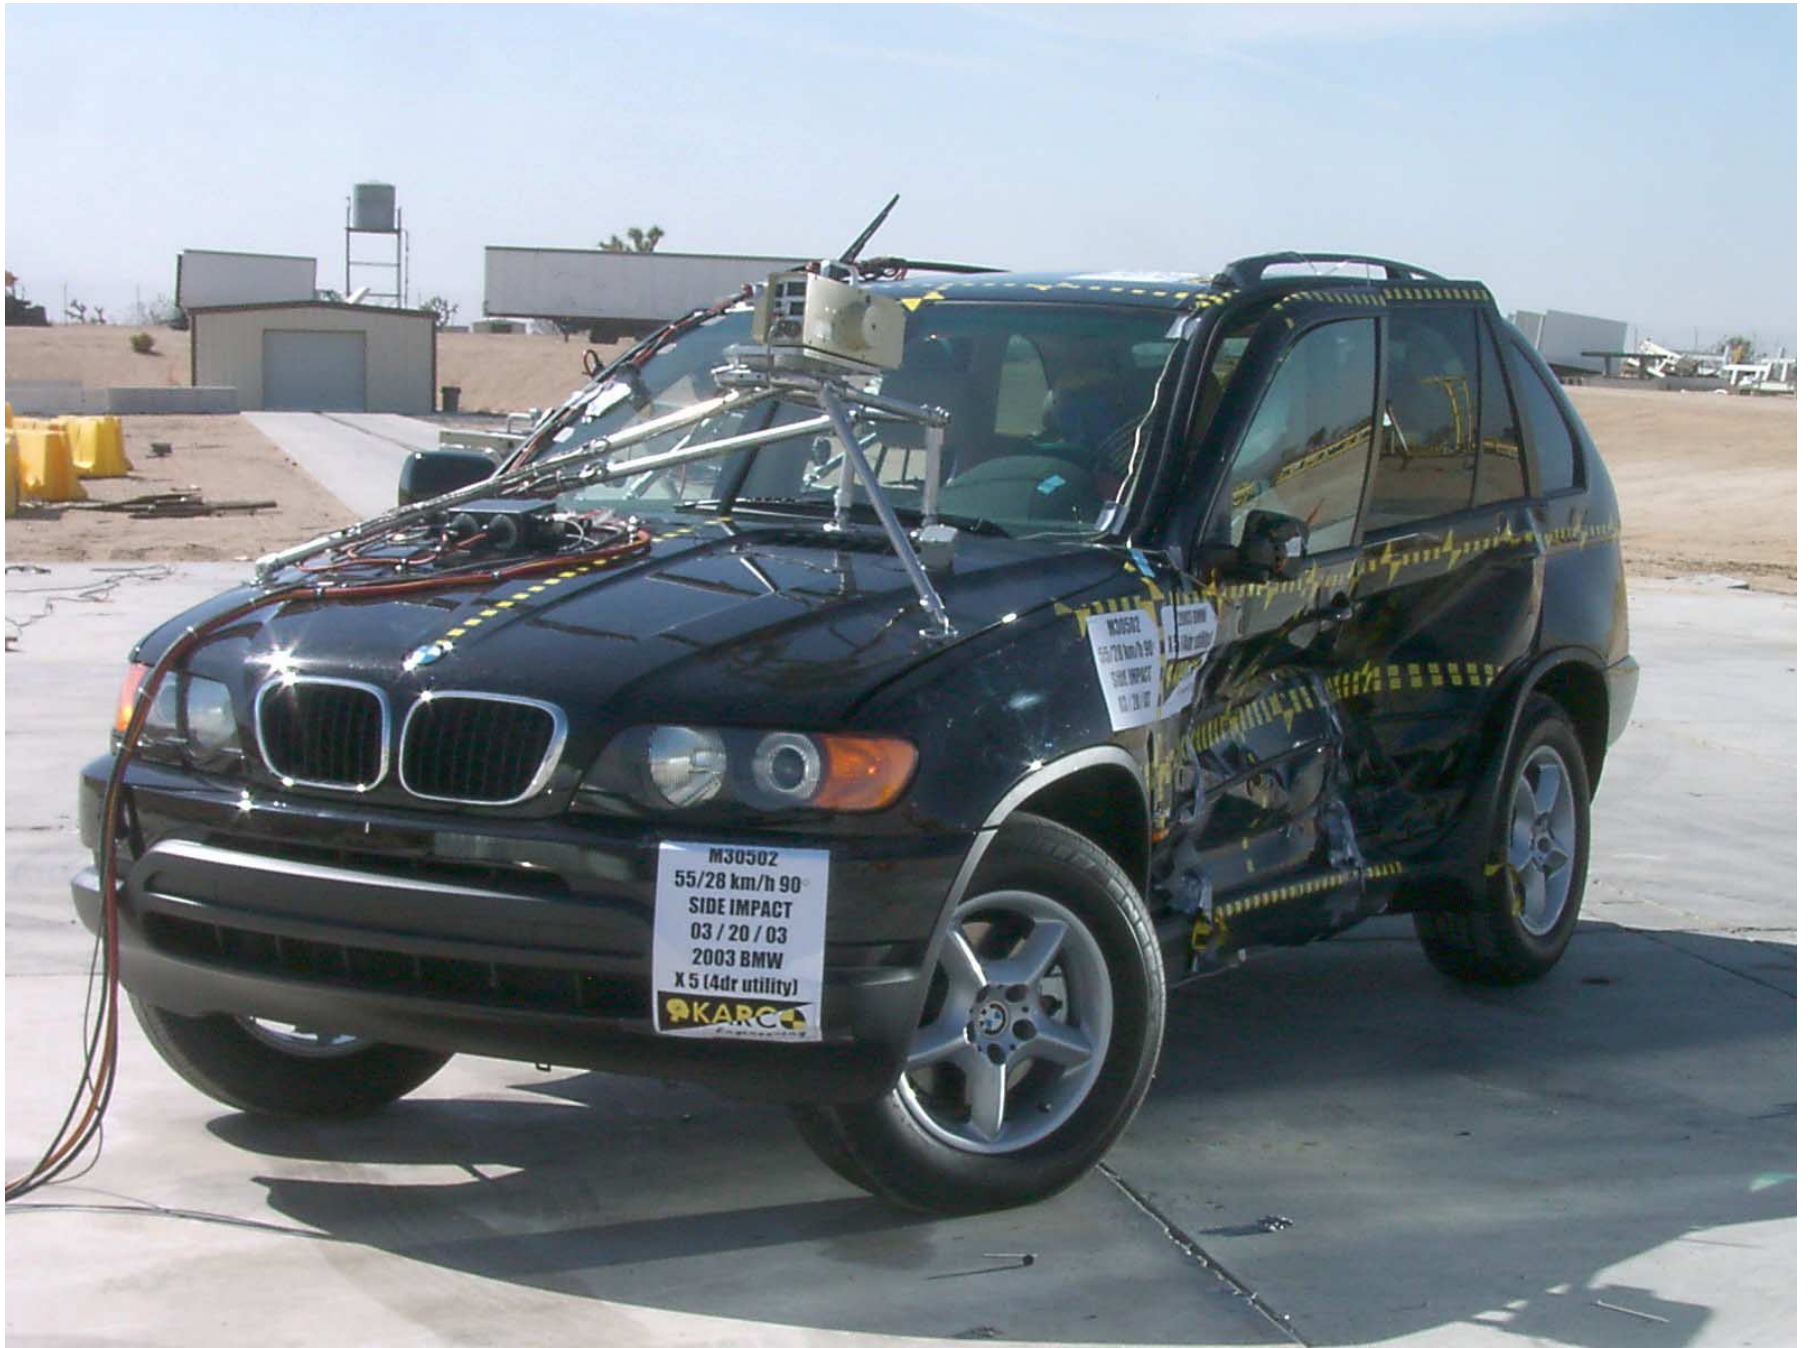
Figure A-8: Left Front ¾ View, Post-Test

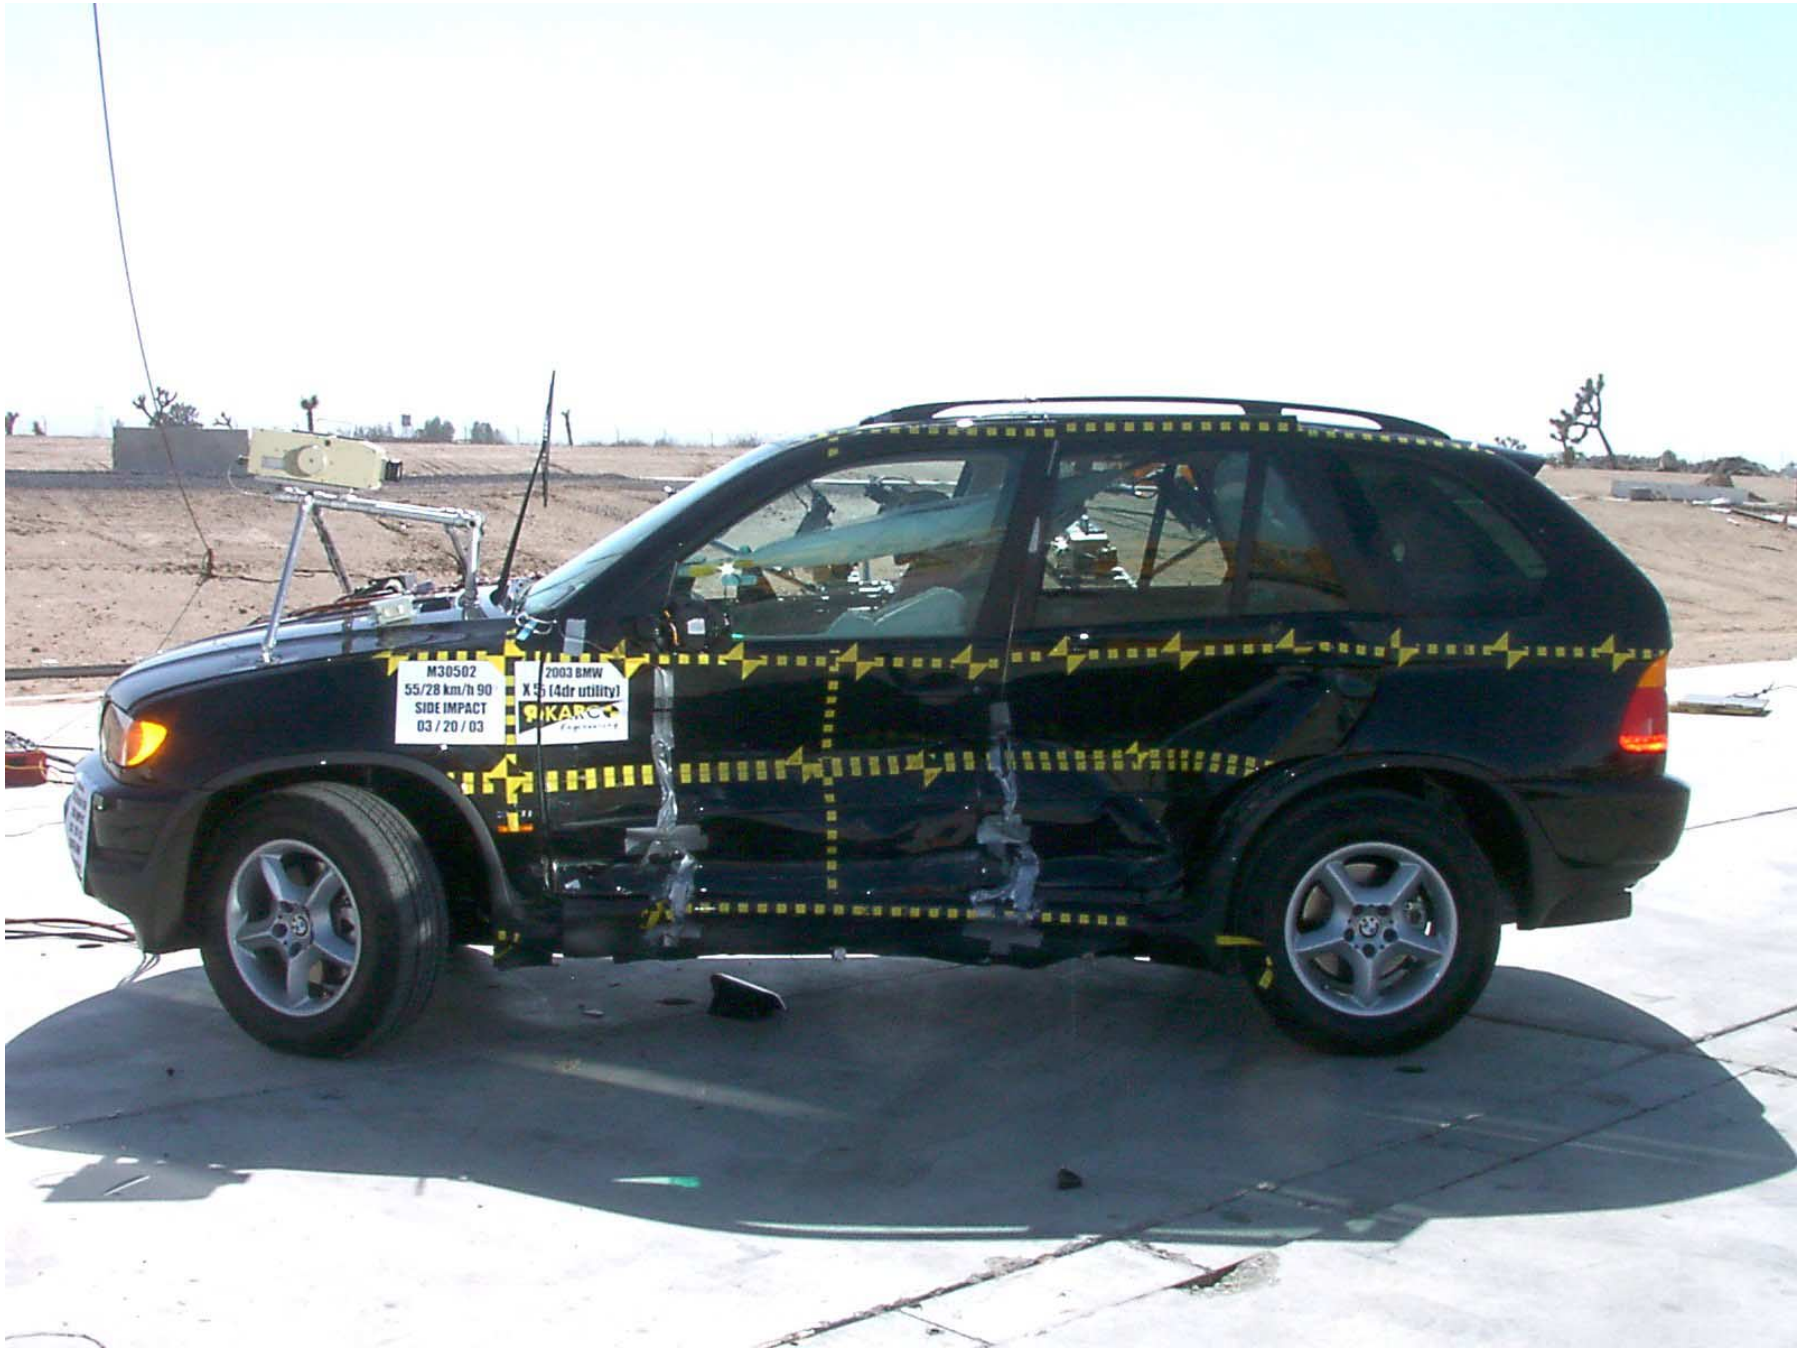
Figure A-10: Left (Impacted) Side View, Post-Test

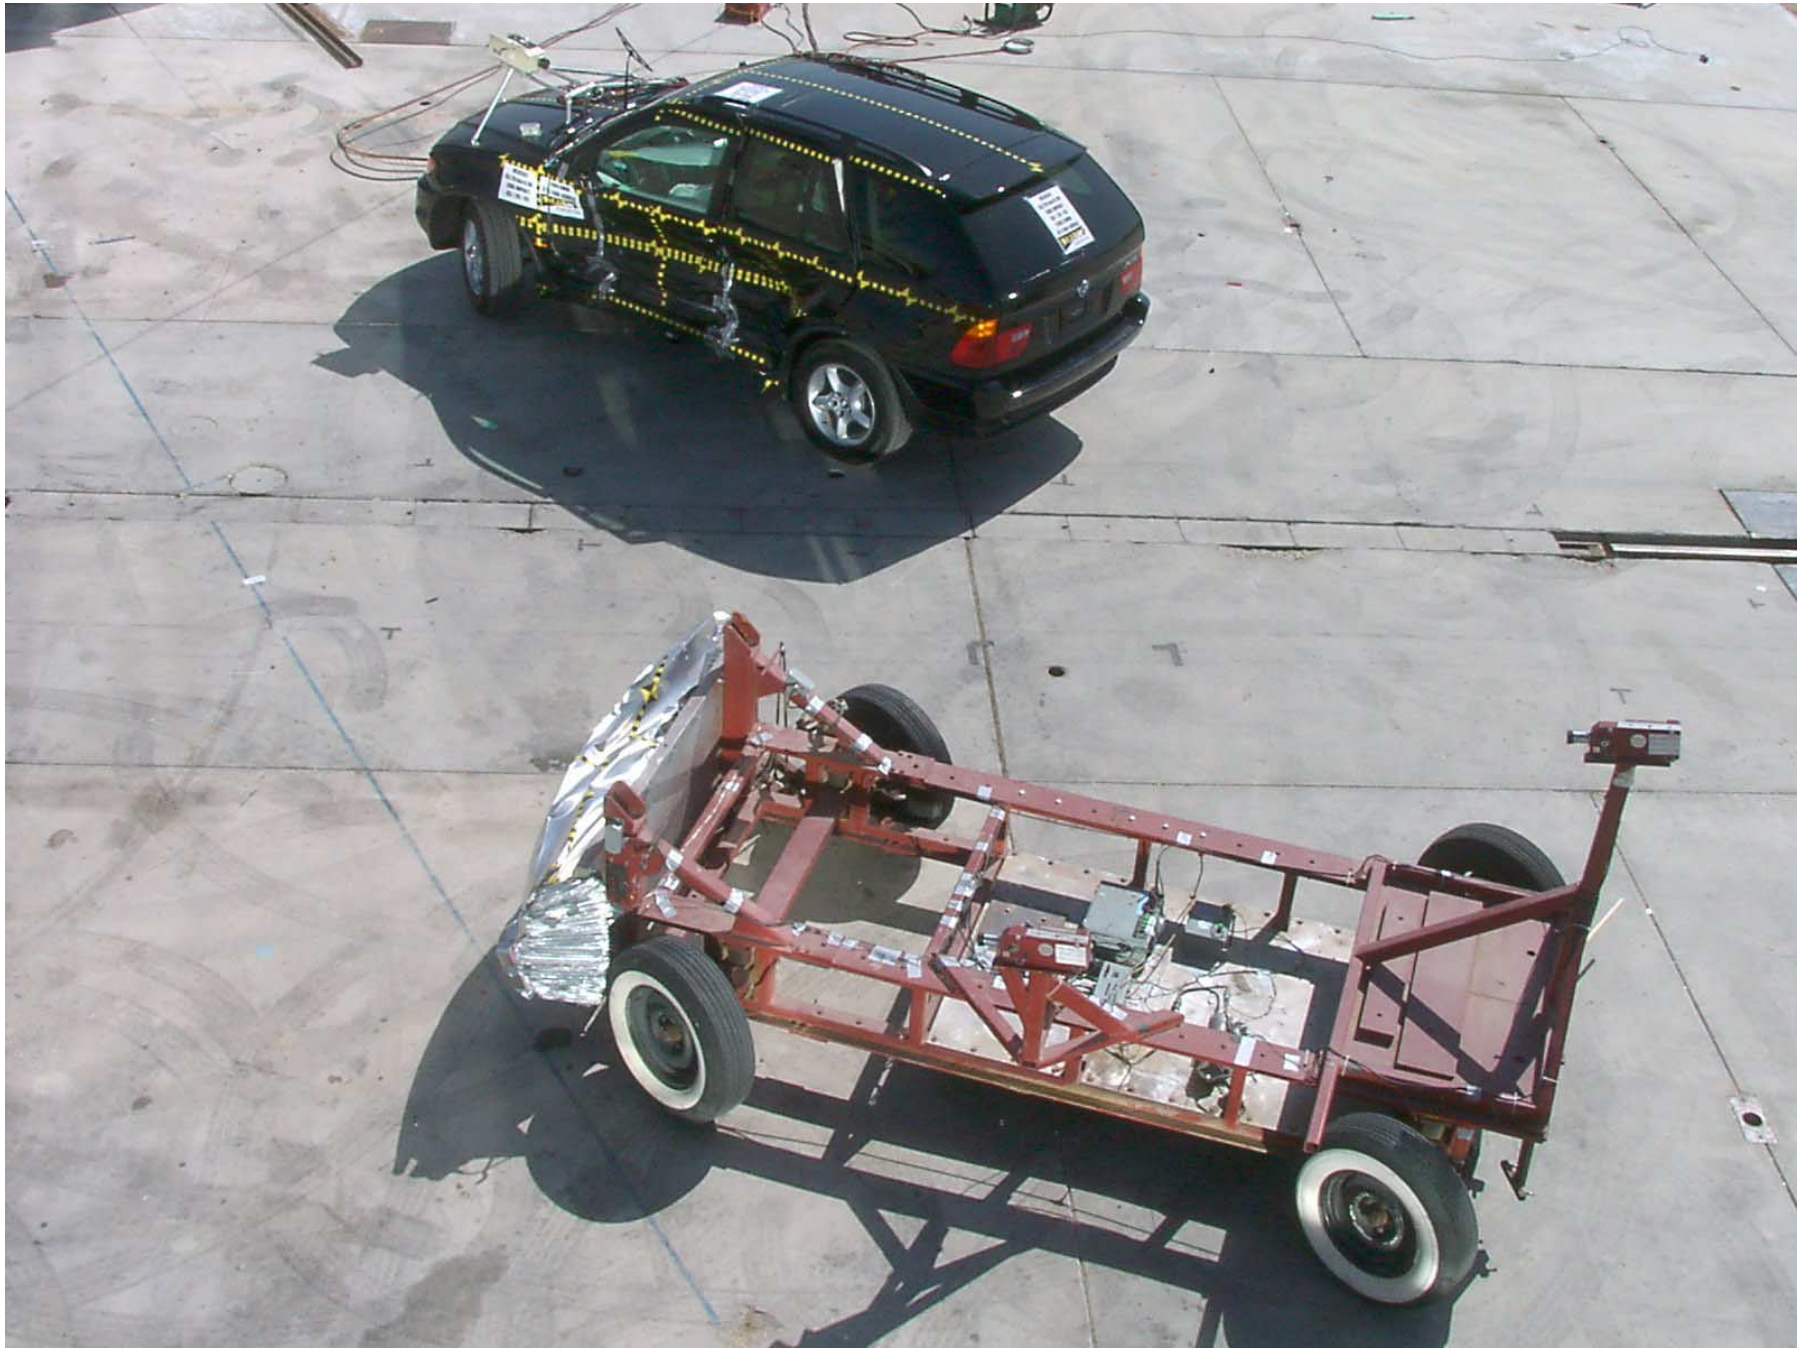
Figure A-16: Overhead Overall View, Post-Test

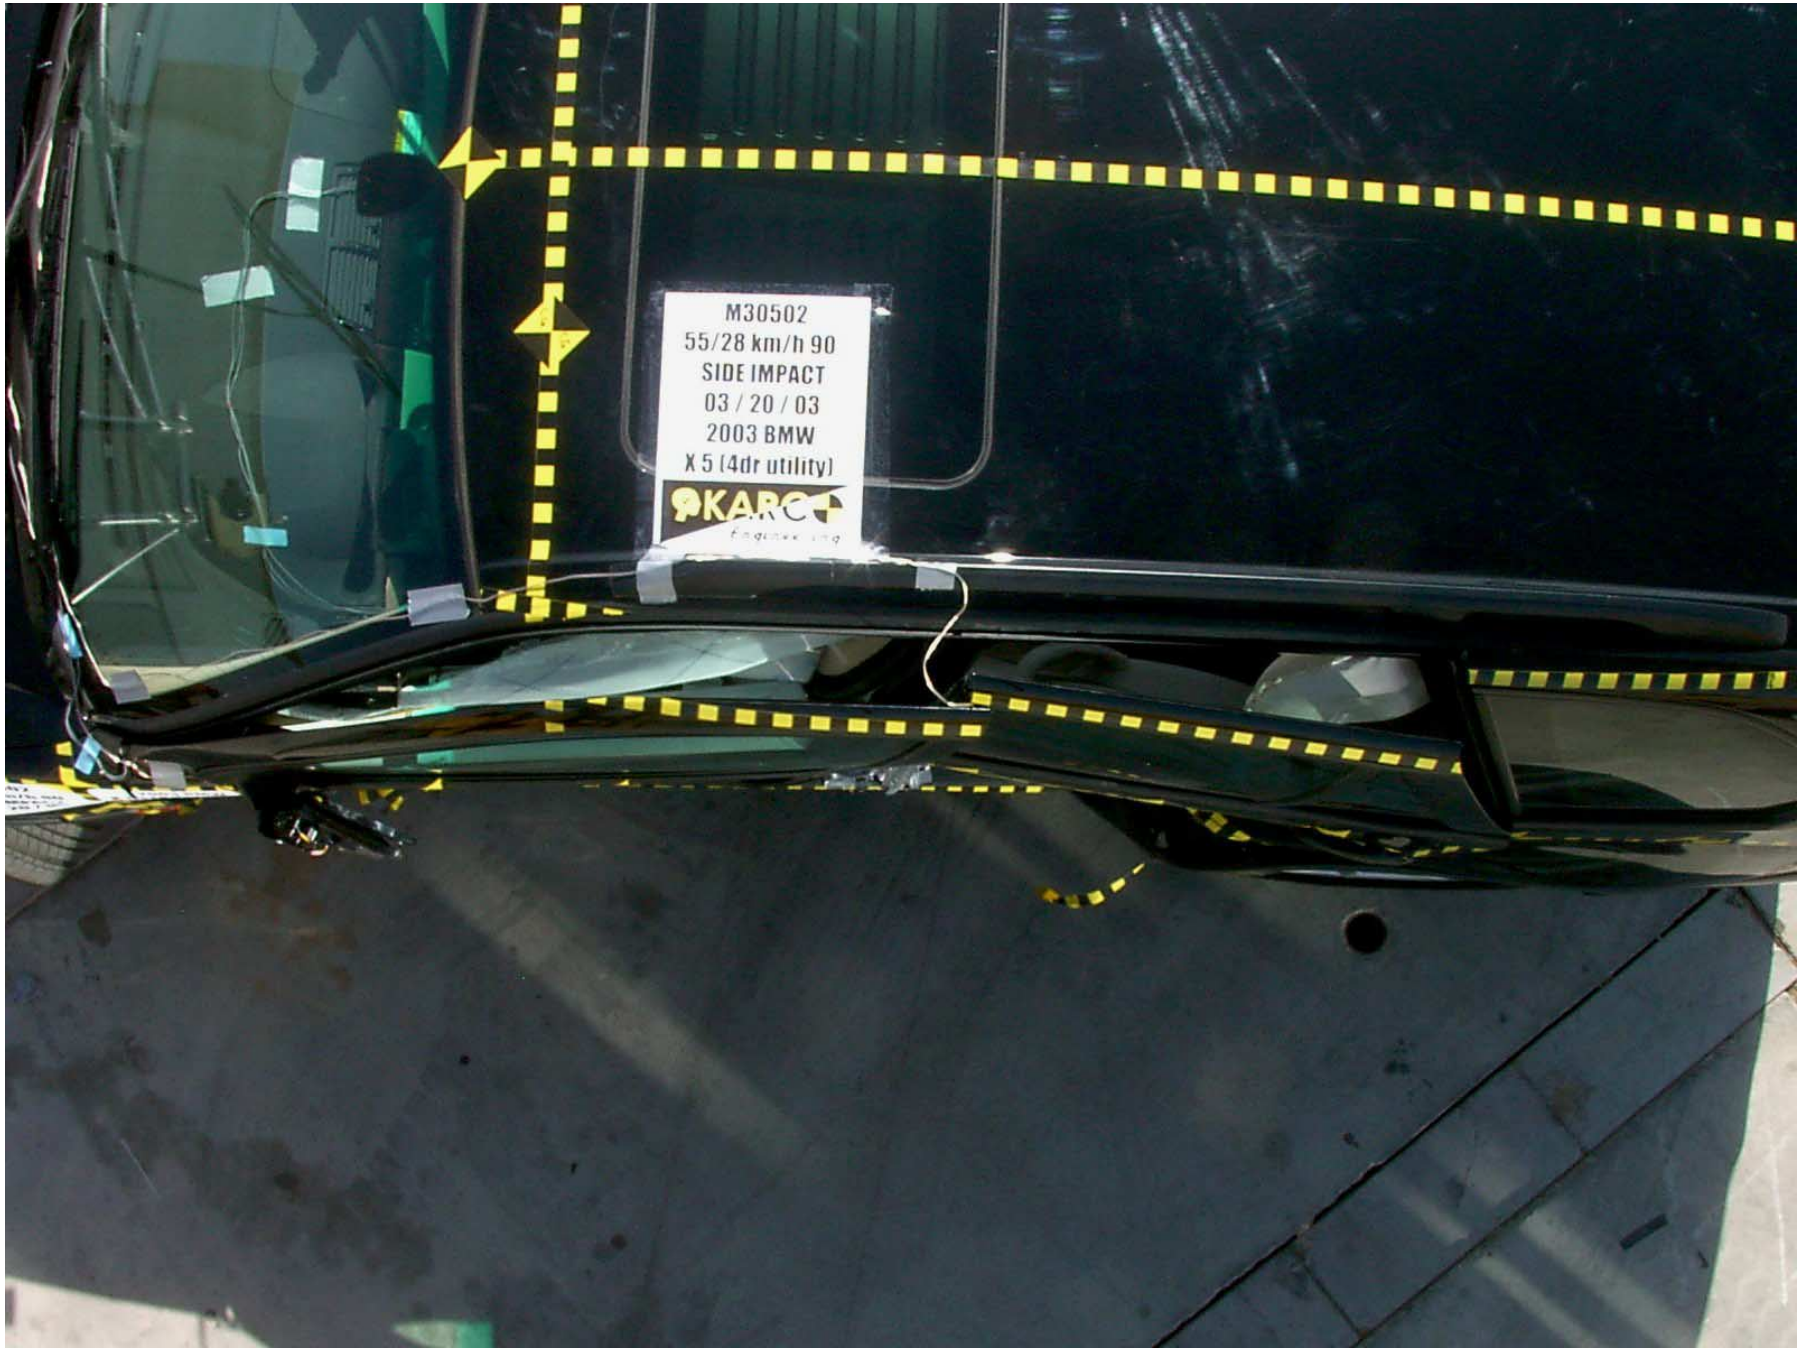
Figure A-18: Overhead Close-up View, Post-Test

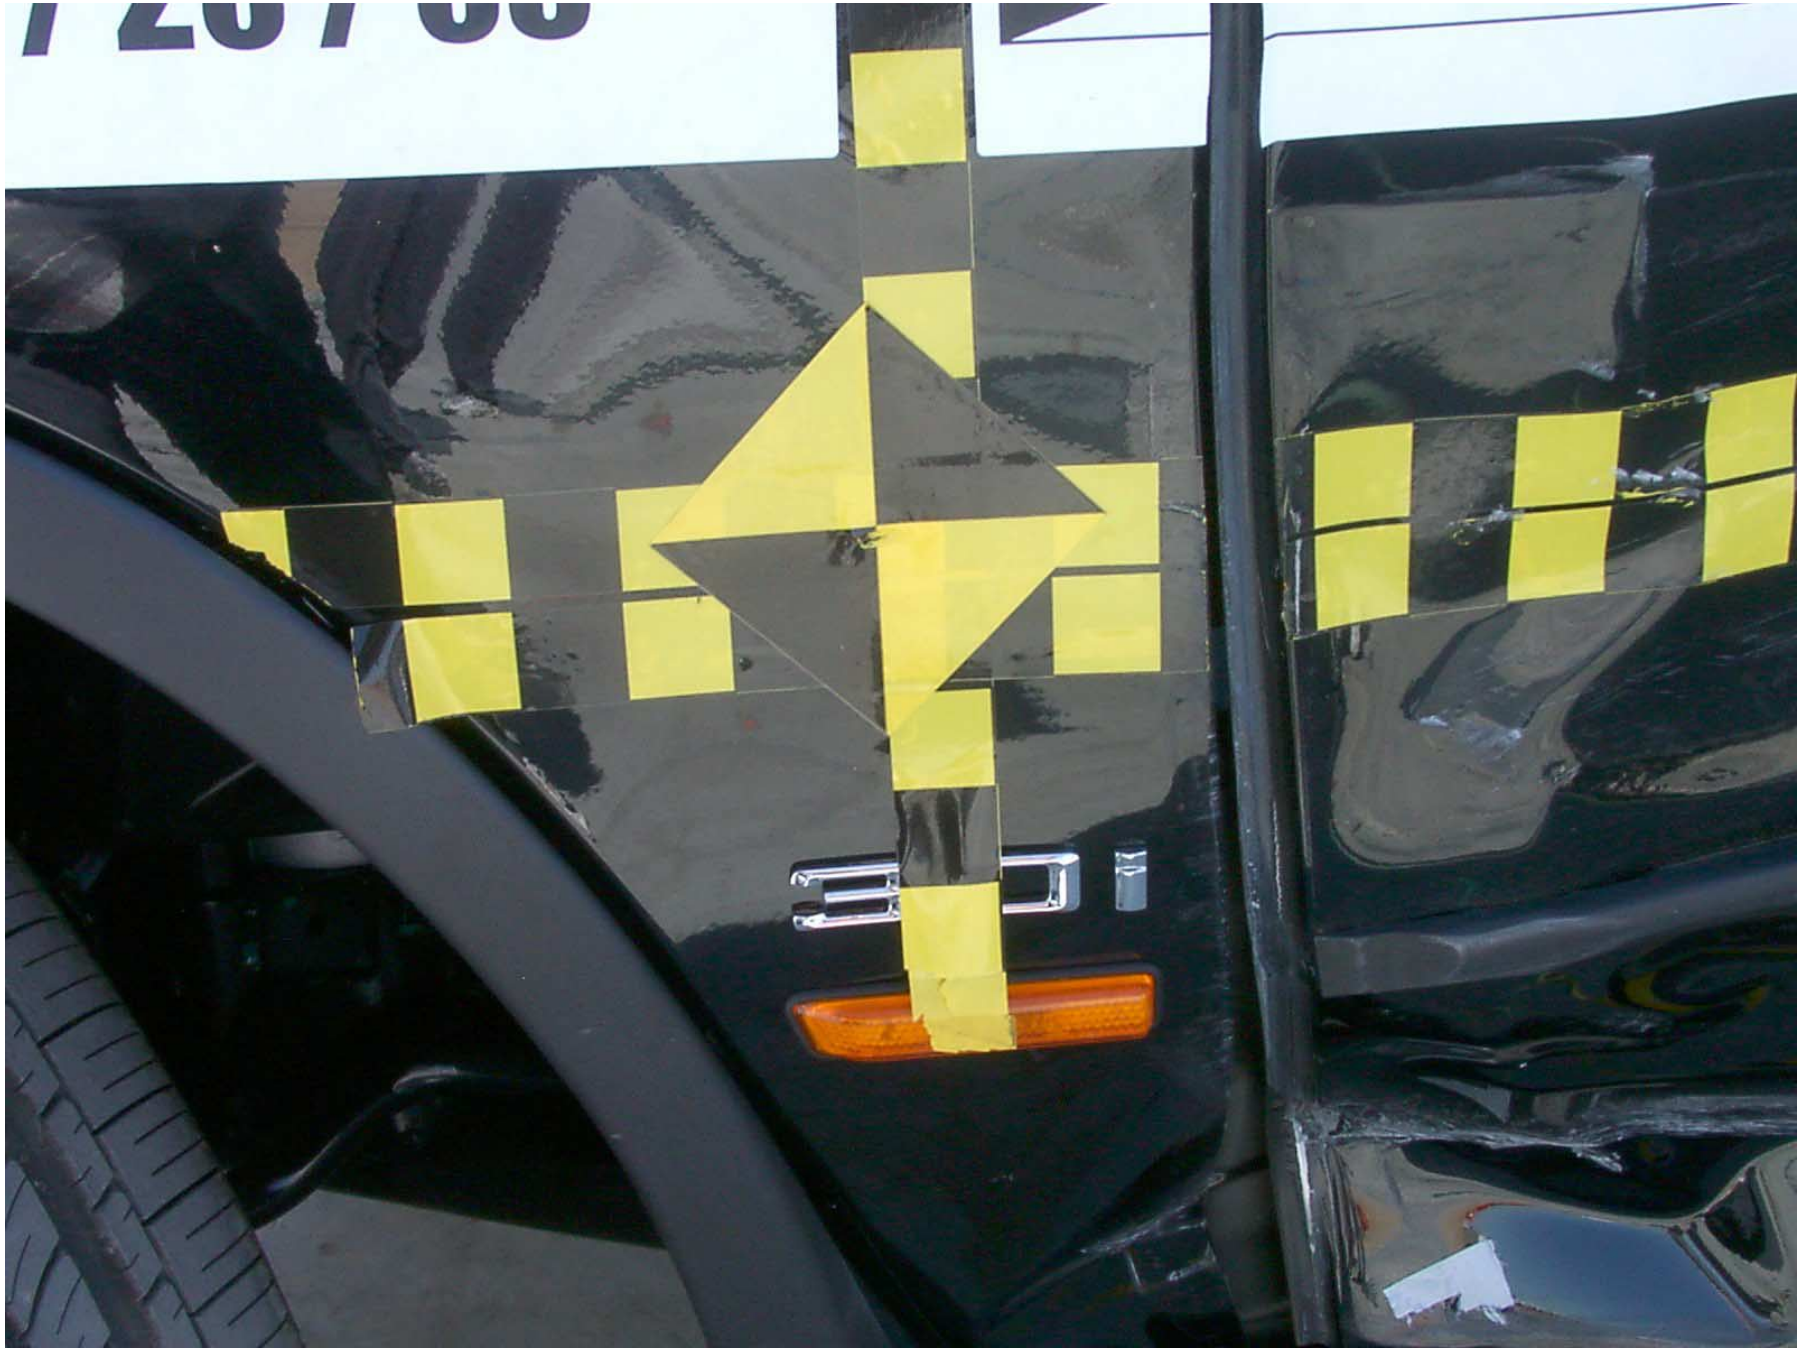
Figure A-20: Impact Point Target, Post-Test

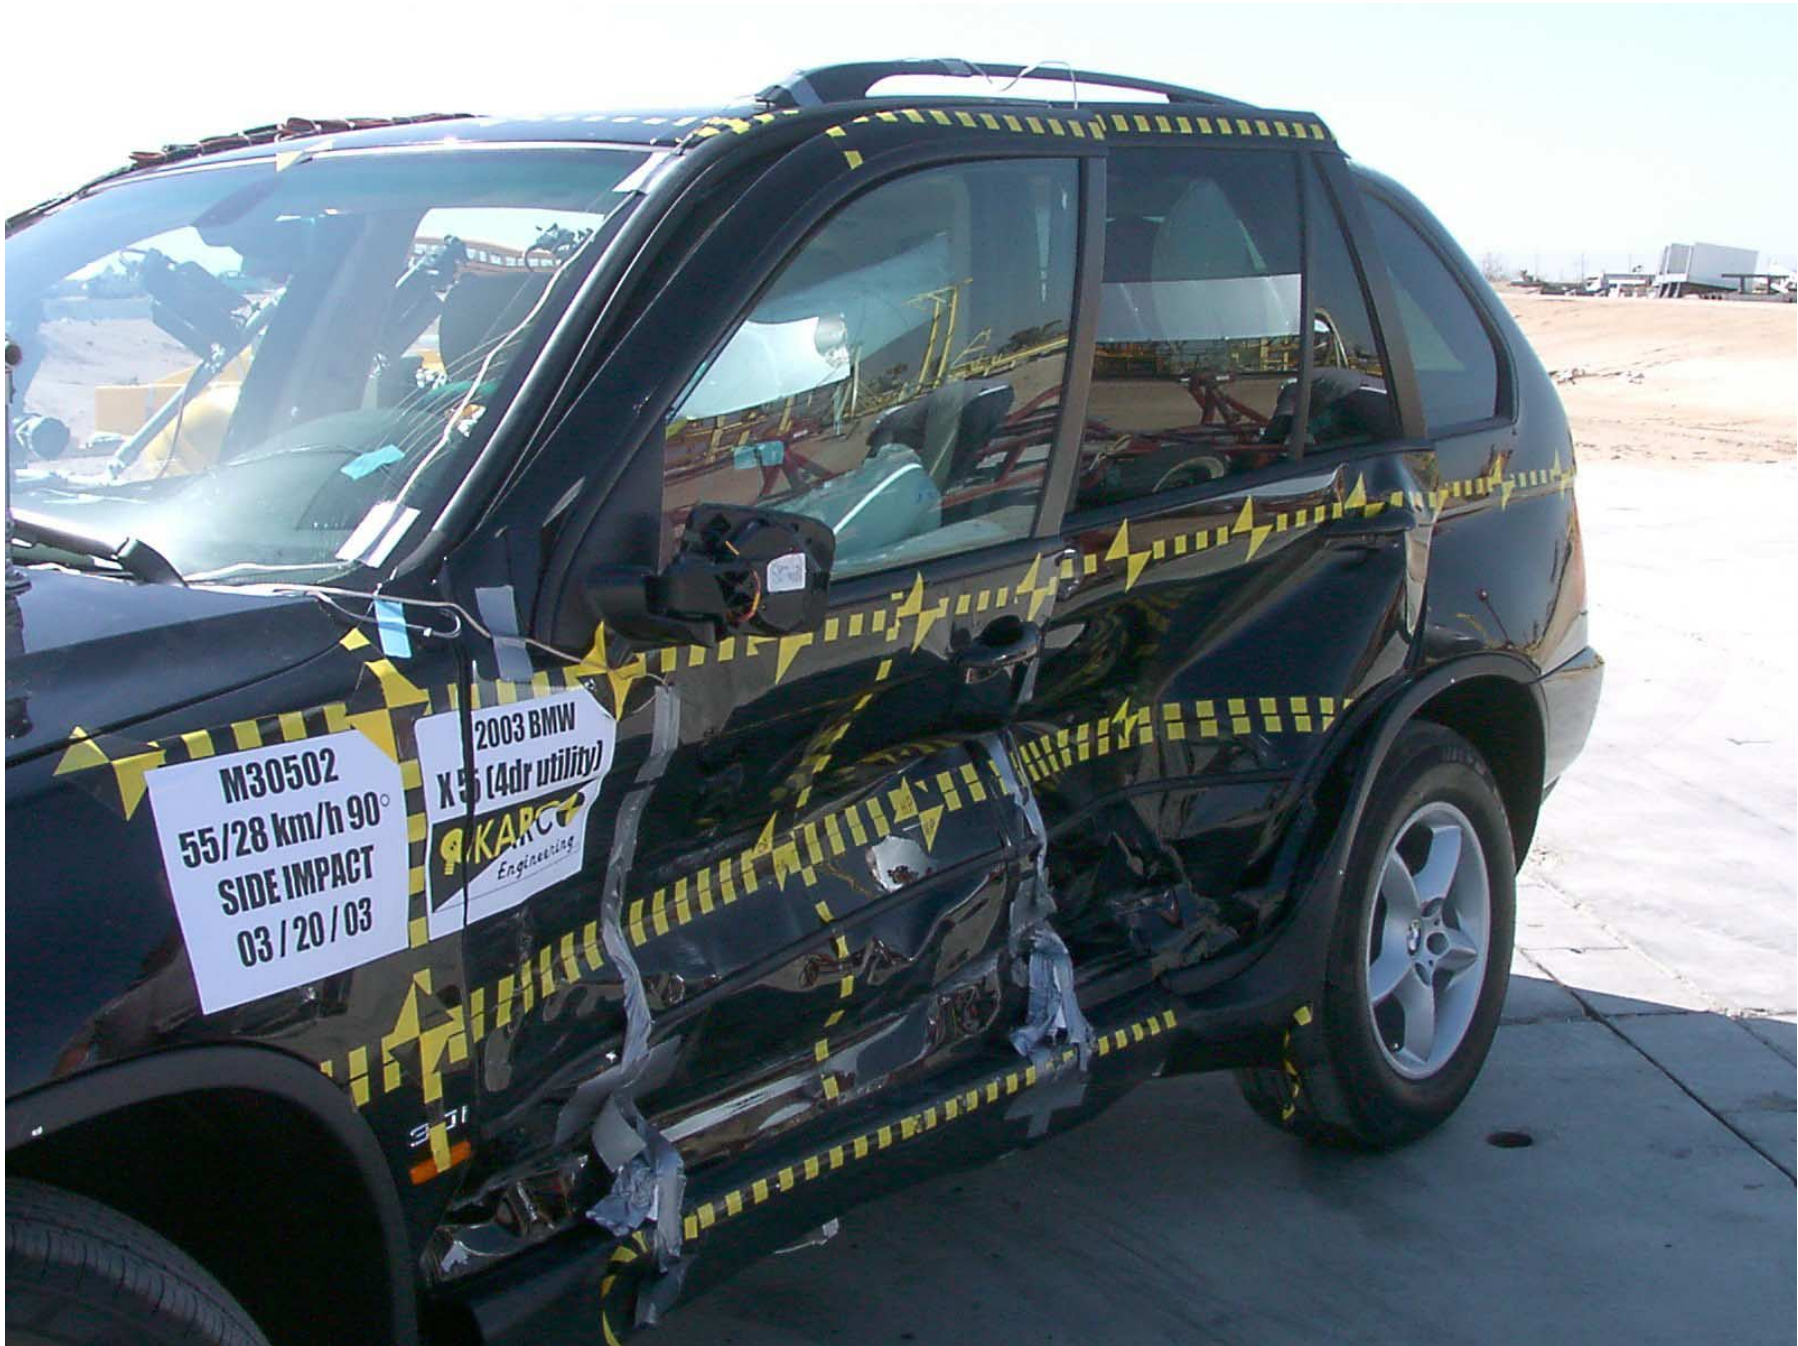
Figure A-22: Front ¾ View of Left Side Doors, Post-Test

Description	Front	Rear
Left Side Door Opening	Remained closed/latched inoperable	Remained closed/latched inoperable
Right Side Door Opening	Remained closed/latched operable	Remained closed/latched operable
Seat Movement	None	None
Seat Back Failure	None	None

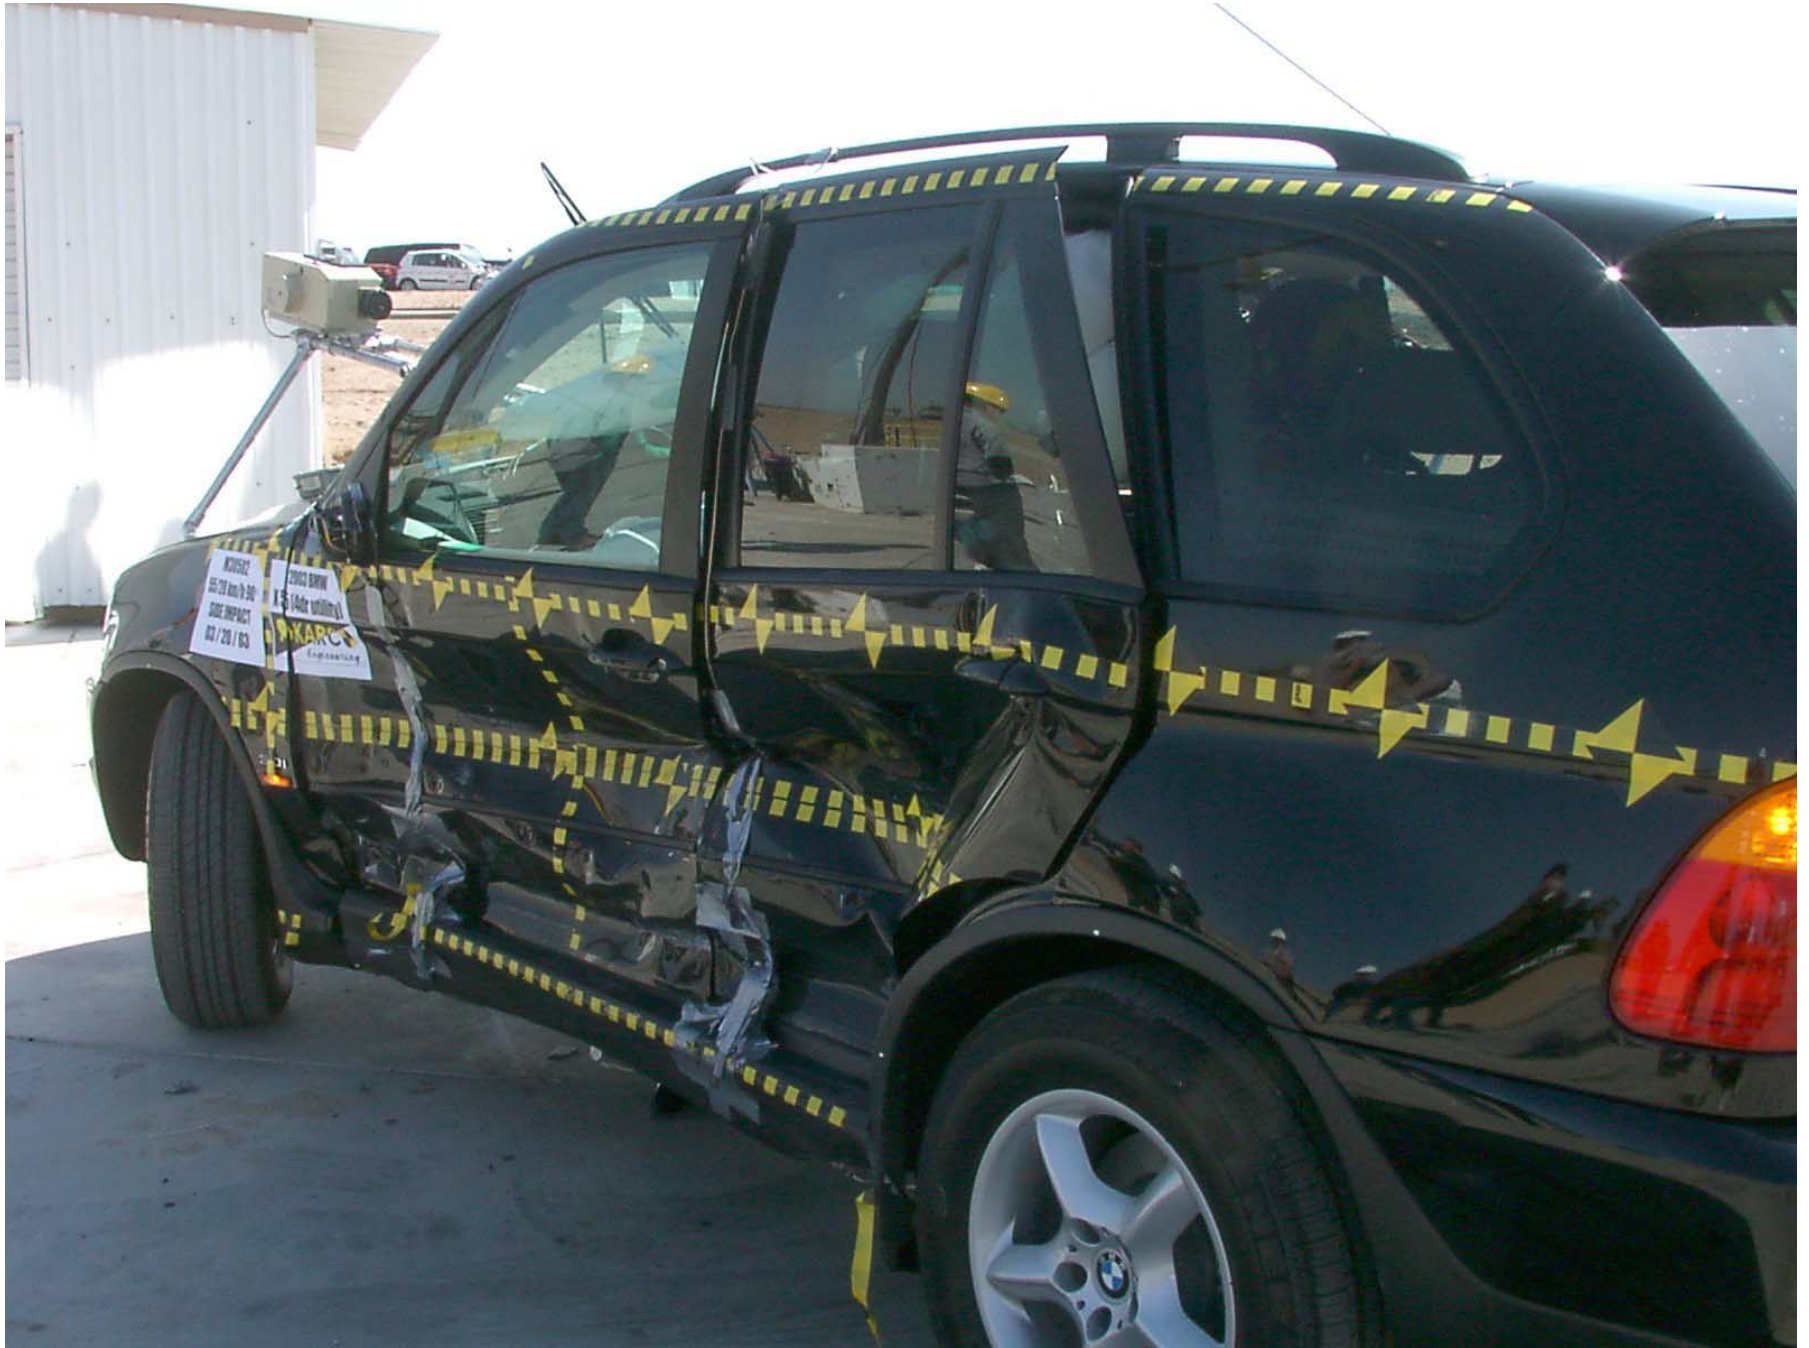
Figure A-24: Rear ¾ View of Left Side Doors, Post-Test

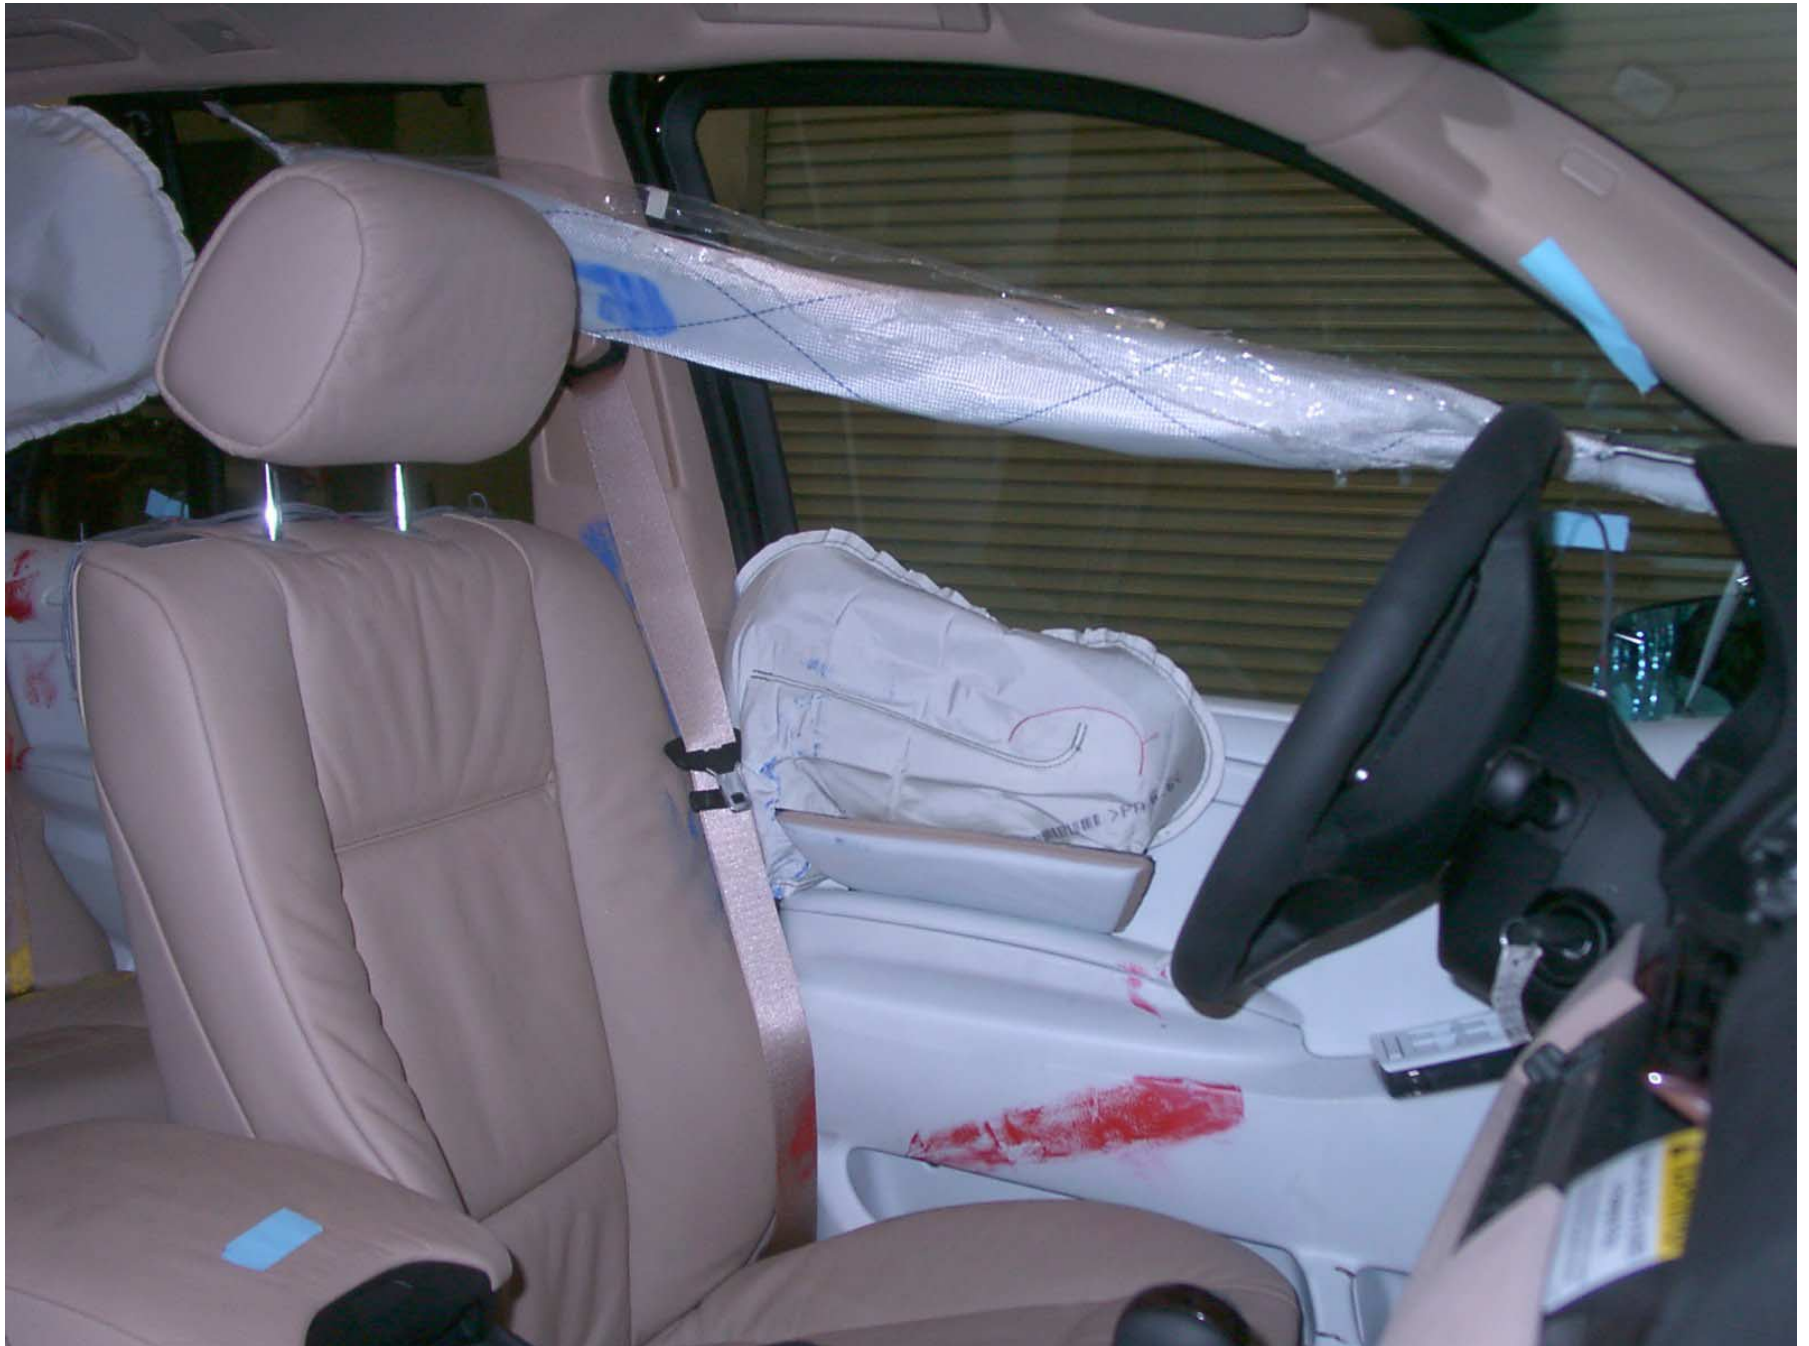
Figure A-37: Driver Dummy Contact Points Inside View, Post-Test (Vehicle Moved)
