**NEW CAR ASSESSMENT PROGRAM
SIDE IMPACT TEST**

**BAYERISCHE MOTORENWERKE AG
2003 BMW X5 3.0i
SUV**

NHTSA NUMBER: M30502

**Prepared By:
KARCO ENGINEERING, LLC
9270 HOLLY ROAD
ADELANTO, CALIFORNIA 92301**

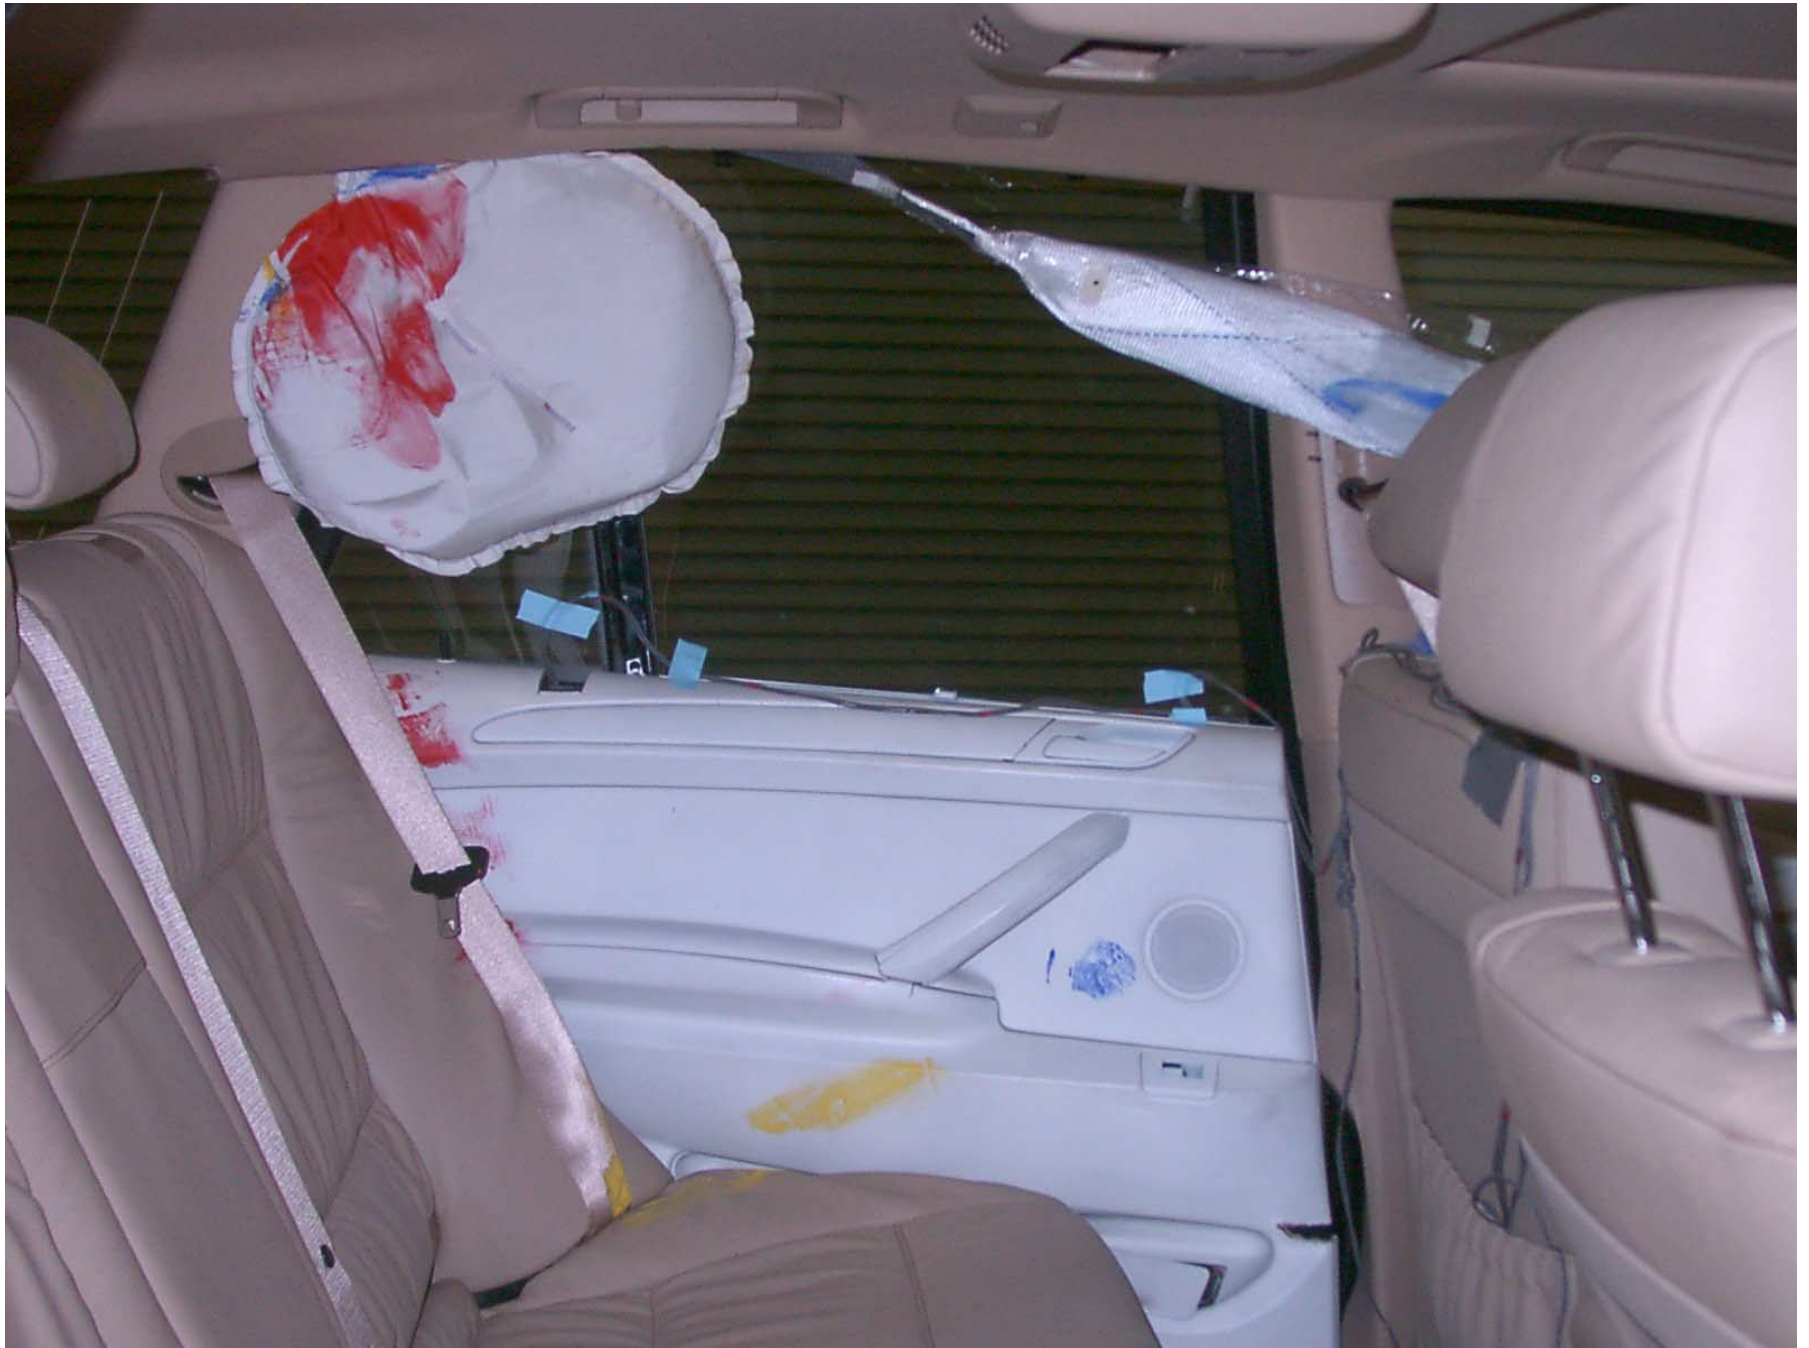
Figure A-46: Passenger Dummy Contact Points Inside View, Post-Test (Vehicle Moved)

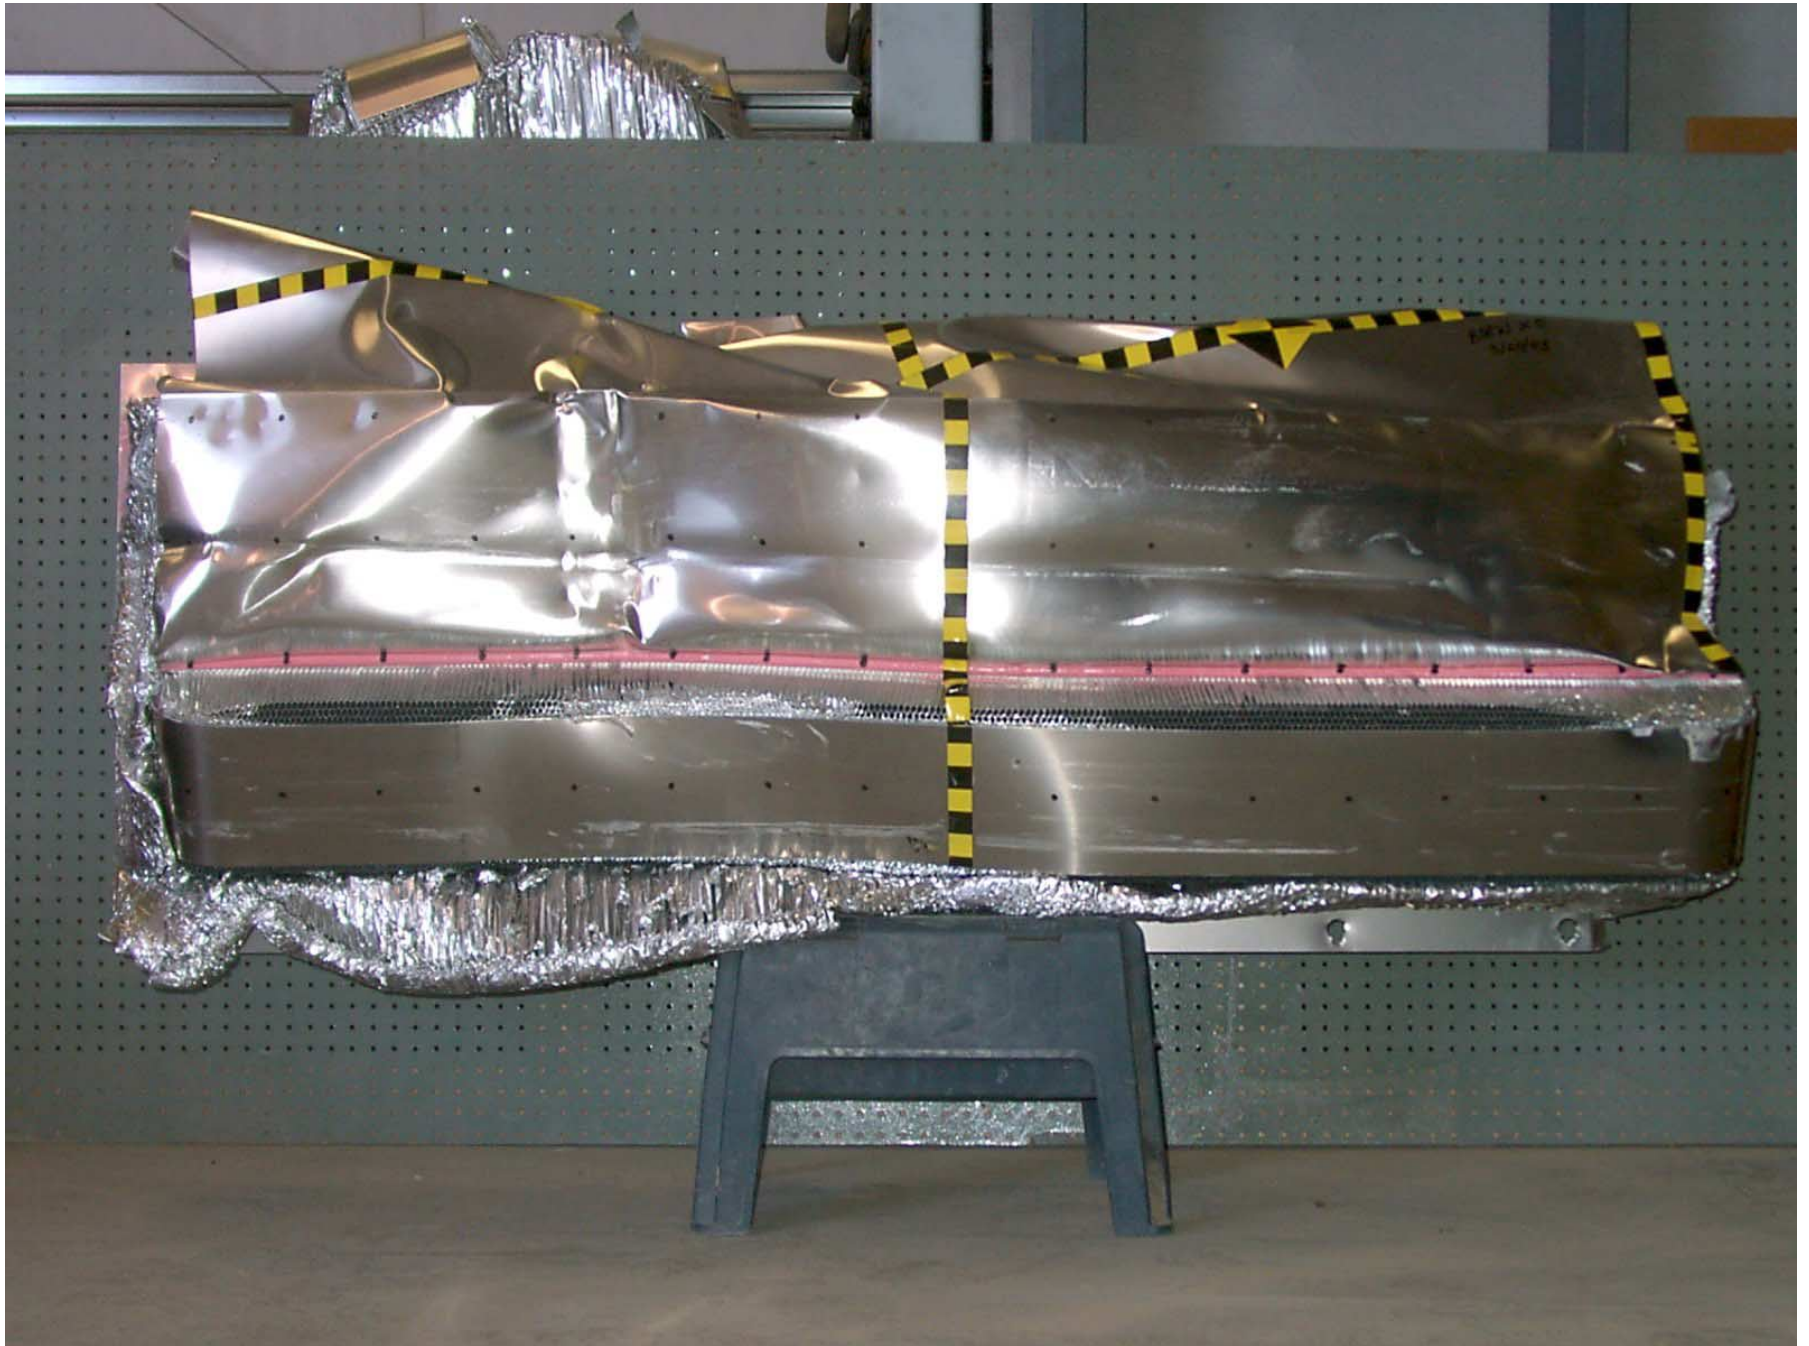
Figure A-48: Front View of Deformable Barrier, Post-Test

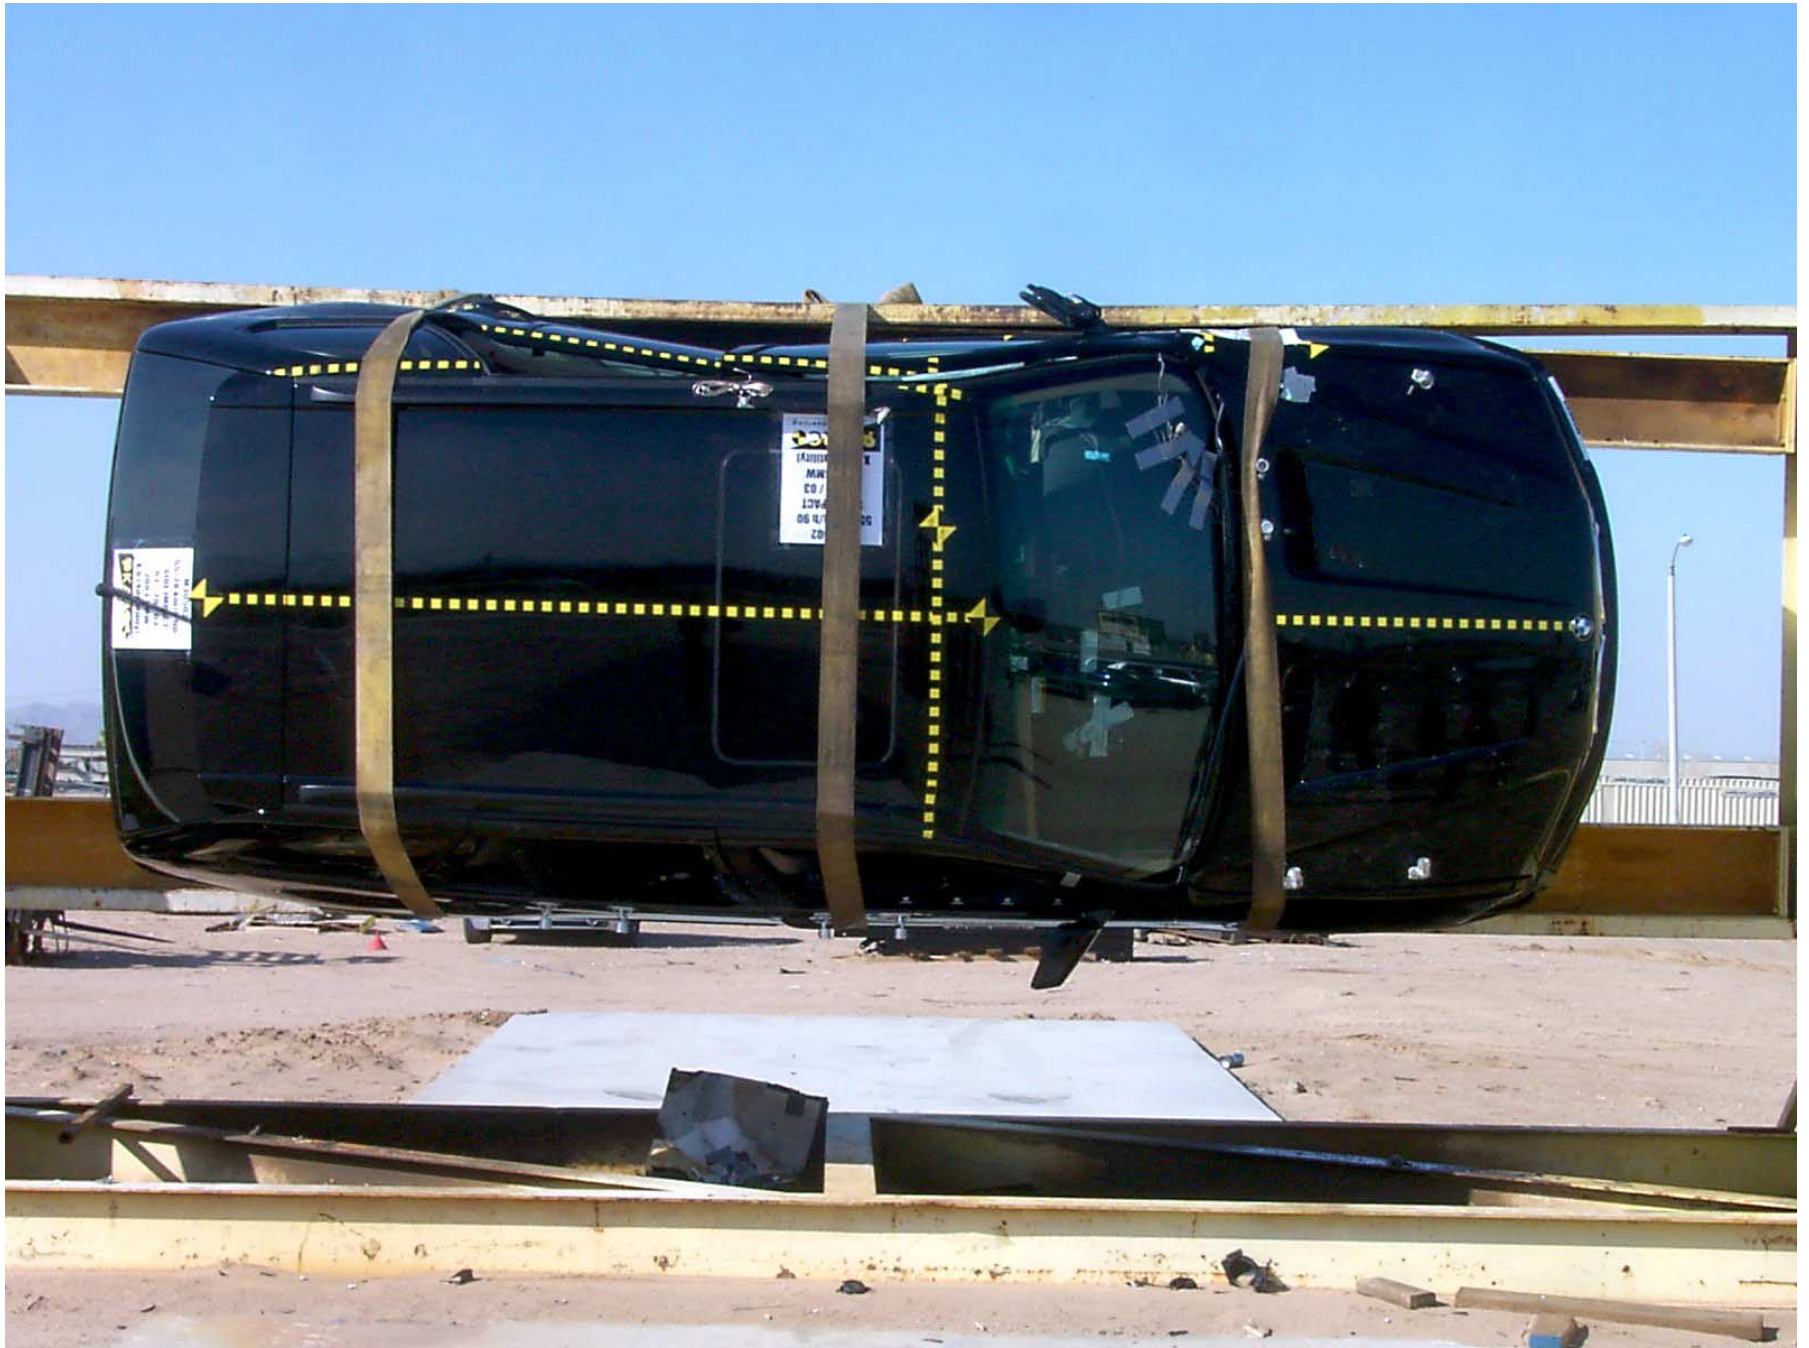
Figure A-55: Vehicle on Rollover Device, Top View

- A. From impact until vehicle motion ceases: 0.0 oz.
(Maximum Allowable = 1 ounce)
- B. For the 5 minute period after motion ceases: 0.0 oz.
(Maximum Allowable = 5 ounces)
- C. For the following 25 minutes: 0.0 oz.
(Maximum Allowable = 1 oz./minute)
- D. Spillage Details: No leakage occurred

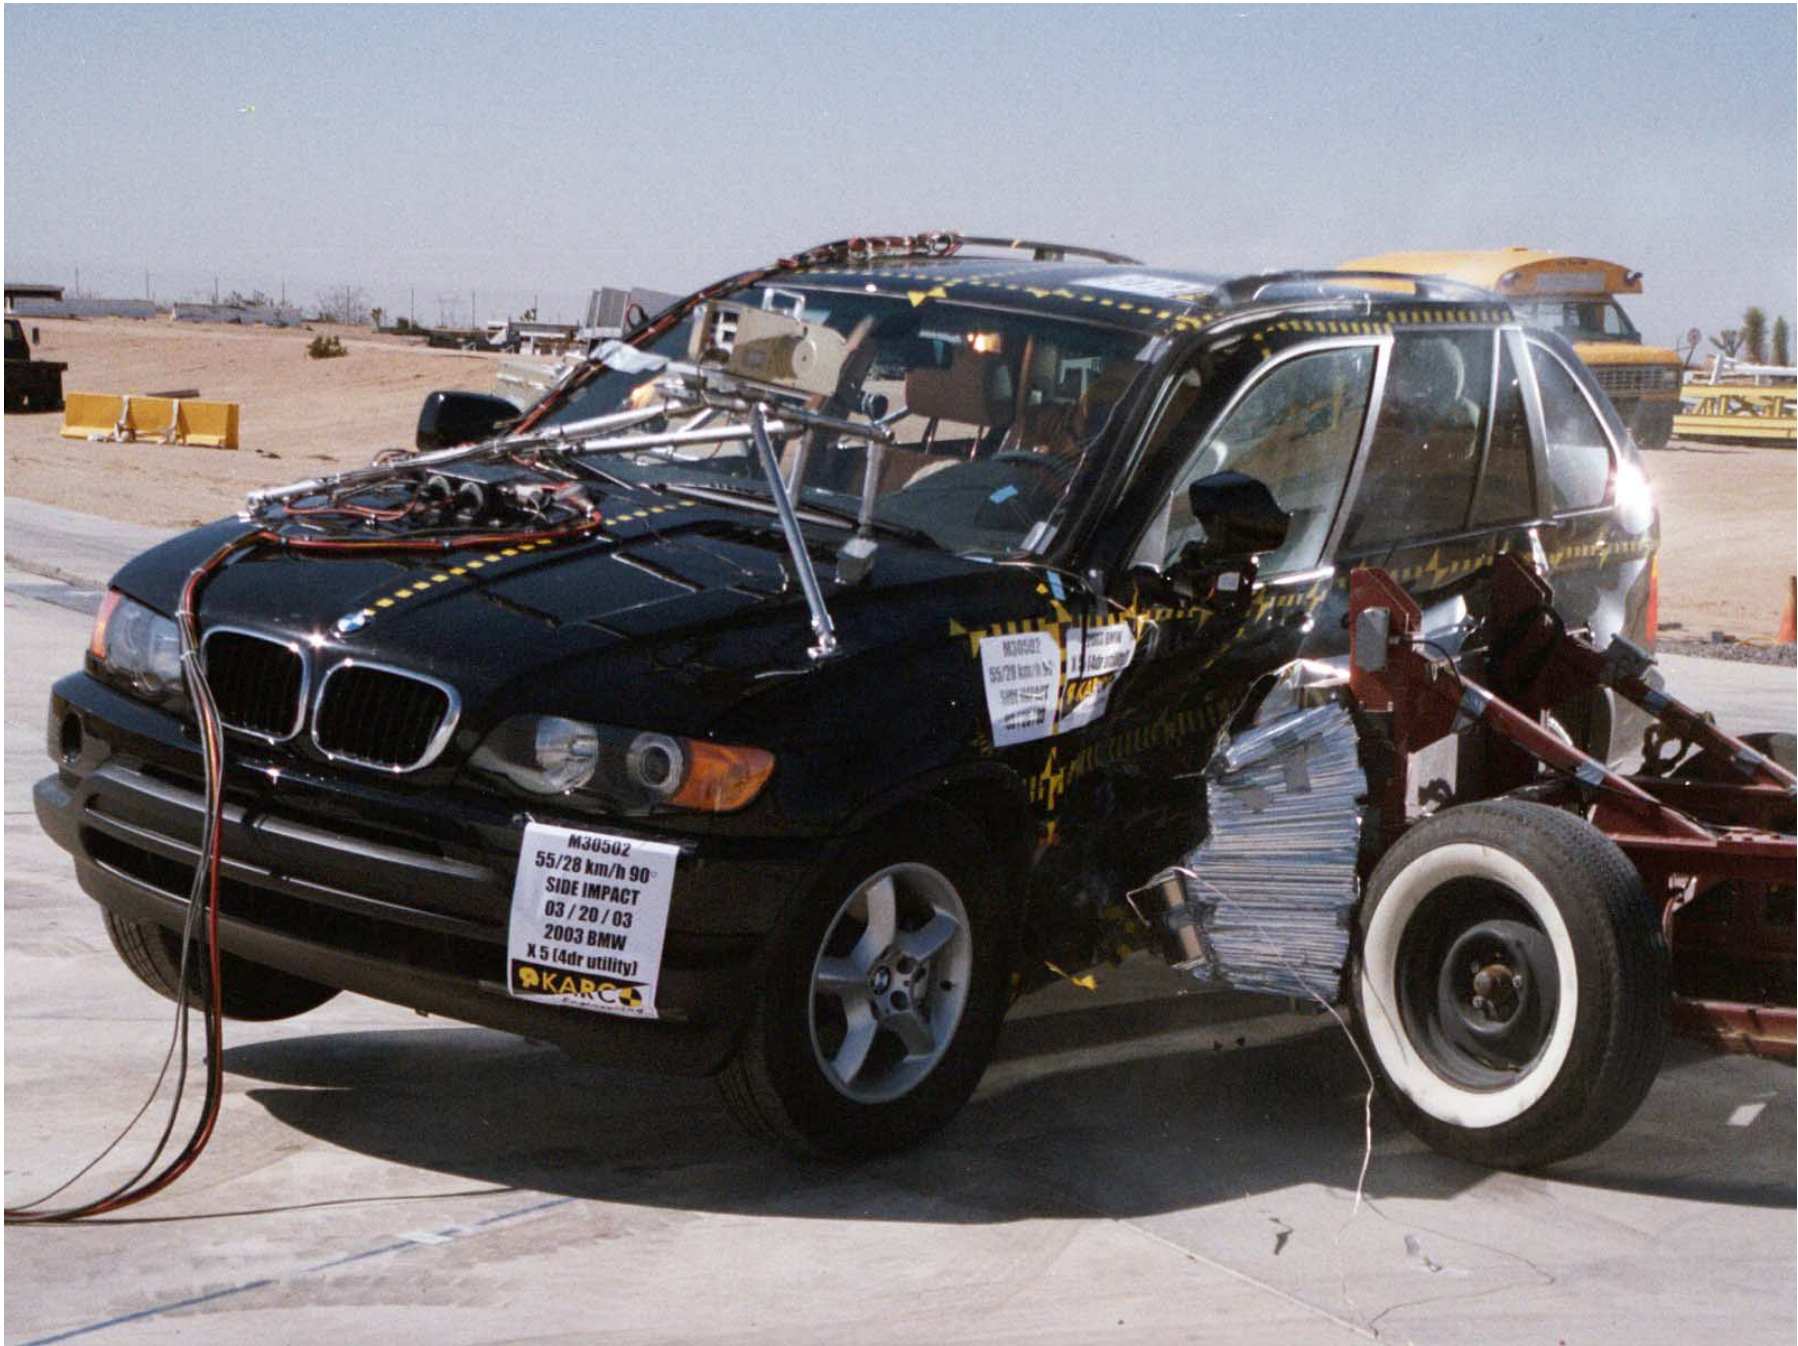
Figure A-56: Vehicle During Impact

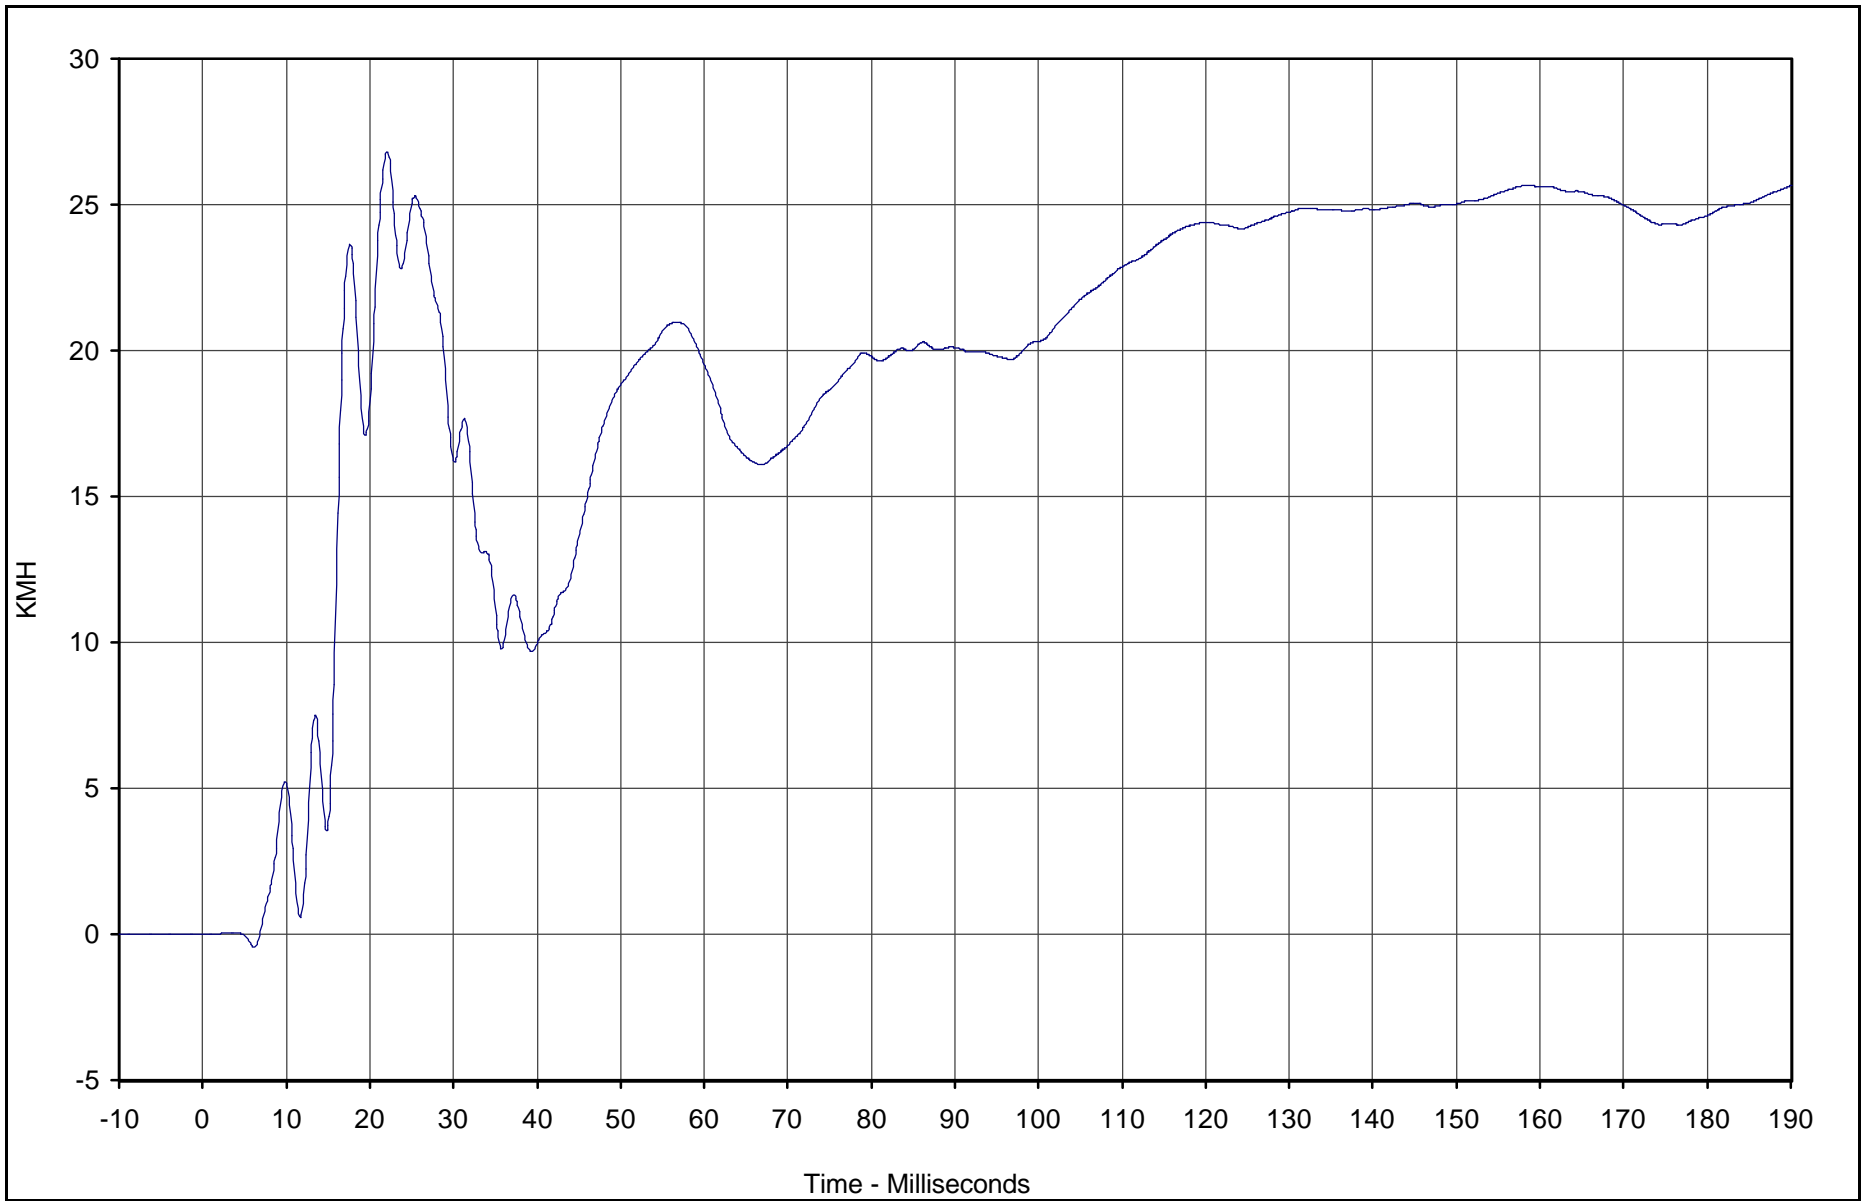
B-113

* Channel failed at 22.1 msec.

Curve Description	CURNO	Type	Units	Max	Time	Min	Time	SAE Class
Left Front Door Upper CL Y Velocity	059	IN1	KMH	26.8	22.1	-0.5	6.2	180

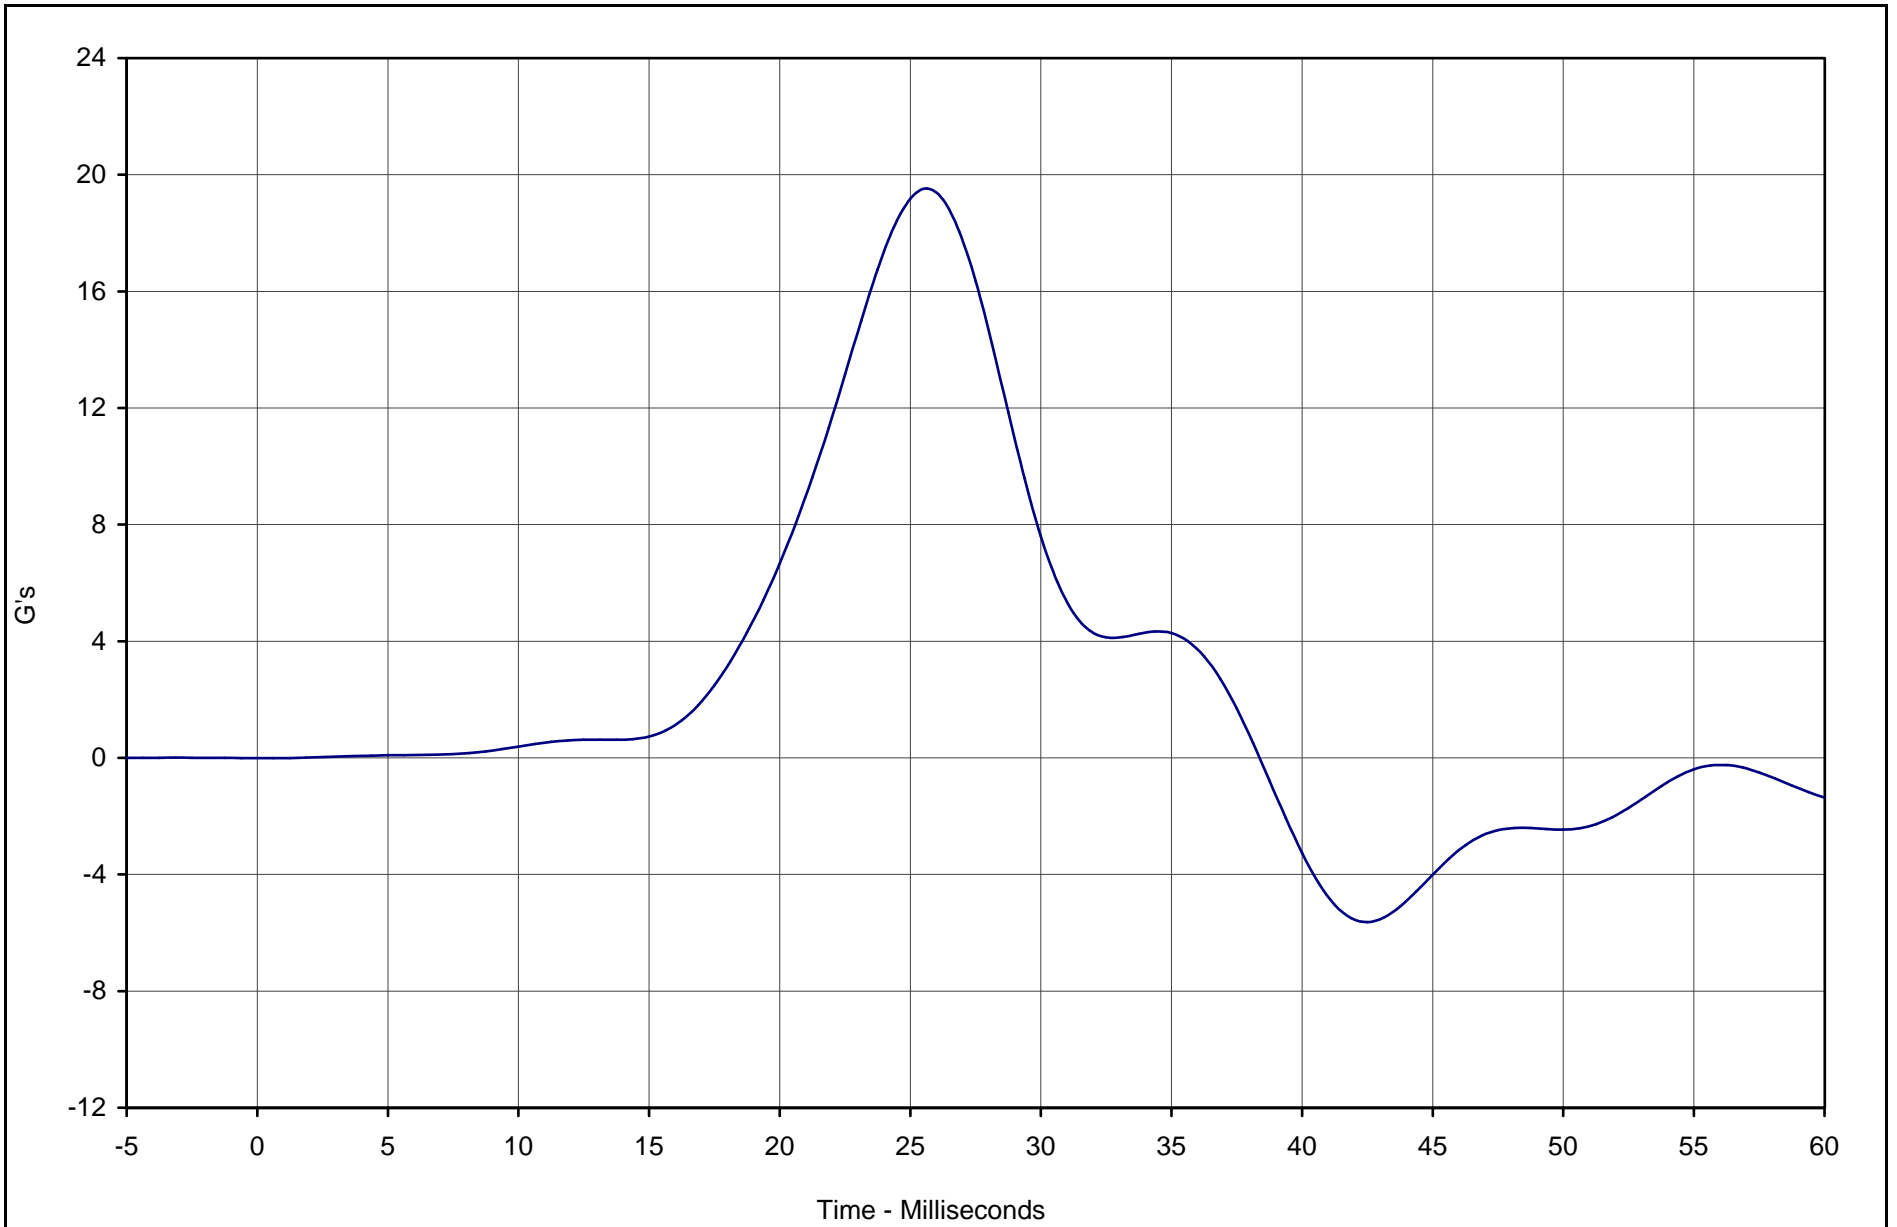
Test I.D.: TH03C

Curve Description	CURNO	Type	Units	Max	Time	Min	Time	SAE Class
Lower Spine Y Acceleration	003	FIL	G's	19.5	25.6	-5.6	42.5	FIR100

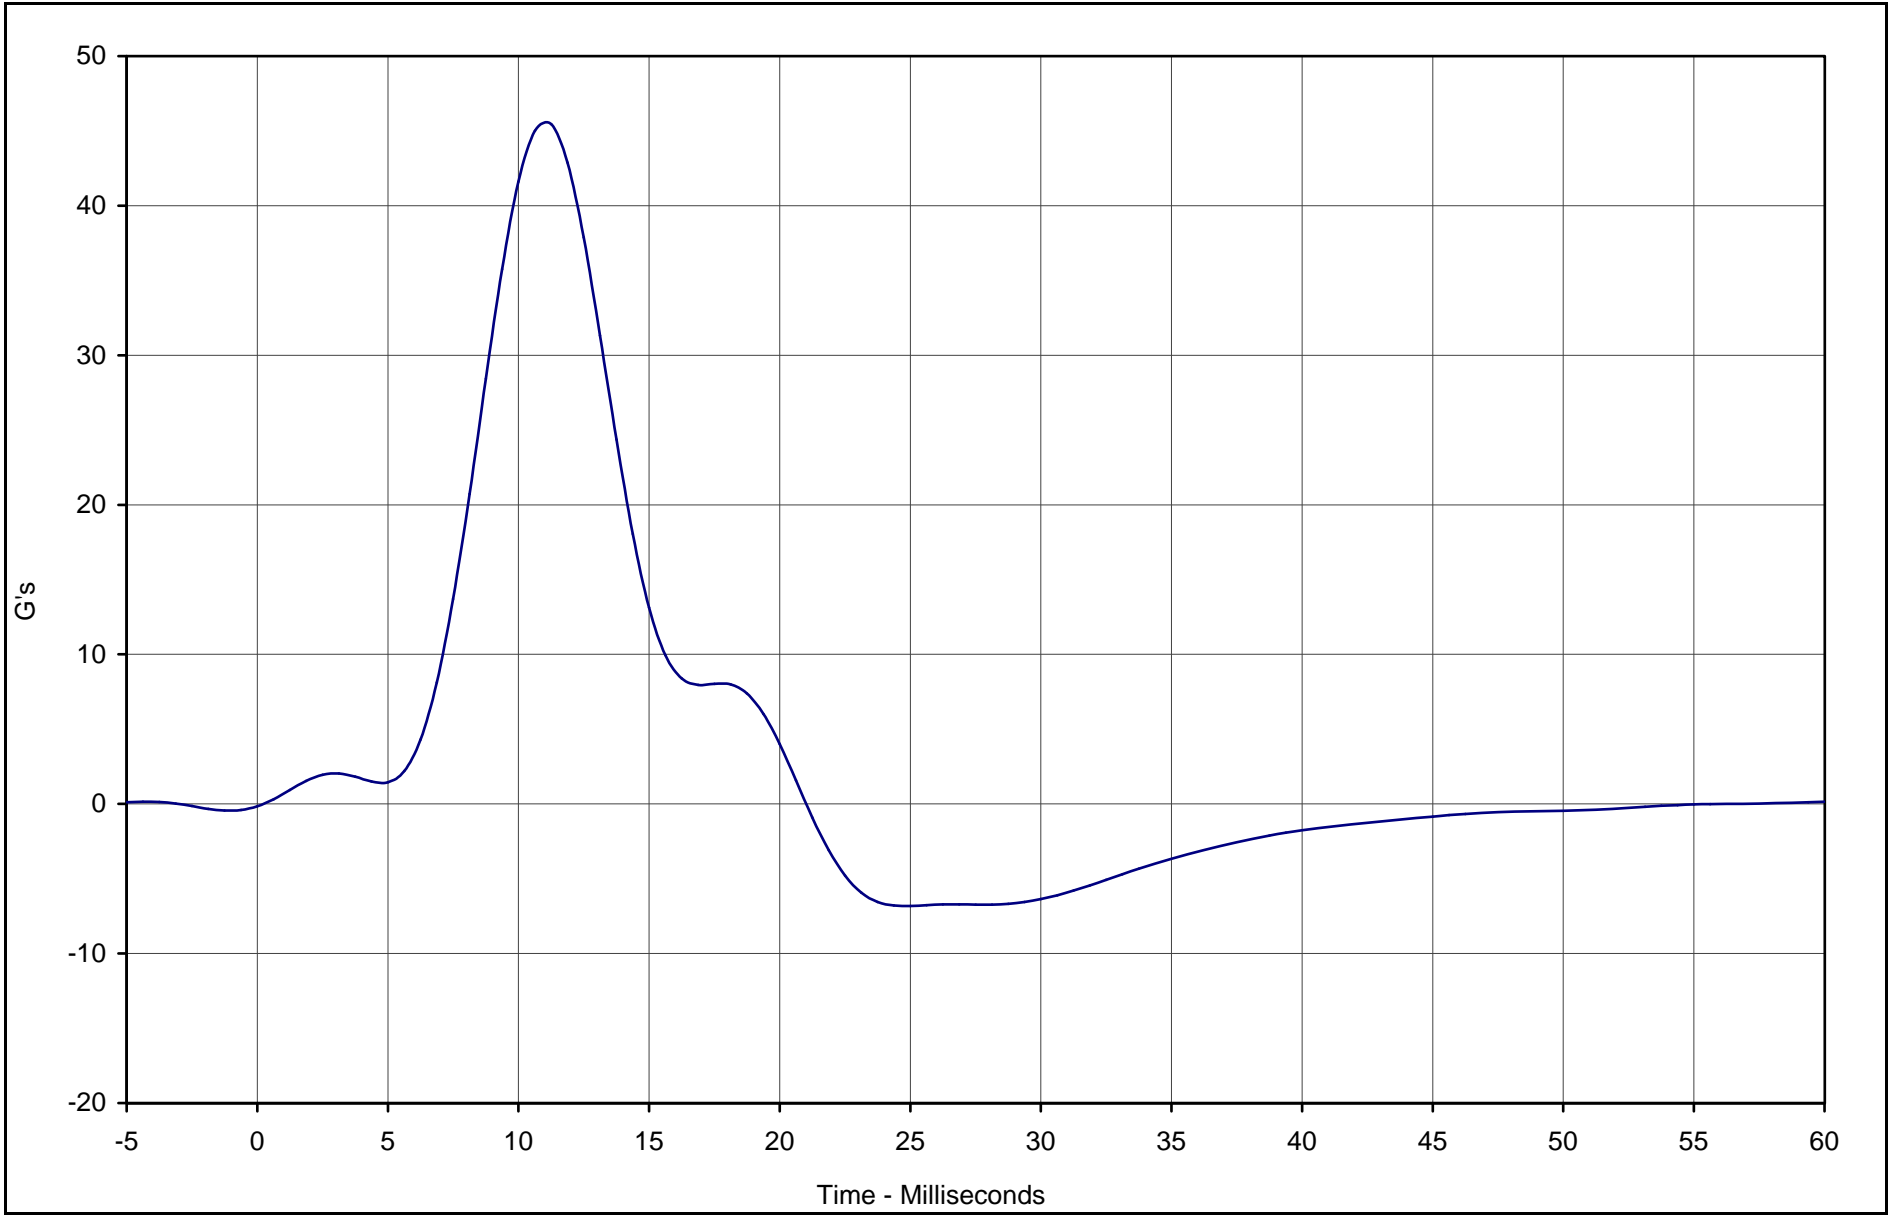
C-7

Curve Description	CURNO	Type	Units	Max	Time	Min	Time	SAE Class
Pelvis Y Acceleration	001	FIL	G's	45.4	11.3	-8.5	0.0	FIR100

Tested Parameter	Units	Specification	Result	Pass/Fail
Laboratory Temperature	°C	18.9 to 25.6	21.1	Pass
Laboratory Relative Humidity	%	10 to 70	30	Pass
Probe Velocity	m/s	4.21 to 4.33	4.26	Pass
Peak Pelvis Acceleration	G's	40.0 to 60.0	45.4	Pass
Acceleration Time Above 20 G's	Msec.	3.0 to 7.0	6.3	Pass
Overall Test Results				Pass

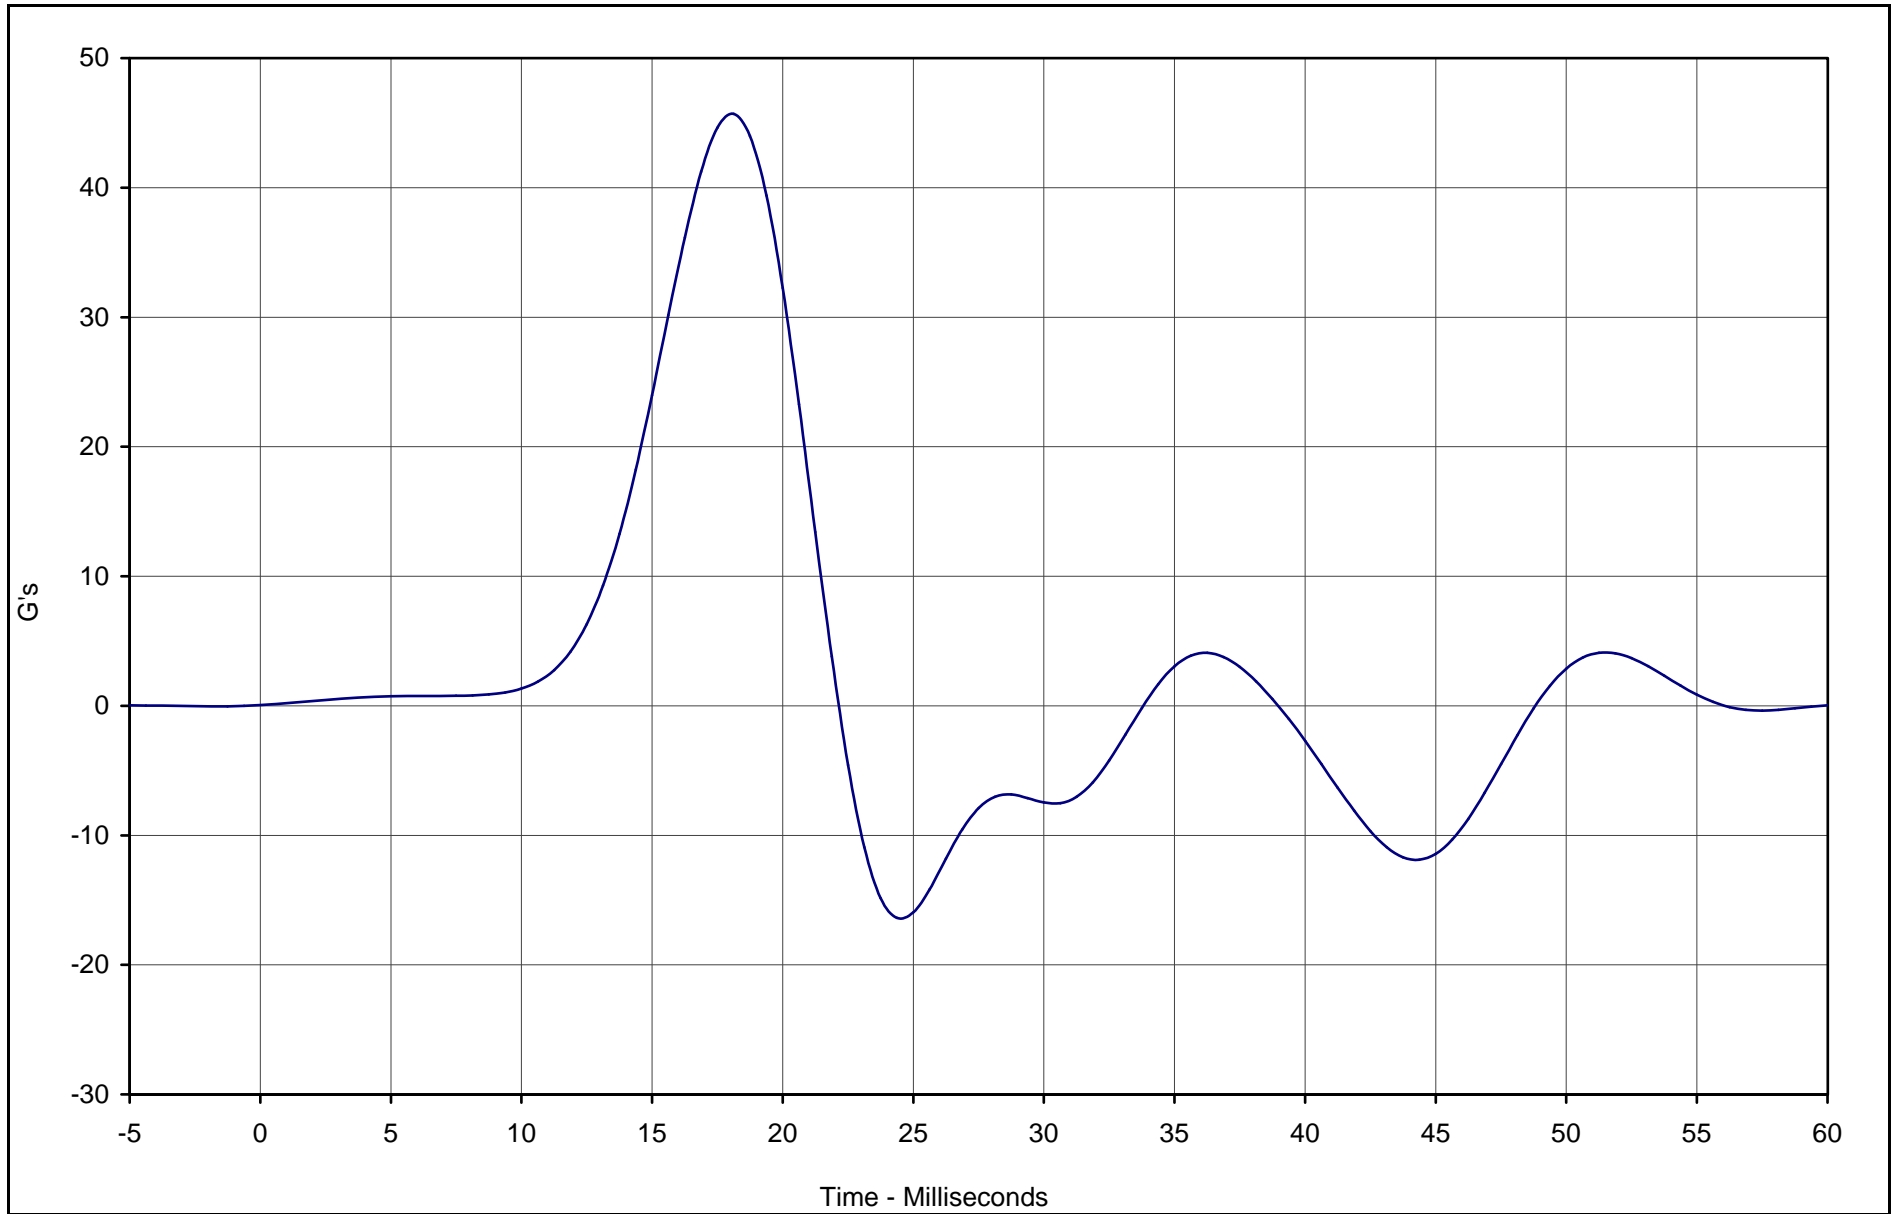
Test I.D.: TH03D

Curve Description	CURNO	Type	Units	Max	Time	Min	Time	SAE Class
Lower Rib Y Acceleration	002	FIL	G's	45.7	18.1	-16.4	24.4	FIR100

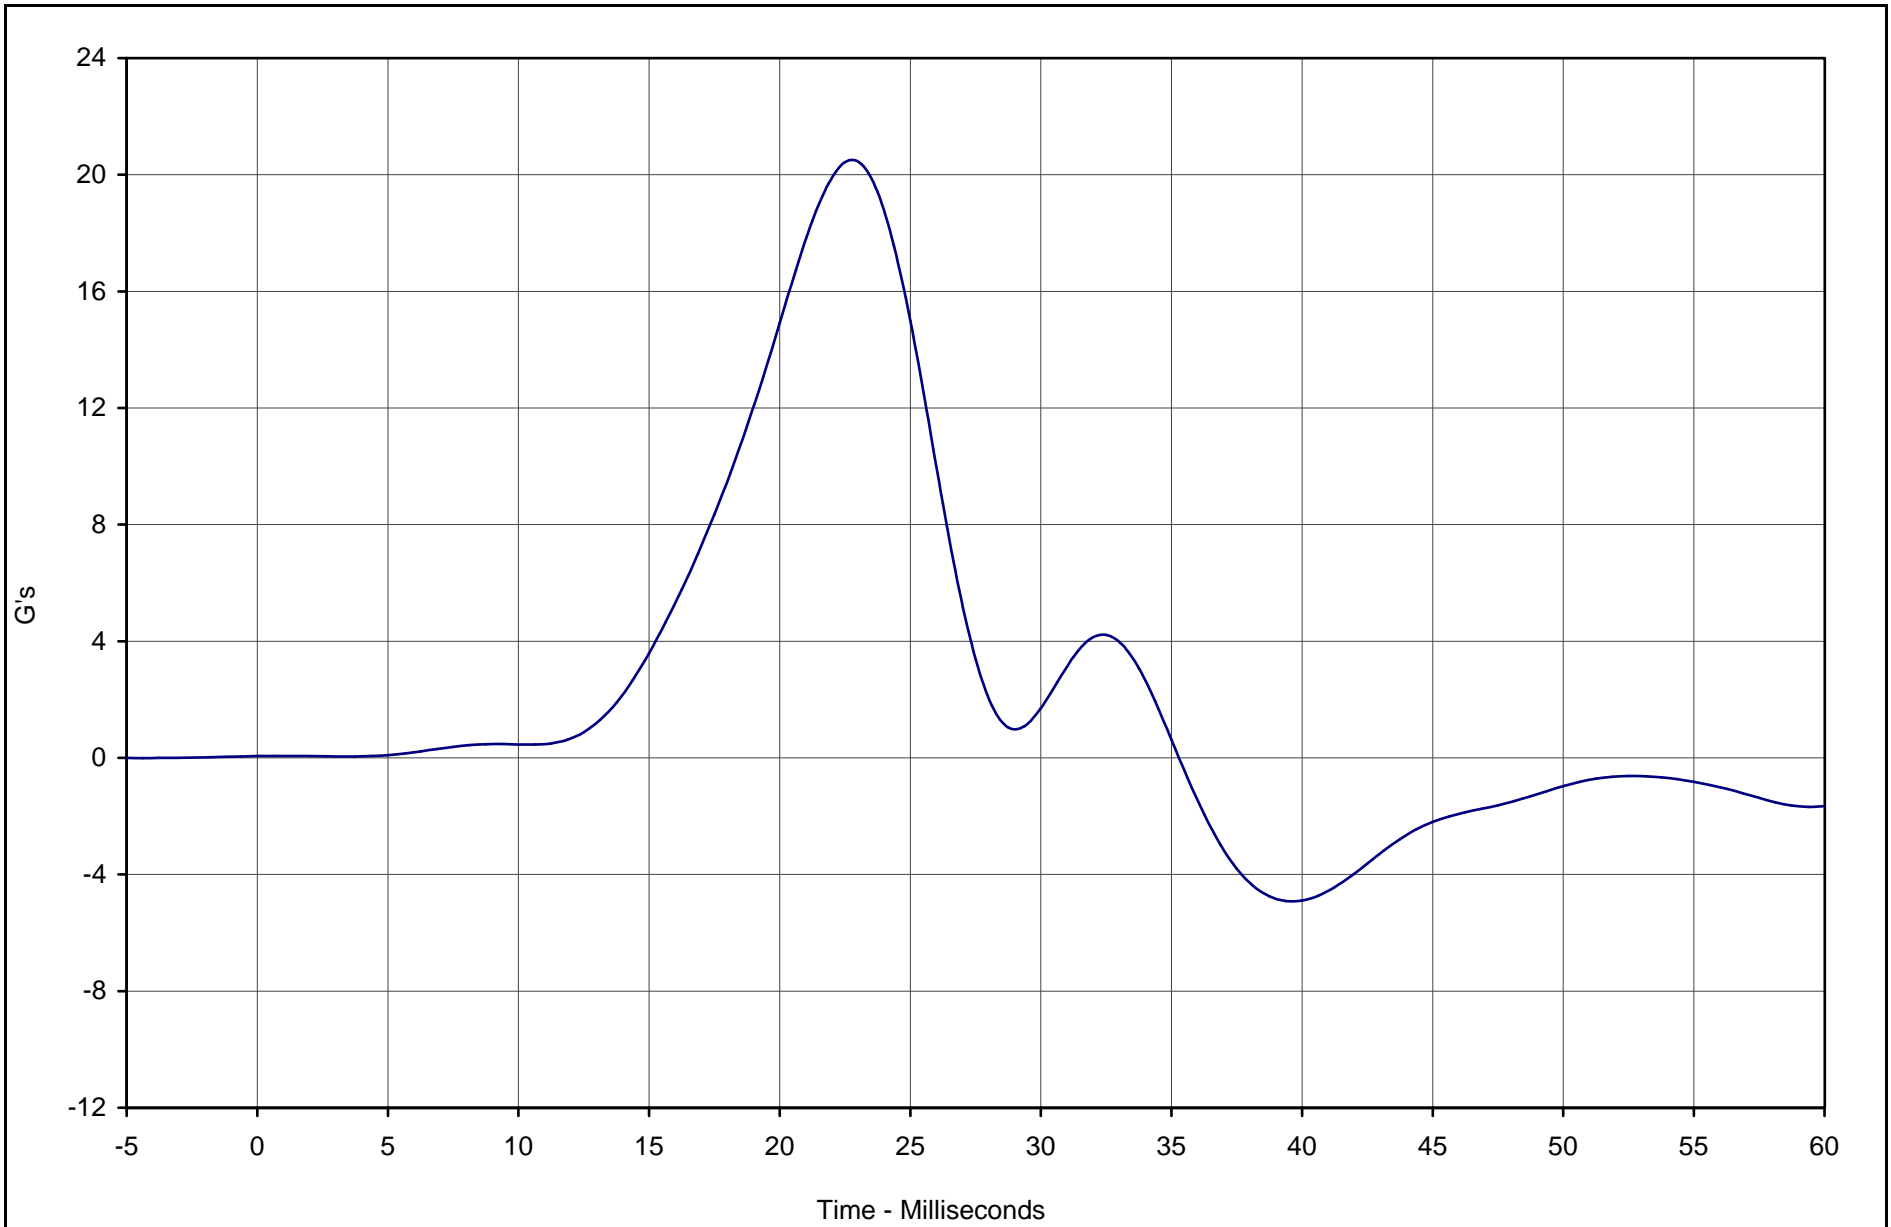
Test I.D.: TH03D

Curve Description	CURNO	Type	Units	Max	Time	Min	Time	SAE Class
Lower Spine Y Acceleration	003	FIL	G's	20.4	22.5	-4.9	39.4	FIR100
