**NEW CAR ASSESSMENT PROGRAM
SIDE IMPACT TEST**

**BAYERISCHE MOTORENWERKE AG
2003 BMW X5 3.0i
SUV**

NHTSA NUMBER: M30502

**Prepared By:
KARCO ENGINEERING, LLC
9270 HOLLY ROAD
ADELANTO, CALIFORNIA 92301**

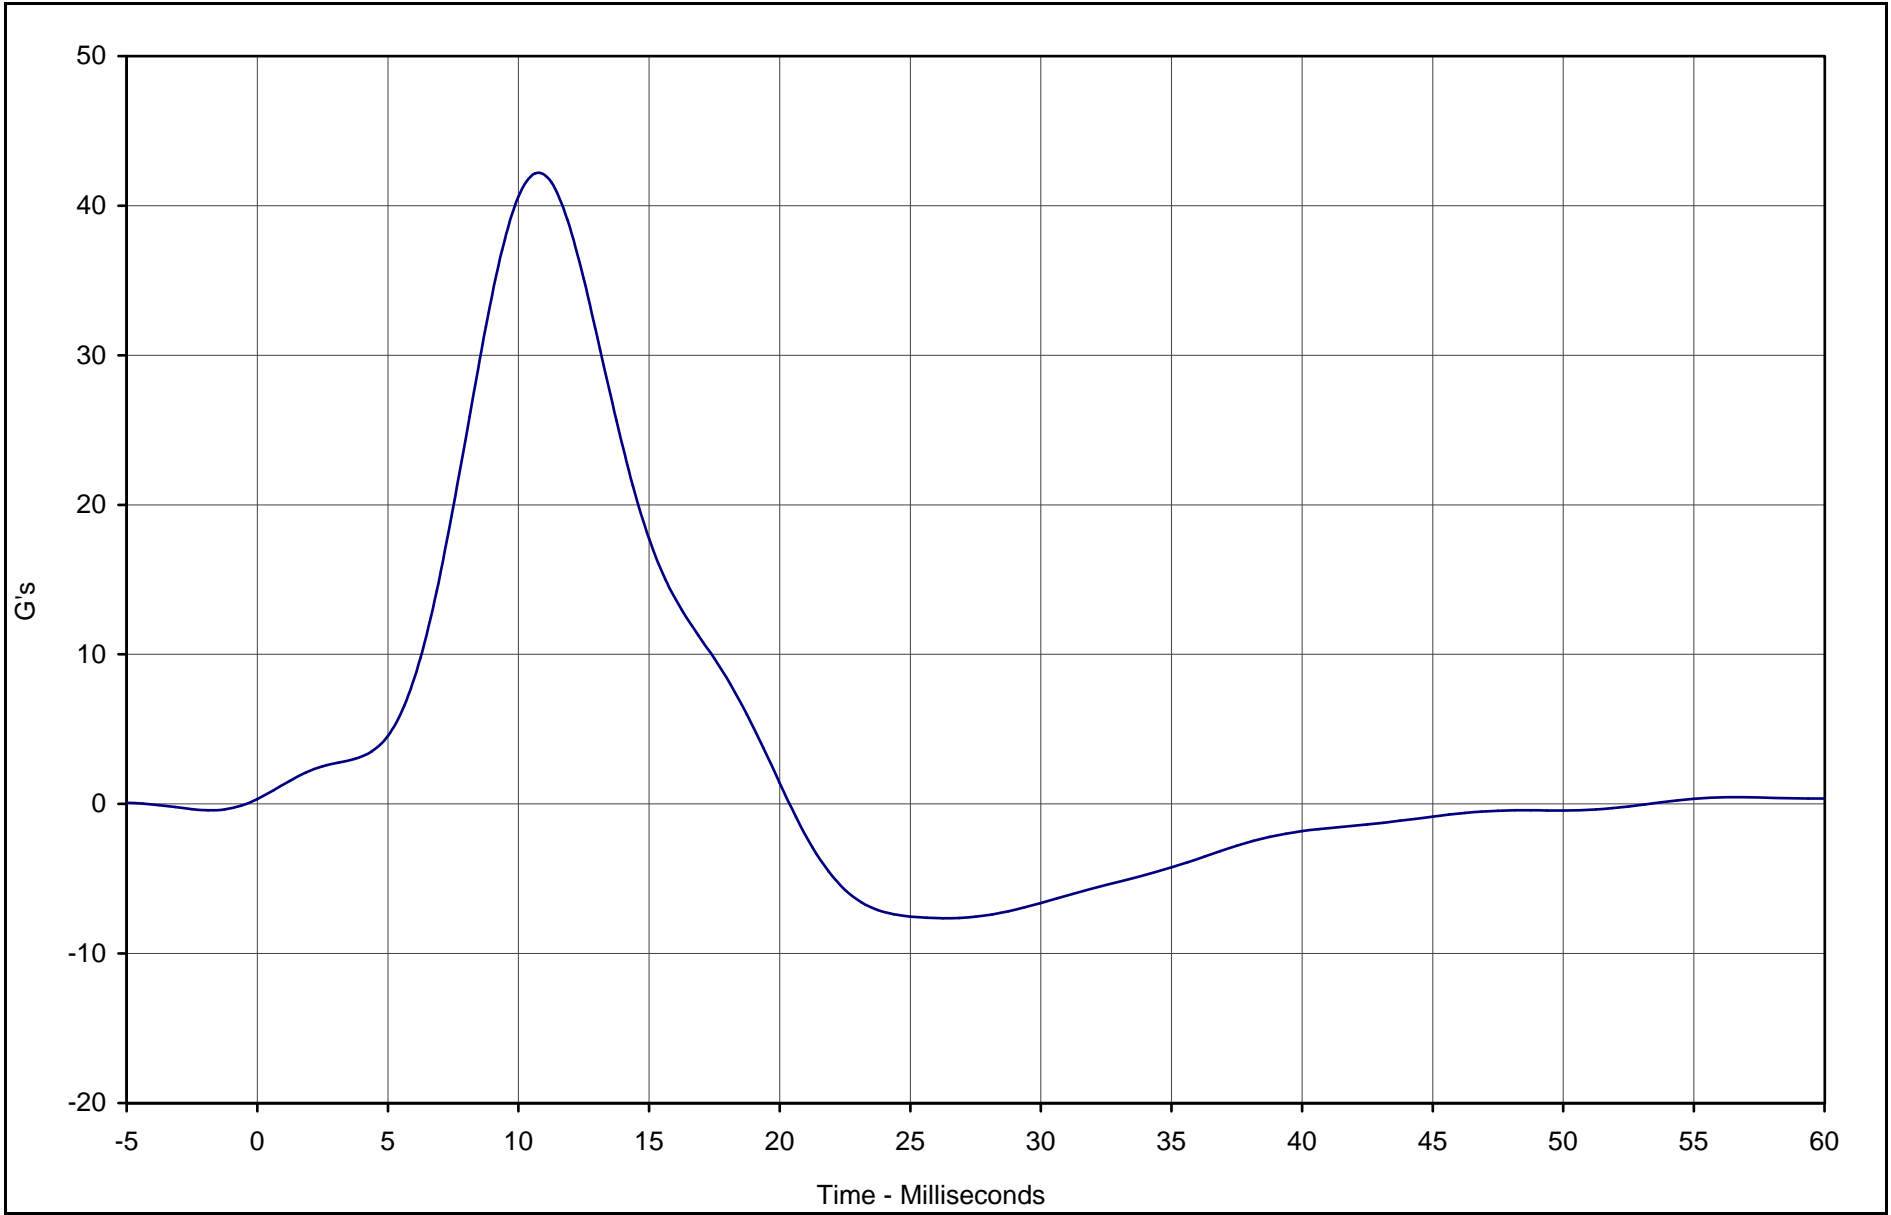
Curve Description	CURNO	Type	Units	Max	Time	Min	Time	SAE Class
Pelvis Y Acceleration	001	FIL	G's	42.2	10.6	-7.6	26.3	FIR100

Tested Parameter	Units	Specification	Result	Pass/Fail
Laboratory Temperature	°C	18.9 to 25.6	21.1	Pass
Laboratory Relative Humidity	%	10 to 70	30	Pass
Probe Velocity	m/s	4.21 to 4.33	4.29	Pass
Peak Pelvis Acceleration	G's	40.0 to 60.0	42.2	Pass
Acceleration Time Above 20 G's	Msec.	3.0 to 7.0	6.9	Pass
Overall Test Results				Pass

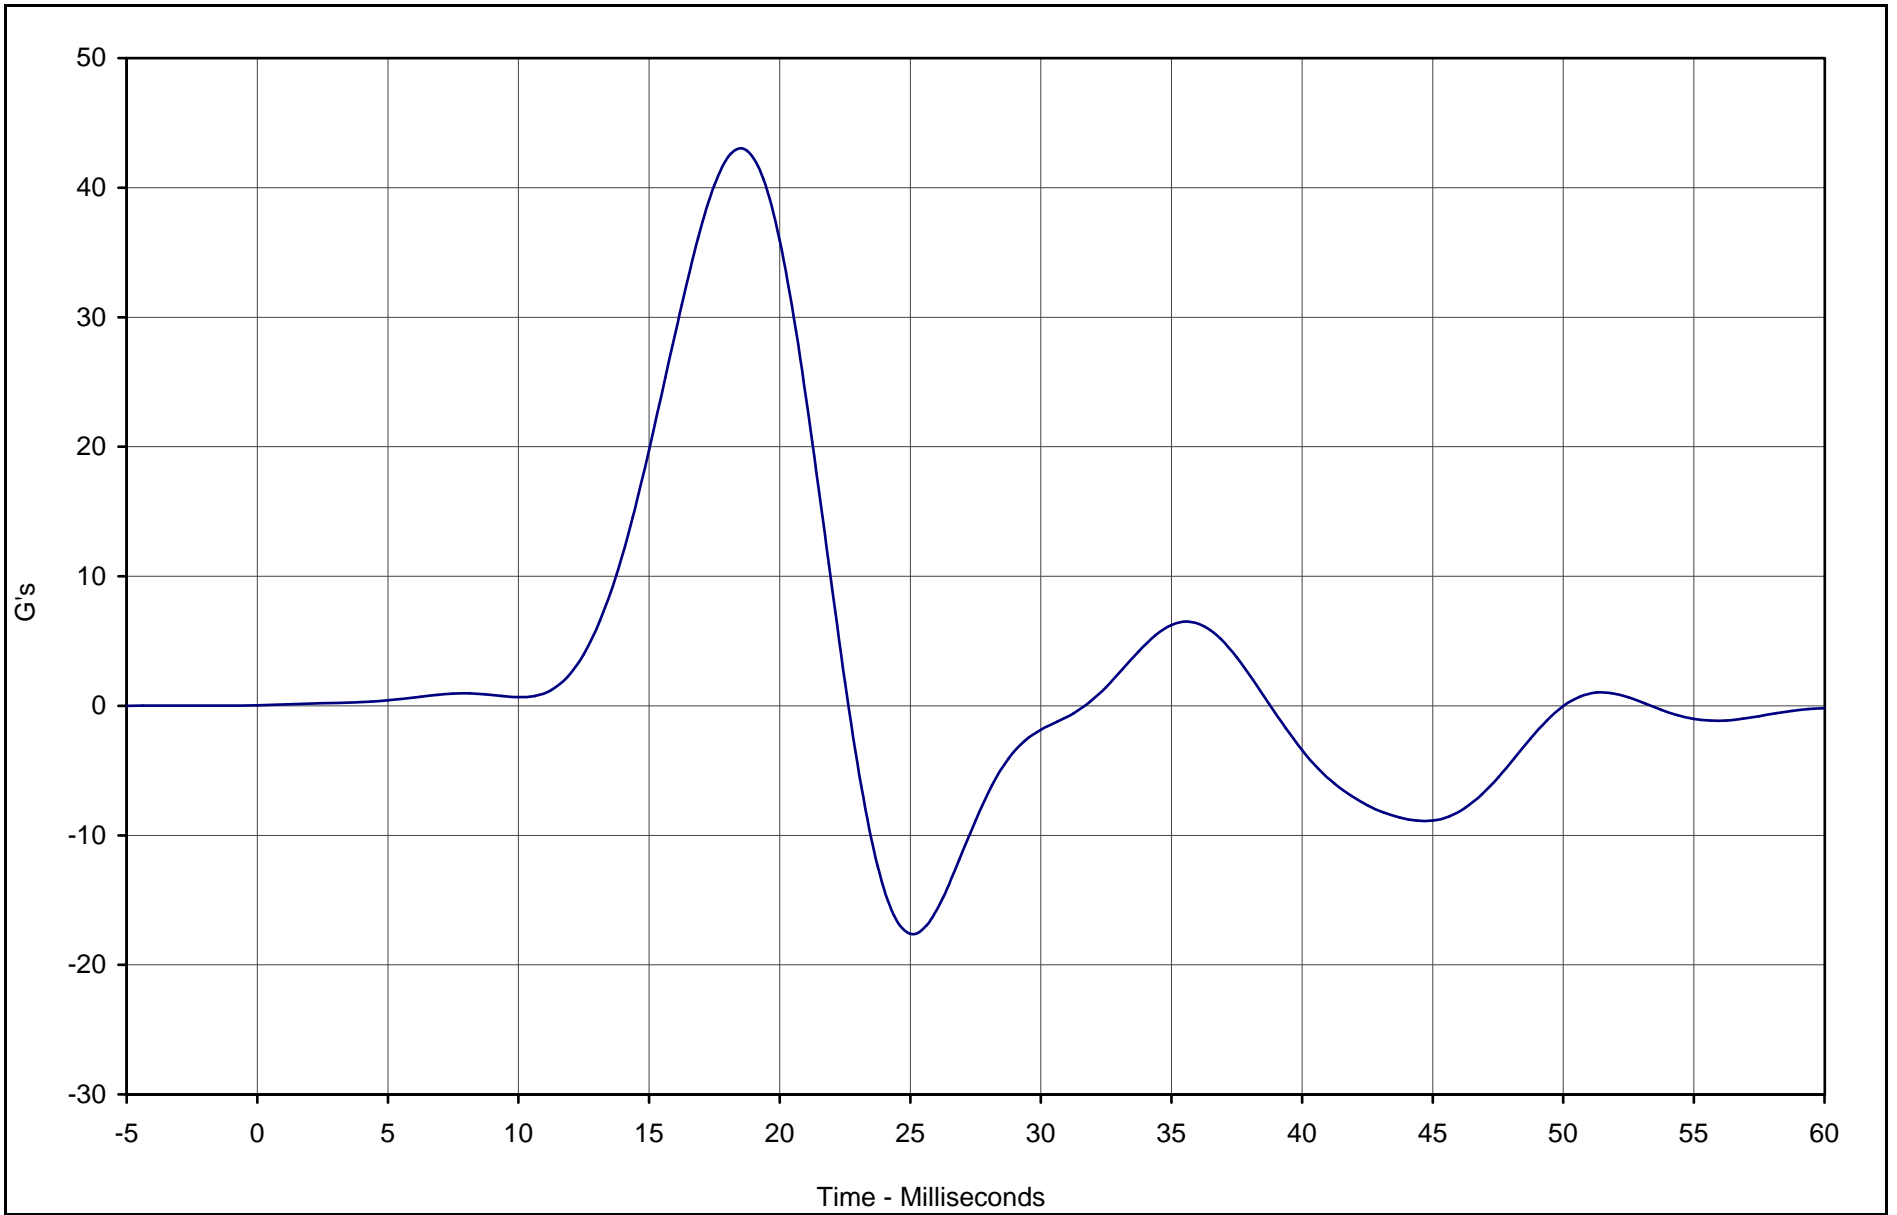
Curve Description	CURNO	Type	Units	Max	Time	Min	Time	SAE Class
Upper Rib Y Acceleration	001	FIL	G's	42.9	18.8	-17.6	25.0	FIR100

Tested Parameter	Units	Specification	Result	Pass/Fail
Laboratory Temperature	°C	18.9 to 25.6	21.1	Pass
Laboratory Relative Humidity	%	10 to 70	30	Pass
Probe Velocity	m/s	4.21 to 4.33	4.30	Pass
Upper Rib Acceleration	G's	37.0 to 46.0	42.9	Pass
Lower Rib Acceleration	G's	37.0 to 46.0	43.6	Pass
Thoracic Spine Acceleration	G's	15.0 to 22.0	19.3	Pass
Overall Test Results				Pass

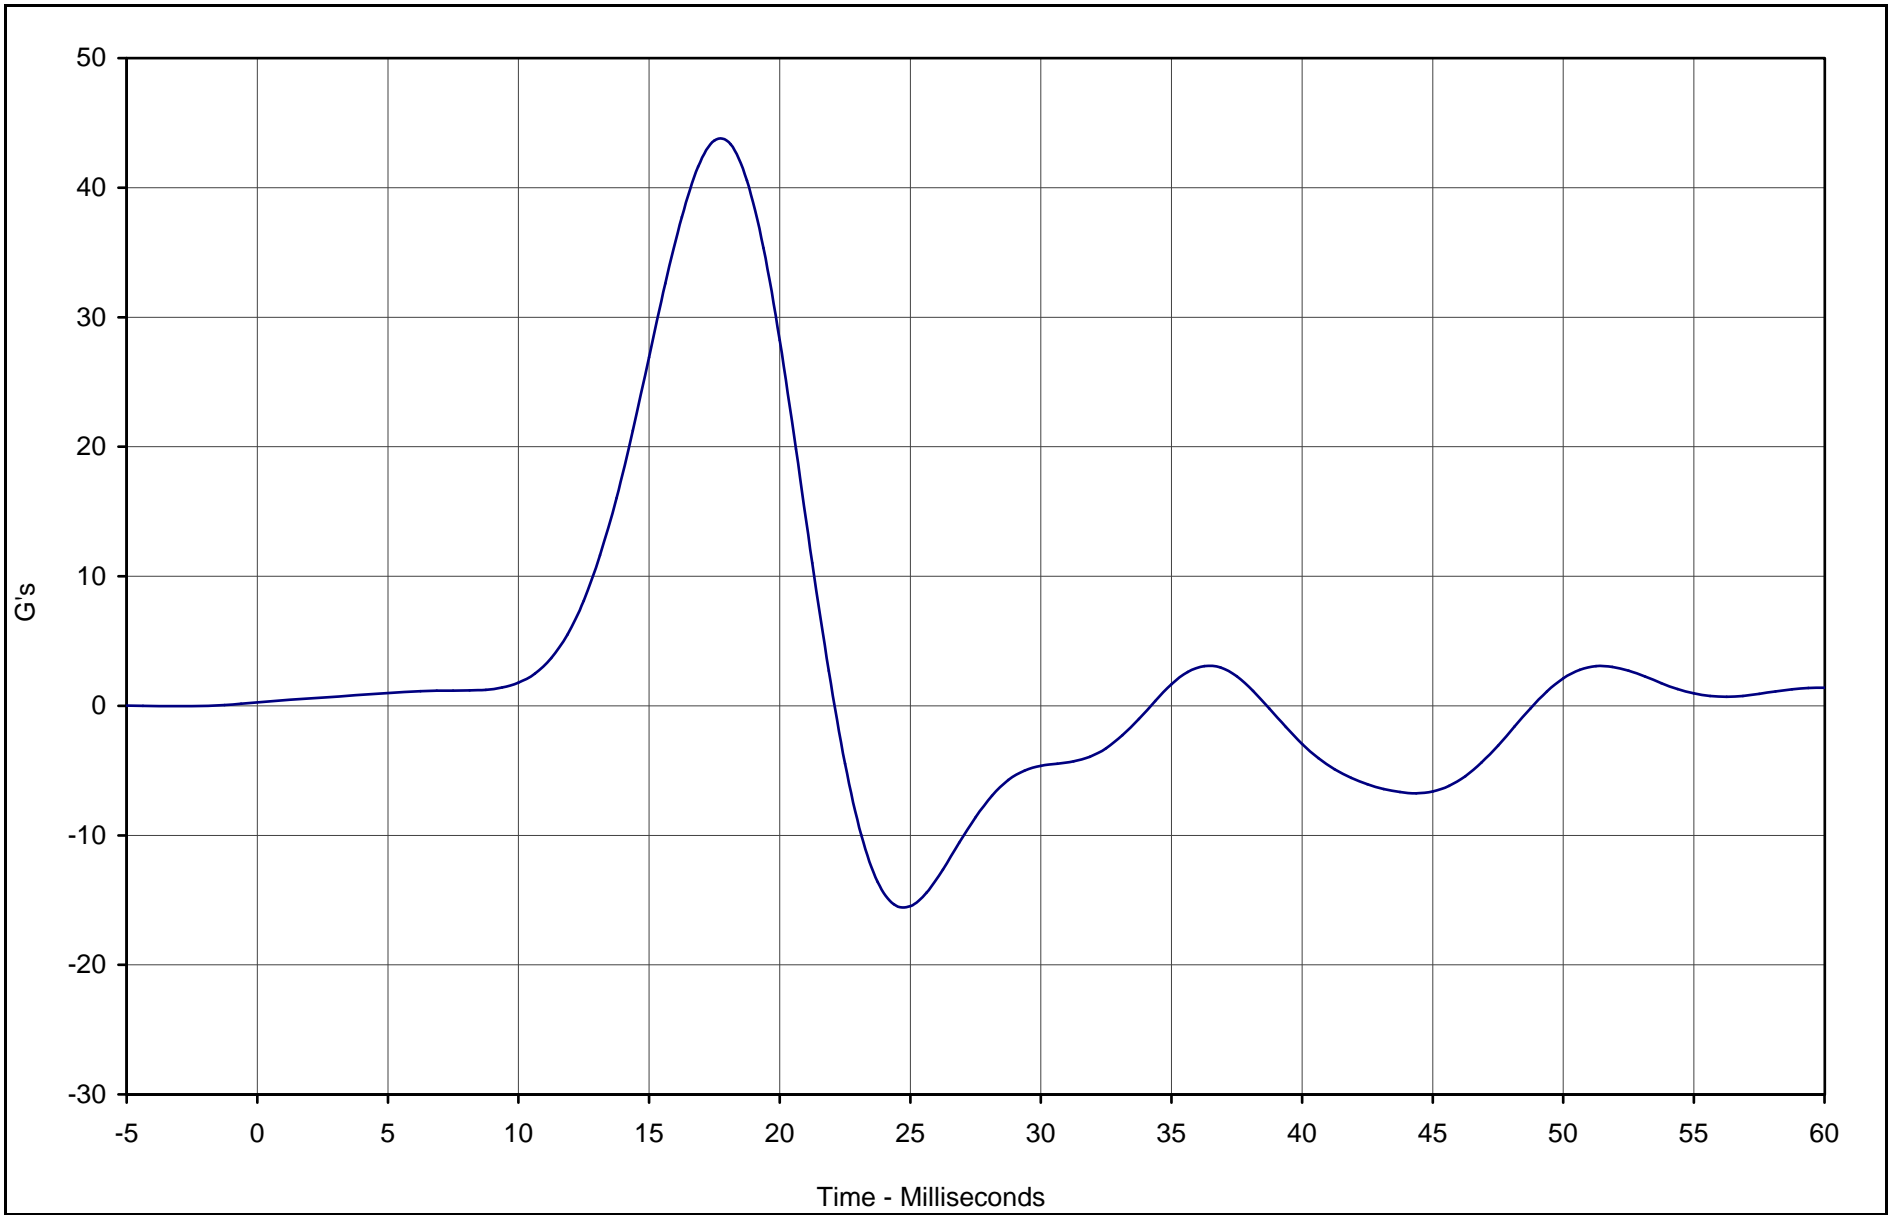
Test I.D.: TI11D

Curve Description	CURNO	Type	Units	Max	Time	Min	Time	SAE Class
Lower Rib Y Acceleration	002	FIL	G's	43.6	17.5	-15.5	25.0	FIR100

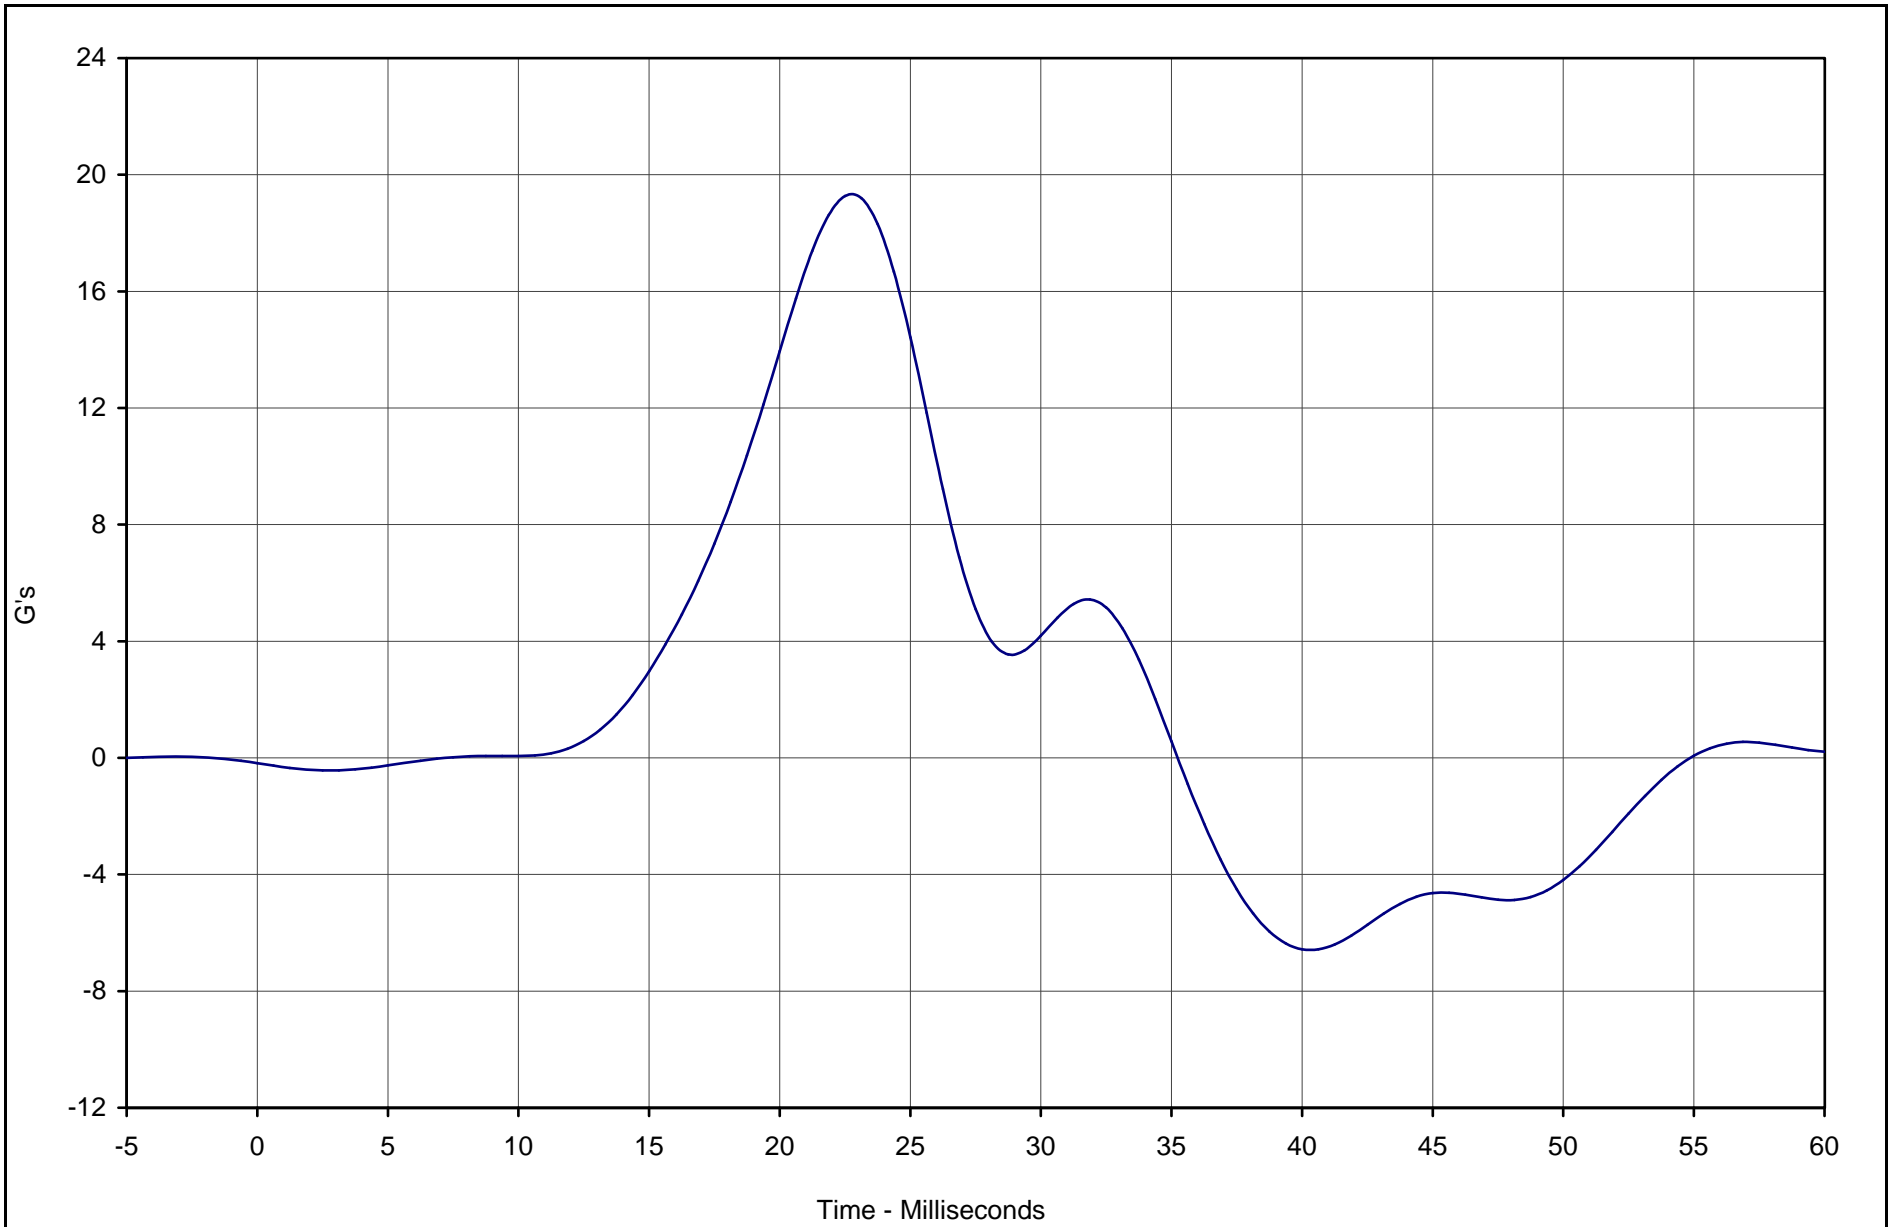
Test I.D.: TI11D

Curve Description	CURNO	Type	Units	Max	Time	Min	Time	SAE Class
Lower Spine Y Acceleration	003	FIL	G's	19.3	22.5	-6.6	40.6	FIR100

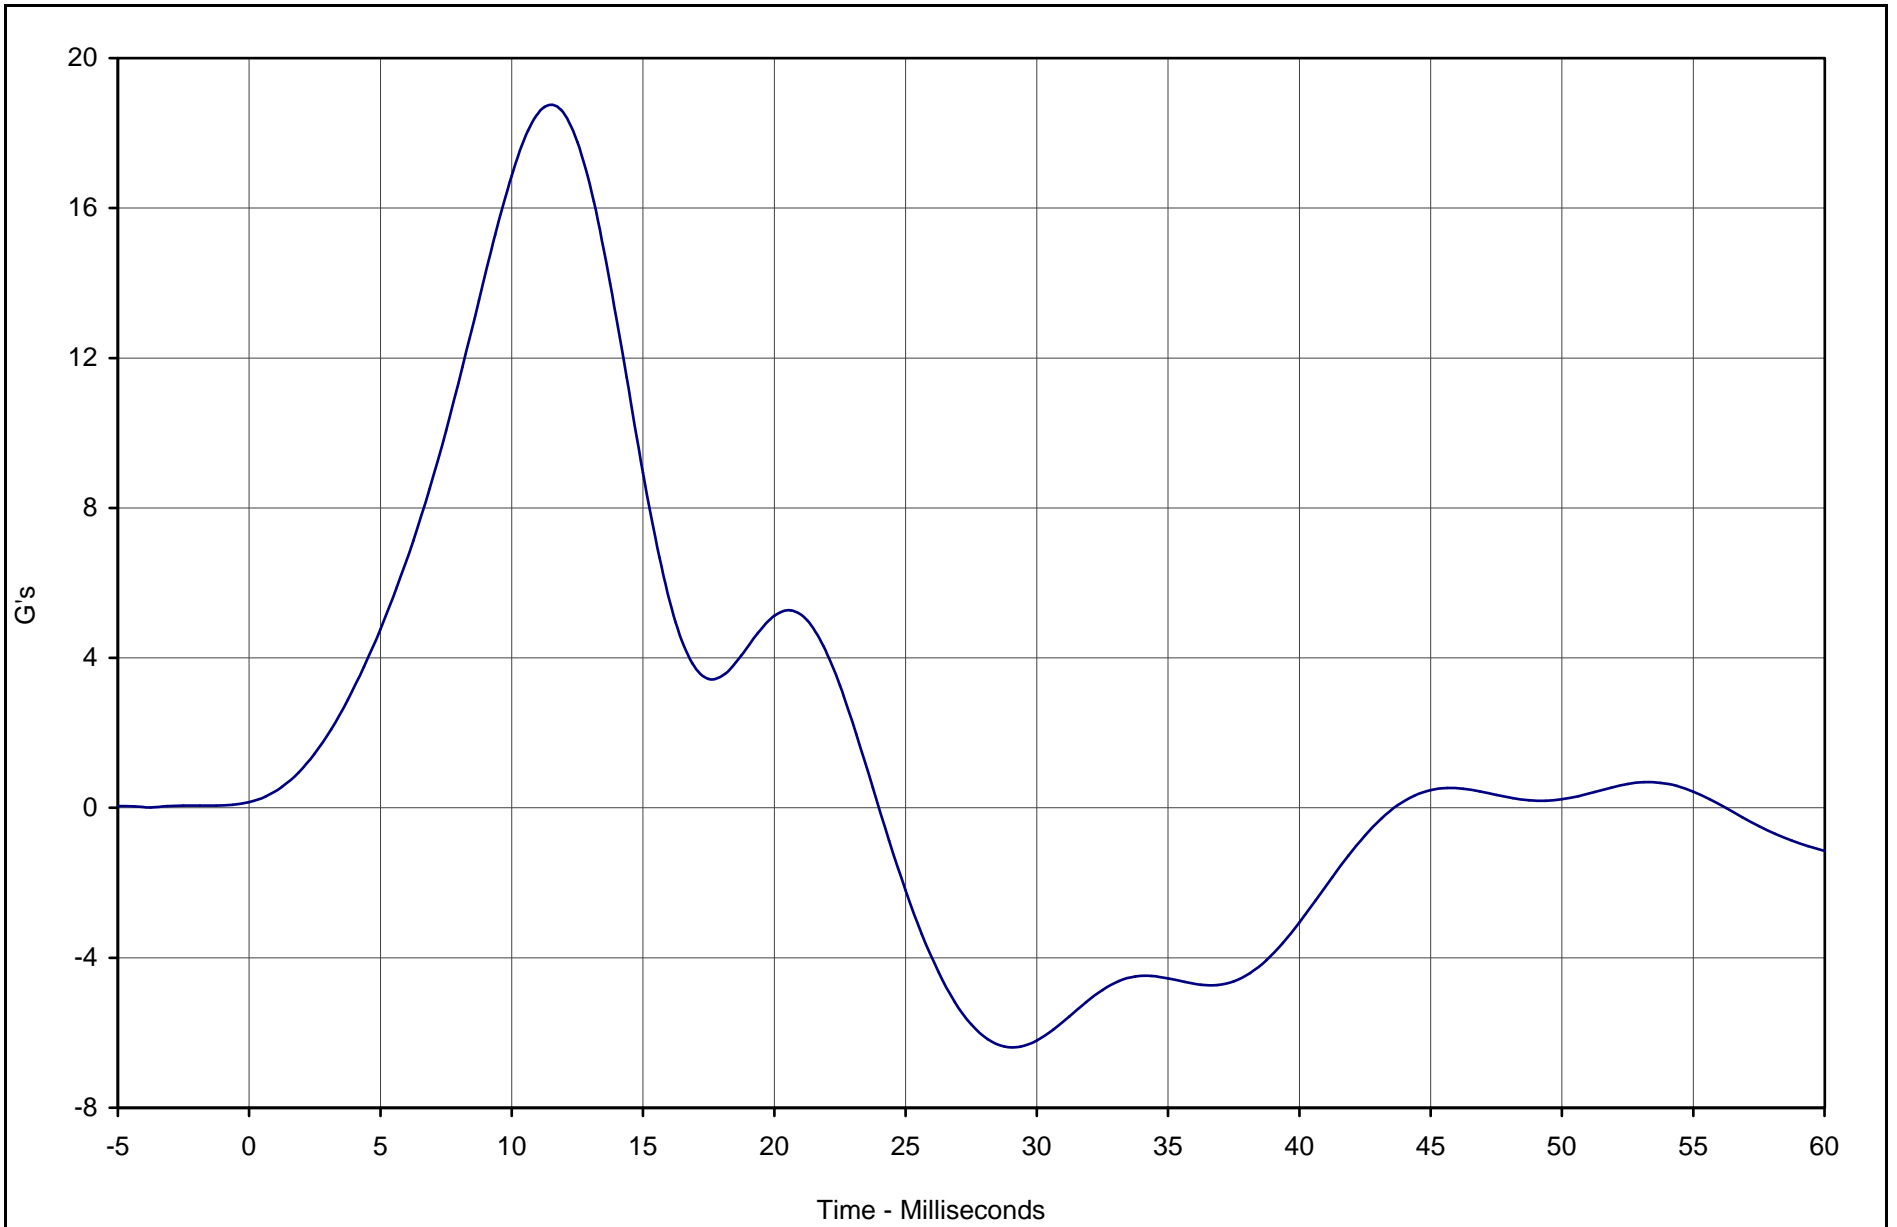
C-41

Curve Description	CURNO	Type	Units	Max	Time	Min	Time	SAE Class
Lower Spine Y Acceleration	003	FIL	G's	18.7	11.3	-6.4	29.4	FIR100

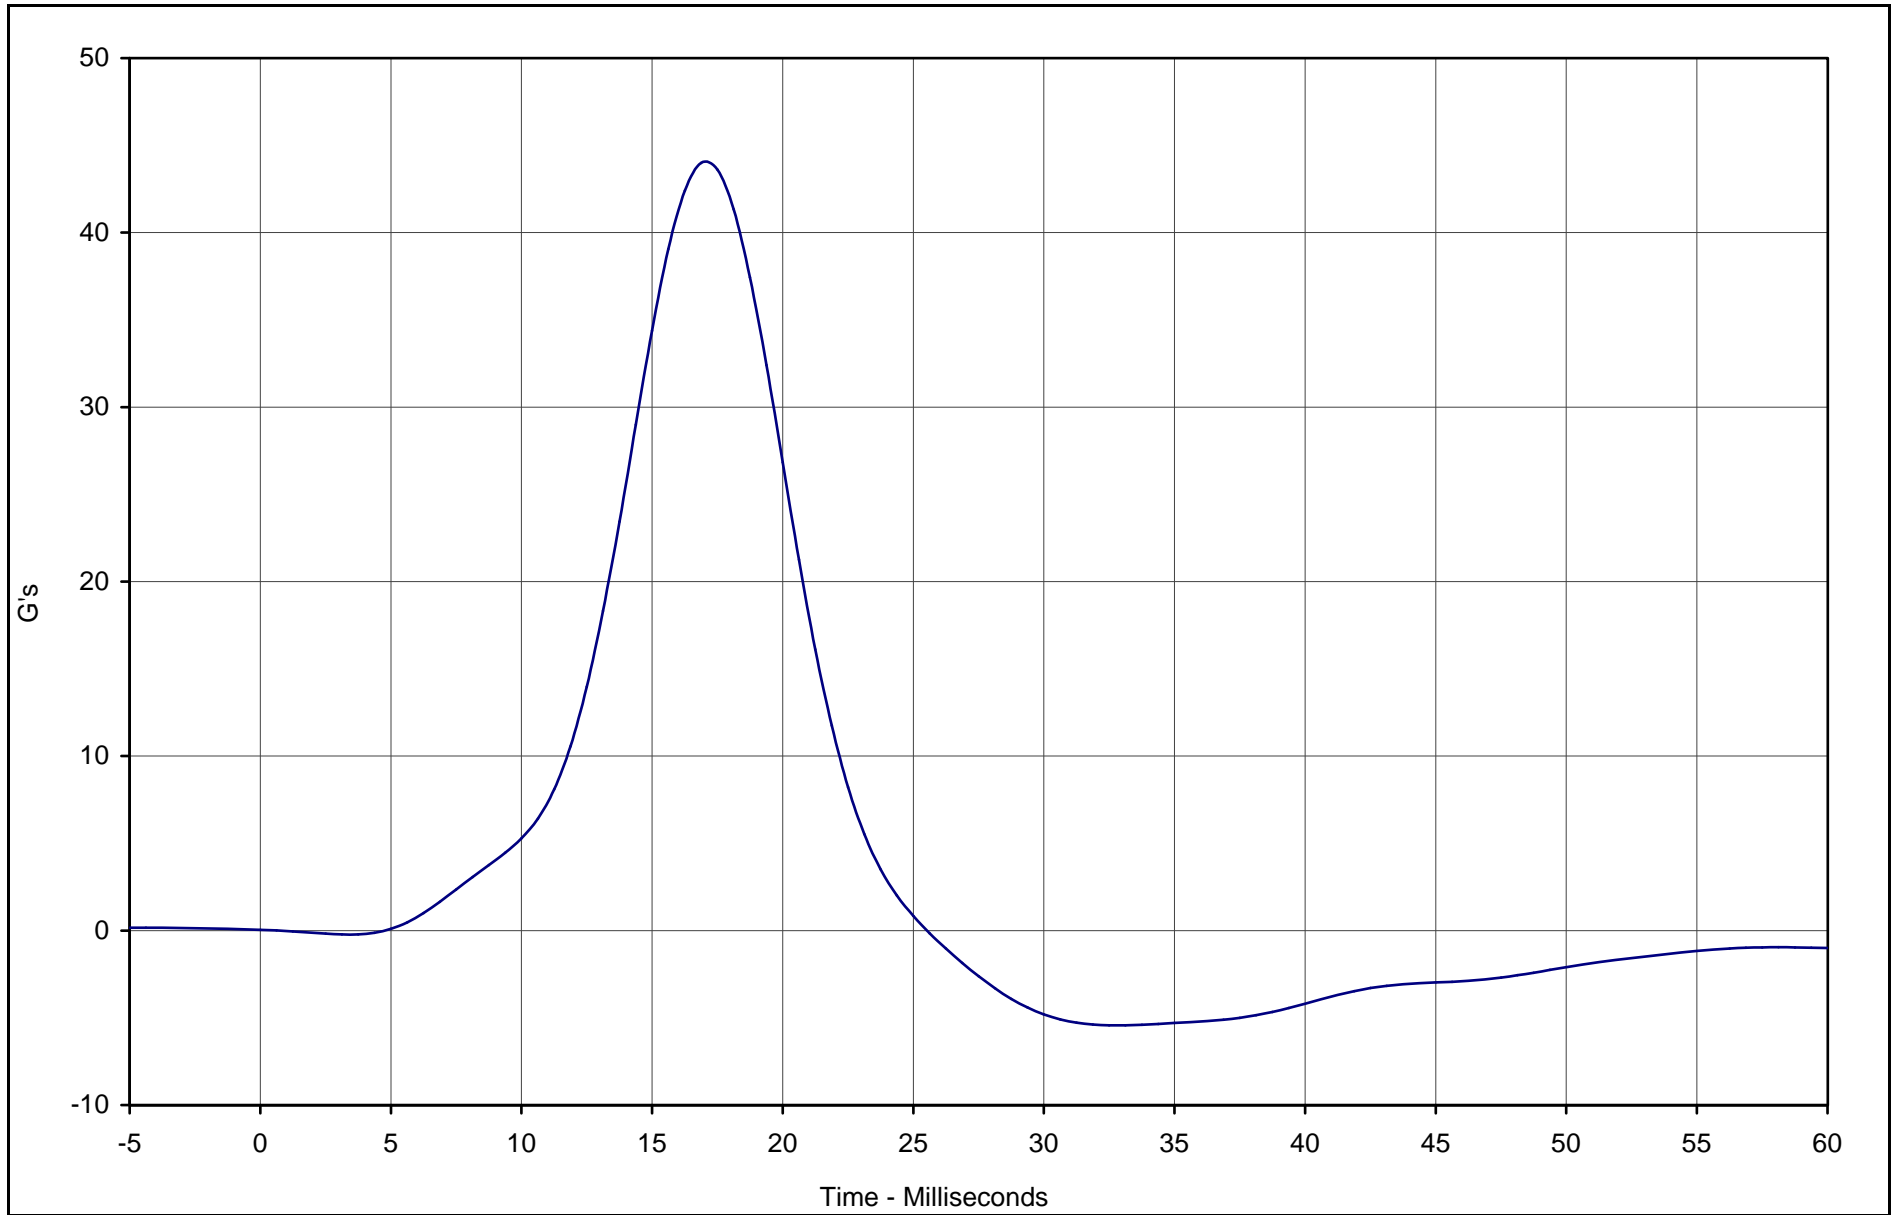
C-43

Curve Description	CURNO	Type	Units	Max	Time	Min	Time	SAE Class
Pelvis Y Acceleration	001	FIL	G's	44.0	16.9	-8.3	0.0	FIR100

Tested Parameter	Units	Specification	Result	Pass/Fail
Laboratory Temperature	°C	18.9 to 25.6	21.1	Pass
Laboratory Relative Humidity	%	10 to 70	30	Pass
Probe Velocity	m/s	4.21 to 4.33	4.28	Pass
Peak Pelvis Acceleration	G's	40.0 to 60.0	44.0	Pass
Acceleration Time Above 20 G's	Msec.	3.0 to 7.0	6.9	Pass
Overall Test Results				Pass
