Report Number: 214-TRC-03-001

Safety Compliance Testing For FMVSS 214
Side Impact Protection

Mazda Motor Corporation
2003 Mazda Protegé 5 4-door Hatchback

NHTSA Number: C35402

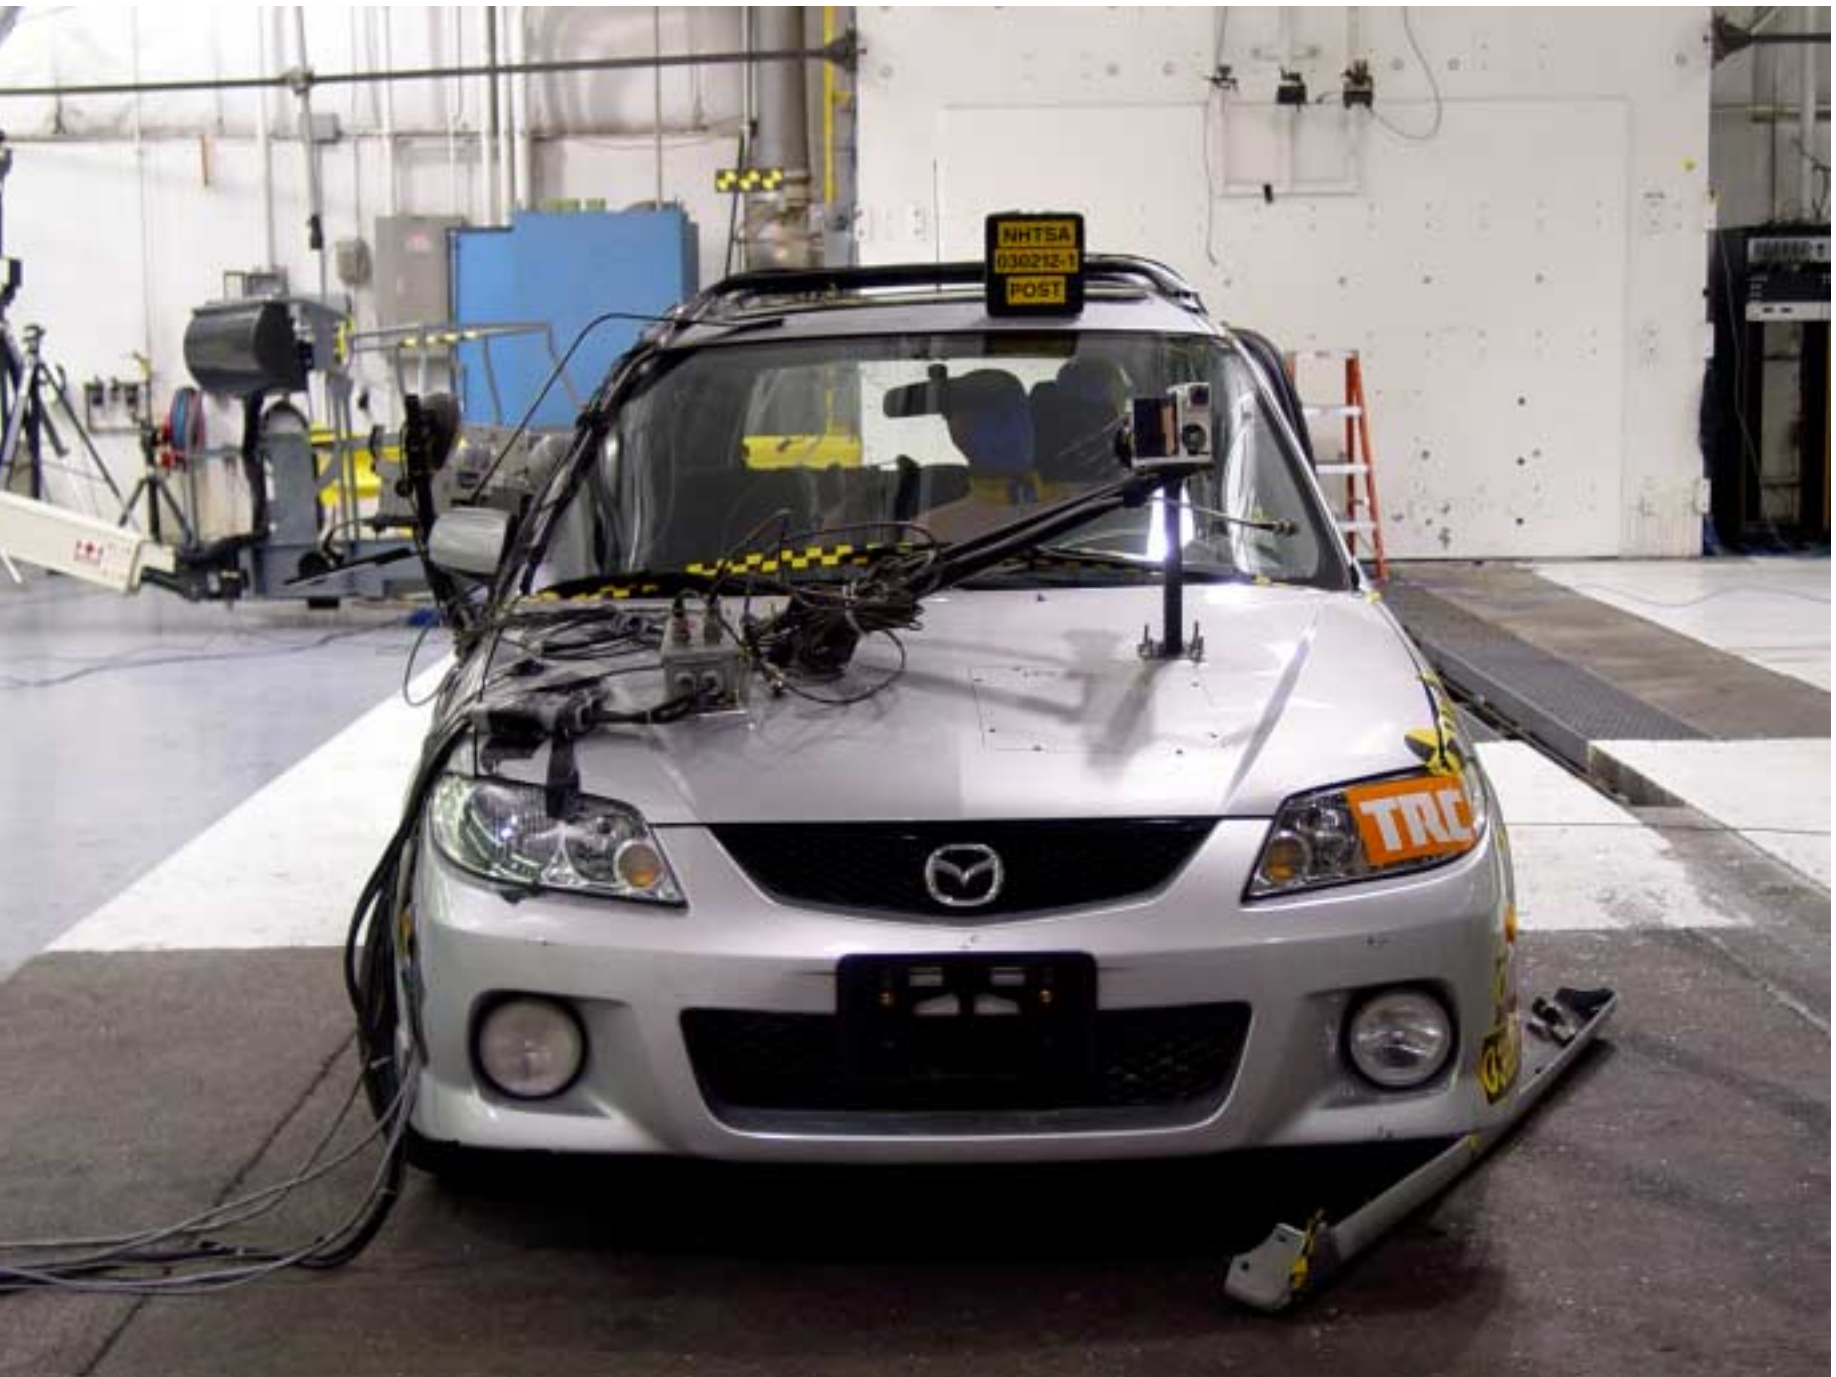
Figure A-2 Post-Test Front View of Test Vehicle

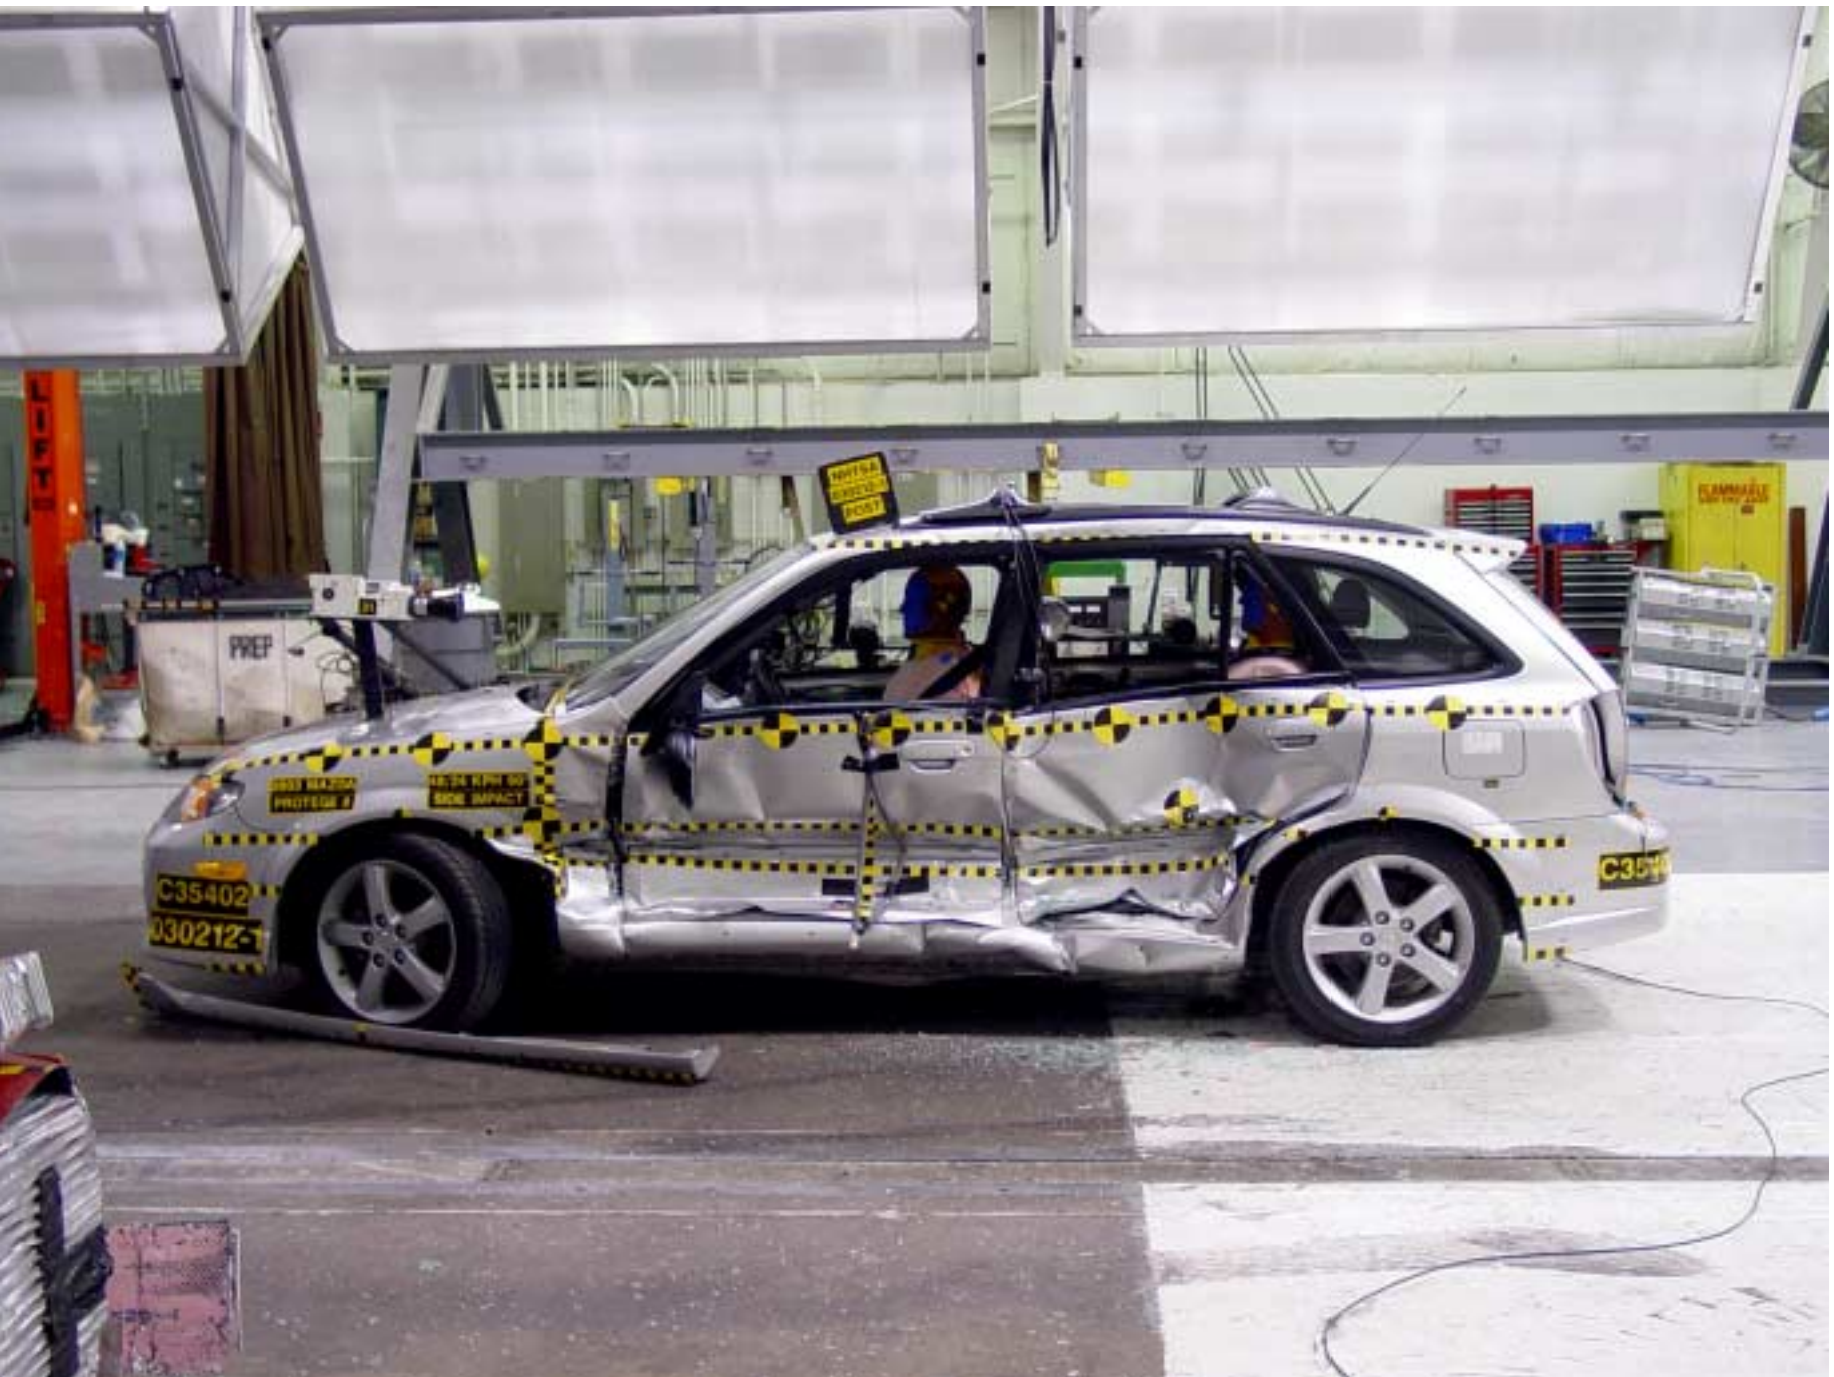
Figure A-4 Post-Test Impacted Side View of Test Vehicle

¹ Struck side doors were opened before post-test measurements were taken. Full length of induced damage was -200 to 2270 mm.

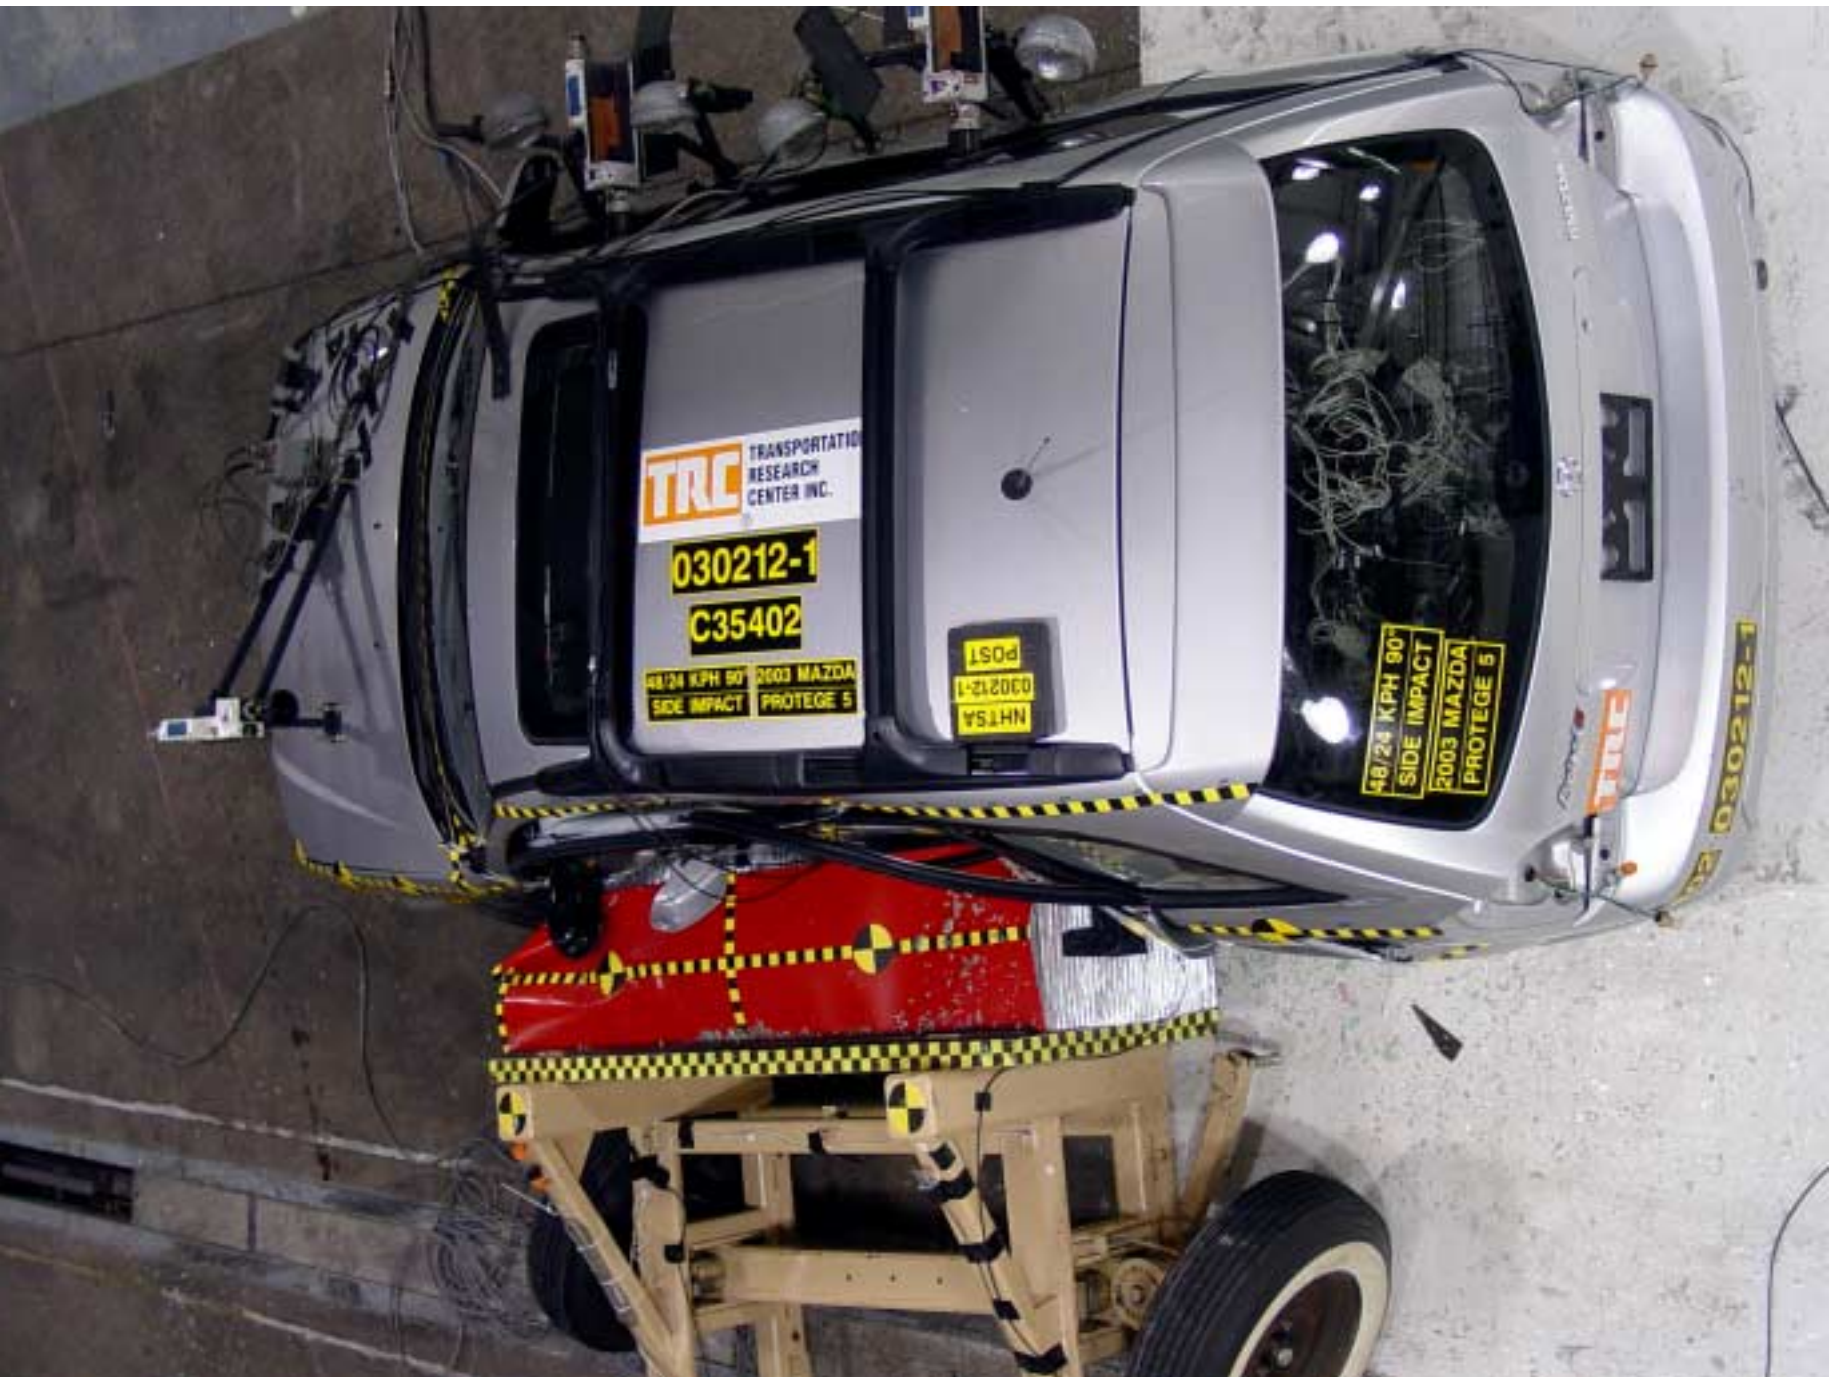
Figure A-17 Post-Test Overhead View of MDB and Vehicle

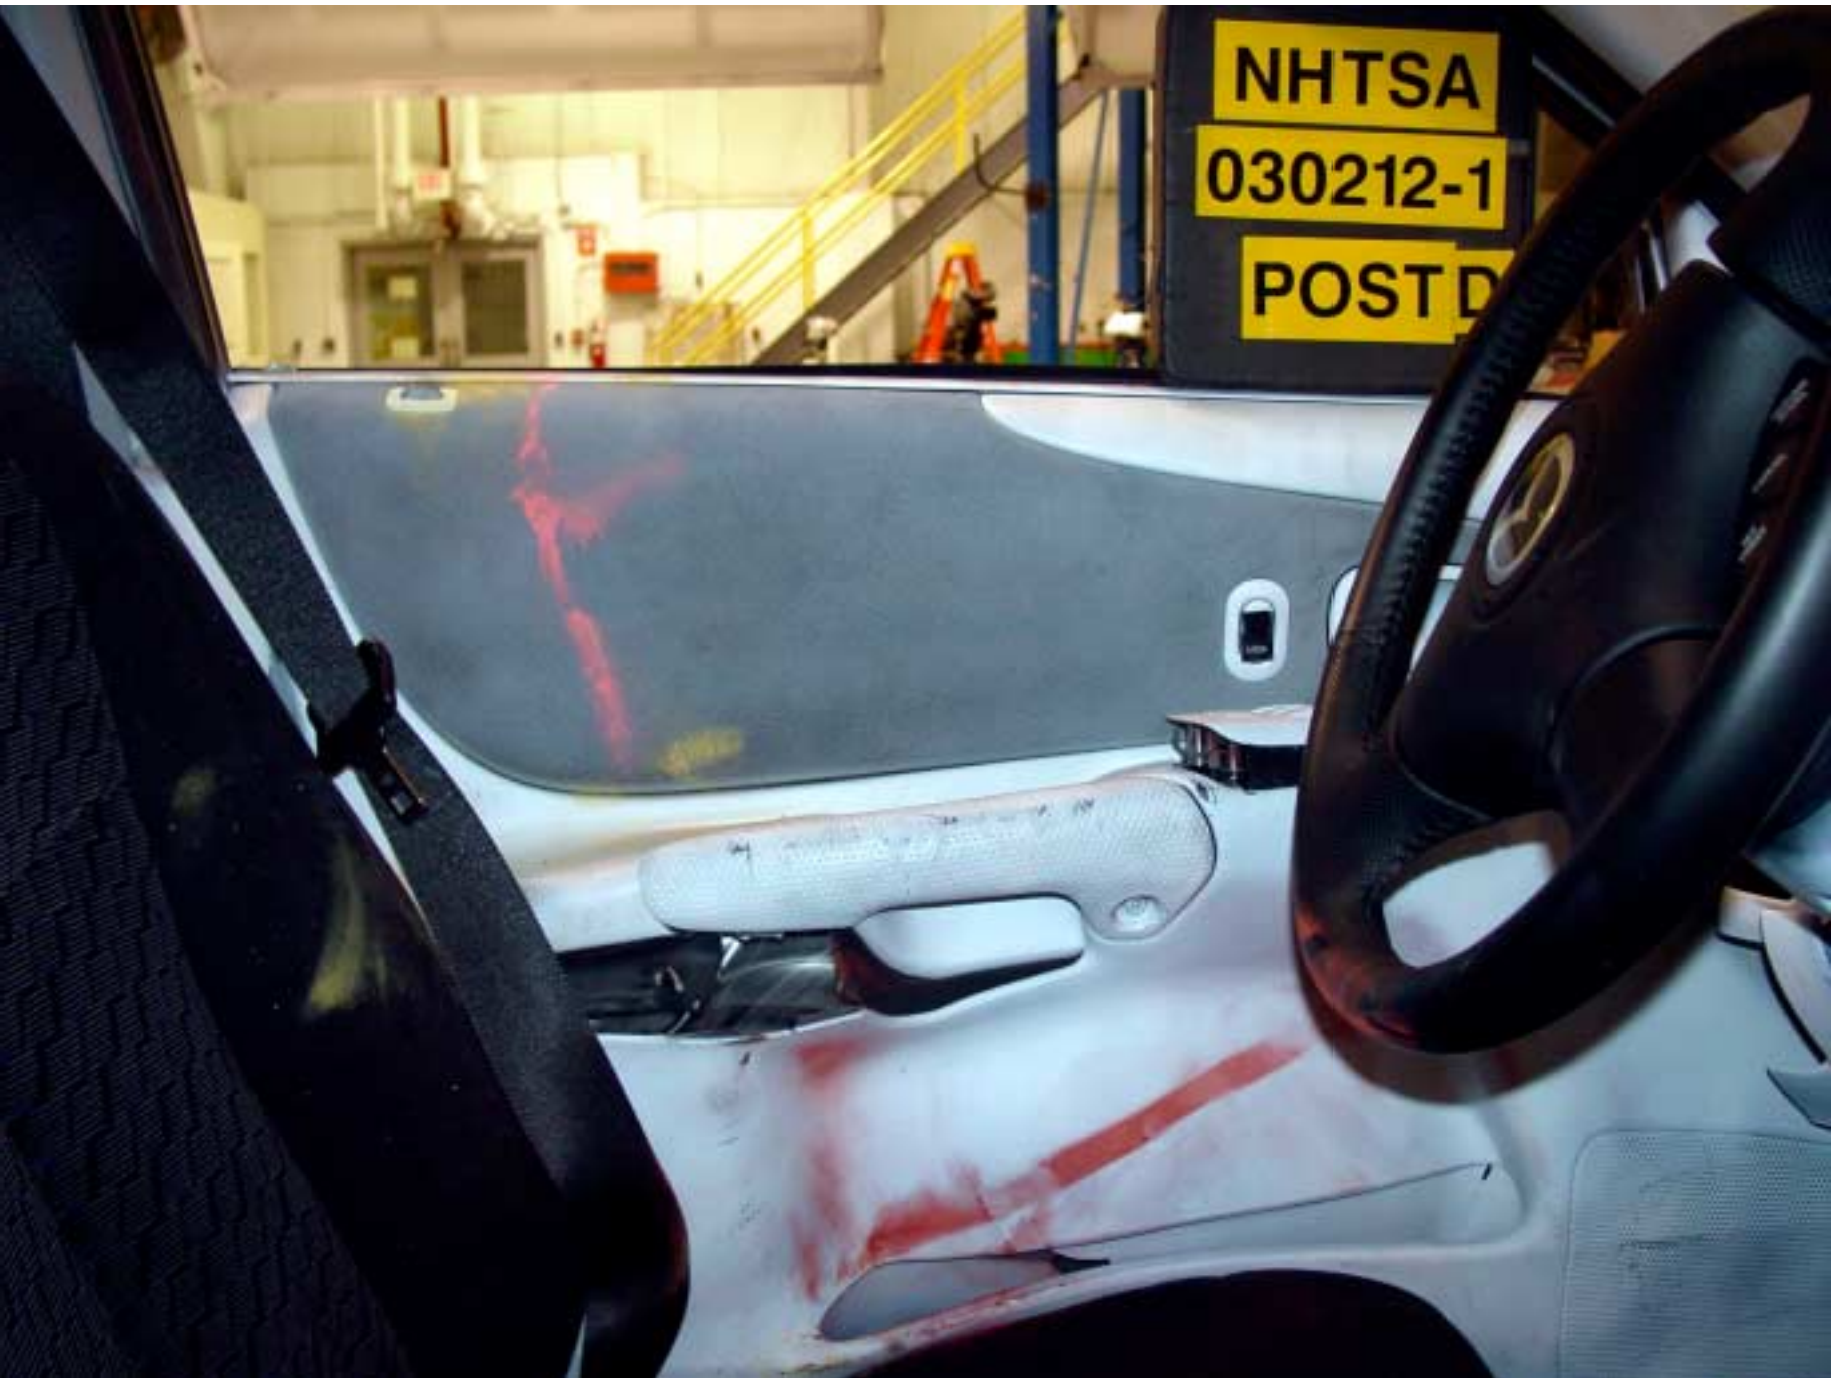
Figure A-31 Post-Test Interior of Front Door Showing SID Impact Locations

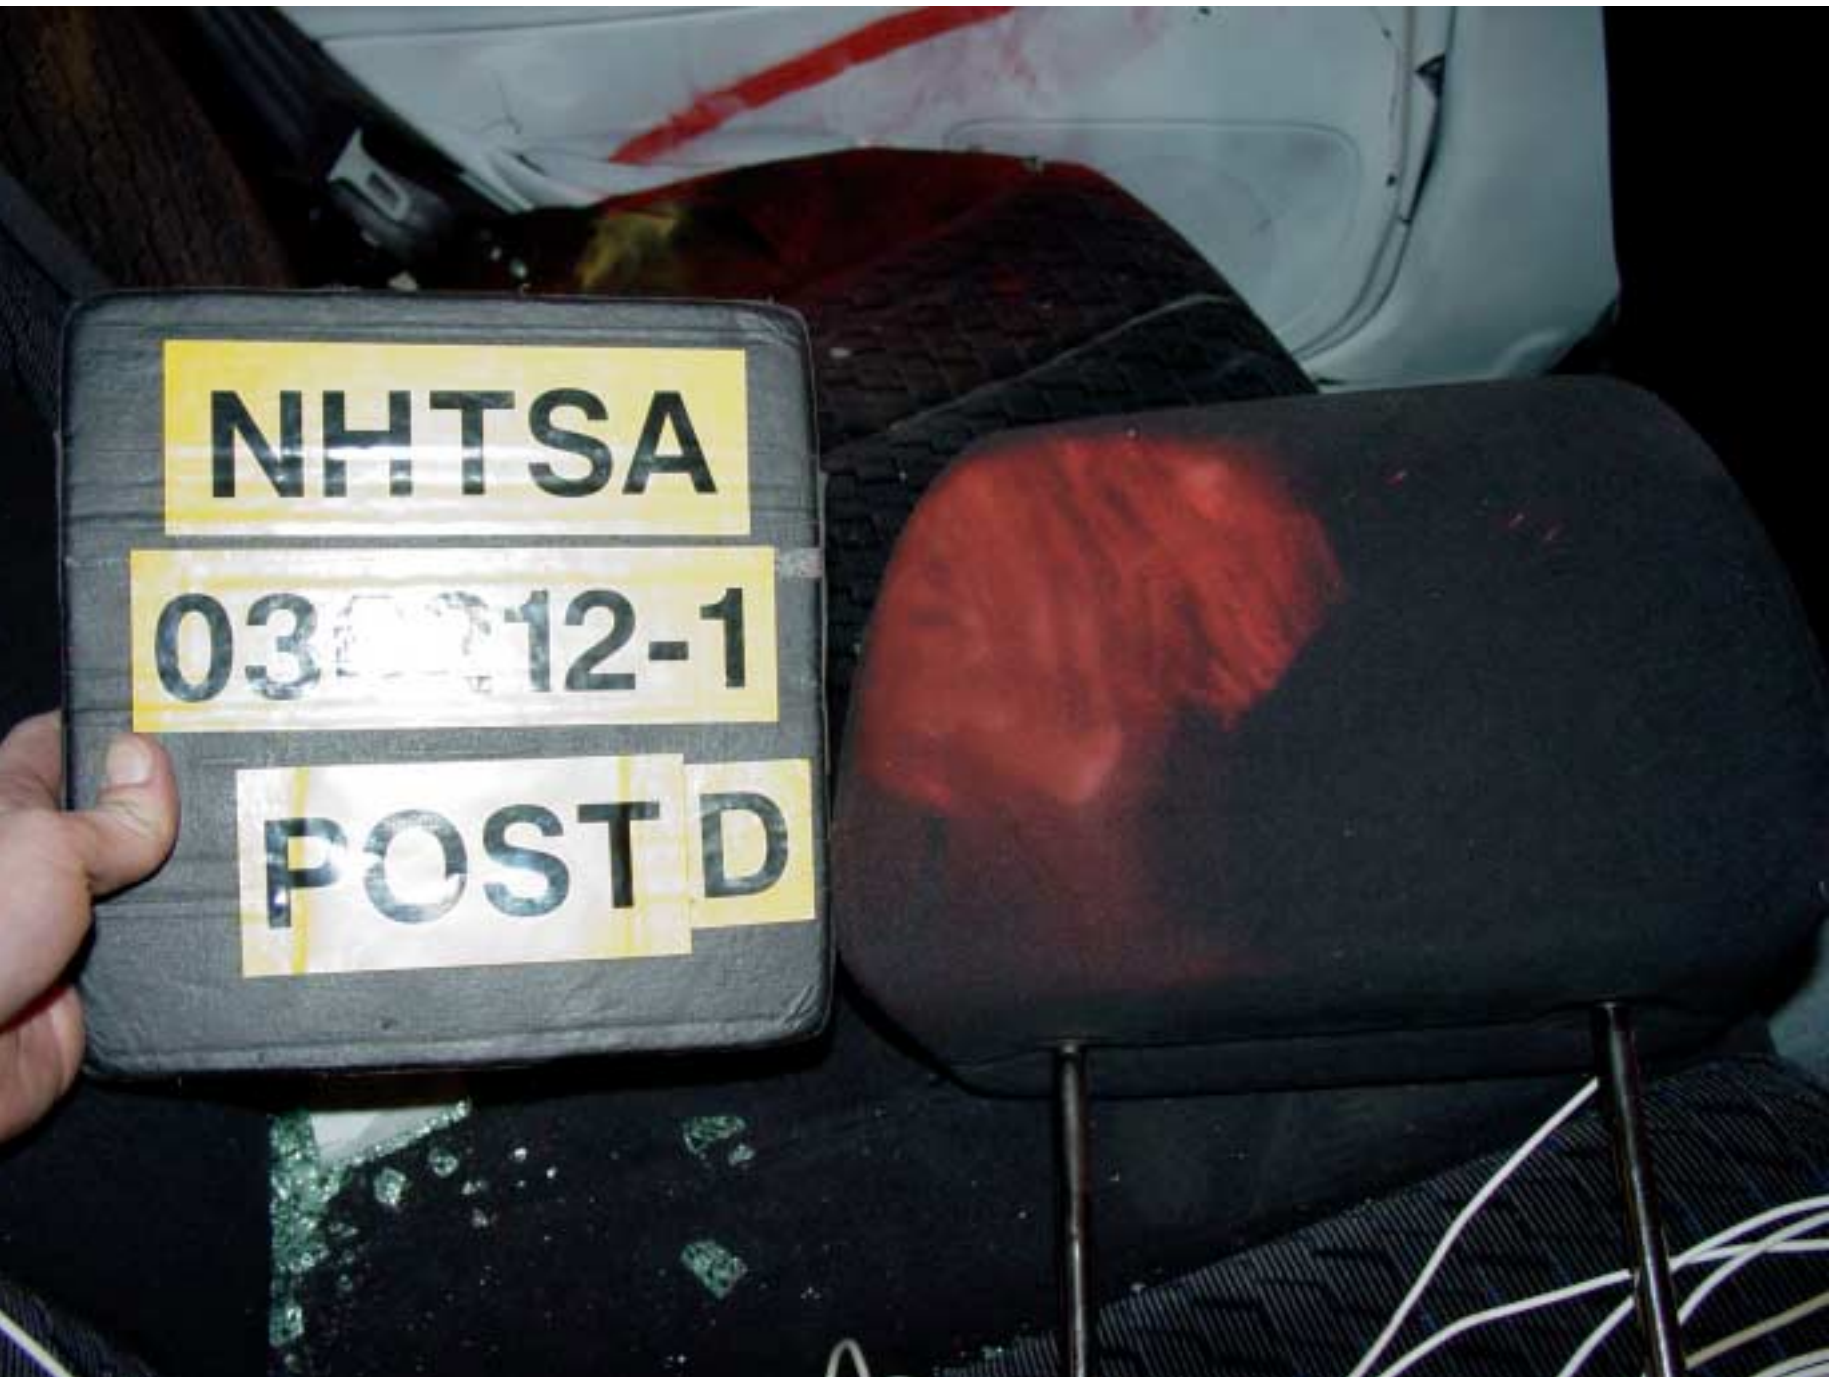
Figure A-32 Post-Test Front SID Contact

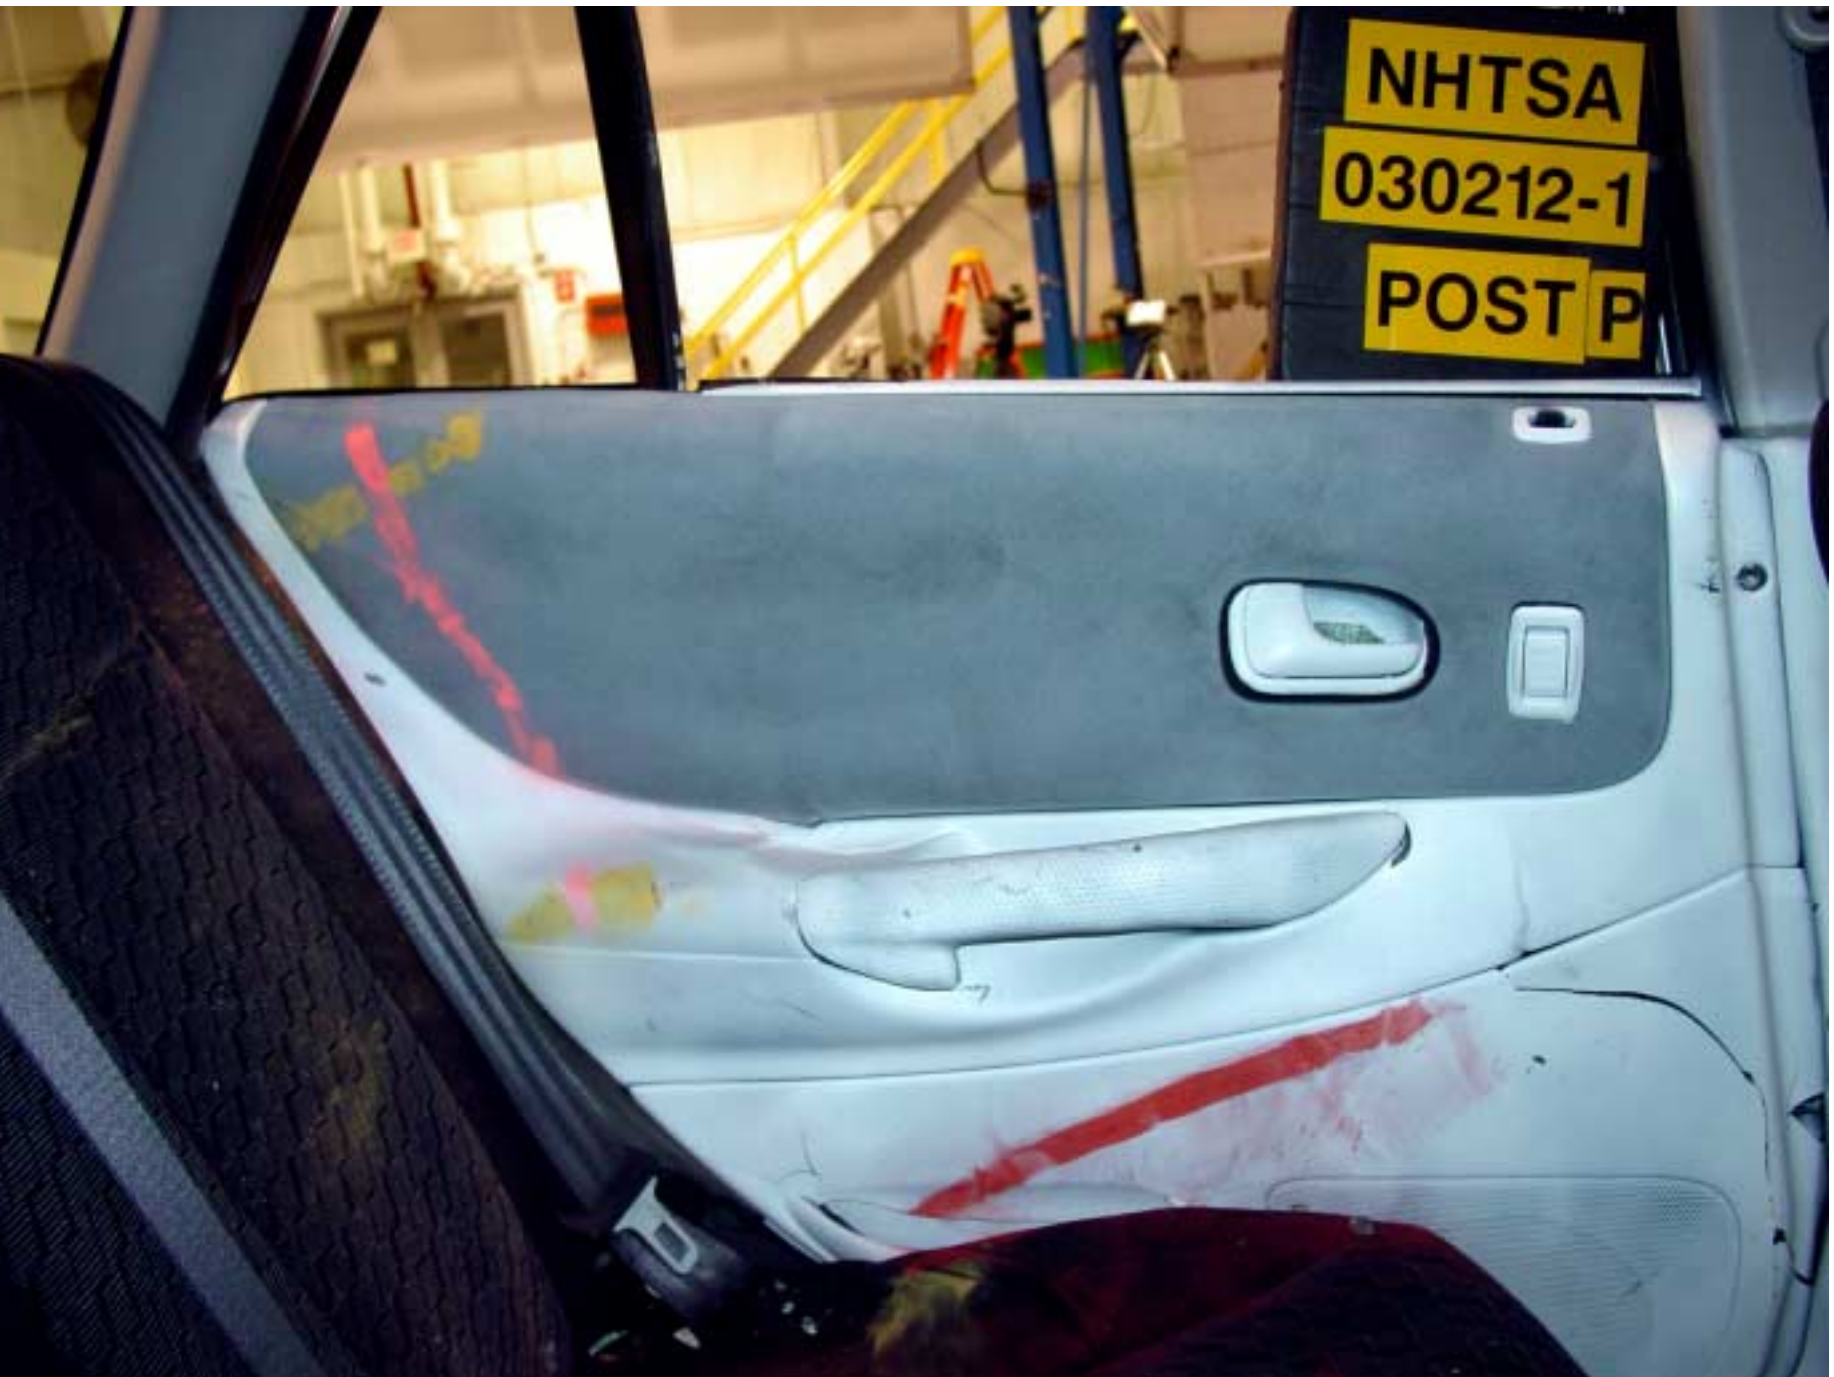
Figure A-34 Post-Test Interior of Rear Panel Showing SID Impact Locations

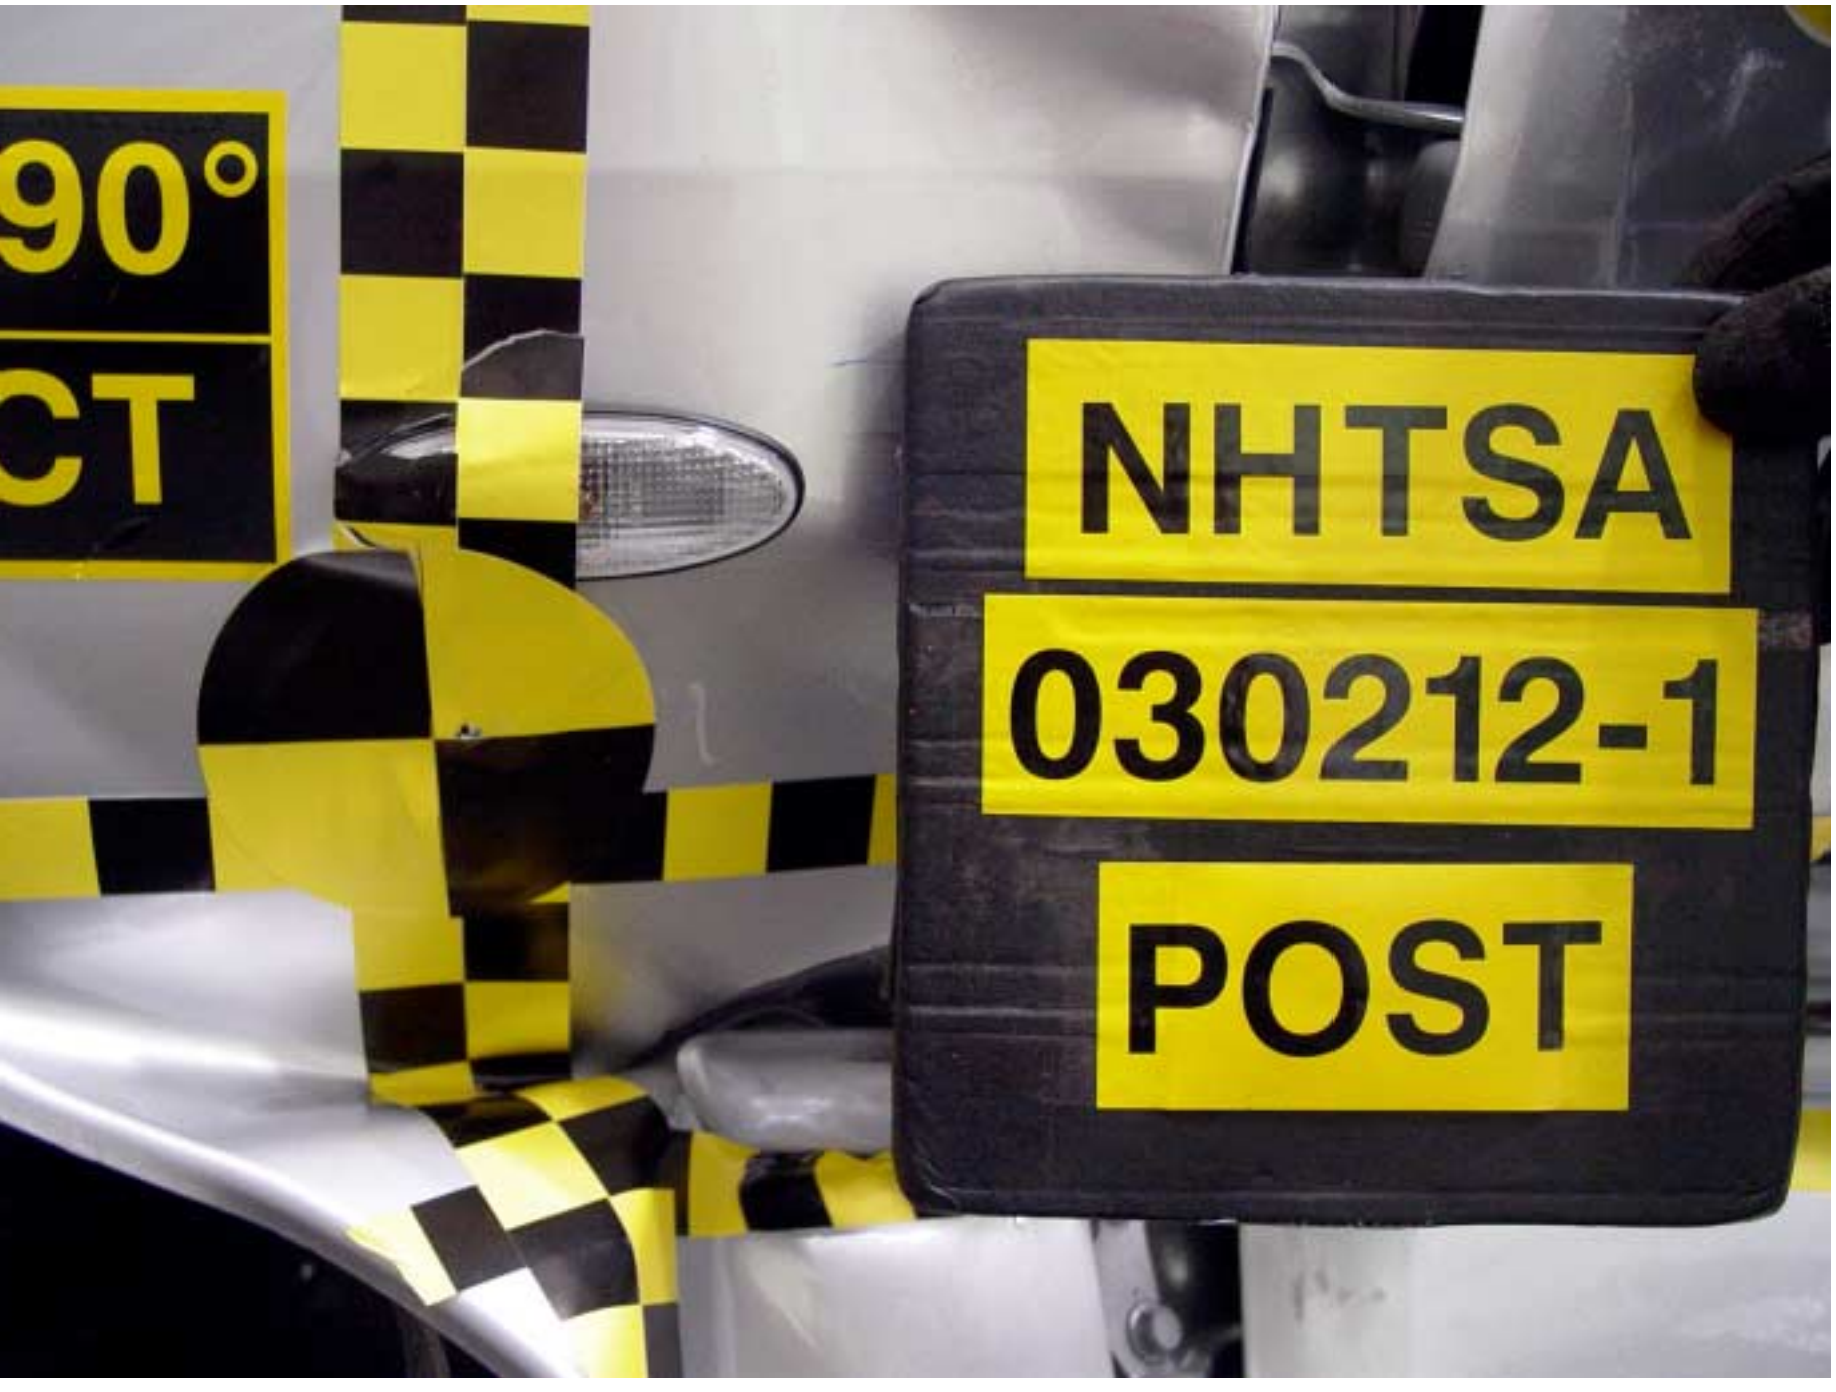
Figure A-39 Post-Test Primary Impact Point View

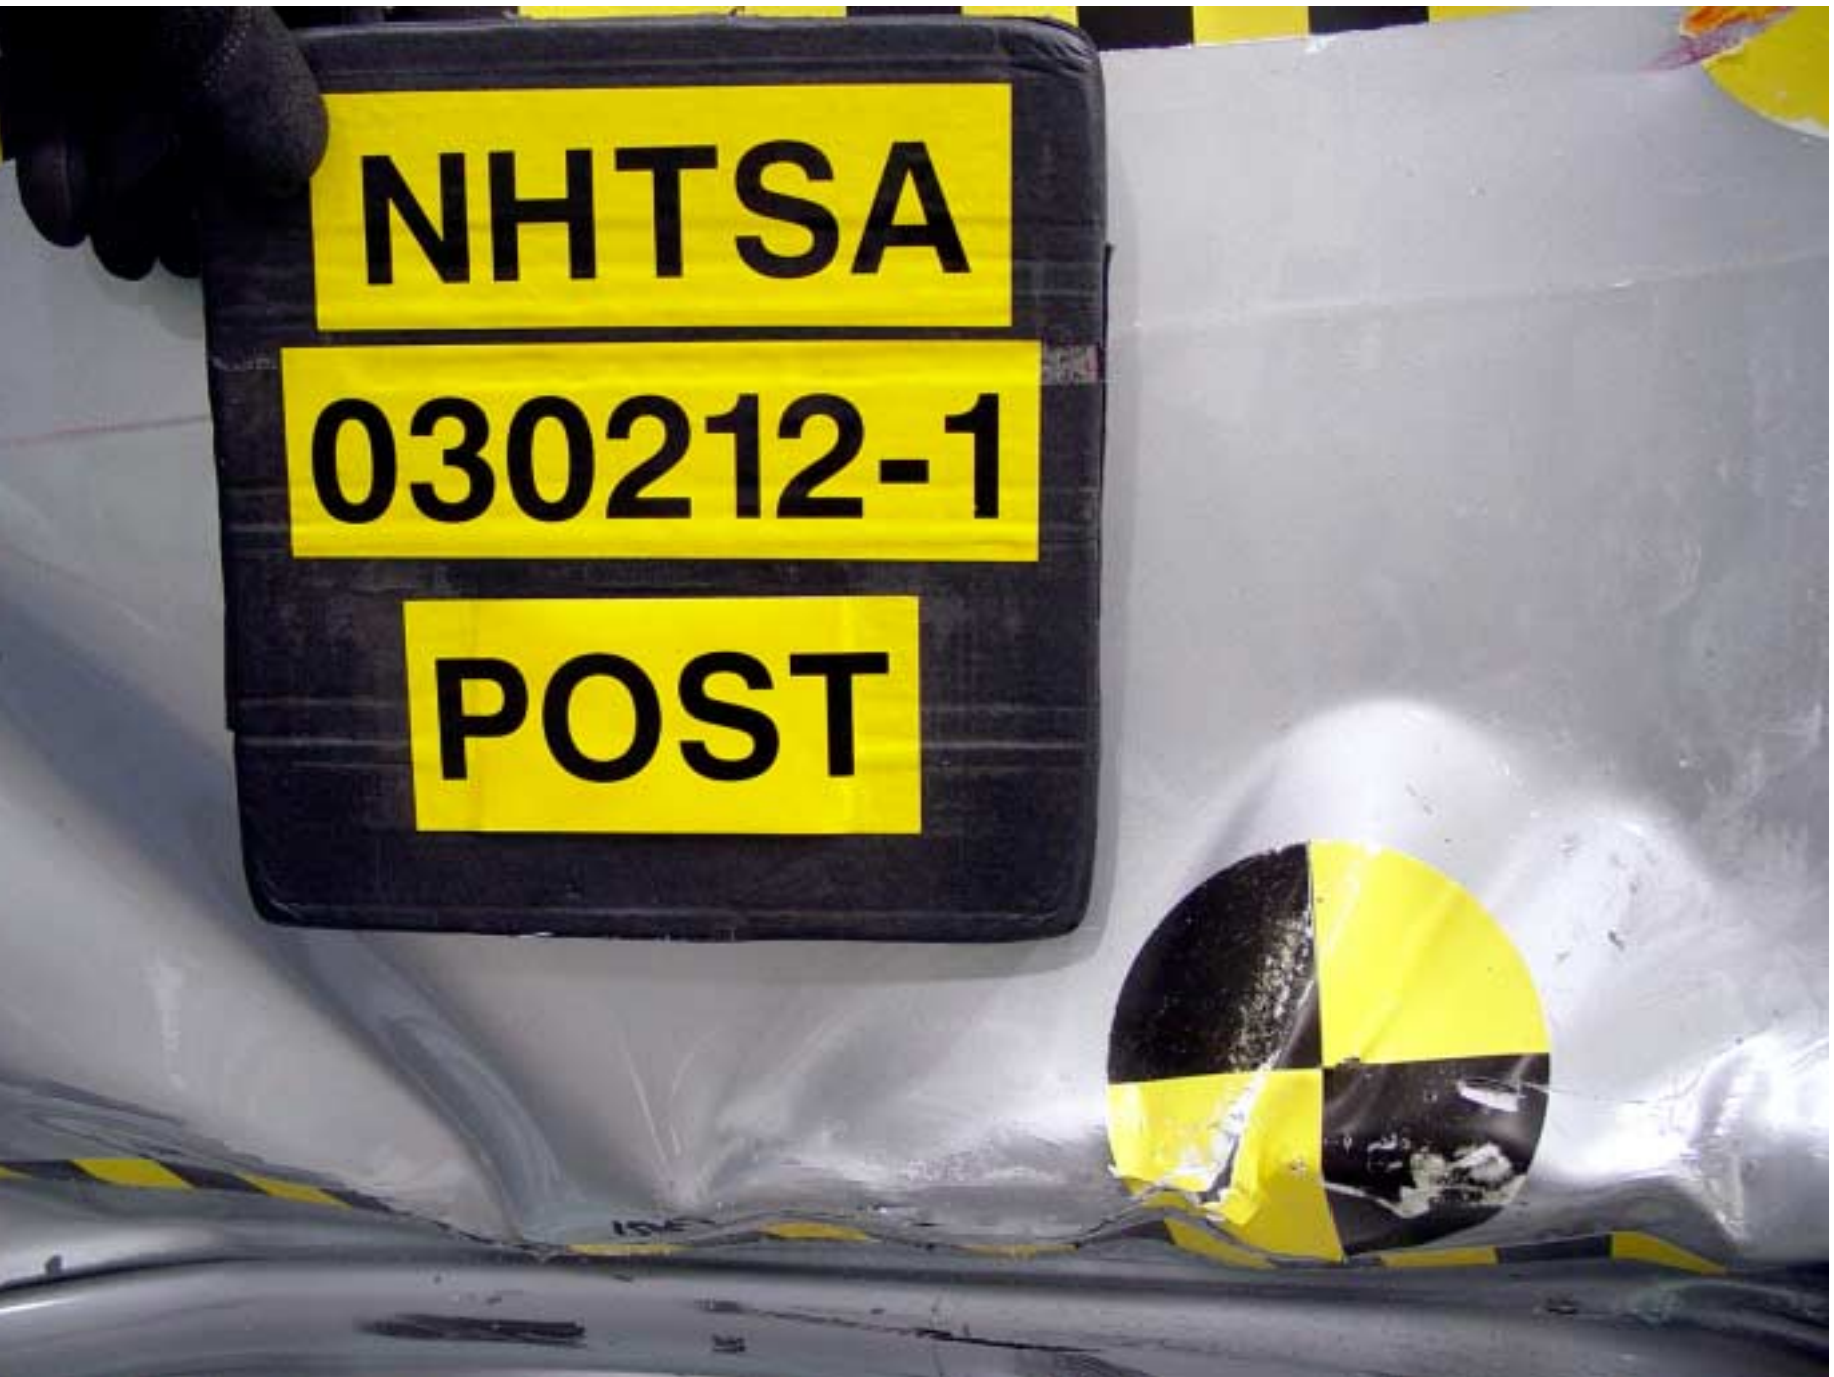
Figure A-42 Post-Test Secondary Impact Point View
