# Insurance Institute for Highway Safety Crashworthiness Evaluation

## Crash Test Report 2002 Acura RL (CEF0224)

**Vehicle identification number:** JH4KA96542C015470  
**Body style:** Large 4-door sedan  
**Engine/transmission:** Longitudinal 3.5-liter V6, 4-speed automatic, front-wheel drive

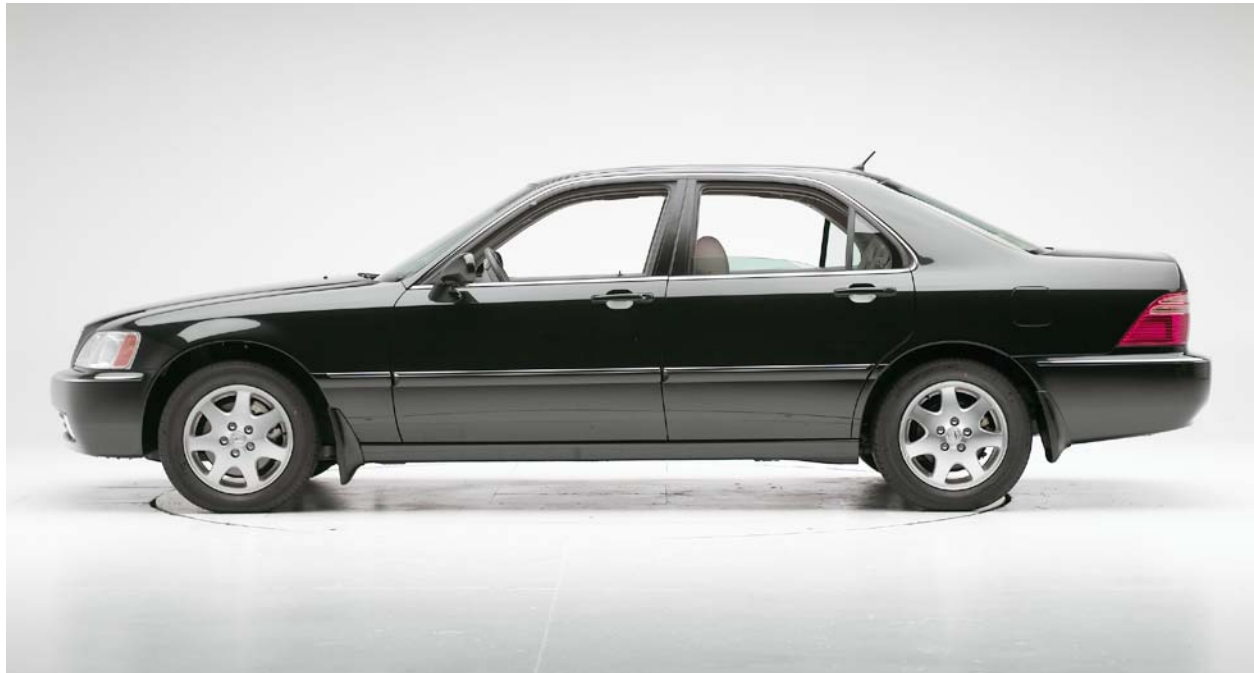
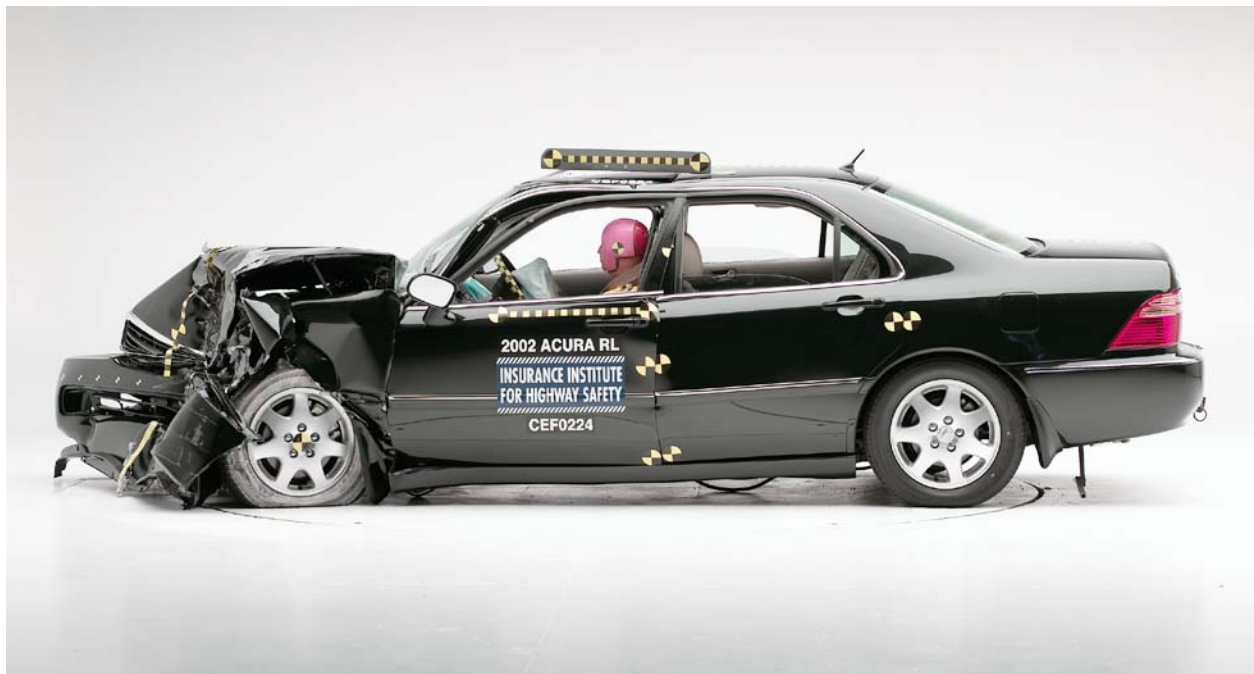
**Figure 1**  
**Pre-crash and Post-crash Side Views — 2002 Acura RL**

Measures of intrusion taken after the crash indicated the lower instrument panel in front of the dummy moved rearward 5-6 cm. Resultant intrusion in the driver footwell measured 13 cm at the footrest and 15-24 cm at other places on the toepan. All four doors remained closed during the crash. The door handle mechanism on the driver door malfunctioned; thus tools were required to release the door latch and open the door after the crash. The left rear door required additional effort but no tools to open. The right front and right rear doors opened with ease.
